# IndianOil

## JOURNEY RISK MANAGEMENT (JRM) STUDY

### Salem Terminal to SIVAMBIGA FUELS

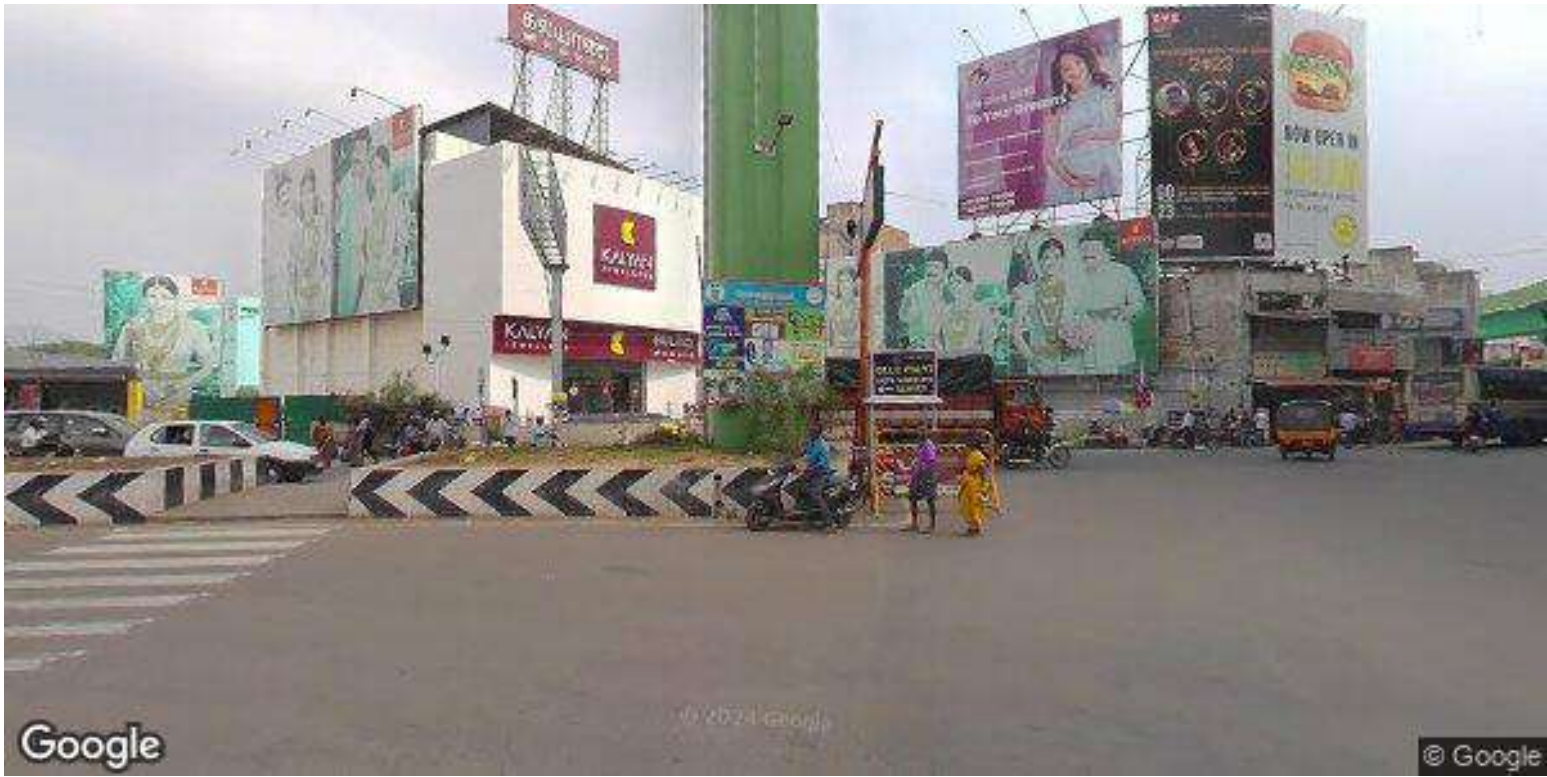
**Coordinates: 11.67563, 78.13375**

Risk Type: Roundabout  
Risk Level: High

**Speed Limit: 15 KM/Hr**

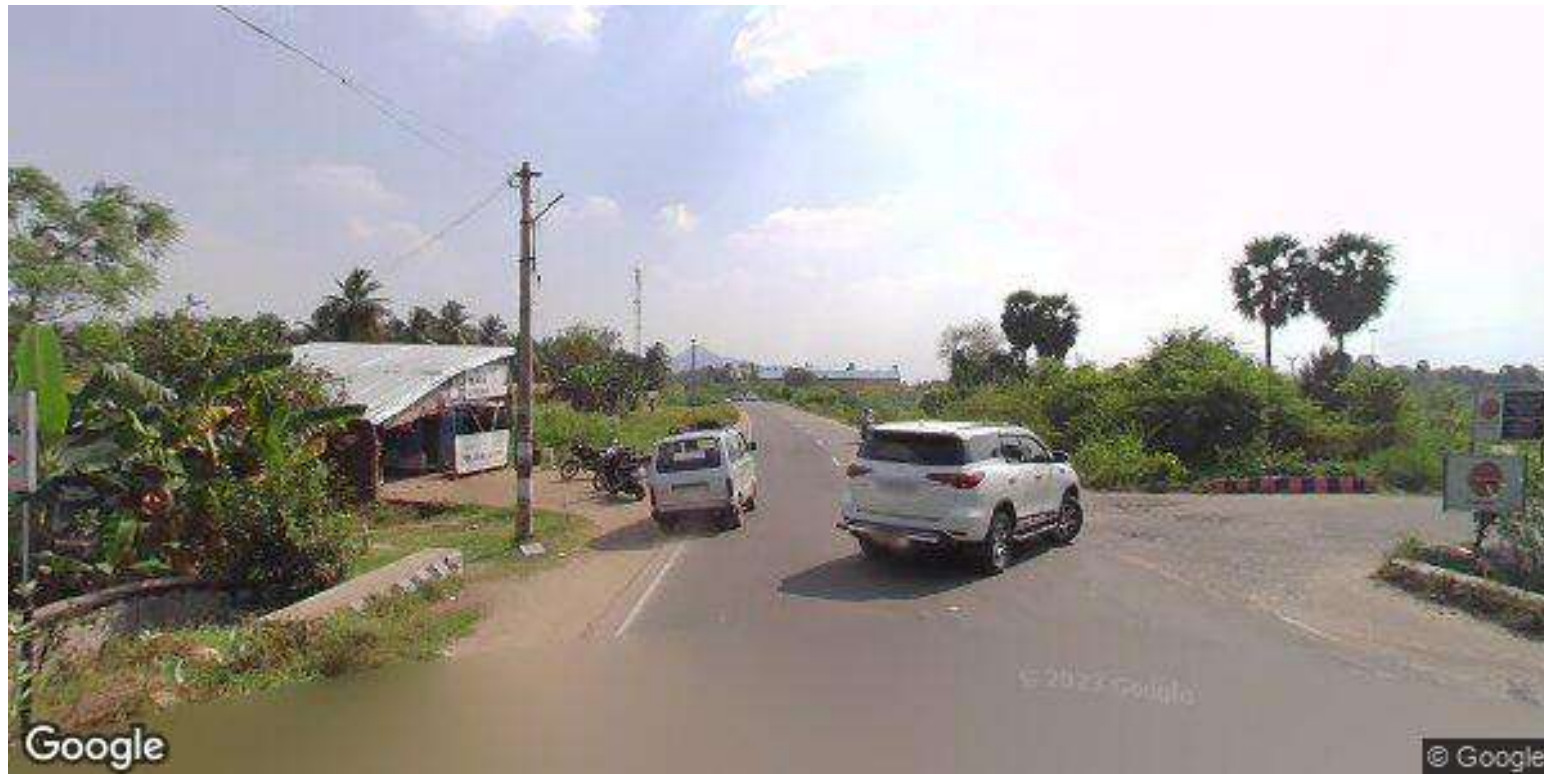
**Coordinates: 11.44029, 77.87544**

**Risk Type: Turn**

**Risk Level: High**

**Speed Limit: 15 KM/Hr**

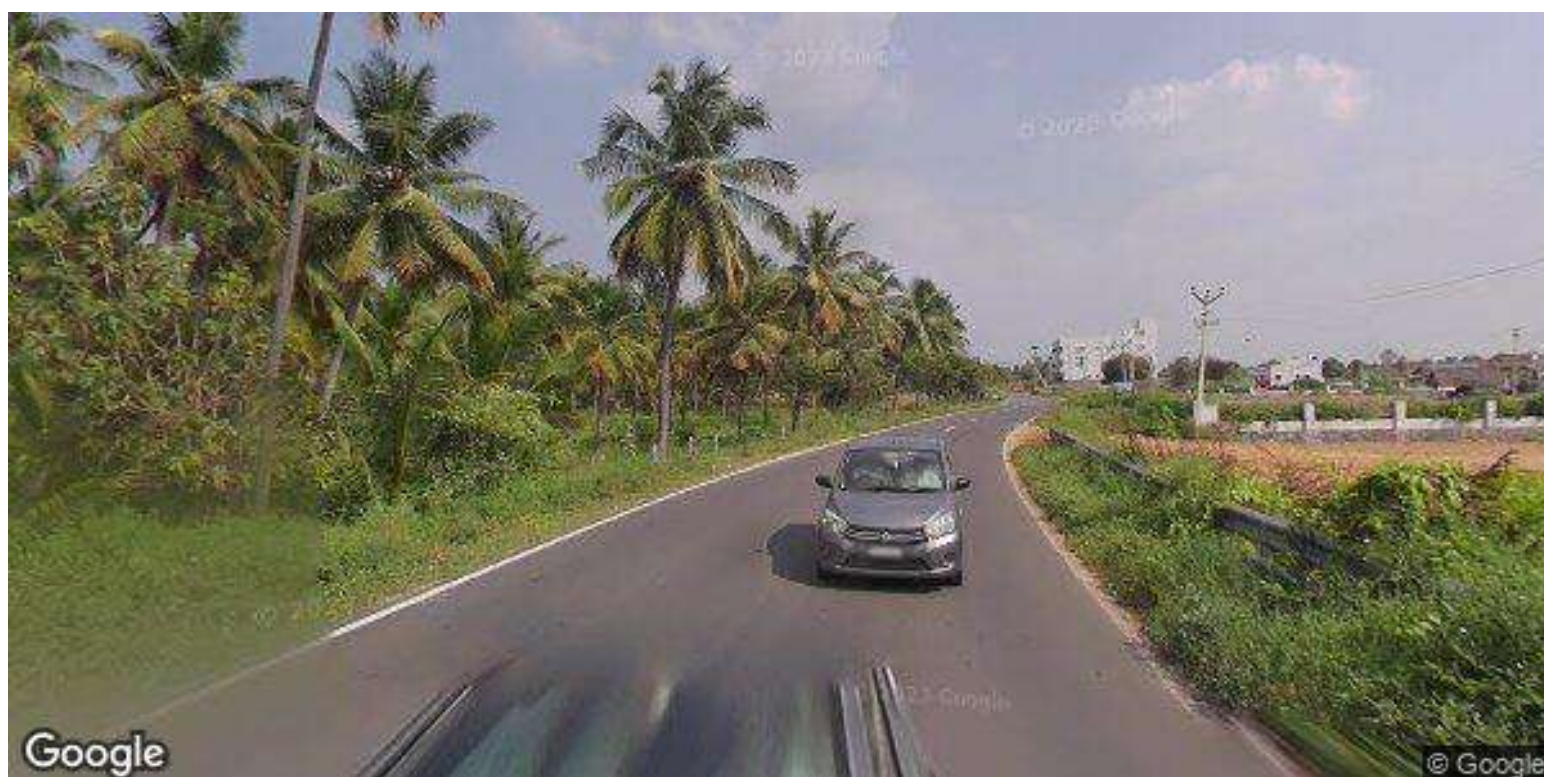
**Coordinates: 11.45357, 77.85789**

**Risk Type: Turn**

**Risk Level: Medium**

**Speed Limit: 30 KM/Hr**

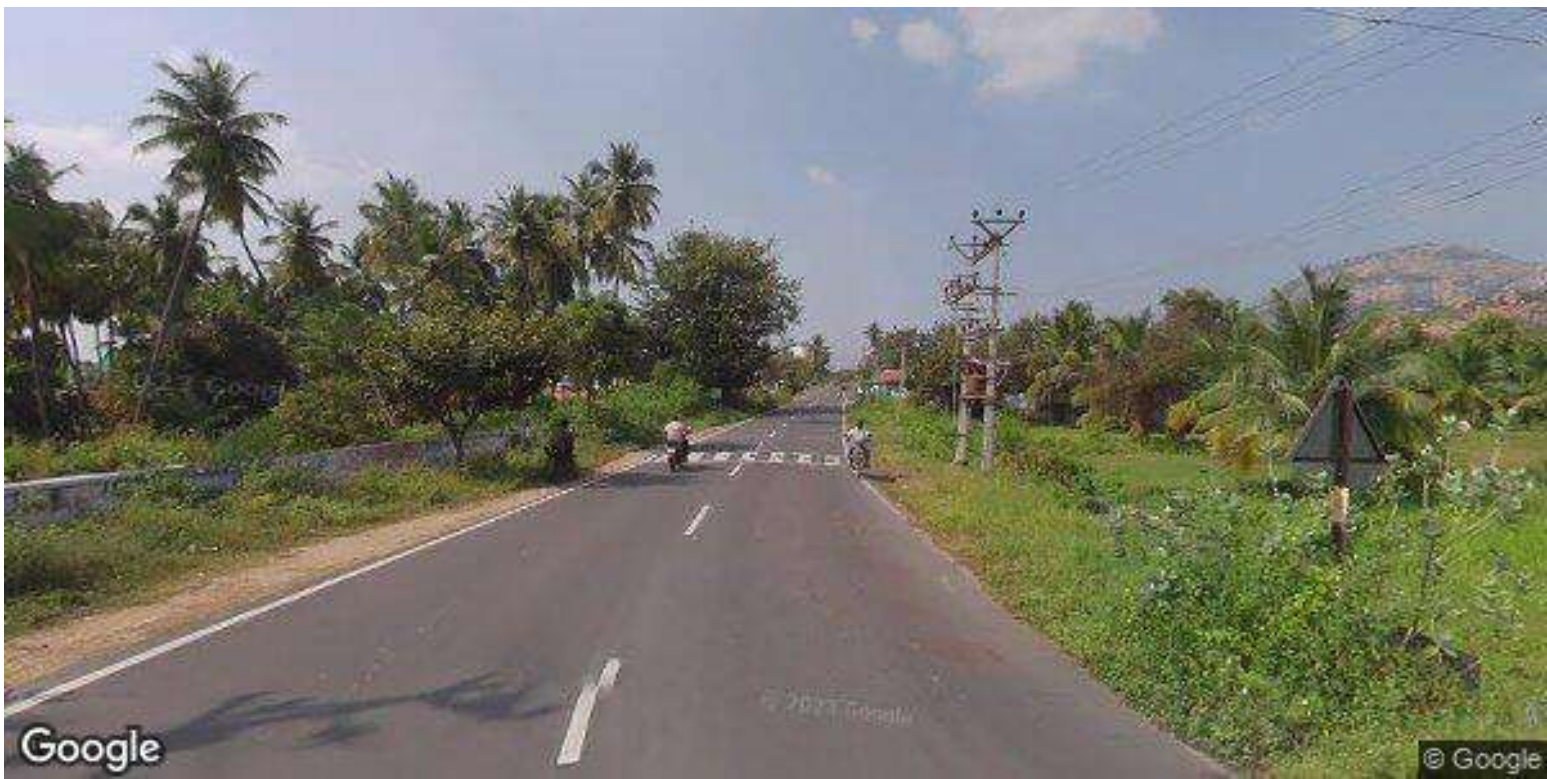
**Coordinates:** 11.45352, 77.85698

**Risk Type:** Turn

**Risk Level:** Medium

**Speed Limit:** 30 KM/Hr

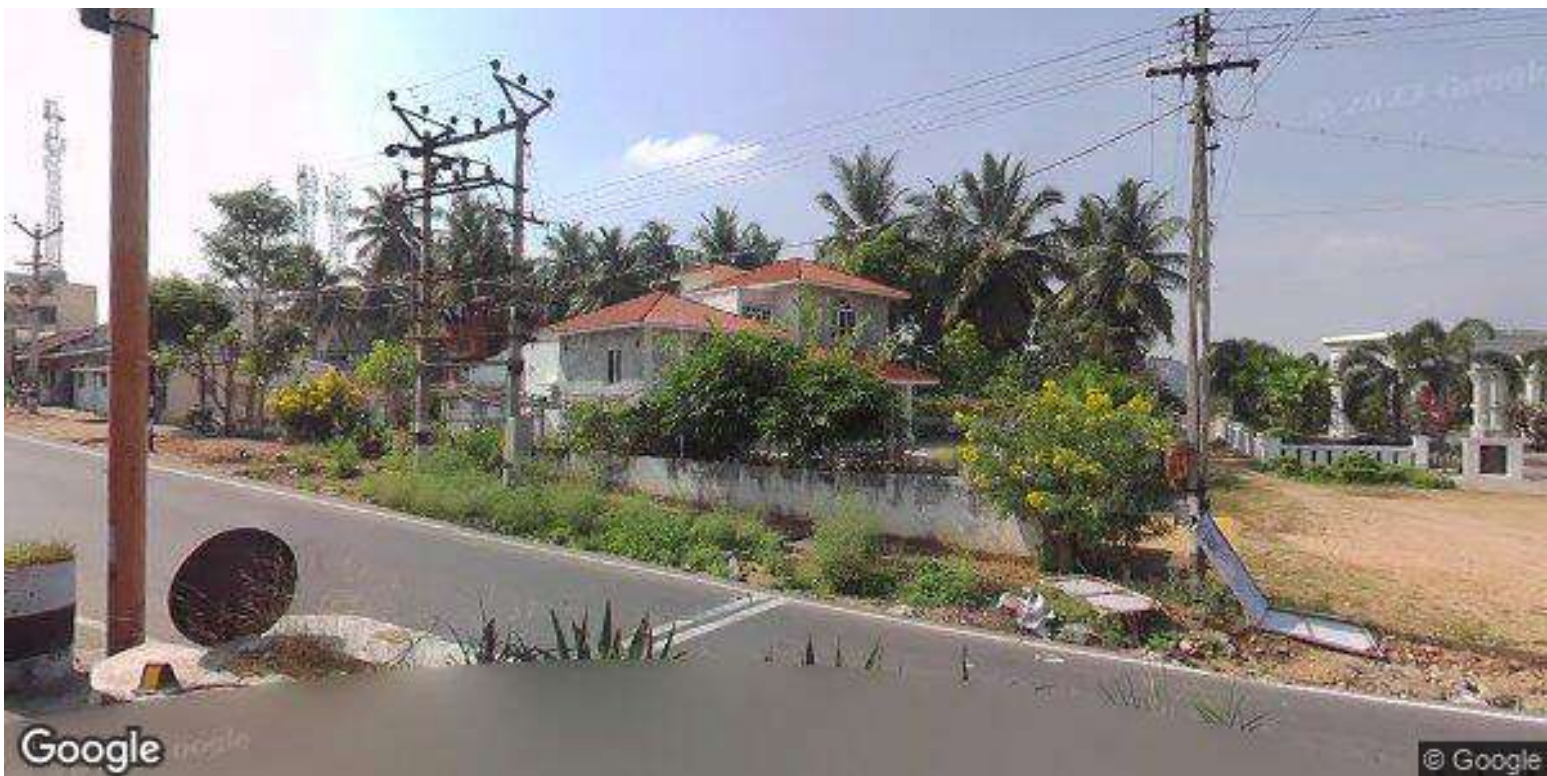
**Coordinates:** 11.46303, 77.84945

**Risk Type:** Turn

**Risk Level:** Medium

**Speed Limit:** 30 KM/Hr

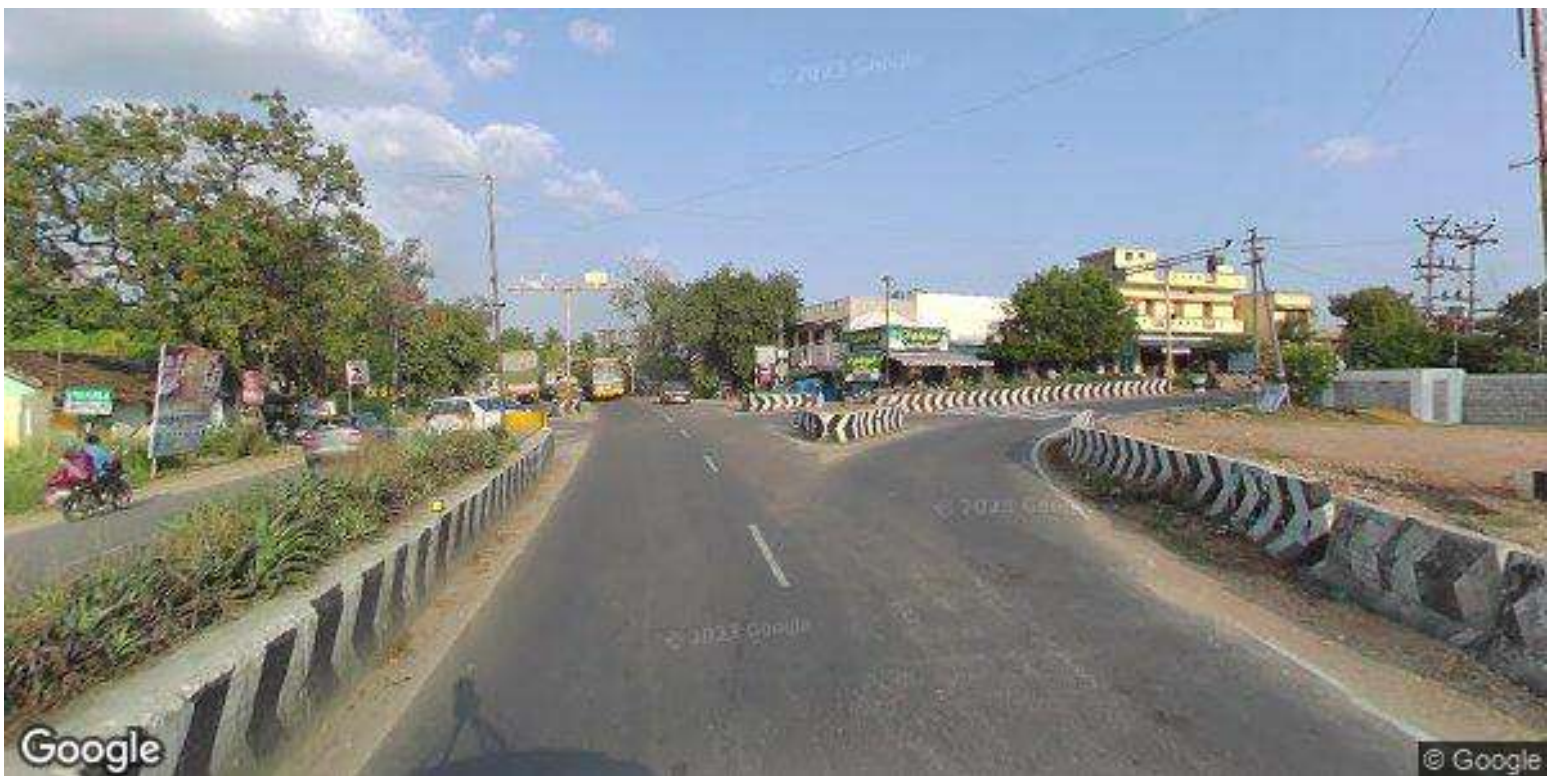
**Risk Type:** Turn  
**Risk Level:** Medium  
**Speed Limit:** 30 KM/Hr  
**Coordinates:** 11.46318, 77.84913

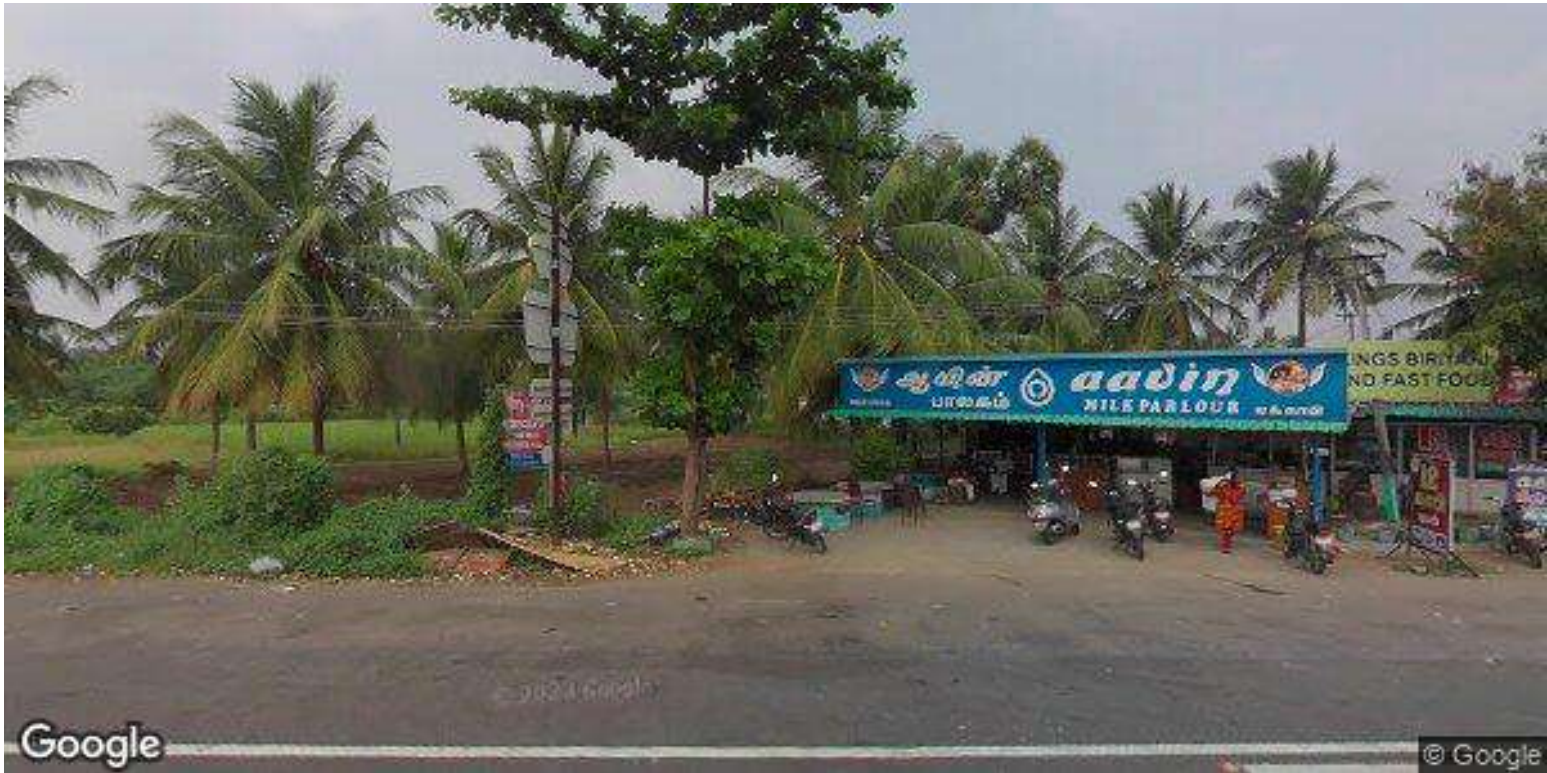
**Risk Type:** Turn  
**Risk Level:** High  
**Speed Limit:** 15 KM/Hr  
**Coordinates:** 11.45631, 77.81668

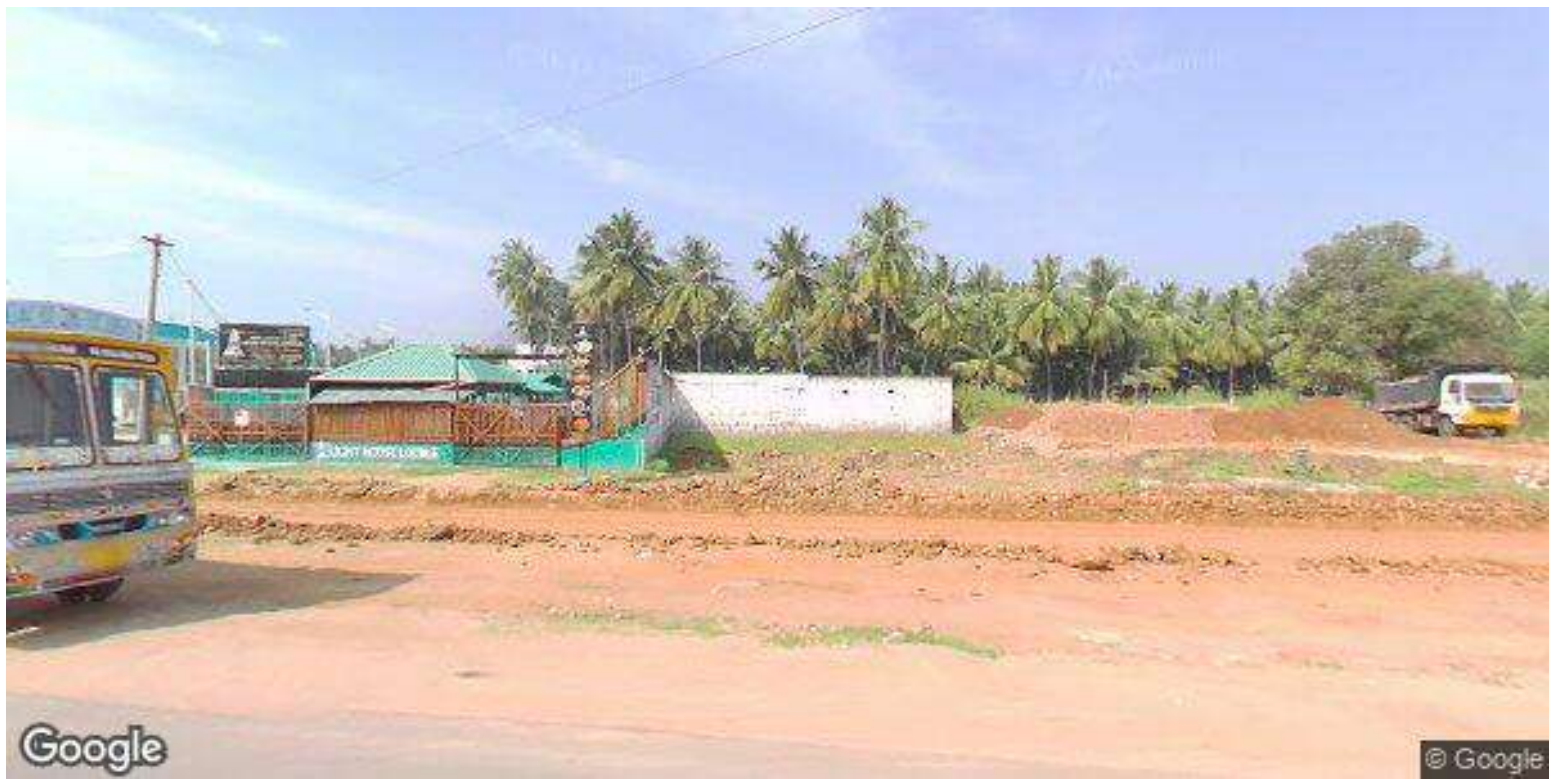
**Risk Type:** Turn  
**Risk Level:** Medium  
**Speed Limit:** 30 KM/Hr  
**Coordinates:** 11.61736, 78.10588

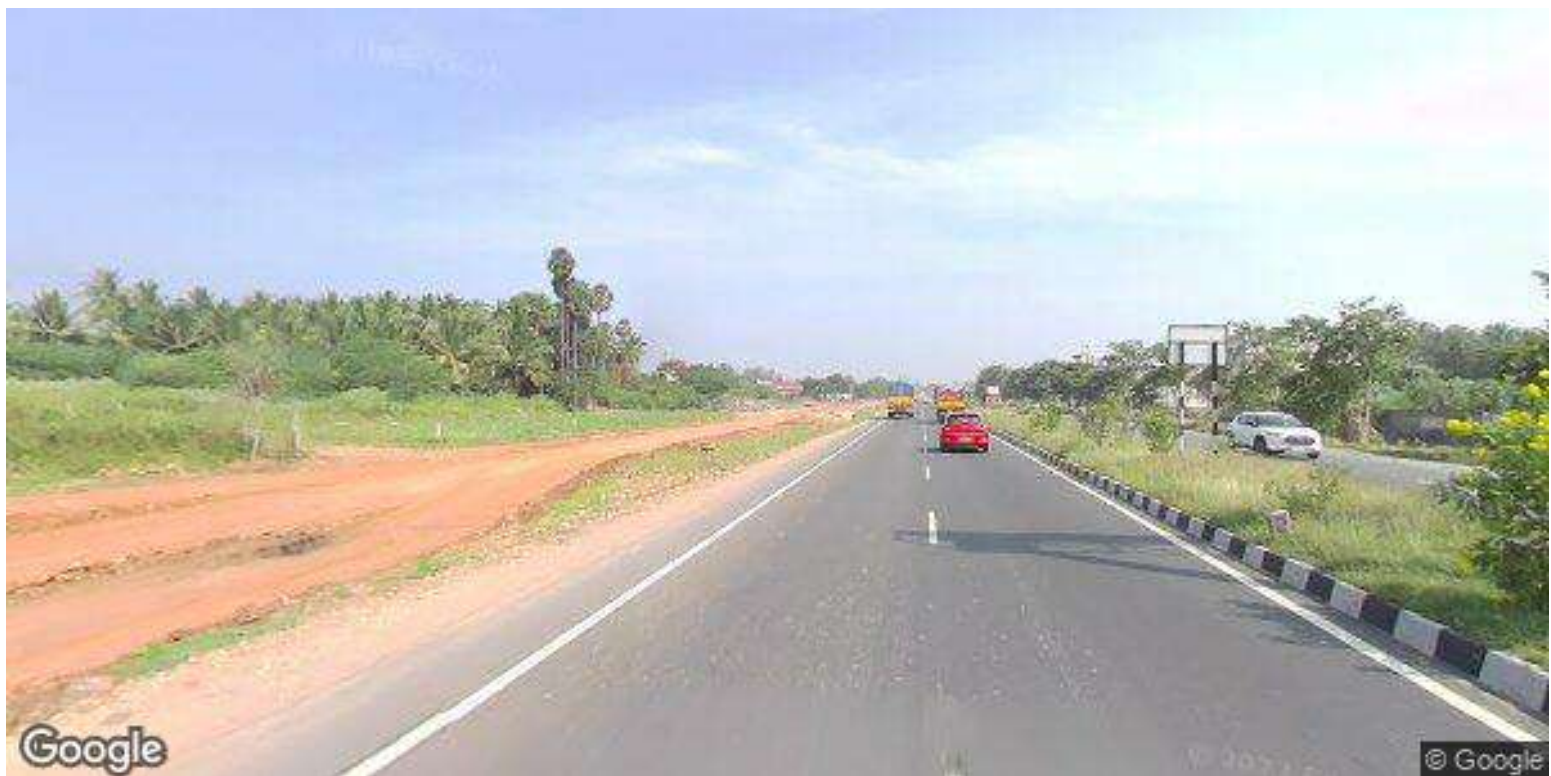
**Risk Type:** Turn  
**Risk Level:** Medium  
**Speed Limit:** 30 KM/Hr  
**Coordinates:** 11.61753, 78.10608

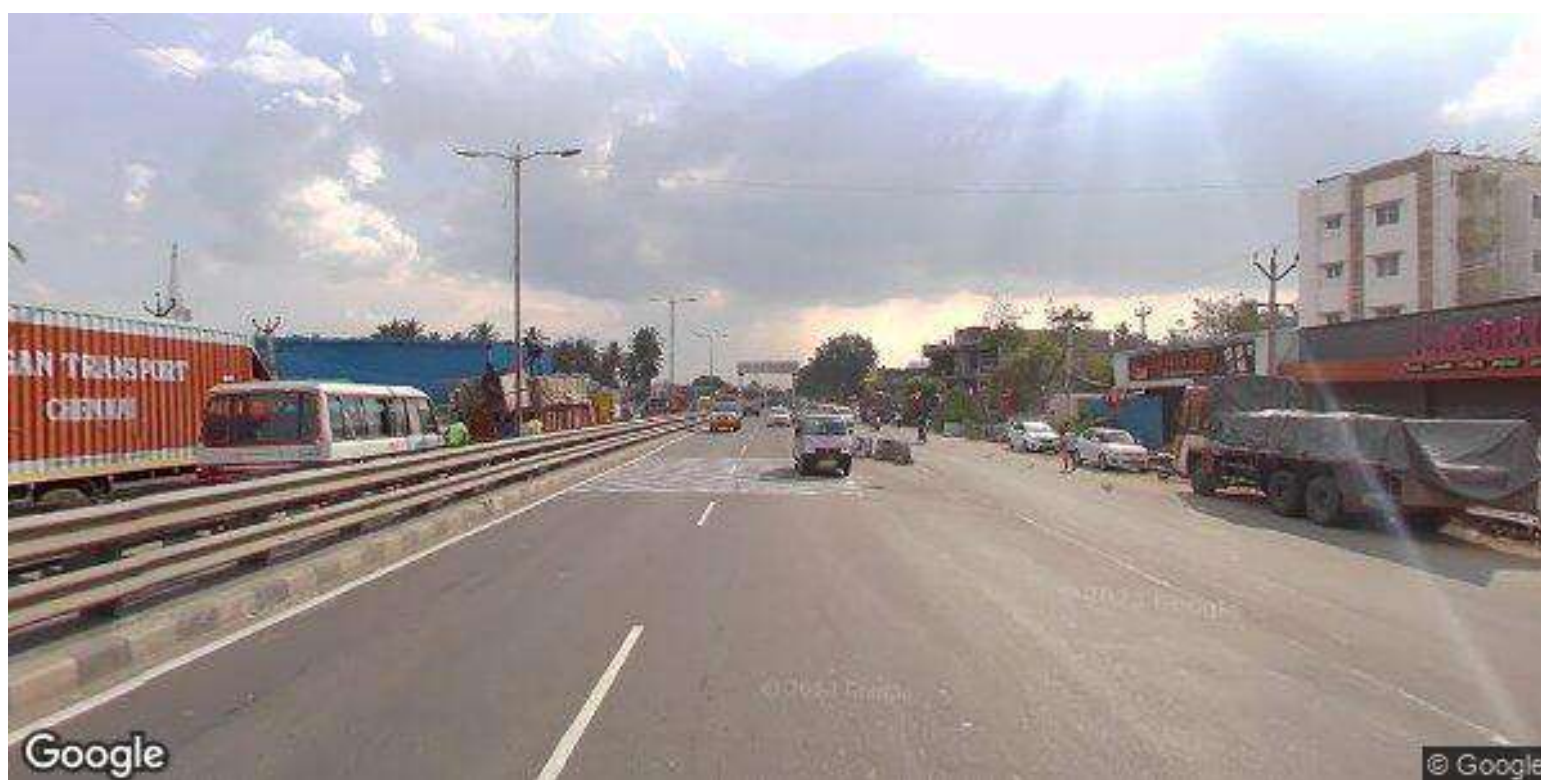
**Coordinates: 11.67074, 78.12668**

**Risk Type: Turn**

**Risk Level: High**

**Speed Limit: 15 KM/Hr**

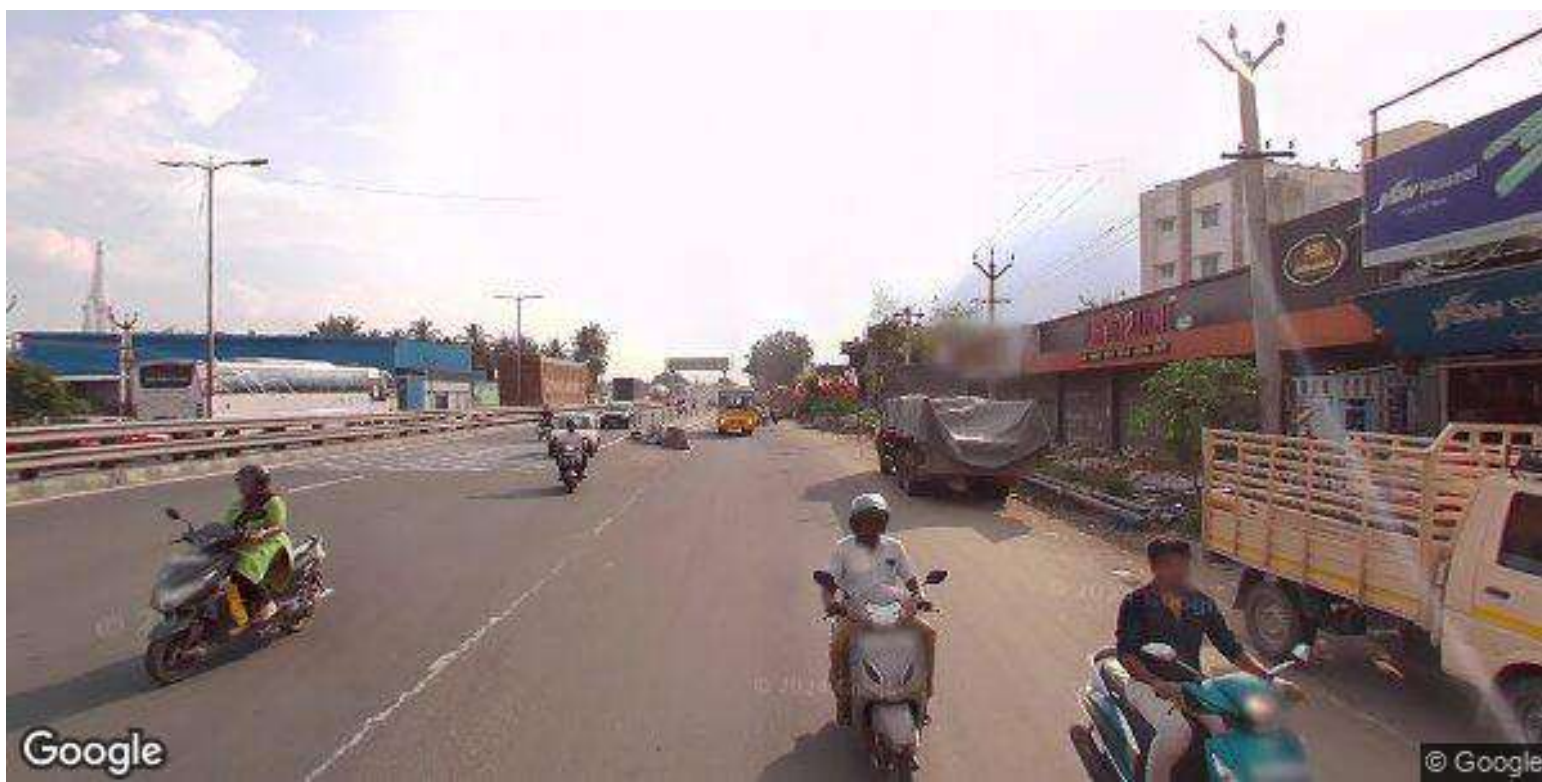
**Coordinates: 11.67081, 78.12661**

**Risk Type: Turn**

**Risk Level: High**

**Speed Limit: 15 KM/Hr**

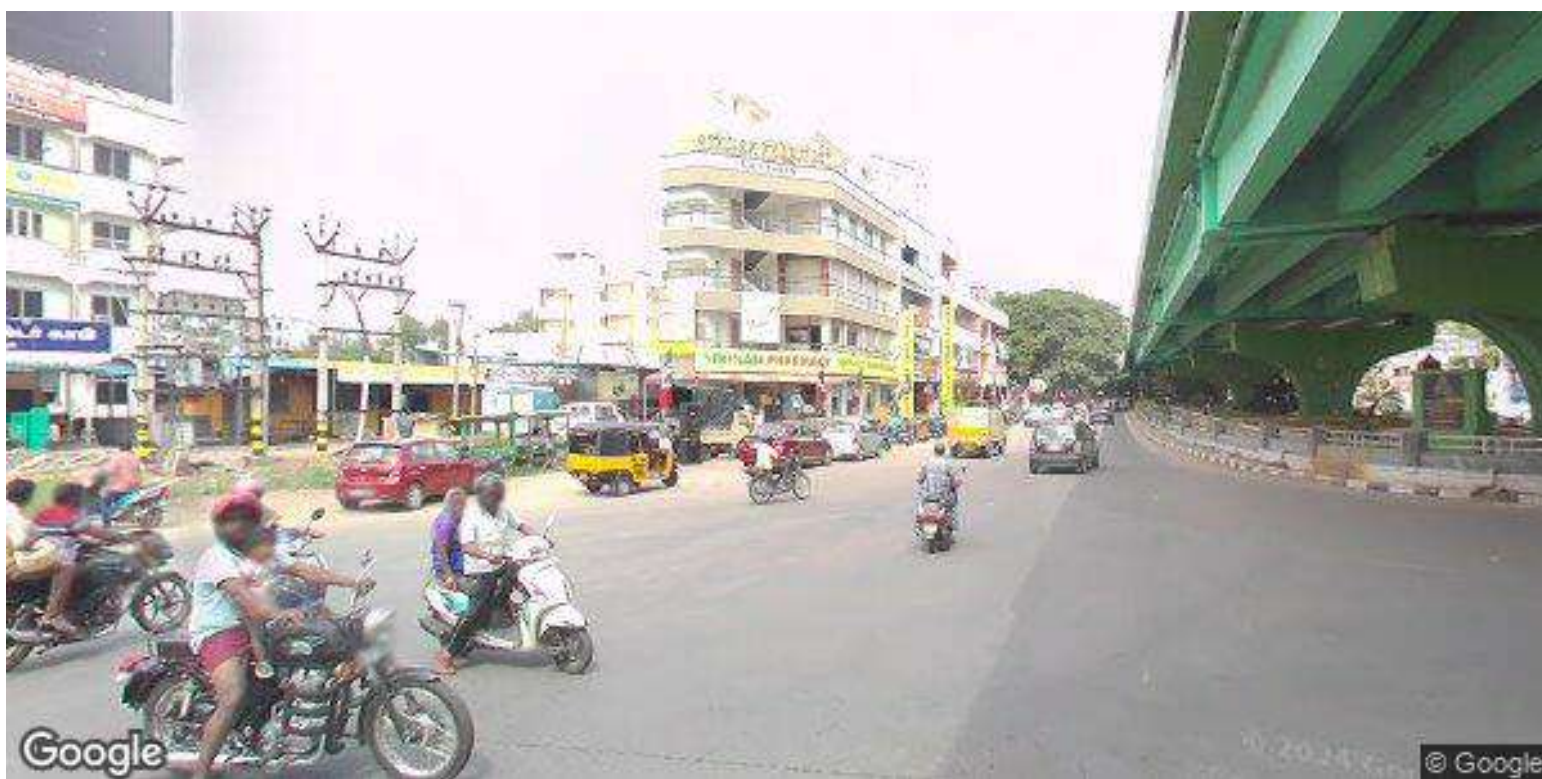
**Coordinates: 11.67582, 78.12786**

**Risk Type: Turn**

**Risk Level: High**

**Speed Limit: 15 KM/Hr**
