# IndianOil

## JOURNEY RISK MANAGEMENT (JRM) STUDY

### Salem Terminal TO SRI VARALAKSHMI FUELS

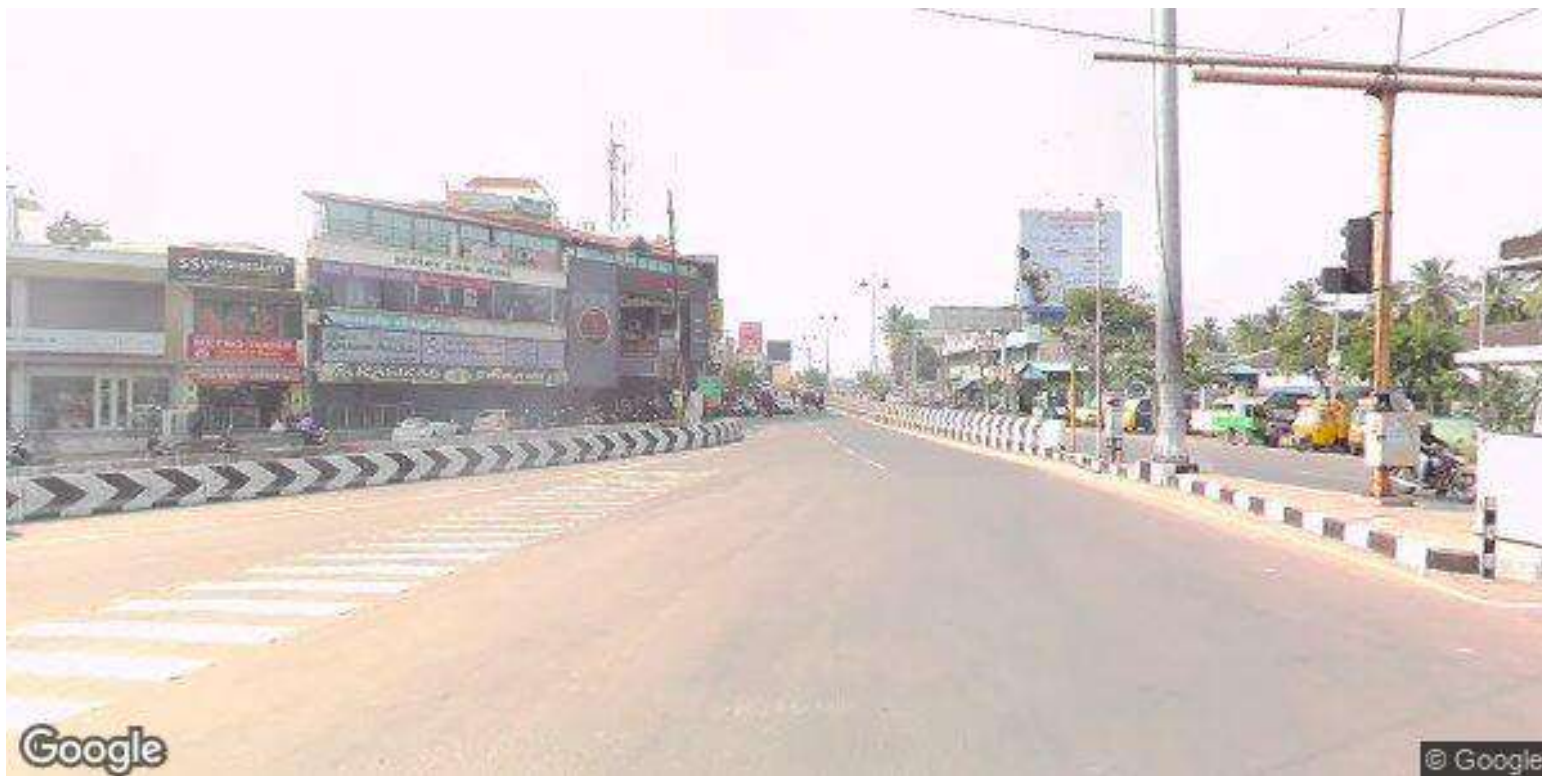
**Coordinates:** 11.6674963, 78.12460569999999

**Risk Type:** U-Turn

**Risk Level:** High

**Speed Limit:** 10 KM/Hr

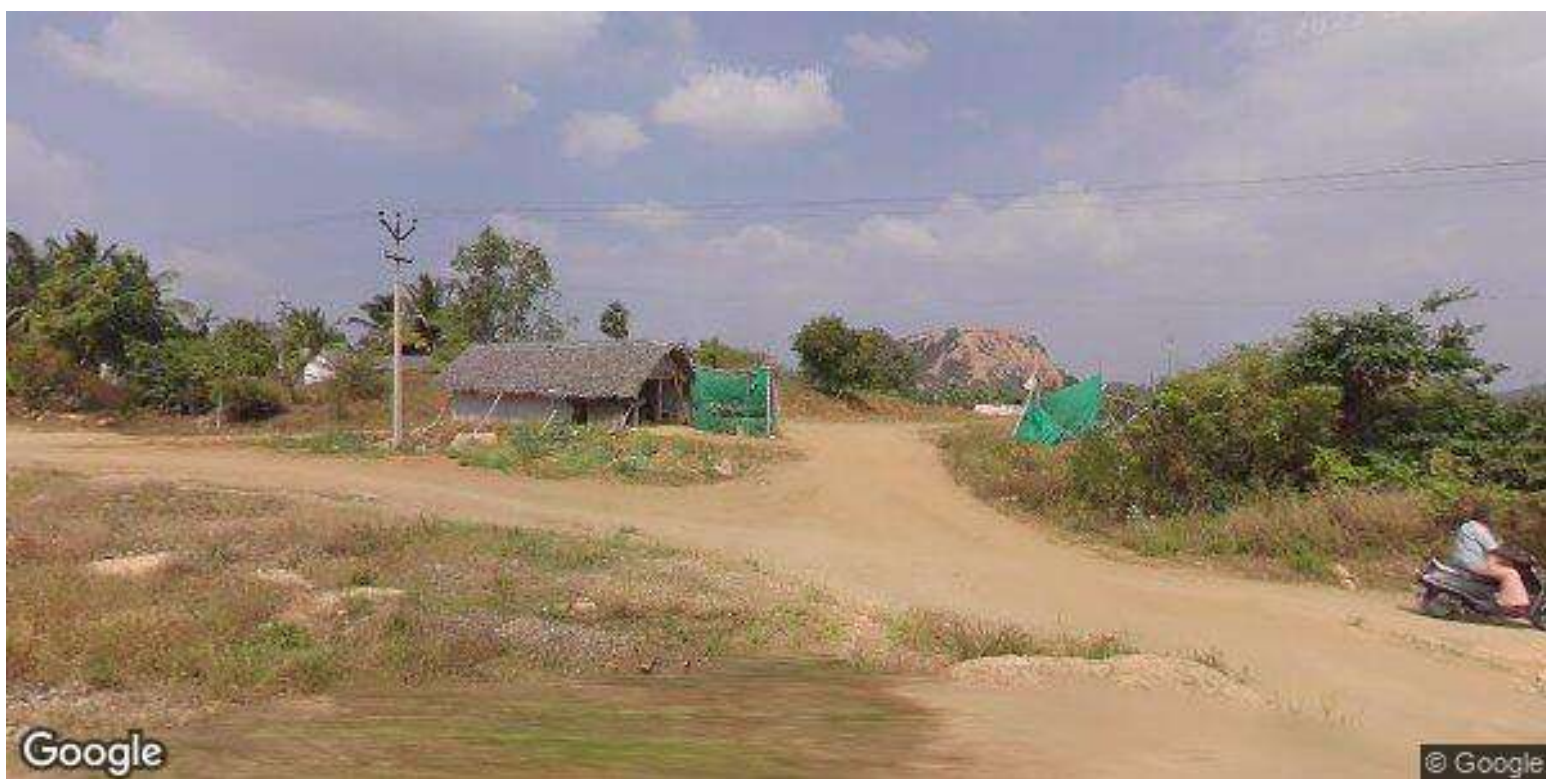
**Coordinates:** 11.49419, 77.88015

**Risk Type:** Turn

**Risk Level:** Medium

**Speed Limit:** 30 KM/Hr

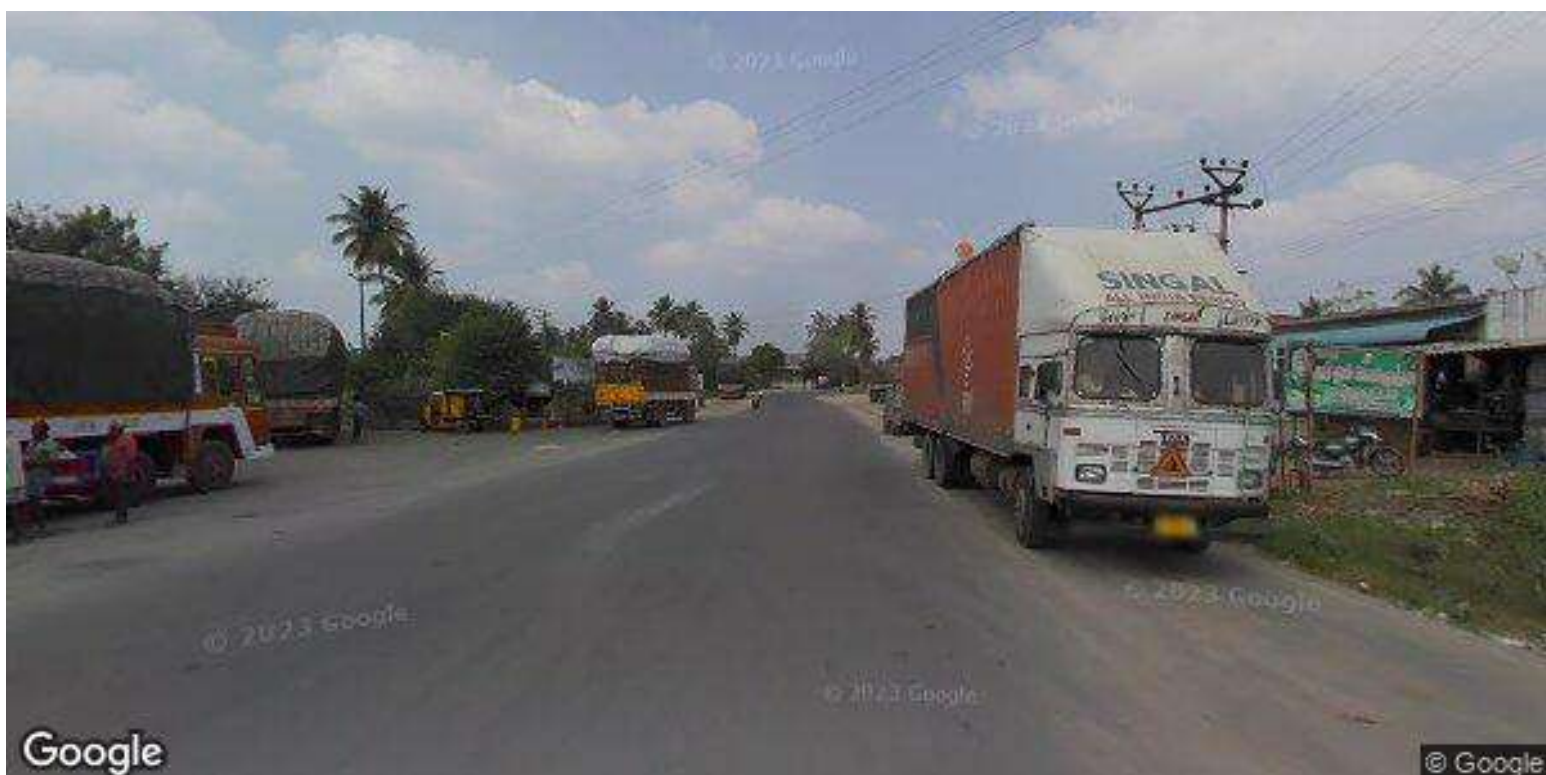
**Coordinates: 11.49377, 77.88573**

**Risk Type: Turn**

**Risk Level: Medium**

**Speed Limit: 30 KM/Hr**

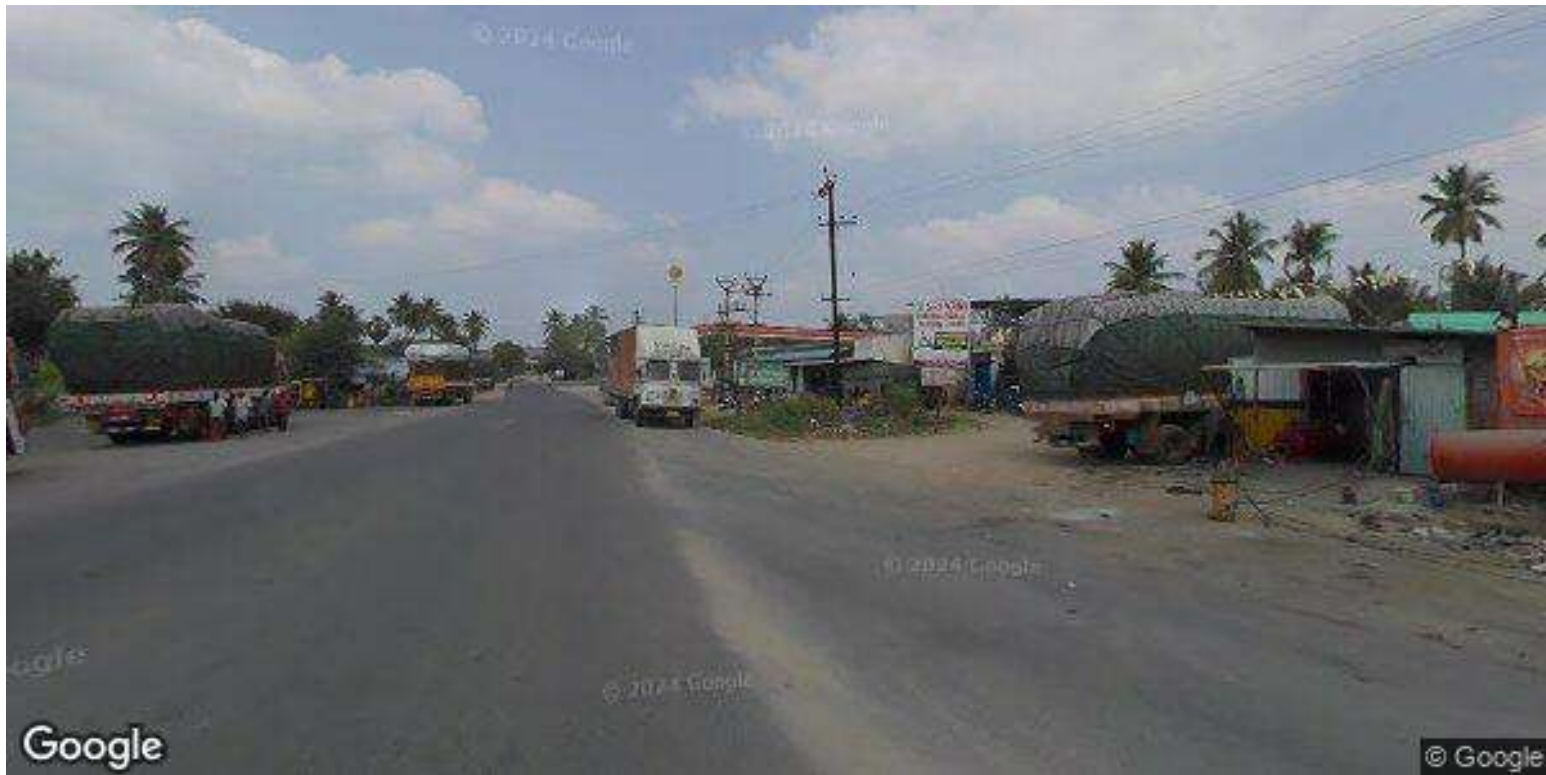
**Coordinates: 11.49363, 77.88590**

**Risk Type: Turn**

**Risk Level: High**

**Speed Limit: 15 KM/Hr**

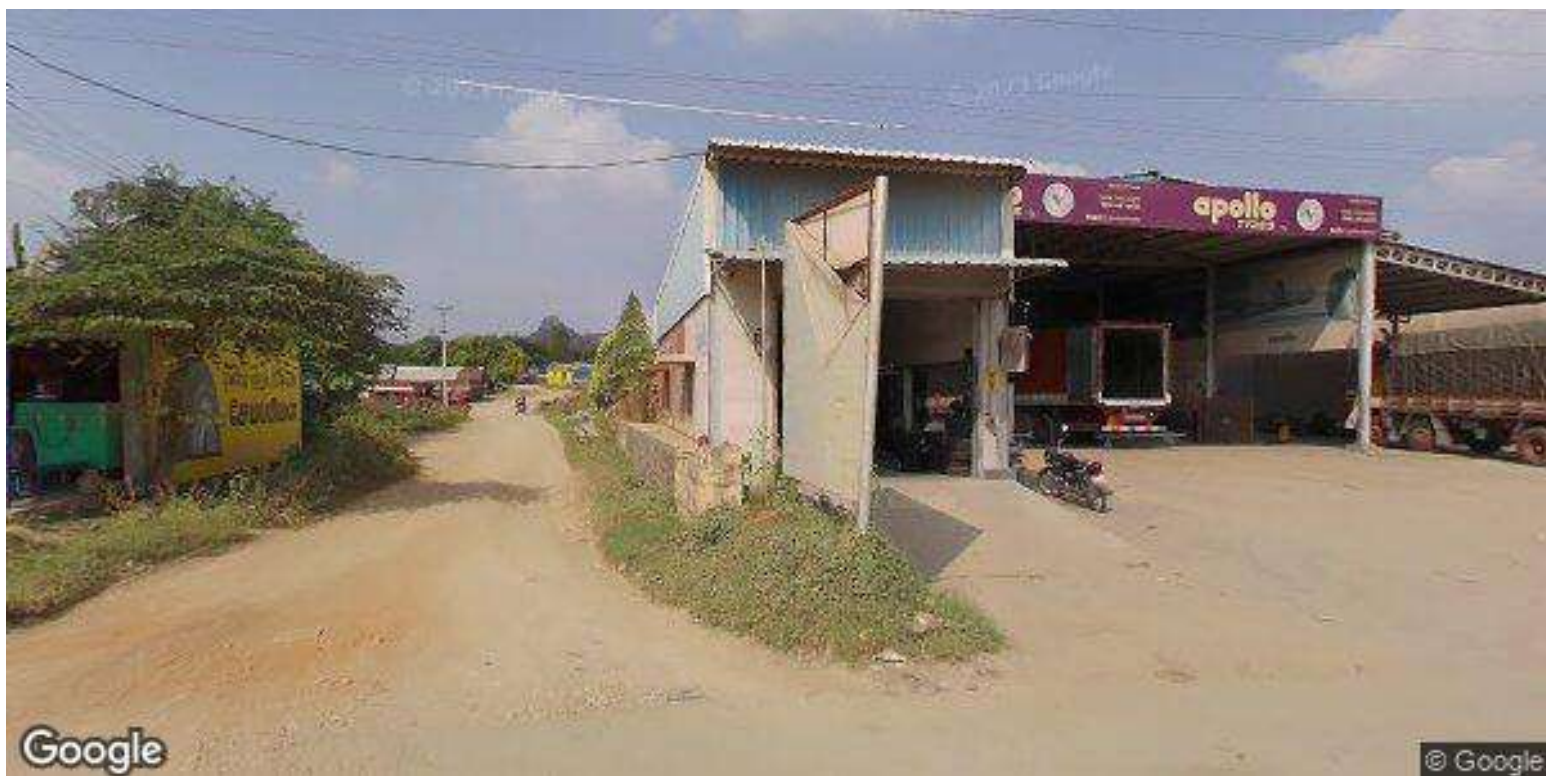
**Coordinates: 11.49235, 77.89561**

**Risk Type: Turn**

**Risk Level: High**

**Speed Limit: 15 KM/Hr**

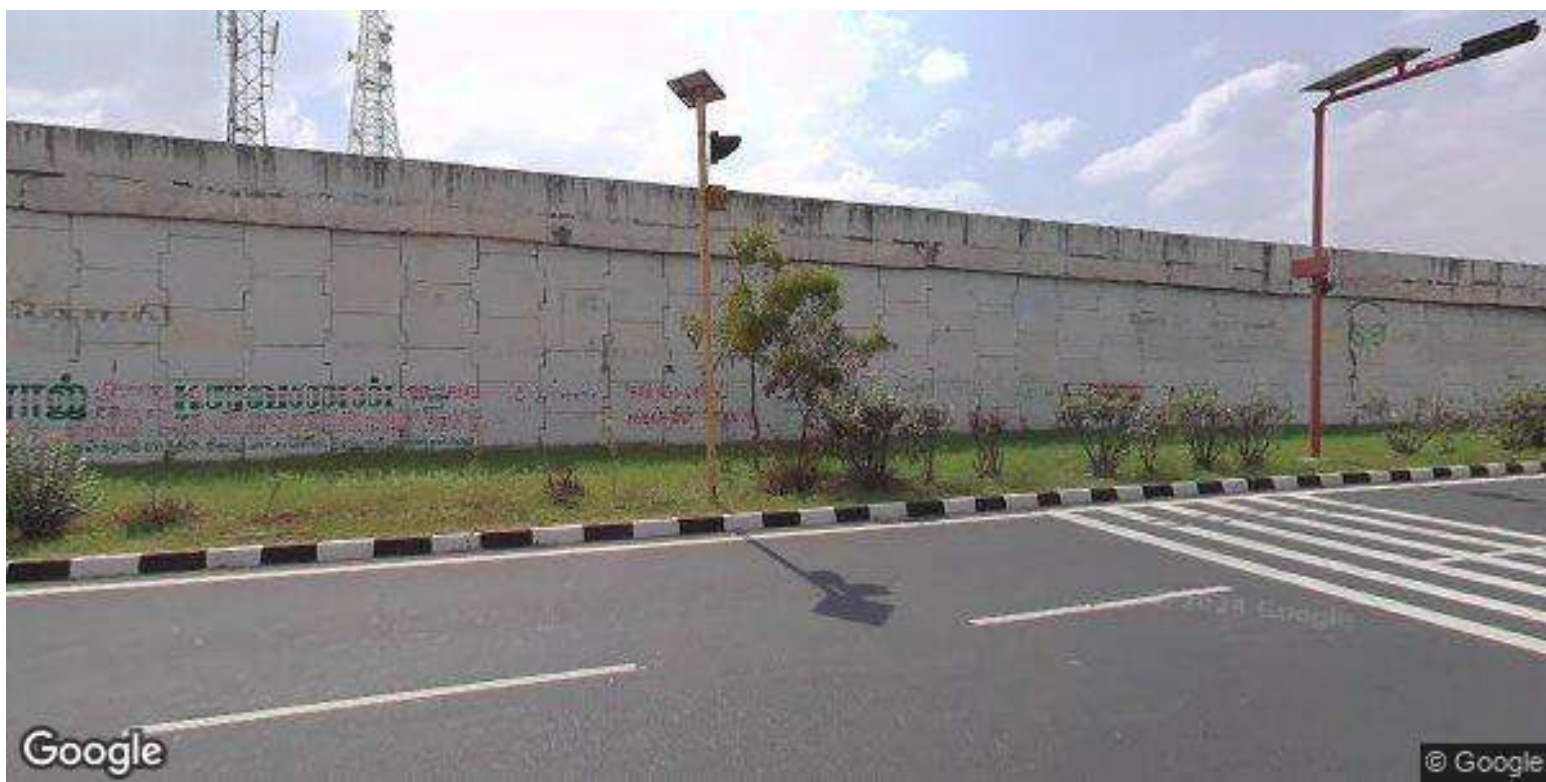
**Coordinates:** 11.49225, 77.89560

**Risk Type:** Blind Spot

**Risk Level:** Blind Spot

**Speed Limit:** 10 KM/Hr

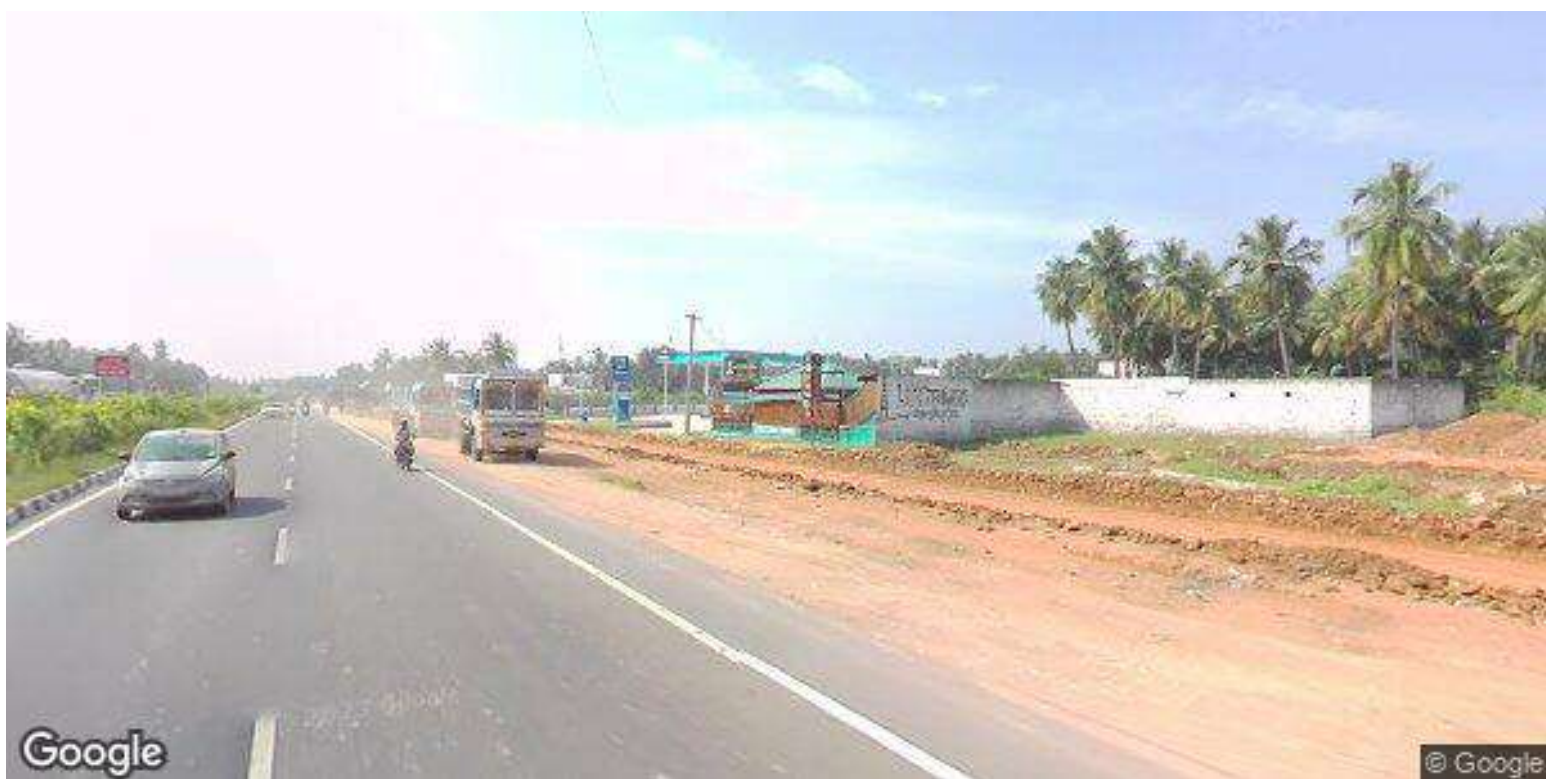
**Coordinates:** 11.61748, 78.10604

**Risk Type:** Turn

**Risk Level:** Medium

**Speed Limit:** 30 KM/Hr

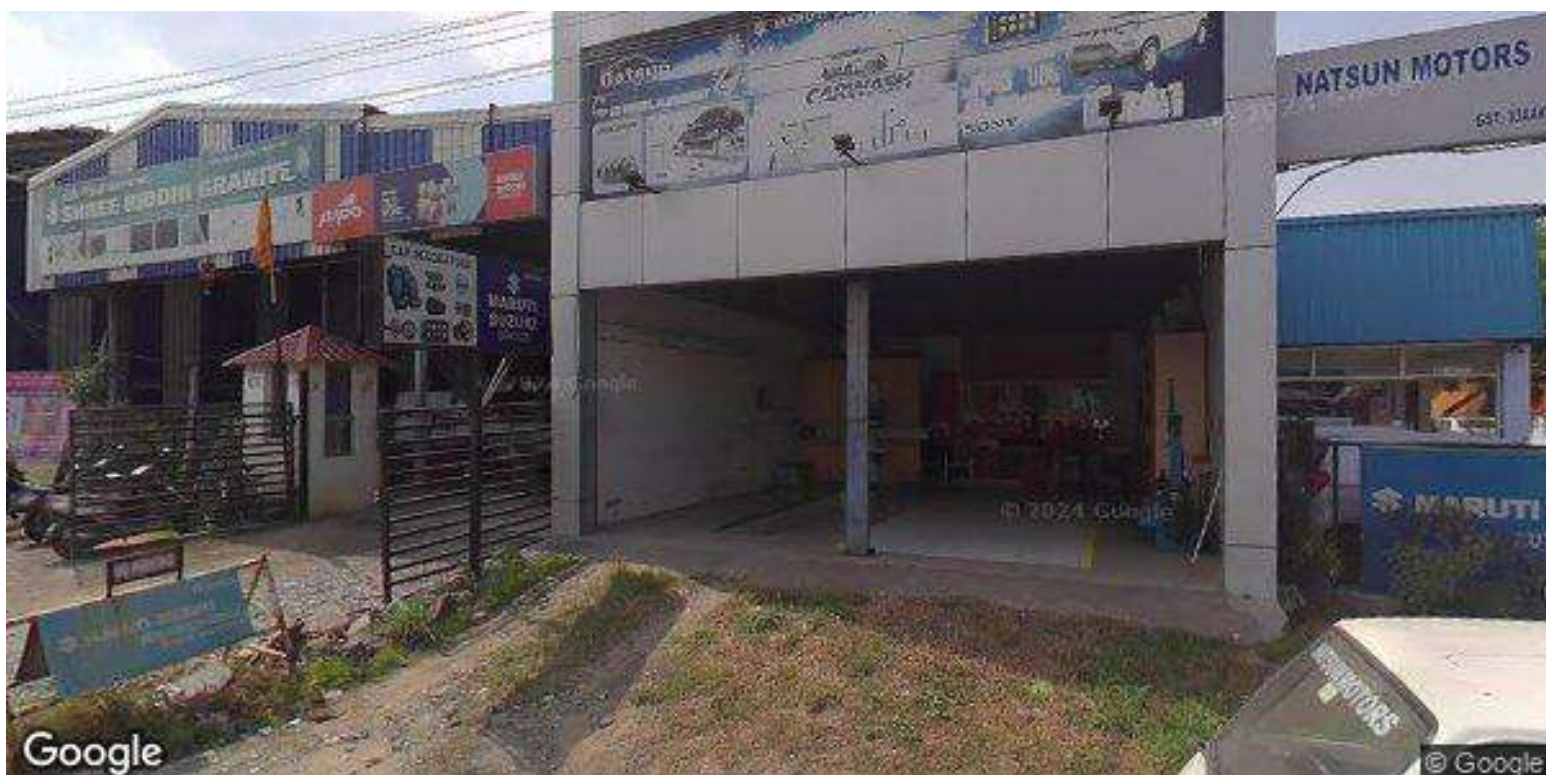
**Coordinates: 11.64490, 78.12024**

**Risk Type: Turn**

**Risk Level: Medium**

**Speed Limit: 30 KM/Hr**

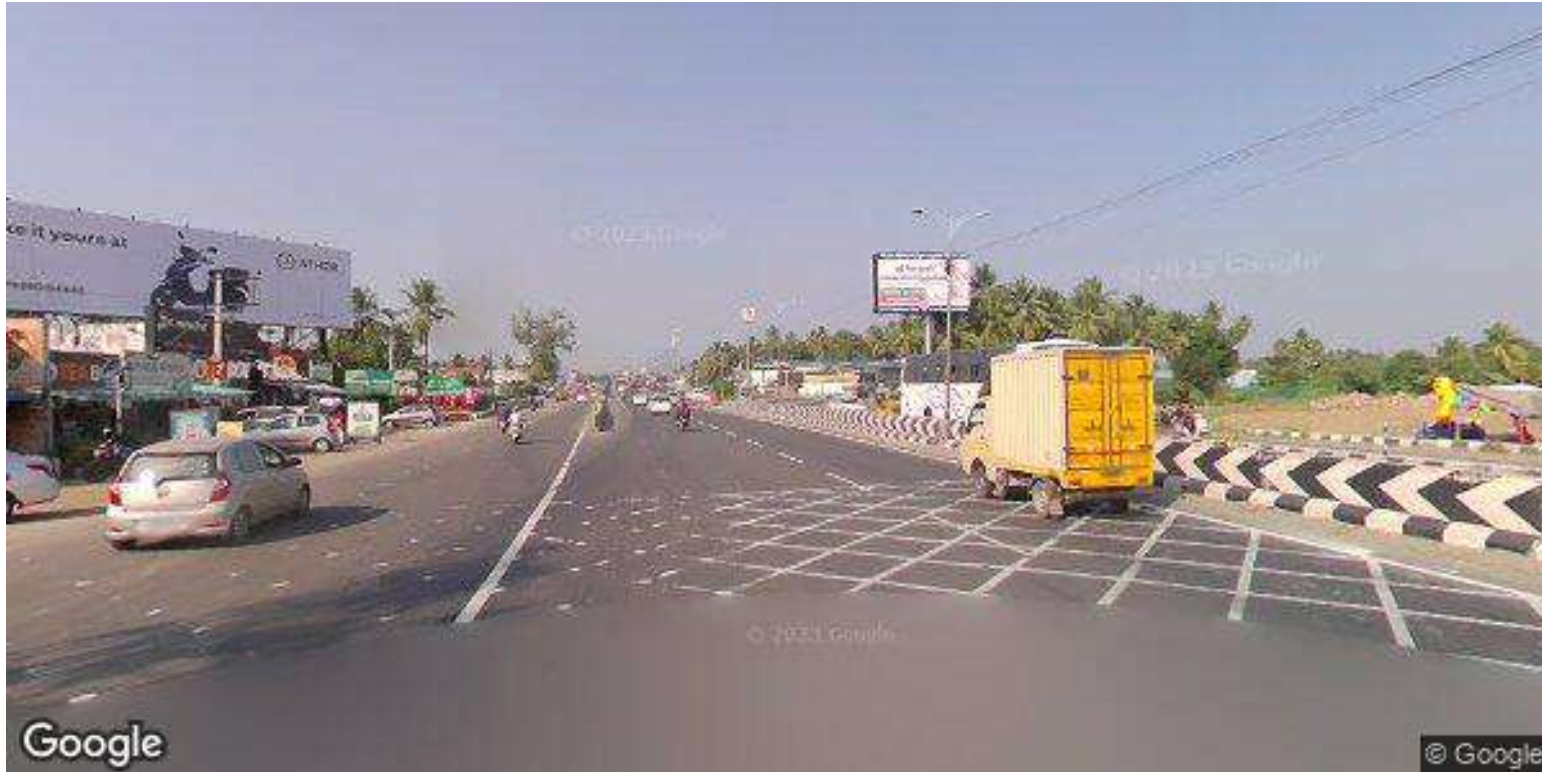
**Coordinates: 11.64503, 78.12034**

**Risk Type: Turn**

**Risk Level: Medium**

**Speed Limit: 30 KM/Hr**

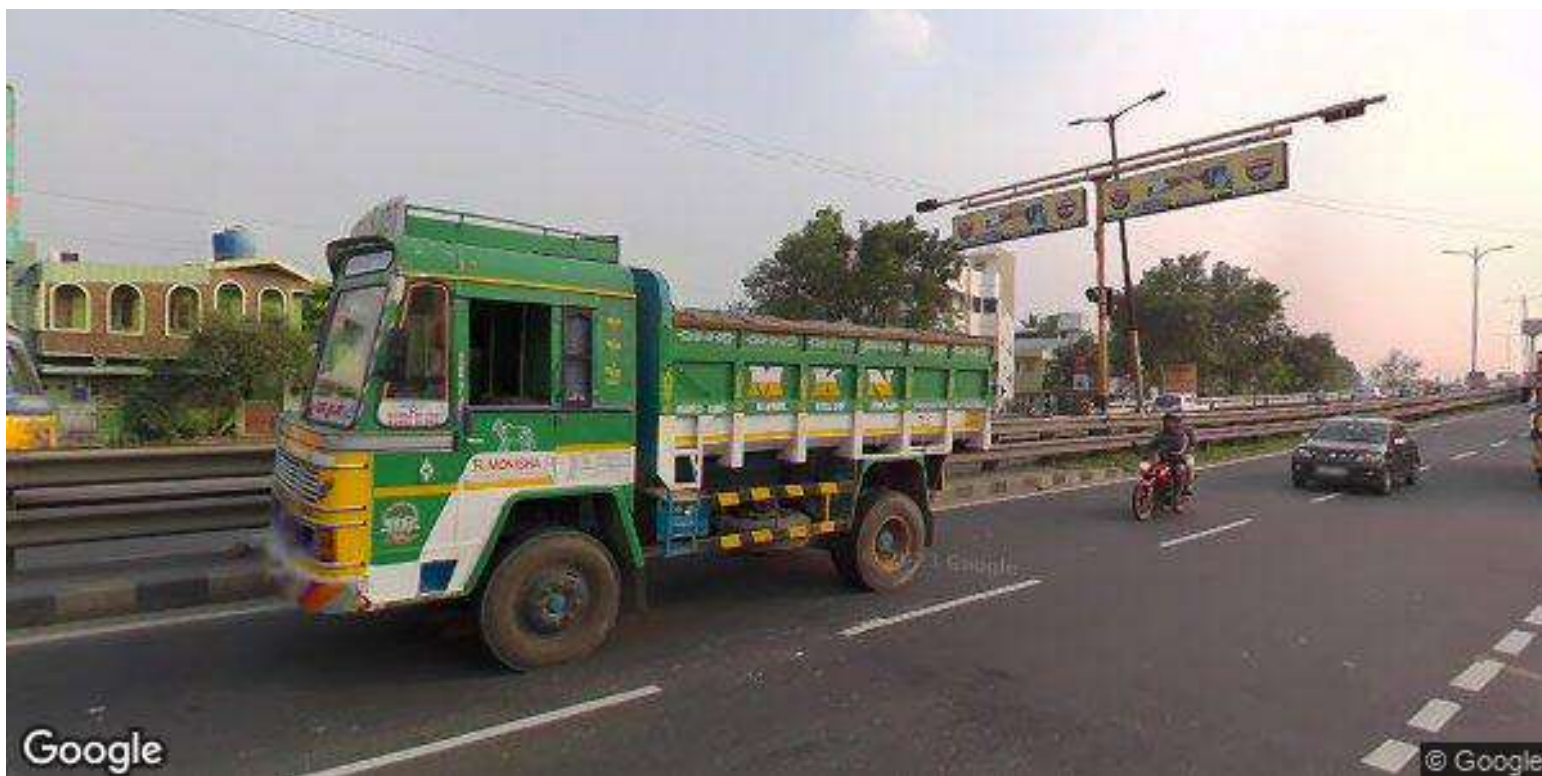
**Coordinates: 11.66458, 78.12303**

**Risk Type: Turn**

**Risk Level: High**

**Speed Limit: 15 KM/Hr**

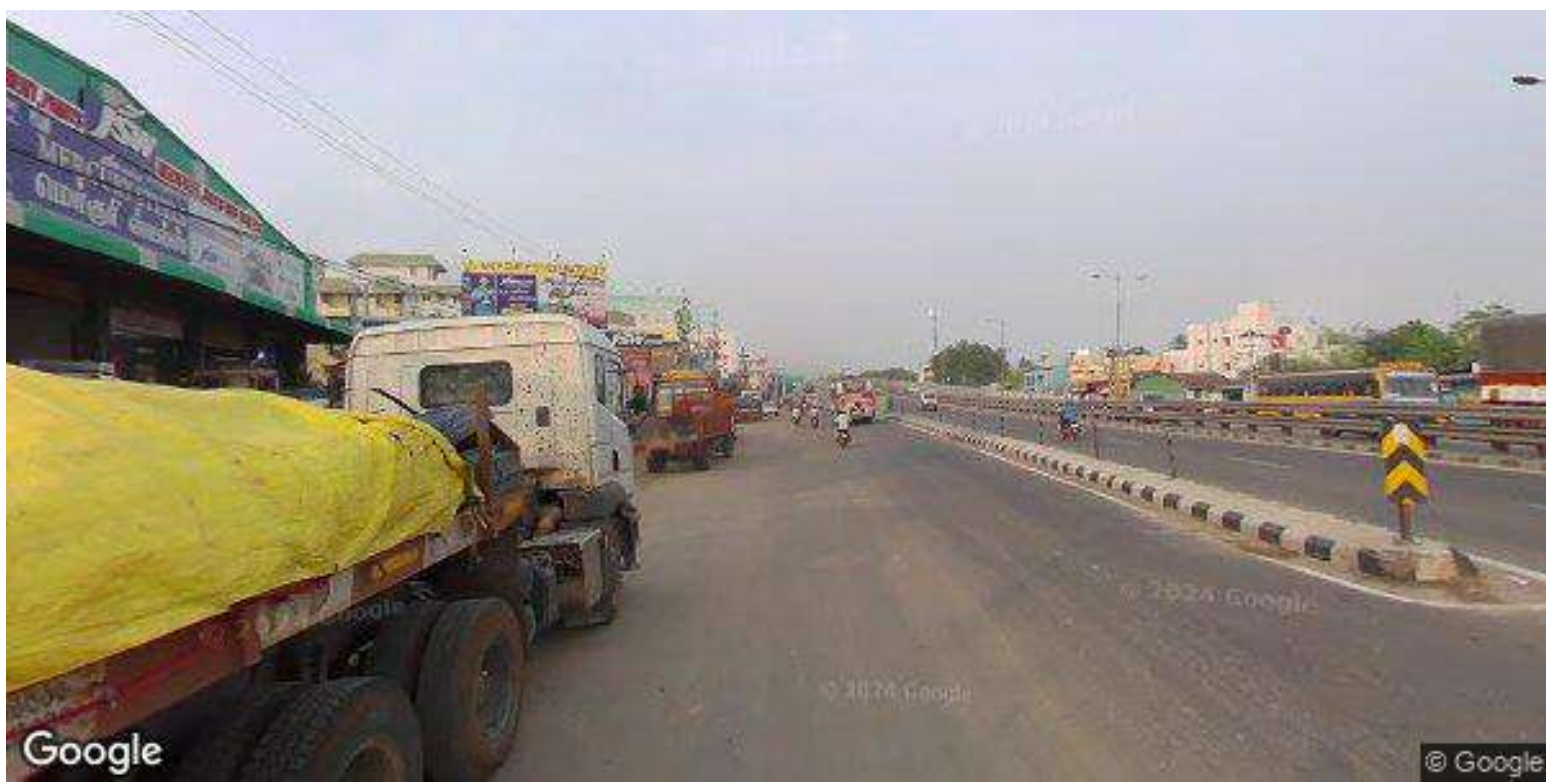
**Coordinates:** 11.66477, 78.12298

**Risk Type:** Turn

**Risk Level:** High

**Speed Limit:** 15 KM/Hr

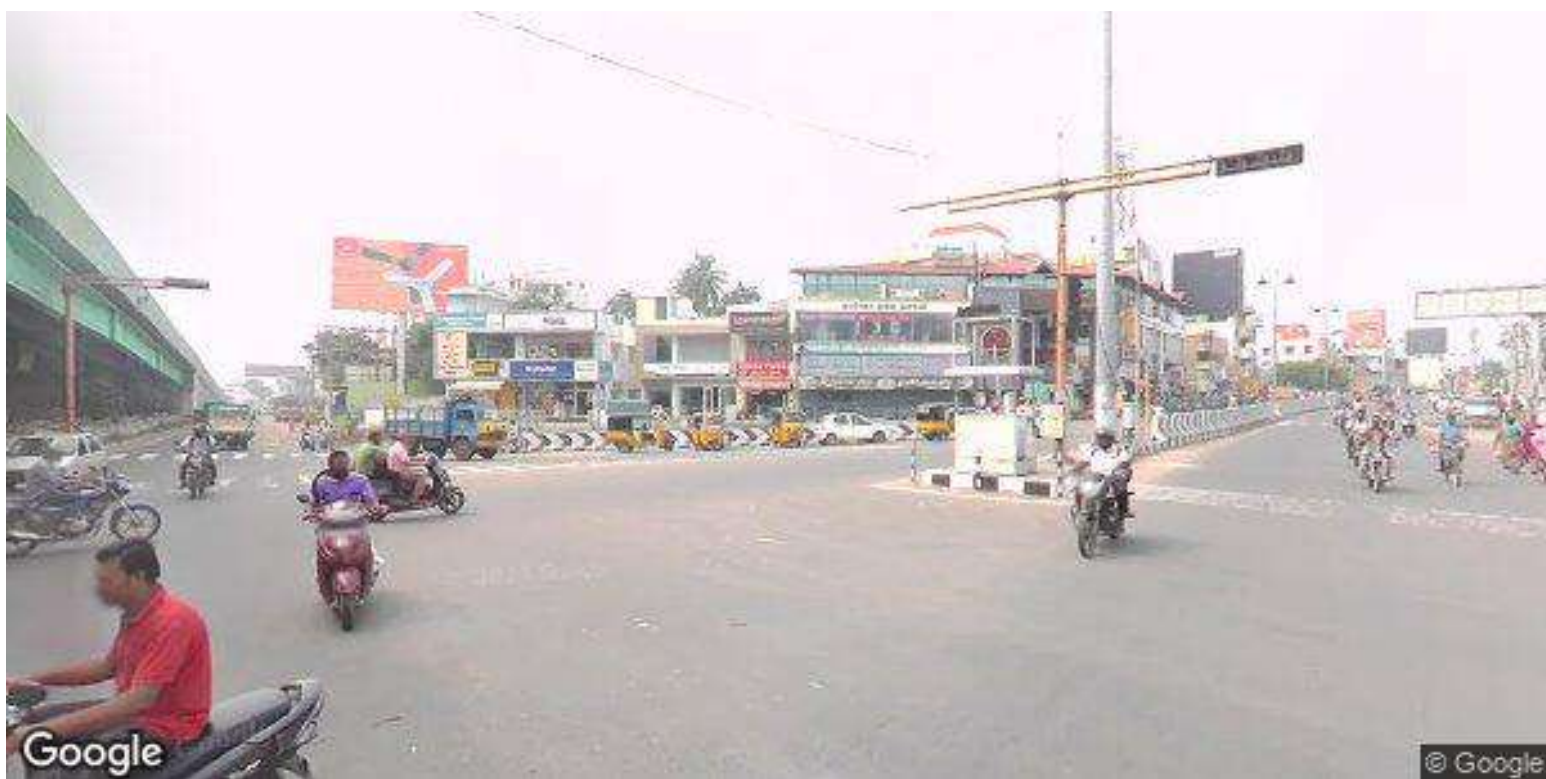
**Coordinates:** 11.66763, 78.12466

**Risk Type:** Turn

**Risk Level:** High

**Speed Limit:** 15 KM/Hr

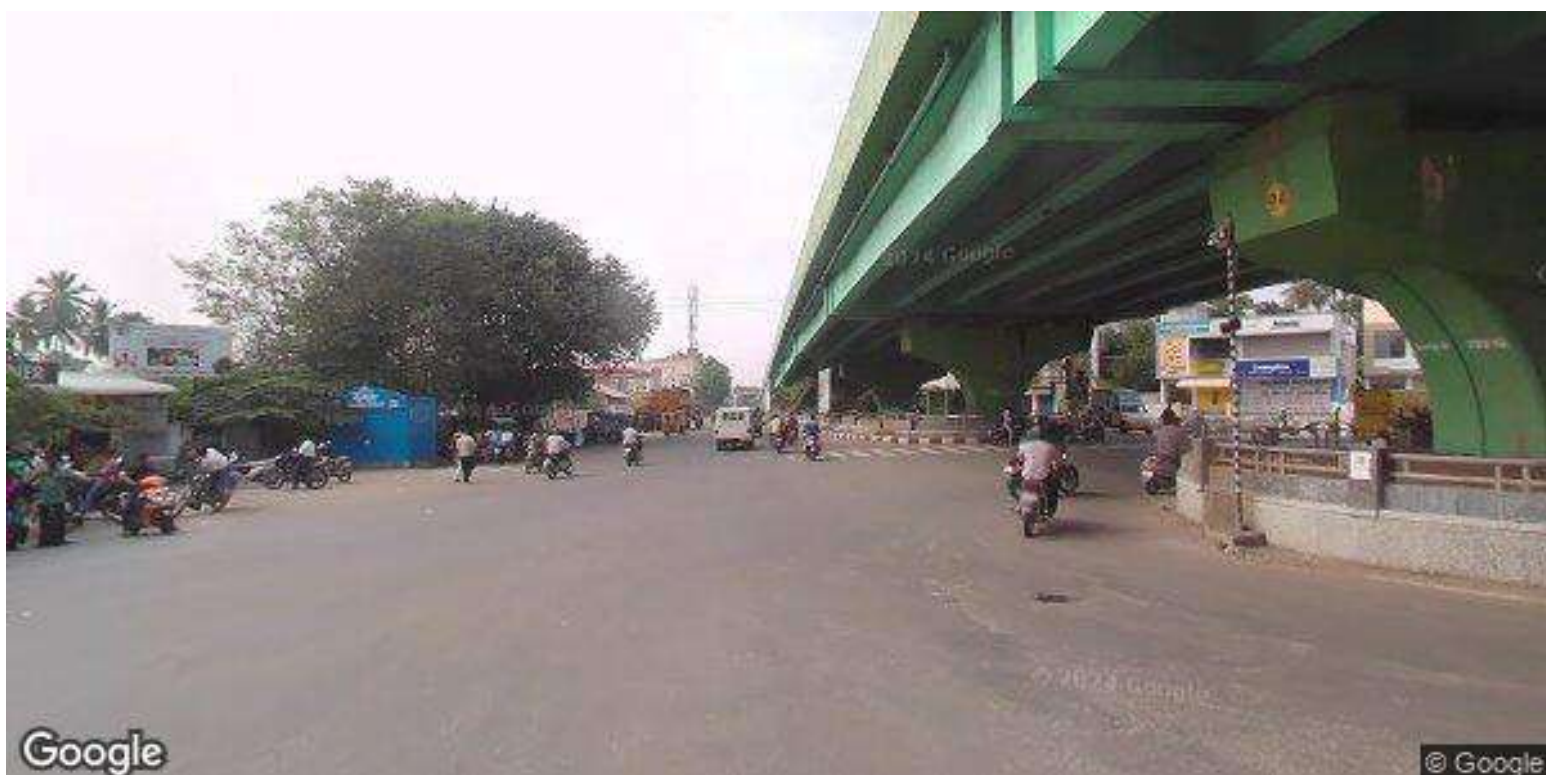
**Coordinates:** 11.66754, 78.12492

**Risk Type:** Turn

**Risk Level:** High

**Speed Limit:** 15 KM/Hr
