## JOURNEY RISK MANAGEMENT (JRM) STUDY

### Salem Terminal to SREE SARATHI & CO

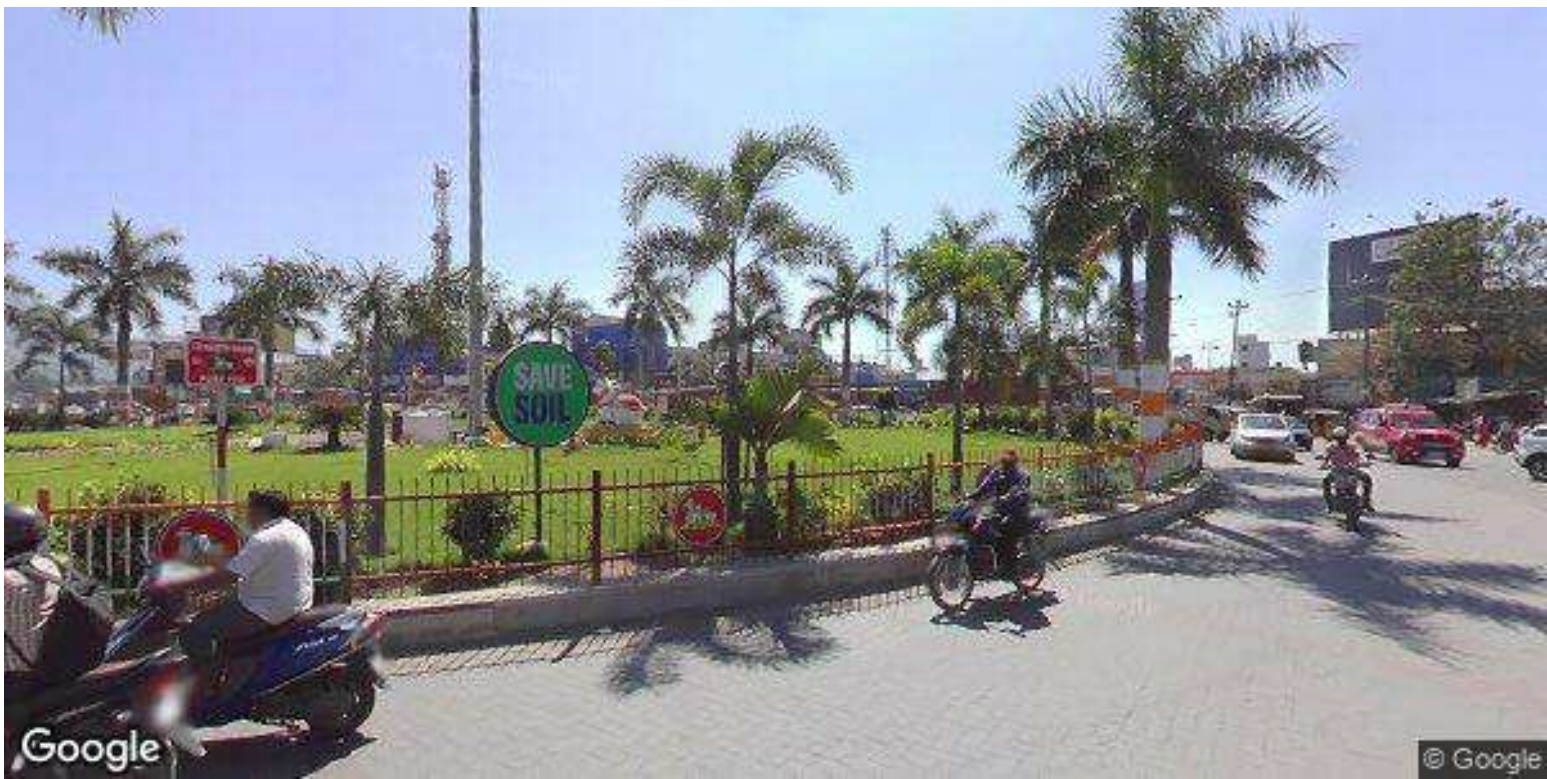
**Risk Type:** Roundabout  
**Risk Level:** High  
**Speed Limit:** 15 KM/Hr  
**Coordinates:** 11.63303, 78.12713

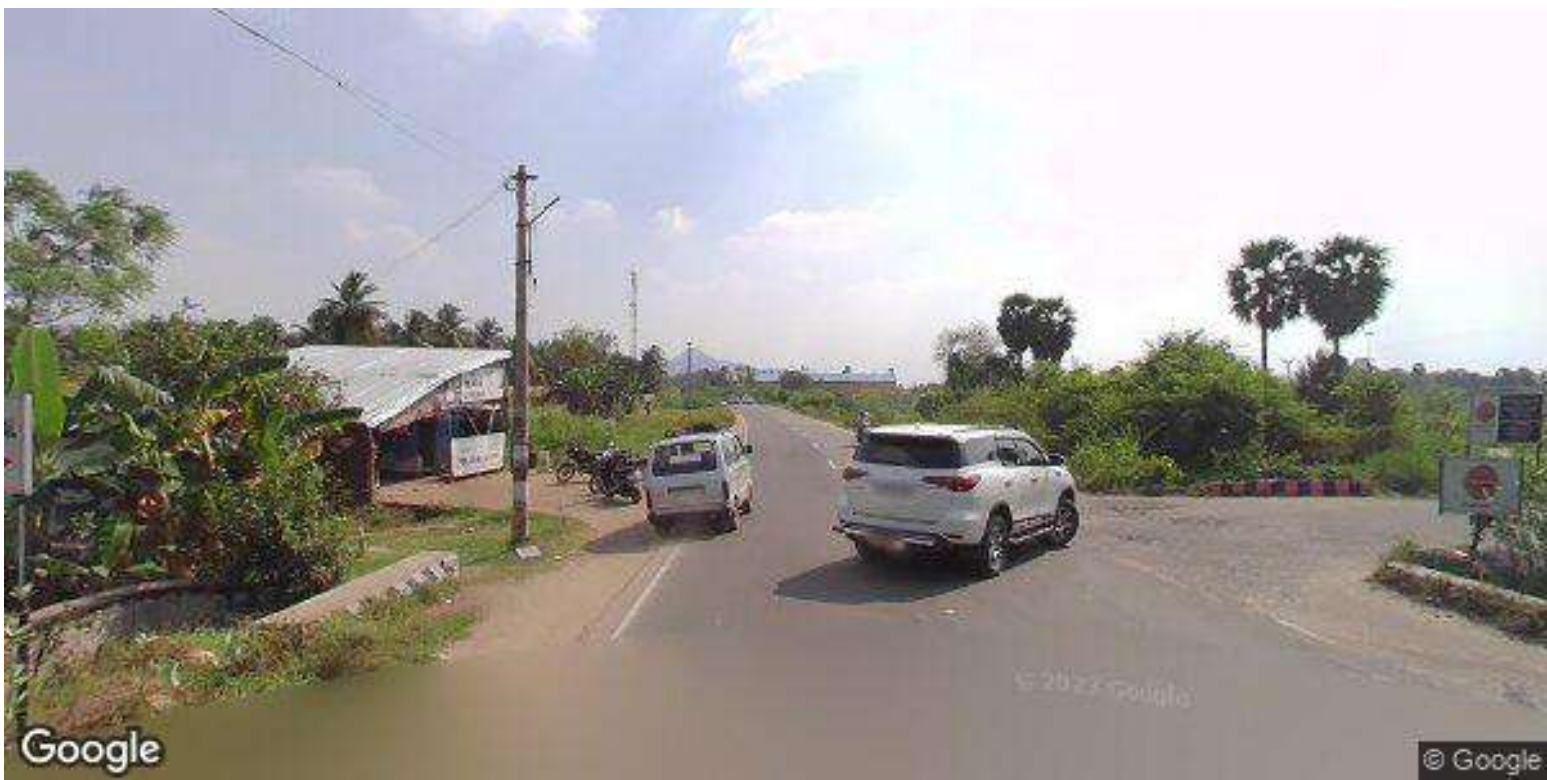
**Risk Type:** Turn  
**Risk Level:** High  
**Speed Limit:** 15 KM/Hr  
**Coordinates:** 11.44029, 77.87544

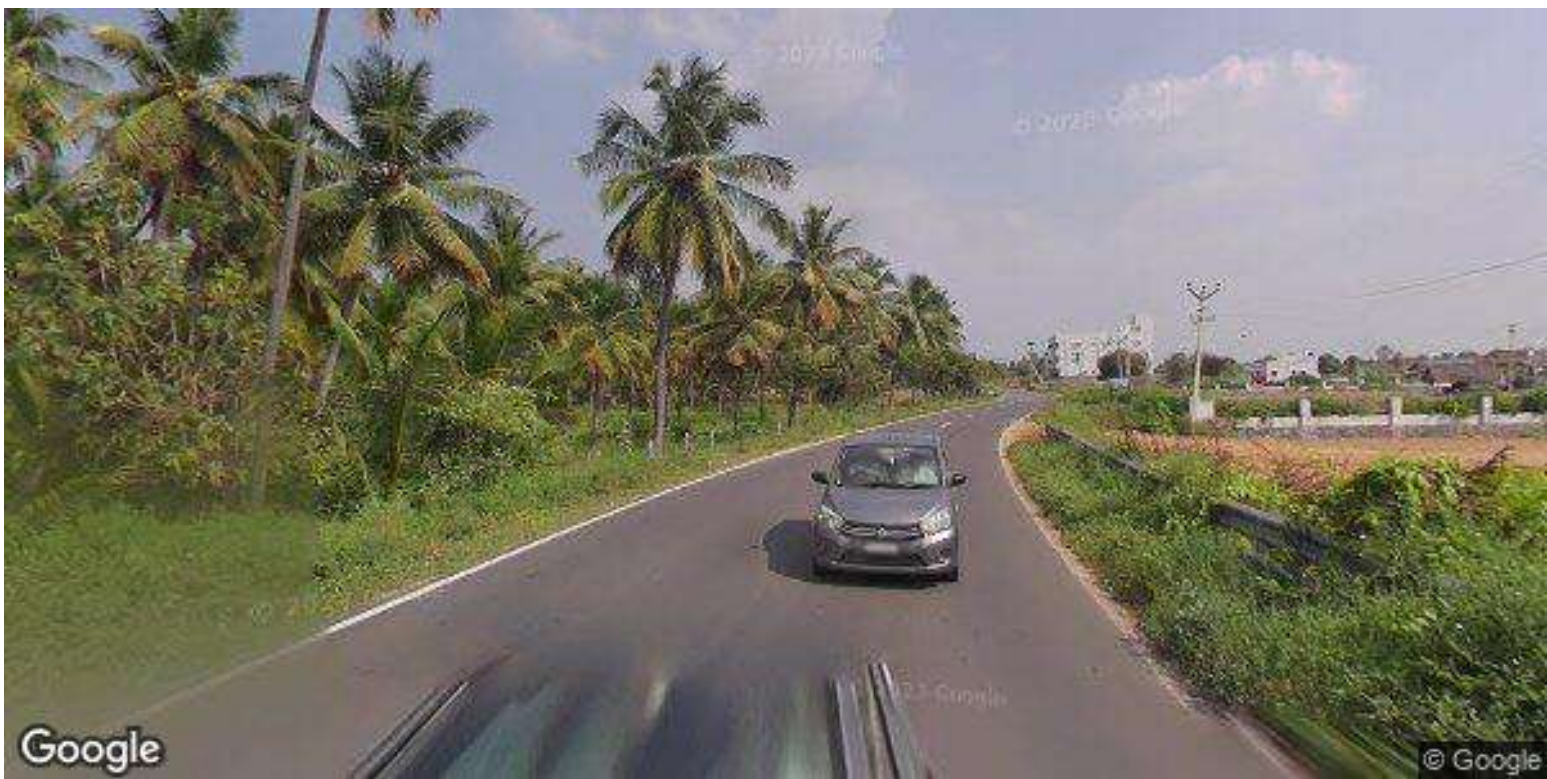
**Risk Type: Turn**

**Risk Level: Medium**

**Speed Limit: 30 KM/Hr**

**Coordinates: 11.45357, 77.85789**

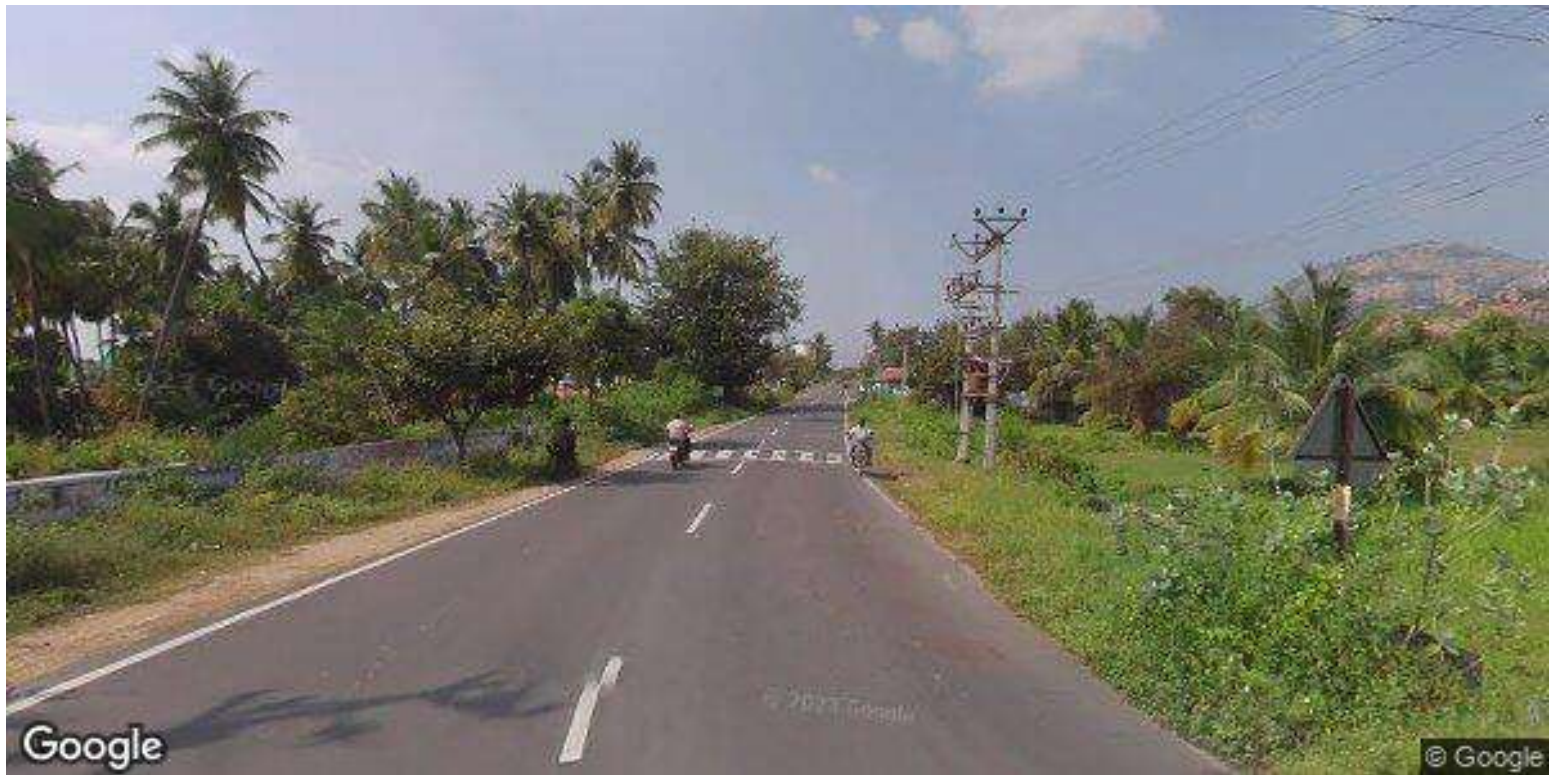
**Risk Type: Turn**

**Risk Level: Medium**

**Speed Limit: 30 KM/Hr**

**Coordinates: 11.45352, 77.85698**

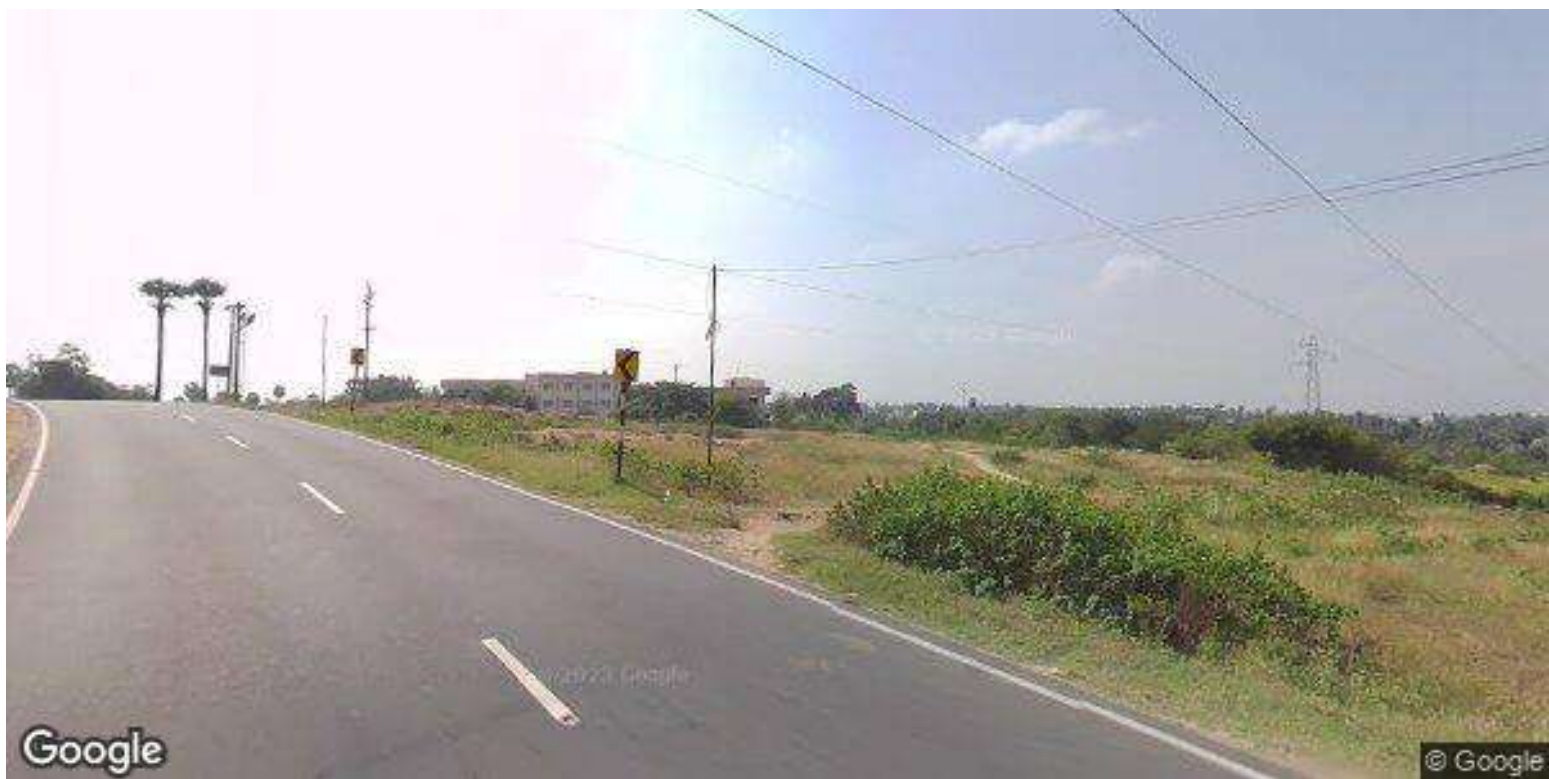
**Risk Type: Turn**

**Risk Level: Medium**

**Speed Limit: 30 KM/Hr**

**Coordinates: 11.46048, 77.85036**

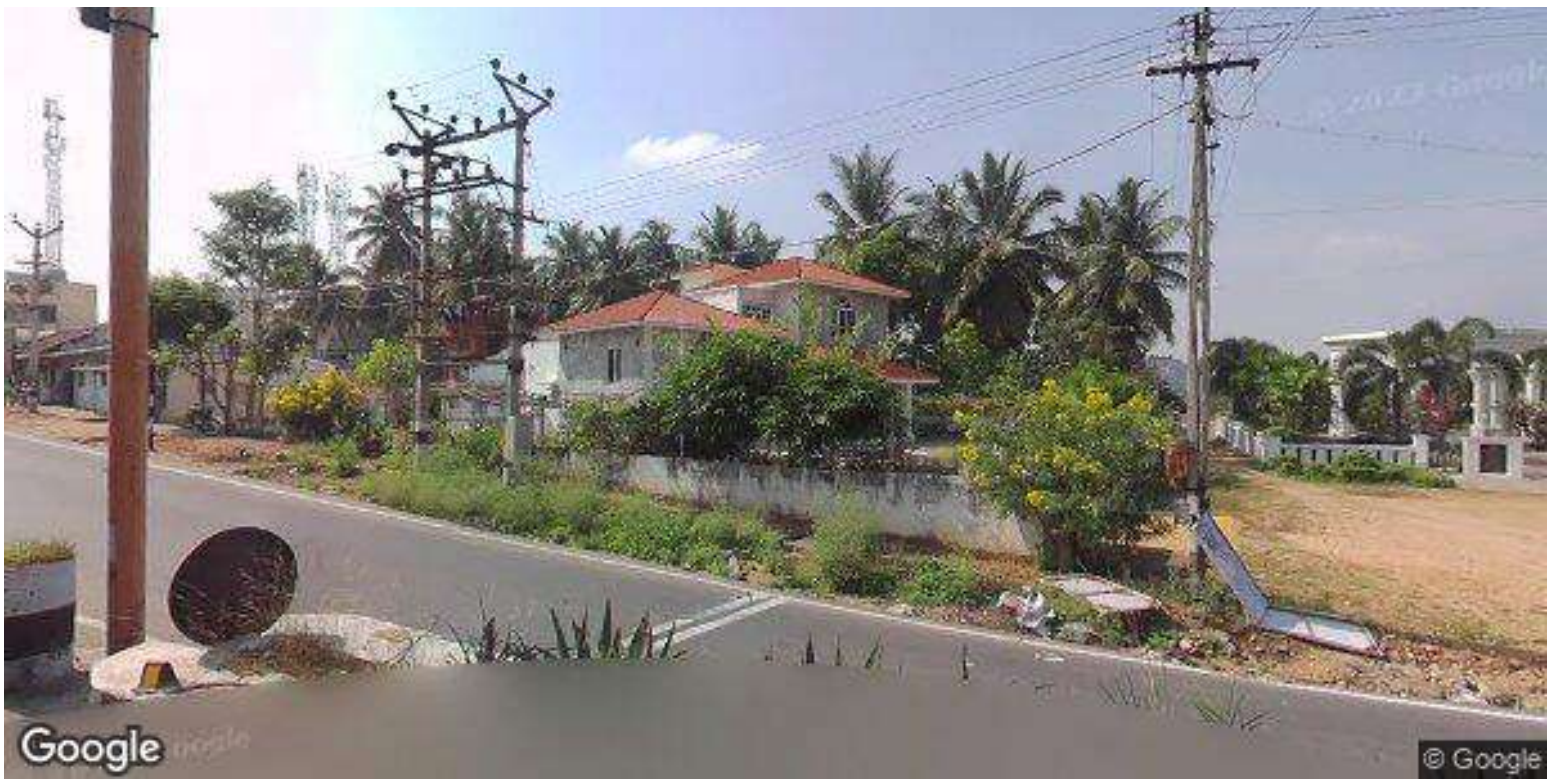
**Risk Type:** Turn  
**Risk Level:** Medium  
**Speed Limit:** 30 KM/Hr  
**Coordinates:** 11.46303, 77.84945

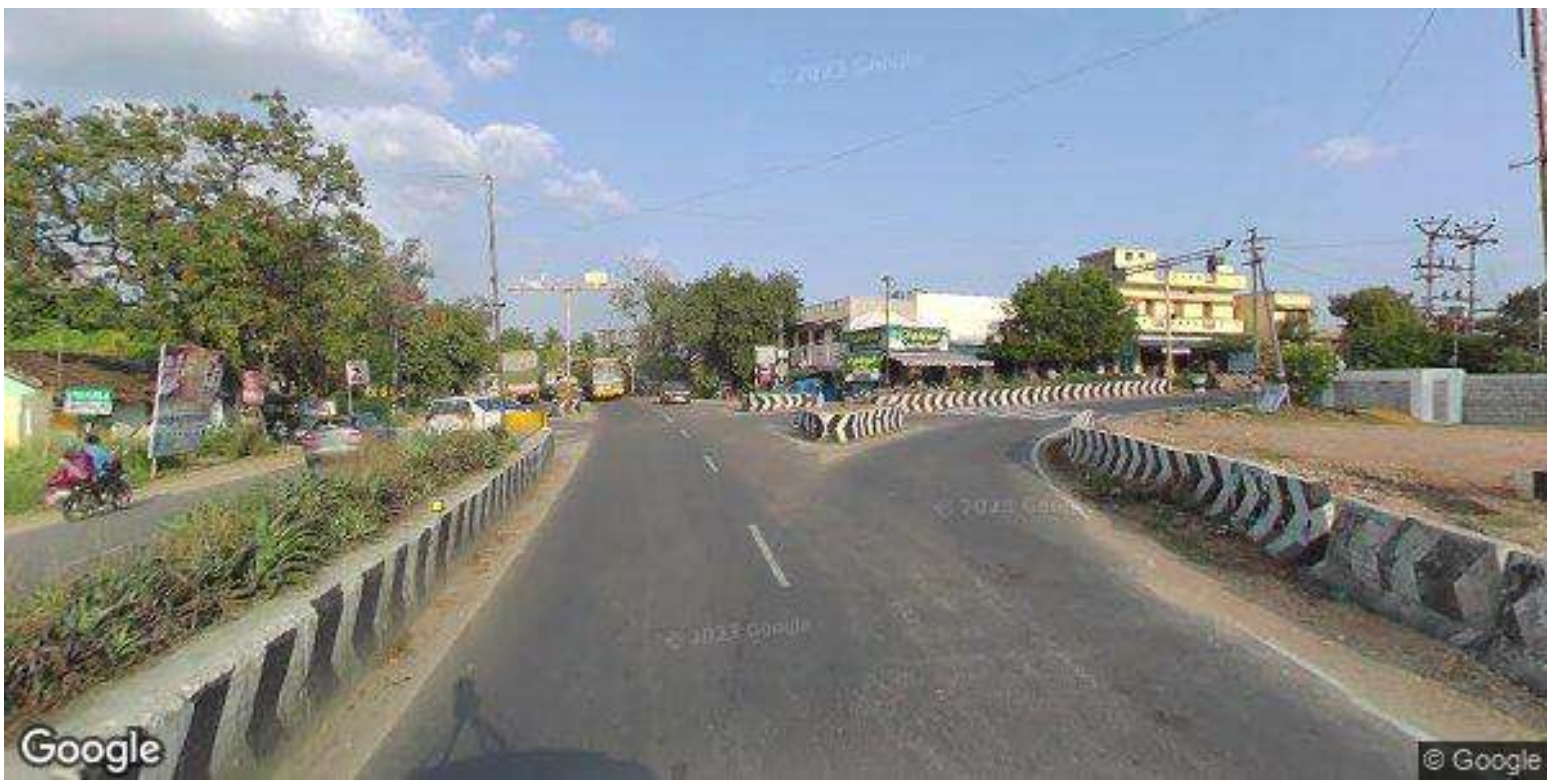
**Risk Type:** Turn  
**Risk Level:** Medium  
**Speed Limit:** 30 KM/Hr  
**Coordinates:** 11.46318, 77.84913

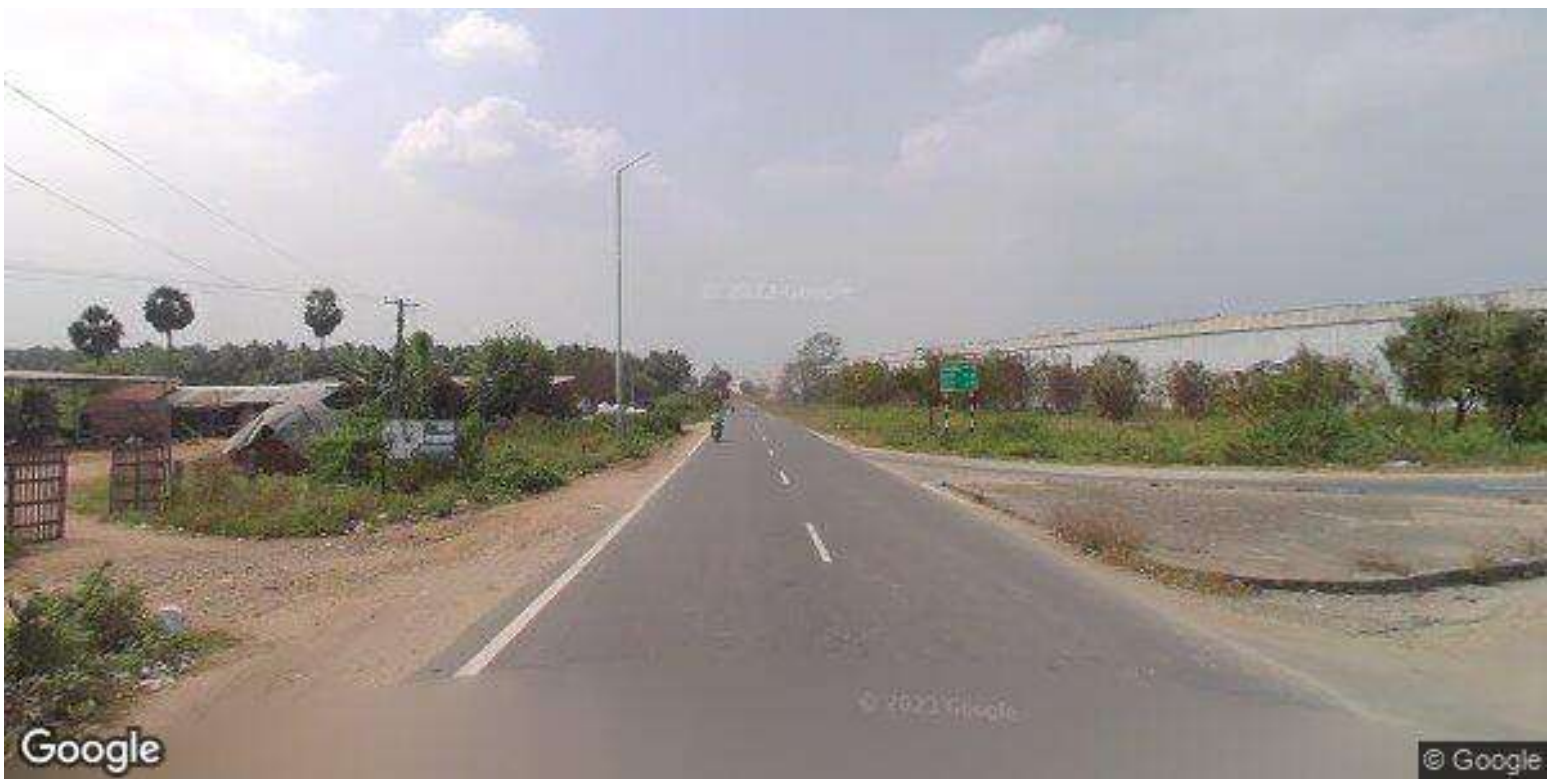
**Risk Type:** Turn  
**Risk Level:** High  
**Speed Limit:** 15 KM/Hr  
**Coordinates:** 11.45542, 77.81725

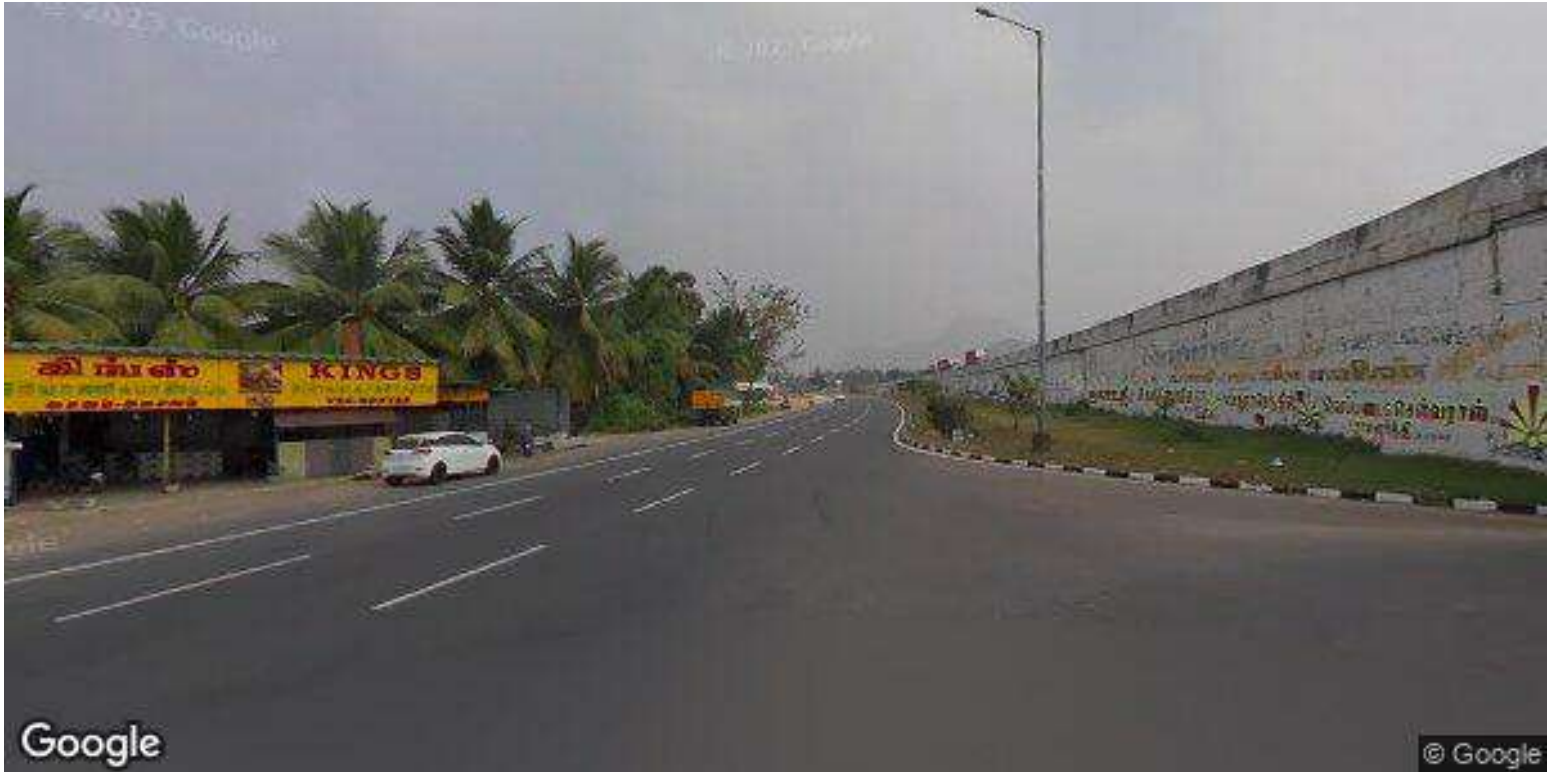
**Risk Type:** Turn  
**Risk Level:** High  
**Speed Limit:** 15 KM/Hr  
**Coordinates:** 11.45634, 77.81673

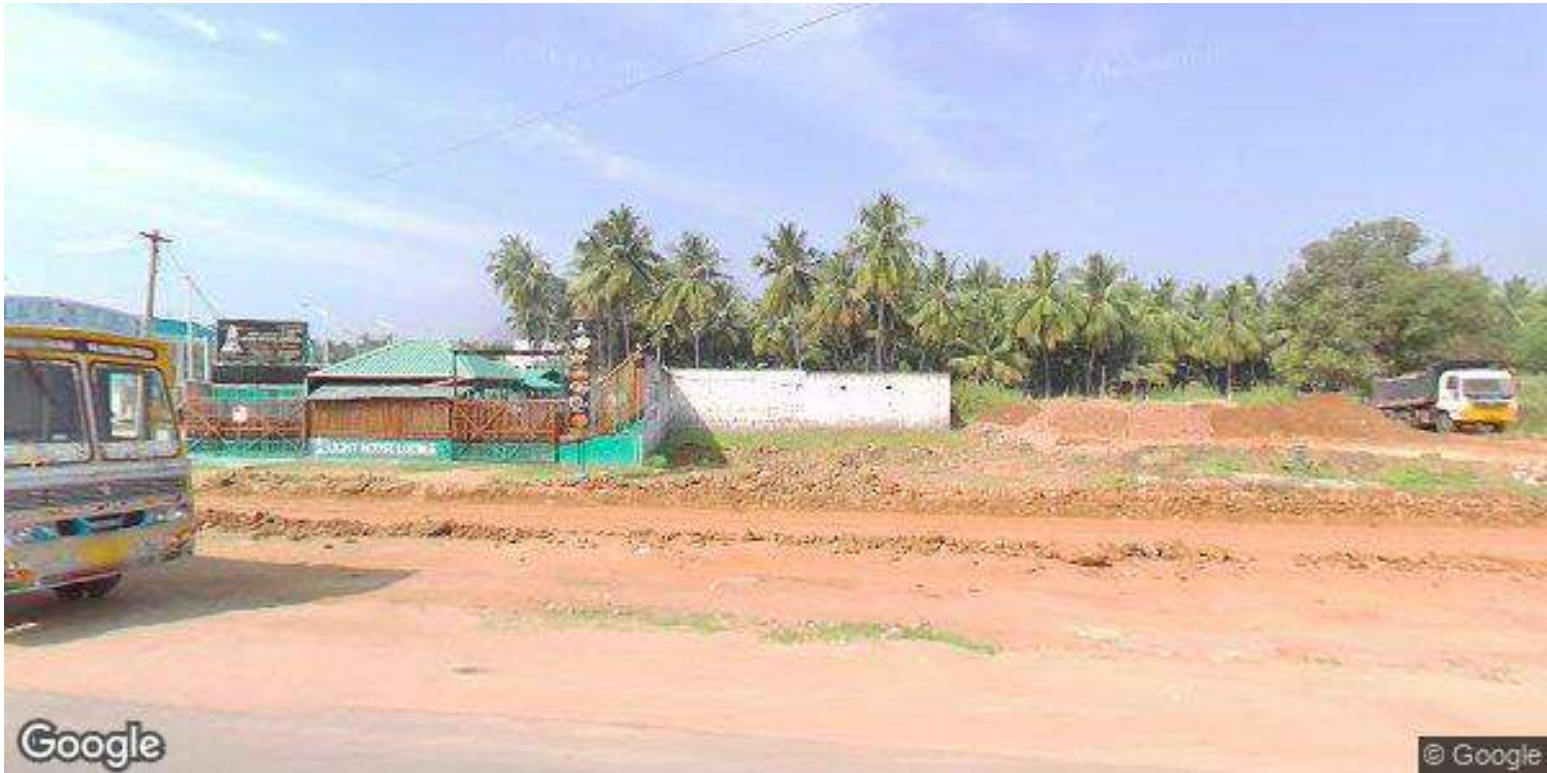
**Risk Type:** Turn  
**Risk Level:** Medium  
**Speed Limit:** 30 KM/Hr  
**Coordinates:** 11.61736, 78.10588

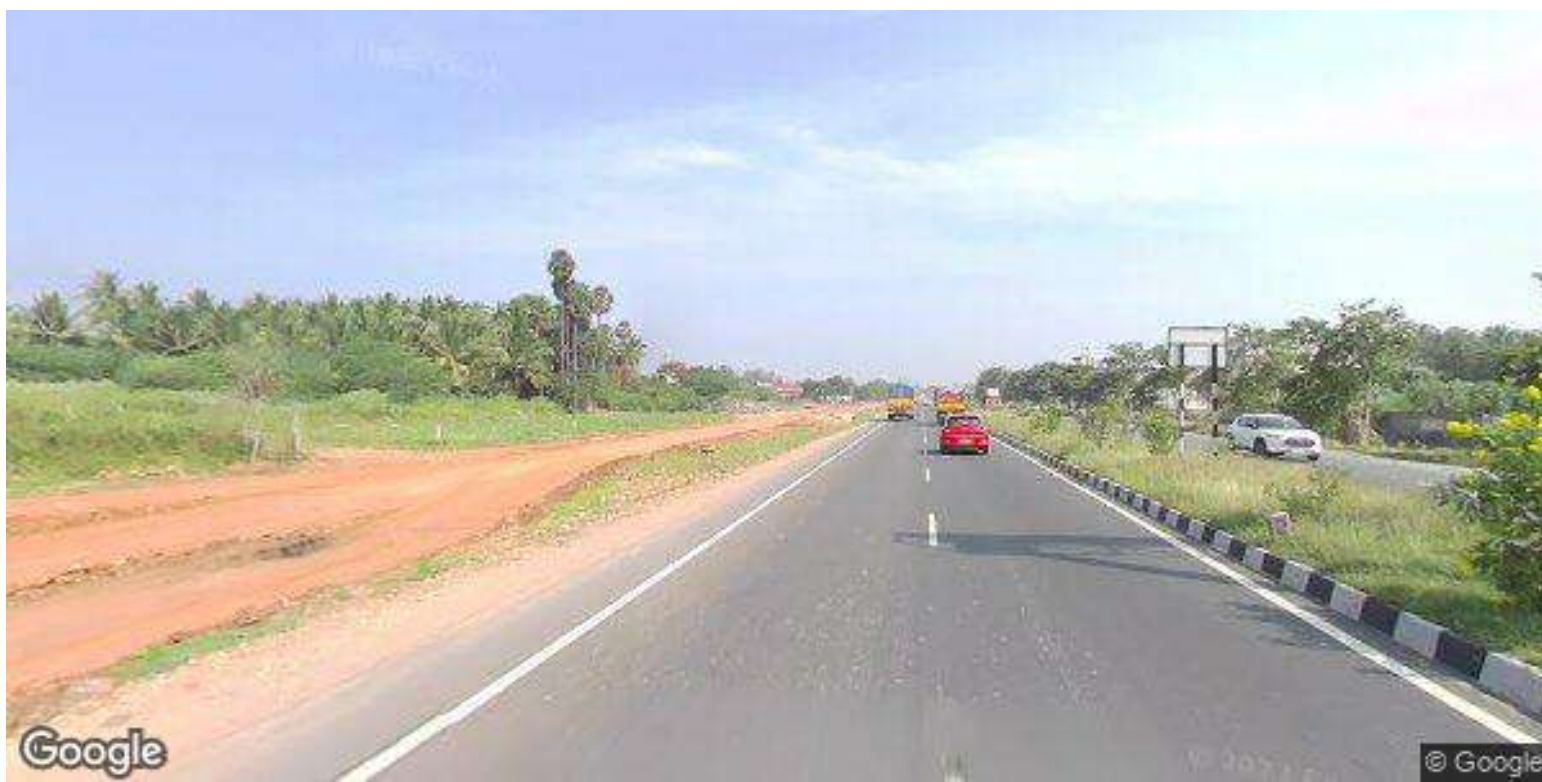
**Risk Type:** Turn

**Risk Level:** Medium

**Speed Limit:** 30 KM/Hr

**Coordinates:** 11.61753, 78.10608

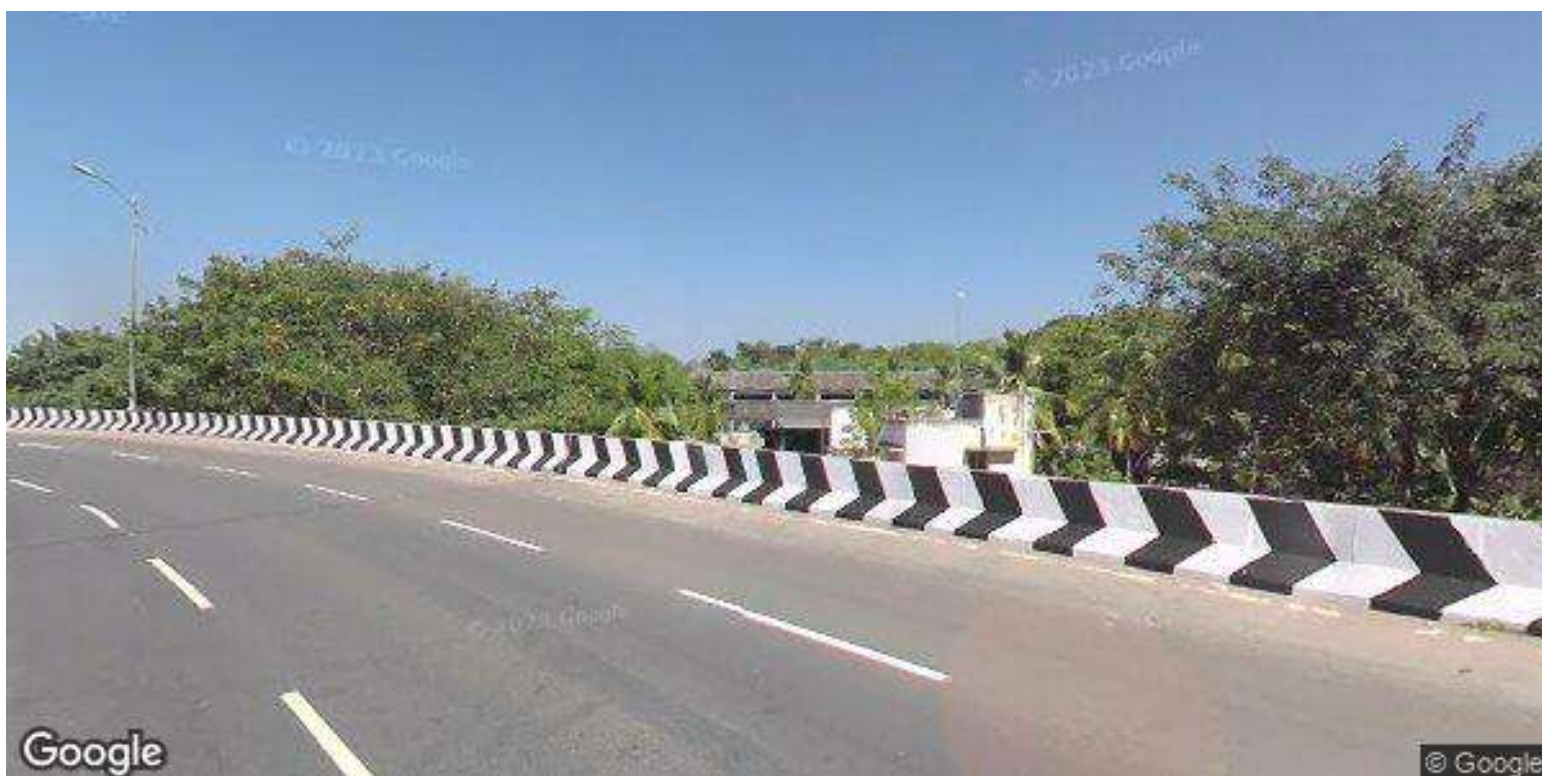
**Risk Type:** Turn

**Risk Level:** Medium

**Speed Limit:** 30 KM/Hr

**Coordinates:** 11.64162, 78.12160

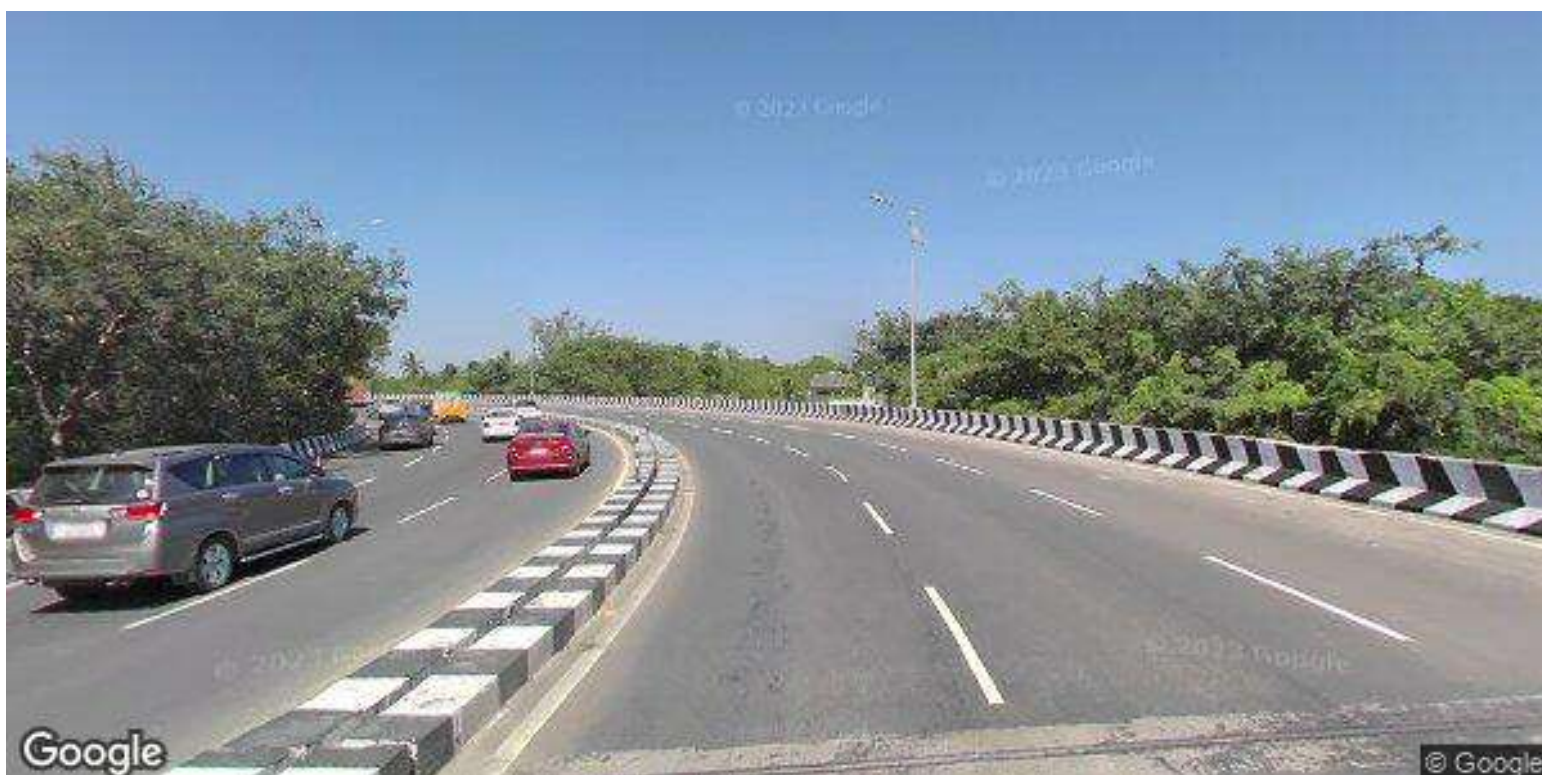
**Risk Type: Turn**

**Risk Level: Medium**

**Speed Limit: 30 KM/Hr**

**Coordinates: 11.64120, 78.12168**

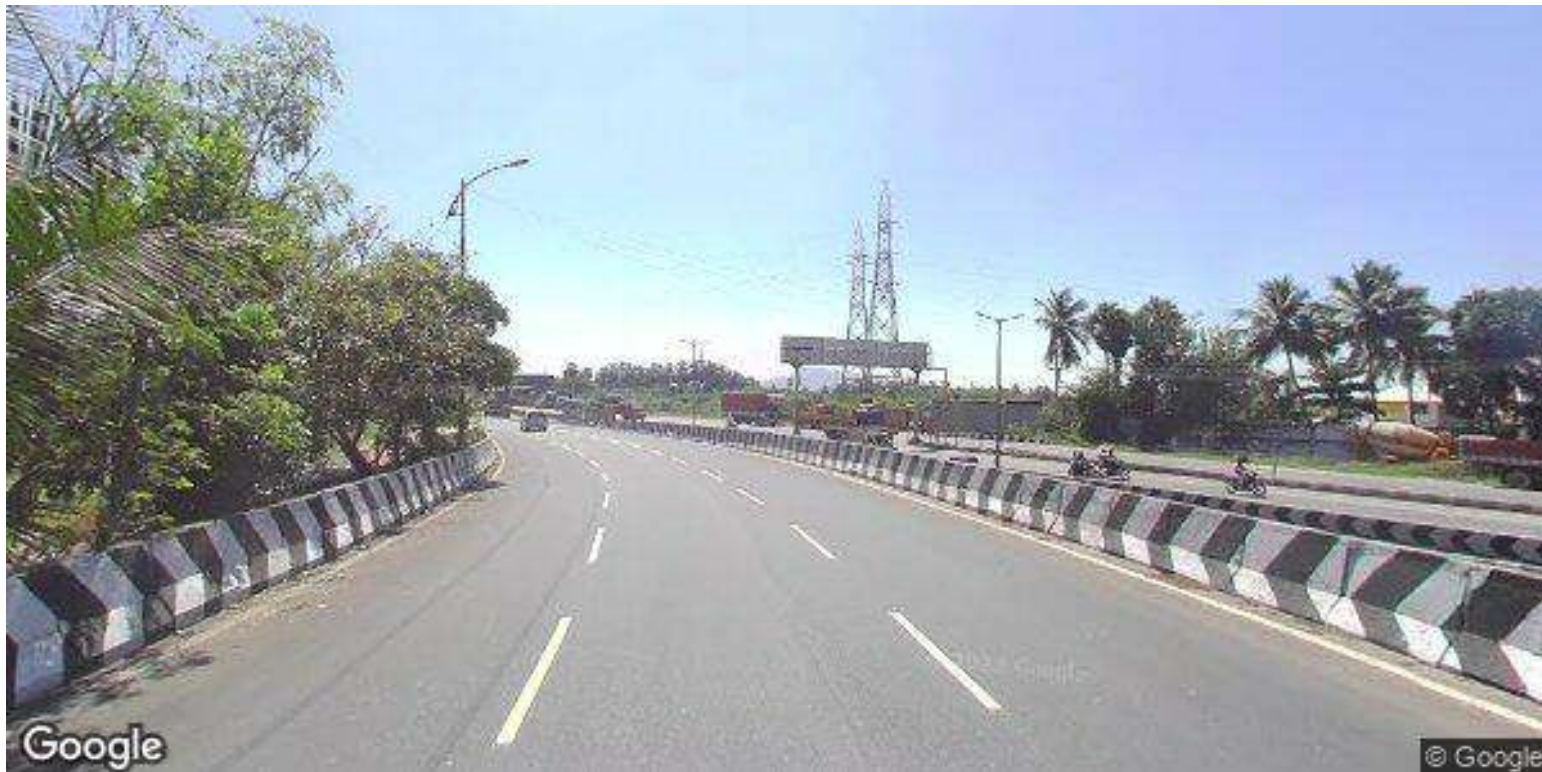
**Risk Type: Turn**

**Risk Level: Medium**

**Speed Limit: 30 KM/Hr**

**Coordinates: 11.63948, 78.12081**

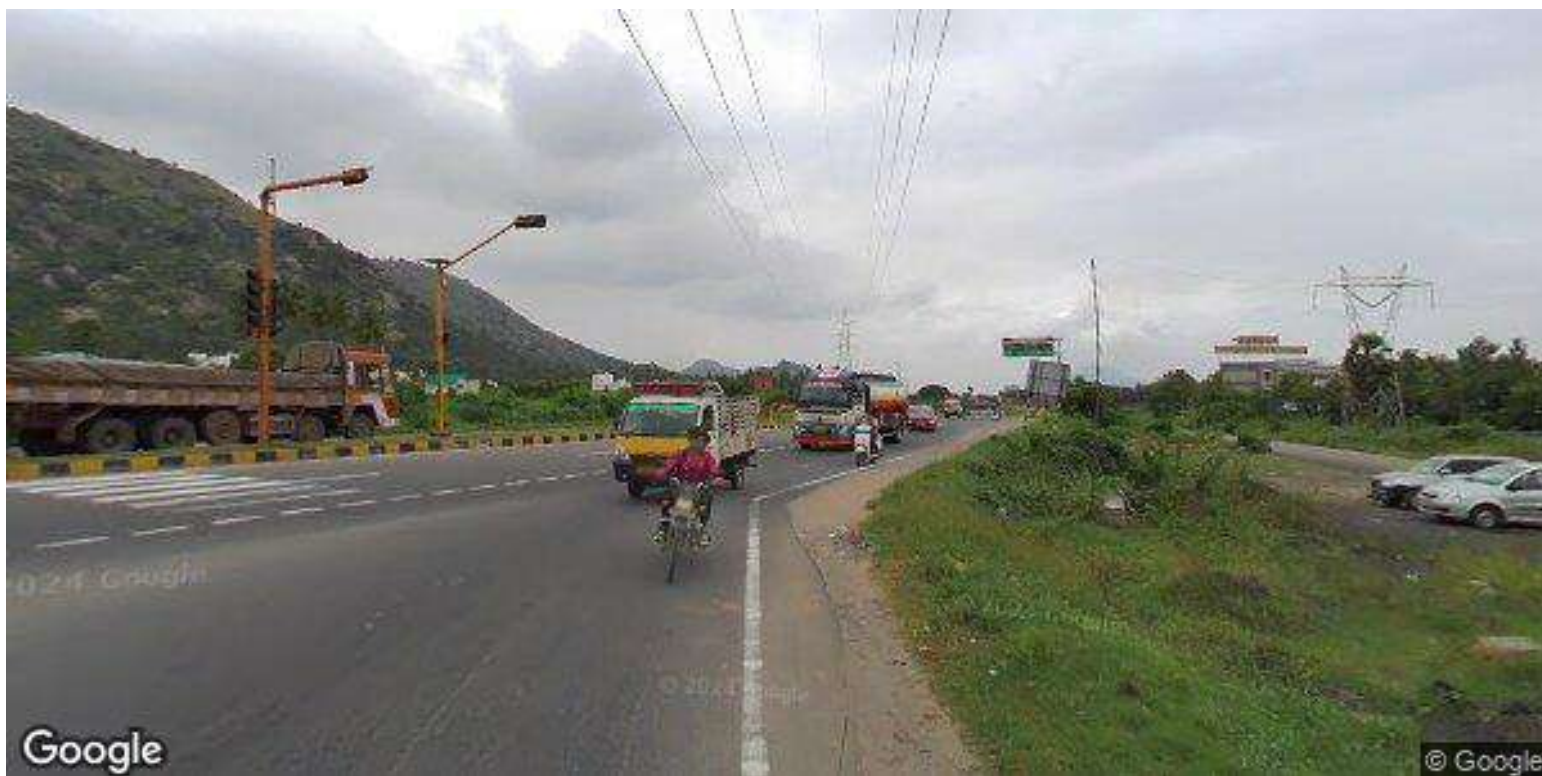
**Risk Type: Turn**

**Risk Level: Medium**

**Speed Limit: 30 KM/Hr**

**Coordinates: 11.65627, 78.20215**
