# IndianOil

## JOURNEY RISK MANAGEMENT (JRM) STUDY

### Salem Terminal TO SENGOTTAIYAN AGENCIES

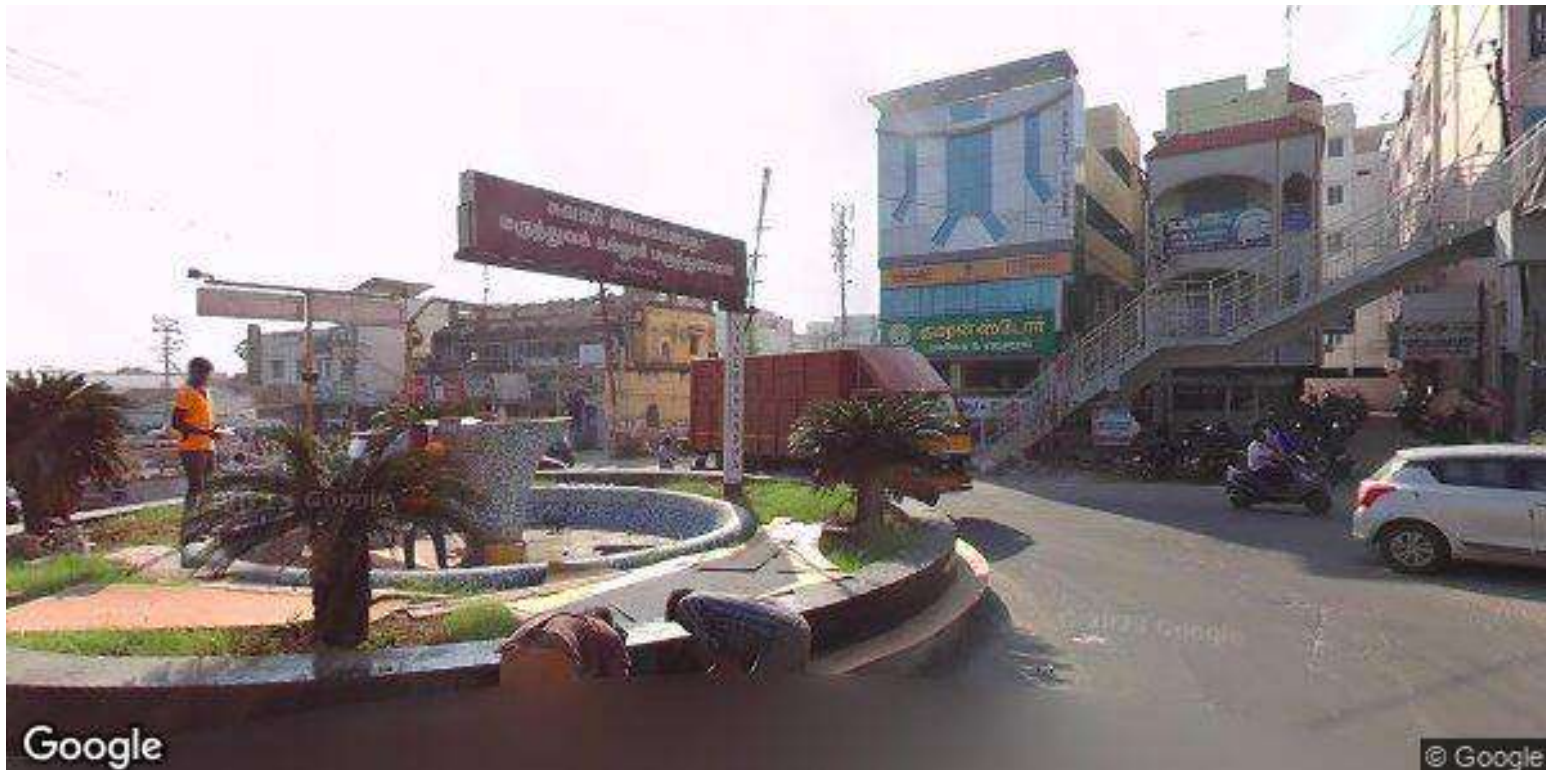
**Coordinates:** 11.38395, 77.89480

| | Risk Type | Risk Level | Coordinates | Speed Limit |
|---|---|---|---|---|
| 0 | Roundabout | High | 11.38395, 77.89480 | 15 KM/Hr |

**Risk Type:** Roundabout

**Risk Level:** High

**Speed Limit:** 15 KM/Hr

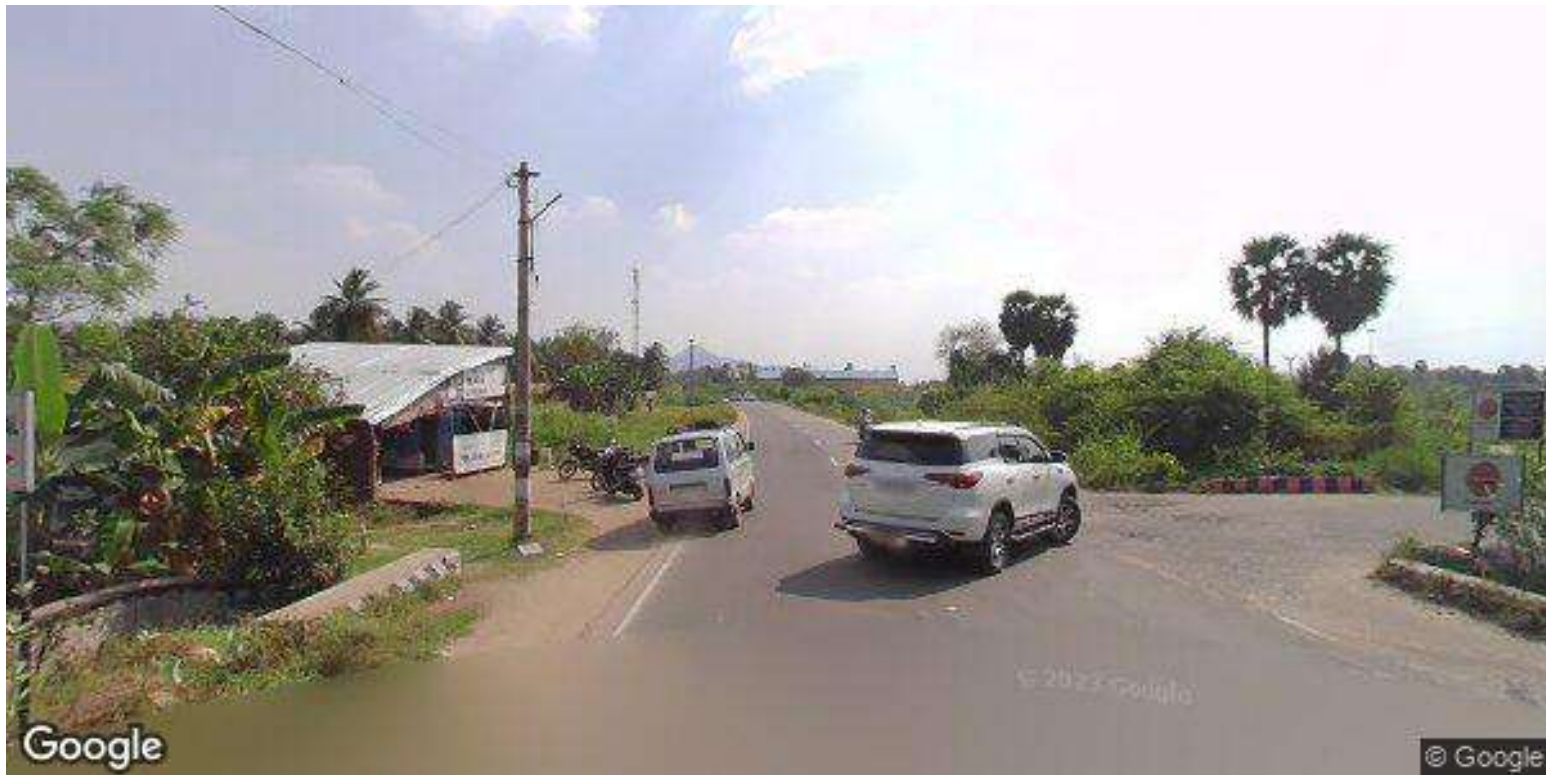
**Coordinates:** 11.44029, 77.87544

| | Risk Type | Risk Level | Coordinates | Speed Limit |
|---|---|---|---|---|
| 4 | Blind Spot | Blind Spot | 11.44029, 77.87544 | 10 KM/Hr |

**Risk Type:** Blind Spot

**Risk Level:** Blind Spot

**Speed Limit:** 10 KM/Hr

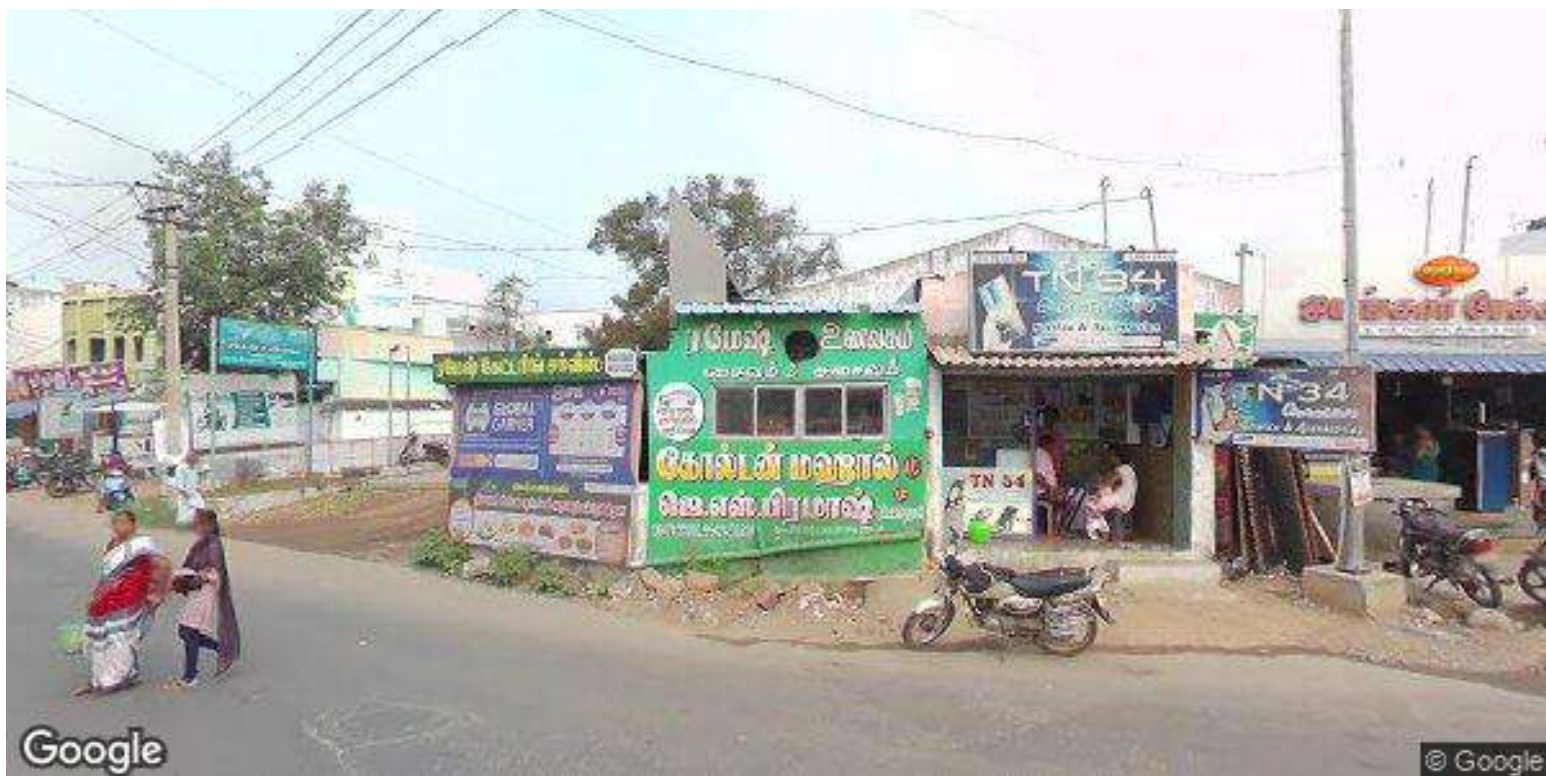
**Coordinates:** 11.38346, 77.89975

| | Risk Type | Risk Level | Coordinates | Speed Limit |
|---|---|---|---|---|
| 5 | Turn | Medium | 11.38346, 77.89975 | 30 KM/Hr |

**Risk Type:** Turn

**Risk Level:** Medium

**Speed Limit:** 30 KM/Hr

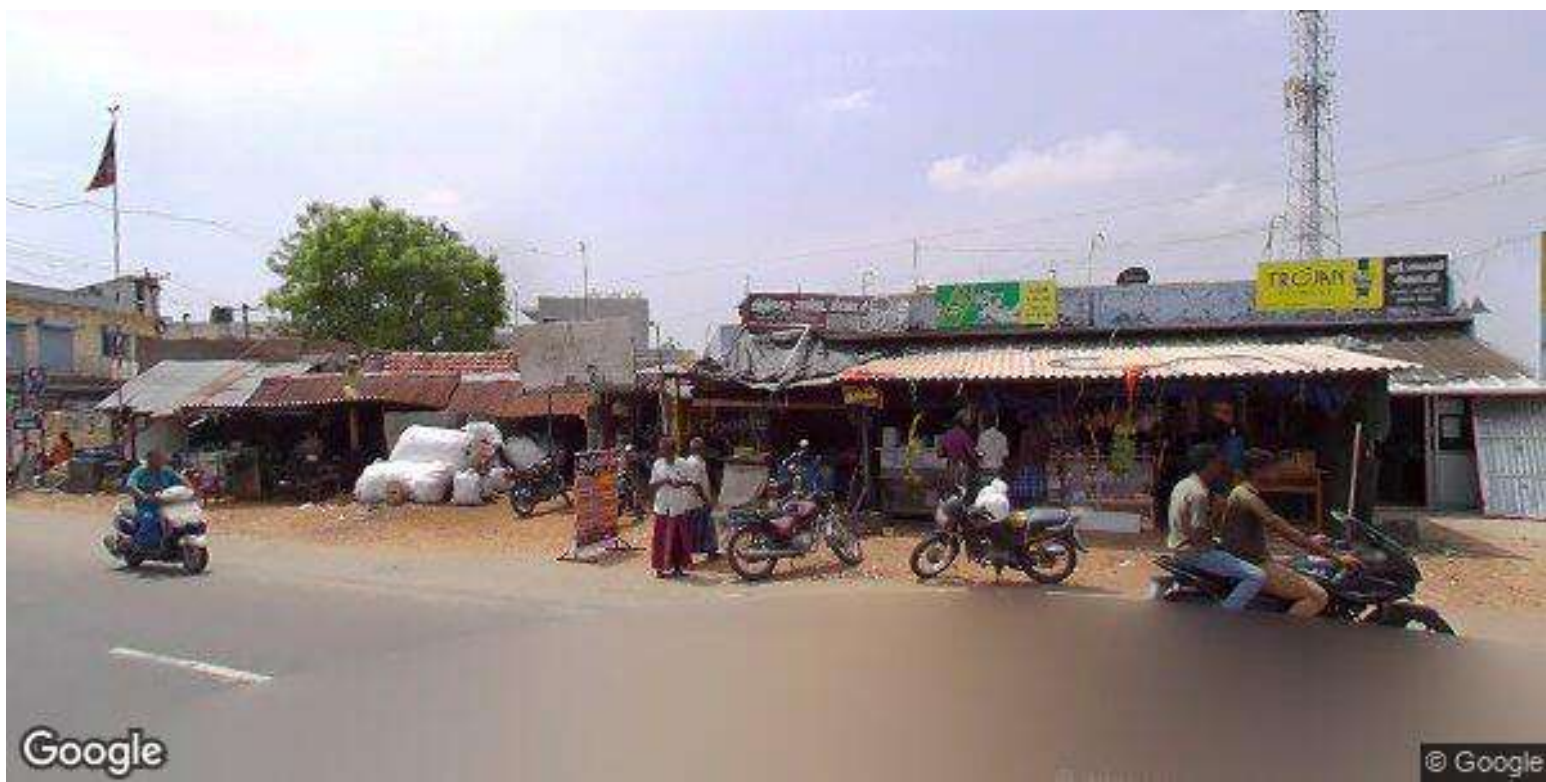
**Coordinates:** 11.44387, 77.96283

| | Risk Type | Risk Level | Coordinates | Speed Limit |
|---|---|---|---|---|
| 6 | Blind Spot | Blind Spot | 11.44387, 77.96283 | 10 KM/Hr |

**Risk Type:** Blind Spot

**Risk Level:** Blind Spot

**Speed Limit:** 10 KM/Hr

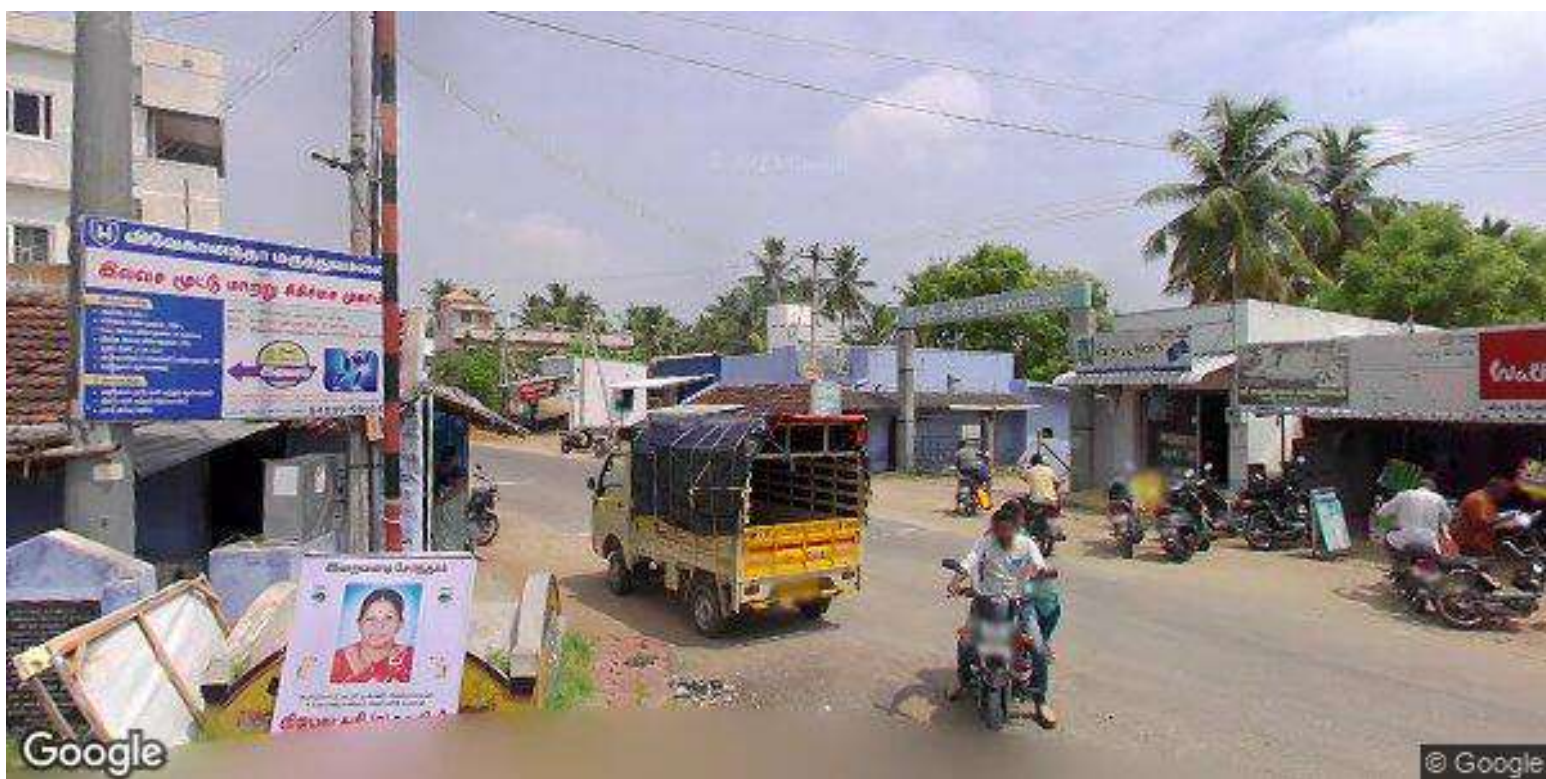
**Coordinates:** 11.44391, 77.96278

| | Risk Type | Risk Level | Coordinates | Speed Limit |
|---|---|---|---|---|
| 7 | Blind Spot | Blind Spot | 11.44391, 77.96278 | 10 KM/Hr |

**Risk Type:** Blind Spot

**Risk Level:** Blind Spot

**Speed Limit:** 10 KM/Hr

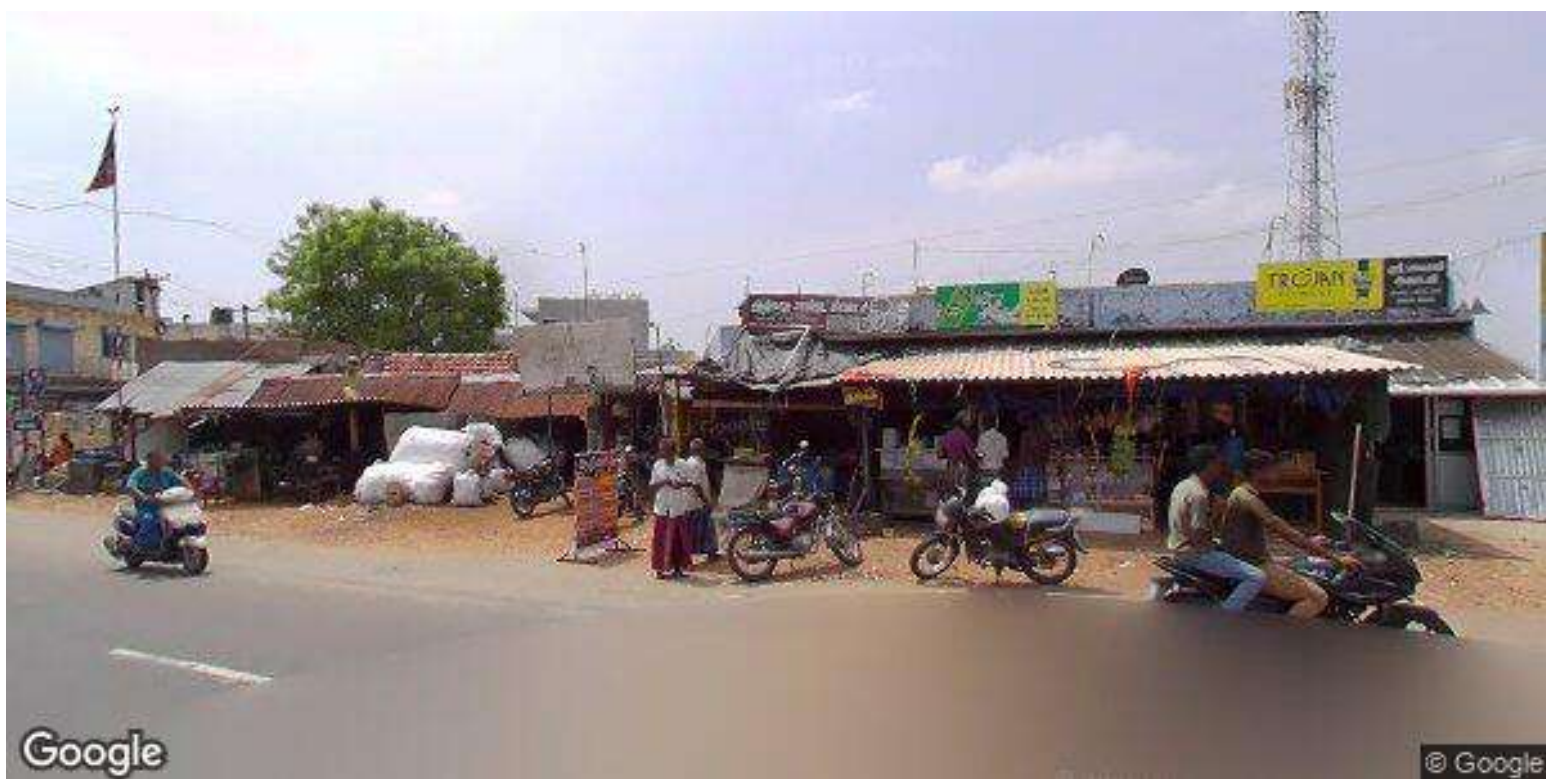
**Coordinates:** 11.44387, 77.96283

| | Risk Type | Risk Level | Coordinates | Speed Limit |
|---|---|---|---|---|
| 8 | Turn | High | 11.44387, 77.96283 | 15 KM/Hr |

**Risk Type:** Turn

**Risk Level:** High

**Speed Limit:** 15 KM/Hr
