## JOURNEY RISK MANAGEMENT (JRM) STUDY

### Salem Terminal TO VELU SERVICE STN.

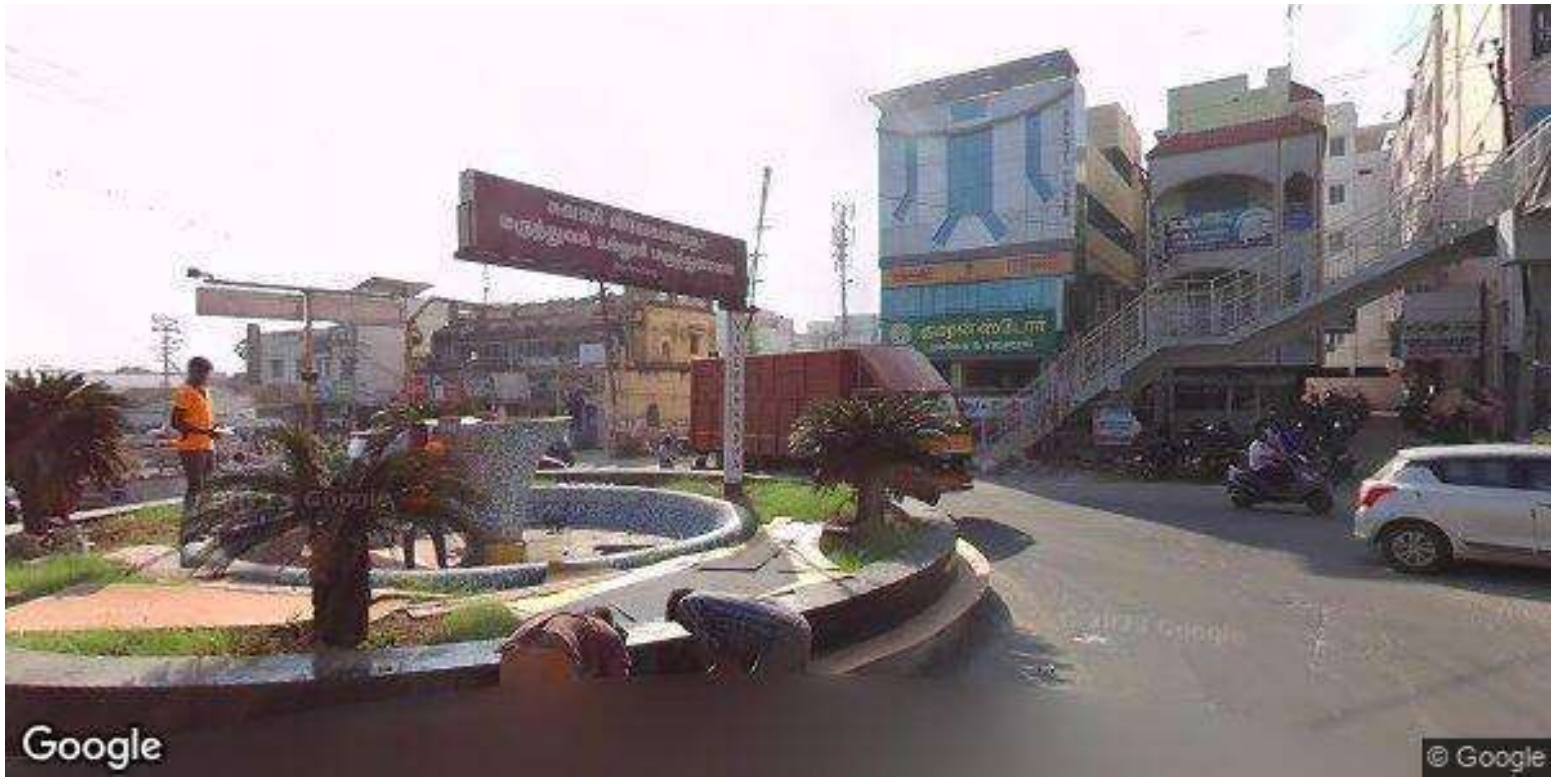
Risk Type: Roundabout  
Risk Level: High  
Speed Limit: 15 KM/Hr  
Coordinates: 11.38395, 77.89480

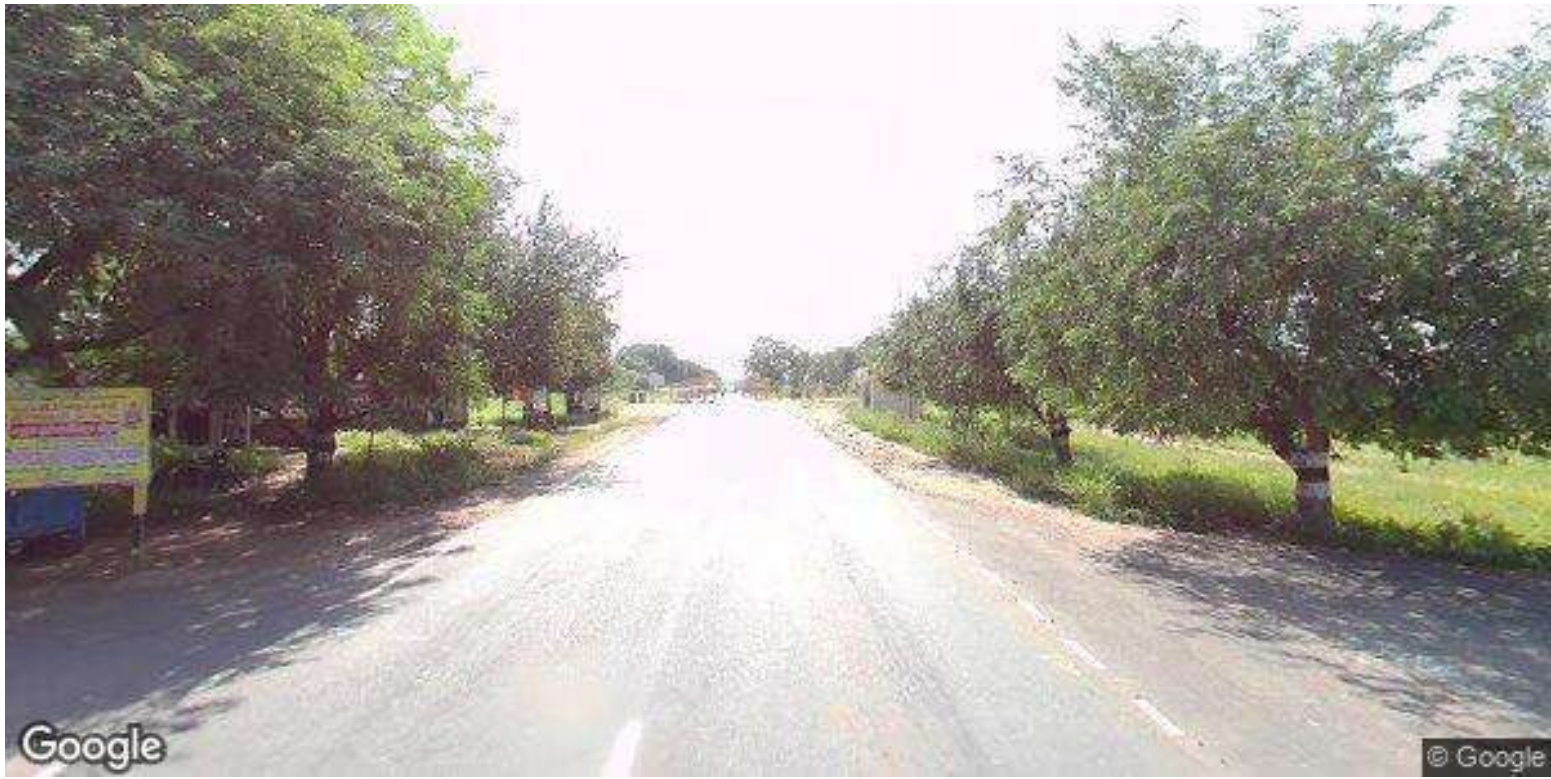
Risk Type: U-Turn  
Risk Level: High  
Speed Limit: 10 KM/Hr  
Coordinates: 11.1045639, 78.2397434

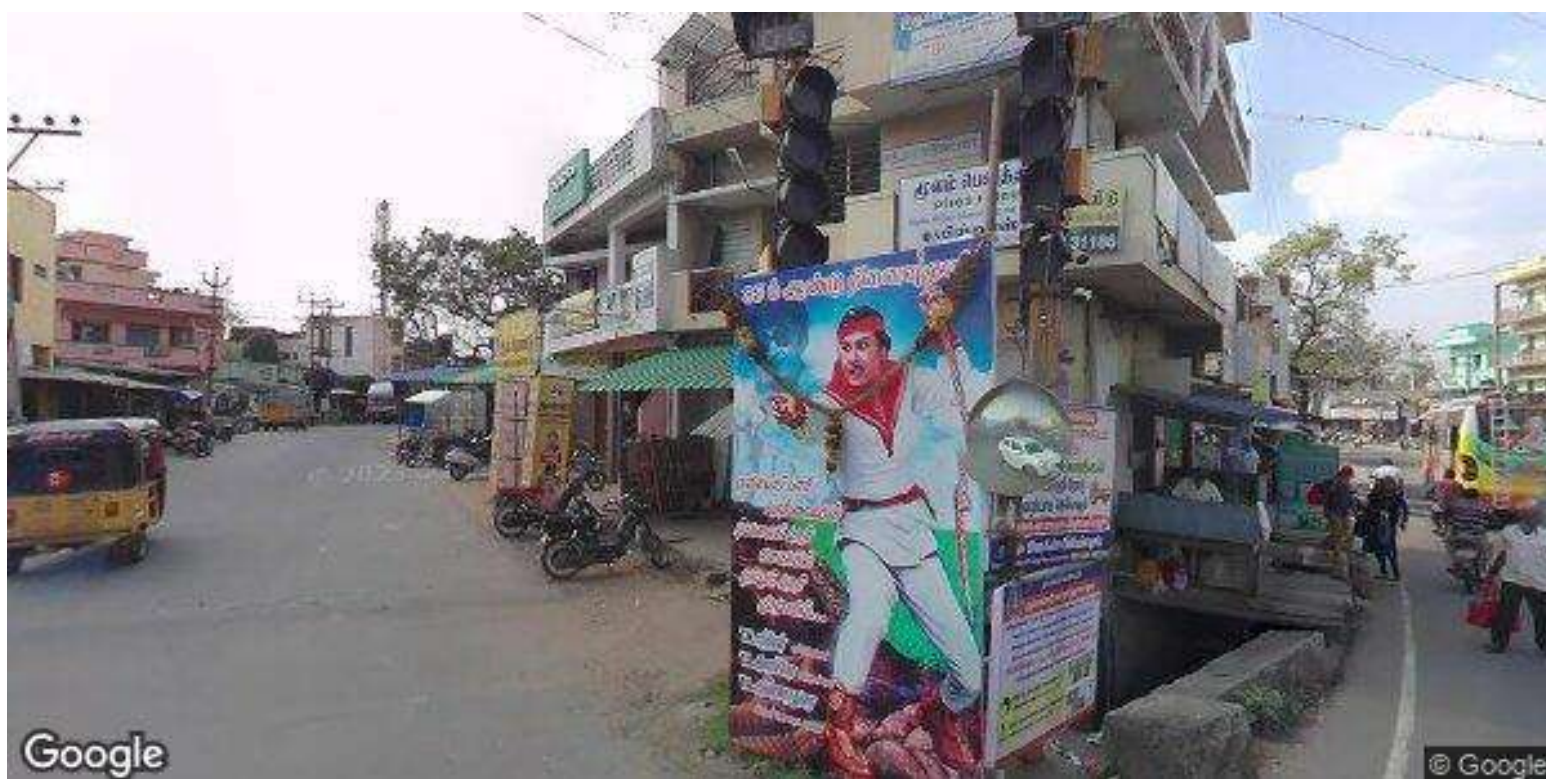
**Coordinates:** 11.38342, 77.89975

**Risk Type:** Turn

**Risk Level:** Medium

**Speed Limit:** 30 KM/Hr

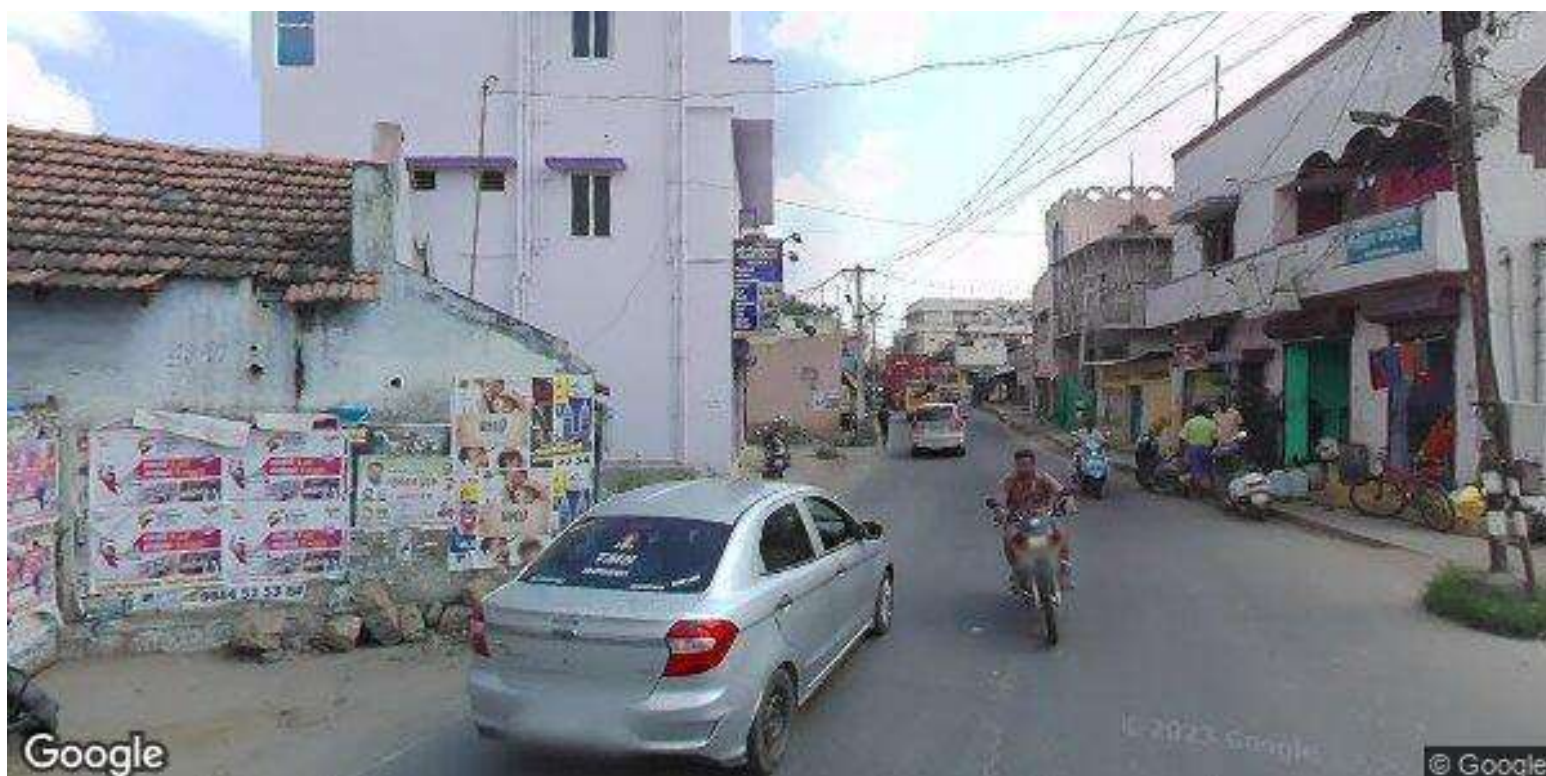
**Risk Type:** Turn  
**Risk Level:** Medium  
**Speed Limit:** 30 KM/Hr  
**Coordinates:** 11.38295, 77.90001

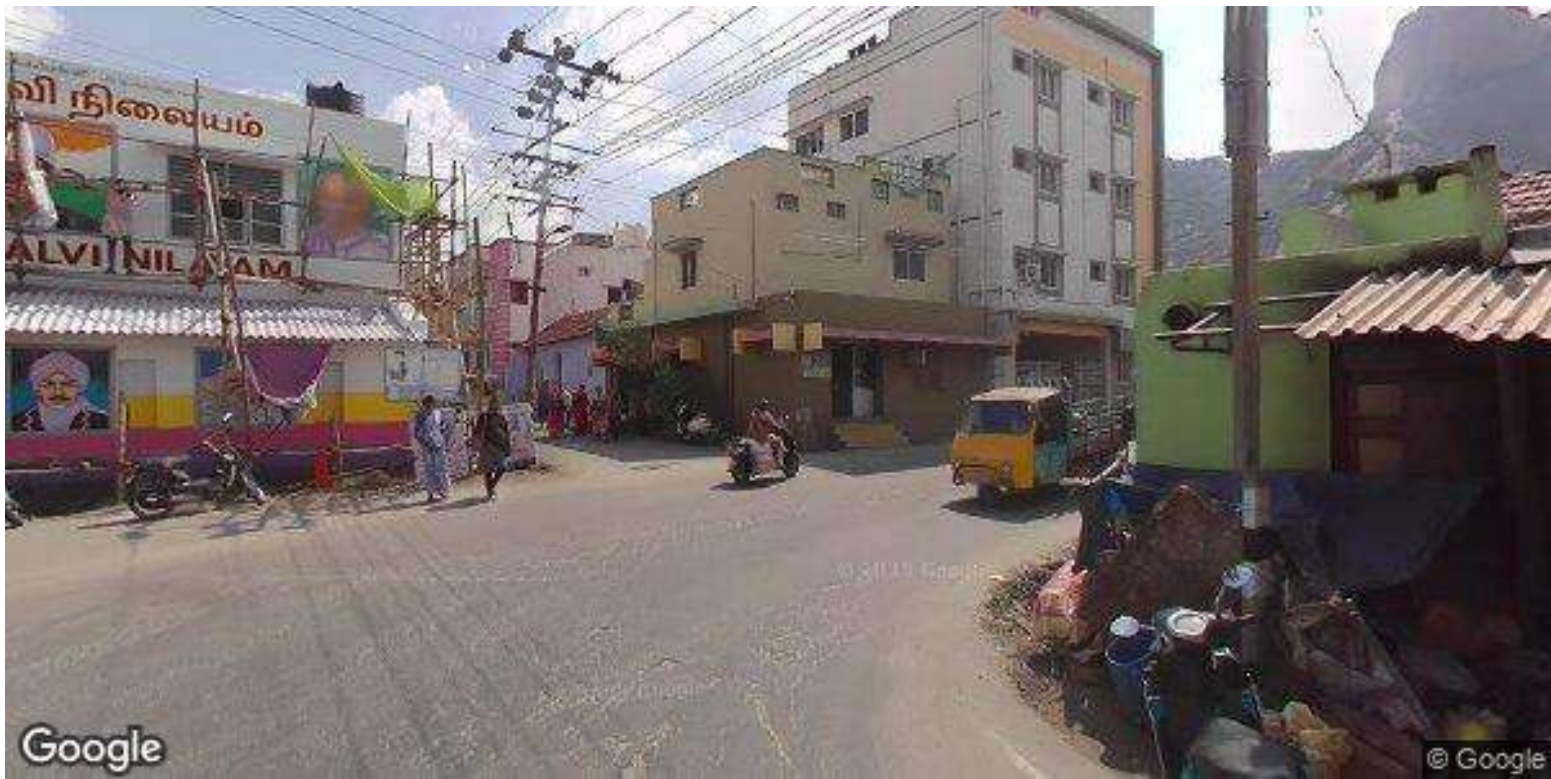
**Risk Type:** Turn  
**Risk Level:** High  
**Speed Limit:** 15 KM/Hr  
**Coordinates:** 11.38186, 77.90258

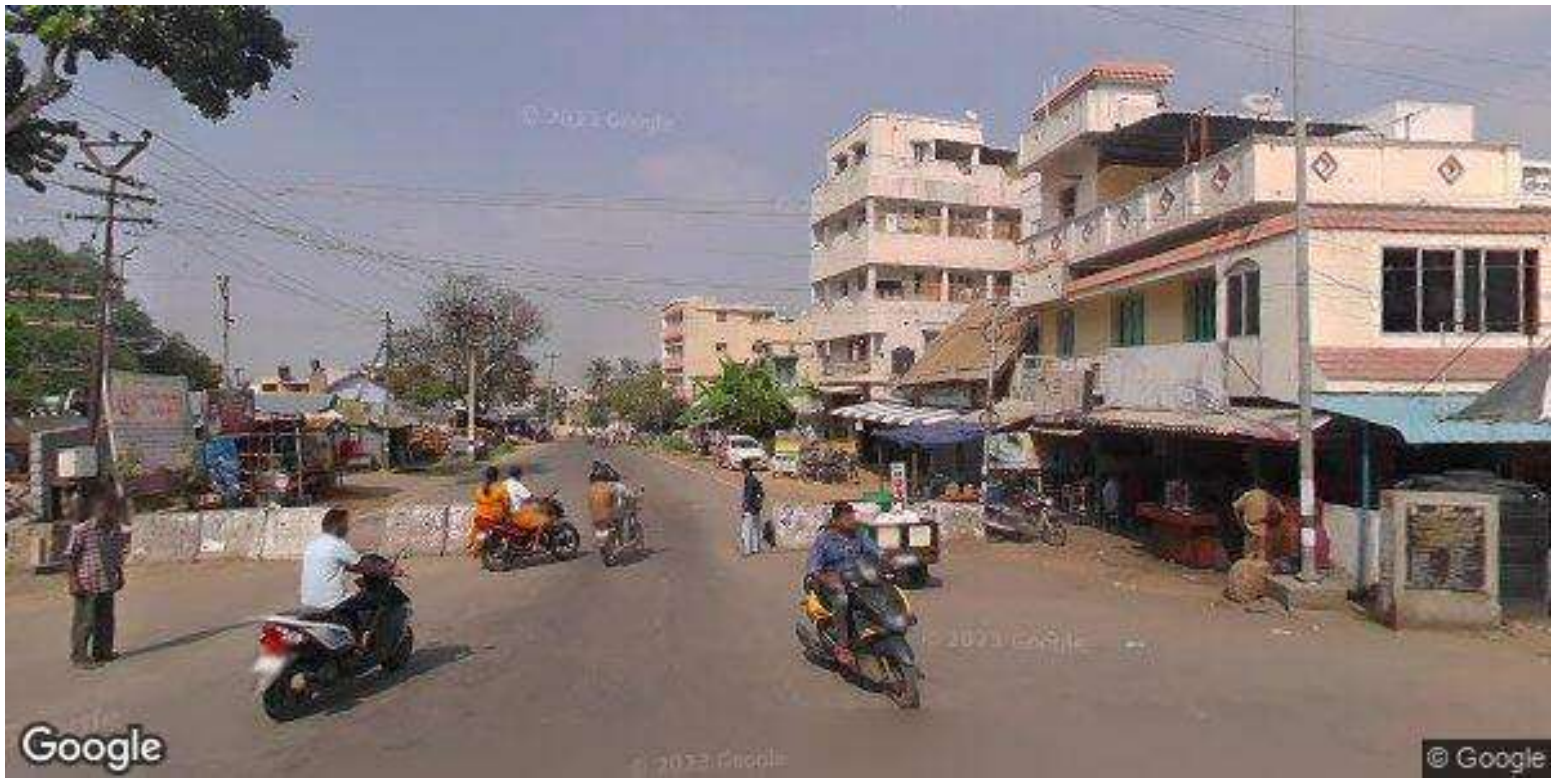
**Risk Type:** Blind Spot  
**Risk Level:** Blind Spot  
**Speed Limit:** 10 KM/Hr  
**Coordinates:** 11.37841, 77.90140

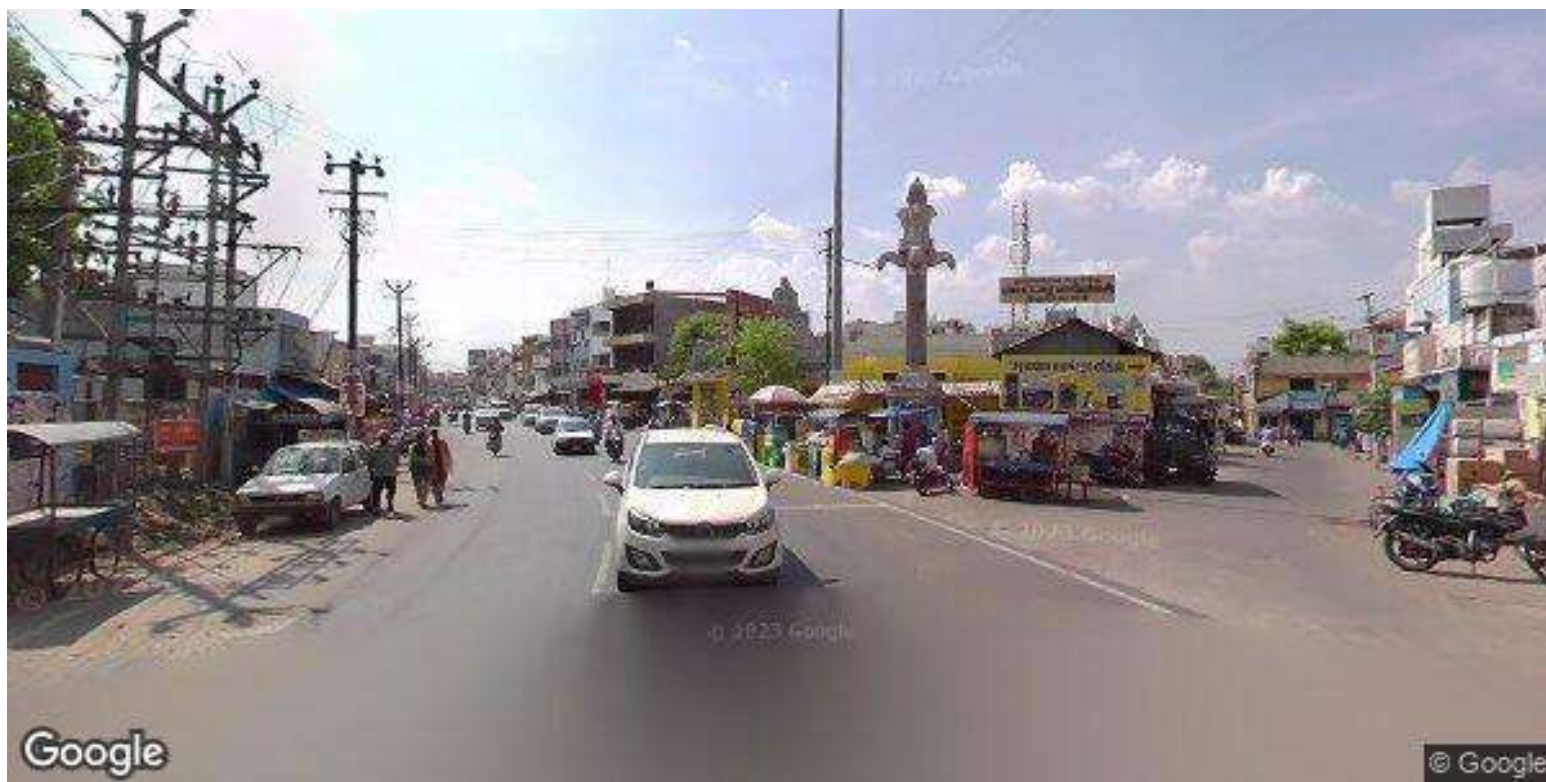
**Coordinates:** 11.22411, 78.16637

**Risk Type:** Turn

**Risk Level:** Medium

**Speed Limit:** 30 KM/Hr

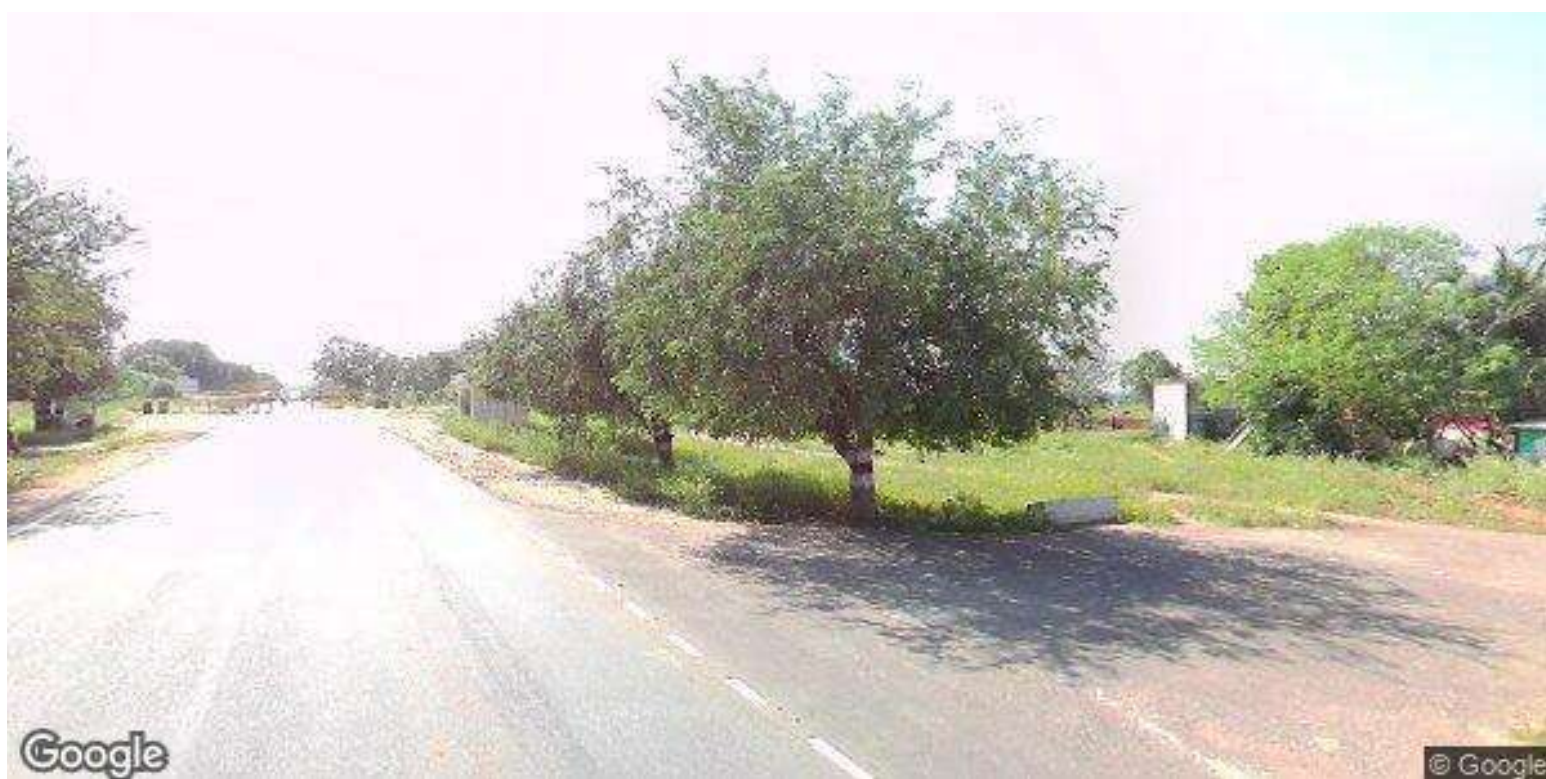
**Coordinates:** 11.10456, 78.23974

**Risk Type:** Turn

**Risk Level:** High

**Speed Limit:** 15 KM/Hr

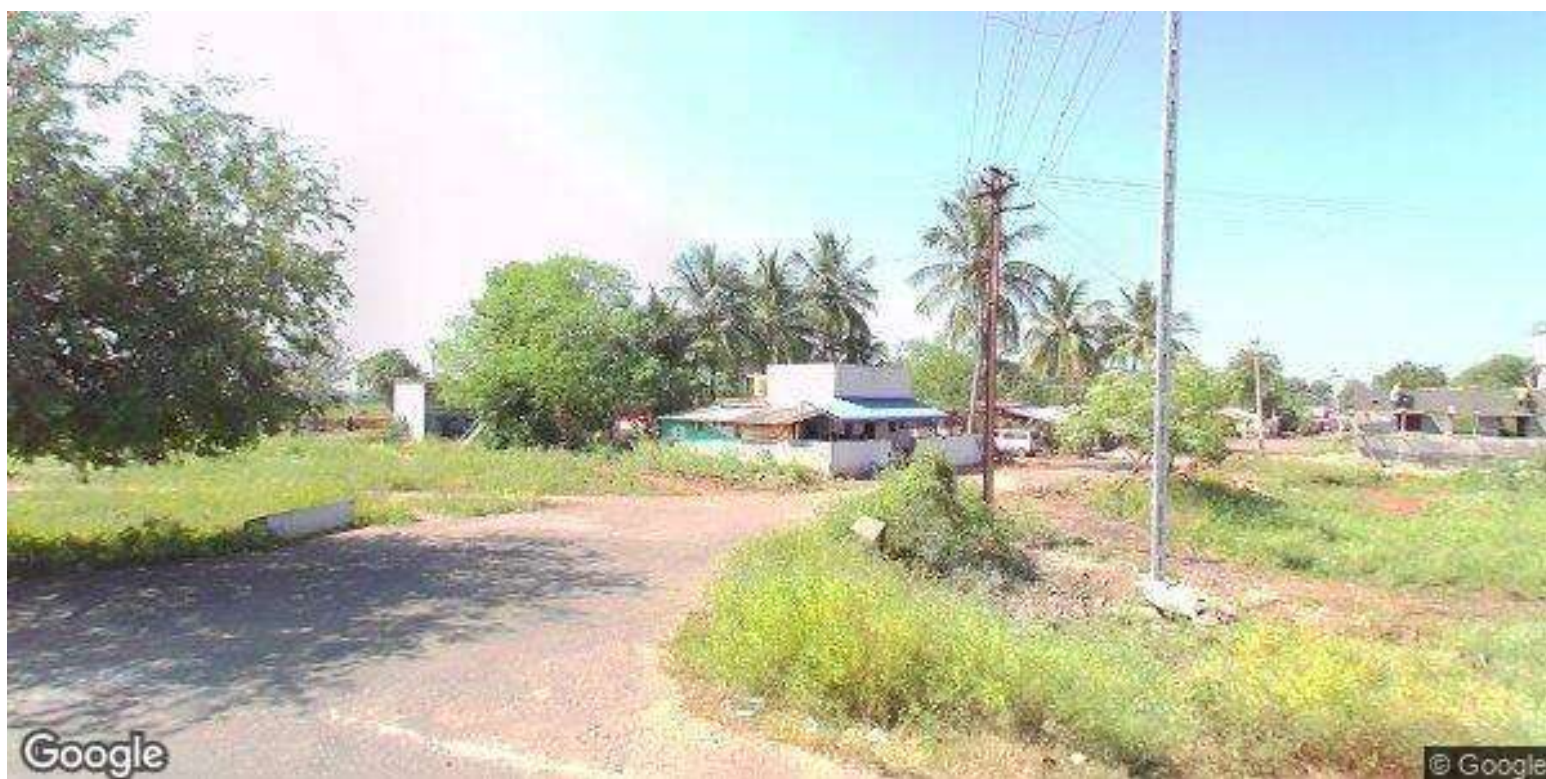
**Coordinates:** 11.10453, 78.23967

**Risk Type:** Blind Spot

**Risk Level:** Blind Spot

**Speed Limit:** 10 KM/Hr

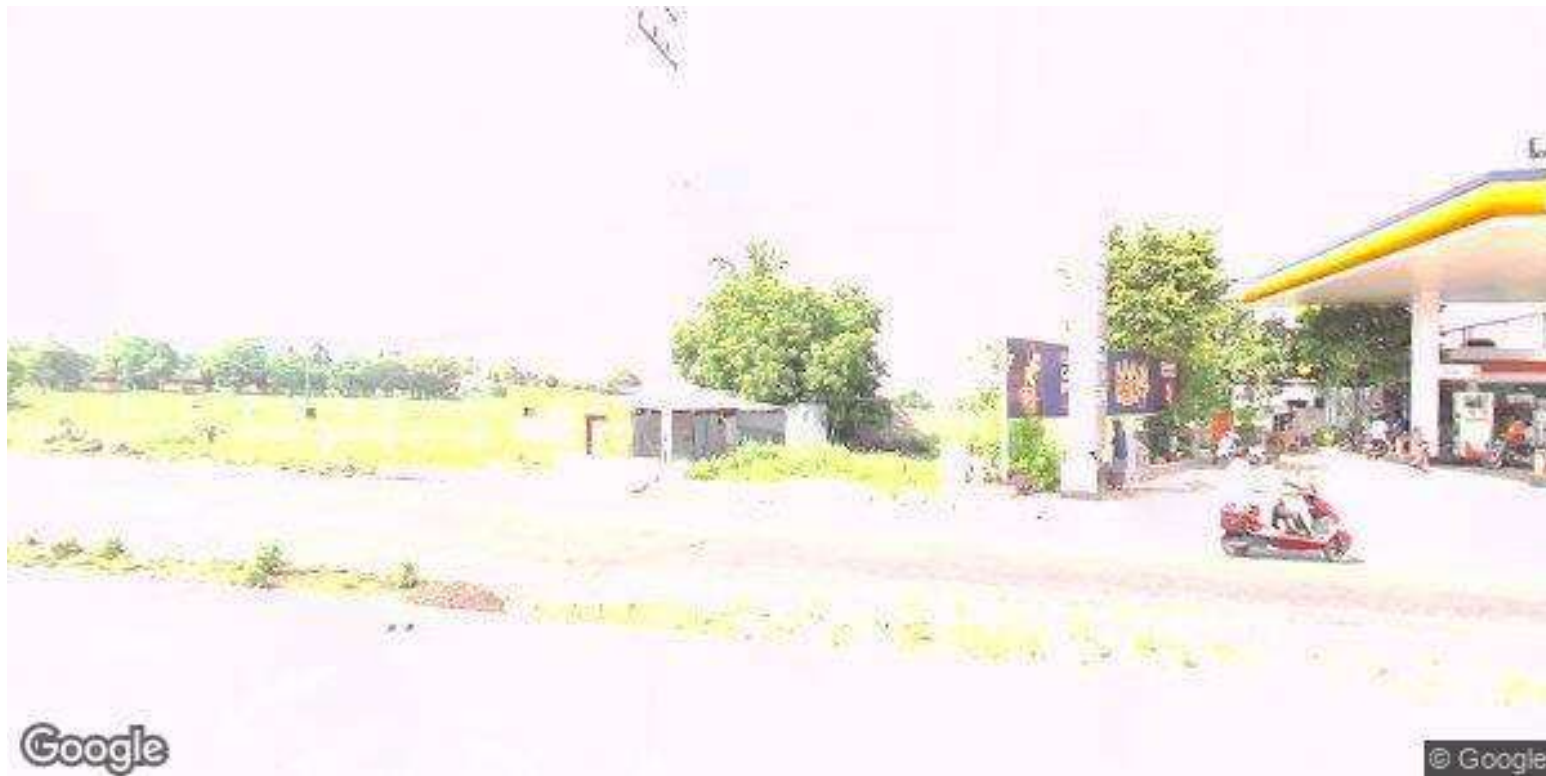
**Coordinates:** 11.10607, 78.23912

**Risk Type:** Turn

**Risk Level:** Medium

**Speed Limit:** 30 KM/Hr

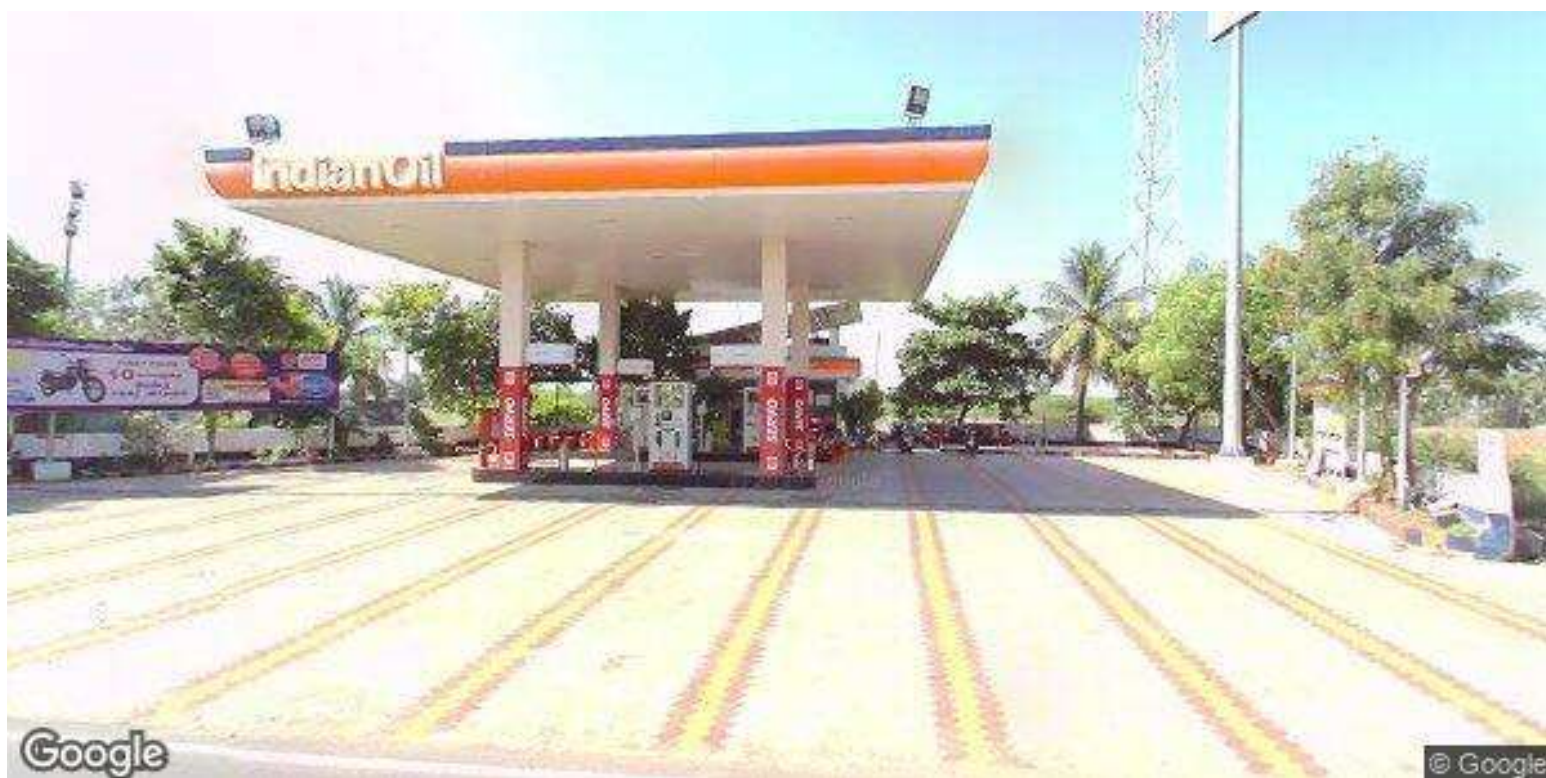
**Coordinates:** 11.10620, 78.23888

**Risk Type:** Turn

**Risk Level:** High

**Speed Limit:** 15 KM/Hr
