## JOURNEY RISK MANAGEMENT (JRM) STUDY

### Salem Terminal to PALANI VELAYUDAM TRADERS

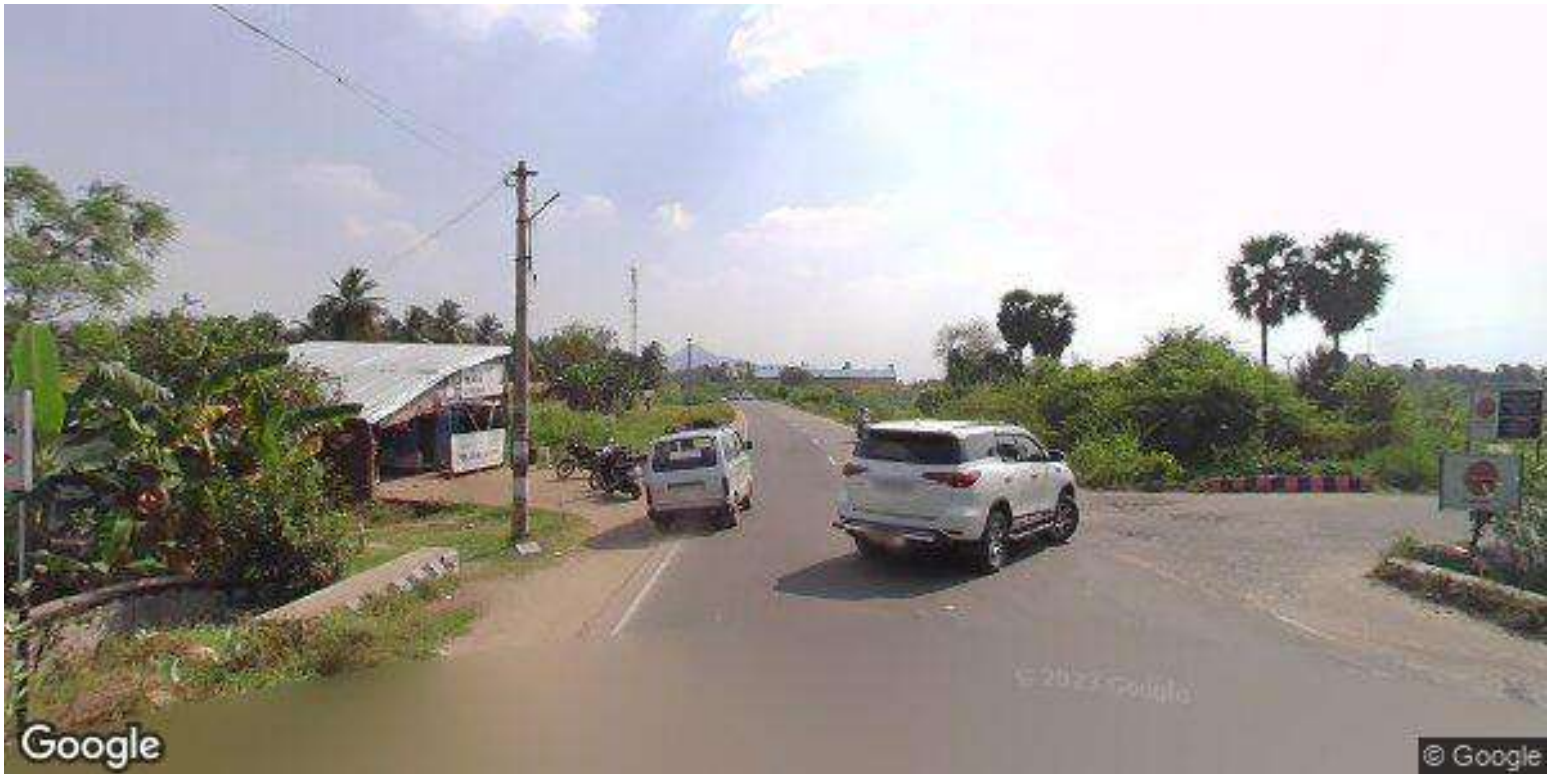
Coordinates: 11.44029, 77.87544

Risk Type: Turn

Risk Level: High

Speed Limit: 15 KM/Hr

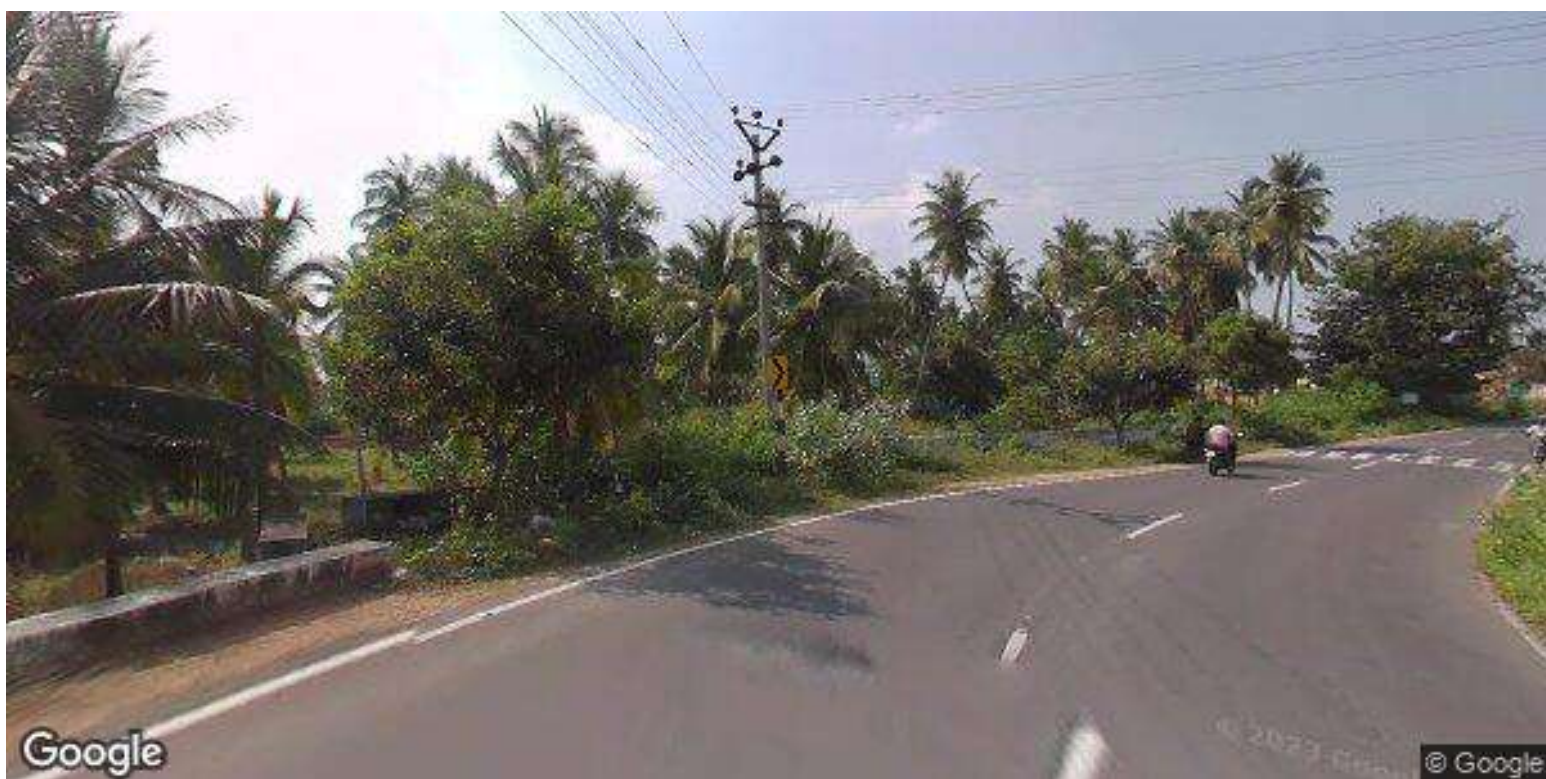
**Coordinates: 11.45348, 77.85706**

**Risk Type: Turn**

**Risk Level: Medium**

**Speed Limit: 30 KM/Hr**

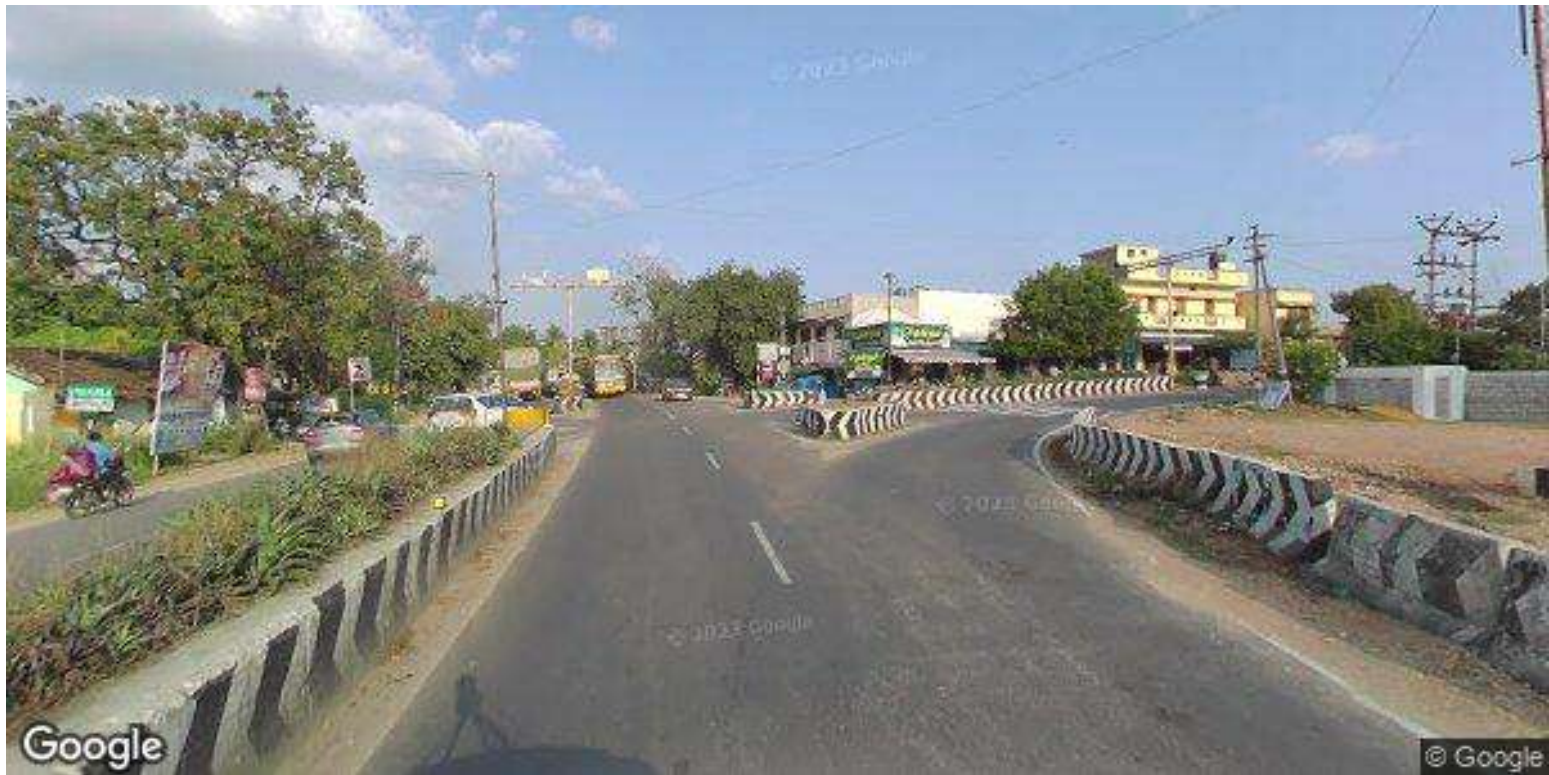
**Coordinates: 11.46318, 77.84913**

**Risk Type: Turn**

**Risk Level: Medium**

**Speed Limit: 30 KM/Hr**

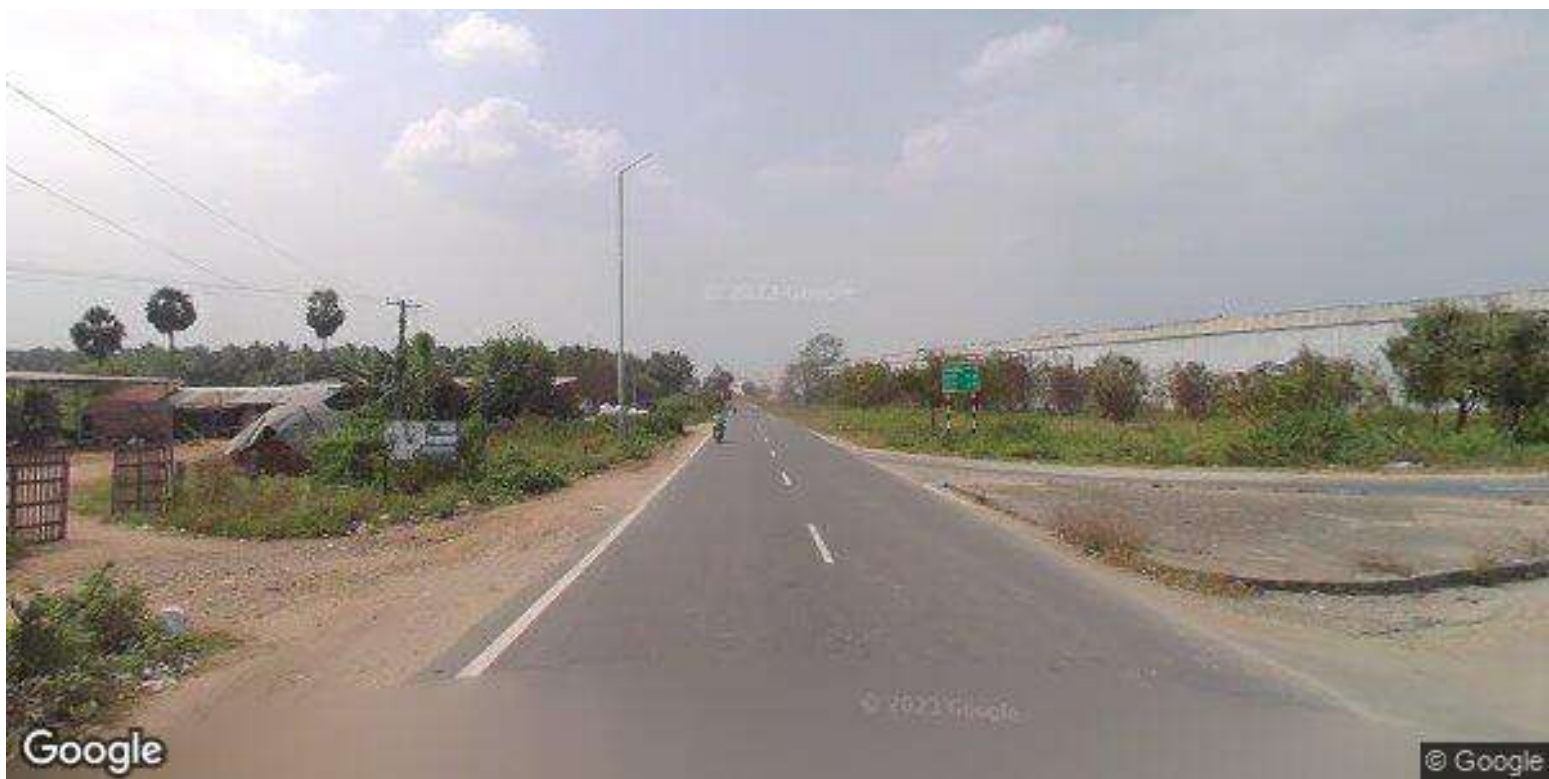
**Coordinates: 11.45542, 77.81725**

**Risk Type: Turn**

**Risk Level: High**

**Speed Limit: 15 KM/Hr**

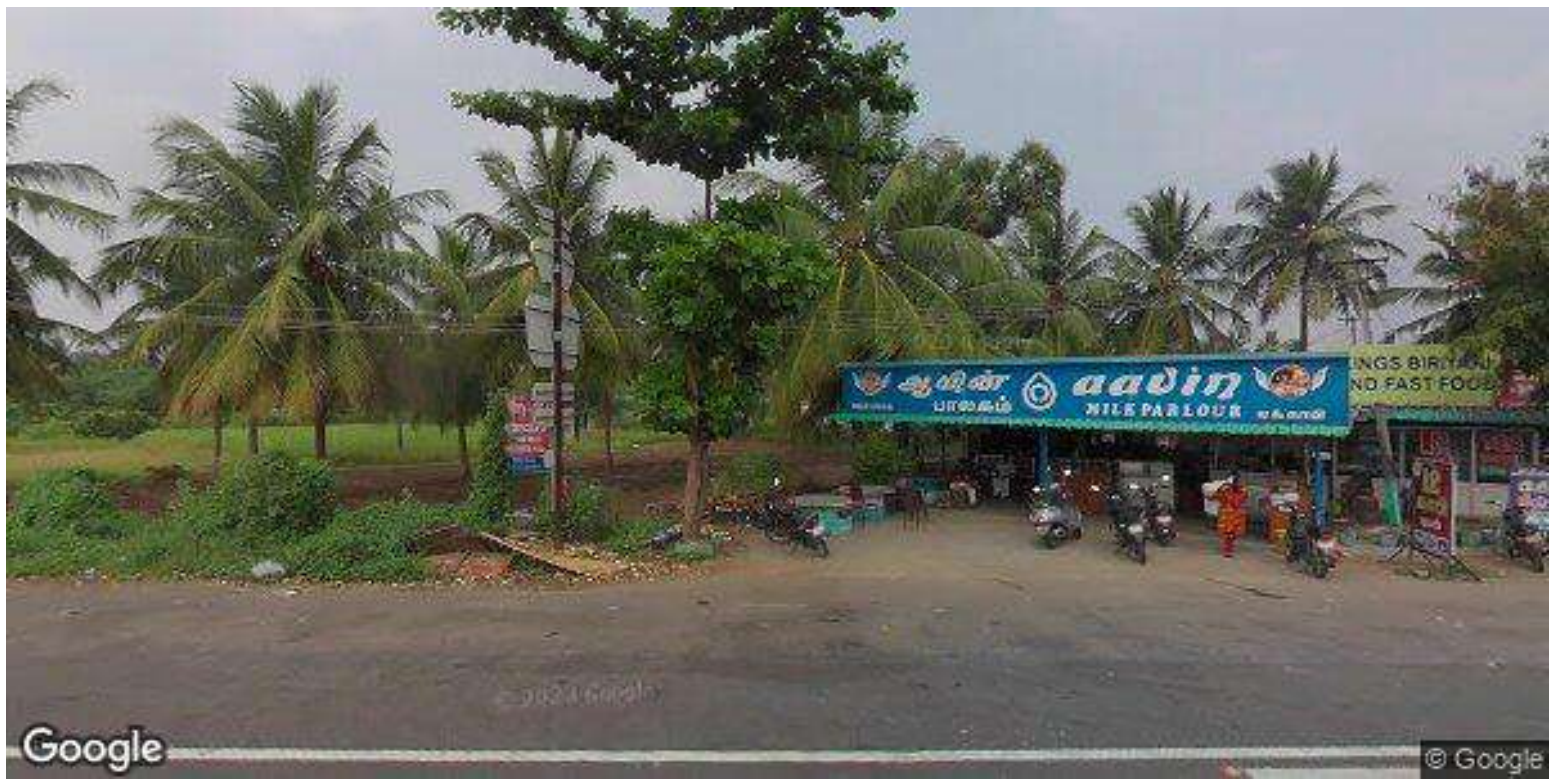
**Coordinates:** 11.45631, 77.81668

**Risk Type:** Turn

**Risk Level:** High

**Speed Limit:** 15 KM/Hr

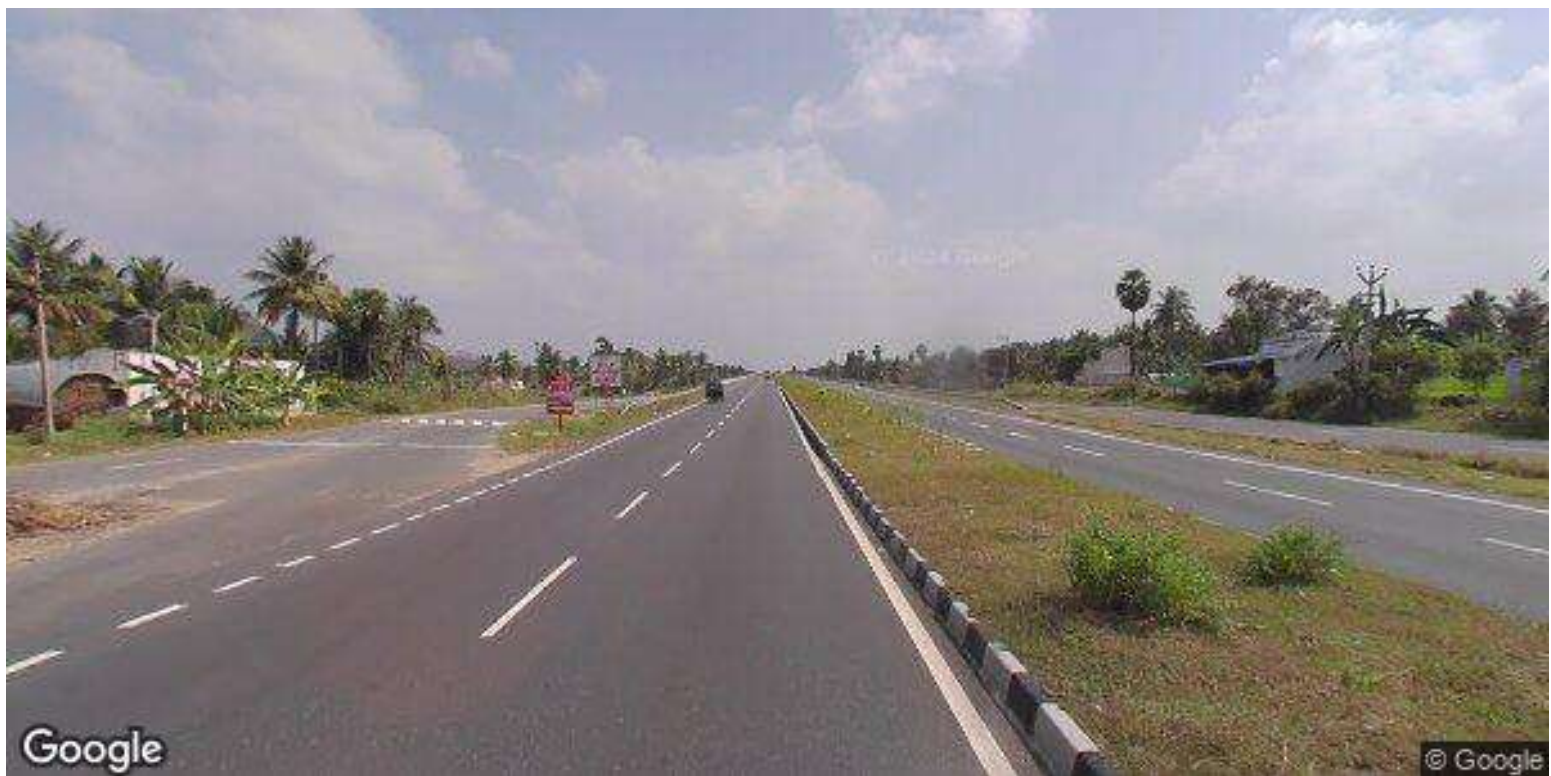
**Coordinates:** 11.49249, 77.85820

**Risk Type:** Turn

**Risk Level:** Medium

**Speed Limit:** 30 KM/Hr

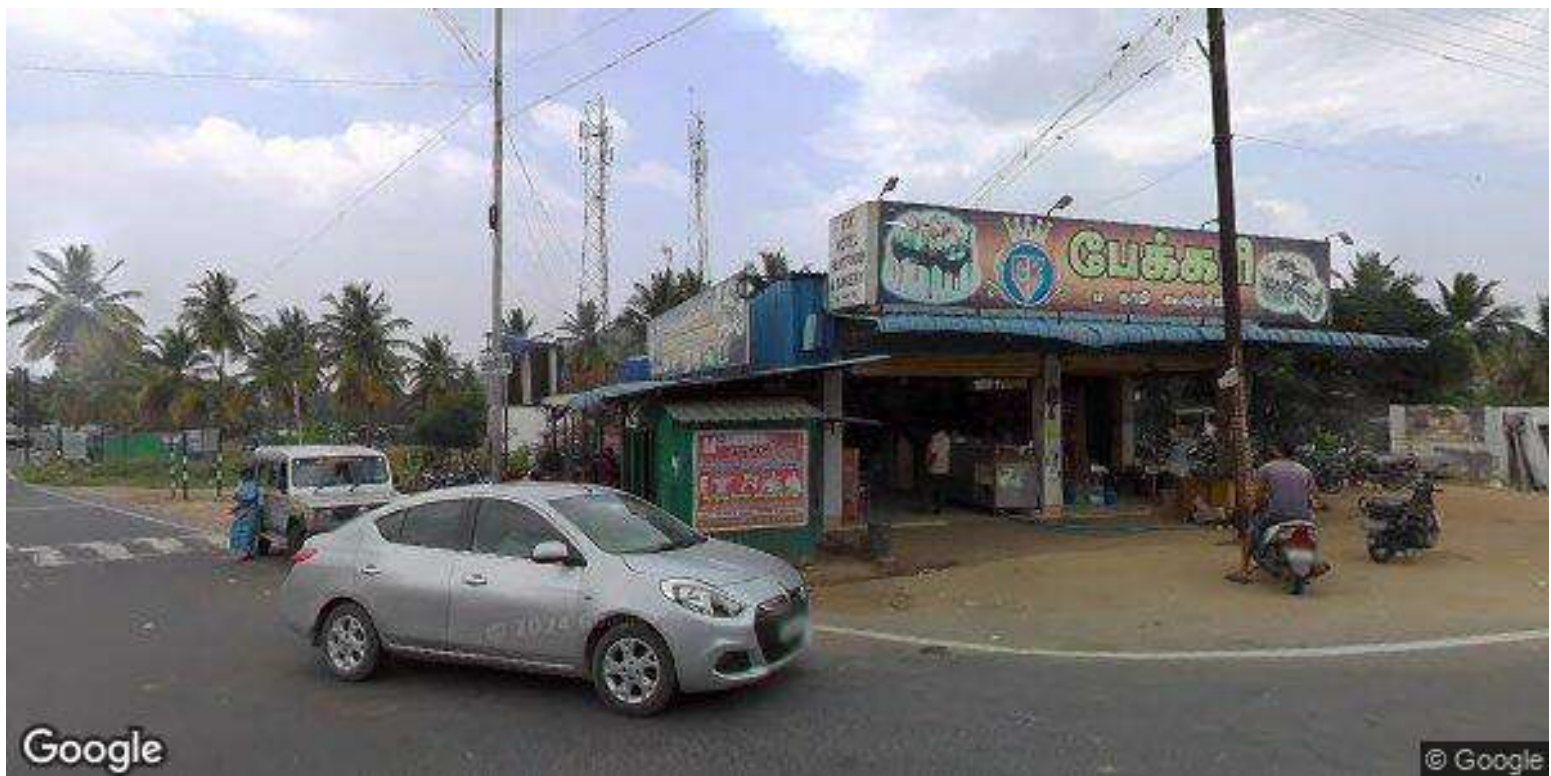
**Coordinates:** 11.49390, 77.86748

**Risk Type:** Blind Spot

**Risk Level:** Blind Spot

**Speed Limit:** 10 KM/Hr

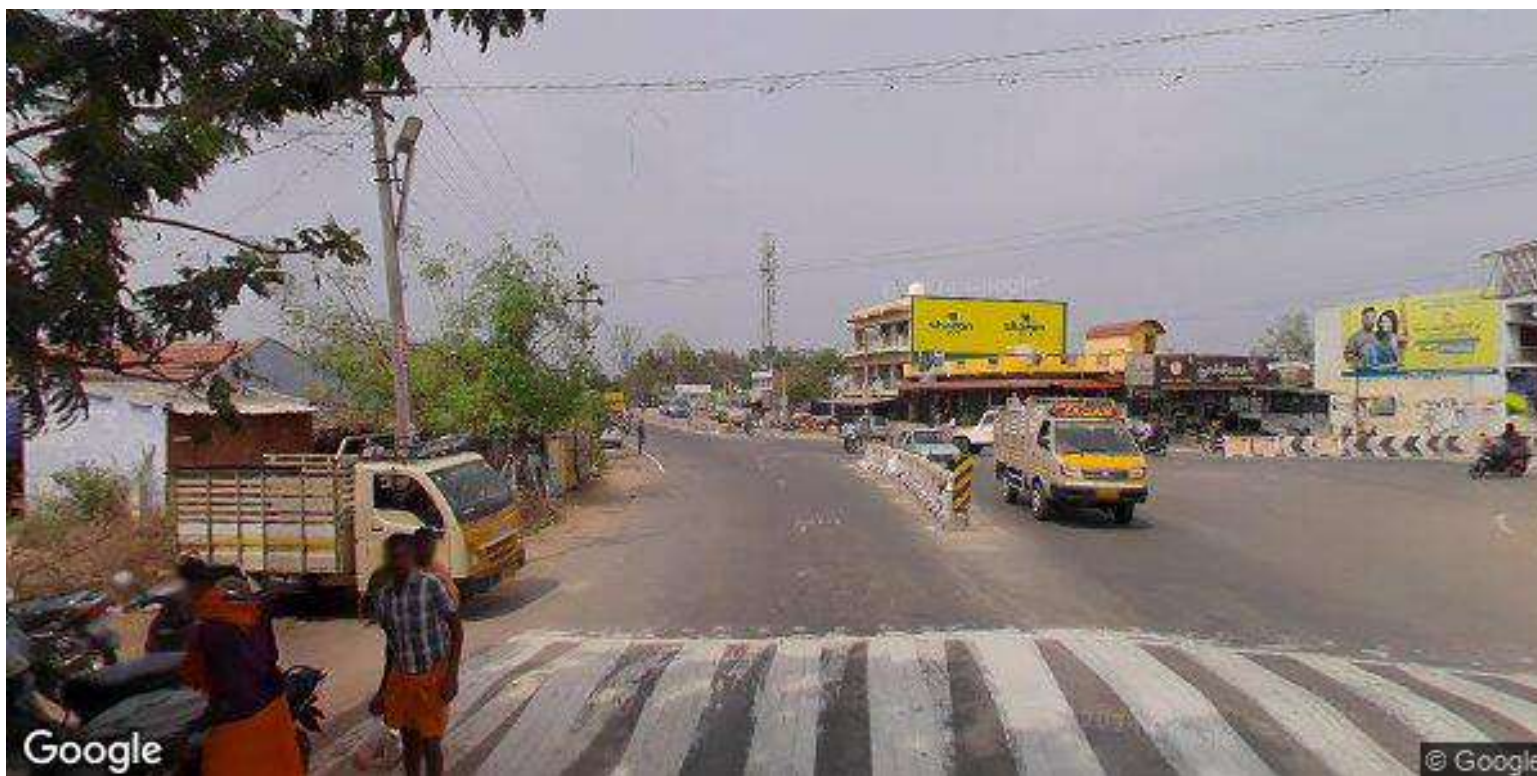
**Coordinates:** 11.58296, 77.85419

**Risk Type:** Turn

**Risk Level:** Medium

**Speed Limit:** 30 KM/Hr

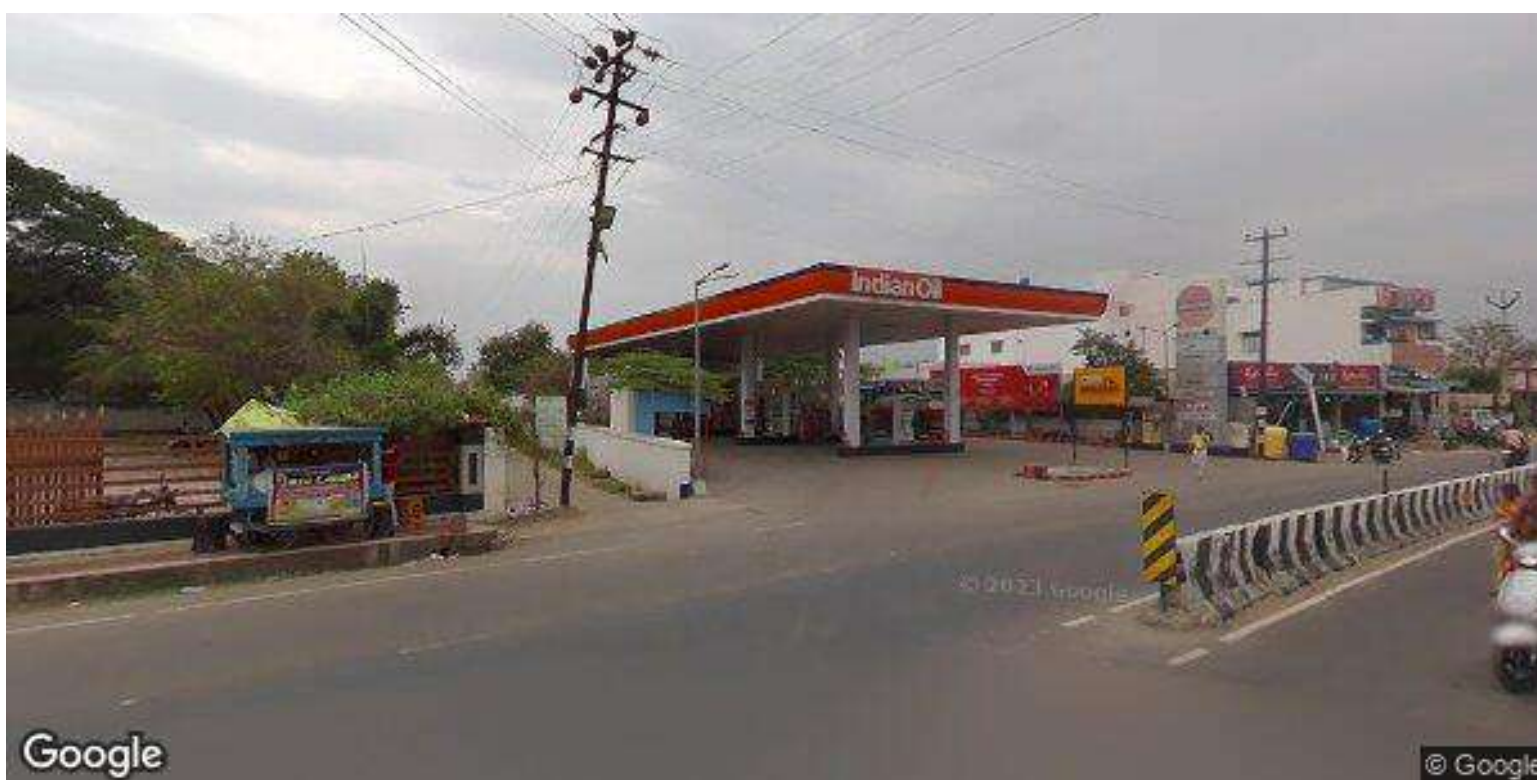
**Coordinates:** 11.58516, 77.84187

**Risk Type:** Turn

**Risk Level:** High

**Speed Limit:** 15 KM/Hr
