## JOURNEY RISK MANAGEMENT (JRM) STUDY

### Salem Terminal to MOOKAMBIKAI SERVICE STATION

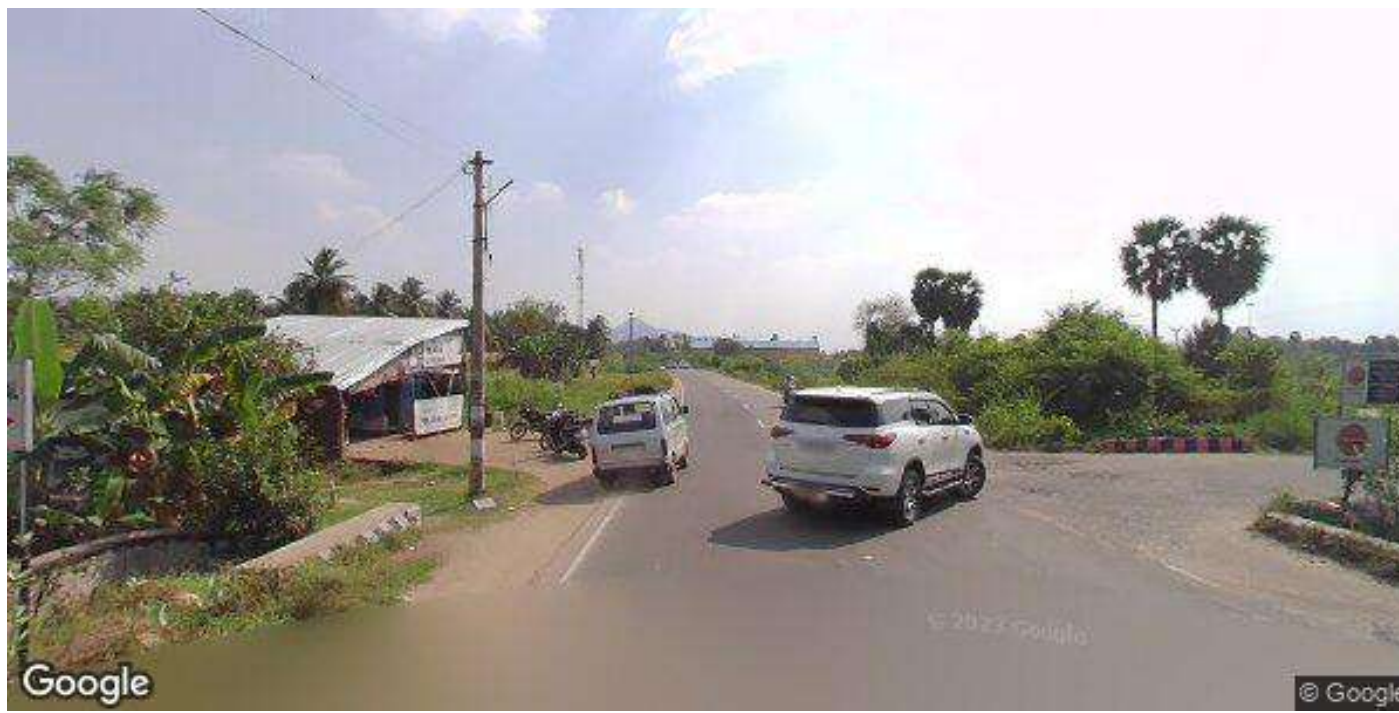
**Risk Type:** Turn  
**Risk Level:** High  
**Speed Limit:** 15 KM/Hr  
**Coordinates:** 11.44029, 77.87544

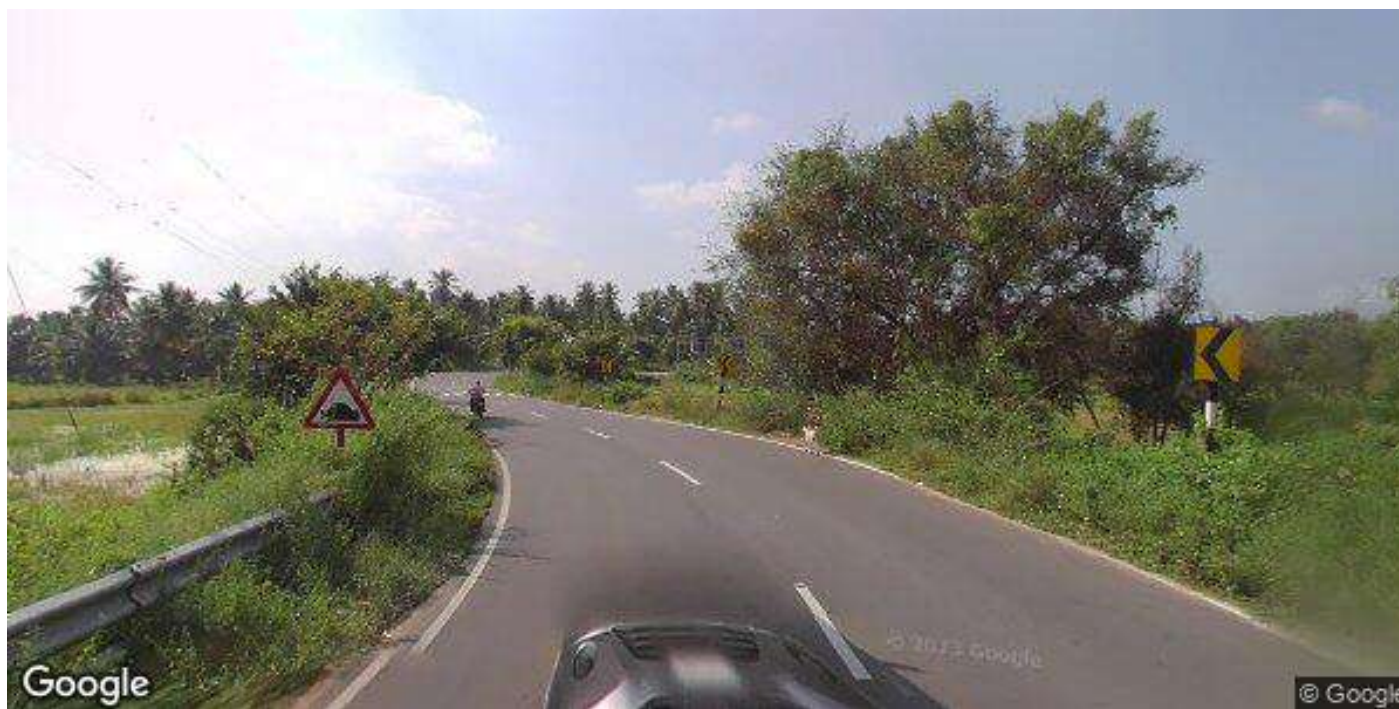
**Risk Type:** Turn  
**Risk Level:** Medium  
**Speed Limit:** 30 KM/Hr  
**Coordinates:** 11.45358, 77.85781

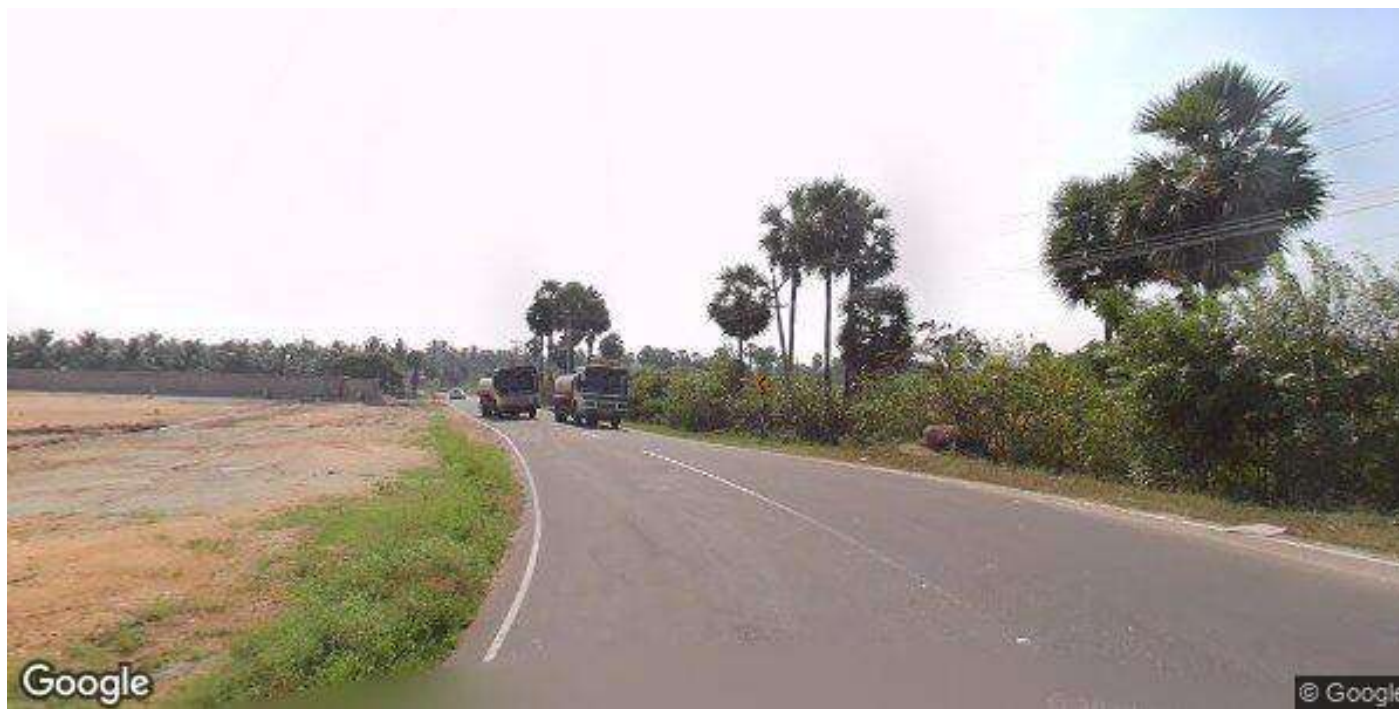
**Risk Type:** Turn  
**Risk Level:** Medium  
**Speed Limit:** 30 KM/Hr  
**Coordinates:** 11.45839, 77.85143

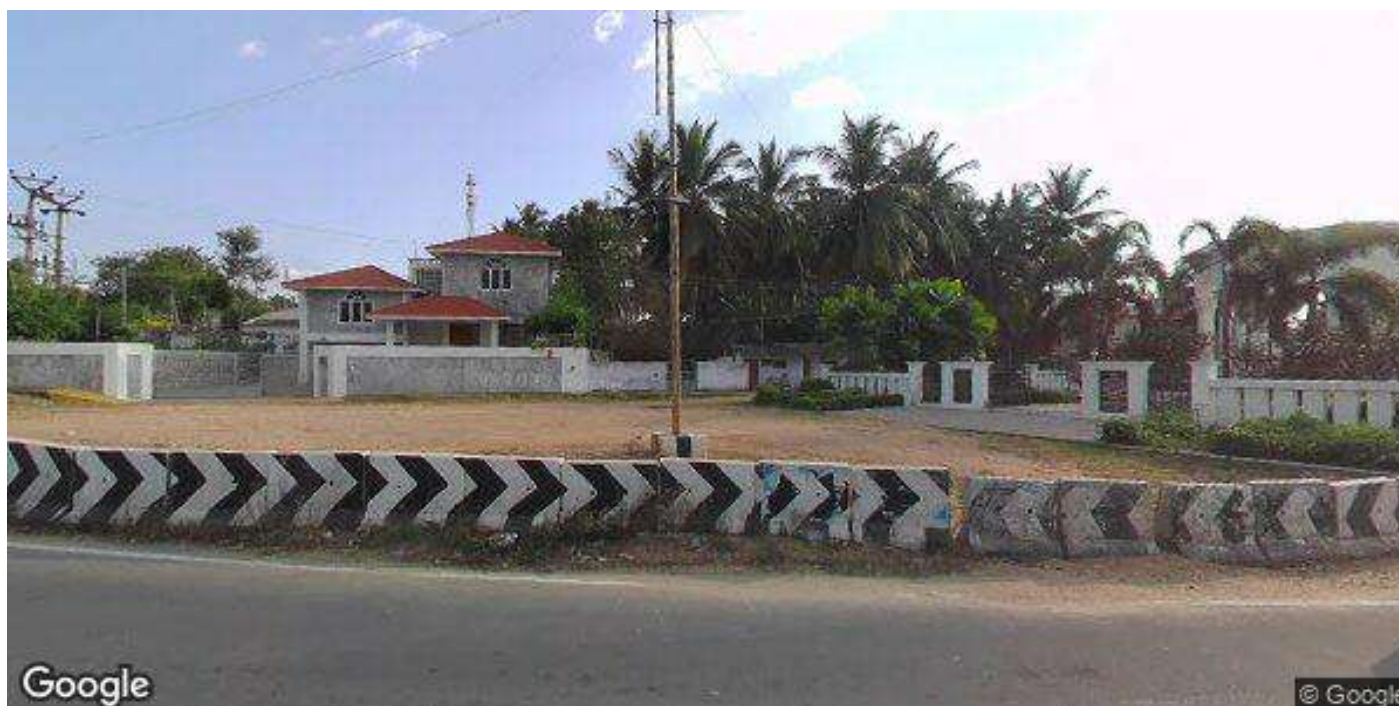
**Risk Type:** Turn  
**Risk Level:** Medium  
**Speed Limit:** 30 KM/Hr  
**Coordinates:** 11.46316, 77.84921

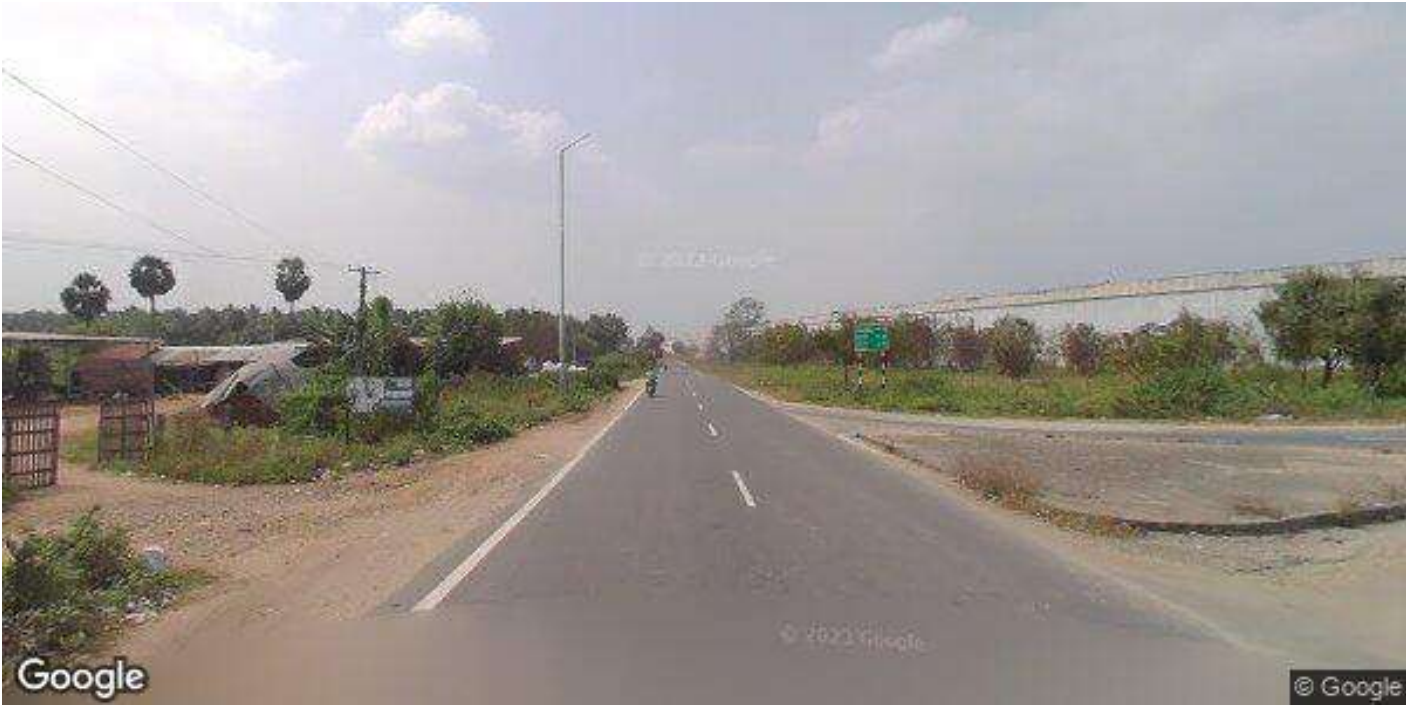
**Risk Type:** Turn  
**Risk Level:** High  
**Speed Limit:** 15 KM/Hr  
**Coordinates:** 11.45542, 77.81725

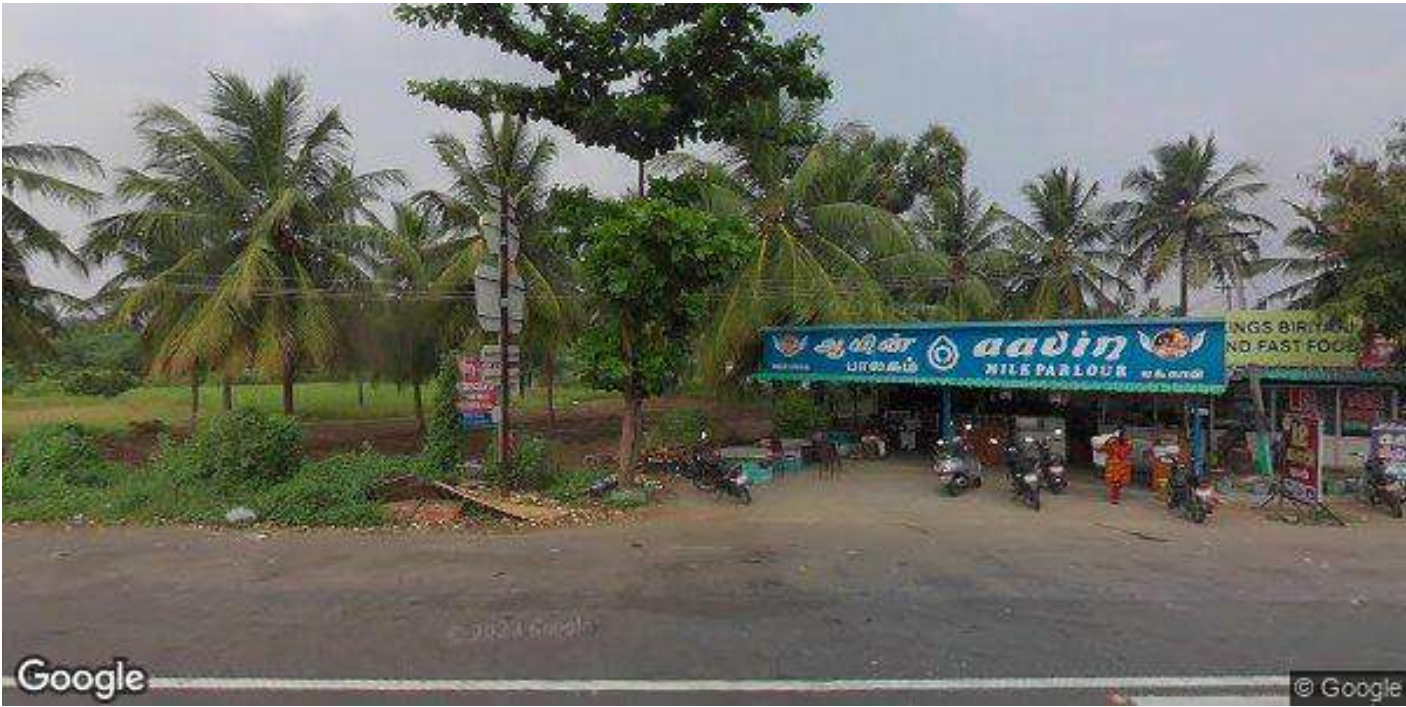
**Risk Type:** Blind Spot  
**Risk Level:** Blind Spot  
**Speed Limit:** 10 KM/Hr  
**Coordinates:** 11.45631, 77.81668

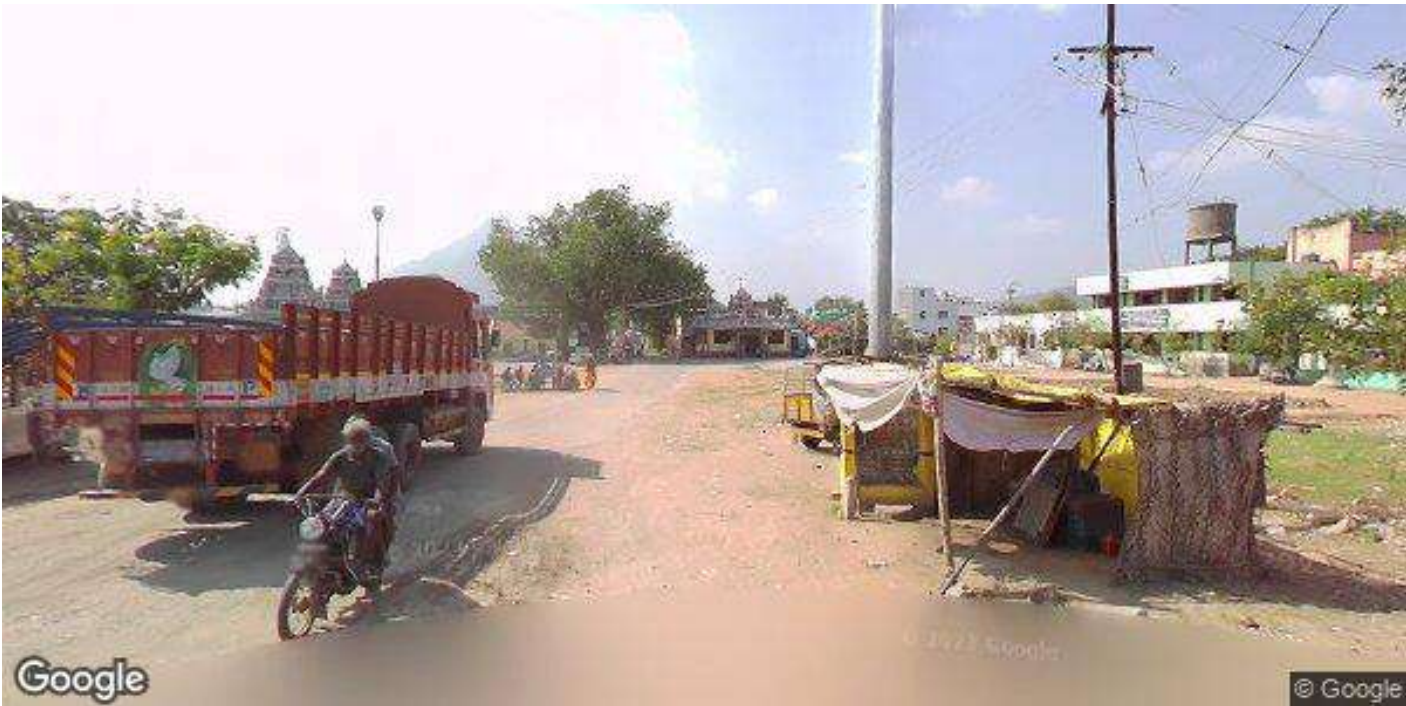
**Risk Type:** Blind Spot  
**Risk Level:** Blind Spot  
**Speed Limit:** 10 KM/Hr  
**Coordinates:** 11.62145, 78.10740

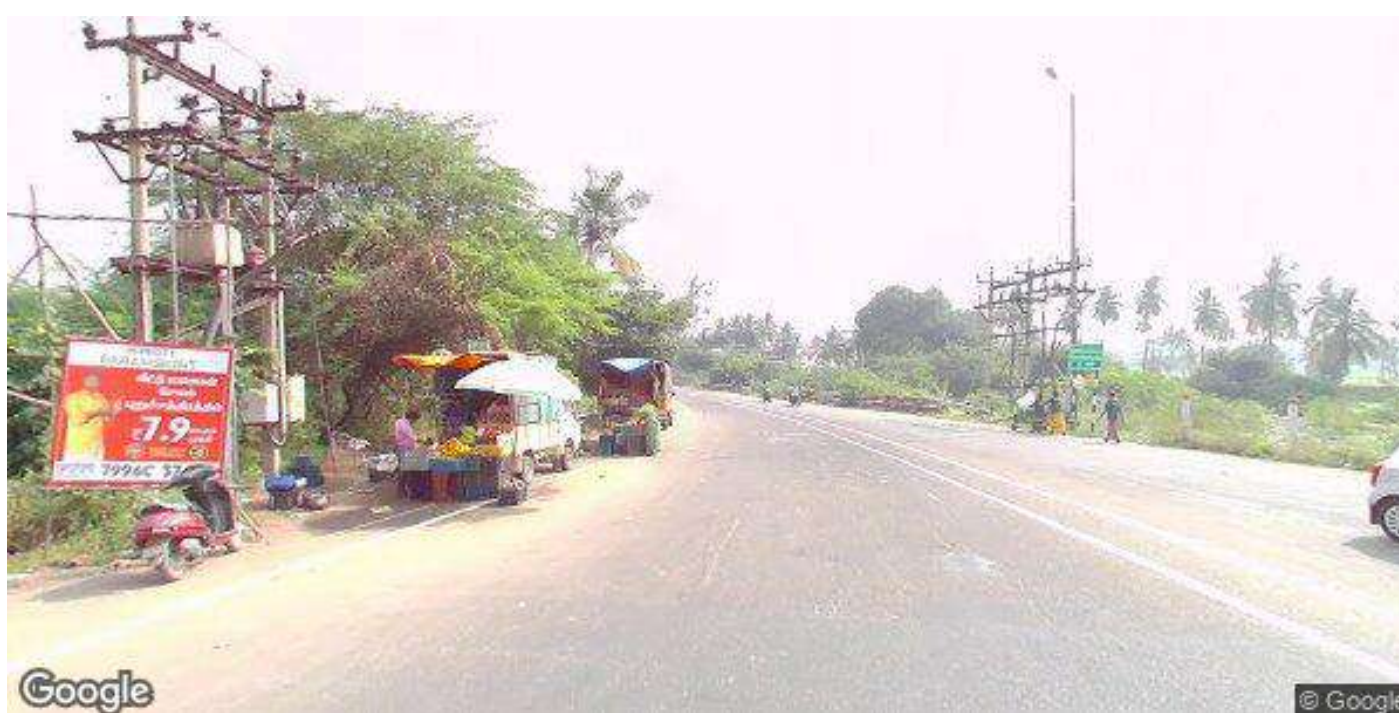
**Risk Type:** Blind Spot  
**Risk Level:** Blind Spot  
**Speed Limit:** 10 KM/Hr  
**Coordinates:** 11.61217, 78.10439

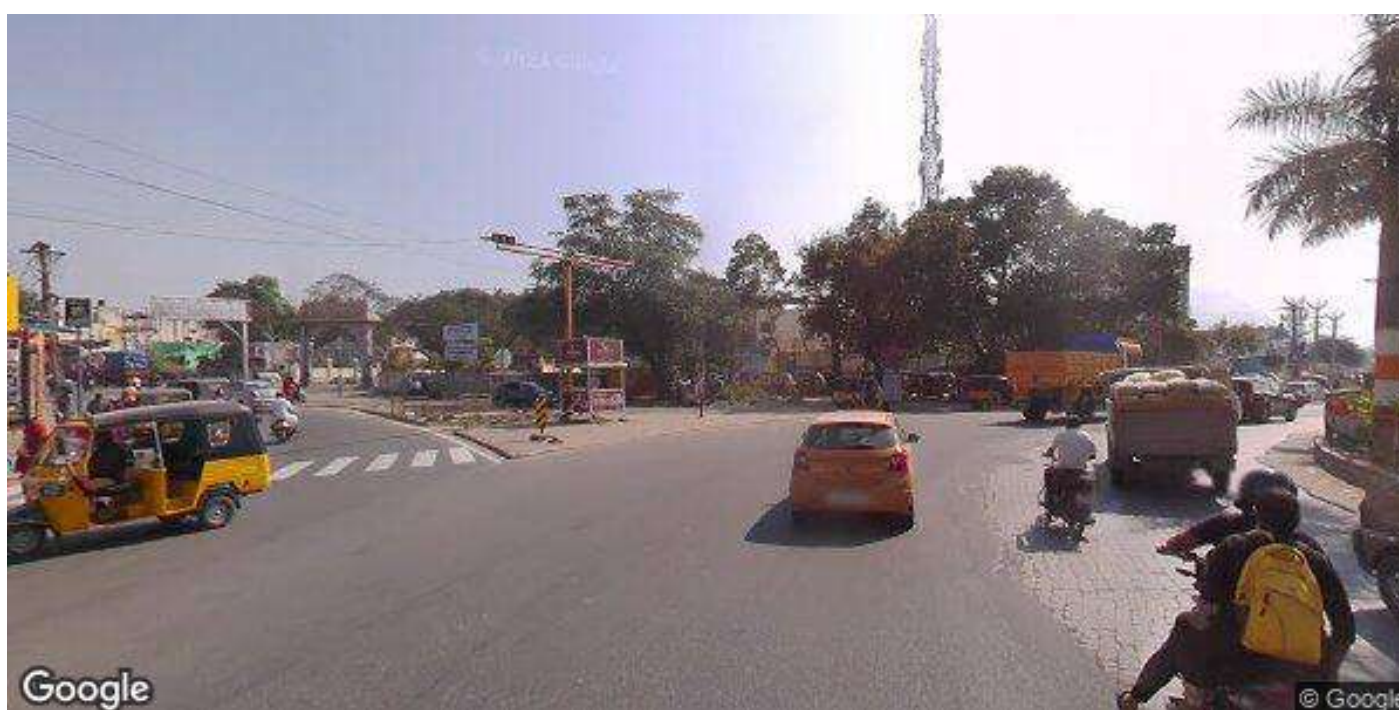
**Risk Type:** Turn  
**Risk Level:** Medium  
**Speed Limit:** 30 KM/Hr  
**Coordinates:** 11.63306, 78.12731

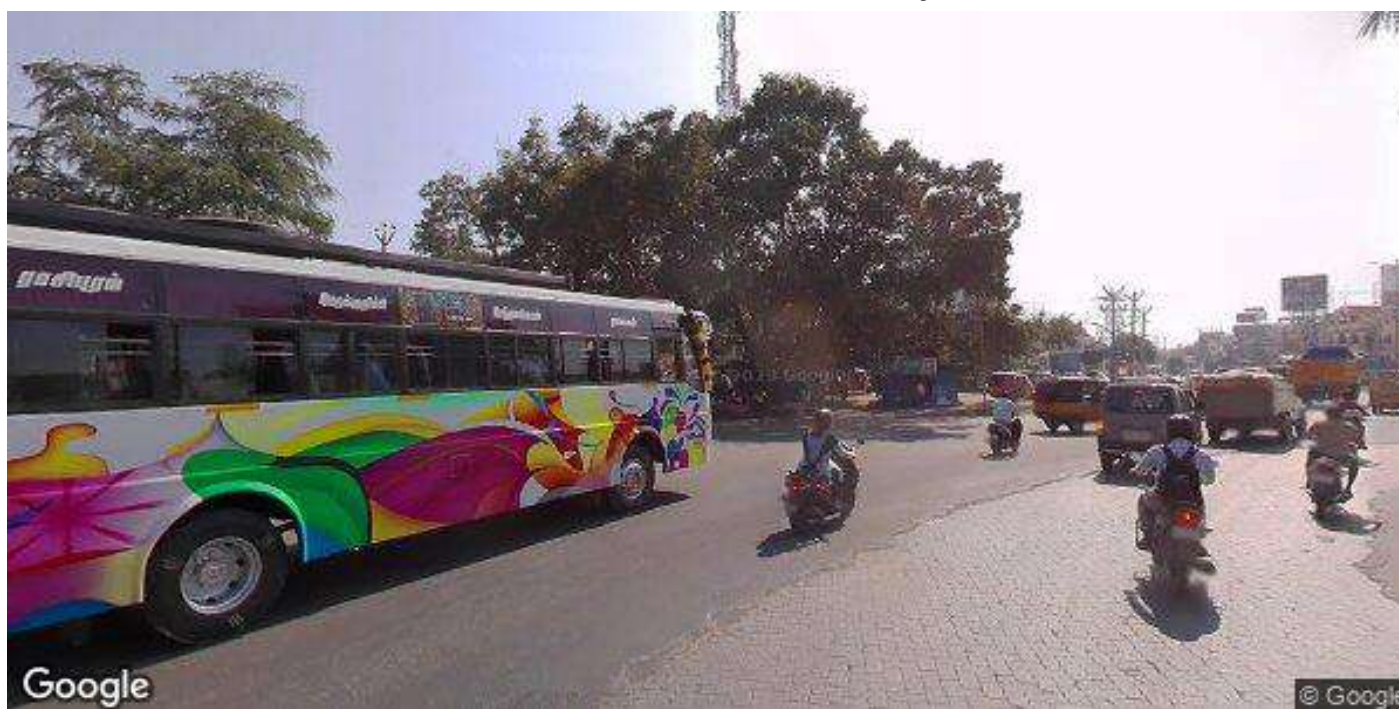
**Risk Type:** Turn  
**Risk Level:** Medium  
**Speed Limit:** 30 KM/Hr  
**Coordinates:** 11.63300, 78.12746

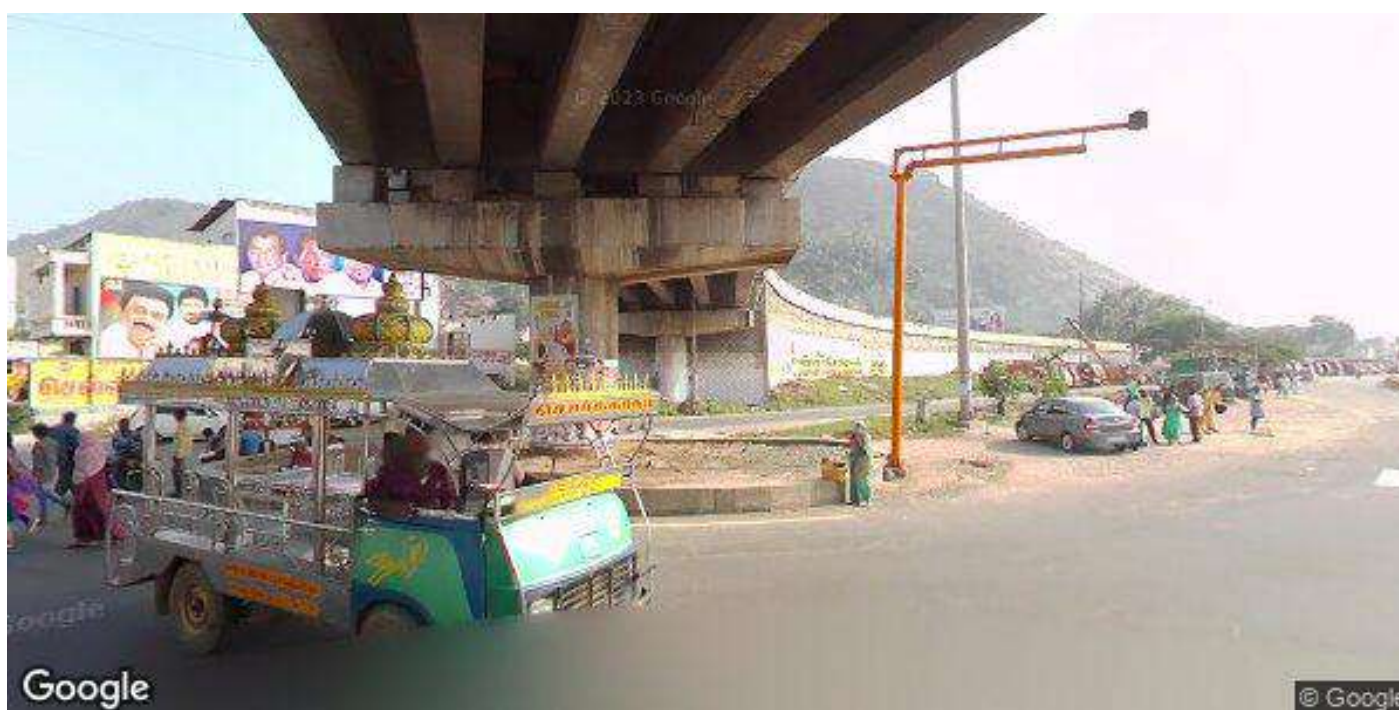
**Risk Type:** Turn  
**Risk Level:** Medium  
**Speed Limit:** 30 KM/Hr  
**Coordinates:** 11.62509, 78.14758

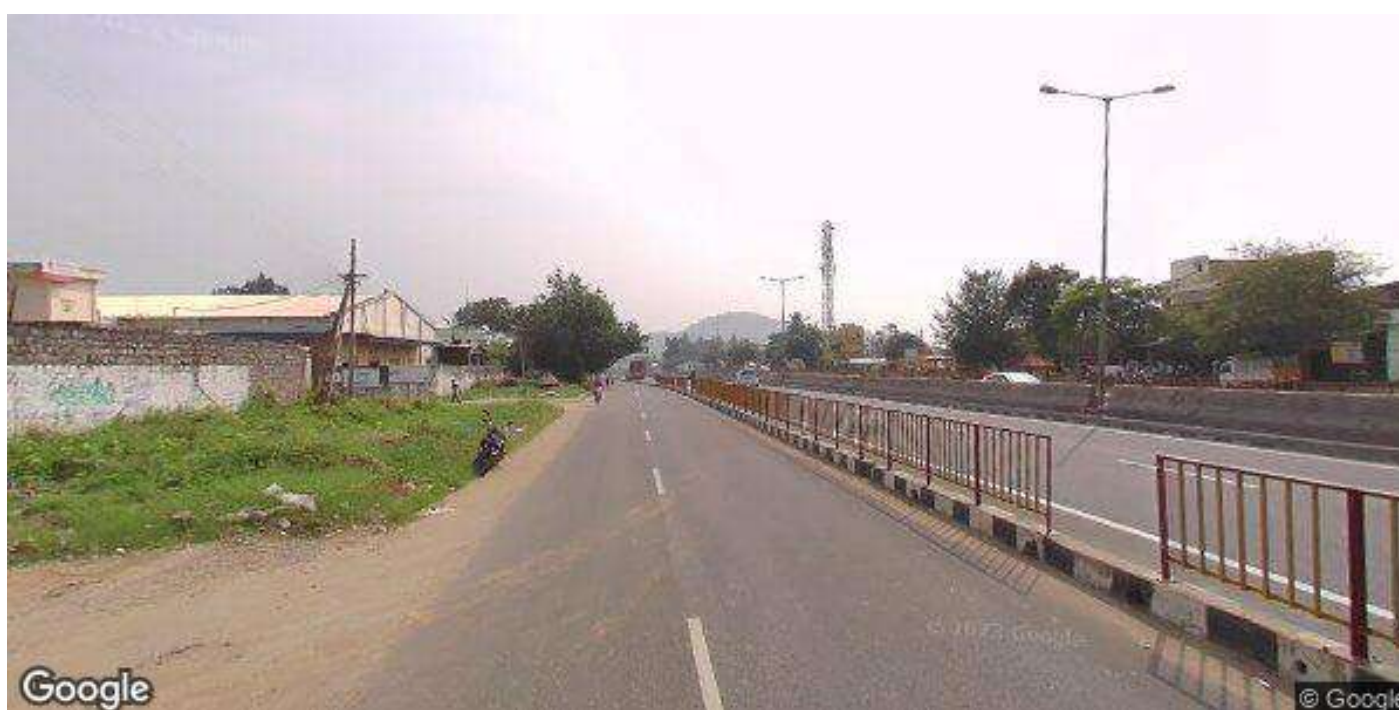
**Risk Type:** Turn  
**Risk Level:** High  
**Speed Limit:** 15 KM/Hr  
**Coordinates:** 11.60280, 78.14689
