# IndianOil

## JOURNEY RISK MANAGEMENT (JRM) STUDY

### Salem Terminal to DEVI TRADERS

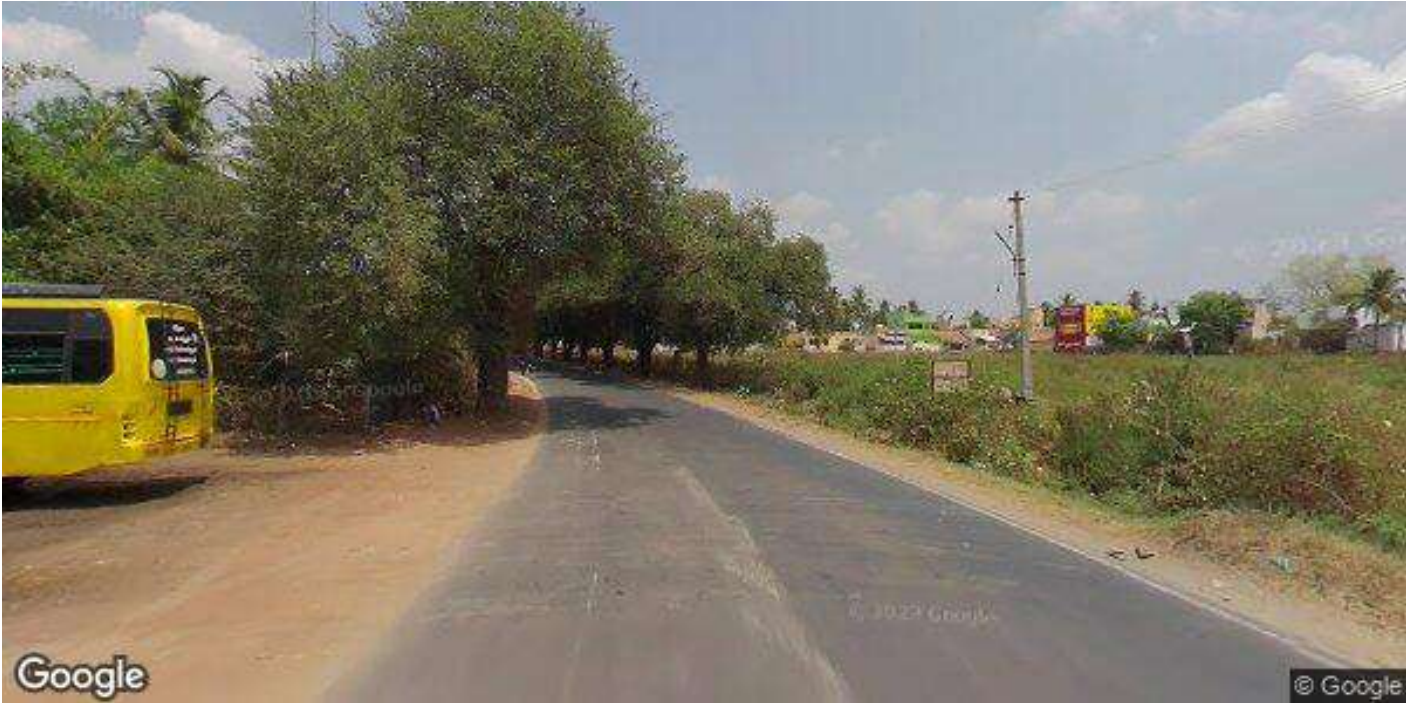
| | Risk Type | Risk Level | Coordinates | Speed Limit |
|---|---|---|---|---|
| 0 | Roundabout | High | 11.56180, 77.90019 | 15 KM/Hr |

Risk Type: Roundabout

Risk Level: High

Speed Limit: 15 KM/Hr

Coordinates: 11.56180, 77.90019

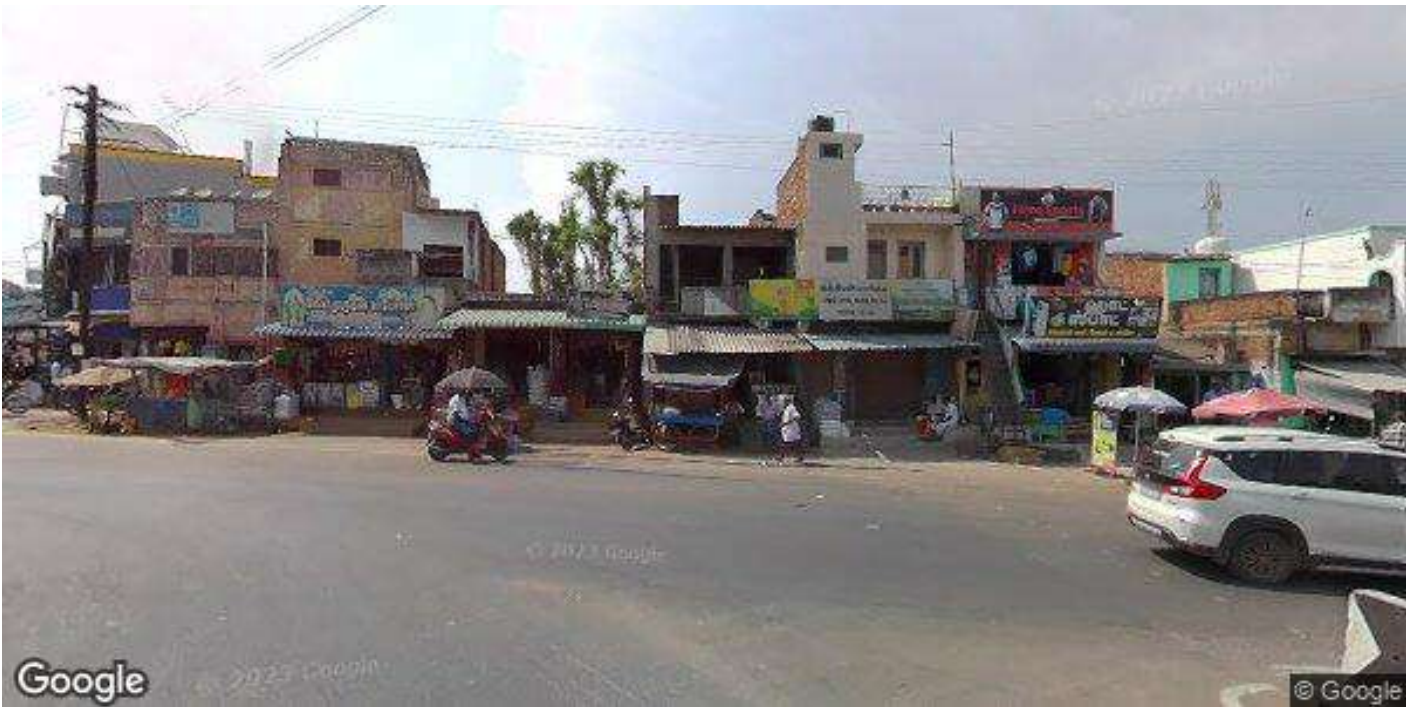
| | Risk Type | Risk Level | Coordinates | Speed Limit |
|---|---|---|---|---|
| 1 | Roundabout | High | 11.57053, 77.90246 | 15 KM/Hr |

Risk Type: Roundabout

Risk Level: High

Speed Limit: 15 KM/Hr

Coordinates: 11.57053, 77.90246

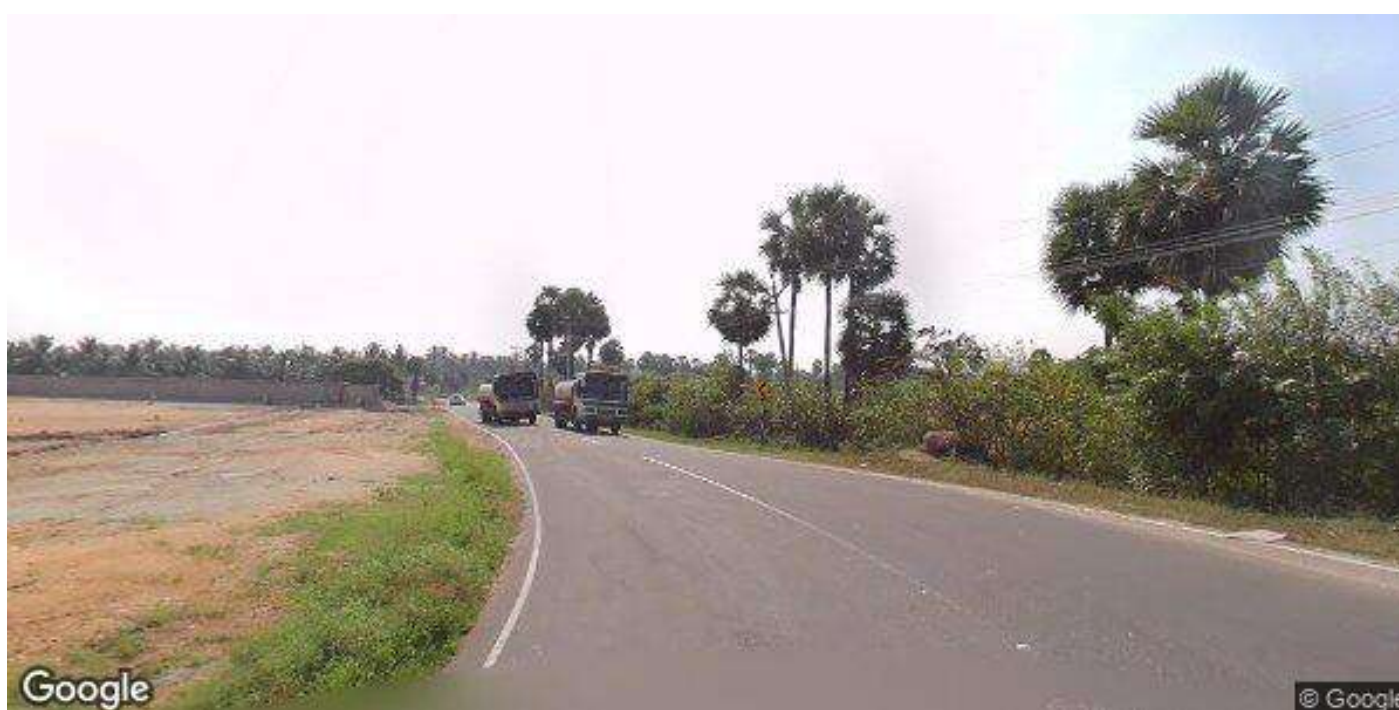
| | Risk Type | Risk Level | Coordinates | Speed Limit |
|---|---|---|---|---|
| 8 | Turn | Medium | 11.45839, 77.85143 | 30 KM/Hr |

**Risk Type:** Turn  
**Risk Level:** Medium  
**Speed Limit:** 30 KM/Hr  
**Coordinates:** 11.45839, 77.85143

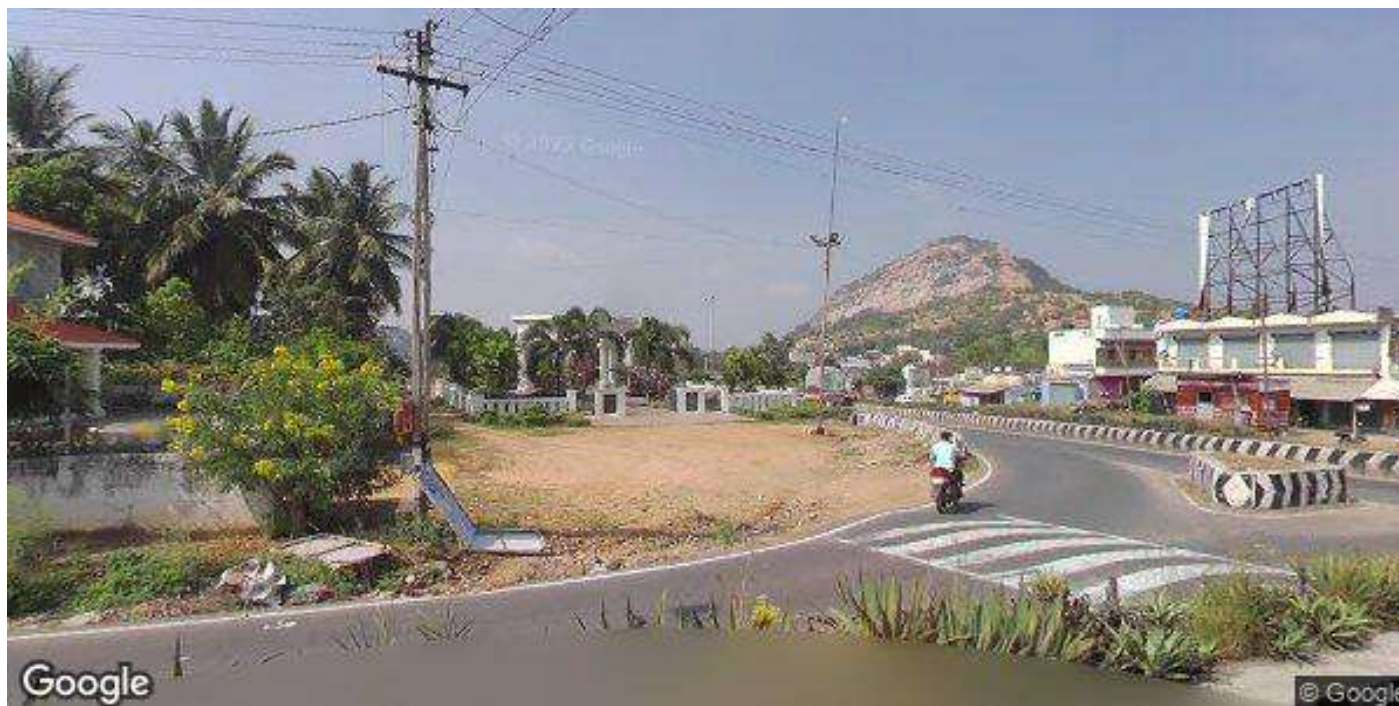
| | Risk Type | Risk Level | Coordinates | Speed Limit |
|---|---|---|---|---|
| 9 | Turn | Medium | 11.46307, 77.84941 | 30 KM/Hr |

**Risk Type:** Turn  
**Risk Level:** Medium  
**Speed Limit:** 30 KM/Hr  
**Coordinates:** 11.46307, 77.84941

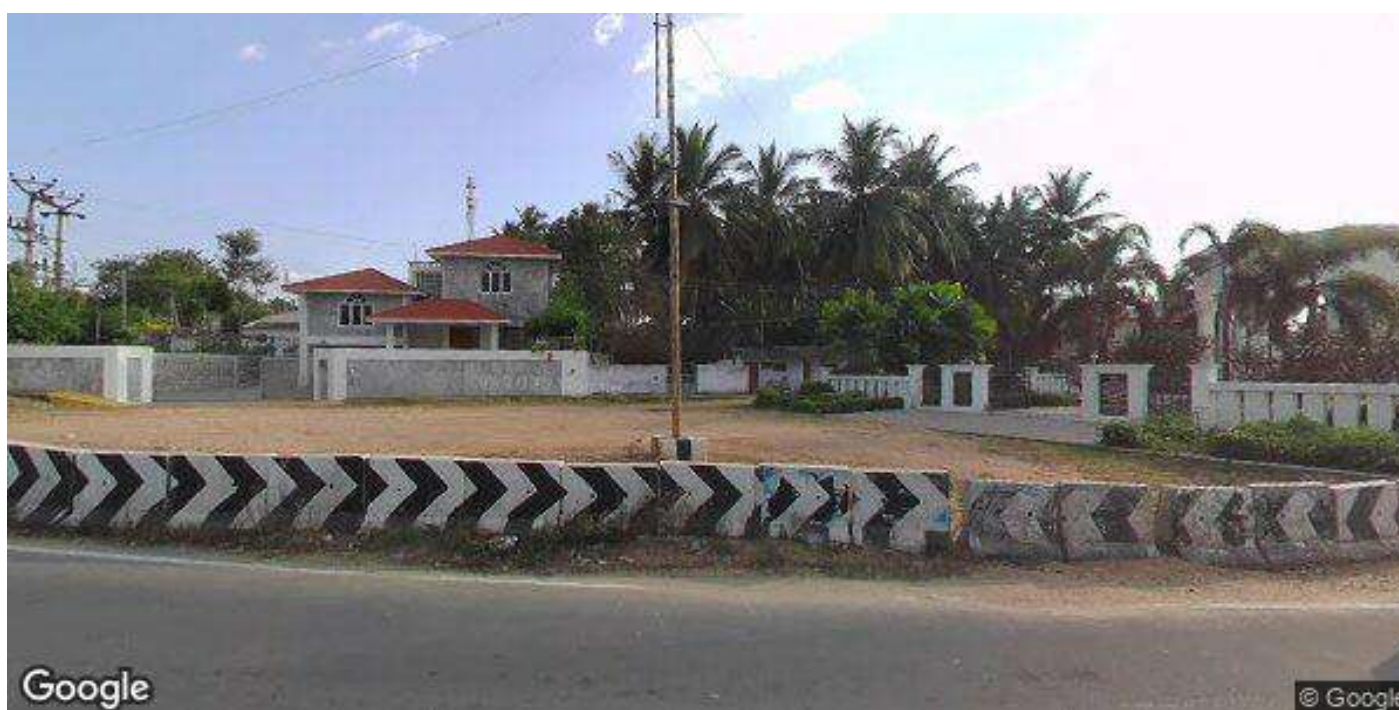
| | Risk Type | Risk Level | Coordinates | Speed Limit |
|---|---|---|---|---|
| 10 | Turn | Medium | 11.46316, 77.84921 | 30 KM/Hr |

**Risk Type:** Turn  
**Risk Level:** Medium  
**Speed Limit:** 30 KM/Hr  
**Coordinates:** 11.46316, 77.84921

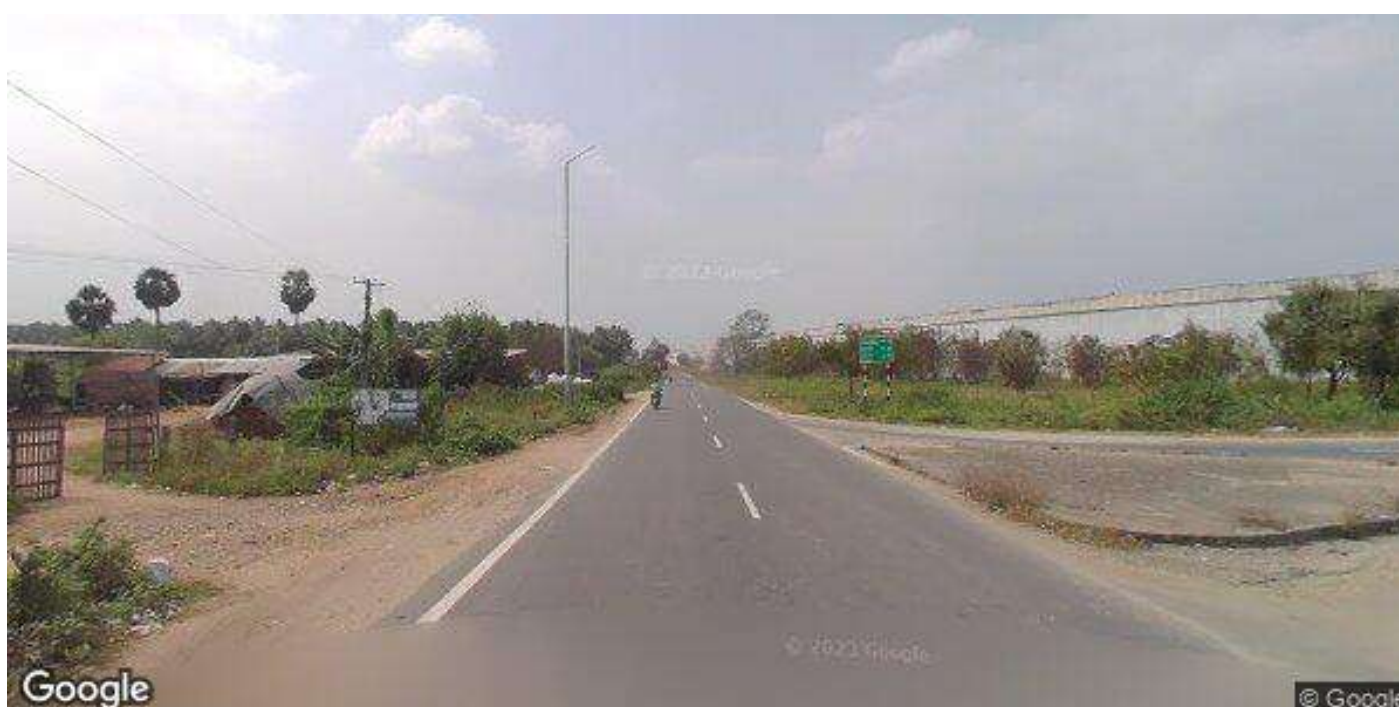
| | Risk Type | Risk Level | Coordinates | Speed Limit |
|---|---|---|---|---|
| 11 | Turn | High | 11.45542, 77.81725 | 15 KM/Hr |

**Risk Type:** Turn  
**Risk Level:** High  
**Speed Limit:** 15 KM/Hr  
**Coordinates:** 11.45542, 77.81725

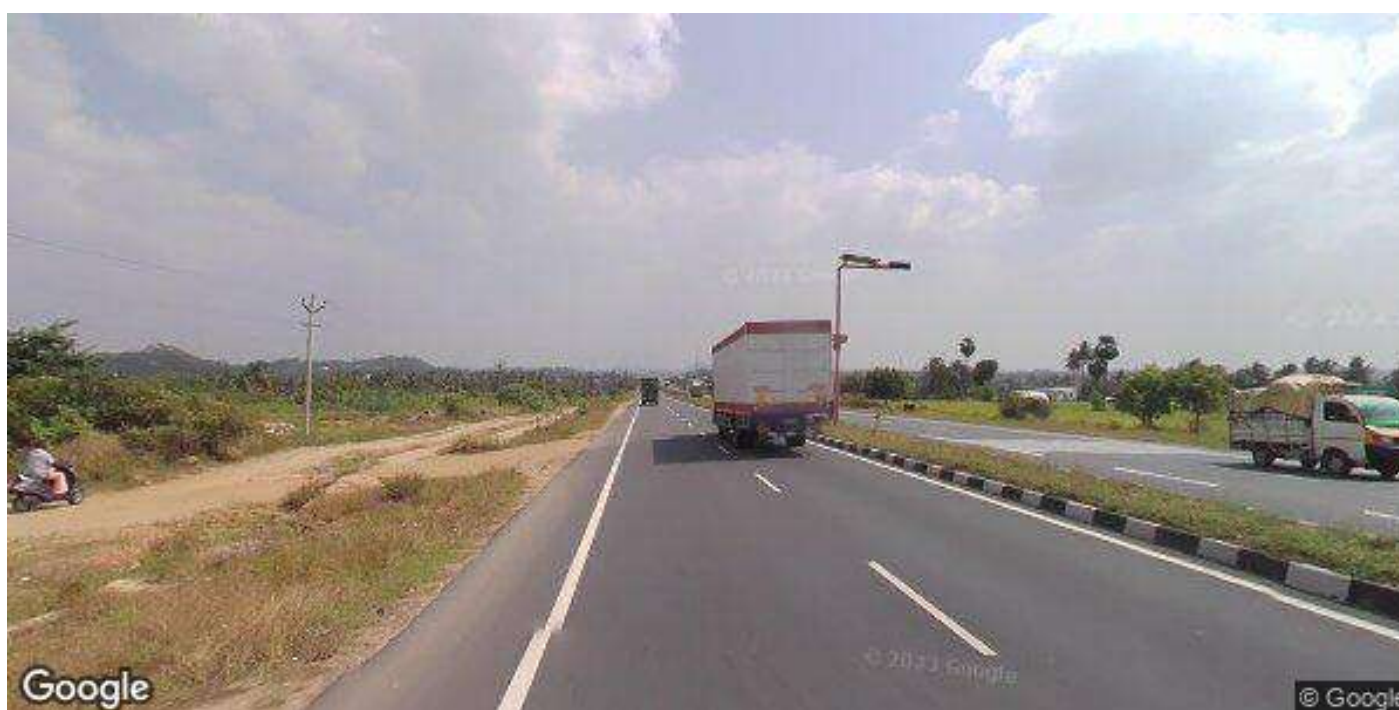
| | Risk Type | Risk Level | Coordinates | Speed Limit |
|---|---|---|---|---|
| 13 | Turn | High | 11.49409, 77.88004 | 15 KM/Hr |

**Risk Type:** Turn  
**Risk Level:** High  
**Speed Limit:** 15 KM/Hr  
**Coordinates:** 11.49409, 77.88004

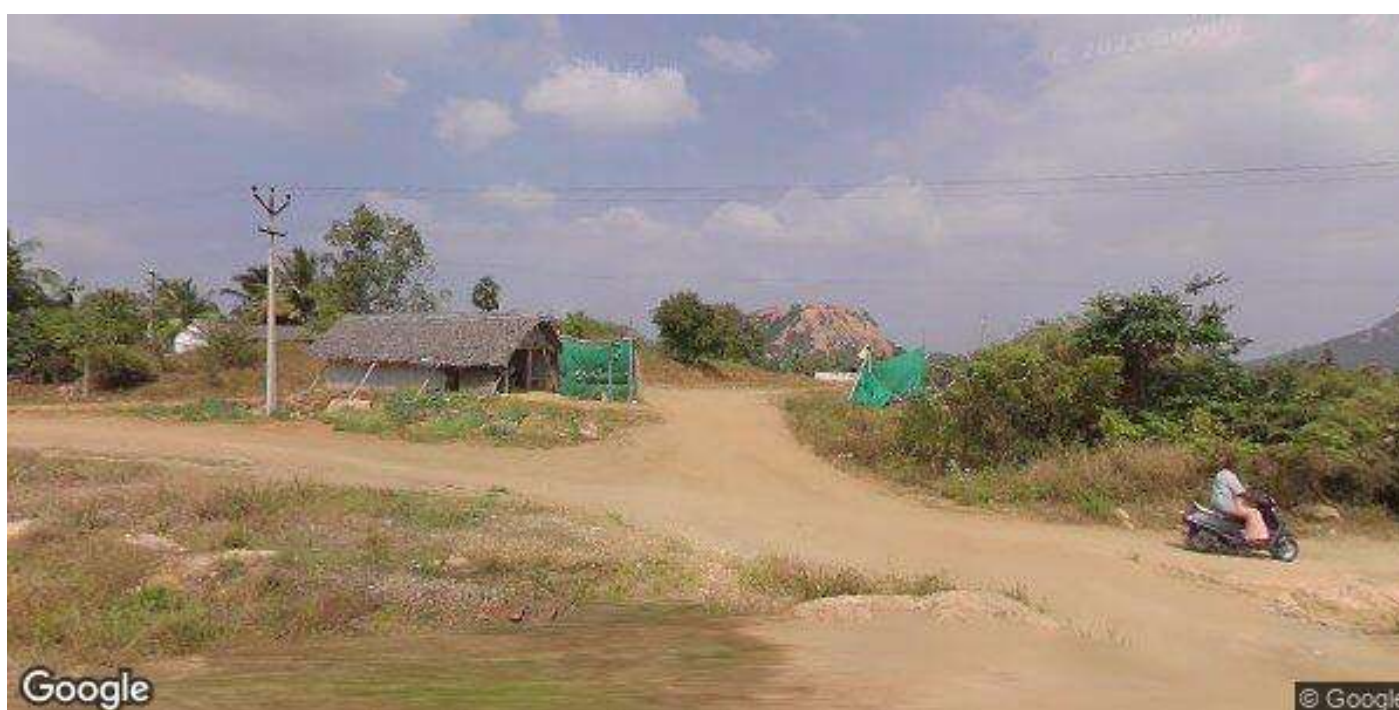
| | Risk Type | Risk Level | Coordinates | Speed Limit |
|---|---|---|---|---|
| 14 | Turn | Medium | 11.49420, 77.88016 | 30 KM/Hr |

**Risk Type:** Turn  
**Risk Level:** Medium  
**Speed Limit:** 30 KM/Hr  
**Coordinates:** 11.49420, 77.88016

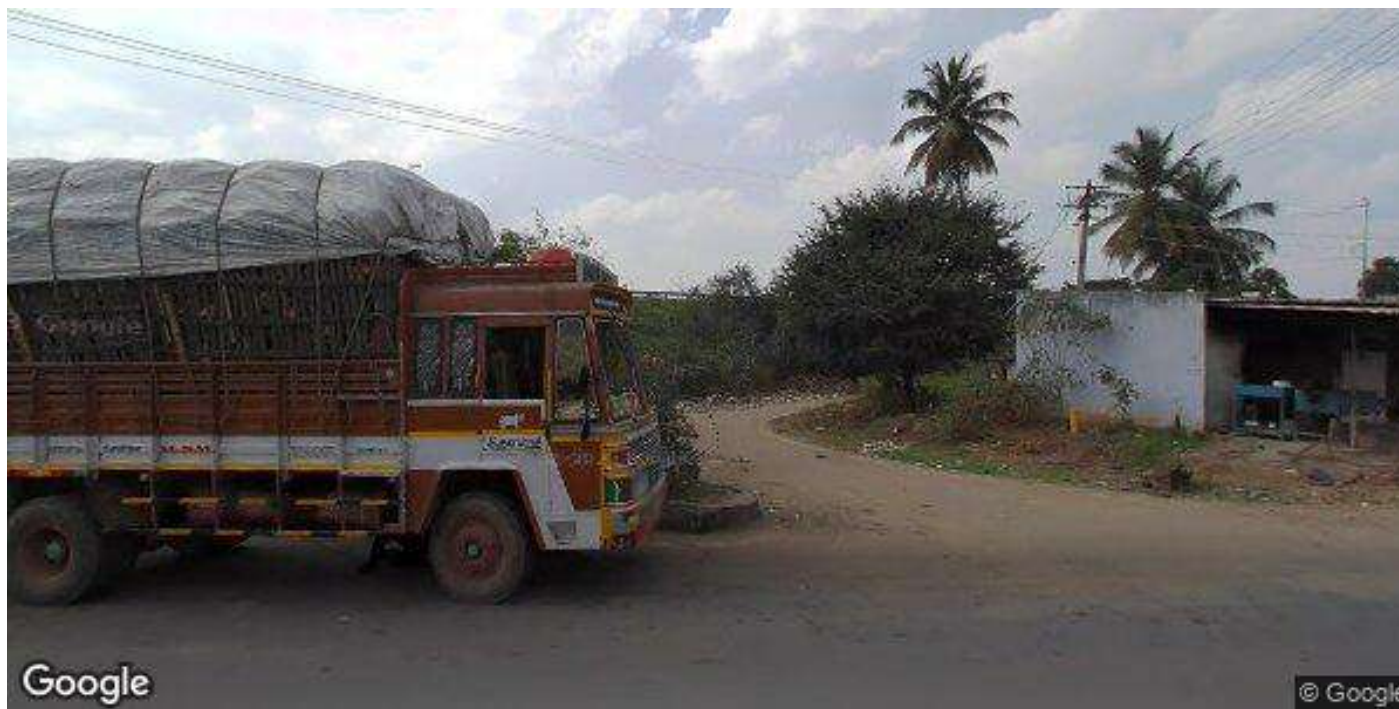
| | Risk Type | Risk Level | Coordinates | Speed Limit |
|---|---|---|---|---|
| 15 | Turn | High | 11.49382, 77.88530 | 15 KM/Hr |

**Risk Type:** Turn  
**Risk Level:** High  
**Speed Limit:** 15 KM/Hr  
**Coordinates:** 11.49382, 77.88530

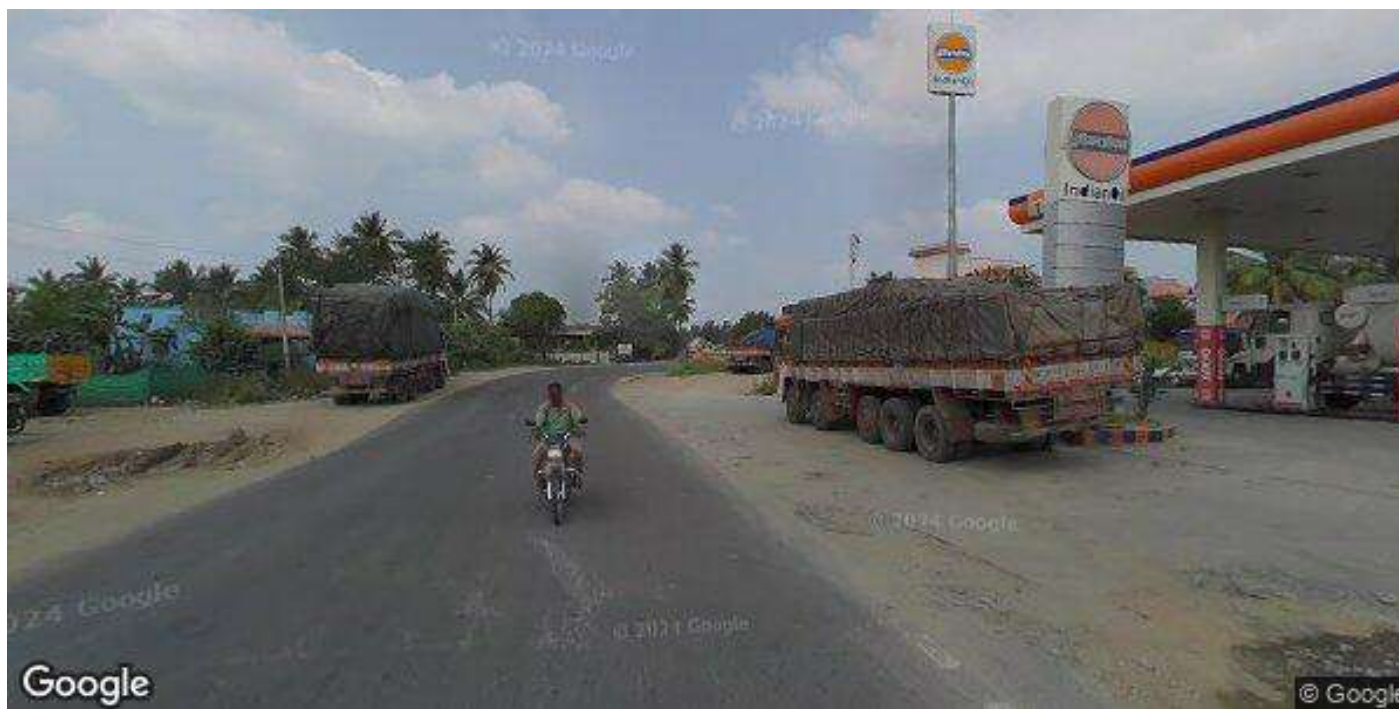
| | Risk Type | Risk Level | Coordinates | Speed Limit |
|---|---|---|---|---|
| 16 | Turn | High | 11.49408, 77.88538 | 15 KM/Hr |

**Risk Type:** Turn  
**Risk Level:** High  
**Speed Limit:** 15 KM/Hr  
**Coordinates:** 11.49408, 77.88538

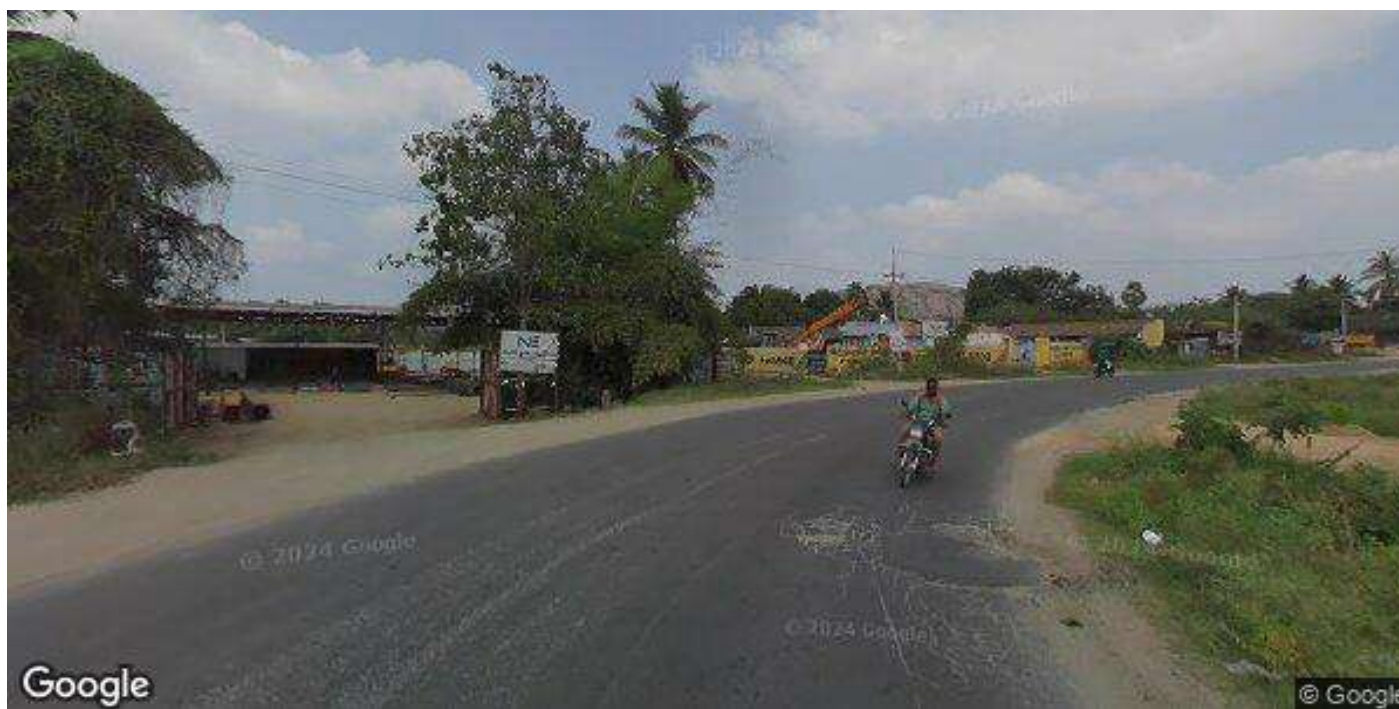
| | Risk Type | Risk Level | Coordinates | Speed Limit |
|---|---|---|---|---|
| 17 | Turn | Medium | 11.49444, 77.88492 | 30 KM/Hr |

**Risk Type:** Turn  
**Risk Level:** Medium  
**Speed Limit:** 30 KM/Hr  
**Coordinates:** 11.49444, 77.88492

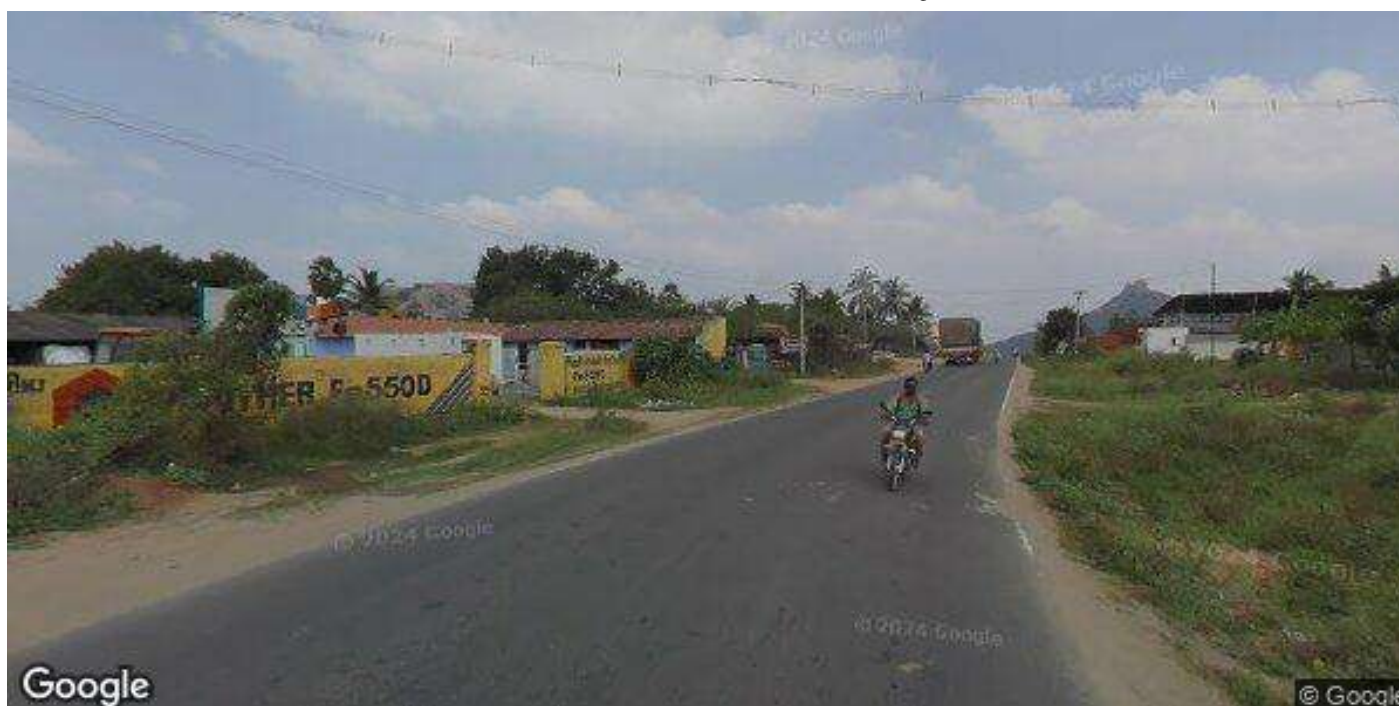
| | Risk Type | Risk Level | Coordinates | Speed Limit |
|---|---|---|---|---|
| 18 | Turn | Medium | 11.49469, 77.88488 | 30 KM/Hr |

**Risk Type:** Turn  
**Risk Level:** Medium  
**Speed Limit:** 30 KM/Hr  
**Coordinates:** 11.49469, 77.88488

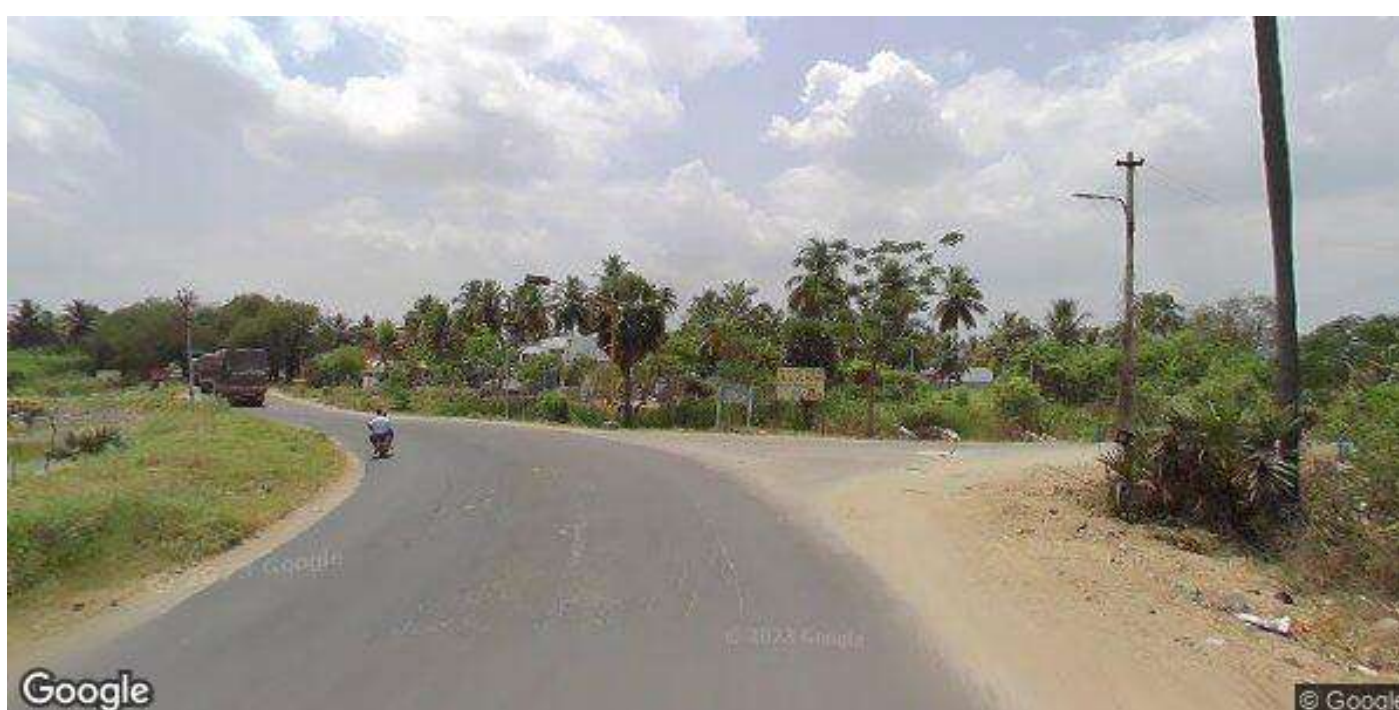
| | Risk Type | Risk Level | Coordinates | Speed Limit |
|---|---|---|---|---|
| 19 | Turn | Medium | 11.56096, 77.89931 | 30 KM/Hr |

**Risk Type:** Turn  
**Risk Level:** Medium  
**Speed Limit:** 30 KM/Hr  
**Coordinates:** 11.56096, 77.89931

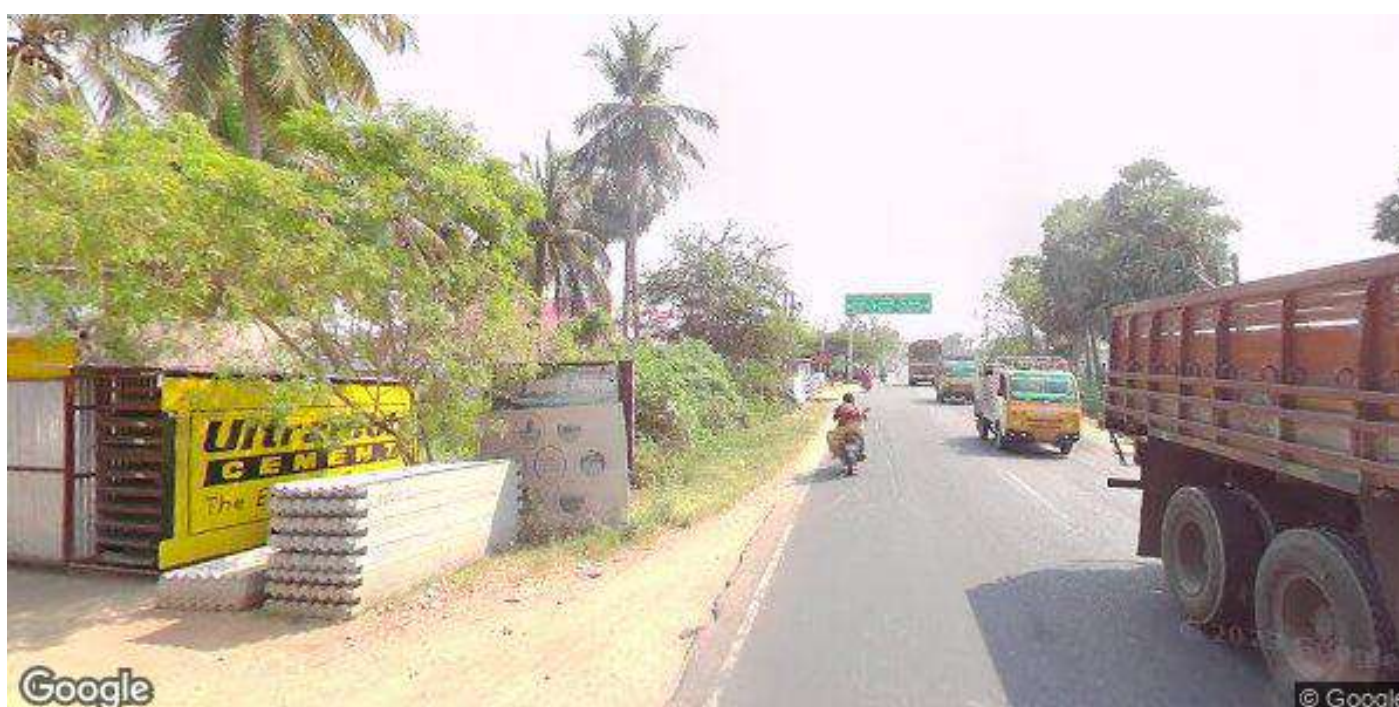
**Risk Type:** Blind Spot  
**Risk Level:** Blind Spot  
**Speed Limit:** 10 KM/Hr  
**Coordinates:** 11.57236, 77.90352

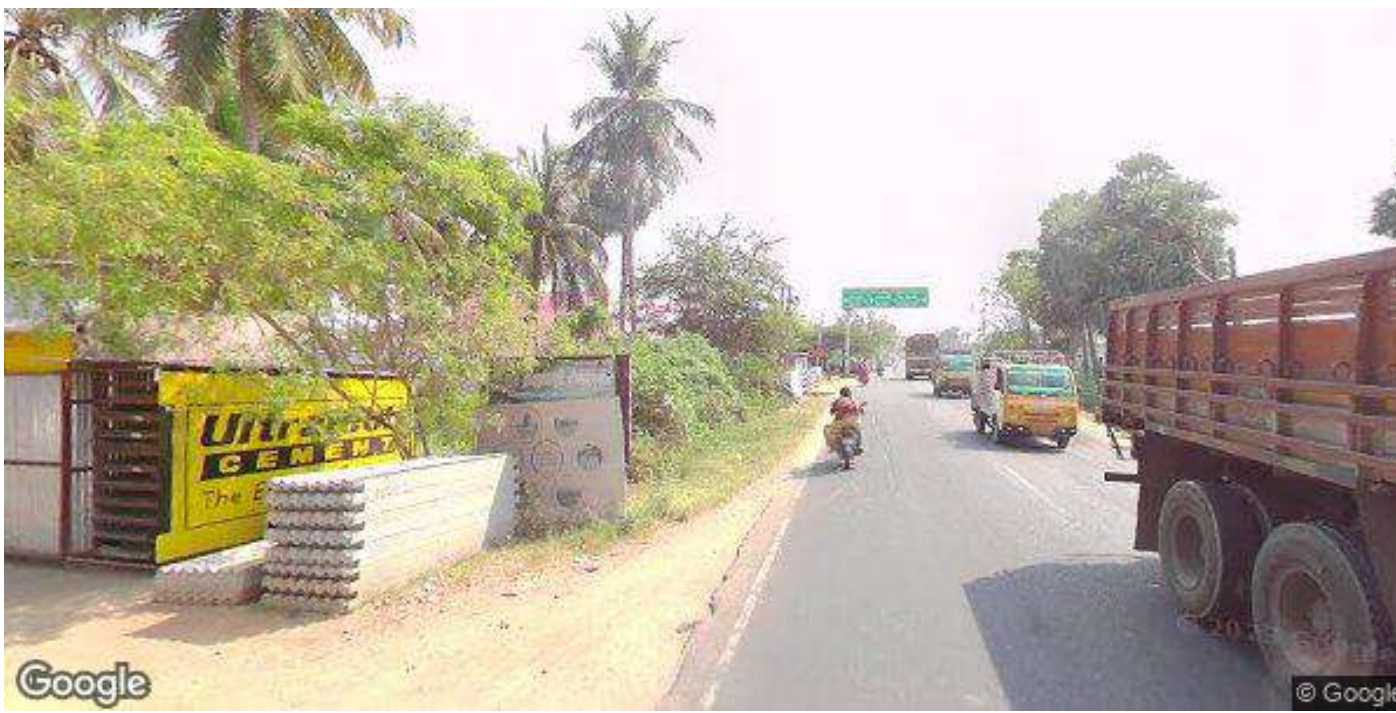
**Risk Type:** Blind Spot  
**Risk Level:** Blind Spot  
**Speed Limit:** 10 KM/Hr  
**Coordinates:** 11.57236, 77.90352
