# IndianOil

## JOURNEY RISK MANAGEMENT (JRM) STUDY

**Salem Terminal TO PON NATARAJAN AGENCIES**

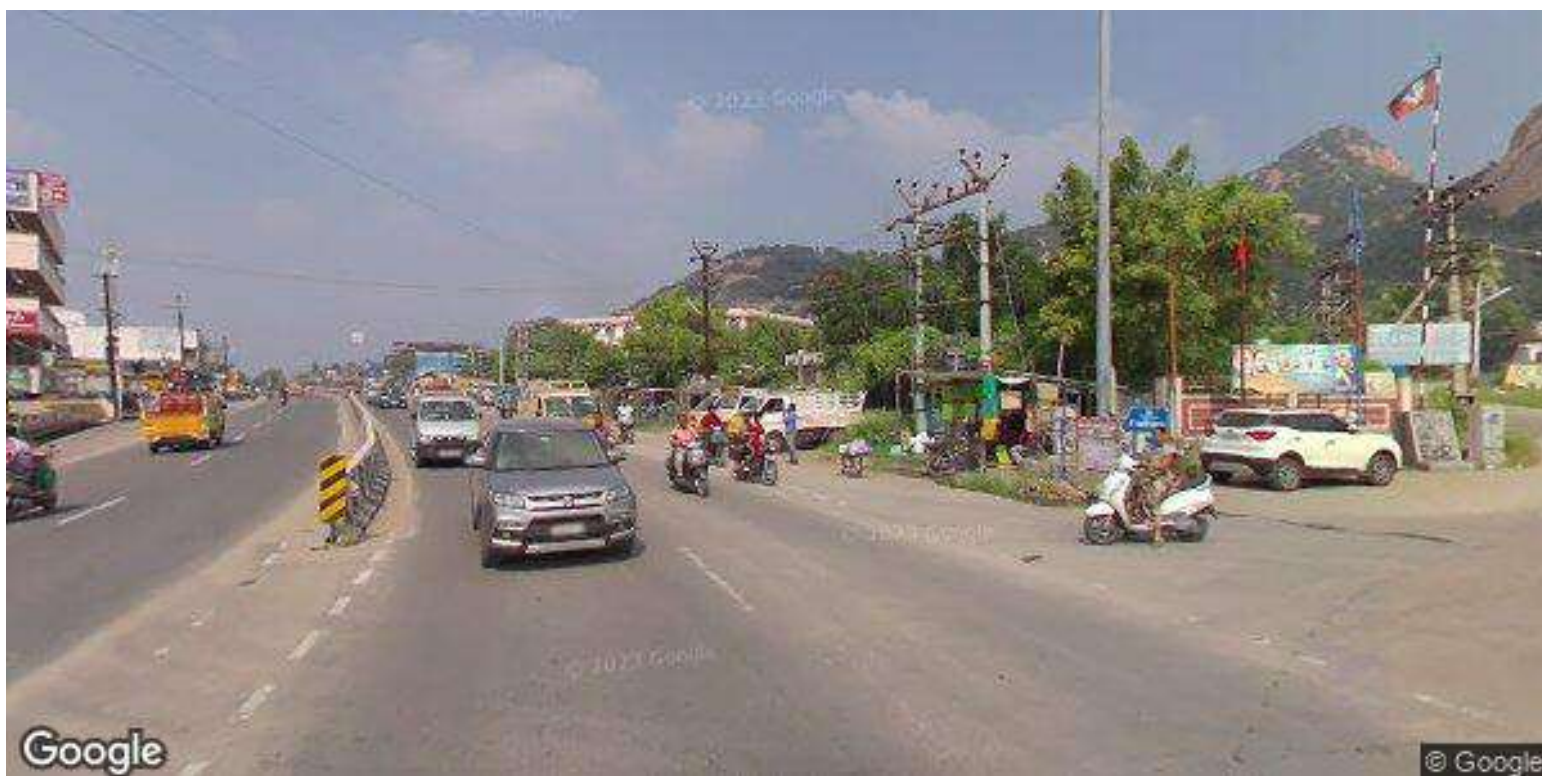
**Coordinates:** 11.39671, 77.88878

**Risk Type:** Turn

**Speed Limit:** 15 KM/Hr

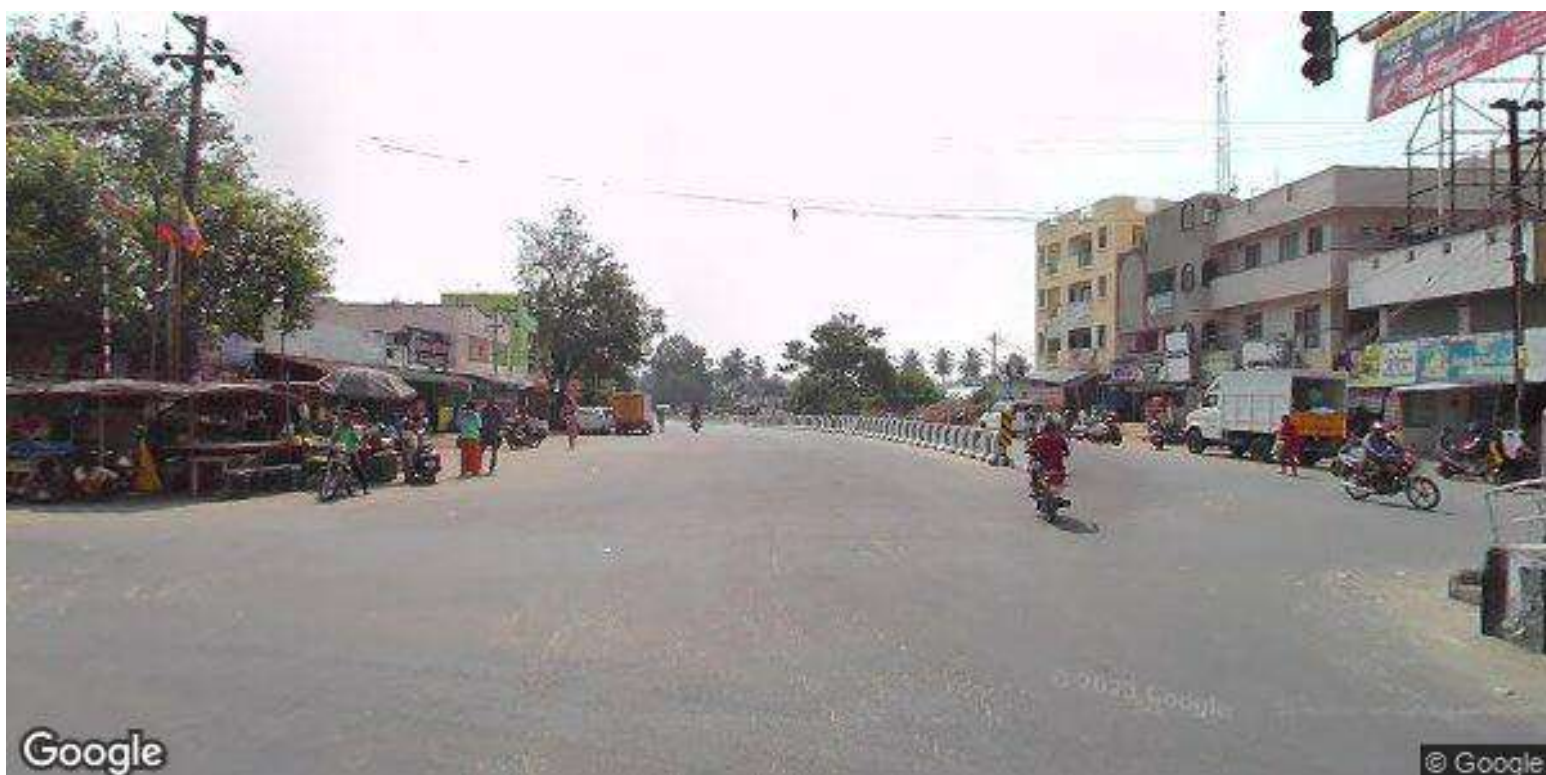
**Risk Type:** Turn  
**Speed Limit:** 15 KM/Hr  
**Distance from Start:** 9.66 km  
**Coordinates:** 11.36604, 77.88887

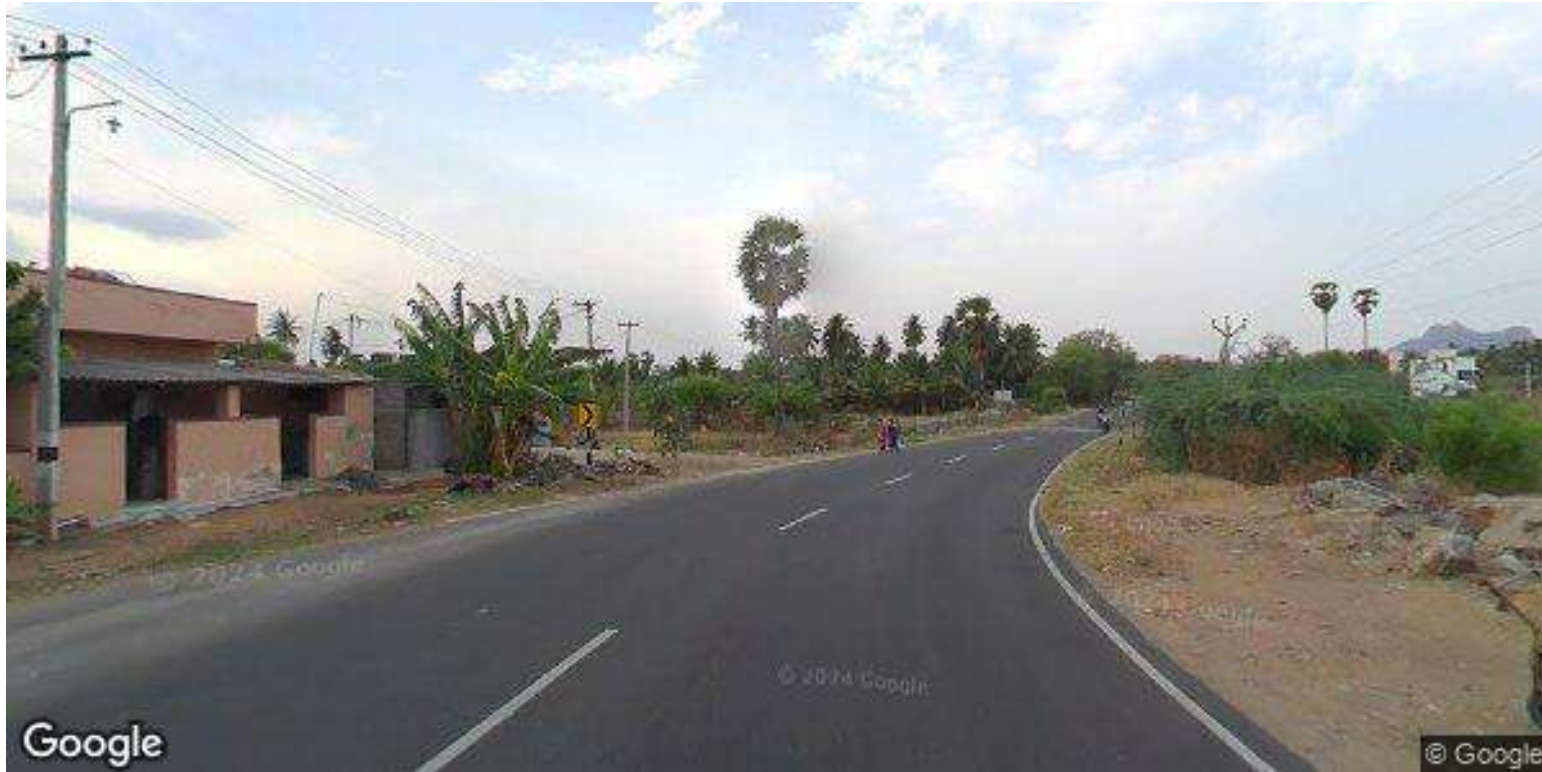
**Risk Type:** Turn  
**Speed Limit:** 15 KM/Hr  
**Distance from Start:** 13.80 km  
**Coordinates:** 11.33882, 77.86218

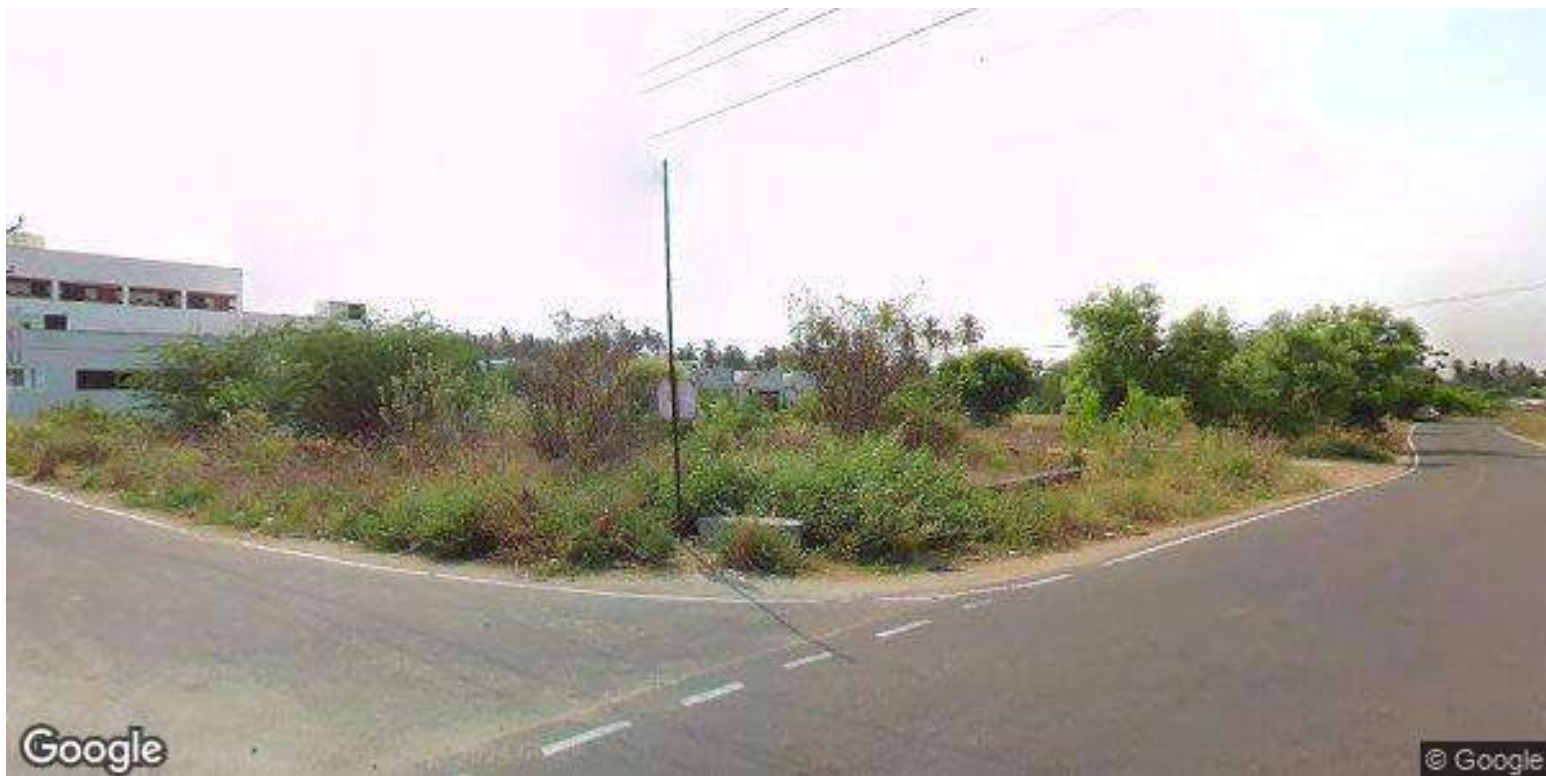
**Coordinates:** 11.29133, 77.74660

**Risk Type:** Turn

**Speed Limit:** 15 KM/Hr

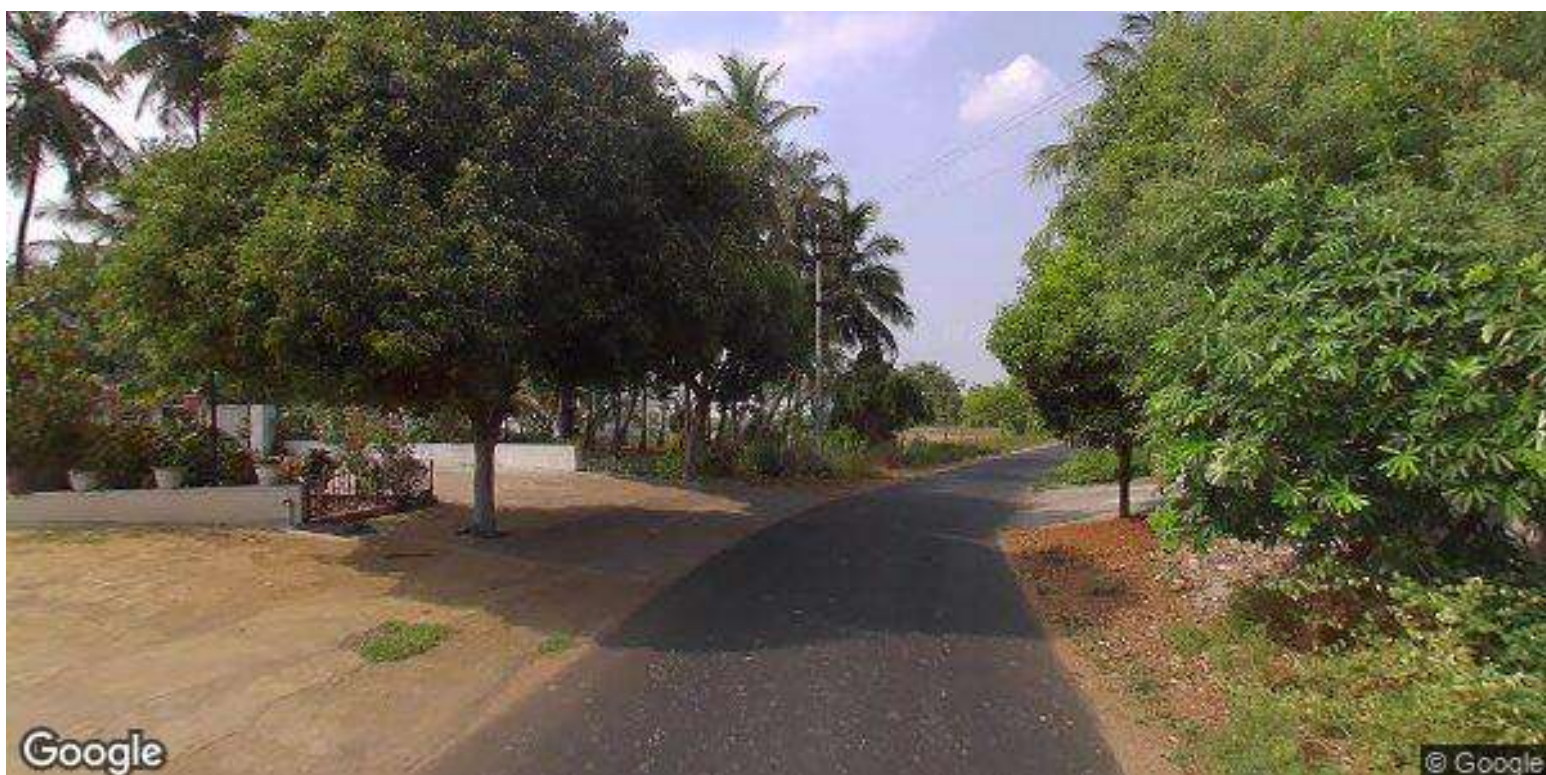
**Coordinates: 11.28859, 77.74323**

**Risk Type: Turn**

**Speed Limit: 15 KM/Hr**

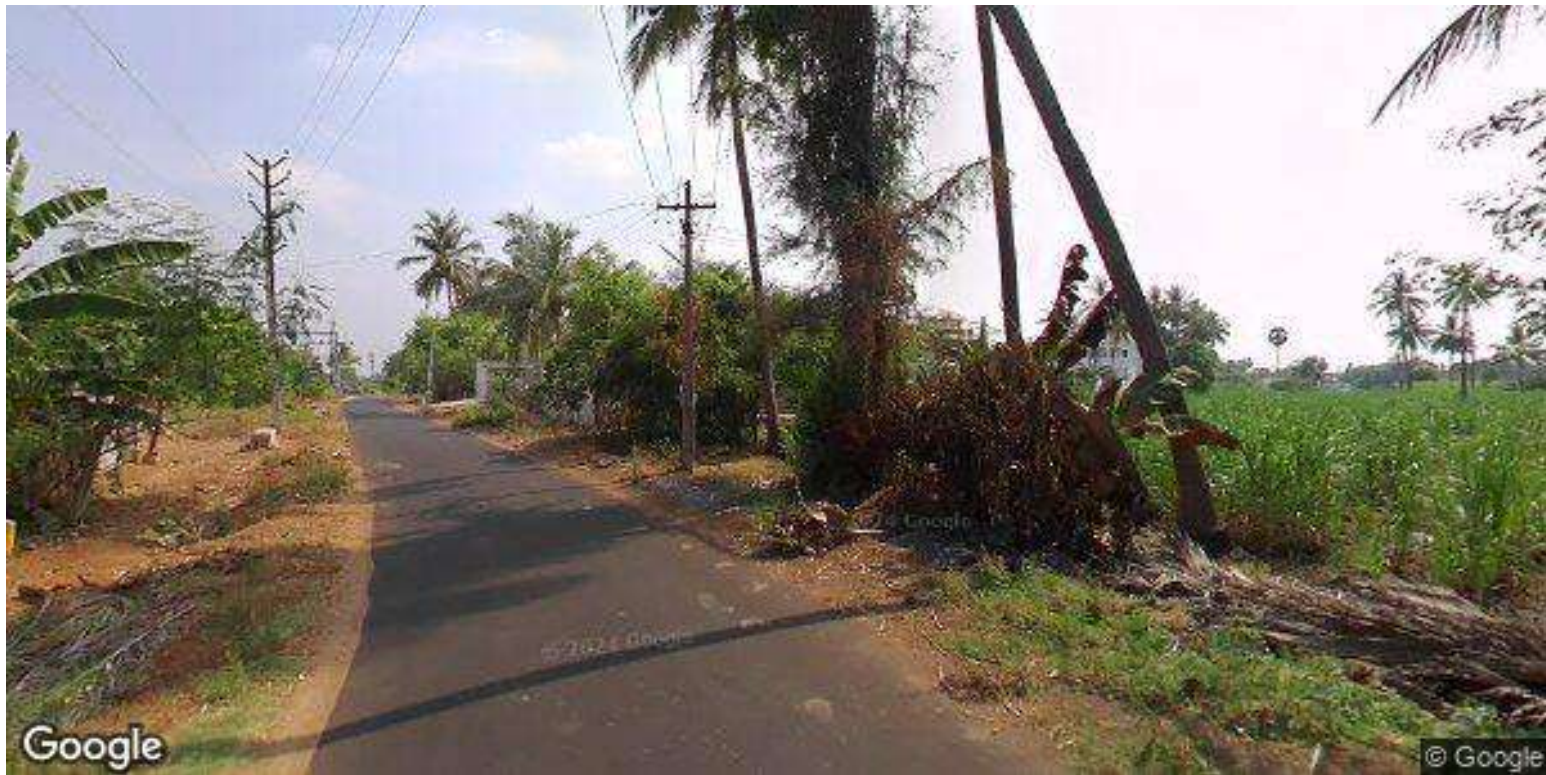
**Coordinates: 11.27558, 77.73107**

**Risk Type: Turn**

**Speed Limit: 15 KM/Hr**

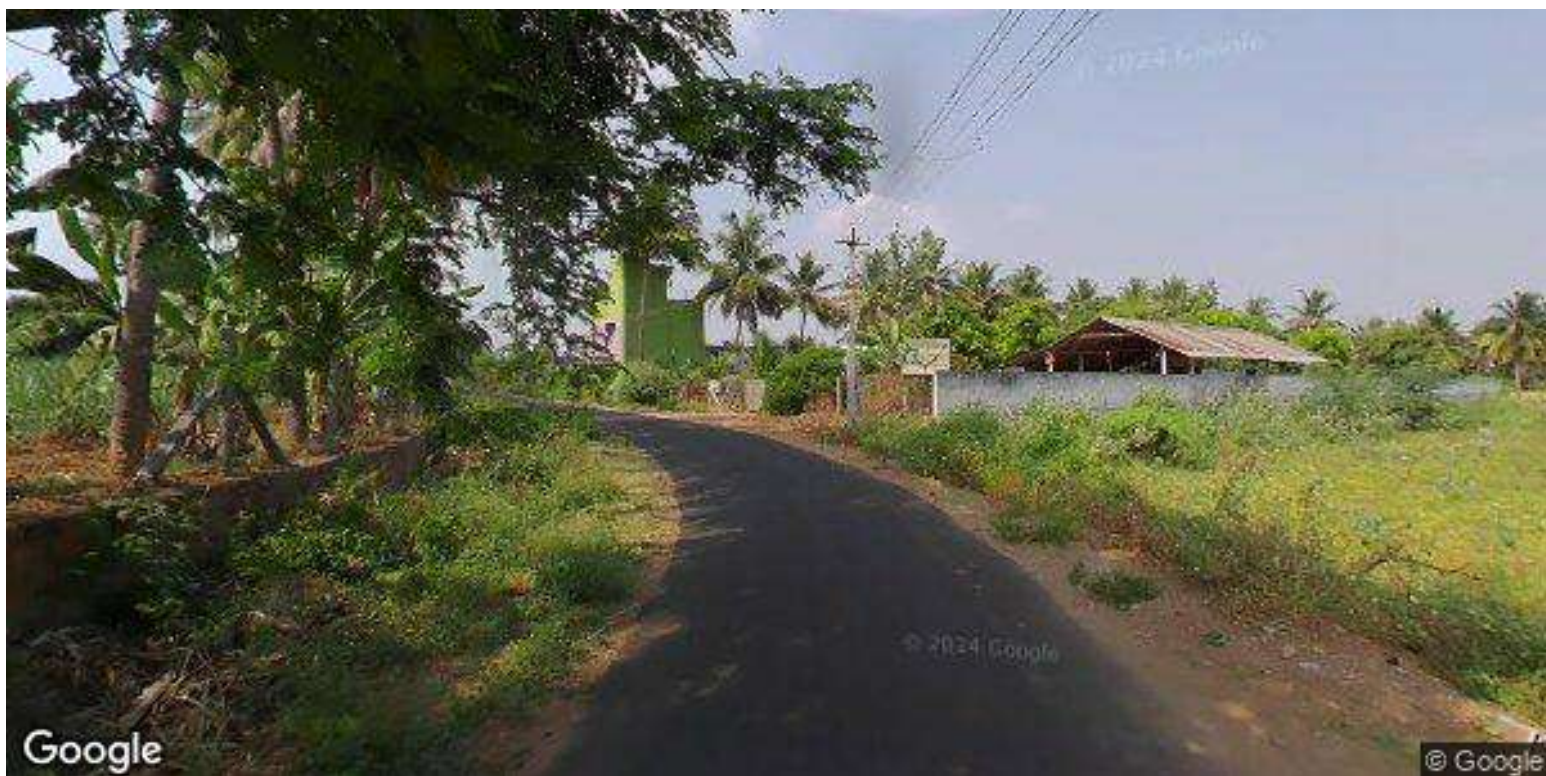
**Coordinates: 11.27326, 77.72991**

**Risk Type: Turn**

**Speed Limit: 15 KM/Hr**

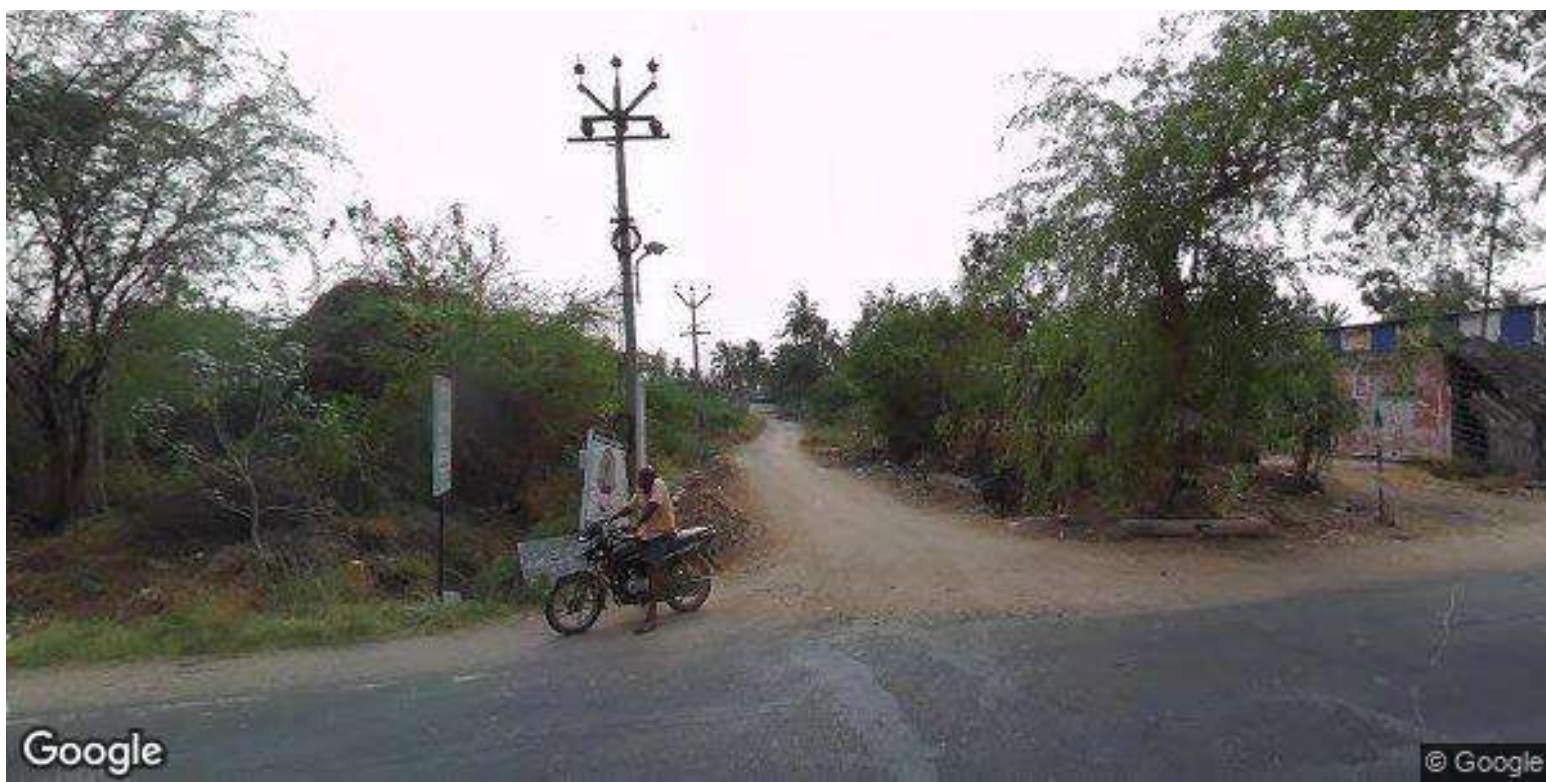
**Coordinates:** 11.27330, 77.72711

**Risk Type:** Turn

**Speed Limit:** 15 KM/Hr

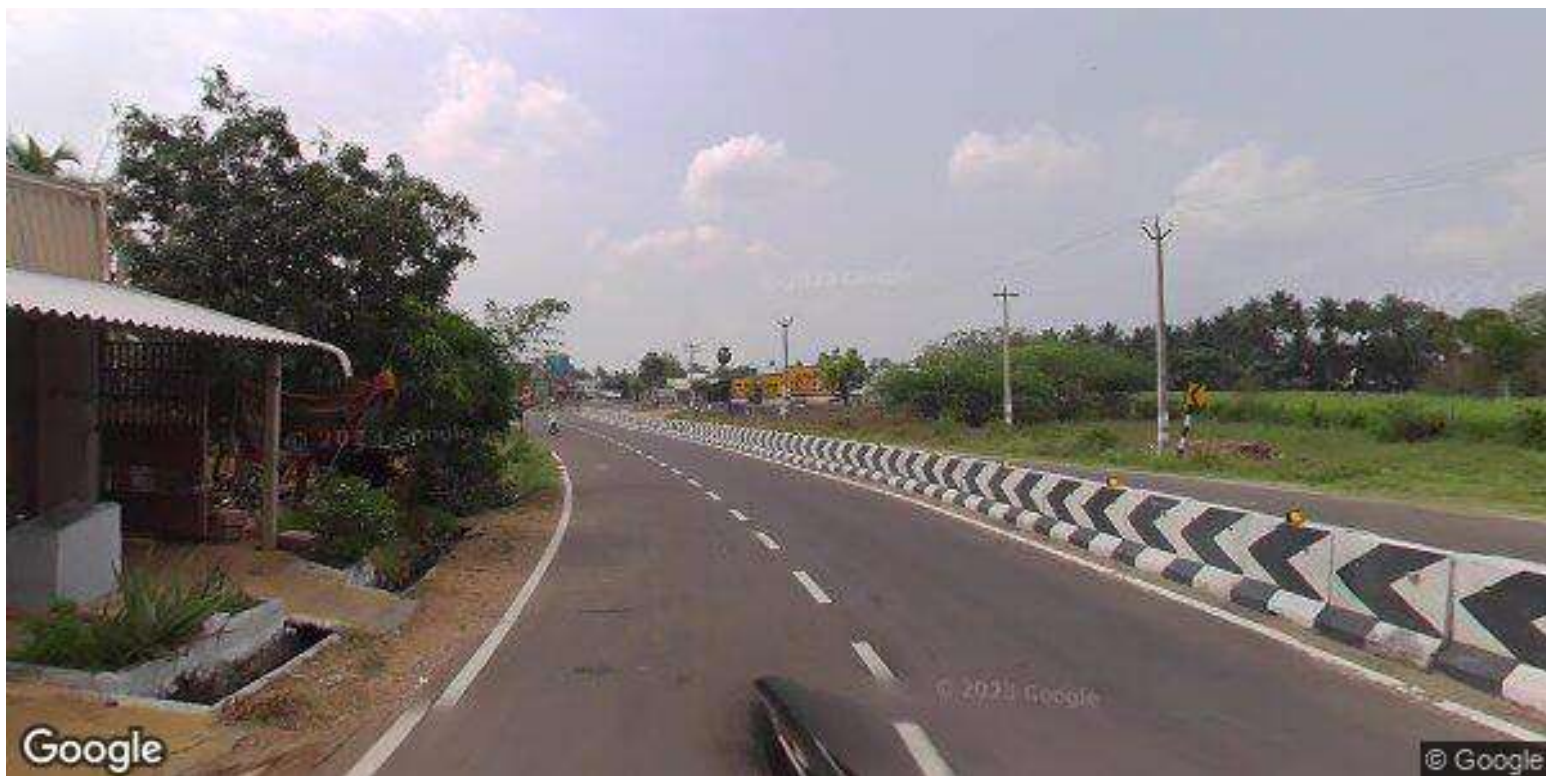
**Coordinates:** 11.22378, 77.71384

**Risk Type:** Turn

**Speed Limit:** 15 KM/Hr
