# IndianOil

## JOURNEY RISK MANAGEMENT (JRM) STUDY

### Salem Terminal to ANITHA AUTO SERVICE

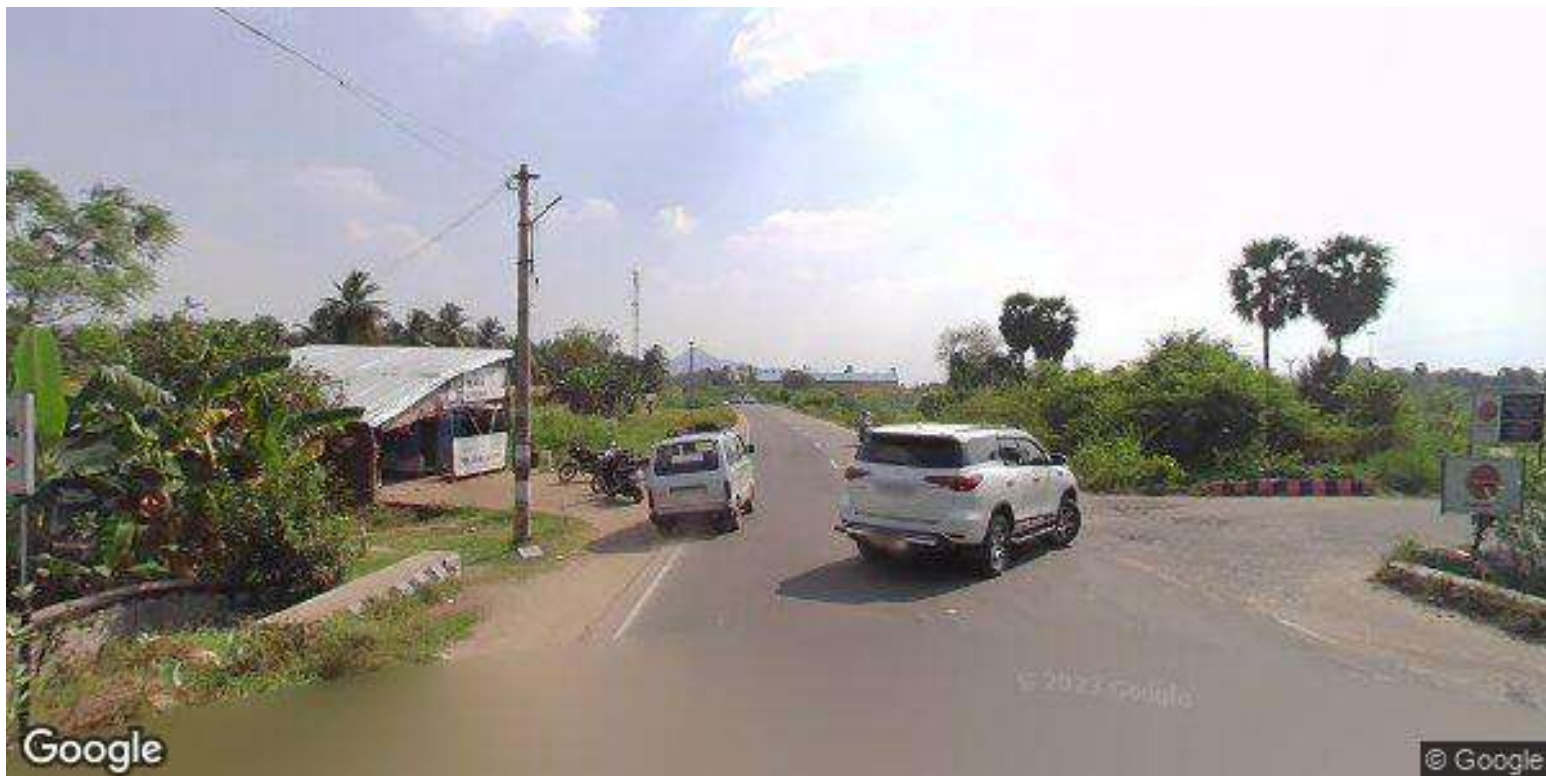
**Coordinates:** 11.44029, 77.87544

**Risk Type:** Turn

**Risk Level:** High

**Speed Limit:** 15 KM/Hr

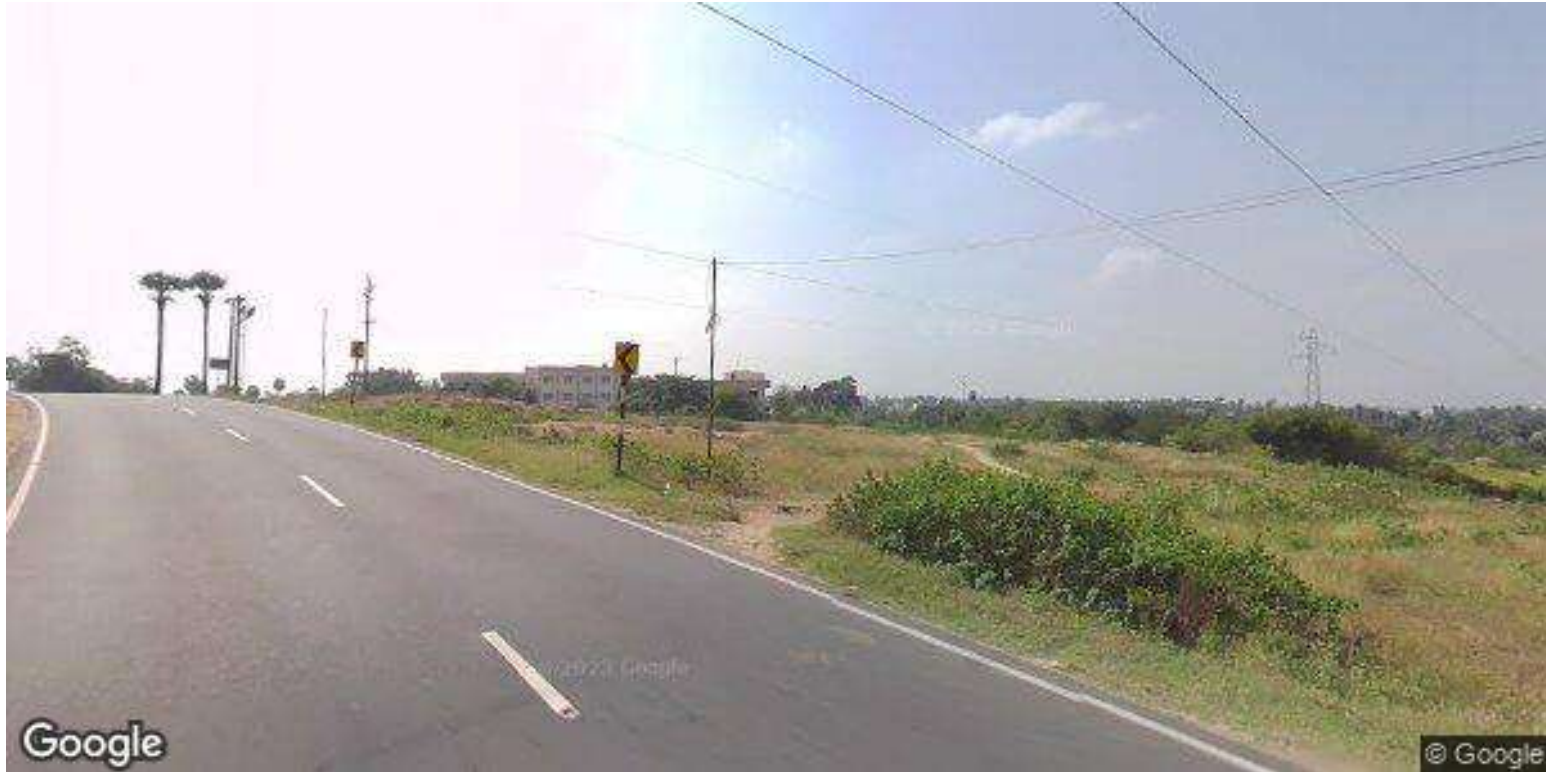
**Risk Type:** Turn  
**Risk Level:** Medium  
**Speed Limit:** 30 KM/Hr  
**Coordinates:** 11.46048, 77.85036

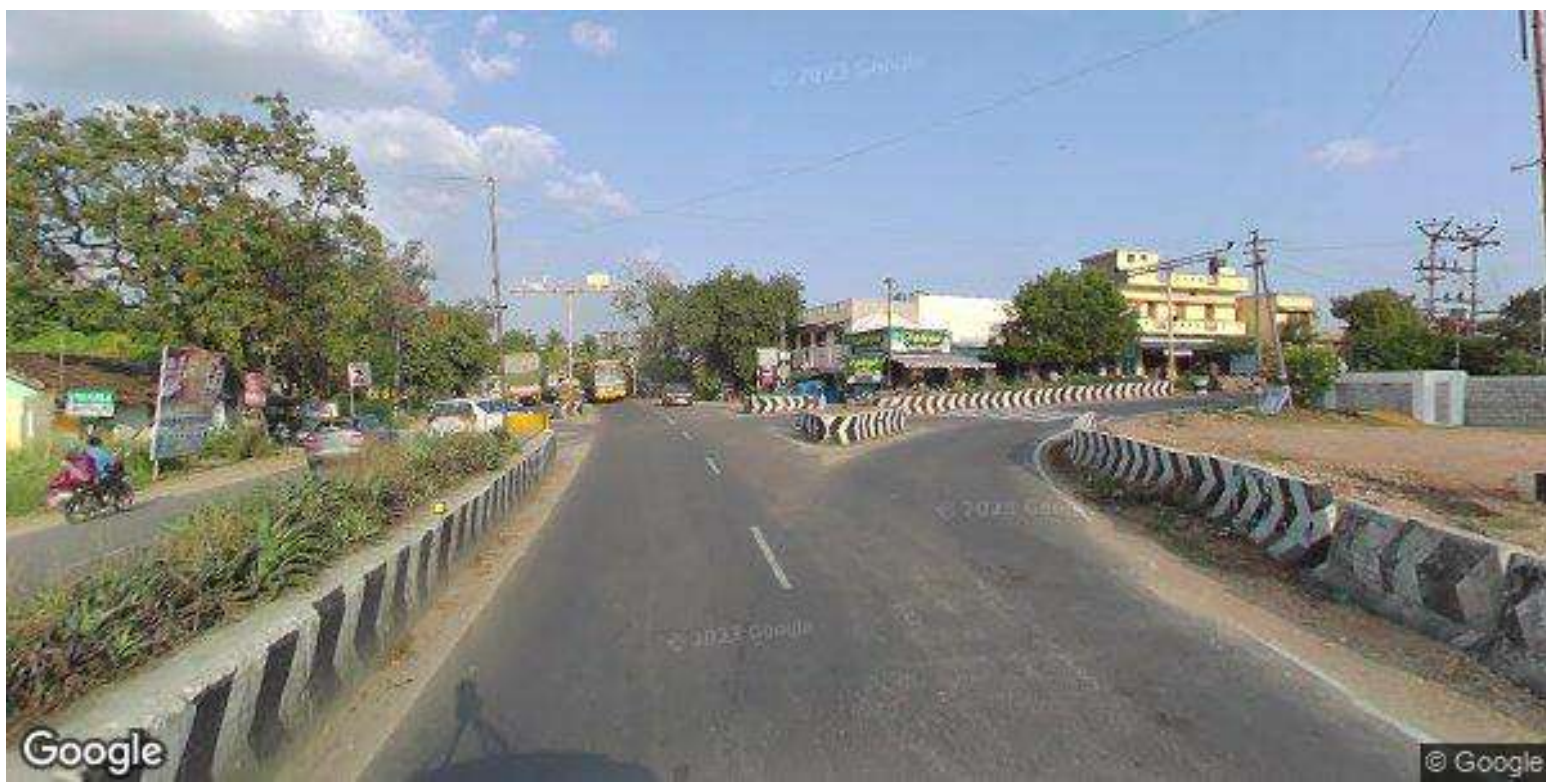
**Coordinates:** 11.46318, 77.84913

**Risk Type:** Turn

**Risk Level:** Medium

**Speed Limit:** 30 KM/Hr

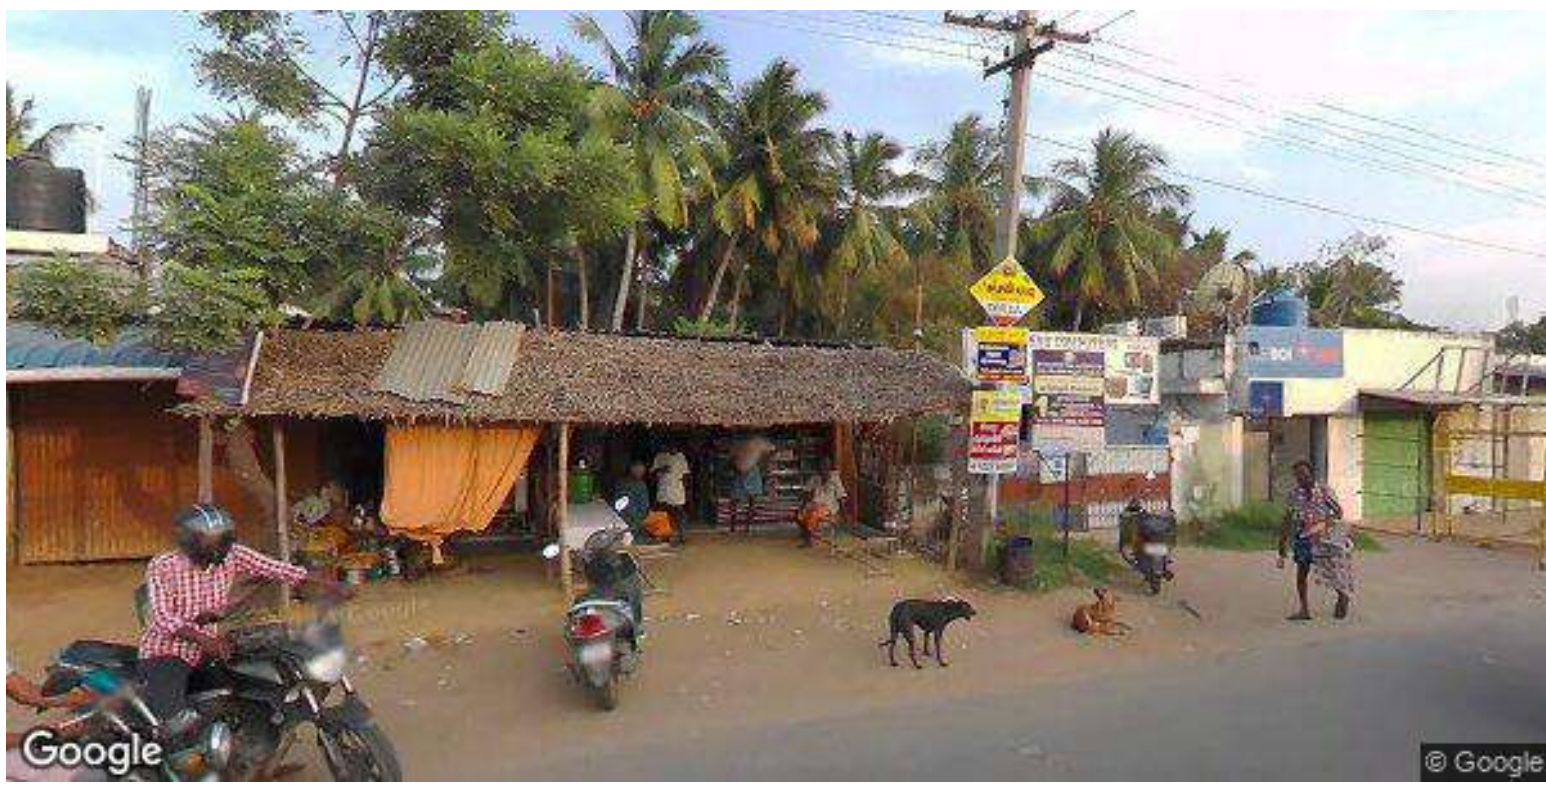
**Coordinates:** 11.44985, 77.69520

**Risk Type:** Turn

**Risk Level:** High

**Speed Limit:** 15 KM/Hr

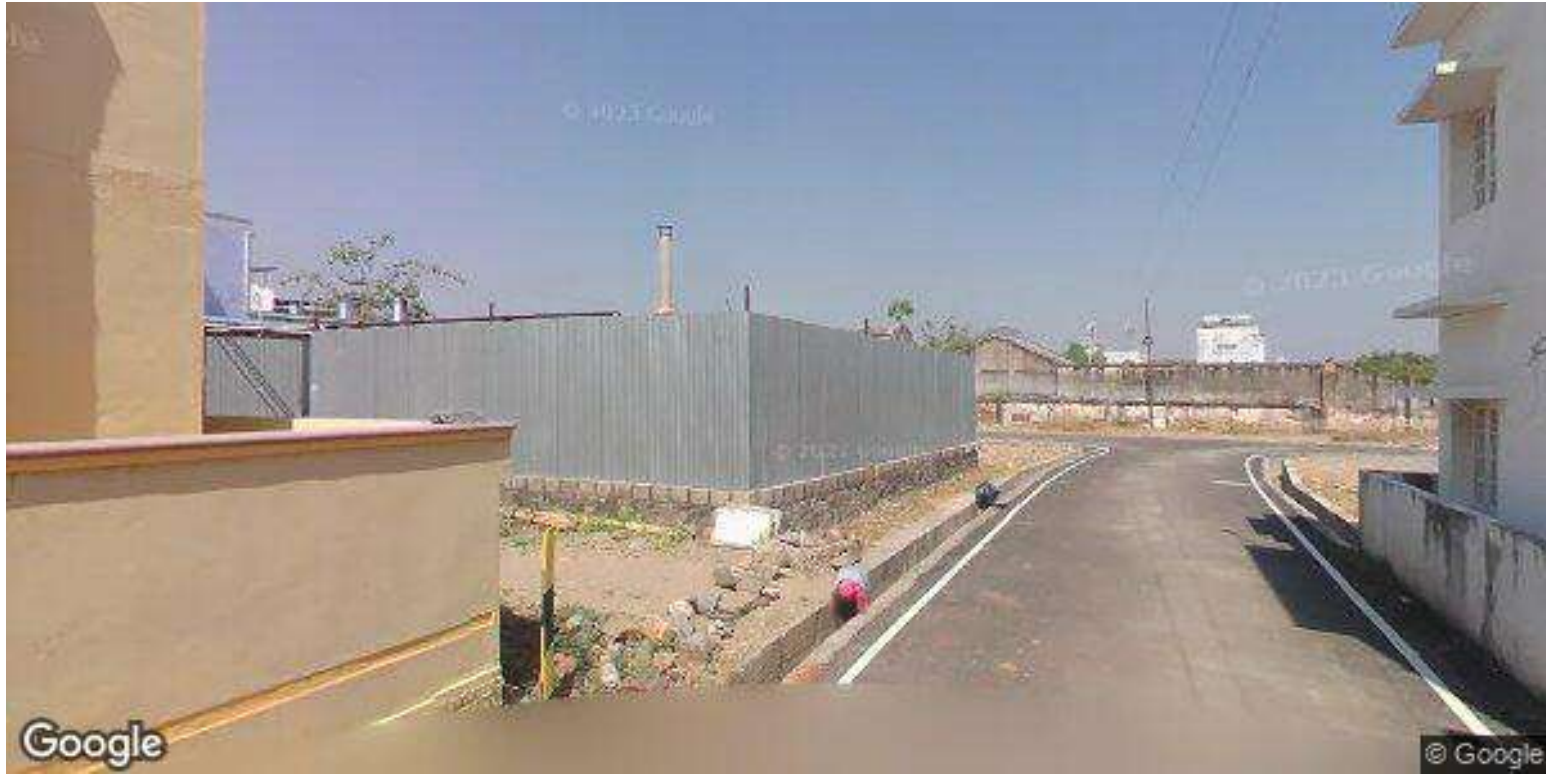
**Risk Type:** Turn  
**Risk Level:** High  
**Speed Limit:** 15 KM/Hr  
**Coordinates:** 11.44948, 77.68645

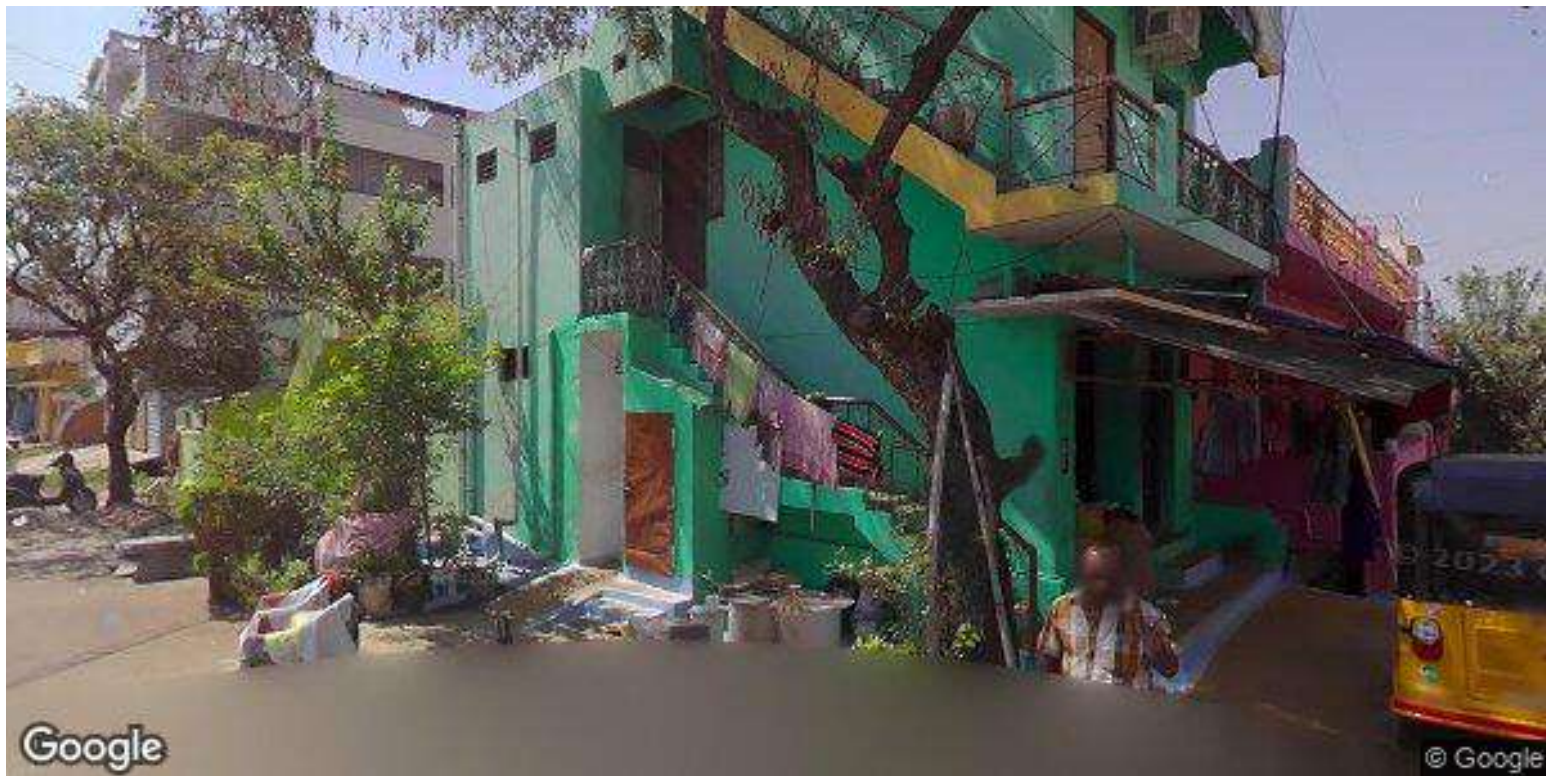
**Risk Type:** Turn  
**Risk Level:** High  
**Speed Limit:** 15 KM/Hr  
**Coordinates:** 11.44801, 77.68596

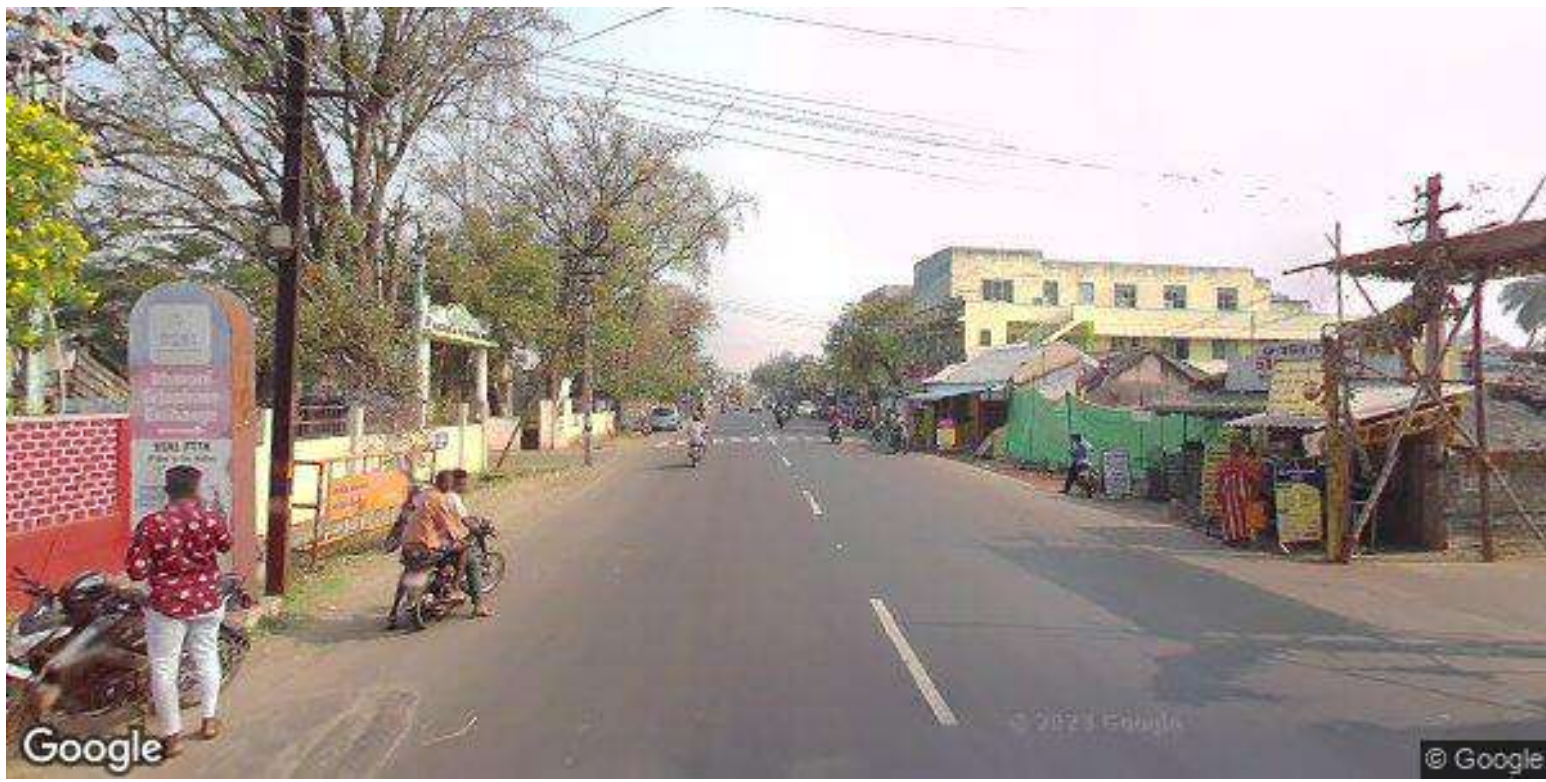
**Coordinates:** 11.44842, 77.68473

**Risk Type:** Blind Spot

**Risk Level:** Blind Spot

**Speed Limit:** 10 KM/Hr
