# IndianOil

## JOURNEY RISK MANAGEMENT (JRM) STUDY

**Salem Terminal TO SIVASAKTHI & CO.**

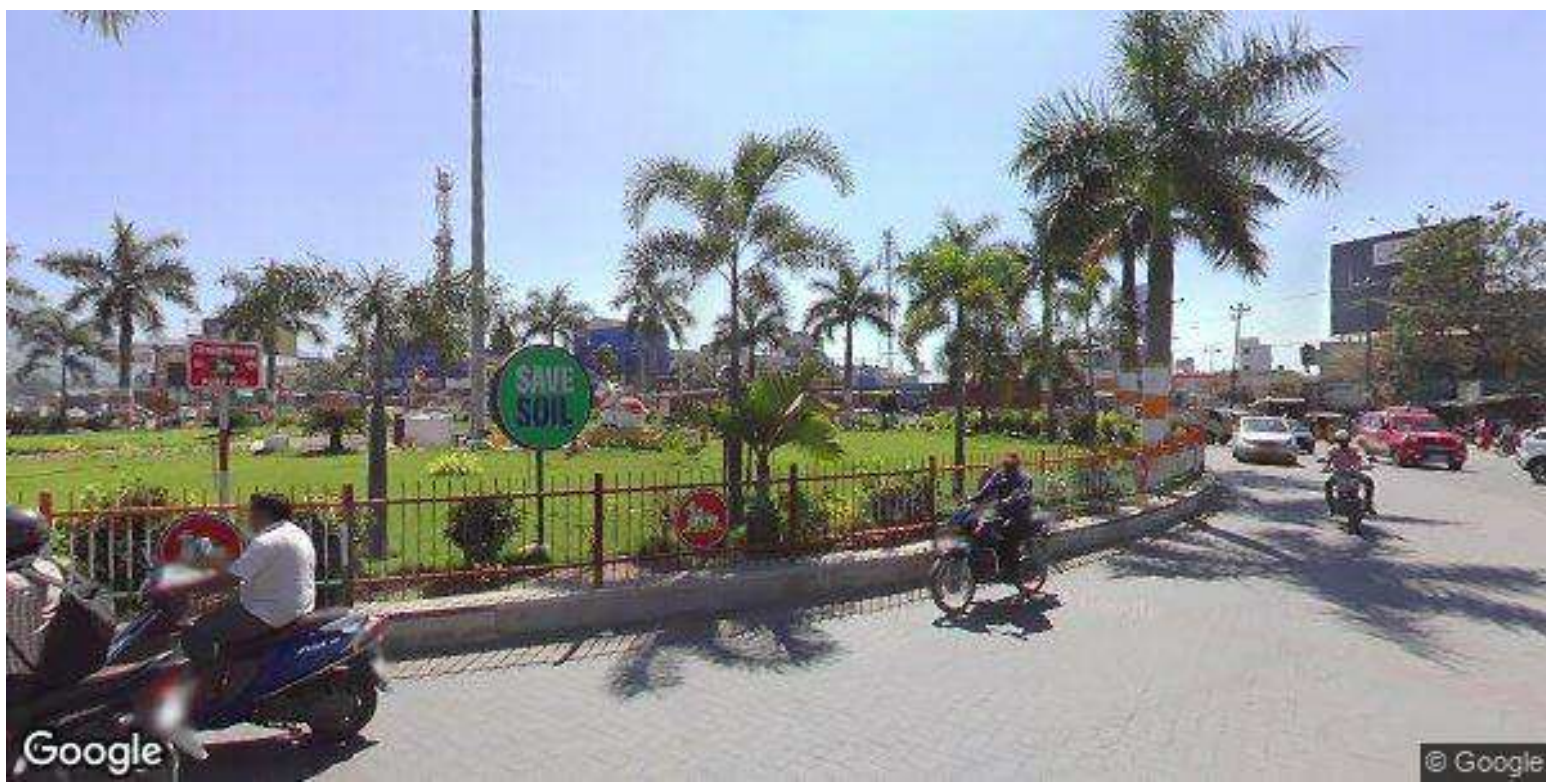
**Coordinates:** 11.63303, 78.12713

**Risk Type:** Roundabout

**Risk Level:** High

**Speed Limit:** 15 KM/Hr

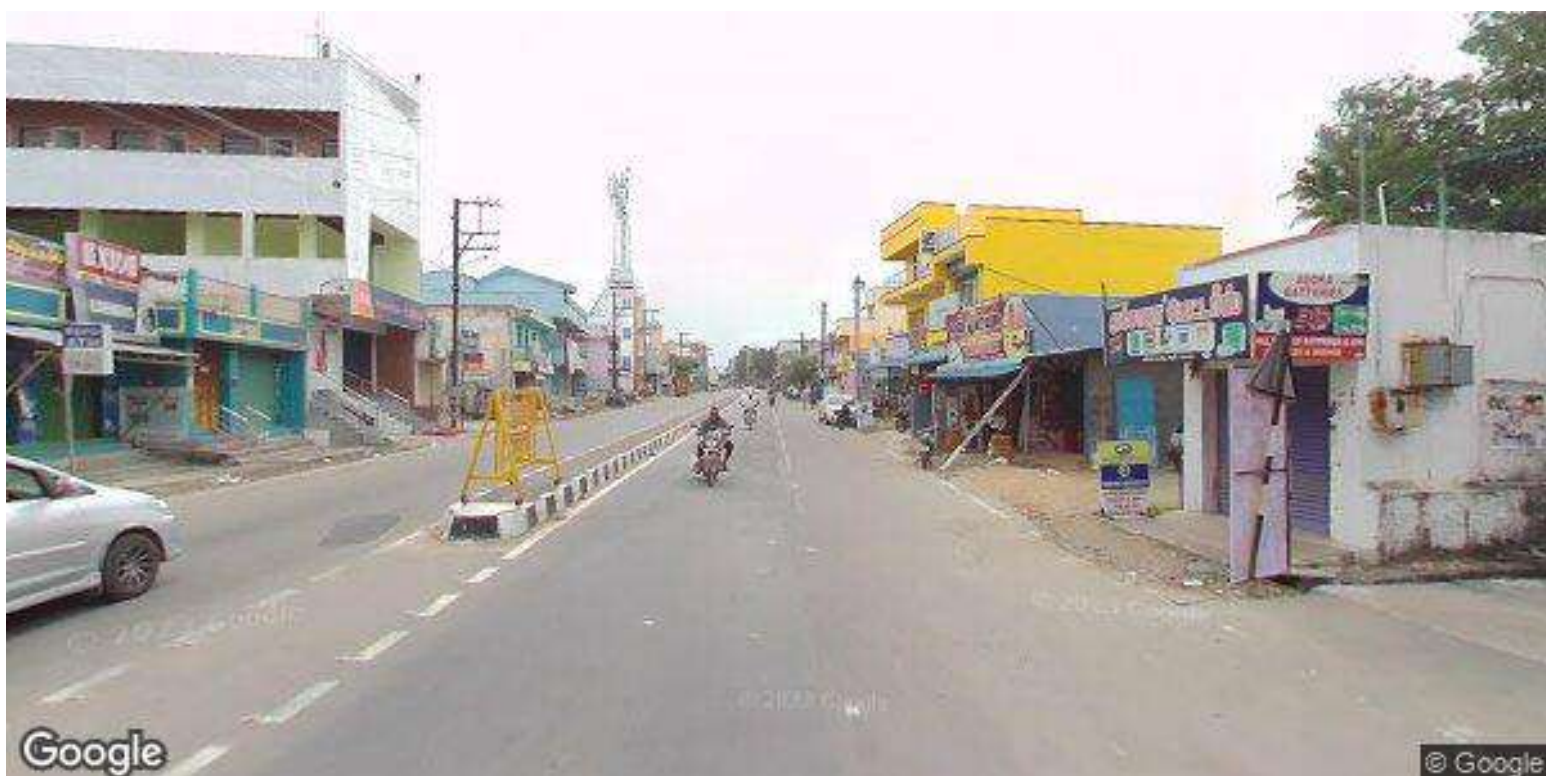
**Coordinates:** 12.0543064, 78.4762765

**Risk Type:** U-Turn

**Risk Level:** High

**Speed Limit:** 10 KM/Hr

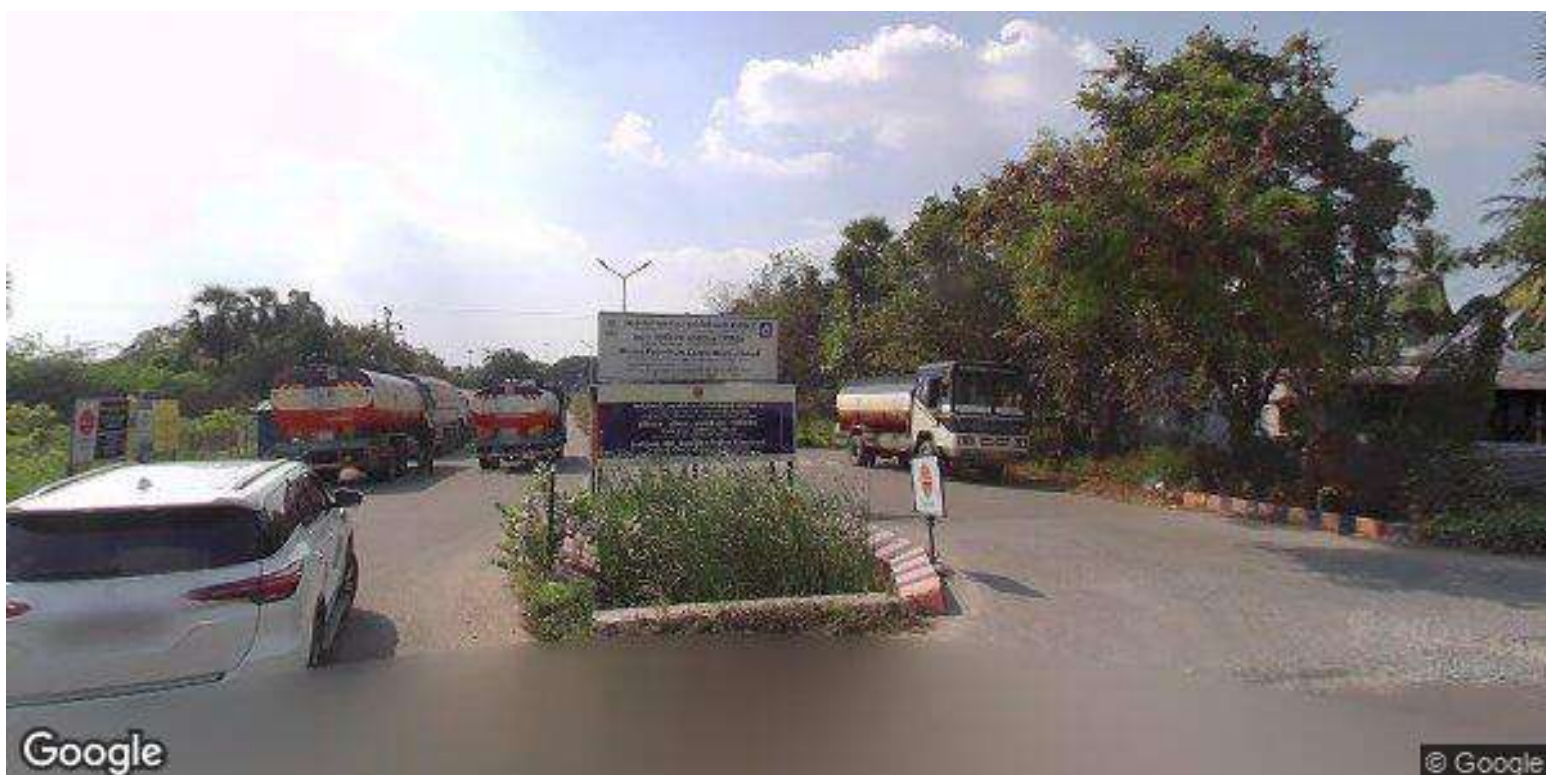
**Risk Type:** Turn  
**Risk Level:** High  
**Speed Limit:** 15 KM/Hr  
**Coordinates:** 11.44024, 77.87528

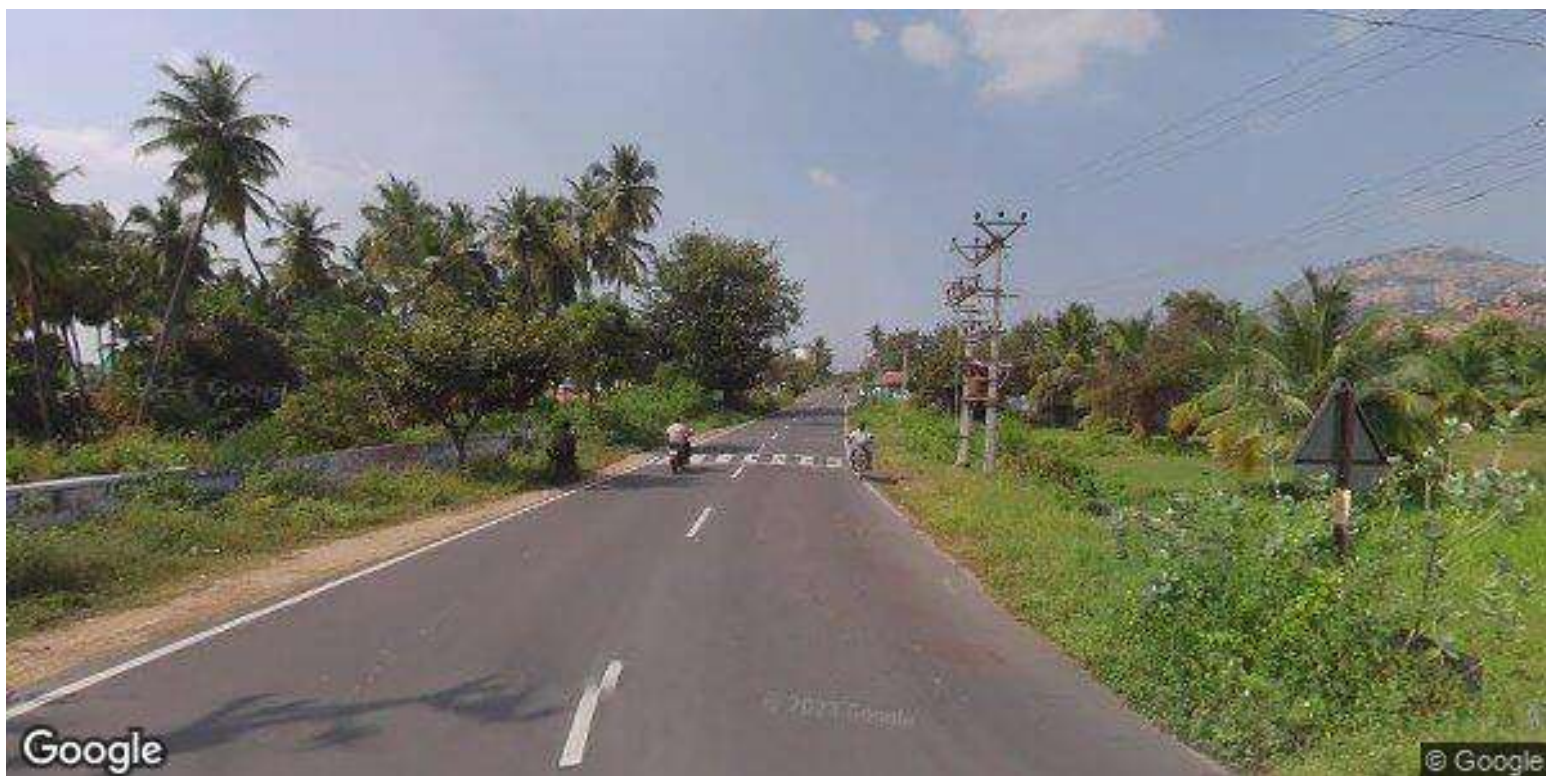
**Risk Type:** Turn  
**Risk Level:** High  
**Speed Limit:** 15 KM/Hr  
**Coordinates:** 11.45352, 77.85698

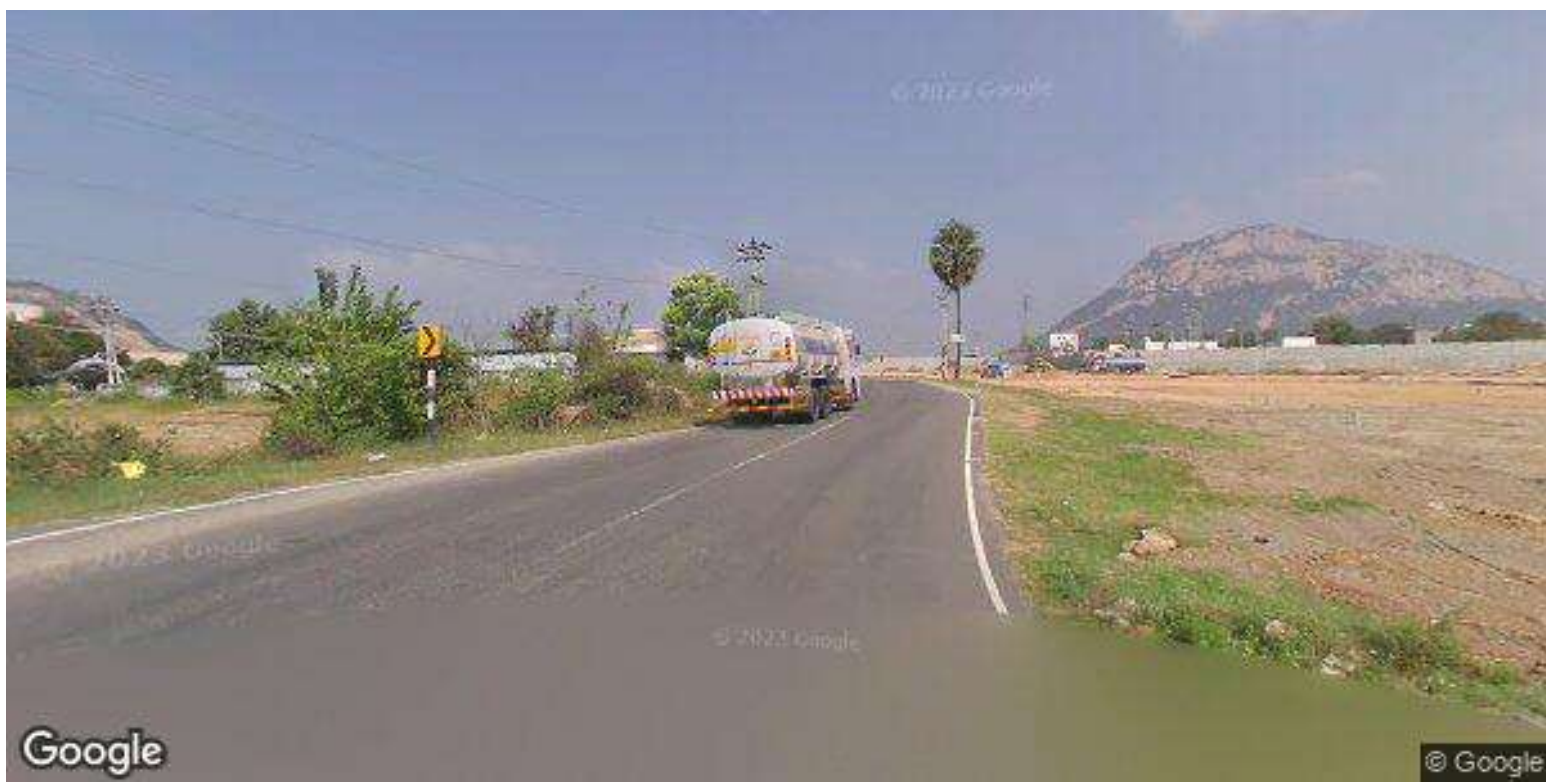
**Coordinates:** 11.45847, 77.85140

**Risk Type:** Turn

**Risk Level:** Medium

**Speed Limit:** 30 KM/Hr

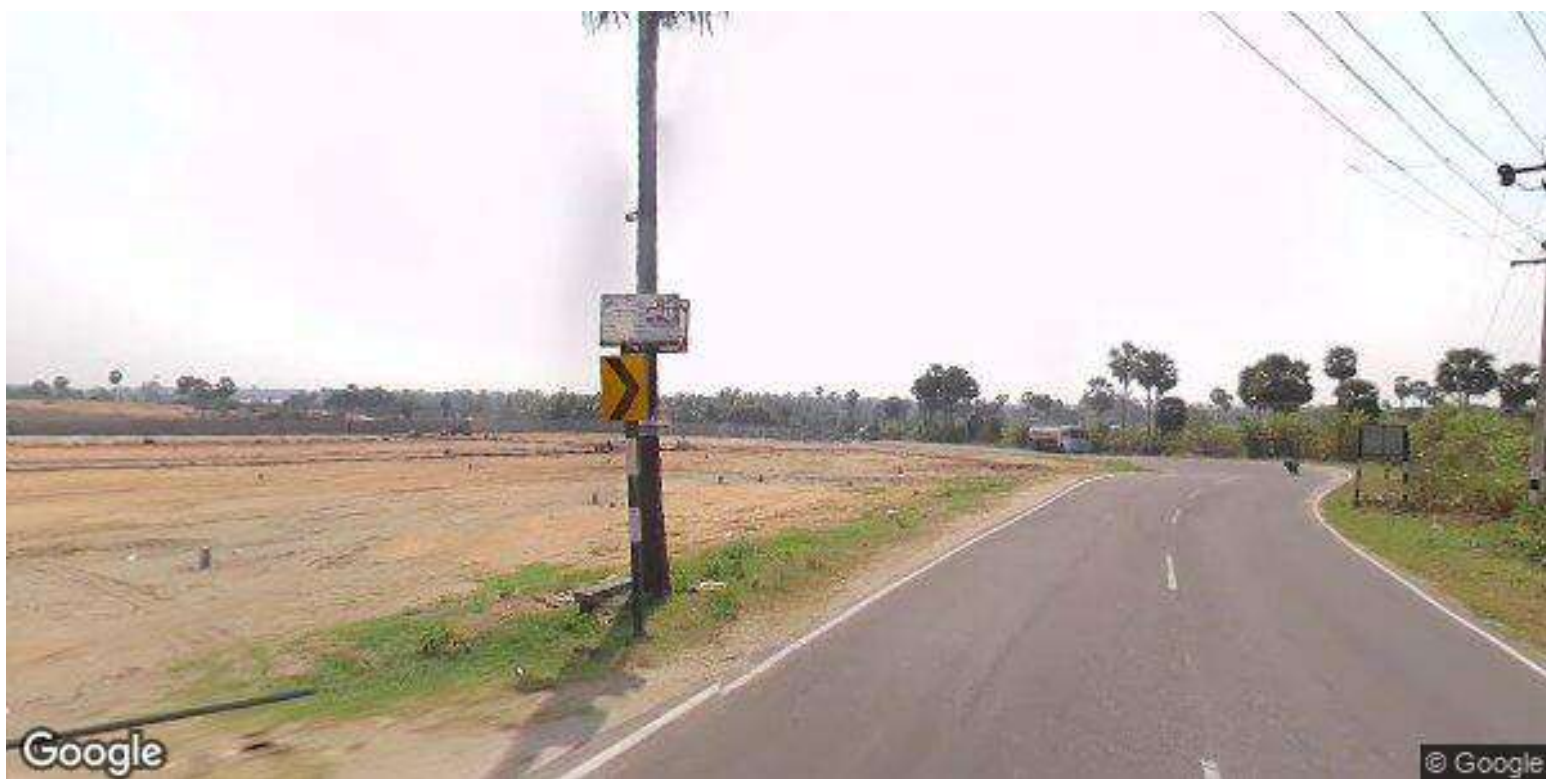
**Coordinates:** 11.45898, 77.85135

**Risk Type:** Turn

**Risk Level:** Medium

**Speed Limit:** 30 KM/Hr

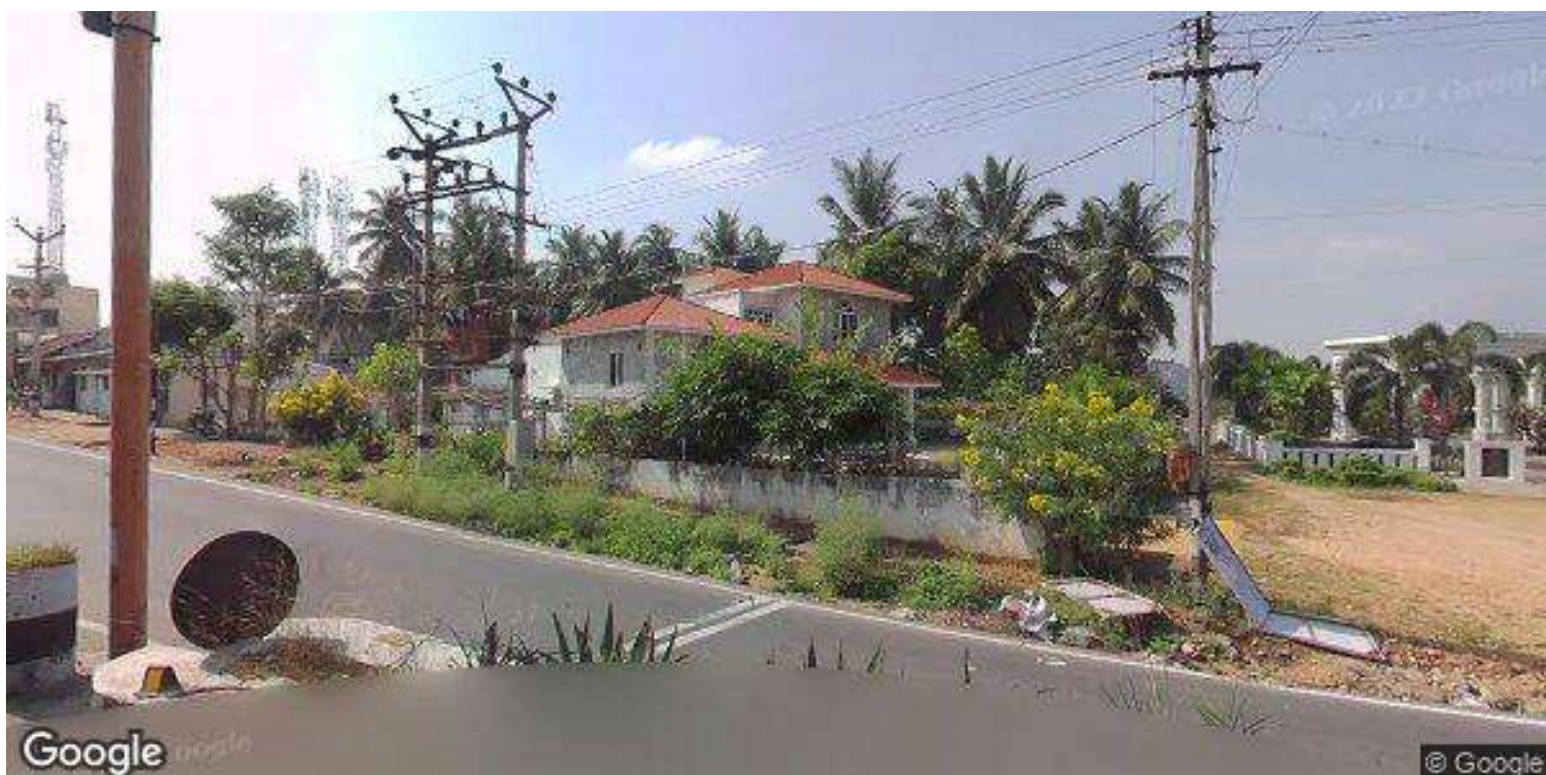
**Coordinates:** 11.46303, 77.84945

**Risk Type:** Turn

**Risk Level:** High

**Speed Limit:** 15 KM/Hr

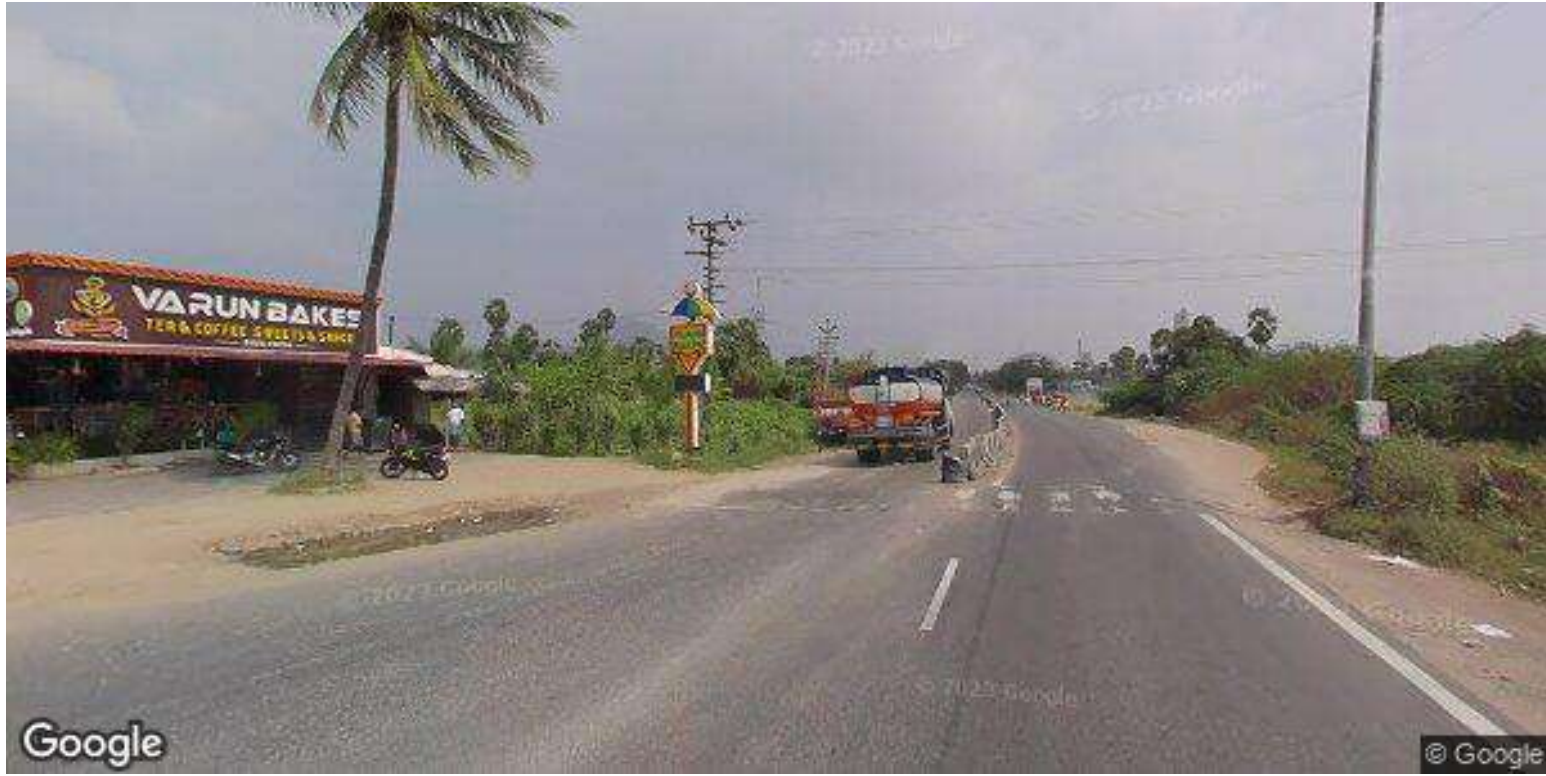
**Coordinates:** 11.45543, 77.81740

**Risk Type:** Turn

**Risk Level:** Medium

**Speed Limit:** 30 KM/Hr

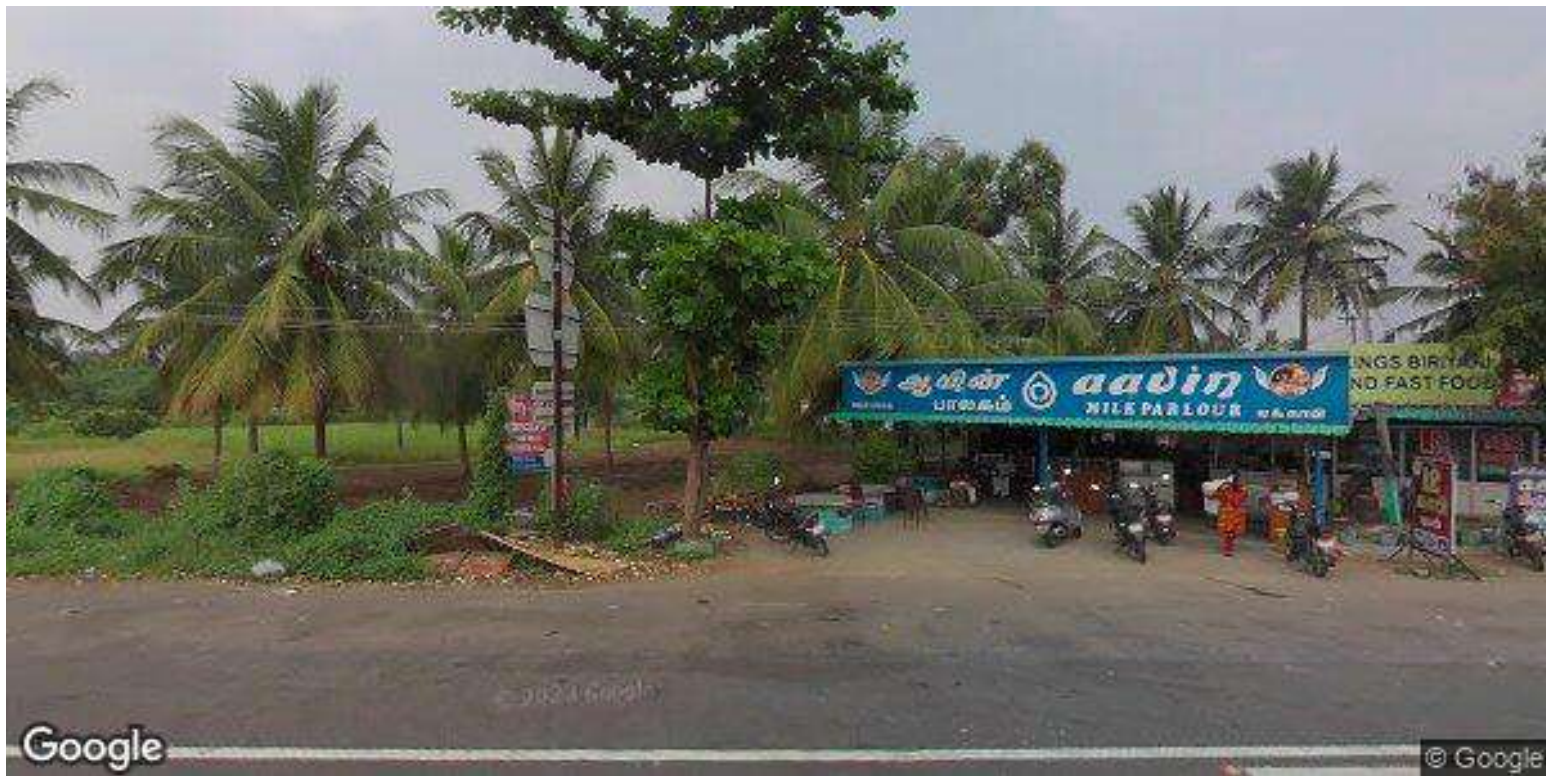
**Coordinates:** 11.45631, 77.81668

**Risk Type:** Turn

**Risk Level:** High

**Speed Limit:** 15 KM/Hr

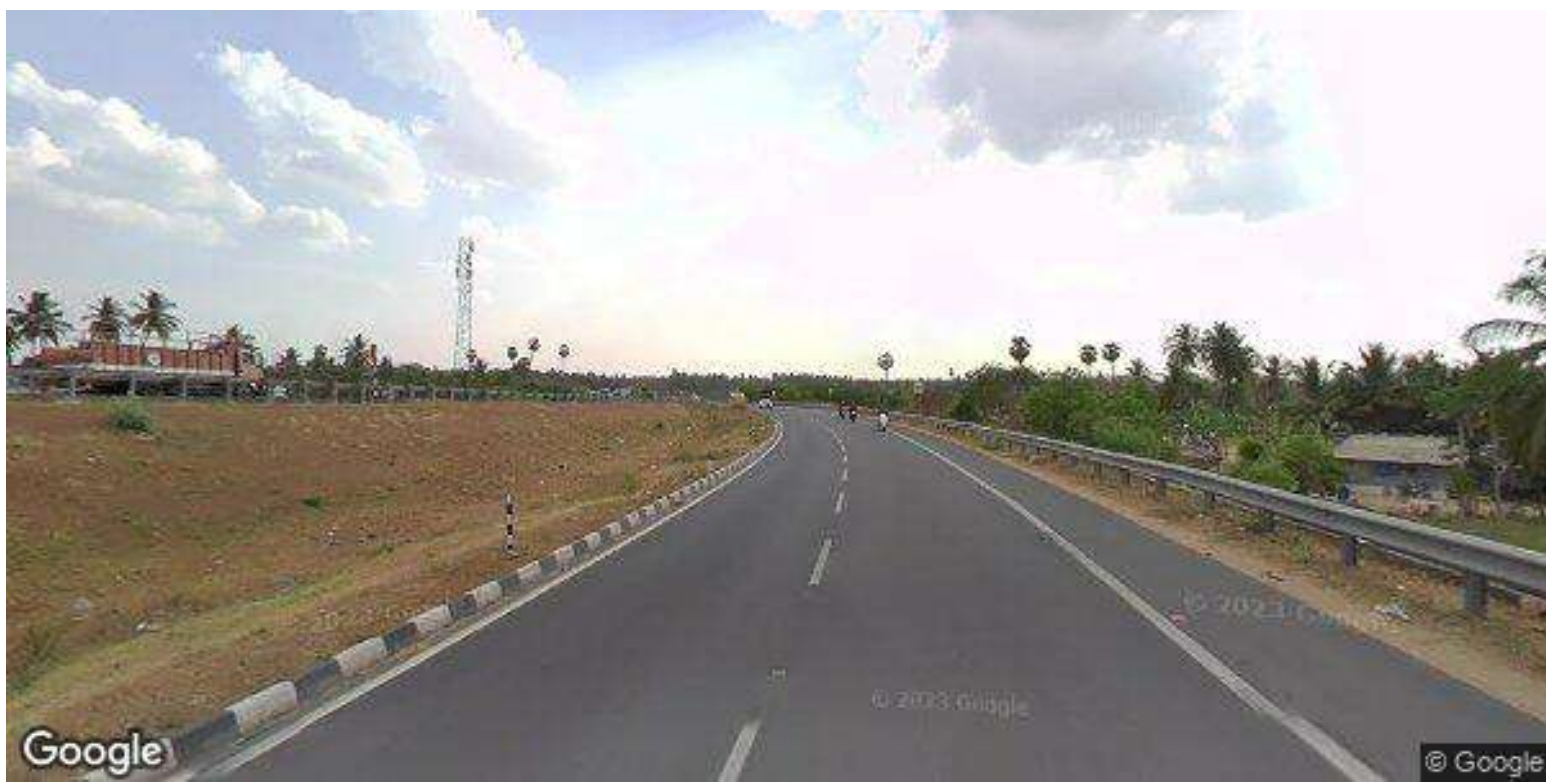
**Coordinates:** 11.53552, 77.95763

**Risk Type:** Turn

**Risk Level:** Medium

**Speed Limit:** 30 KM/Hr

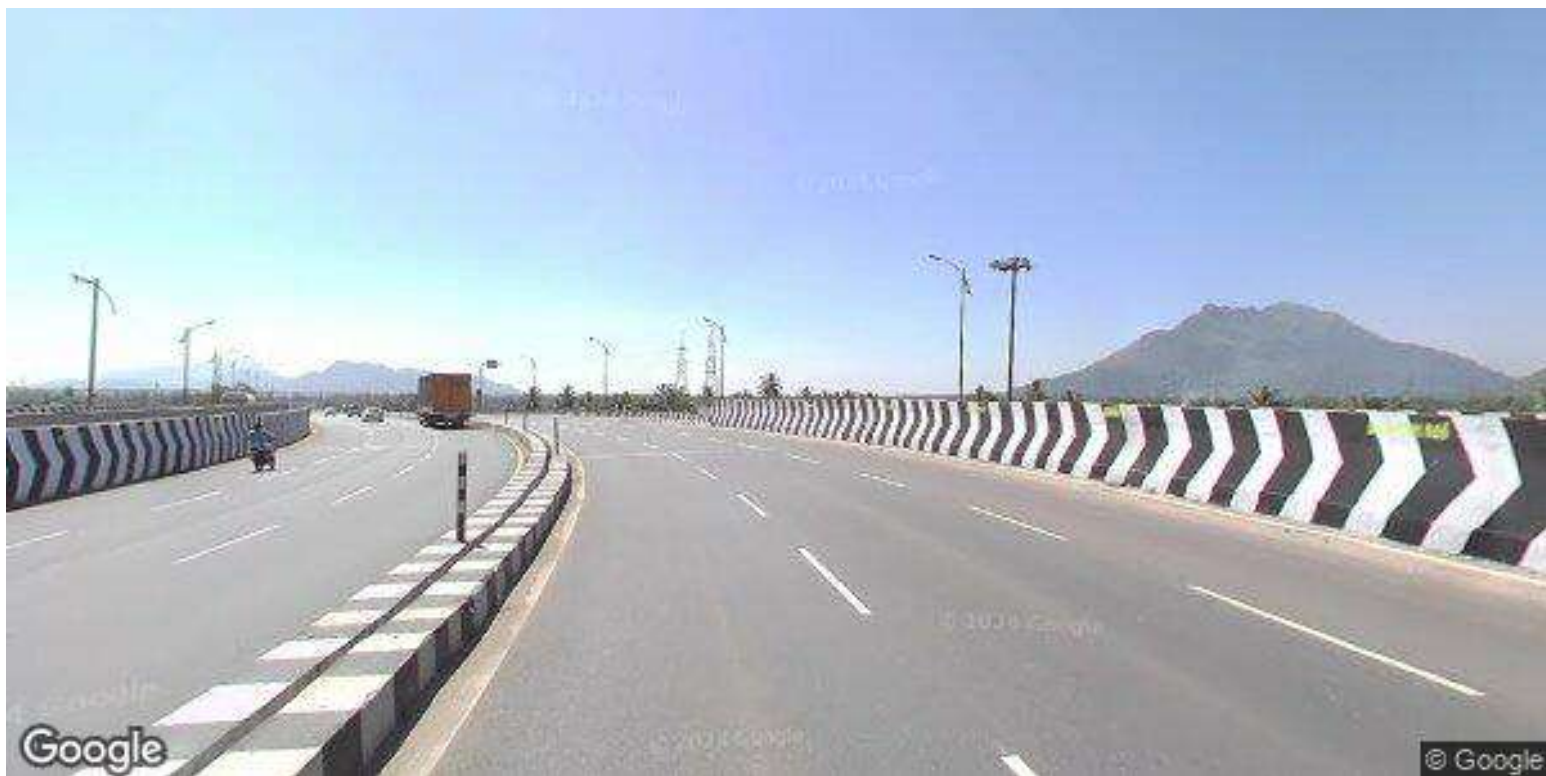
**Coordinates:** 11.64158, 78.11808

**Risk Type:** Turn

**Risk Level:** Medium

**Speed Limit:** 30 KM/Hr

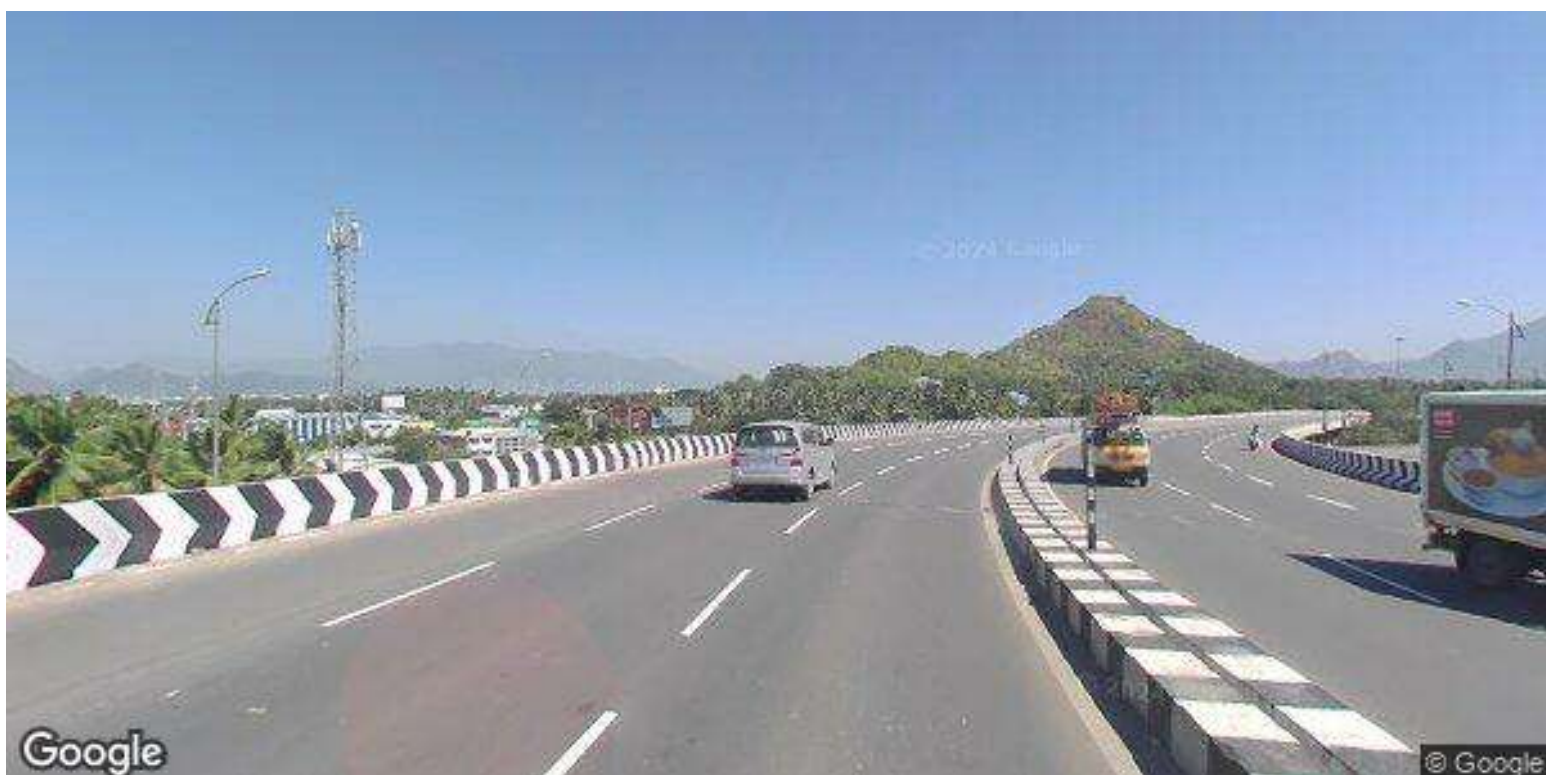
**Risk Type:** Turn  
**Risk Level:** Medium  
**Speed Limit:** 30 KM/Hr  
**Coordinates:** 11.64210, 78.11860

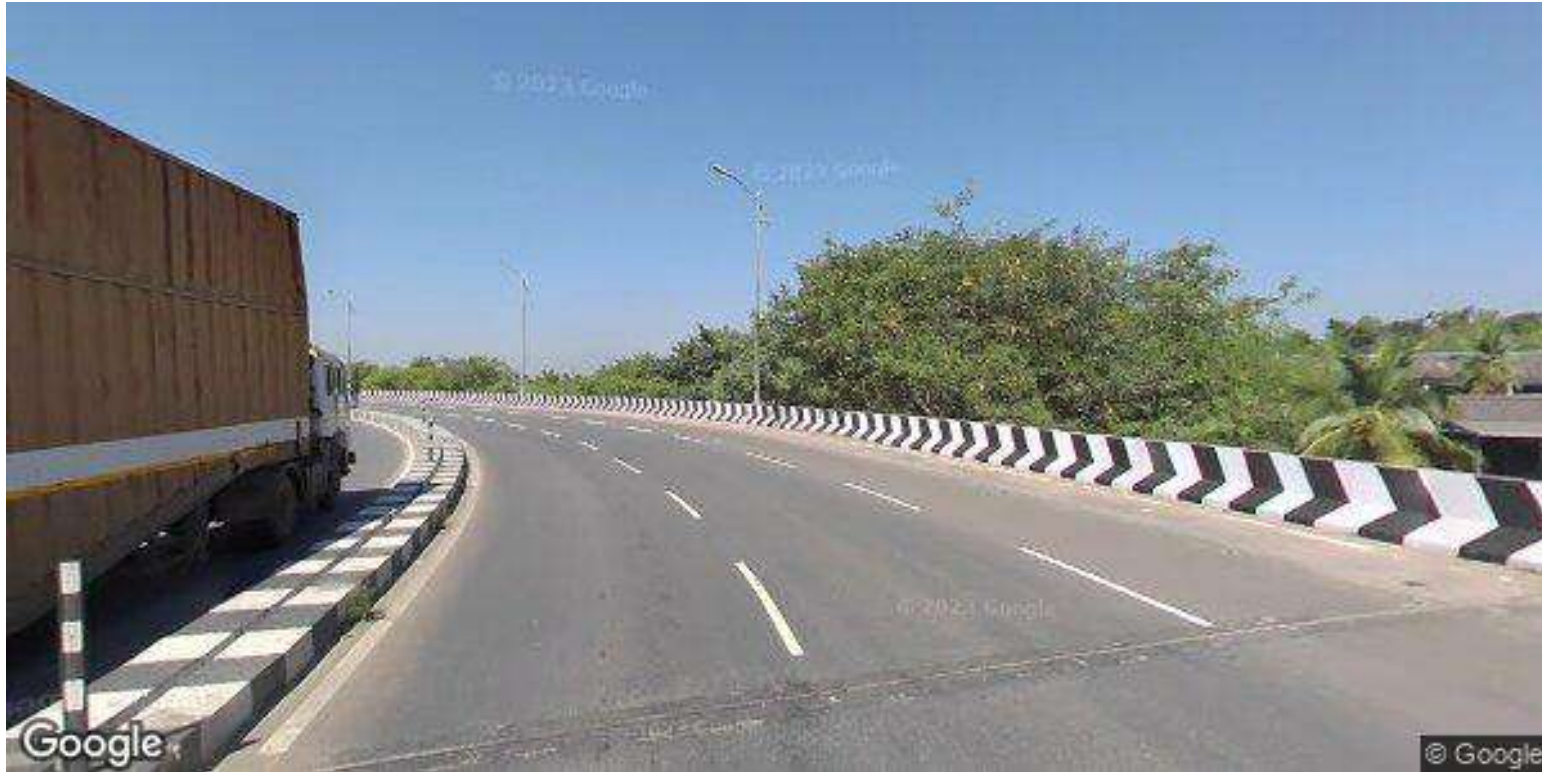
**Risk Type:** Turn  
**Risk Level:** High  
**Speed Limit:** 15 KM/Hr  
**Coordinates:** 11.64172, 78.12154

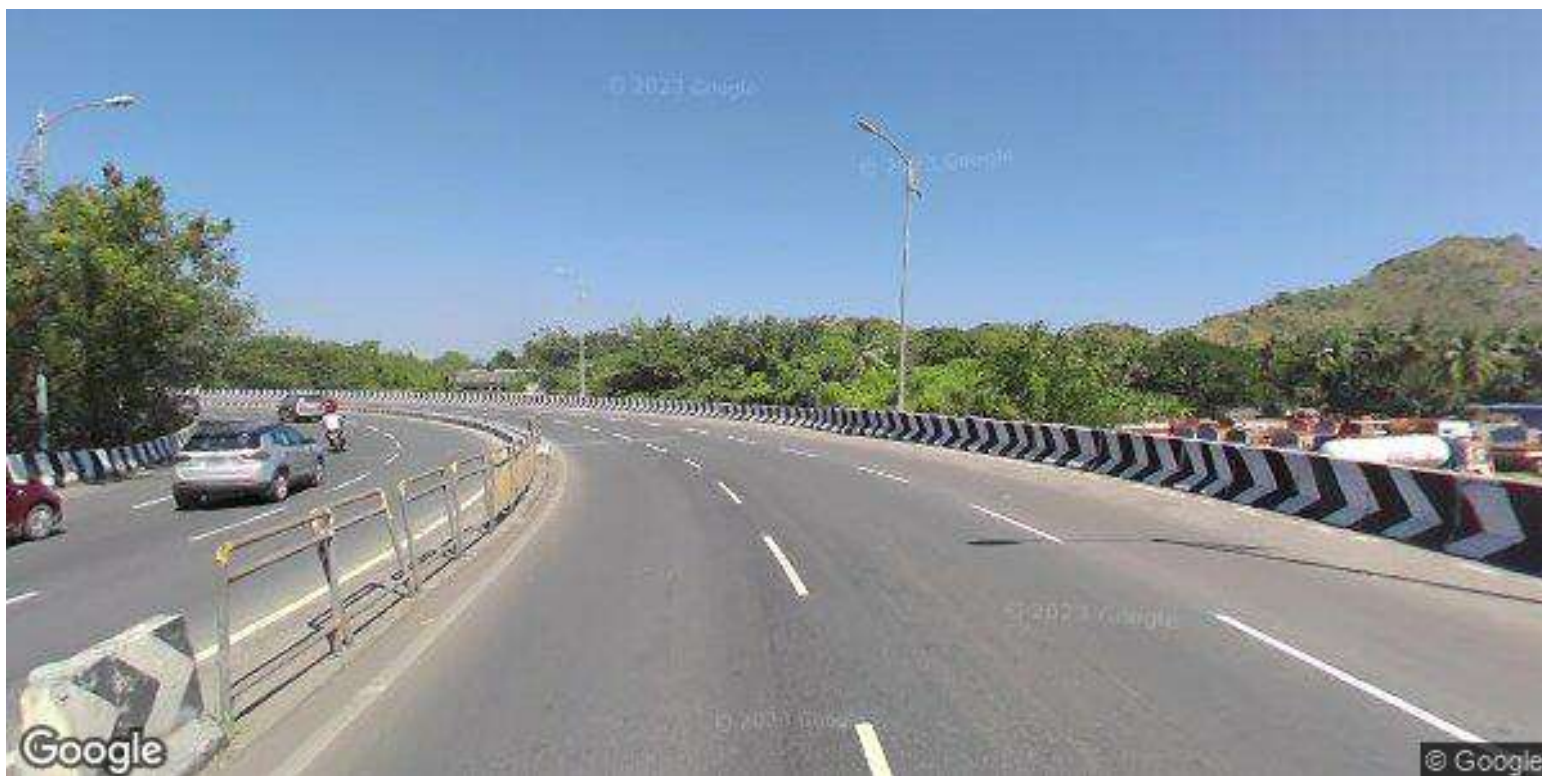
**Risk Type:** Turn  
**Risk Level:** Medium  
**Speed Limit:** 30 KM/Hr  
**Coordinates:** 11.64098, 78.12163

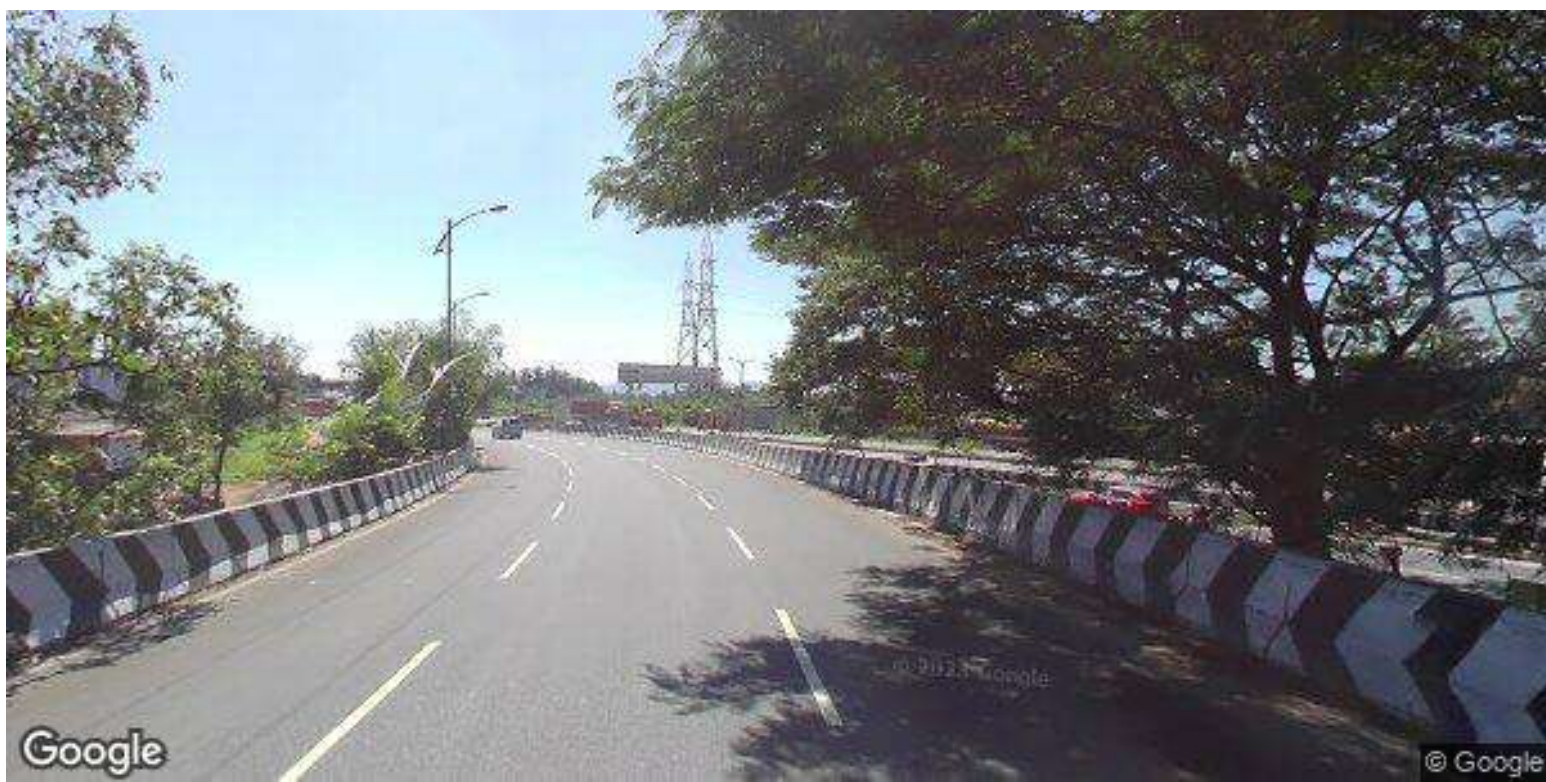
**Coordinates:** 11.63972, 78.12083

**Risk Type:** Turn

**Risk Level:** High

**Speed Limit:** 15 KM/Hr

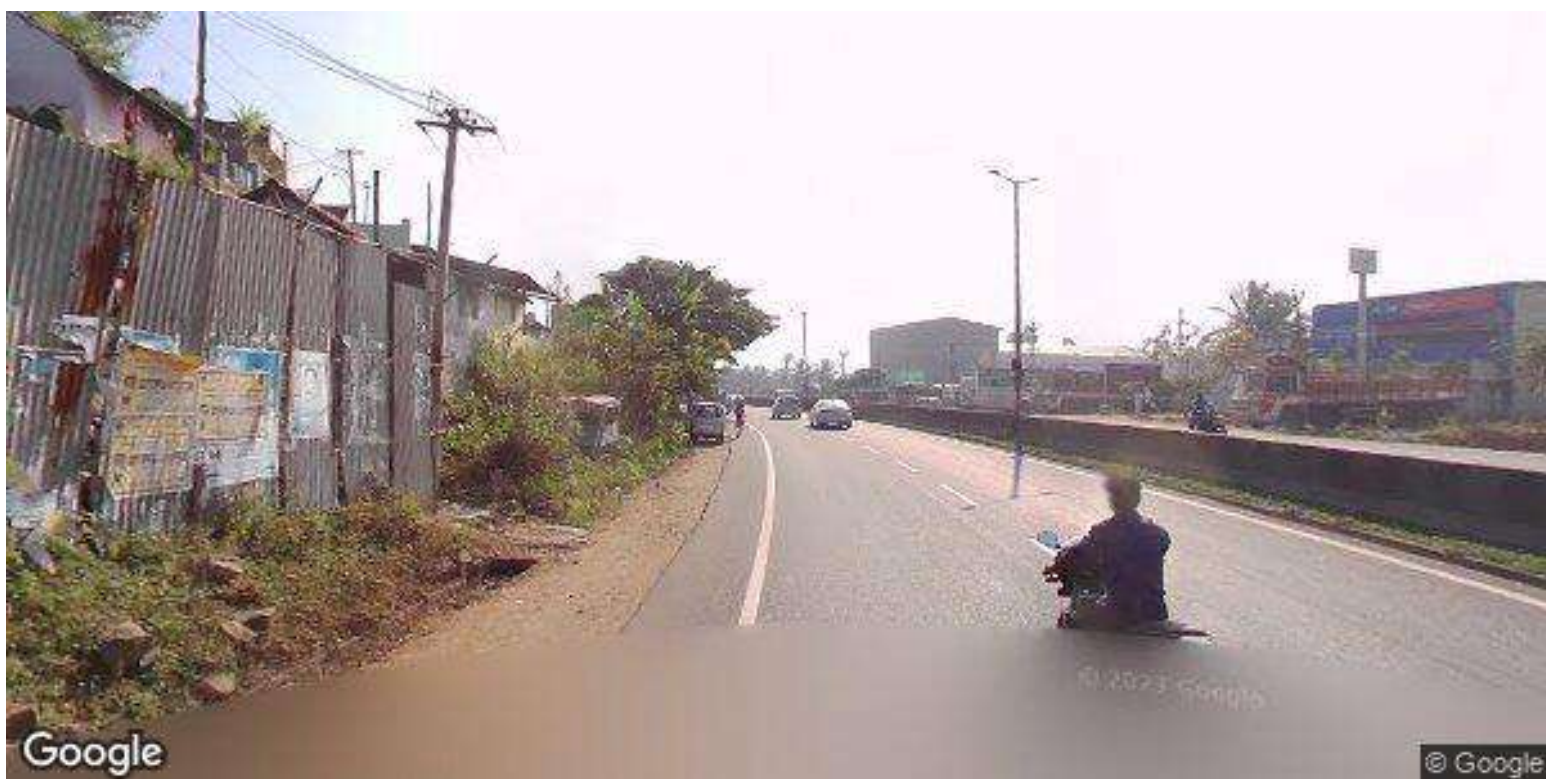
**Coordinates:** 11.62826, 78.13337

**Risk Type:** Turn

**Risk Level:** Medium

**Speed Limit:** 30 KM/Hr

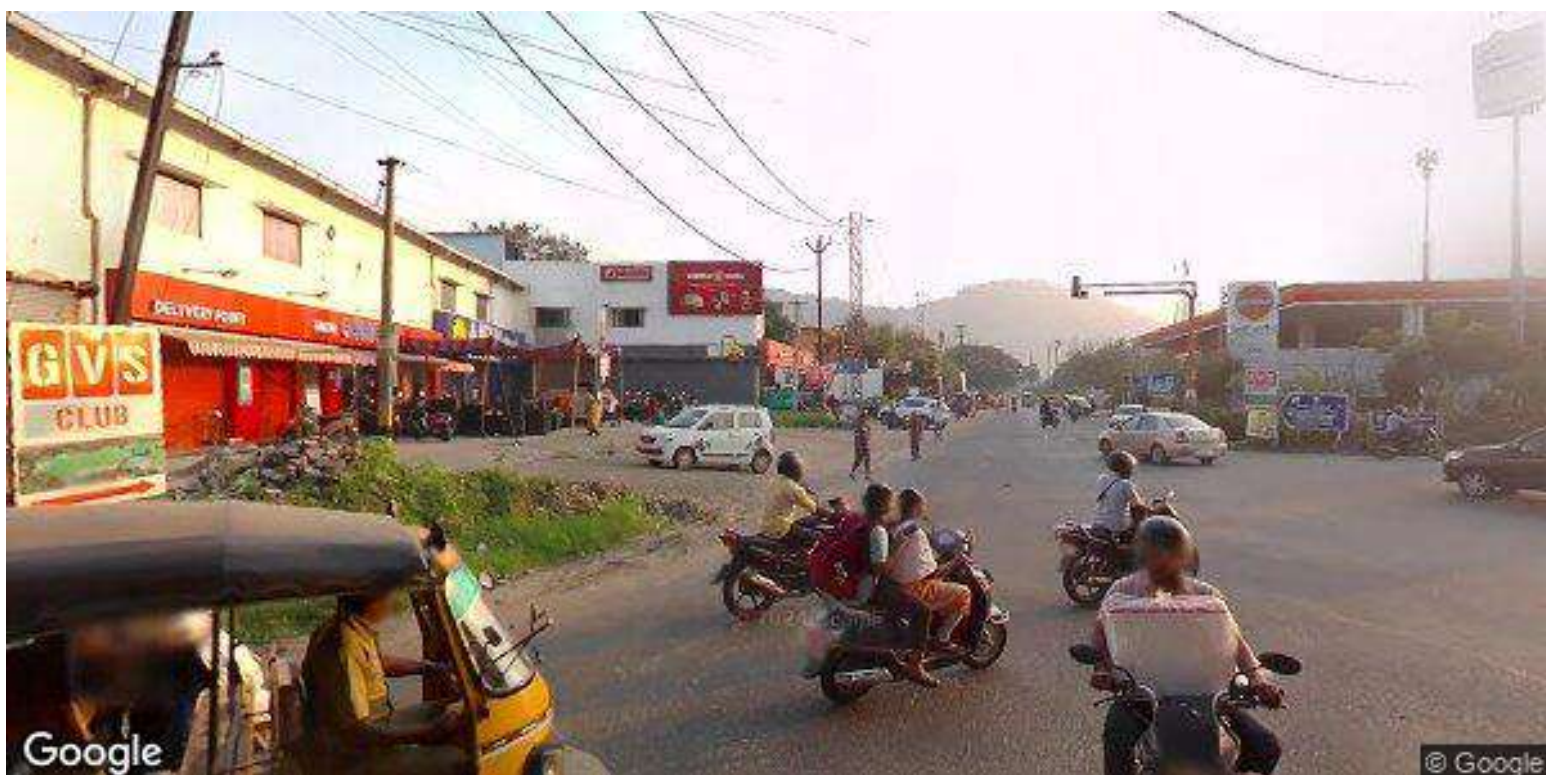
**Risk Type:** Turn  
**Risk Level:** High  
**Speed Limit:** 15 KM/Hr  
**Coordinates:** 11.66372, 78.20649

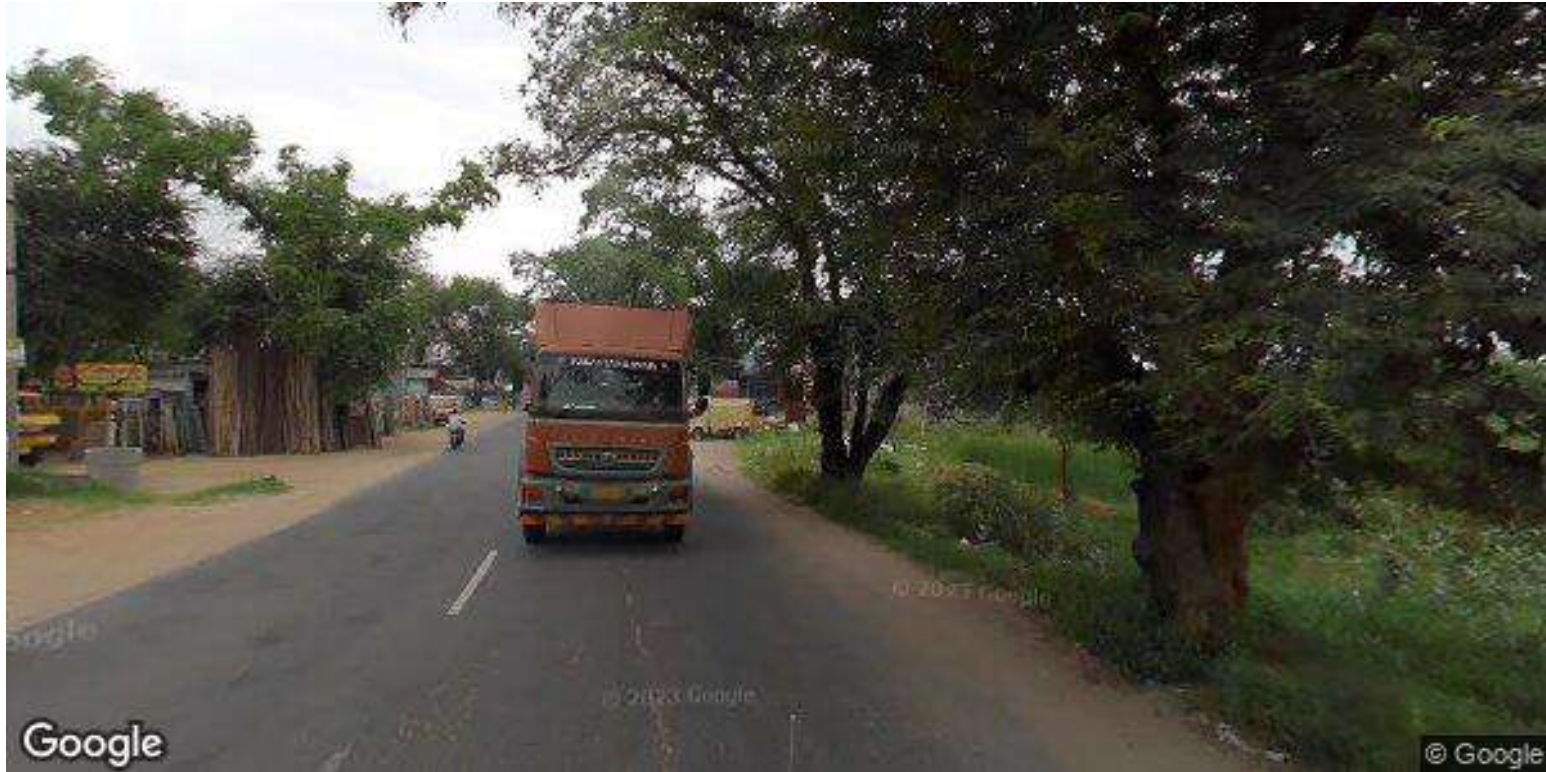
**Risk Type:** Turn  
**Risk Level:** Medium  
**Speed Limit:** 30 KM/Hr  
**Coordinates:** 11.67124, 78.22961

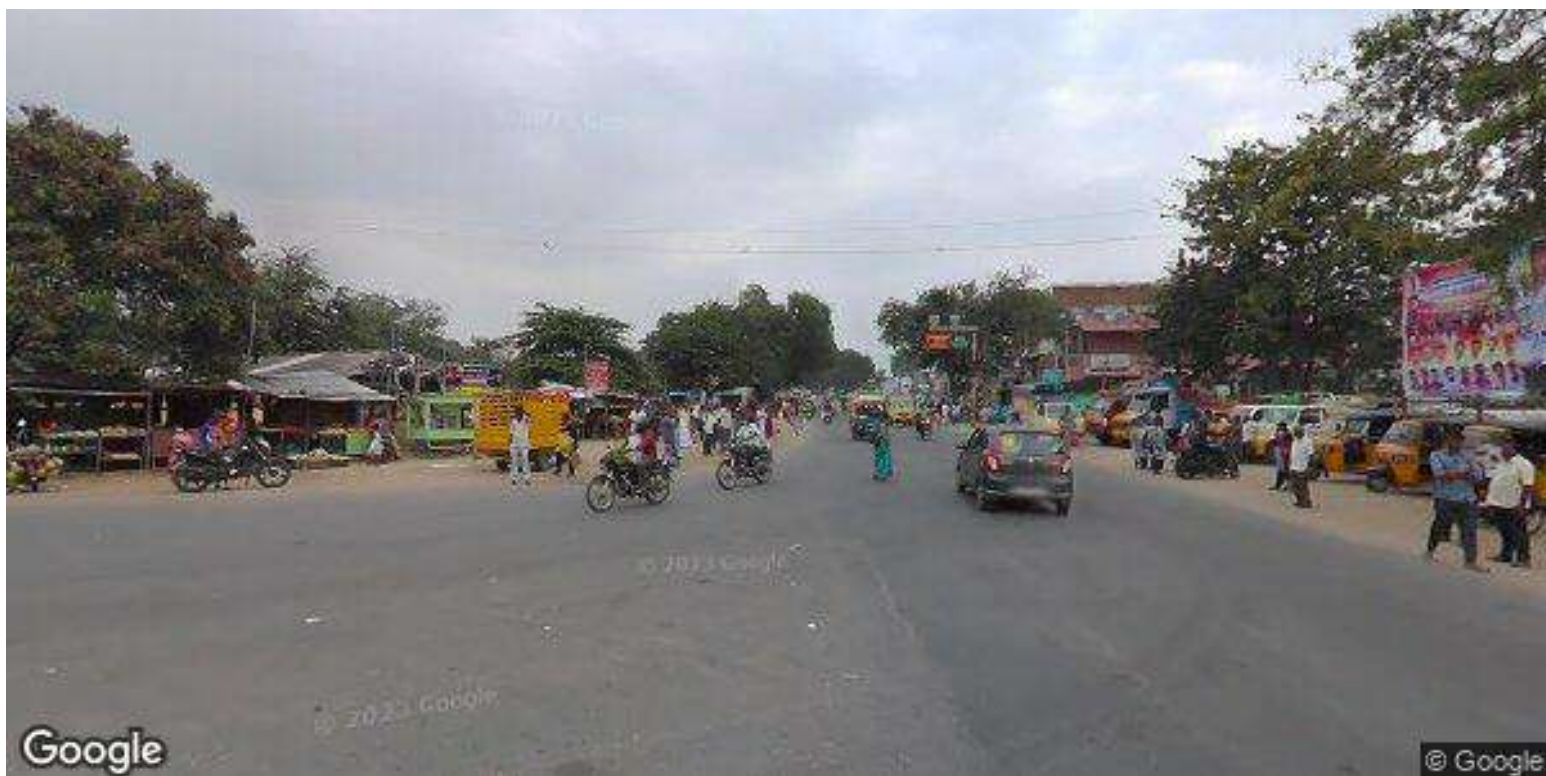
**Risk Type:** Turn  
**Risk Level:** High  
**Speed Limit:** 15 KM/Hr  
**Coordinates:** 11.67111, 78.23134
