# IndianOil

## JOURNEY RISK MANAGEMENT (JRM) STUDY

**Salem Terminal TO SIVASAKTHI & CO.**

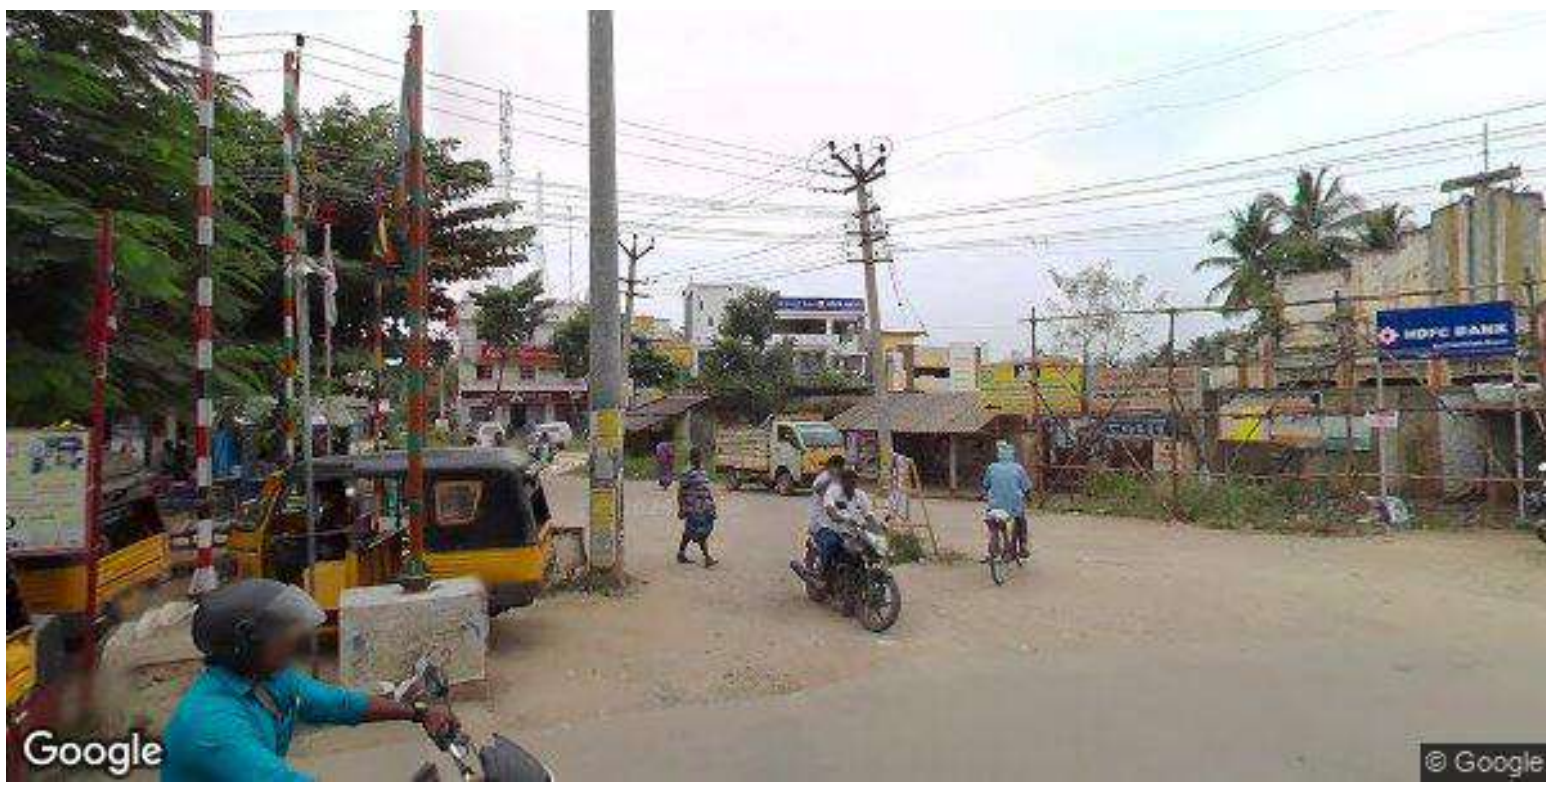
**Coordinates:** 11.67187, 78.23142

**Risk Type:** Turn

**Risk Level:** High

**Speed Limit:** 15 KM/Hr

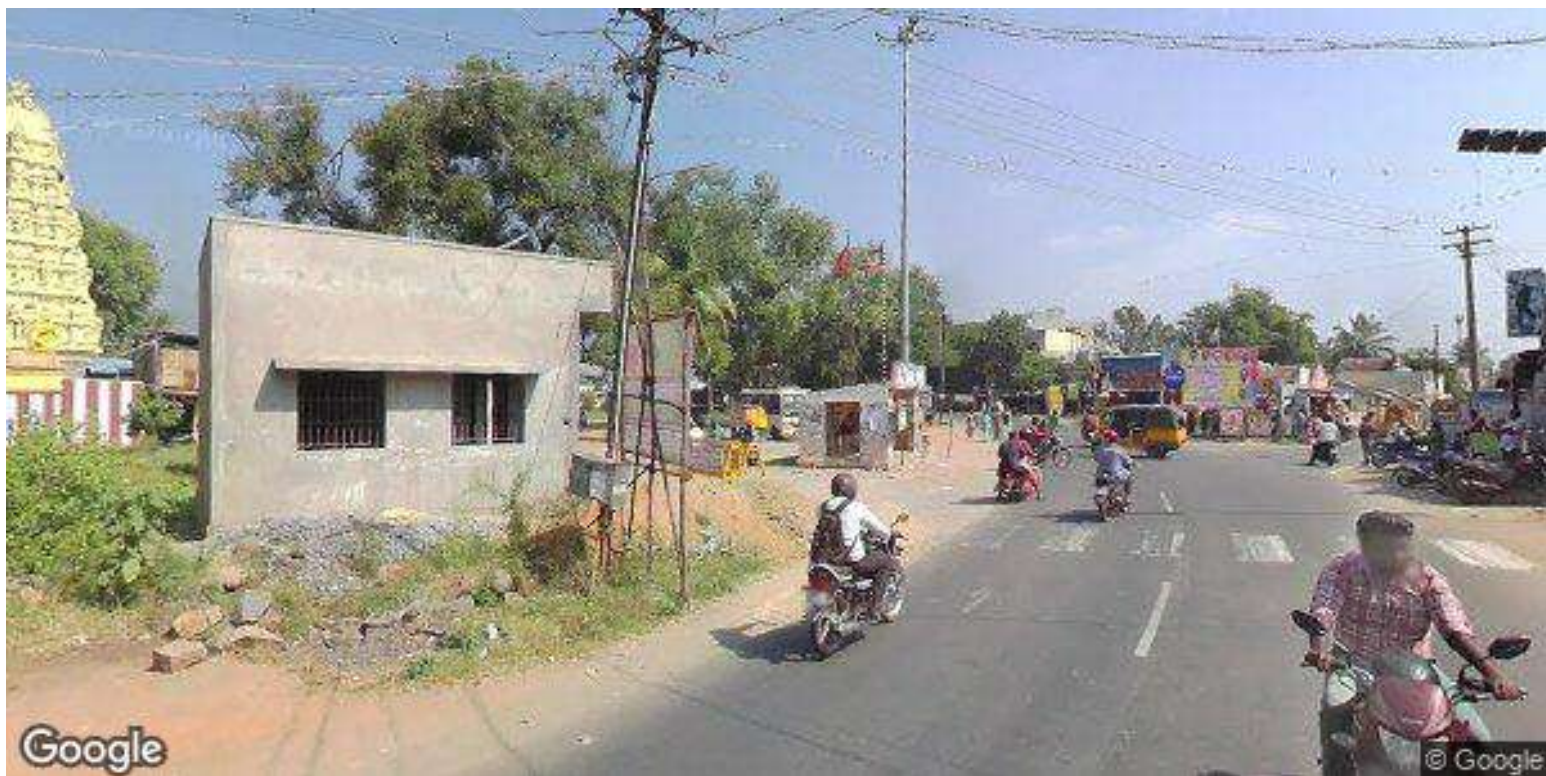
**Coordinates:** 11.67427, 78.23892

**Risk Type:** Turn

**Risk Level:** Medium

**Speed Limit:** 30 KM/Hr

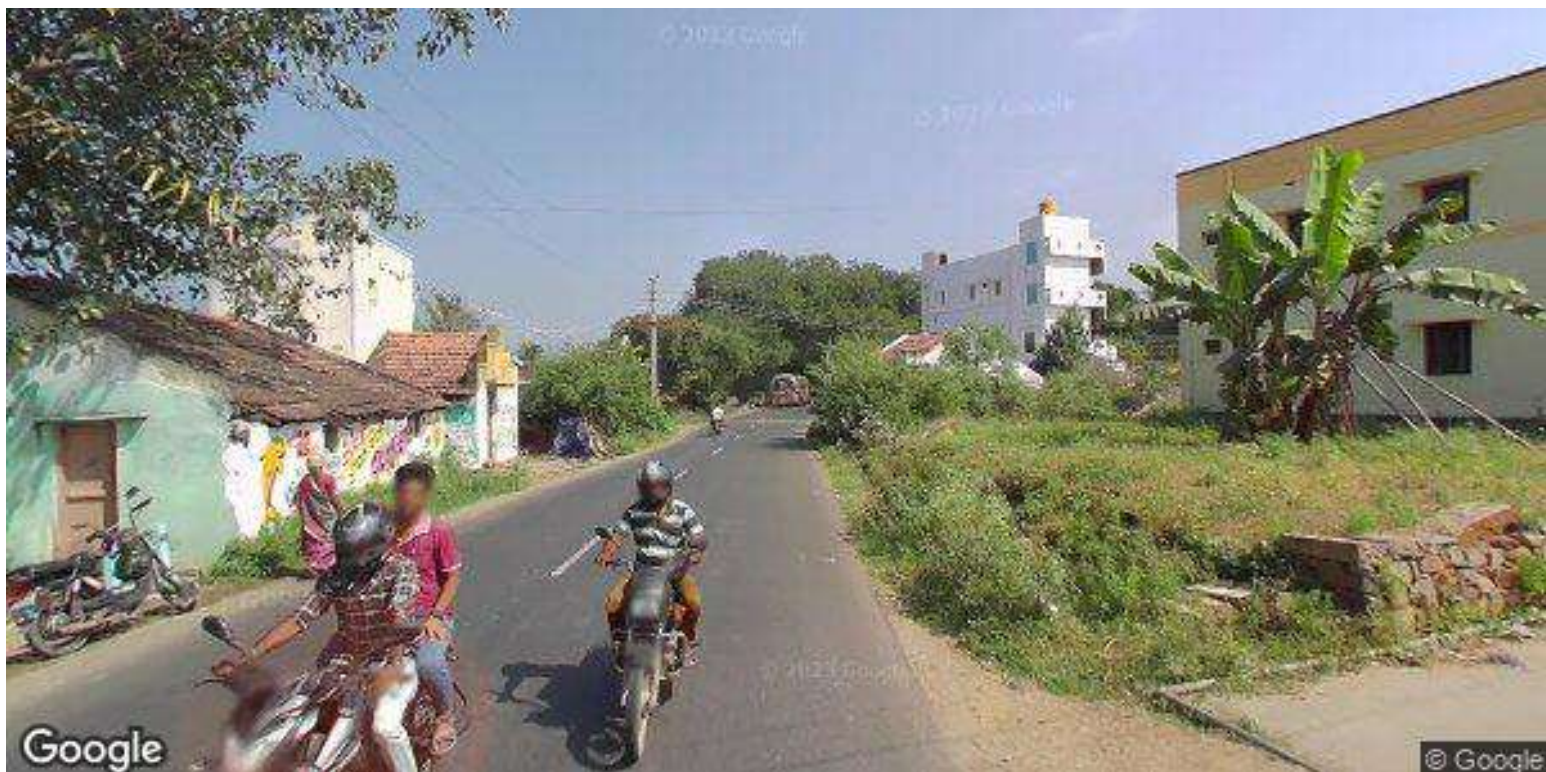
**Risk Type:** Turn  
**Risk Level:** Medium  
**Speed Limit:** 30 KM/Hr  
**Coordinates:** 11.68018, 78.24251

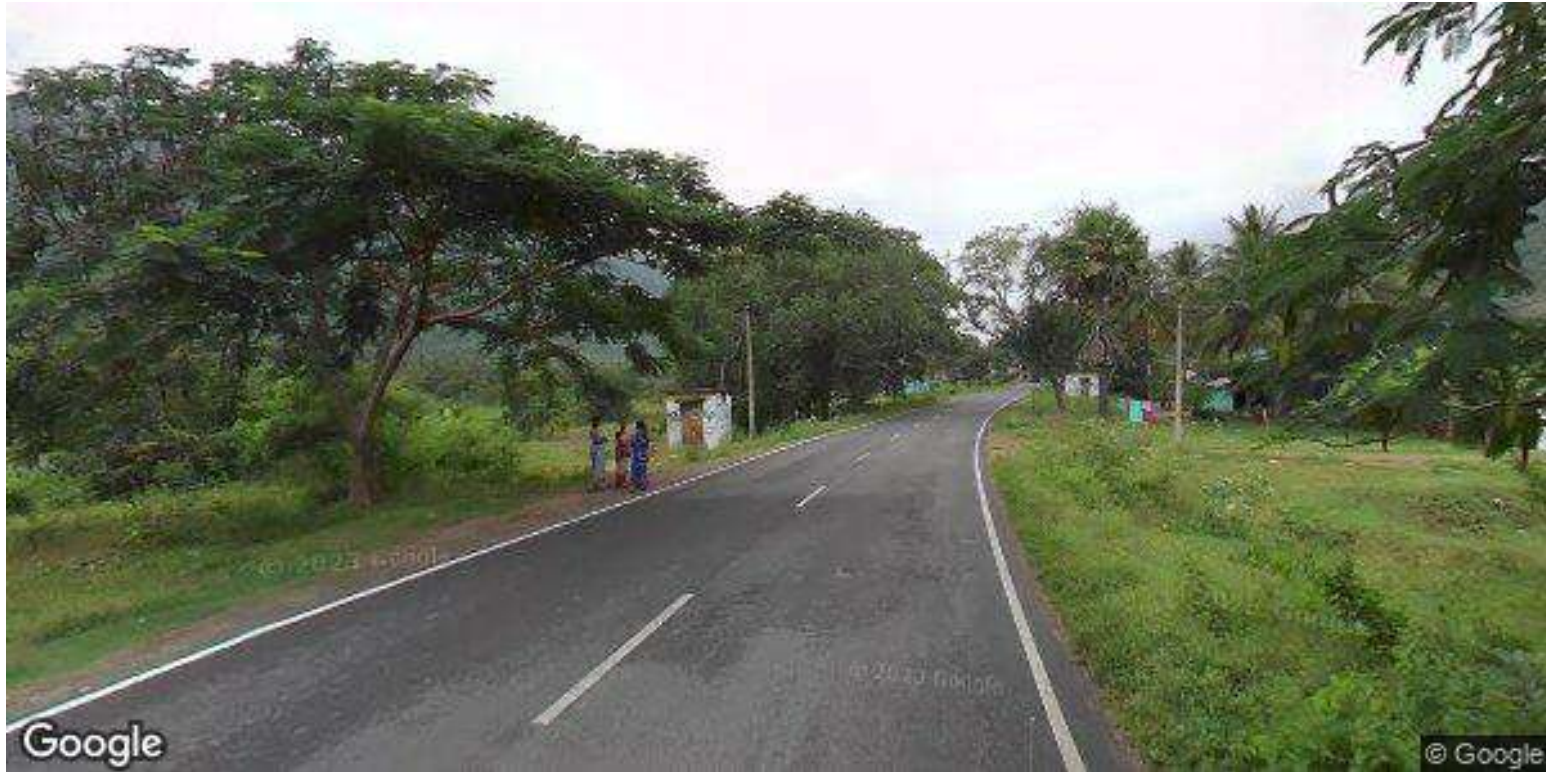
**Risk Type:** Turn  
**Risk Level:** Medium  
**Speed Limit:** 30 KM/Hr  
**Coordinates:** 11.81208, 78.34071

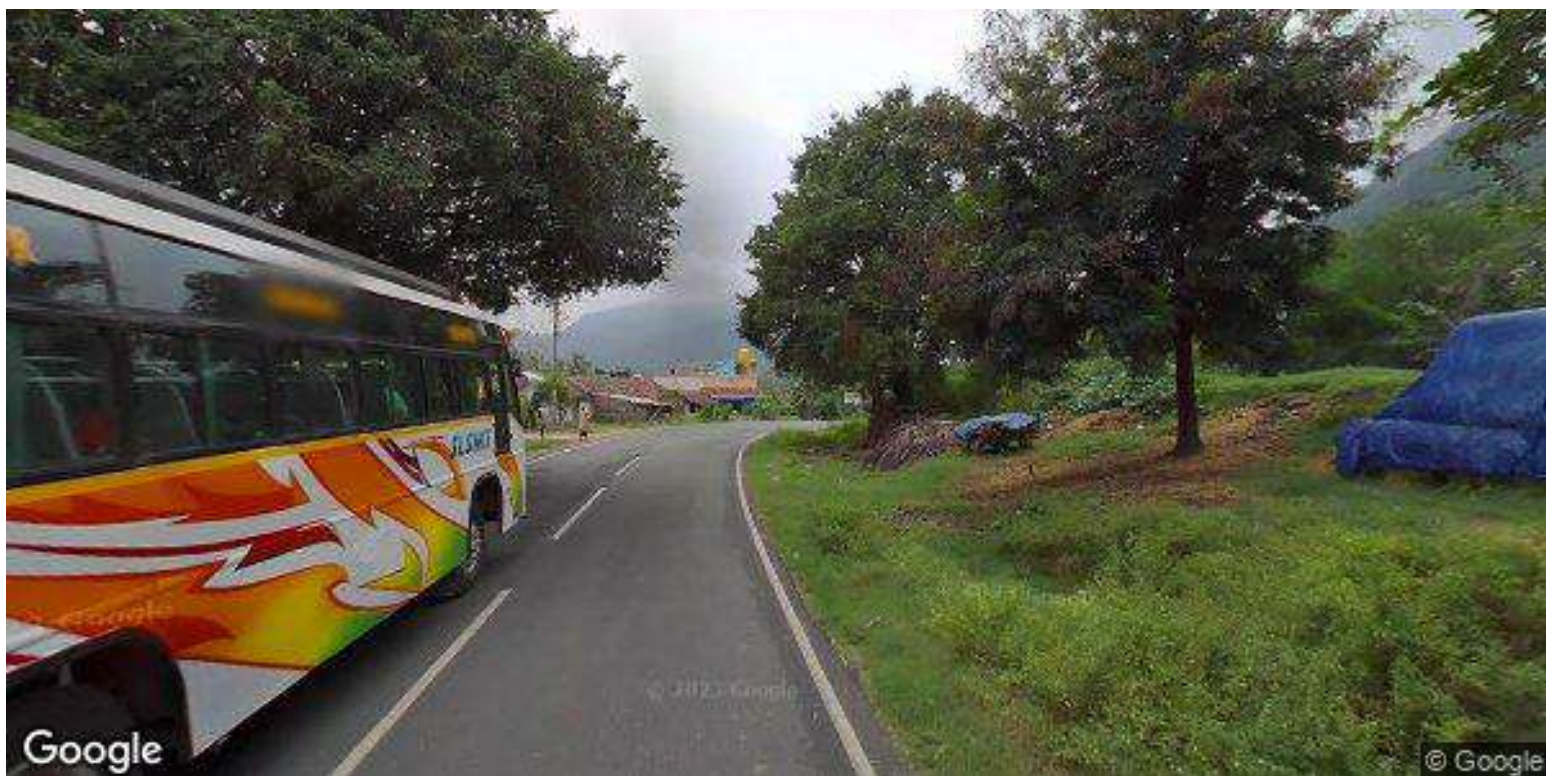
**Risk Type:** Turn  
**Risk Level:** Medium  
**Speed Limit:** 30 KM/Hr  
**Coordinates:** 11.83518, 78.35305

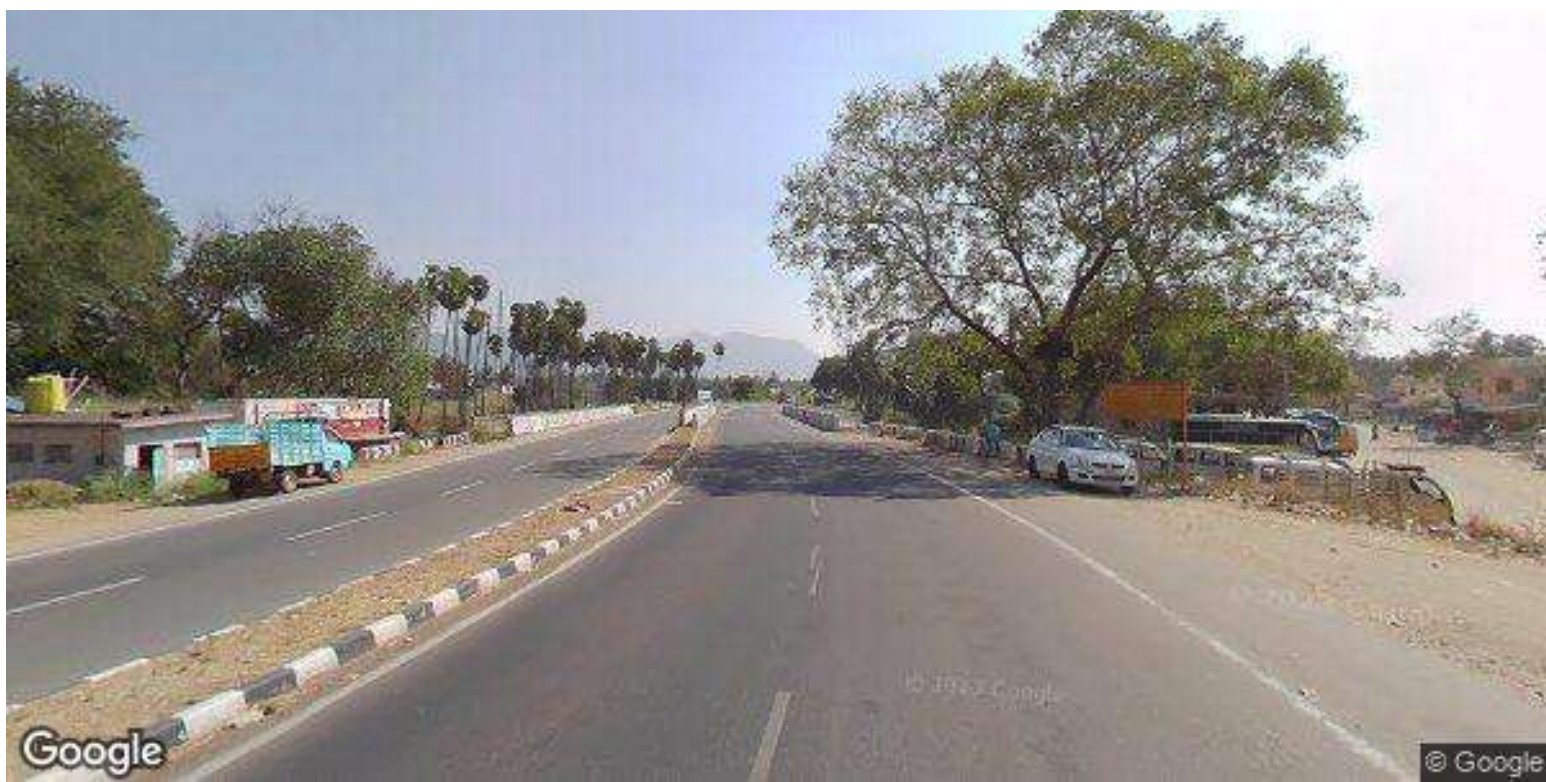
**Coordinates:** 11.99554, 78.44553

**Risk Type:** Turn

**Risk Level:** Medium

**Speed Limit:** 30 KM/Hr

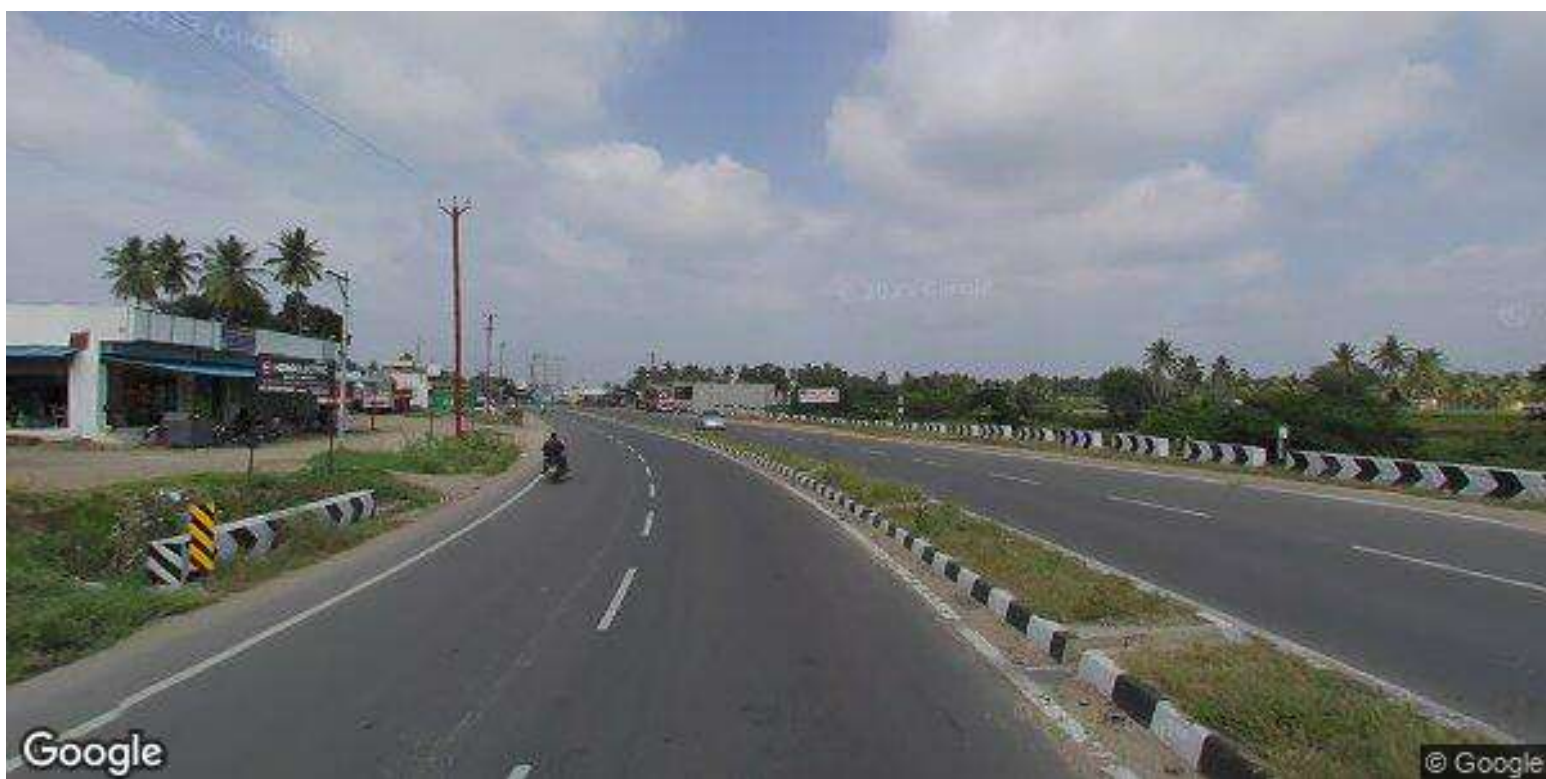
**Coordinates:** 12.04286, 78.48352

**Risk Type:** Turn

**Risk Level:** Medium

**Speed Limit:** 30 KM/Hr

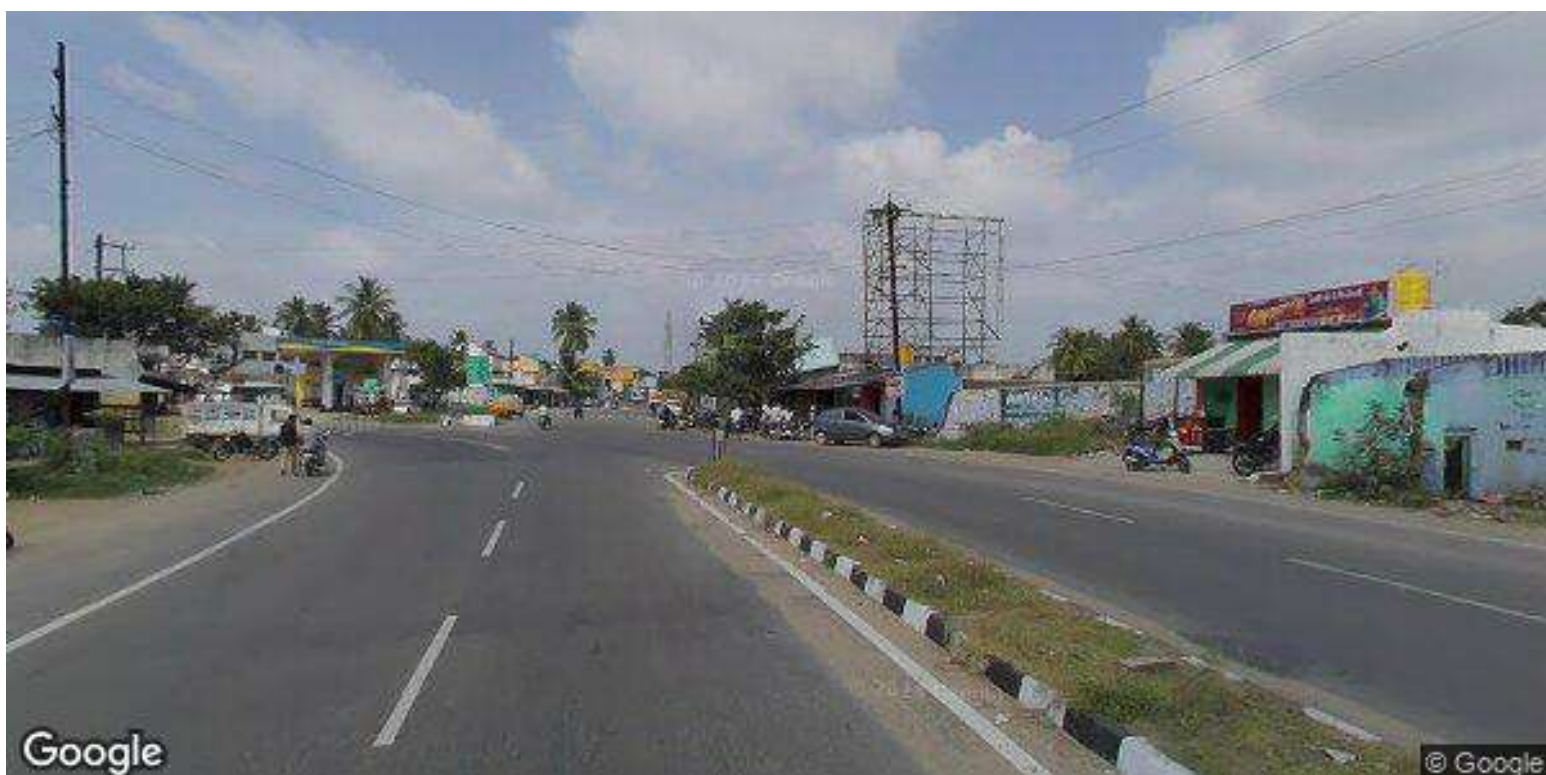
**Risk Type:** Turn  
**Risk Level:** Medium  
**Speed Limit:** 30 KM/Hr  
**Coordinates:** 12.04440, 78.48380

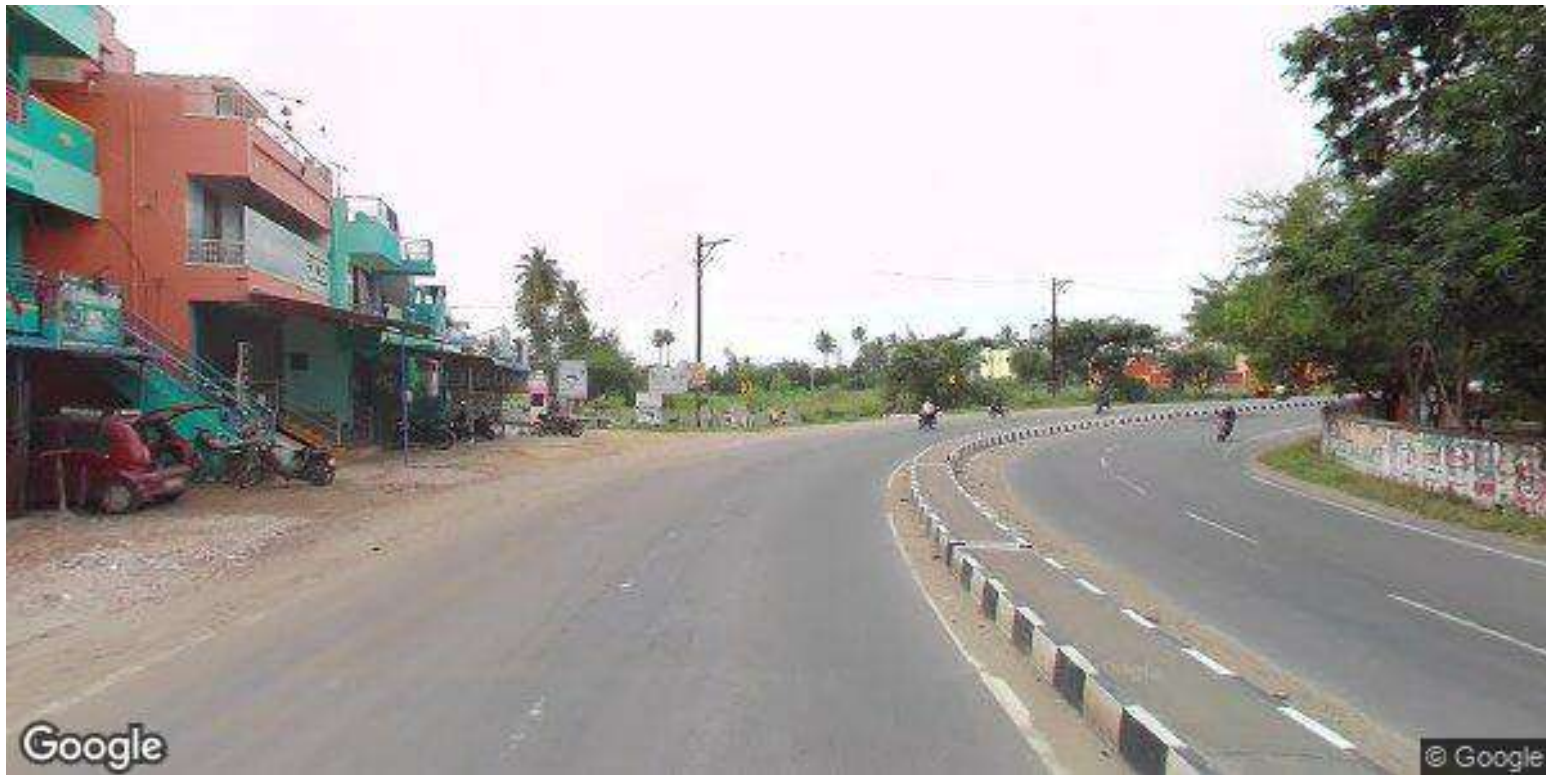
**Risk Type:** Turn  
**Risk Level:** High  
**Speed Limit:** 15 KM/Hr  
**Coordinates:** 12.04973, 78.47494

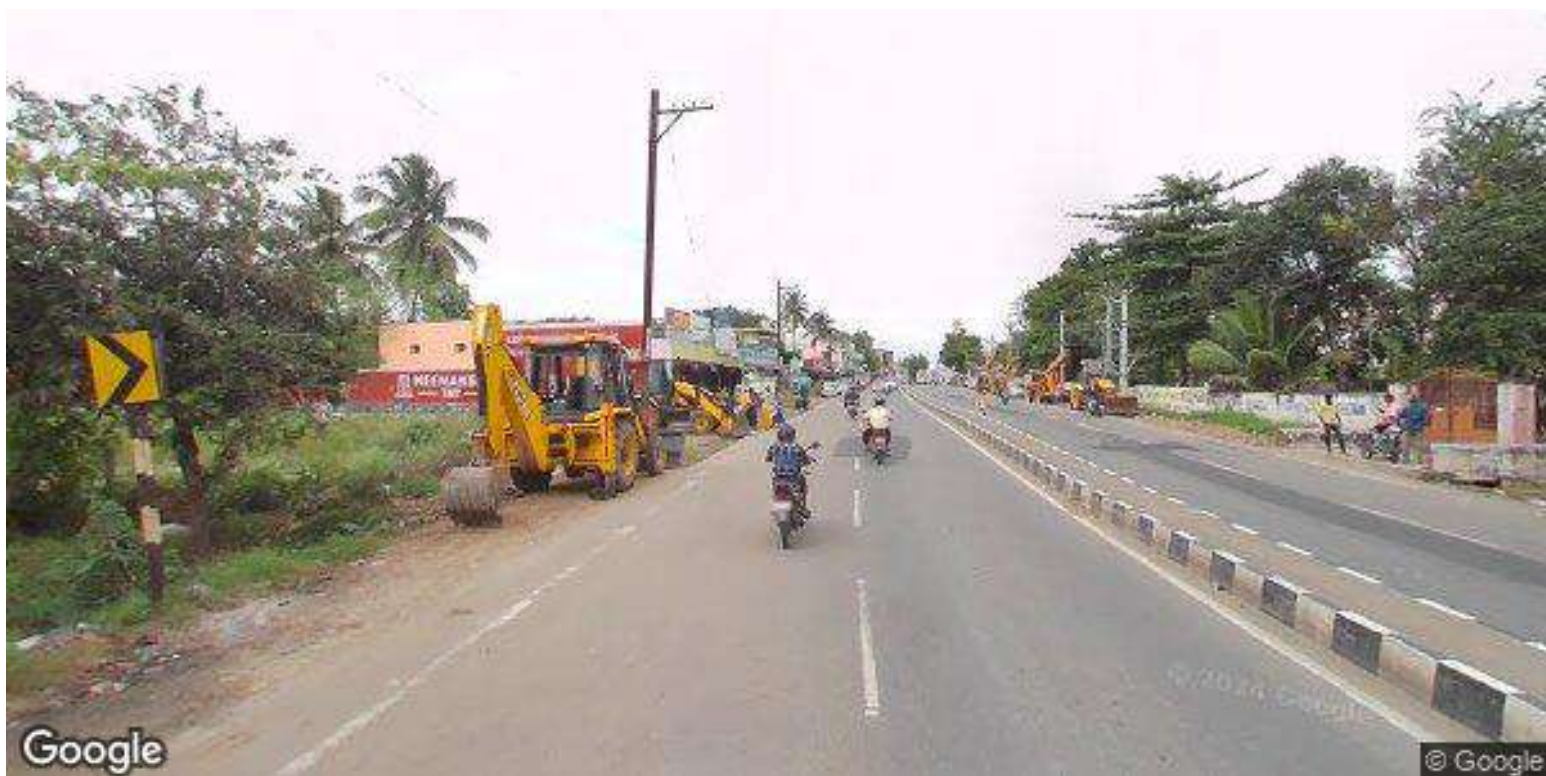
**Risk Type:** Turn  
**Risk Level:** Medium  
**Speed Limit:** 30 KM/Hr  
**Coordinates:** 12.05033, 78.47468

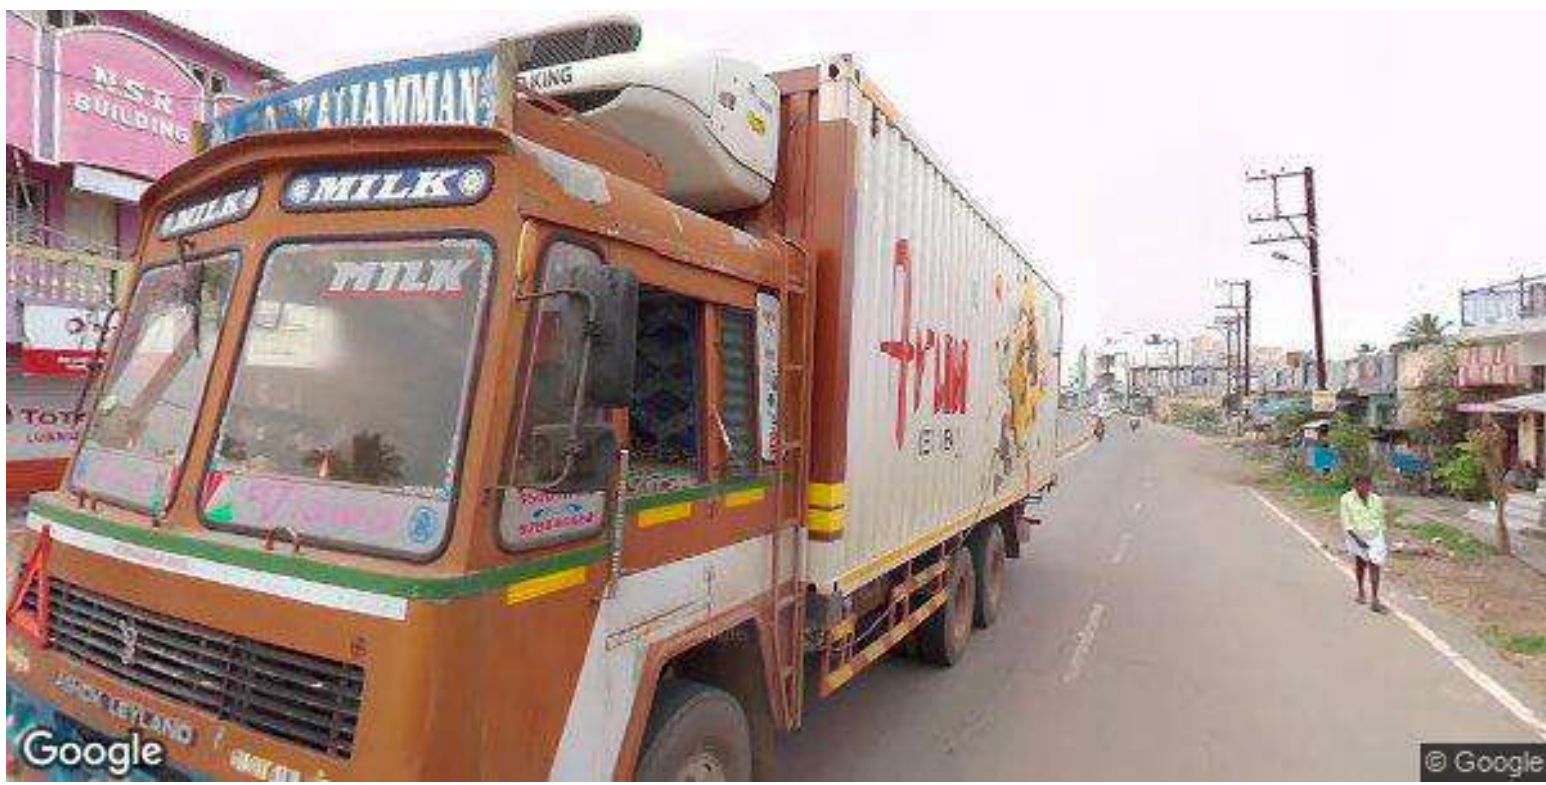
**Coordinates:** 12.05427, 78.47634

**Risk Type:** Blind Spot

**Risk Level:** Blind Spot

**Speed Limit:** 10 KM/Hr
