# IndianOil

## JOURNEY RISK MANAGEMENT (JRM) STUDY

### Salem Terminal TO ROYAL AGENCIES SALEM

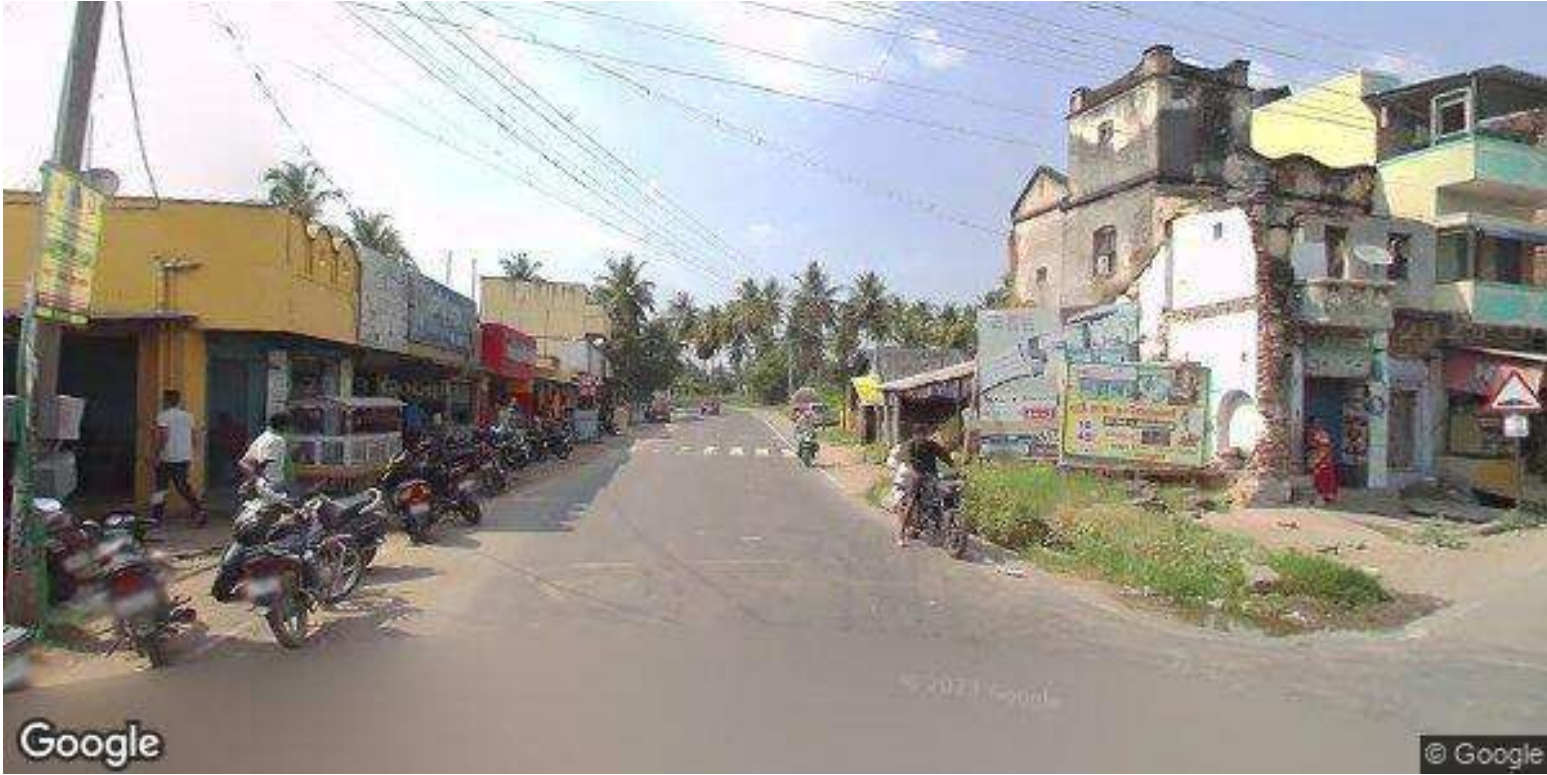
Risk Type: Turn

Risk Level: High

Speed Limit: 15 KM/Hr  
Coordinates: 11.45007, 77.87201

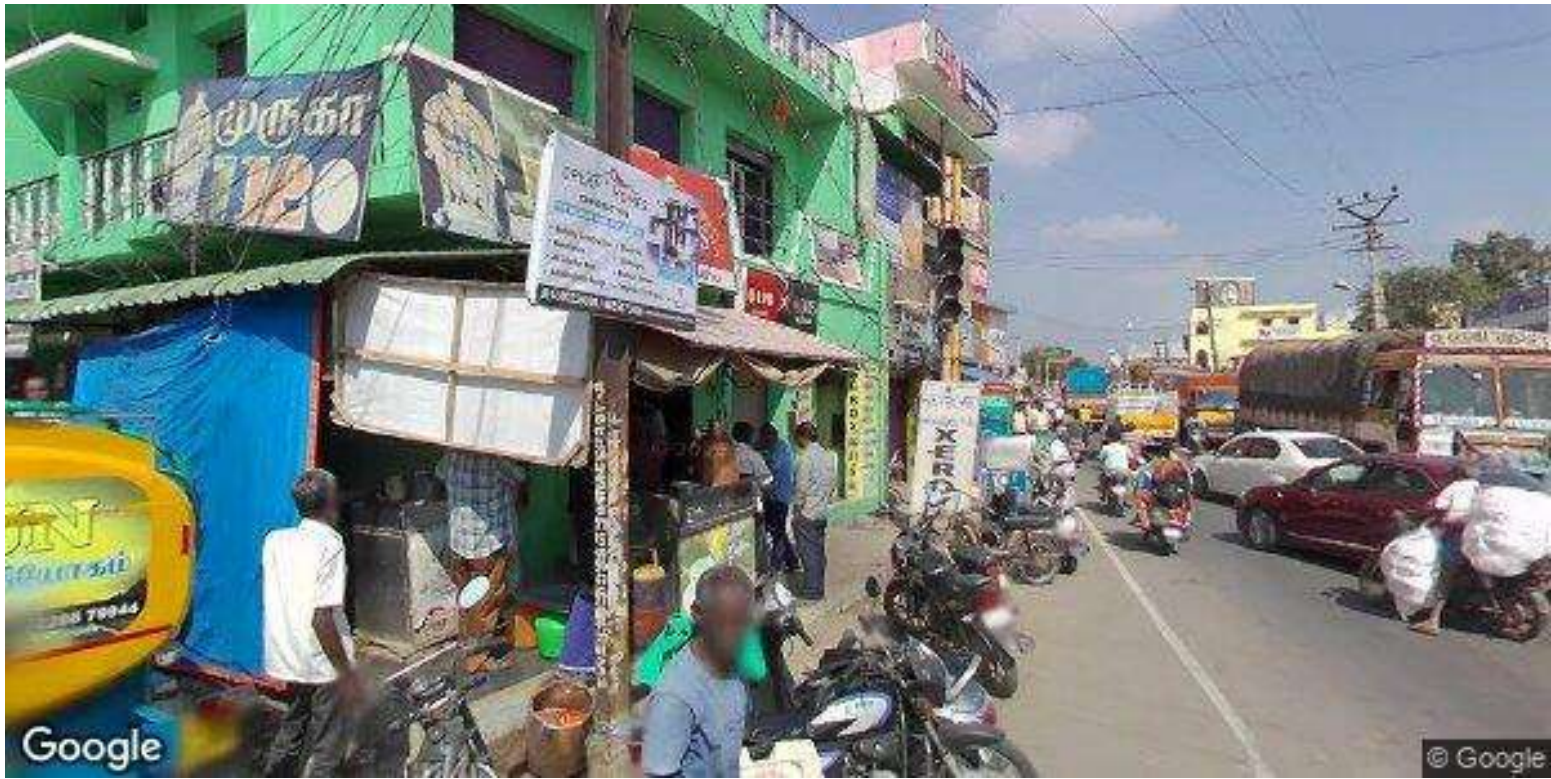
Risk Type: Turn  
Risk Level: High  
Speed Limit: 15 KM/Hr  
Coordinates: 11.47407, 77.86839

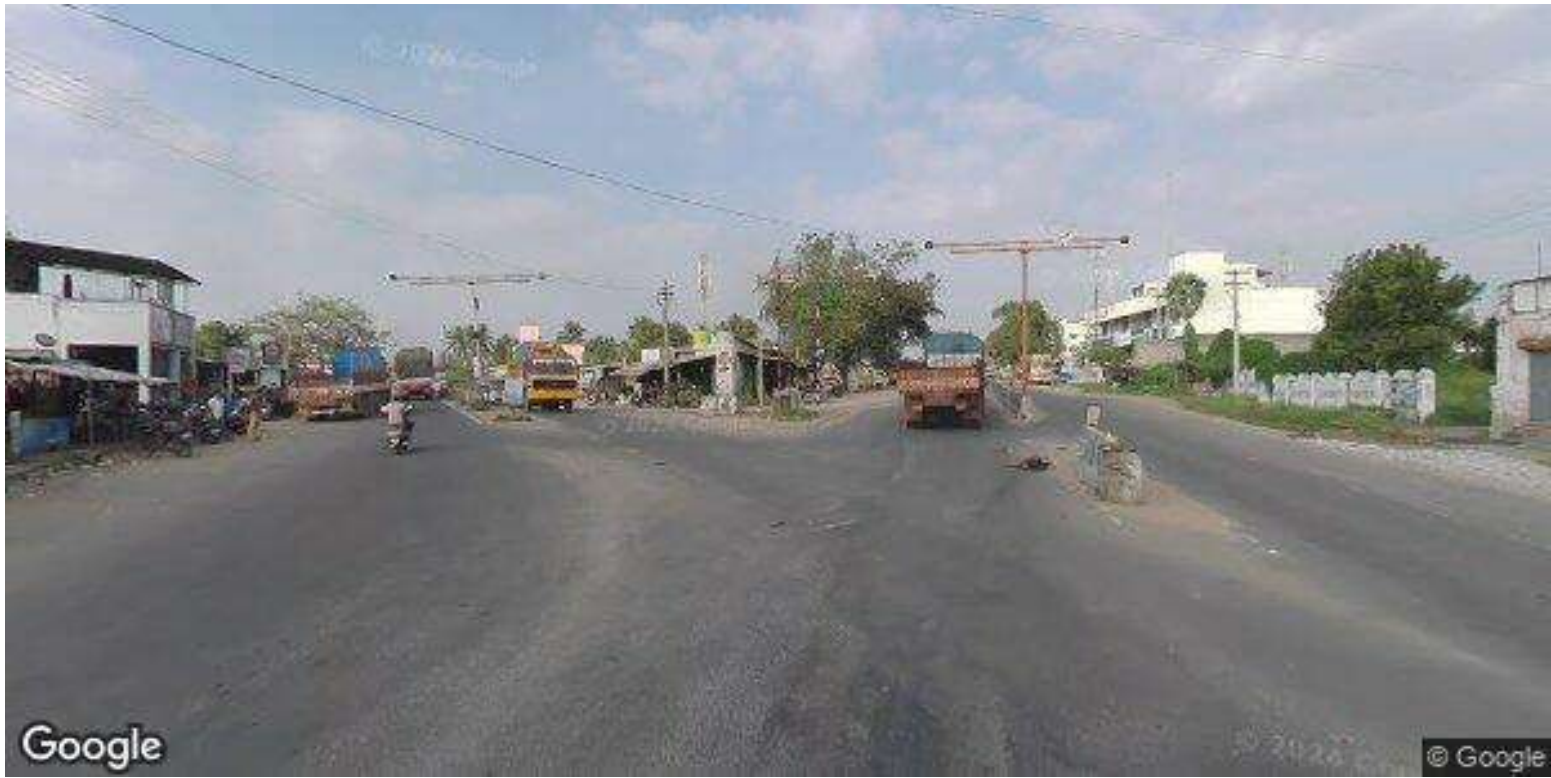
Risk Type: Turn  
Risk Level: Medium  
Speed Limit: 30 KM/Hr  
Coordinates: 11.48366, 77.88781

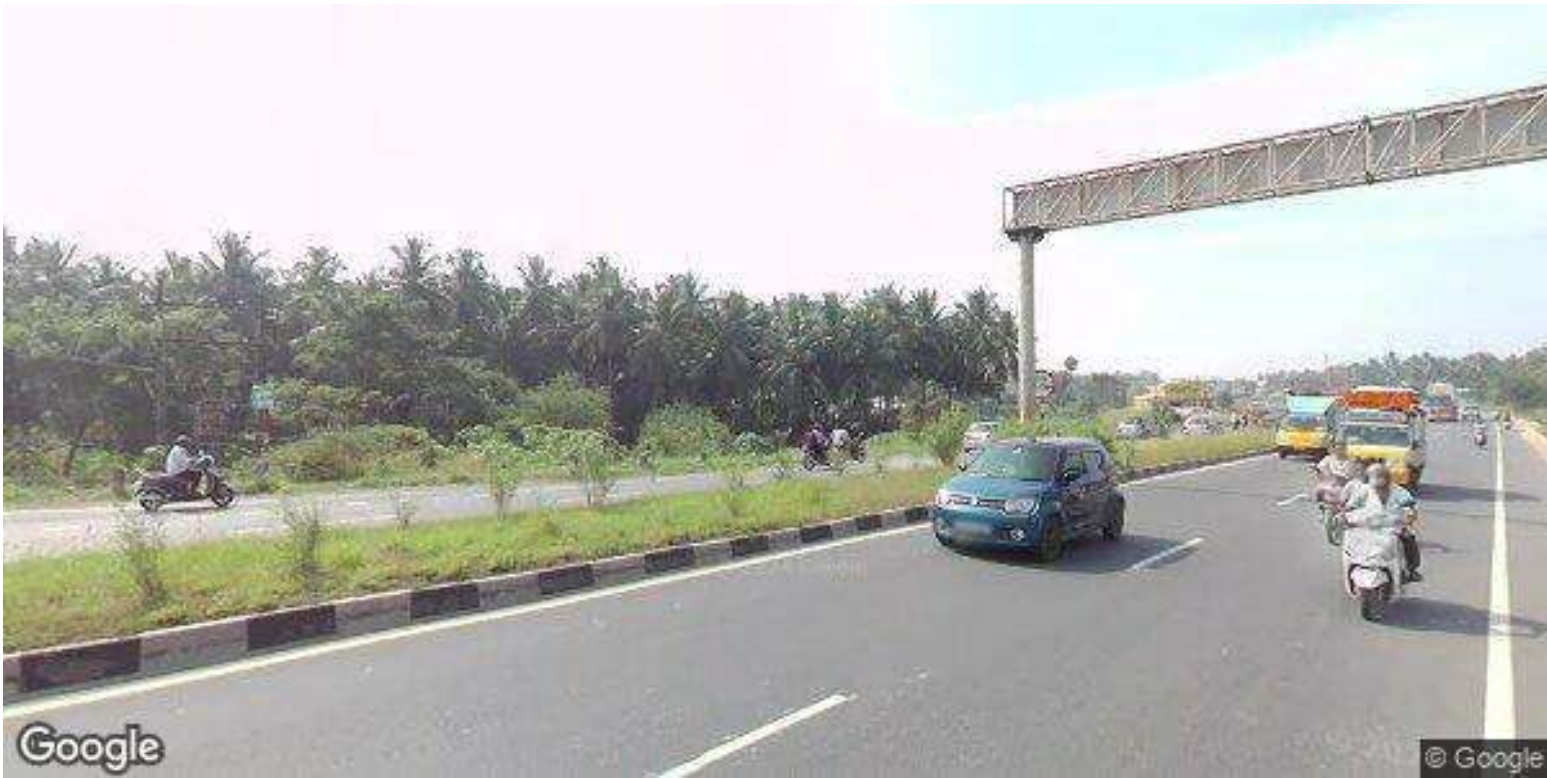
**Risk Type:** Turn  
**Risk Level:** Medium  
**Speed Limit:** 30 KM/Hr  
**Coordinates:** 11.60942, 78.10056

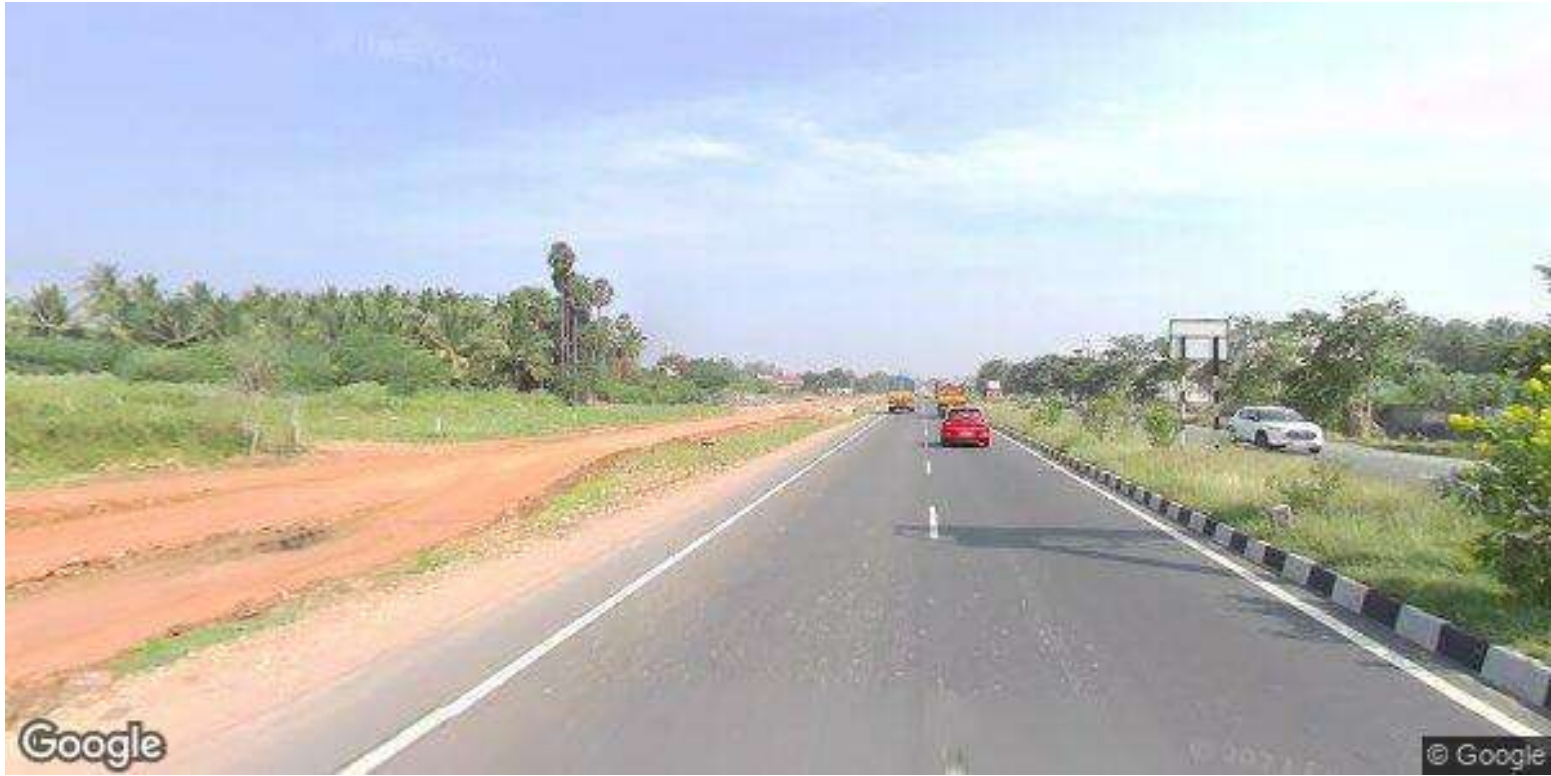
**Risk Type:** Turn  
**Risk Level:** Medium  
**Speed Limit:** 30 KM/Hr  
**Coordinates:** 11.61753, 78.10608

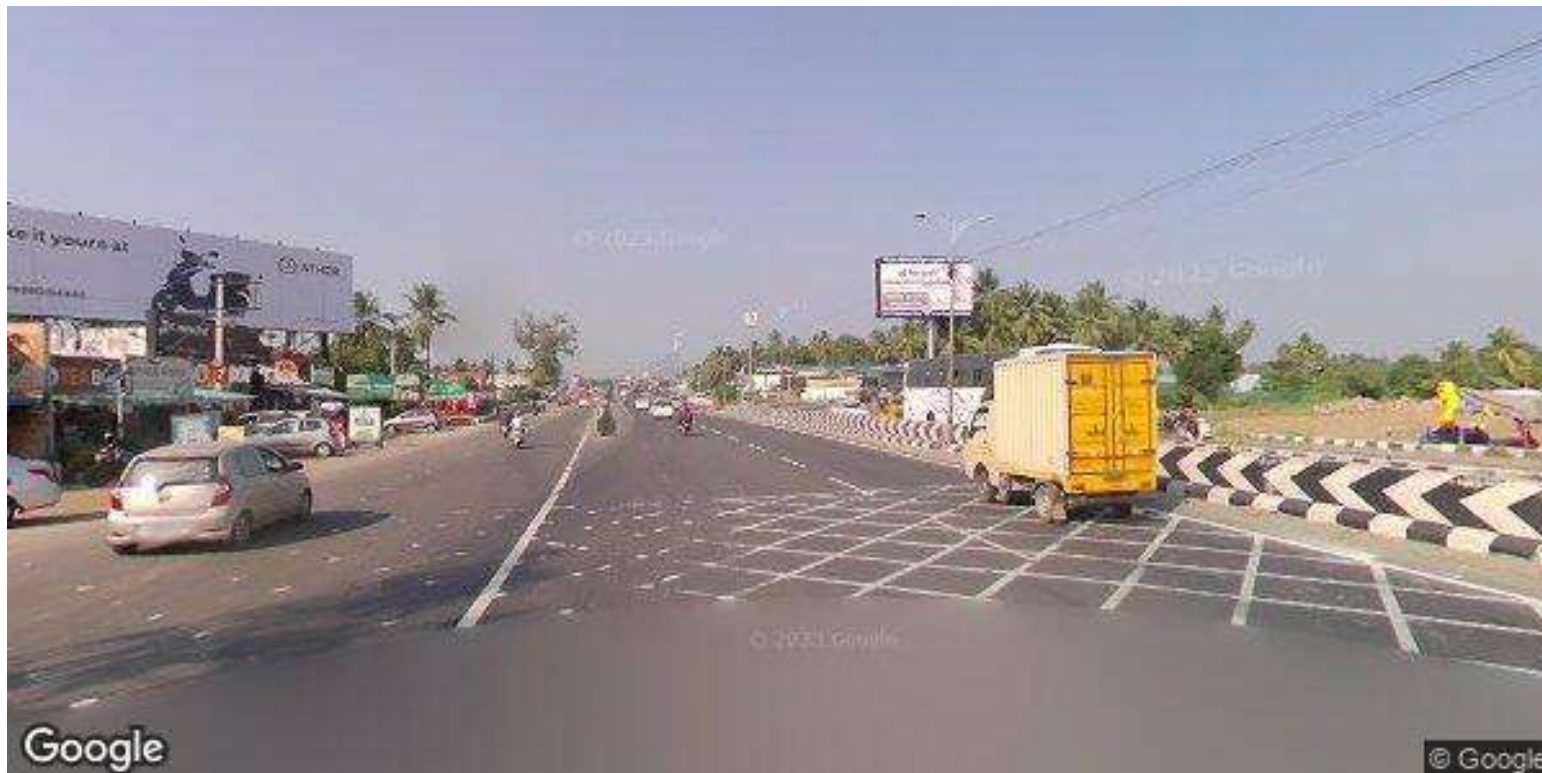
**Coordinates: 11.64503, 78.12034**

**Risk Type: Turn**

**Risk Level: Medium**

**Speed Limit: 30 KM/Hr**

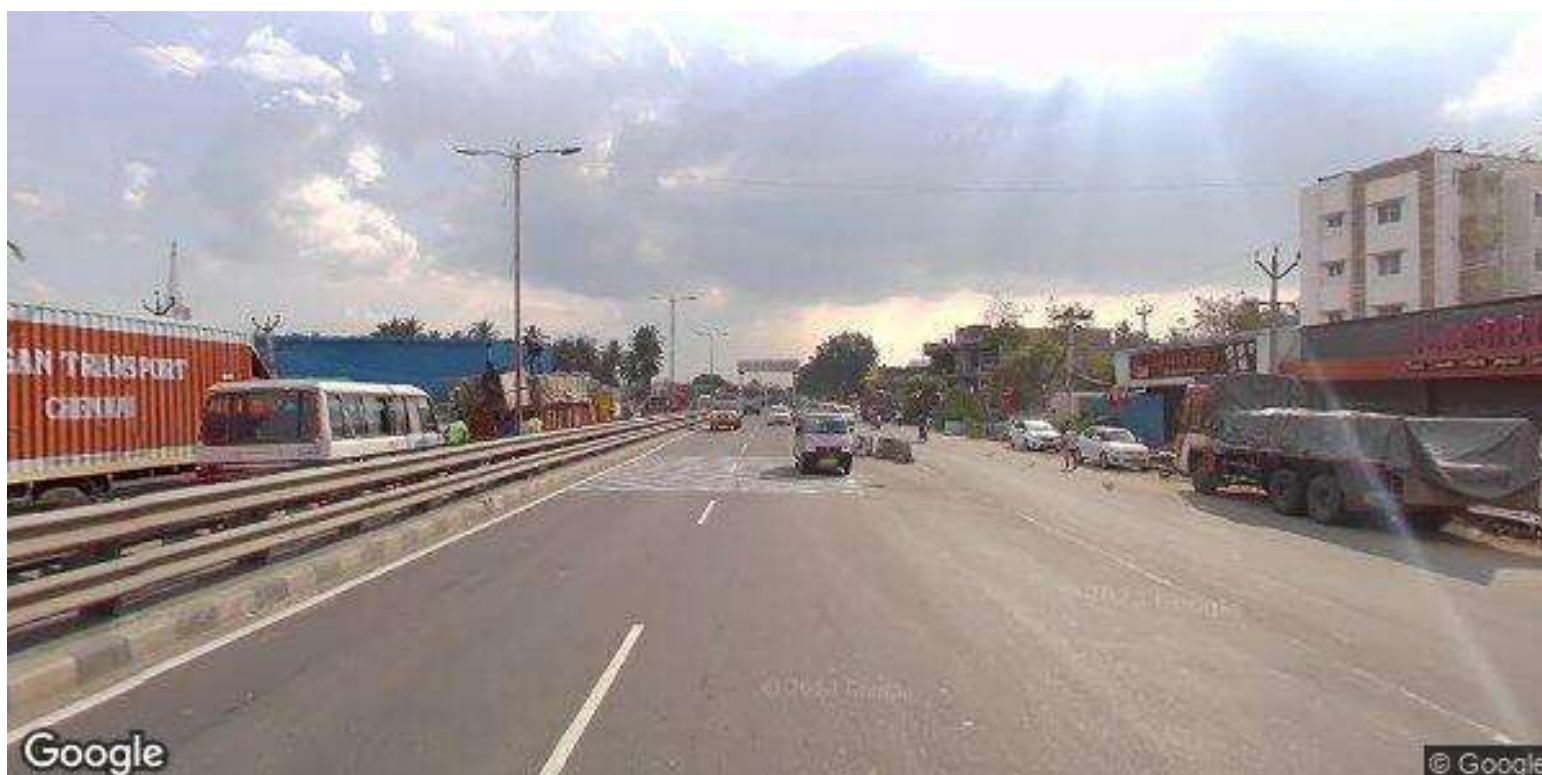
**Coordinates: 11.67074, 78.12668**

**Risk Type: Turn**

**Risk Level: High**

**Speed Limit: 15 KM/Hr**

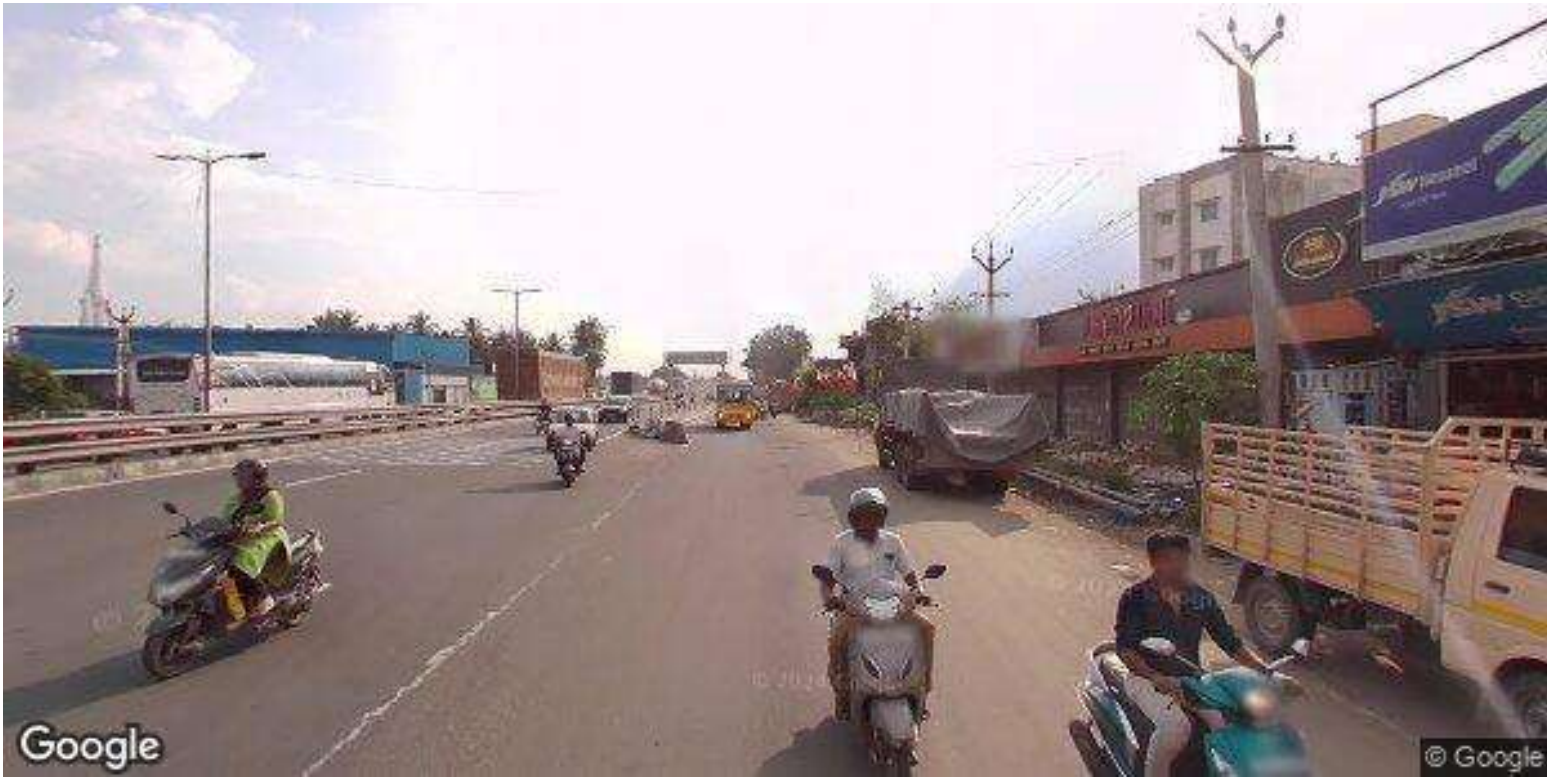
**Risk Type:** Turn  
**Risk Level:** High  
**Speed Limit:** 15 KM/Hr  
**Coordinates:** 11.67081, 78.12661

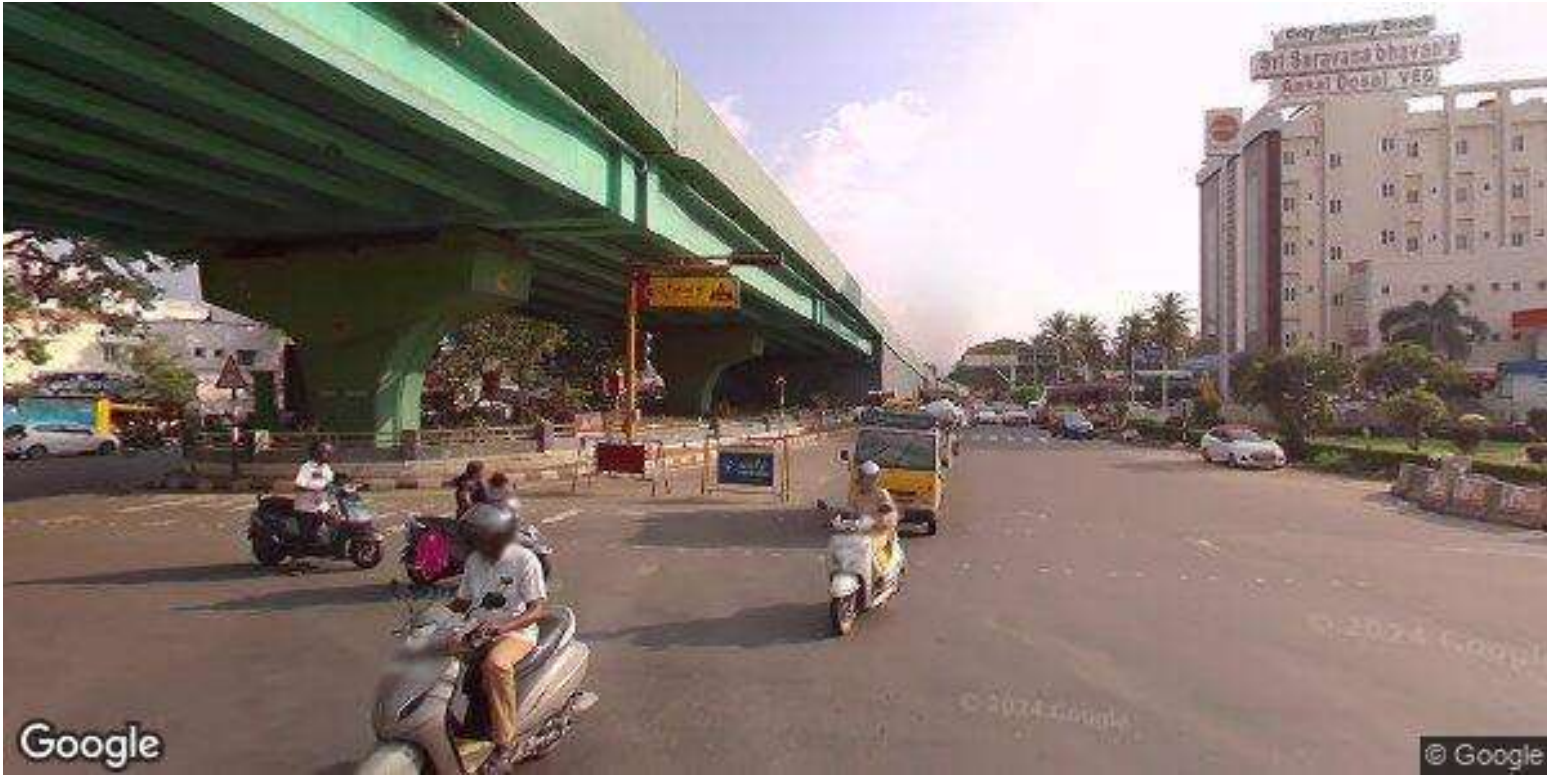
**Risk Type:** Blind Spot  
**Risk Level:** Blind Spot  
**Speed Limit:** 10 KM/Hr  
**Coordinates:** 11.67570, 78.12786
