# IndianOil

## JOURNEY RISK MANAGEMENT (JRM) STUDY

### Salem Terminal TO KSS ENTERPRISES

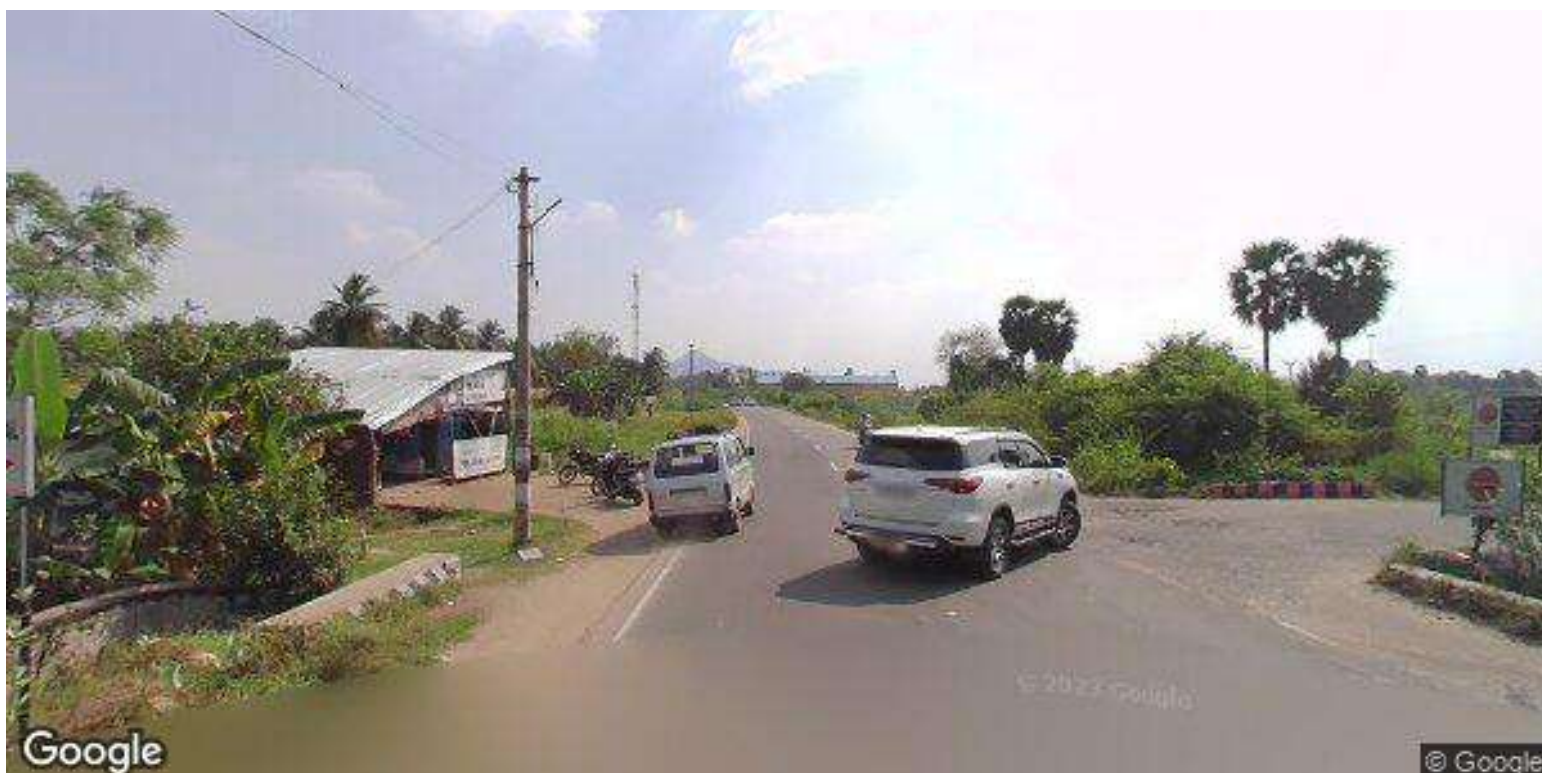
**Speed Limit: 15 KM/Hr**  
**Coordinates: 11.44029, 77.87544**

**Risk Type:** Turn

**Risk Level:** High

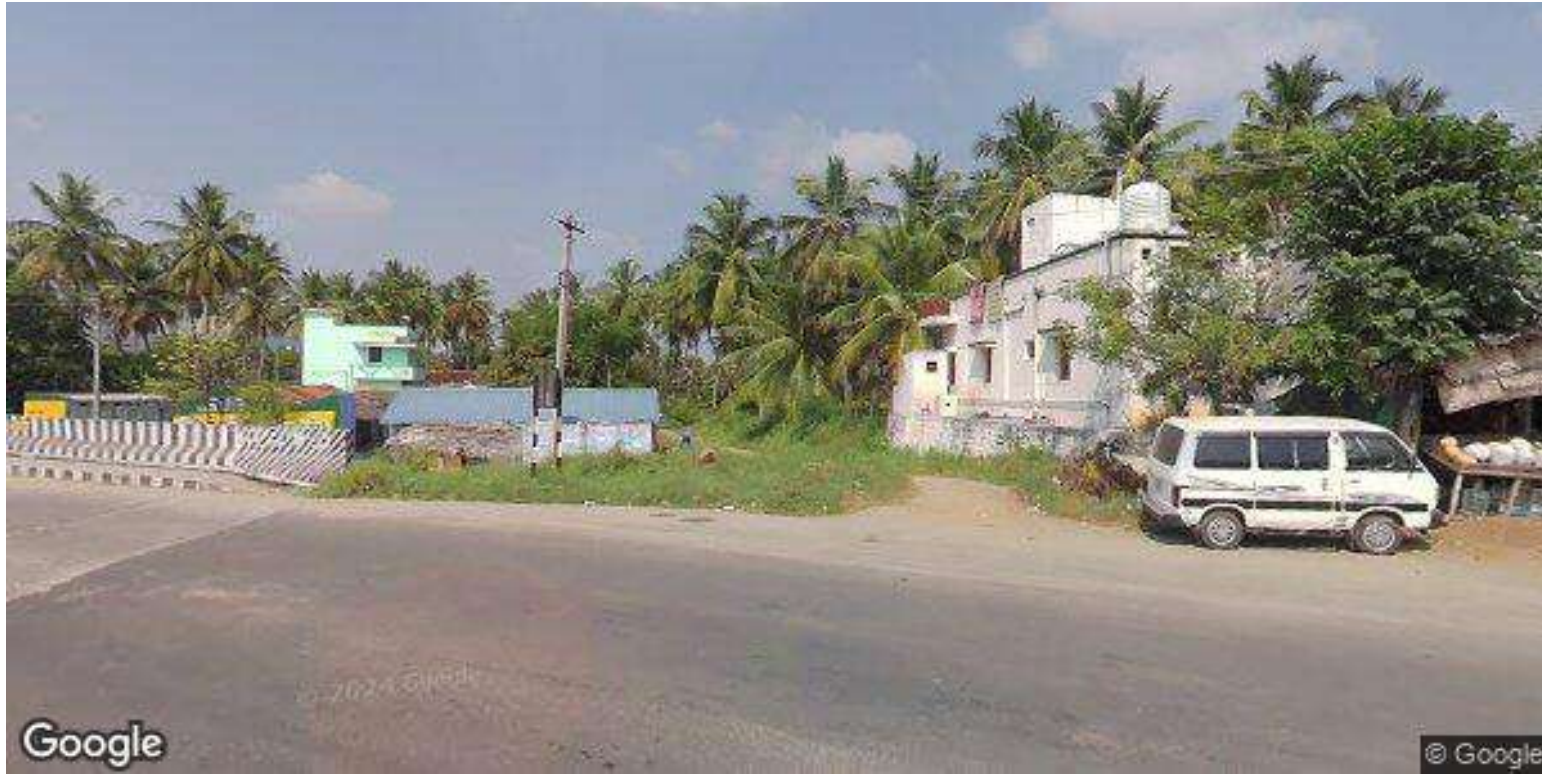
**Risk Type: Turn**  
**Risk Level: Medium**  
**Speed Limit: 30 KM/Hr**  
**Coordinates: 11.44898, 77.87410**

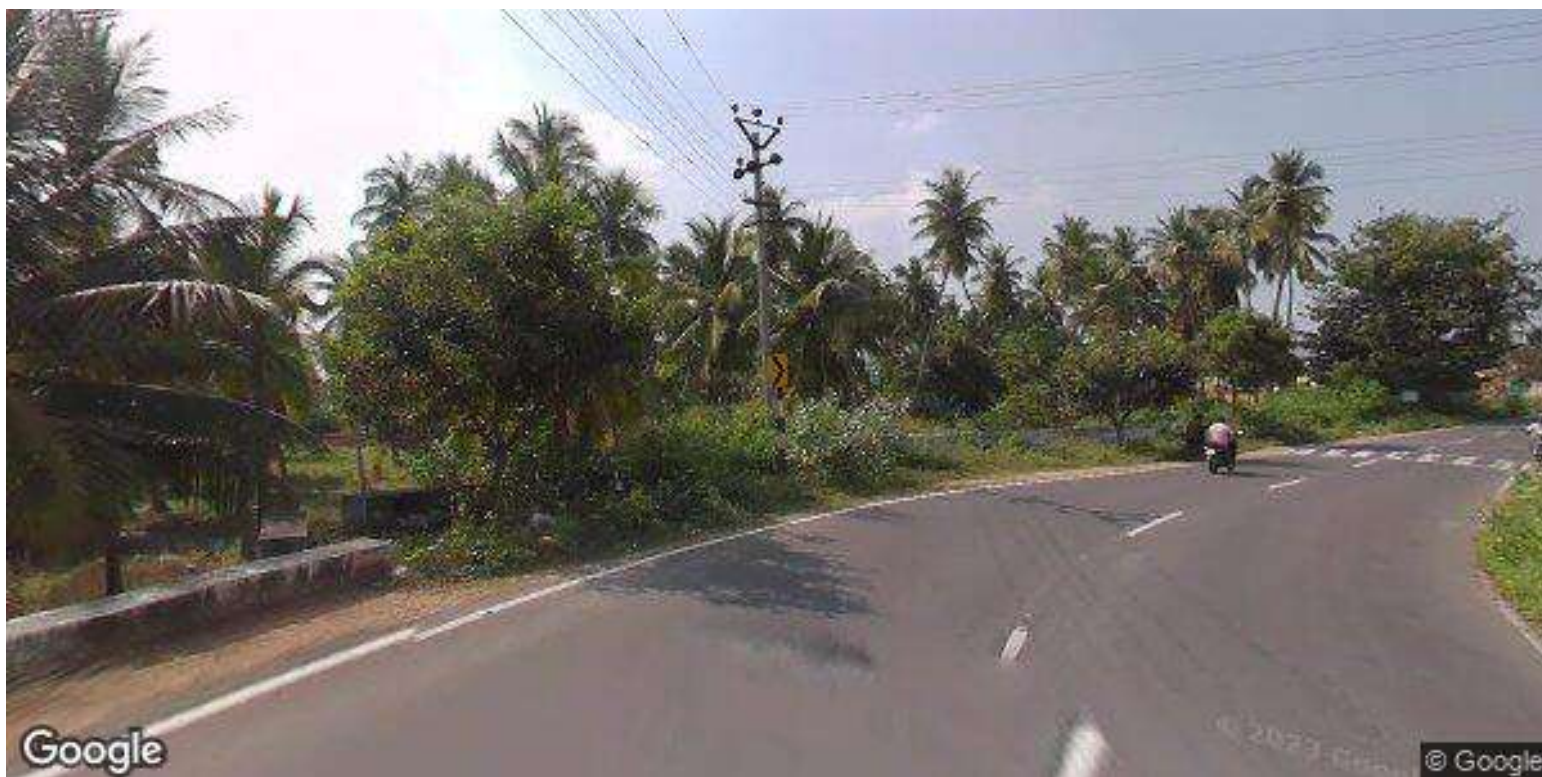
**Risk Type: Turn**  
**Risk Level: Medium**  
**Speed Limit: 30 KM/Hr**  
**Coordinates: 11.45348, 77.85706**

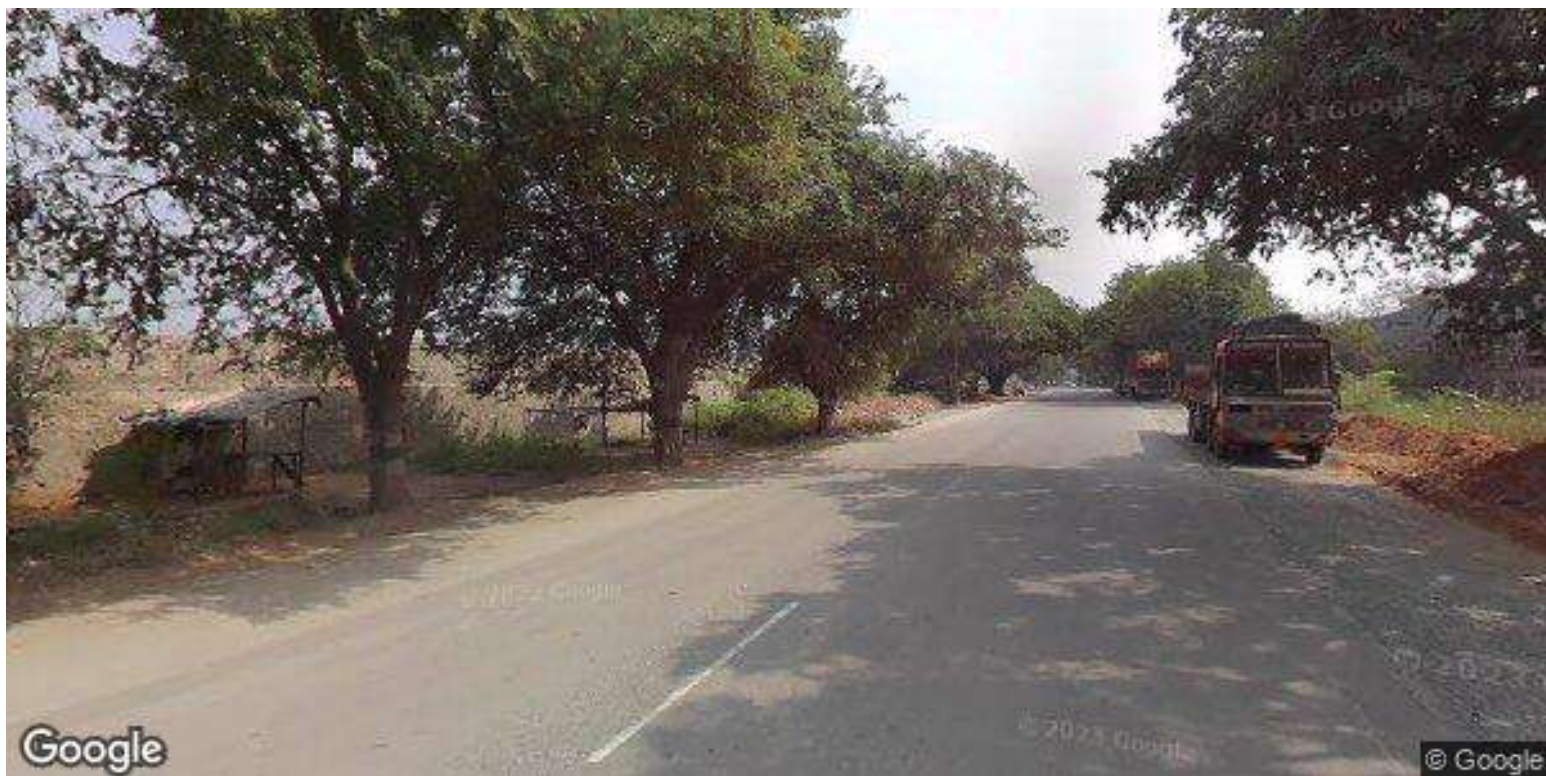
**Coordinates:** 11.45697, 77.82719

**Risk Type:** Turn

**Risk Level:** Medium

**Speed Limit:** 30 KM/Hr

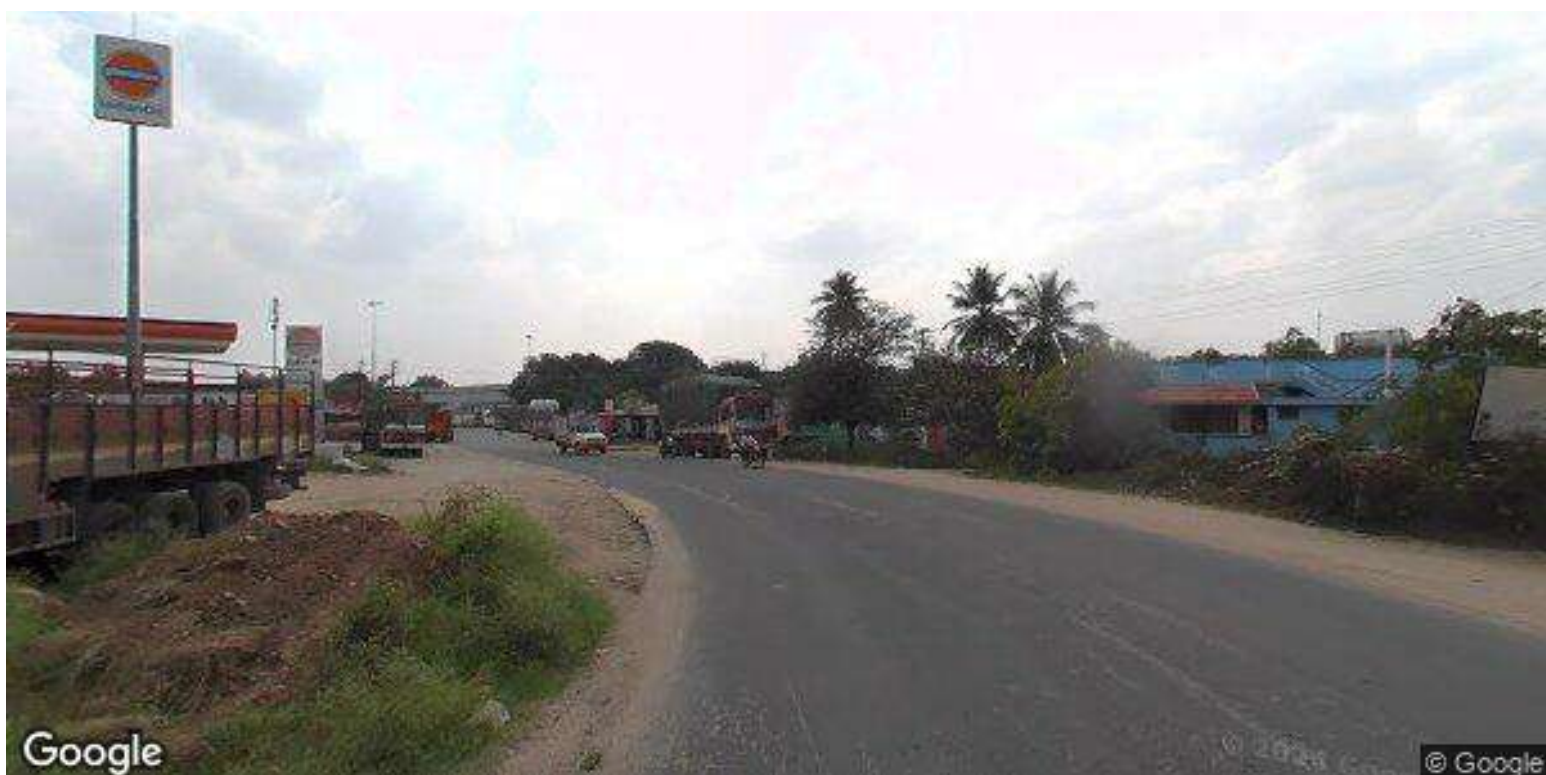
**Coordinates:** 11.49446, 77.88491

**Risk Type:** Turn

**Risk Level:** High

**Speed Limit:** 15 KM/Hr
