# IndianOil

## JOURNEY RISK MANAGEMENT (JRM) STUDY

### Salem Terminal to JP AGENCIES

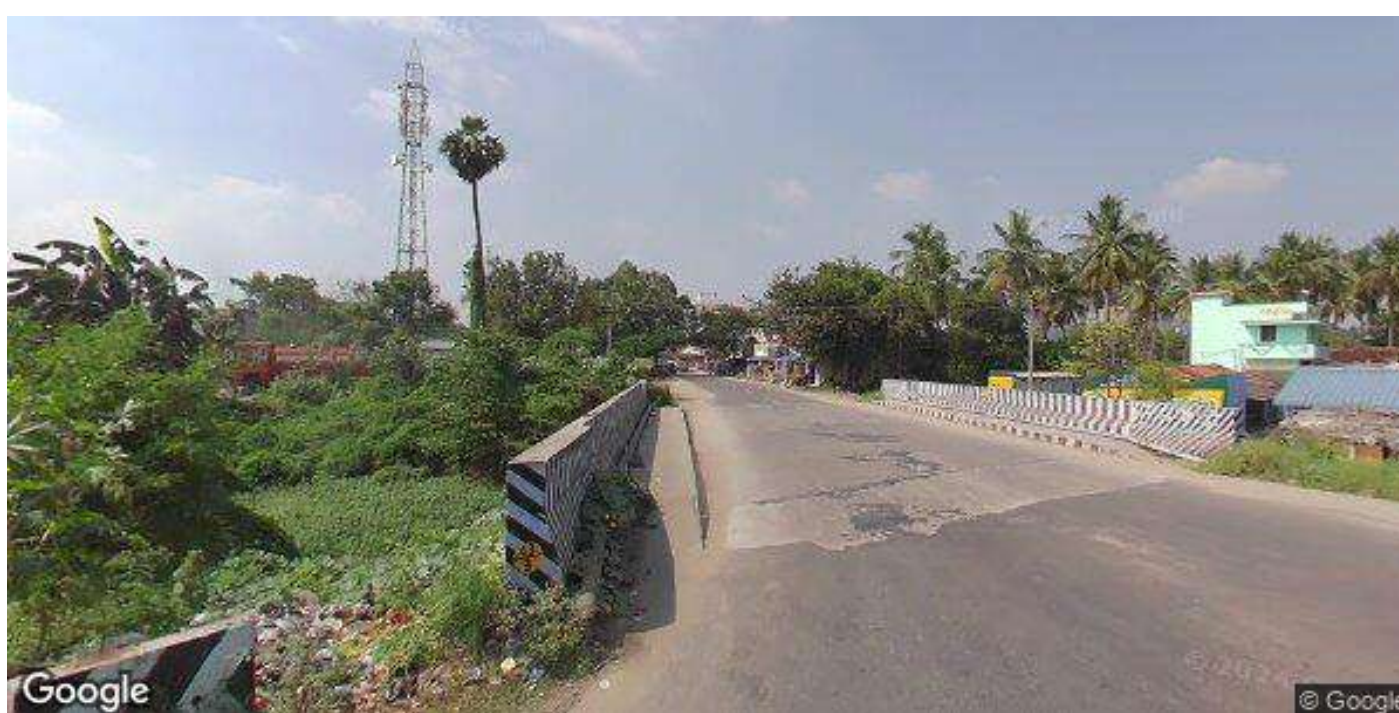
**Risk Type:** Turn  
**Risk Level:** High  
**Speed Limit:** 15 KM/Hr  
**Coordinates:** 11.44900, 77.87406

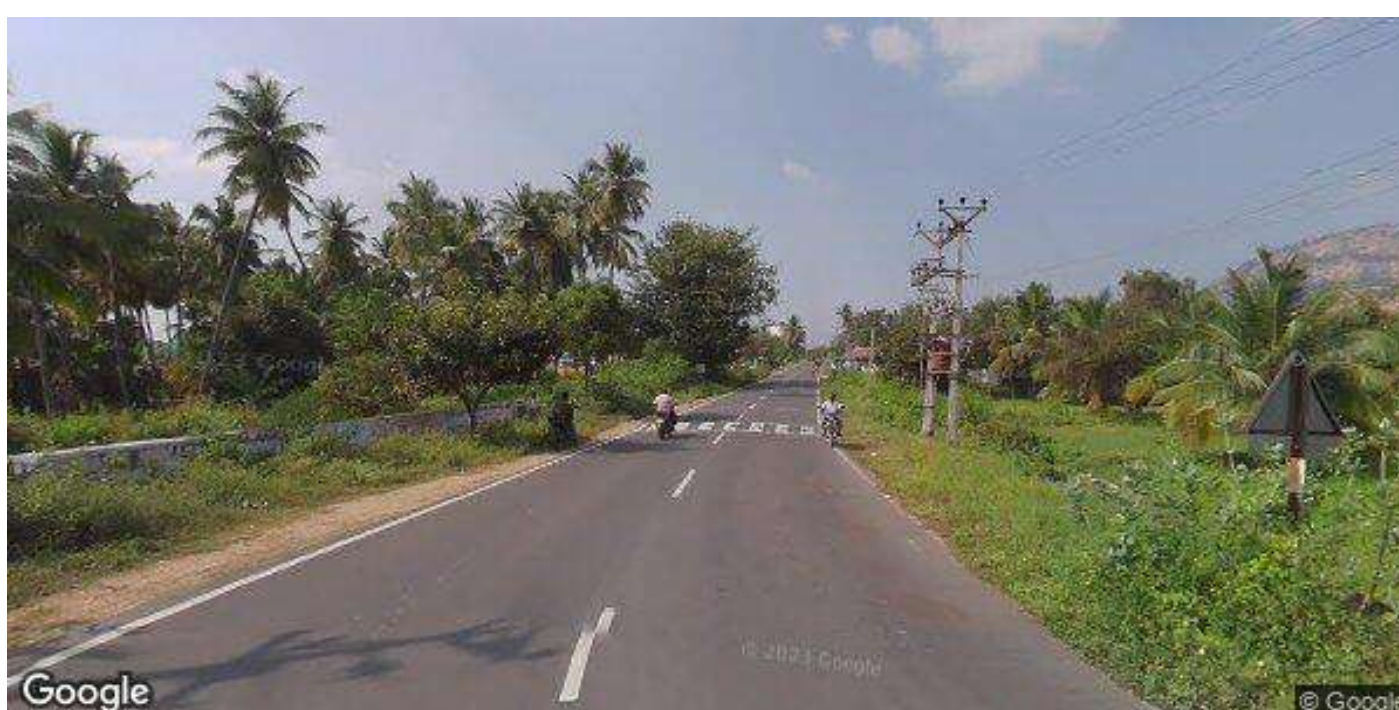
**Risk Type:** Turn  
**Risk Level:** High  
**Speed Limit:** 15 KM/Hr  
**Coordinates:** 11.45353, 77.85697

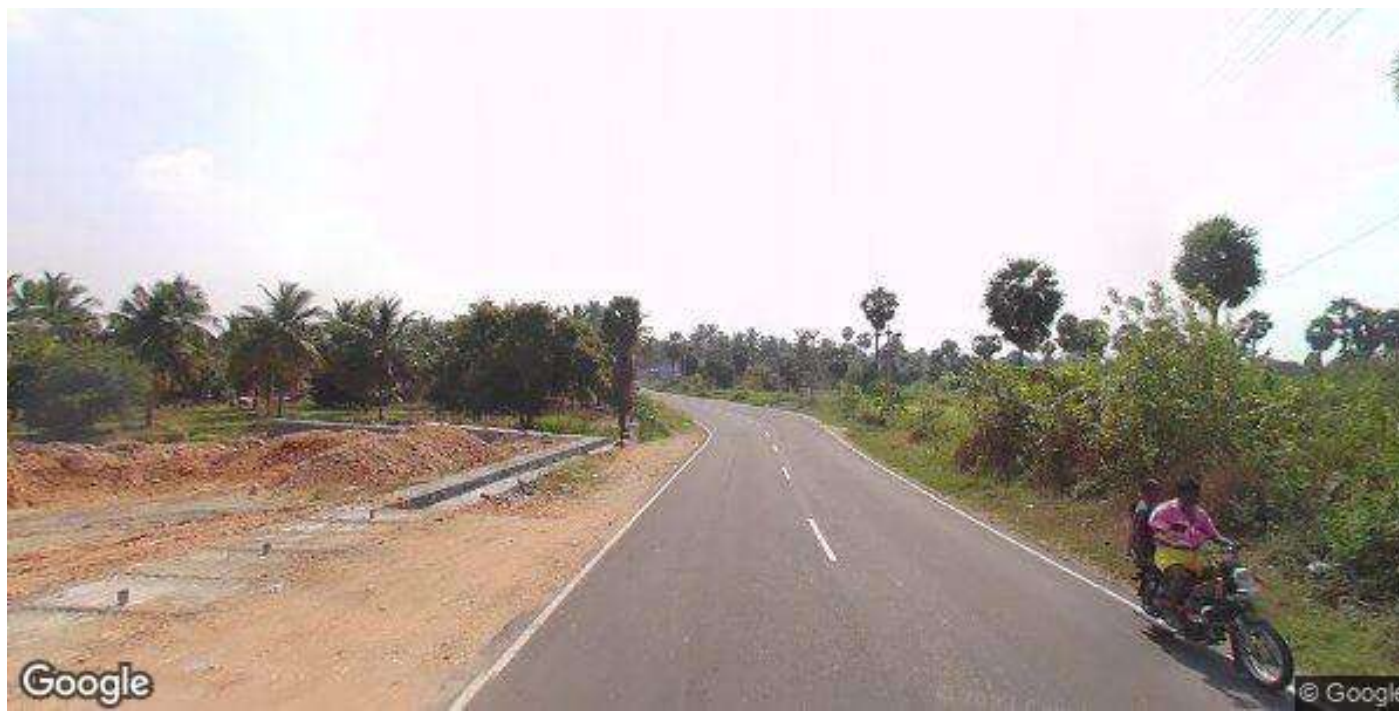
**Risk Type:** Turn  
**Risk Level:** Medium  
**Speed Limit:** 30 KM/Hr  
**Coordinates:** 11.45781, 77.85203

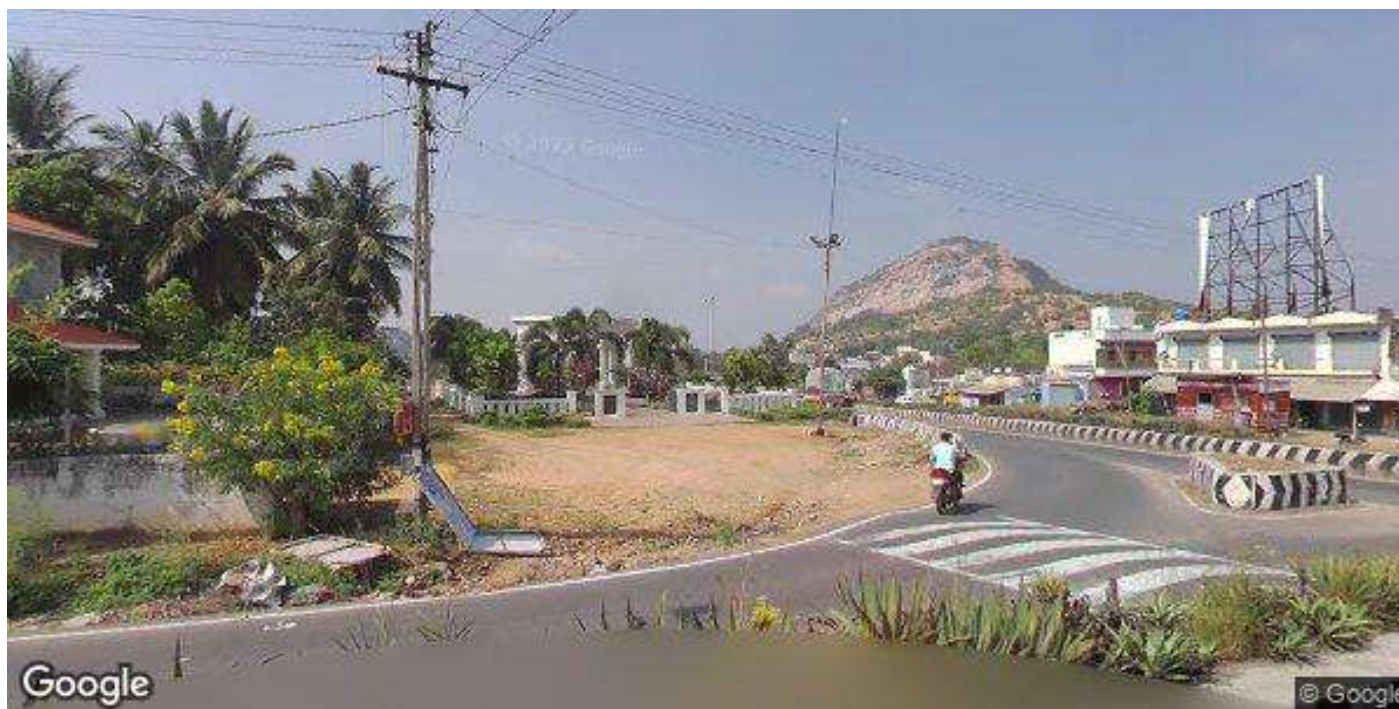
**Risk Type:** Turn  
**Risk Level:** High  
**Speed Limit:** 15 KM/Hr  
**Coordinates:** 11.46307, 77.84941

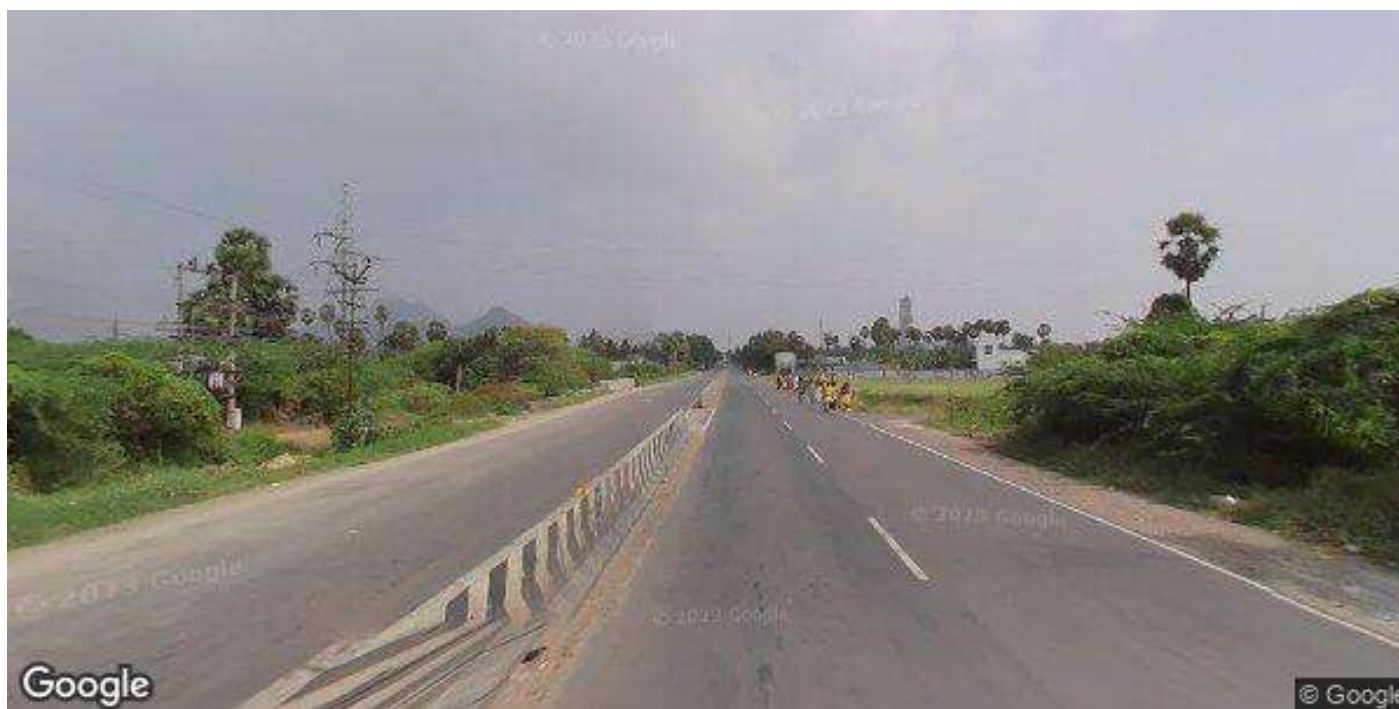
**Risk Type:** Turn  
**Risk Level:** Medium  
**Speed Limit:** 30 KM/Hr  
**Coordinates:** 11.45546, 77.81800

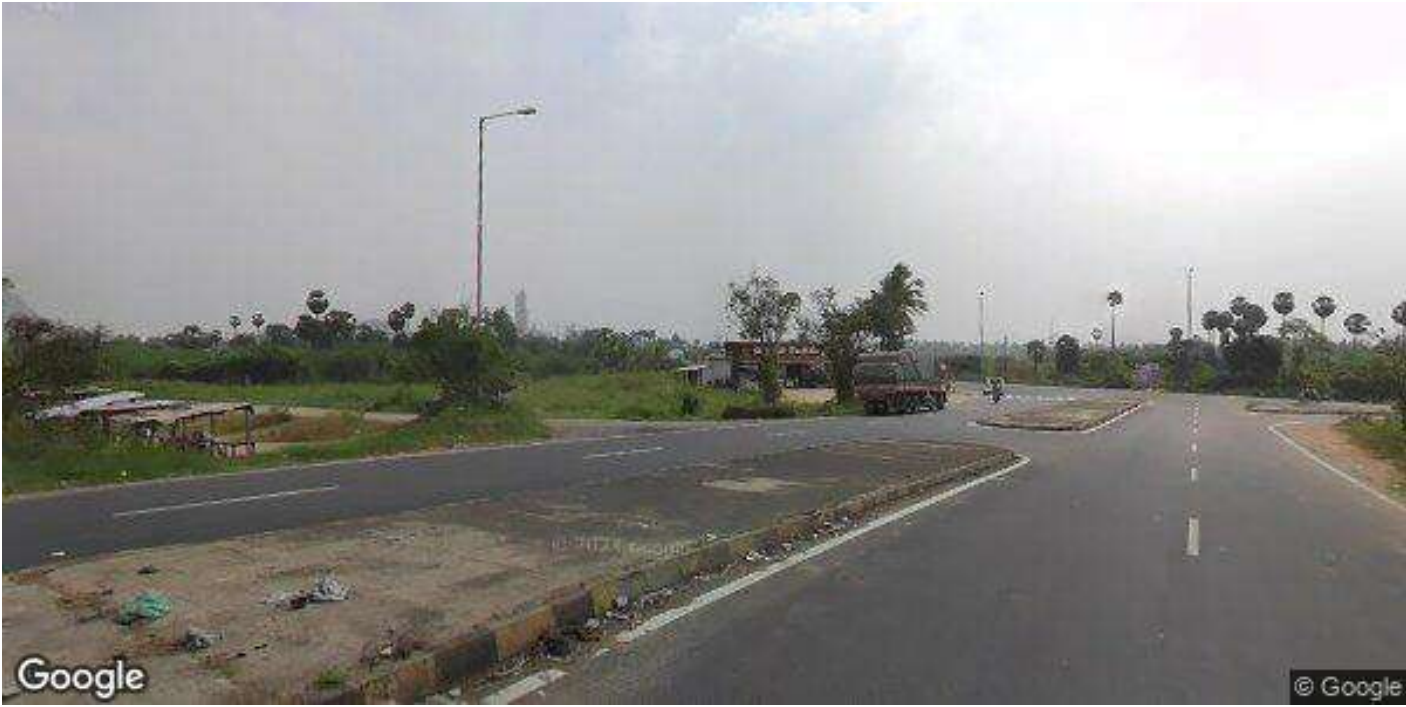
**Risk Type:** Blind Spot  
**Risk Level:** Blind Spot  
**Speed Limit:** 10 KM/Hr  
**Coordinates:** 11.45605, 77.81683

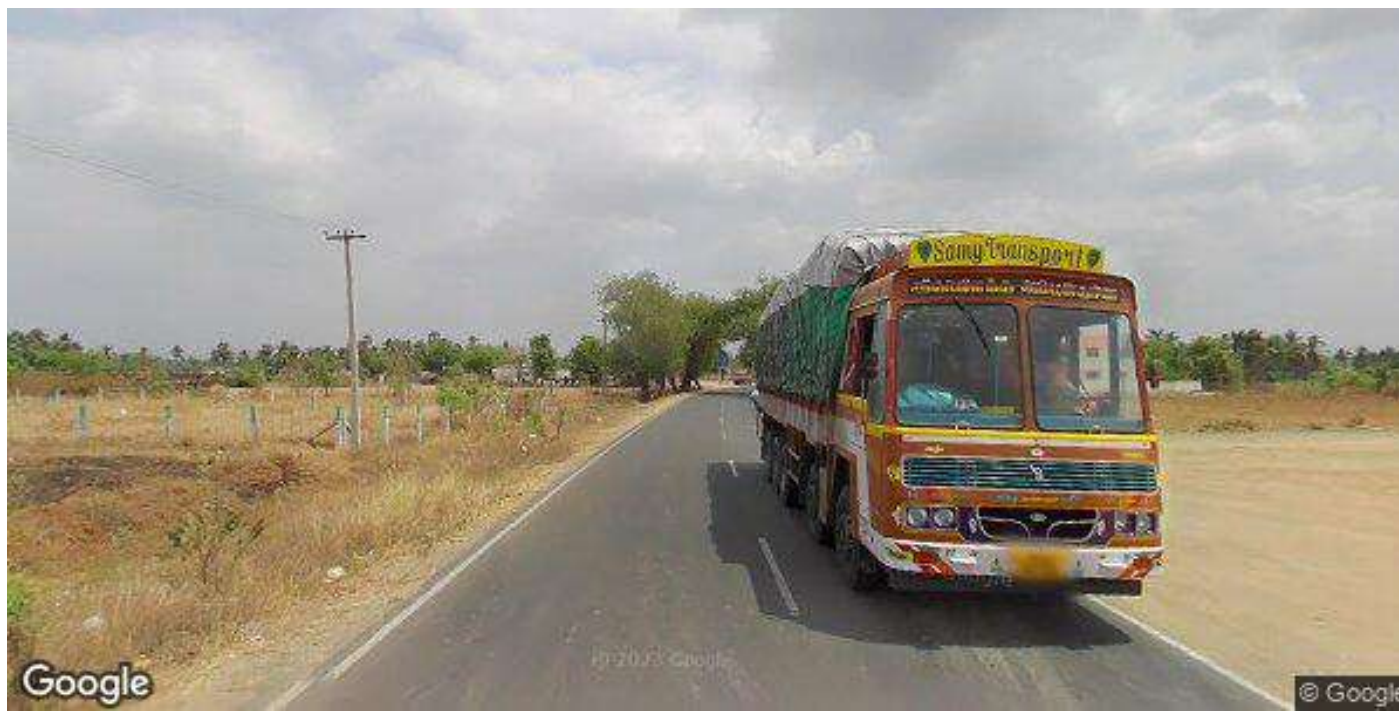
**Risk Type:** Turn  
**Risk Level:** High  
**Speed Limit:** 15 KM/Hr  
**Coordinates:** 11.55614, 77.89764

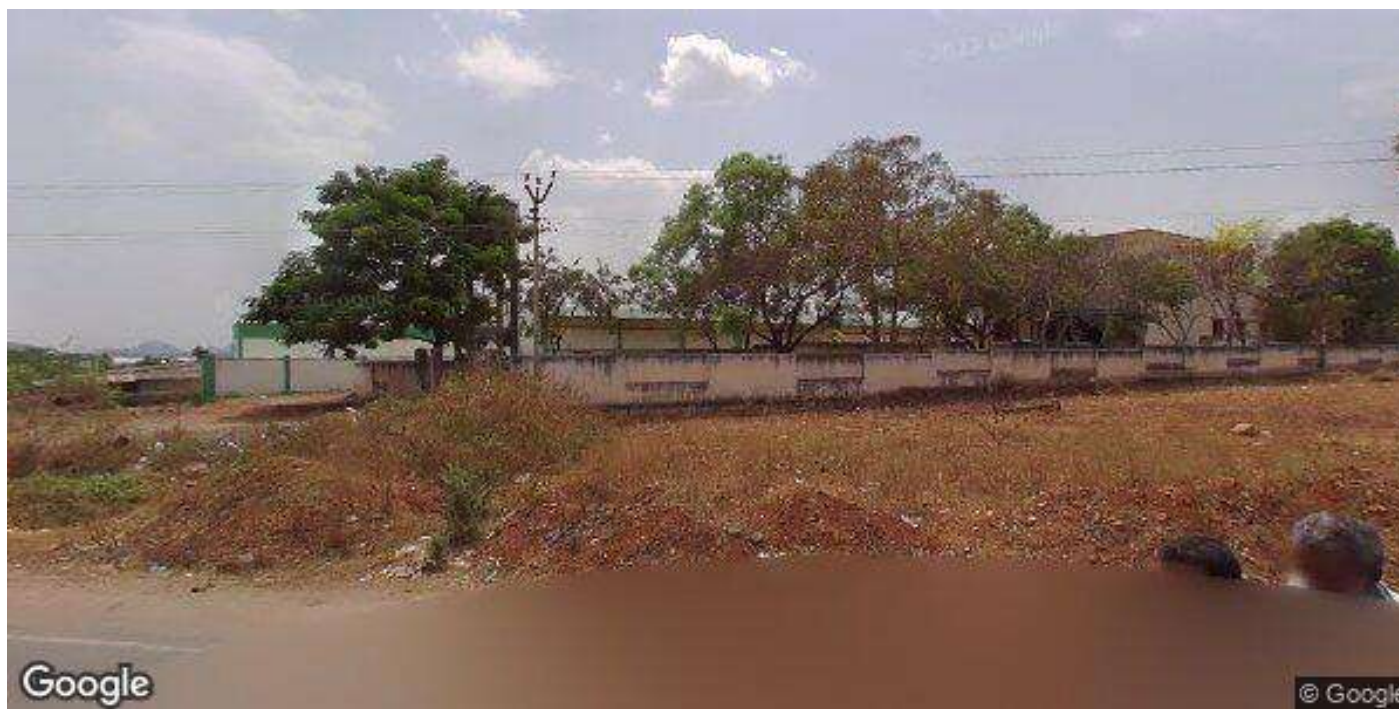
**Risk Type:** Turn  
**Risk Level:** High  
**Speed Limit:** 15 KM/Hr  
**Coordinates:** 11.58330, 77.90642

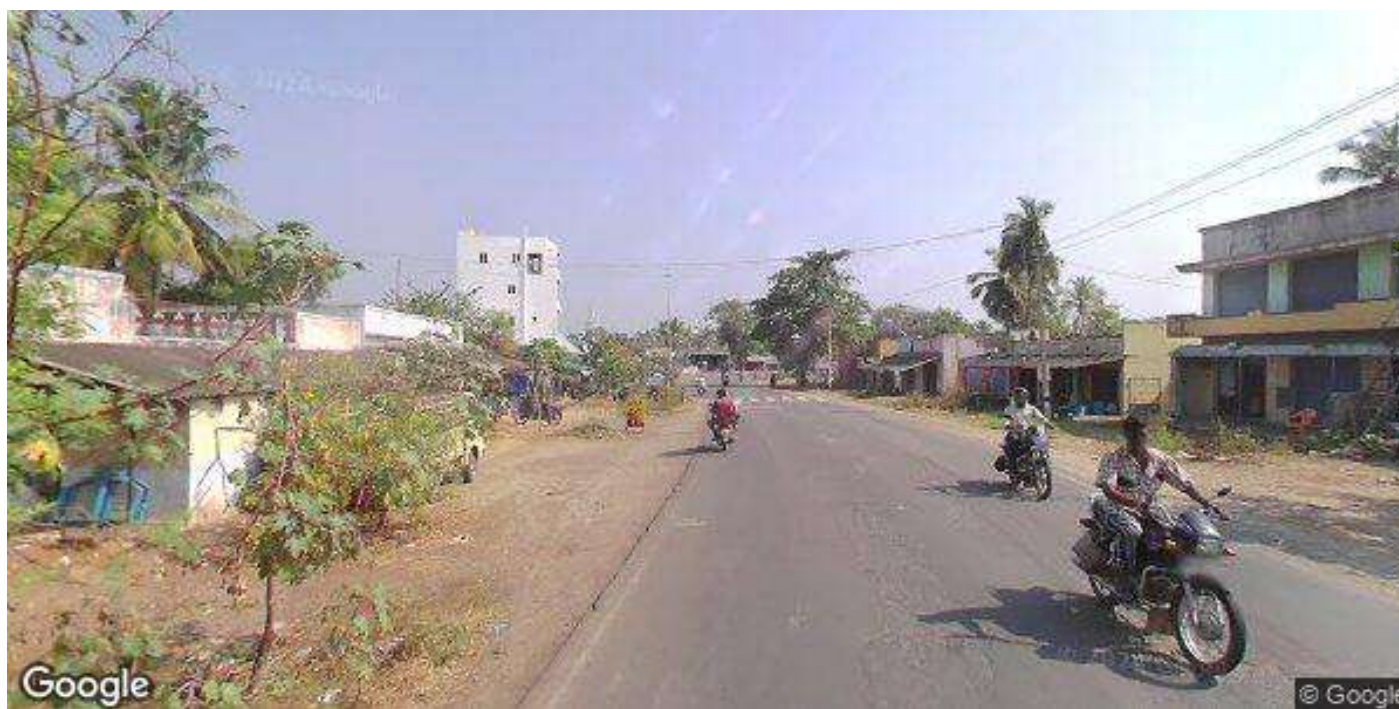
**Risk Type:** Turn  
**Risk Level:** Medium  
**Speed Limit:** 30 KM/Hr  
**Coordinates:** 11.59189, 77.90645

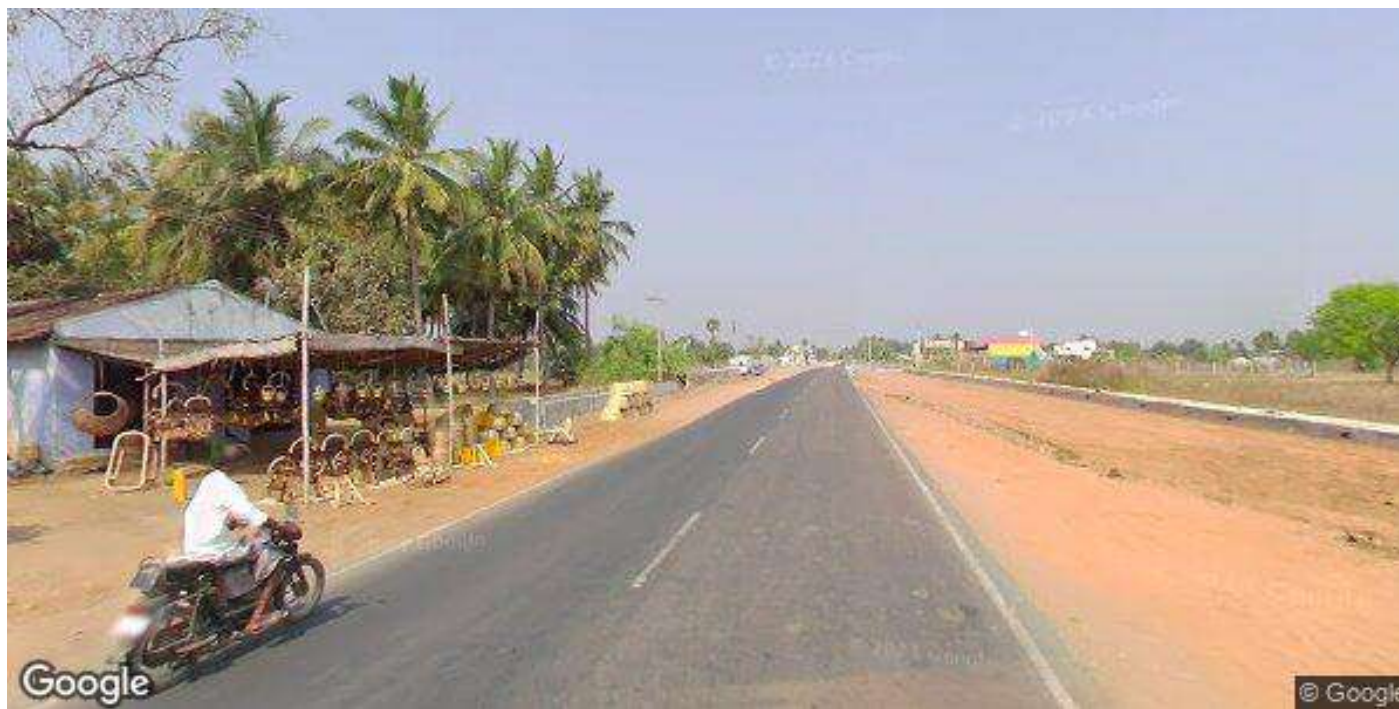
**Risk Type:** Turn  
**Risk Level:** Medium  
**Speed Limit:** 30 KM/Hr  
**Coordinates:** 11.59328, 77.90809

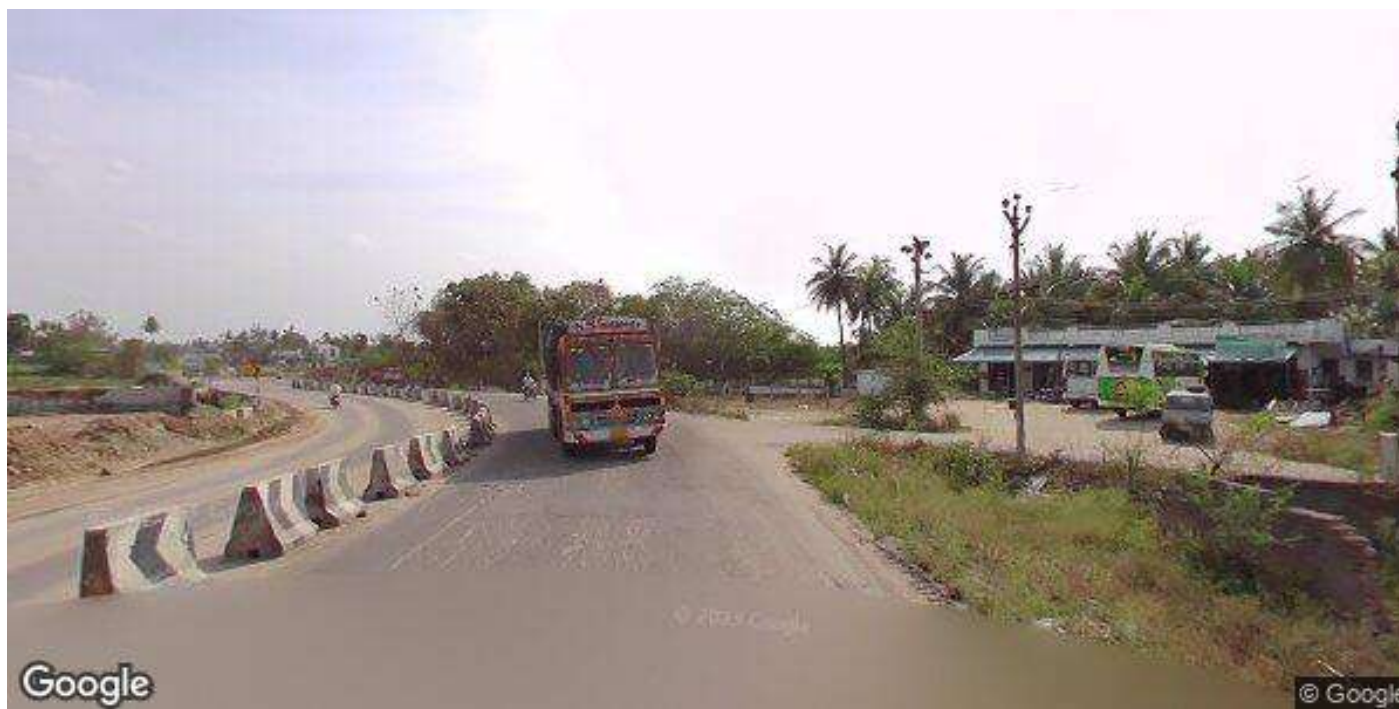
**Risk Type:** Turn  
**Risk Level:** Medium  
**Speed Limit:** 30 KM/Hr  
**Coordinates:** 11.63867, 77.94841

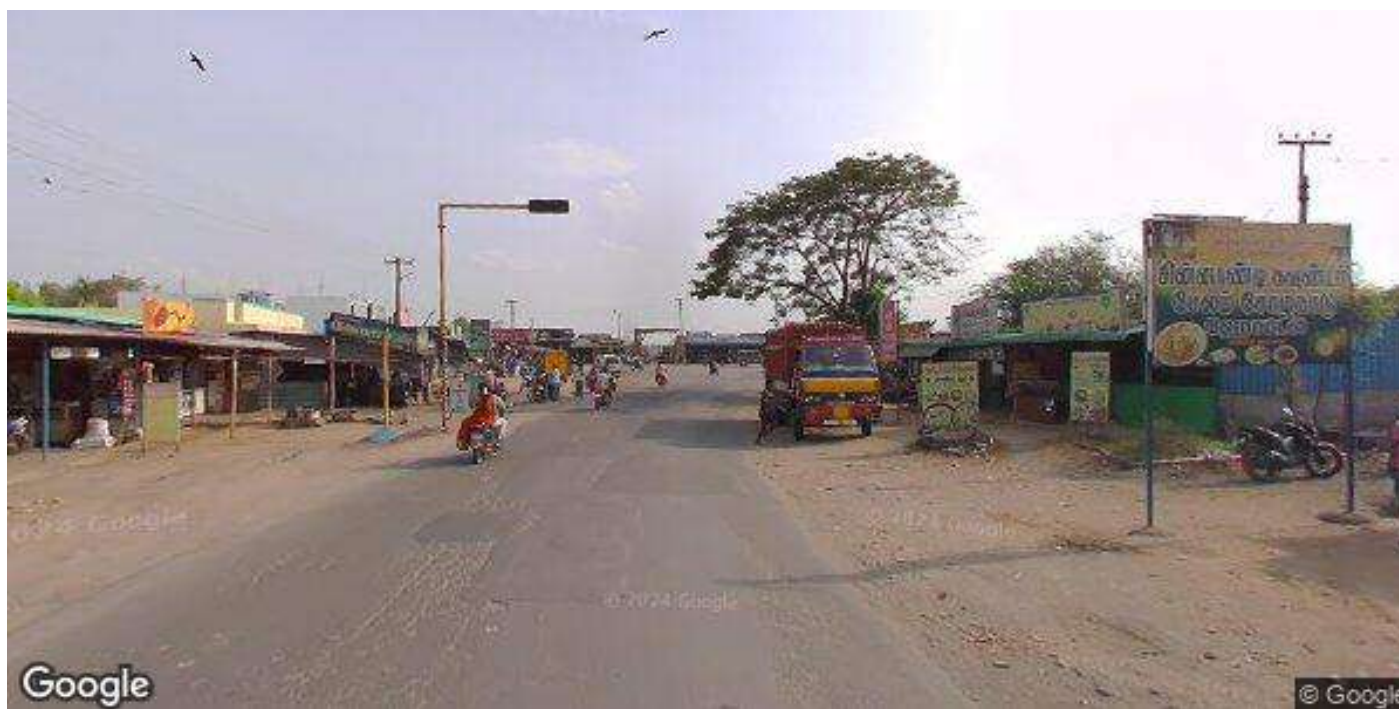
**Risk Type:** Turn  
**Risk Level:** High  
**Speed Limit:** 15 KM/Hr  
**Coordinates:** 11.64217, 77.95200

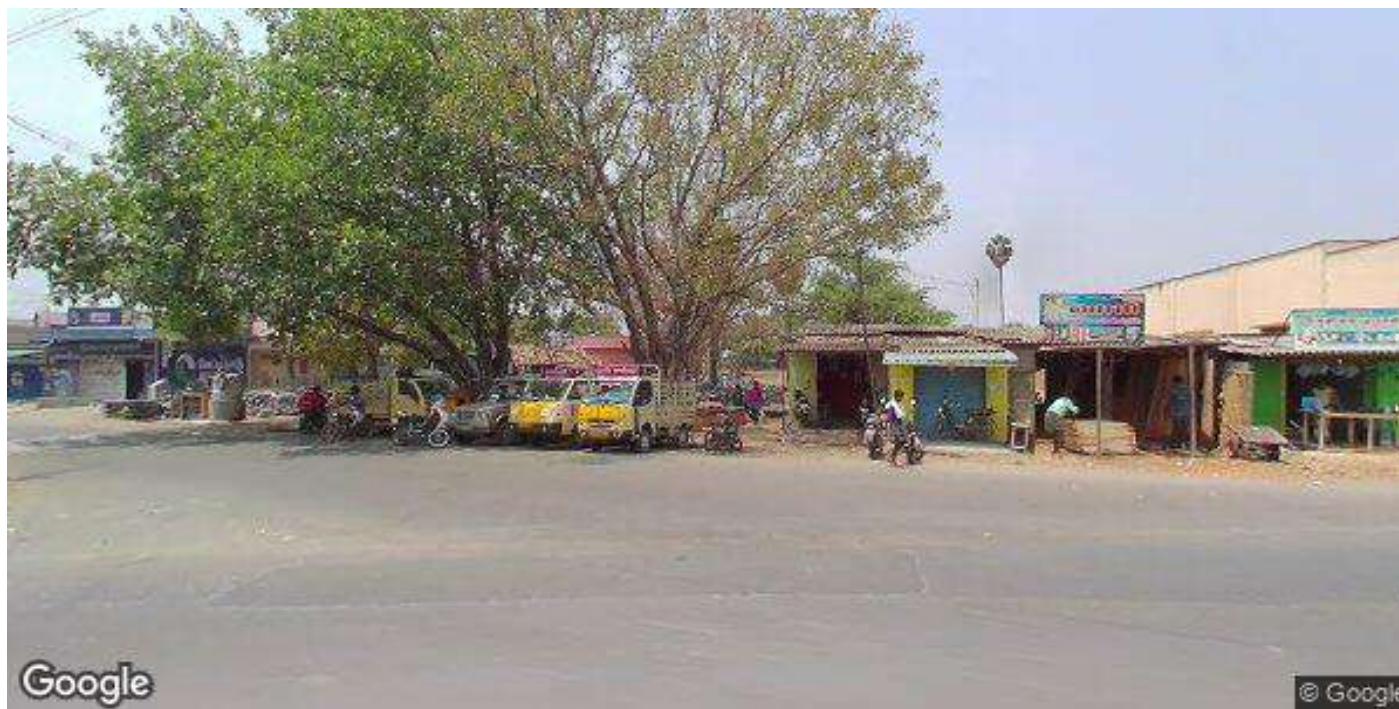
**Risk Type:** Turn  
**Risk Level:** Medium  
**Speed Limit:** 30 KM/Hr  
**Coordinates:** 11.64712, 77.95118

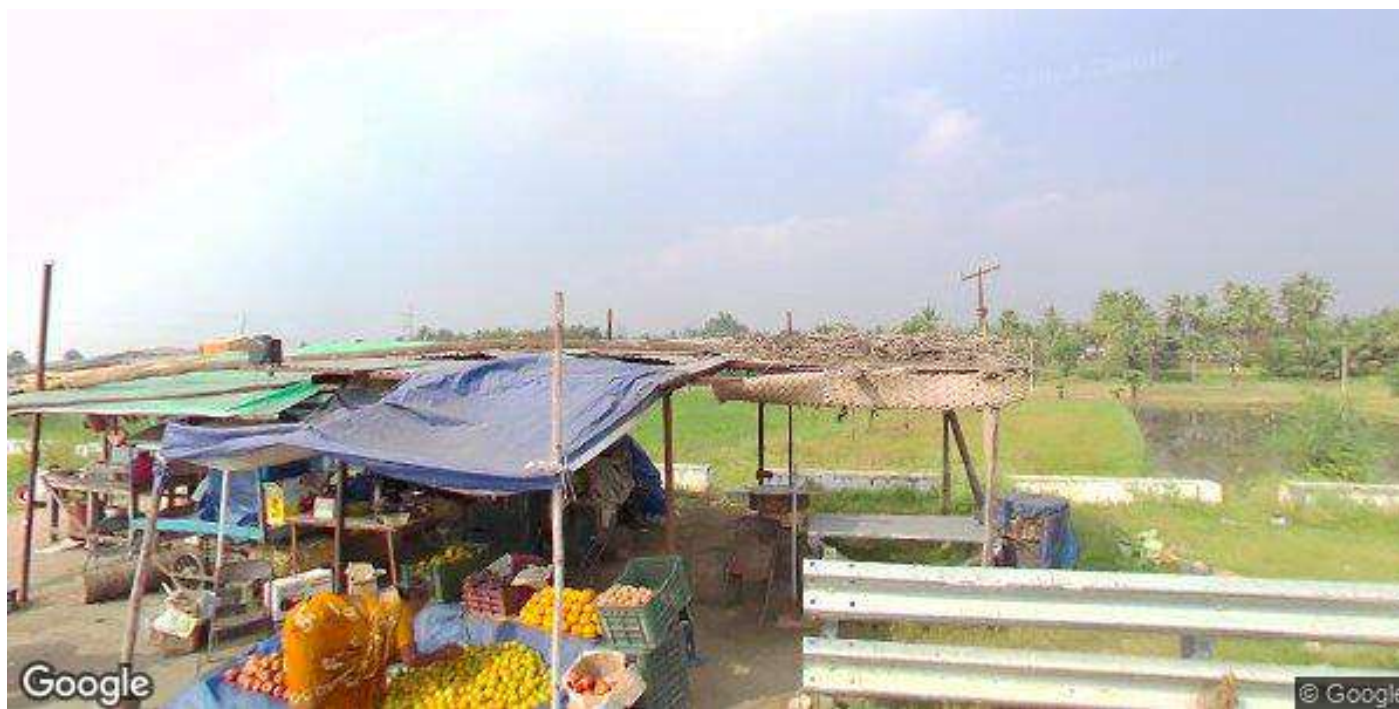
**Risk Type:** Turn  
**Risk Level:** Medium  
**Speed Limit:** 30 KM/Hr  
**Coordinates:** 11.67858, 77.96834

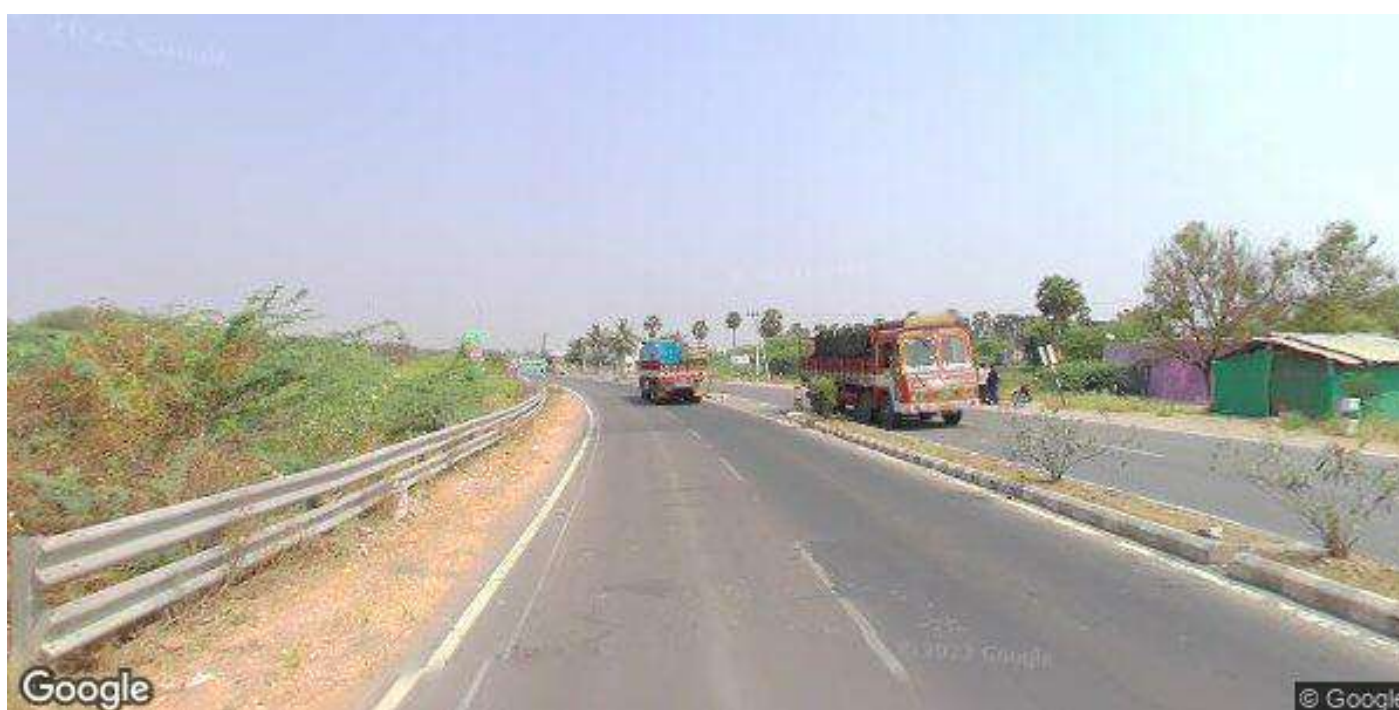
**Risk Type:** Turn  
**Risk Level:** Medium  
**Speed Limit:** 30 KM/Hr  
**Coordinates:** 11.70062, 77.97961

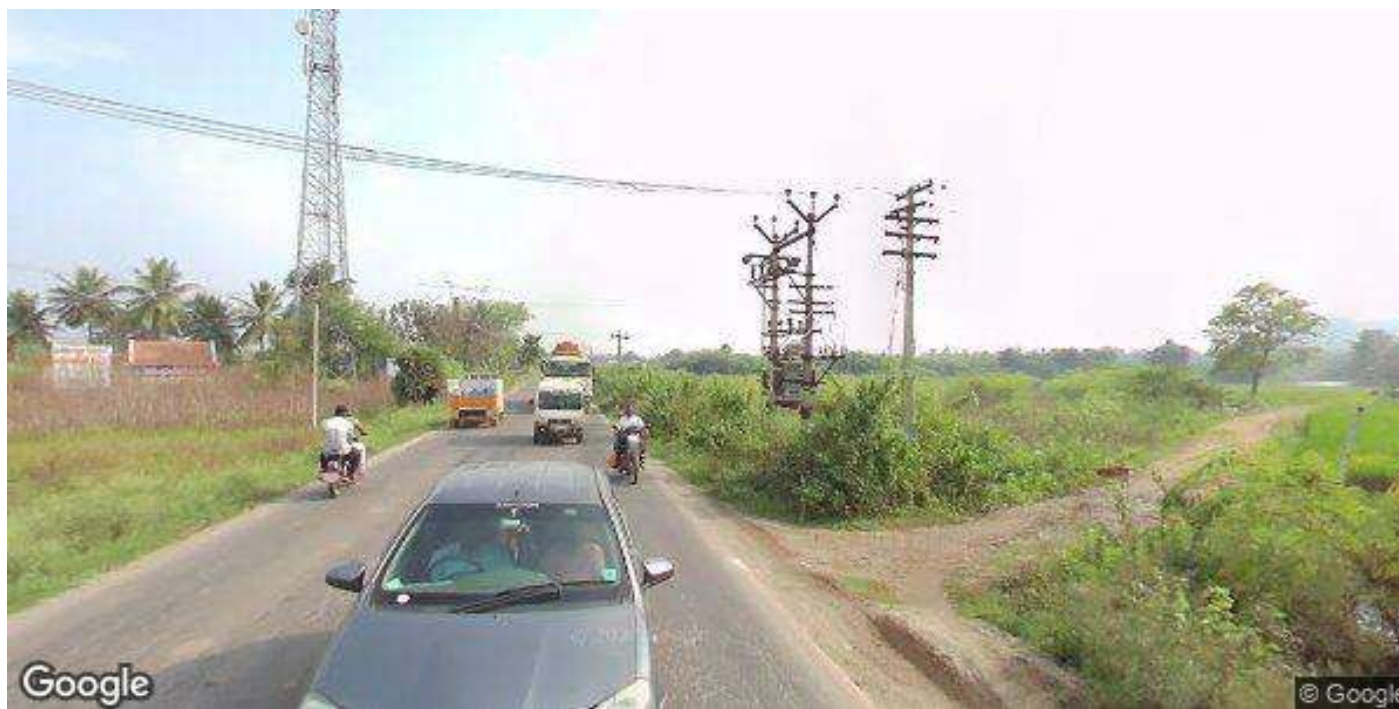
**Risk Type:** Turn  
**Risk Level:** Medium  
**Speed Limit:** 30 KM/Hr  
**Coordinates:** 11.71399, 77.99580

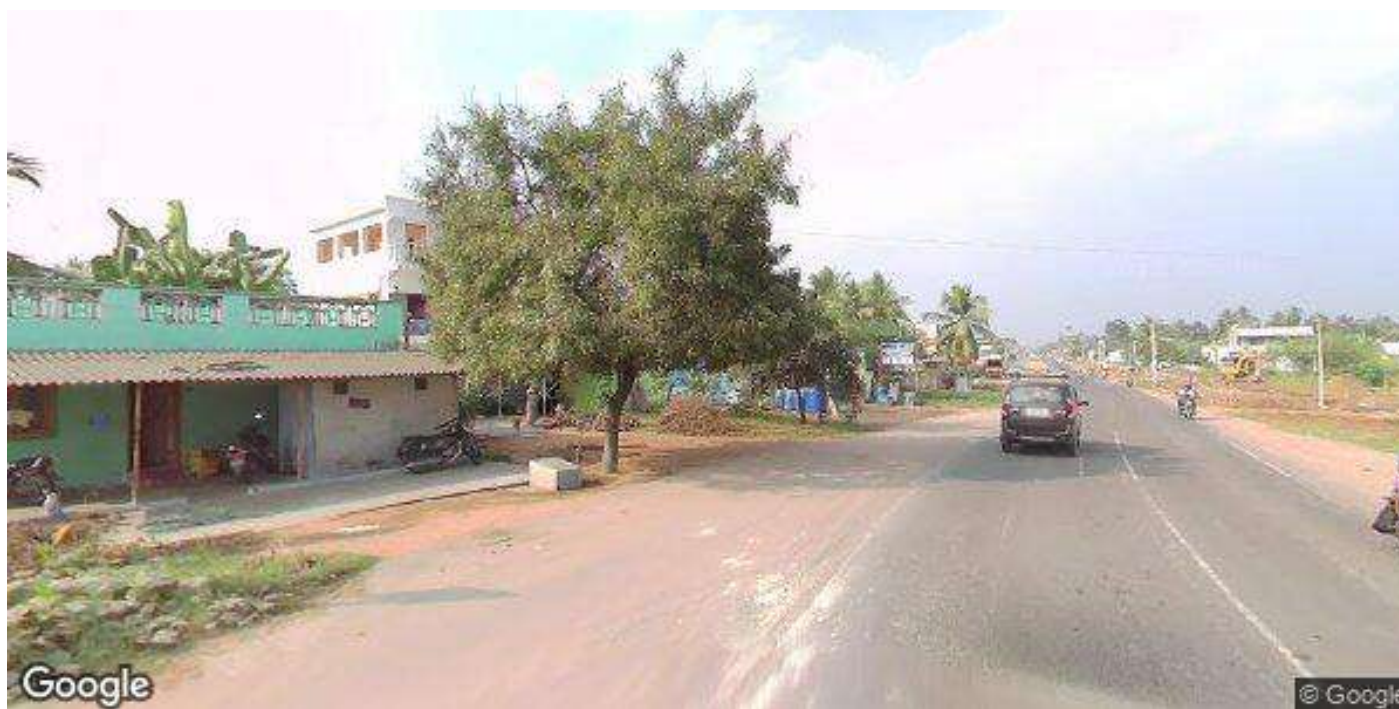
**Risk Type:** Turn  
**Risk Level:** Medium  
**Speed Limit:** 30 KM/Hr  
**Coordinates:** 11.71917, 78.01123

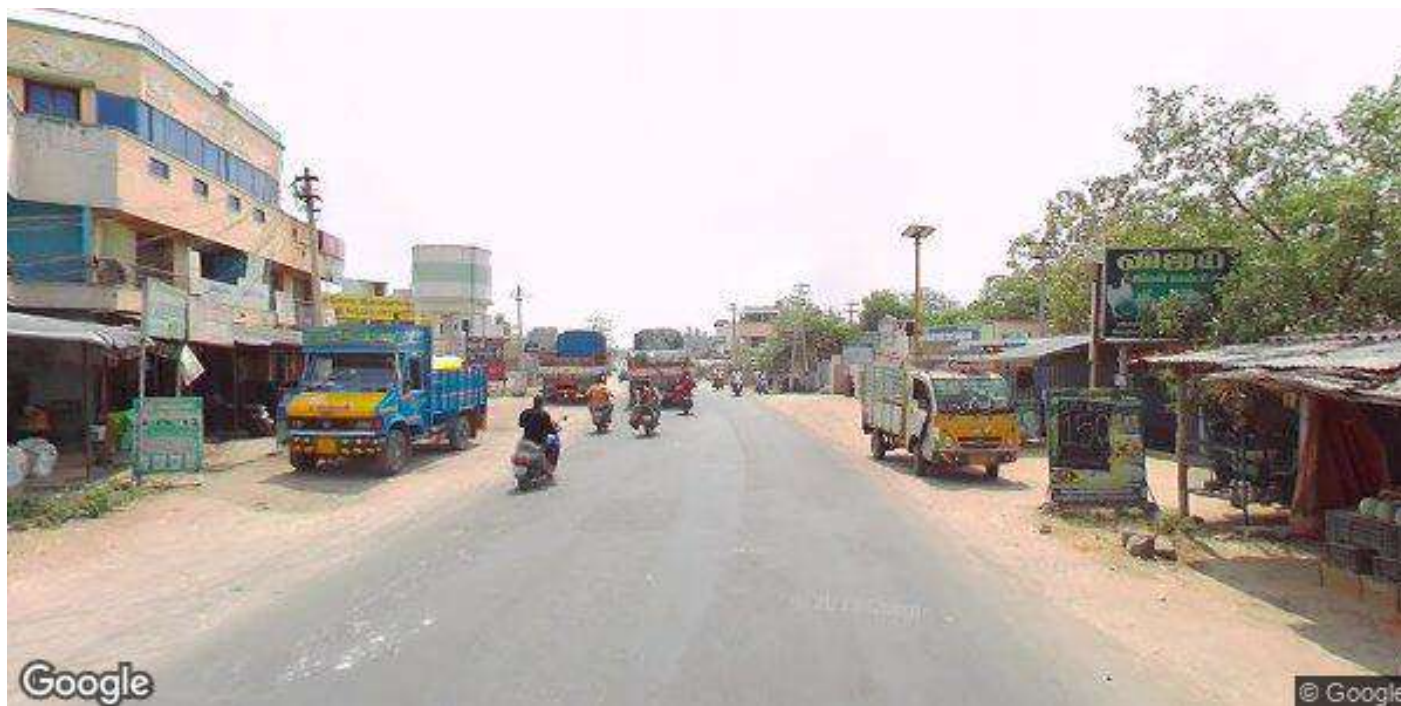
**Risk Type:** Turn  
**Risk Level:** Medium  
**Speed Limit:** 30 KM/Hr  
**Coordinates:** 11.73769, 78.03451

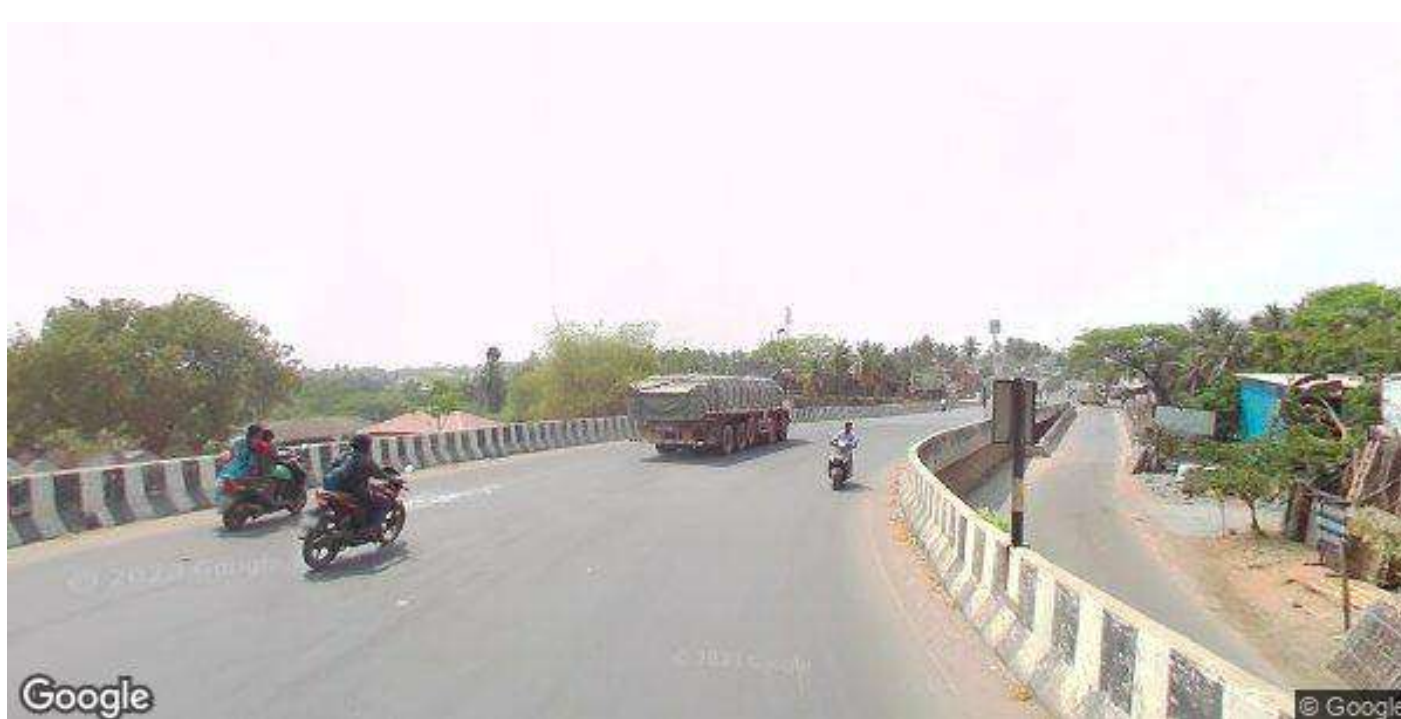
**Risk Type:** Turn  
**Risk Level:** High  
**Speed Limit:** 15 KM/Hr  
**Coordinates:** 11.73651, 78.03871

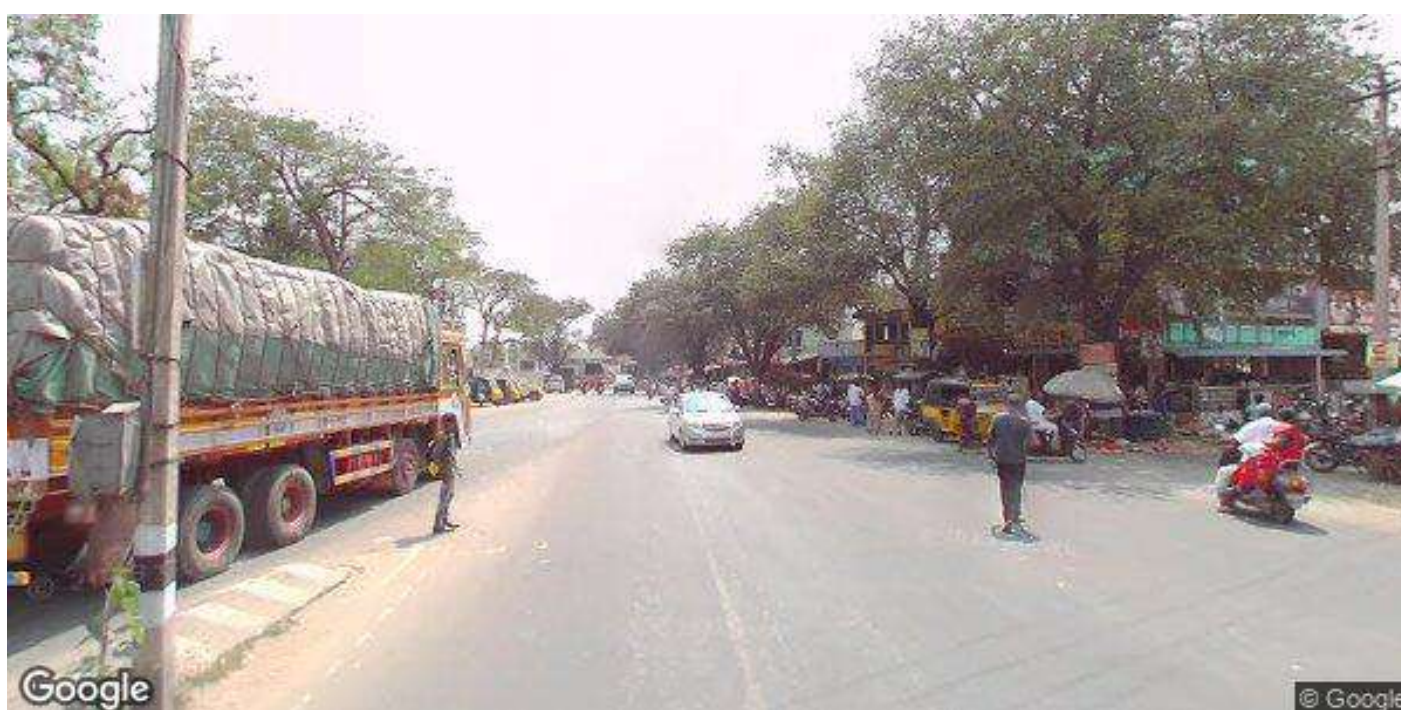
**Risk Type:** Turn  
**Risk Level:** Medium  
**Speed Limit:** 30 KM/Hr  
**Coordinates:** 11.74271, 78.04717

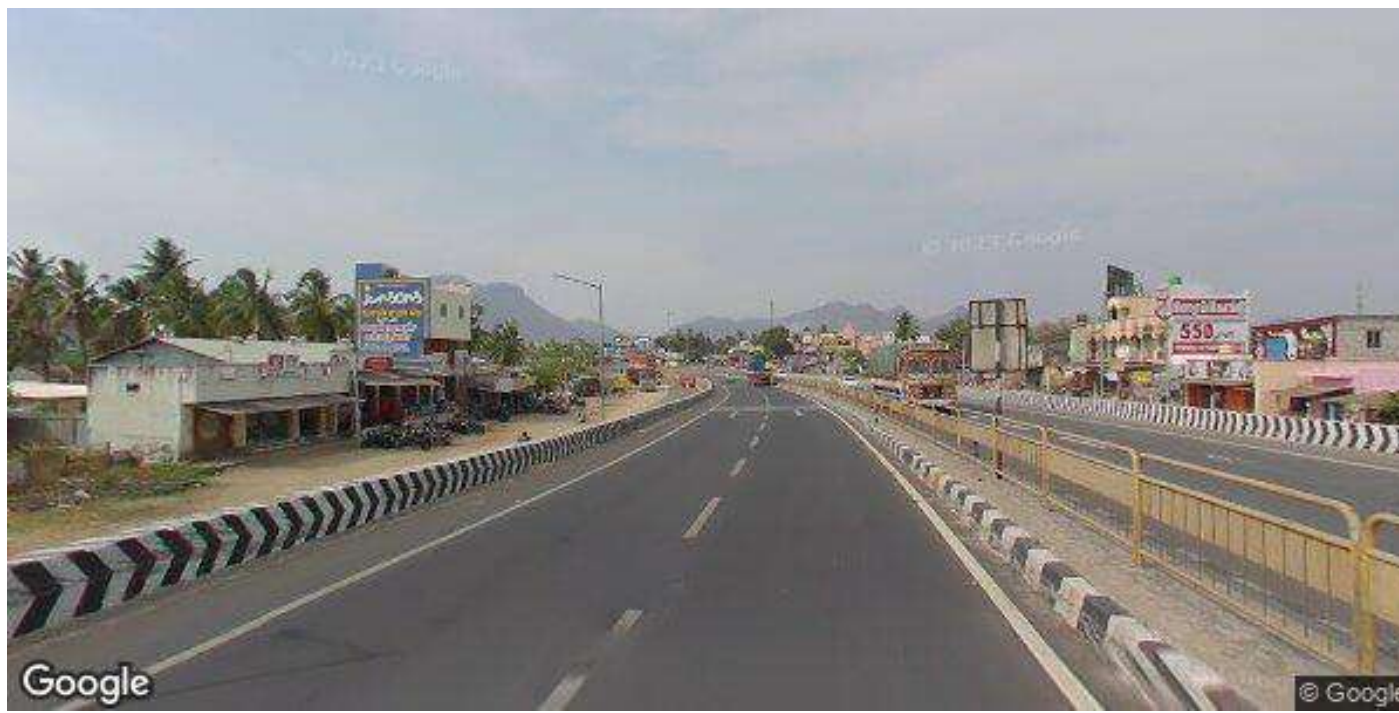
**Risk Type:** Turn  
**Risk Level:** Medium  
**Speed Limit:** 30 KM/Hr  
**Coordinates:** 11.86847, 78.08367

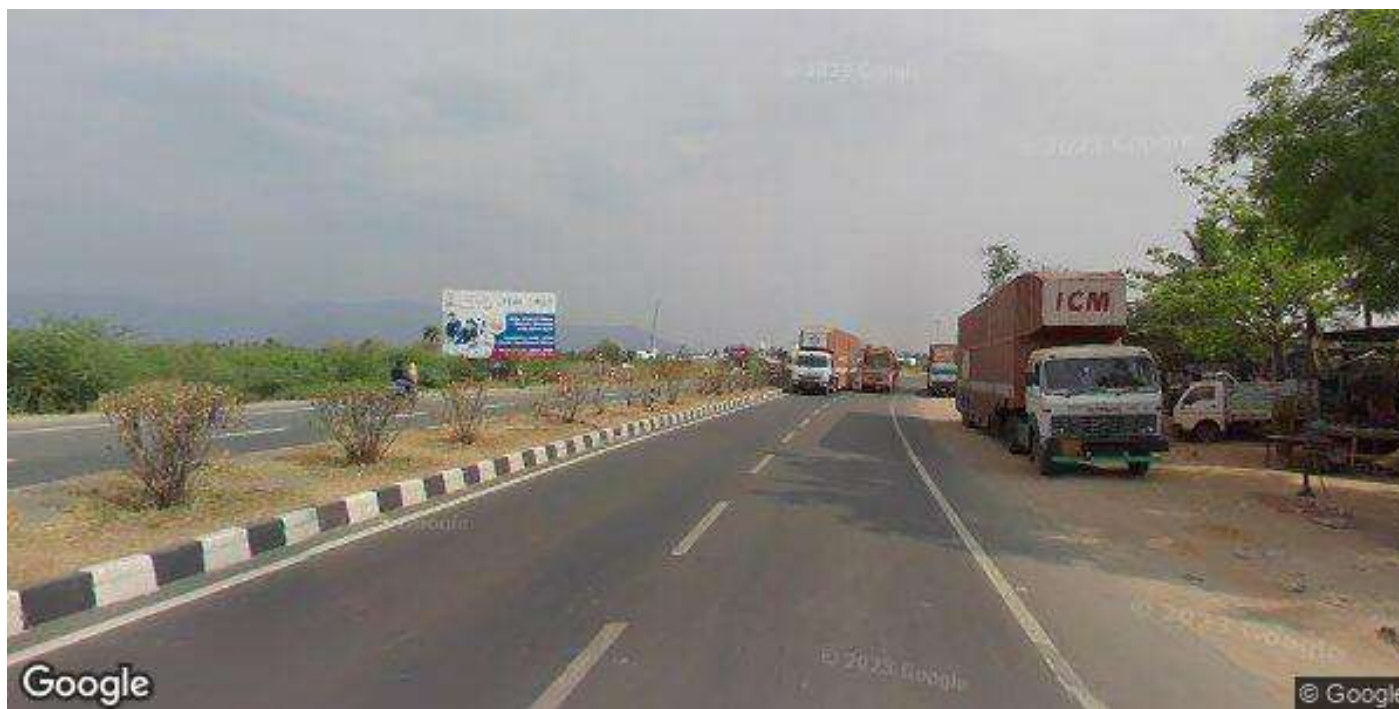
**Risk Type:** Turn  
**Risk Level:** Medium  
**Speed Limit:** 30 KM/Hr  
**Coordinates:** 11.87942, 78.08197
