# IndianOil

## JOURNEY RISK MANAGEMENT (JRM) STUDY

### Salem Terminal to JP AGENCIES

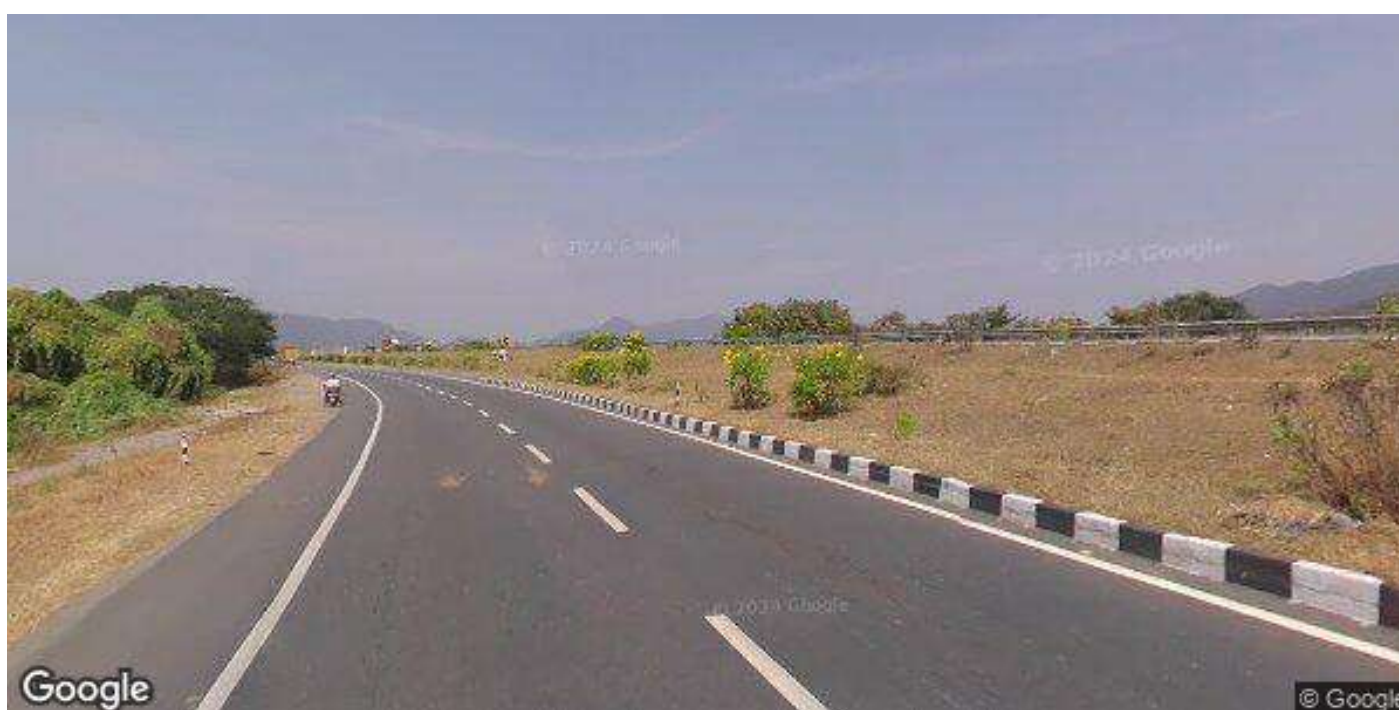
**Risk Type:** Turn  
**Risk Level:** Medium  
**Speed Limit:** 30 KM/Hr  
**Coordinates:** 11.92585, 78.06507

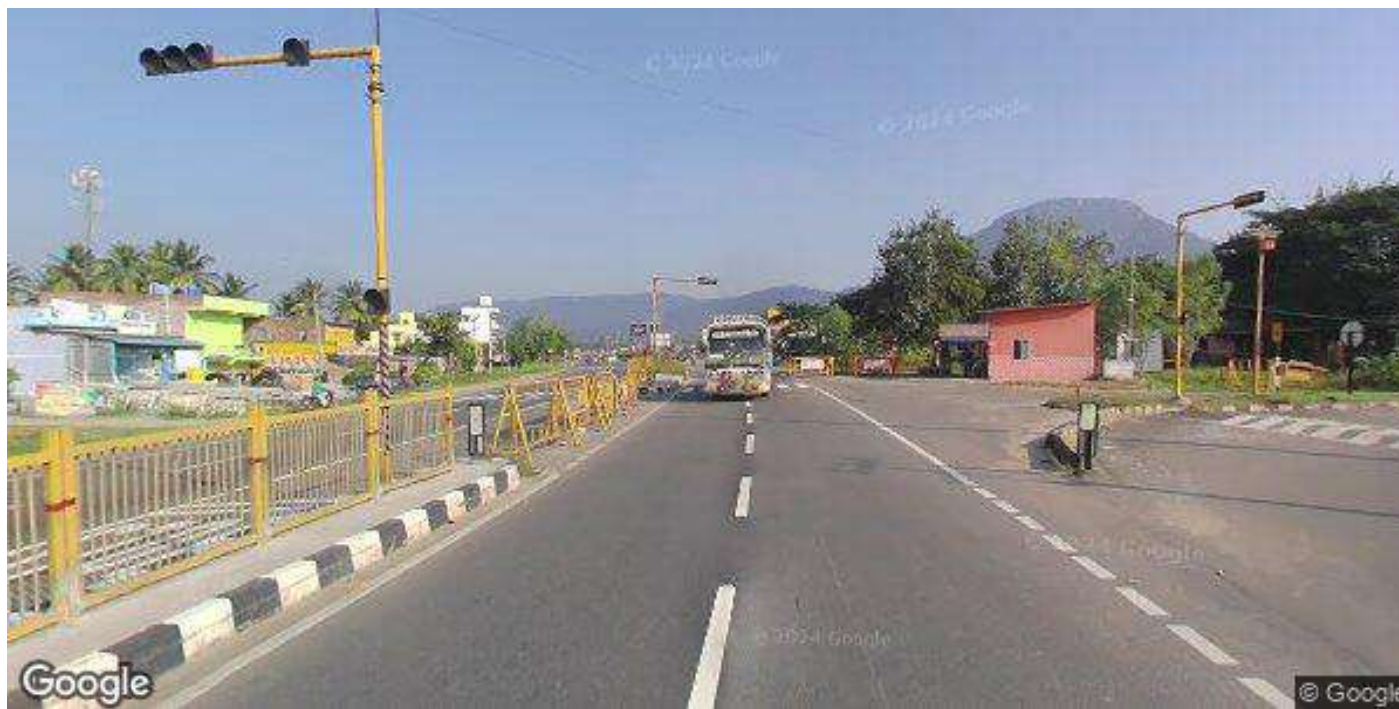
**Risk Type:** Turn  
**Risk Level:** Medium  
**Speed Limit:** 30 KM/Hr  
**Coordinates:** 11.93704, 78.05402

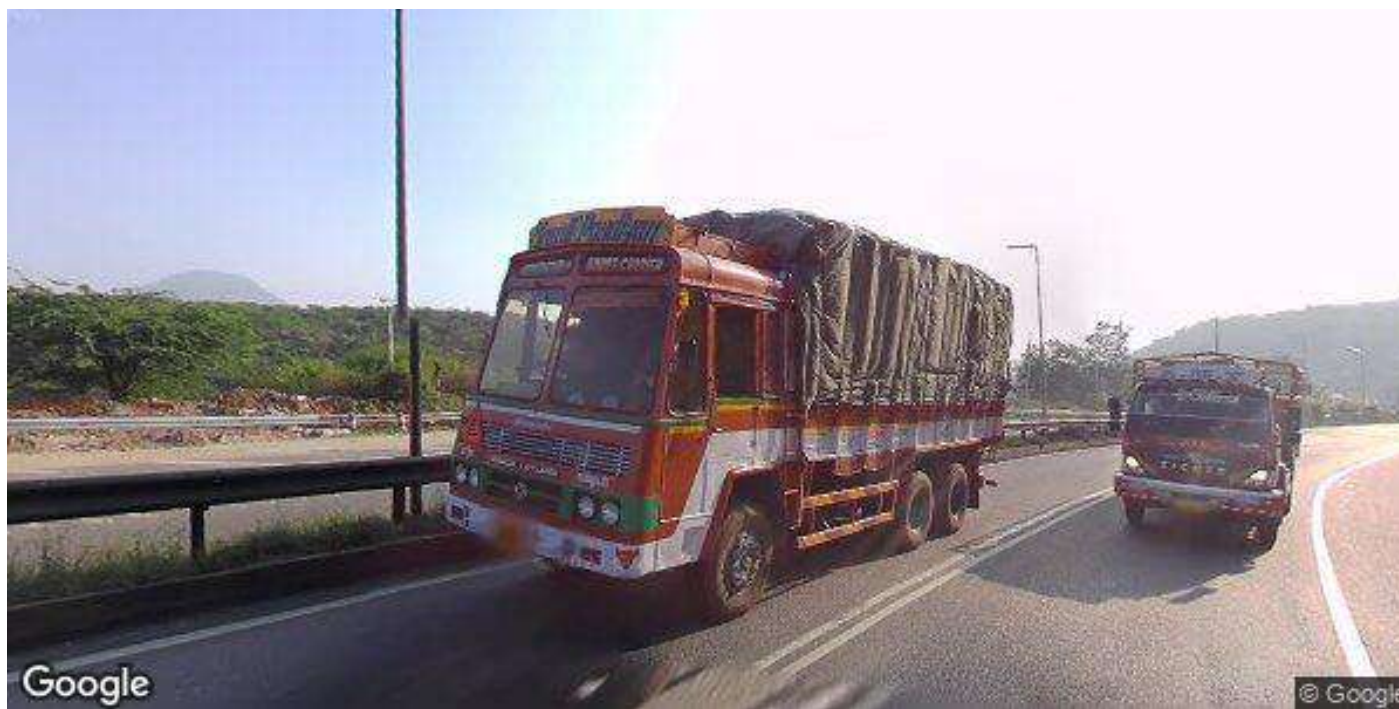
**Risk Type:** Turn  
**Risk Level:** High  
**Speed Limit:** 15 KM/Hr  
**Coordinates:** 11.95818, 78.04978

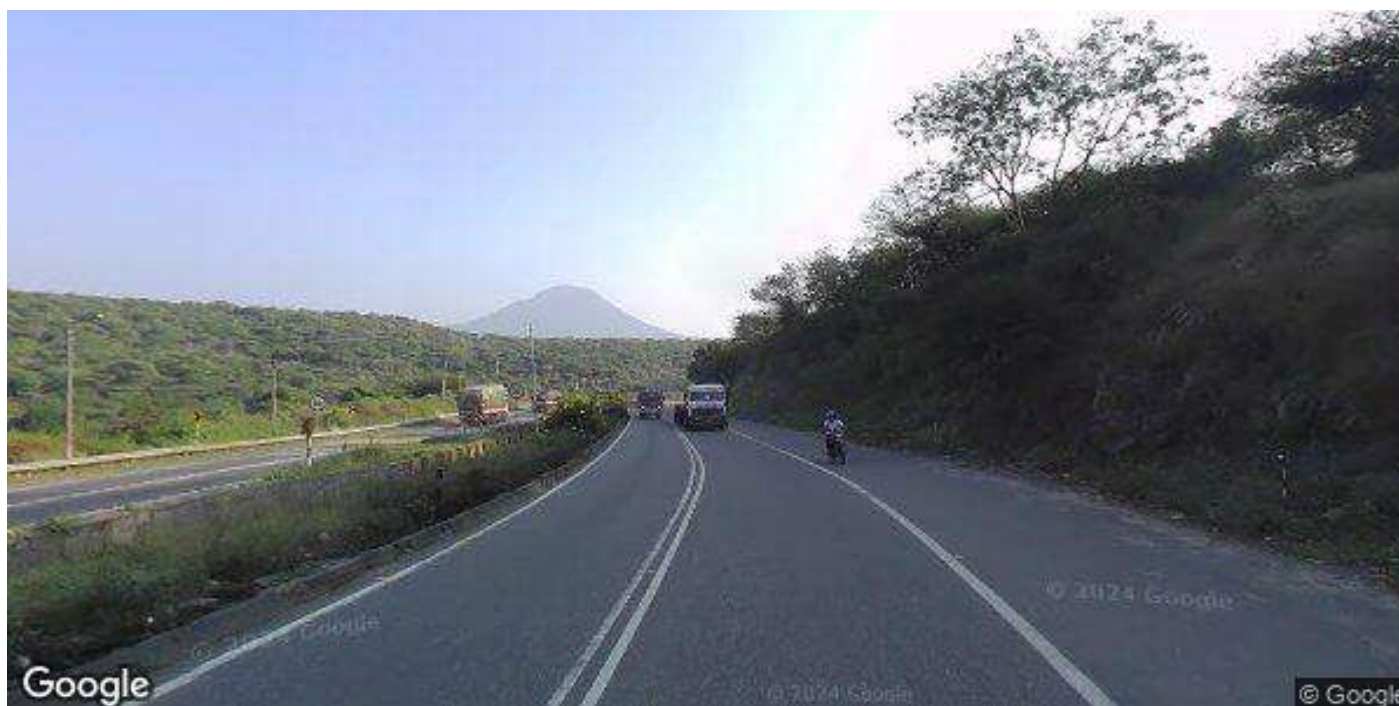
**Risk Type:** Turn  
**Risk Level:** Medium  
**Speed Limit:** 30 KM/Hr  
**Coordinates:** 11.95988, 78.04948

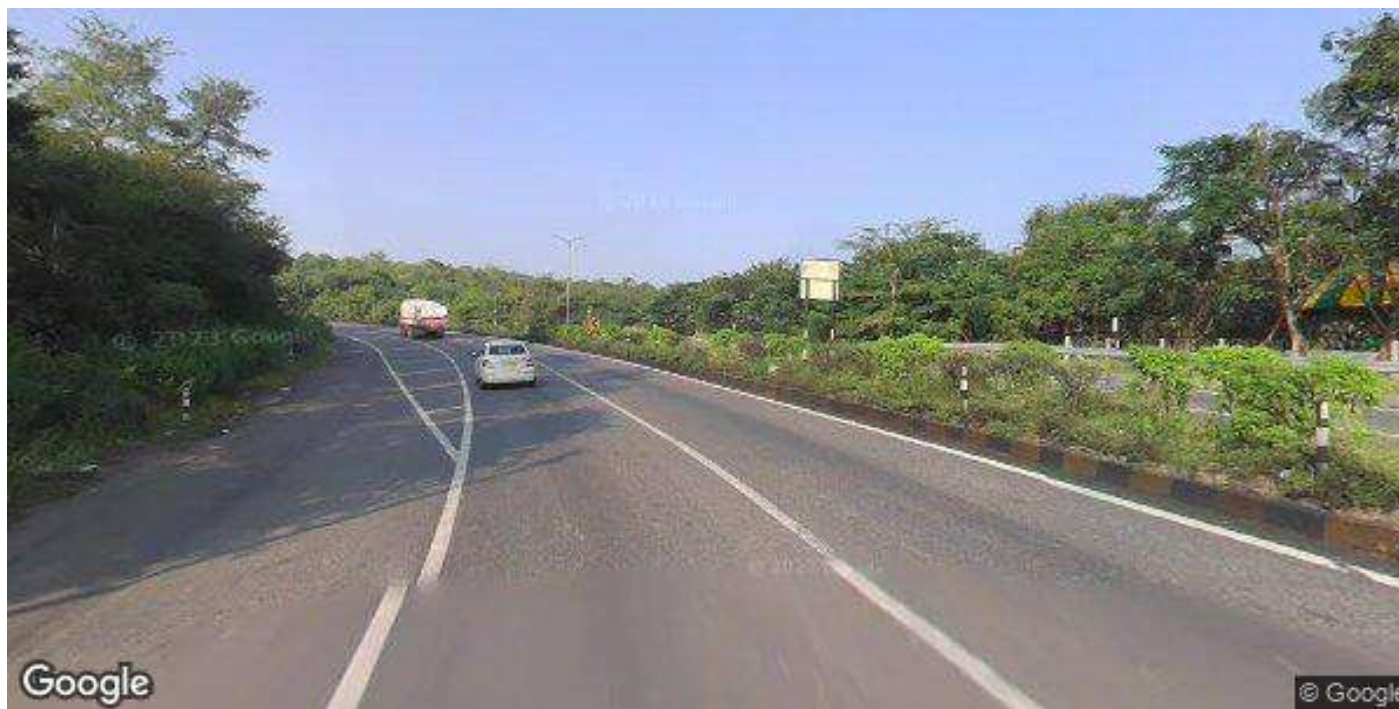
**Risk Type:** Turn  
**Risk Level:** Medium  
**Speed Limit:** 30 KM/Hr  
**Coordinates:** 11.96304, 78.05136

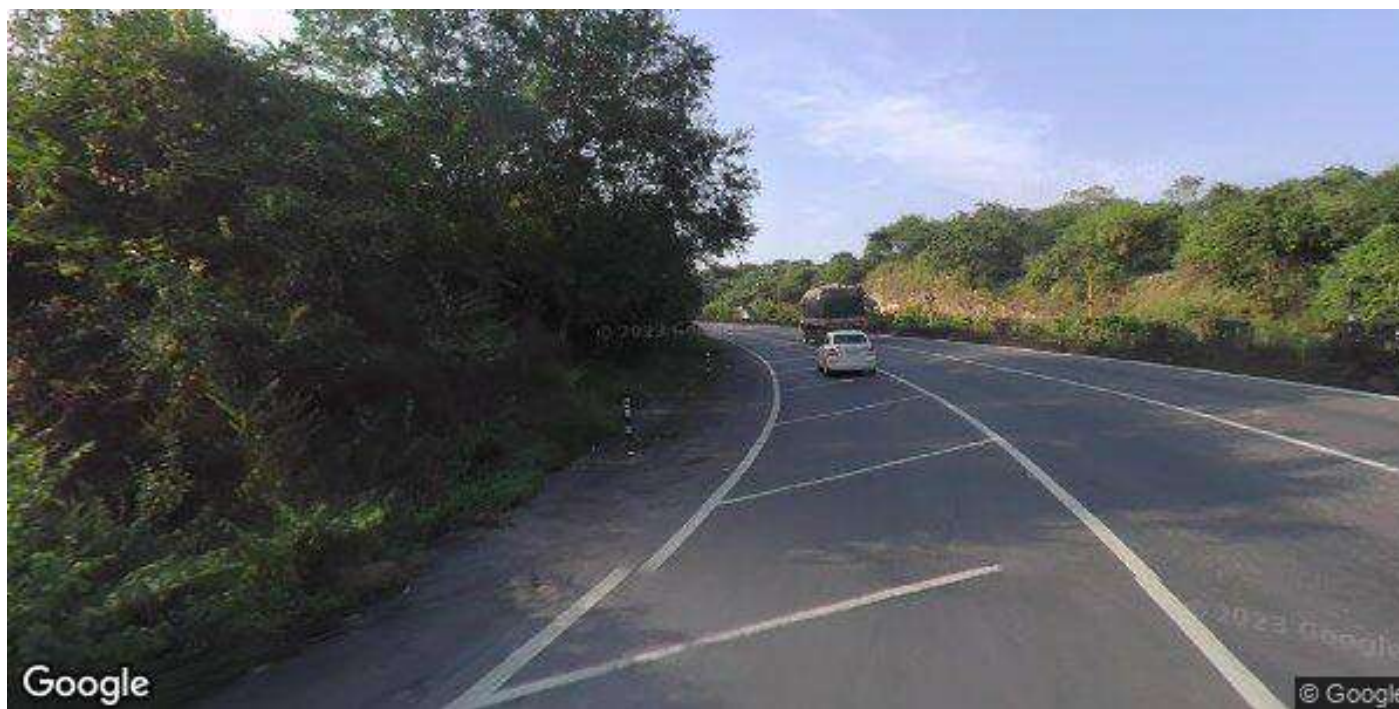
**Risk Type:** Turn  
**Risk Level:** High  
**Speed Limit:** 15 KM/Hr  
**Coordinates:** 11.96399, 78.05135

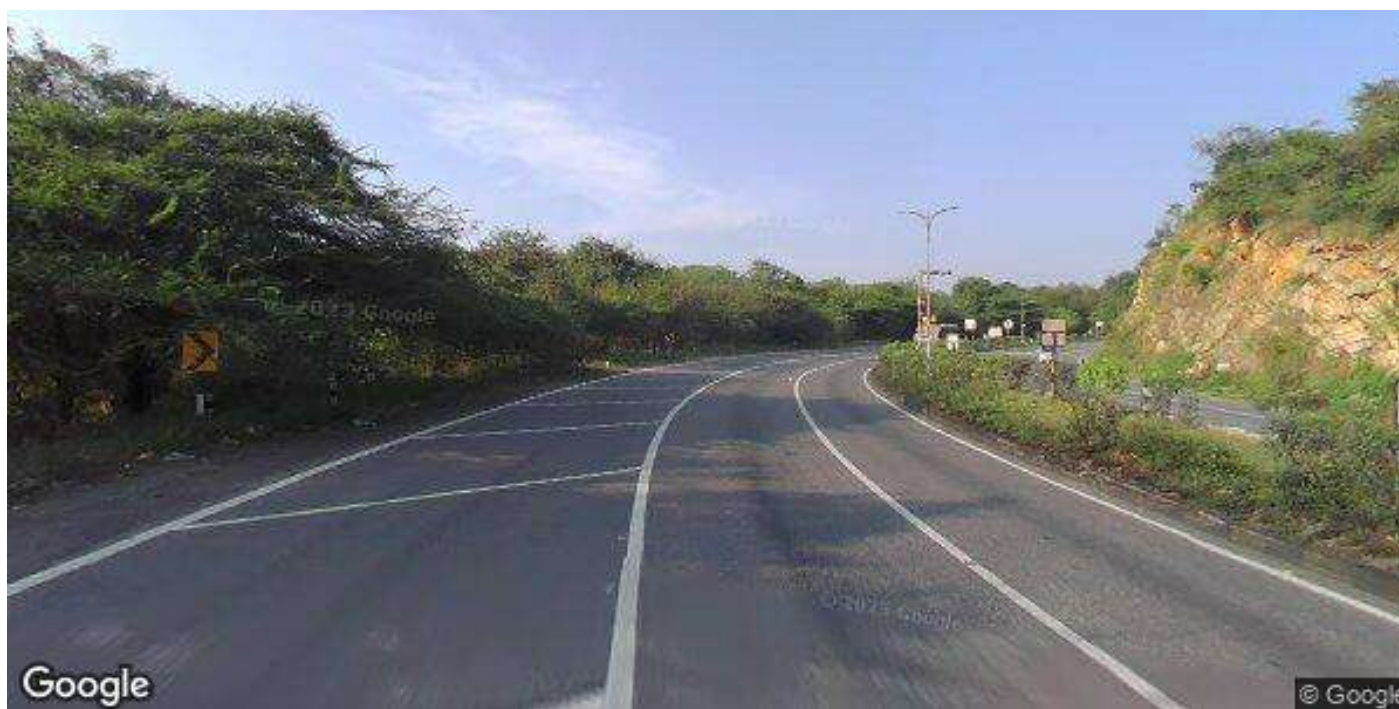
**Risk Type:** Turn  
**Risk Level:** High  
**Speed Limit:** 15 KM/Hr  
**Coordinates:** 11.96580, 78.04923

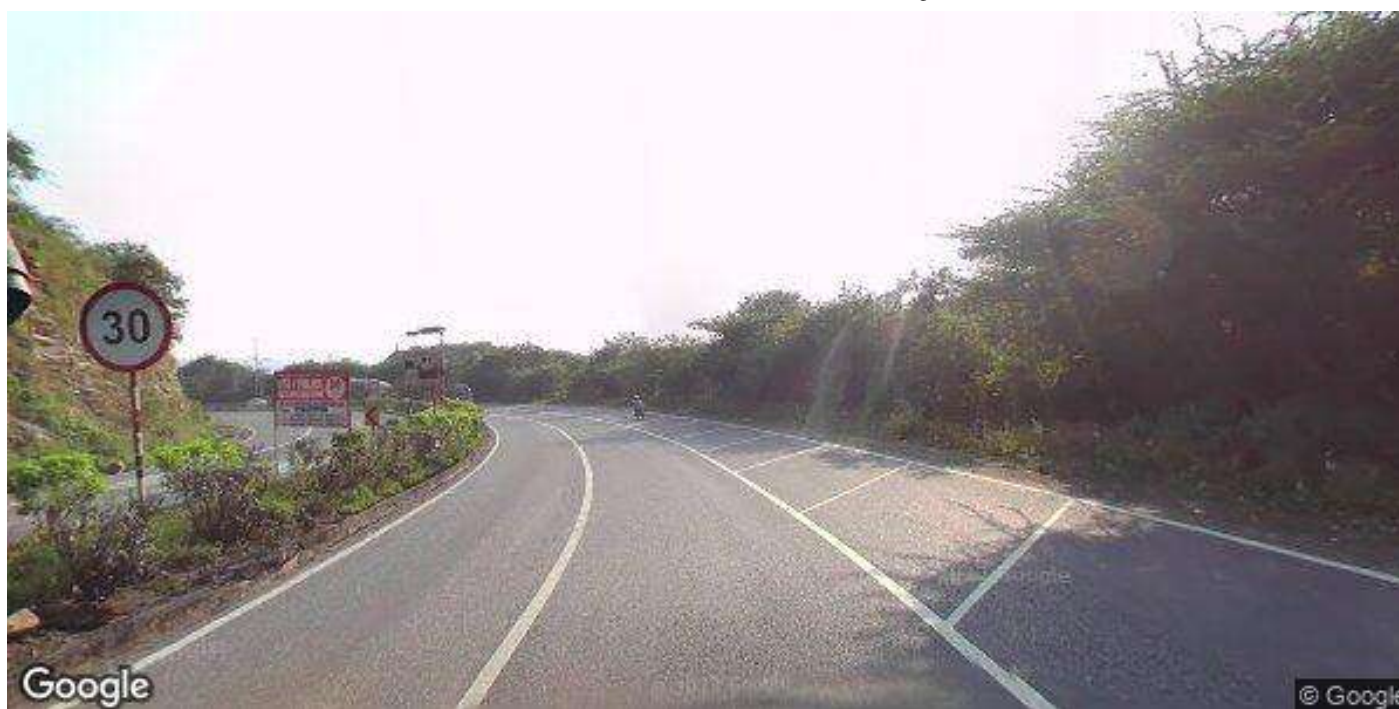
**Risk Type:** Turn  
**Risk Level:** Medium  
**Speed Limit:** 30 KM/Hr  
**Coordinates:** 11.96675, 78.04939

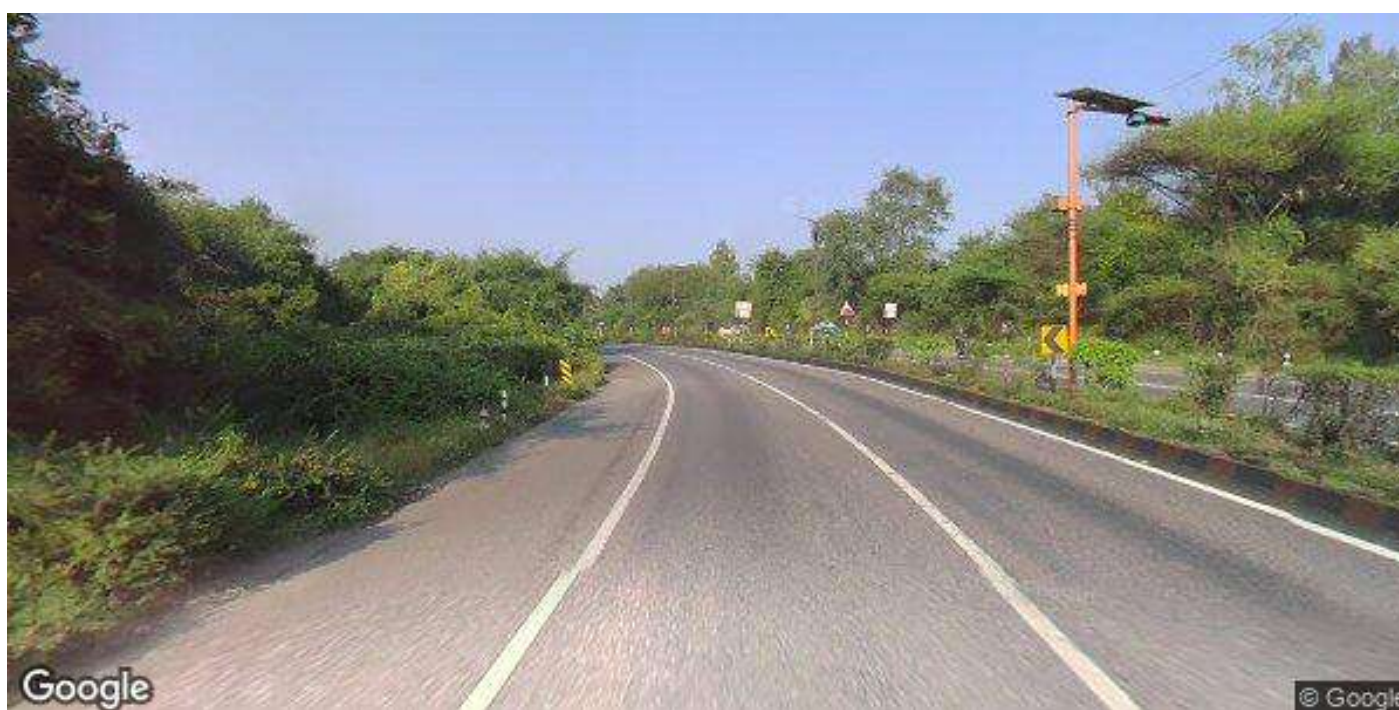
**Risk Type:** Turn  
**Risk Level:** Medium  
**Speed Limit:** 30 KM/Hr  
**Coordinates:** 11.96791, 78.05070

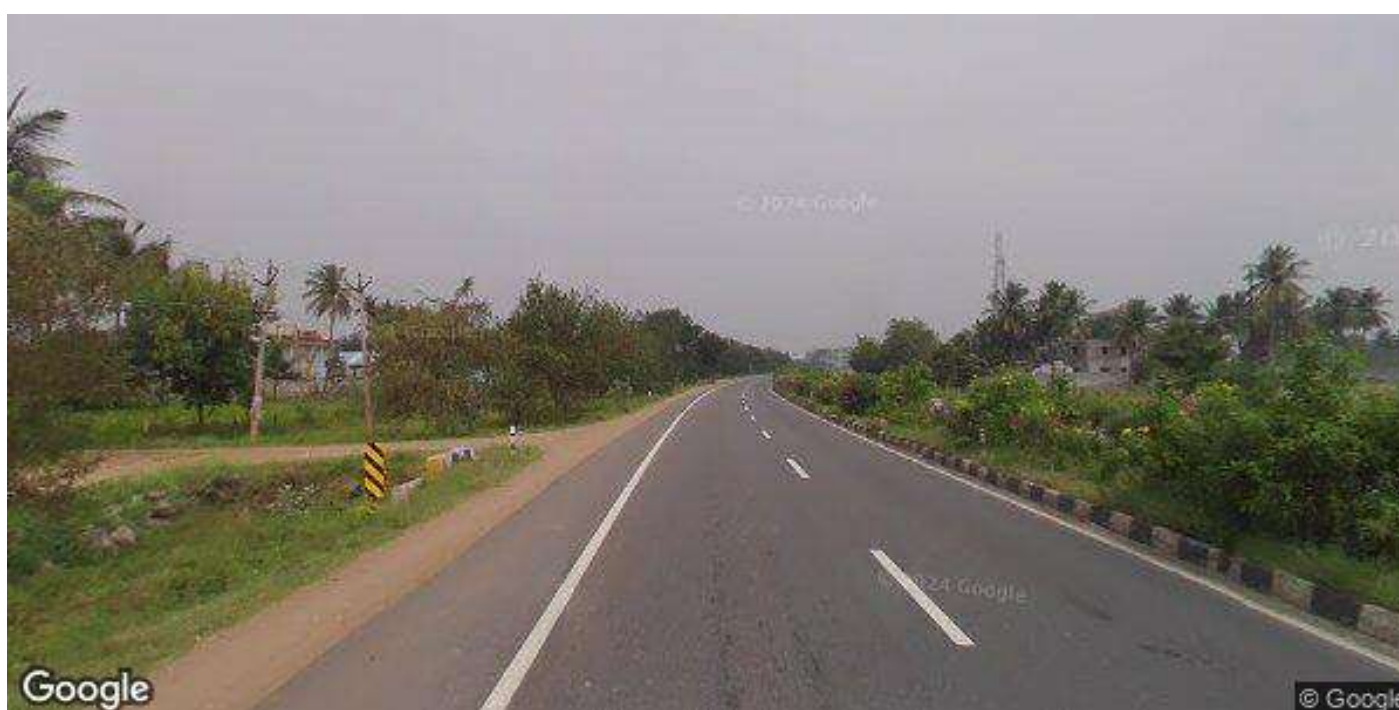
**Risk Type:** Turn  
**Risk Level:** Medium  
**Speed Limit:** 30 KM/Hr  
**Coordinates:** 12.19881, 78.18157

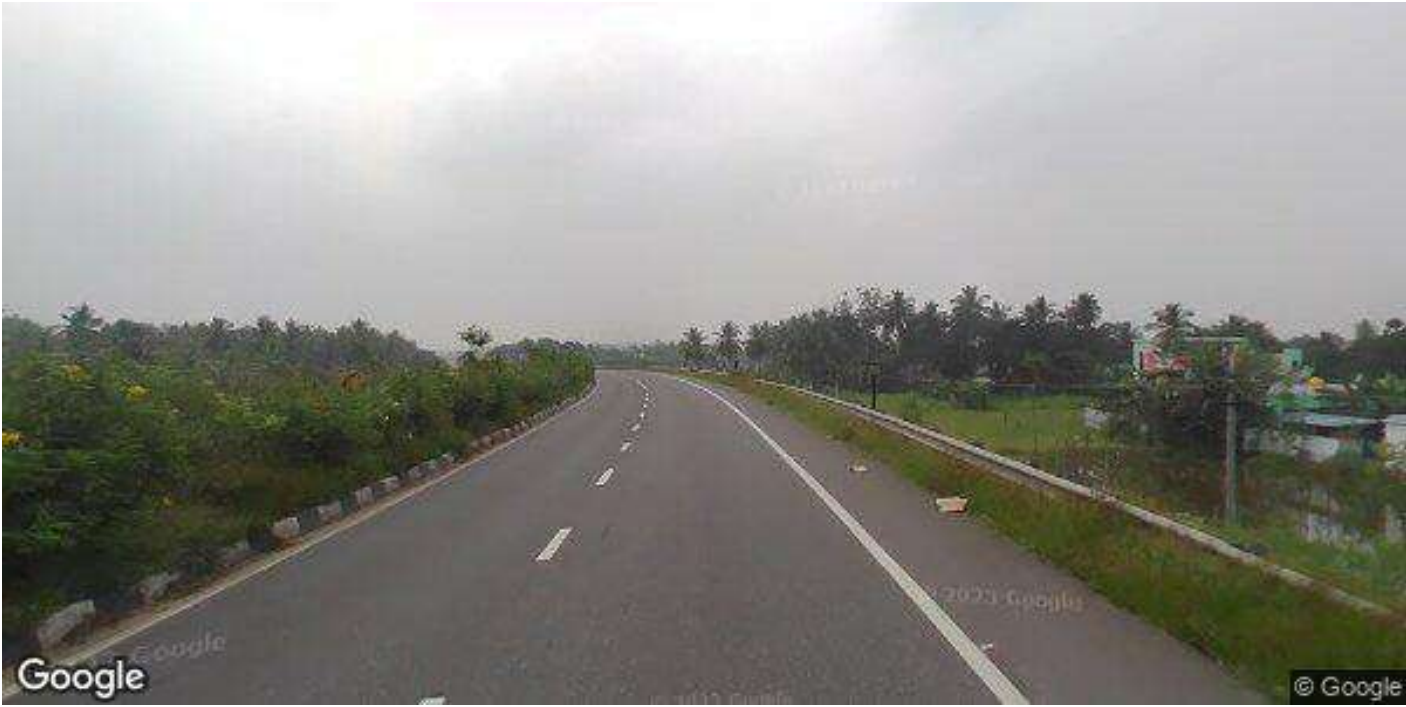
**Risk Type:** Turn  
**Risk Level:** Medium  
**Speed Limit:** 30 KM/Hr  
**Coordinates:** 12.22459, 78.19136

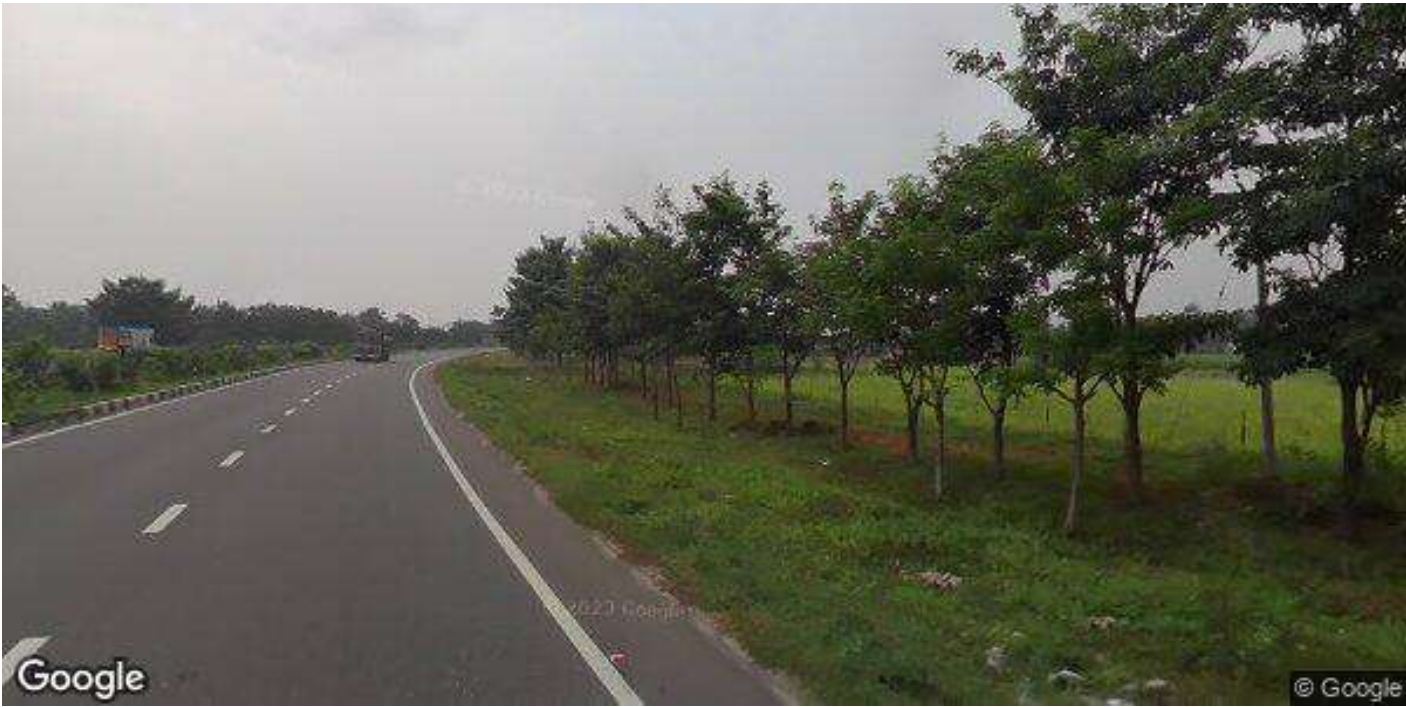
**Risk Type:** Turn  
**Risk Level:** Medium  
**Speed Limit:** 30 KM/Hr  
**Coordinates:** 12.25060, 78.19977

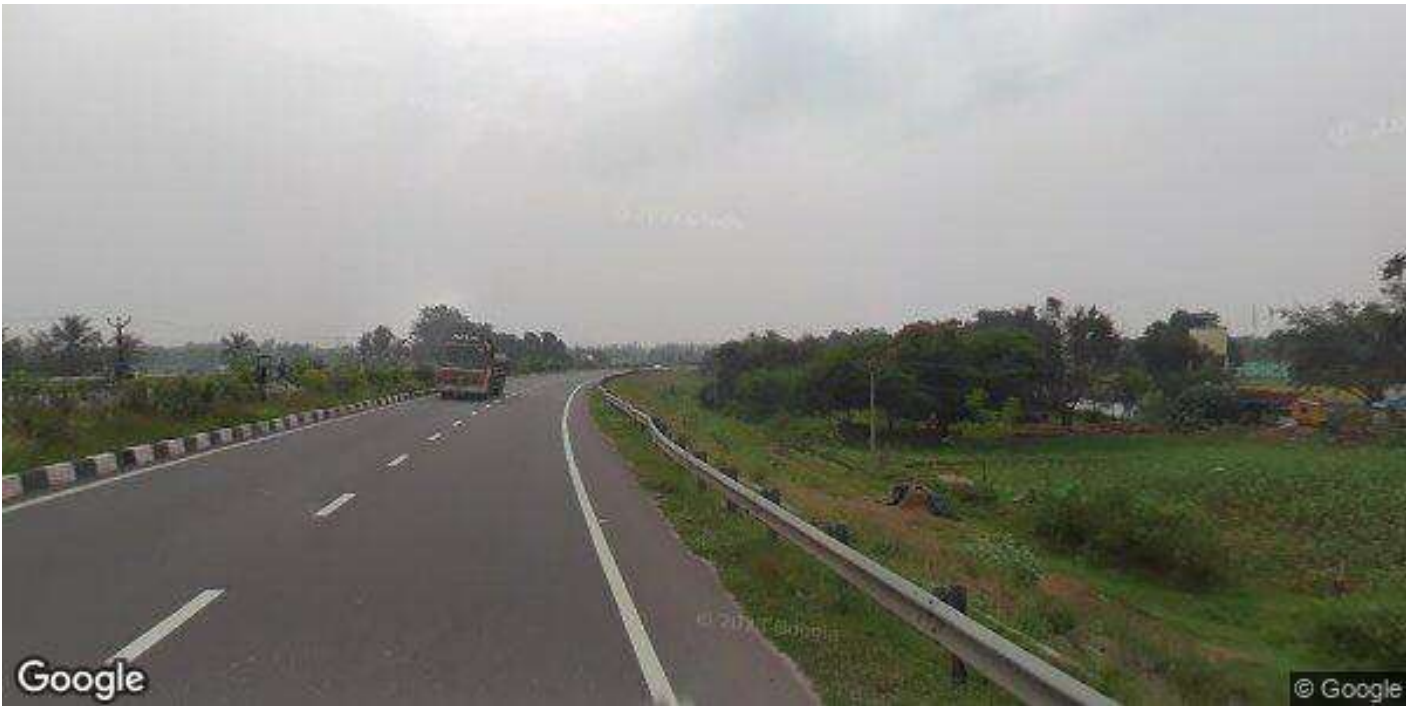
**Risk Type:** Turn  
**Risk Level:** Medium  
**Speed Limit:** 30 KM/Hr  
**Coordinates:** 12.25329, 78.20039

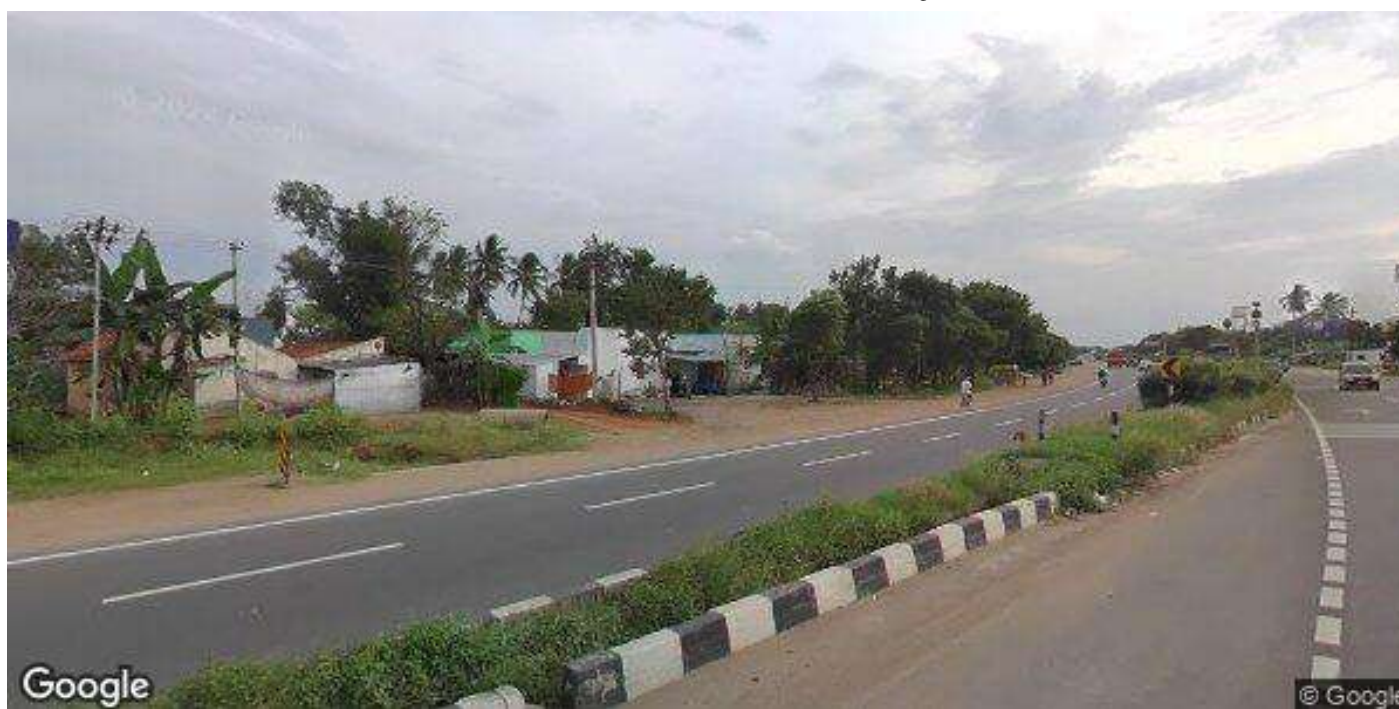
**Risk Type:** Turn  
**Risk Level:** Medium  
**Speed Limit:** 30 KM/Hr  
**Coordinates:** 12.29110, 78.19909

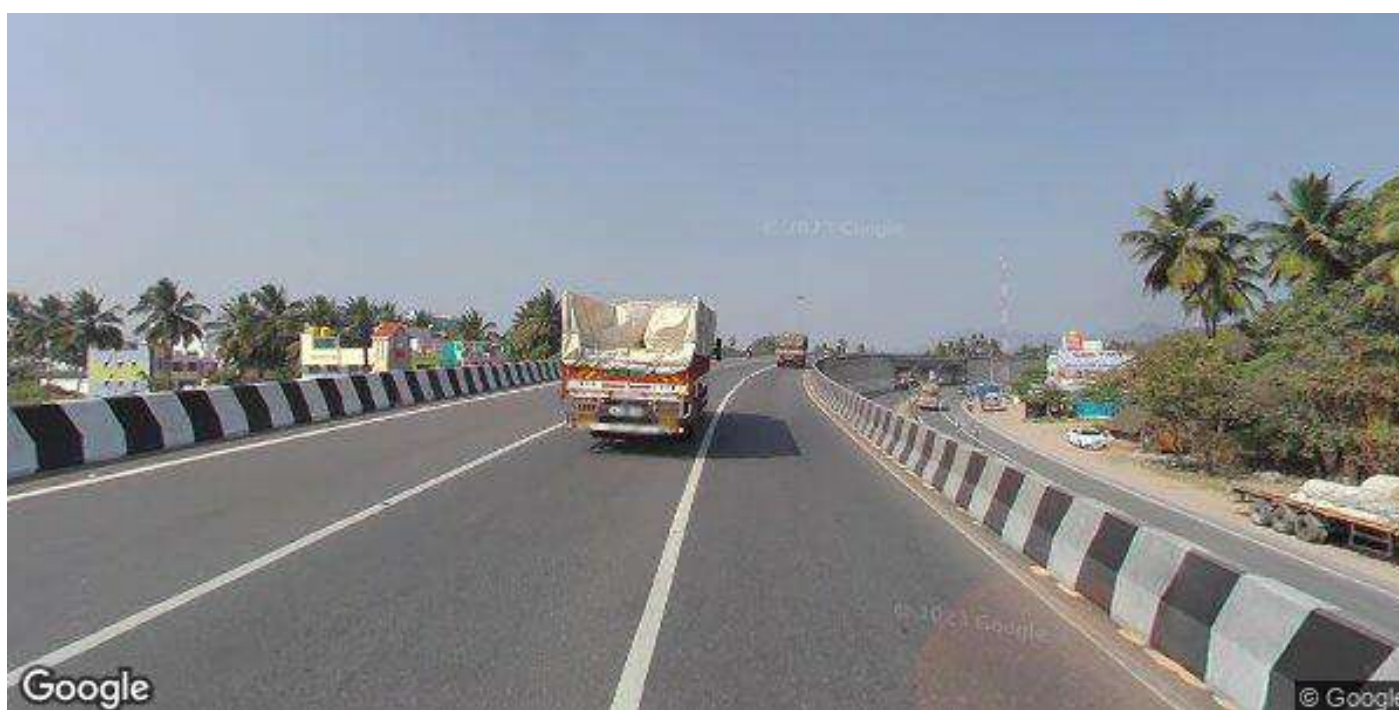
**Risk Type:** Turn  
**Risk Level:** Medium  
**Speed Limit:** 30 KM/Hr  
**Coordinates:** 12.39904, 78.21764

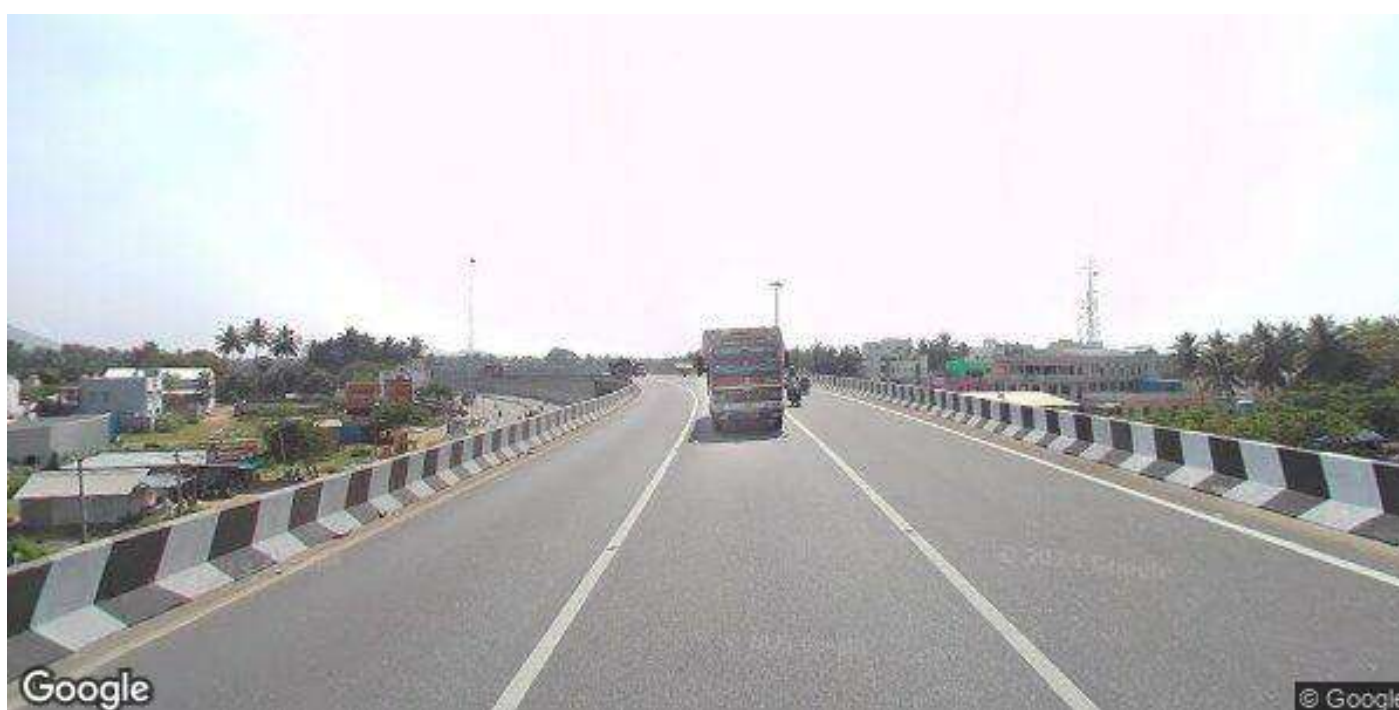
**Risk Type:** Turn  
**Risk Level:** Medium  
**Speed Limit:** 30 KM/Hr  
**Coordinates:** 12.40156, 78.21845

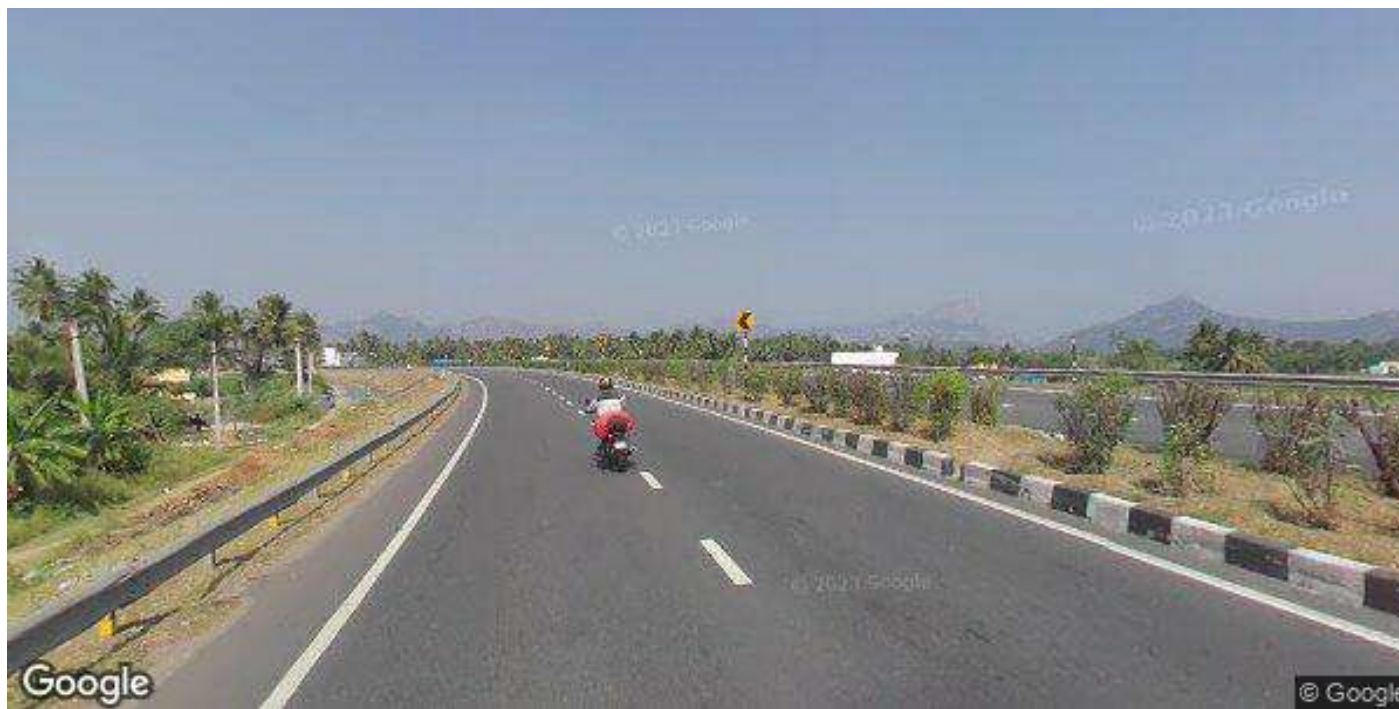
**Risk Type:** Turn  
**Risk Level:** Medium  
**Speed Limit:** 30 KM/Hr  
**Coordinates:** 12.40589, 78.22275

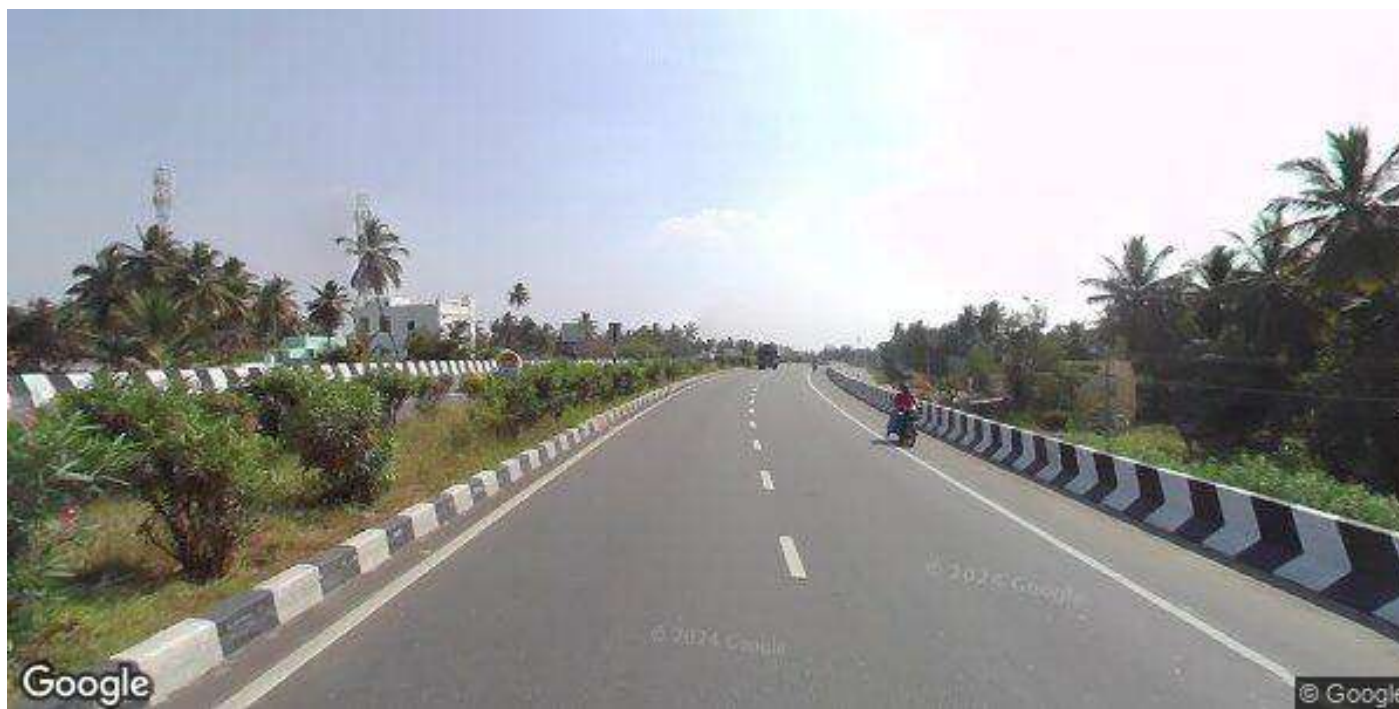
**Risk Type:** Turn  
**Risk Level:** Medium  
**Speed Limit:** 30 KM/Hr  
**Coordinates:** 12.45018, 78.21828

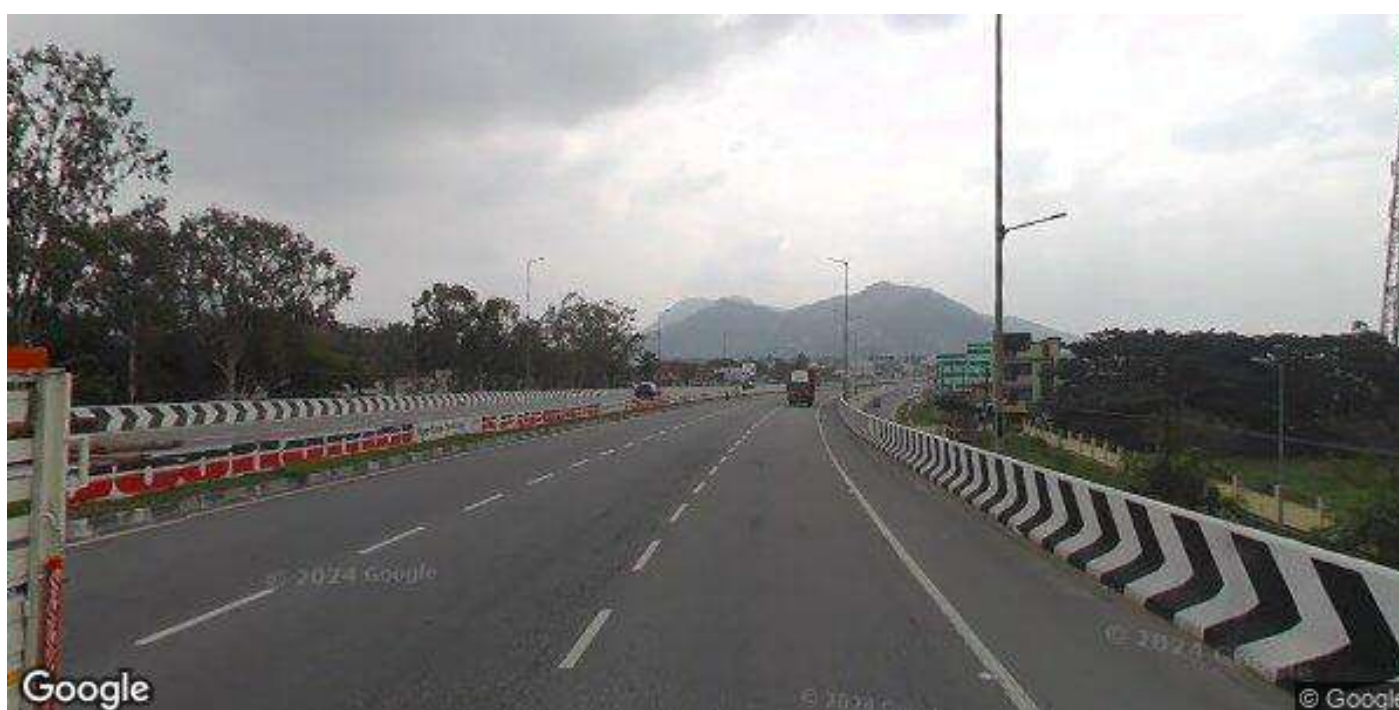
**Risk Type:** Turn  
**Risk Level:** Medium  
**Speed Limit:** 30 KM/Hr  
**Coordinates:** 12.50553, 78.22318

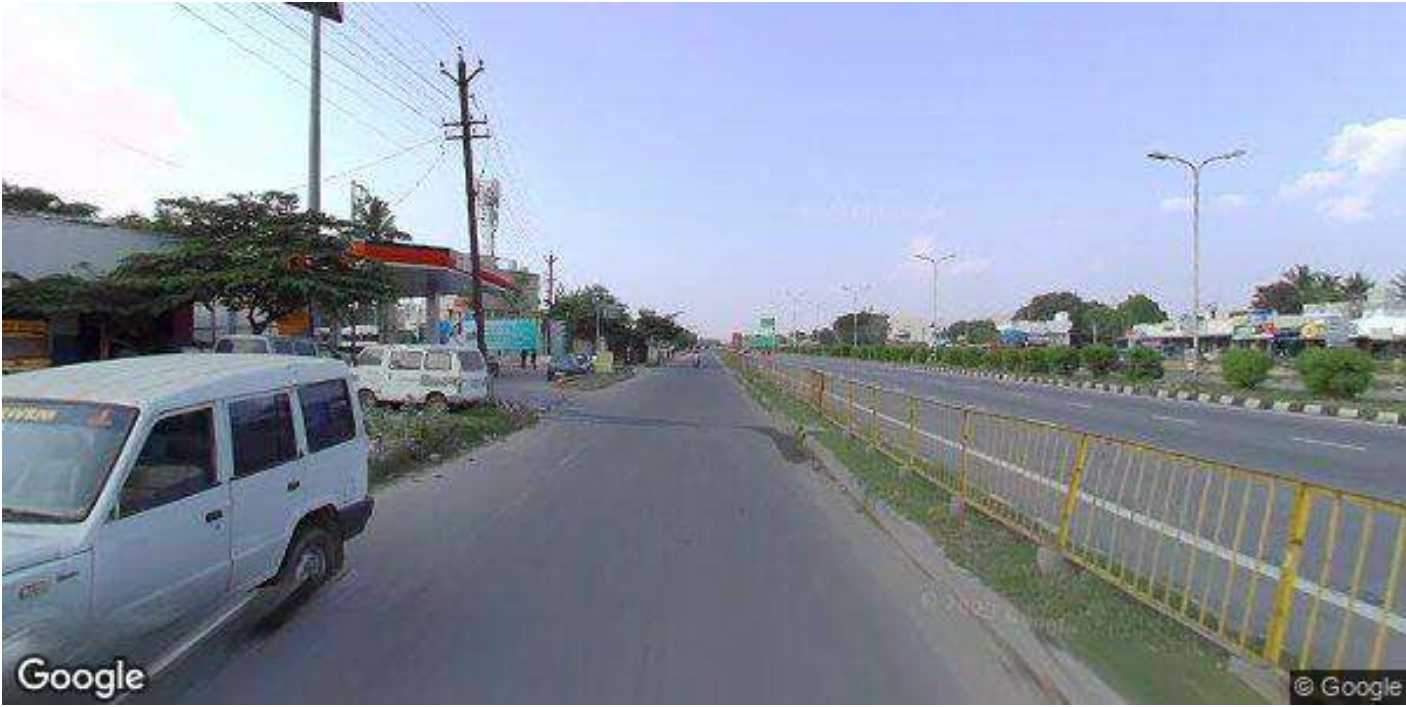
**Risk Type:** Turn  
**Risk Level:** Medium  
**Speed Limit:** 30 KM/Hr  
**Coordinates:** 12.53868, 78.20296
