# IndianOil

## JOURNEY RISK MANAGEMENT (JRM) STUDY

### Salem Terminal TO SRI RANGANATHAR & CO

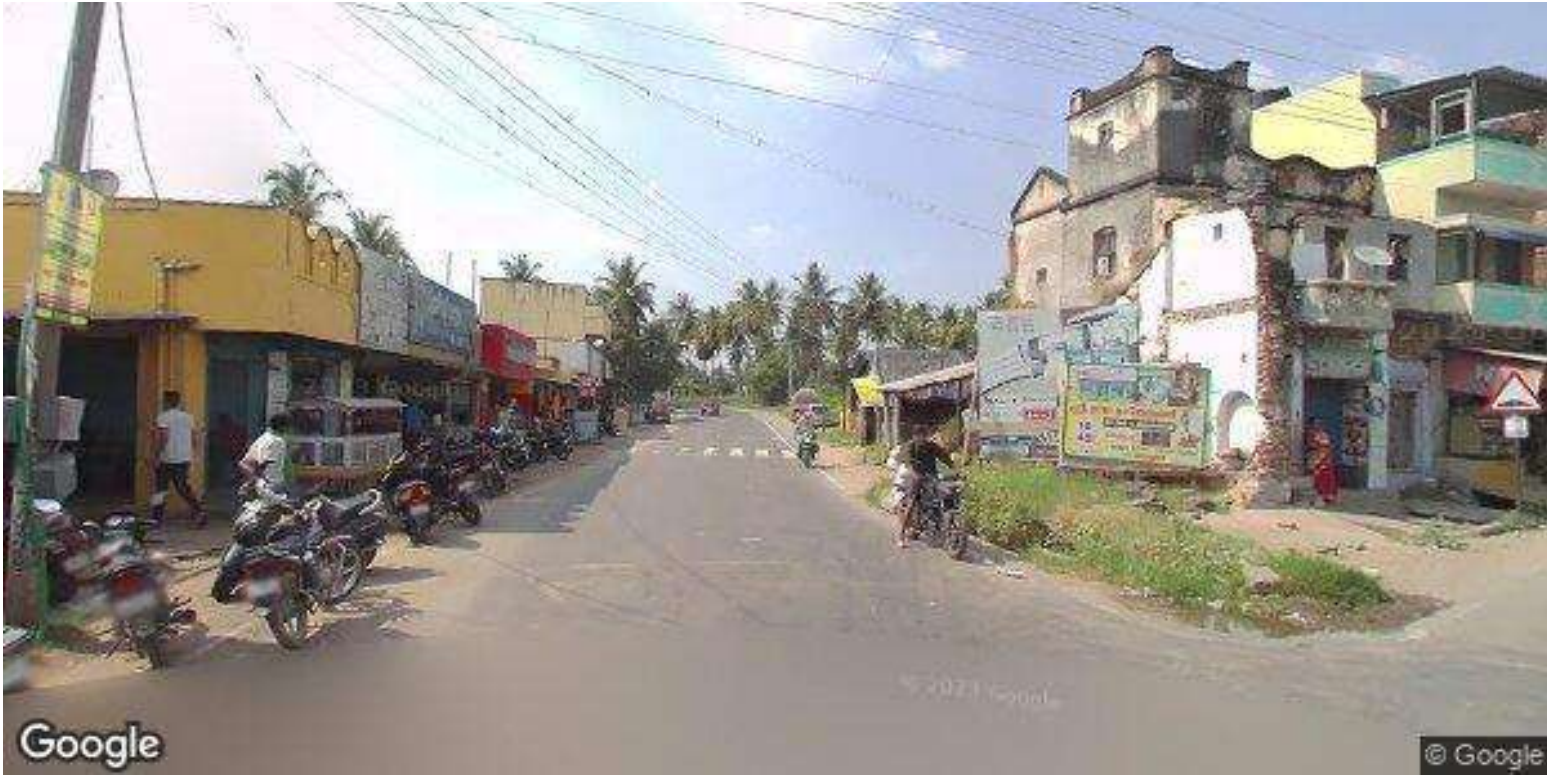
**Risk Type:** Turn  
**Risk Level:** High  
**Speed Limit:** 15 KM/Hr  
**Coordinates:** 11.45007, 77.87201

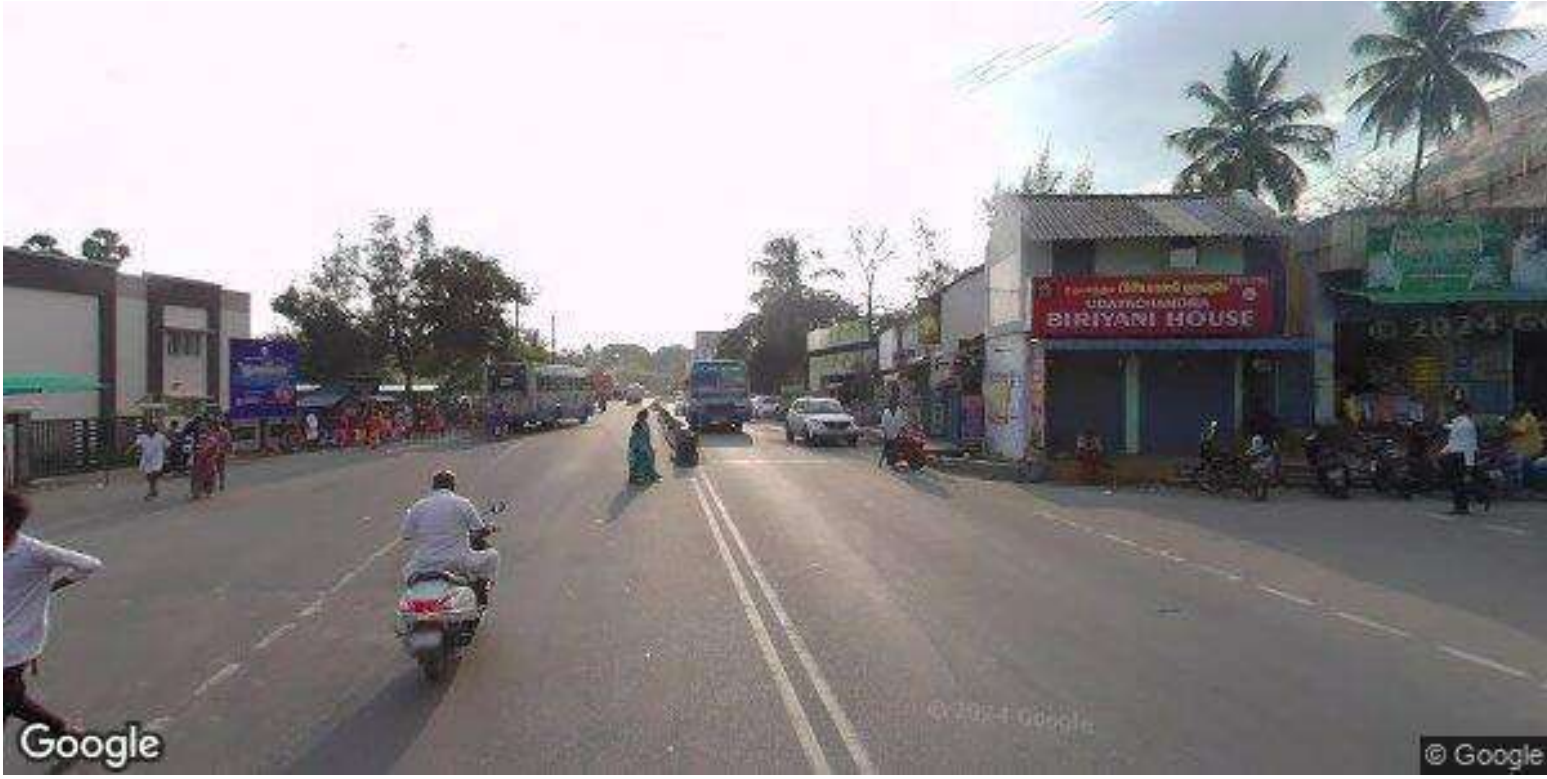
**Risk Type:** Turn  
**Risk Level:** High  
**Speed Limit:** 15 KM/Hr  
**Coordinates:** 11.47403, 77.86841

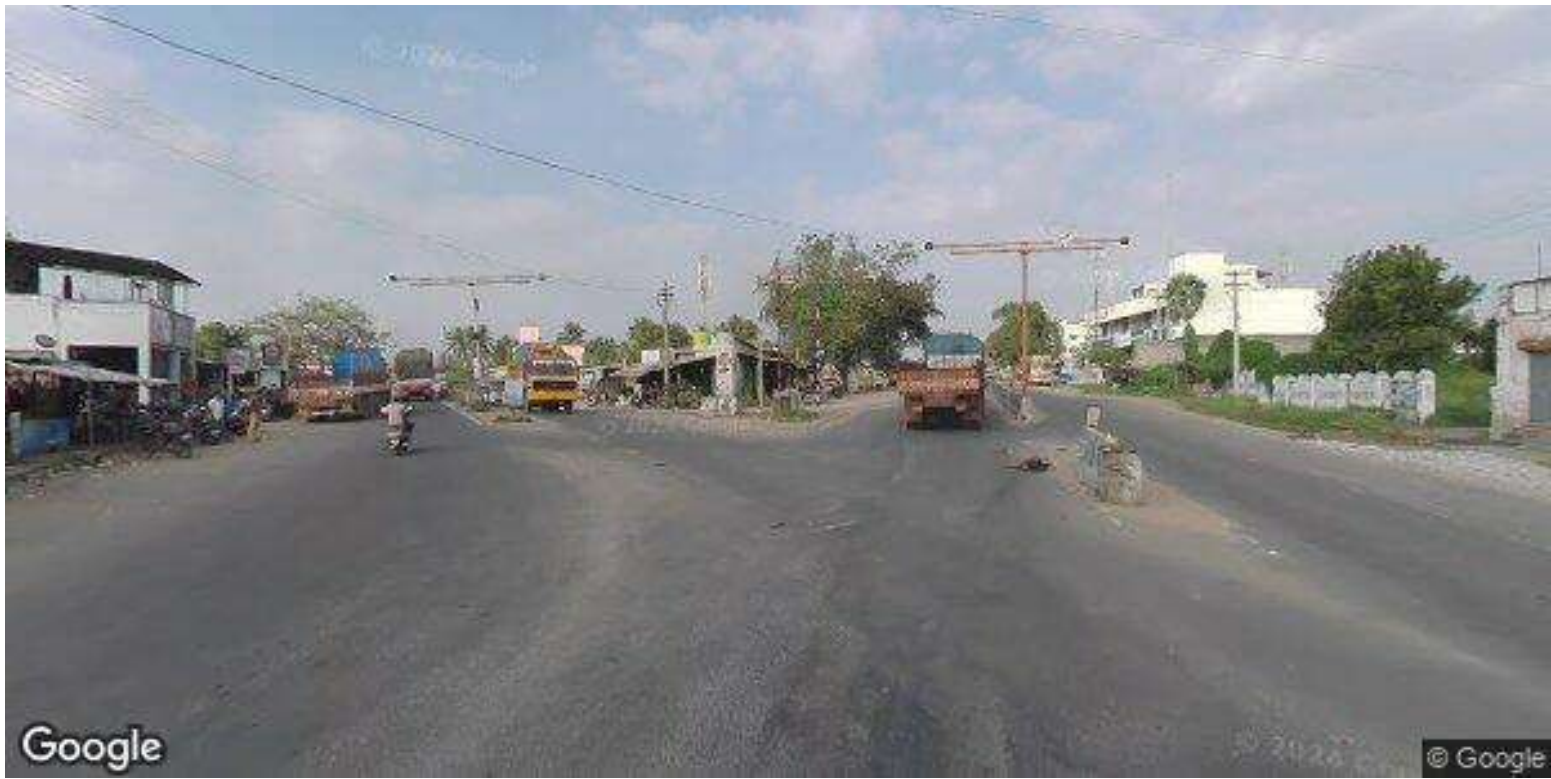
**Risk Type:** Turn  
**Risk Level:** Medium  
**Speed Limit:** 30 KM/Hr  
**Coordinates:** 11.48366, 77.88781

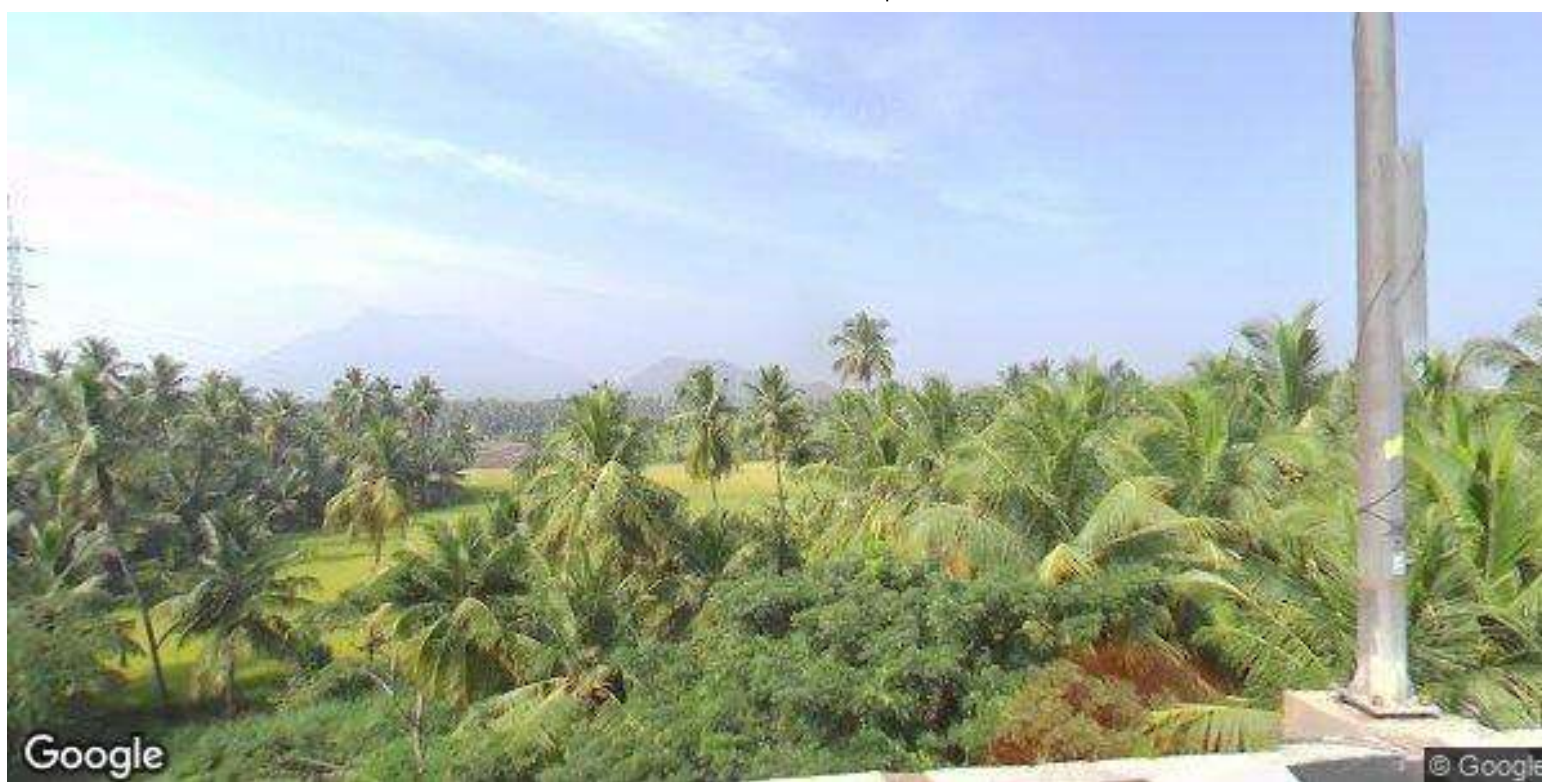
**Risk Type:** Turn

**Risk Level:** Medium

**Speed Limit:** 30 KM/Hr

**Coordinates:** 11.64020, 78.11786

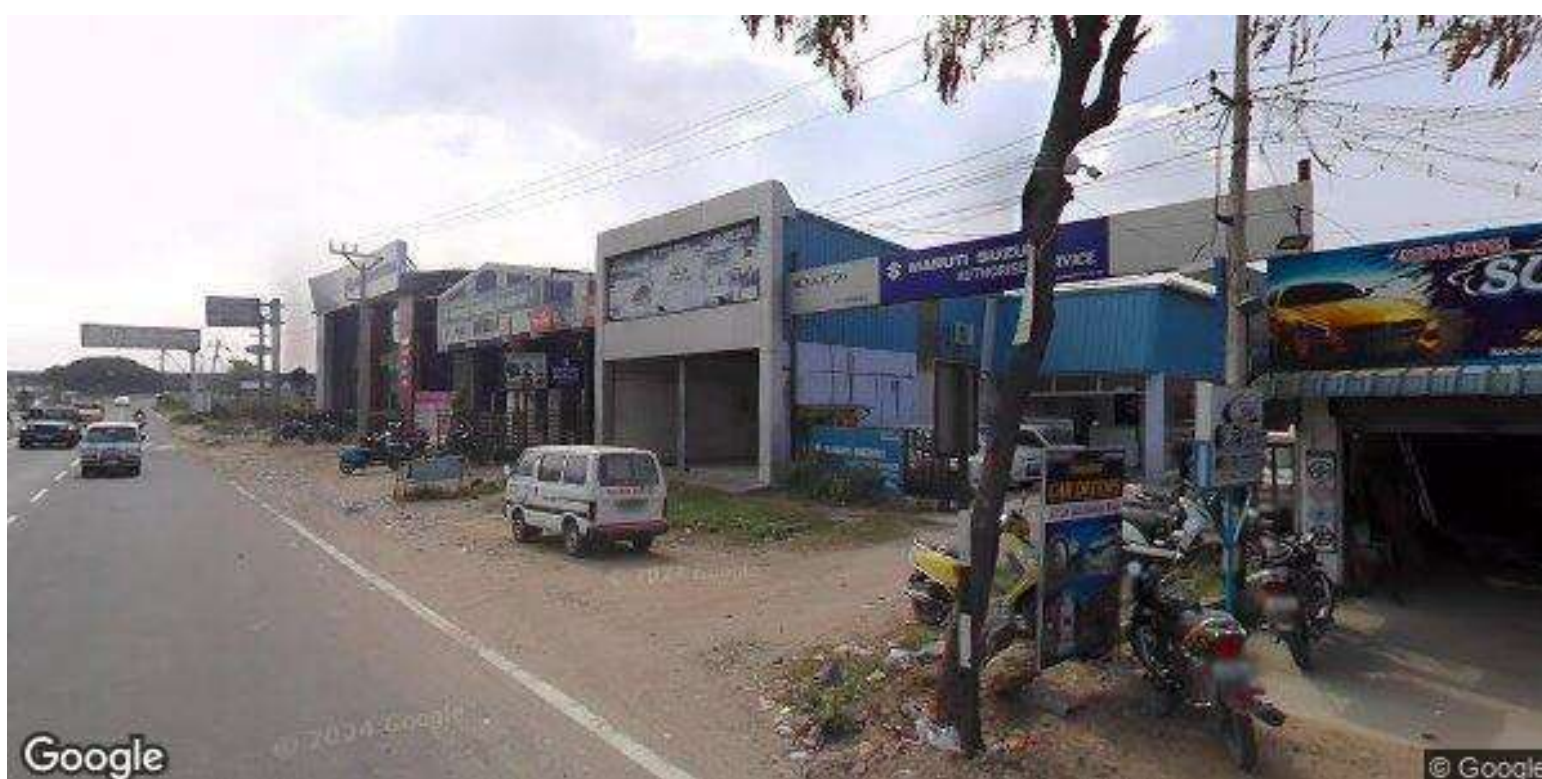
**Risk Type:** Turn

**Risk Level:** Medium

**Speed Limit:** 30 KM/Hr

**Coordinates:** 11.64497, 78.12028

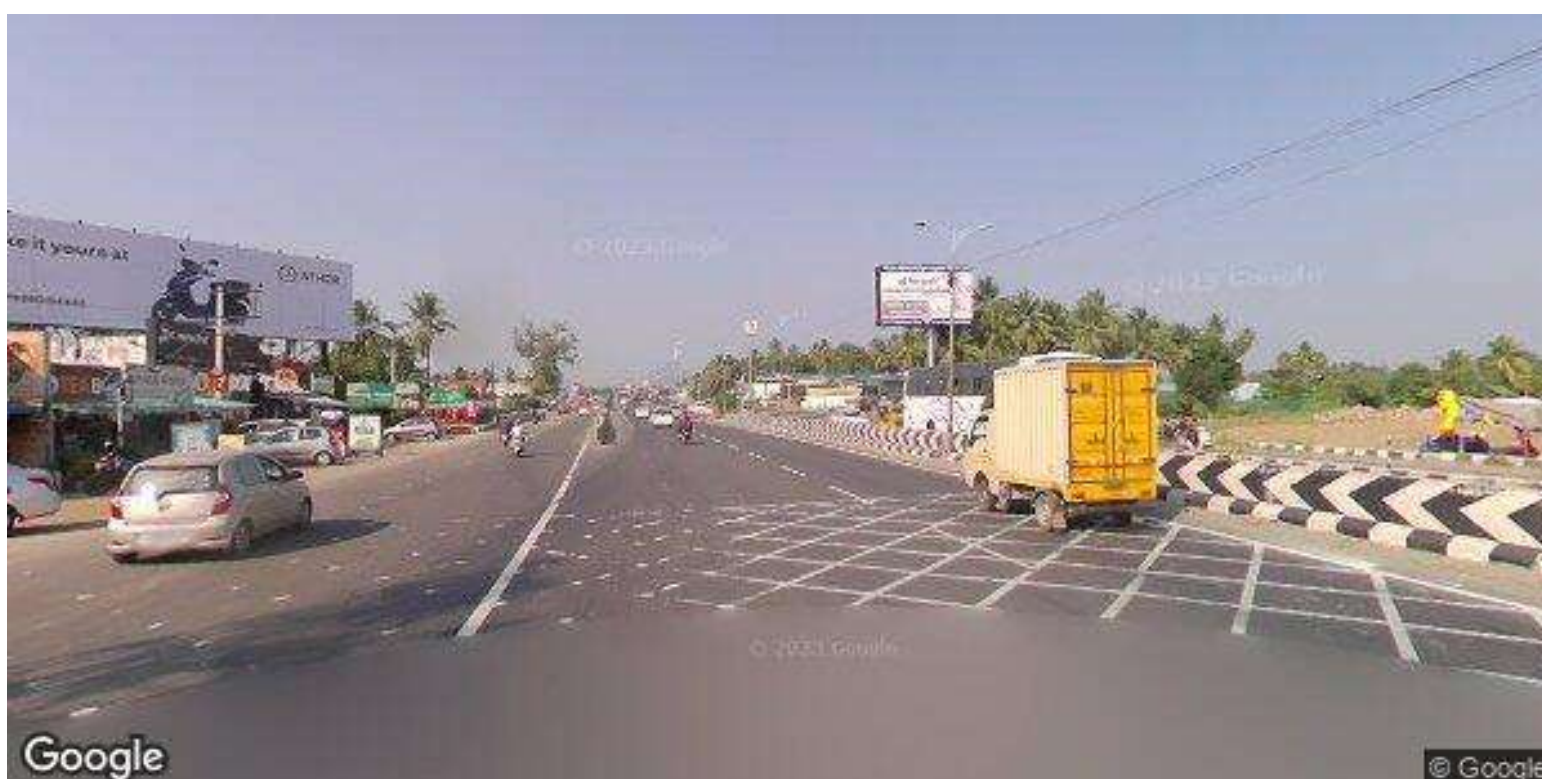
**Risk Type: Turn**

**Risk Level: Medium**

**Speed Limit: 30 KM/Hr**

**Coordinates: 11.64503, 78.12034**

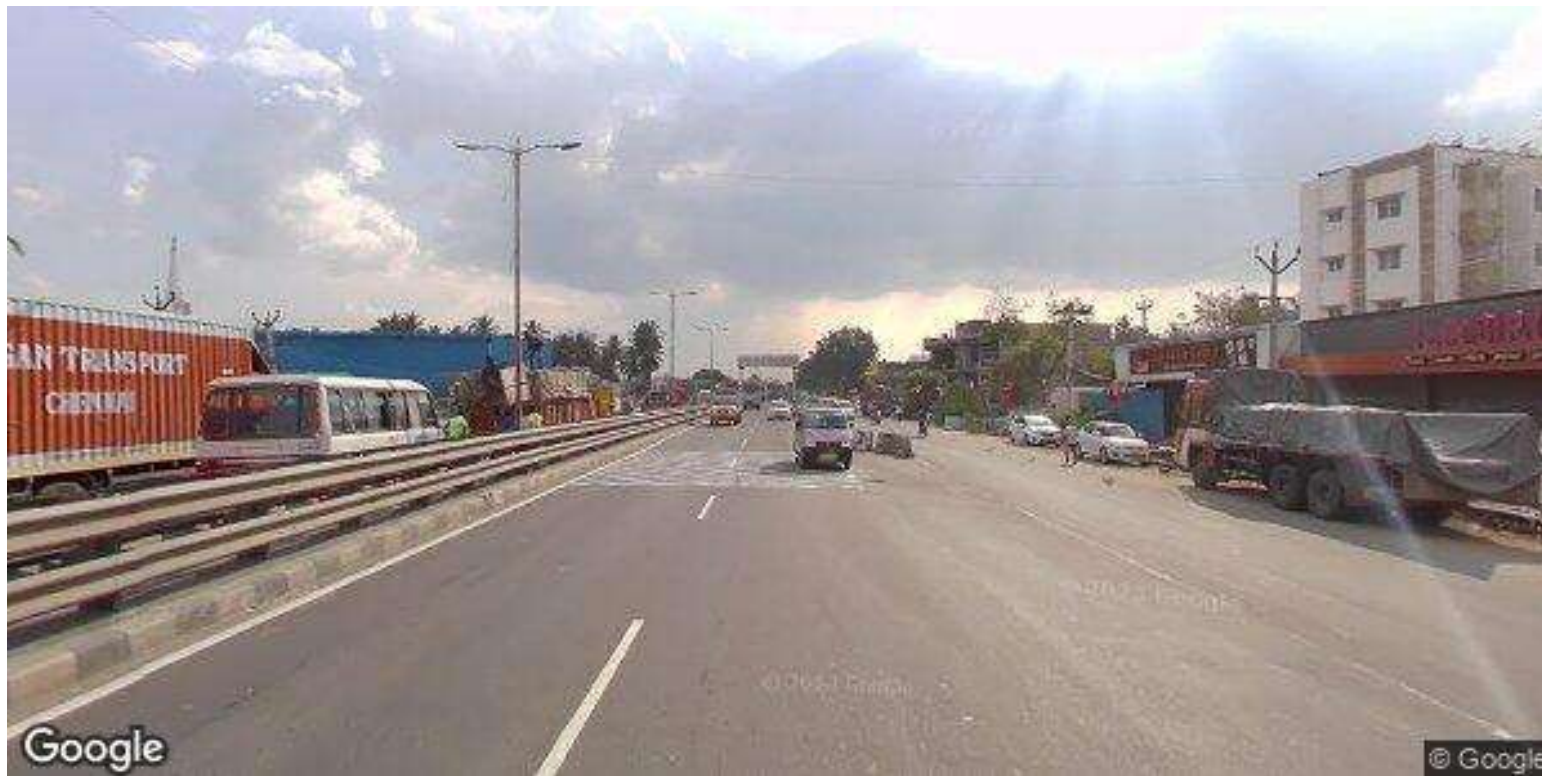
**Risk Type: Turn**

**Risk Level: High**

**Speed Limit: 15 KM/Hr**

**Coordinates: 11.67074, 78.12668**

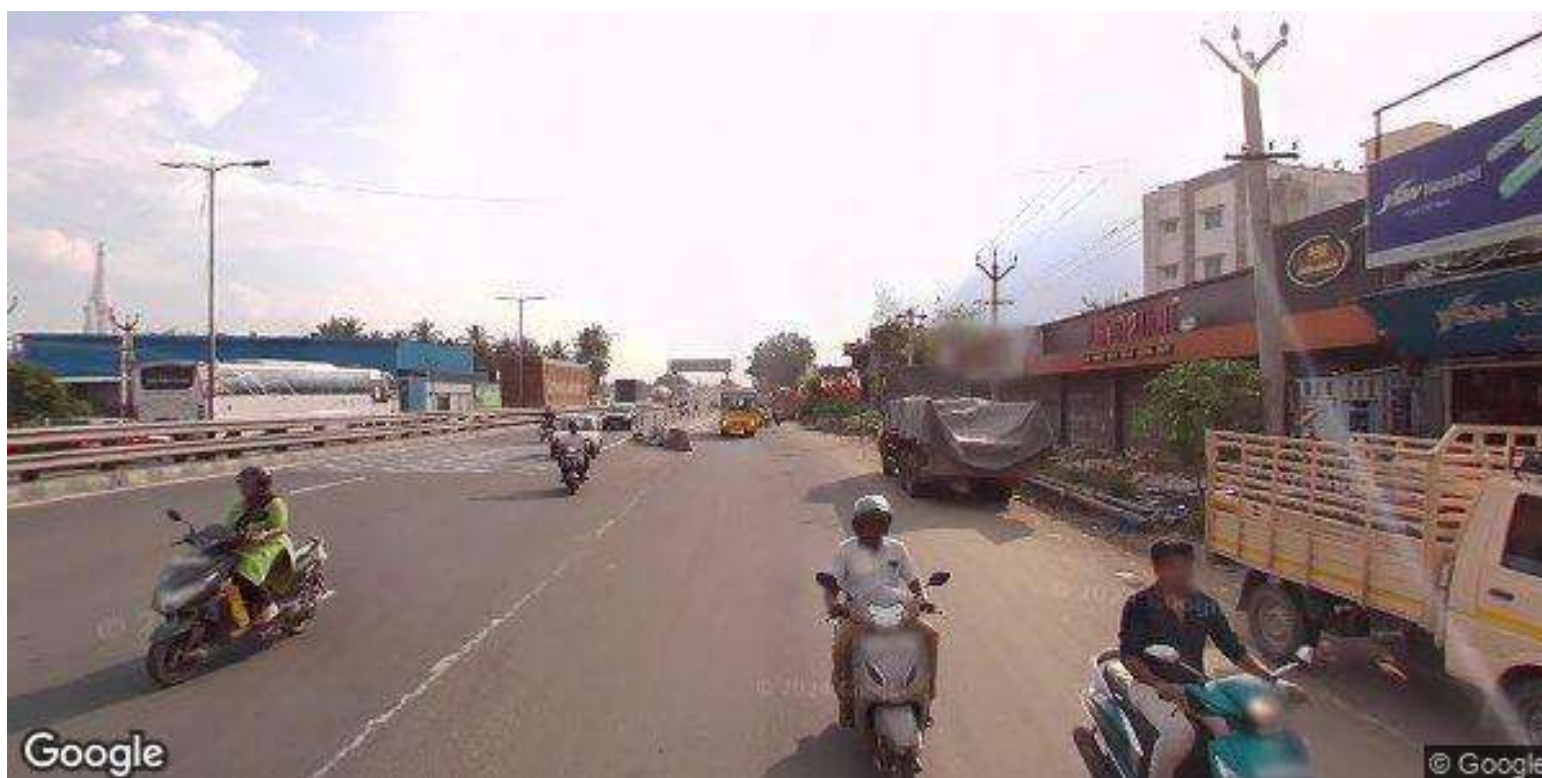
**Risk Type: Turn**

**Risk Level: High**

**Speed Limit: 15 KM/Hr**

**Coordinates: 11.67081, 78.12661**

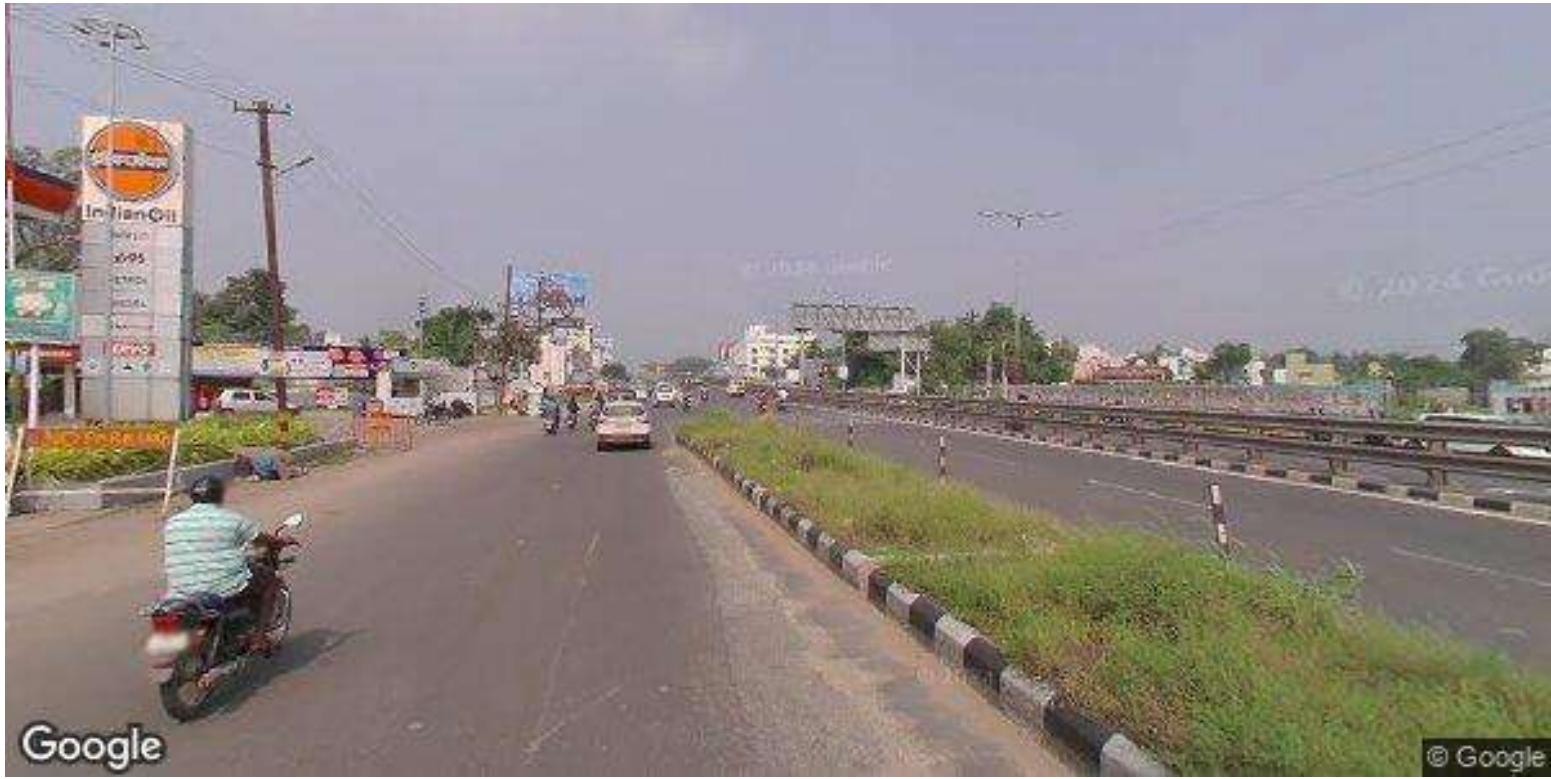
**Risk Type:** Blind Spot  
**Risk Level:** Blind Spot  
**Speed Limit:** 10 KM/Hr  
**Coordinates:** 11.68318, 78.12489
