# IndianOil

## JOURNEY RISK MANAGEMENT (JRM) STUDY

### Salem Terminal TO GUNA AGENCIES

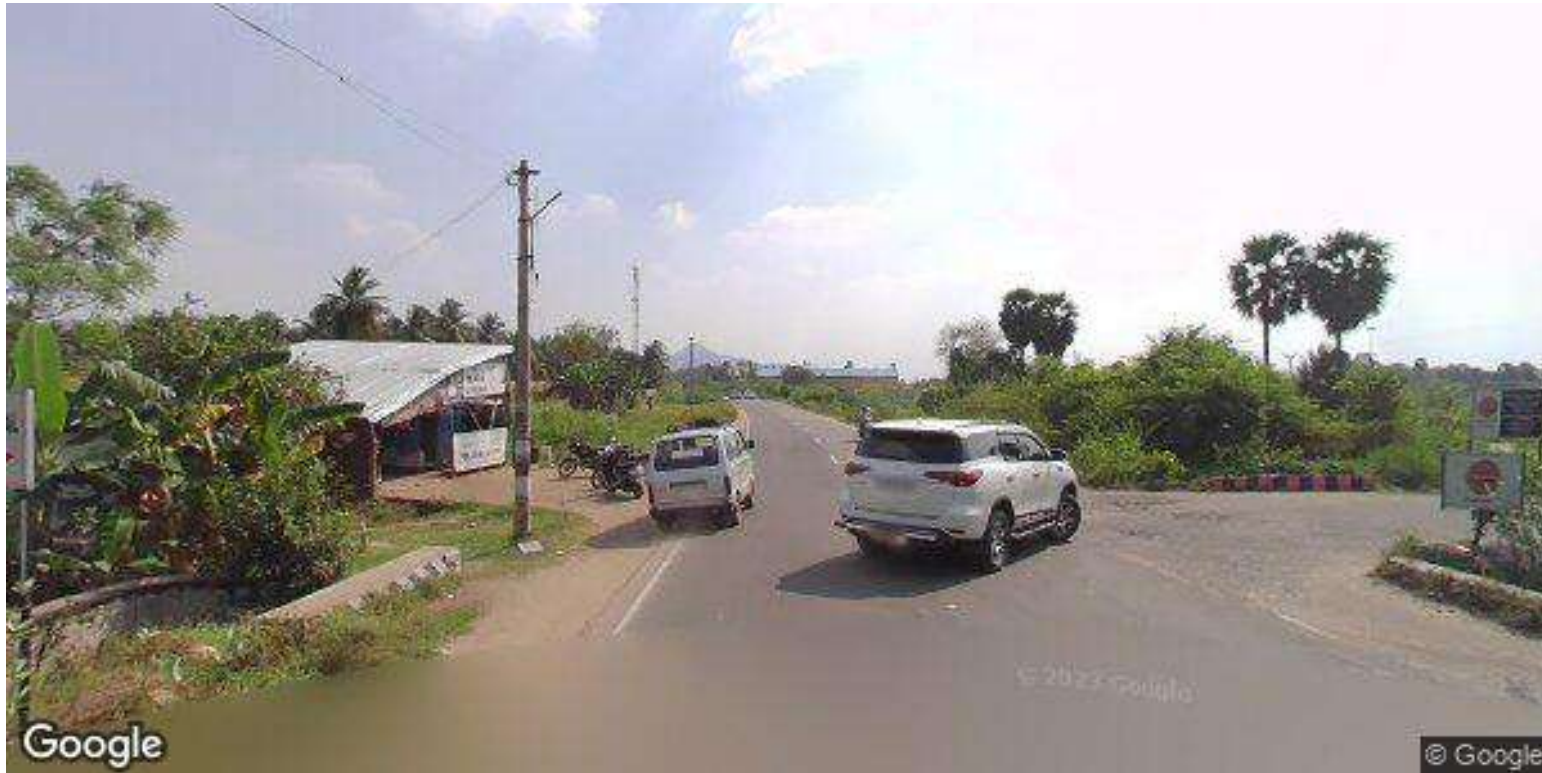
**Coordinates:** 11.44029, 77.87544

**Risk Type:** Turn

**Risk Level:** High

**Speed Limit:** 15 KM/Hr

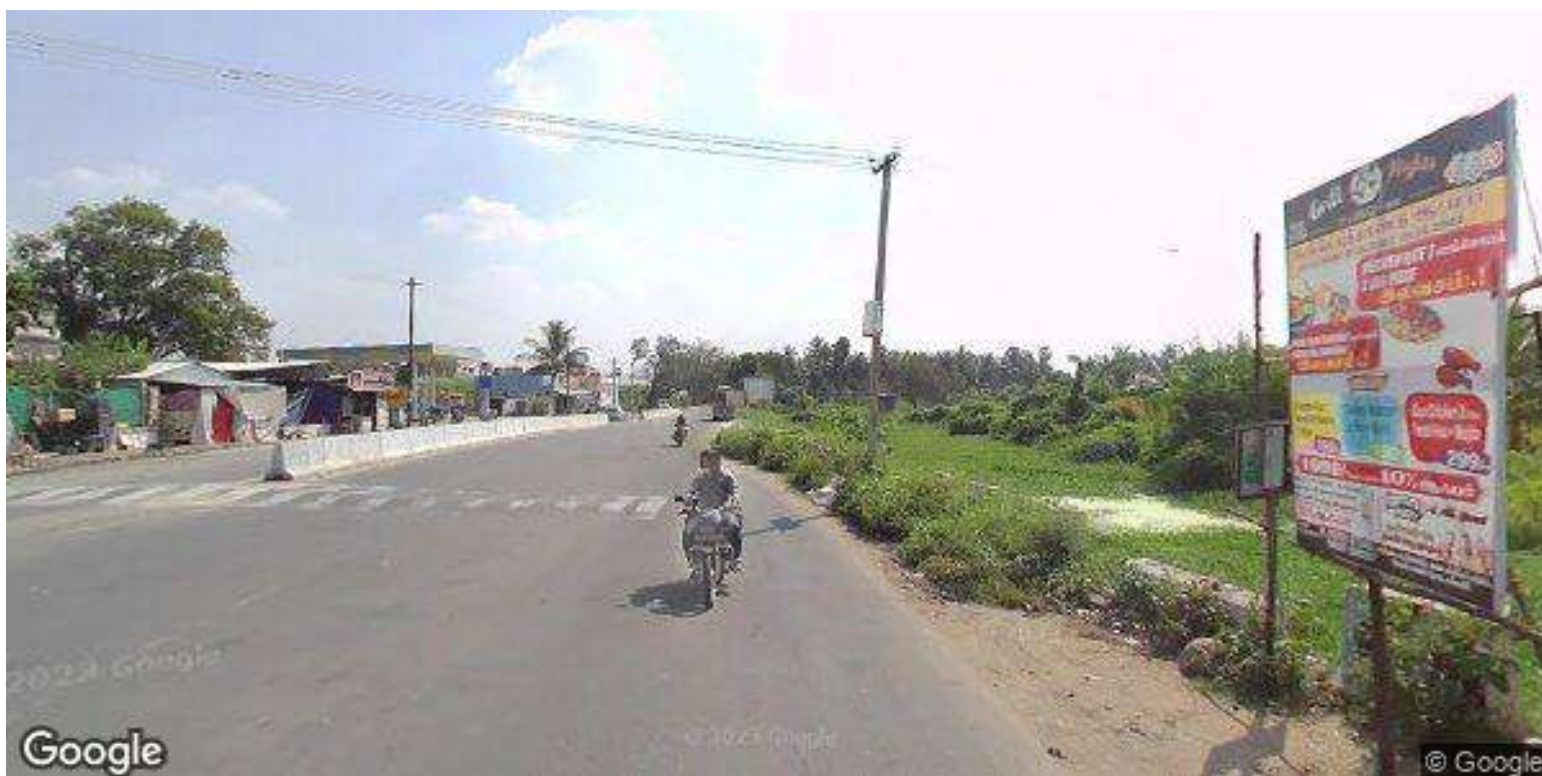
**Coordinates:** 11.44861, 77.87429

**Risk Type:** Turn

**Risk Level:** High

**Speed Limit:** 15 KM/Hr

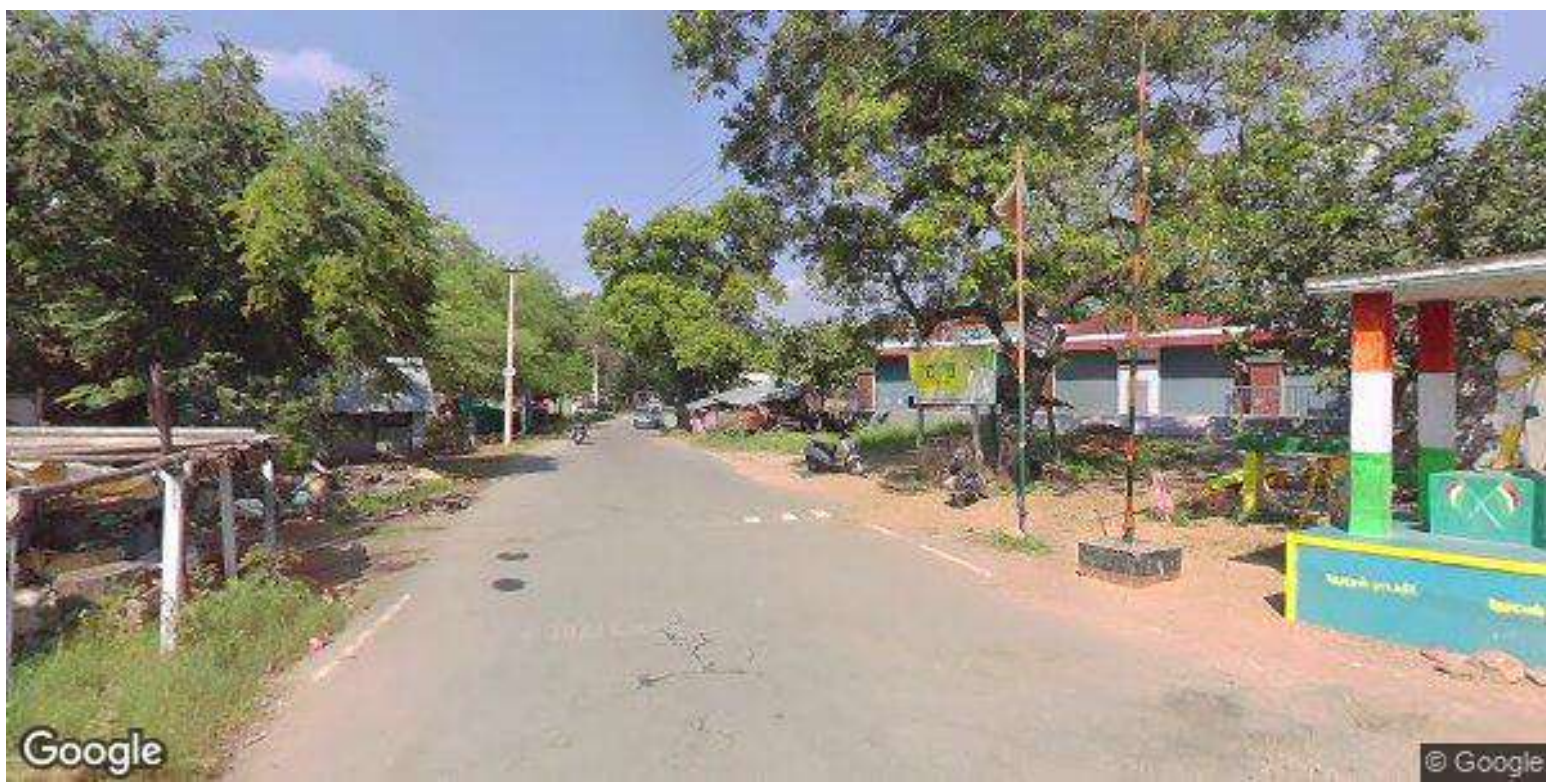
**Risk Type:** Blind Spot  
**Risk Level:** Blind Spot  
**Speed Limit:** 10 KM/Hr  
**Coordinates:** 11.43673, 77.91703

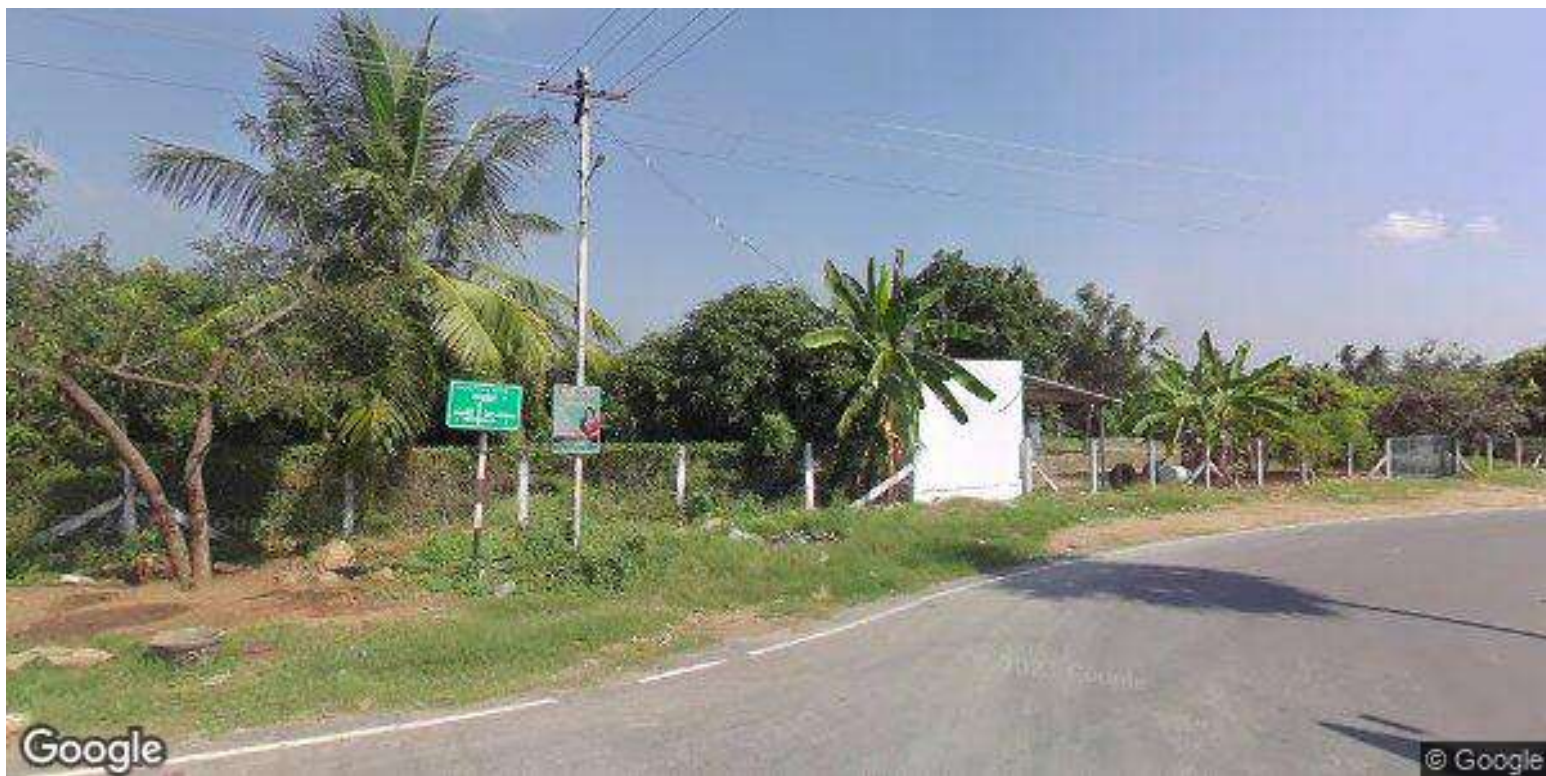
**Risk Type:** Turn  
**Risk Level:** High  
**Speed Limit:** 15 KM/Hr  
**Coordinates:** 11.43926, 77.91705

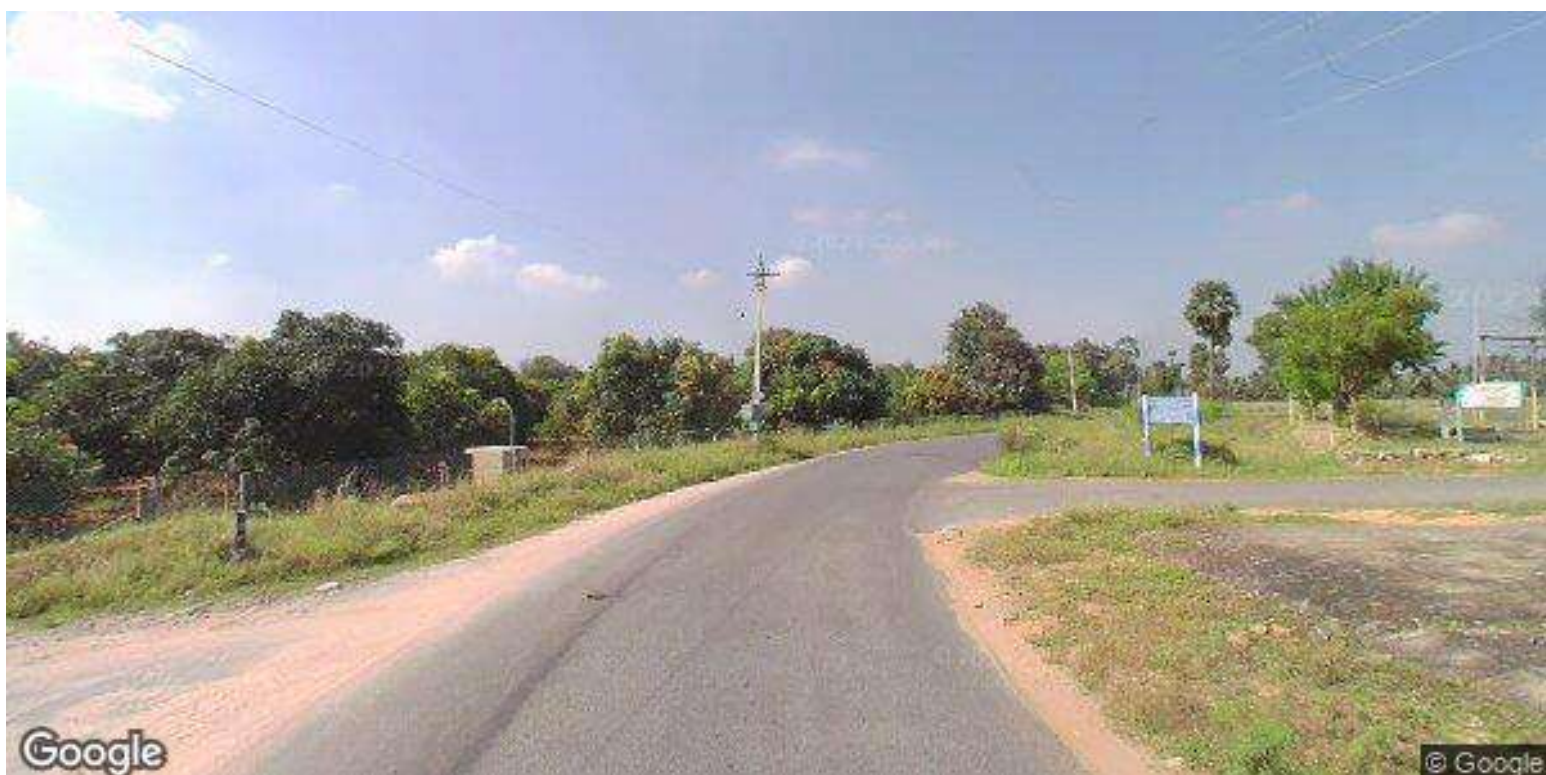
**Risk Type:** Turn  
**Risk Level:** Medium  
**Speed Limit:** 30 KM/Hr  
**Coordinates:** 11.43936, 77.92301

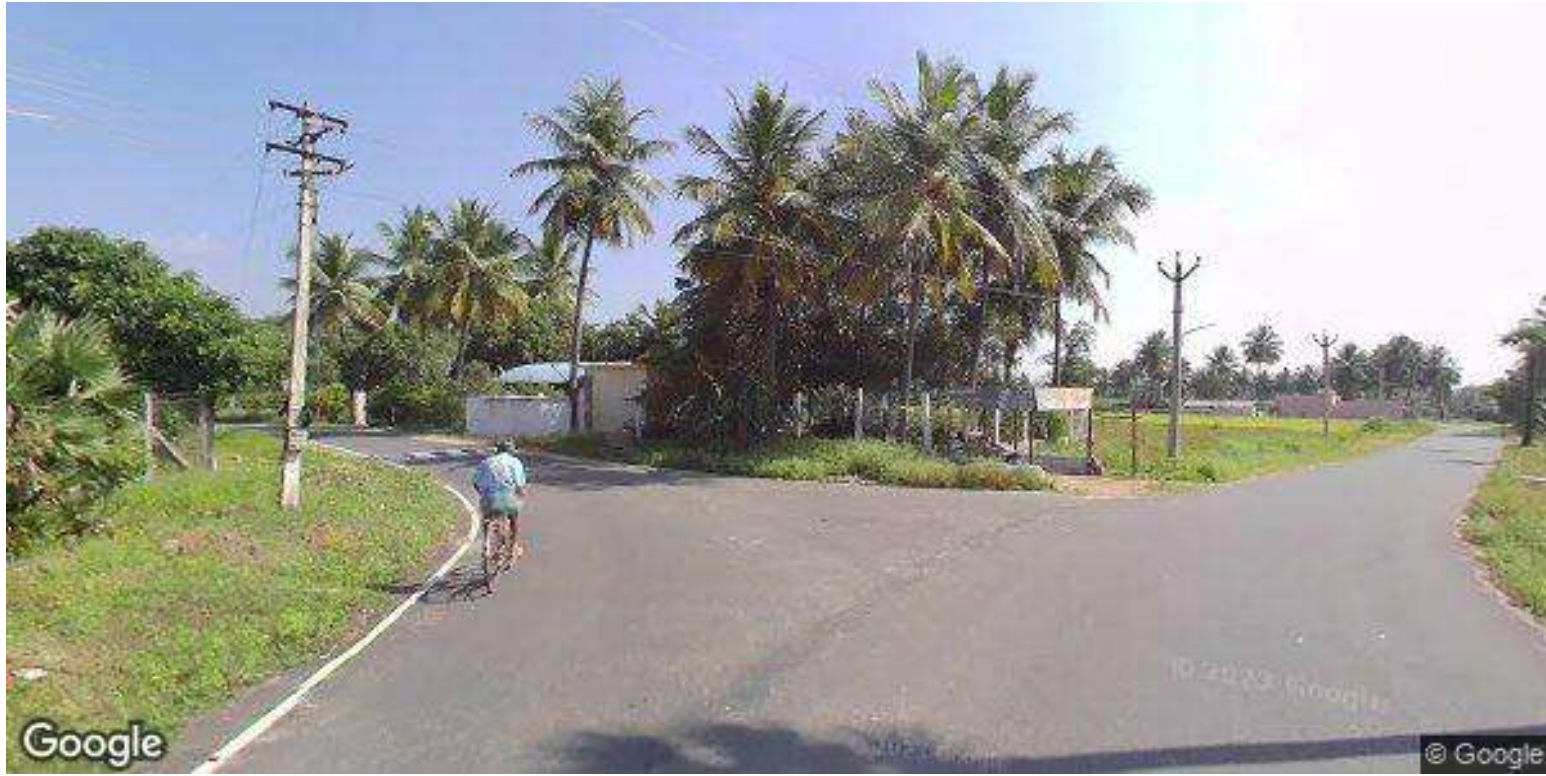
**Risk Type:** Turn  
**Risk Level:** Medium  
**Speed Limit:** 30 KM/Hr  
**Coordinates:** 11.43997, 77.92587

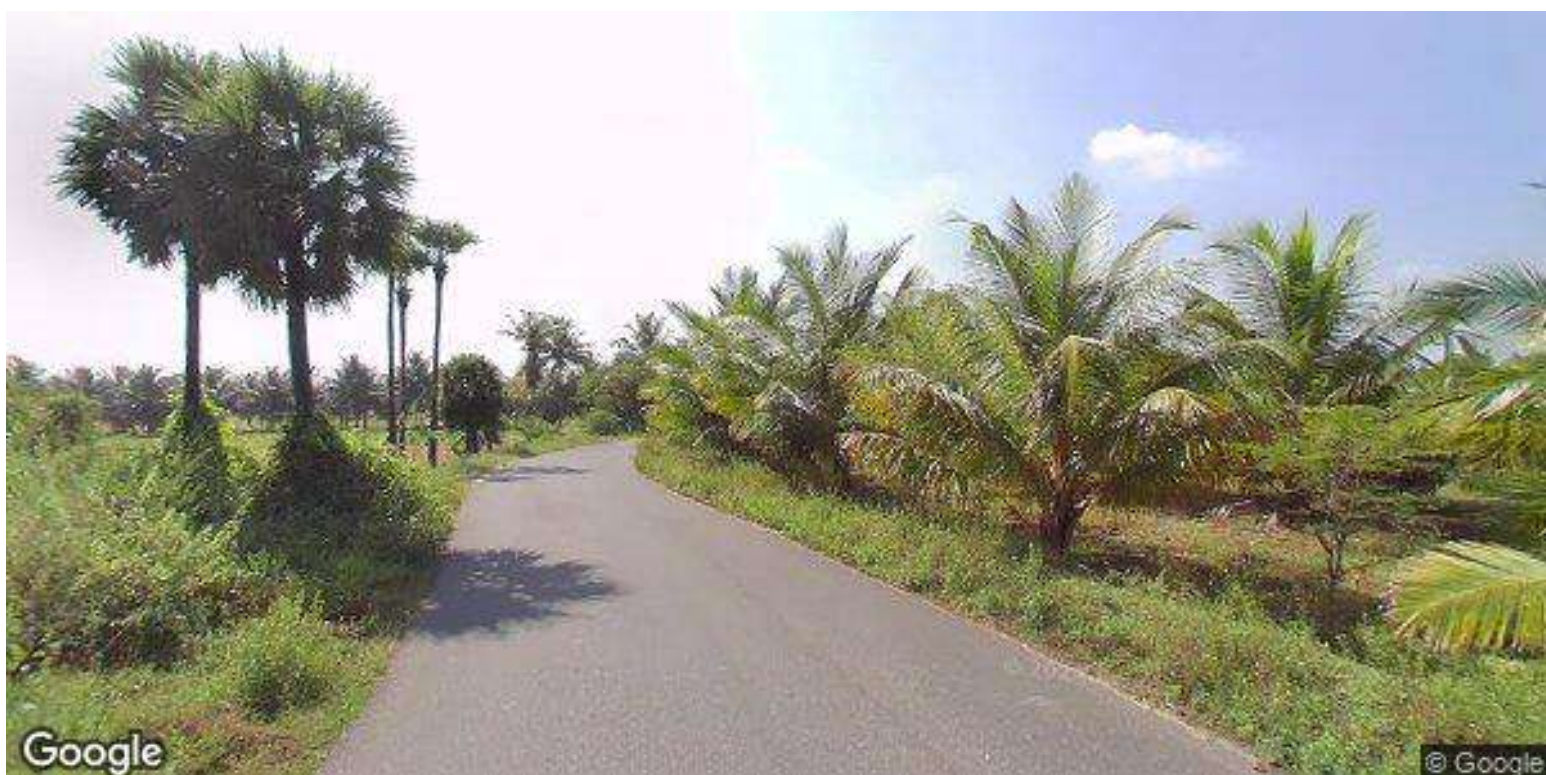
**Coordinates:** 11.44127, 77.93218

**Risk Type:** Turn

**Risk Level:** Medium

**Speed Limit:** 30 KM/Hr

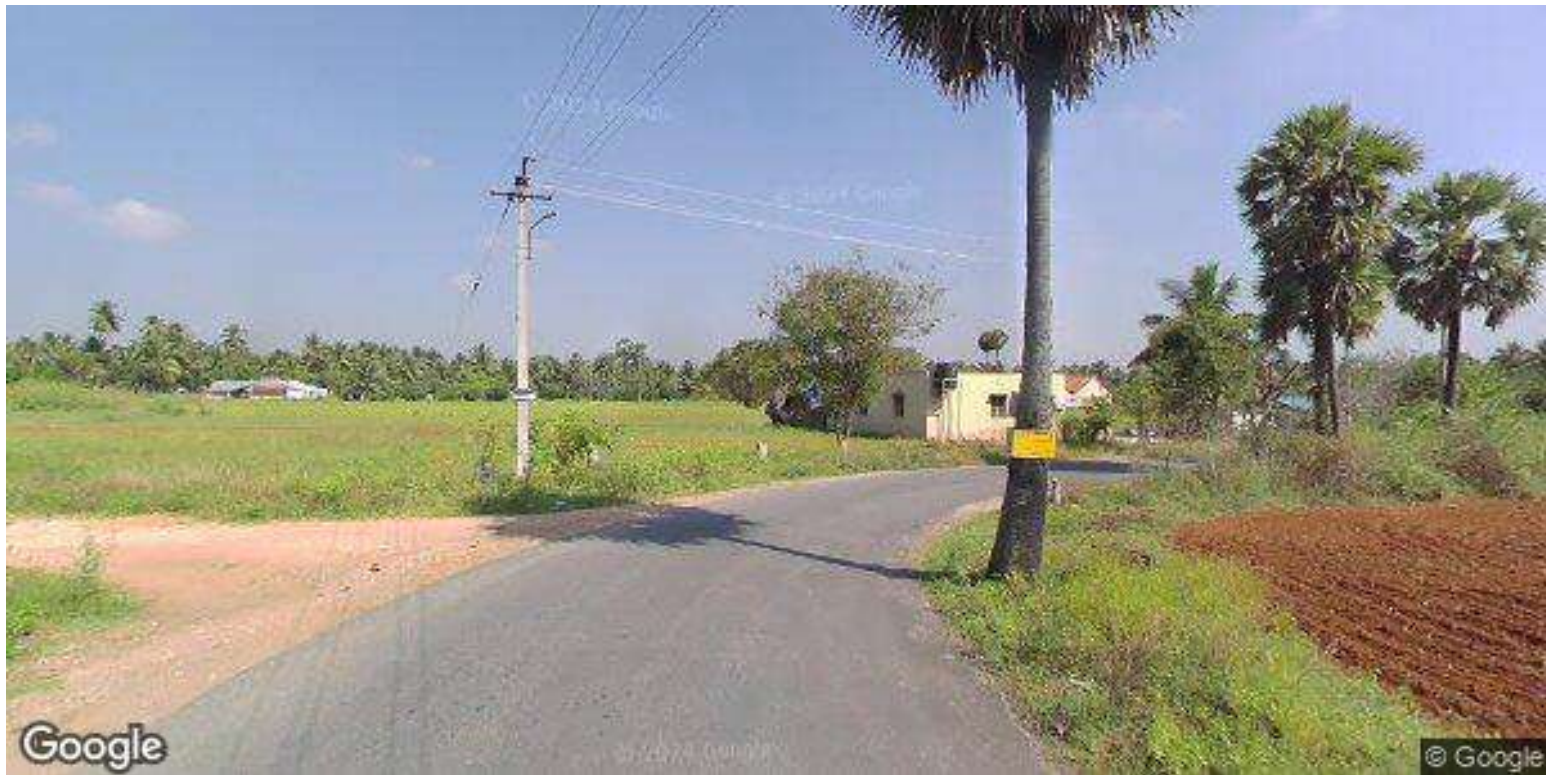
**Coordinates:** 11.44243, 77.93244

**Risk Type:** Turn

**Risk Level:** Medium

**Speed Limit:** 30 KM/Hr

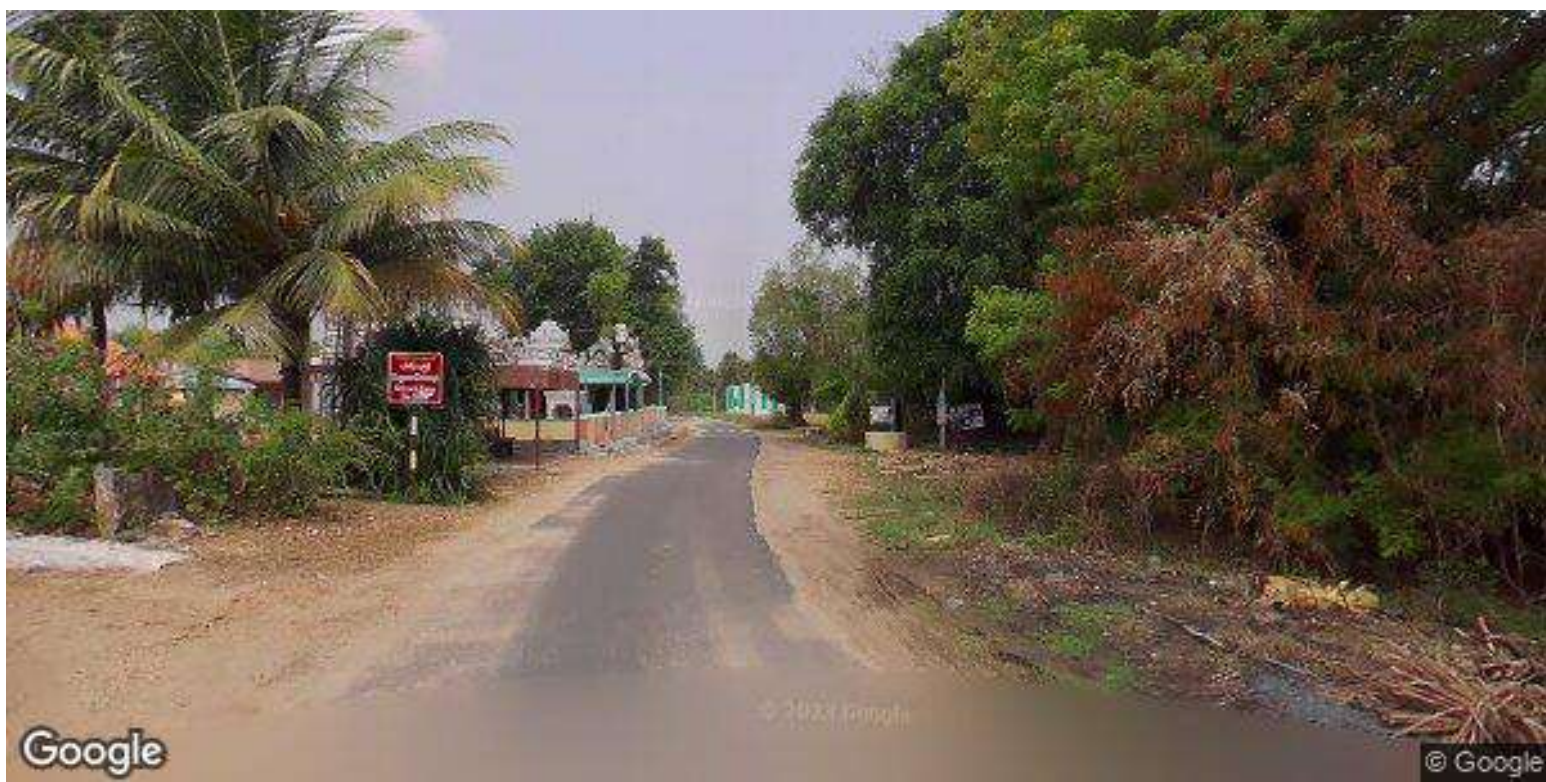
**Coordinates:** 11.44172, 77.94140

**Risk Type:** Turn

**Risk Level:** Medium

**Speed Limit:** 30 KM/Hr

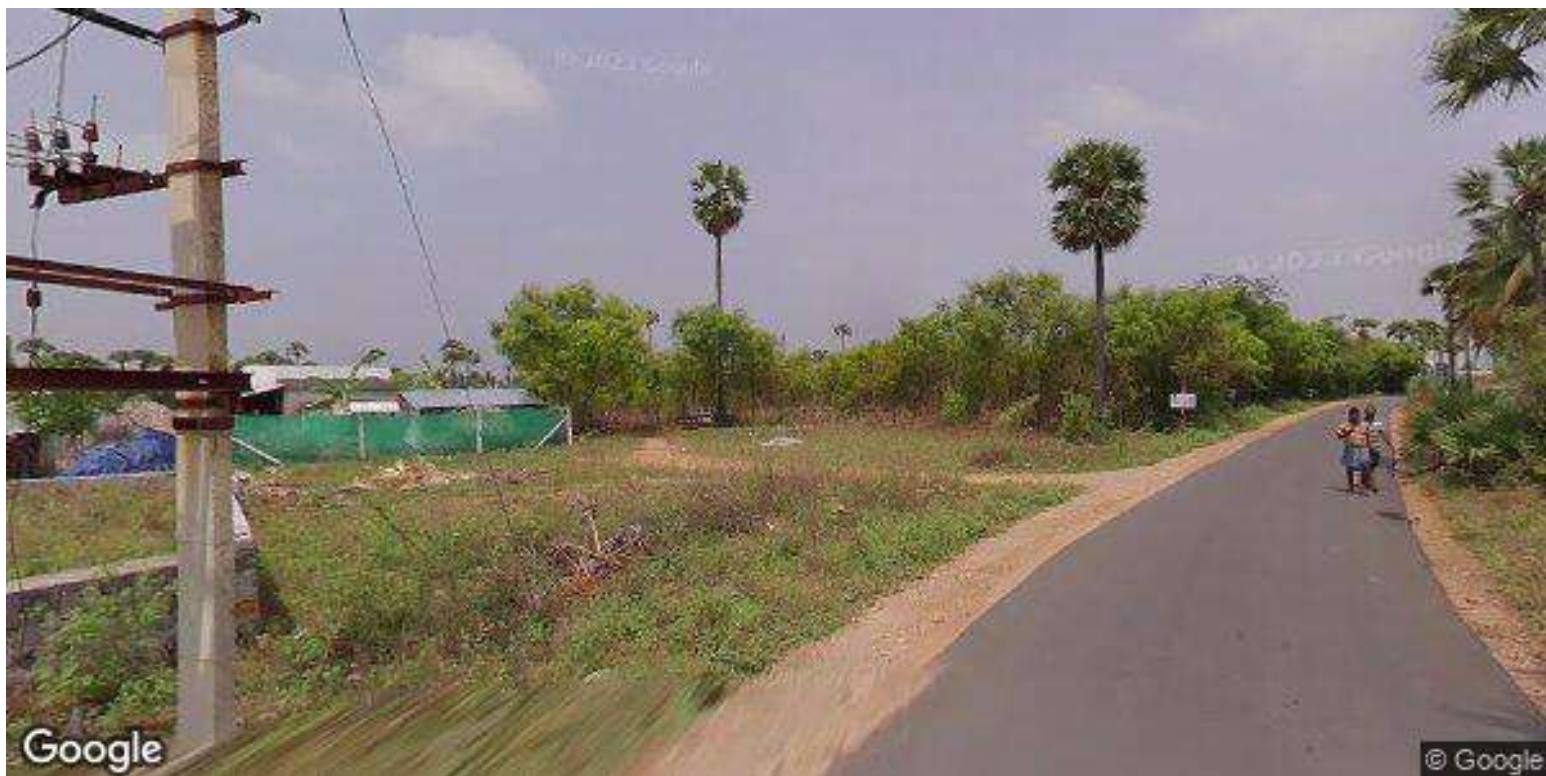
**Coordinates:** 11.44369, 77.96036

**Risk Type:** Turn

**Risk Level:** Medium

**Speed Limit:** 30 KM/Hr

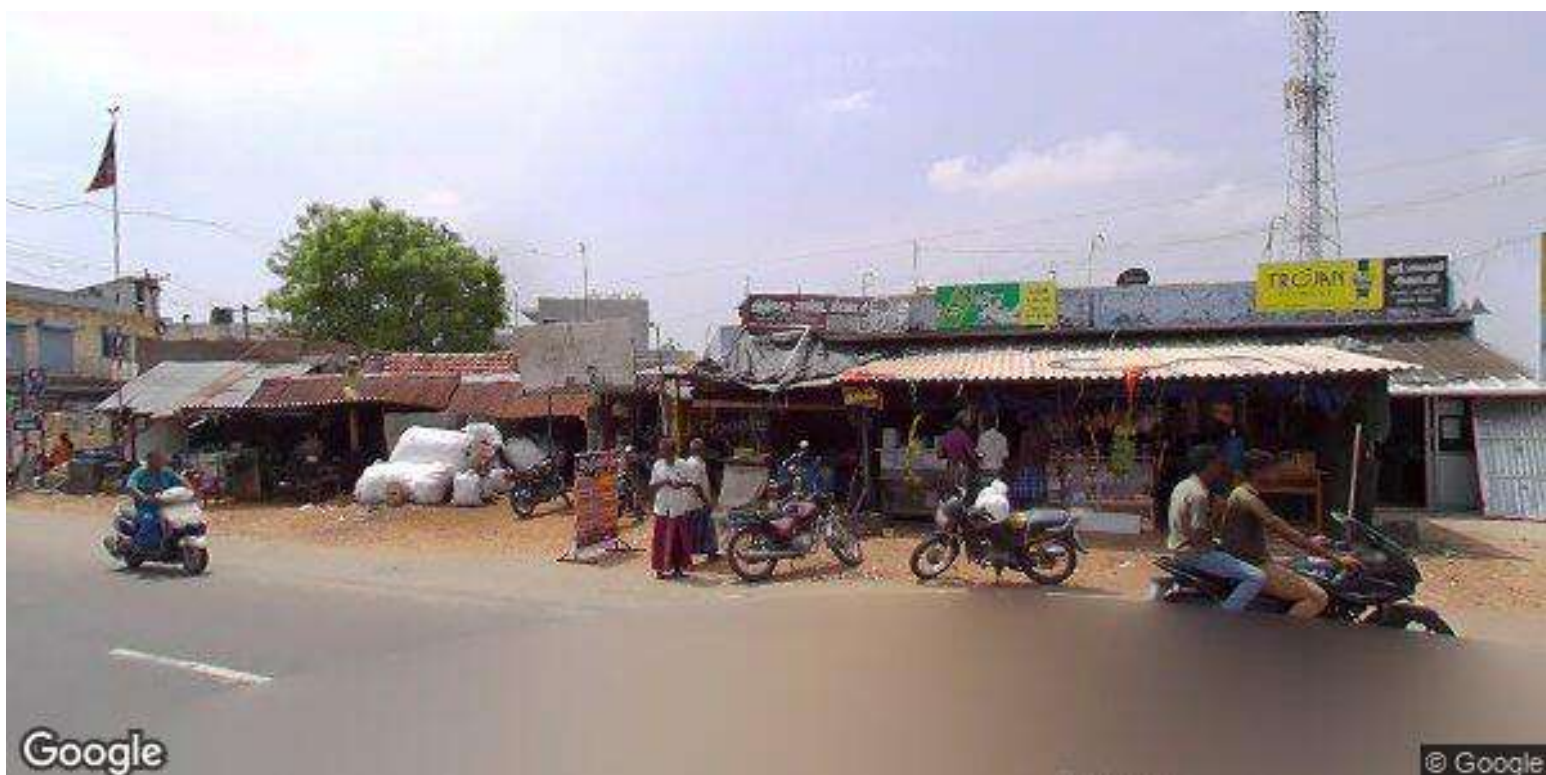
**Coordinates:** 11.44387, 77.96283

**Risk Type:** Turn

**Risk Level:** High

**Speed Limit:** 15 KM/Hr

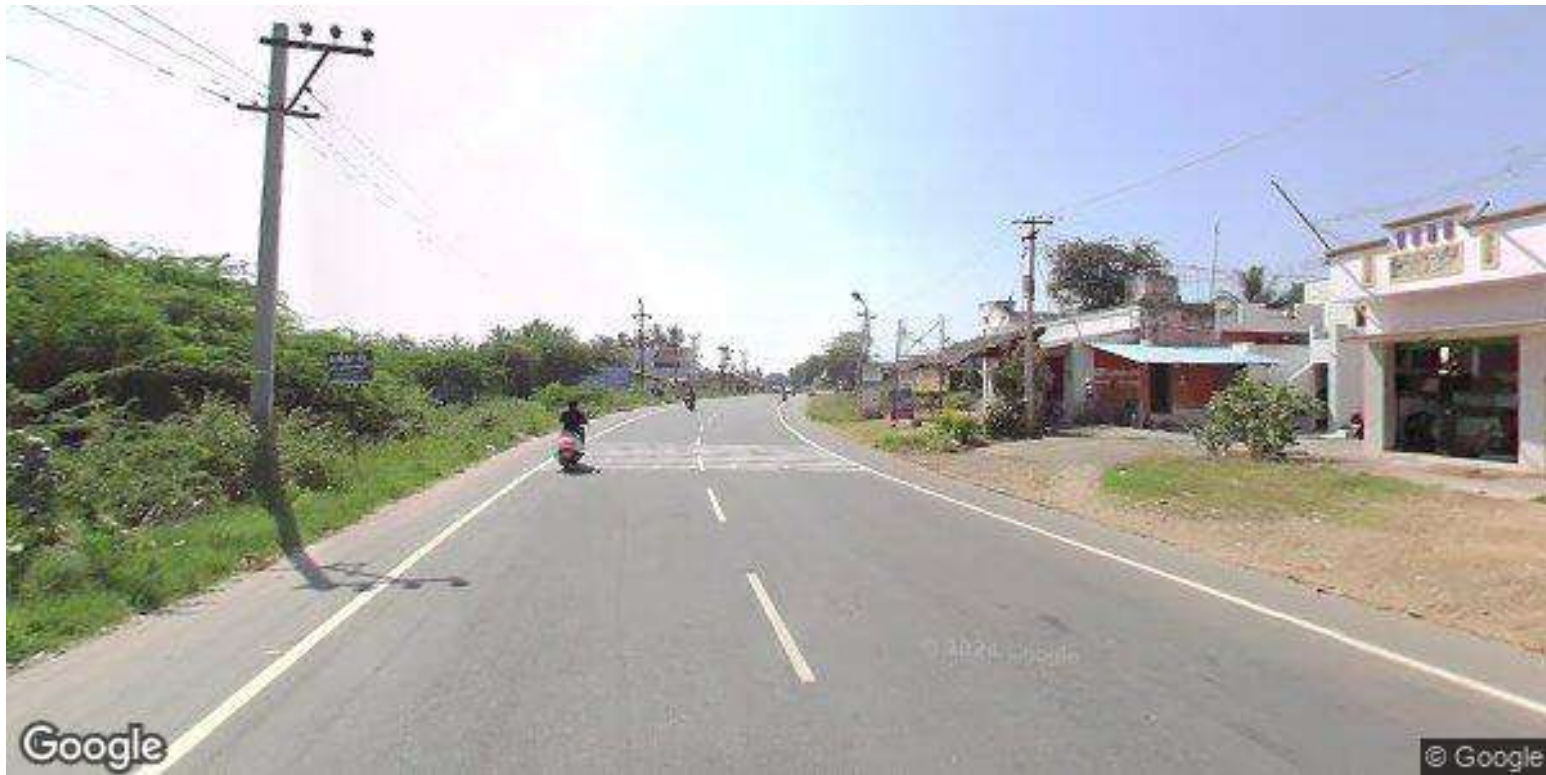
**Coordinates:** 11.52943, 78.04650

**Risk Type:** Blind Spot

**Risk Level:** Blind Spot

**Speed Limit:** 10 KM/Hr
