# IndianOil

## JOURNEY RISK MANAGEMENT (JRM) STUDY

### Salem Terminal to SANKAGIRI LORRY OWENER'S ASSOCIAATI

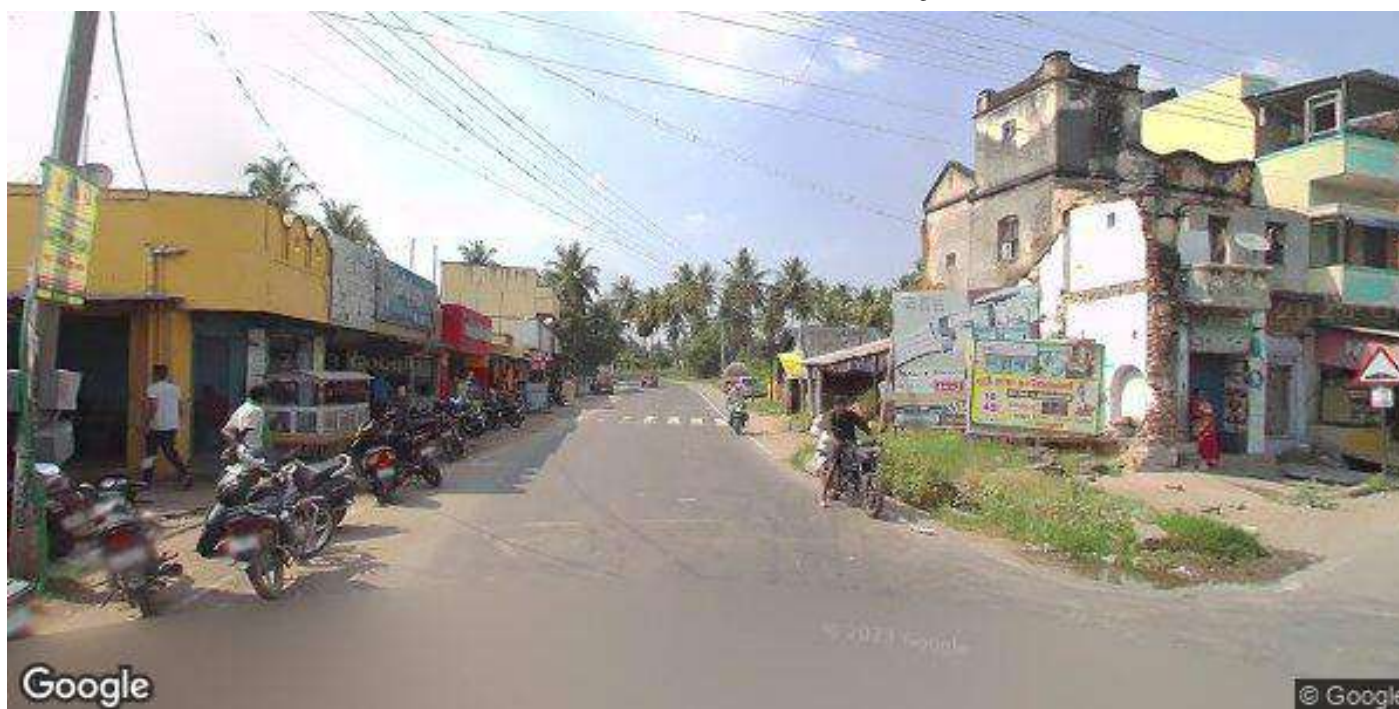
| | Risk Type | Risk Level | Coordinates | Speed Limit |
|---|---|---|---|---|
| 4 | Turn | High | 11.45007, 77.87201 | 15 KM/Hr |

**Risk Type:** Turn  
**Risk Level:** High  
**Speed Limit:** 15 KM/Hr  
**Coordinates:** 11.45007, 77.87201

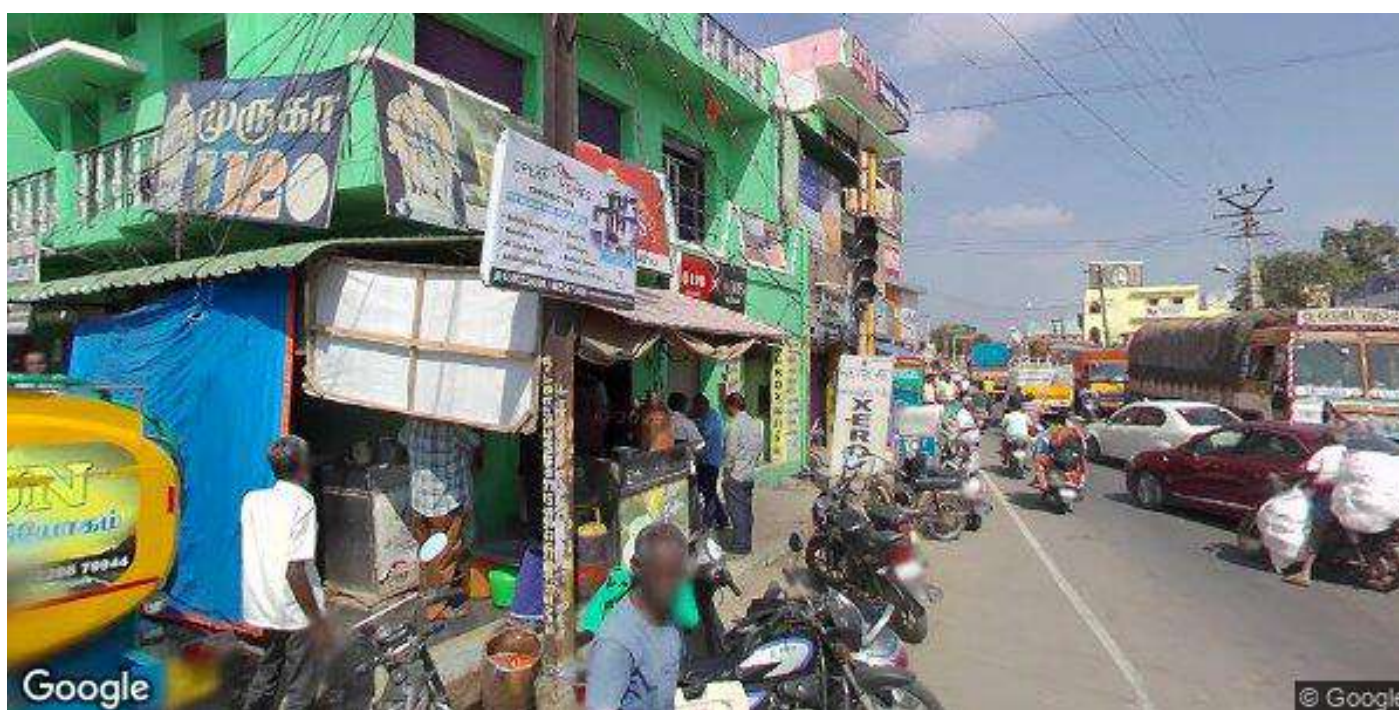
| | Risk Type | Risk Level | Coordinates | Speed Limit |
|---|---|---|---|---|
| 5 | Turn | High | 11.47407, 77.86839 | 15 KM/Hr |

**Risk Type:** Turn  
**Risk Level:** High  
**Speed Limit:** 15 KM/Hr  
**Coordinates:** 11.47407, 77.86839

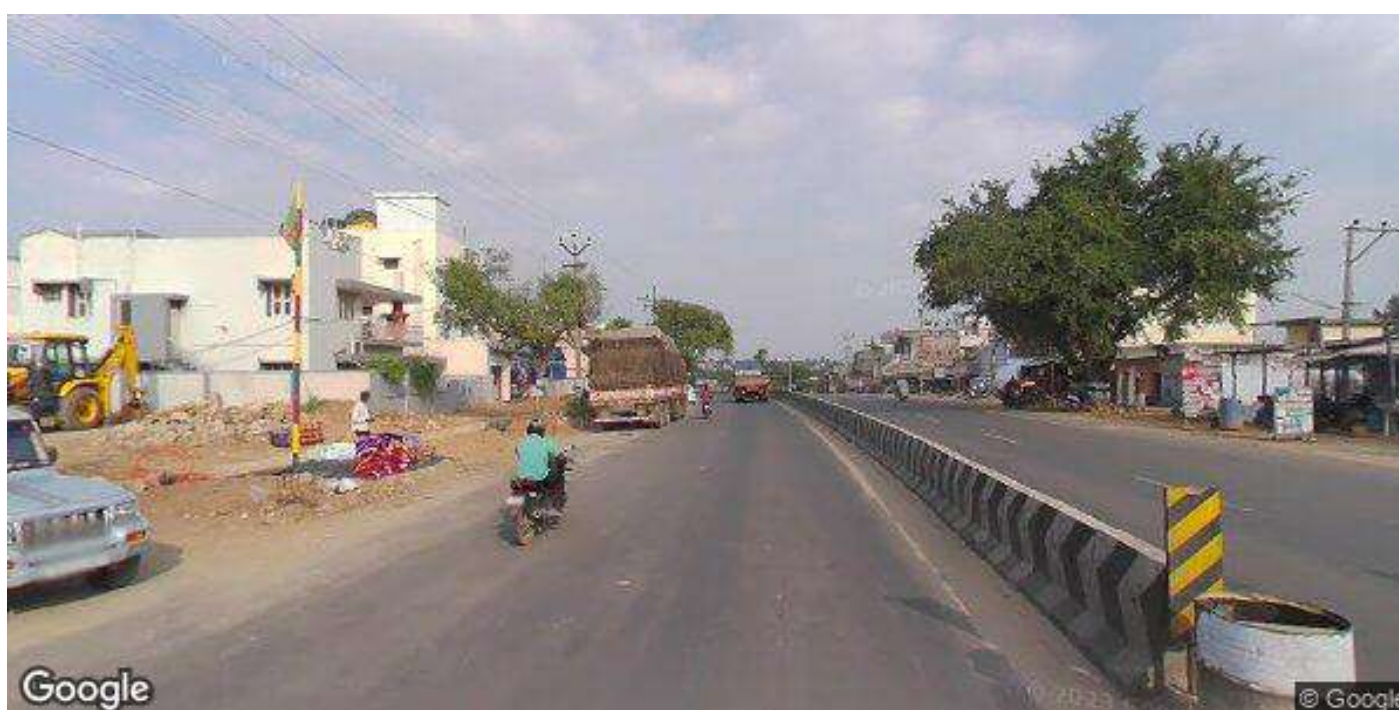
| | Risk Type | Risk Level | Coordinates | Speed Limit |
|---|---|---|---|---|
| 6 | Blind Spot | Blind Spot | 11.47946, 77.88218 | 10 KM/Hr |

**Risk Type:** Blind Spot  
**Risk Level:** Blind Spot  
**Speed Limit:** 10 KM/Hr  
**Coordinates:** 11.47946, 77.88218
