## JOURNEY RISK MANAGEMENT (JRM) STUDY

### Salem Terminal to SANKAGIRI LORRY OWENER'S ASSOCIAATI

Route Safety Analysis: CVQF+23W, Sangagiri to FR34+R2F, Virachchipalayam

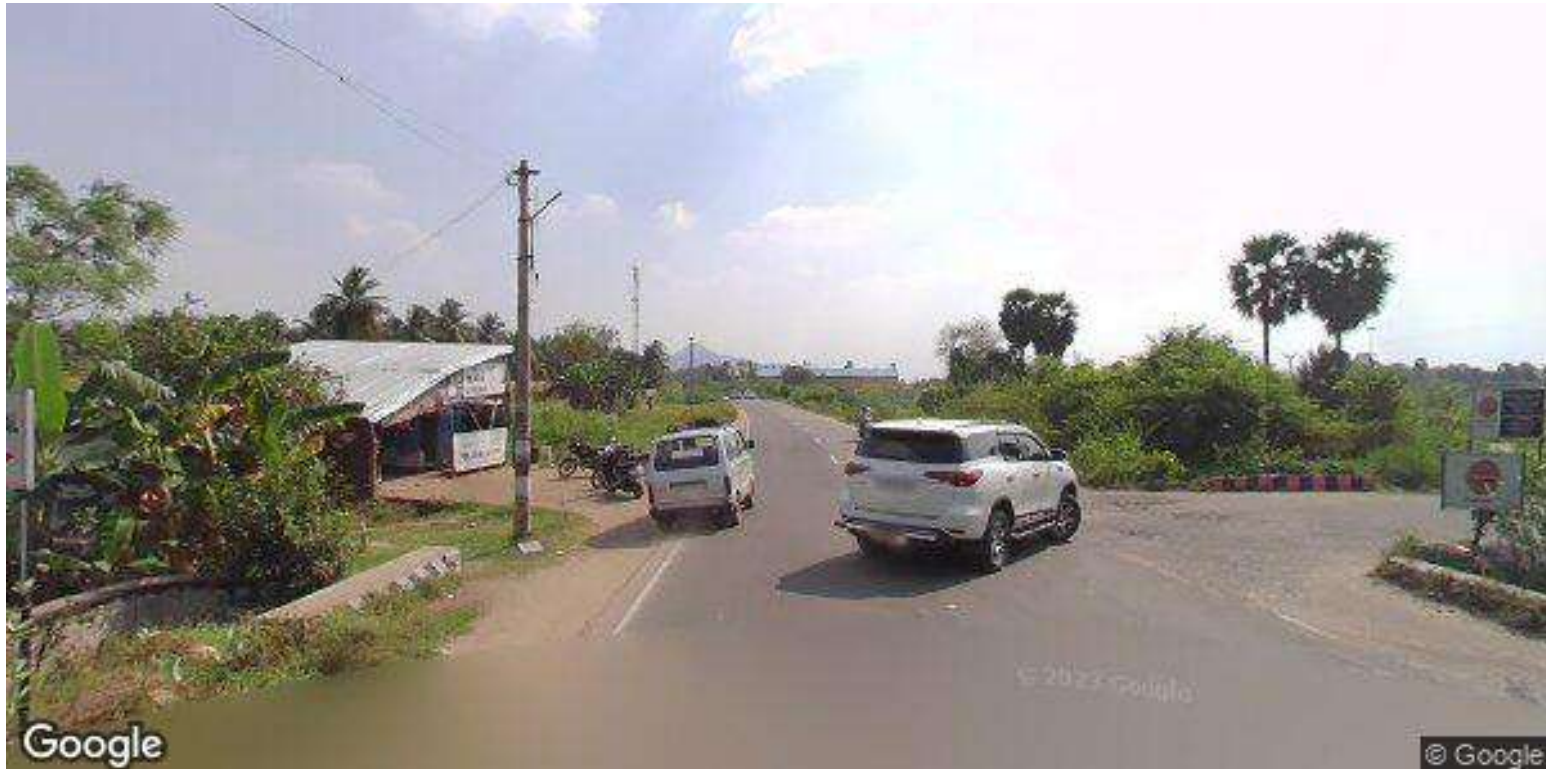
**Coordinates:** 11.44029, 77.87544

**Risk Type:** Turn

**Risk Level:** High

**Speed Limit:** 15 KM/Hr

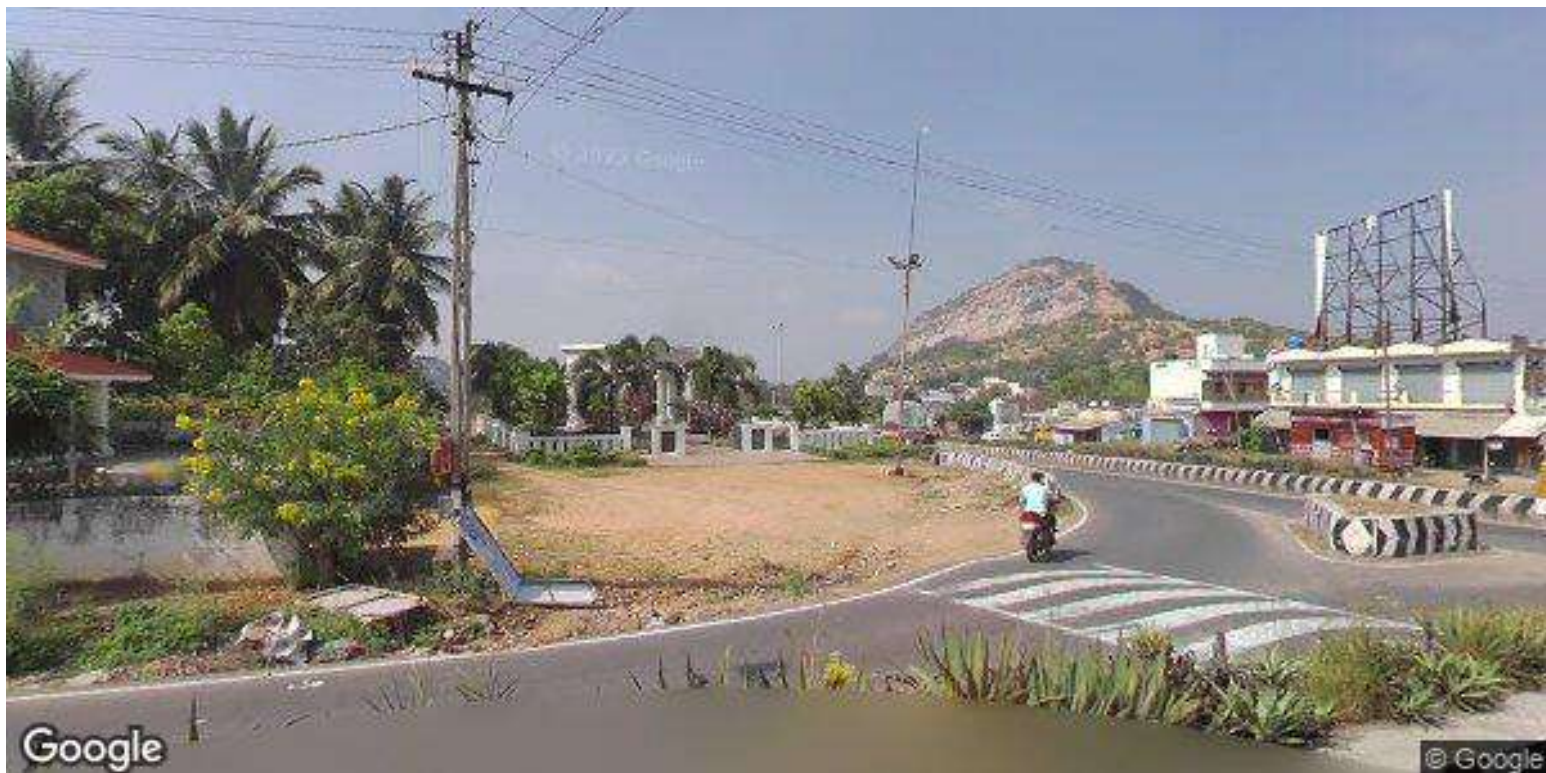
**Coordinates:** 11.46307, 77.84941

**Risk Type:** Turn

**Risk Level:** Medium

**Speed Limit:** 30 KM/Hr

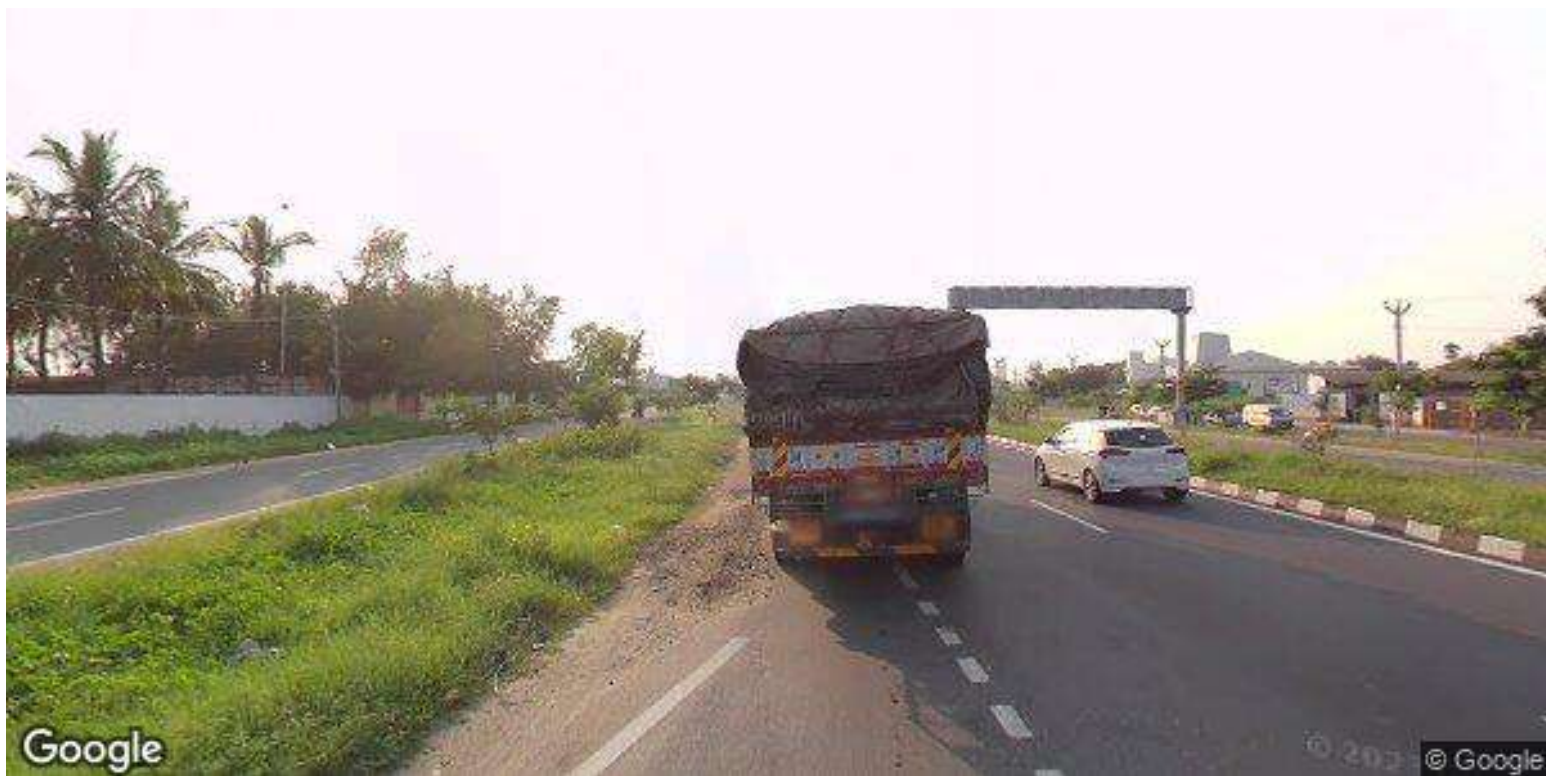
**Coordinates:** 11.45517, 77.81345

**Risk Type:** Turn

**Risk Level:** High

**Speed Limit:** 15 KM/Hr

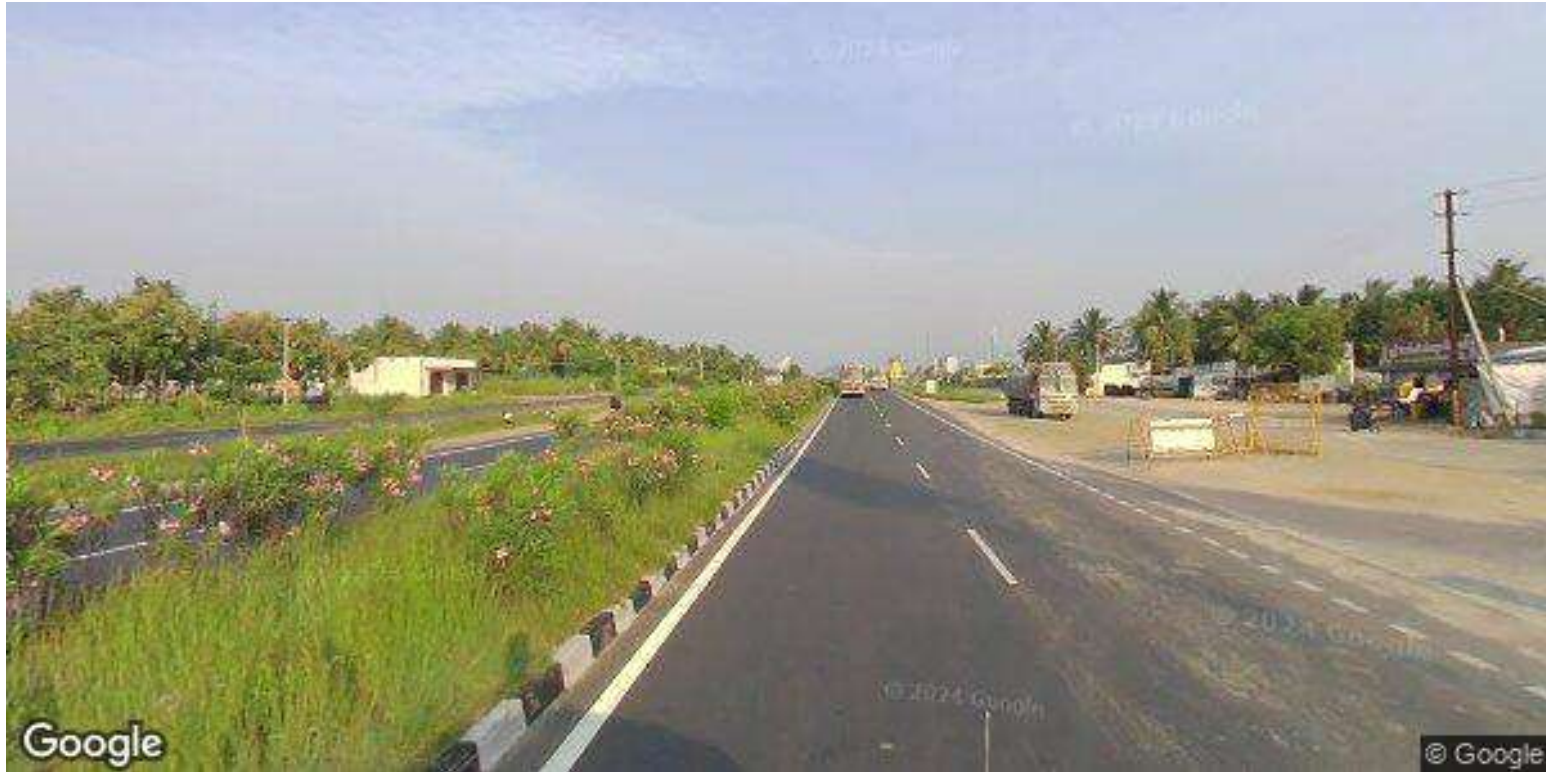
**Risk Type:** Blind Spot  
**Risk Level:** Blind Spot  
**Speed Limit:** 10 KM/Hr  
**Coordinates:** 11.45481, 77.80540

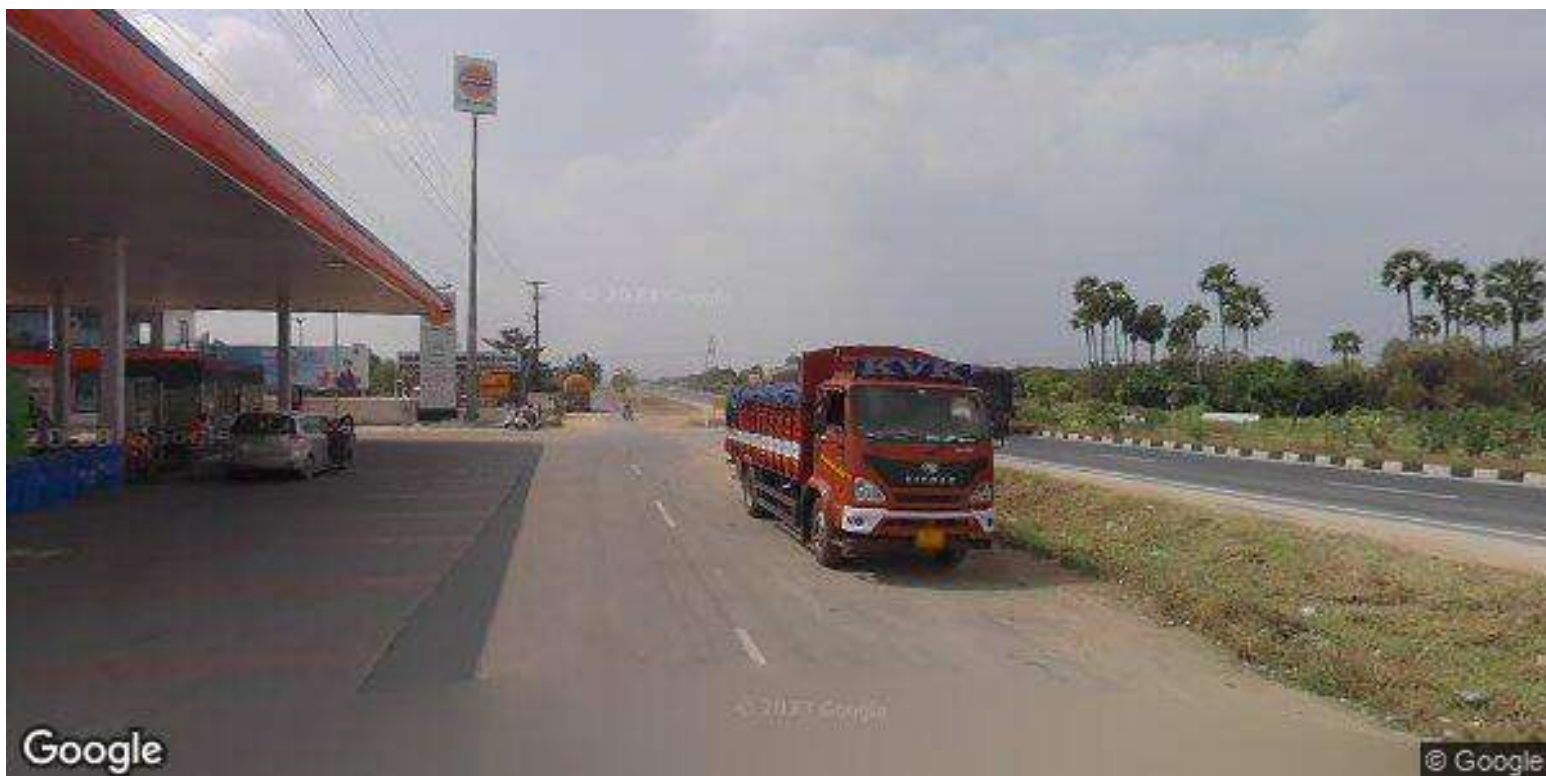
**Risk Type:** Turn  
**Risk Level:** High  
**Speed Limit:** 15 KM/Hr  
**Coordinates:** 11.45465, 77.80541

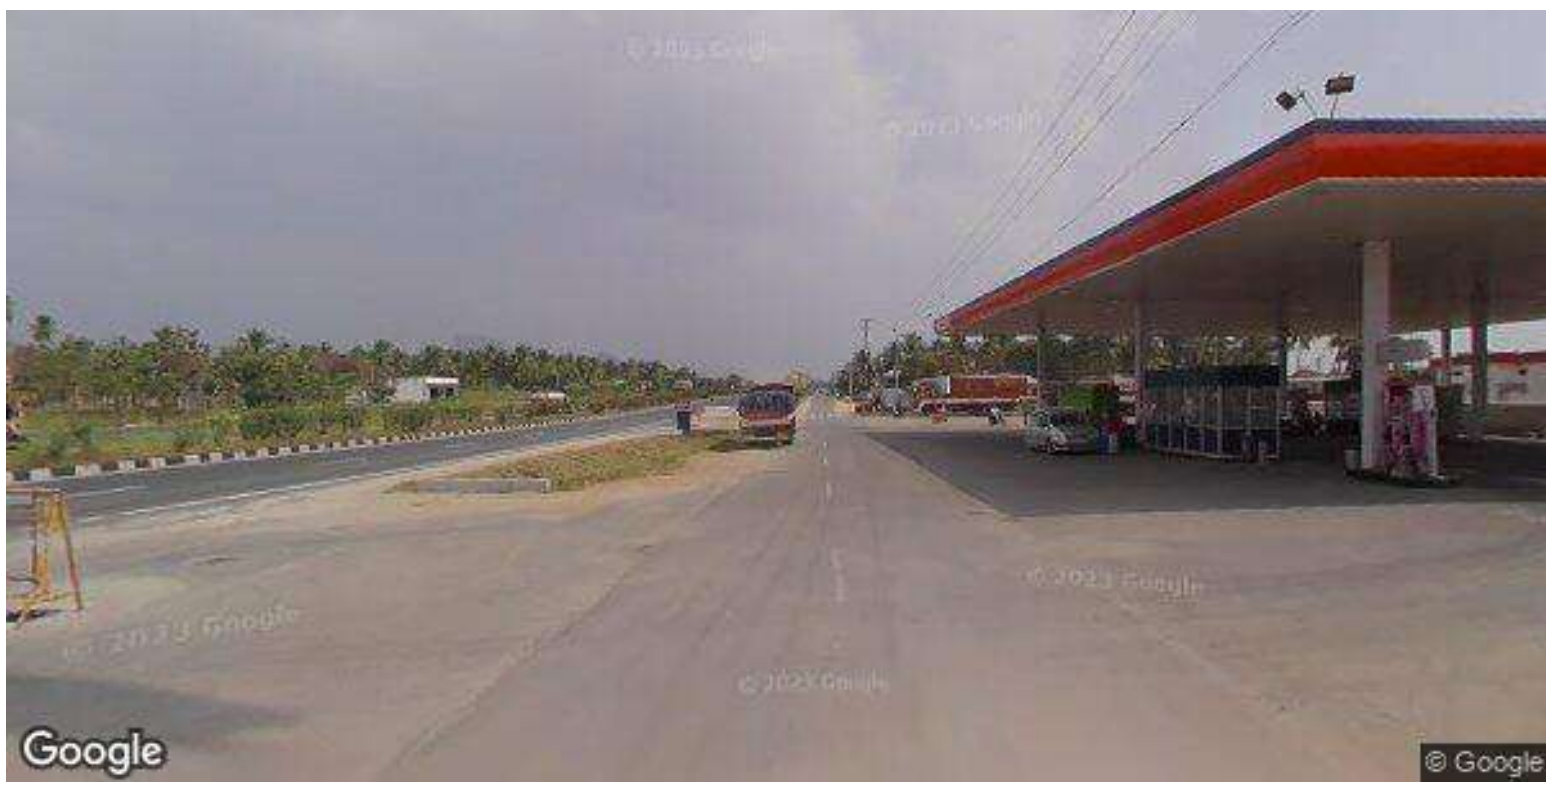
**Coordinates:** 11.45464, 77.80498

**Risk Type:** Blind Spot

**Risk Level:** Blind Spot

**Speed Limit:** 10 KM/Hr
