# IndianOil

## JOURNEY RISK MANAGEMENT (JRM) STUDY

### Salem Terminal TO LAKSHMI AGENCIES

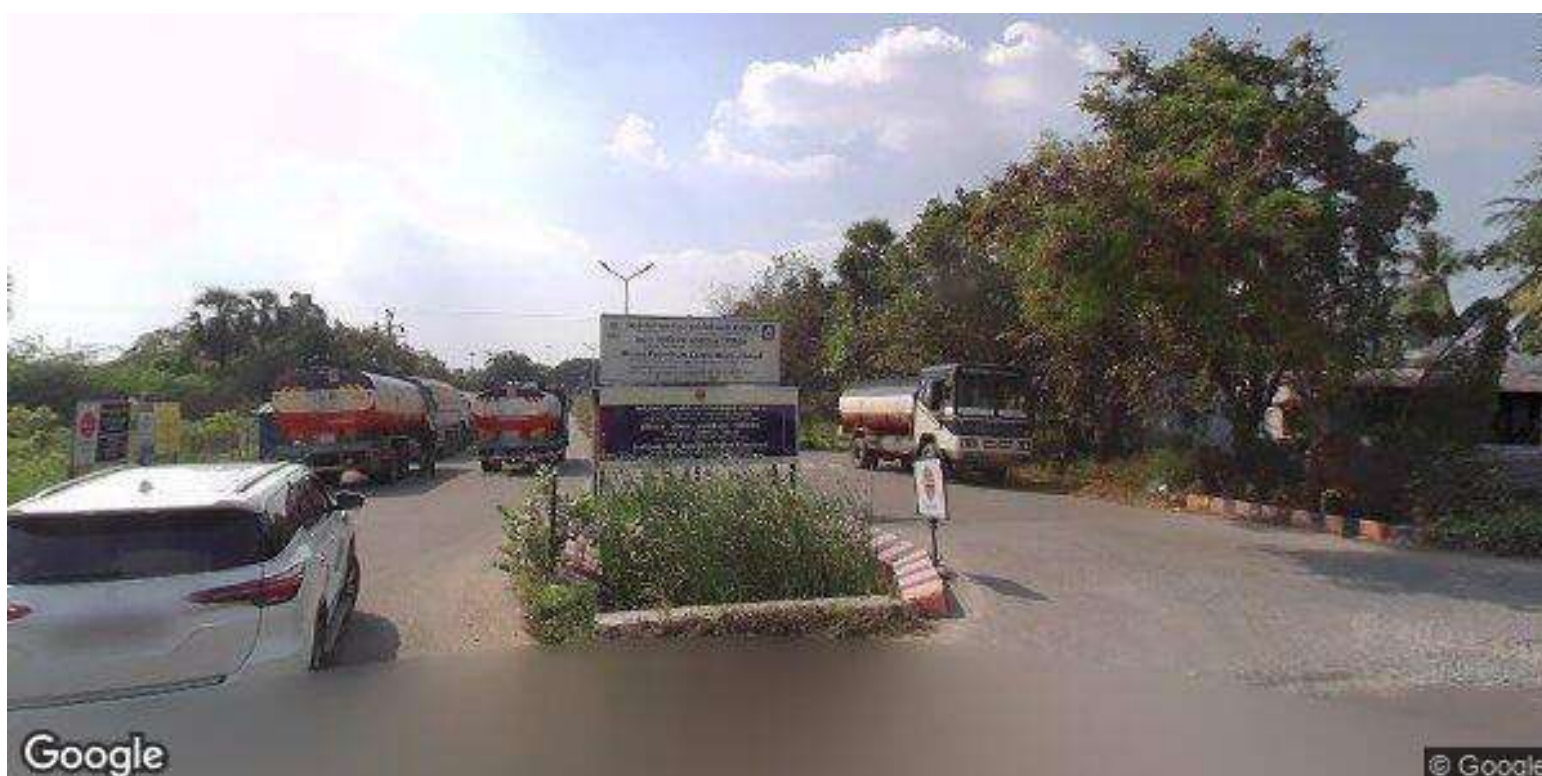
**Coordinates:** 11.44024, 77.87528

**Risk Type:** Turn

**Risk Level:** High

**Speed Limit:** 15 KM/Hr

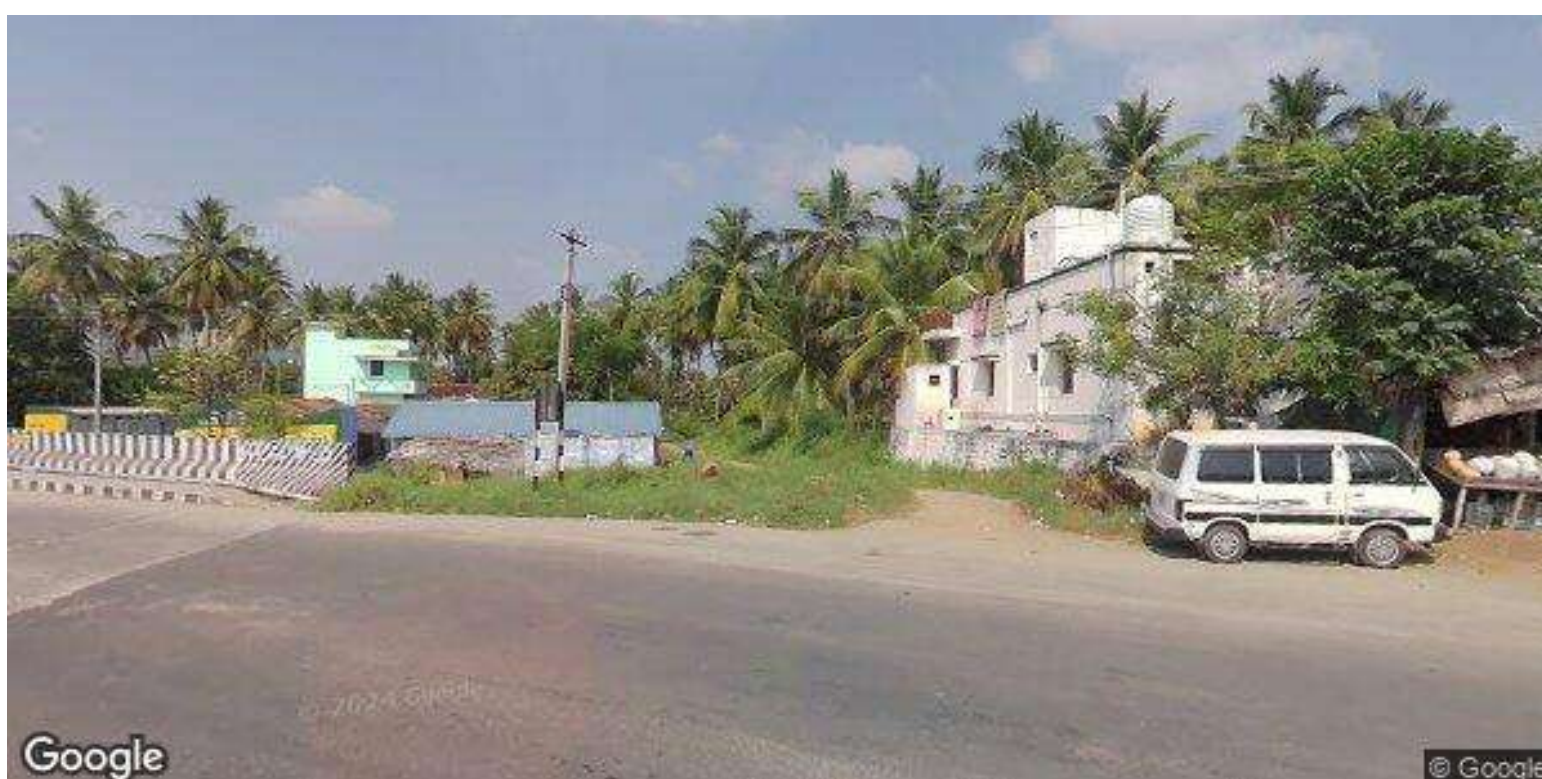
**Coordinates:** 11.44898, 77.87410

**Risk Type:** Turn

**Risk Level:** High

**Speed Limit:** 15 KM/Hr

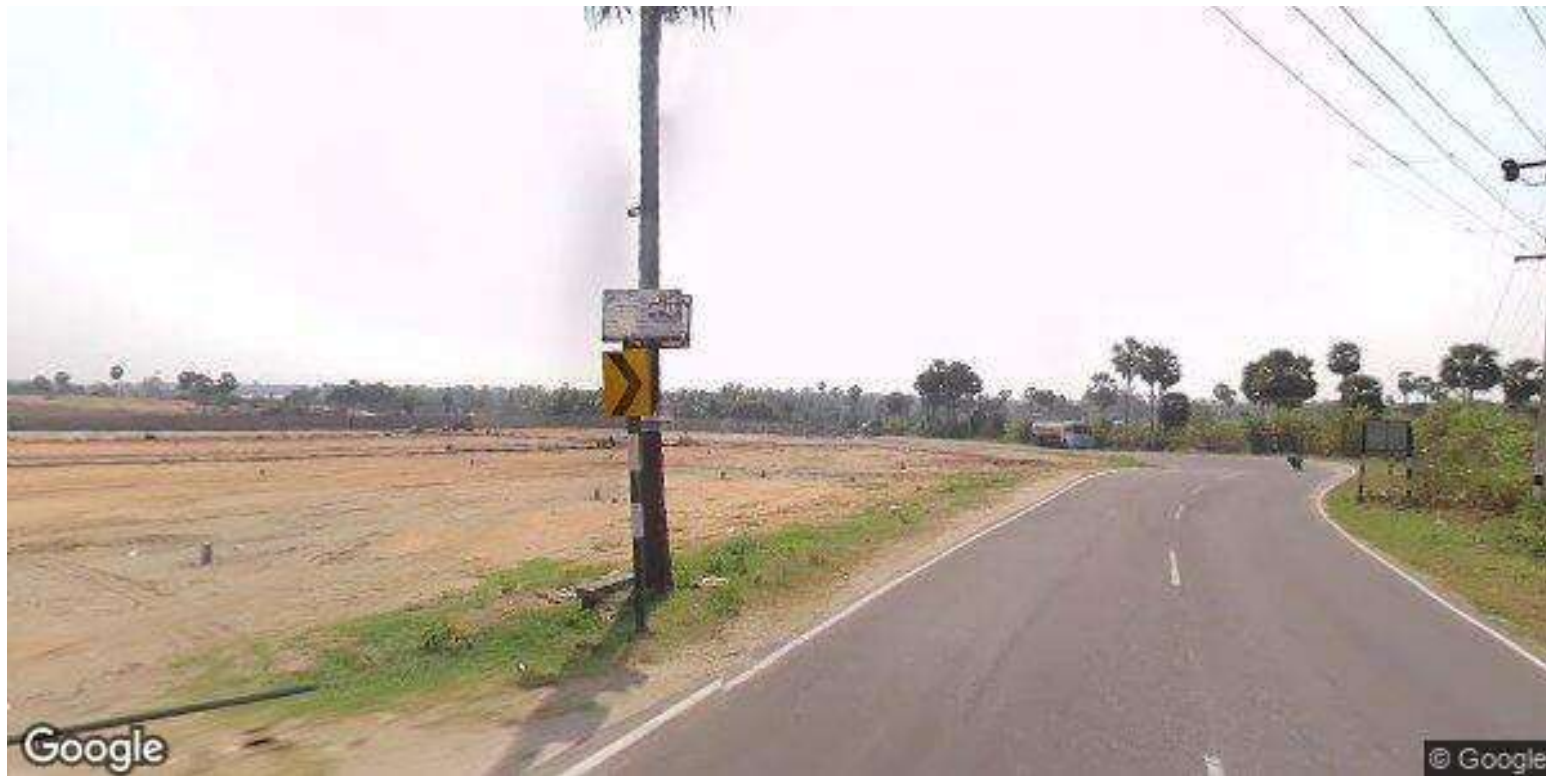
**Coordinates: 11.45898, 77.85135**

**Risk Type: Turn**

**Risk Level: Medium**

**Speed Limit: 30 KM/Hr**

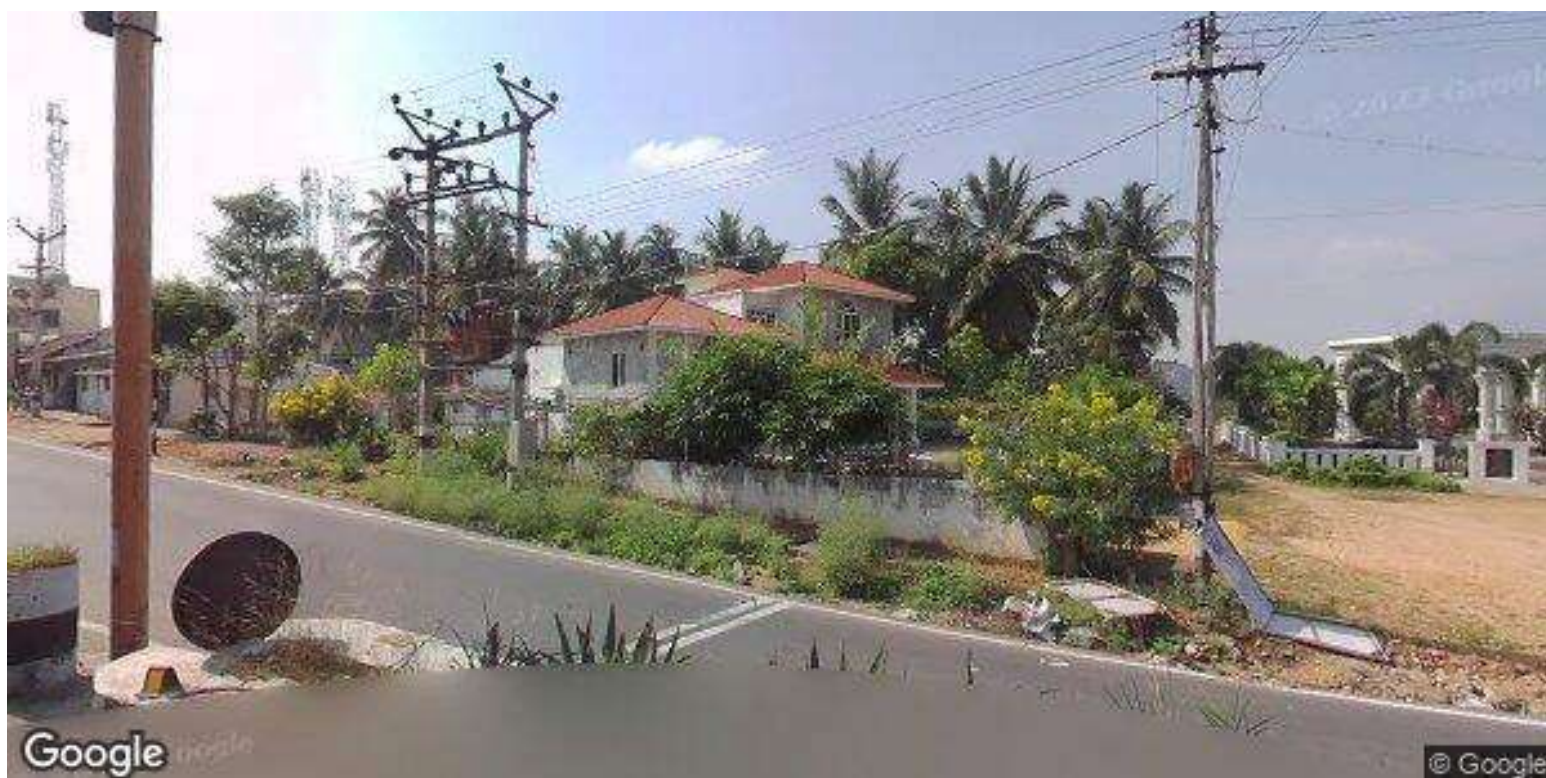
**Coordinates: 11.46303, 77.84945**

**Risk Type: Turn**

**Risk Level: High**

**Speed Limit: 15 KM/Hr**

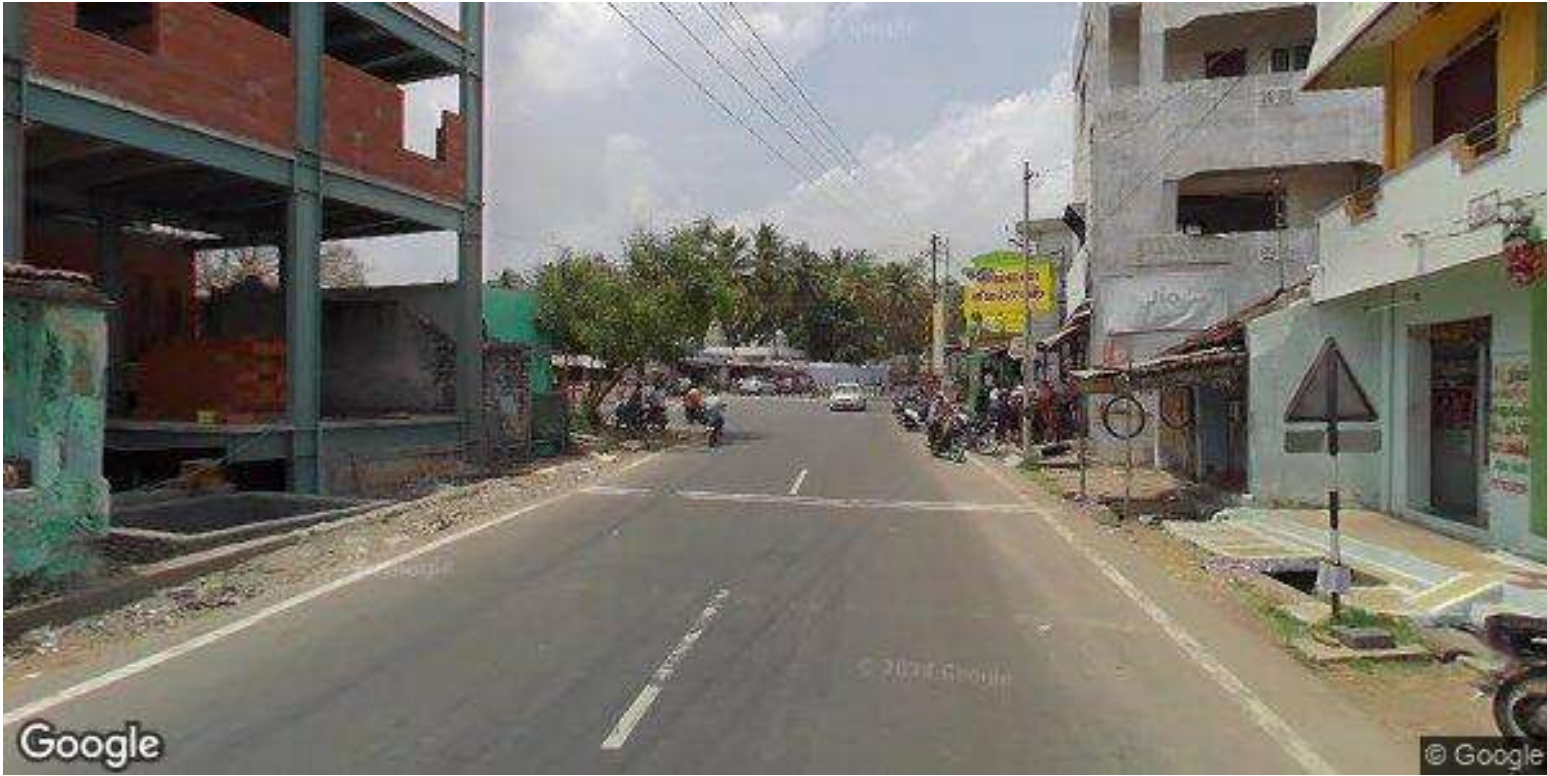
**Risk Type:** Turn  
**Risk Level:** Medium  
**Speed Limit:** 30 KM/Hr  
**Coordinates:** 11.17111, 77.45547

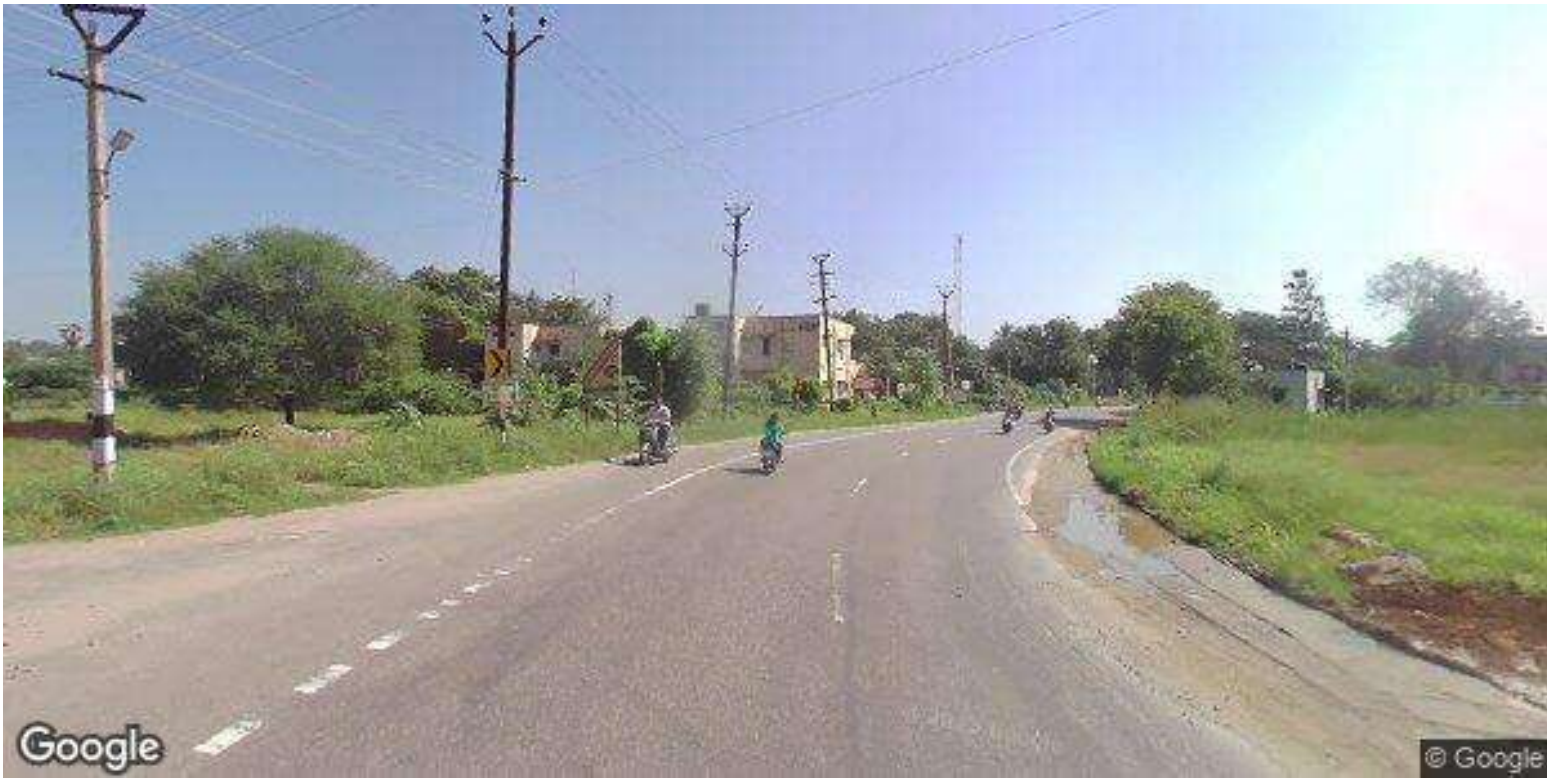
**Risk Type:** Turn  
**Risk Level:** High  
**Speed Limit:** 15 KM/Hr  
**Coordinates:** 11.16959, 77.44396

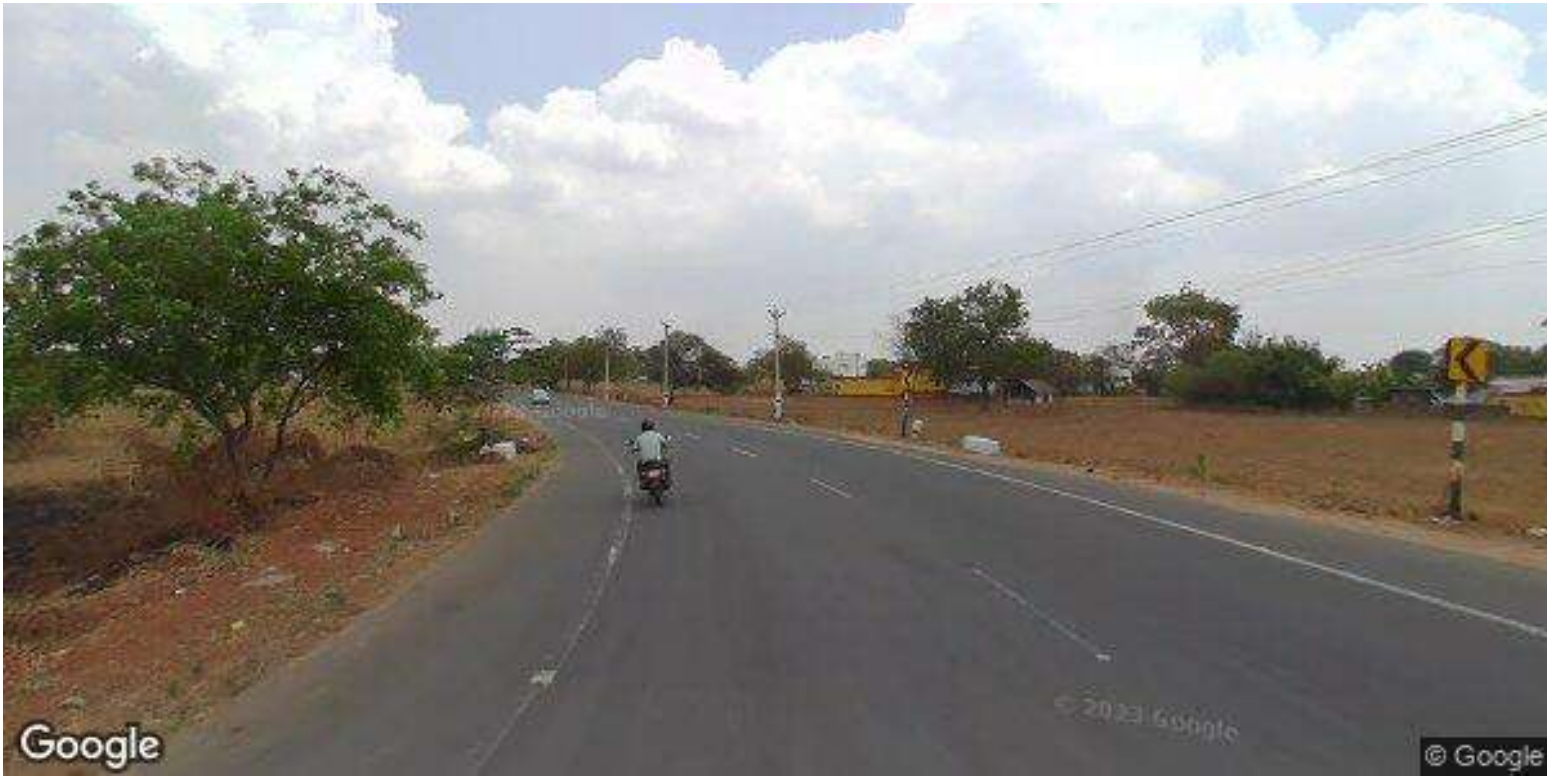
**Risk Type:** Turn  
**Risk Level:** Medium  
**Speed Limit:** 30 KM/Hr  
**Coordinates:** 11.16381, 77.43700

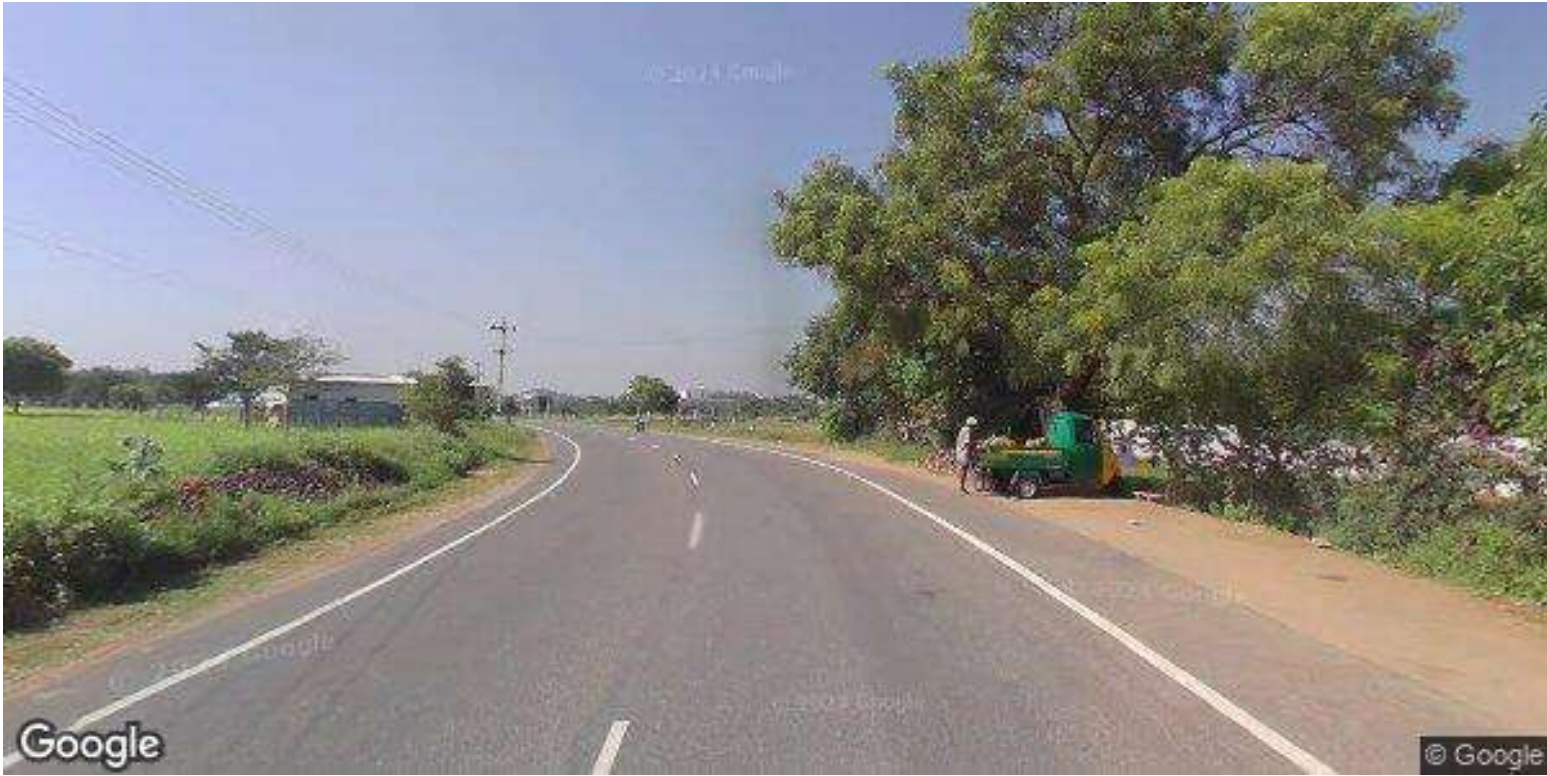
**Risk Type:** Turn  
**Risk Level:** Medium  
**Speed Limit:** 30 KM/Hr  
**Coordinates:** 11.16280, 77.43139

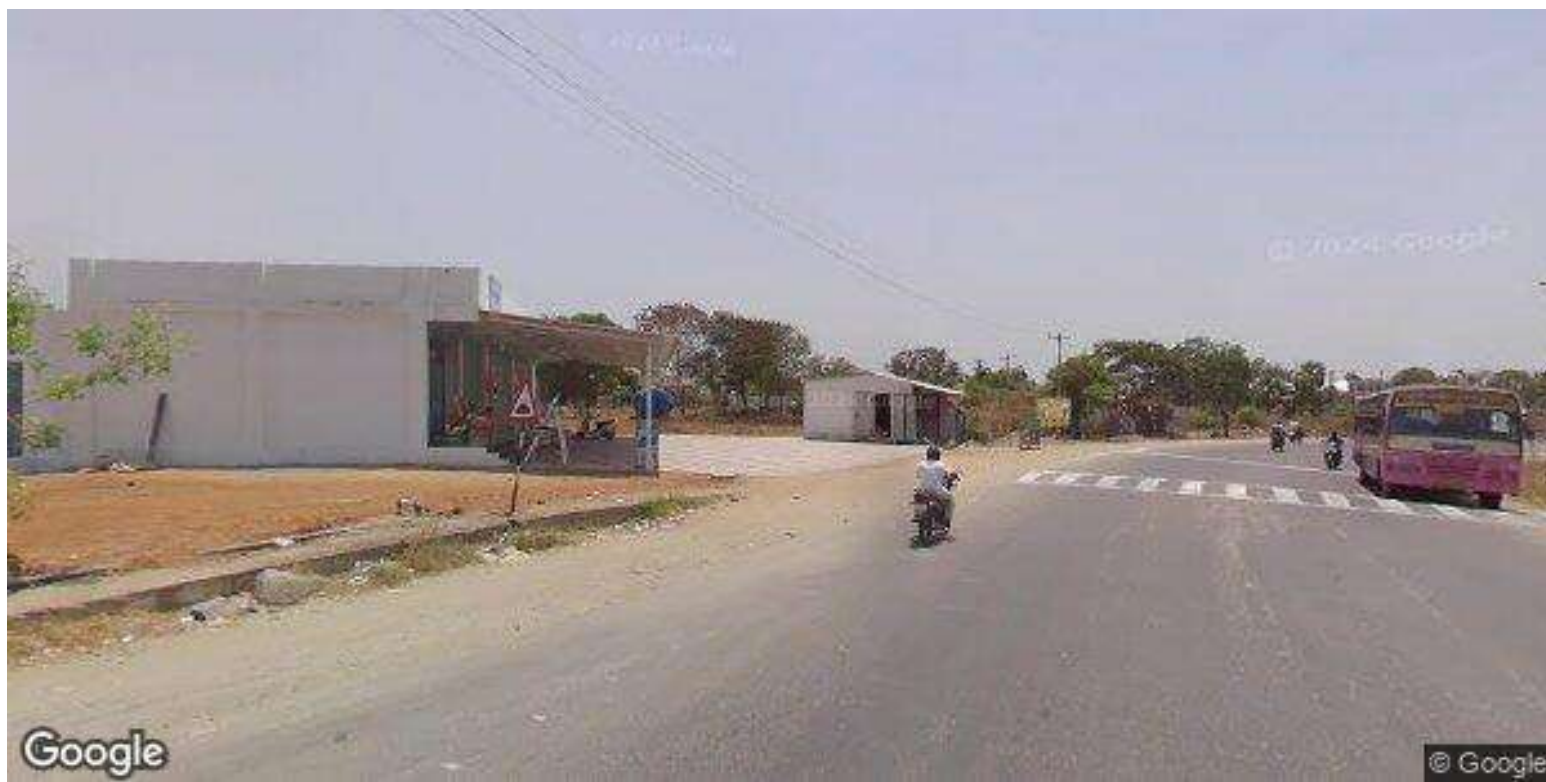
**Coordinates:** 11.15023, 77.42247

**Risk Type:** Turn

**Risk Level:** Medium

**Speed Limit:** 30 KM/Hr

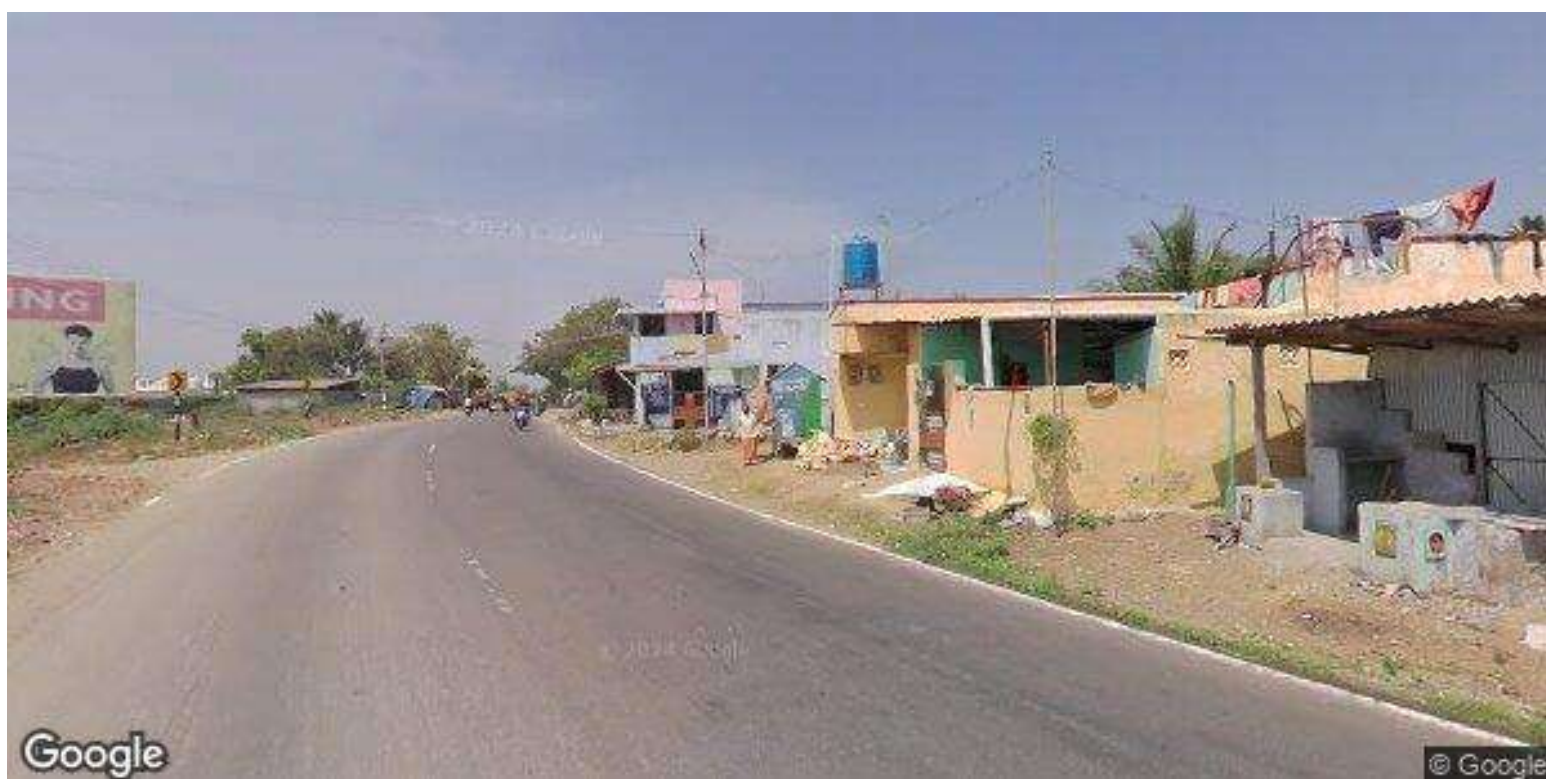
**Coordinates:** 11.13848, 77.41611

**Risk Type:** Turn

**Risk Level:** Medium

**Speed Limit:** 30 KM/Hr

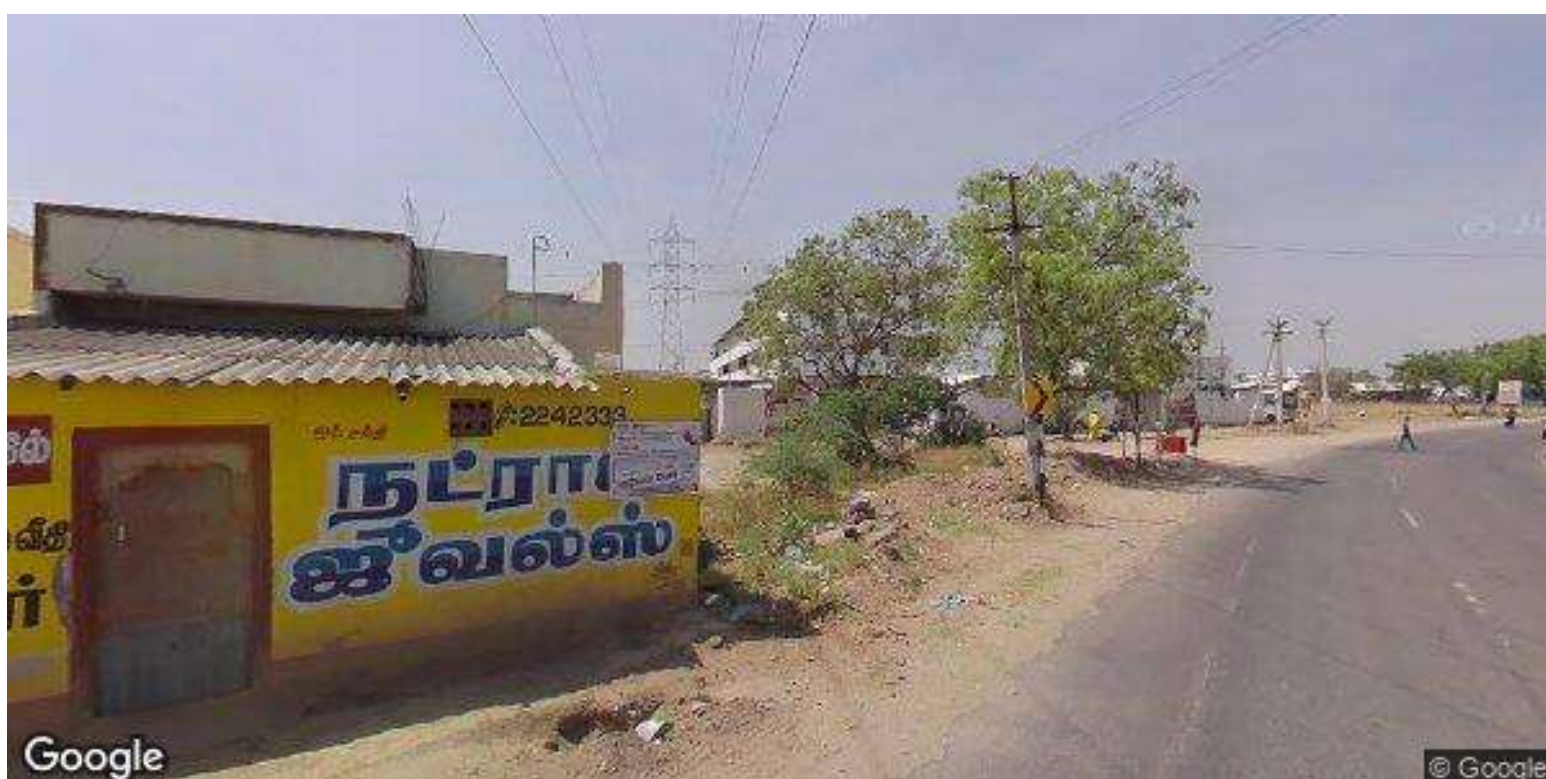
**Risk Type:** Turn  
**Risk Level:** Medium  
**Speed Limit:** 30 KM/Hr  
**Coordinates:** 11.13578, 77.41299

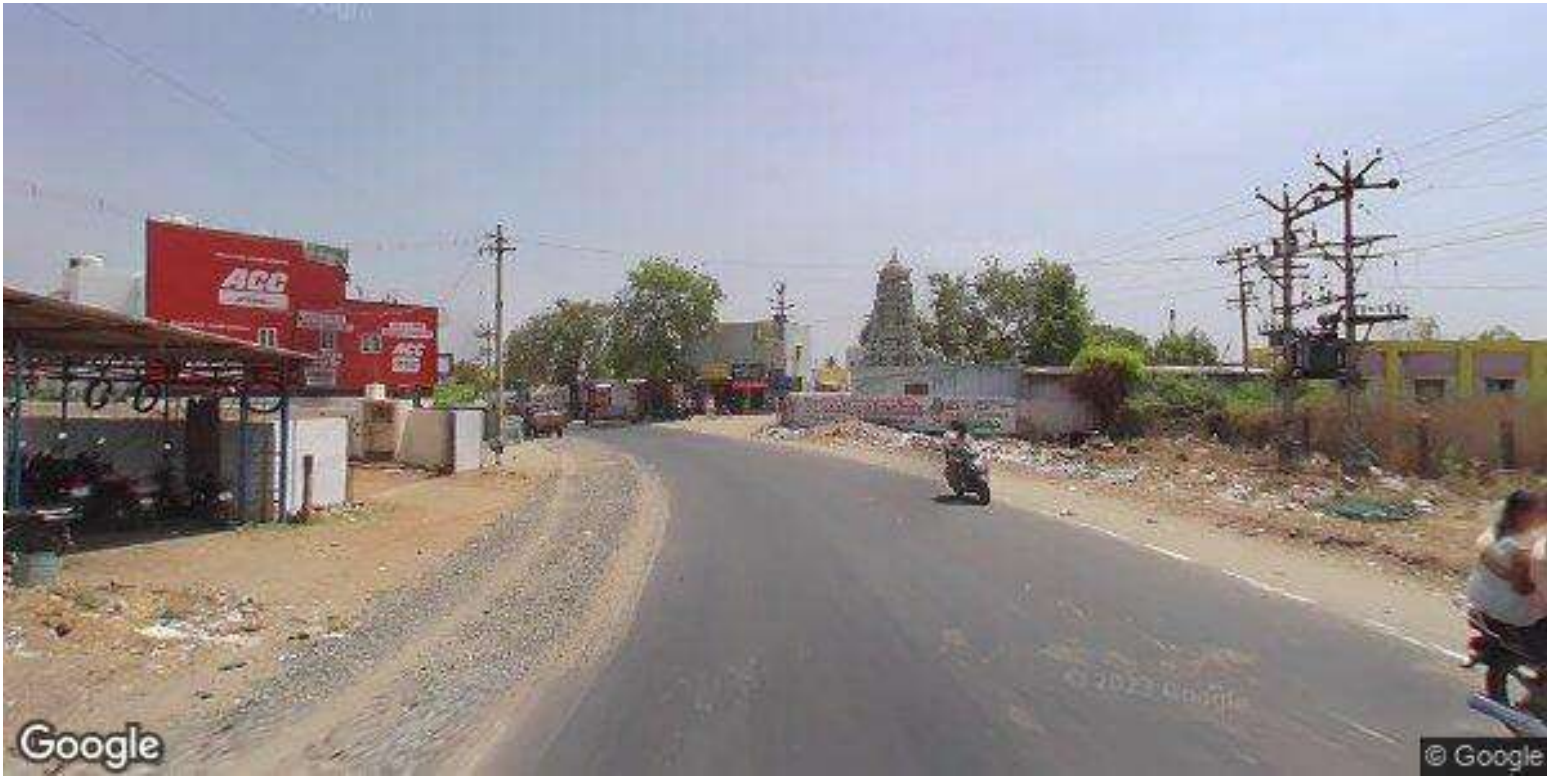
**Risk Type:** Turn  
**Risk Level:** Medium  
**Speed Limit:** 30 KM/Hr  
**Coordinates:** 11.12989, 77.40302

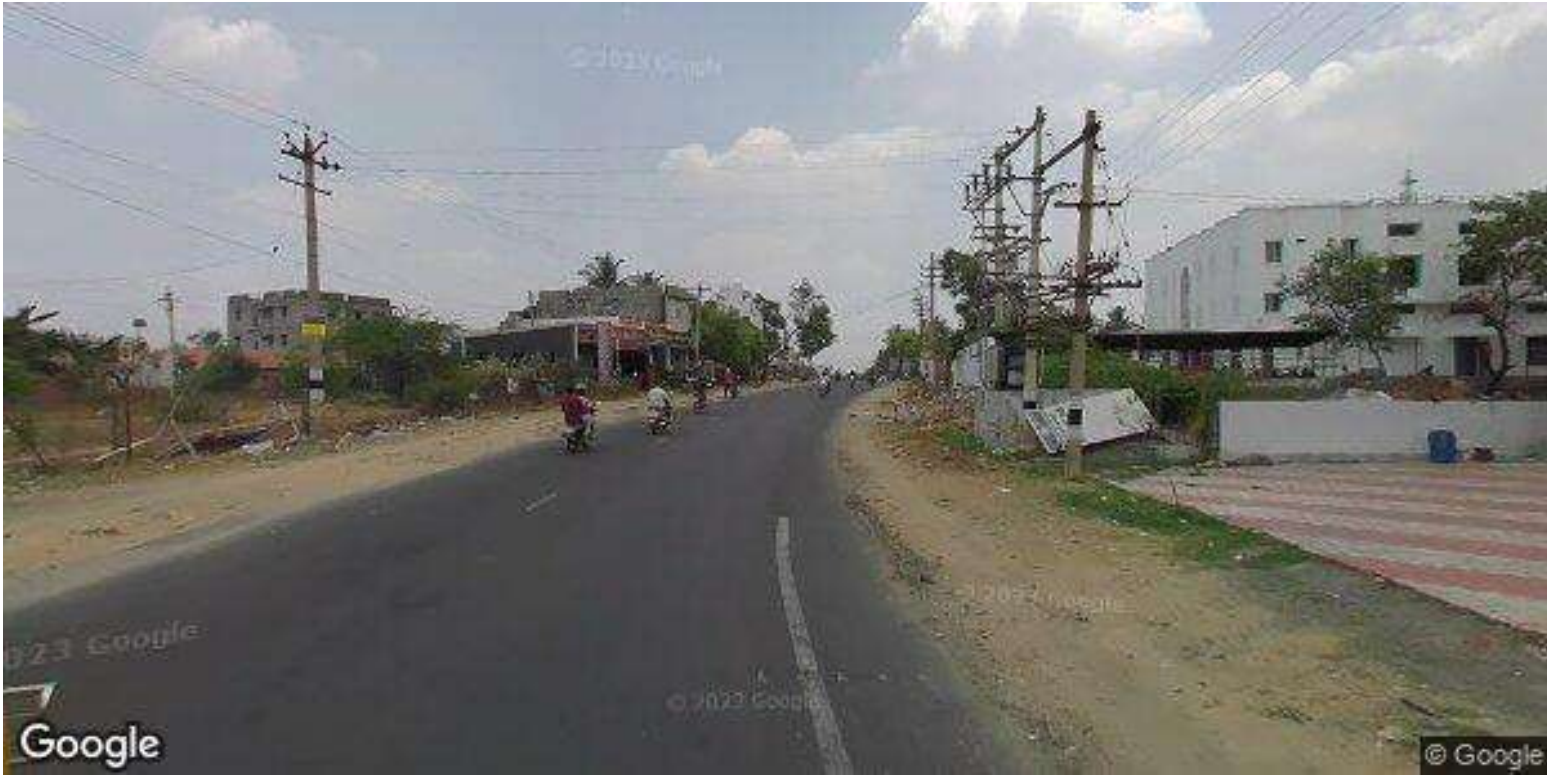
**Risk Type:** Turn  
**Risk Level:** Medium  
**Speed Limit:** 30 KM/Hr  
**Coordinates:** 11.12465, 77.38649

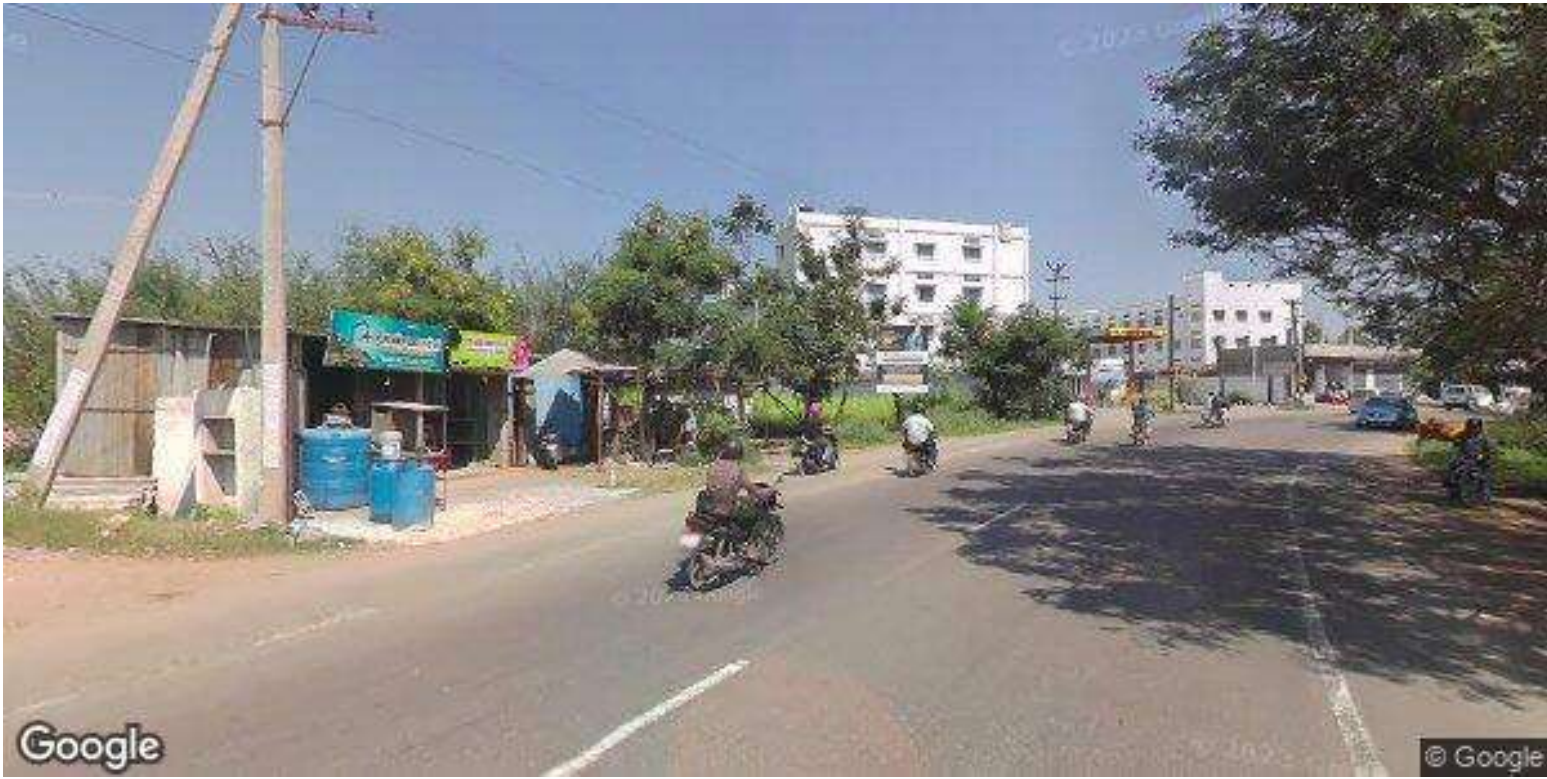
**Risk Type:** Turn  
**Risk Level:** Medium  
**Speed Limit:** 30 KM/Hr  
**Coordinates:** 11.12232, 77.38291

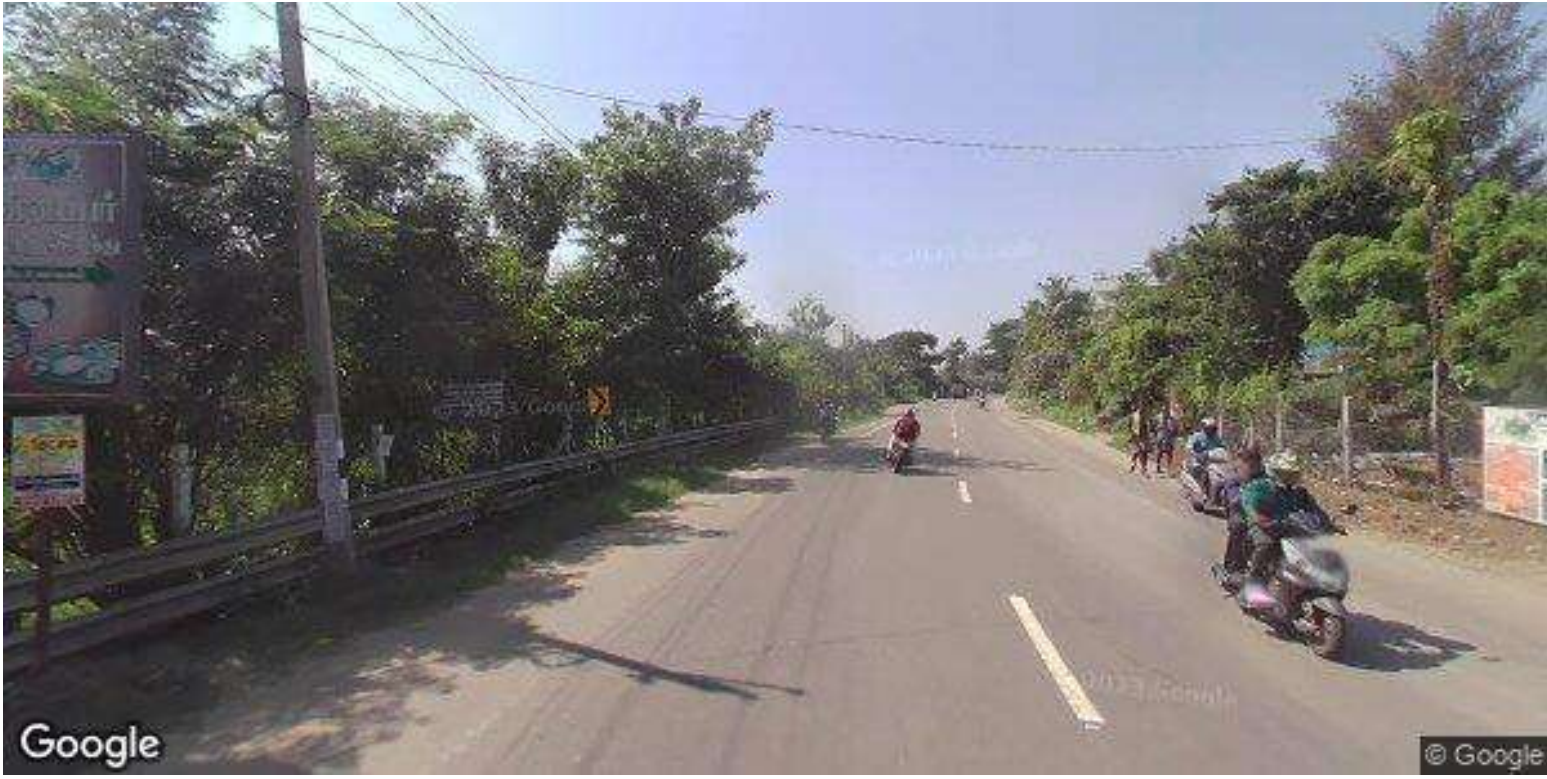
**Risk Type:** Turn  
**Risk Level:** Medium  
**Speed Limit:** 30 KM/Hr  
**Coordinates:** 11.12104, 77.38220

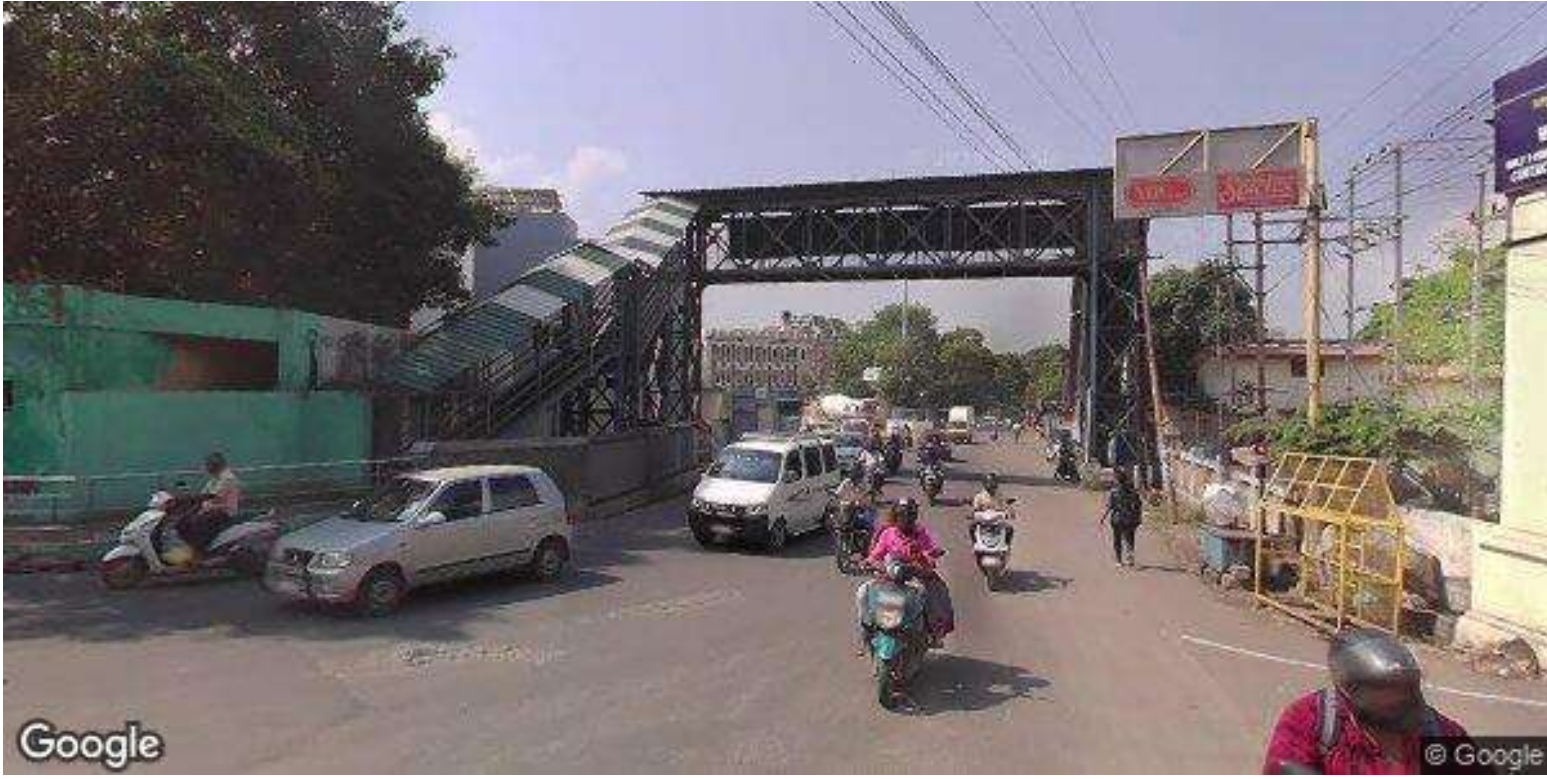
**Coordinates:** 11.10798, 77.34071

**Risk Type:** Blind Spot

**Risk Level:** Blind Spot

**Speed Limit:** 10 KM/Hr

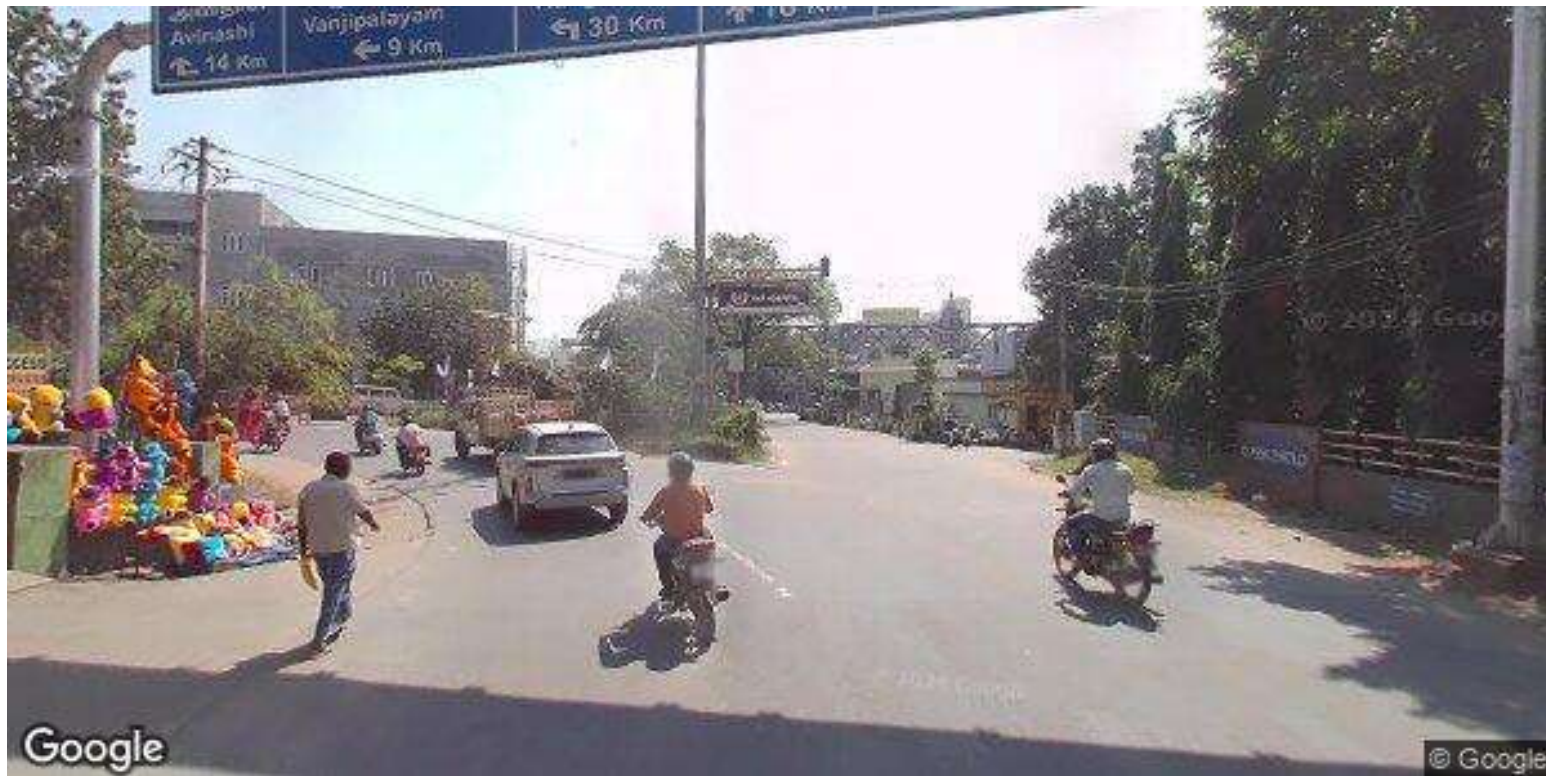
**Coordinates:** 11.10746, 77.34098

**Risk Type:** Turn

**Risk Level:** Medium

**Speed Limit:** 30 KM/Hr

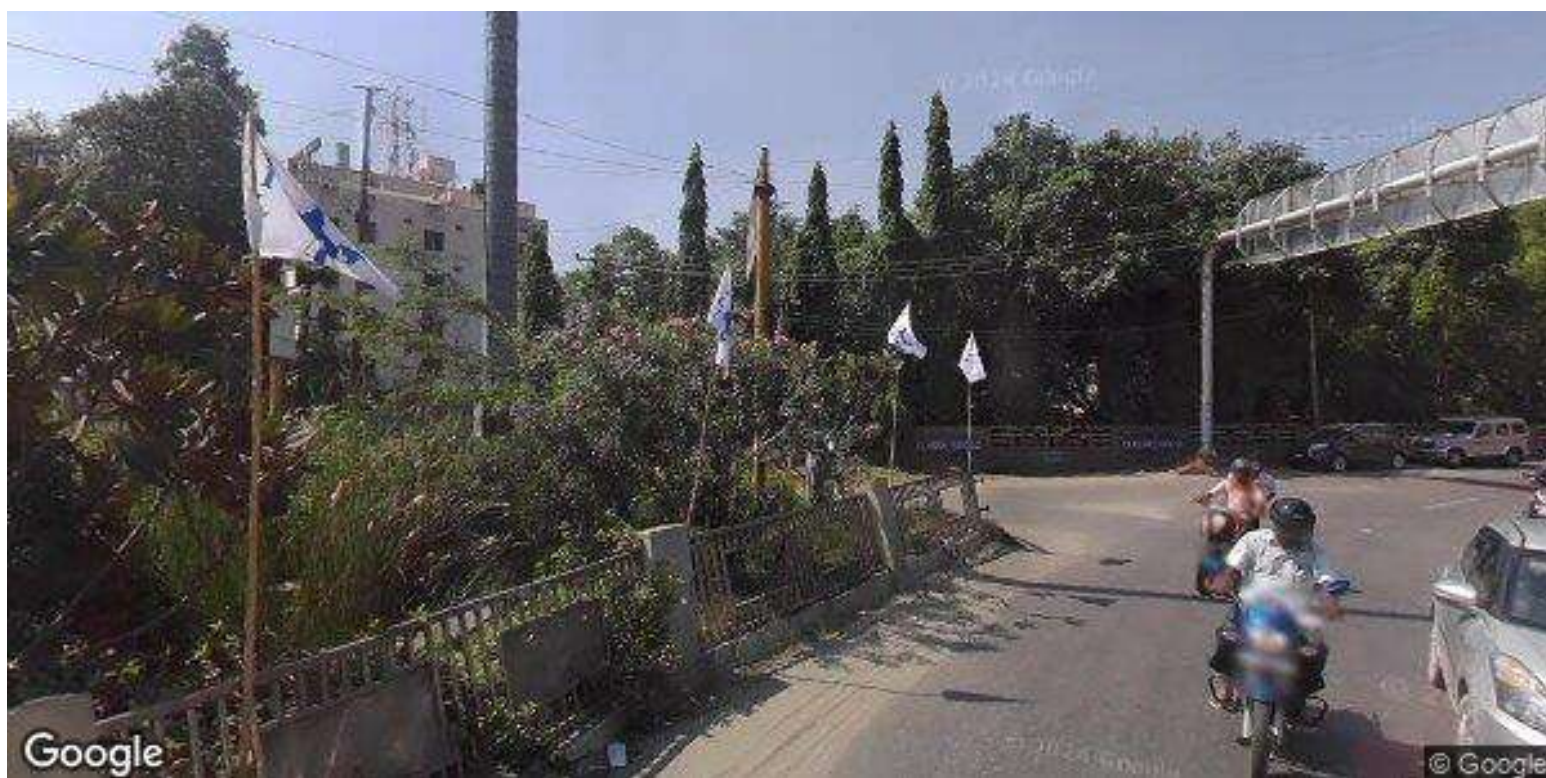
**Coordinates:** 11.10736, 77.34122

**Risk Type:** Turn

**Risk Level:** Medium

**Speed Limit:** 30 KM/Hr
