# IndianOil

## JOURNEY RISK MANAGEMENT (JRM) STUDY

### Salem Terminal TO LAKSHMI AGENCIES

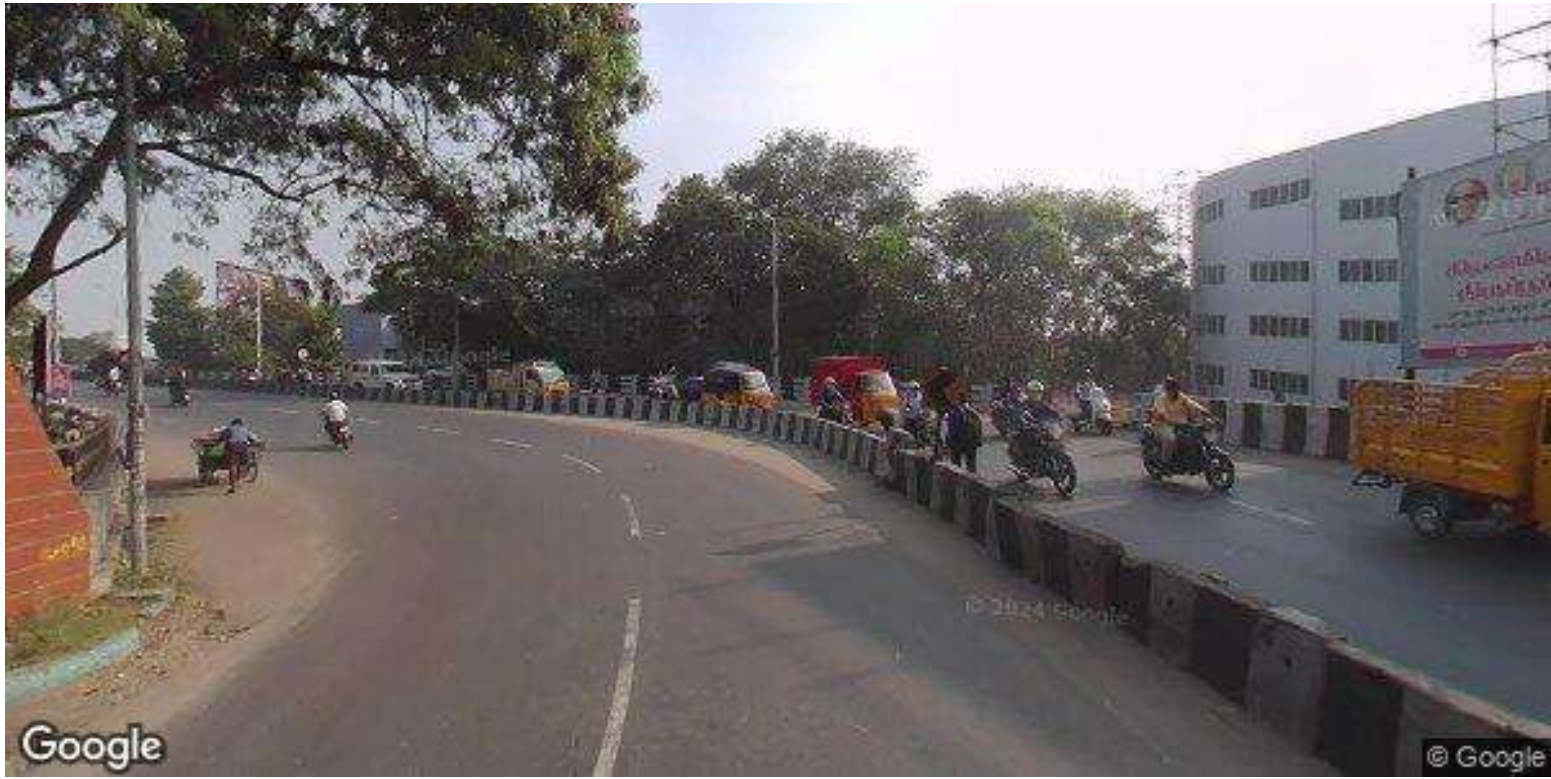
**Risk Type:** Turn  
**Risk Level:** Medium  
**Speed Limit:** 30 KM/Hr  
**Coordinates:** 11.10748, 77.34161

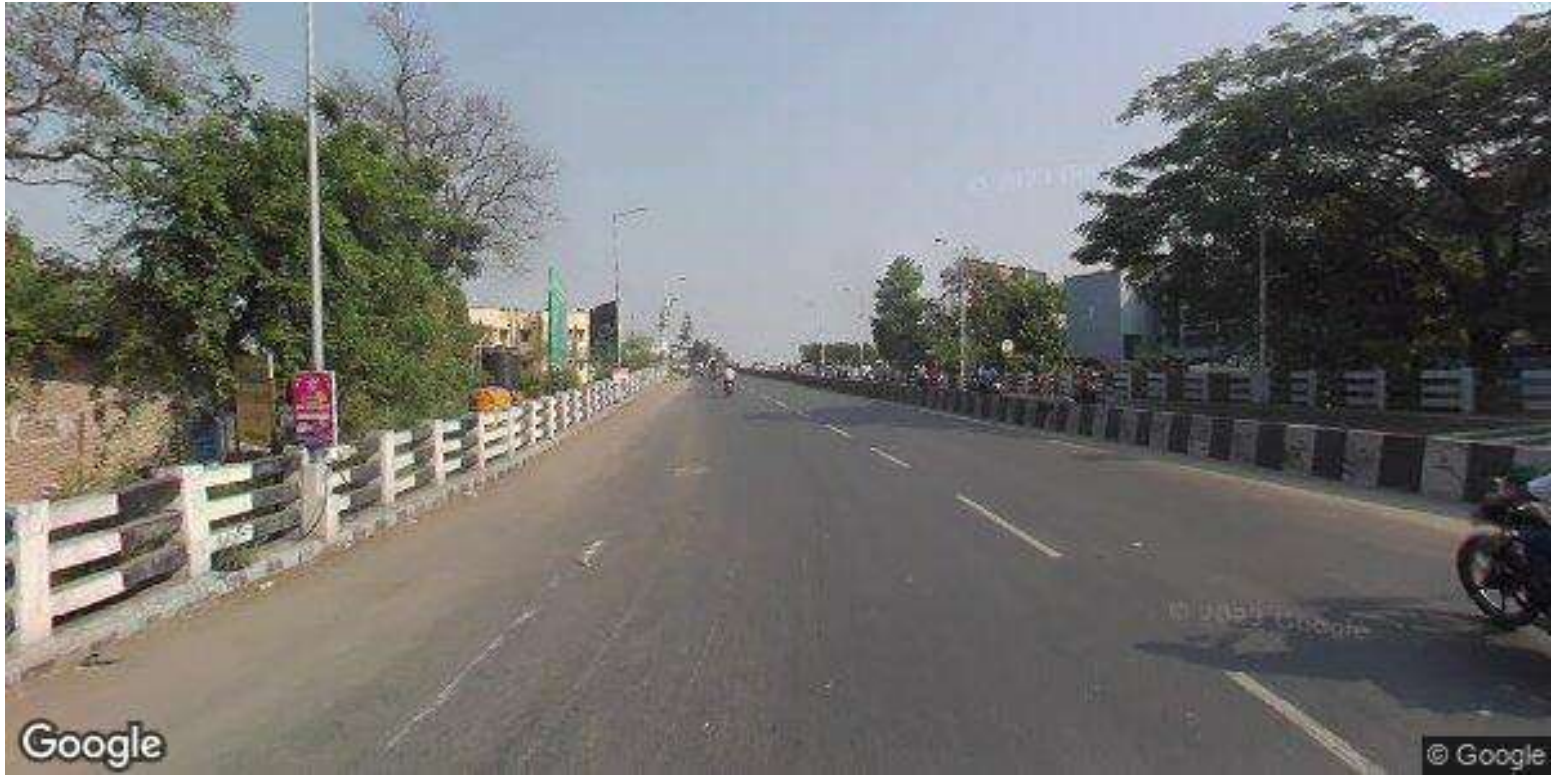
**Risk Type:** Turn  
**Risk Level:** Medium  
**Speed Limit:** 30 KM/Hr  
**Coordinates:** 11.10764, 77.34174

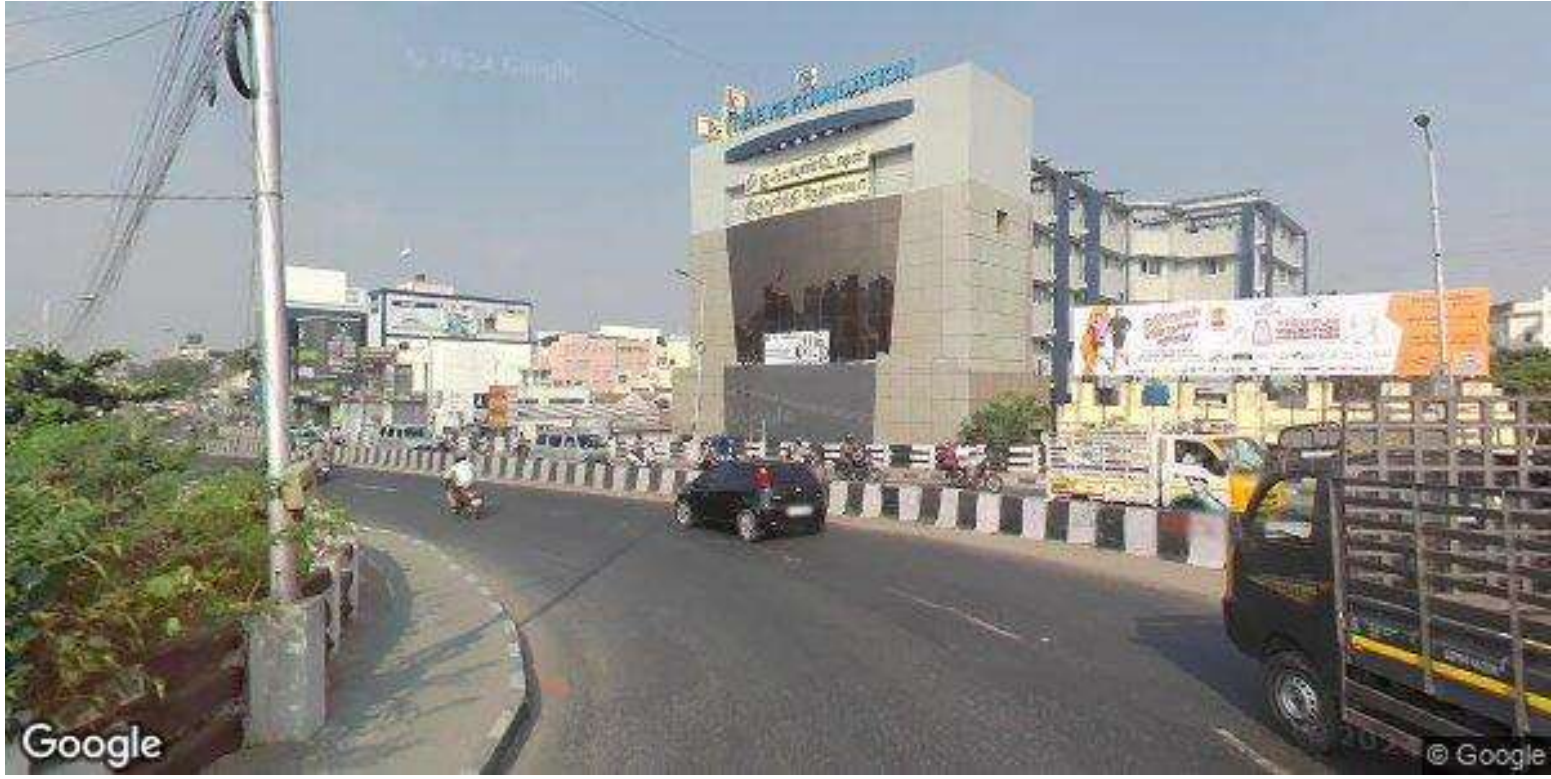
Coordinates: 11.10982, 77.34146

| | Risk Type | Risk Level | Coordinates | Speed Limit |
|---|---|---|---|---|
| 35 | Turn | High | 11.10982, 77.34146 | 15 KM/Hr |

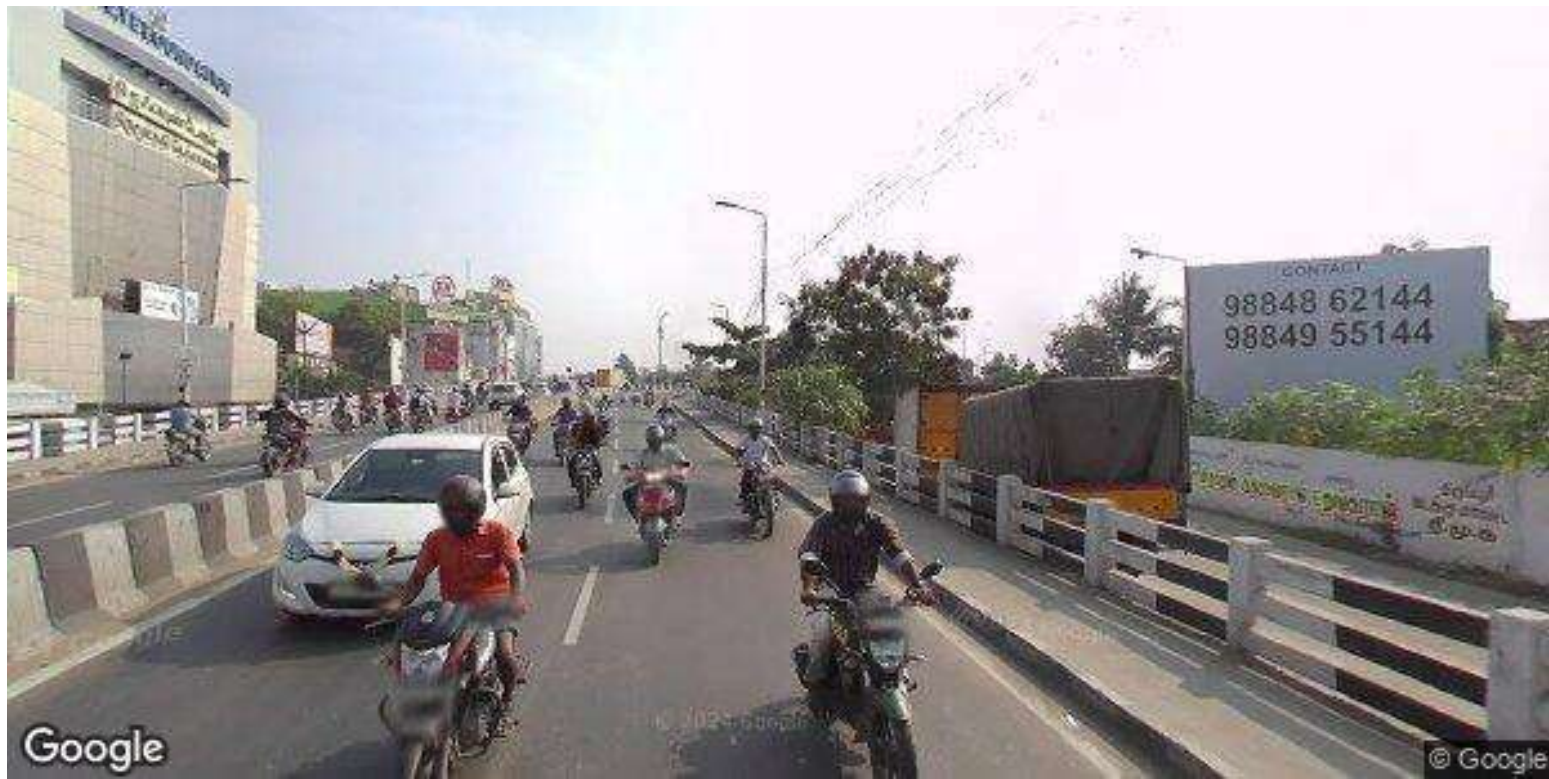
Coordinates: 11.10971, 77.34076

| | Risk Type | Risk Level | Coordinates | Speed Limit |
|---|---|---|---|---|
| 36 | Turn | Medium | 11.10971, 77.34076 | 30 KM/Hr |
