# IndianOil

## JOURNEY RISK MANAGEMENT (JRM) STUDY

### Salem Terminal TO MAHALAKSHMI & CO

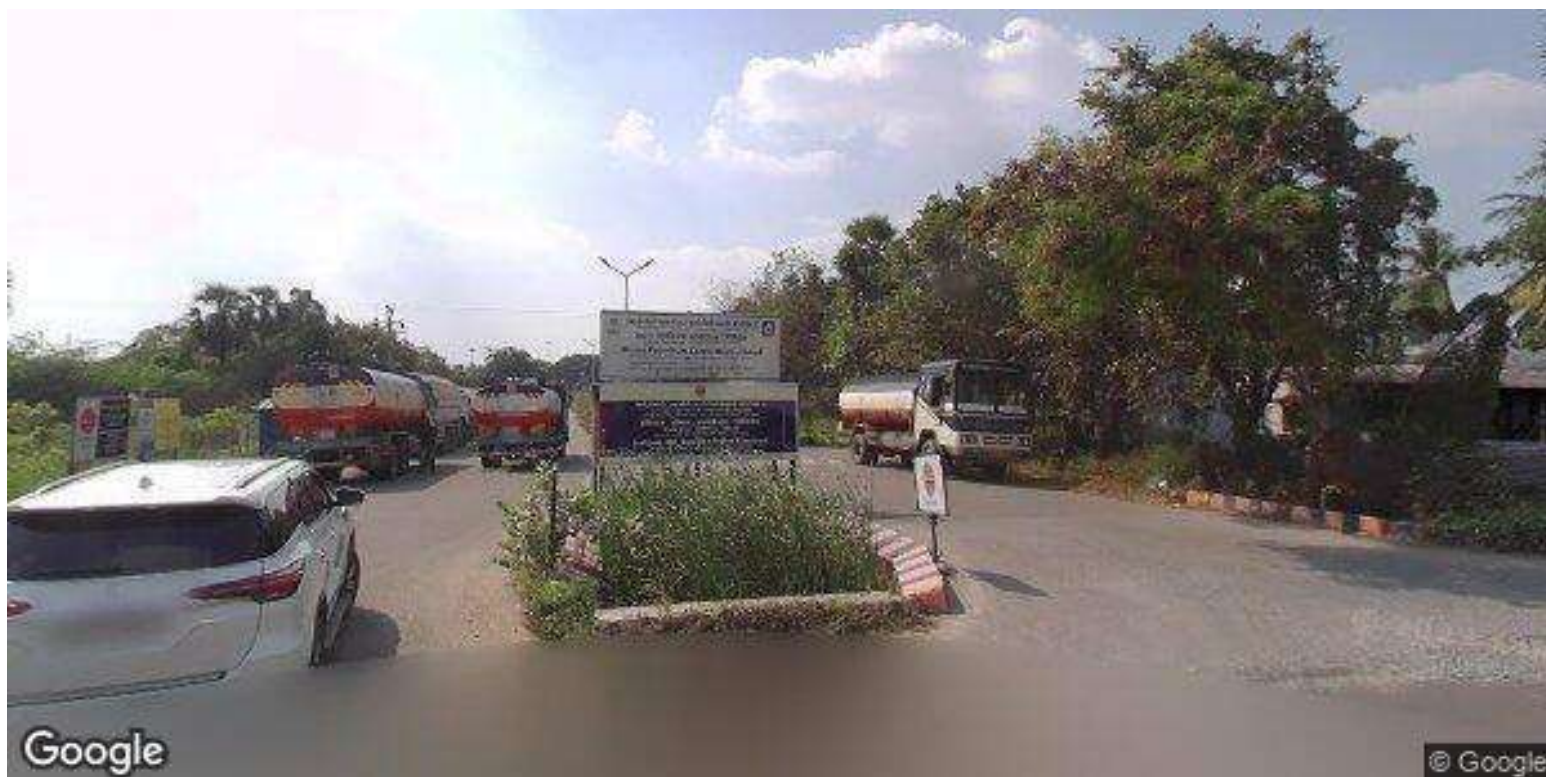
**Risk Type:** Turn

**Risk Level:** High

**Speed Limit:** 15 KM/Hr

**Coordinates:** 11.44024, 77.87528

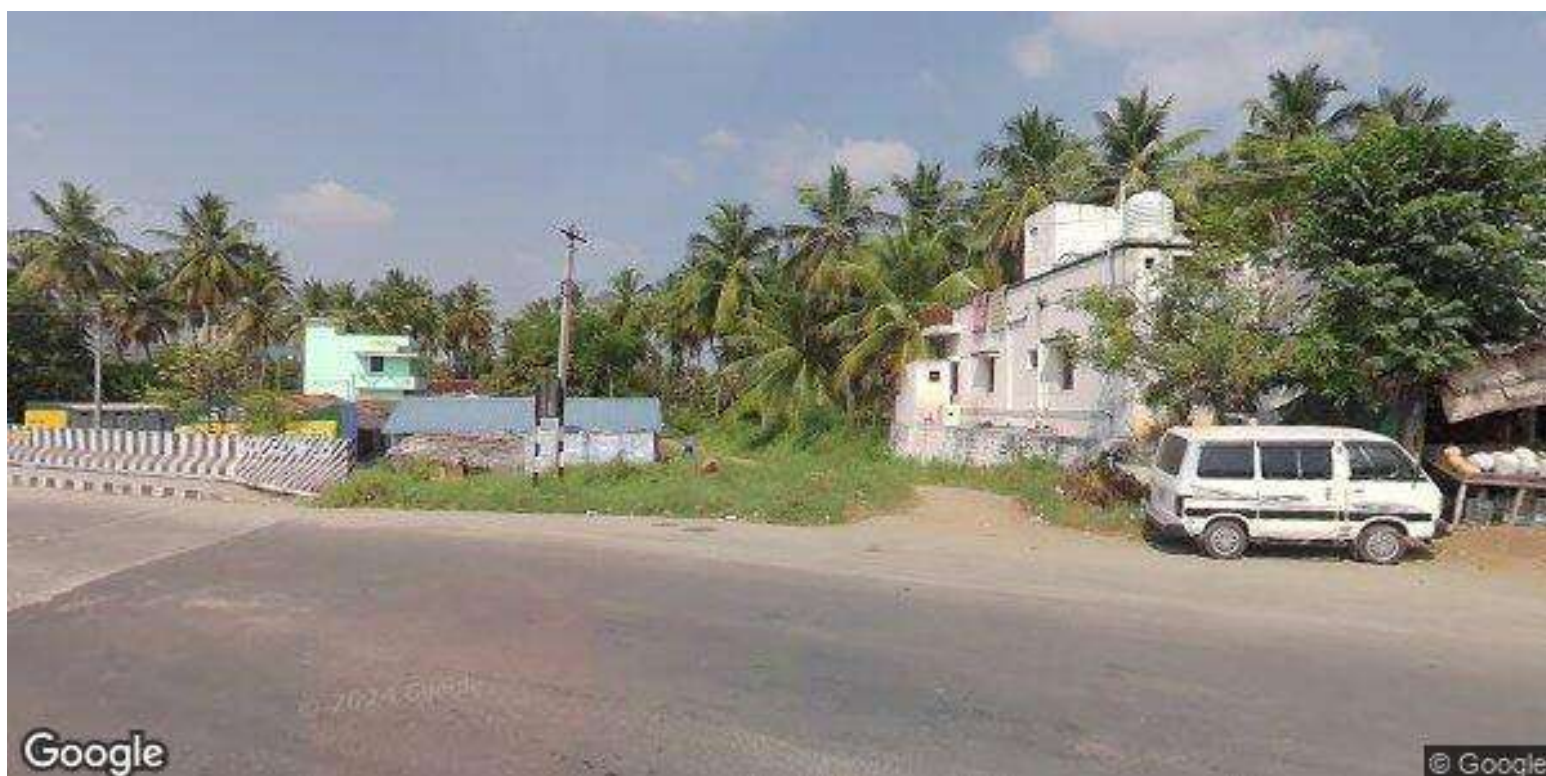
**Risk Type:** Turn

**Risk Level:** High

**Speed Limit:** 15 KM/Hr

**Coordinates:** 11.44898, 77.87410

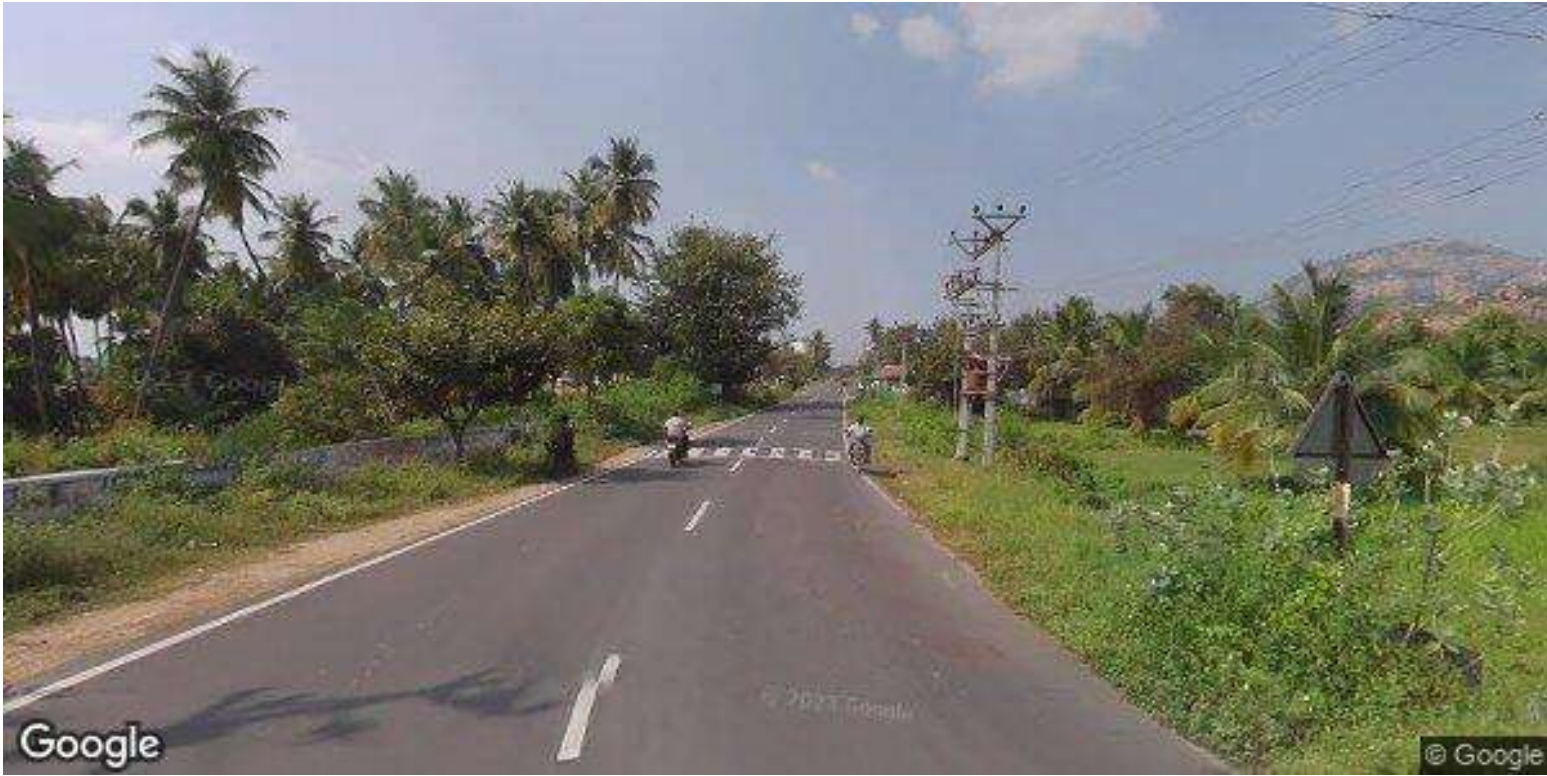
**Risk Type:** Turn  
**Risk Level:** High  
**Speed Limit:** 15 KM/Hr  
**Coordinates:** 11.45352, 77.85698

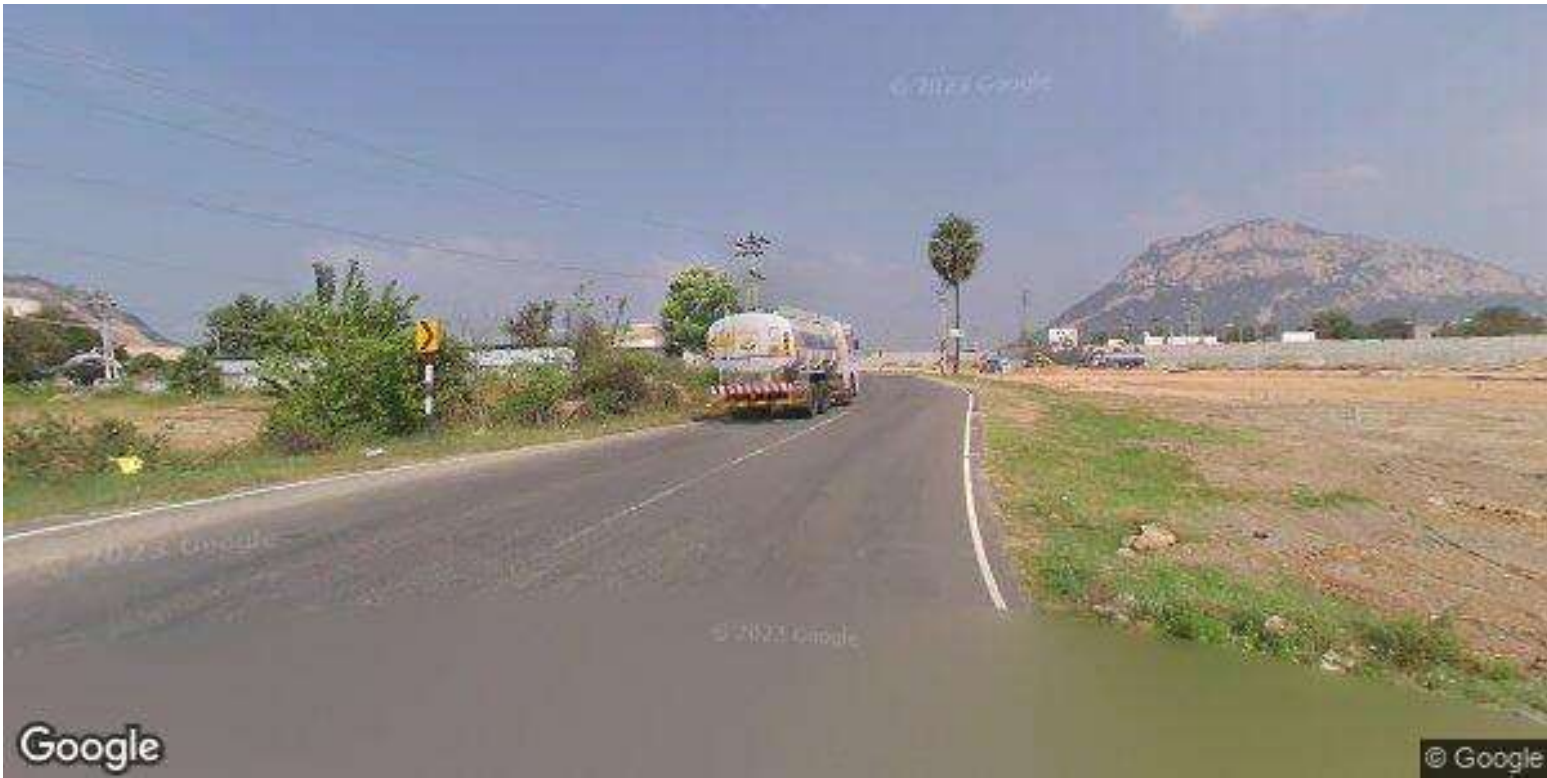
**Risk Type: Turn**

**Risk Level: Medium**

**Speed Limit: 30 KM/Hr**

**Coordinates: 11.45847, 77.85140**

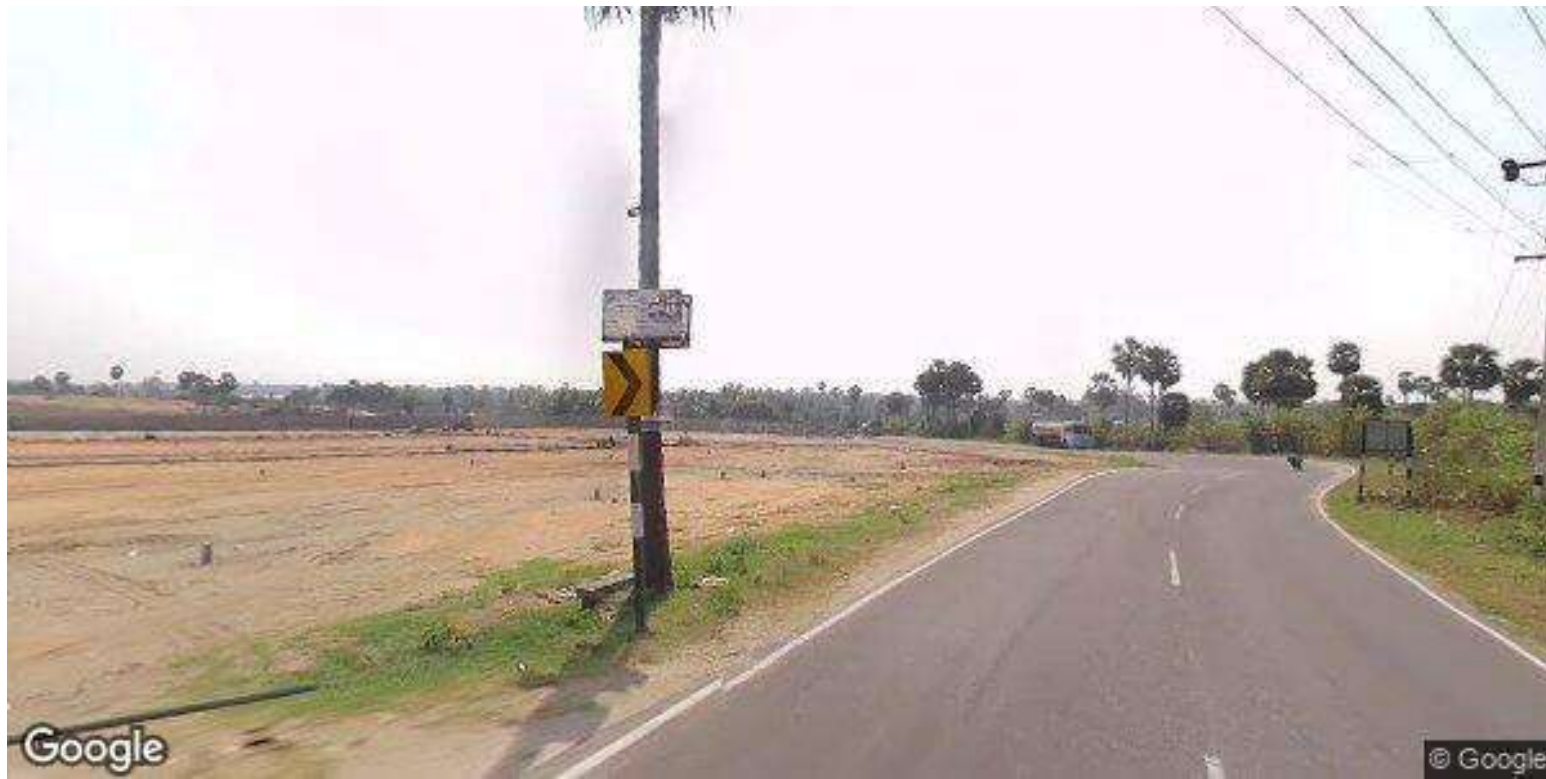
**Risk Type: Turn**

**Risk Level: Medium**

**Speed Limit: 30 KM/Hr**

**Coordinates: 11.45898, 77.85135**

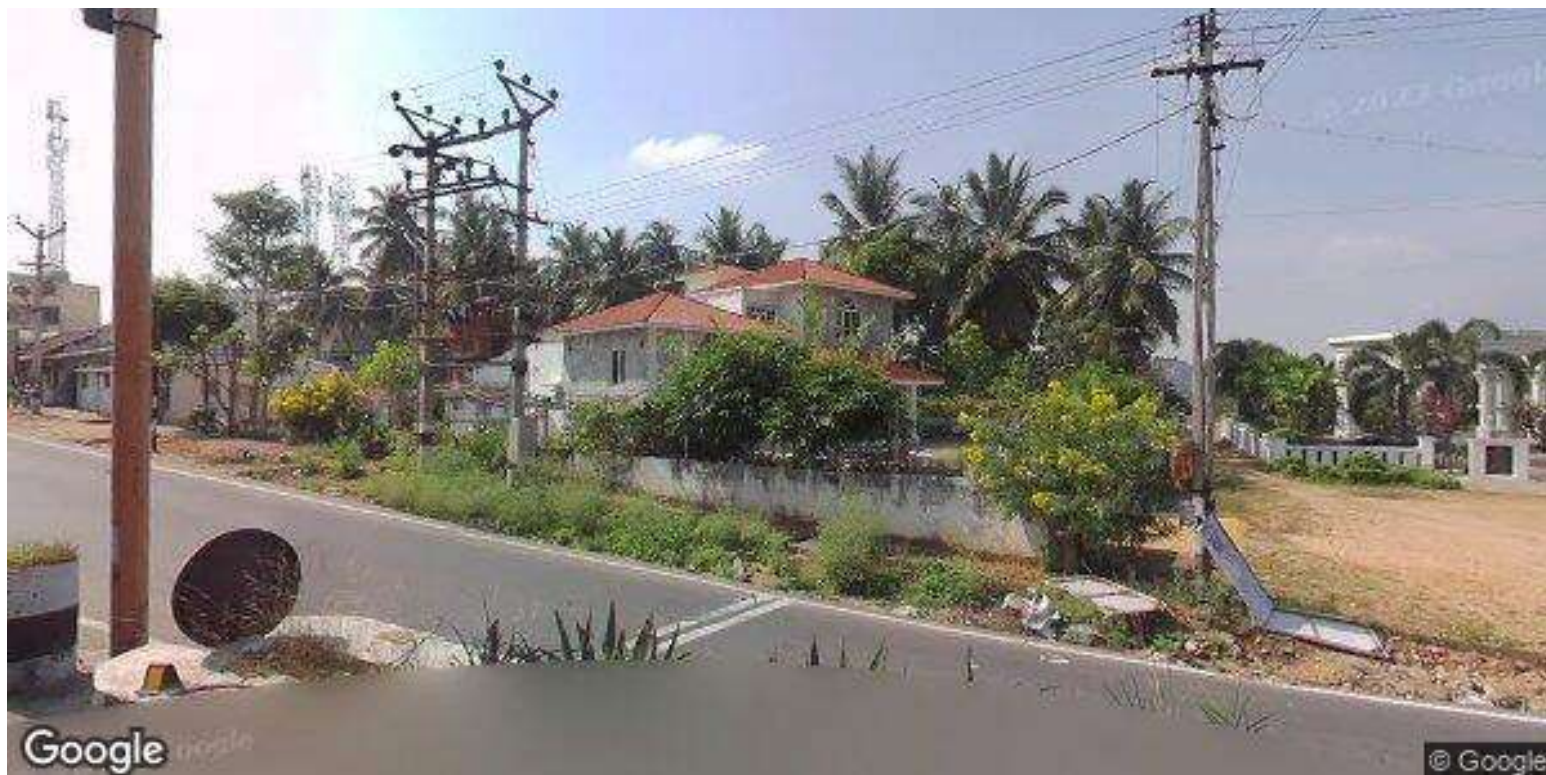
**Risk Type: Turn**

**Risk Level: High**

**Speed Limit: 15 KM/Hr**

**Coordinates: 11.46303, 77.84945**

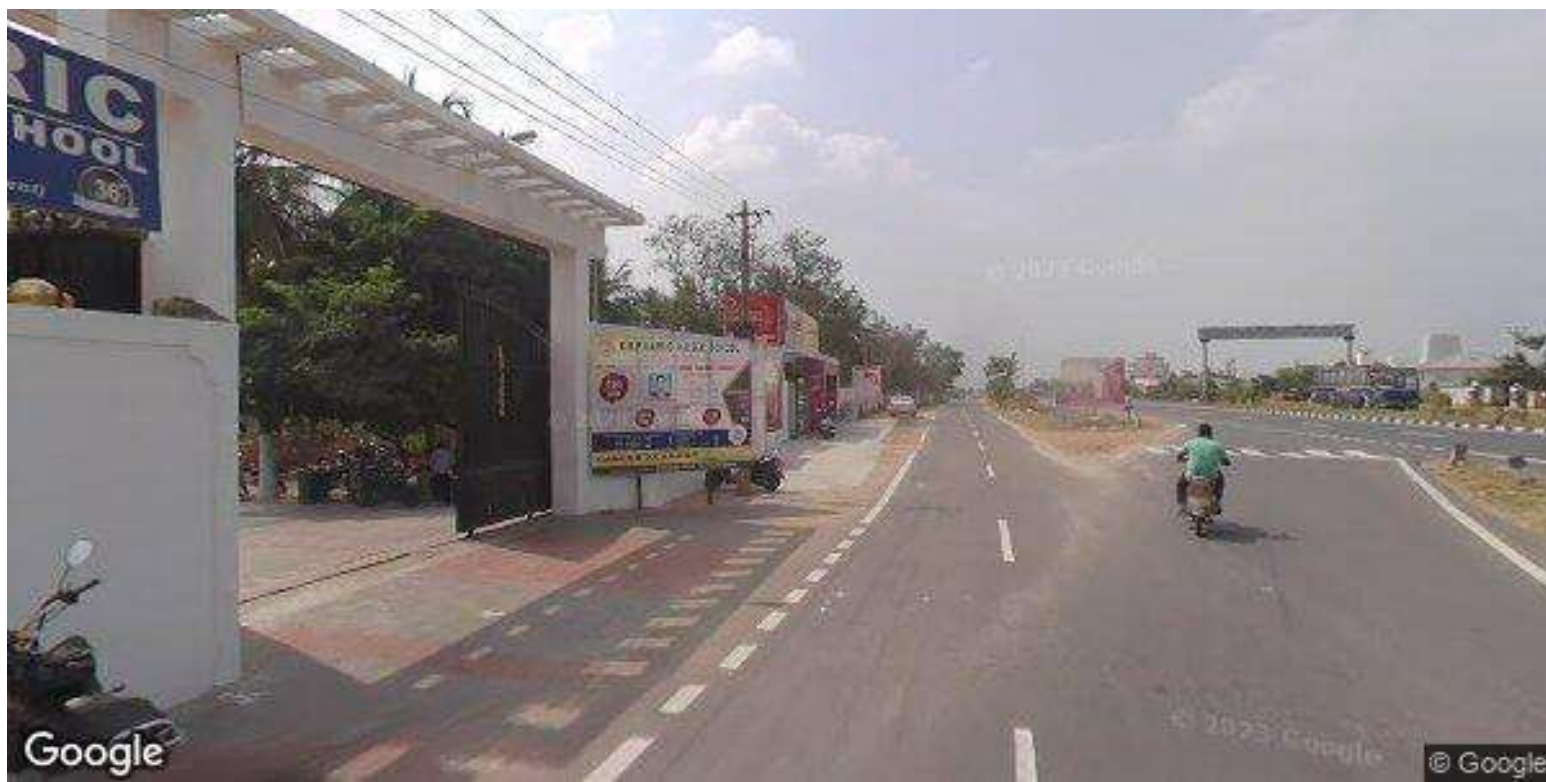
**Risk Type:** Turn

**Risk Level:** Medium

**Speed Limit:** 30 KM/Hr

**Coordinates:** 11.45509, 77.81383

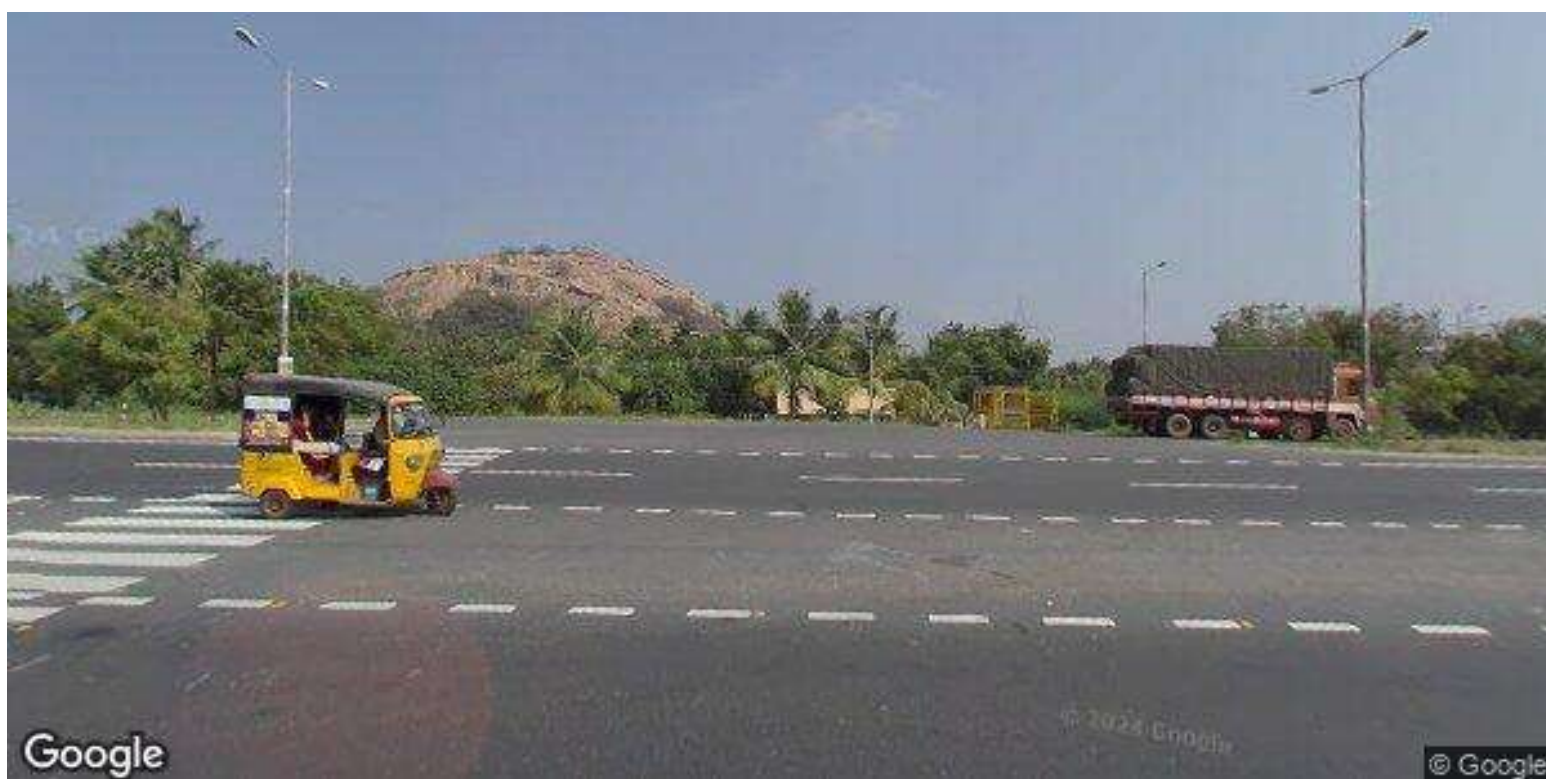
**Risk Type:** Turn

**Risk Level:** Medium

**Speed Limit:** 30 KM/Hr

**Coordinates:** 11.45085, 77.77020

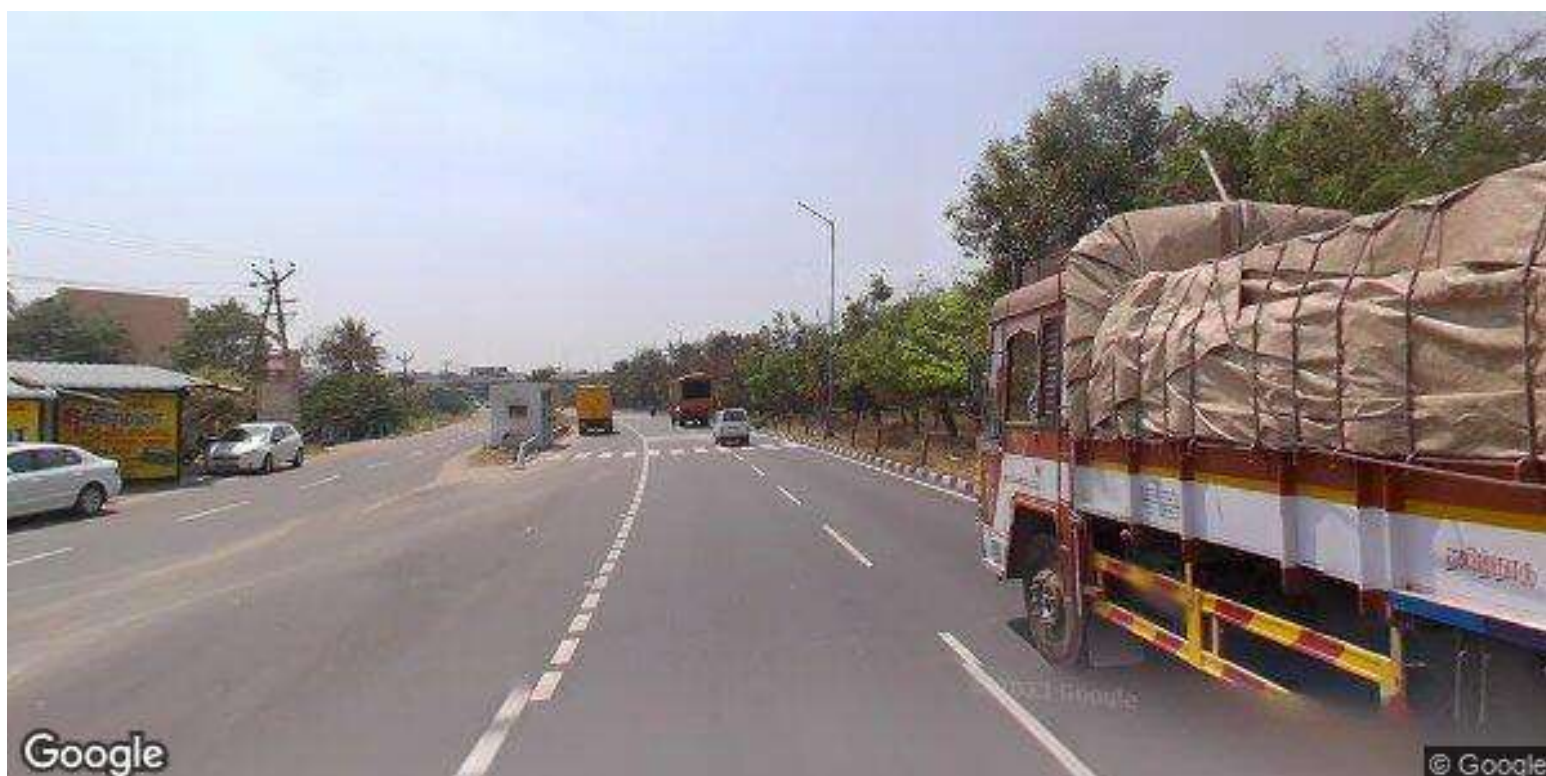
**Risk Type:** Turn  
**Risk Level:** Medium  
**Speed Limit:** 30 KM/Hr  
**Coordinates:** 11.43165, 77.67734

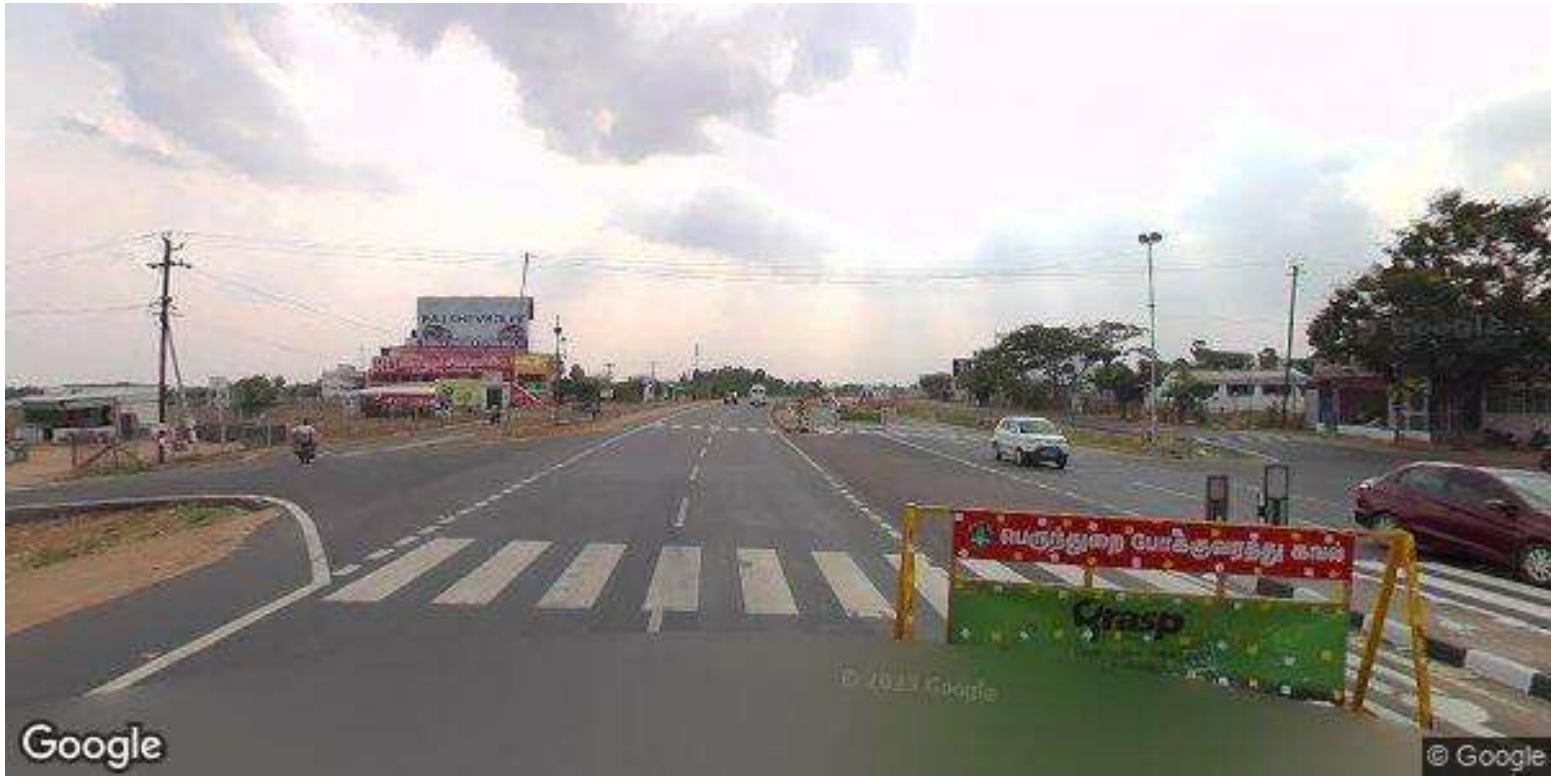
**Risk Type:** Turn  
**Risk Level:** Medium  
**Speed Limit:** 30 KM/Hr  
**Coordinates:** 11.23724, 77.50686

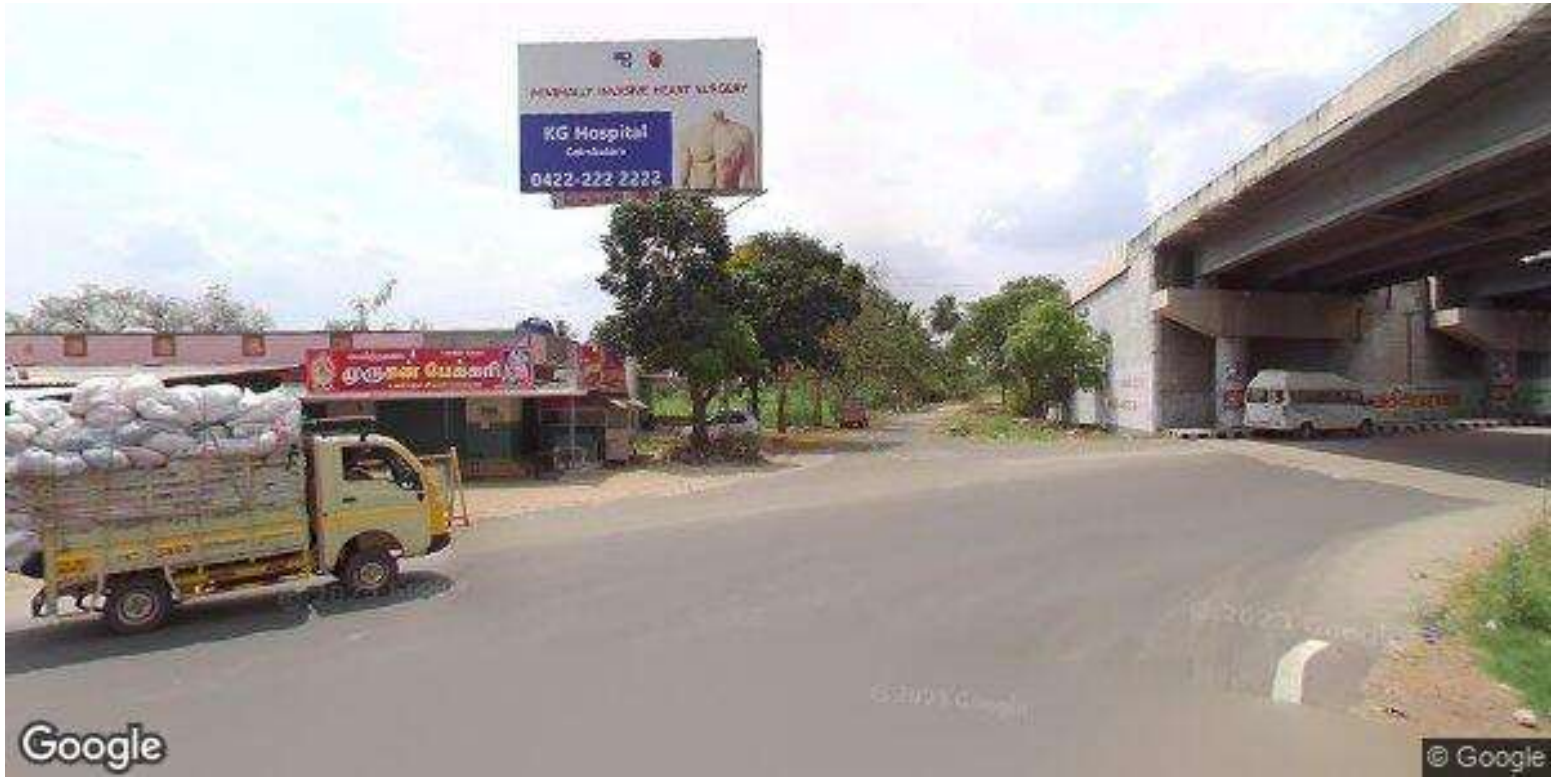
**Risk Type:** Blind Spot  
**Risk Level:** Blind Spot  
**Speed Limit:** 10 KM/Hr  
**Coordinates:** 11.23686, 77.50216

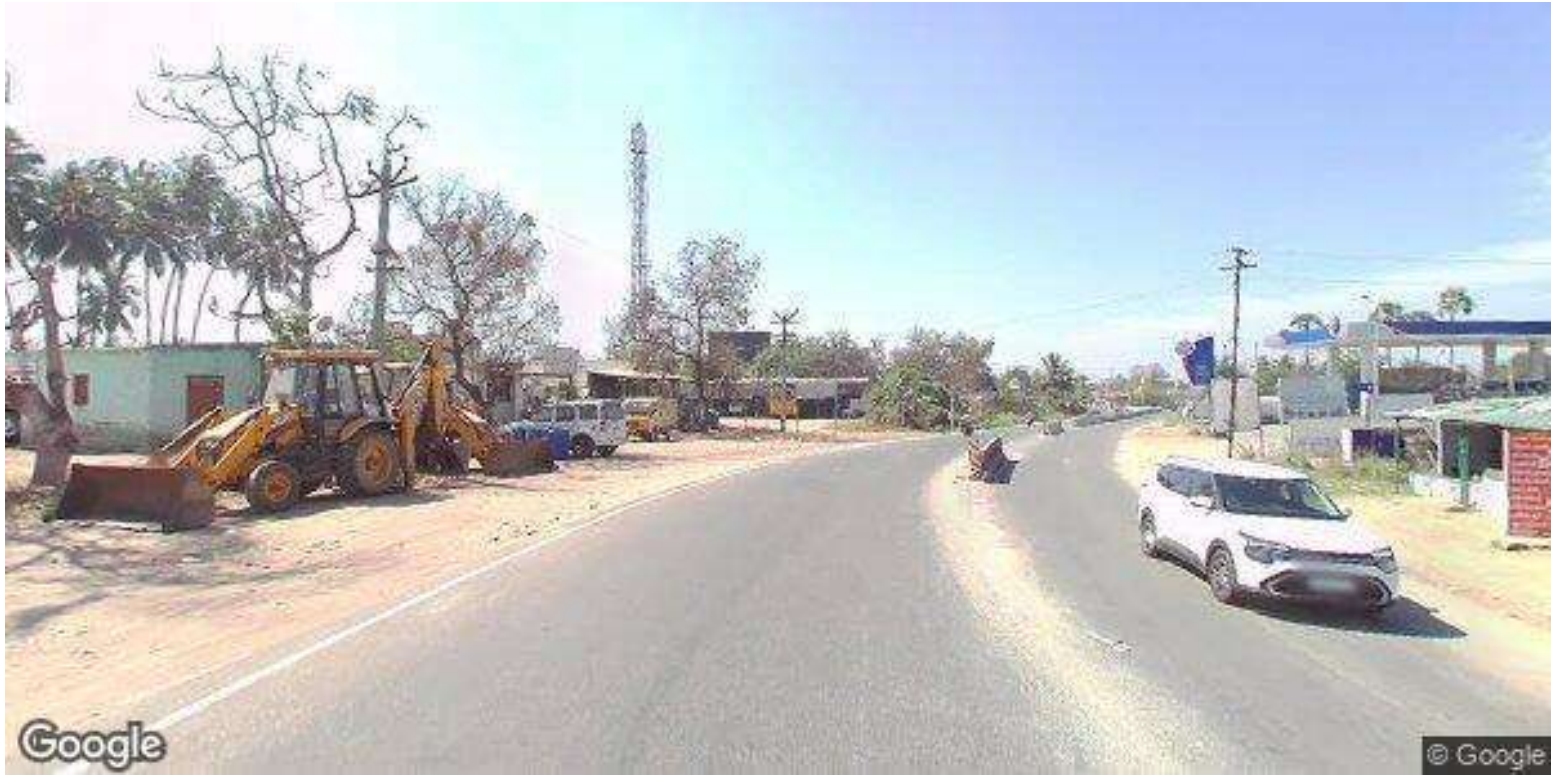
**Risk Type:** Turn  
**Risk Level:** Medium  
**Speed Limit:** 30 KM/Hr  
**Coordinates:** 11.23649, 77.50219

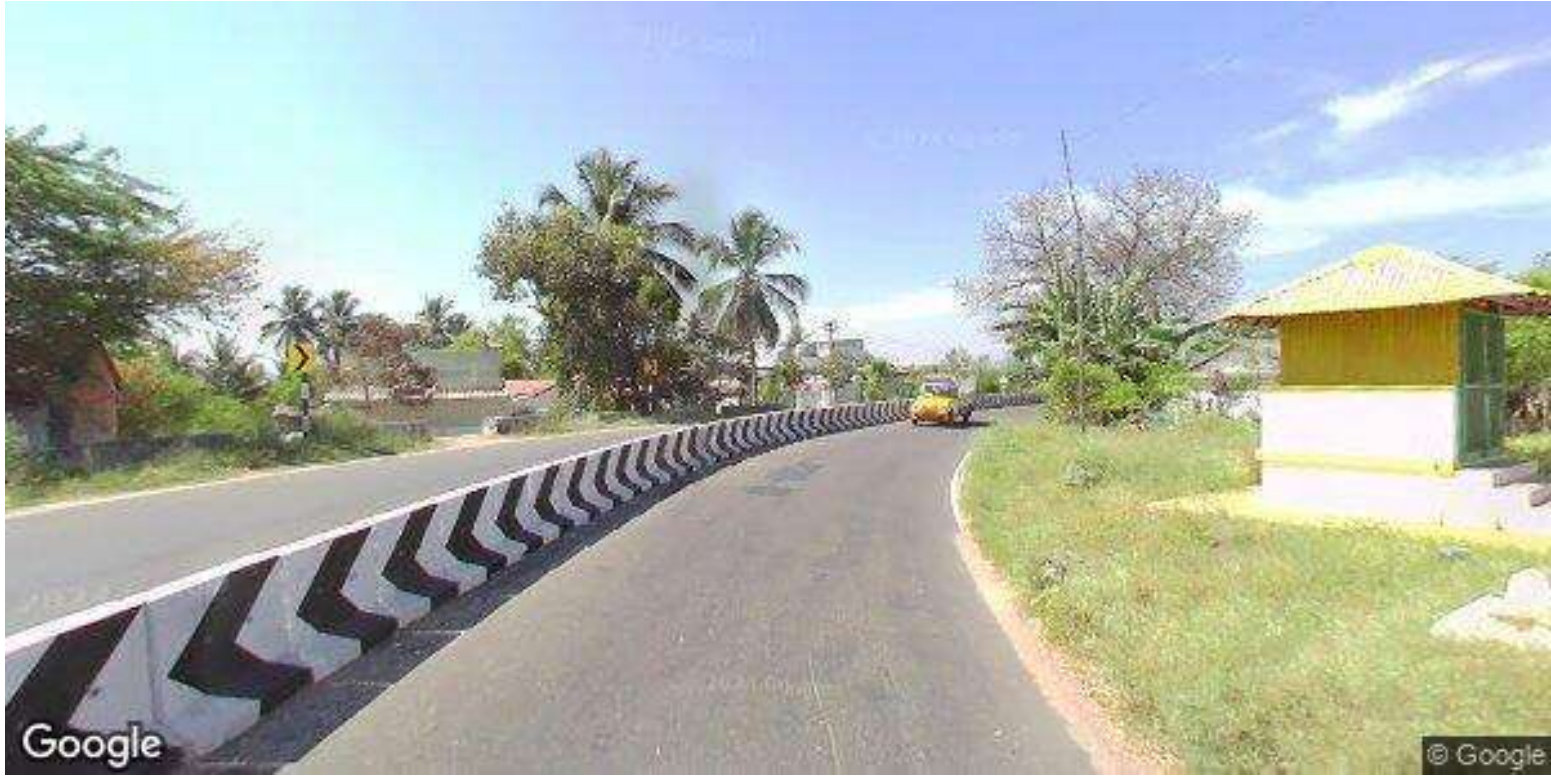
**Risk Type:** Turn  
**Risk Level:** High  
**Speed Limit:** 15 KM/Hr  
**Coordinates:** 11.23396, 77.50105

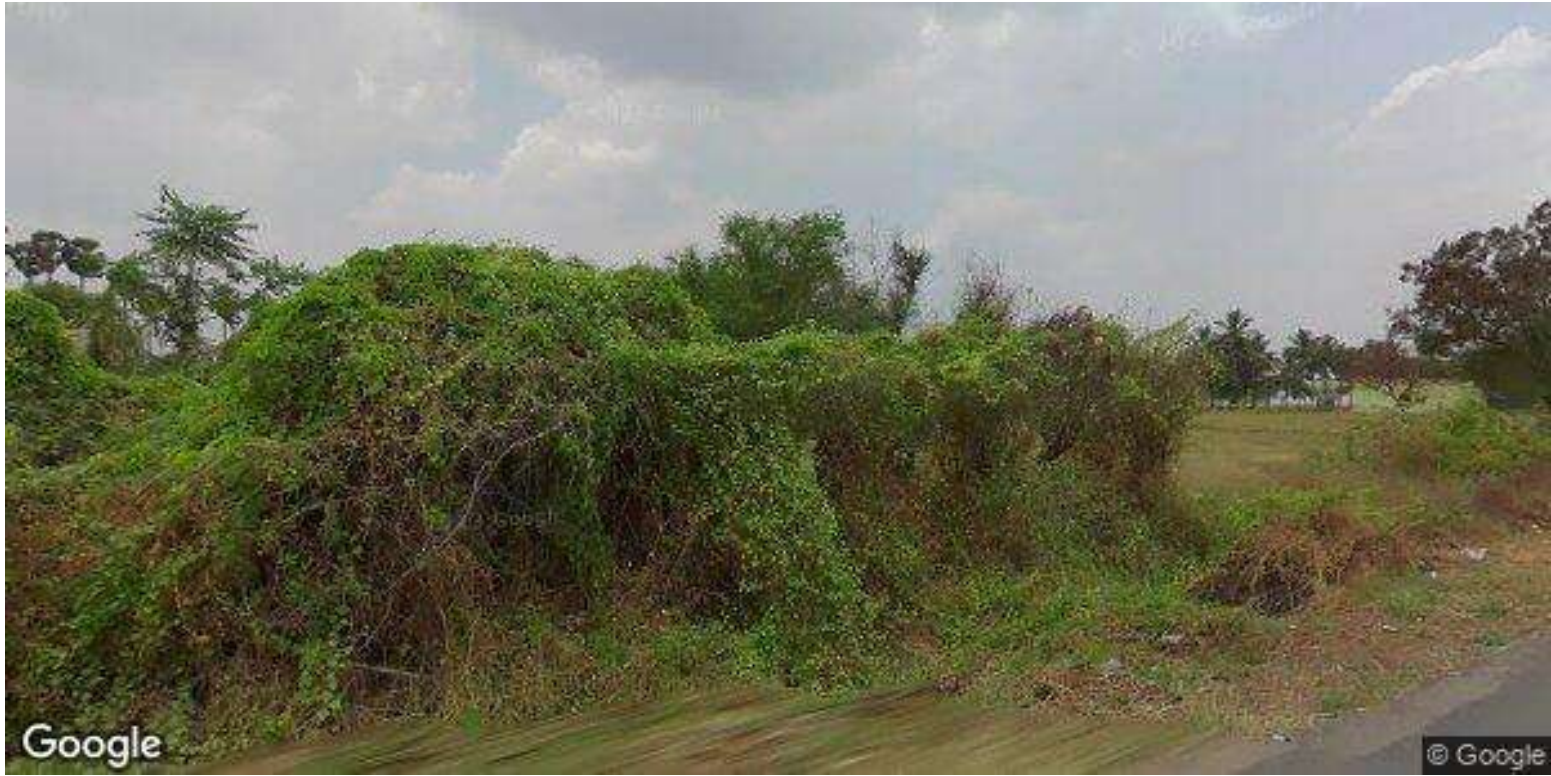
**Risk Type:** Turn  
**Risk Level:** Medium  
**Speed Limit:** 30 KM/Hr  
**Coordinates:** 11.17851, 77.46169

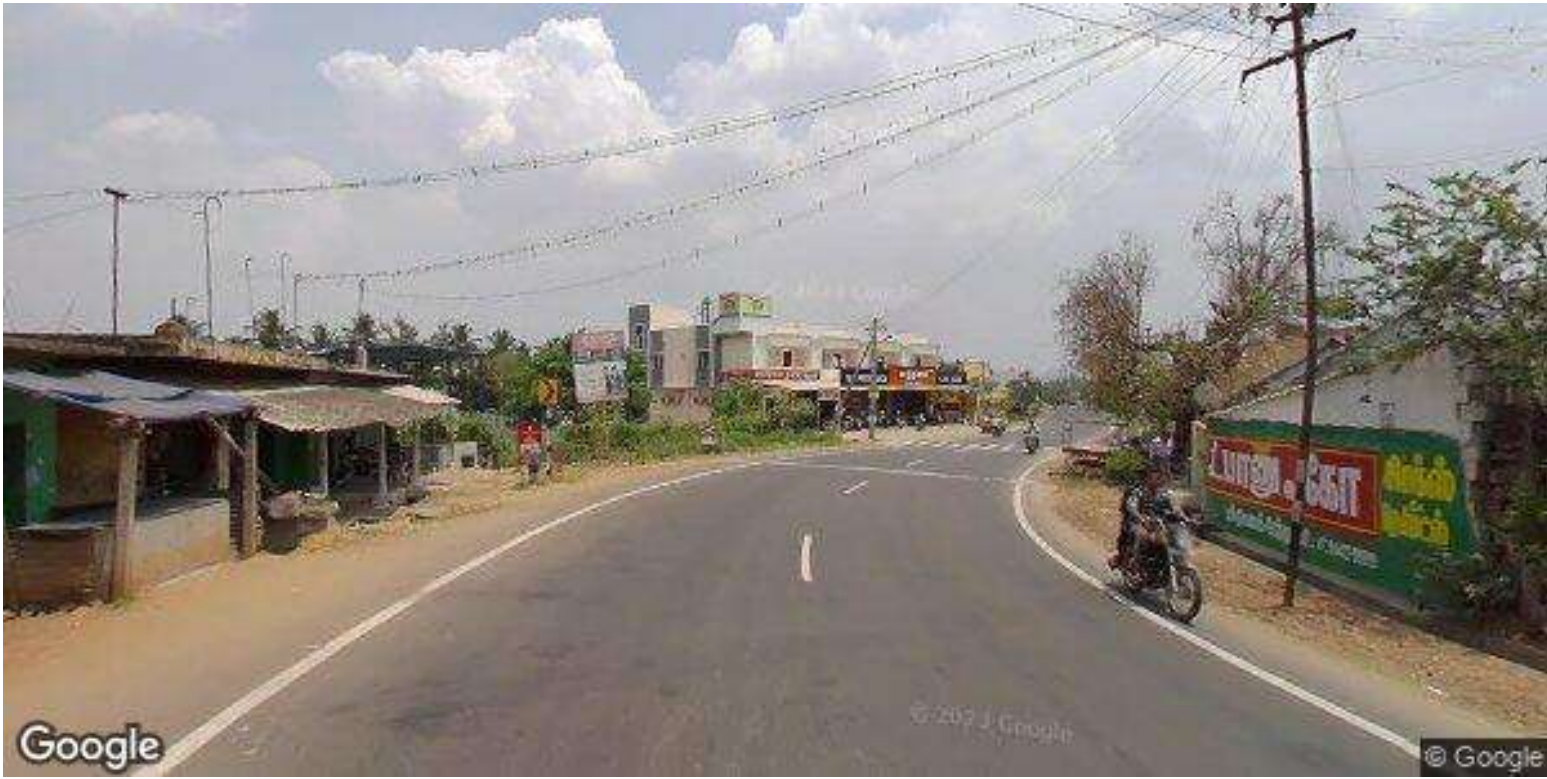
**Risk Type:** Turn  
**Risk Level:** Medium  
**Speed Limit:** 30 KM/Hr  
**Coordinates:** 11.17368, 77.45730

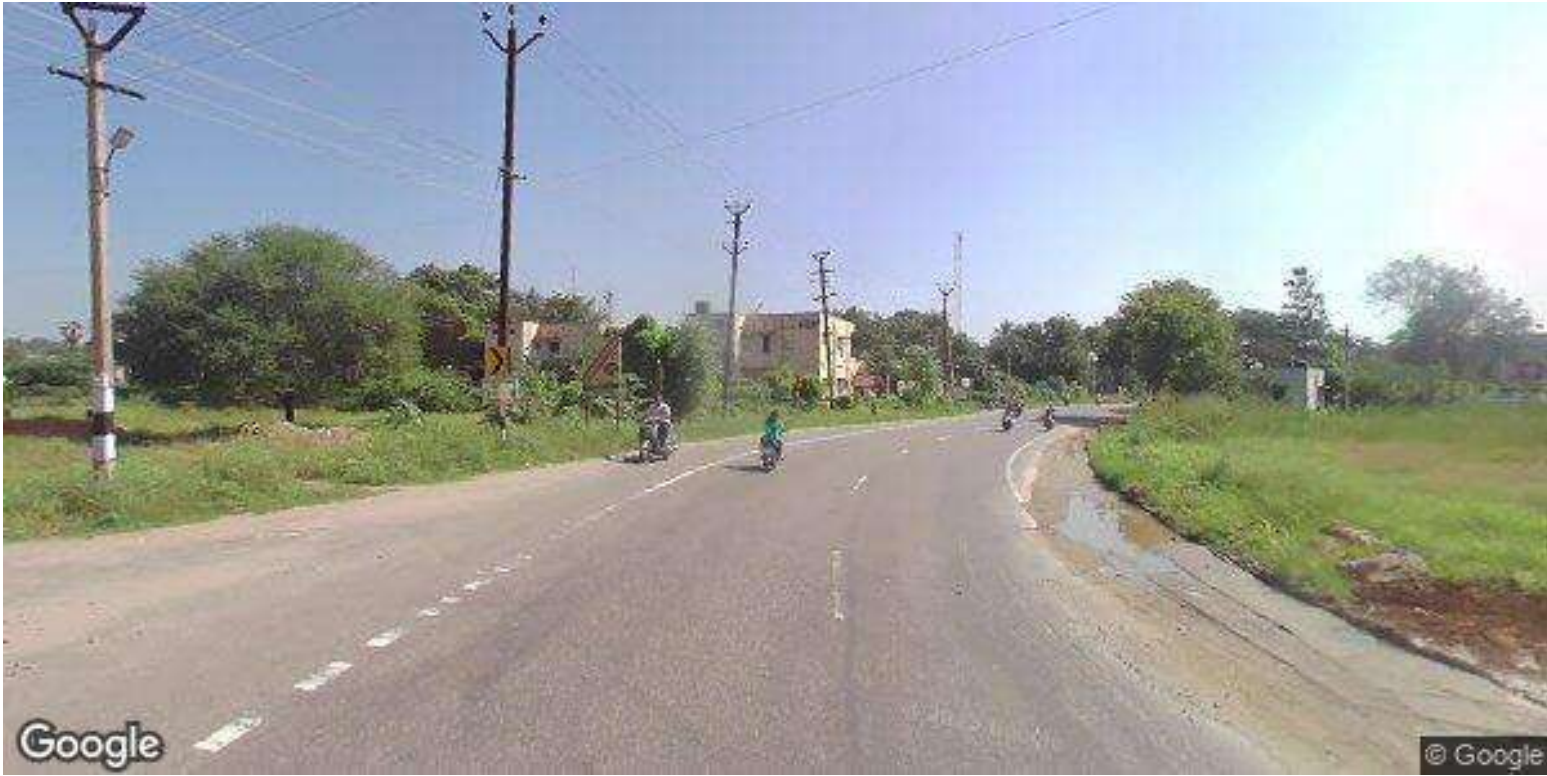
**Risk Type:** Turn  
**Risk Level:** High  
**Speed Limit:** 15 KM/Hr  
**Coordinates:** 11.16959, 77.44396

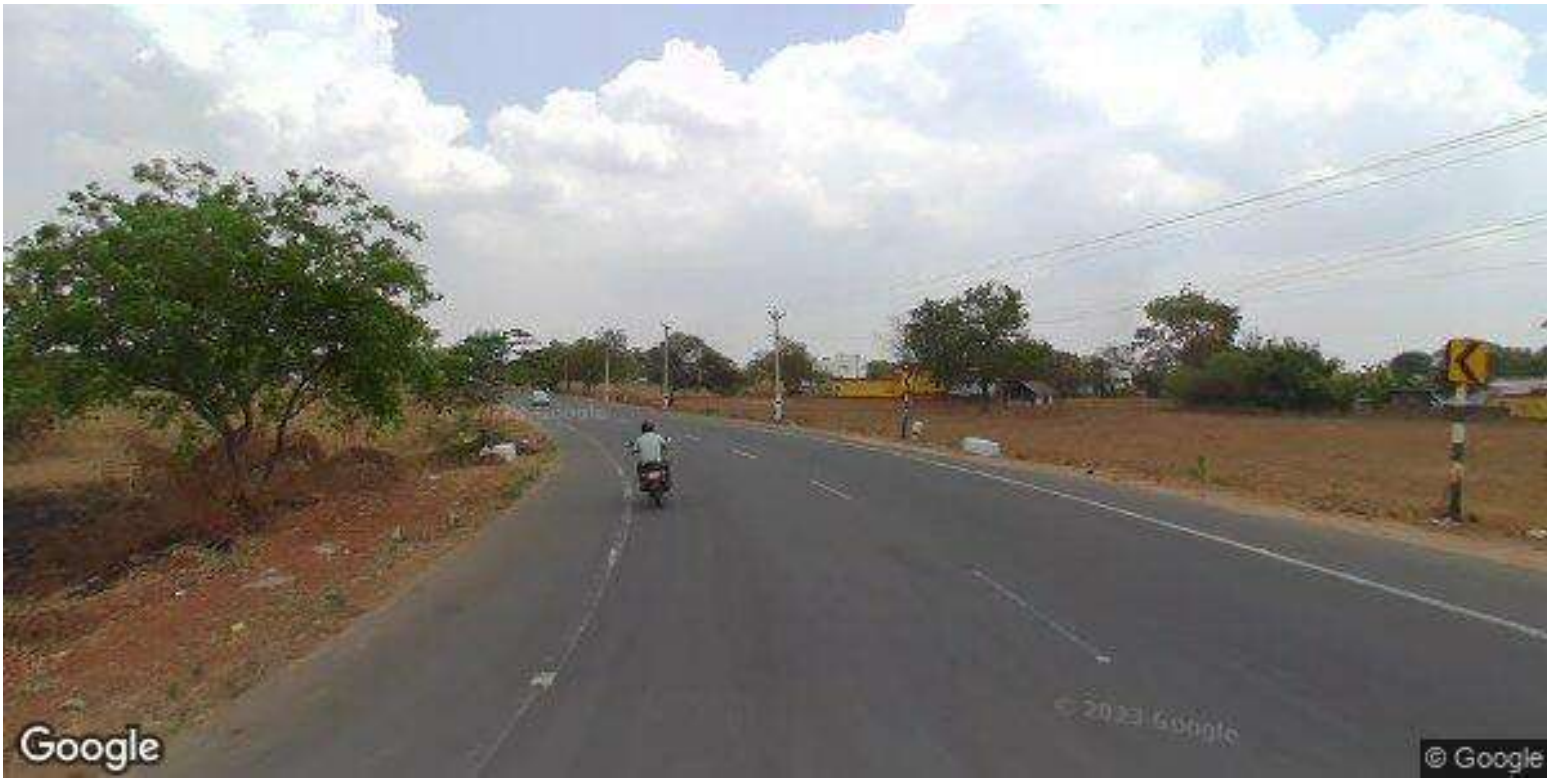
**Risk Type:** Turn  
**Risk Level:** Medium  
**Speed Limit:** 30 KM/Hr  
**Coordinates:** 11.16381, 77.43700

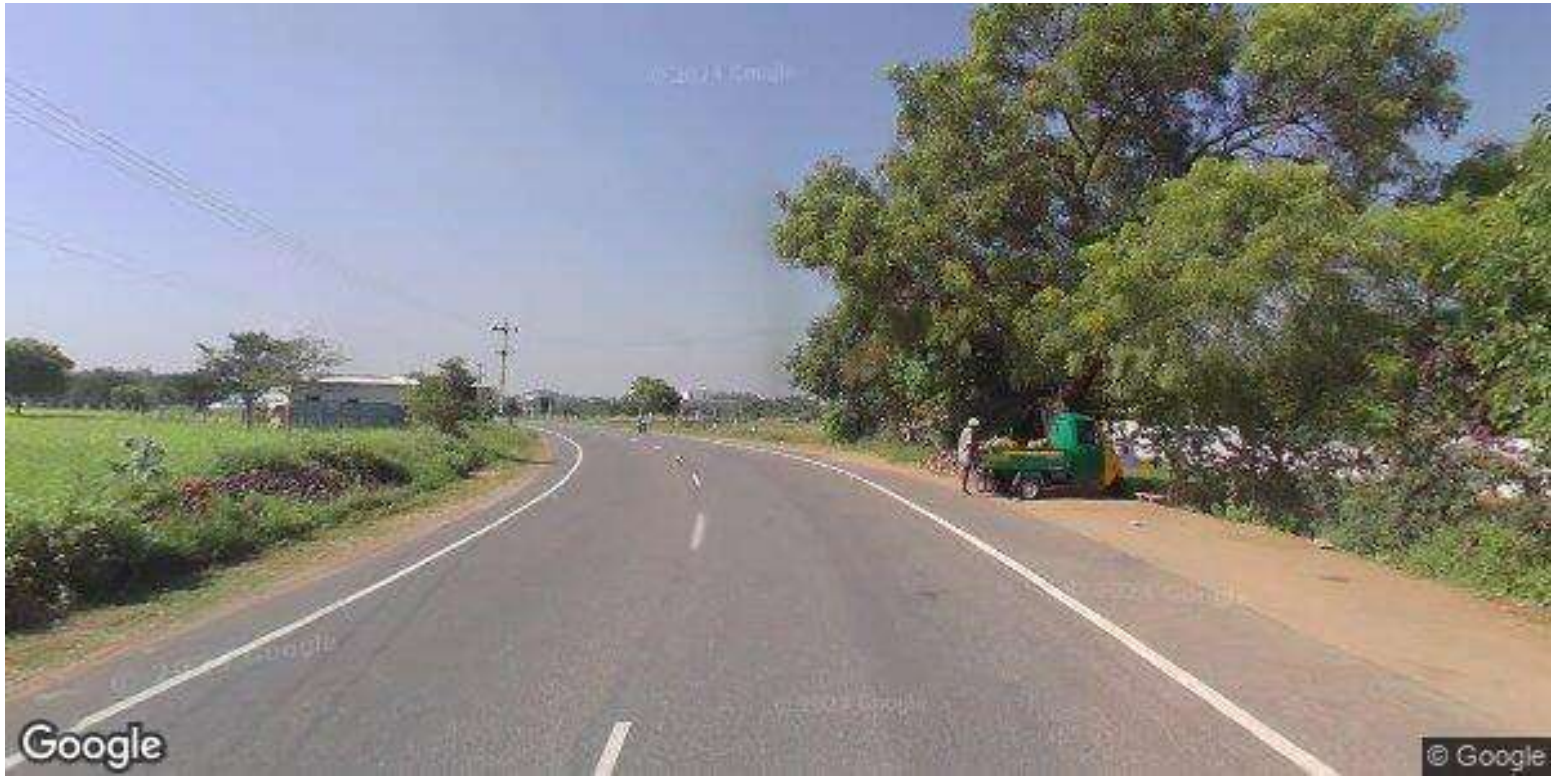
**Risk Type:** Turn  
**Risk Level:** Medium  
**Speed Limit:** 30 KM/Hr  
**Coordinates:** 11.16280, 77.43139
