# IndianOil

## JOURNEY RISK MANAGEMENT (JRM) STUDY

### Salem Terminal TO MAHALAKSHMI & CO

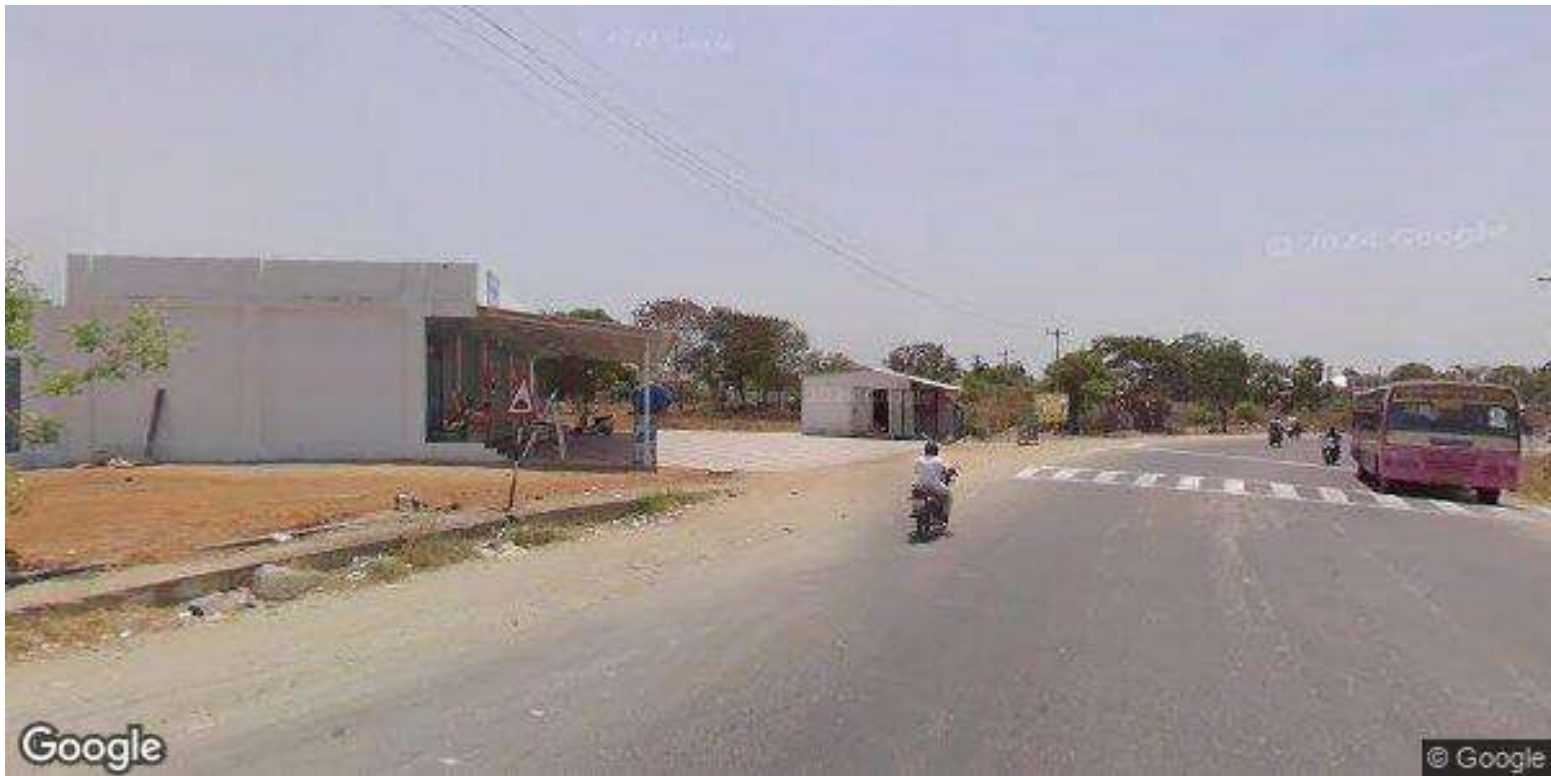
**Risk Type:** Turn  
**Risk Level:** Medium  
**Speed Limit:** 30 KM/Hr  
**Coordinates:** 11.15023, 77.42247

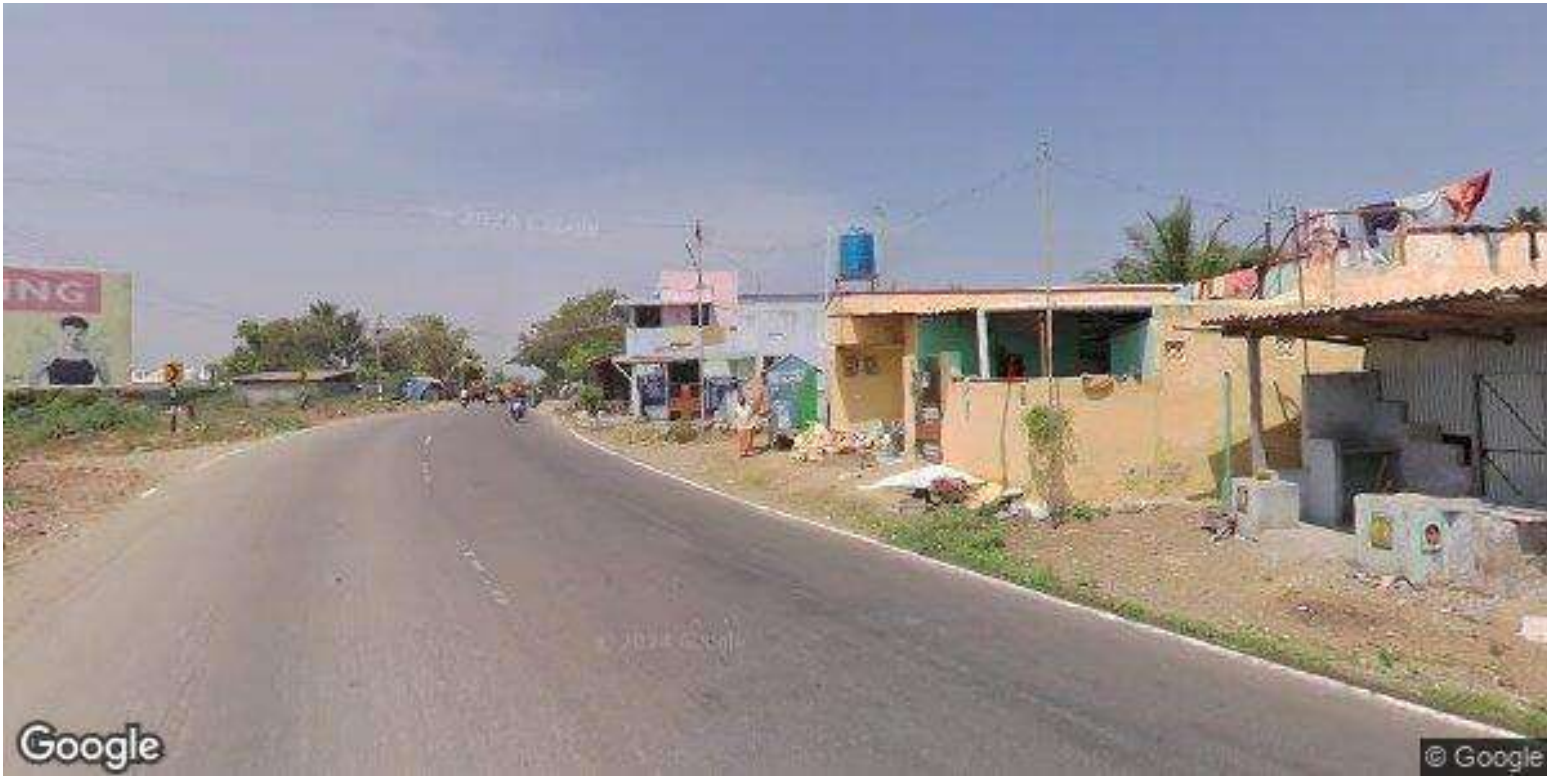
**Risk Type:** Turn  
**Risk Level:** Medium  
**Speed Limit:** 30 KM/Hr  
**Coordinates:** 11.13848, 77.41611

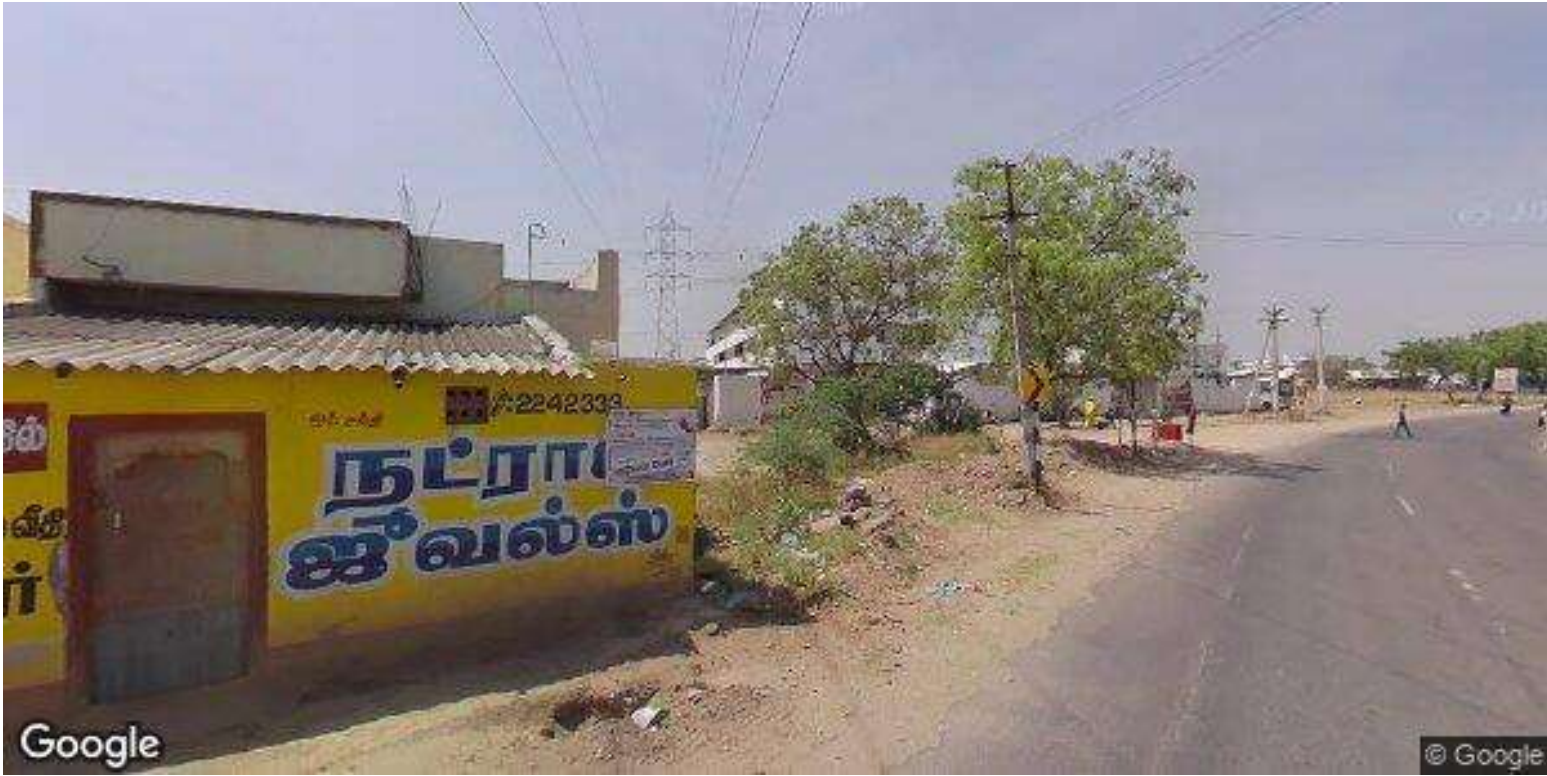
**Risk Type:** Turn  
**Risk Level:** Medium  
**Speed Limit:** 30 KM/Hr  
**Coordinates:** 11.13578, 77.41299

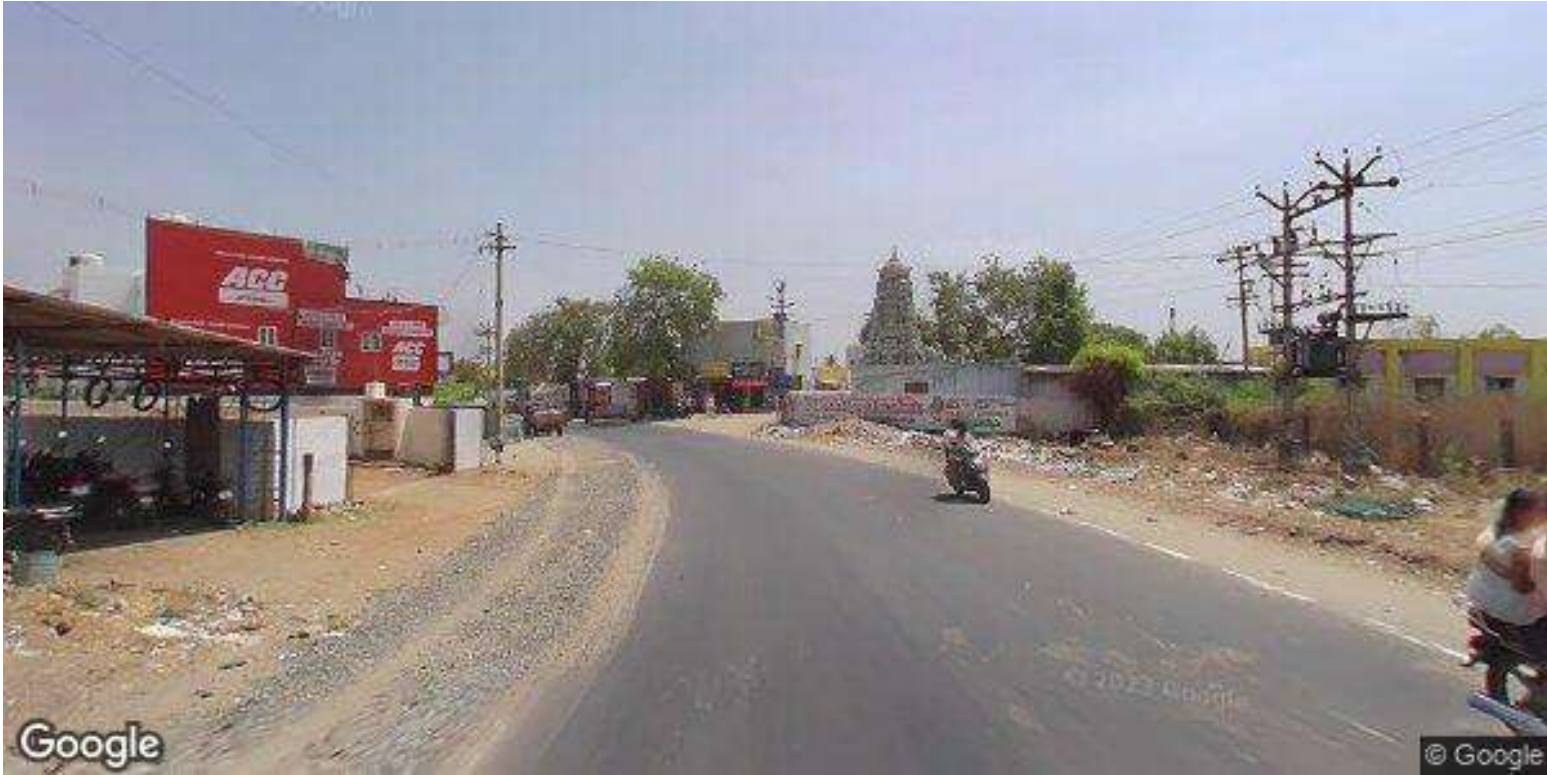
**Risk Type:** Turn  
**Risk Level:** Medium  
**Speed Limit:** 30 KM/Hr  
**Coordinates:** 11.12989, 77.40302

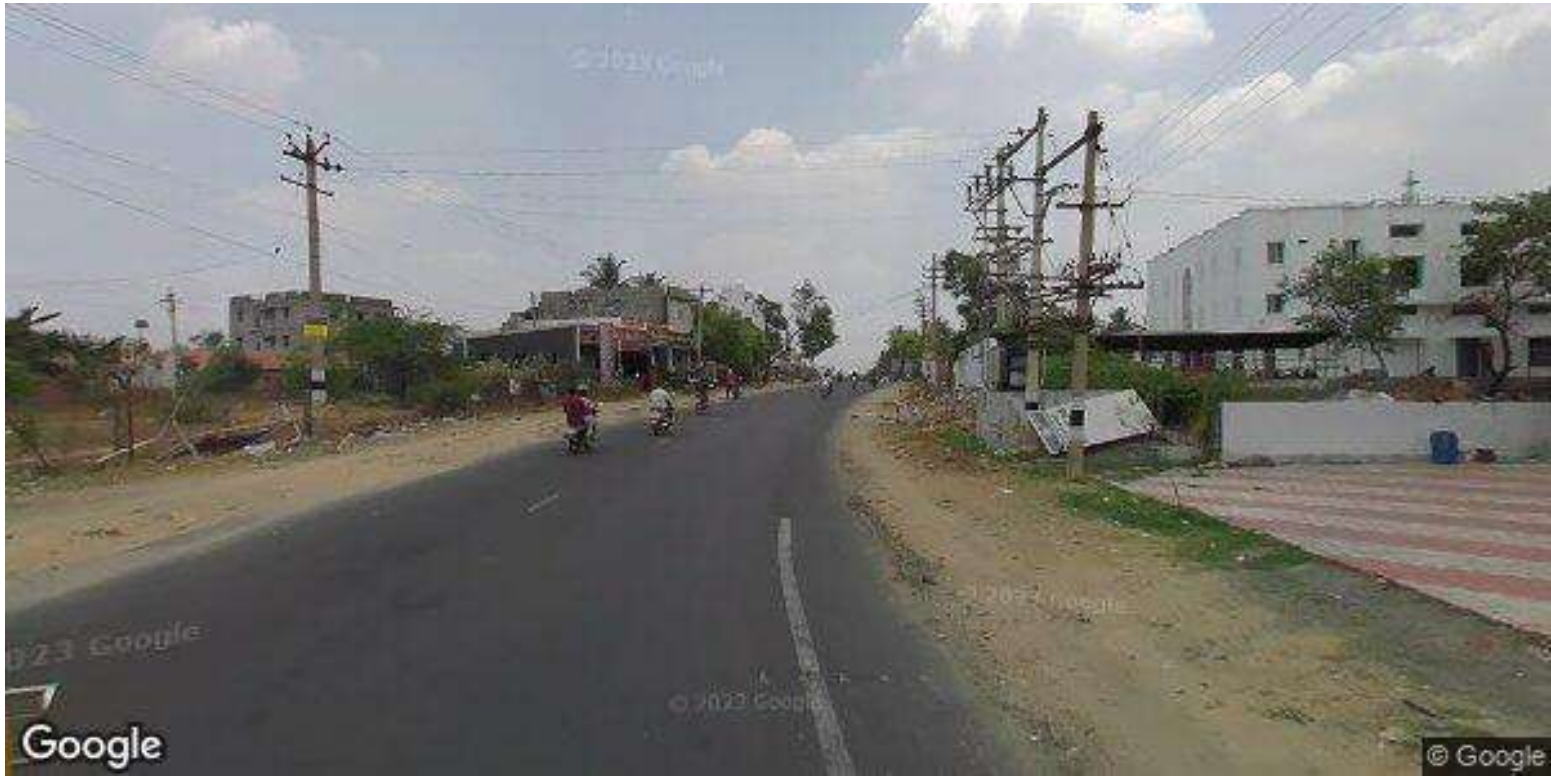
**Risk Type:** Turn  
**Risk Level:** Medium  
**Speed Limit:** 30 KM/Hr  
**Coordinates:** 11.12465, 77.38649

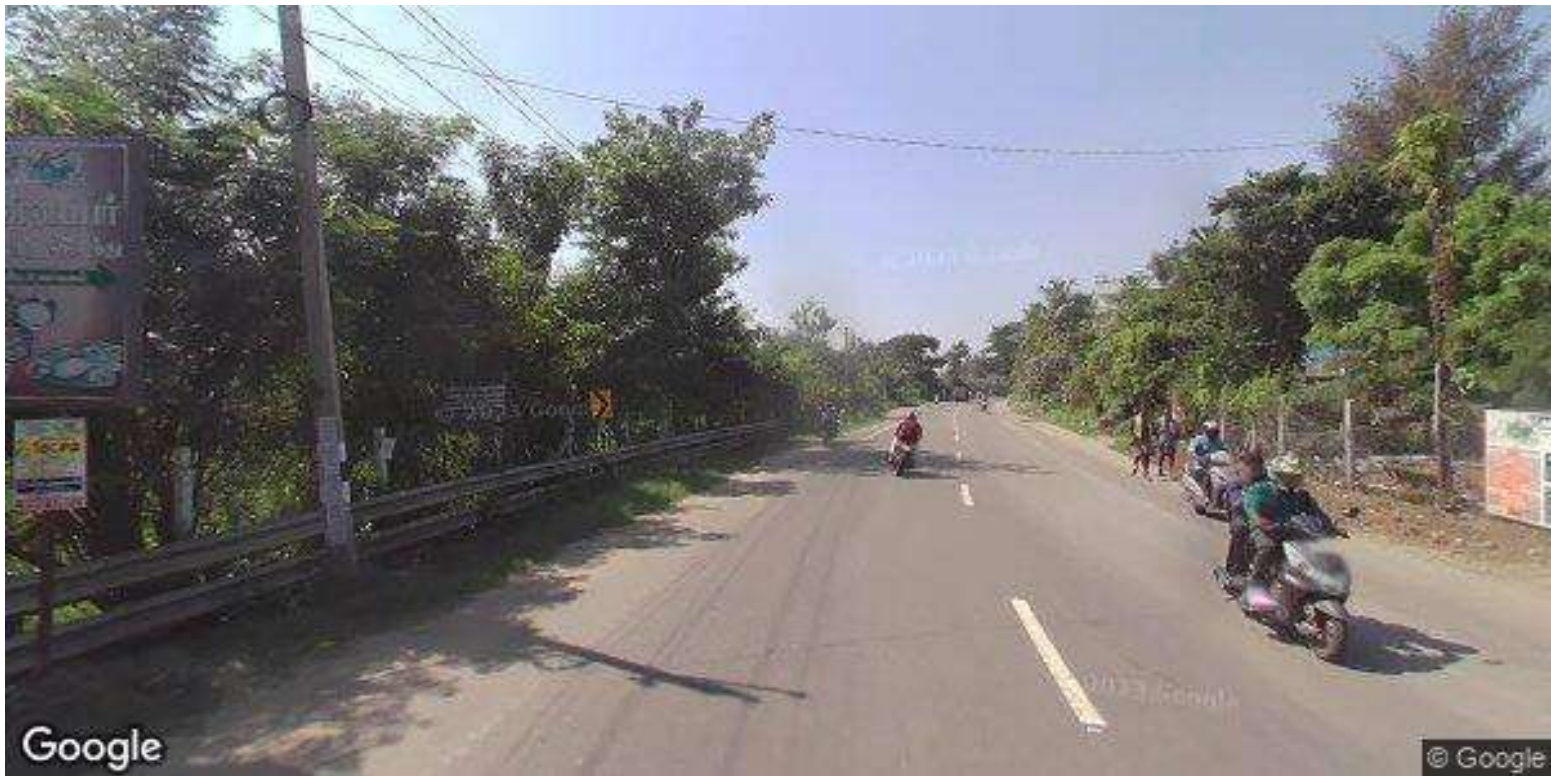
**Risk Type:** Turn  
**Risk Level:** Medium  
**Speed Limit:** 30 KM/Hr  
**Coordinates:** 11.12104, 77.38220

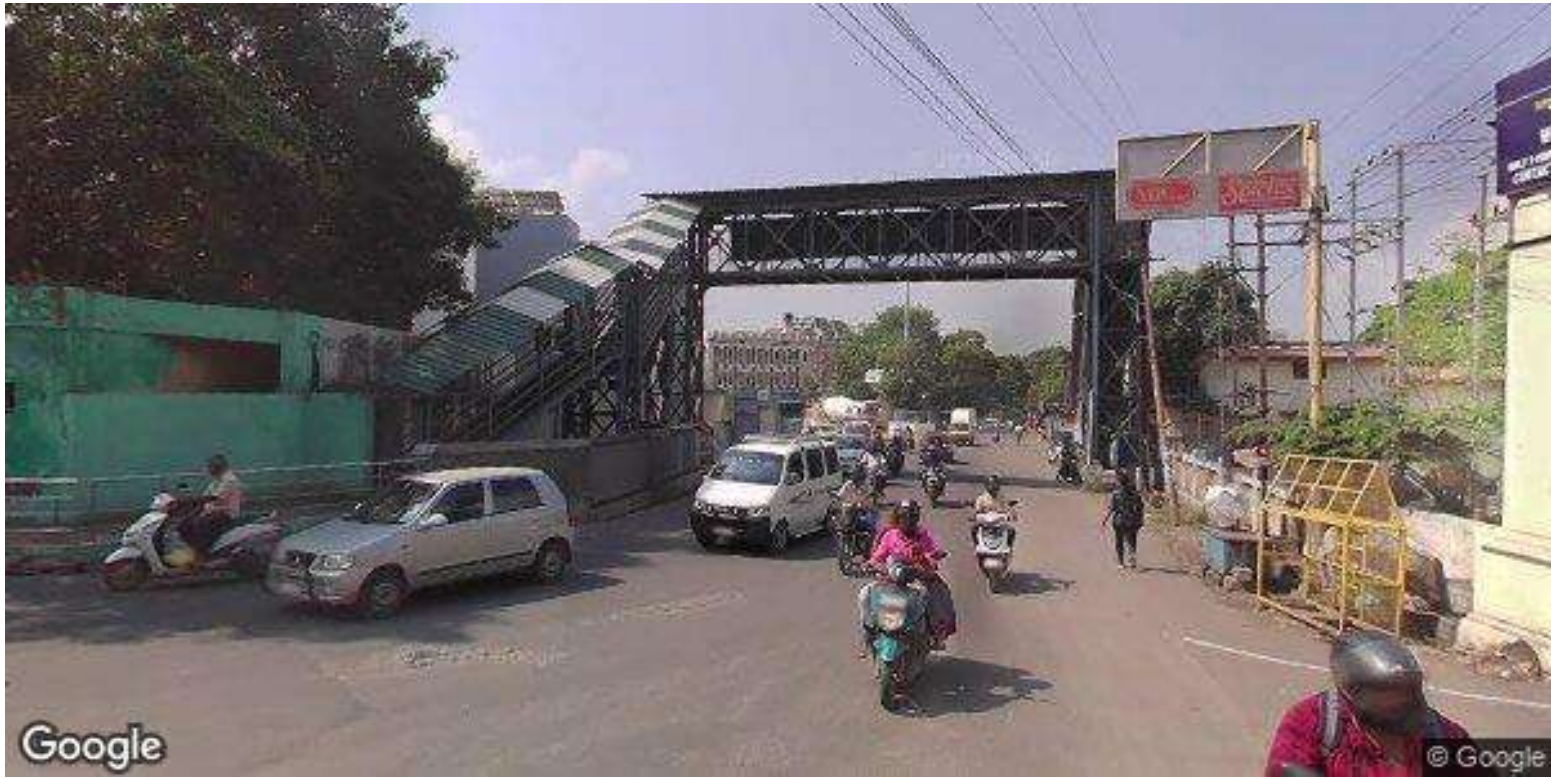
**Risk Type:** Blind Spot  
**Risk Level:** Blind Spot  
**Speed Limit:** 10 KM/Hr  
**Coordinates:** 11.10798, 77.34071
