## JOURNEY RISK MANAGEMENT (JRM) STUDY

**Salem Terminal to AKM NATARAJAN CHETTY**

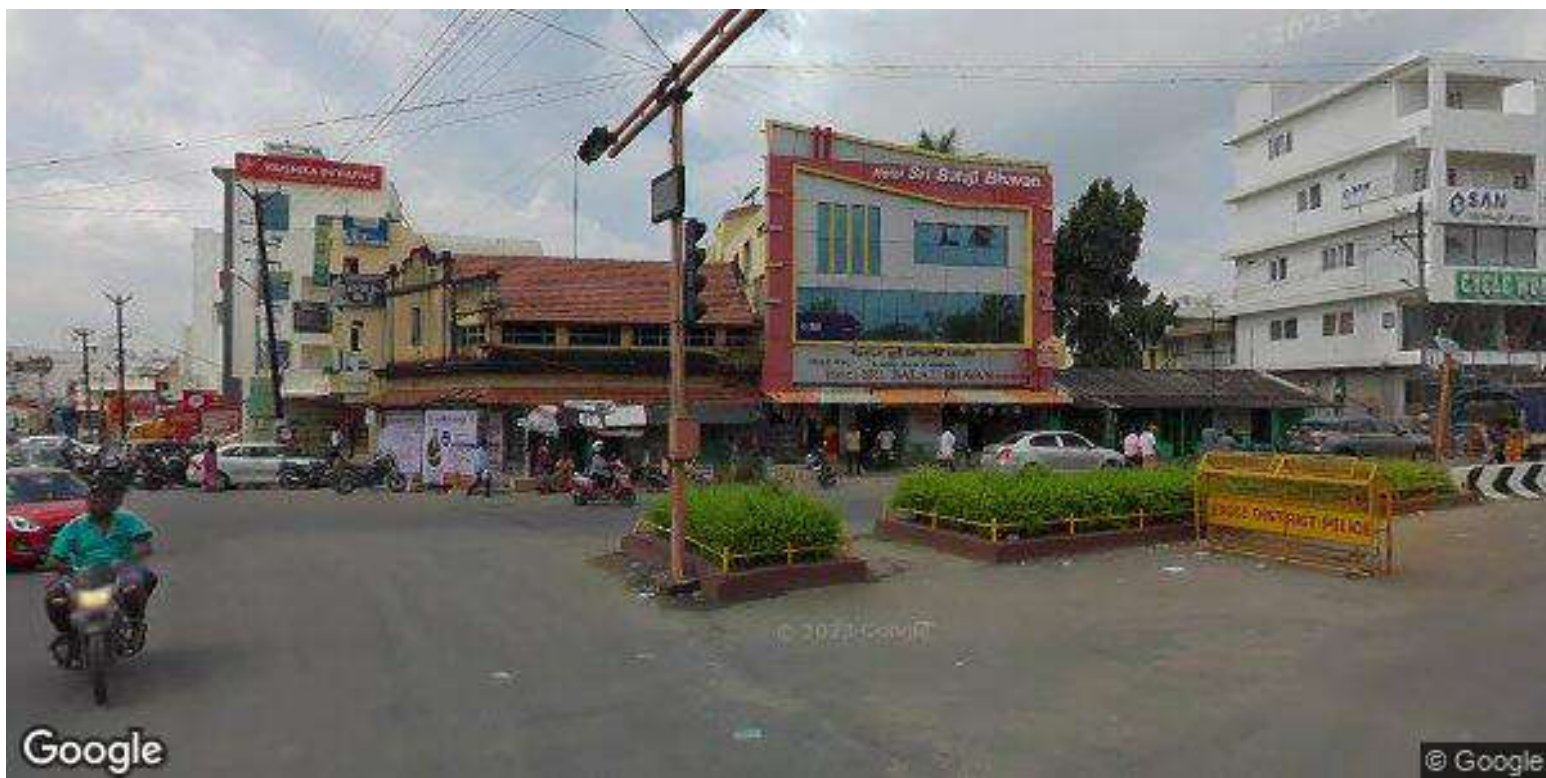
**Coordinates:** 11.27925, 77.58494

**Risk Type:** Roundabout

**Risk Level:** High

**Speed Limit:** 15 KM/Hr

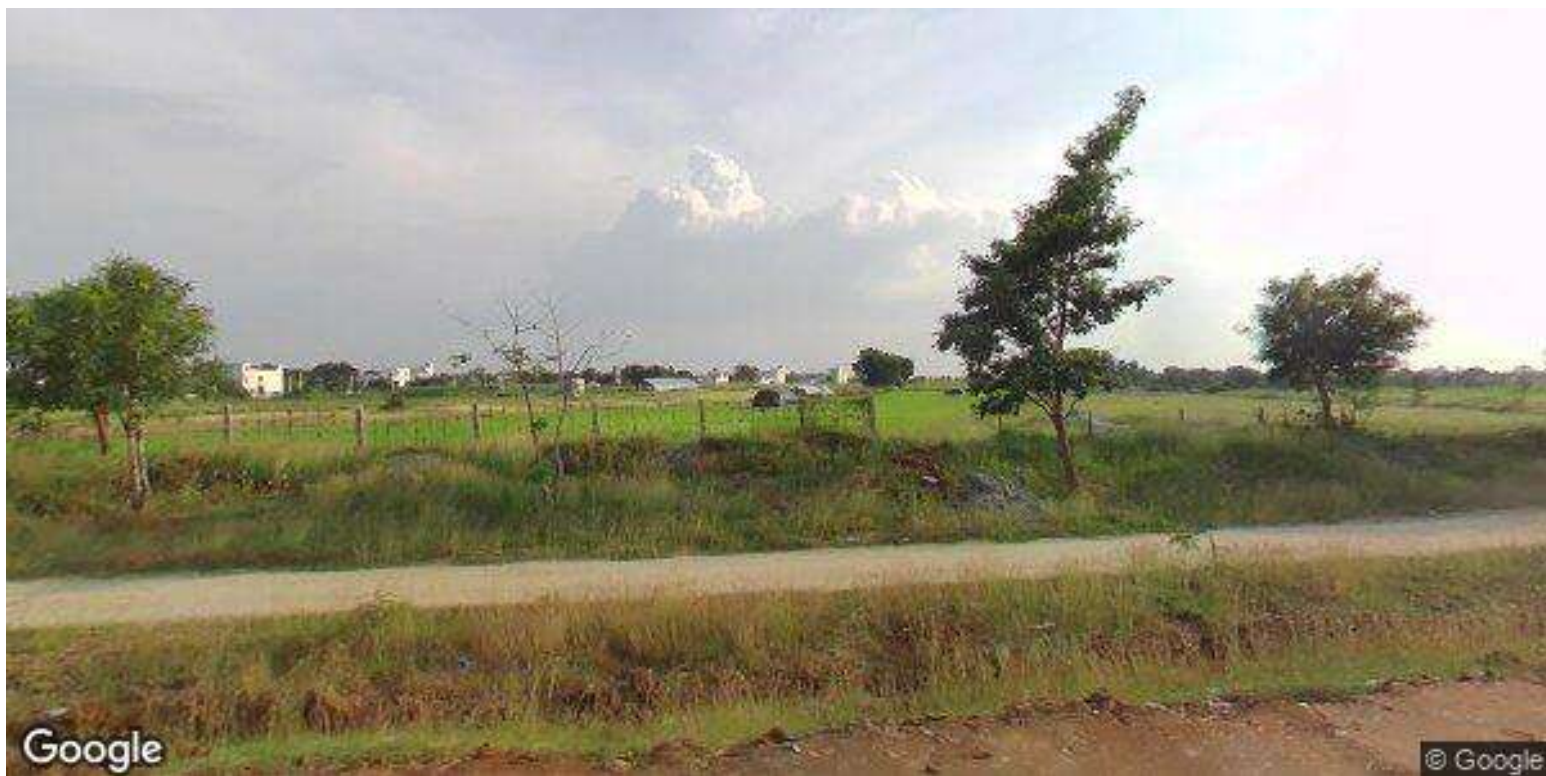
**Coordinates:** 11.29288, 77.59029

**Risk Type:** Turn

**Risk Level:** Medium

**Speed Limit:** 30 KM/Hr

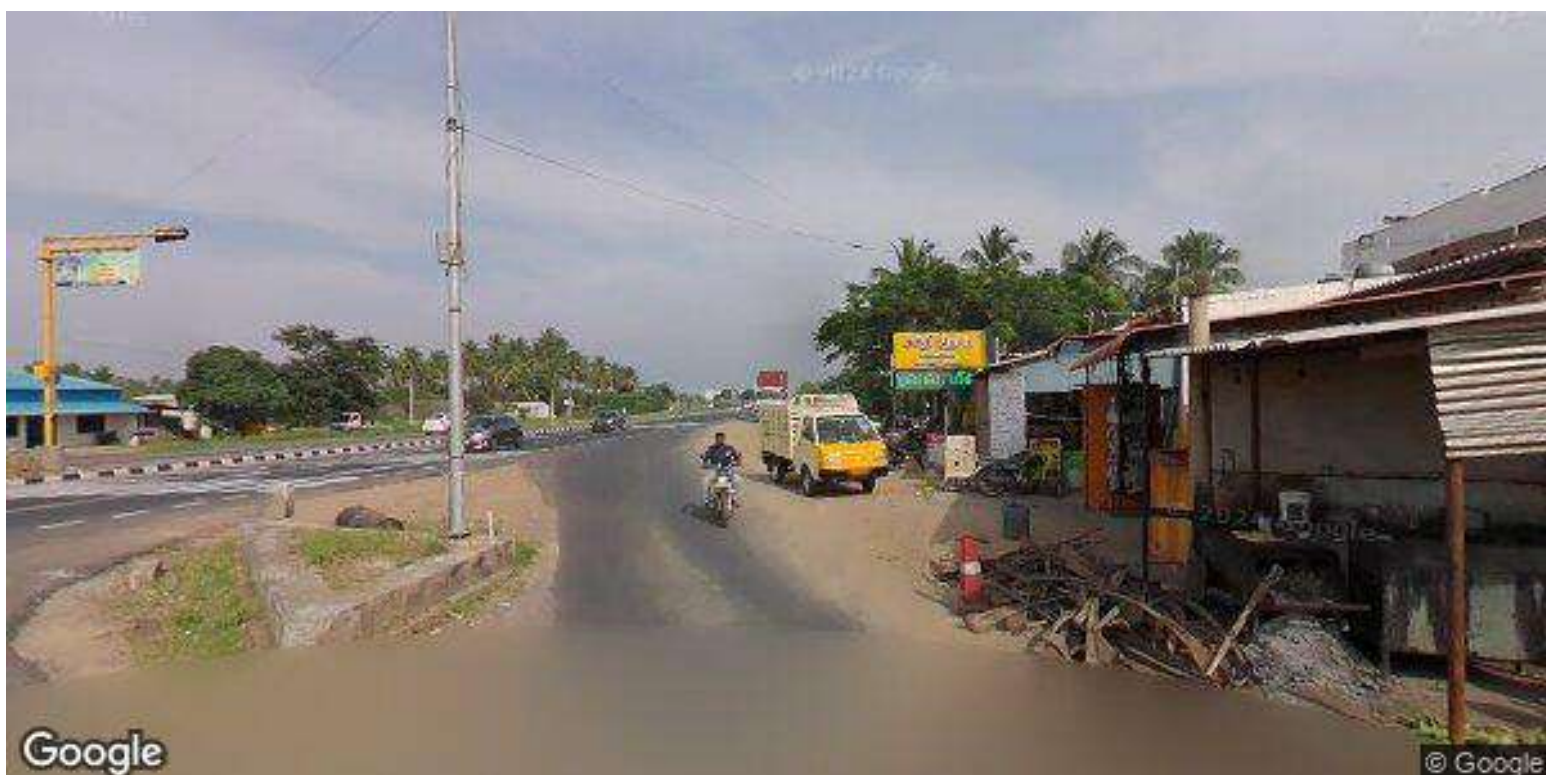
**Coordinates:** 11.29164, 77.58610

**Risk Type:** Turn

**Risk Level:** Medium

**Speed Limit:** 30 KM/Hr

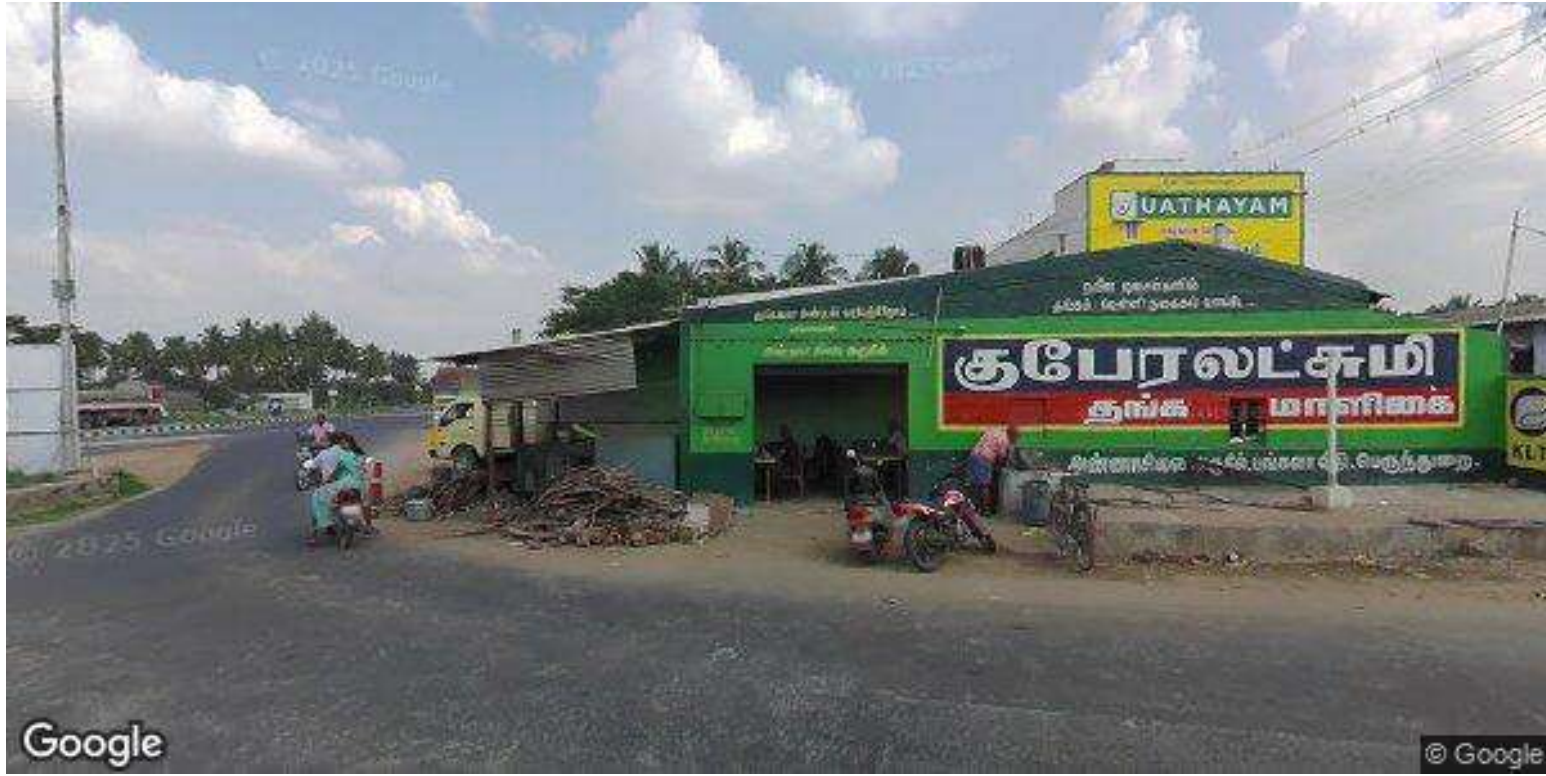
**Coordinates:** 11.29158, 77.58600

**Risk Type:** Turn

**Risk Level:** Medium

**Speed Limit:** 30 KM/Hr

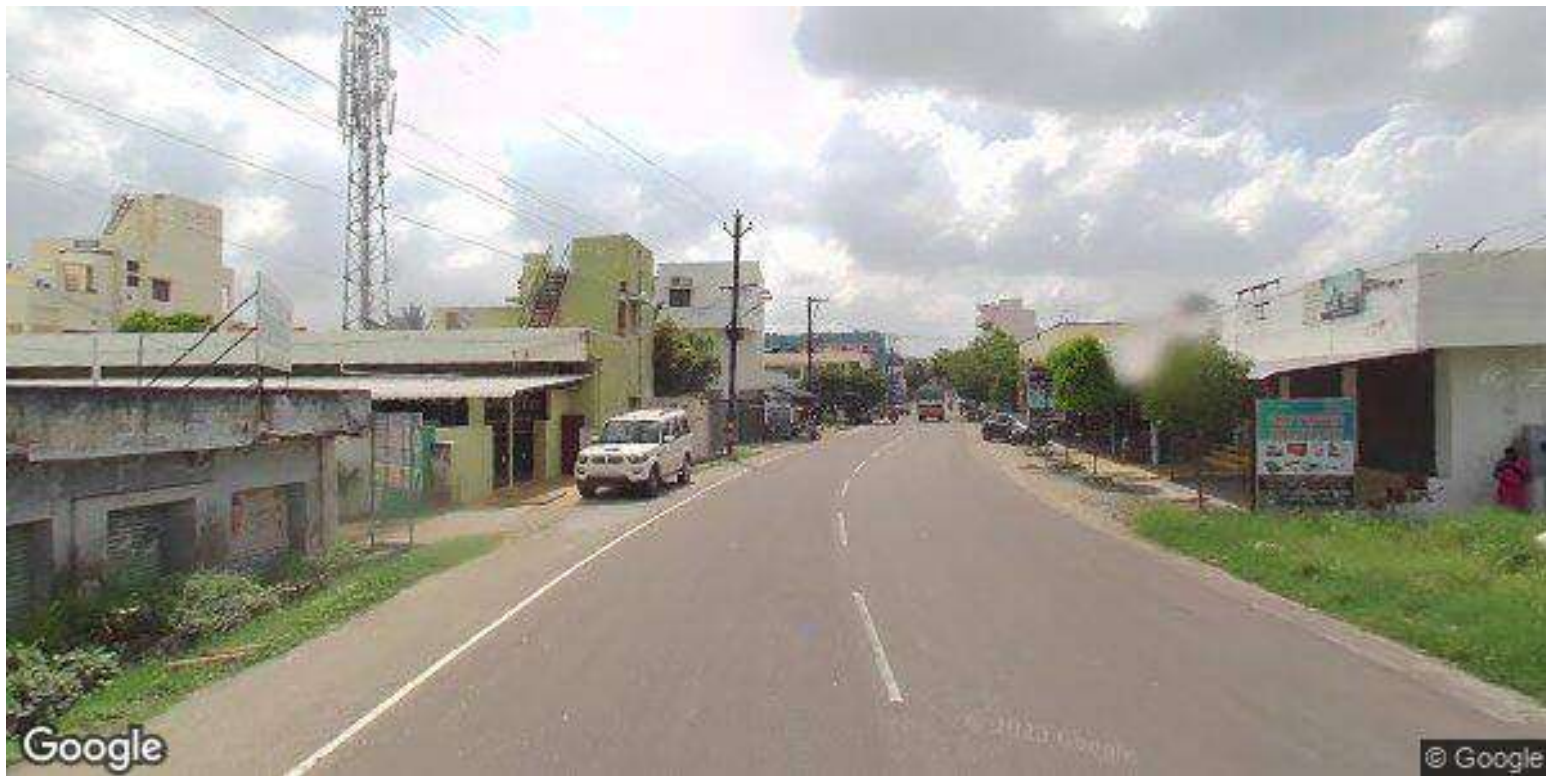
**Coordinates:** 11.28223, 77.58511

**Risk Type:** Turn

**Risk Level:** Medium

**Speed Limit:** 30 KM/Hr

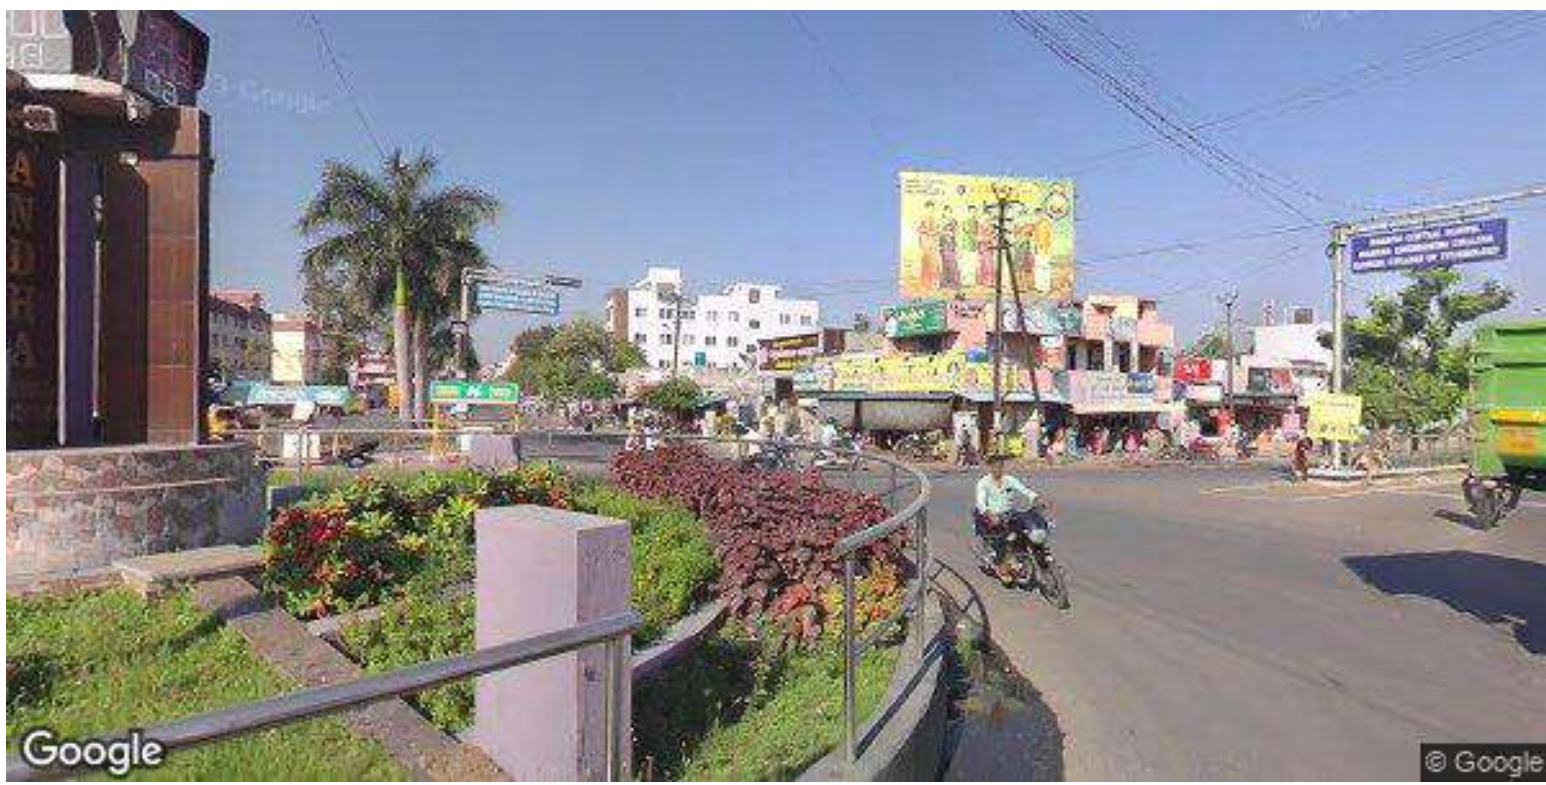
**Coordinates:** 11.27446, 77.58267

**Risk Type:** Turn

**Risk Level:** High

**Speed Limit:** 15 KM/Hr

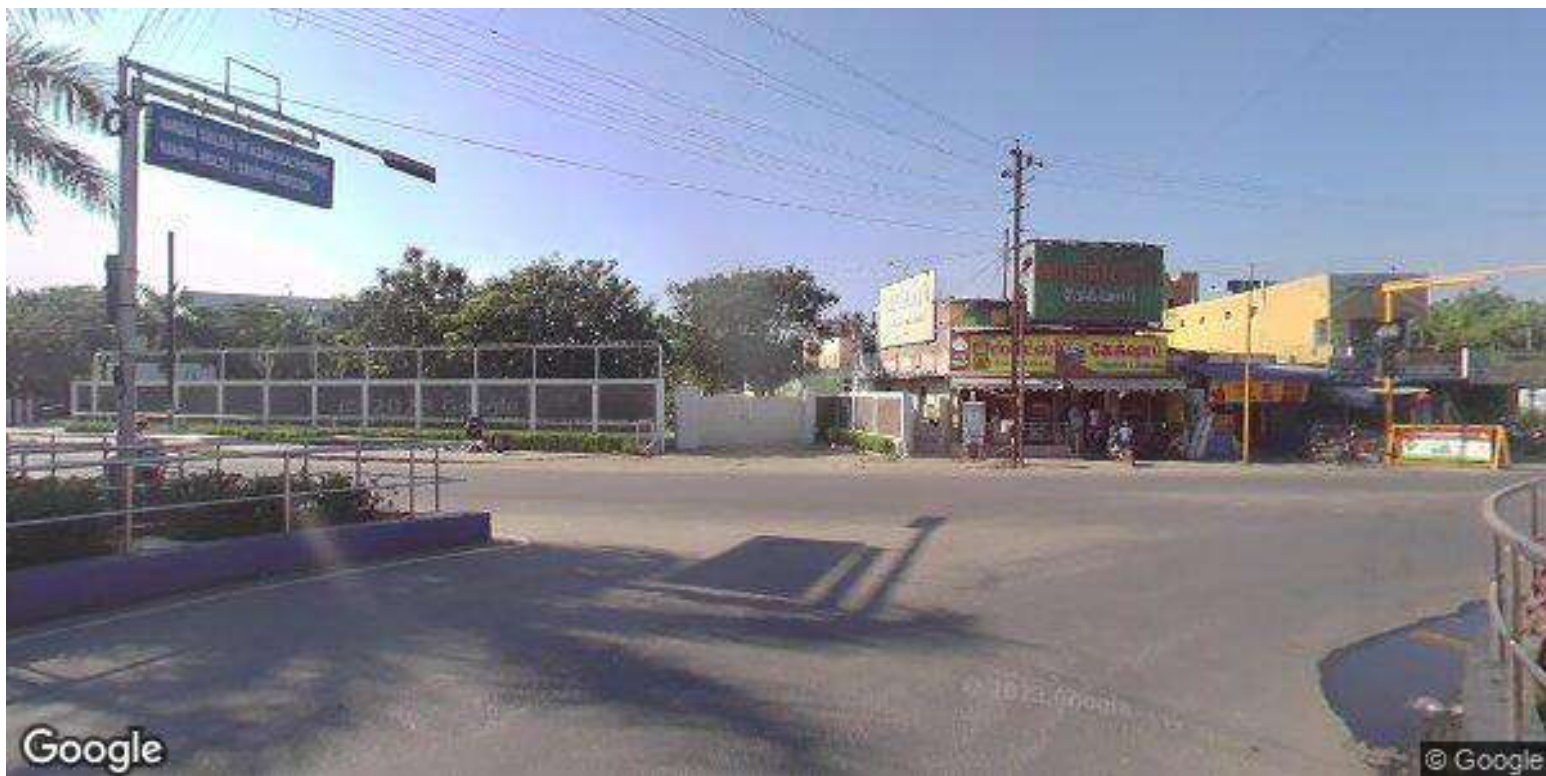
**Coordinates:** 11.27446, 77.58255

**Risk Type:** Turn

**Risk Level:** Medium

**Speed Limit:** 30 KM/Hr
