# IndianOil

## JOURNEY RISK MANAGEMENT (JRM) STUDY

### Salem Terminal TO MARTHAR AGENCIES

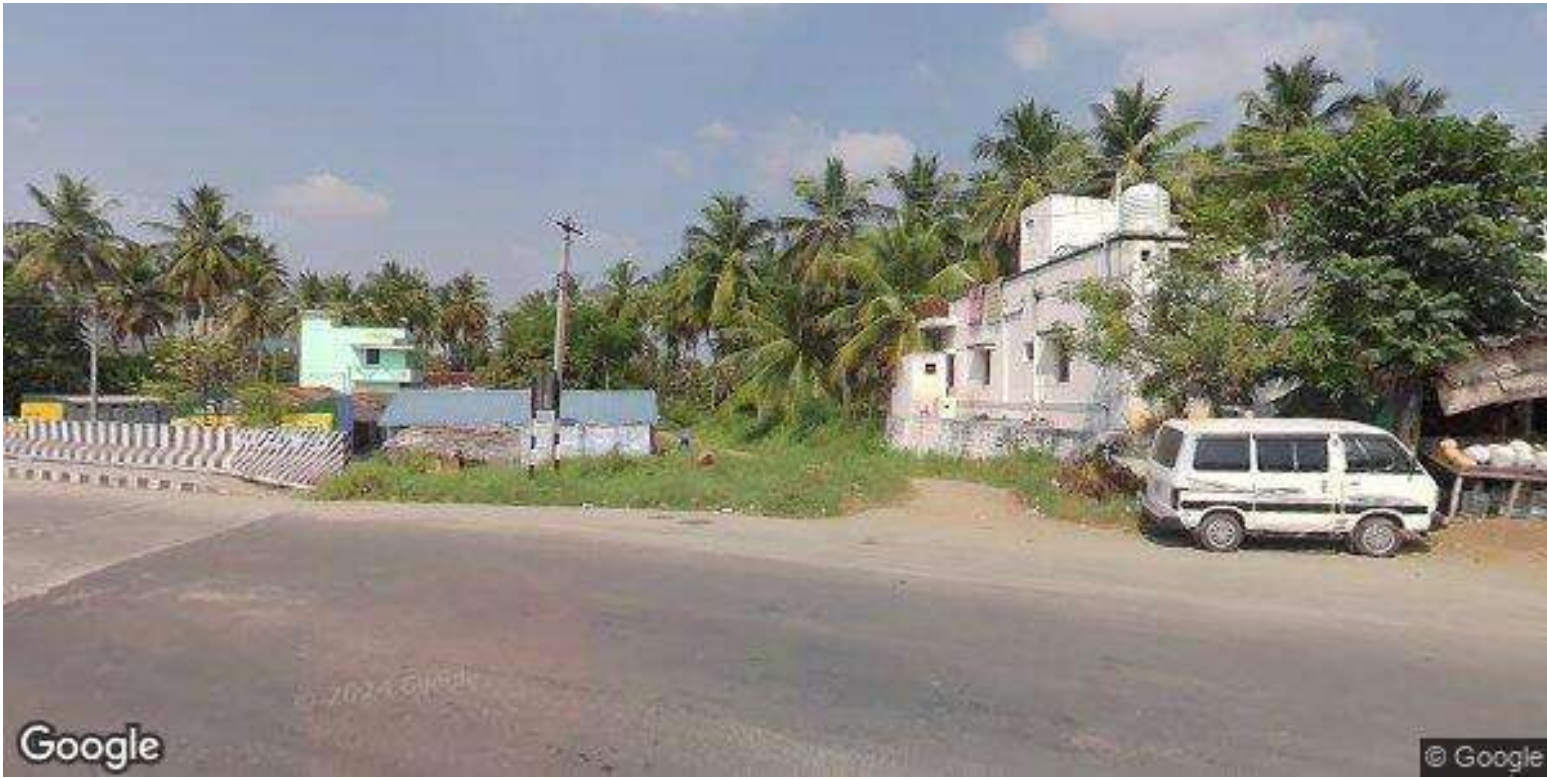
**Risk Type:** Turn  
**Risk Level:** High  
**Speed Limit:** 15 KM/Hr  
**Coordinates:** 11.44898, 77.87410

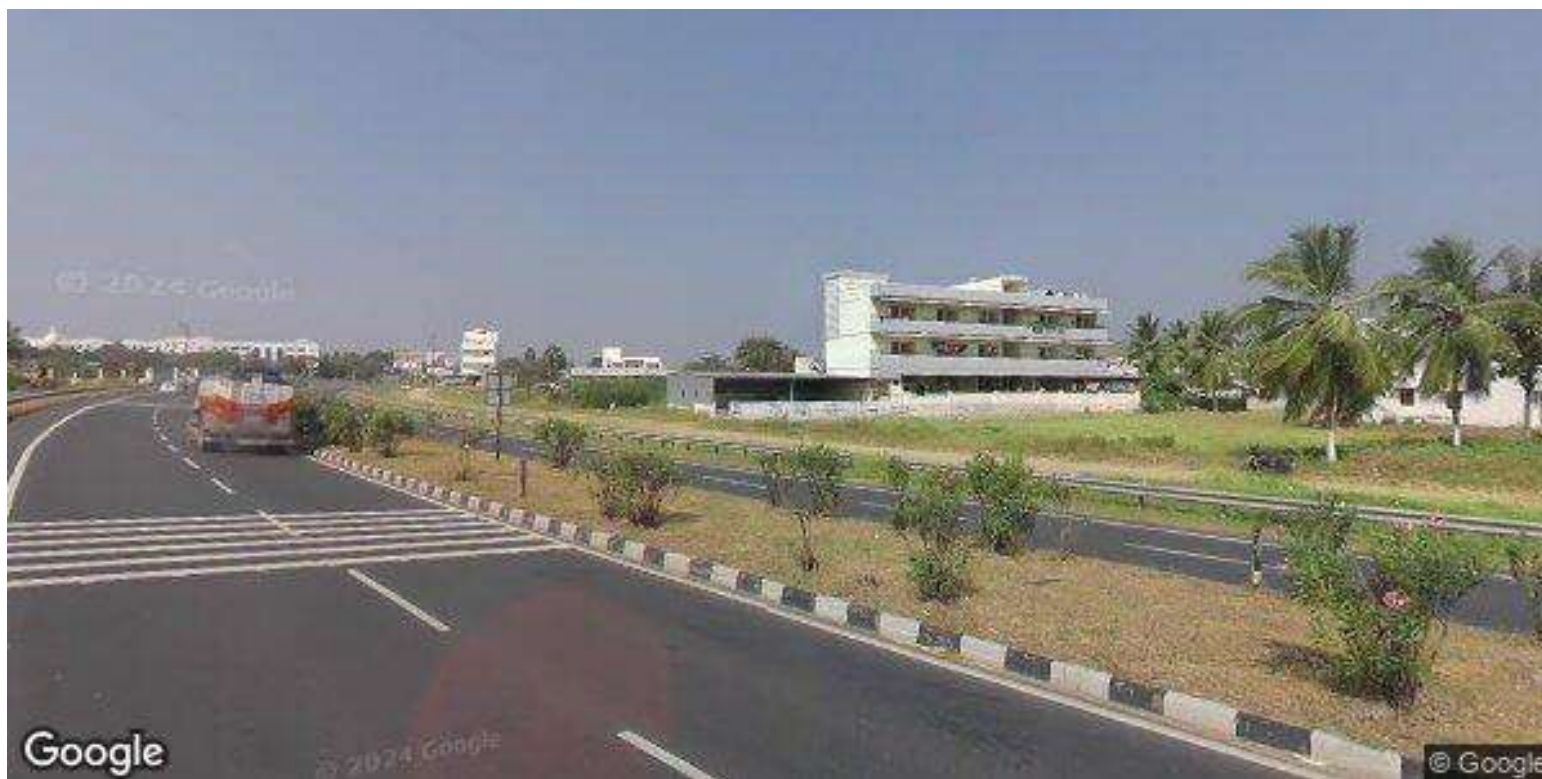
**Coordinates:** 11.44965, 77.77565

**Risk Type:** Turn

**Risk Level:** Medium

**Speed Limit:** 30 KM/Hr

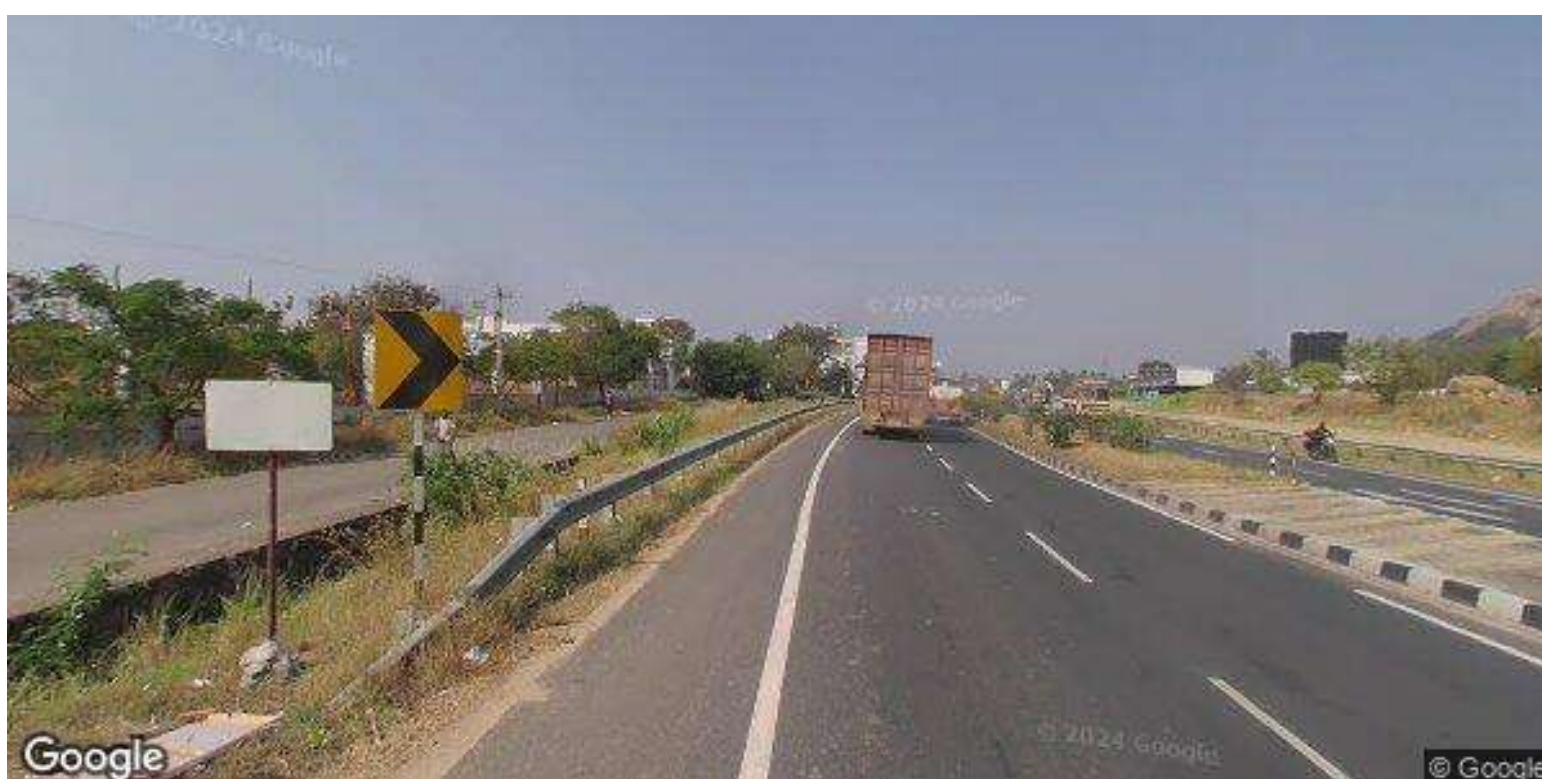
**Coordinates:** 11.44953, 77.77344

**Risk Type:** Turn

**Risk Level:** Medium

**Speed Limit:** 30 KM/Hr

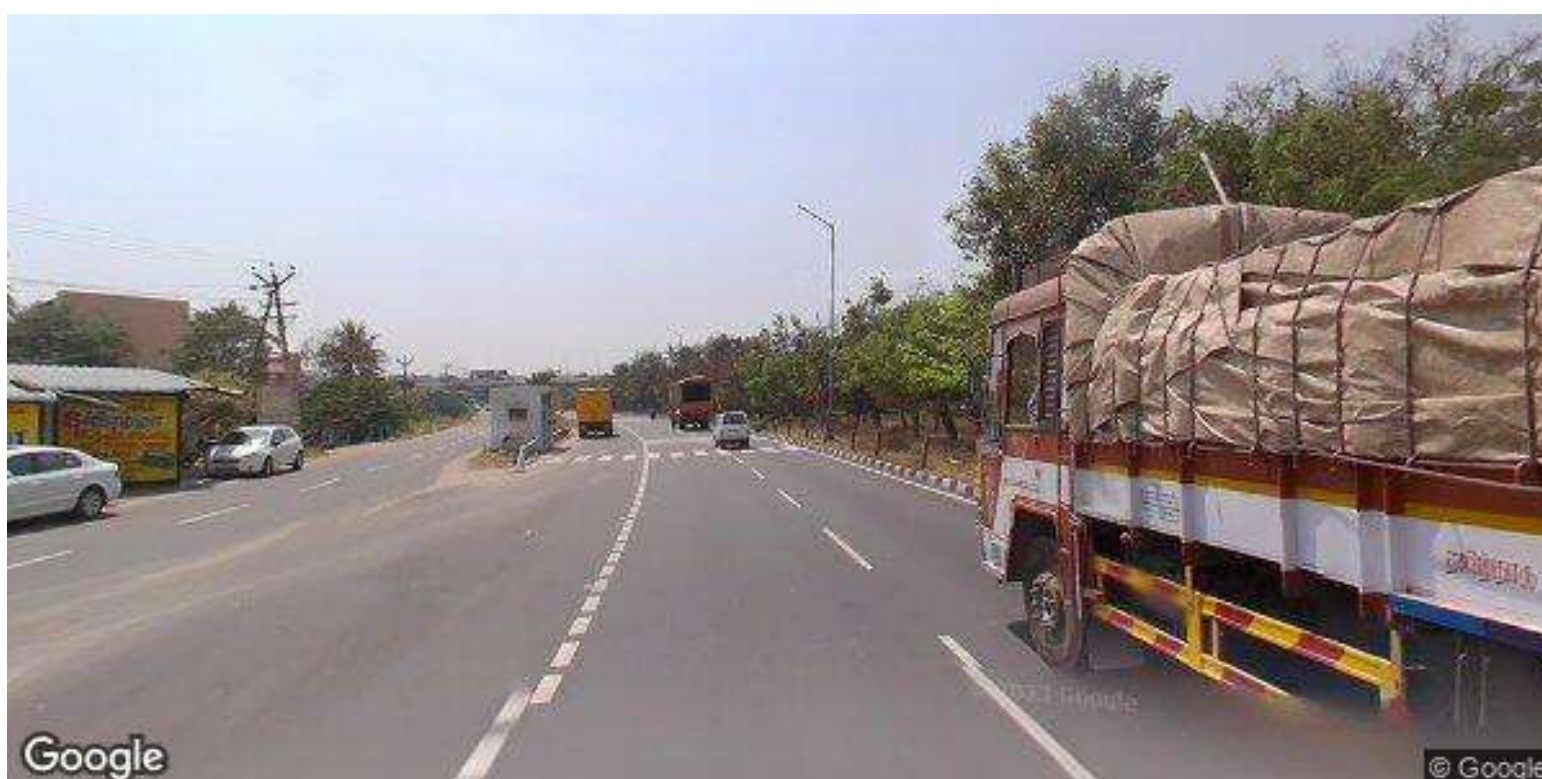
**Risk Type:** Turn  
**Risk Level:** Medium  
**Speed Limit:** 30 KM/Hr  
**Coordinates:** 11.43165, 77.67734

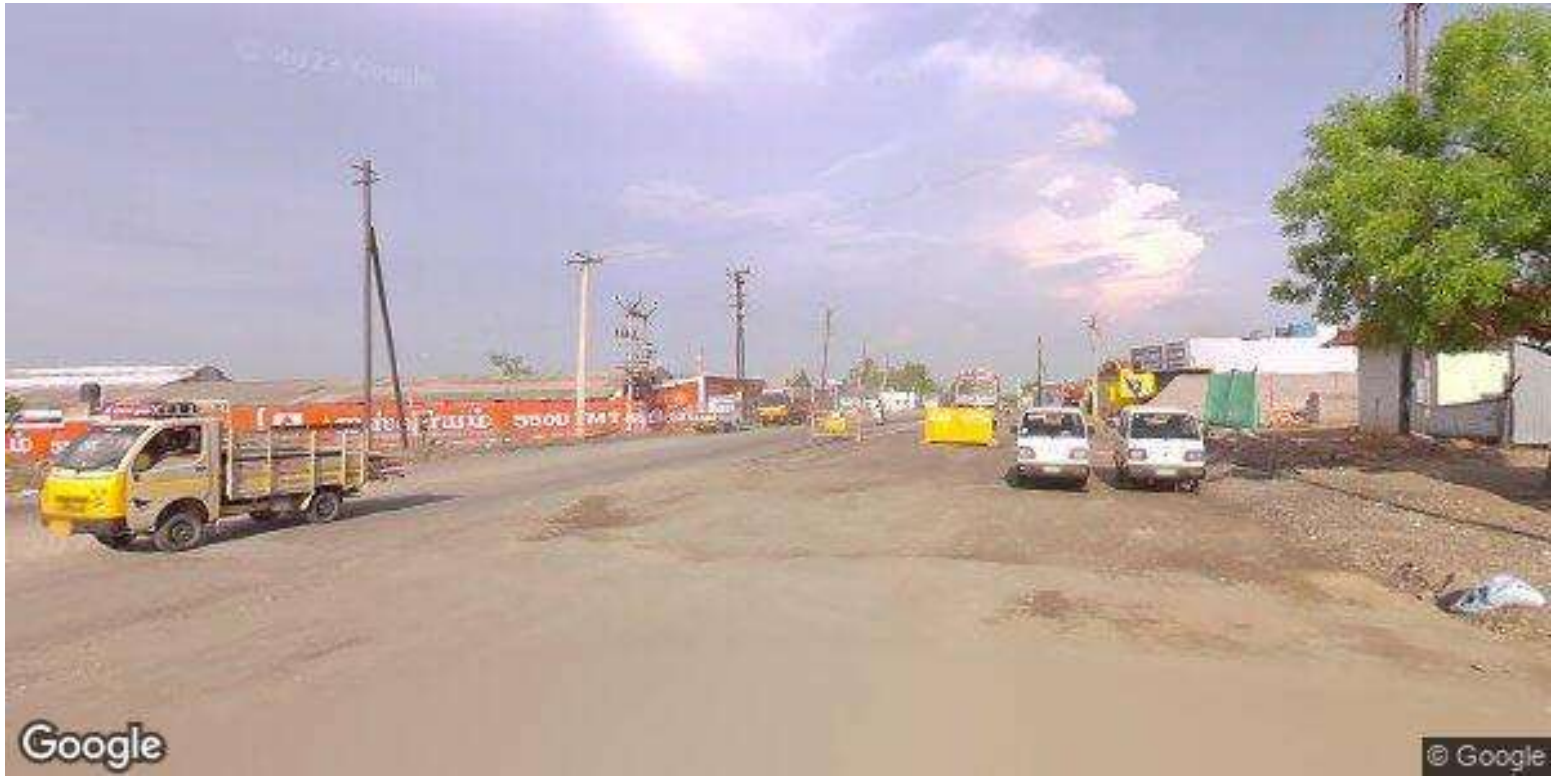
**Risk Type:** Turn  
**Risk Level:** High  
**Speed Limit:** 15 KM/Hr  
**Coordinates:** 11.39829, 77.65233

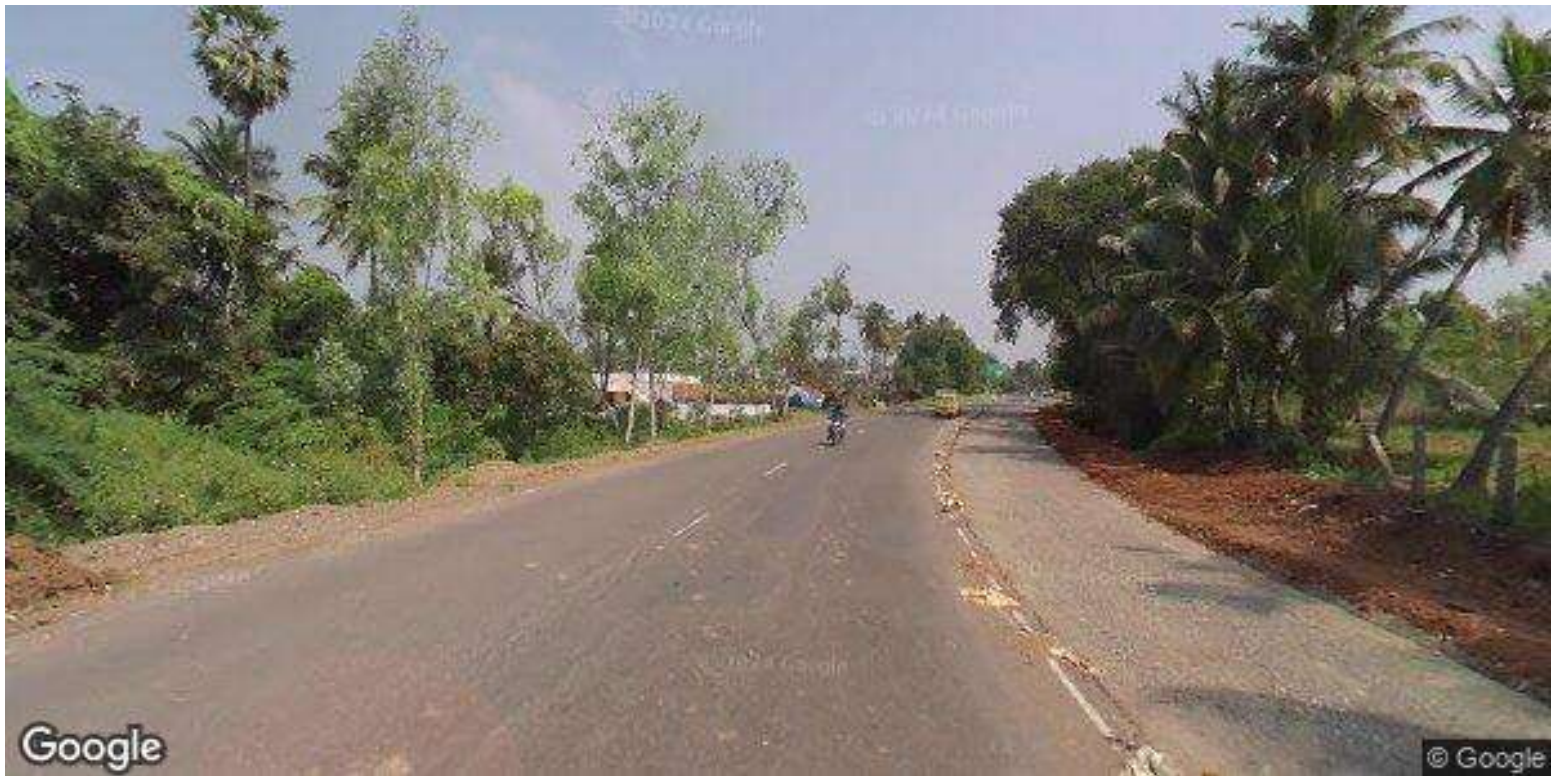
**Risk Type:** Turn  
**Risk Level:** Medium  
**Speed Limit:** 30 KM/Hr  
**Coordinates:** 11.45763, 77.36309

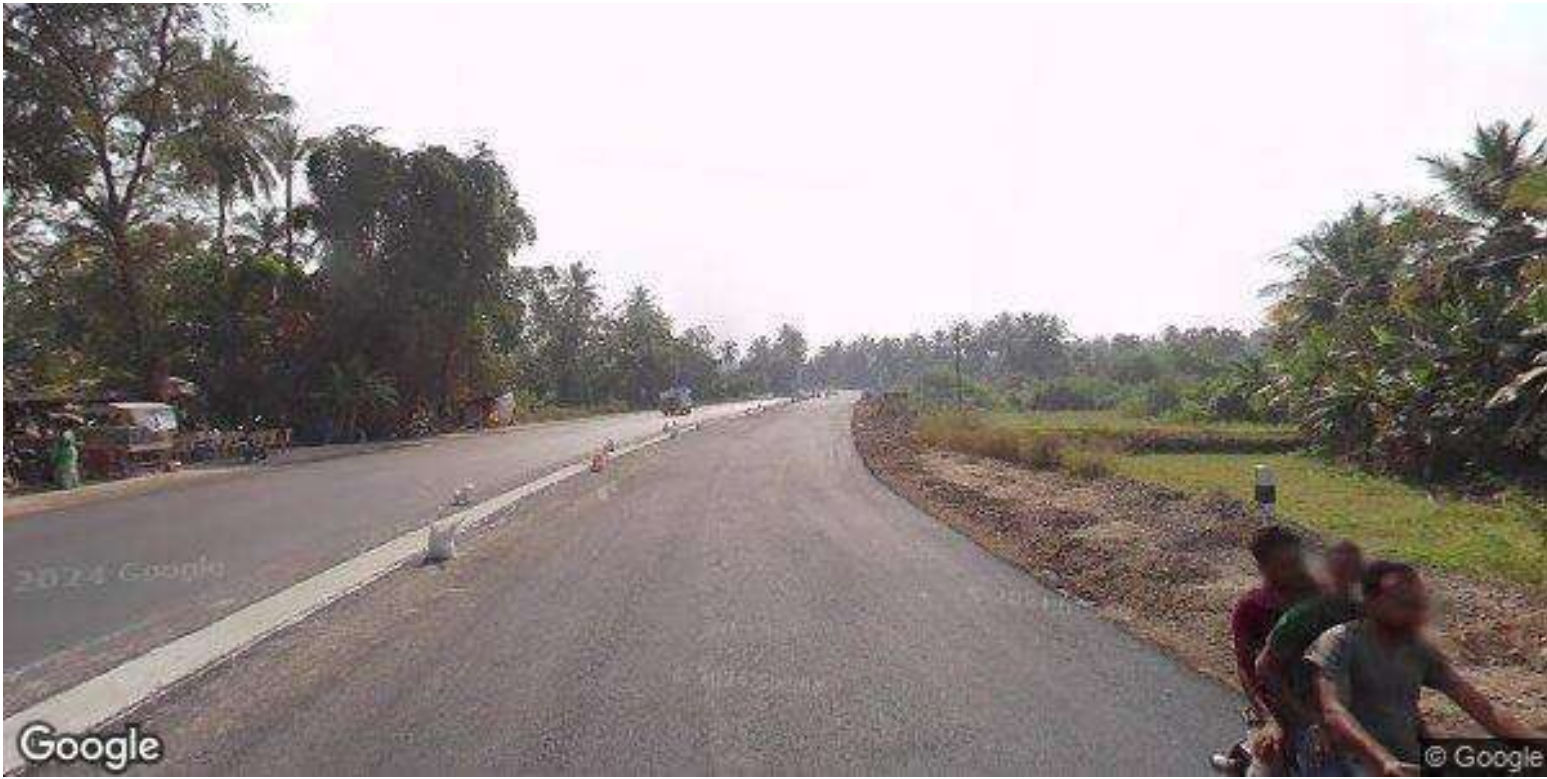
**Risk Type:** Turn  
**Risk Level:** Medium  
**Speed Limit:** 30 KM/Hr  
**Coordinates:** 11.45750, 77.35617

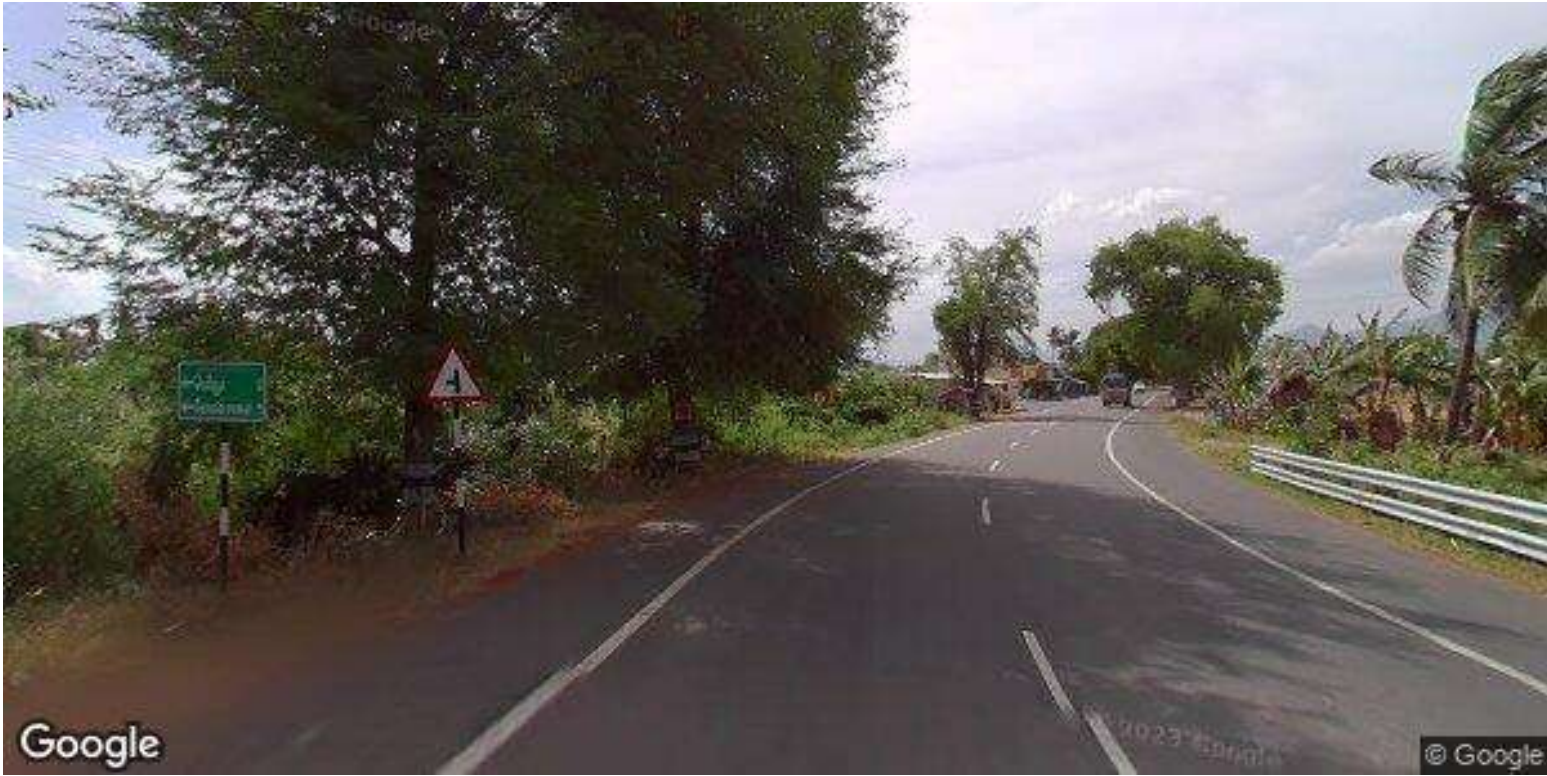
**Risk Type:** Turn  
**Risk Level:** Medium  
**Speed Limit:** 30 KM/Hr  
**Coordinates:** 11.45536, 77.25423

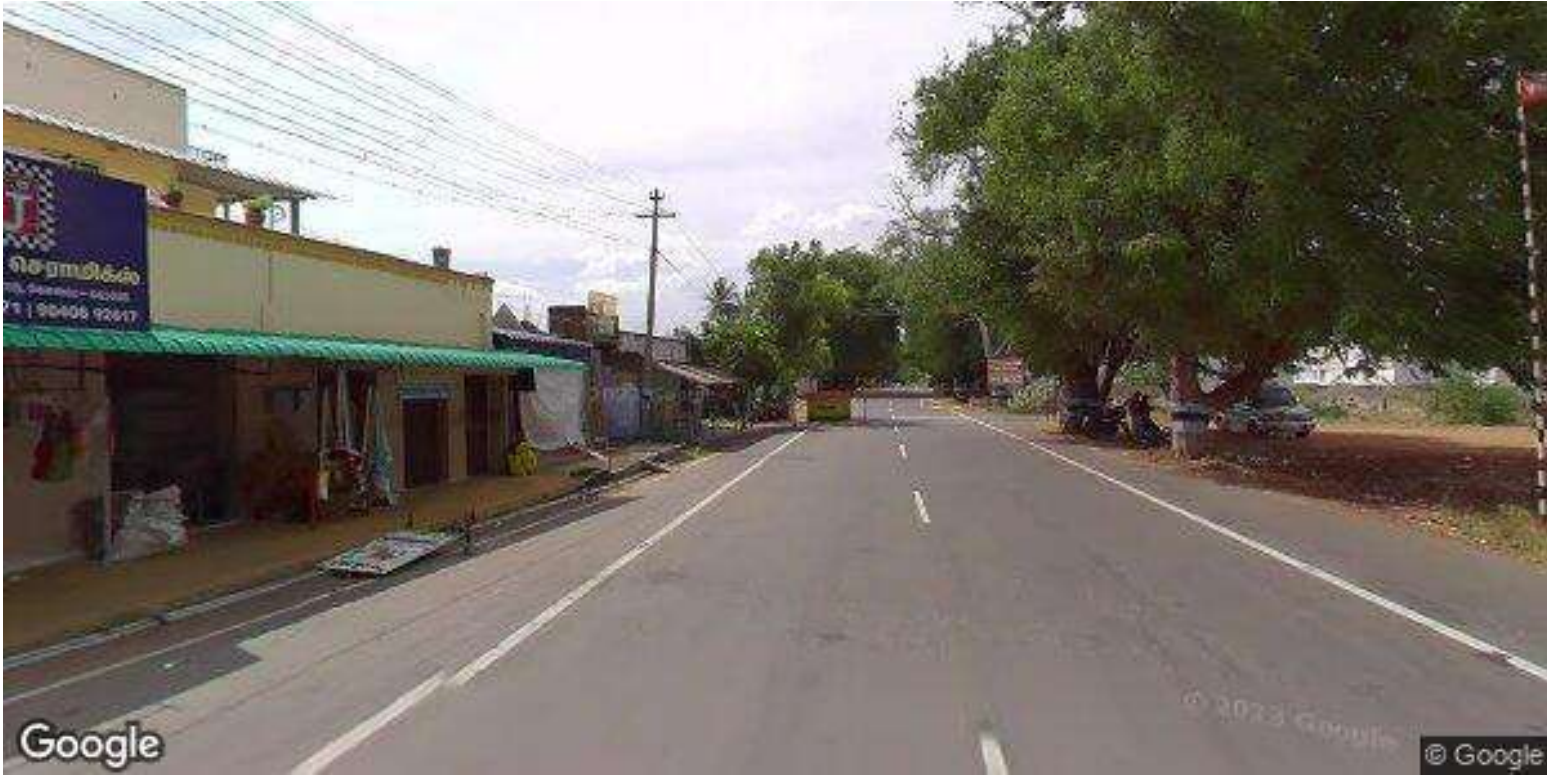
**Risk Type:** Turn  
**Risk Level:** High  
**Speed Limit:** 15 KM/Hr  
**Coordinates:** 11.45616, 77.25388

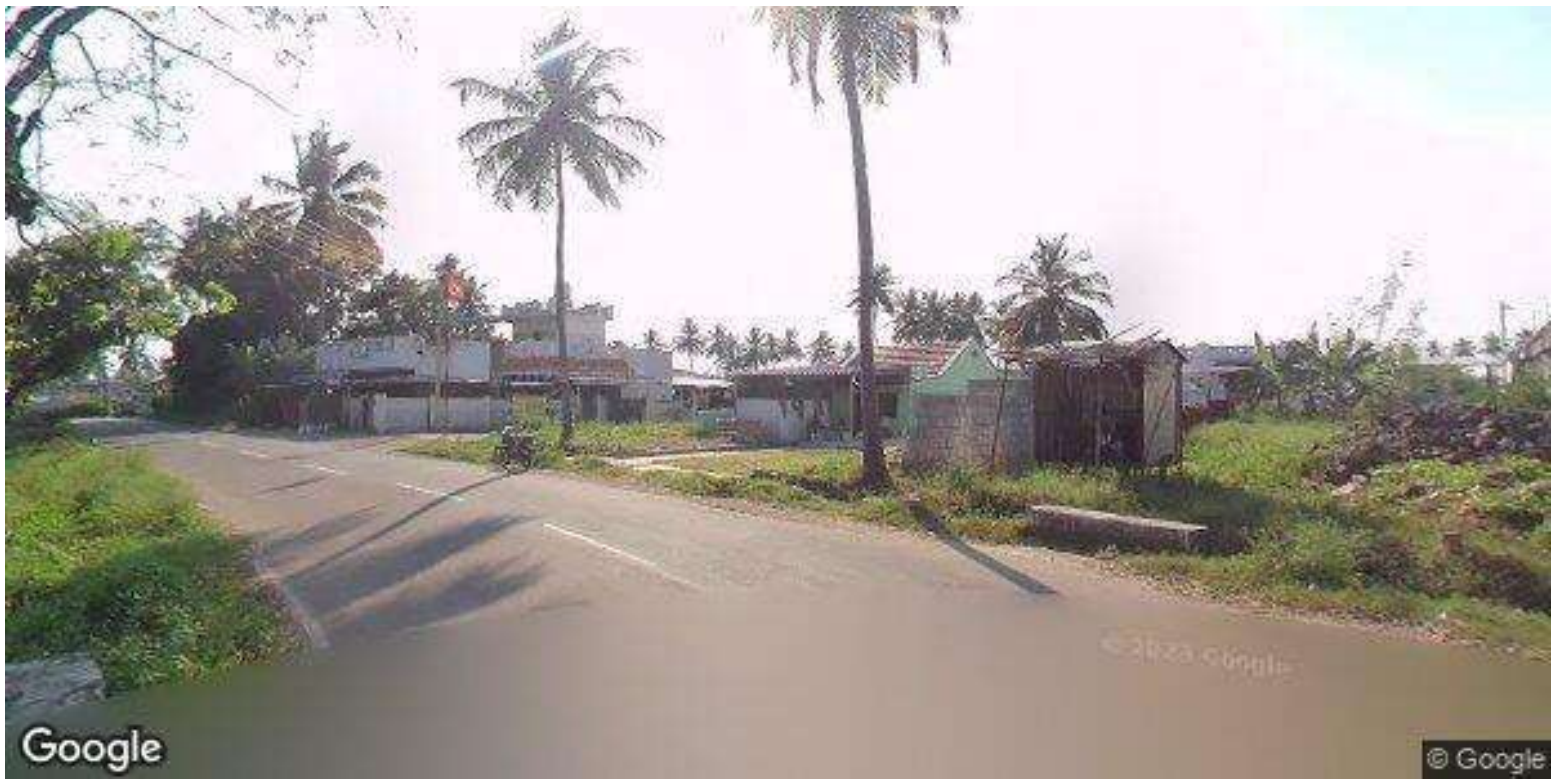
**Risk Type:** Turn  
**Risk Level:** High  
**Speed Limit:** 15 KM/Hr  
**Coordinates:** 11.45630, 77.25276

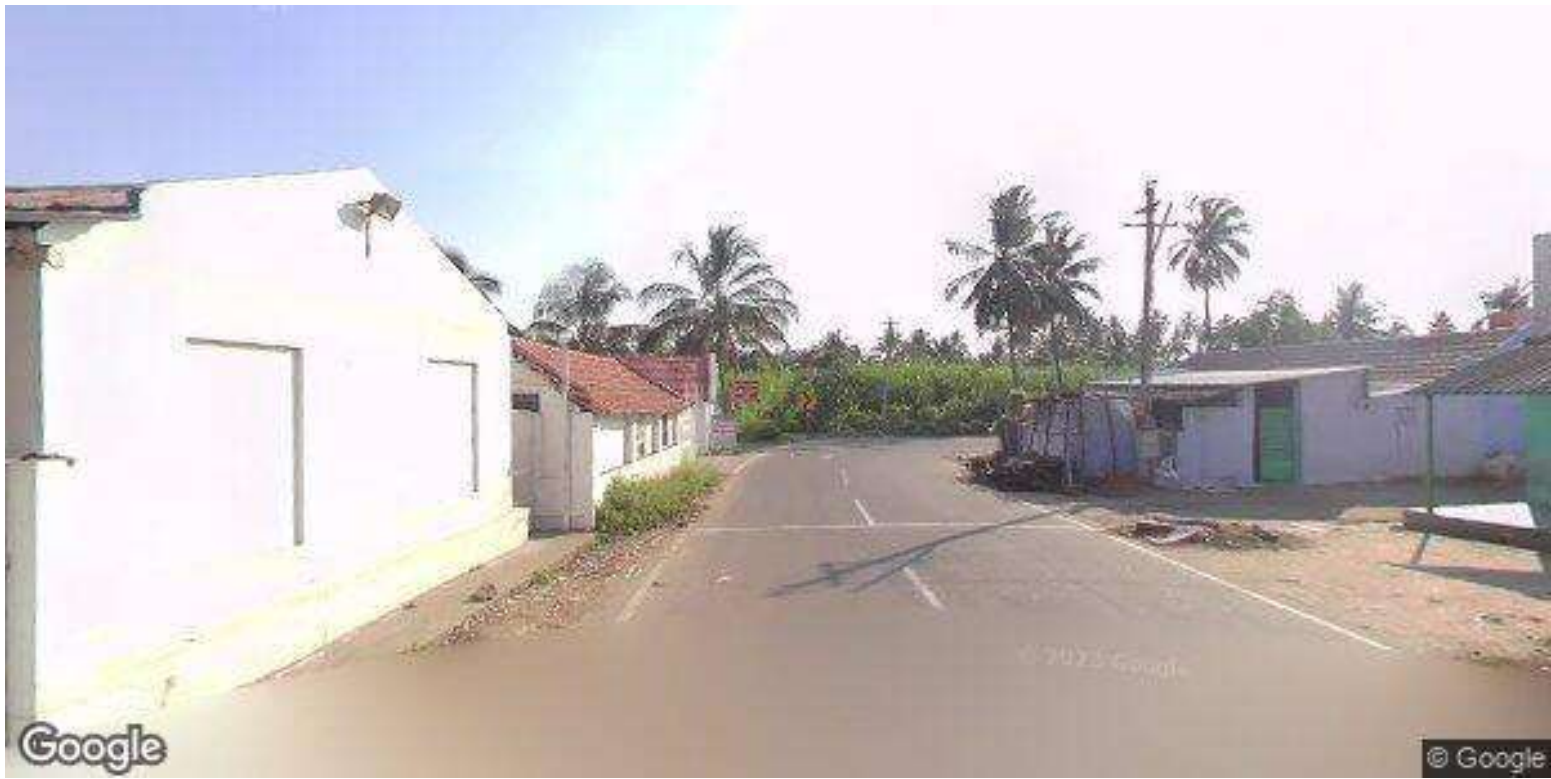
**Risk Type:** Turn  
**Risk Level:** High  
**Speed Limit:** 15 KM/Hr  
**Coordinates:** 11.45413, 77.25226

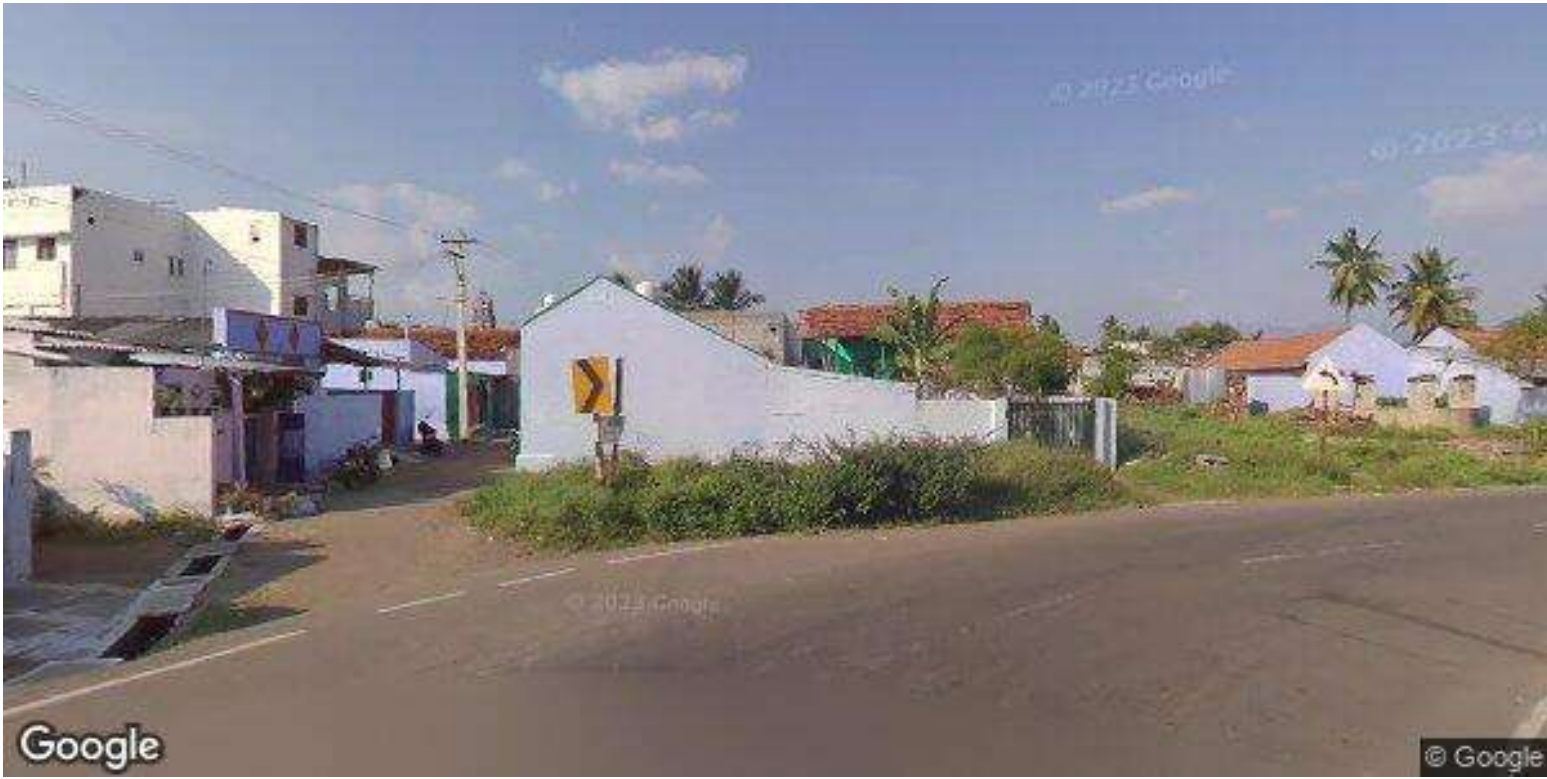
**Risk Type:** Turn  
**Risk Level:** High  
**Speed Limit:** 15 KM/Hr  
**Coordinates:** 11.45371, 77.25149

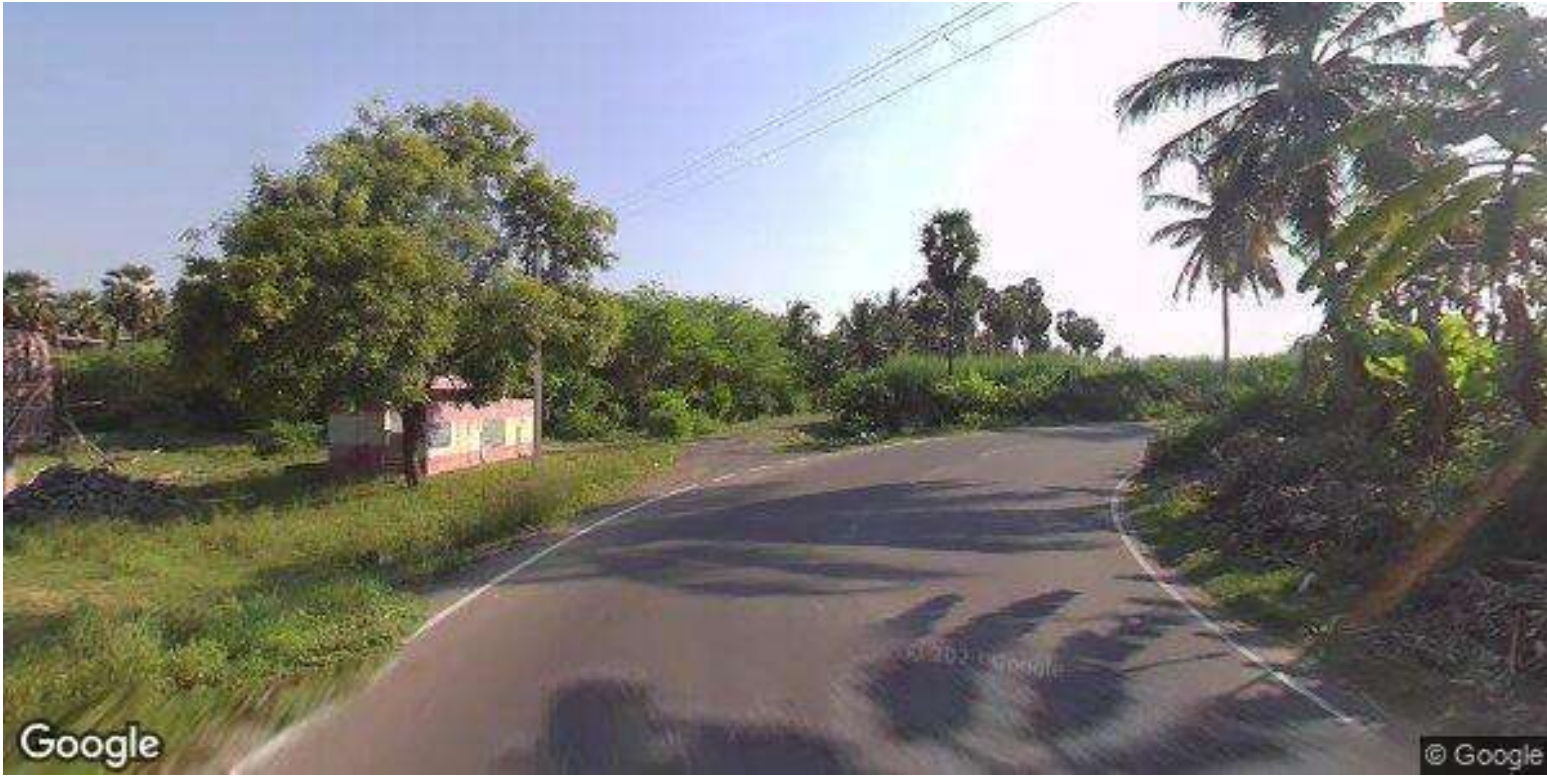
**Risk Type:** Turn  
**Risk Level:** High  
**Speed Limit:** 15 KM/Hr  
**Coordinates:** 11.45298, 77.25182

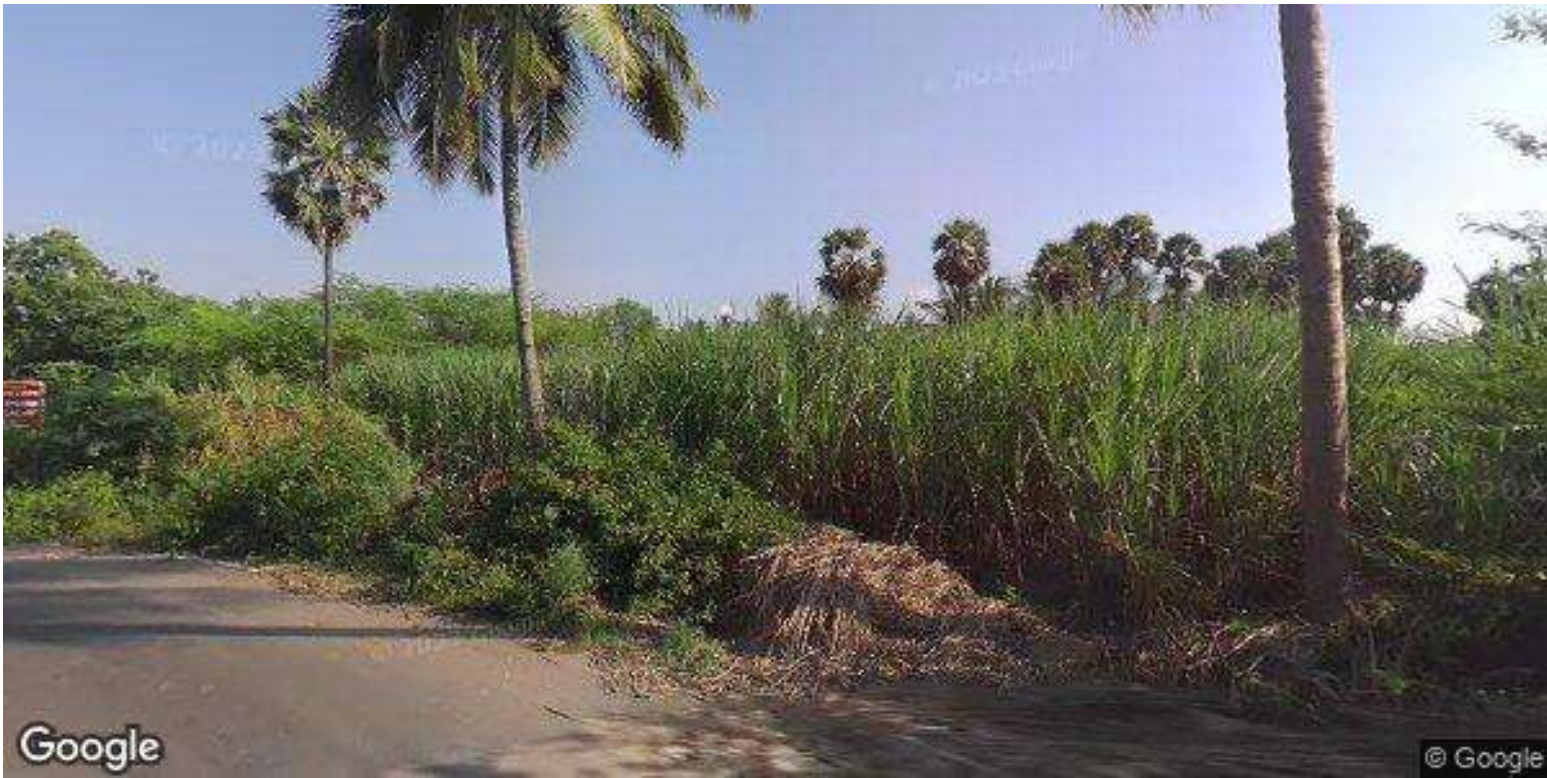
**Risk Type:** Turn  
**Risk Level:** High  
**Speed Limit:** 15 KM/Hr  
**Coordinates:** 11.45270, 77.25157

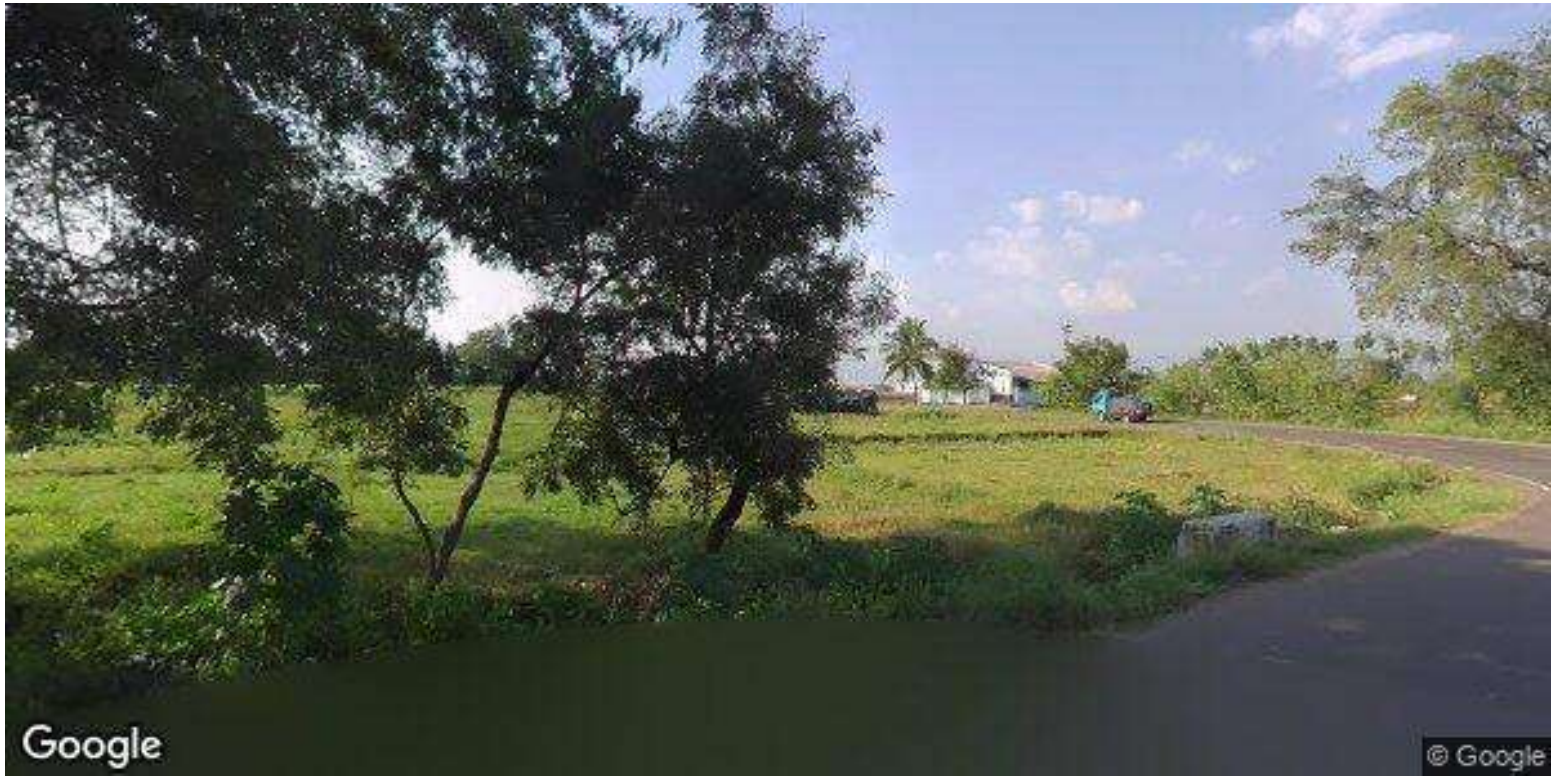
**Risk Type:** Turn  
**Risk Level:** High  
**Speed Limit:** 15 KM/Hr  
**Coordinates:** 11.45322, 77.24737

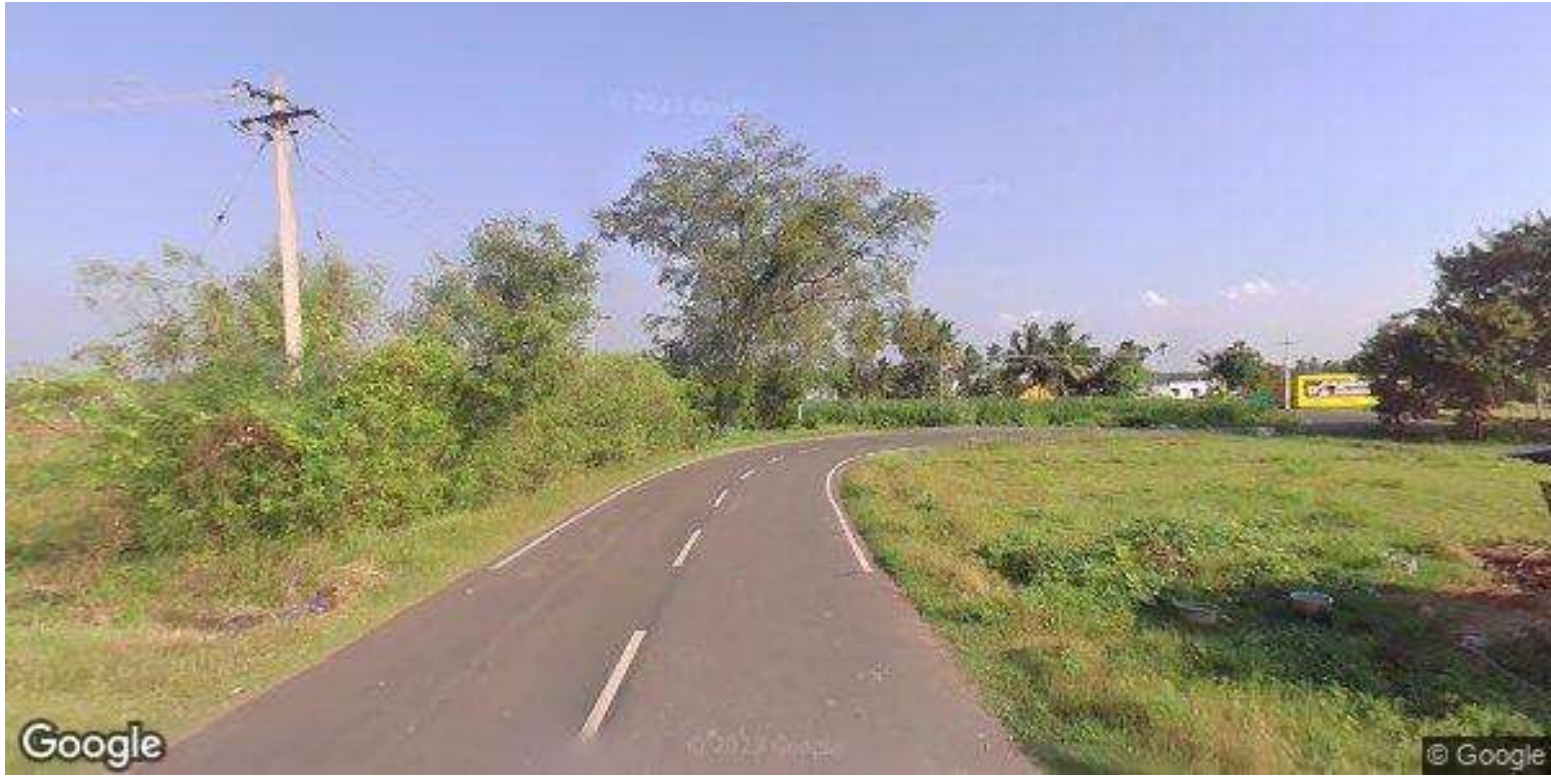
**Risk Type:** Turn  
**Risk Level:** Medium  
**Speed Limit:** 30 KM/Hr  
**Coordinates:** 11.45376, 77.24707

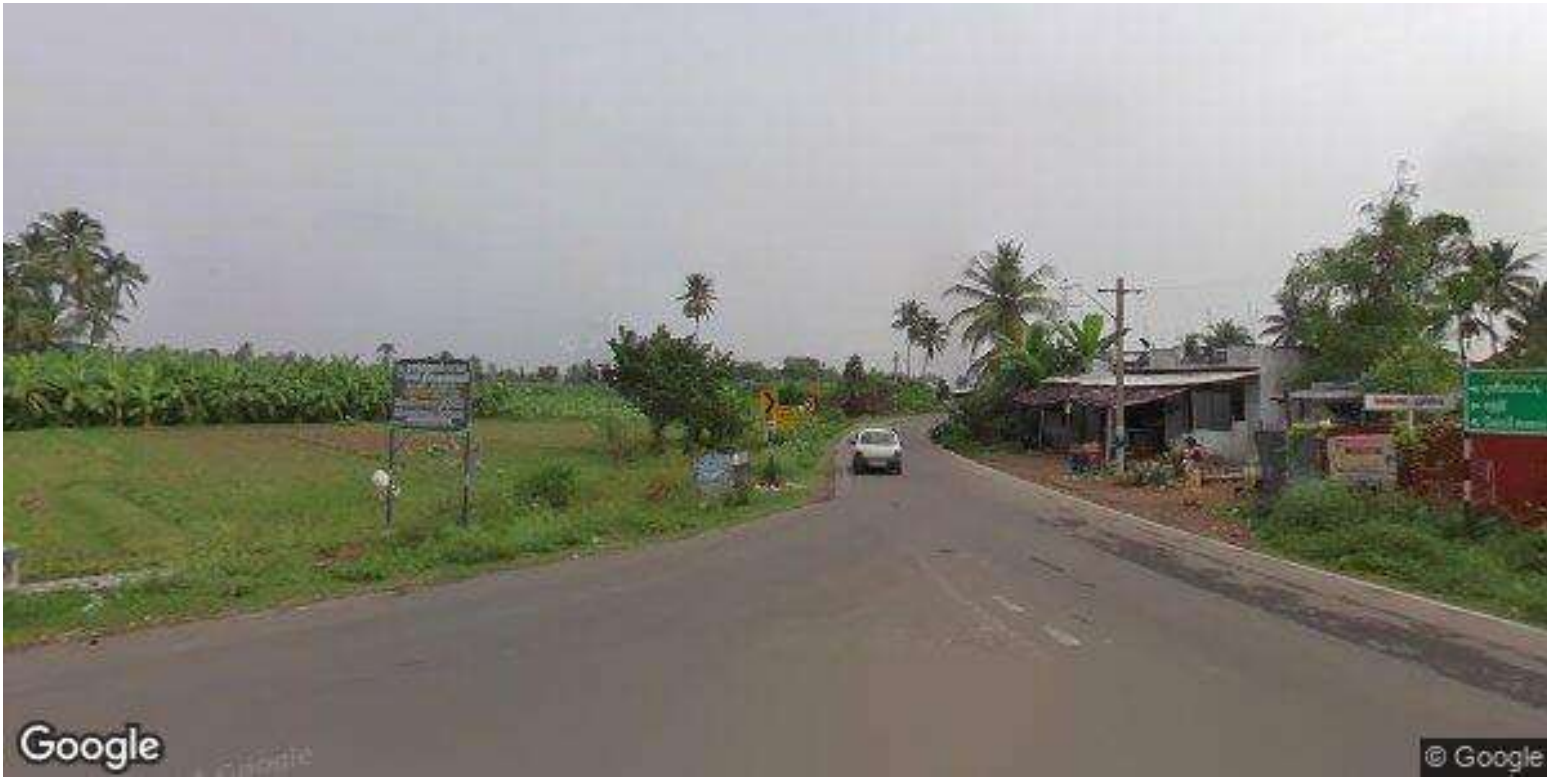
**Risk Type:** Turn  
**Risk Level:** High  
**Speed Limit:** 15 KM/Hr  
**Coordinates:** 11.45308, 77.23644

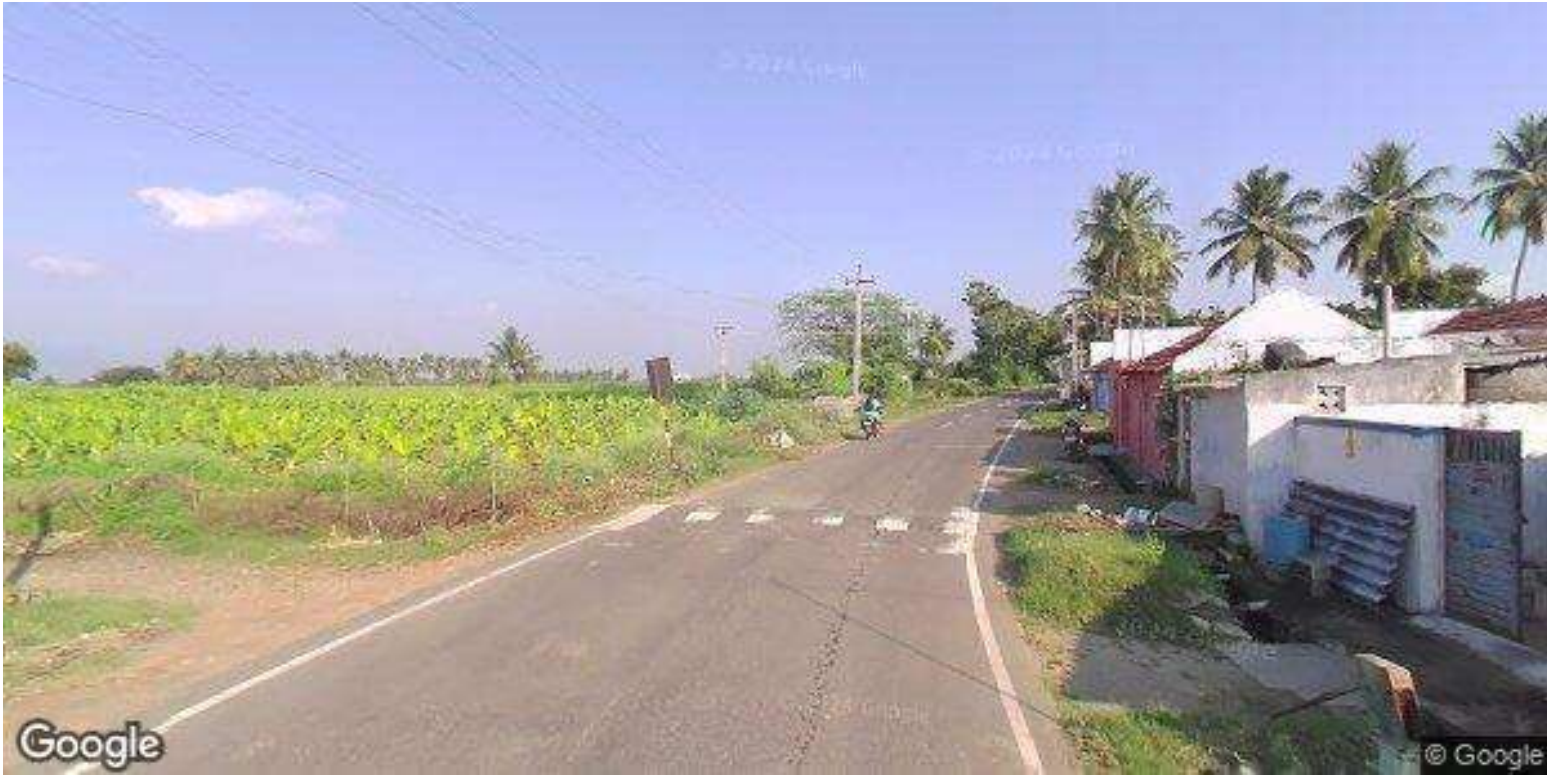
**Risk Type:** Turn  
**Risk Level:** Medium  
**Speed Limit:** 30 KM/Hr  
**Coordinates:** 11.45545, 77.23047
