# IndianOil

## JOURNEY RISK MANAGEMENT (JRM) STUDY

### Salem Terminal TO MARTHAR AGENCIES

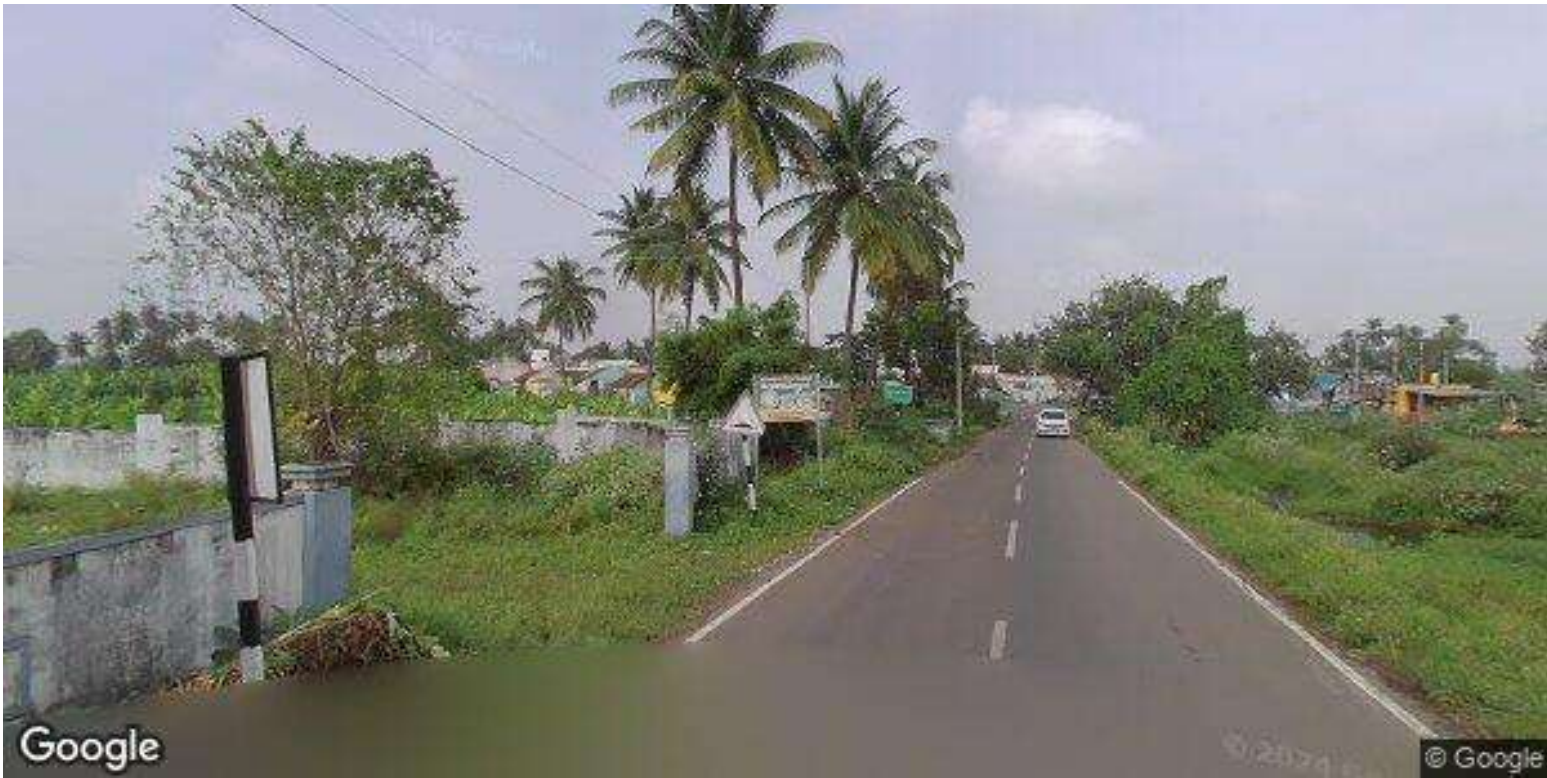
**Risk Type:** Turn  
**Risk Level:** High  
**Speed Limit:** 15 KM/Hr  
**Coordinates:** 11.45516, 77.22964

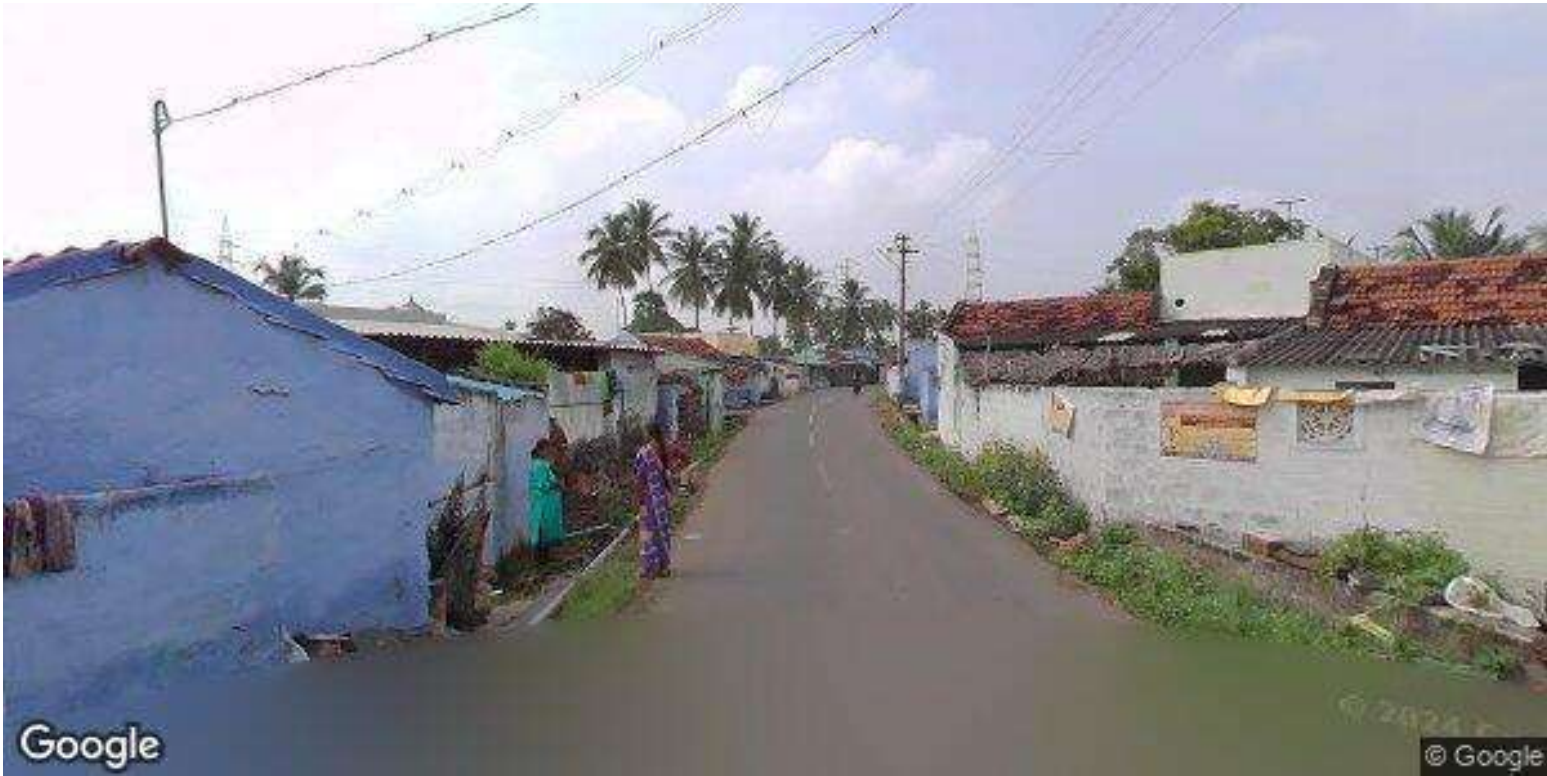
**Risk Type:** Turn  
**Risk Level:** High  
**Speed Limit:** 15 KM/Hr  
**Coordinates:** 11.45580, 77.22882

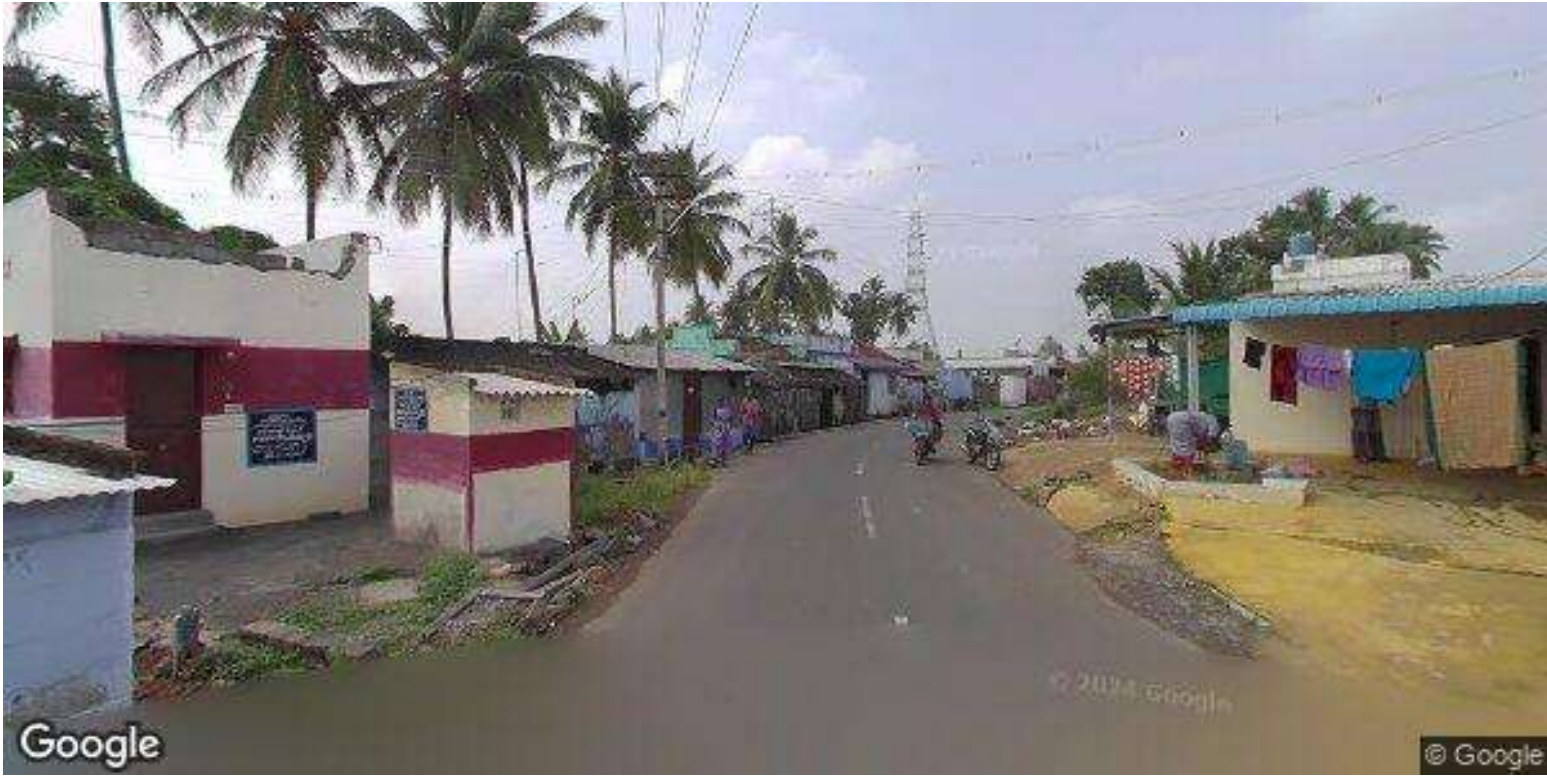
**Risk Type:** Turn  
**Risk Level:** Medium  
**Speed Limit:** 30 KM/Hr  
**Coordinates:** 11.45555, 77.22843

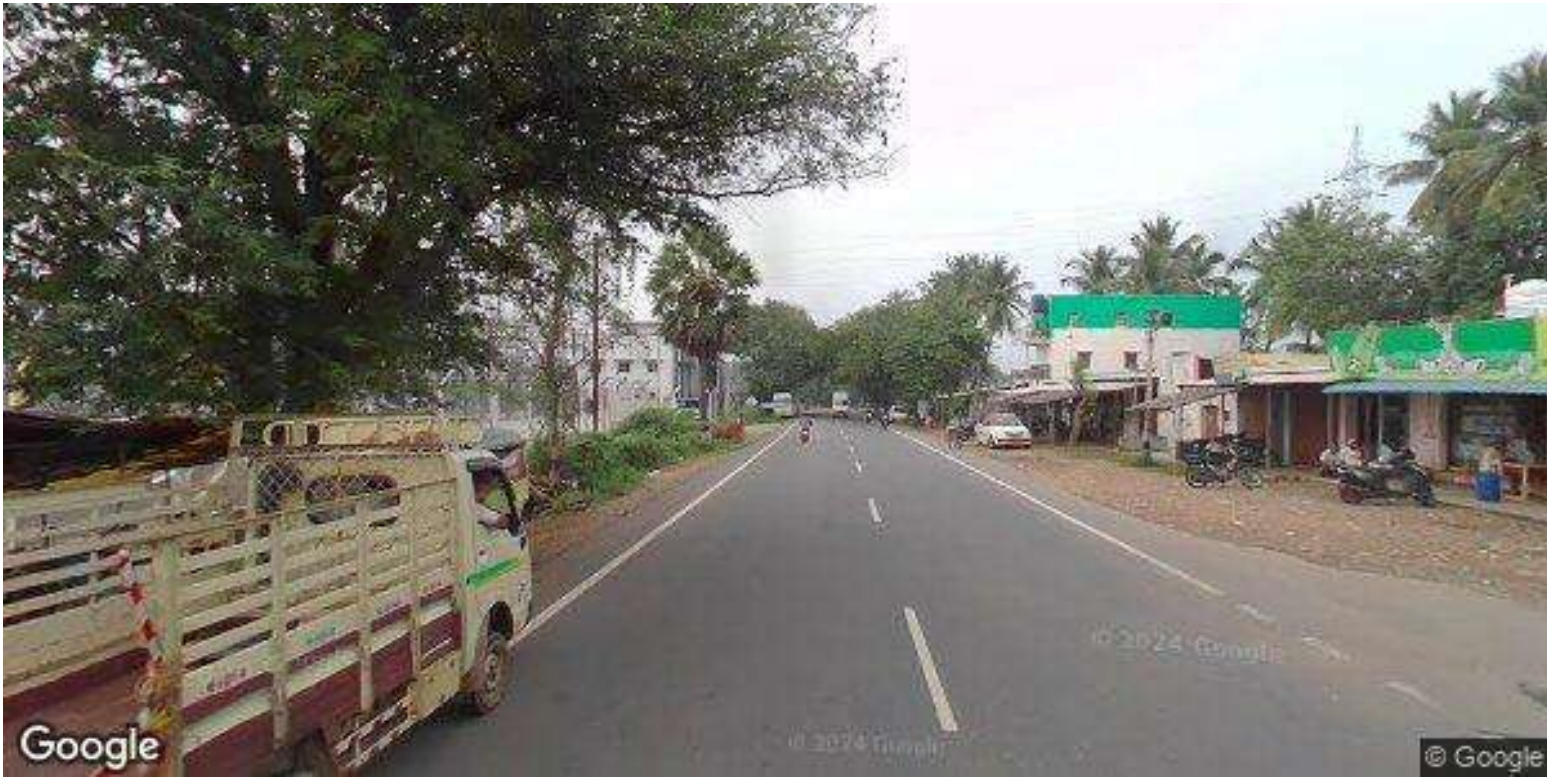
**Risk Type:** Turn  
**Risk Level:** High  
**Speed Limit:** 15 KM/Hr  
**Coordinates:** 11.45708, 77.21660

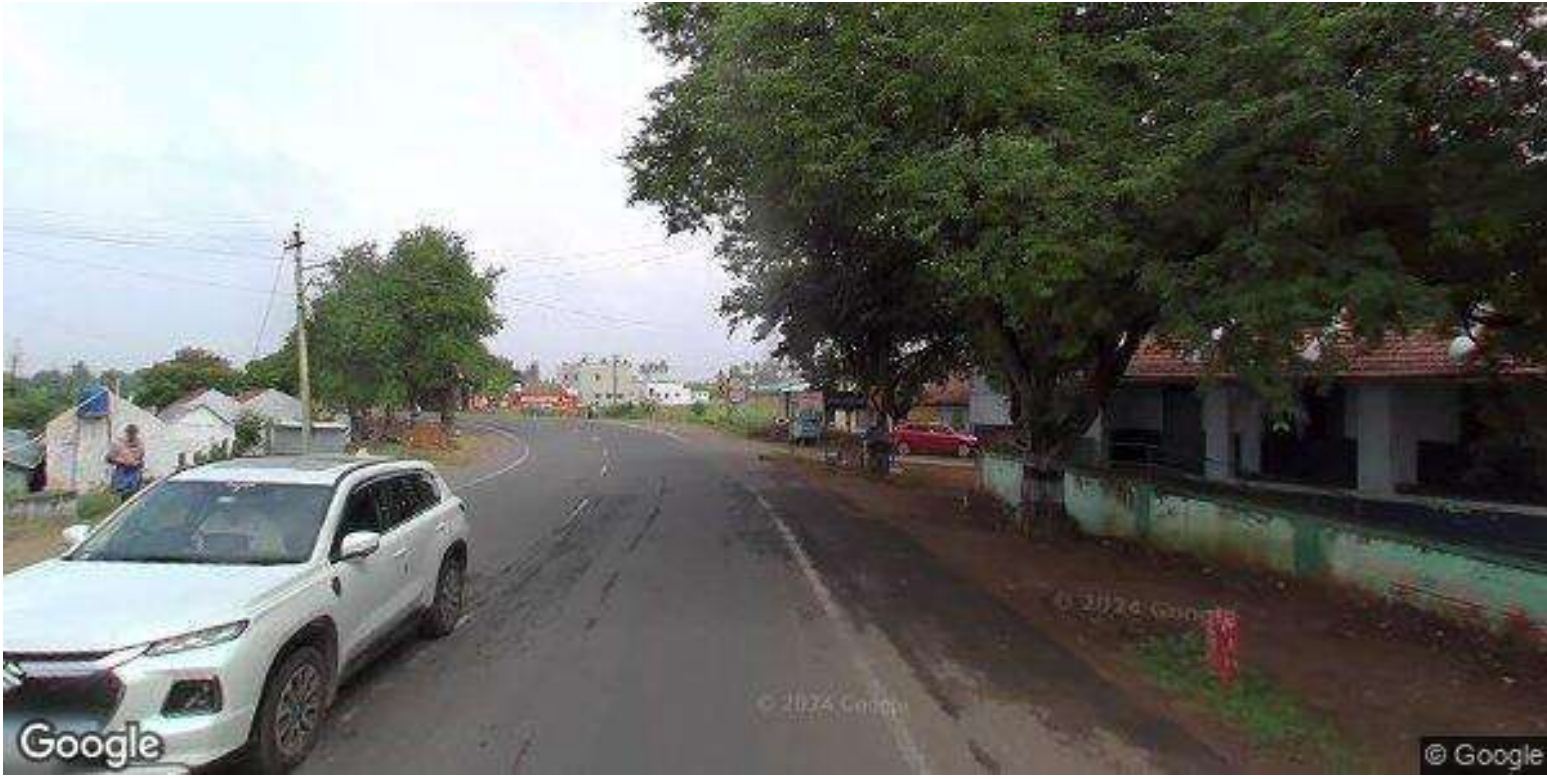
**Risk Type:** Turn  
**Risk Level:** Medium  
**Speed Limit:** 30 KM/Hr  
**Coordinates:** 11.45099, 77.21508

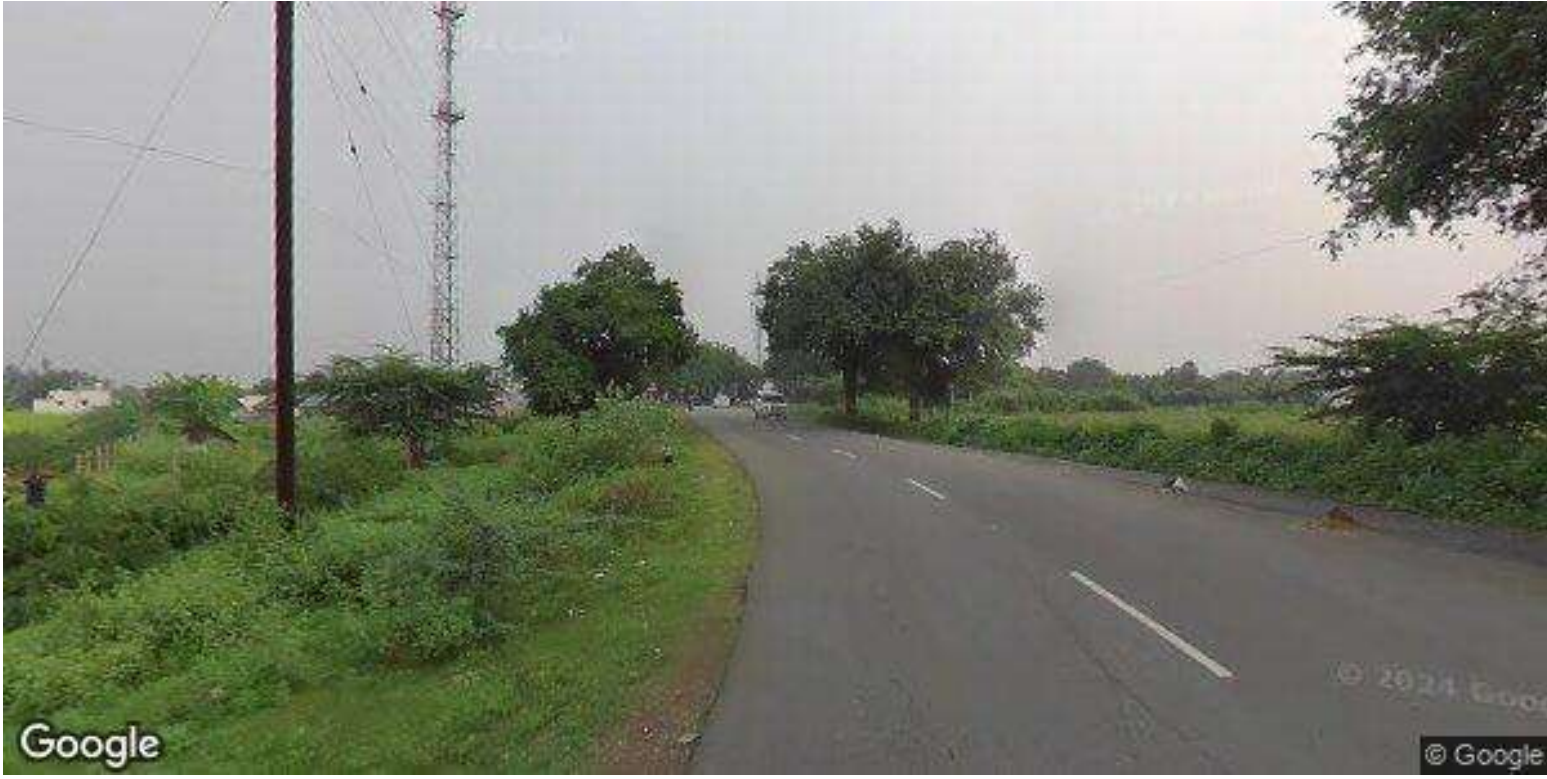
**Risk Type:** Turn  
**Risk Level:** Medium  
**Speed Limit:** 30 KM/Hr  
**Coordinates:** 11.42096, 77.19395

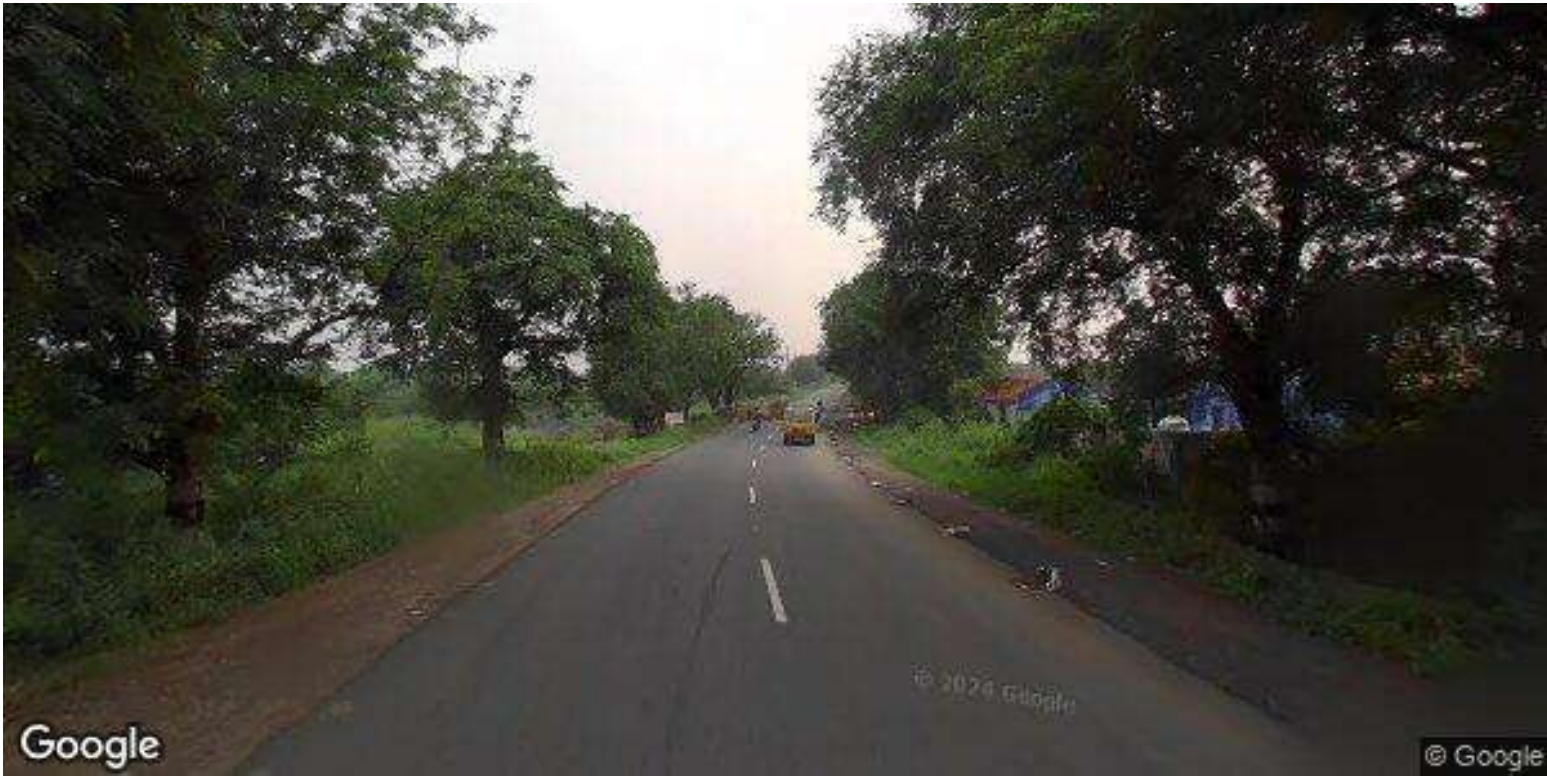
**Risk Type:** Turn  
**Risk Level:** Medium  
**Speed Limit:** 30 KM/Hr  
**Coordinates:** 11.41965, 77.19493

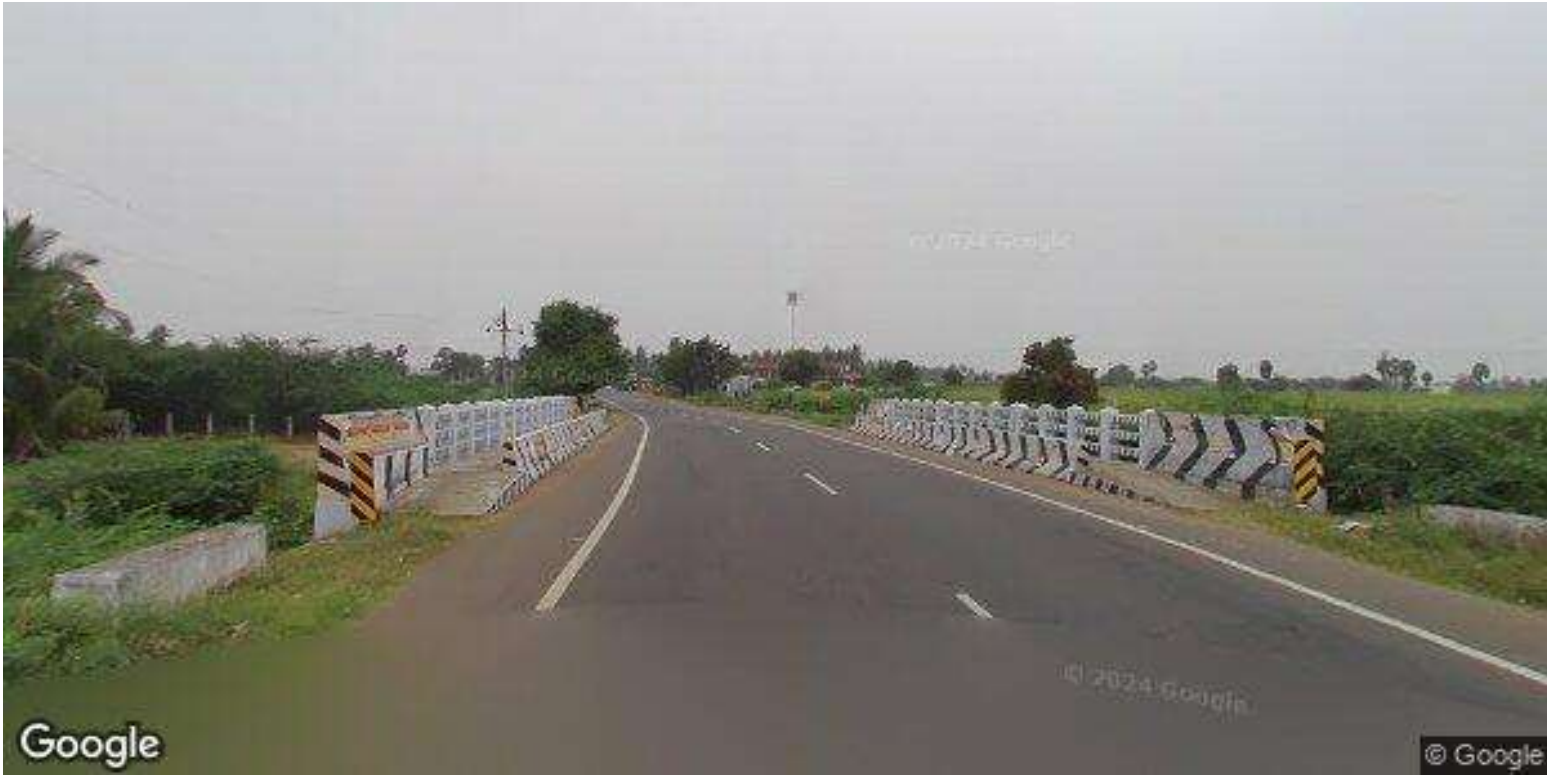
**Risk Type:** Turn  
**Risk Level:** Medium  
**Speed Limit:** 30 KM/Hr  
**Coordinates:** 11.40475, 77.19260

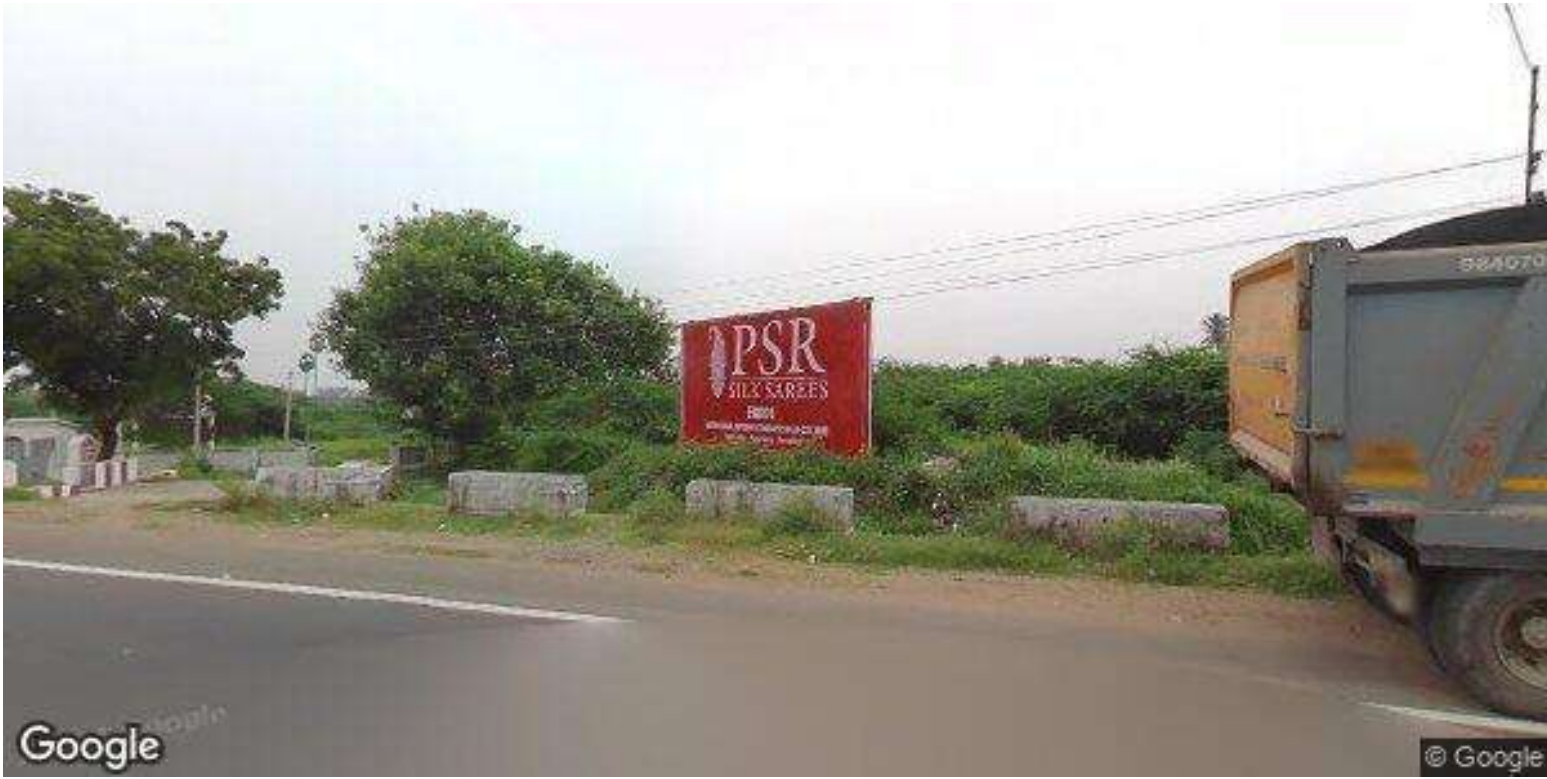
**Risk Type:** Turn  
**Risk Level:** Medium  
**Speed Limit:** 30 KM/Hr  
**Coordinates:** 11.40421, 77.19221

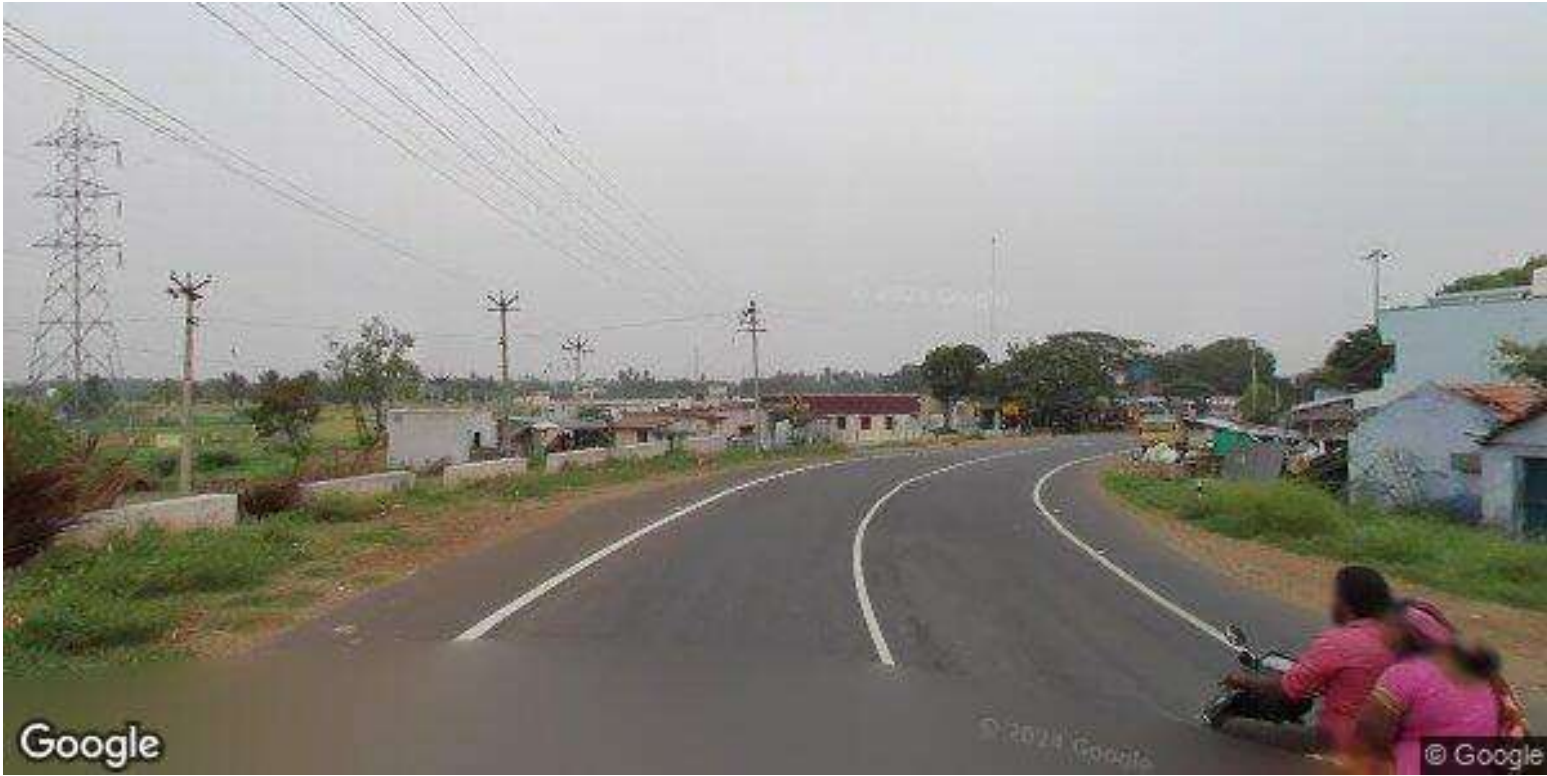
**Risk Type:** Turn  
**Risk Level:** High  
**Speed Limit:** 15 KM/Hr  
**Coordinates:** 11.40325, 77.19002

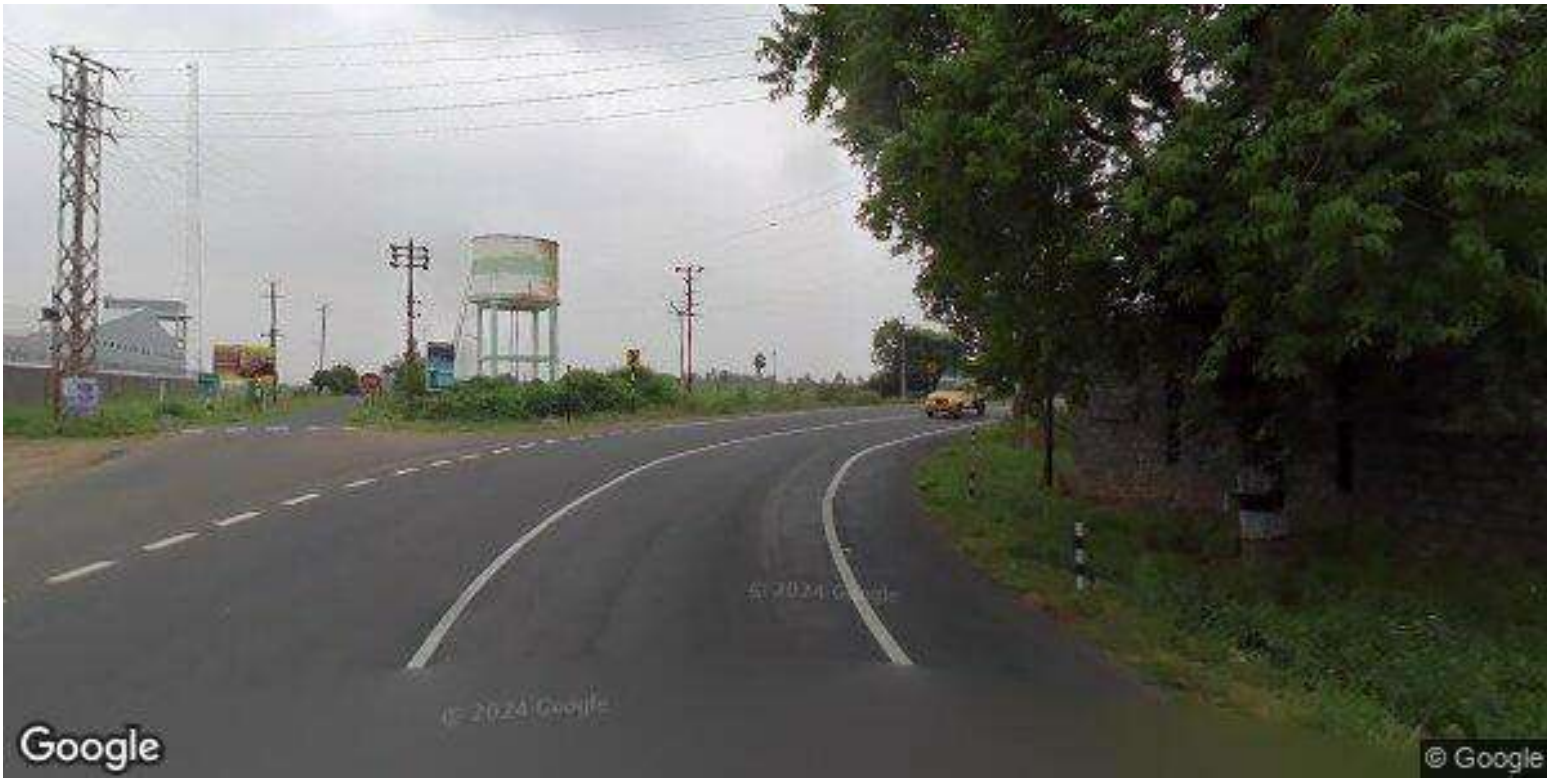
**Risk Type:** Turn  
**Risk Level:** Medium  
**Speed Limit:** 30 KM/Hr  
**Coordinates:** 11.40005, 77.18895

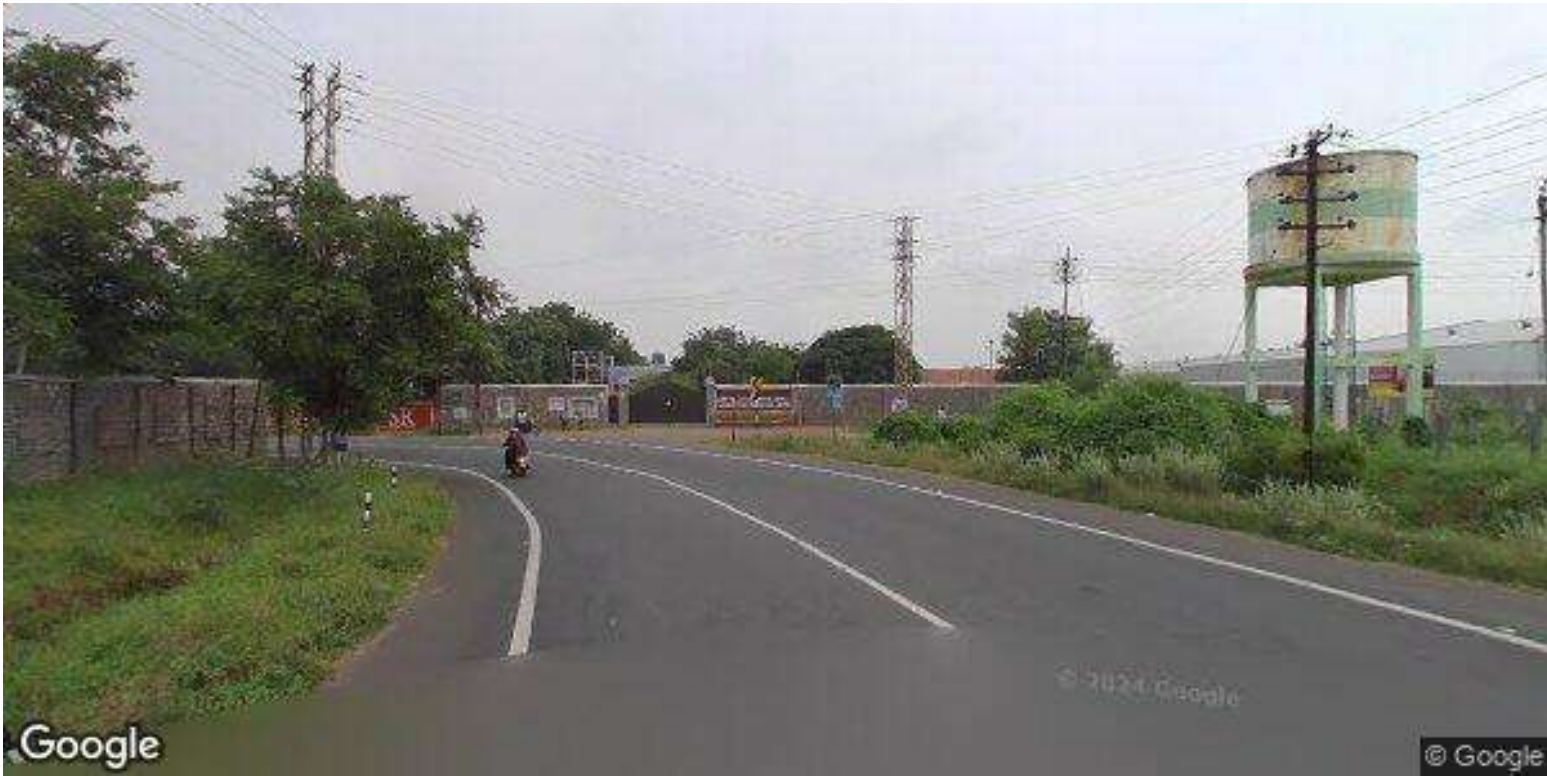
**Risk Type:** Turn  
**Risk Level:** Medium  
**Speed Limit:** 30 KM/Hr  
**Coordinates:** 11.39979, 77.18857

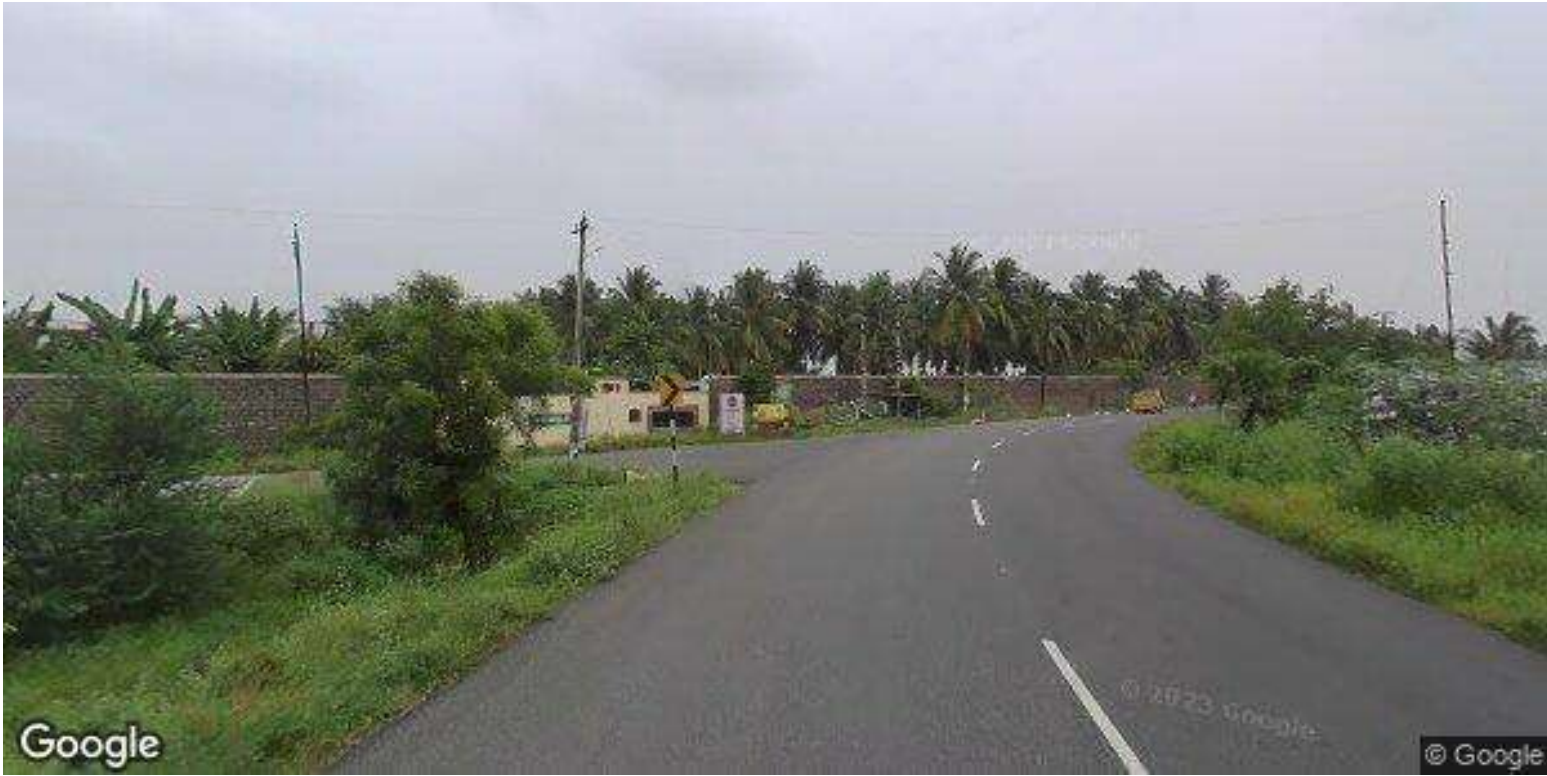
**Risk Type:** Turn  
**Risk Level:** Medium  
**Speed Limit:** 30 KM/Hr  
**Coordinates:** 11.39934, 77.18451

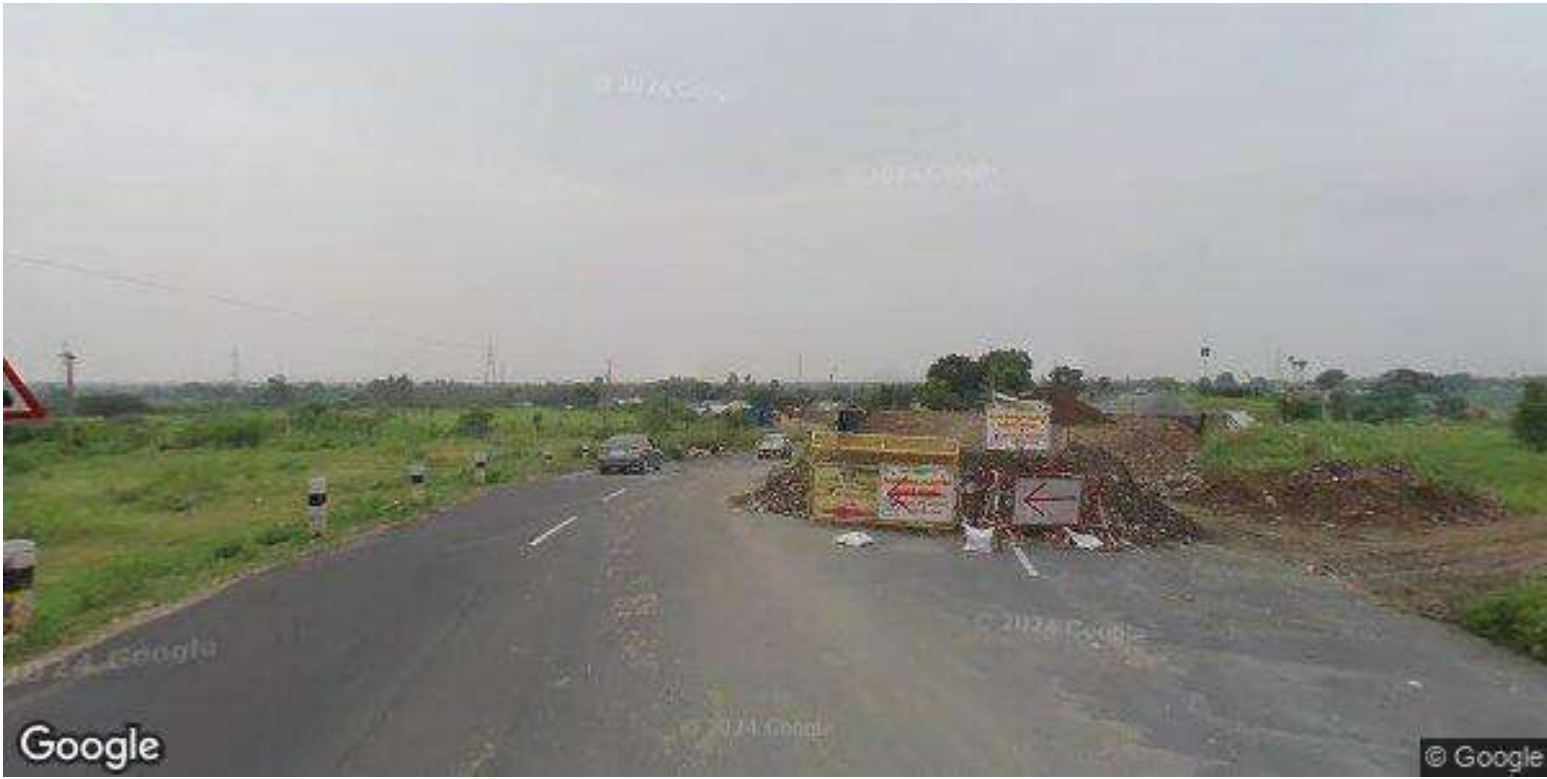
**Risk Type:** Turn  
**Risk Level:** Medium  
**Speed Limit:** 30 KM/Hr  
**Coordinates:** 11.39736, 77.18344

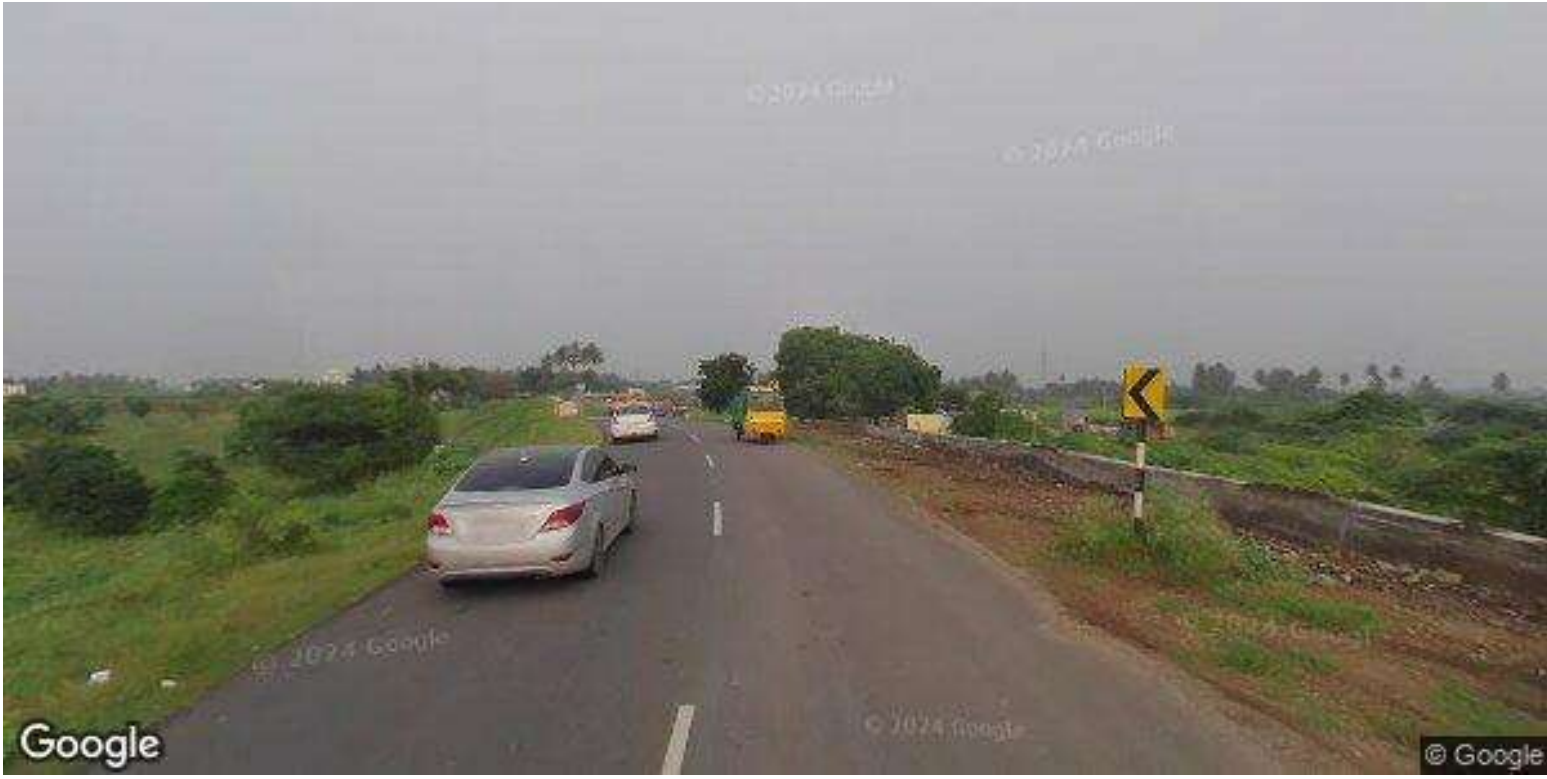
**Risk Type:** Turn  
**Risk Level:** Medium  
**Speed Limit:** 30 KM/Hr  
**Coordinates:** 11.39588, 77.18182

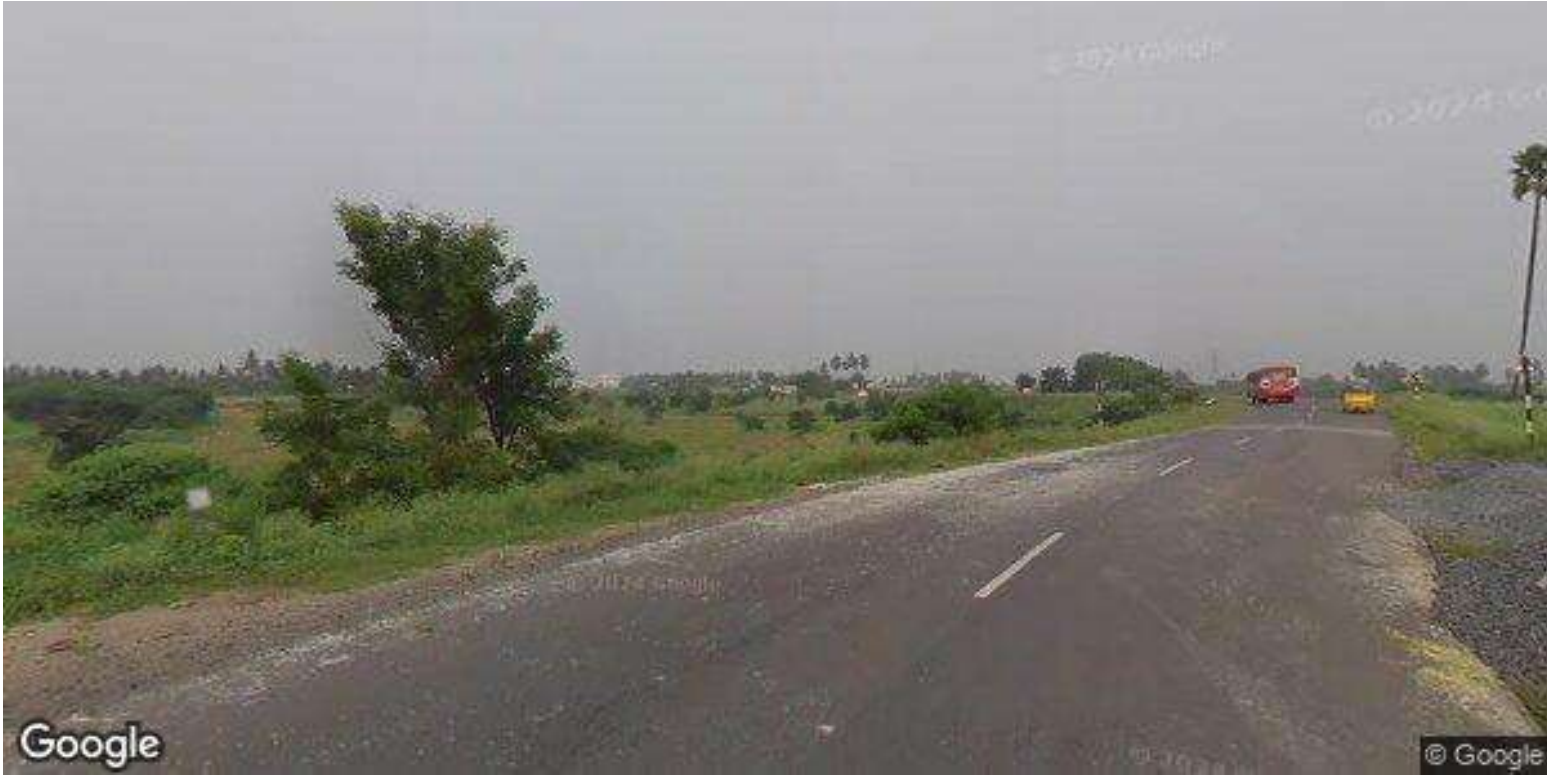
**Risk Type:** Turn  
**Risk Level:** Medium  
**Speed Limit:** 30 KM/Hr  
**Coordinates:** 11.39574, 77.18080

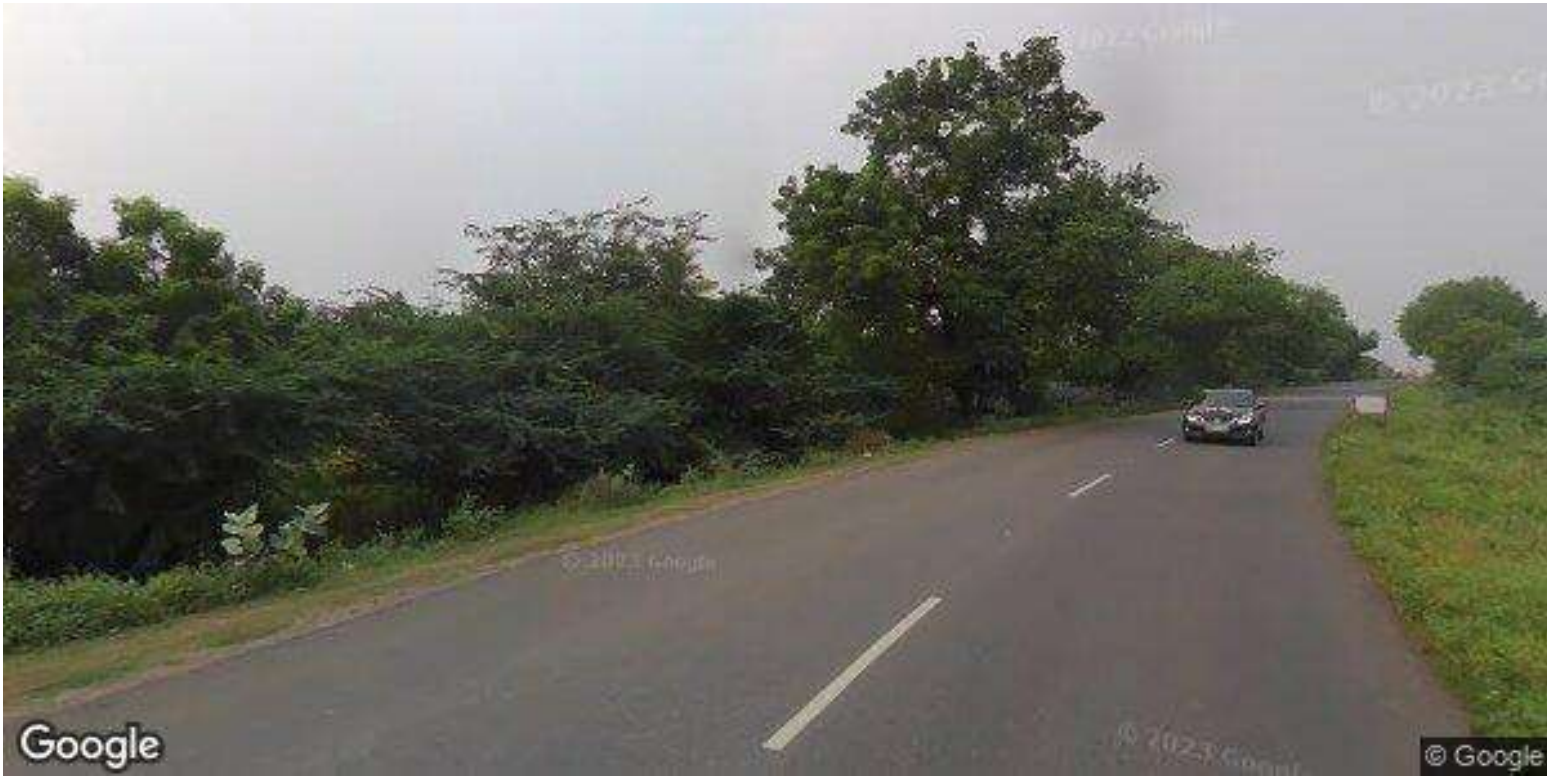
**Risk Type:** Turn  
**Risk Level:** Medium  
**Speed Limit:** 30 KM/Hr  
**Coordinates:** 11.39053, 77.17784

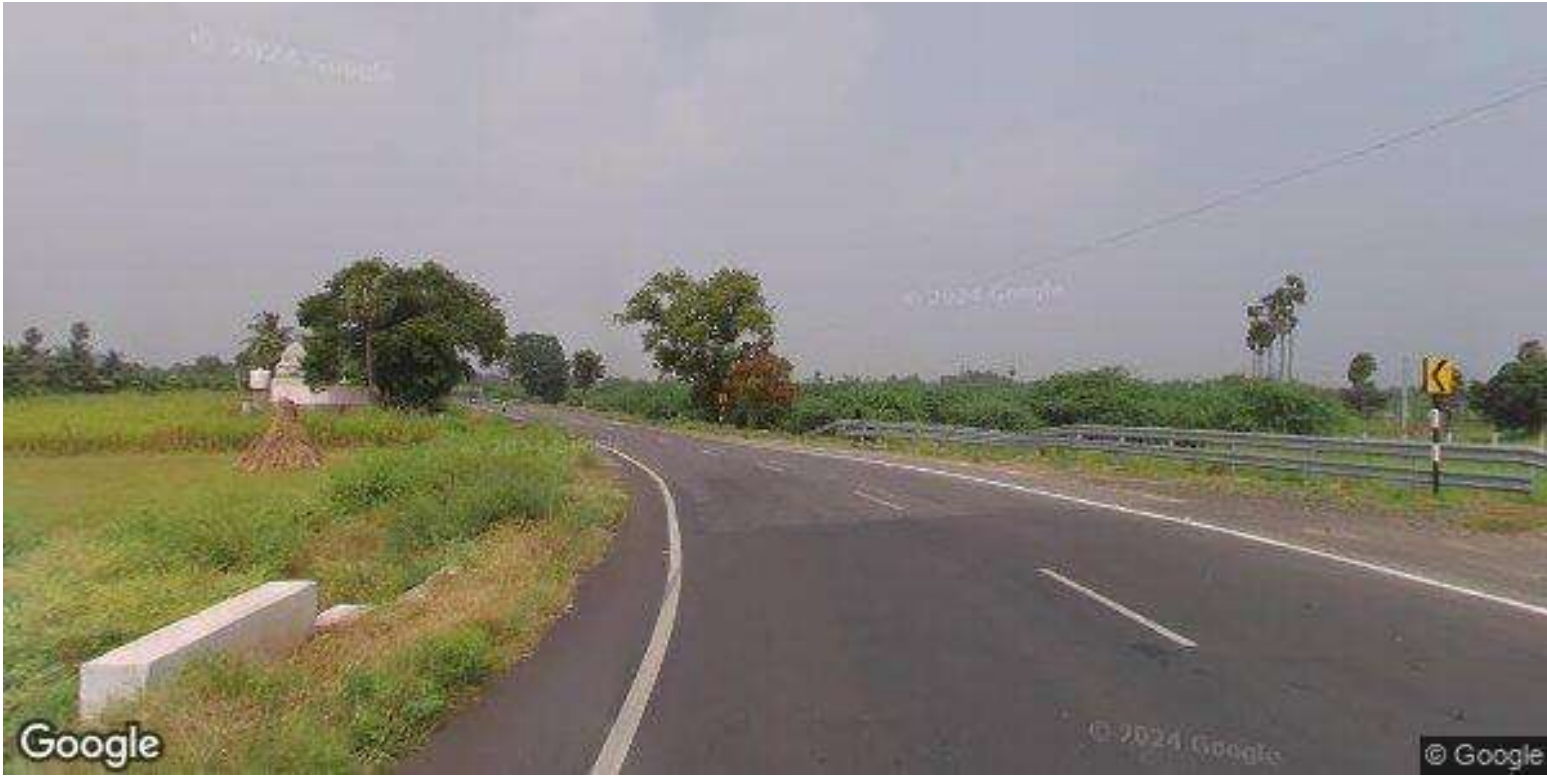
**Risk Type:** Turn  
**Risk Level:** Medium  
**Speed Limit:** 30 KM/Hr  
**Coordinates:** 11.38749, 77.17806
