# IndianOil

## JOURNEY RISK MANAGEMENT (JRM) STUDY

### Salem Terminal TO MARTHAR AGENCIES

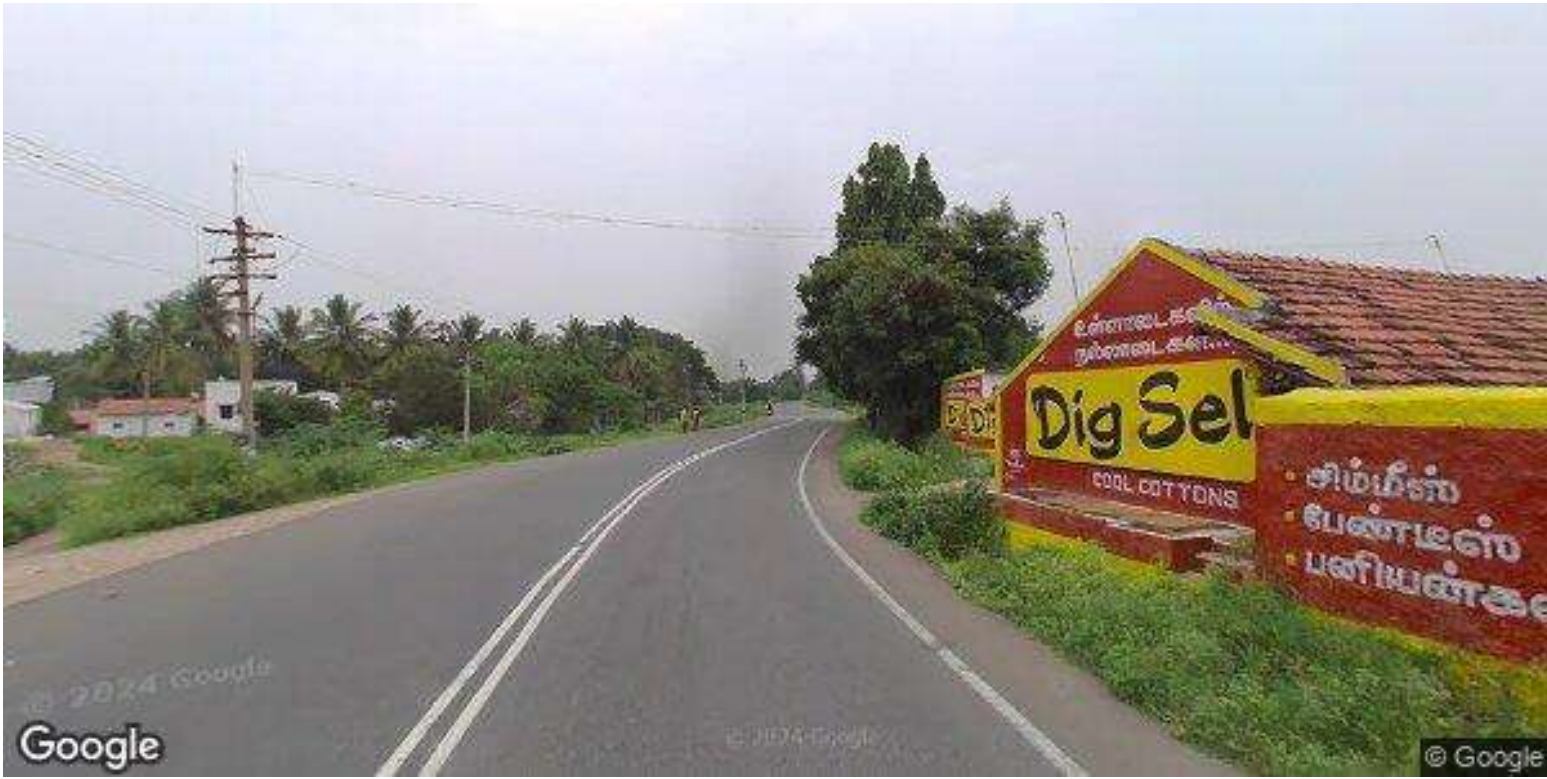
**Coordinates:** 11.38315, 77.17283

**Risk Type:** Turn

**Risk Level:** Medium

**Speed Limit:** 30 KM/Hr
