## **JOURNEY RISK MANAGEMENT (JRM) STUDY**

### **Salem Terminal To SREE SUNTHARAM AGENCIES**

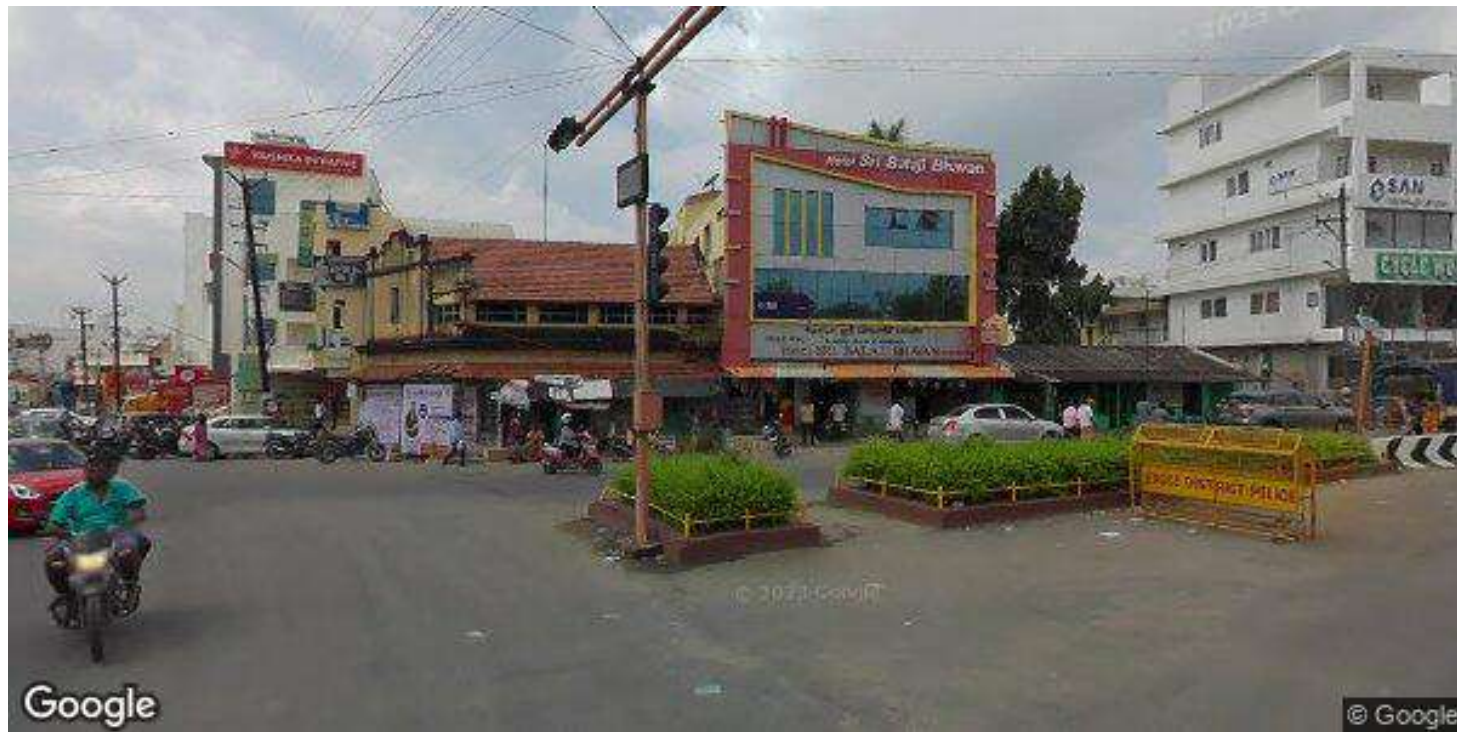
**Coordinates:** 11.27925, 77.58494

**Risk Type:** Roundabout

**Risk Level:** High

**Speed Limit:** 15 KM/Hr

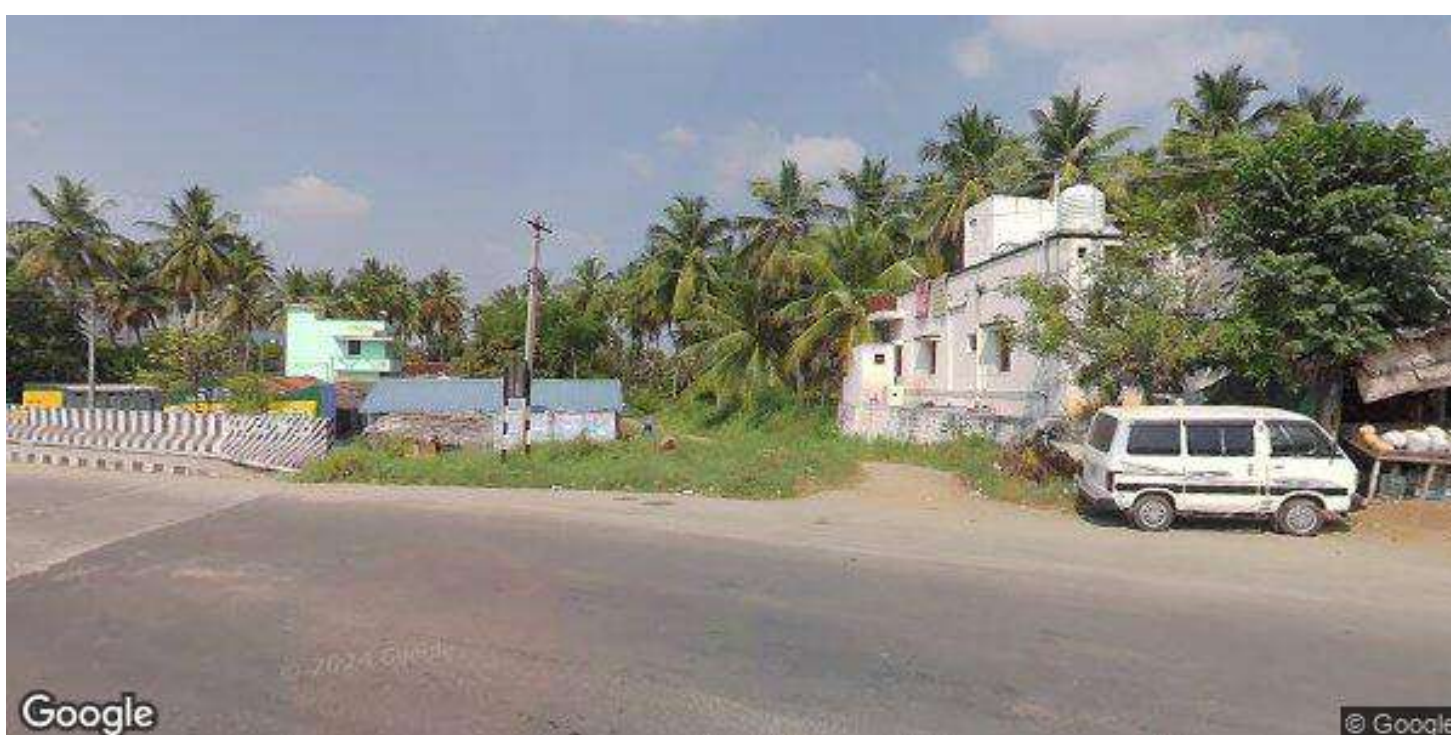
**Coordinates:** 11.44898, 77.87410

**Risk Type:** Turn

**Risk Level:** Medium

**Speed Limit:** 30 KM/Hr

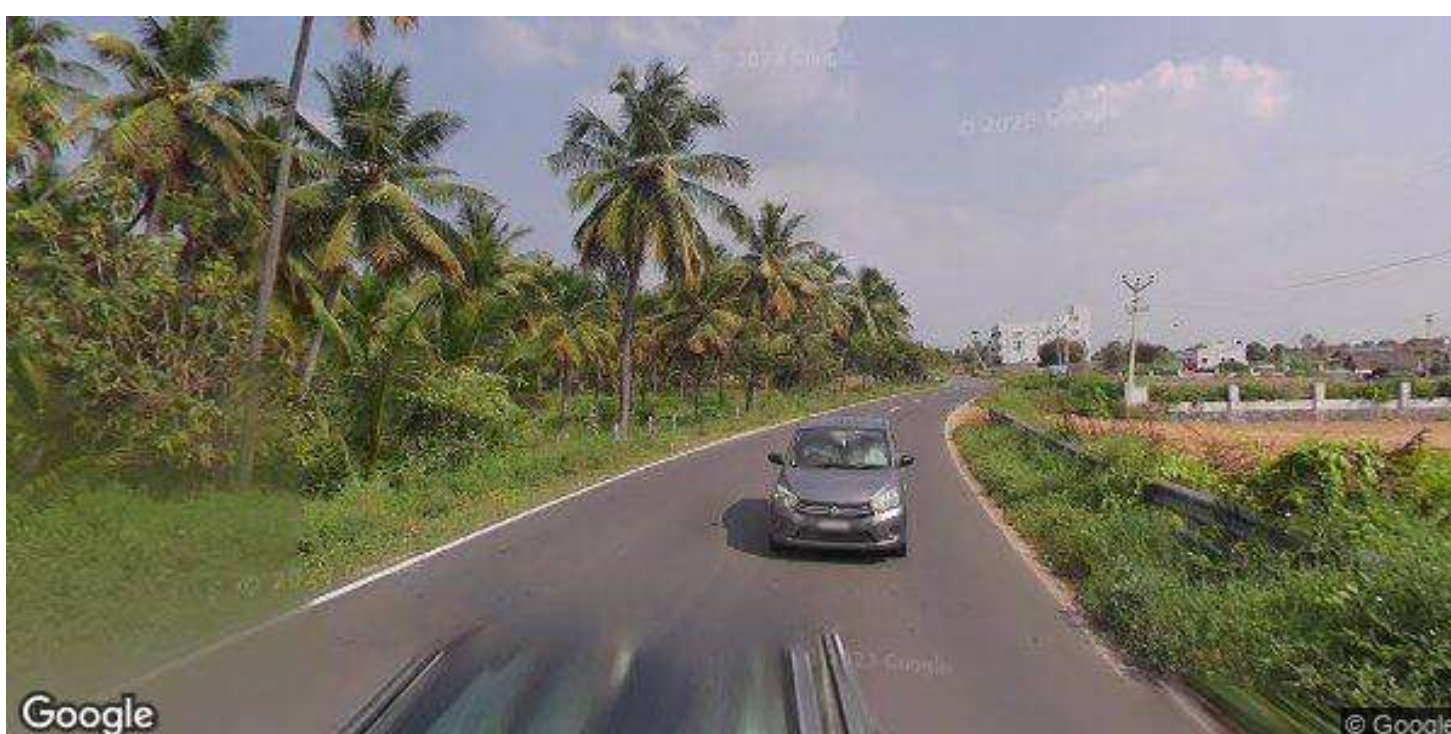
**Coordinates: 11.45357, 77.85789**

**Risk Type:** Turn

**Risk Level:** Medium

**Speed Limit: 30 KM/Hr**

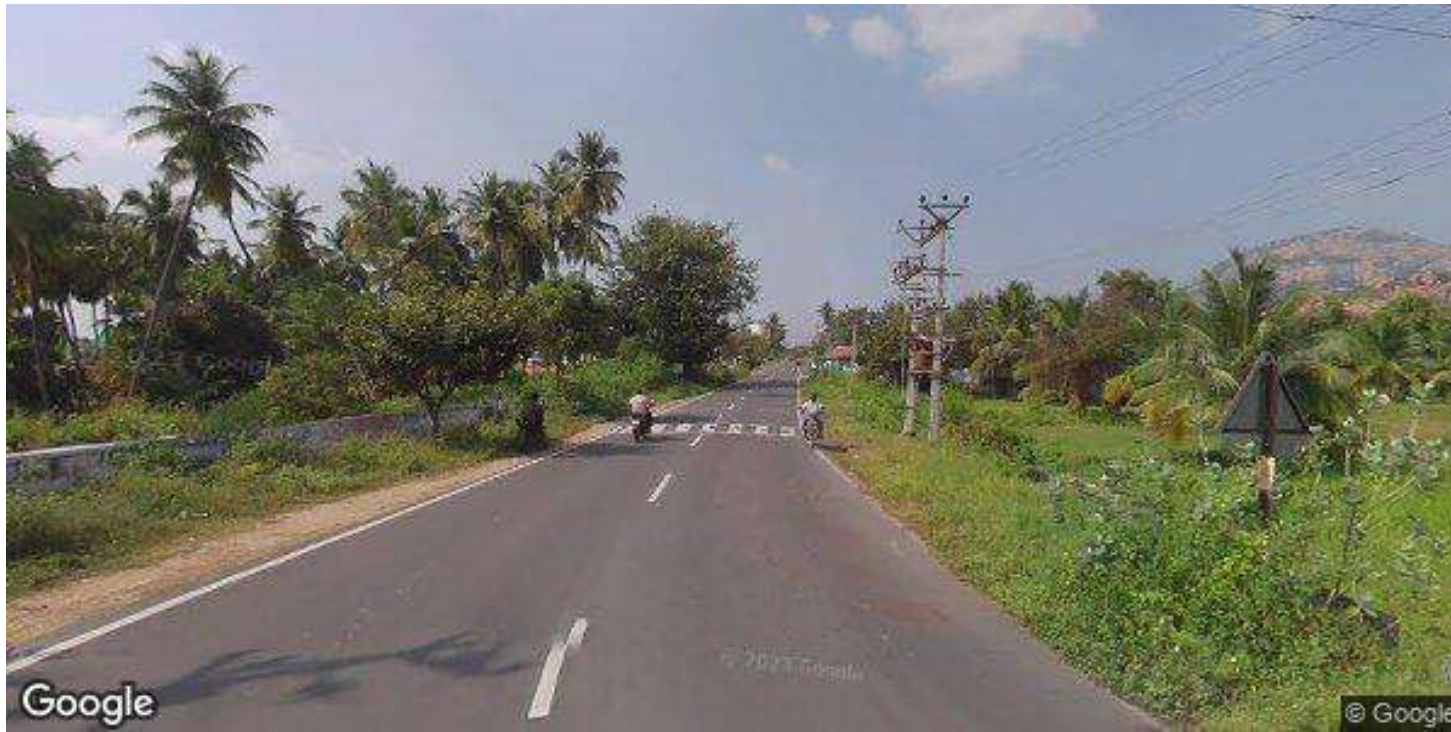
**Coordinates: 11.45352, 77.85698**

**Risk Type: Turn**

**Risk Level: Medium**

**Speed Limit: 30 KM/Hr**

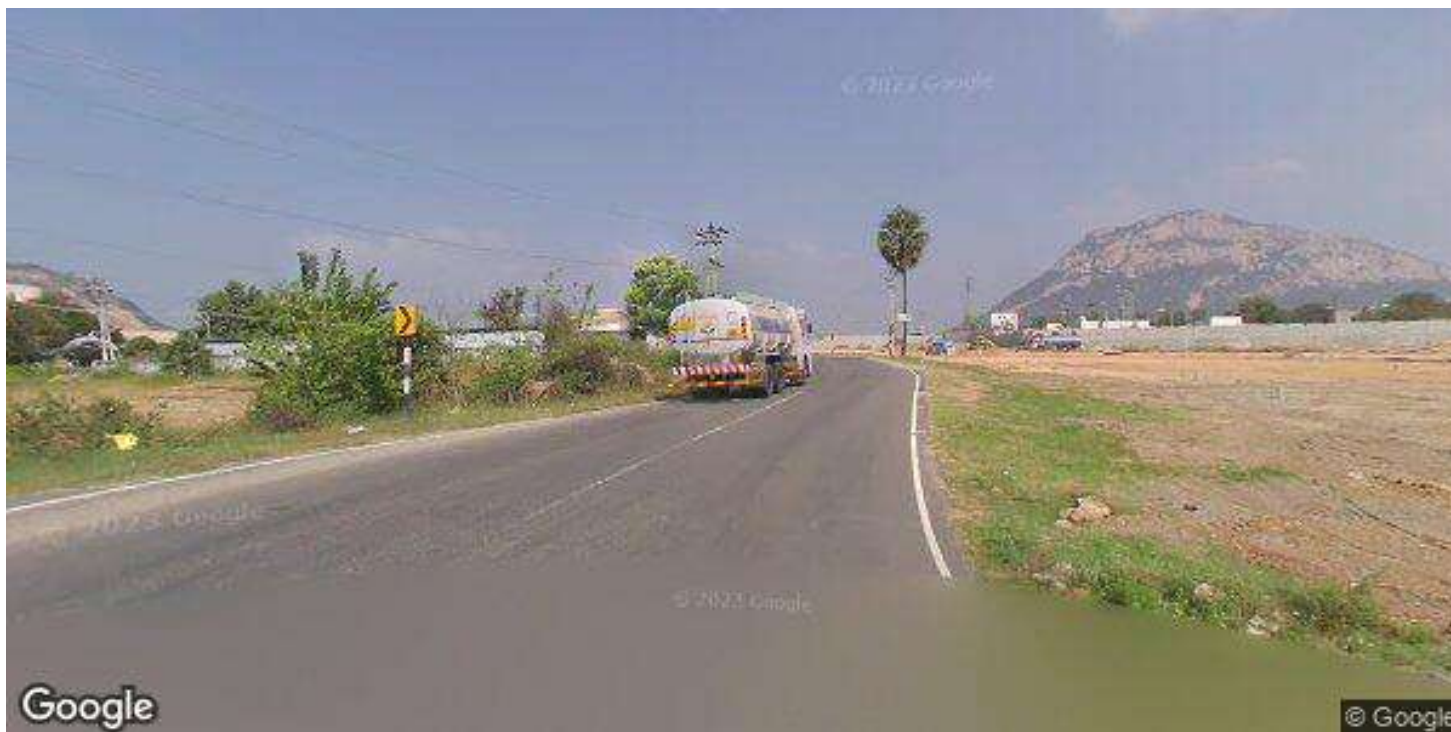
**Coordinates: 11.45847, 77.85140**

**Risk Type: Turn**

**Risk Level: Medium**

**Speed Limit: 30 KM/Hr**

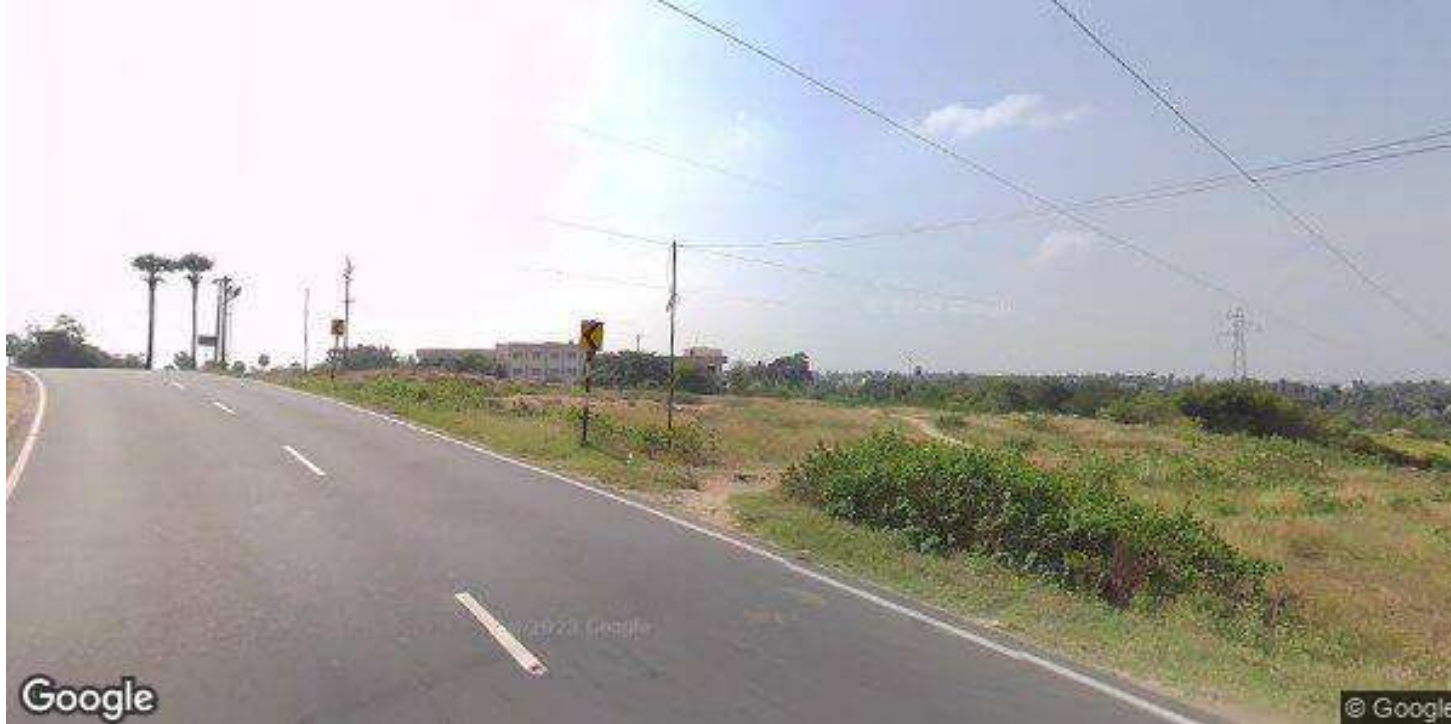
**Risk Type:** Turn  
**Risk Level:** Medium  
**Speed Limit:** 30 KM/Hr  
**Coordinates:** 11.46048, 77.85036

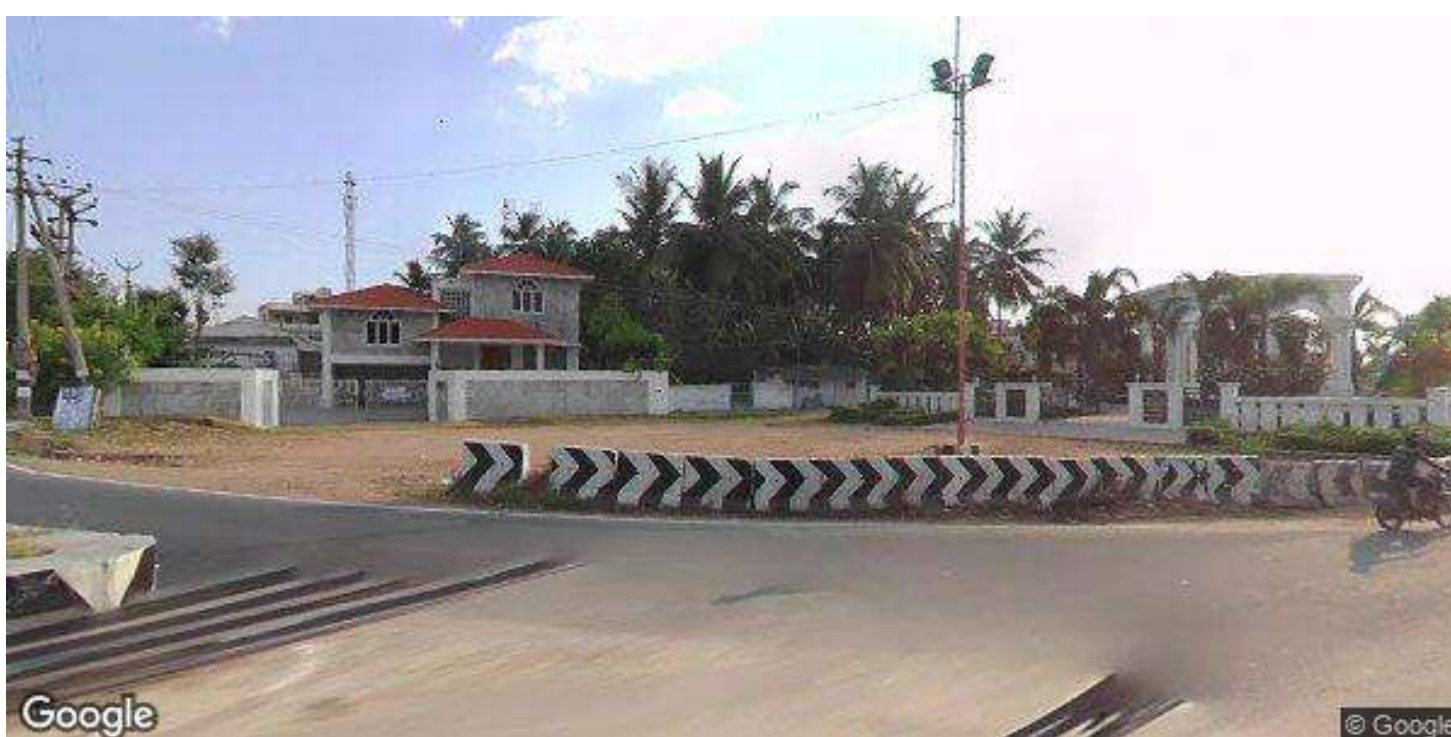
**Coordinates: 11.46314, 77.84928**

**Risk Type:** Turn  
**Risk Level:** Medium

**Speed Limit: 30 KM/Hr**

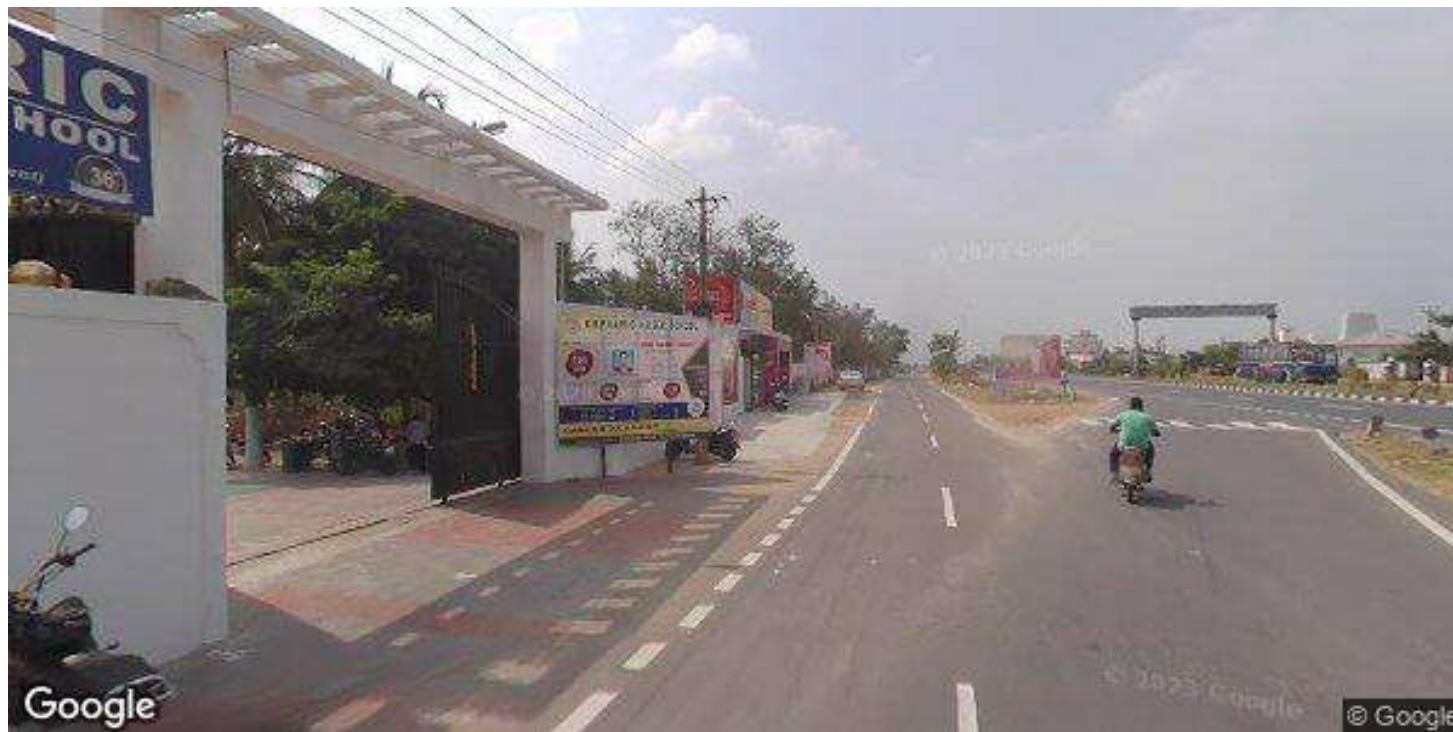
**Coordinates: 11.45509, 77.81383**

**Risk Type: Turn**

**Risk Level: Medium**

**Speed Limit: 30 KM/Hr**

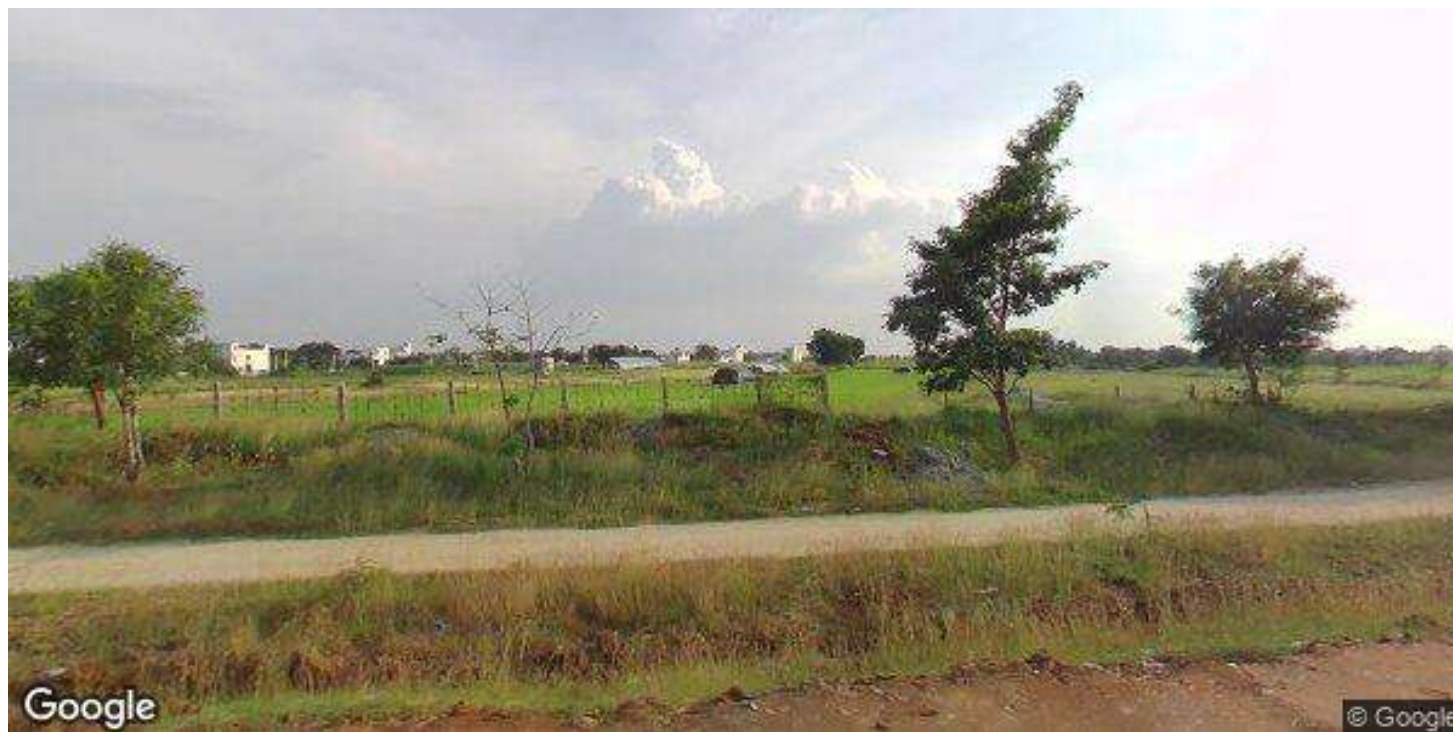
**Coordinates: 11.29288, 77.59029**

**Risk Type: Turn**

**Risk Level: Medium**

**Speed Limit: 30 KM/Hr**

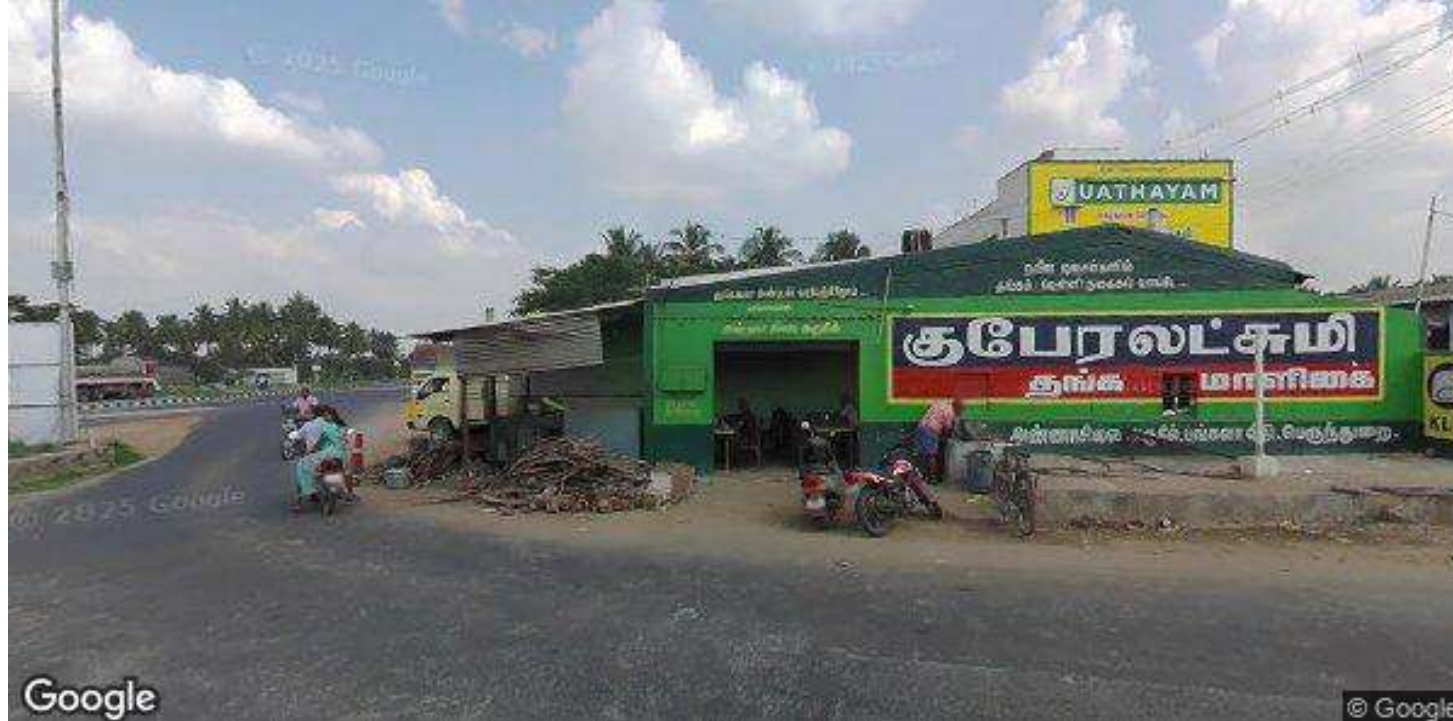
**Coordinates:** 11.29158, 77.58600

**Risk Type:** Turn

**Risk Level:** High

**Speed Limit:** 15 KM/Hr

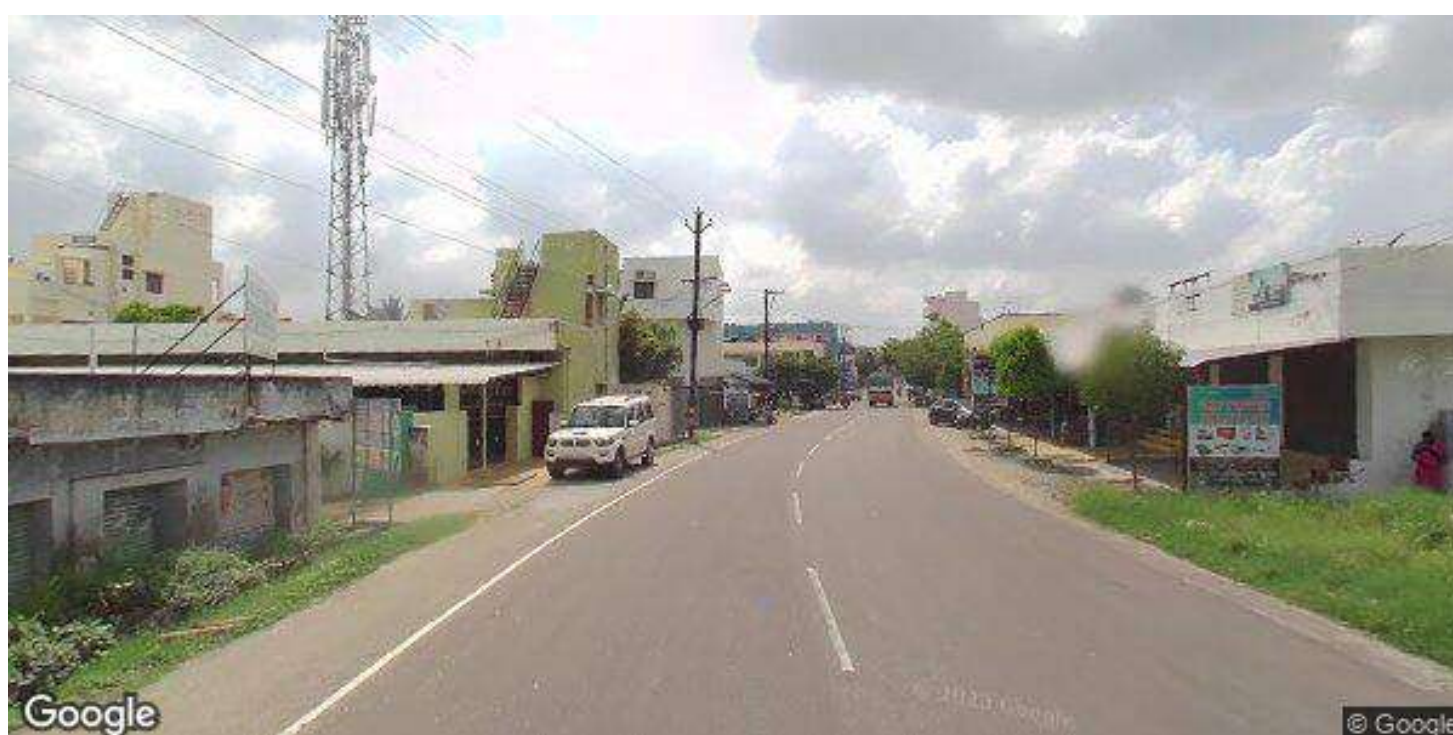
**Coordinates:** 11.28223, 77.58511

**Risk Type:** Turn

**Risk Level:** Medium

**Speed Limit:** 30 KM/Hr

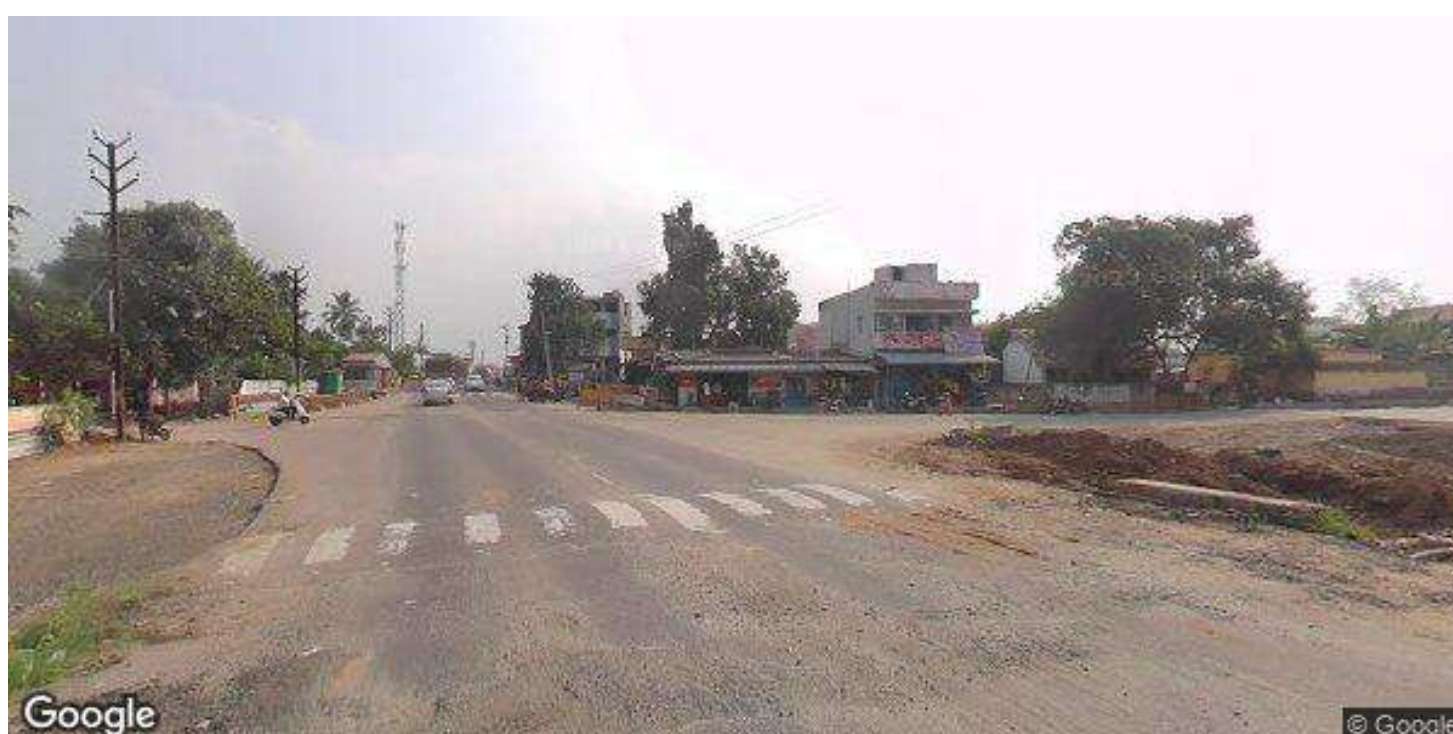
Coordinates: 11.22673, 77.58027

**Risk Type:** Turn

**Risk Level:** Medium

Speed Limit: 30 KM/Hr

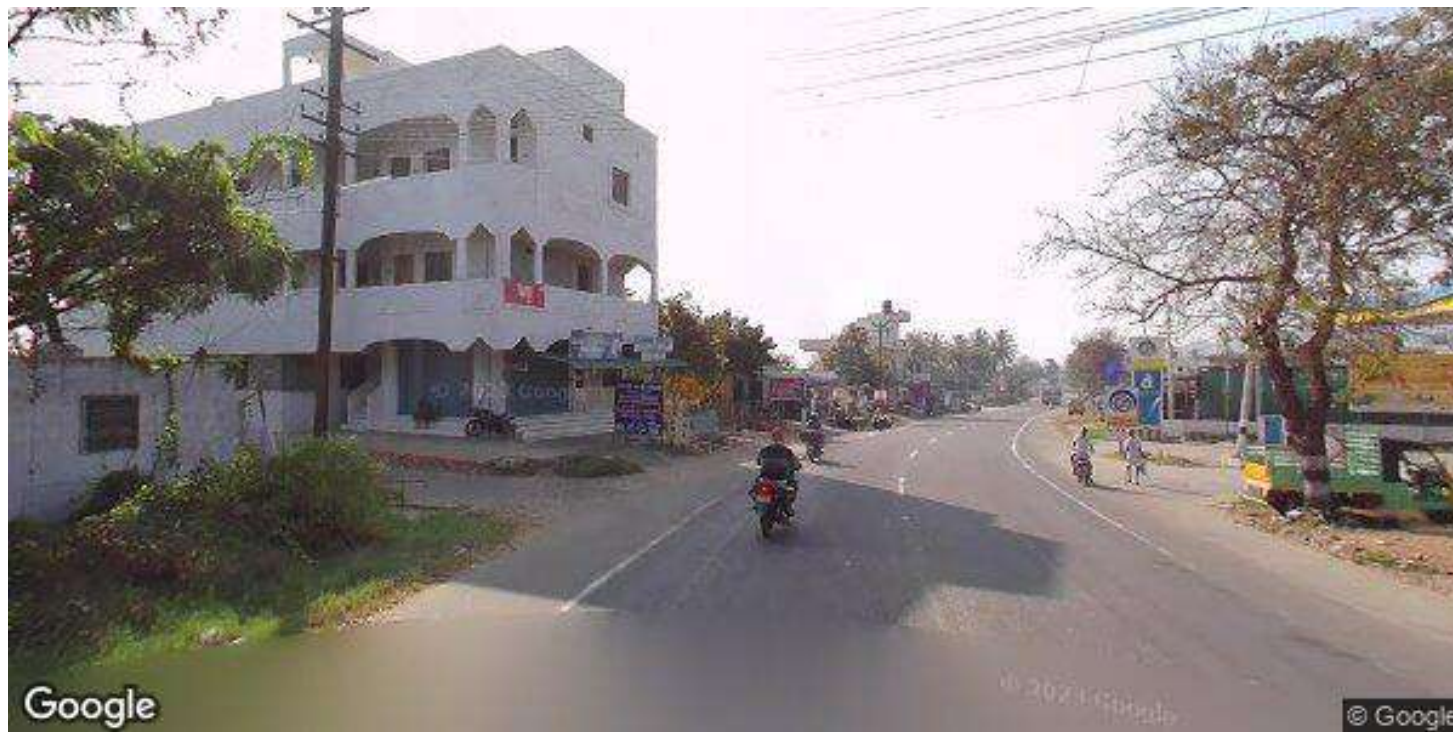
Coordinates: 11.17652, 77.59985

Risk Type: Turn

Risk Level: Medium

Speed Limit: 30 KM/Hr

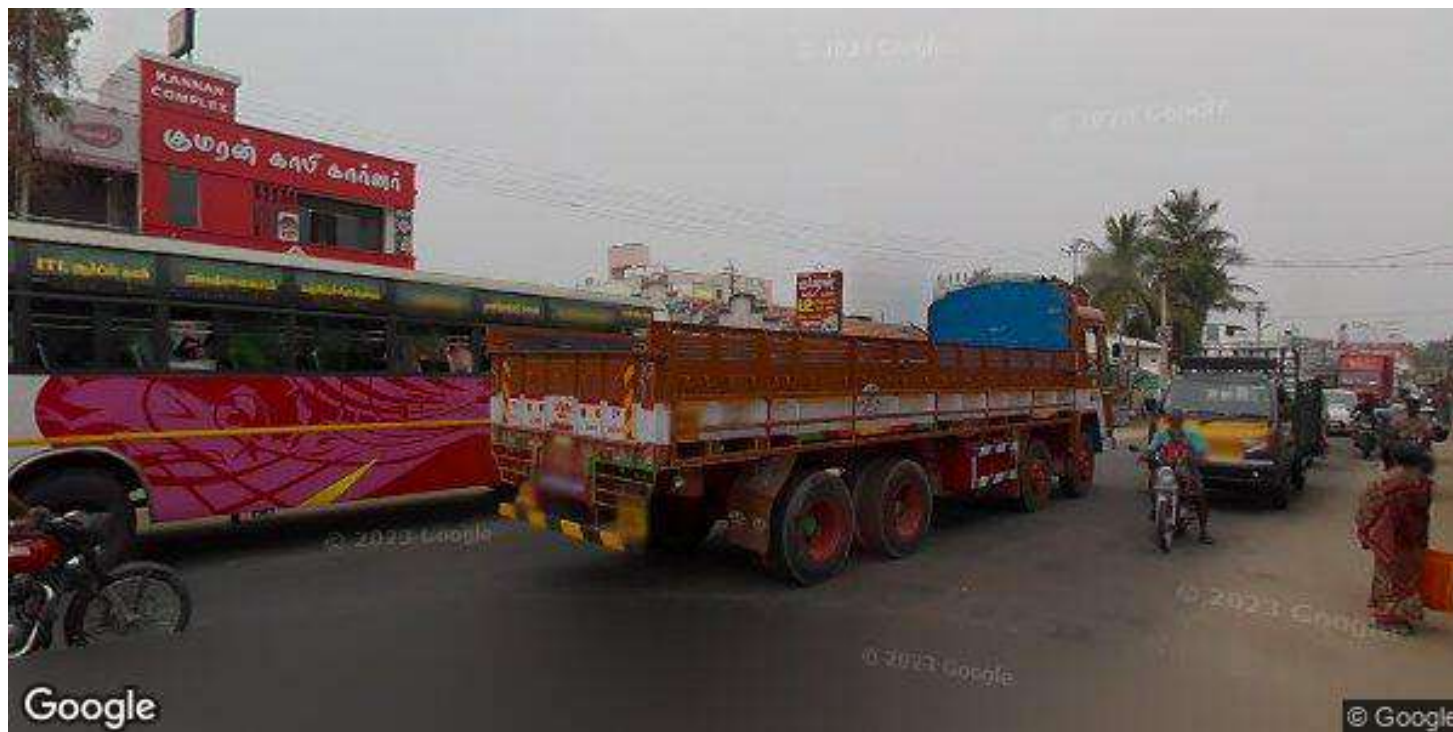
Coordinates: 11.16555, 77.60233

Risk Type: Turn

Risk Level: Medium

Speed Limit: 30 KM/Hr

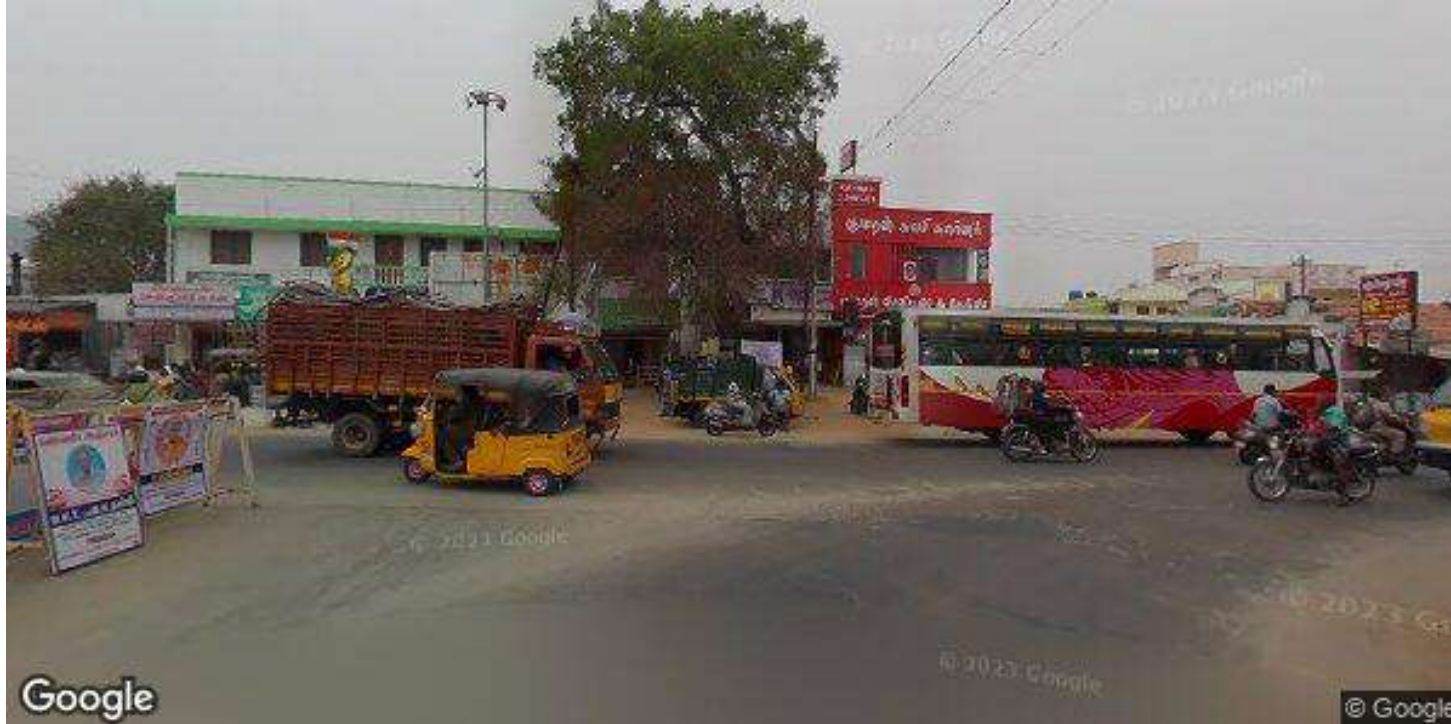
**Coordinates:** 11.16547, 77.60241

**Risk Type:** Turn

**Risk Level:** Medium

**Speed Limit:** 30 KM/Hr

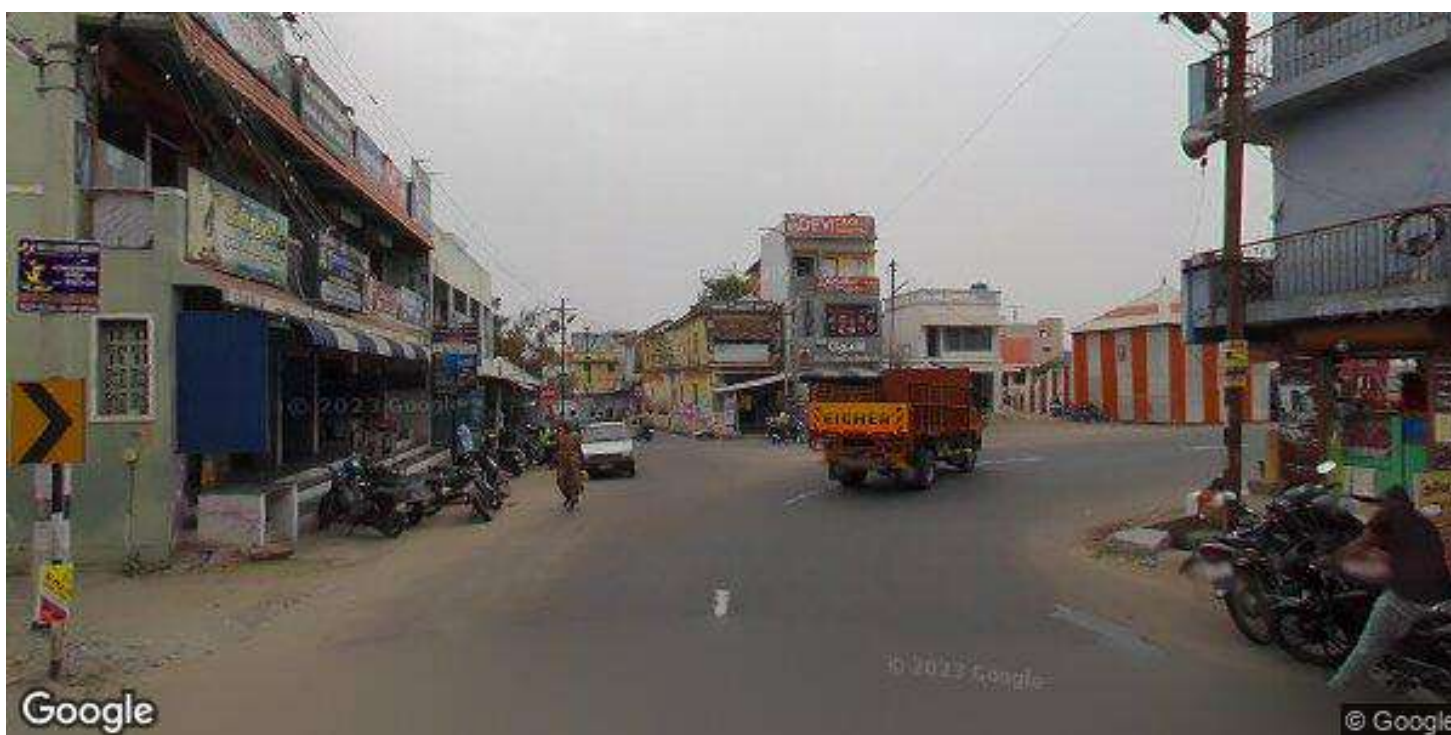
**Coordinates:** 11.16531, 77.60369

**Risk Type:** Turn

**Risk Level:** Medium

**Speed Limit:** 30 KM/Hr

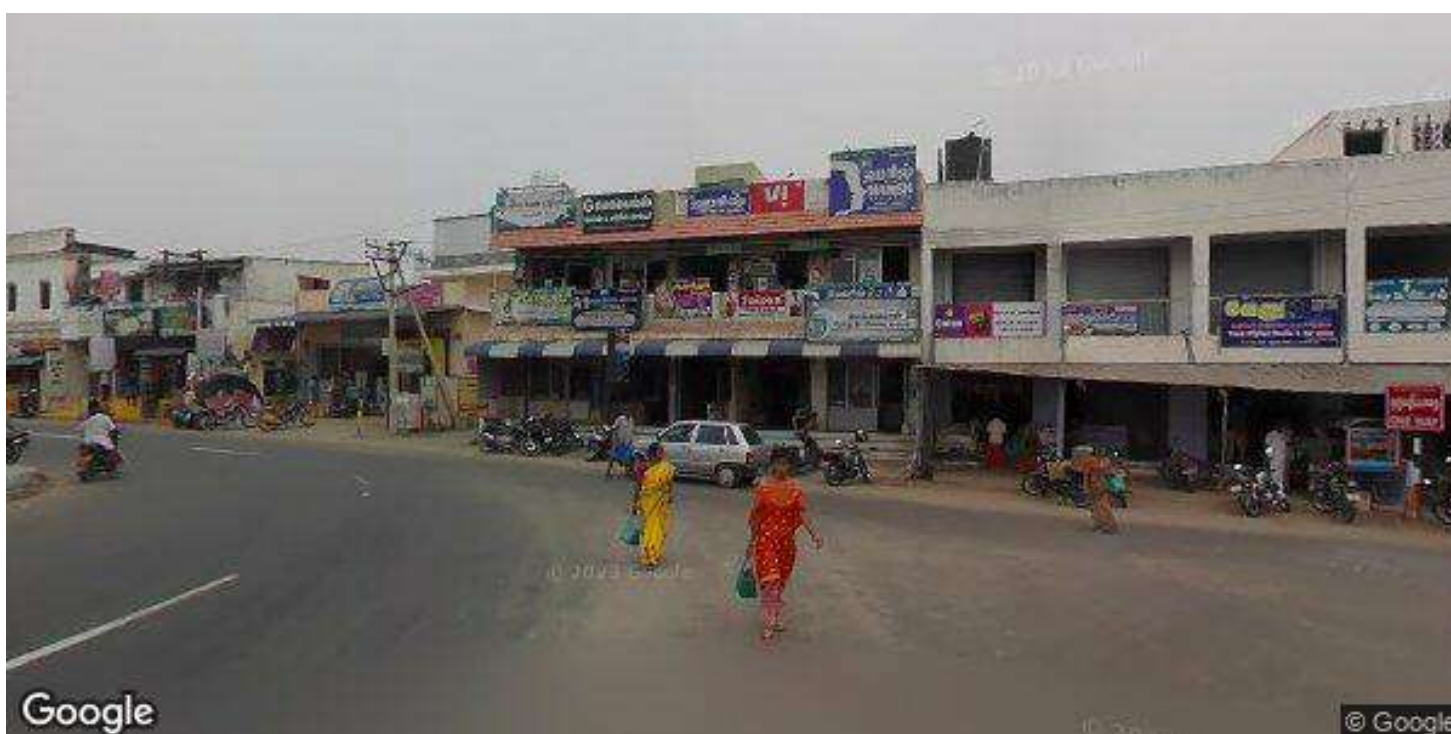
**Risk Type:** Turn

**Risk Level:** High

**Speed Limit: 15 KM/Hr**  
**Coordinates: 11.16521, 77.60379**
