# IndianOil

## JOURNEY RISK MANAGEMENT (JRM) STUDY

### Salem Terminal TO DURAISAMY SONS

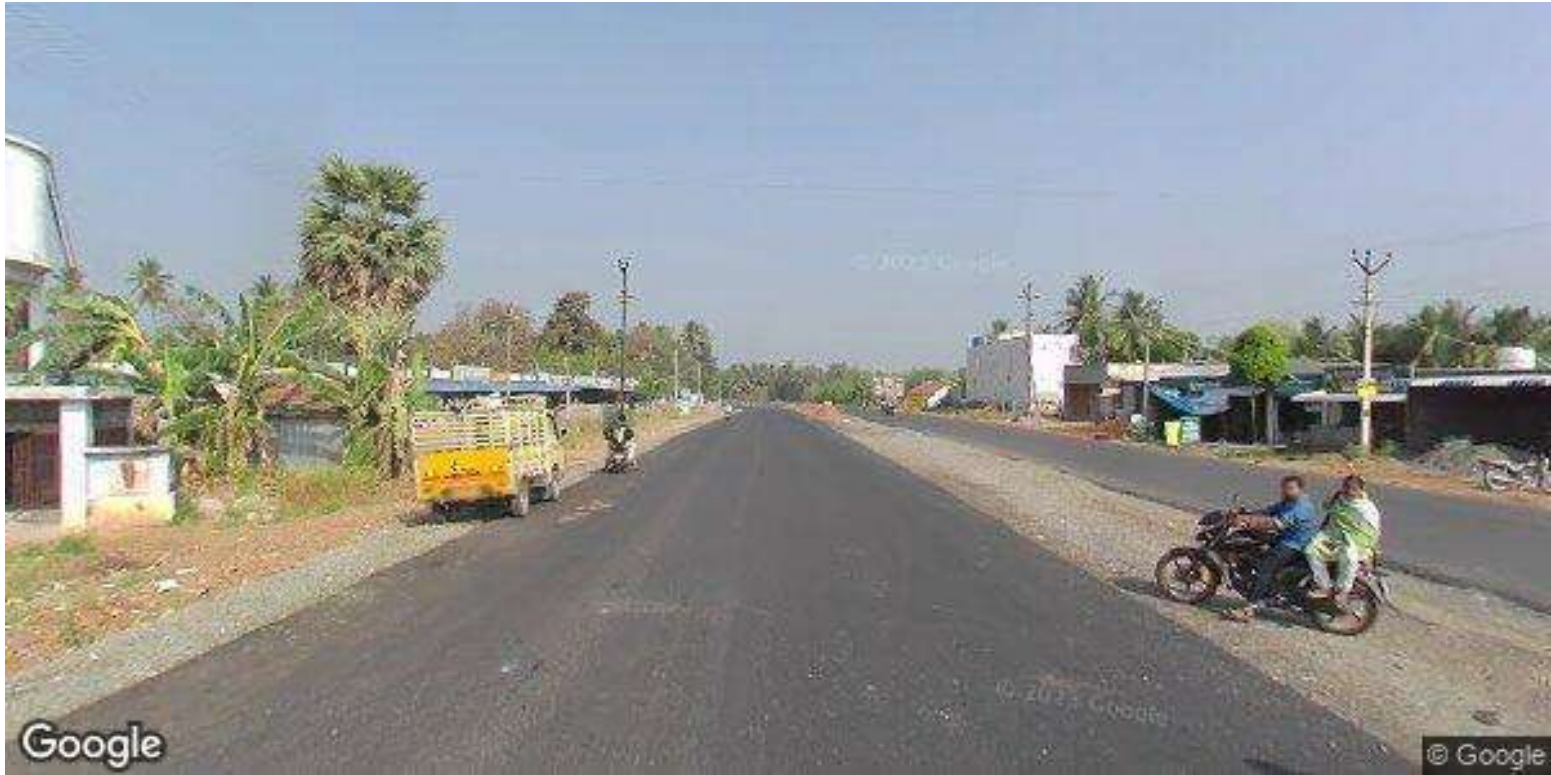
Coordinates: 11.4287655, 77.537661

Risk Type: U-Turn

Risk Level: High

Speed Limit: 10 KM/Hr

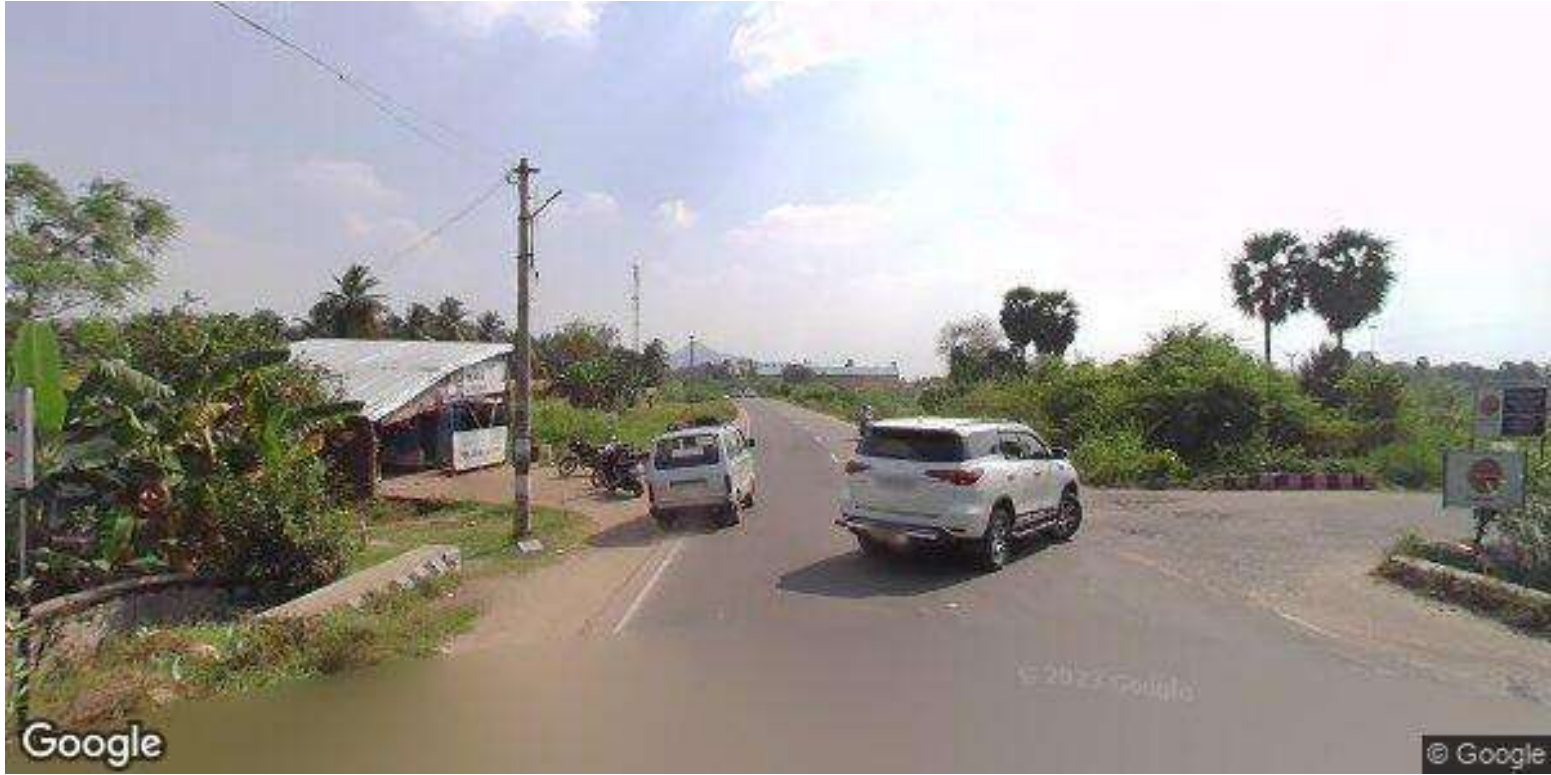
Risk Type: Turn

Risk Level: High

**Speed Limit: 15 KM/Hr**  
**Coordinates: 11.44029, 77.87544**

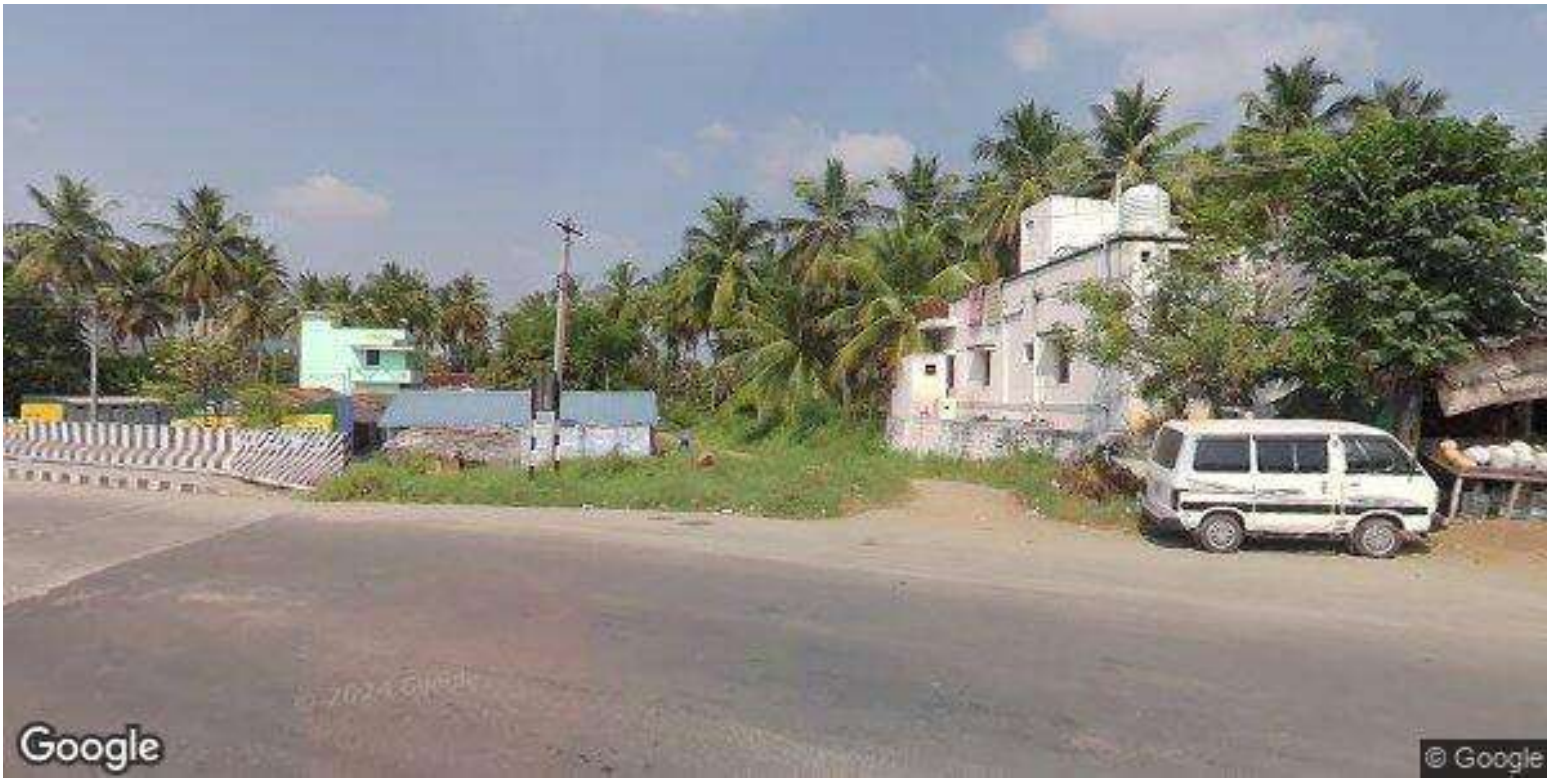
**Risk Type: Turn**  
**Risk Level: Medium**  
**Speed Limit: 30 KM/Hr**  
**Coordinates: 11.44898, 77.87410**

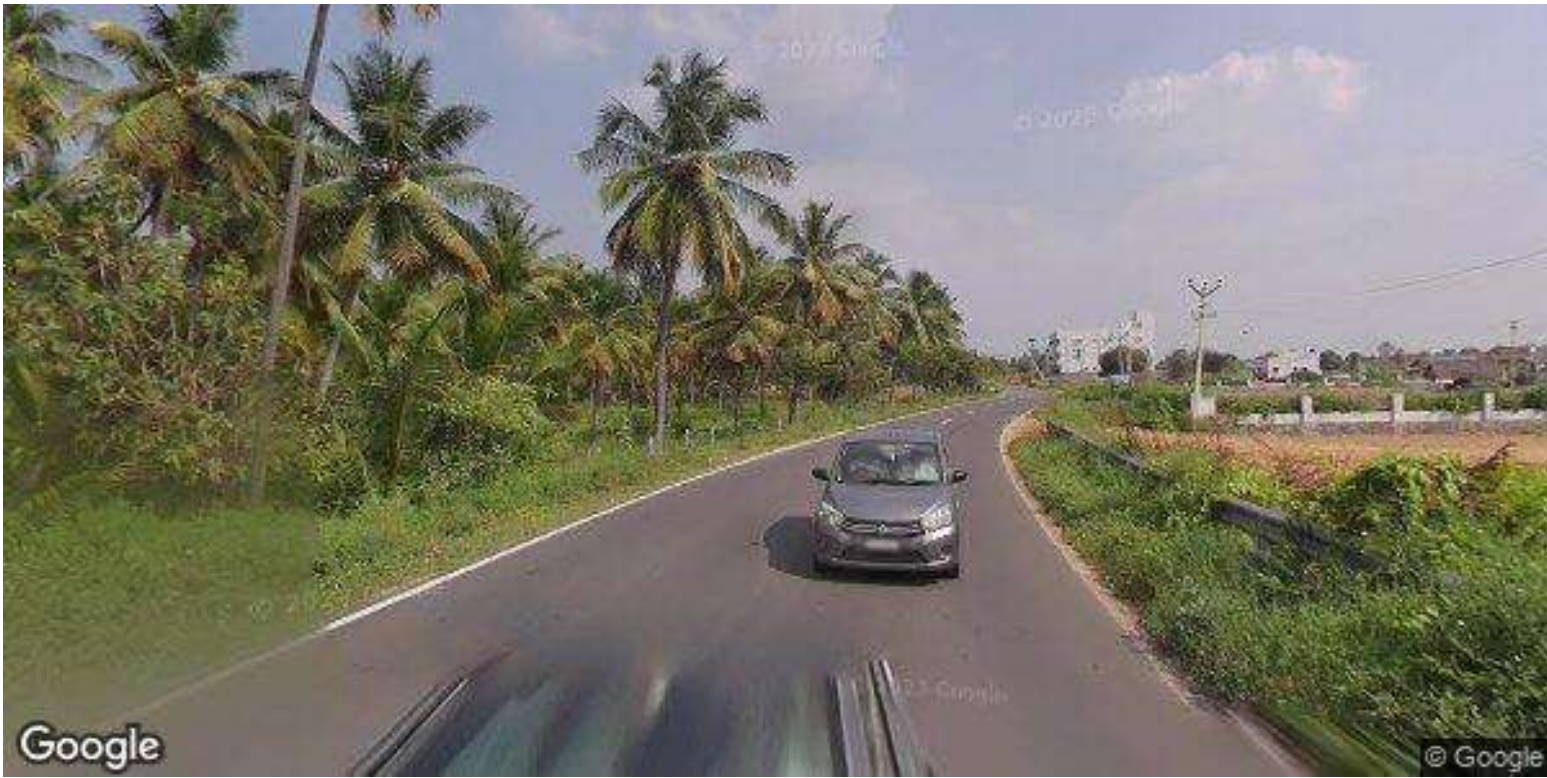
**Risk Type: Turn**  
**Risk Level: Medium**  
**Speed Limit: 30 KM/Hr**  
**Coordinates: 11.45357, 77.85789**

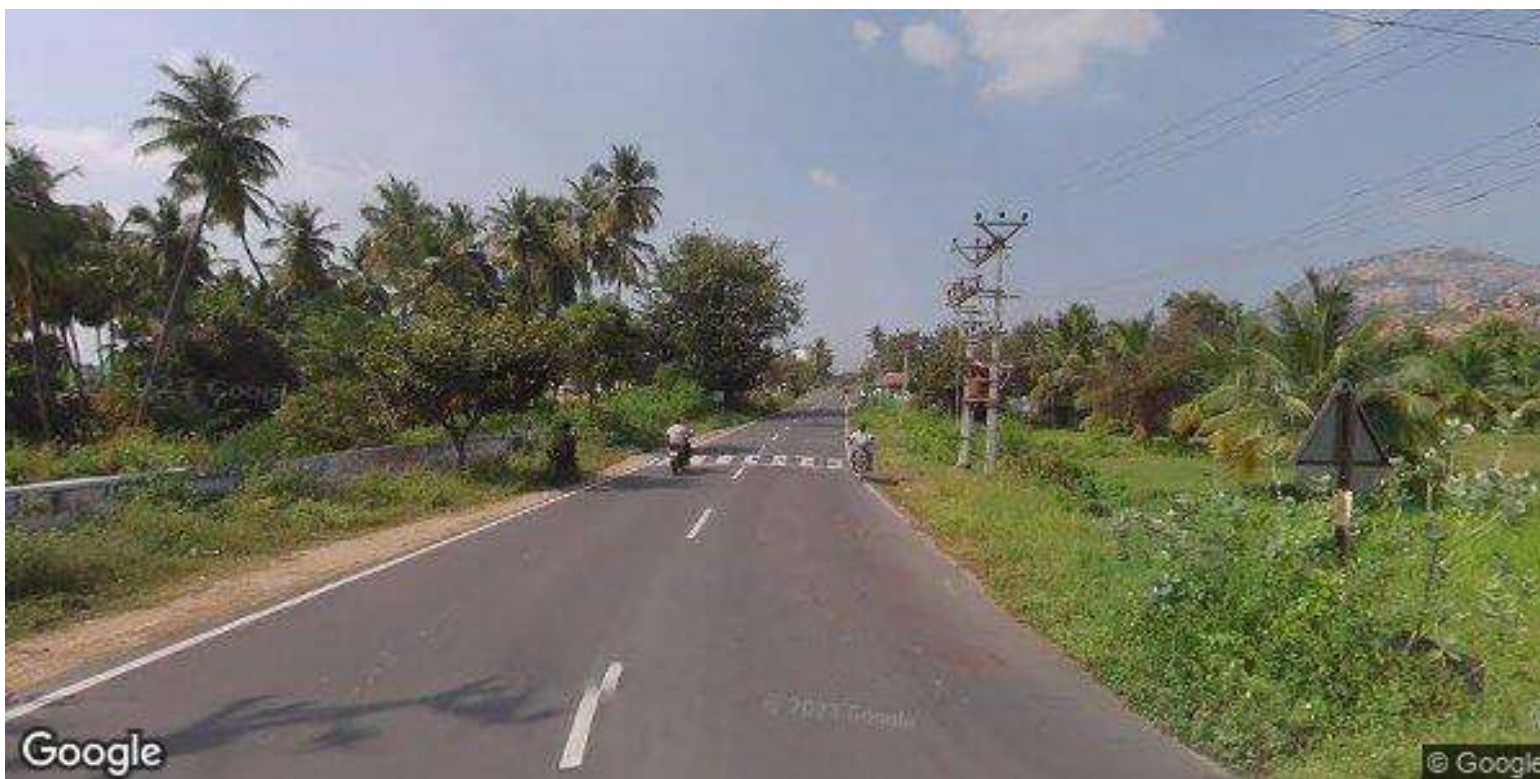
**Coordinates:** 11.45352, 77.85698

**Risk Type:** Turn

**Risk Level:** Medium

**Speed Limit:** 30 KM/Hr

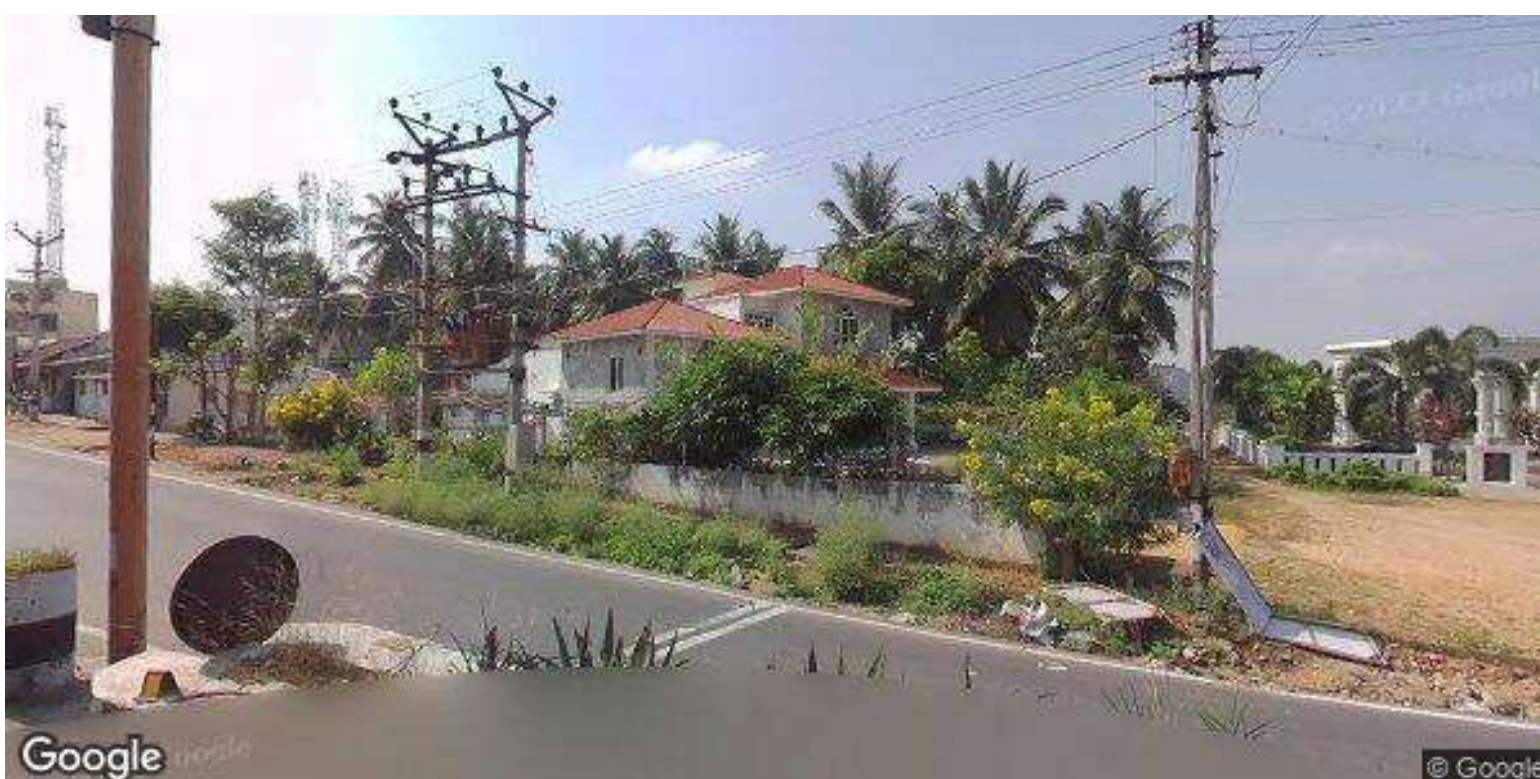
**Coordinates:** 11.46303, 77.84945

**Risk Type:** Turn

**Risk Level:** Medium

**Speed Limit:** 30 KM/Hr

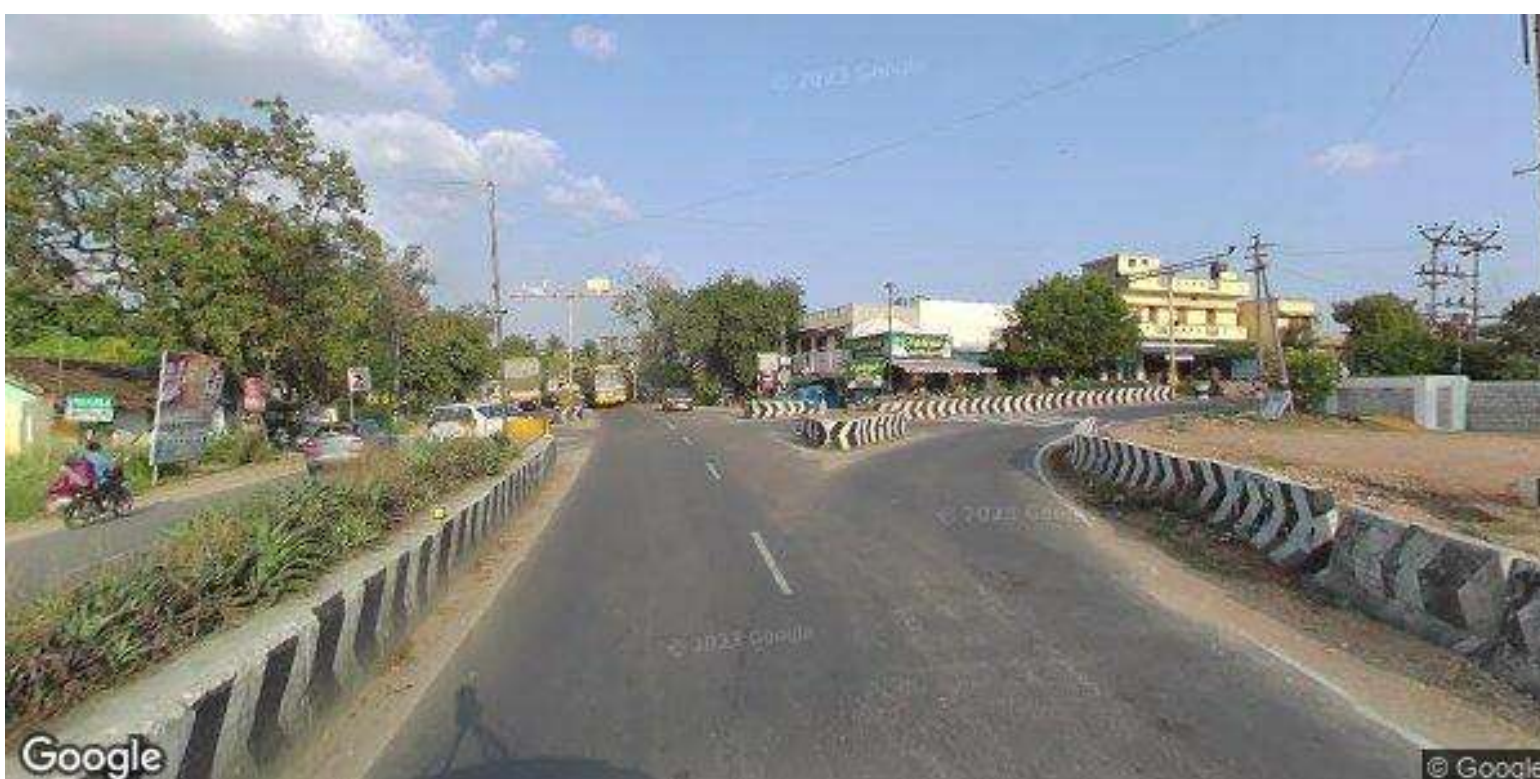
**Risk Type:** Turn  
**Risk Level:** Medium  
**Speed Limit:** 30 KM/Hr  
**Coordinates:** 11.46318, 77.84913

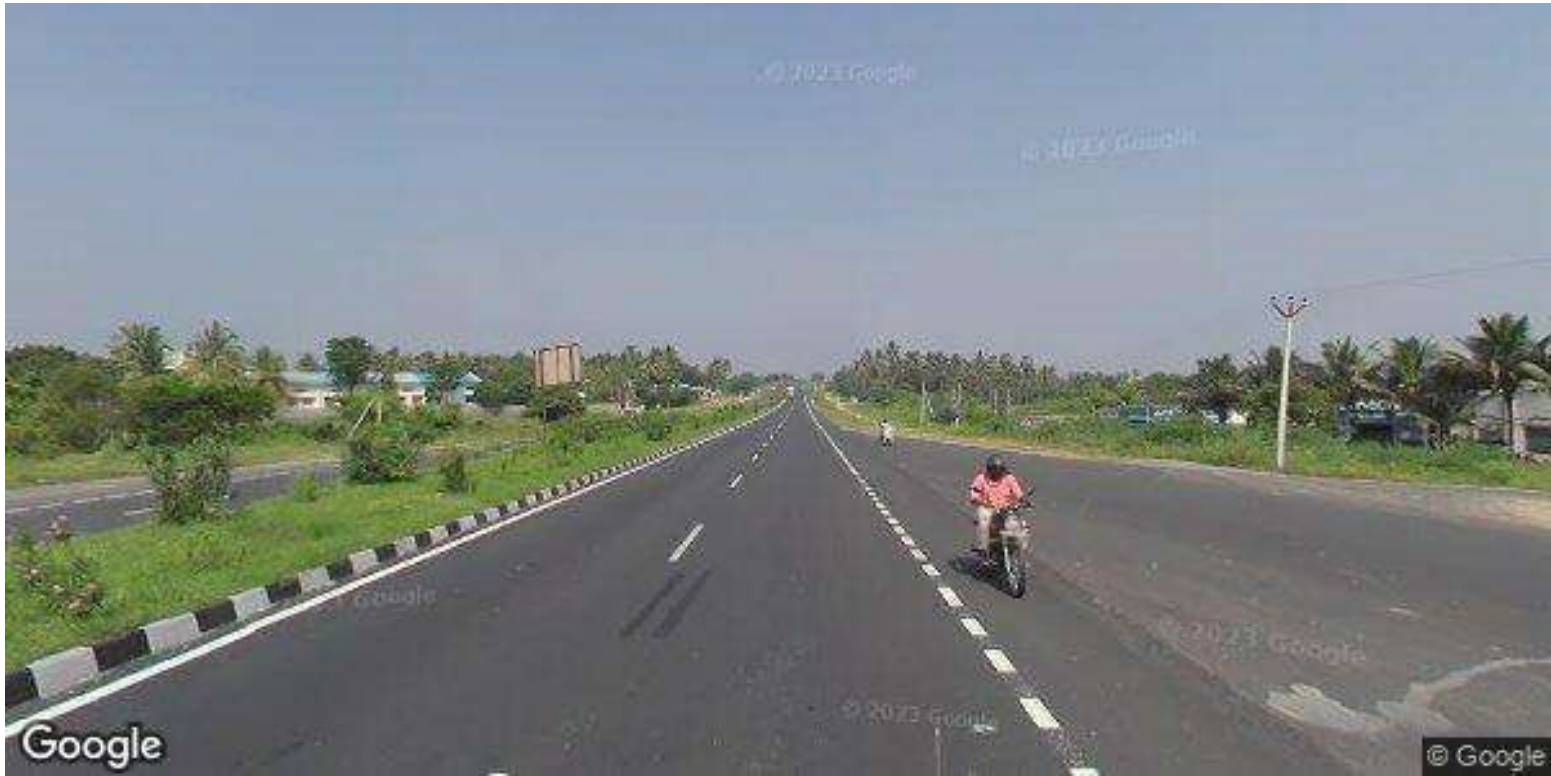
**Risk Type:** Turn  
**Risk Level:** High  
**Speed Limit:** 15 KM/Hr  
**Coordinates:** 11.40046, 77.65371

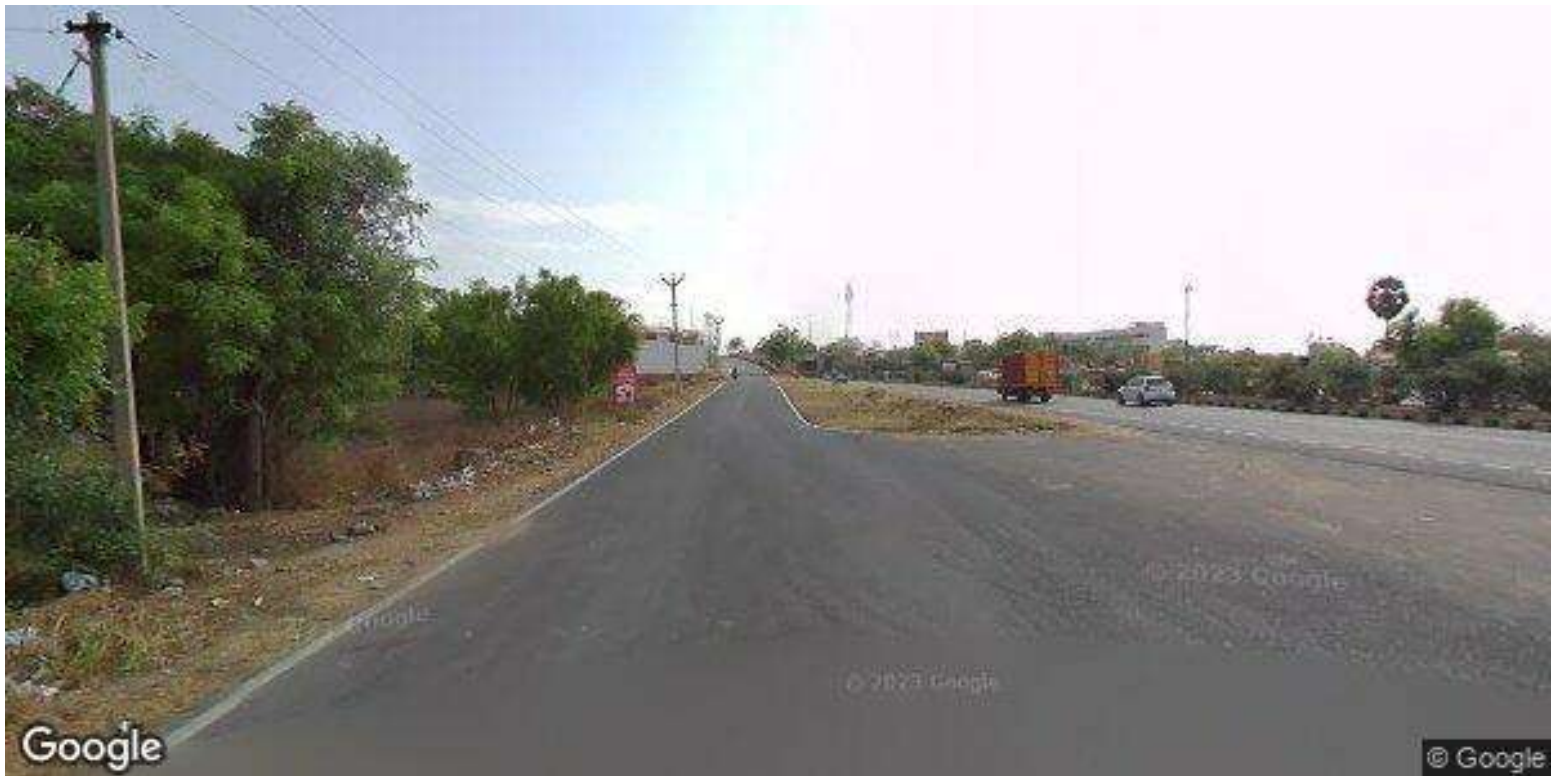
**Risk Type:** Turn  
**Risk Level:** High  
**Speed Limit:** 15 KM/Hr  
**Coordinates:** 11.40035, 77.65383

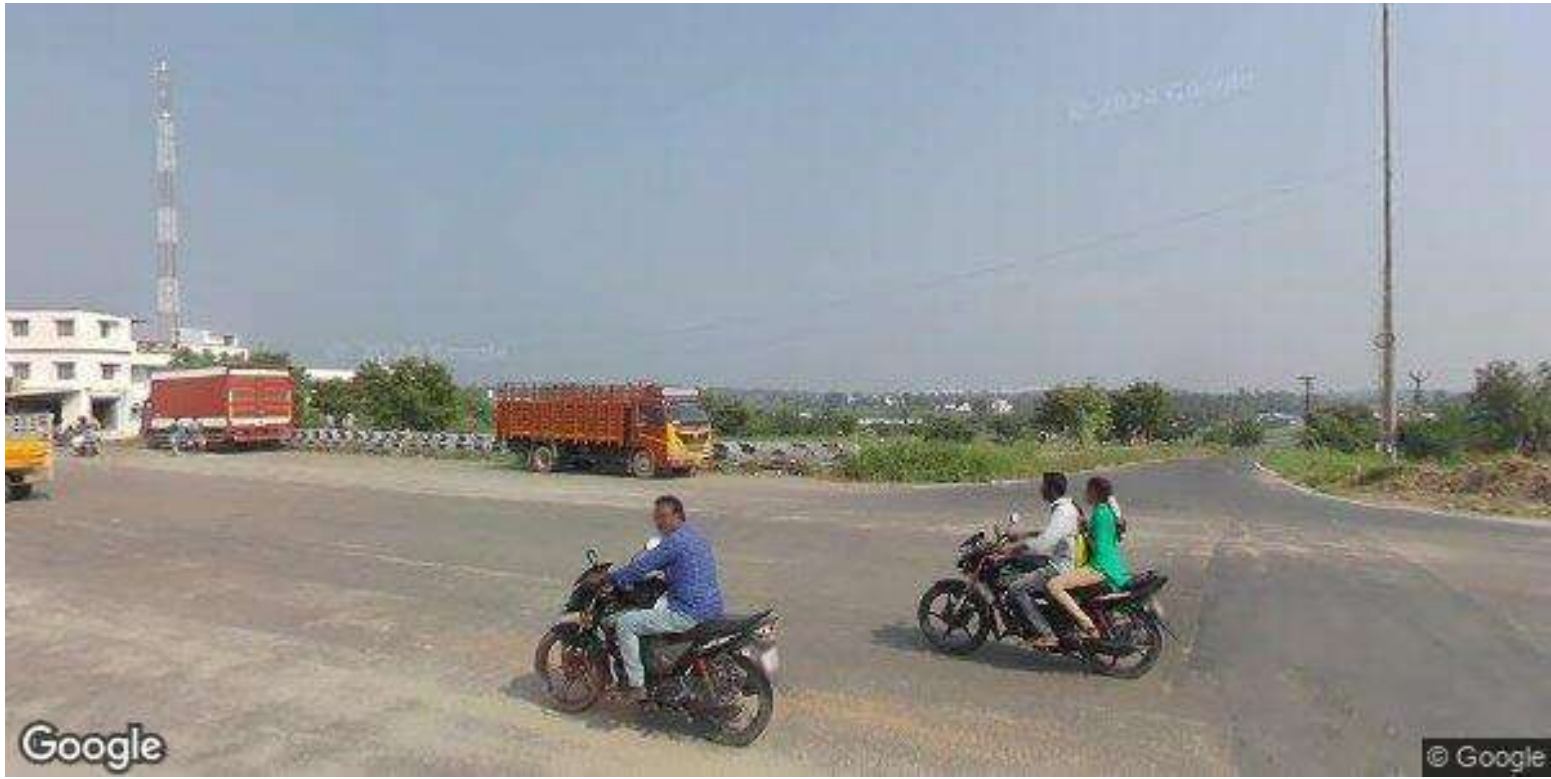
**Risk Type:** Turn  
**Risk Level:** High  
**Speed Limit:** 15 KM/Hr  
**Coordinates:** 11.39827, 77.65237

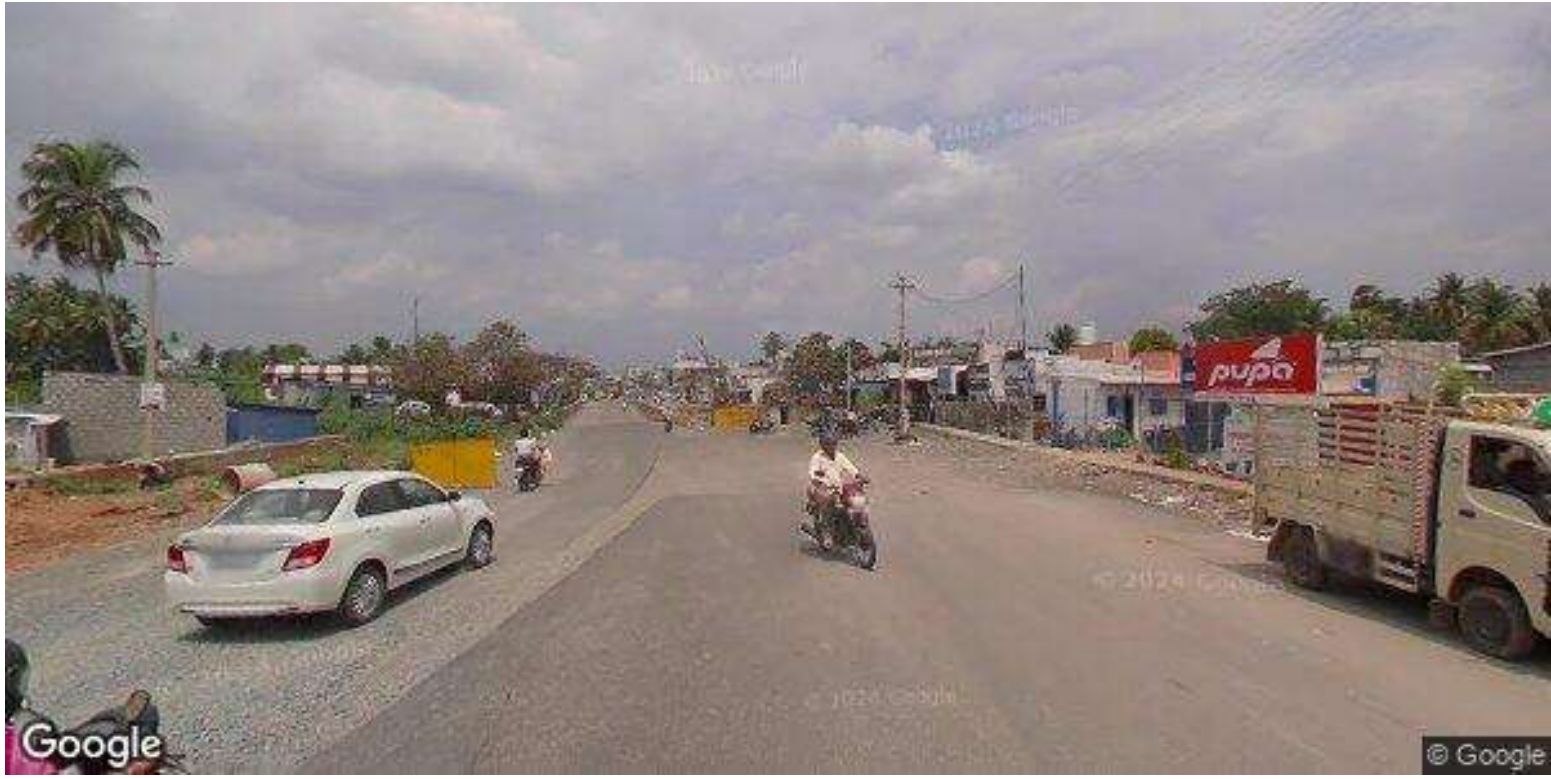
**Risk Type:** Turn  
**Risk Level:** Medium  
**Speed Limit:** 30 KM/Hr  
**Coordinates:** 11.42079, 77.56127

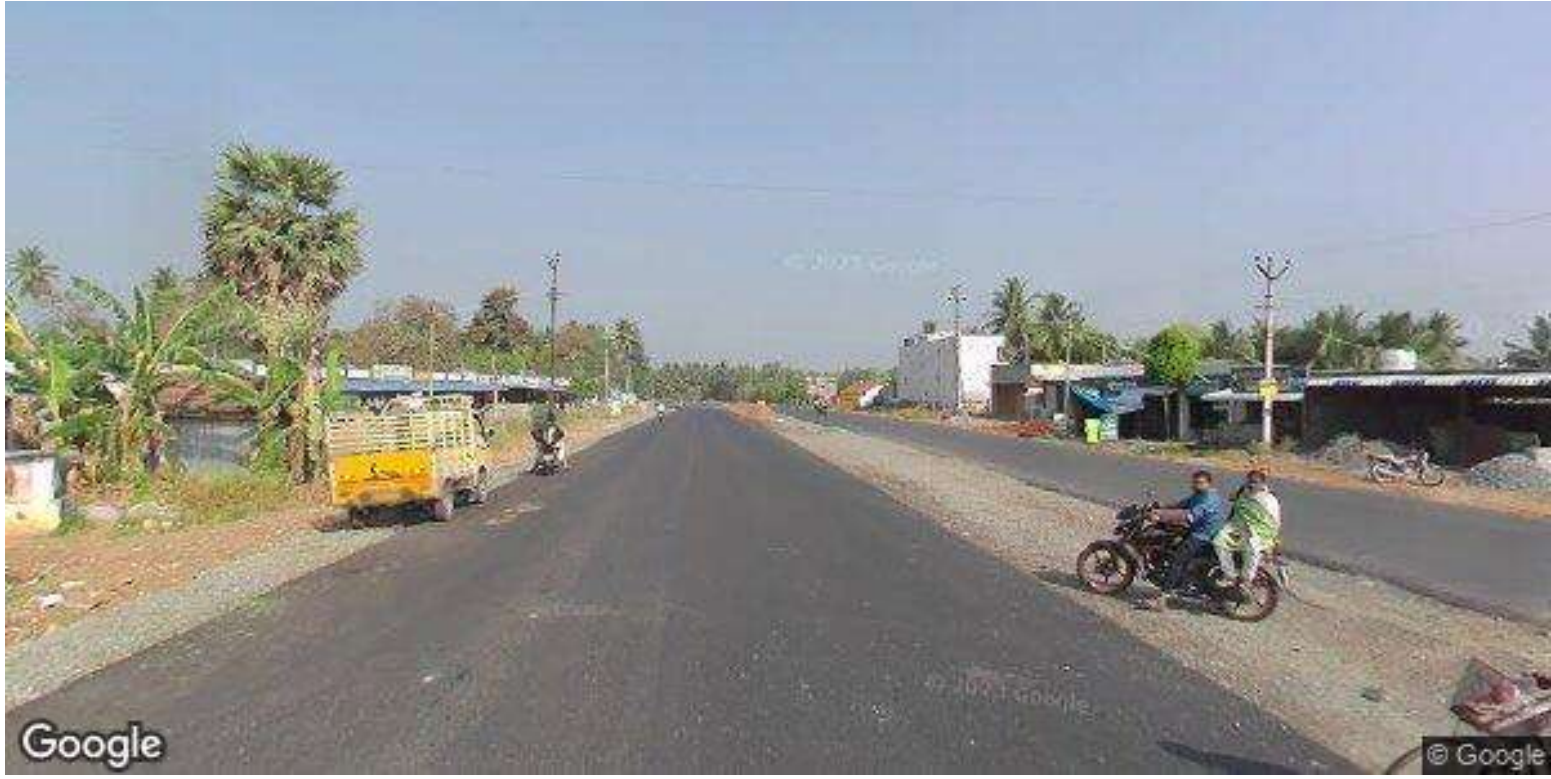
**Risk Type:** Blind Spot  
**Risk Level:** Blind Spot  
**Speed Limit:** 10 KM/Hr  
**Coordinates:** 11.42877, 77.53766

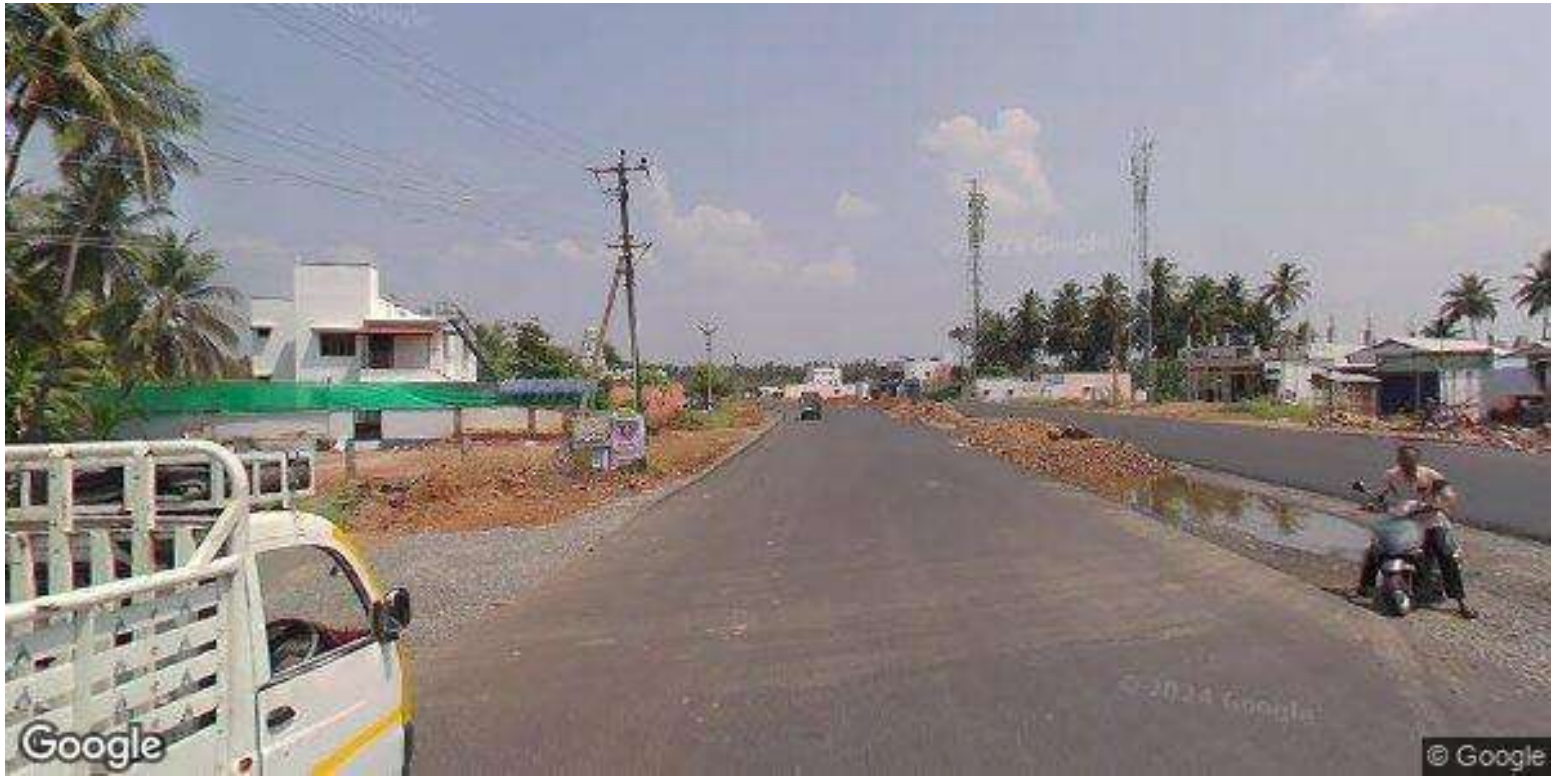
**Risk Type:** Turn  
**Risk Level:** High  
**Speed Limit:** 15 KM/Hr  
**Coordinates:** 11.42885, 77.53775
