# IndianOil

## JOURNEY RISK MANAGEMENT (JRM) STUDY

### Salem Terminal TO KATHIRESWAR & CO

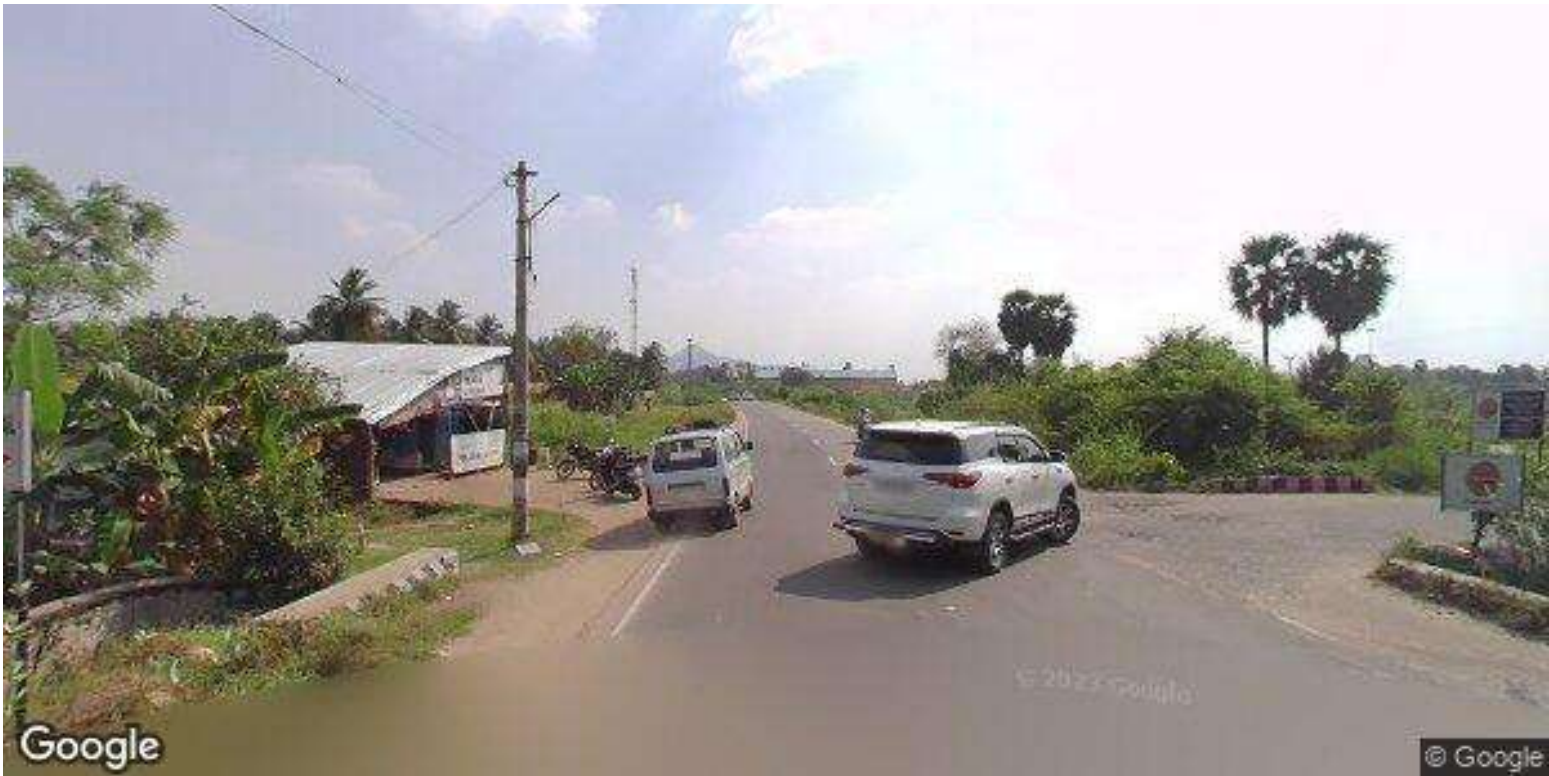
**Risk Type:** Turn  
**Risk Level:** High  
**Speed Limit:** 15 KM/Hr  
**Coordinates:** 11.44029, 77.87544

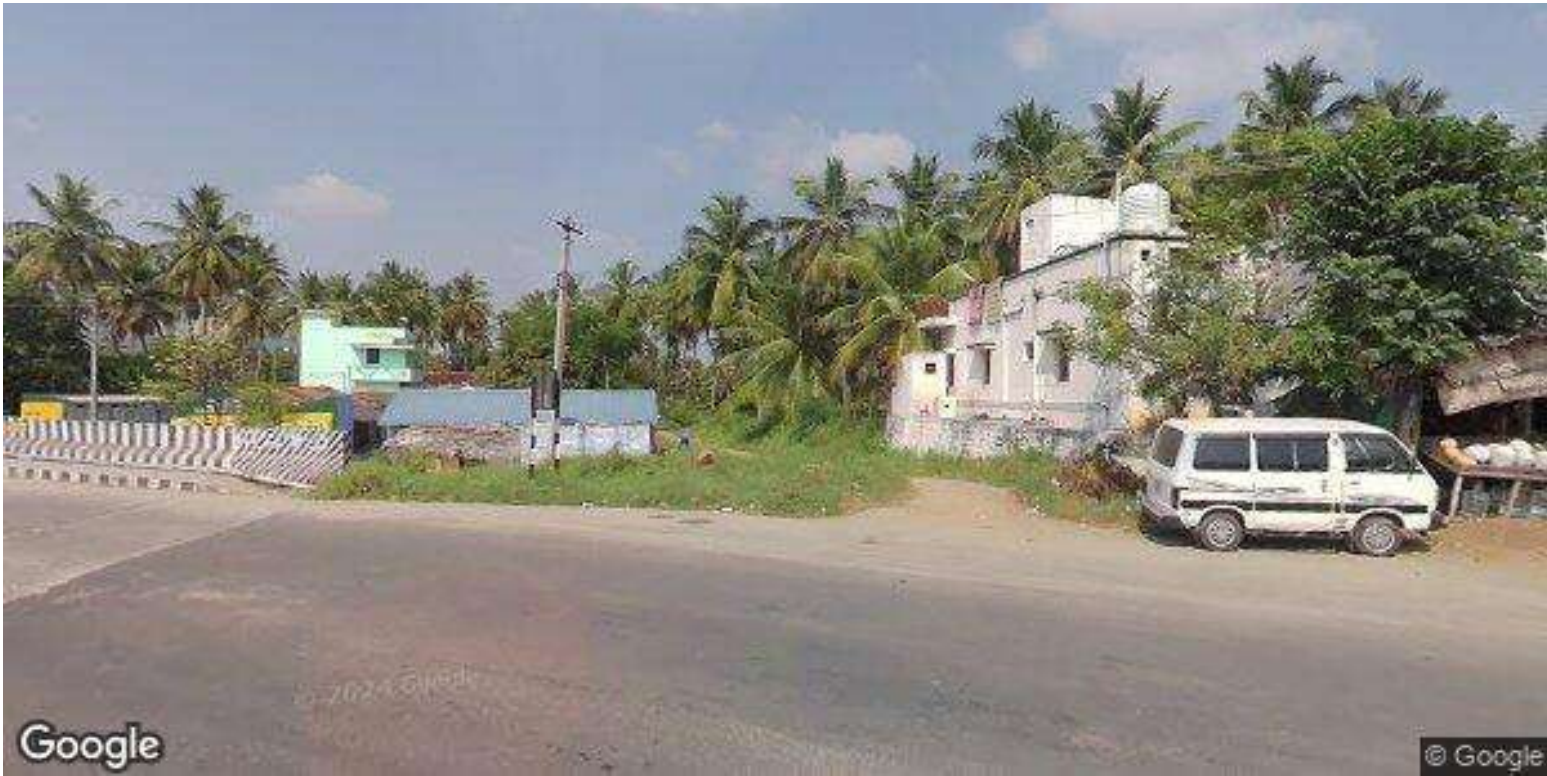
**Risk Type:** Turn  
**Risk Level:** Medium  
**Speed Limit:** 30 KM/Hr  
**Coordinates:** 11.44898, 77.87410

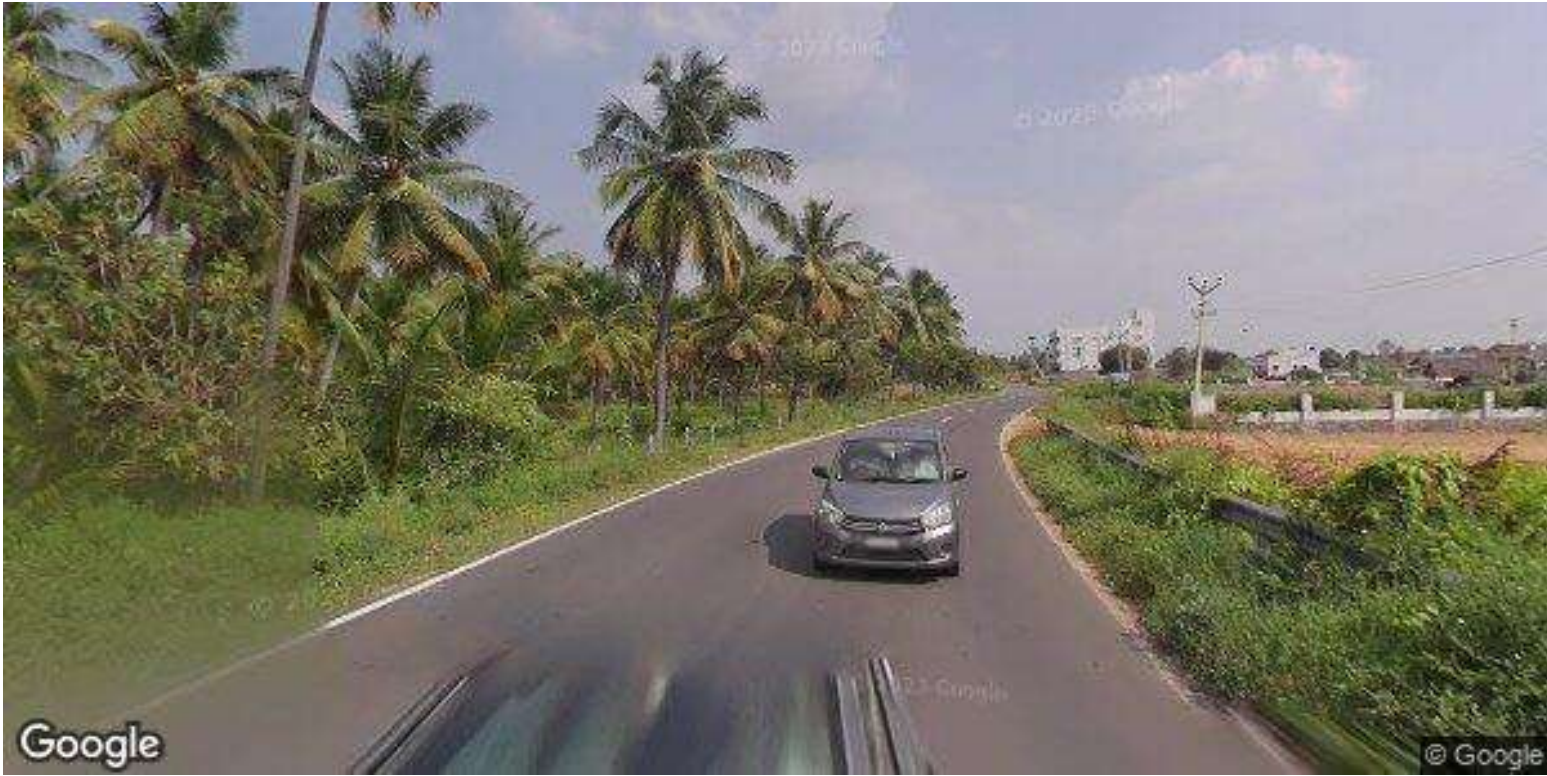
**Risk Type:** Turn  
**Risk Level:** Medium  
**Speed Limit:** 30 KM/Hr  
**Coordinates:** 11.45357, 77.85789

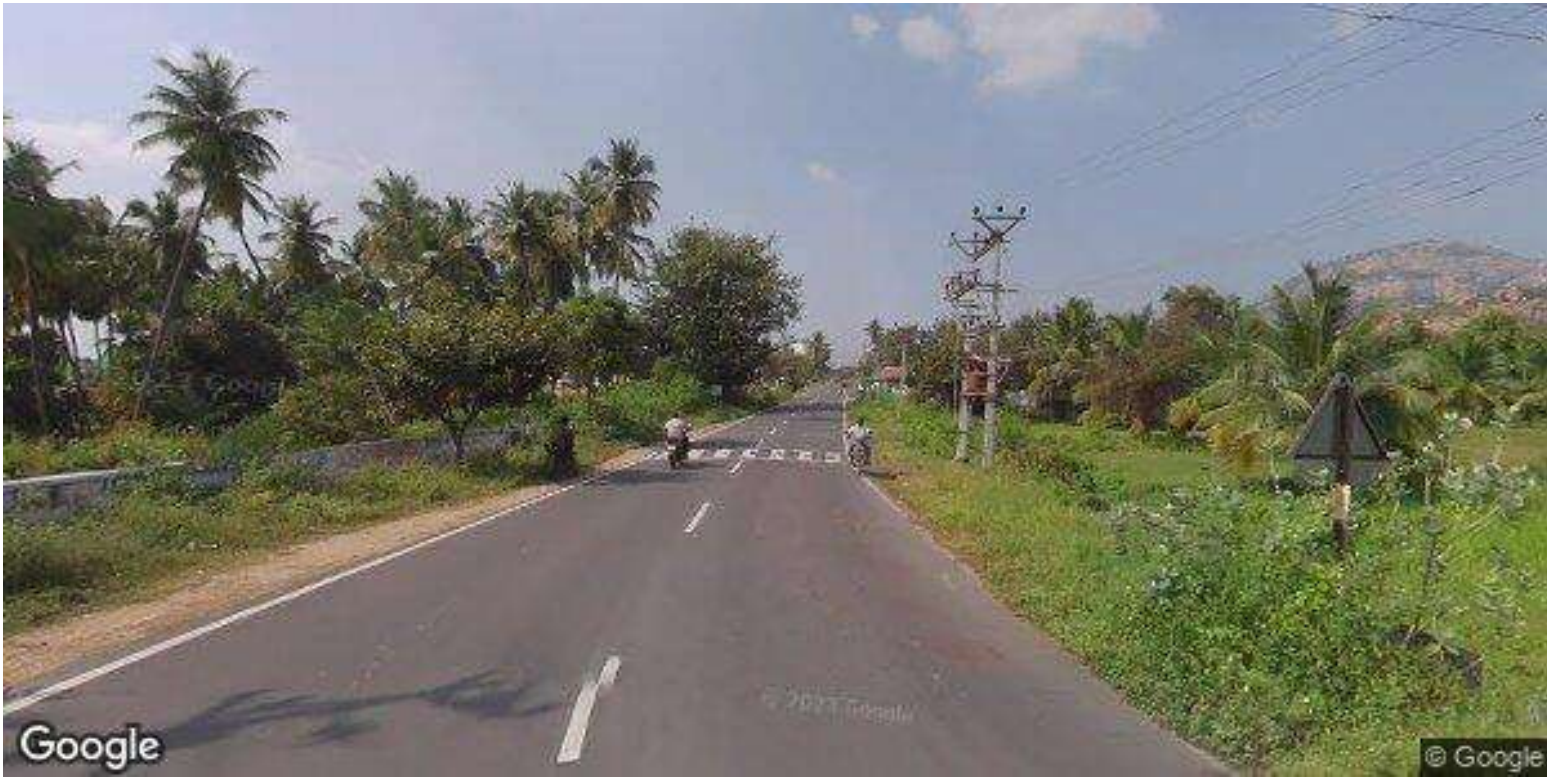
**Risk Type:** Turn  
**Risk Level:** Medium  
**Speed Limit:** 30 KM/Hr  
**Coordinates:** 11.45352, 77.85698

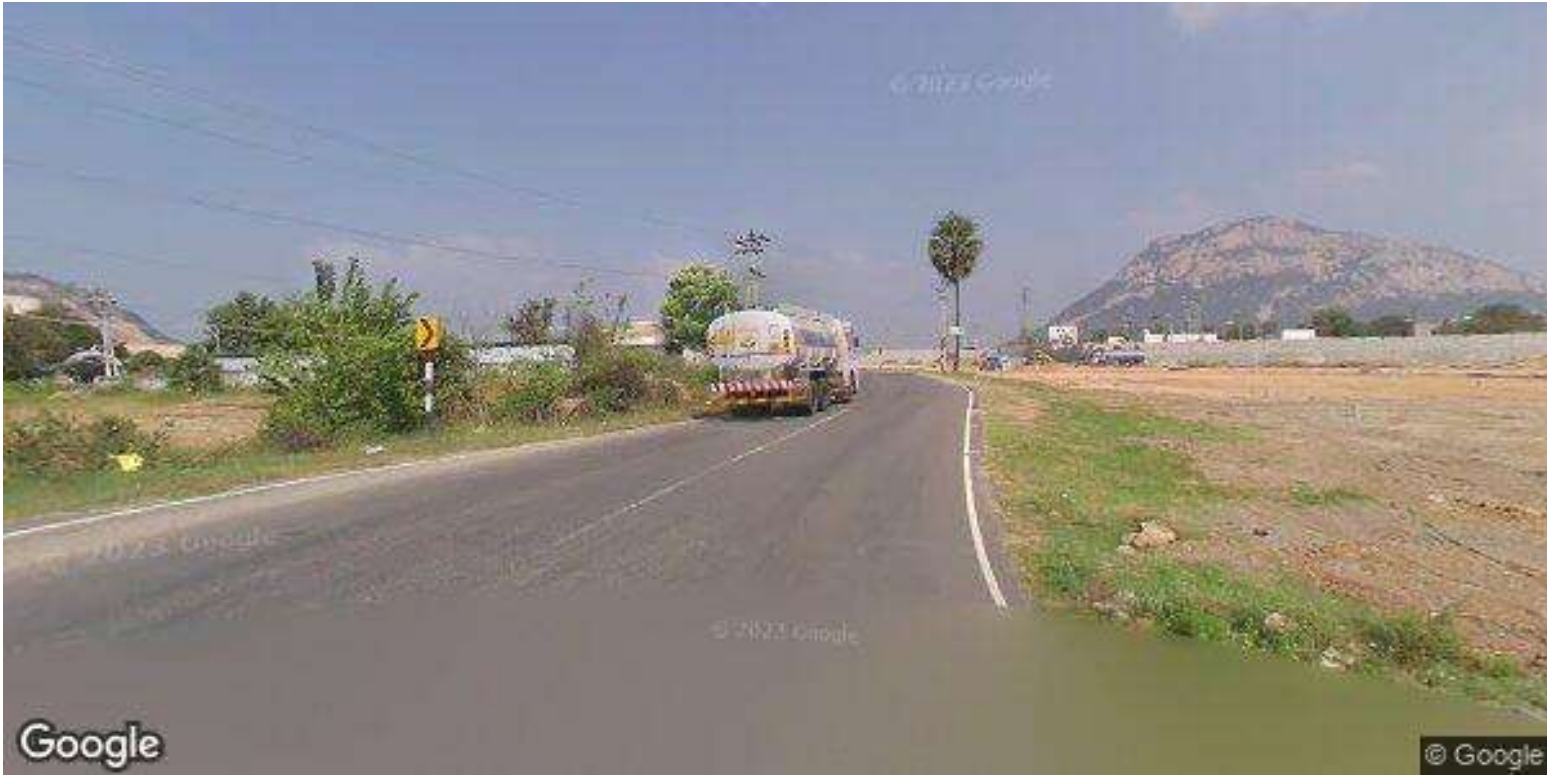
**Risk Type:** Turn  
**Risk Level:** Medium  
**Speed Limit:** 30 KM/Hr  
**Coordinates:** 11.45847, 77.85140

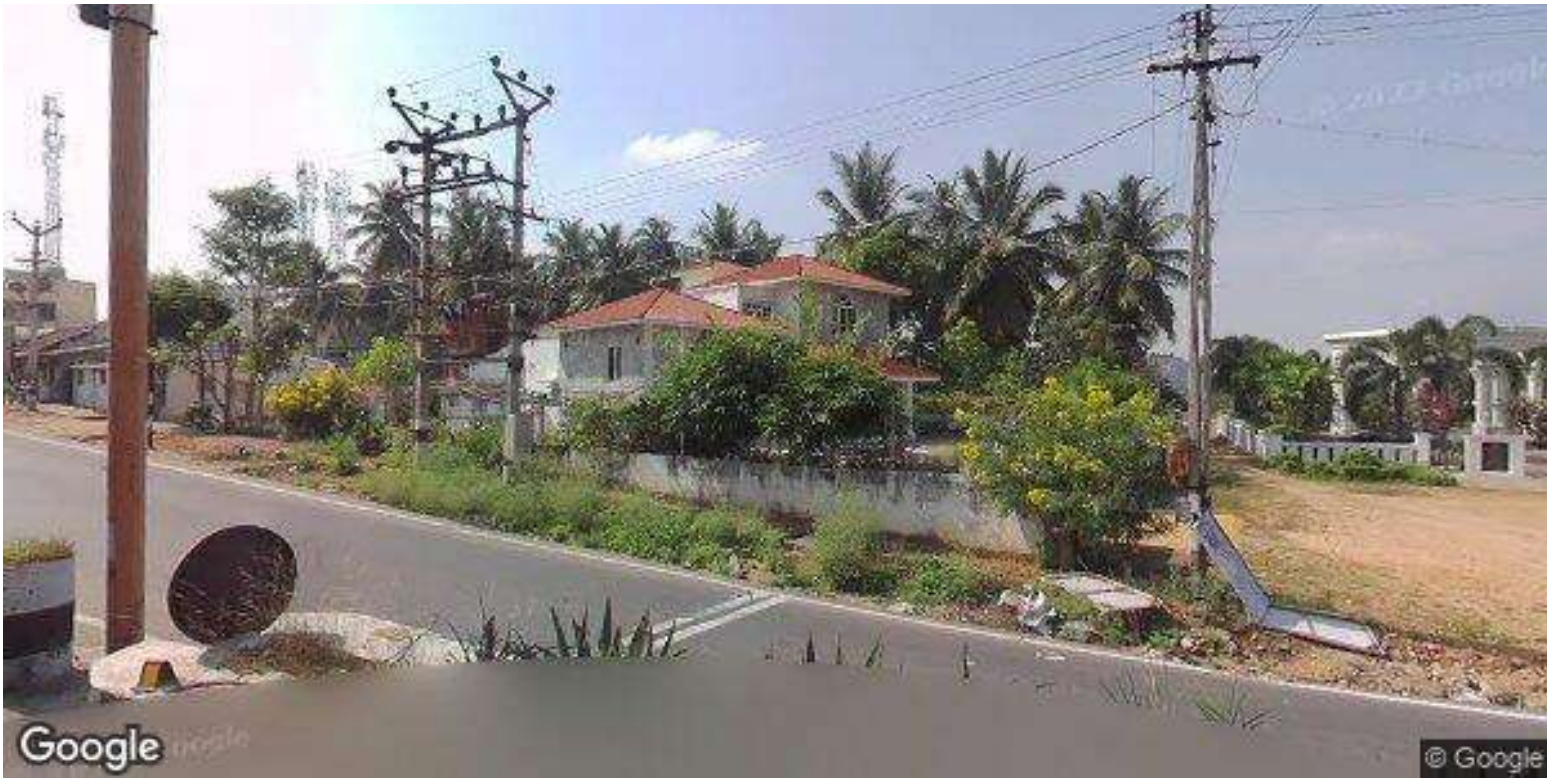
**Risk Type:** Turn  
**Risk Level:** Medium  
**Speed Limit:** 30 KM/Hr  
**Coordinates:** 11.46303, 77.84945

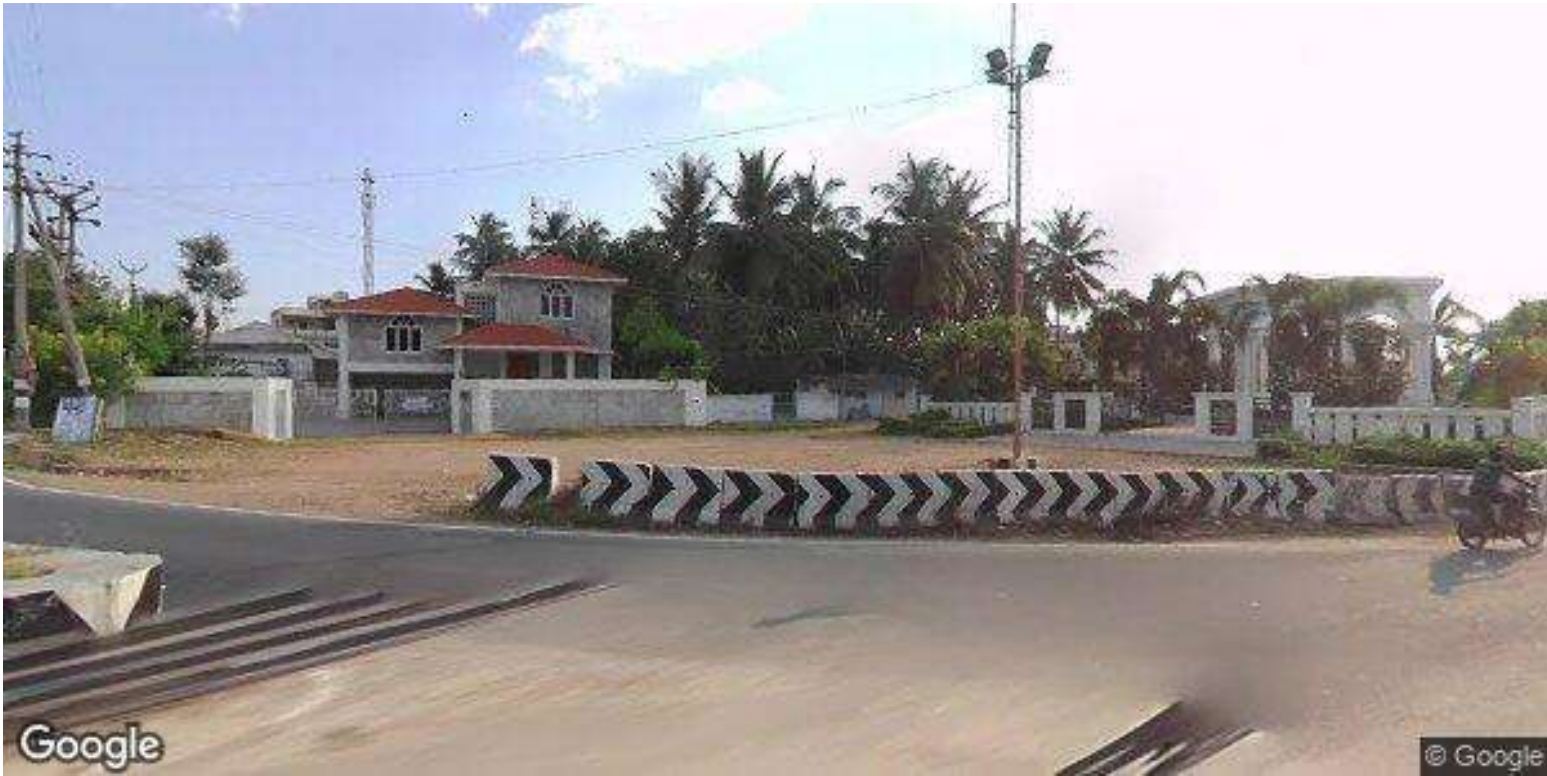
**Risk Type:** Turn  
**Risk Level:** Medium  
**Speed Limit:** 30 KM/Hr  
**Coordinates:** 11.46314, 77.84928

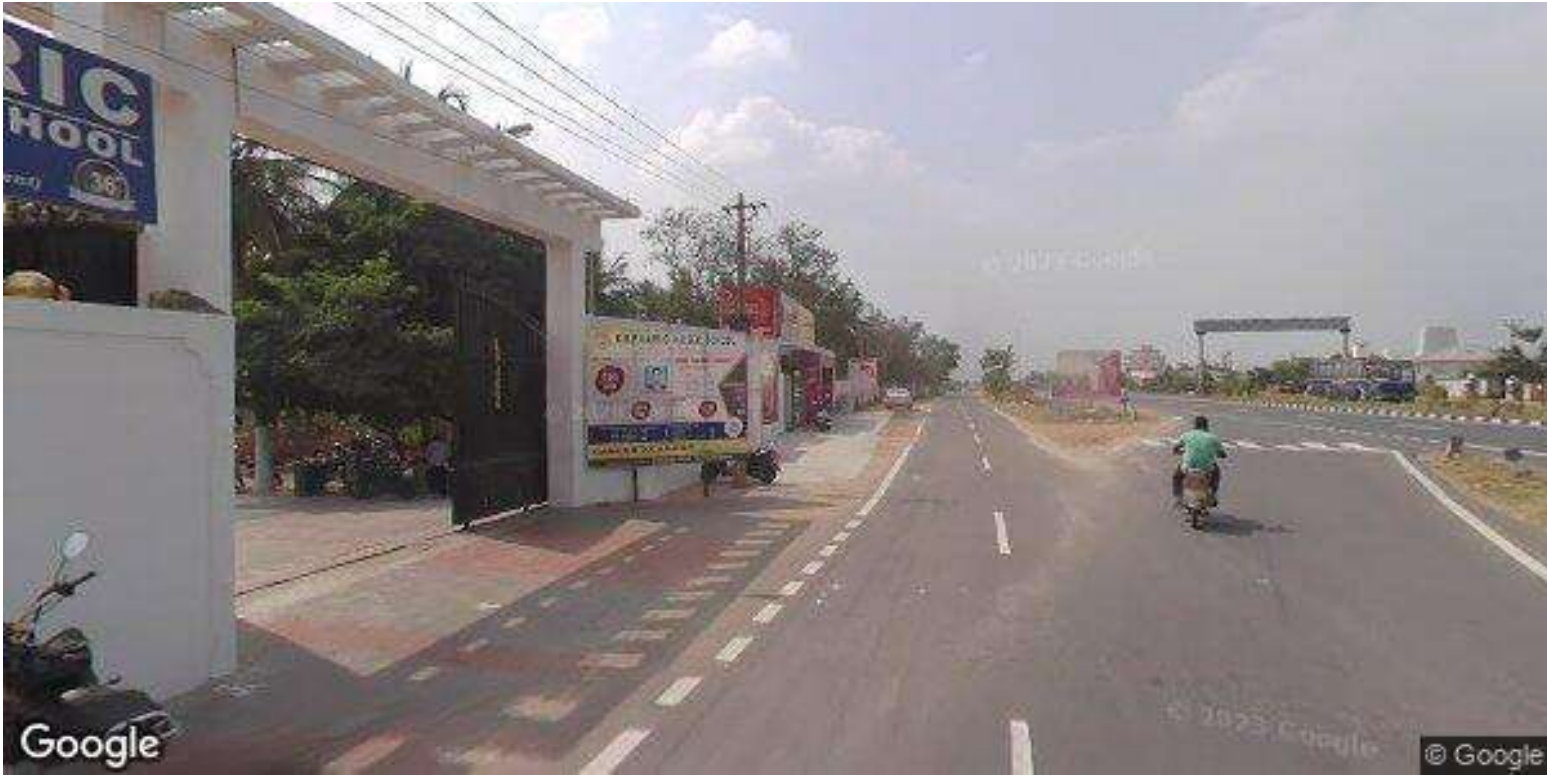
**Risk Type:** Turn  
**Risk Level:** Medium  
**Speed Limit:** 30 KM/Hr  
**Coordinates:** 11.45509, 77.81383

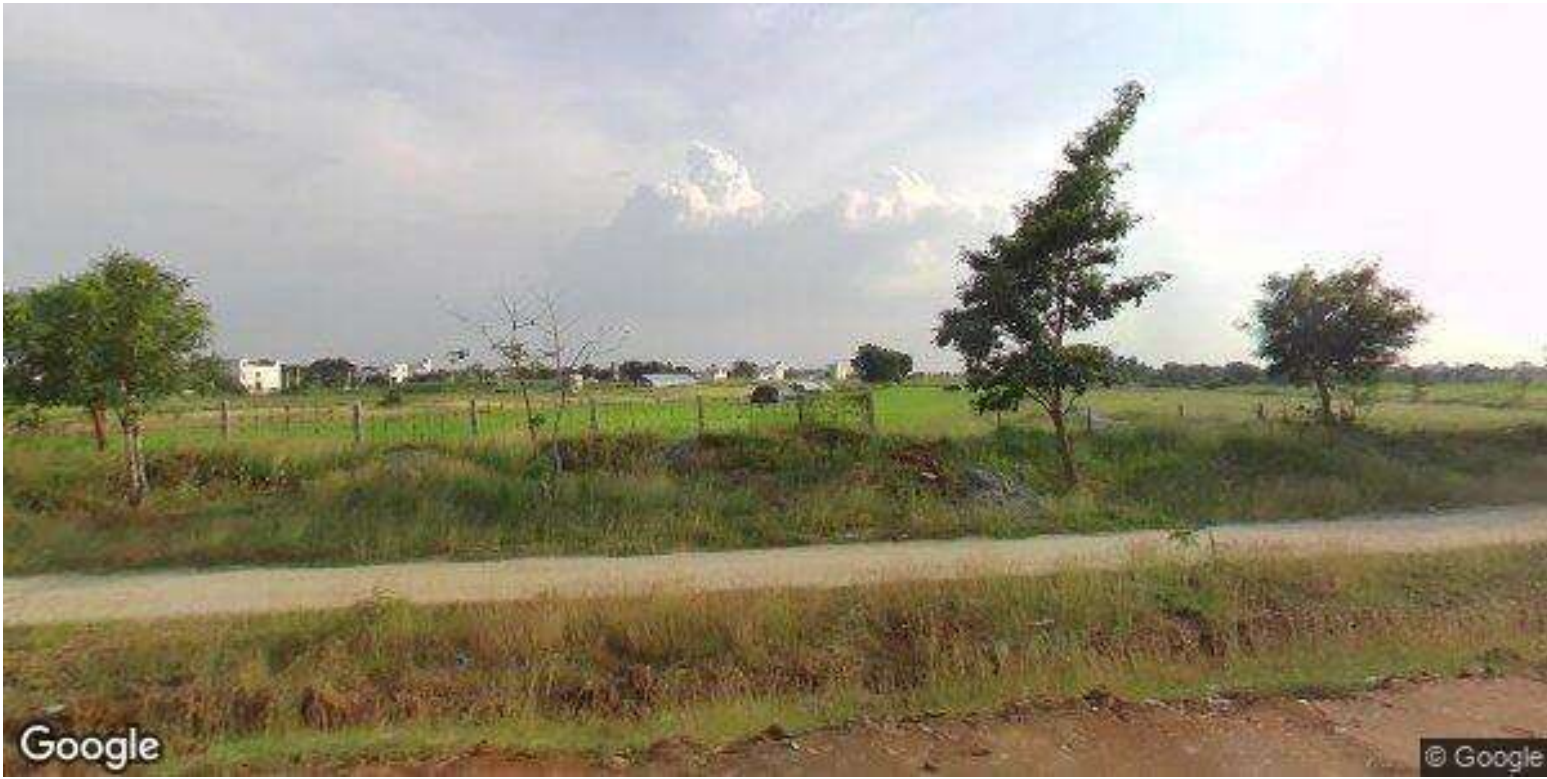
**Risk Type:** Turn  
**Risk Level:** Medium  
**Speed Limit:** 30 KM/Hr  
**Coordinates:** 11.29288, 77.59029

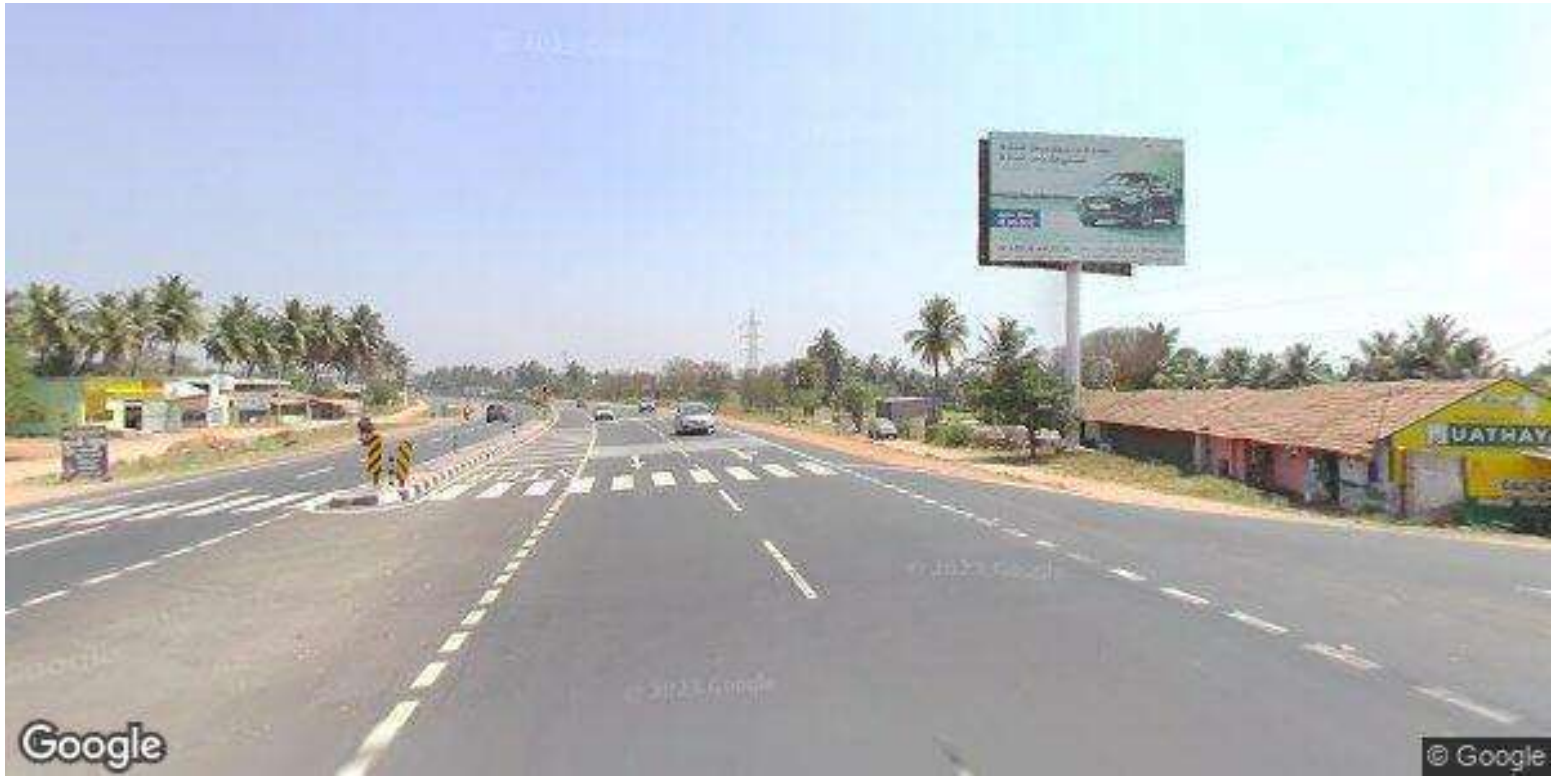
**Risk Type:** Blind Spot  
**Risk Level:** Blind Spot  
**Speed Limit:** 10 KM/Hr  
**Coordinates:** 11.23716, 77.50666

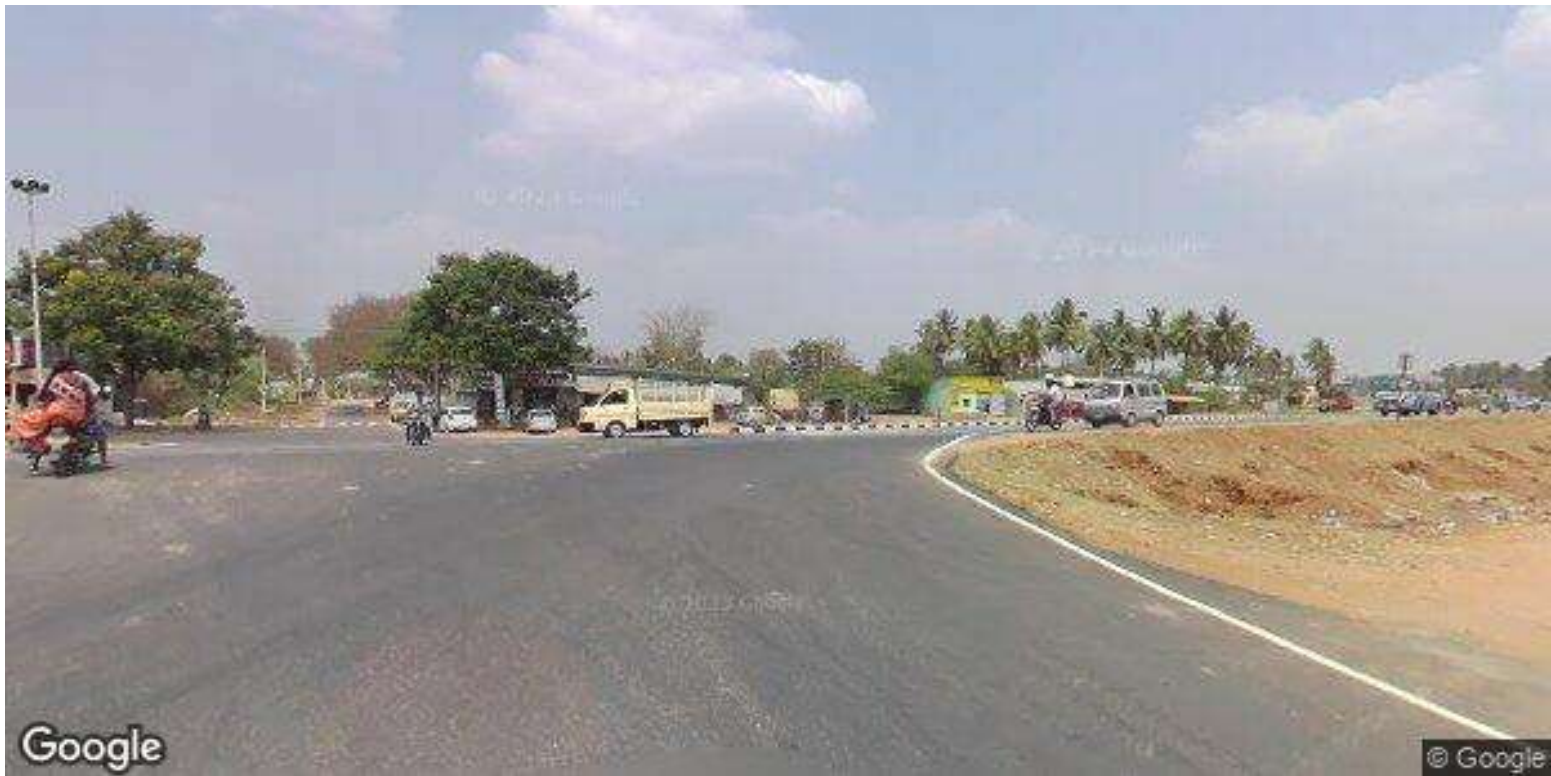
**Risk Type:** Blind Spot  
**Risk Level:** Blind Spot  
**Speed Limit:** 10 KM/Hr  
**Coordinates:** 11.23704, 77.50676

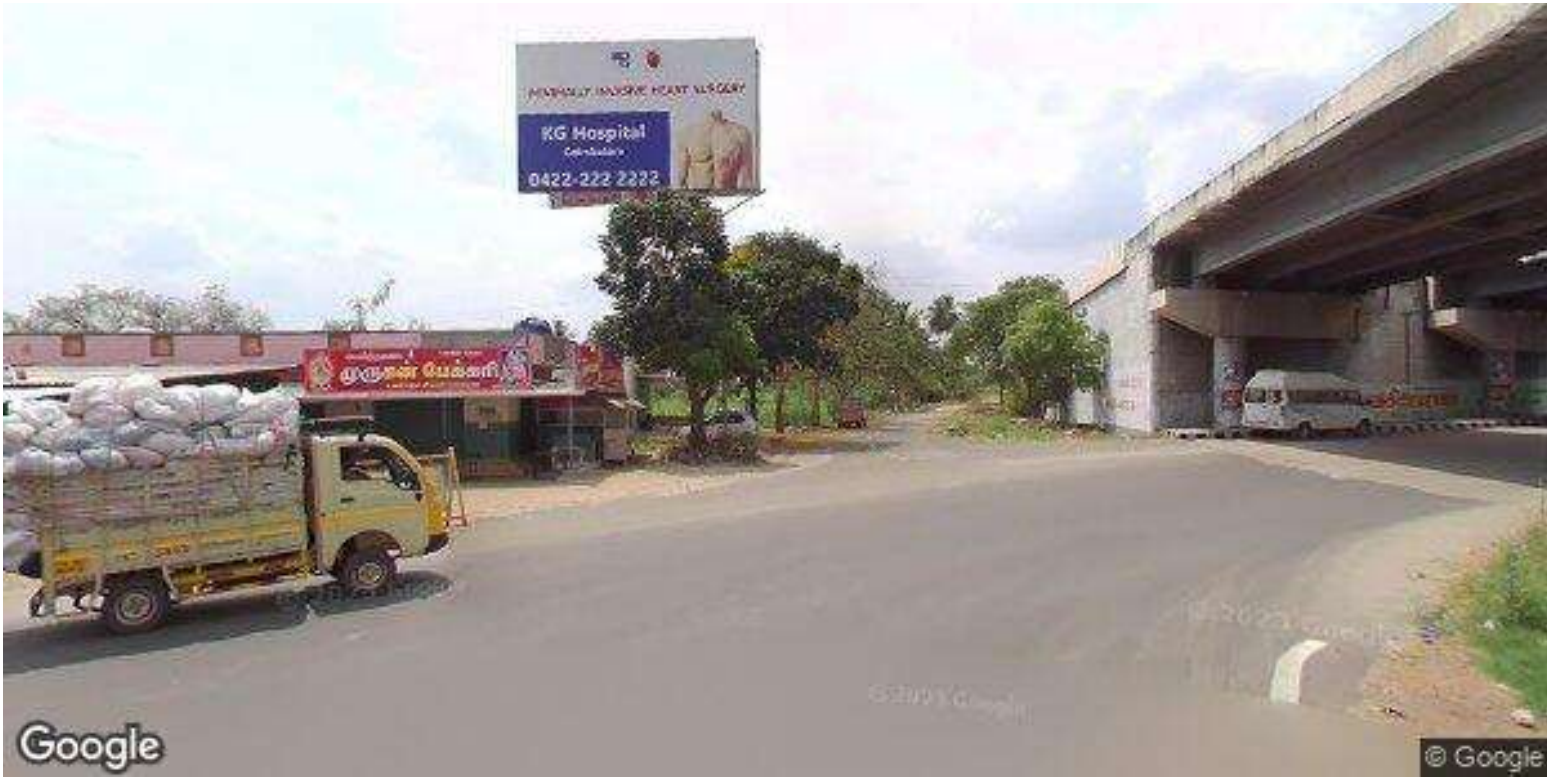
**Risk Type:** Blind Spot  
**Risk Level:** Blind Spot  
**Speed Limit:** 10 KM/Hr  
**Coordinates:** 11.23686, 77.50216

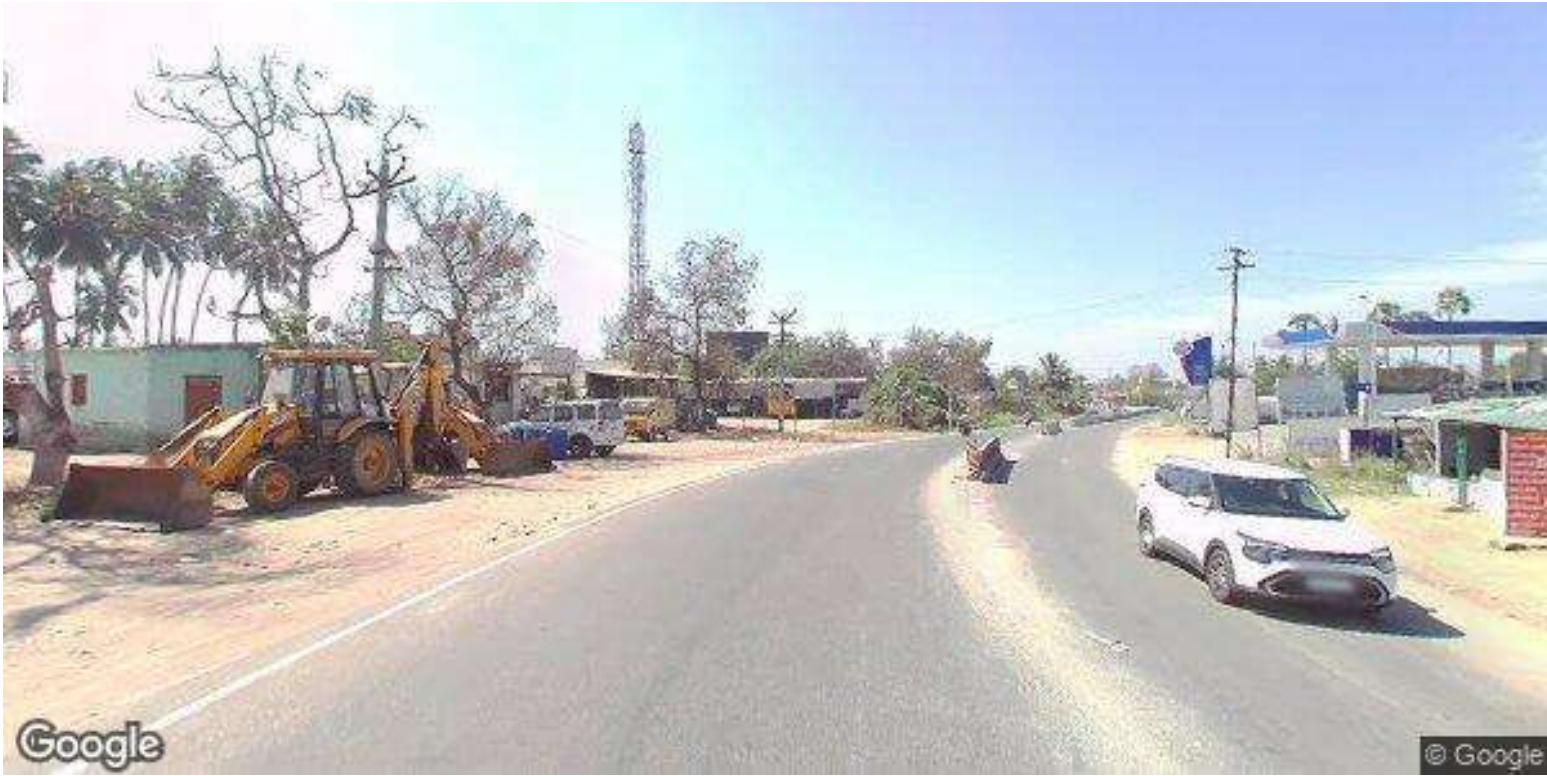
**Risk Type:** Turn  
**Risk Level:** Medium  
**Speed Limit:** 30 KM/Hr  
**Coordinates:** 11.23649, 77.50219

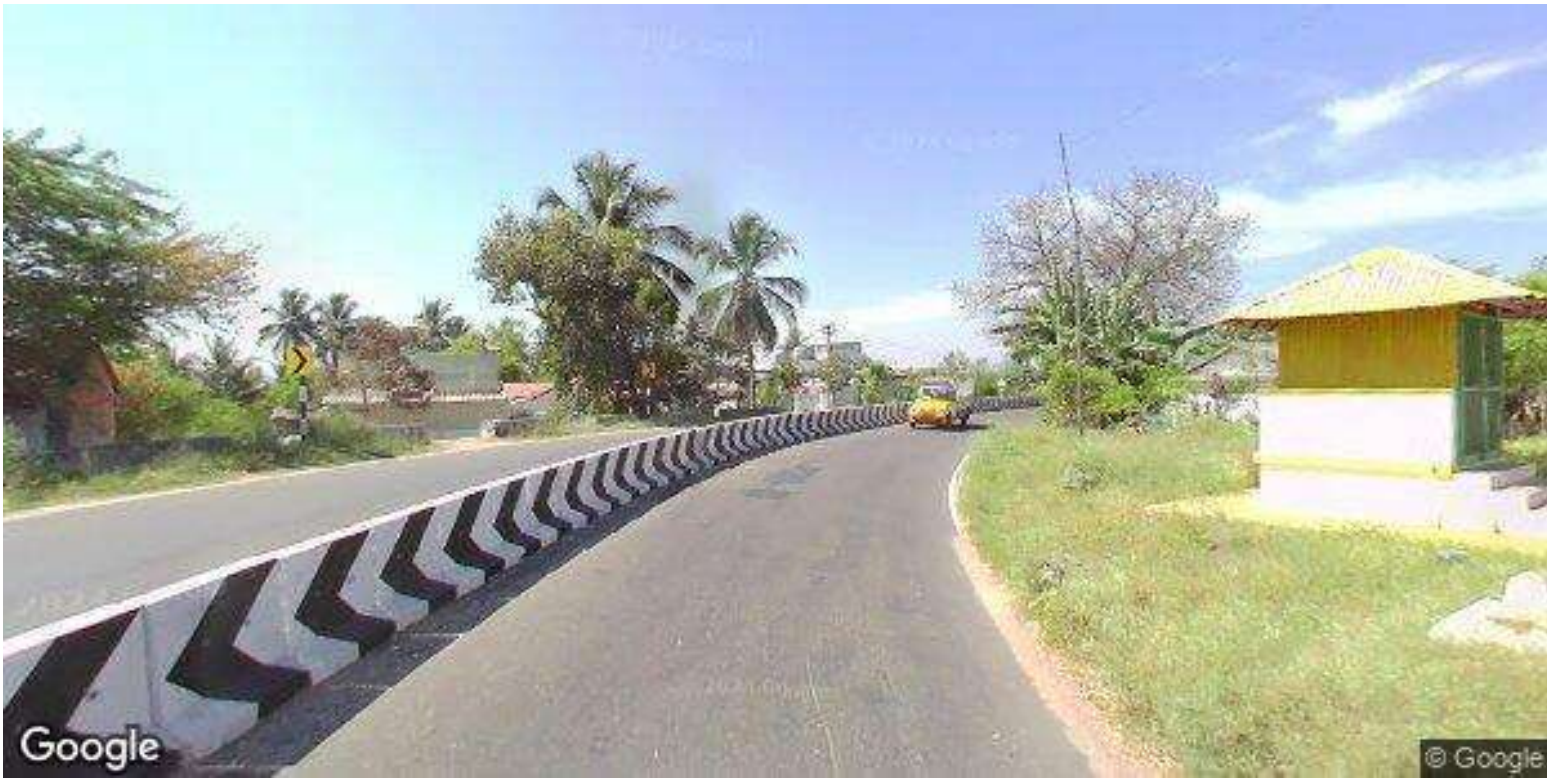
**Risk Type:** Turn  
**Risk Level:** Medium  
**Speed Limit:** 30 KM/Hr  
**Coordinates:** 11.23396, 77.50105

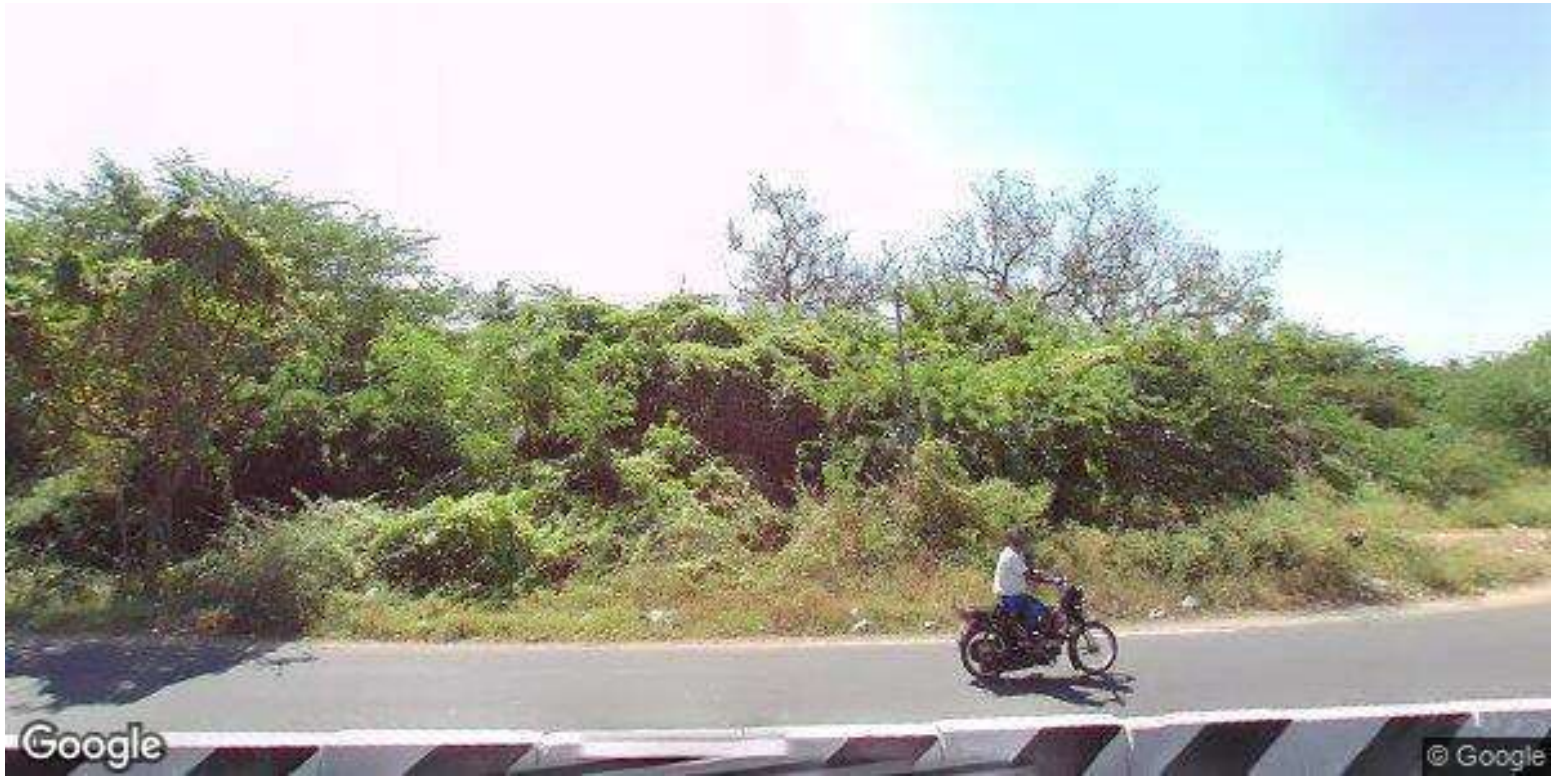
**Risk Type:** Turn  
**Risk Level:** Medium  
**Speed Limit:** 30 KM/Hr  
**Coordinates:** 11.23329, 77.49966

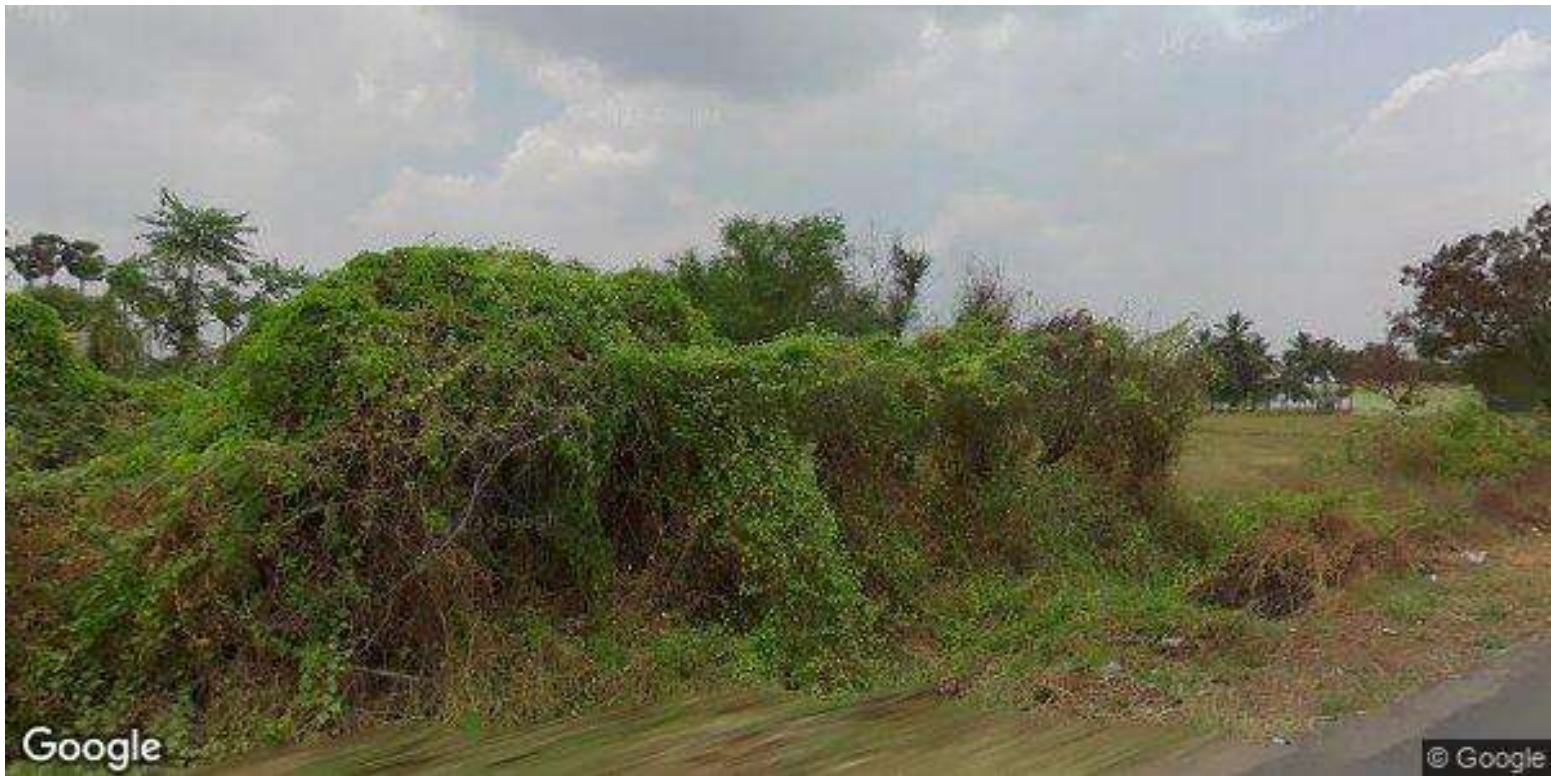
**Risk Type:** Turn  
**Risk Level:** Medium  
**Speed Limit:** 30 KM/Hr  
**Coordinates:** 11.17851, 77.46169
