# IndianOil

## JOURNEY RISK MANAGEMENT (JRM) STUDY

### Salem Terminal to SRI VENKATESHWARA AGENCIES

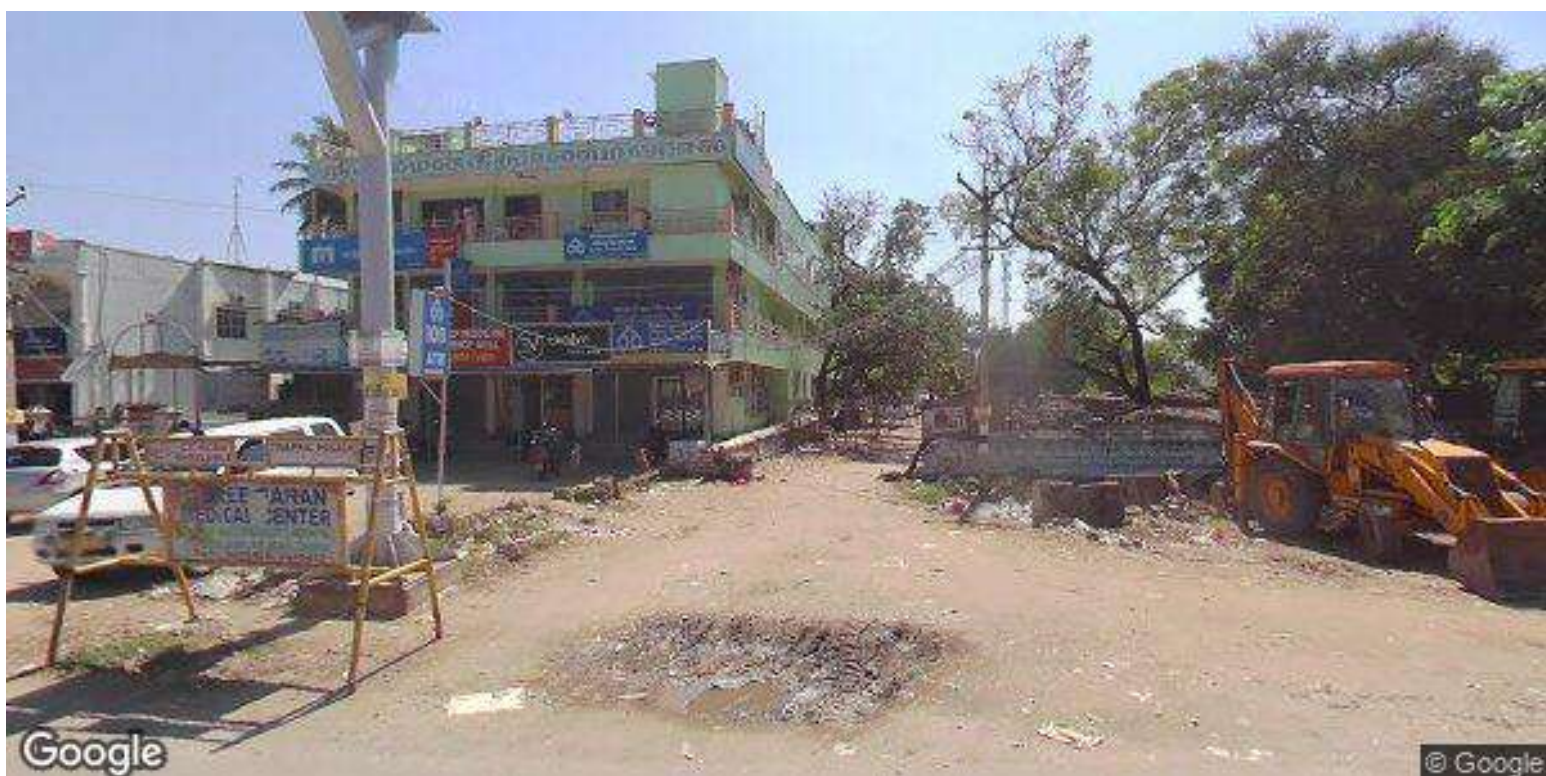
**Coordinates: 11.2075731, 77.36051979999999**

**Risk Type: U-Turn**

**Risk Level: High**

**Speed Limit: 10 KM/Hr**

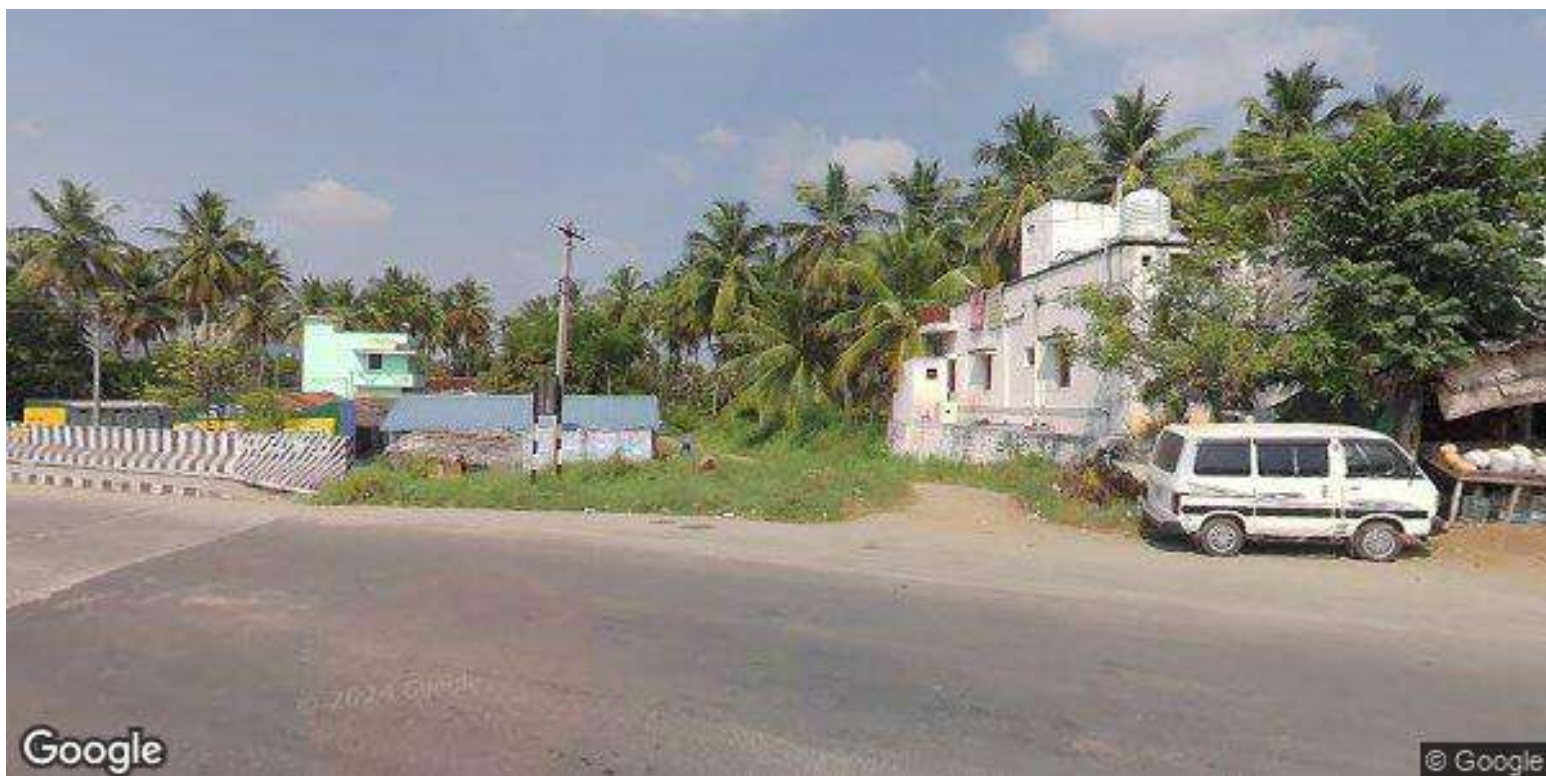
**Coordinates: 11.44898, 77.87410**

**Risk Type: Turn**

**Risk Level: High**

**Speed Limit: 15 KM/Hr**

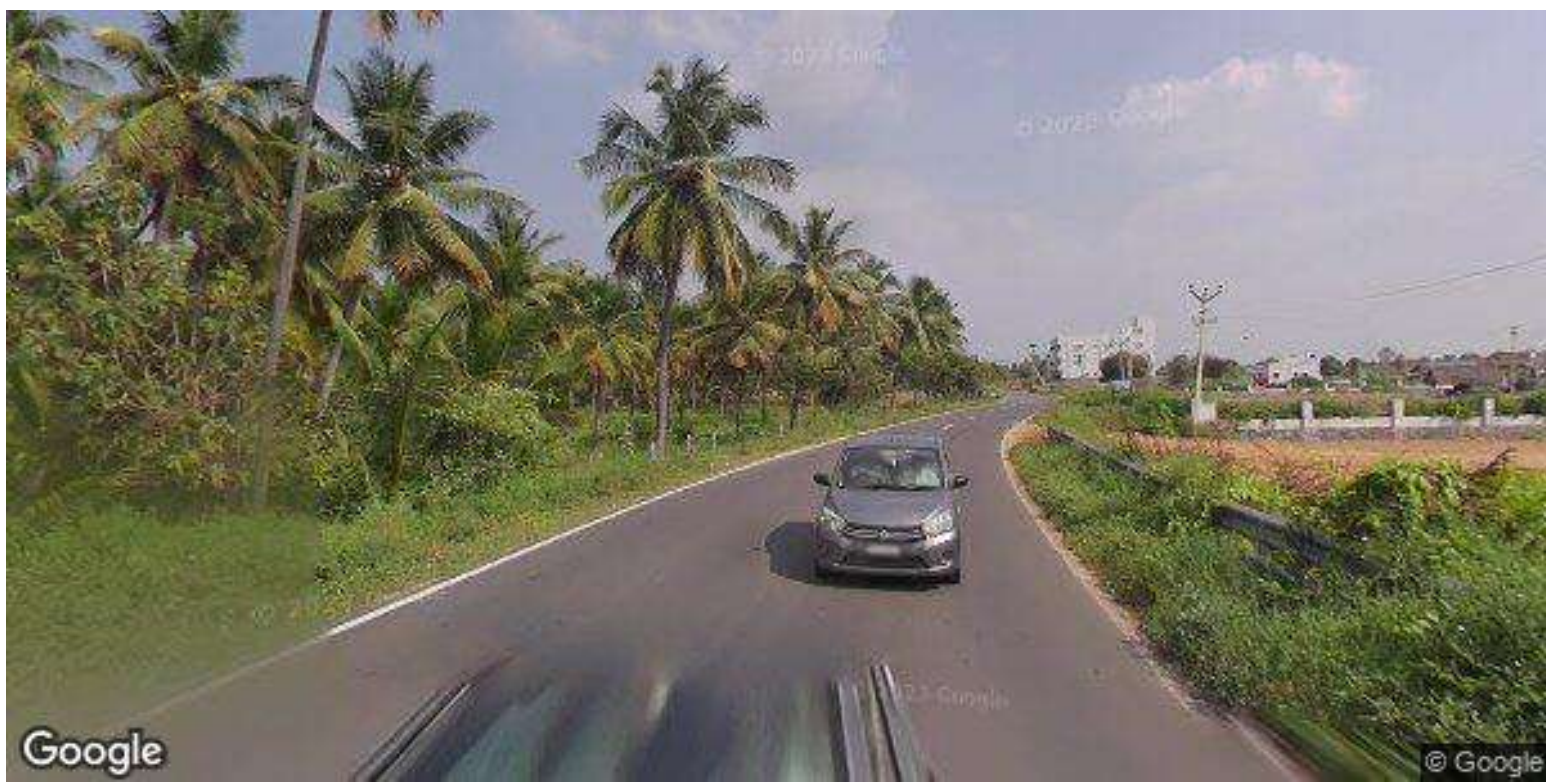
**Coordinates:** 11.45357, 77.85789

**Risk Type:** Turn

**Risk Level:** Medium

**Speed Limit:** 30 KM/Hr

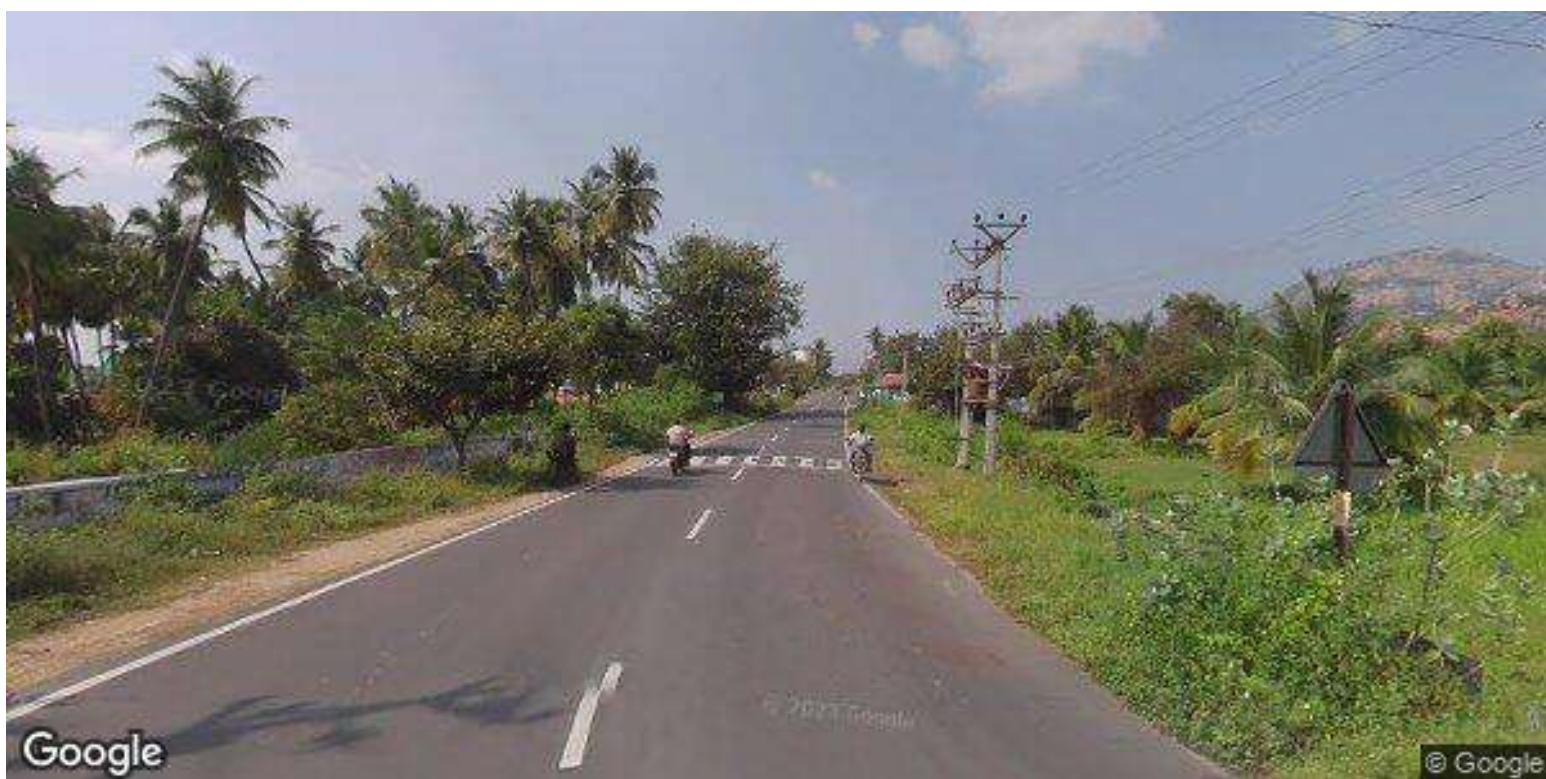
**Coordinates:** 11.45352, 77.85698

**Risk Type:** Turn

**Risk Level:** High

**Speed Limit:** 15 KM/Hr

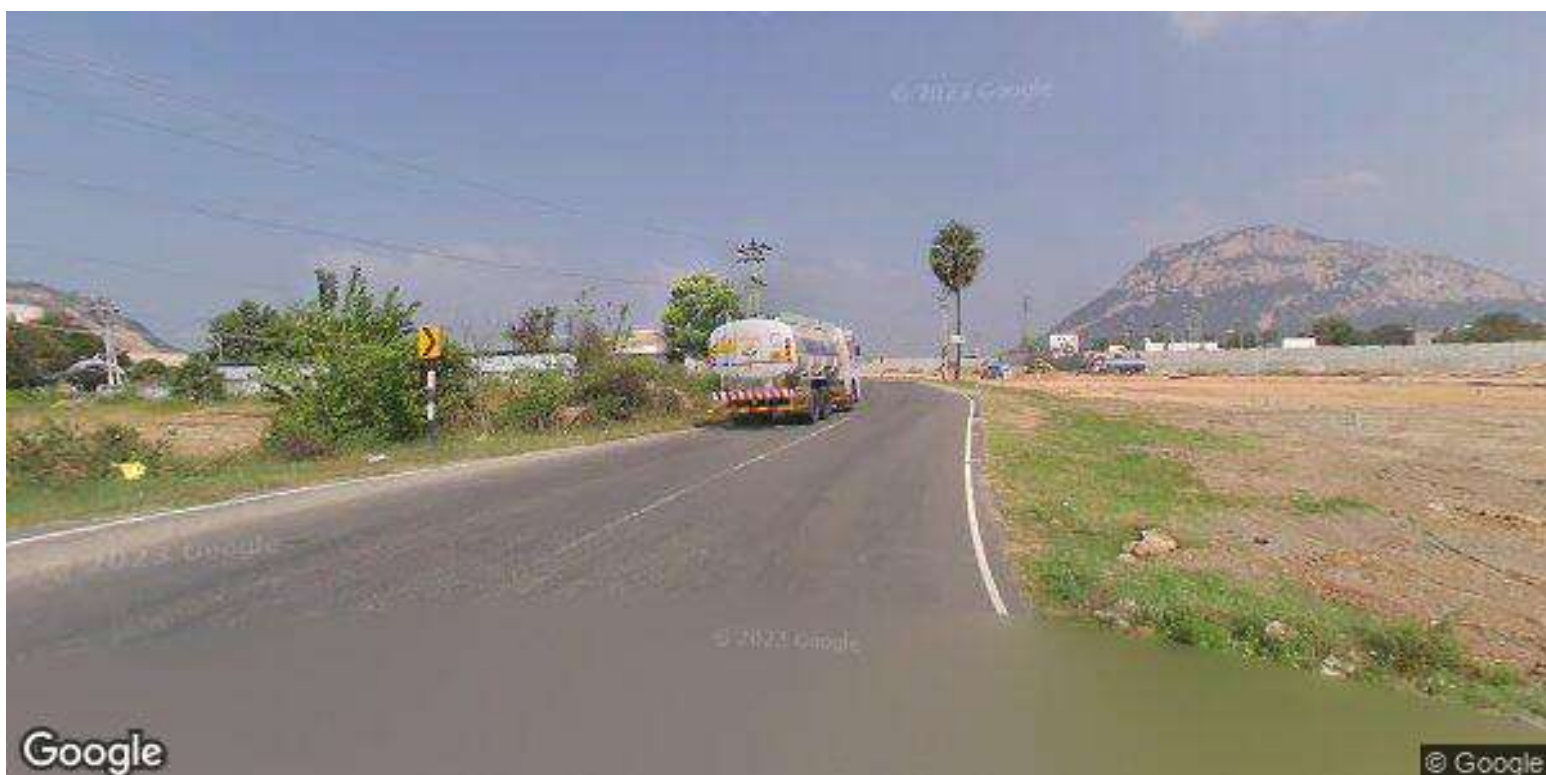
**Coordinates:** 11.45847, 77.85140

**Risk Type:** Turn

**Risk Level:** Medium

**Speed Limit:** 30 KM/Hr

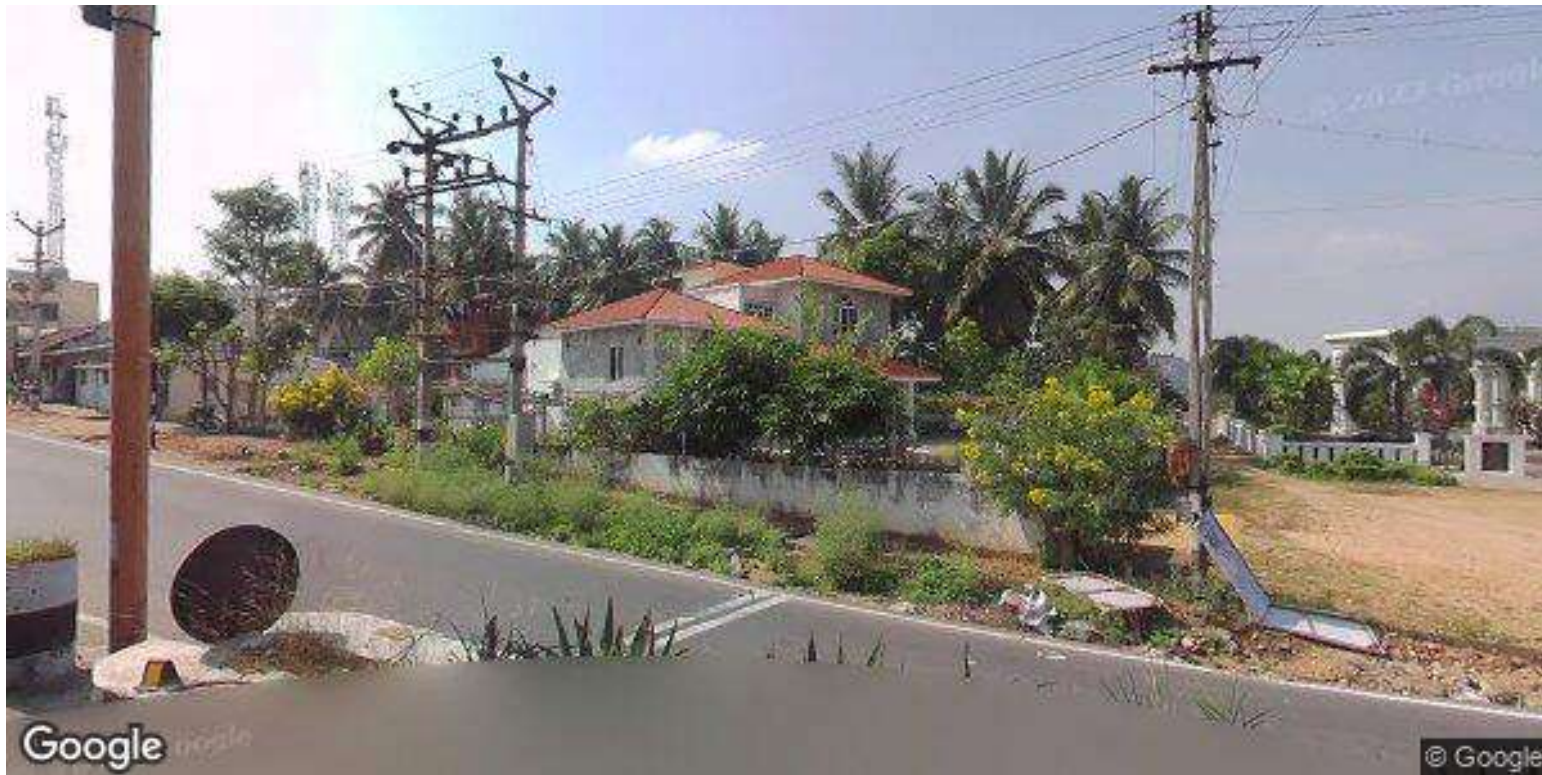
**Coordinates:** 11.46303, 77.84945

**Risk Type:** Turn

**Risk Level:** Medium

**Speed Limit:** 30 KM/Hr

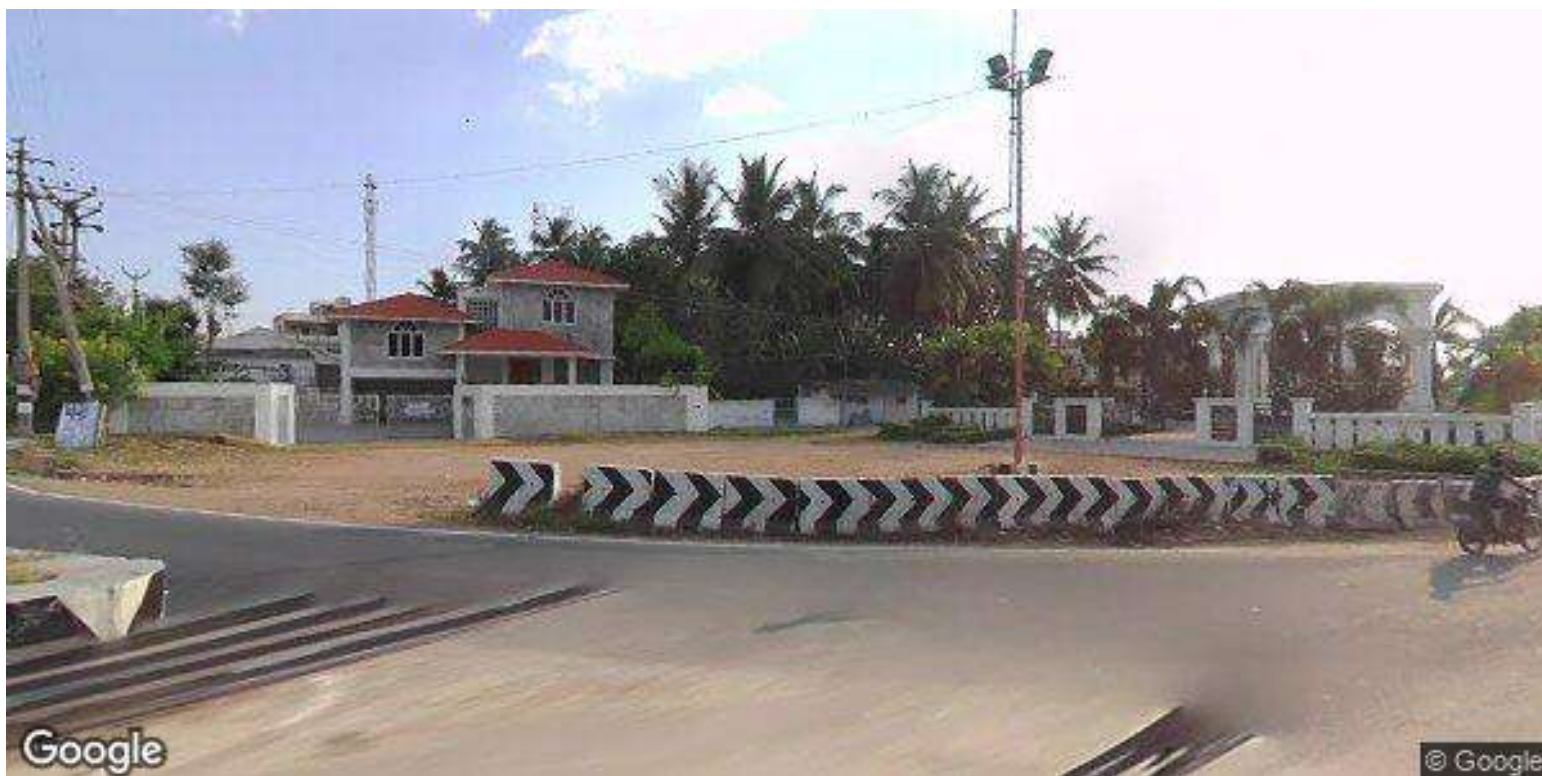
**Coordinates:** 11.46314, 77.84928

**Risk Type:** Turn

**Risk Level:** Medium

**Speed Limit:** 30 KM/Hr

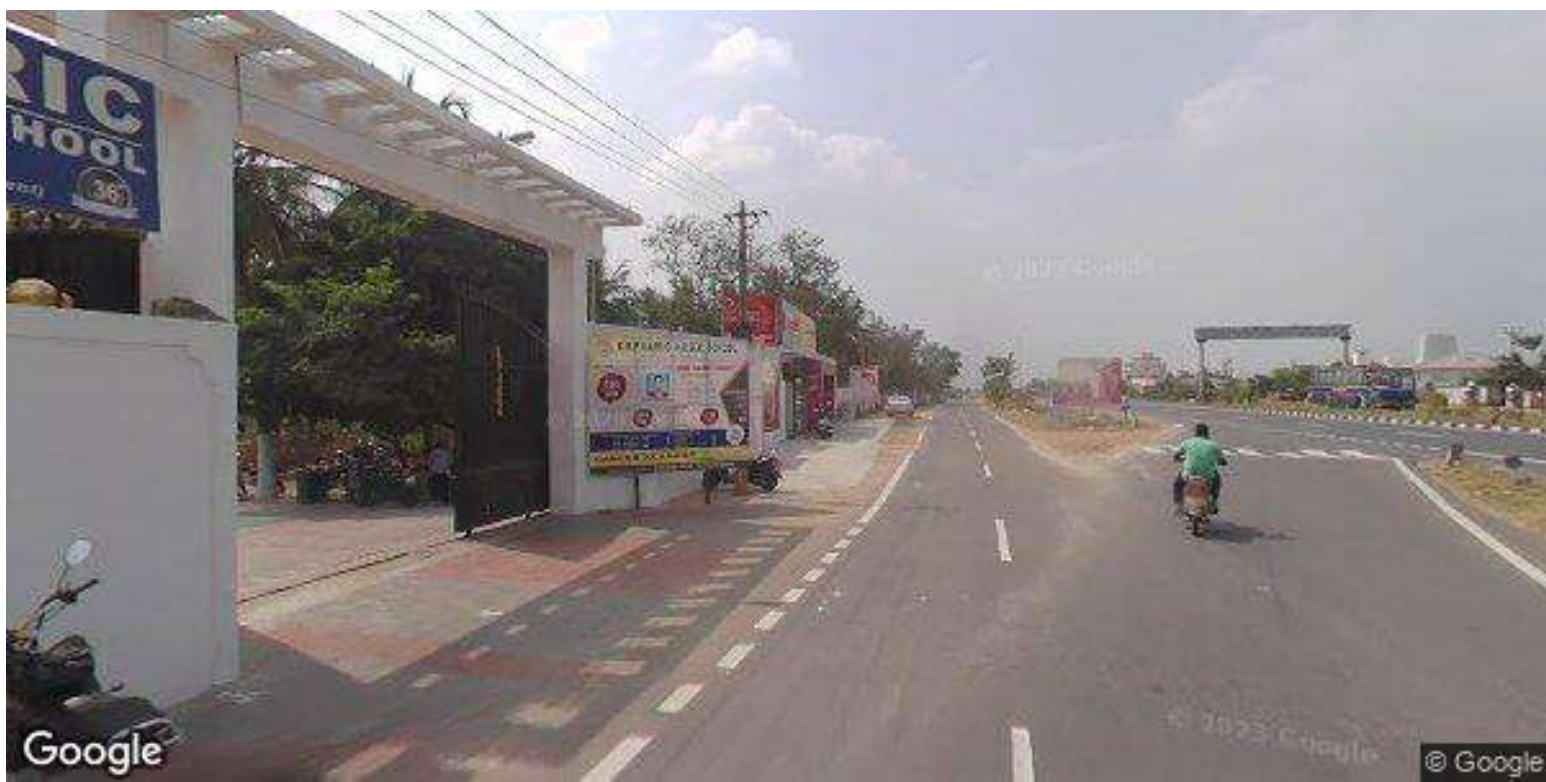
**Coordinates:** 11.45509, 77.81383

**Risk Type:** Turn

**Risk Level:** Medium

**Speed Limit:** 30 KM/Hr

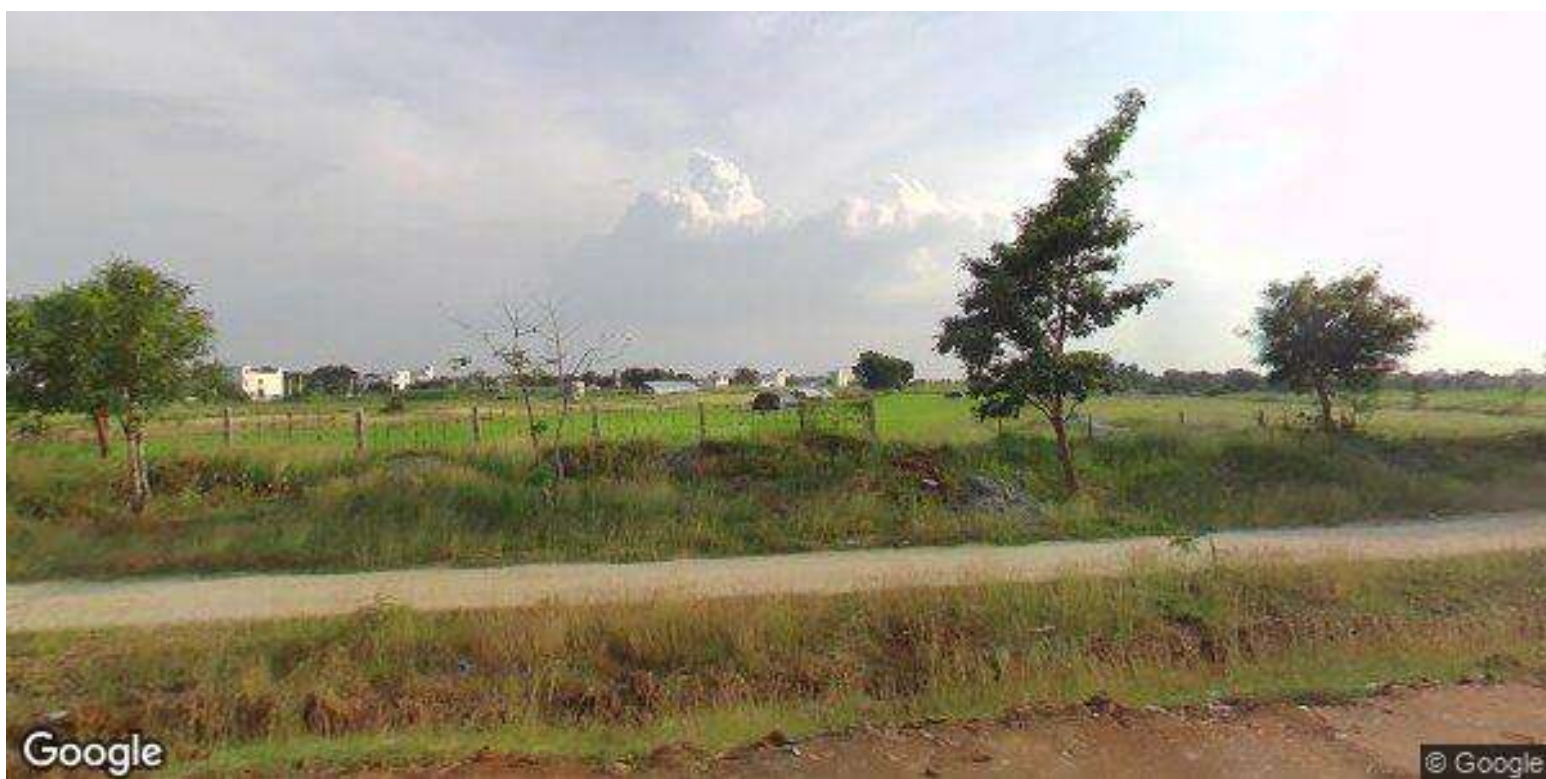
**Coordinates:** 11.29288, 77.59029

**Risk Type:** Turn

**Risk Level:** Medium

**Speed Limit:** 30 KM/Hr

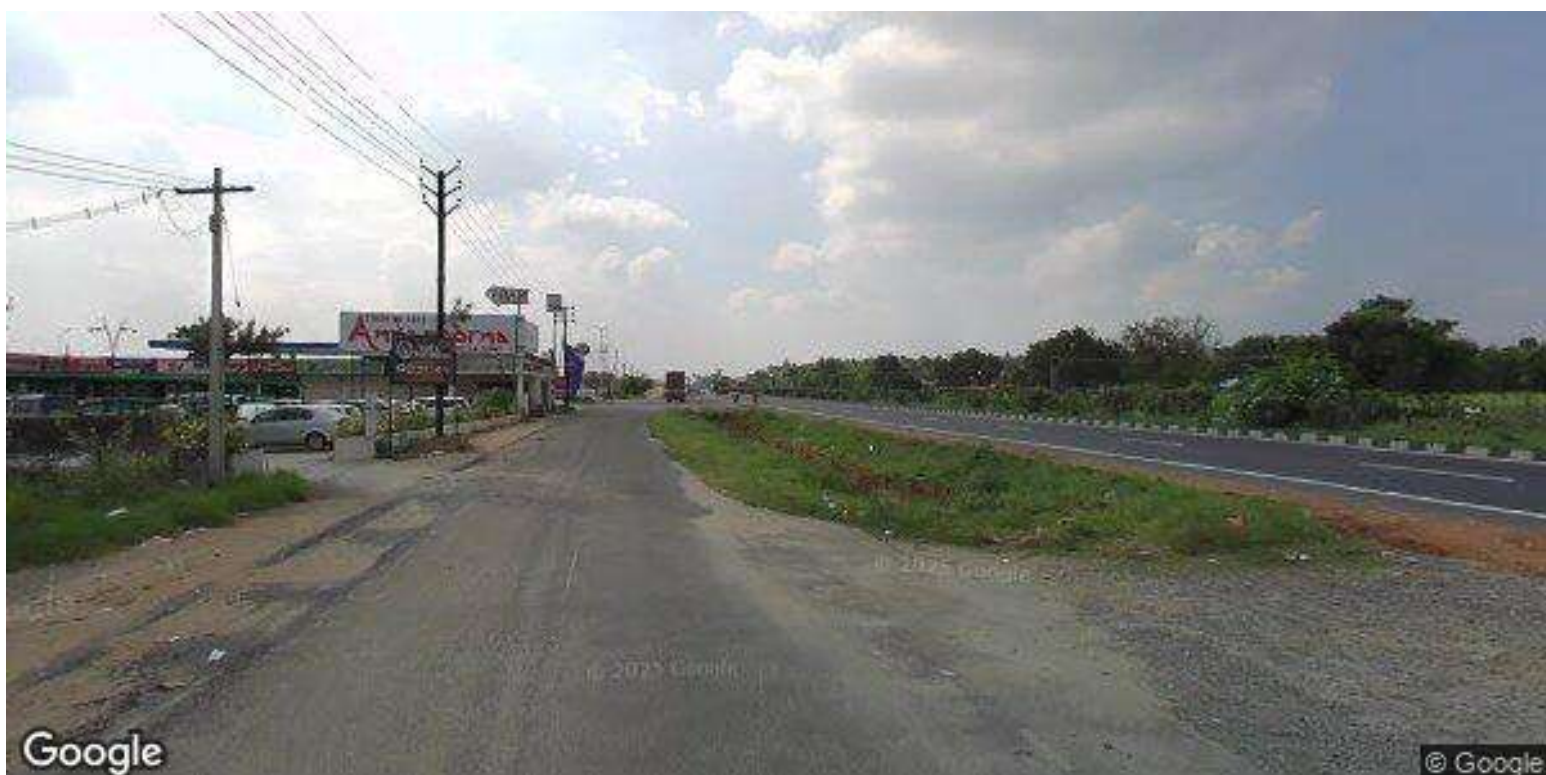
**Coordinates:** 11.29140, 77.58253

**Risk Type:** Turn

**Risk Level:** Medium

**Speed Limit:** 30 KM/Hr

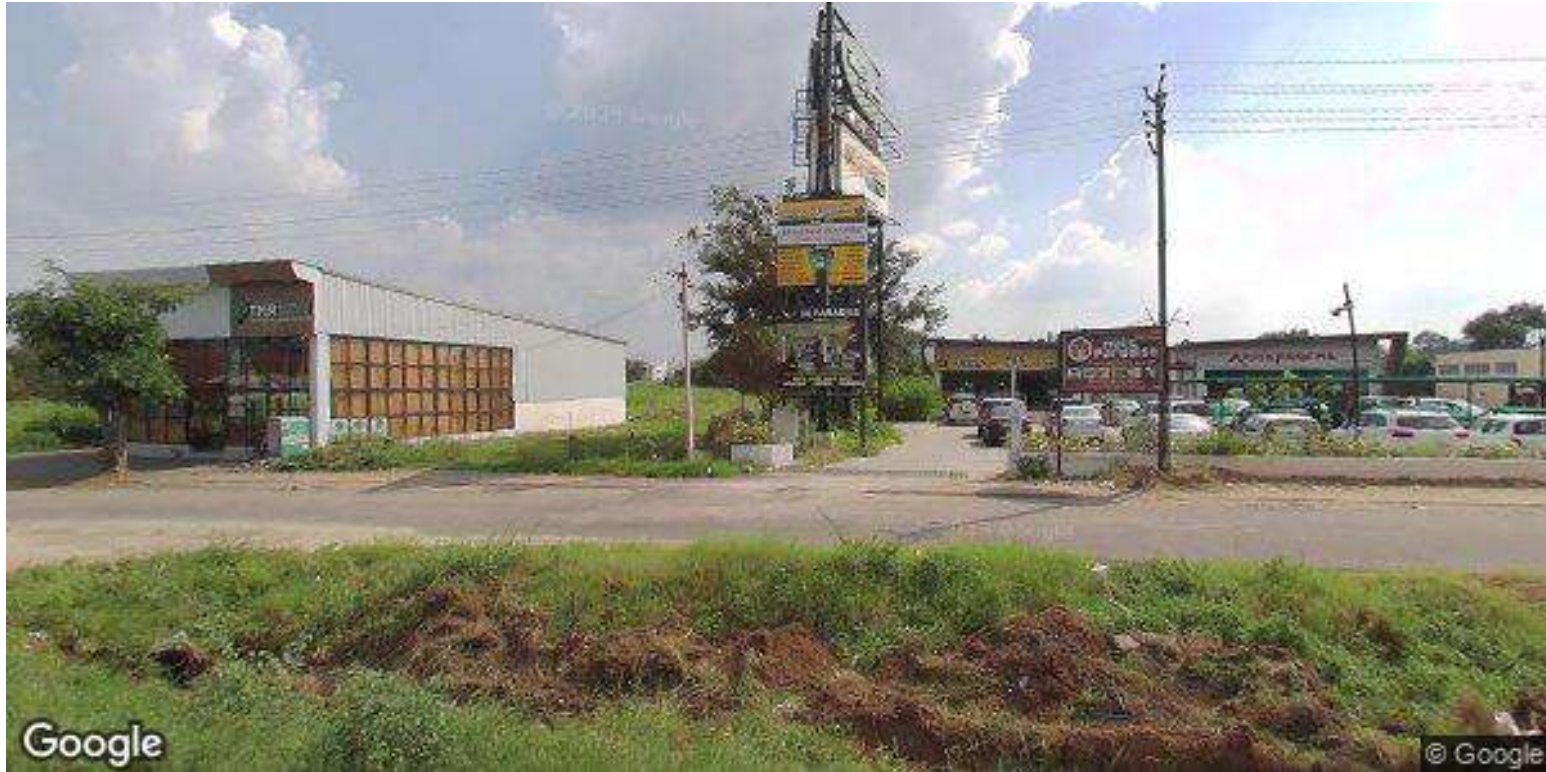
**Coordinates:** 11.29154, 77.58236

**Risk Type:** Turn

**Risk Level:** Medium

**Speed Limit:** 30 KM/Hr

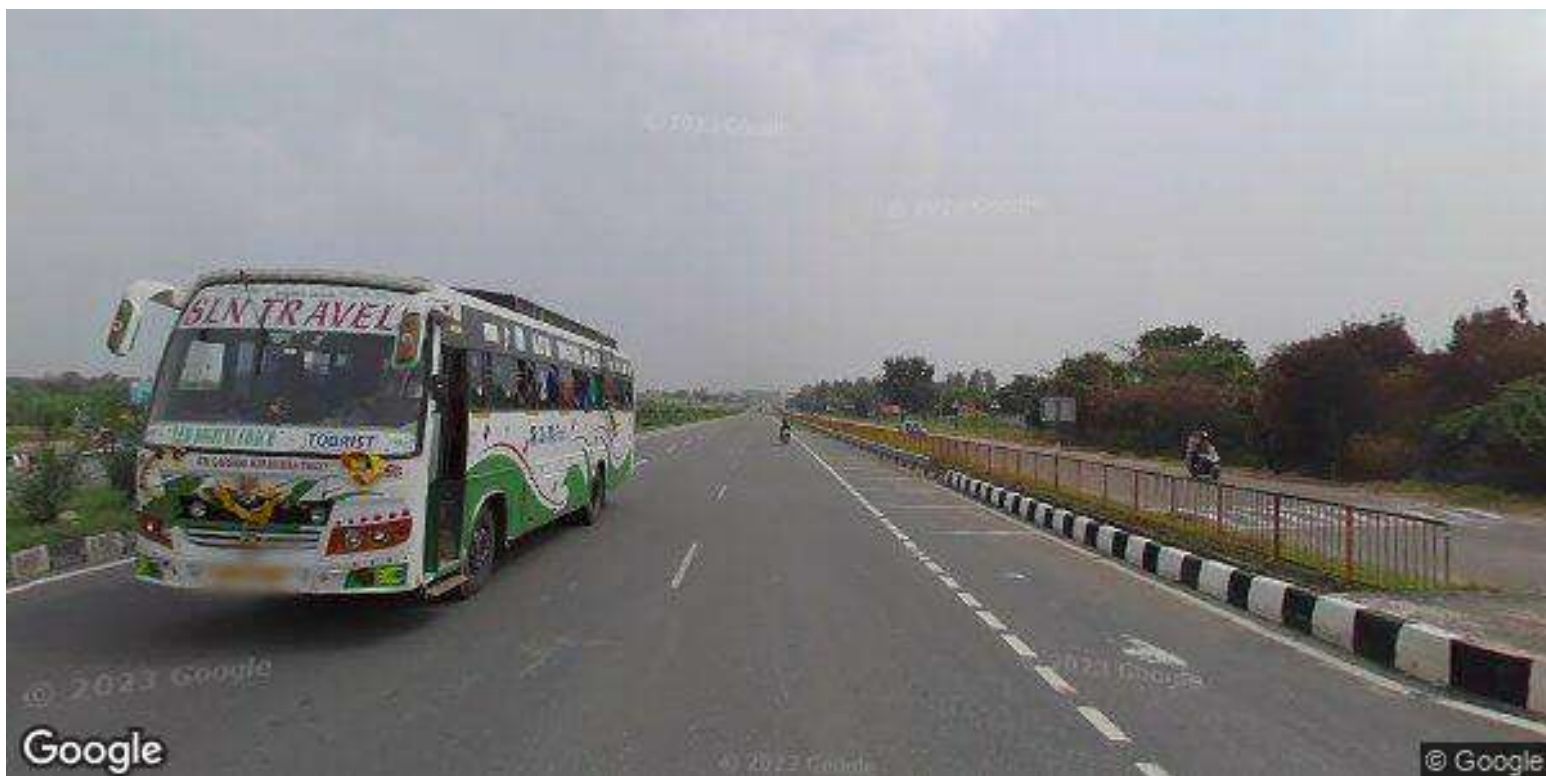
**Coordinates:** 11.20682, 77.37703

**Risk Type:** Turn

**Risk Level:** Medium

**Speed Limit:** 30 KM/Hr

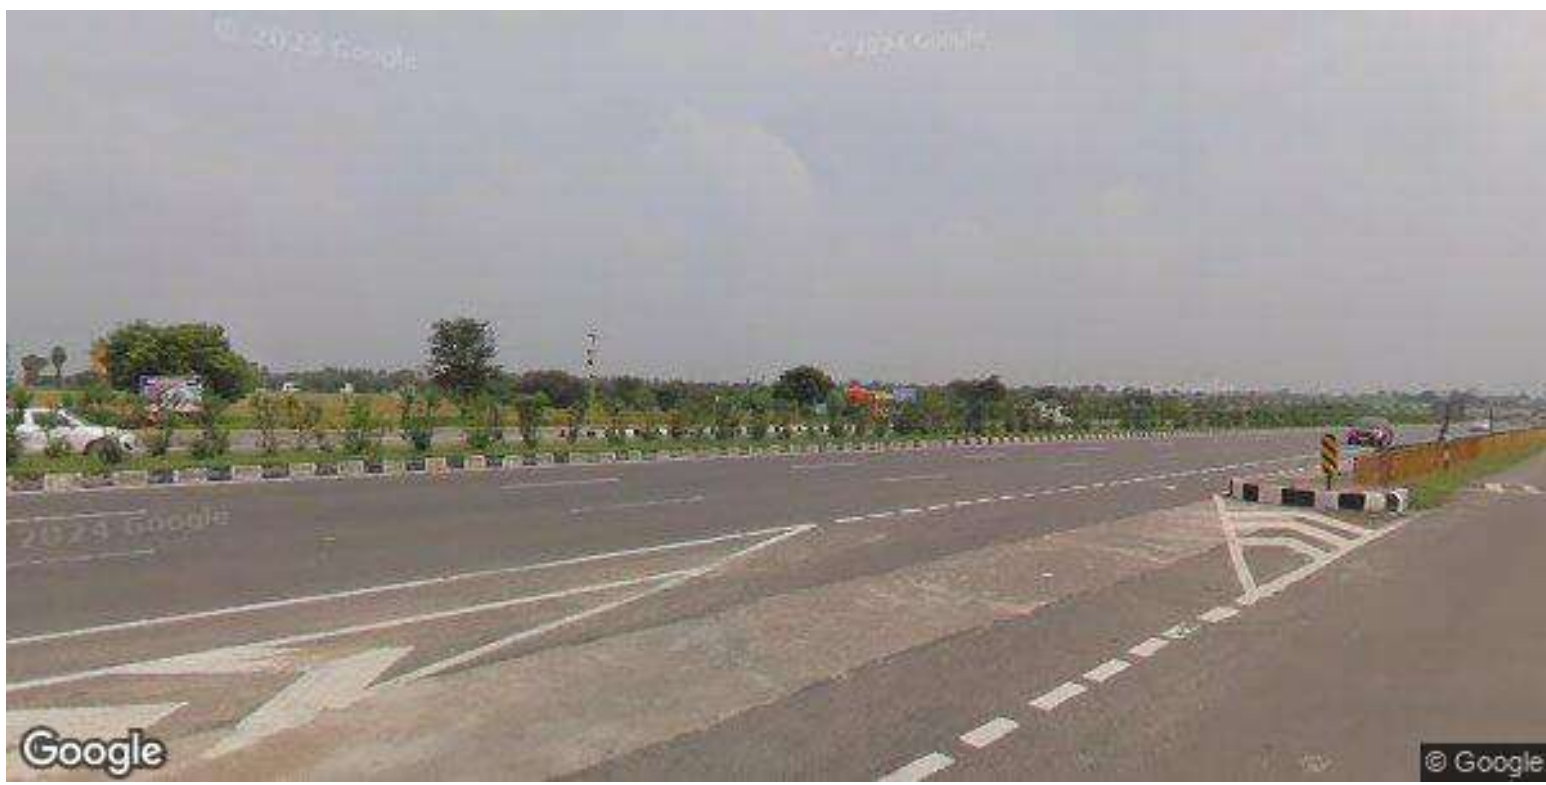
**Coordinates:** 11.20668, 77.37686

**Risk Type:** Turn

**Risk Level:** Medium

**Speed Limit:** 30 KM/Hr

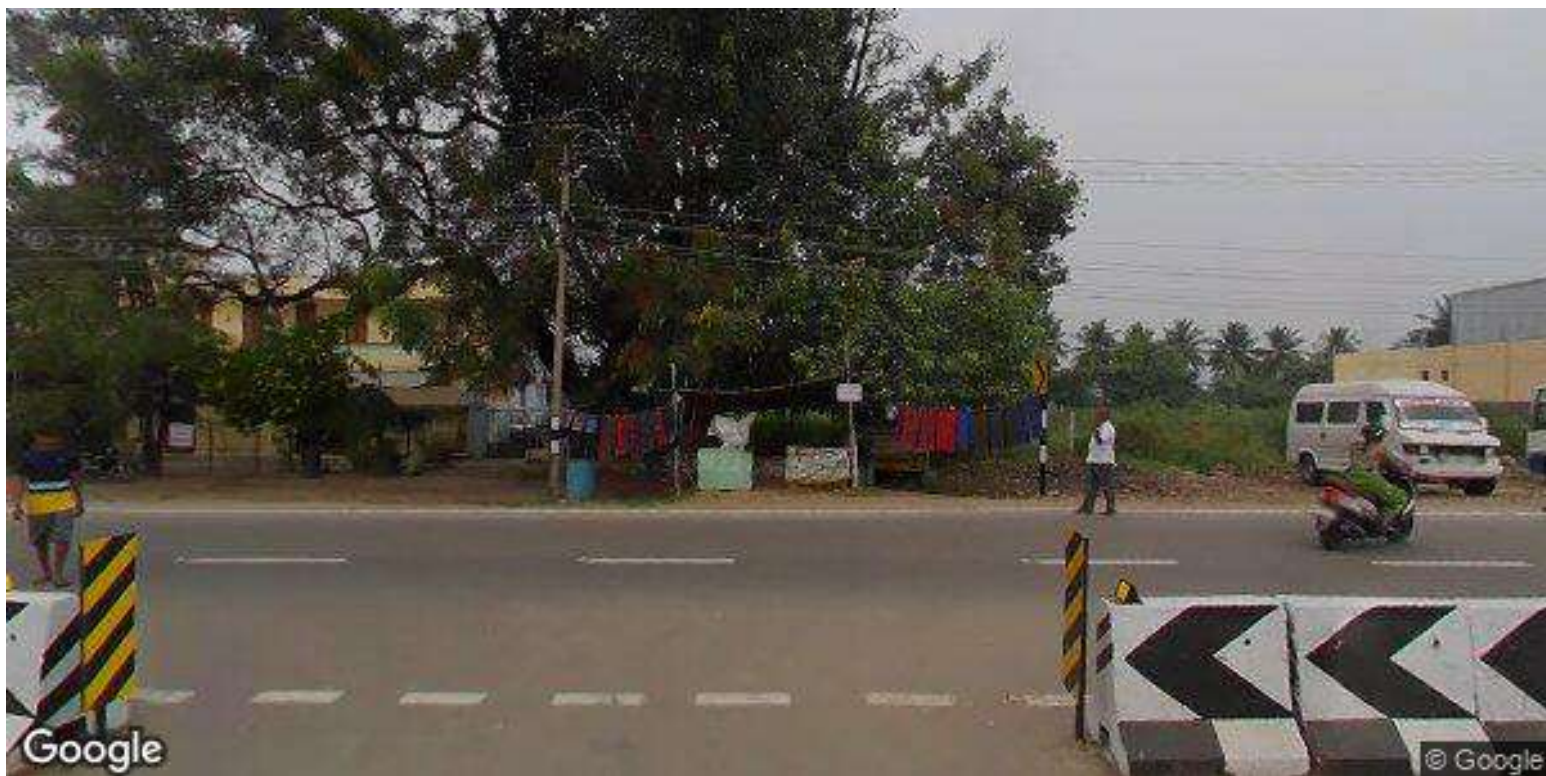
**Coordinates:** 11.20758, 77.36054

**Risk Type:** Blind Spot

**Risk Level:** Blind Spot

**Speed Limit:** 10 KM/Hr
