## JOURNEY RISK MANAGEMENT (JRM) STUDY

### Salem Terminal to AMMAN AGENCIES MULANUR

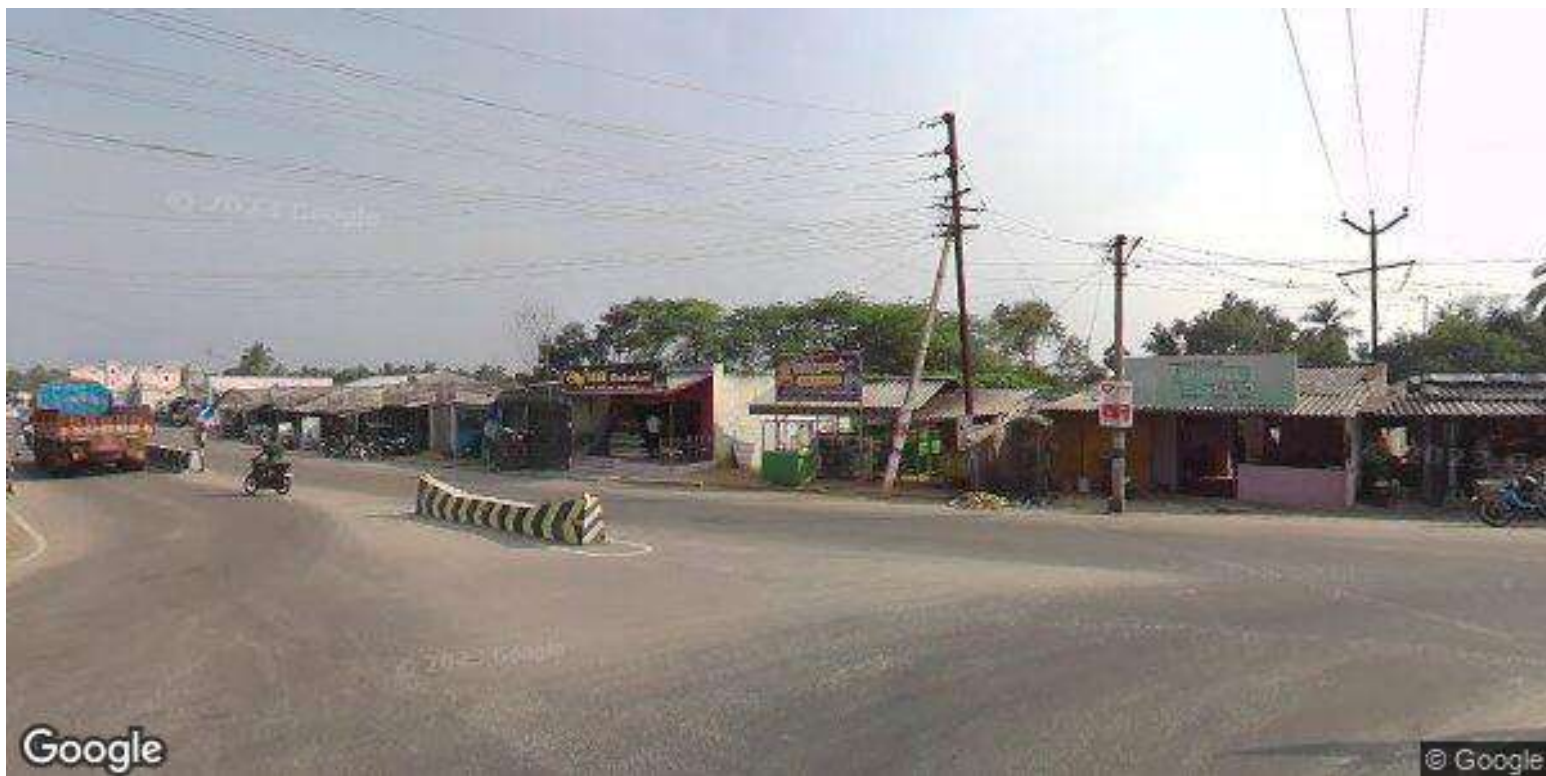
**Coordinates:** 11.04637, 77.73761

**Risk Type:** Roundabout

**Risk Level:** High

**Speed Limit:** 15 KM/Hr

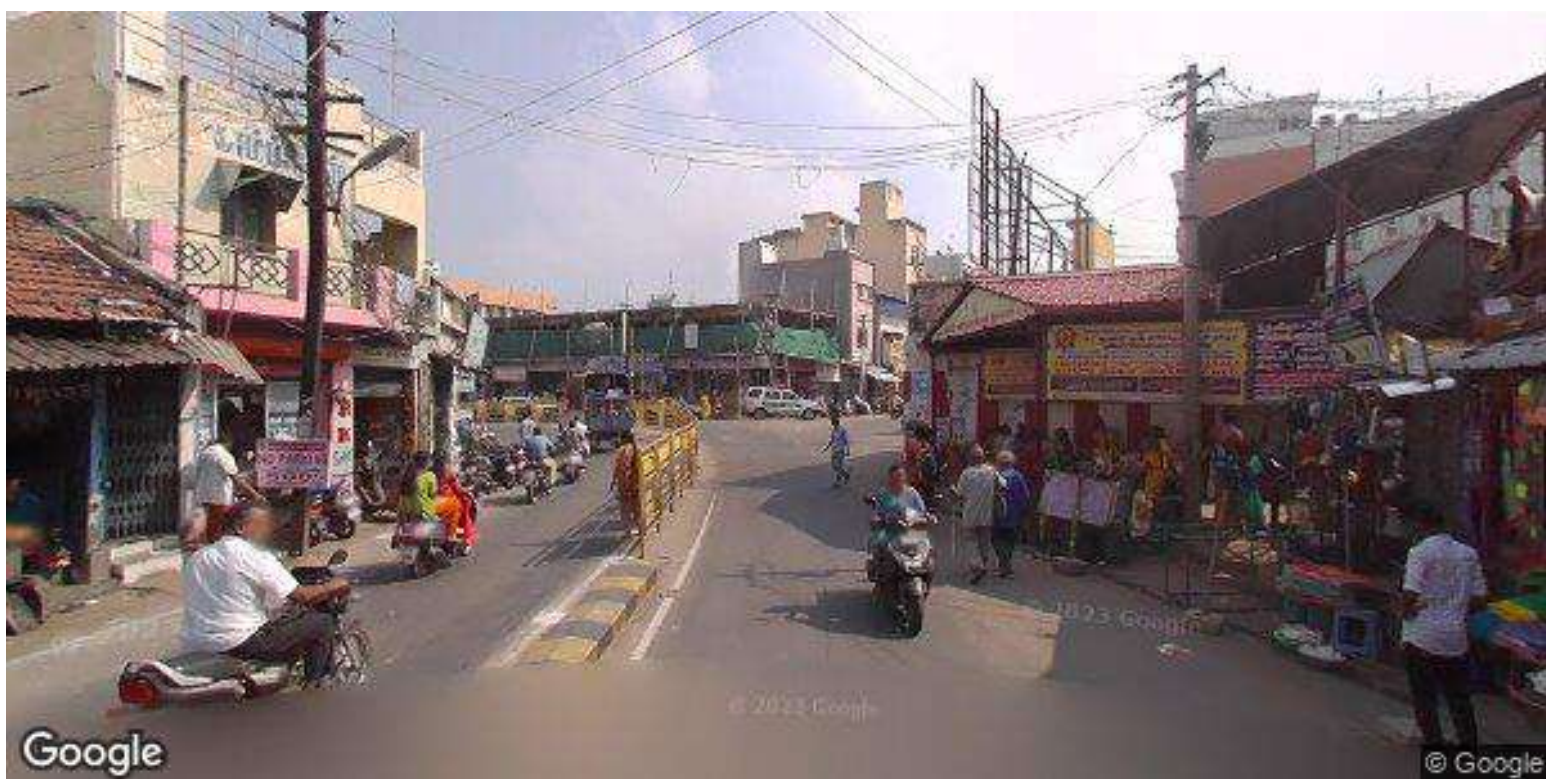
**Coordinates: 11.37857, 77.89473**

**Risk Type: Turn**

**Risk Level: Medium**

**Speed Limit: 30 KM/Hr**

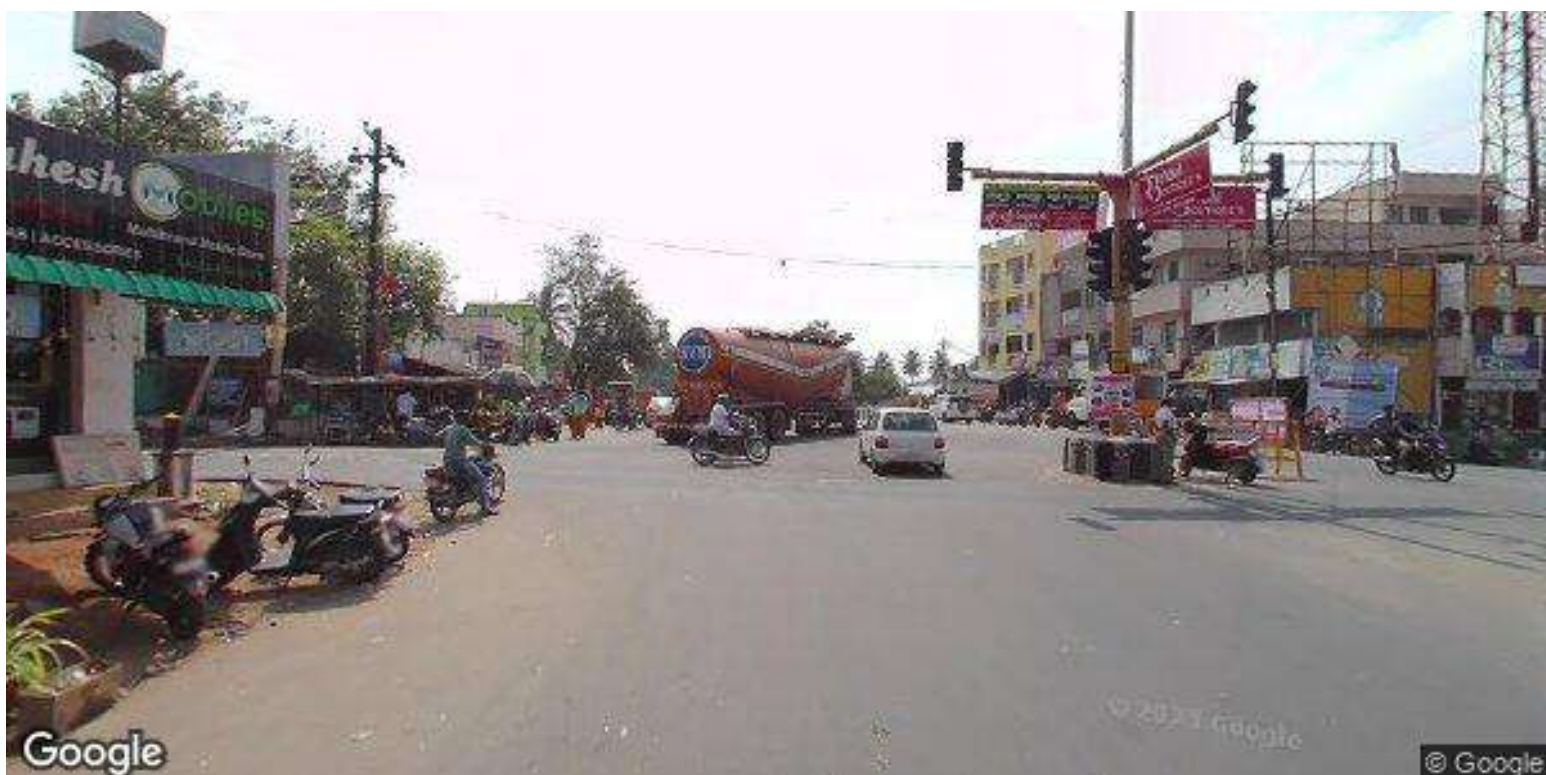
**Risk Type:** Turn  
**Risk Level:** High  
**Speed Limit:** 15 KM/Hr  
**Coordinates:** 11.36616, 77.88885

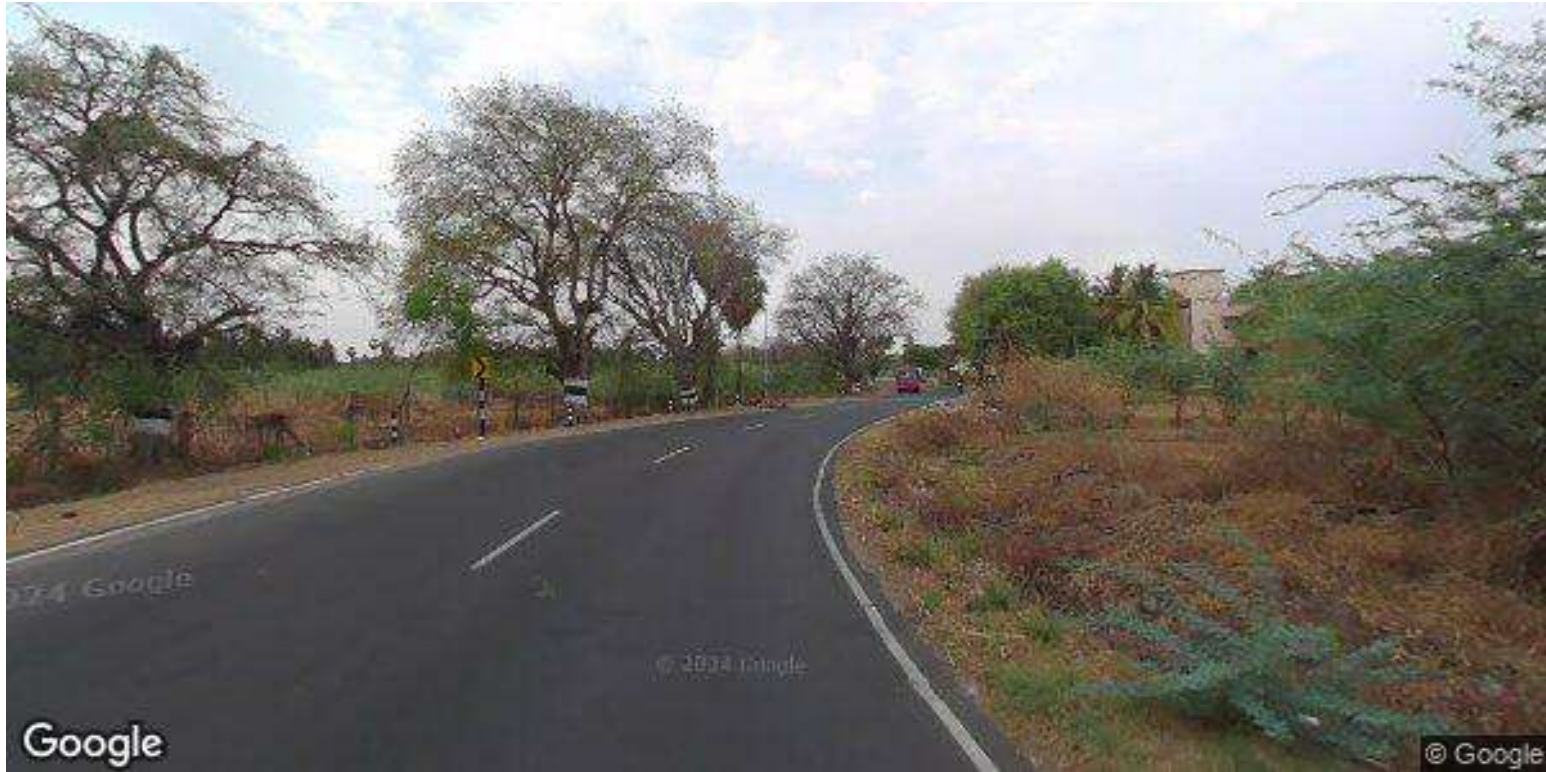
**Risk Type:** Turn  
**Risk Level:** Medium  
**Speed Limit:** 30 KM/Hr  
**Coordinates:** 11.34067, 77.86347

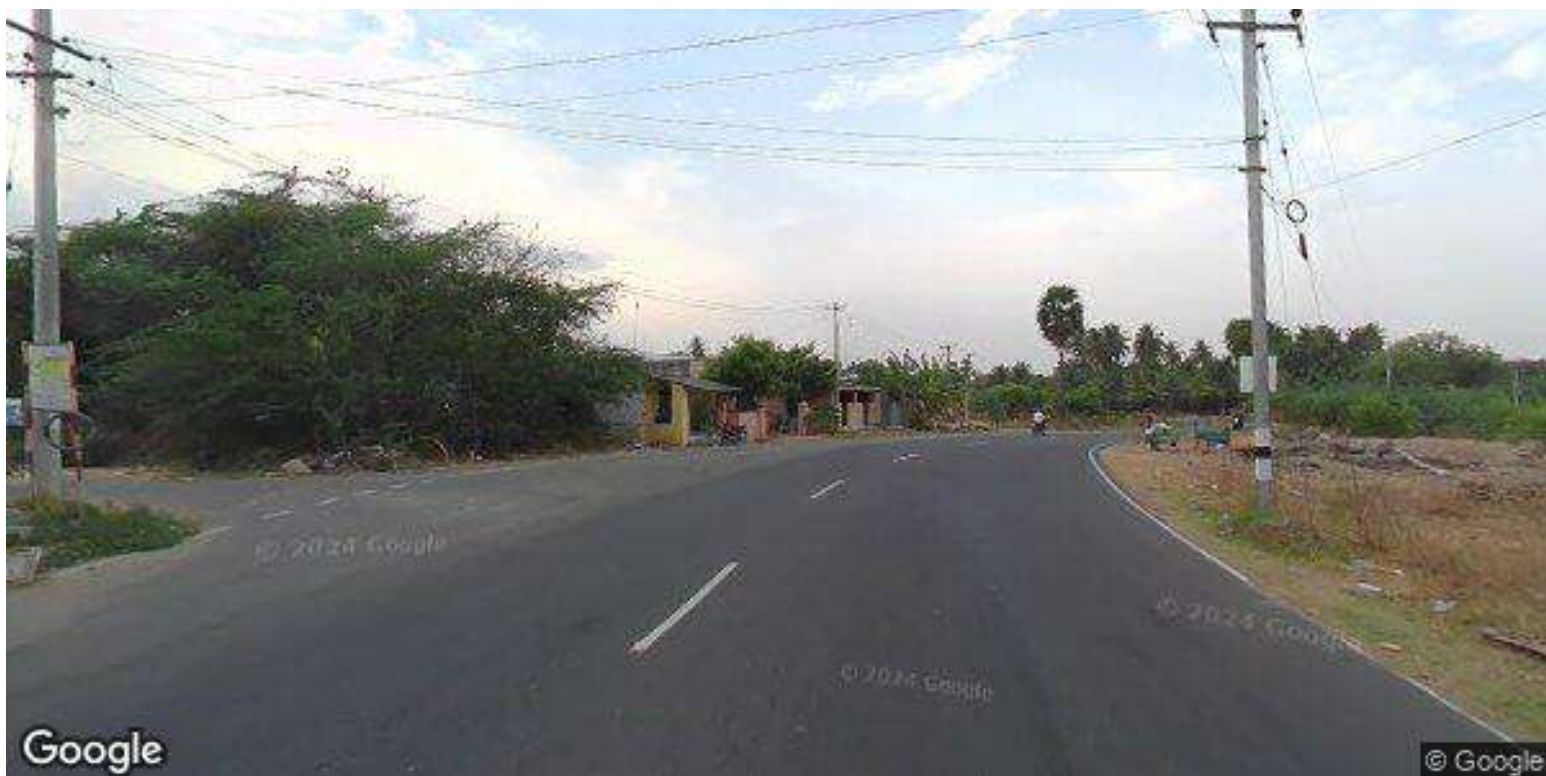
**Risk Type:** Turn  
**Risk Level:** Medium  
**Speed Limit:** 30 KM/Hr  
**Coordinates:** 11.33854, 77.86216

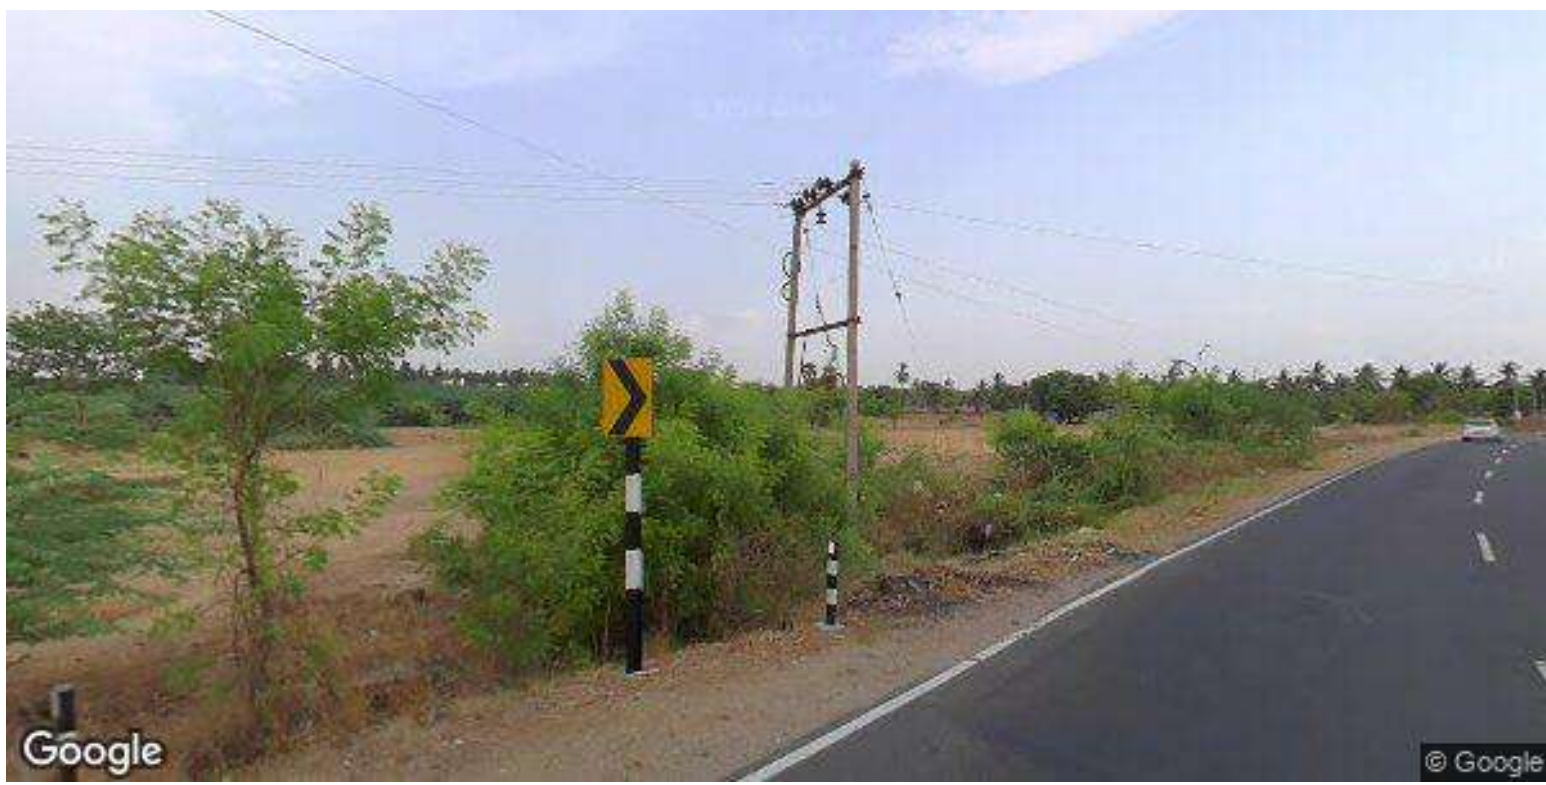
**Coordinates:** 11.33778, 77.86236

**Risk Type:** Turn

**Risk Level:** Medium

**Speed Limit:** 30 KM/Hr

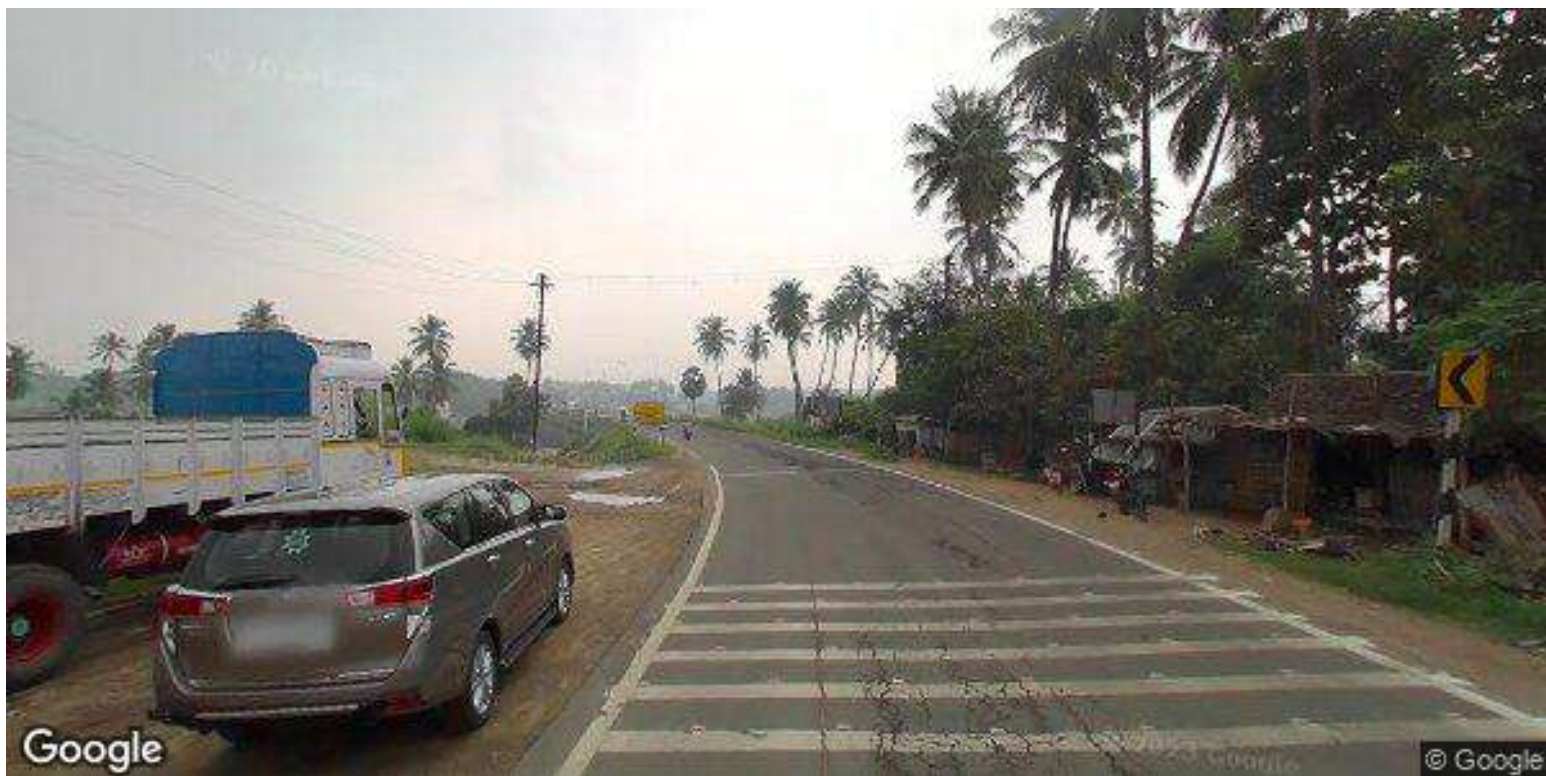
**Coordinates:** 11.30952, 77.77587

**Risk Type:** Turn

**Risk Level:** Medium

**Speed Limit:** 30 KM/Hr

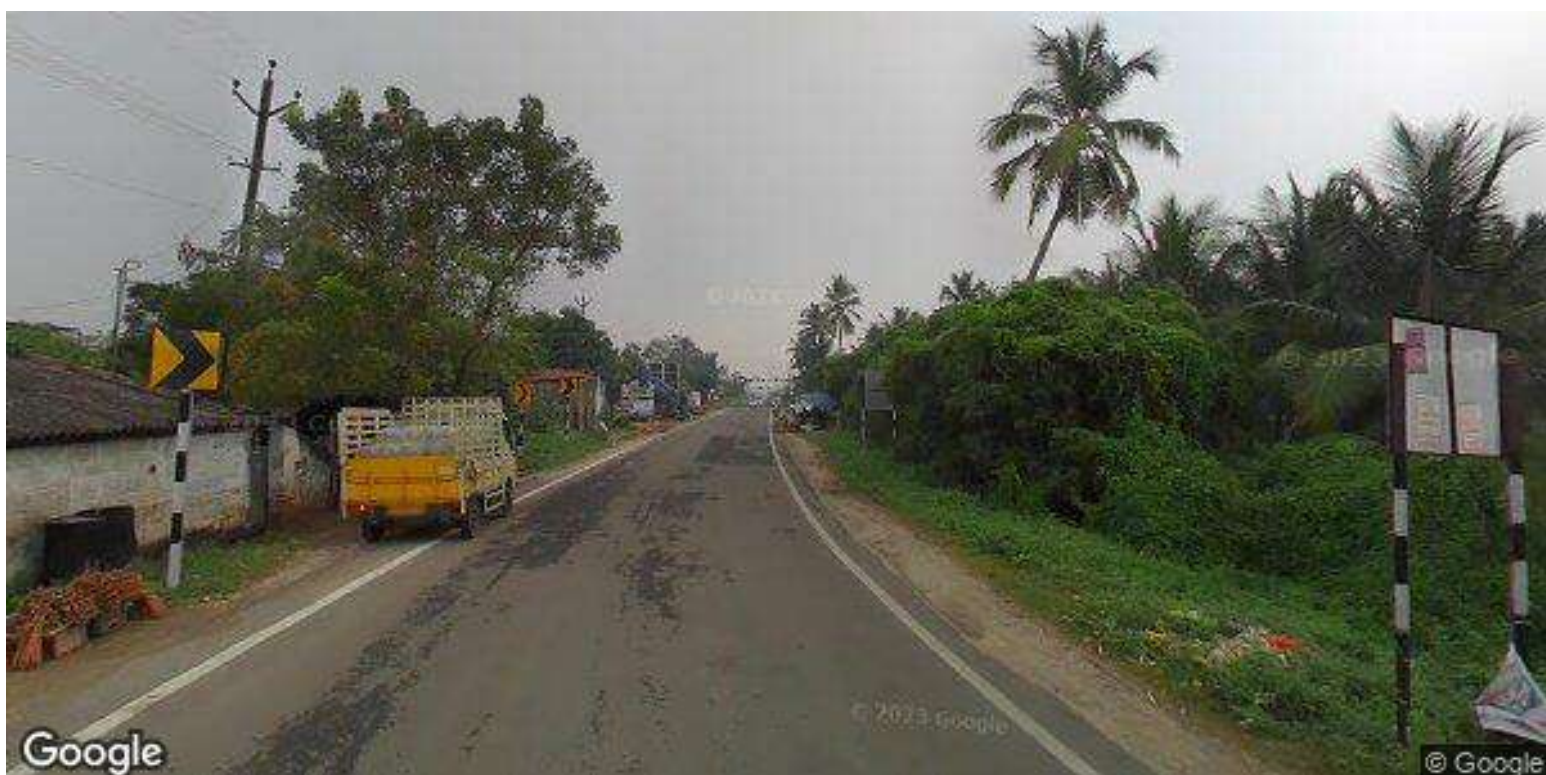
**Coordinates: 11.30973, 77.76712**

**Risk Type: Turn**

**Risk Level: Medium**

**Speed Limit: 30 KM/Hr**

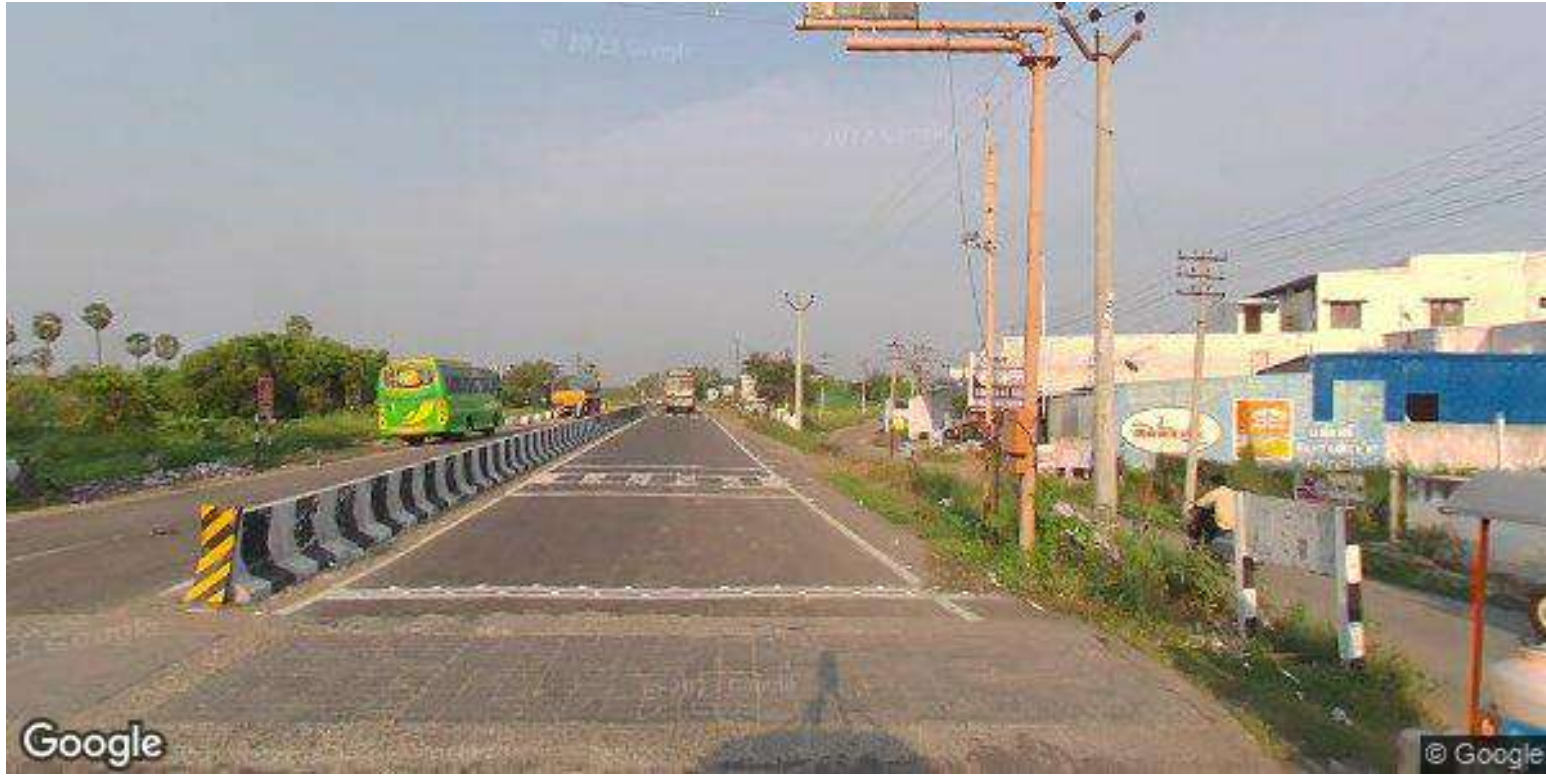
**Coordinates: 11.29908, 77.75818**

**Risk Type: Turn**

**Risk Level: High**

**Speed Limit: 15 KM/Hr**

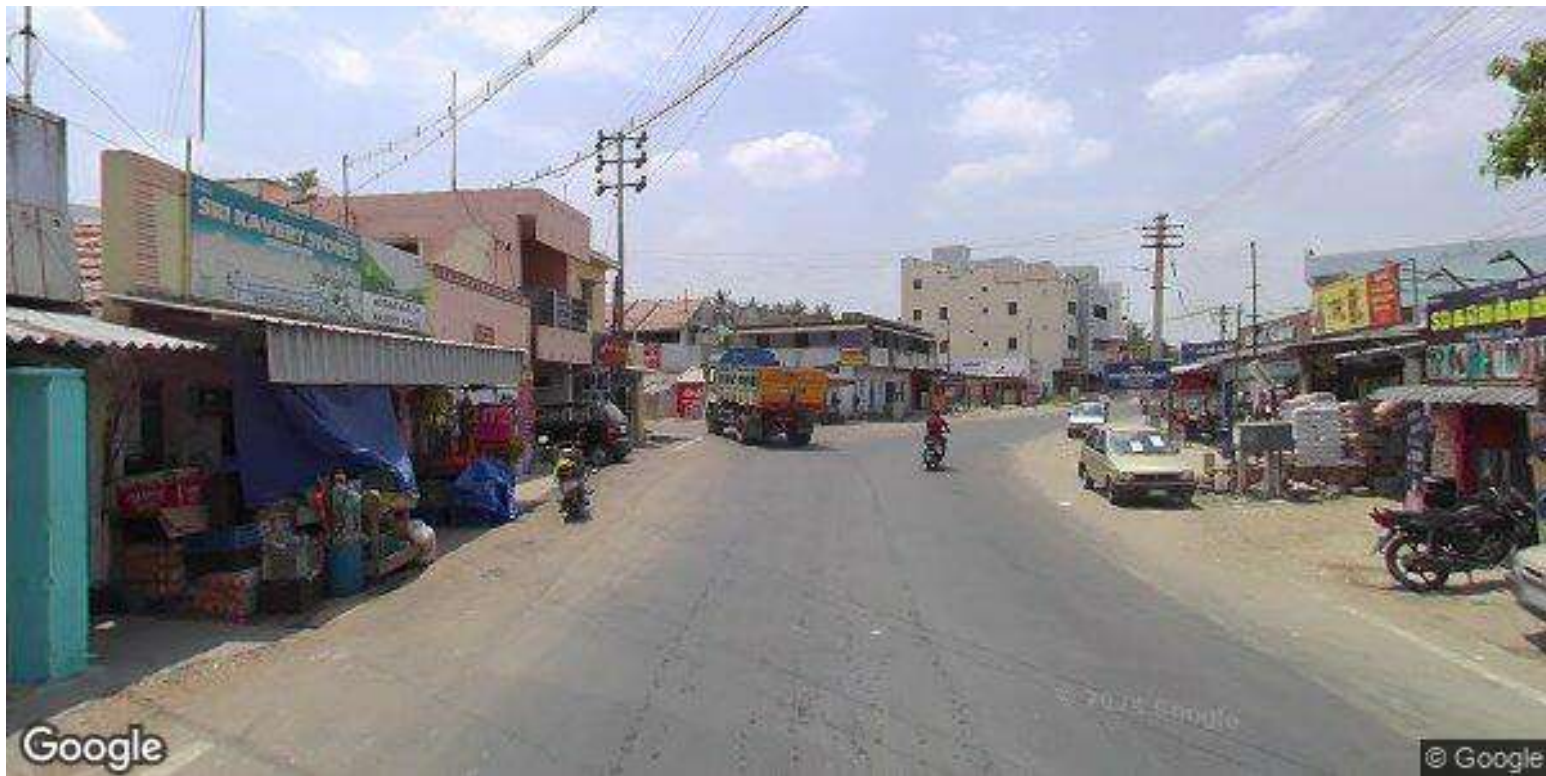
**Coordinates: 11.18935, 77.77078**

**Risk Type: Turn**

**Risk Level: Medium**

**Speed Limit: 30 KM/Hr**

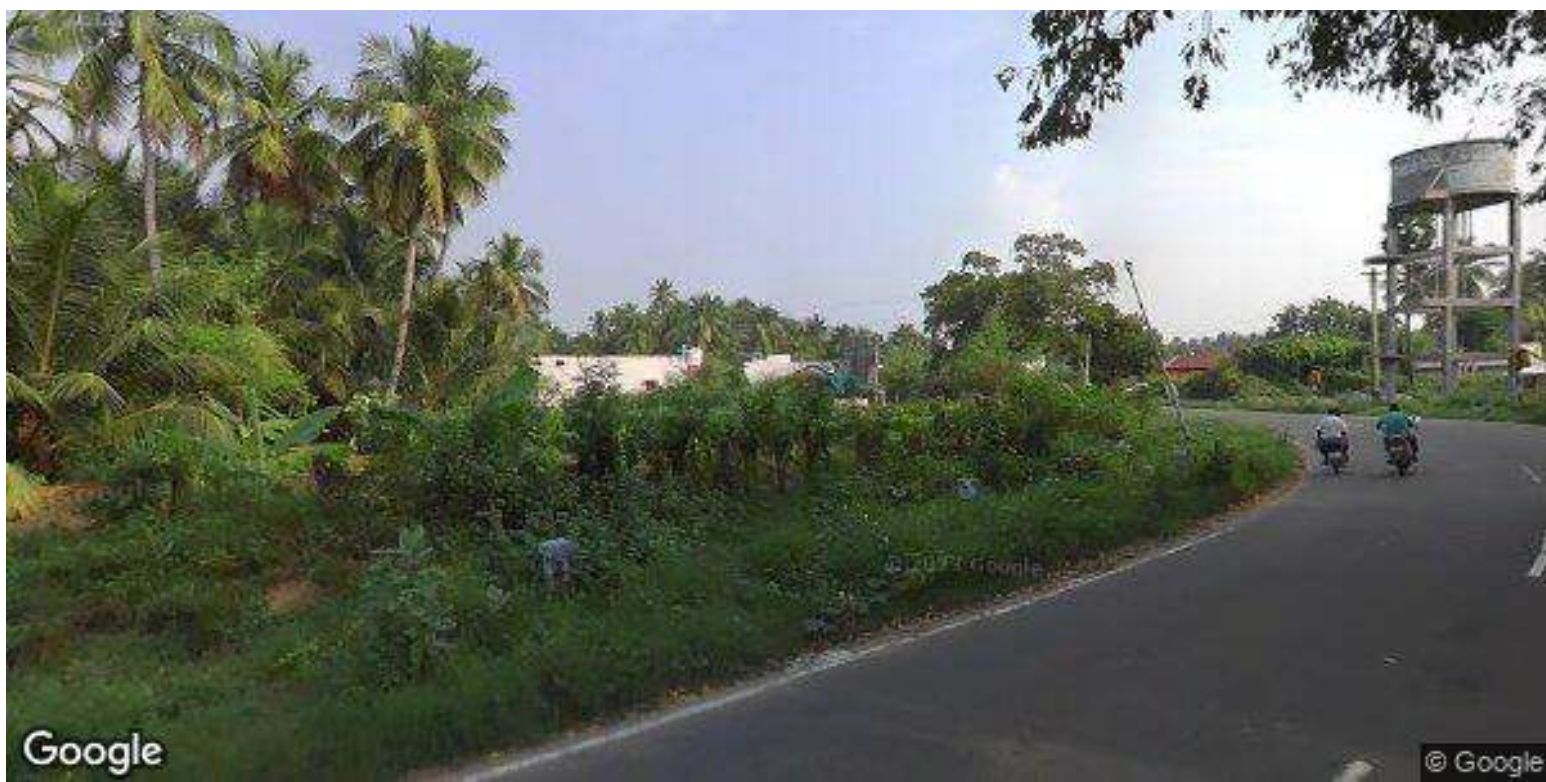
**Coordinates:** 11.16434, 77.77360

**Risk Type:** Turn

**Risk Level:** High

**Speed Limit:** 15 KM/Hr

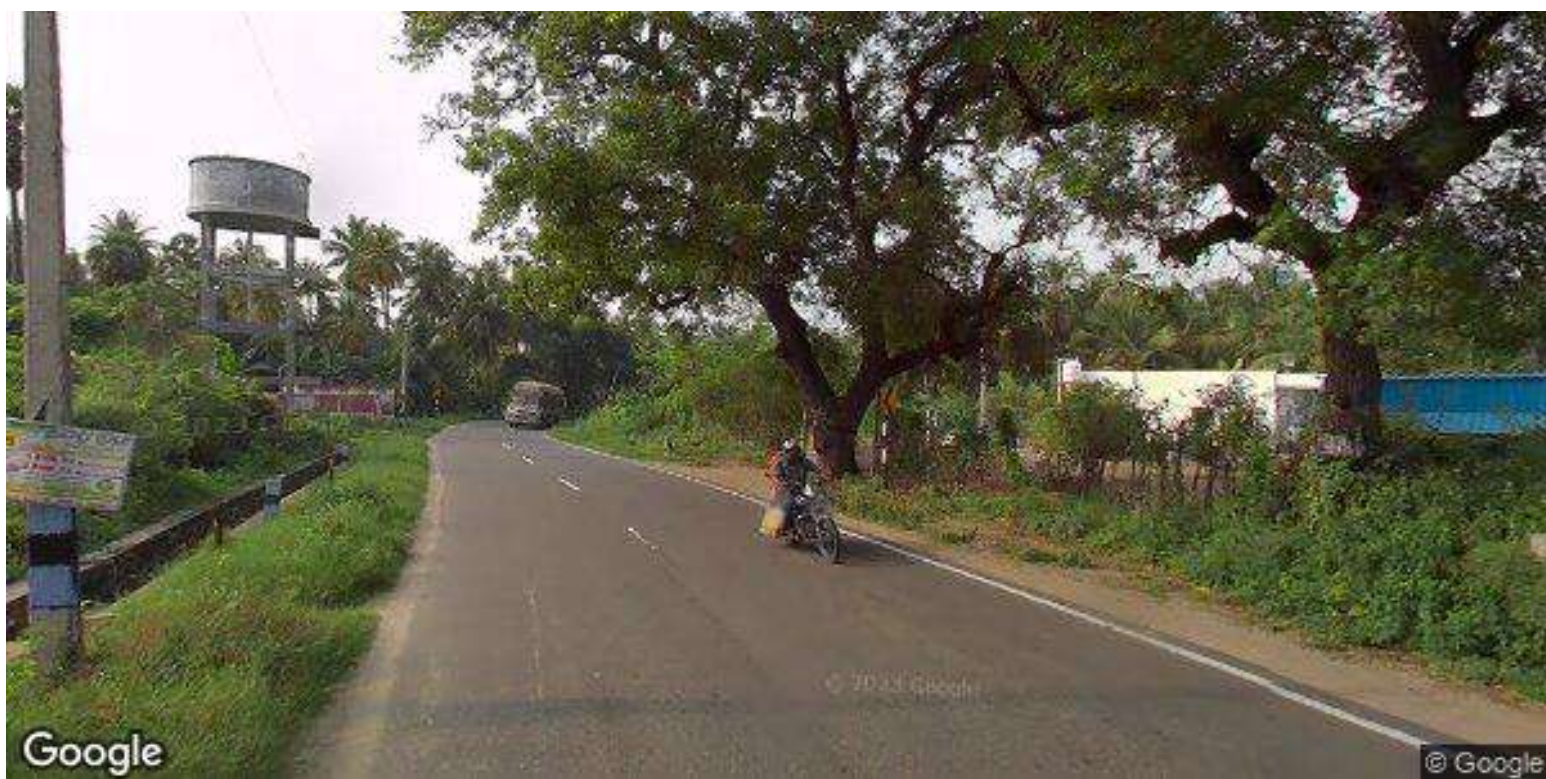
**Coordinates:** 11.16375, 77.77424

**Risk Type:** Turn

**Risk Level:** Medium

**Speed Limit:** 30 KM/Hr

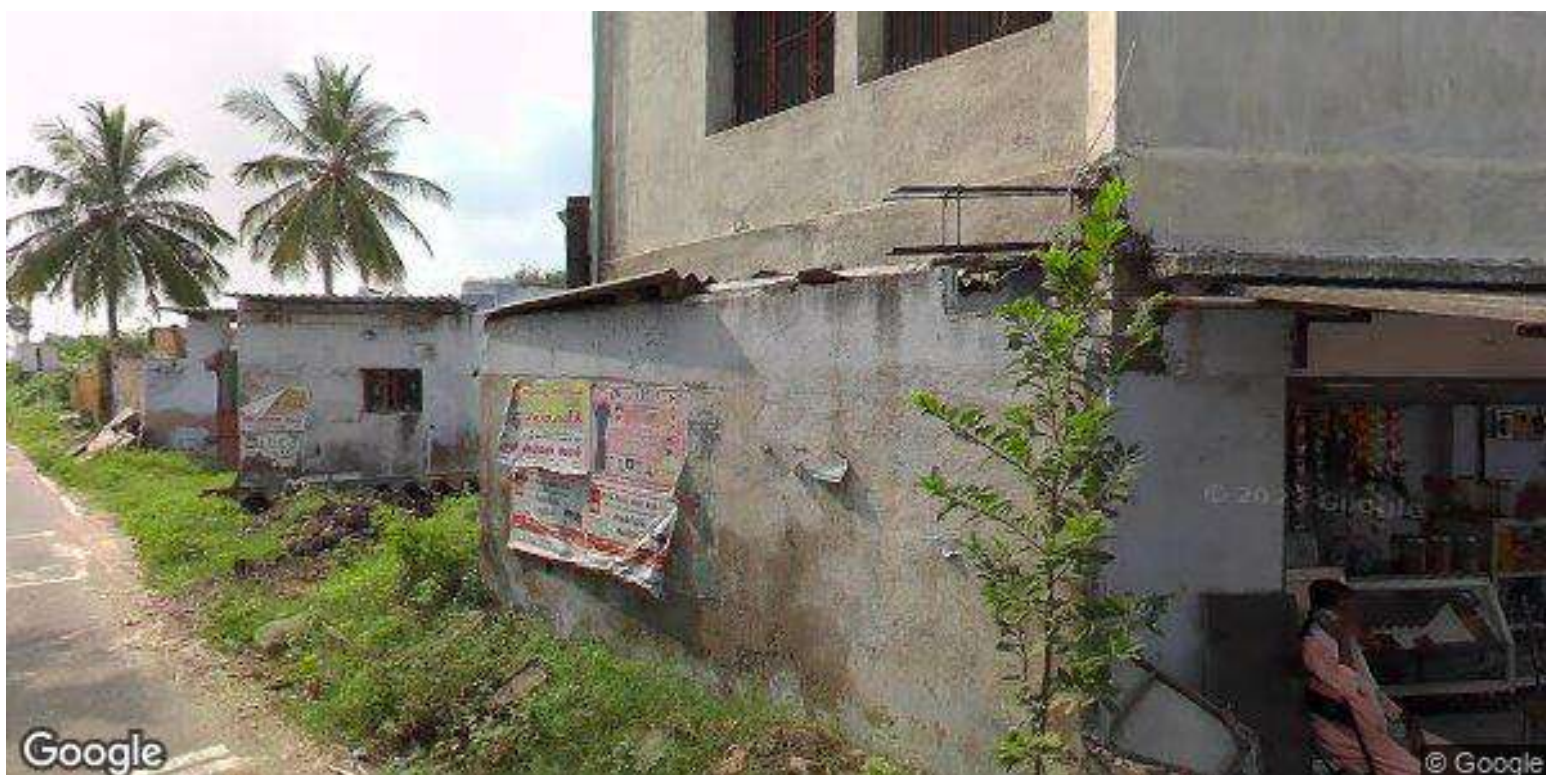
**Coordinates:** 11.13659, 77.76519

**Risk Type:** Turn

**Risk Level:** Medium

**Speed Limit:** 30 KM/Hr

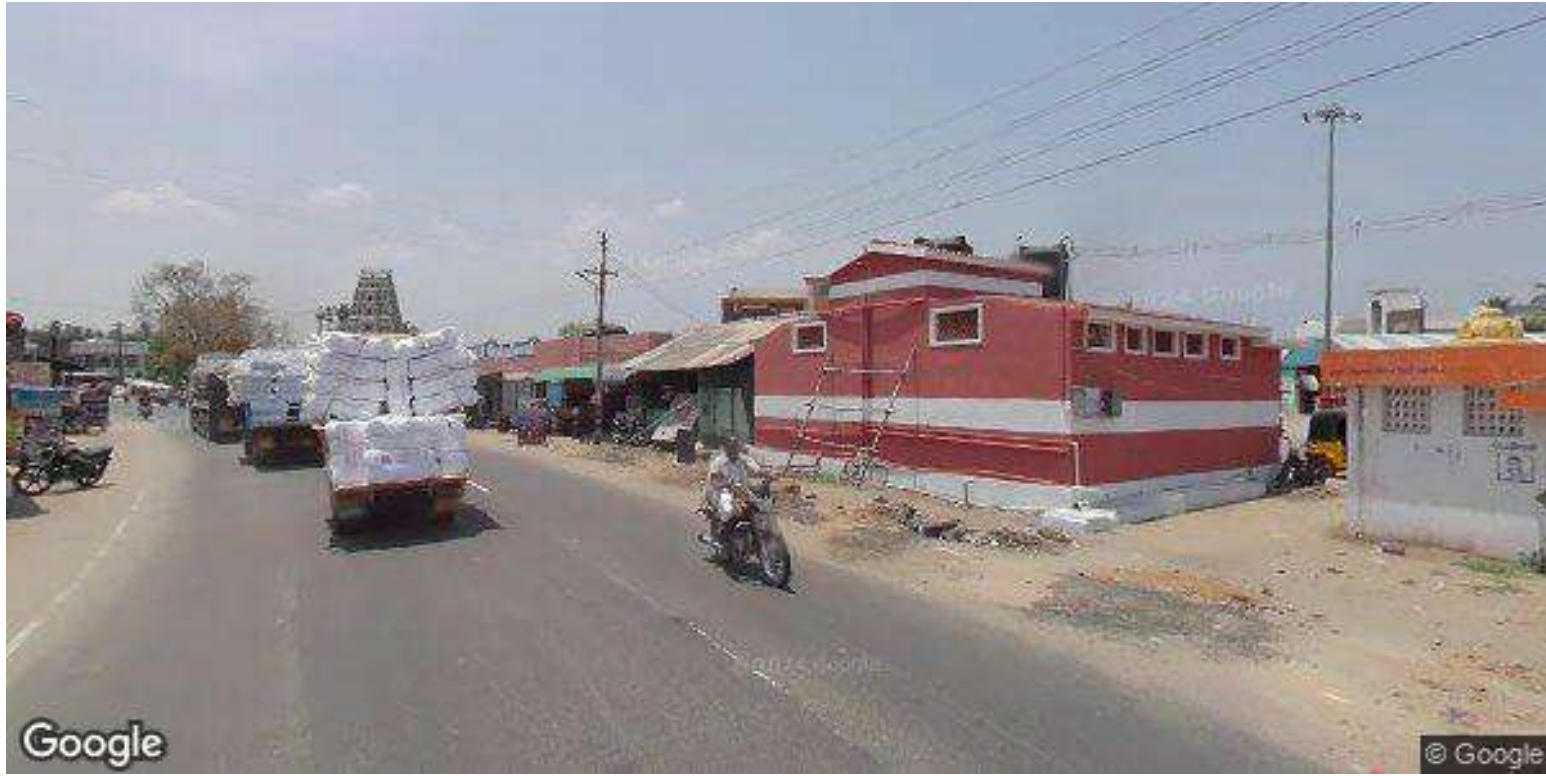
**Coordinates:** 11.04614, 77.73704

**Risk Type:** Turn

**Risk Level:** Medium

**Speed Limit:** 30 KM/Hr

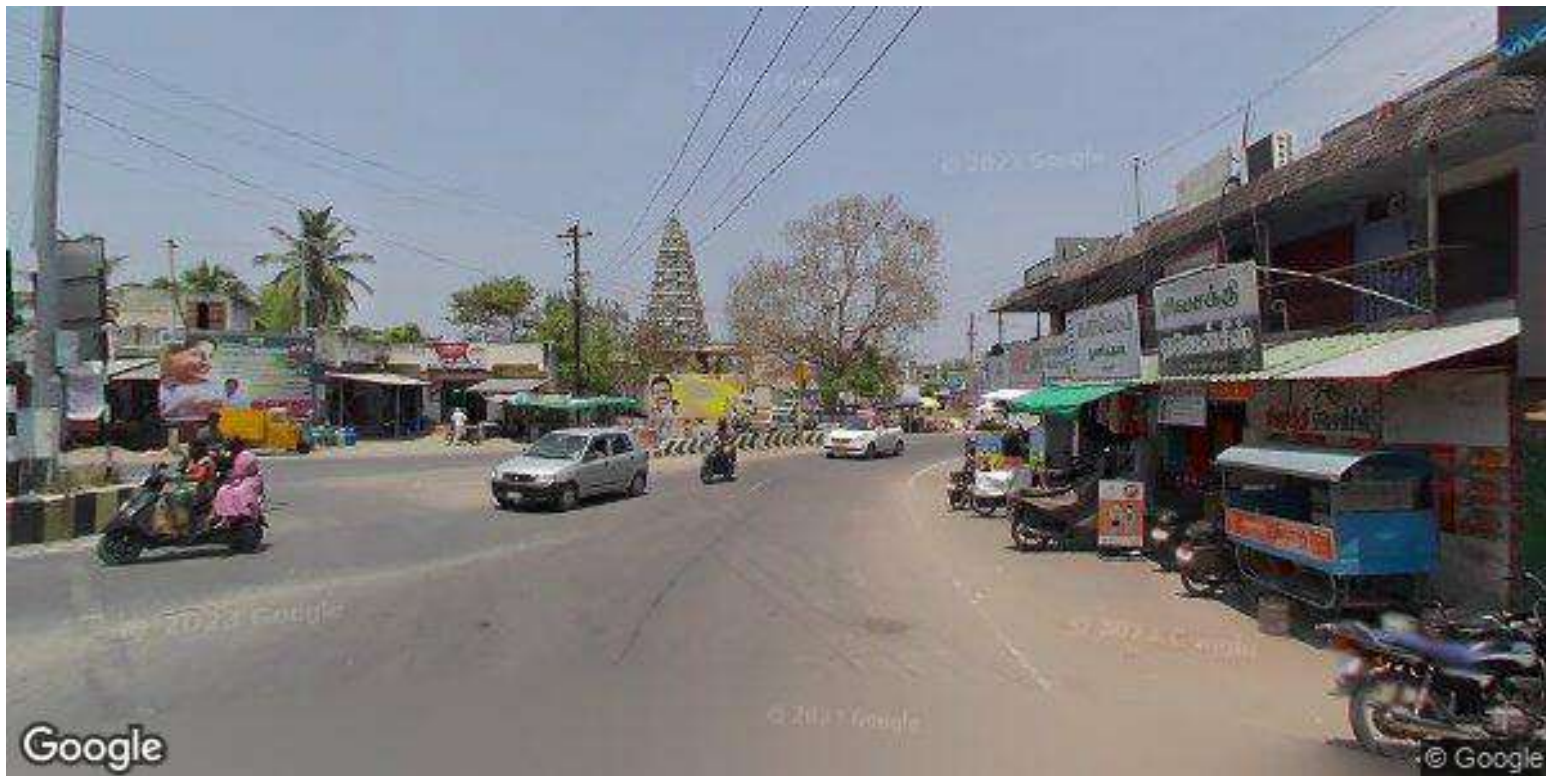
**Coordinates:** 11.04505, 77.73623

**Risk Type:** Turn

**Risk Level:** Medium

**Speed Limit:** 30 KM/Hr

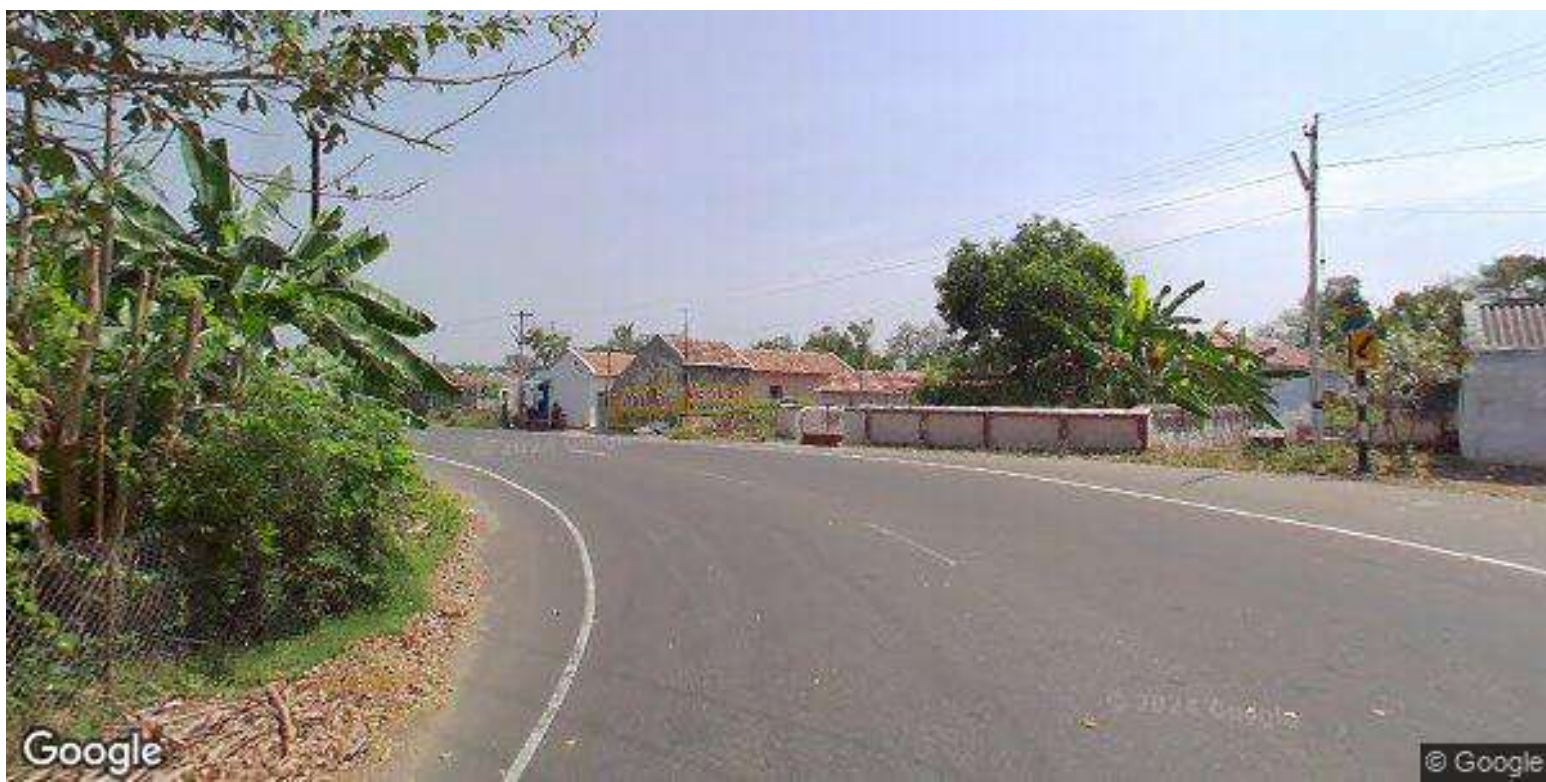
**Coordinates:** 10.99023, 77.72506

**Risk Type:** Turn

**Risk Level:** High

**Speed Limit:** 15 KM/Hr

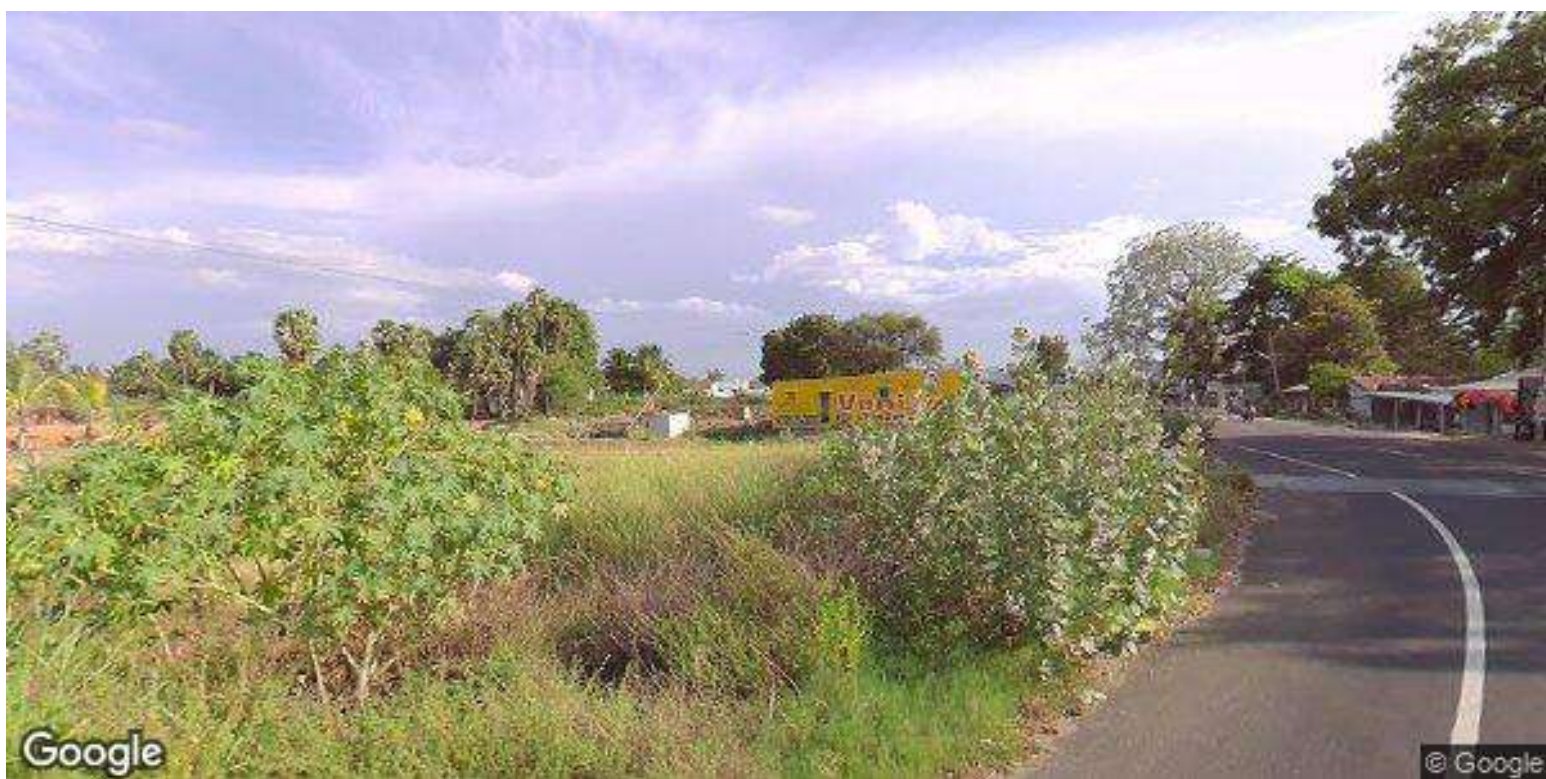
**Coordinates:** 10.98970, 77.72385

**Risk Type:** Turn

**Risk Level:** High

**Speed Limit:** 15 KM/Hr

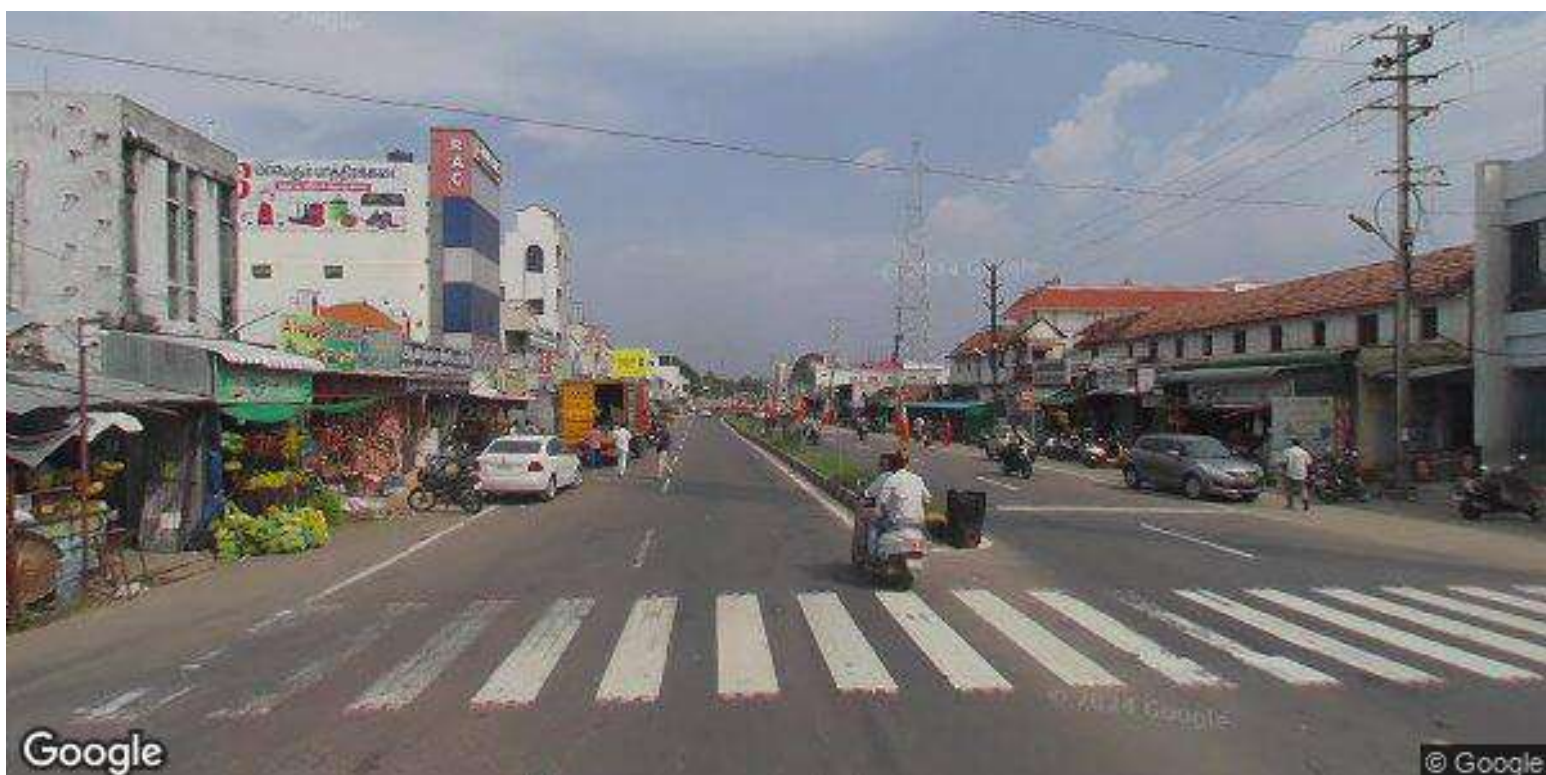
**Risk Type:** Blind Spot  
**Risk Level:** Blind Spot  
**Speed Limit:** 10 KM/Hr  
**Coordinates:** 10.94597, 77.71319

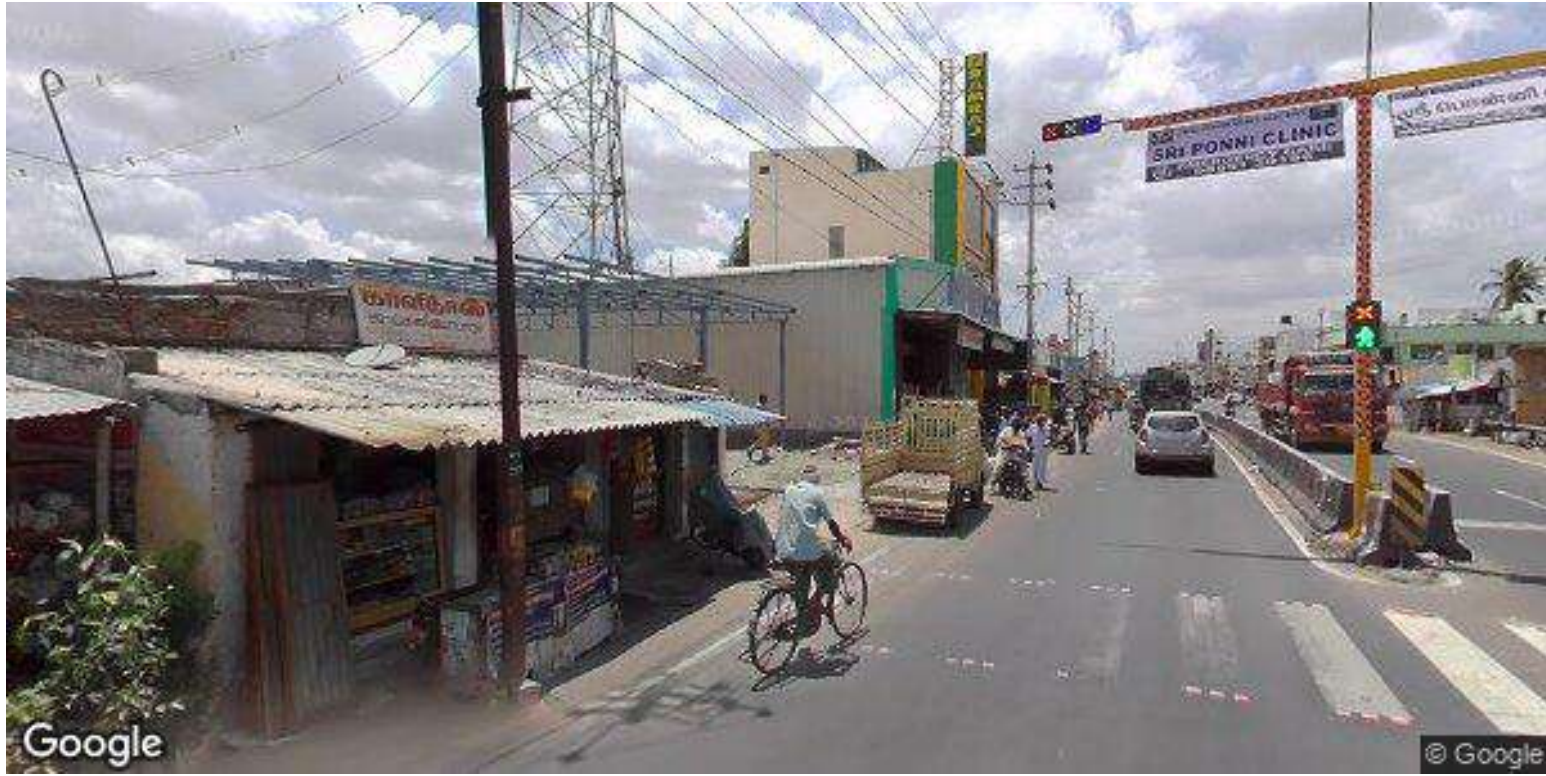
**Risk Type:** Turn  
**Risk Level:** High  
**Speed Limit:** 15 KM/Hr  
**Coordinates:** 10.94563, 77.71574
