## JOURNEY RISK MANAGEMENT (JRM) STUDY

### Salem Terminal to AMMAN AGENCIES MULANUR

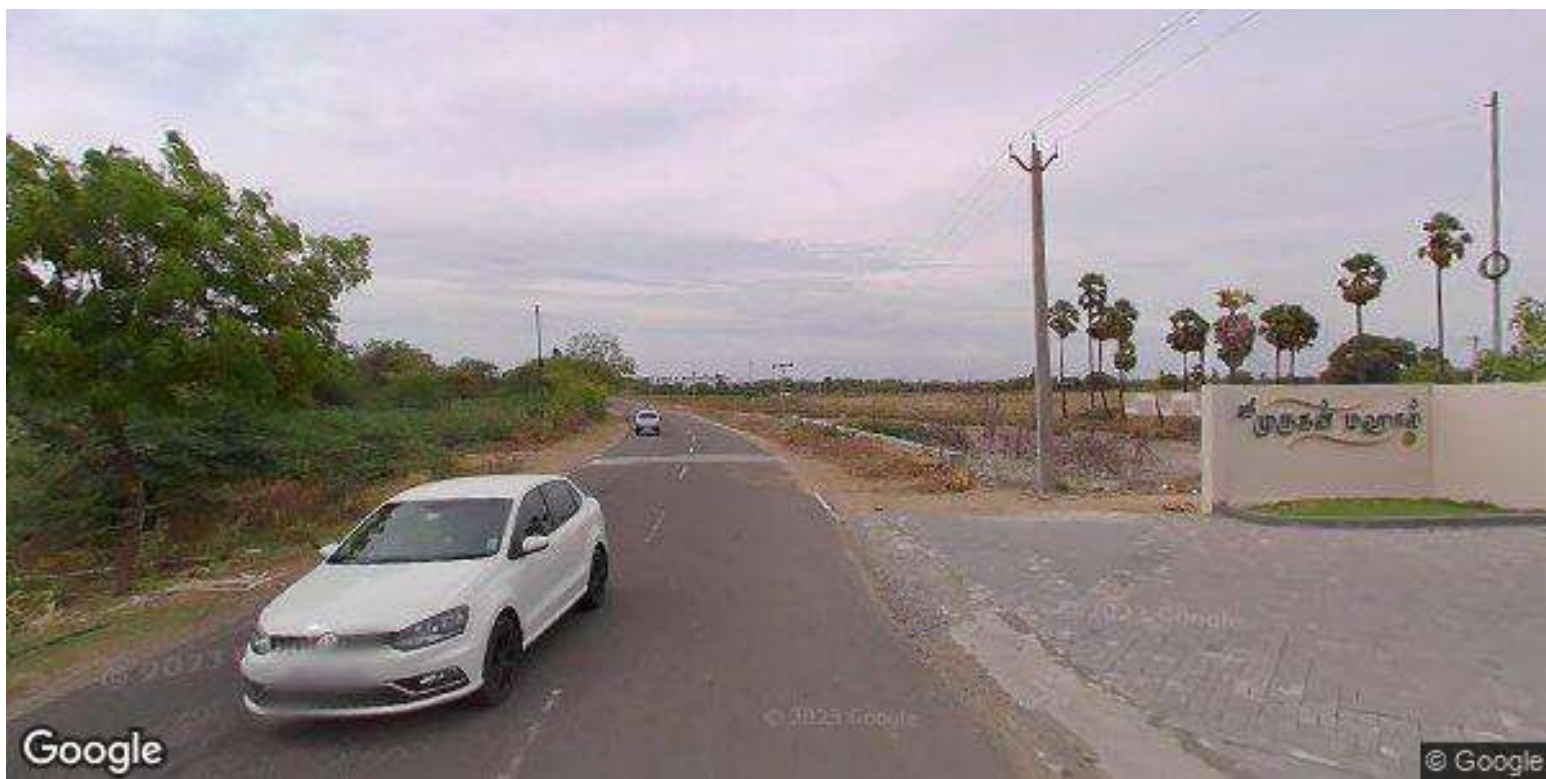
**Risk Type:** Turn  
**Risk Level:** Medium  
**Speed Limit:** 30 KM/Hr  
**Coordinates:** 10.92228, 77.72392

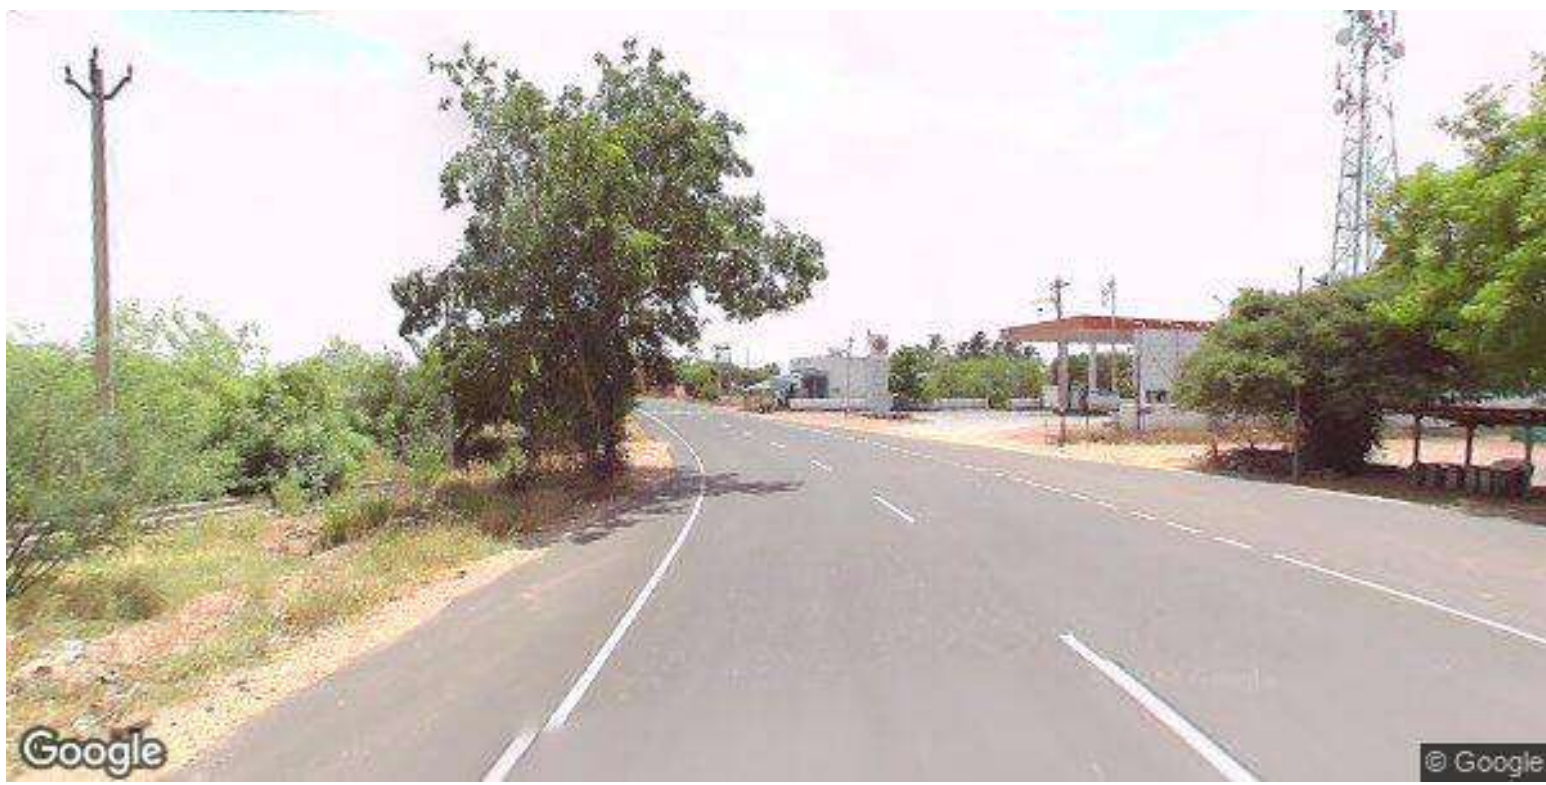
**Coordinates:** 10.86278, 77.72143

**Risk Type:** Turn

**Risk Level:** Medium

**Speed Limit:** 30 KM/Hr

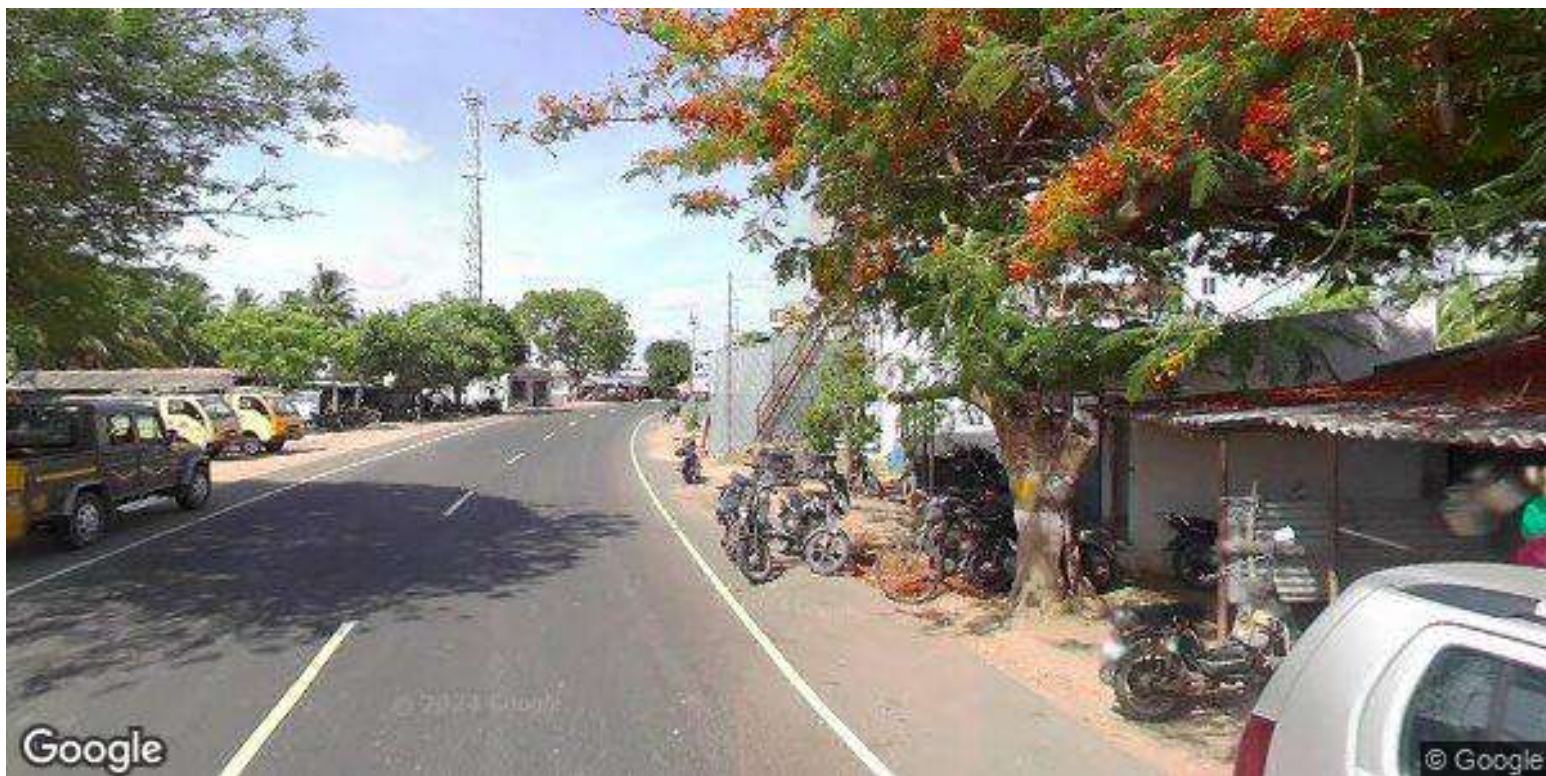
**Coordinates:** 10.86158, 77.71764

**Risk Type:** Turn

**Risk Level:** Medium

**Speed Limit:** 30 KM/Hr

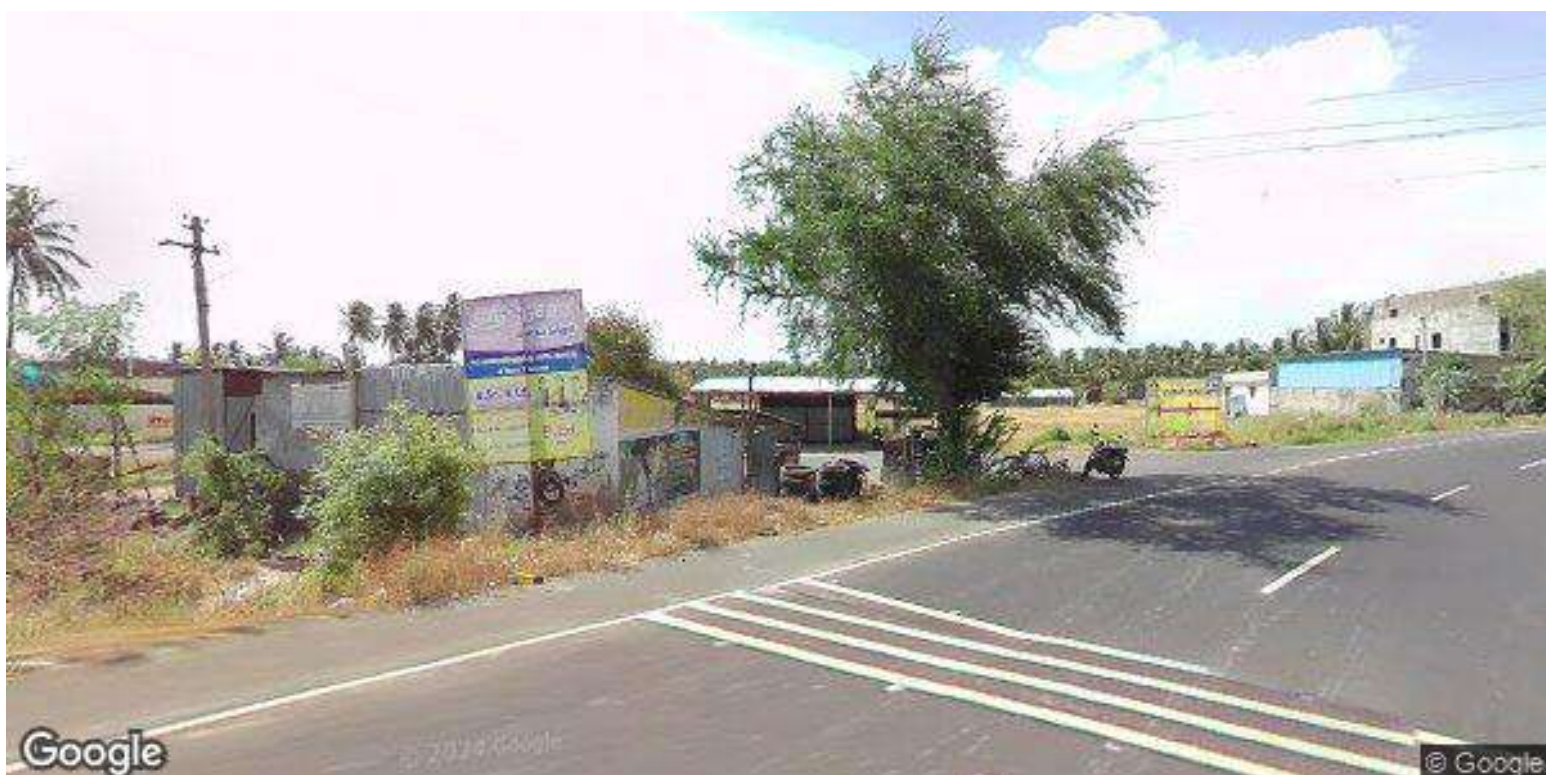
**Risk Type:** Turn  
**Risk Level:** Medium  
**Speed Limit:** 30 KM/Hr  
**Coordinates:** 10.86118, 77.71726

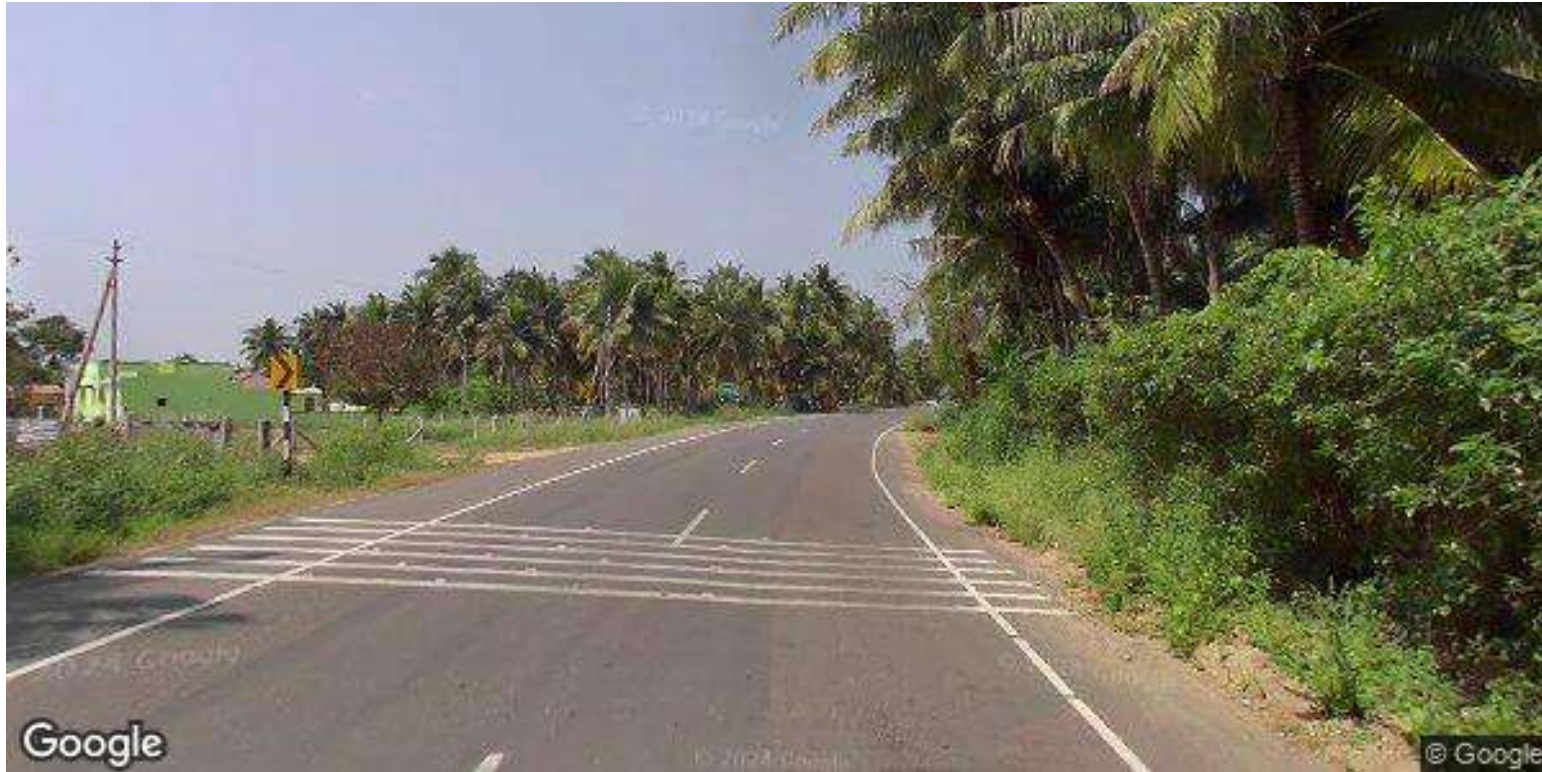
**Risk Type:** Turn  
**Risk Level:** Medium  
**Speed Limit:** 30 KM/Hr  
**Coordinates:** 10.85613, 77.71791

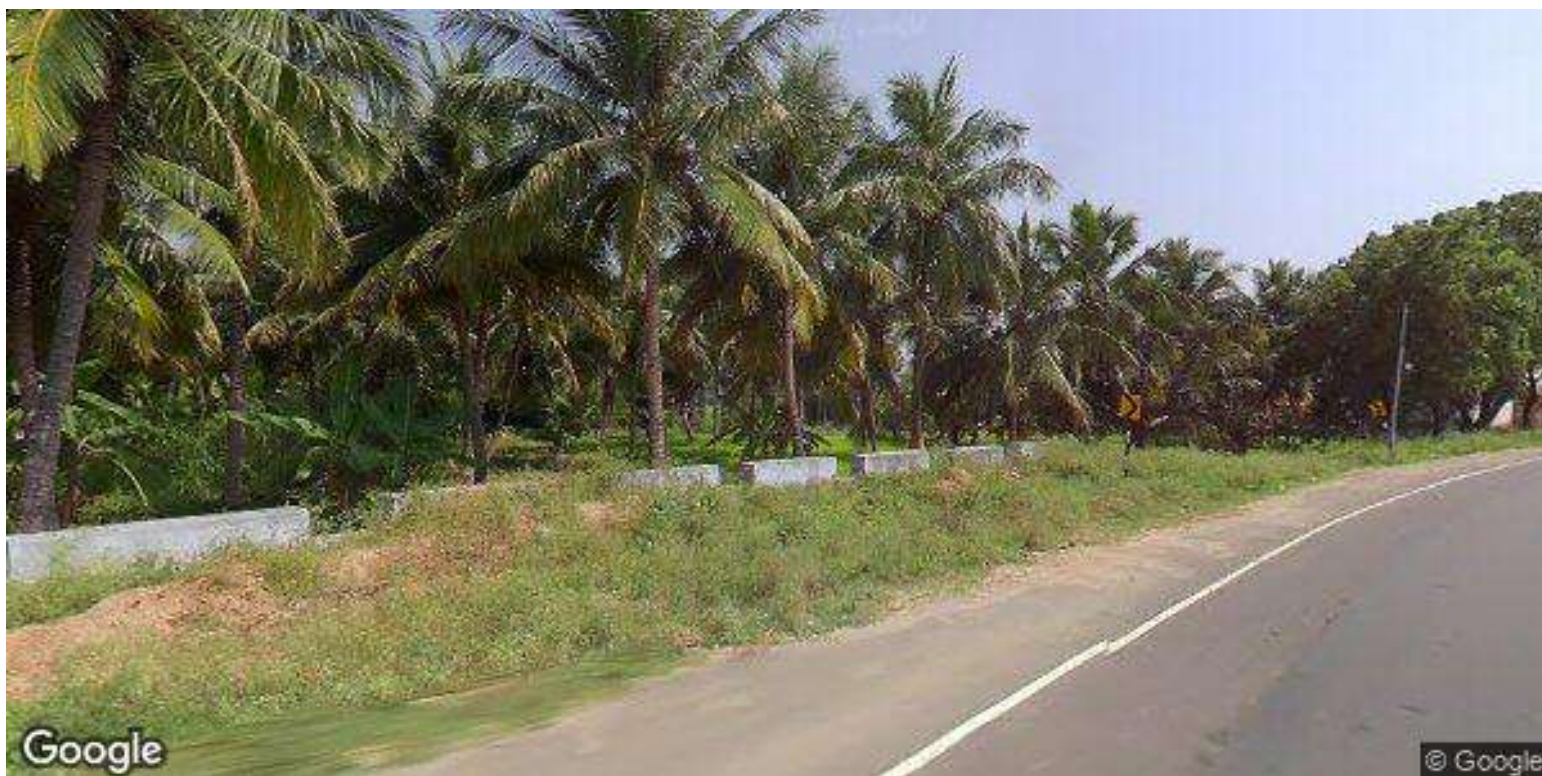
**Risk Type:** Turn  
**Risk Level:** Medium  
**Speed Limit:** 30 KM/Hr  
**Coordinates:** 10.85462, 77.72064

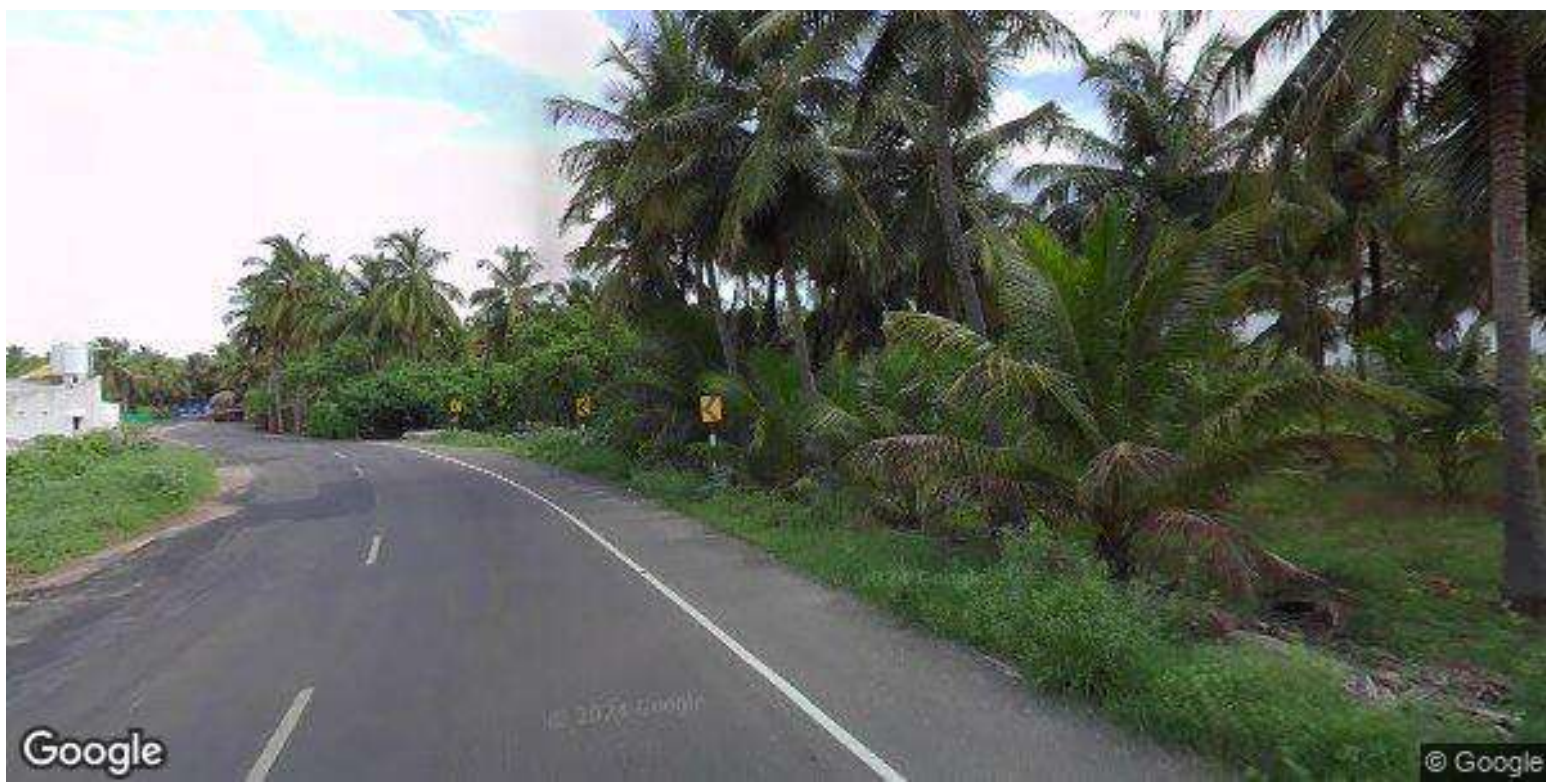
**Coordinates:** 10.84875, 77.72076

**Risk Type:** Turn

**Risk Level:** Medium

**Speed Limit:** 30 KM/Hr

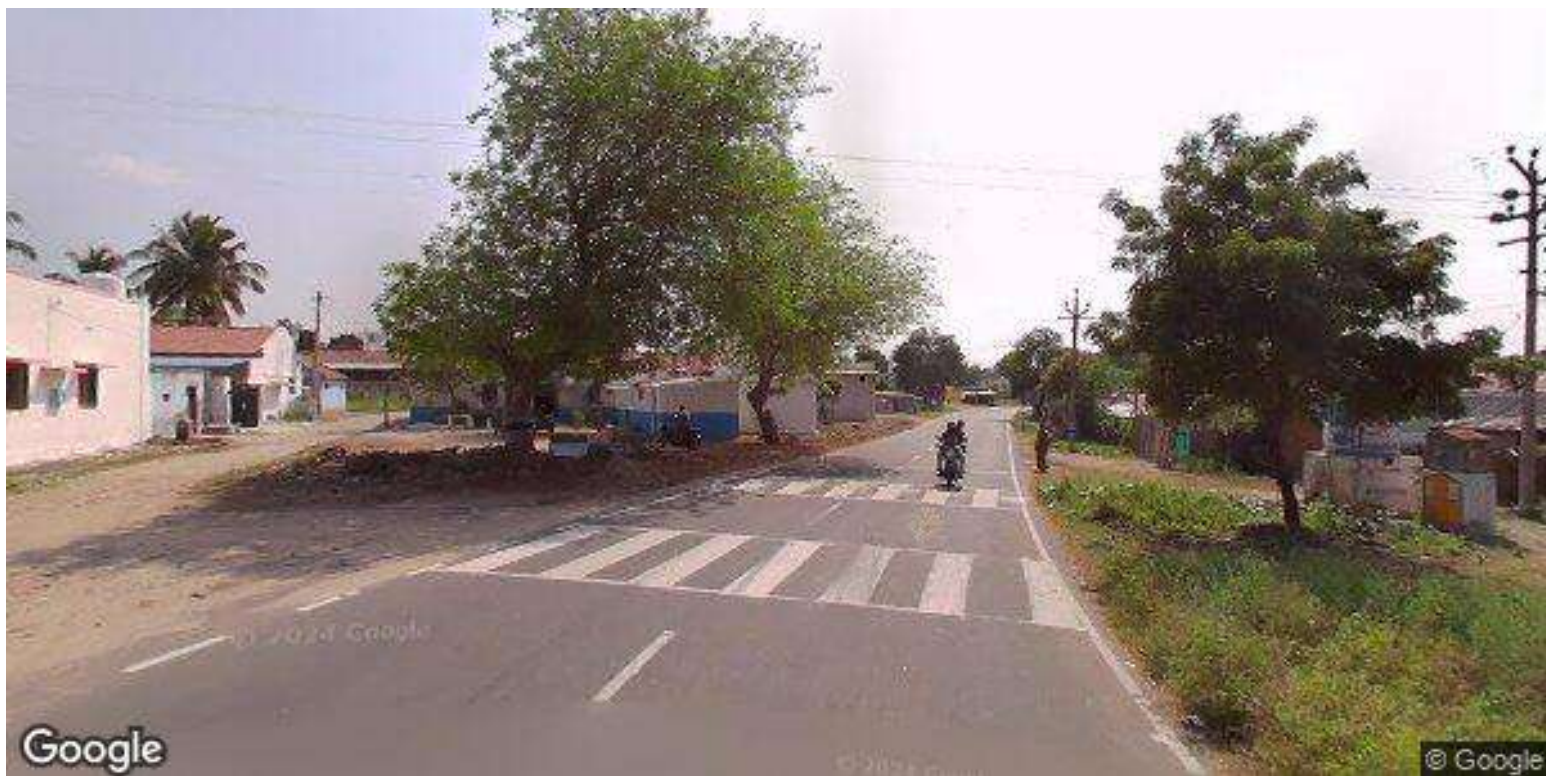
**Coordinates:** 10.82285, 77.72027

**Risk Type:** Turn

**Risk Level:** Medium

**Speed Limit:** 30 KM/Hr

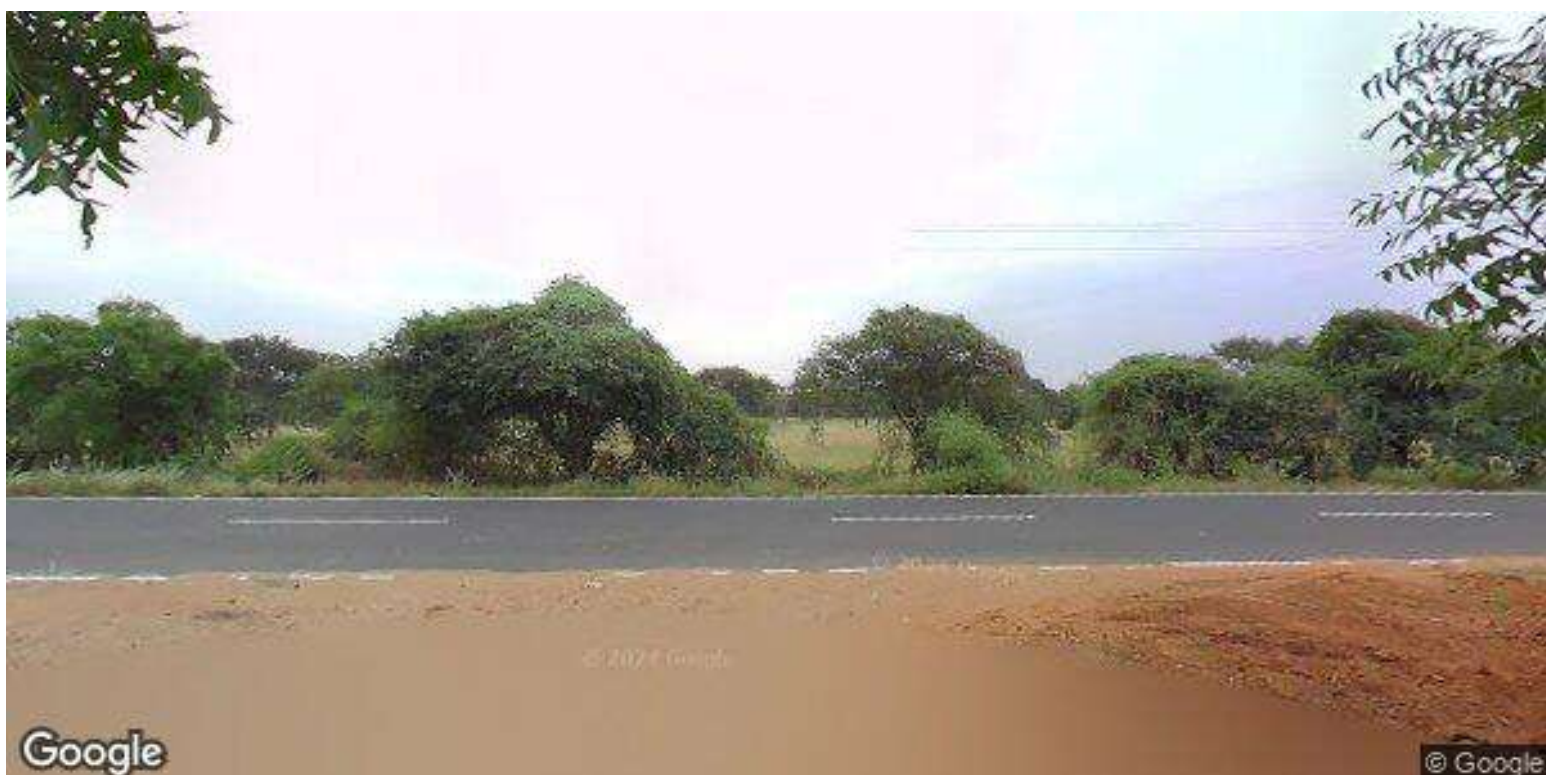
**Risk Type:** Turn  
**Risk Level:** High  
**Speed Limit:** 15 KM/Hr  
**Coordinates:** 10.81280, 77.71753

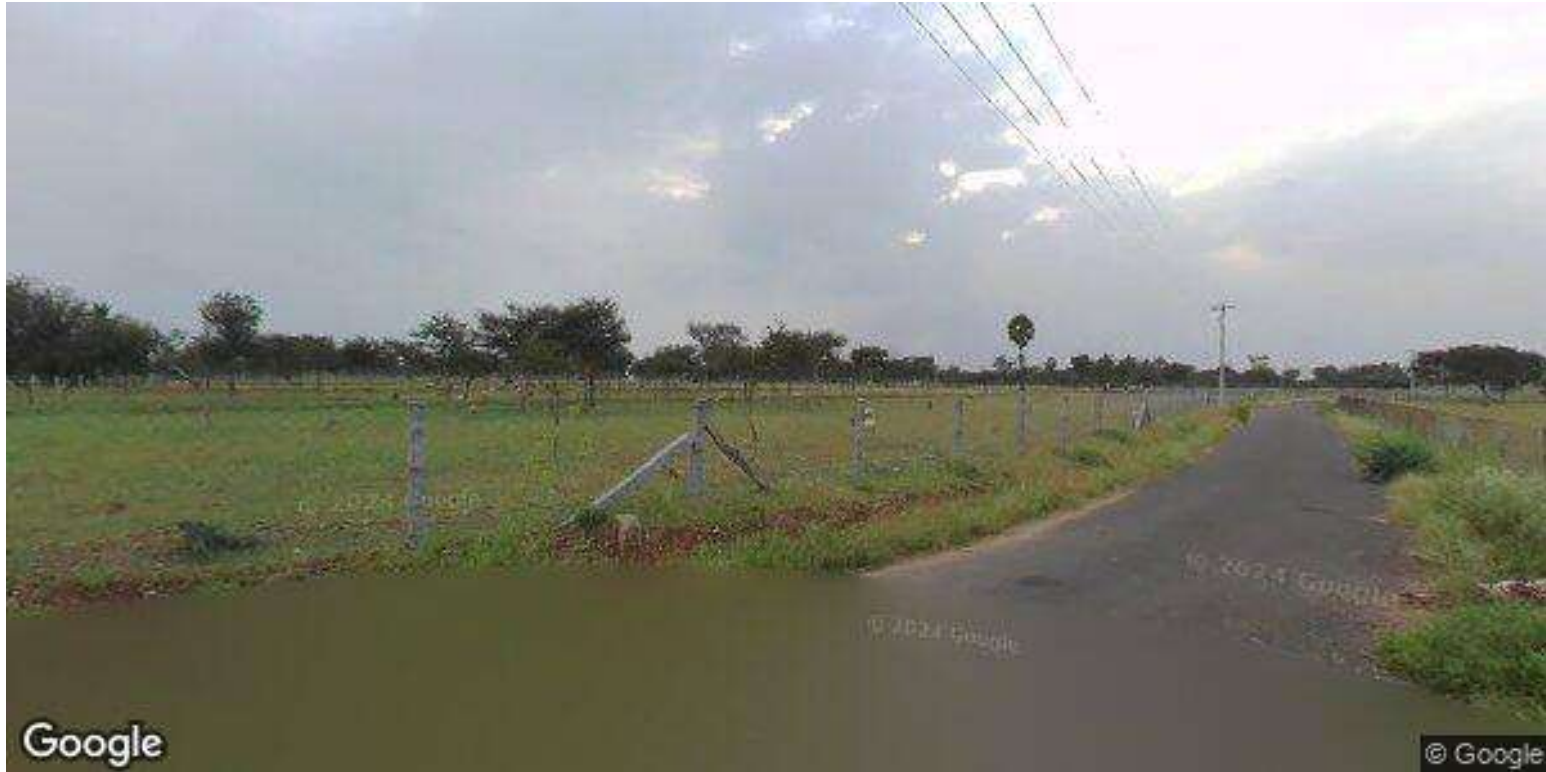
**Risk Type:** Turn  
**Risk Level:** Medium  
**Speed Limit:** 30 KM/Hr  
**Coordinates:** 10.81256, 77.72035

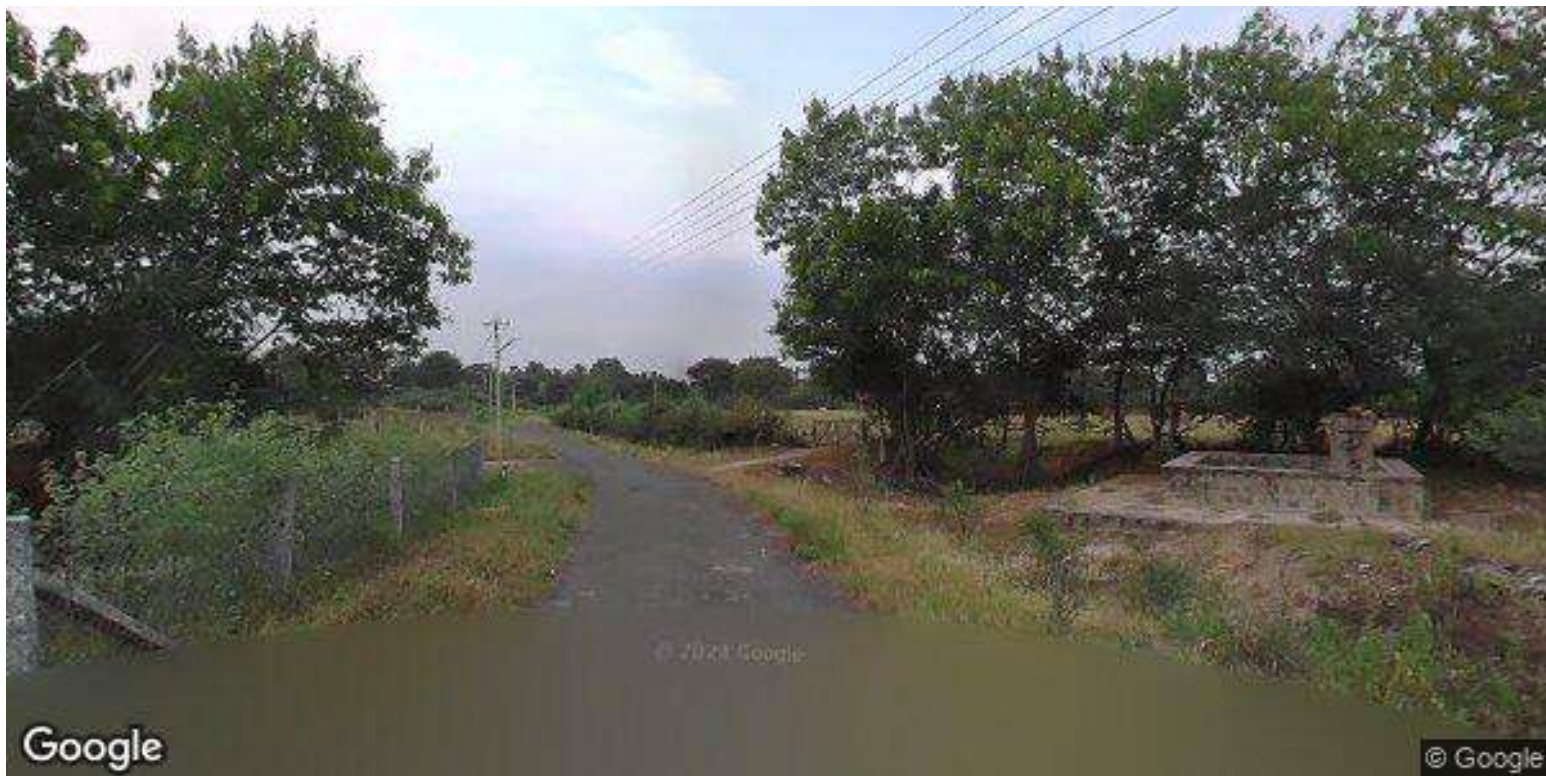
**Risk Type:** Turn  
**Risk Level:** Medium  
**Speed Limit:** 30 KM/Hr  
**Coordinates:** 10.80911, 77.72390

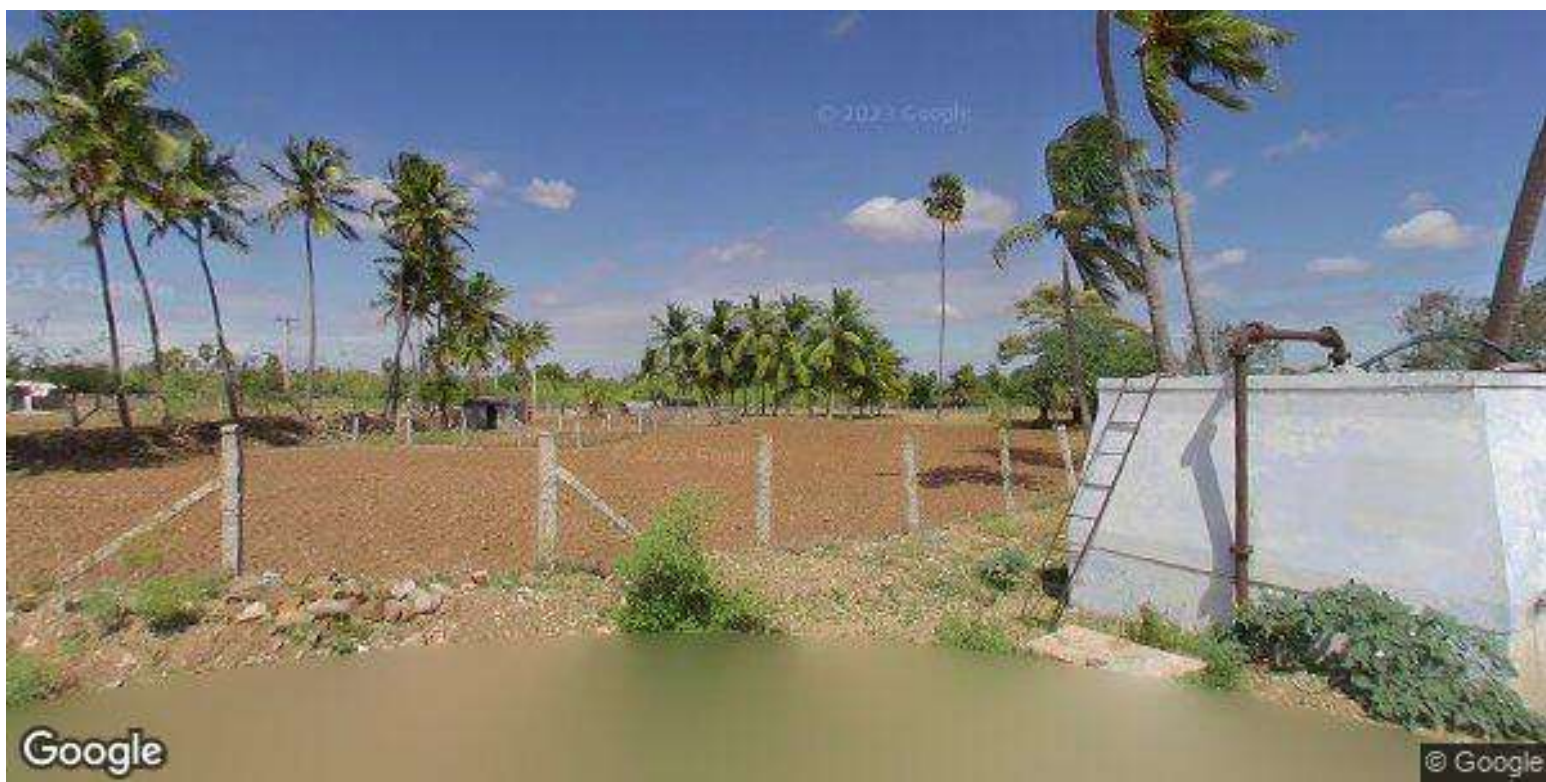
**Coordinates:** 10.80865, 77.72416

**Risk Type:** Turn

**Risk Level:** High

**Speed Limit:** 15 KM/Hr

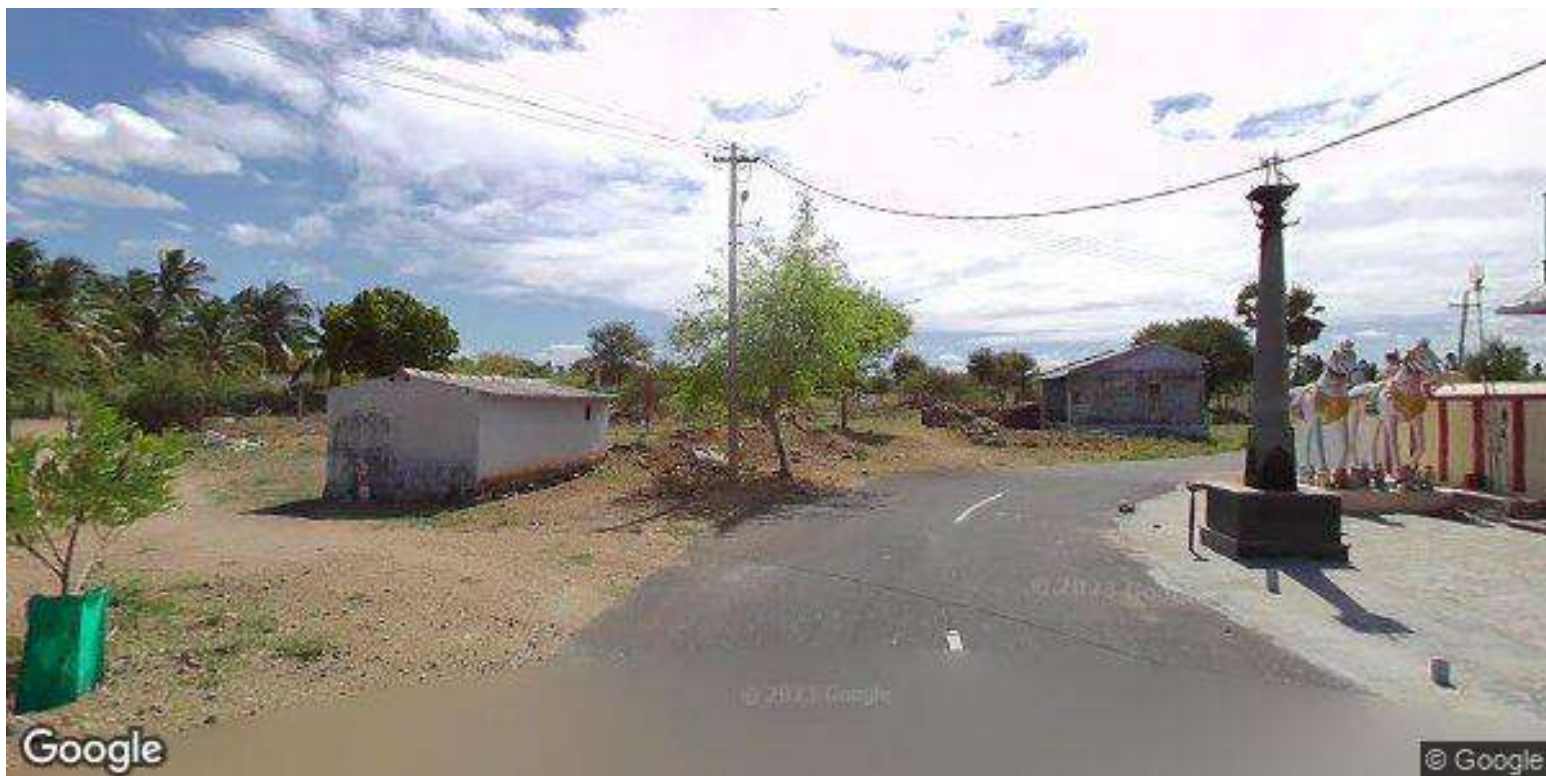
**Coordinates:** 10.80868, 77.72432

**Risk Type:** Turn

**Risk Level:** Medium

**Speed Limit:** 30 KM/Hr

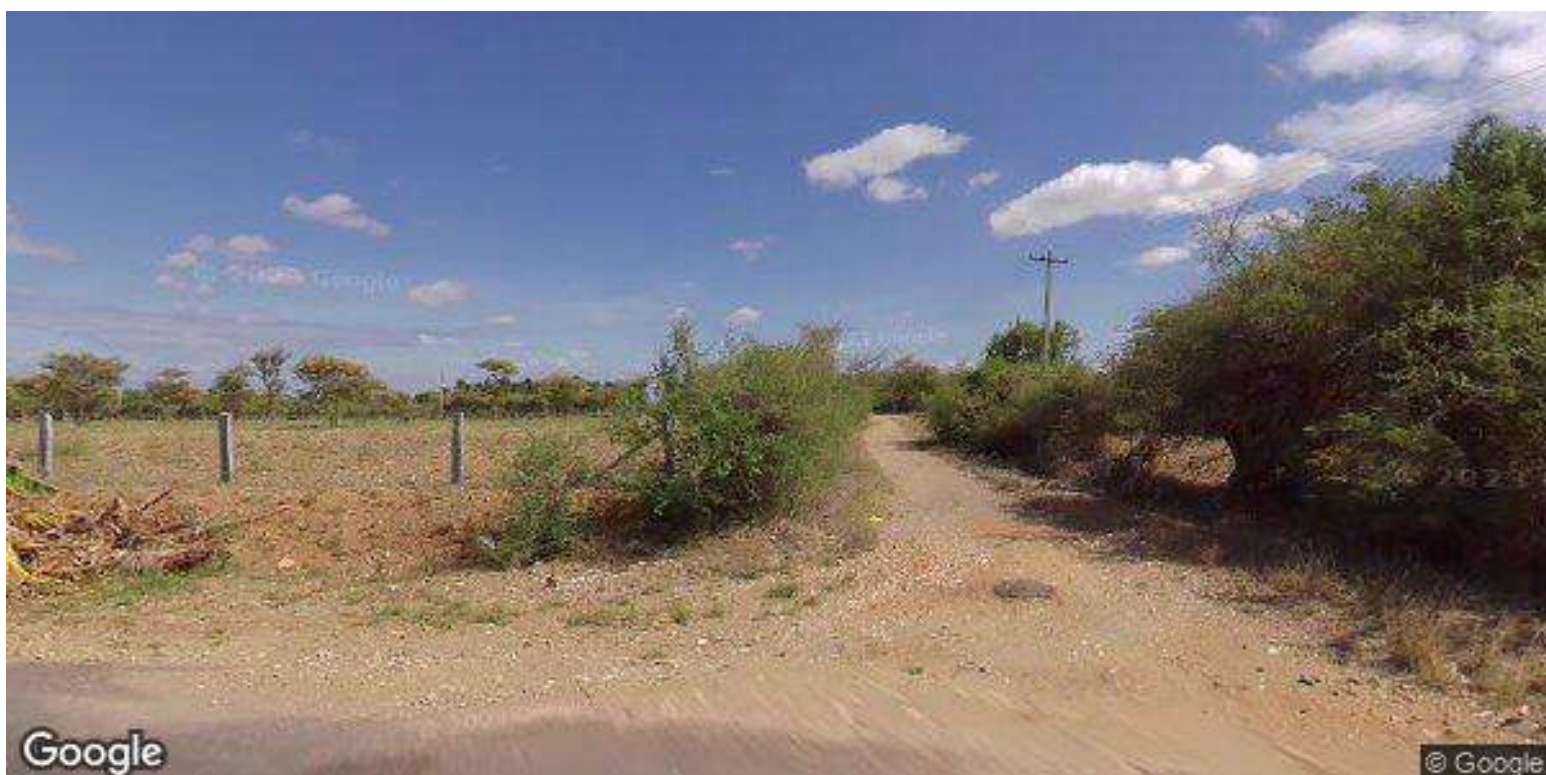
**Coordinates:** 10.80774, 77.72667

**Risk Type:** Turn

**Risk Level:** High

**Speed Limit:** 15 KM/Hr

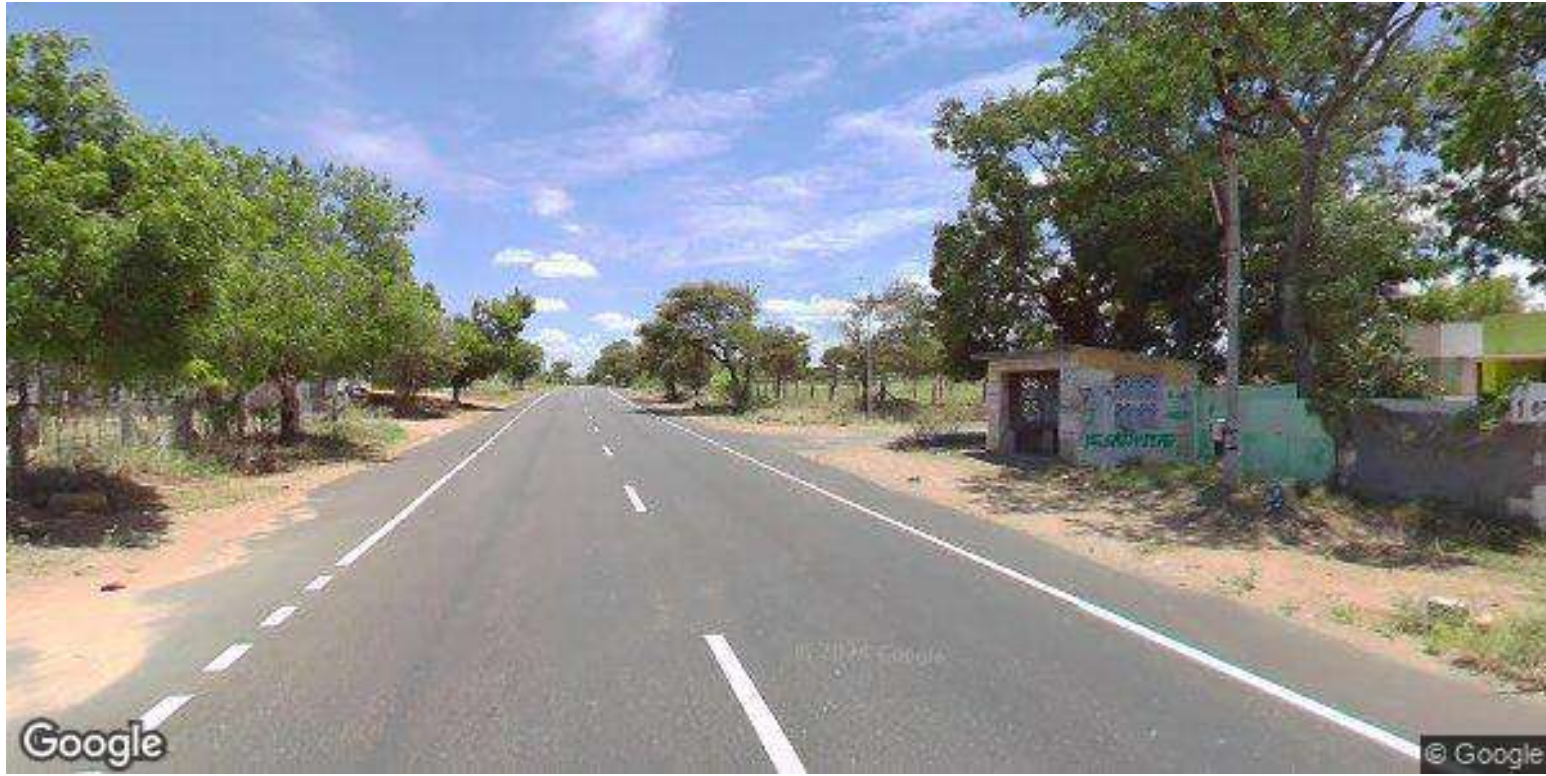
**Coordinates:** 10.80125, 77.72786

**Risk Type:** Turn

**Risk Level:** High

**Speed Limit:** 15 KM/Hr
