## **JOURNEY RISK MANAGEMENT (JRM) STUDY**

### **Salem Terminal To SREE PARANI AGENCIES**

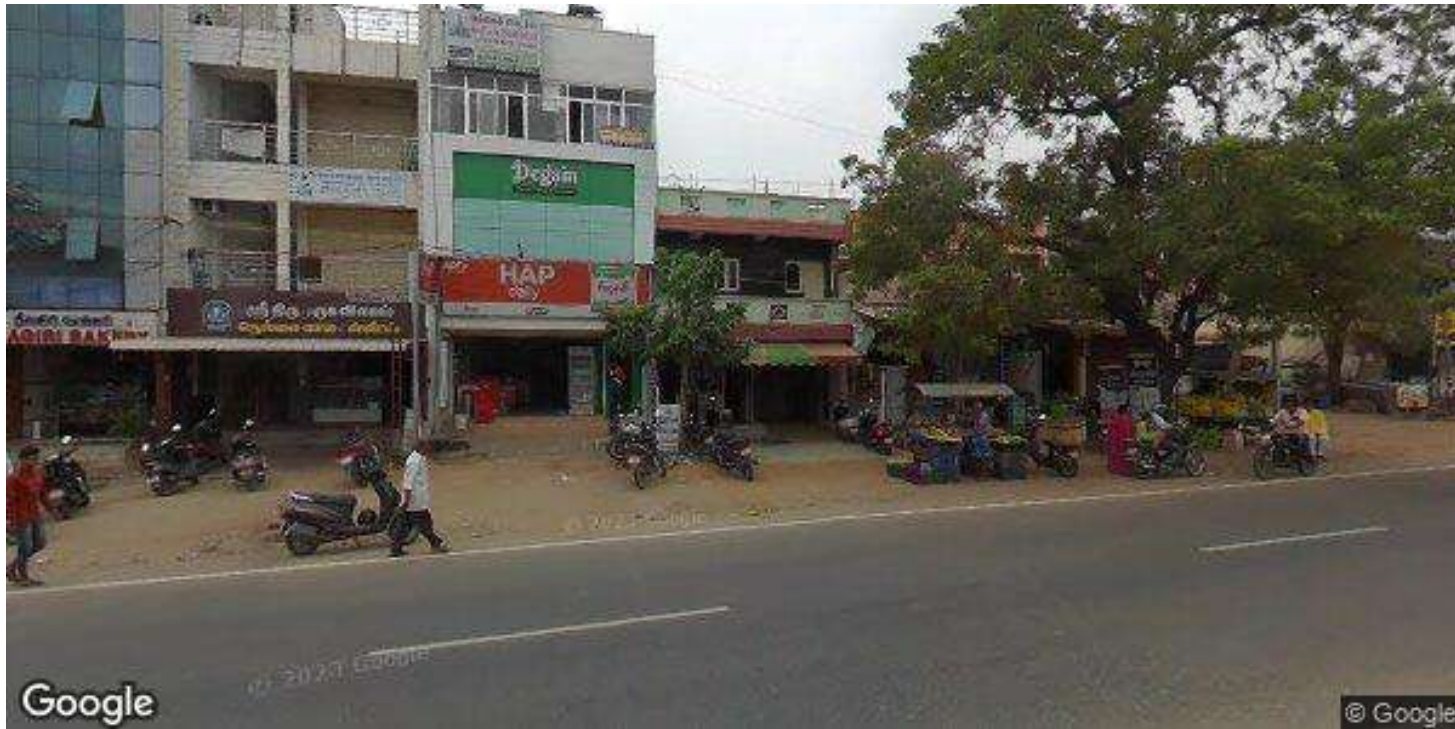
**Coordinates:** 11.1365755, 77.3224245

**Risk Type:** U-Turn

**Risk Level:** High

**Speed Limit:** 10 KM/Hr

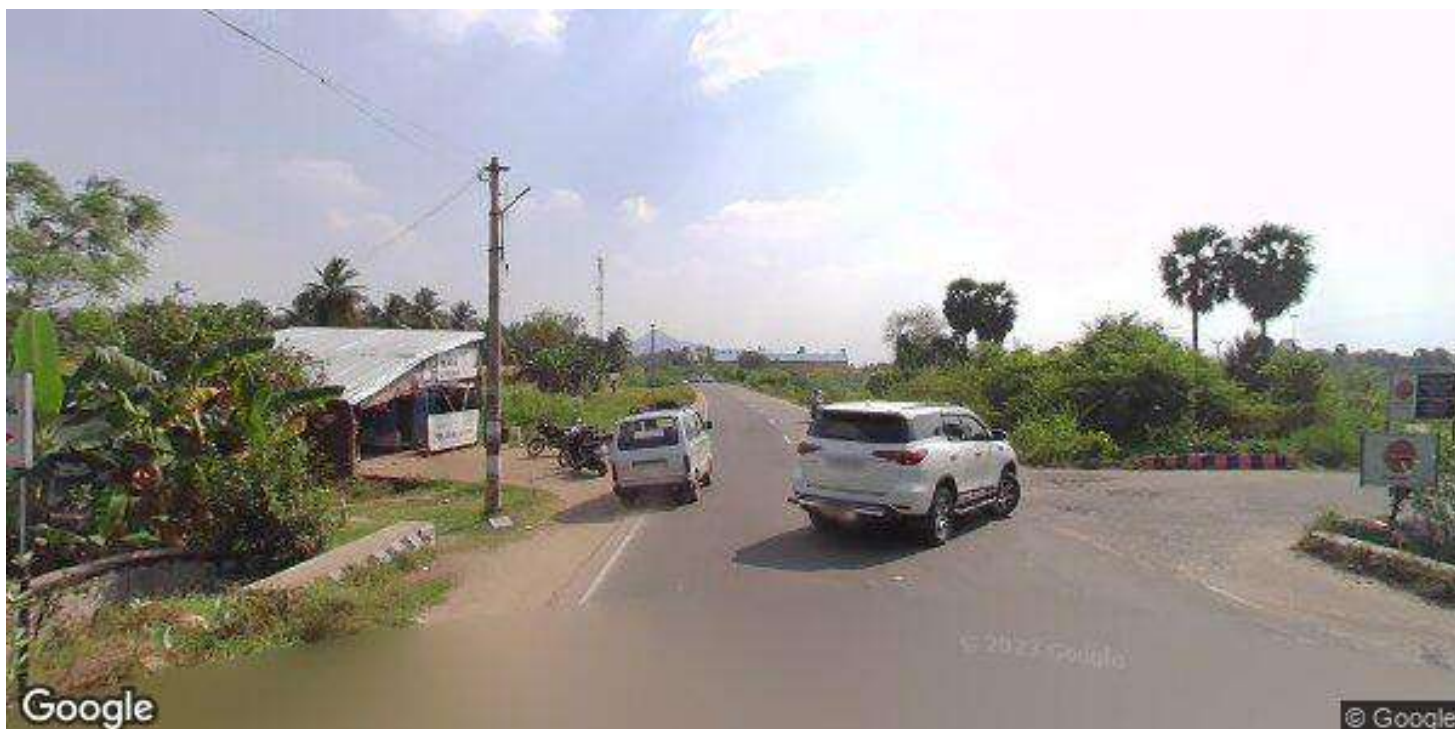
**Risk Type:** Turn  
**Risk Level:** High  
**Speed Limit:** 15 KM/Hr  
**Coordinates:** 11.44029, 77.87544

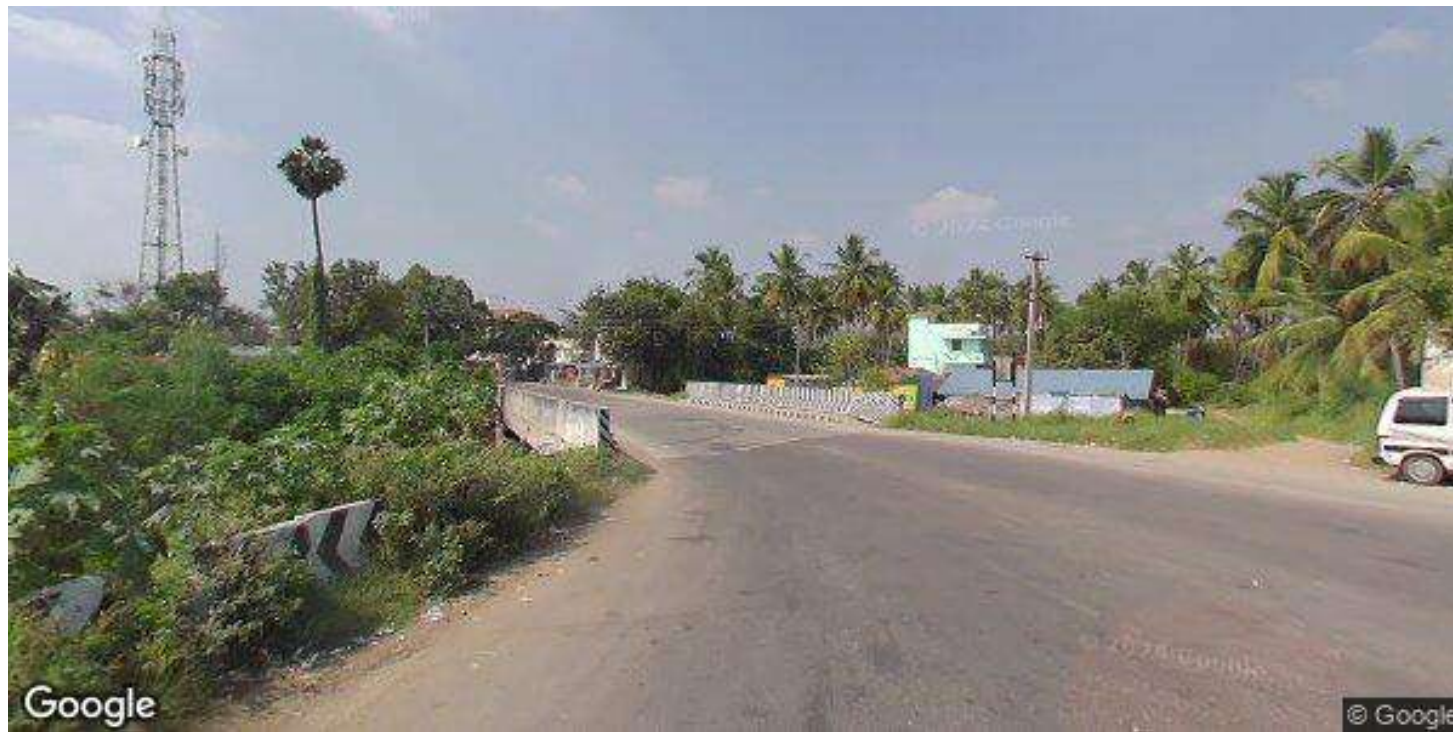
**Risk Type:** Turn  
**Risk Level:** High  
**Speed Limit:** 15 KM/Hr  
**Coordinates:** 11.44893, 77.87413

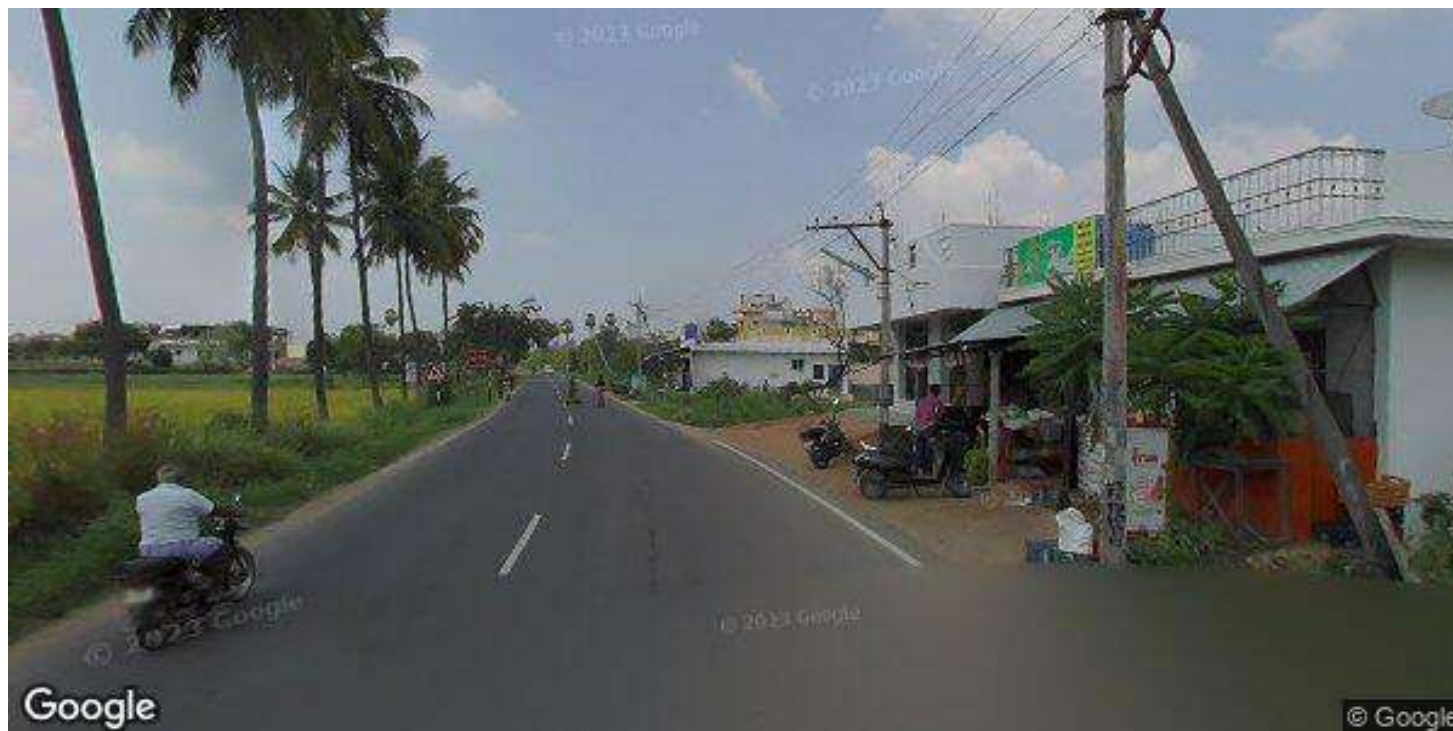
**Risk Type:** Turn  
**Risk Level:** Medium  
**Speed Limit:** 30 KM/Hr  
**Coordinates:** 11.45127, 77.86734

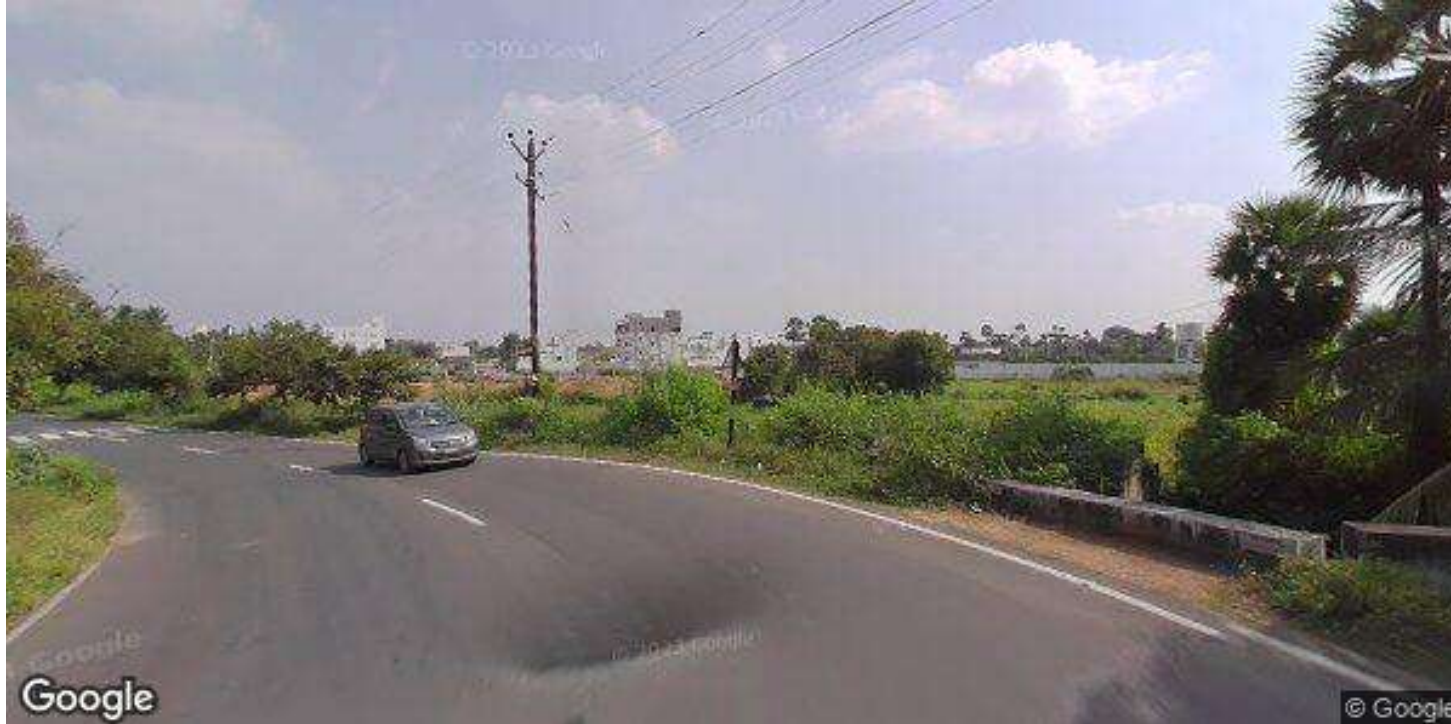
**Risk Type:** Turn  
**Risk Level:** High  
**Speed Limit:** 15 KM/Hr  
**Coordinates:** 11.45350, 77.85700

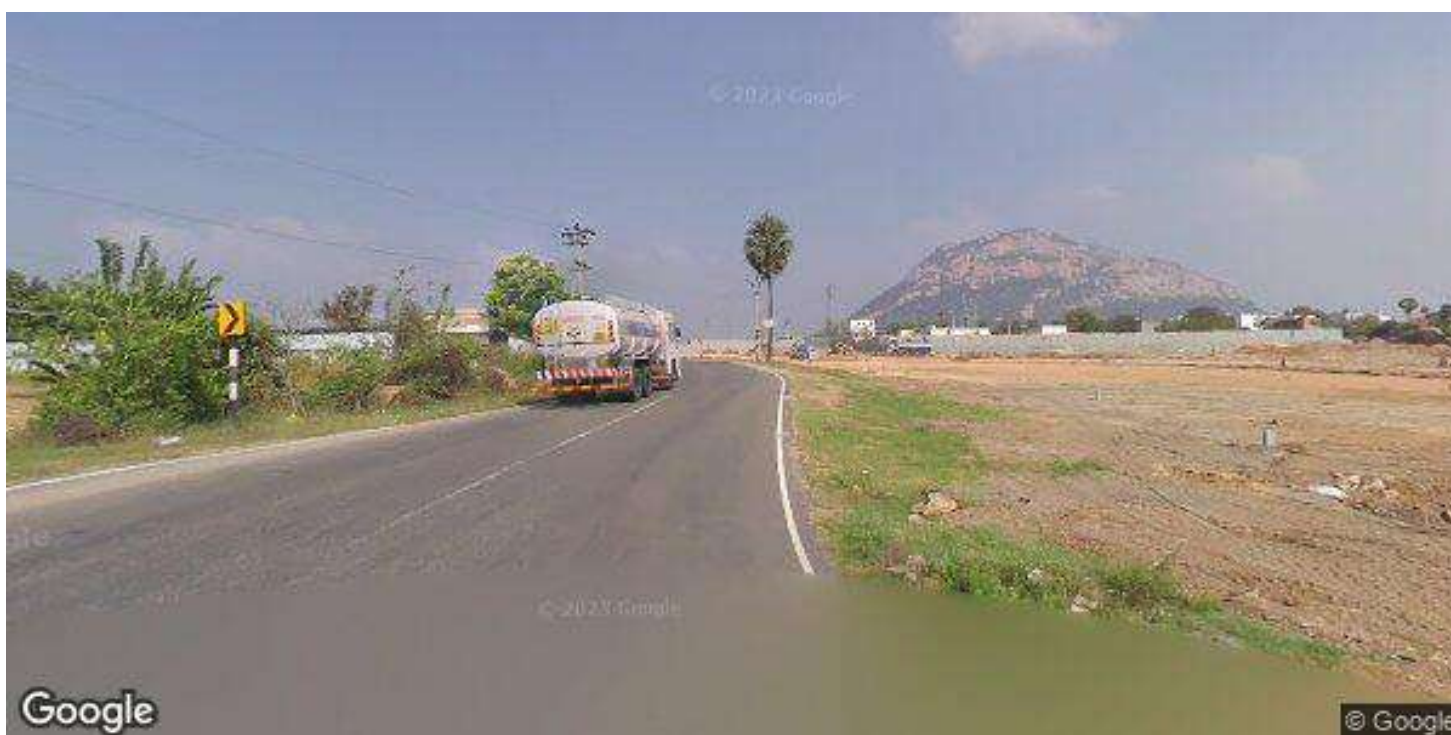
**Risk Type:** Turn  
**Risk Level:** Medium  
**Speed Limit:** 30 KM/Hr  
**Coordinates:** 11.45845, 77.85141

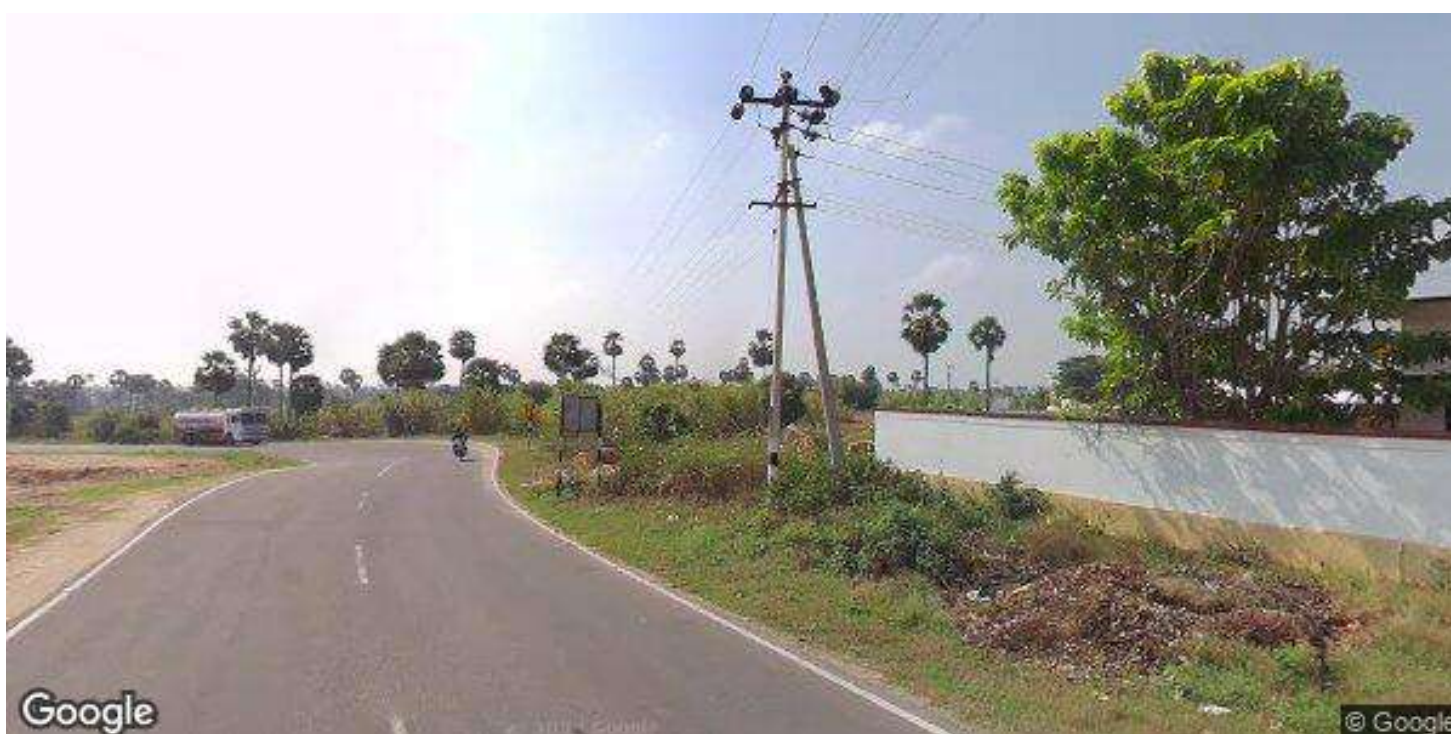
**Coordinates: 11.45889, 77.85136**

**Risk Type:** Turn  
**Risk Level:** Medium

**Speed Limit: 30 KM/Hr**

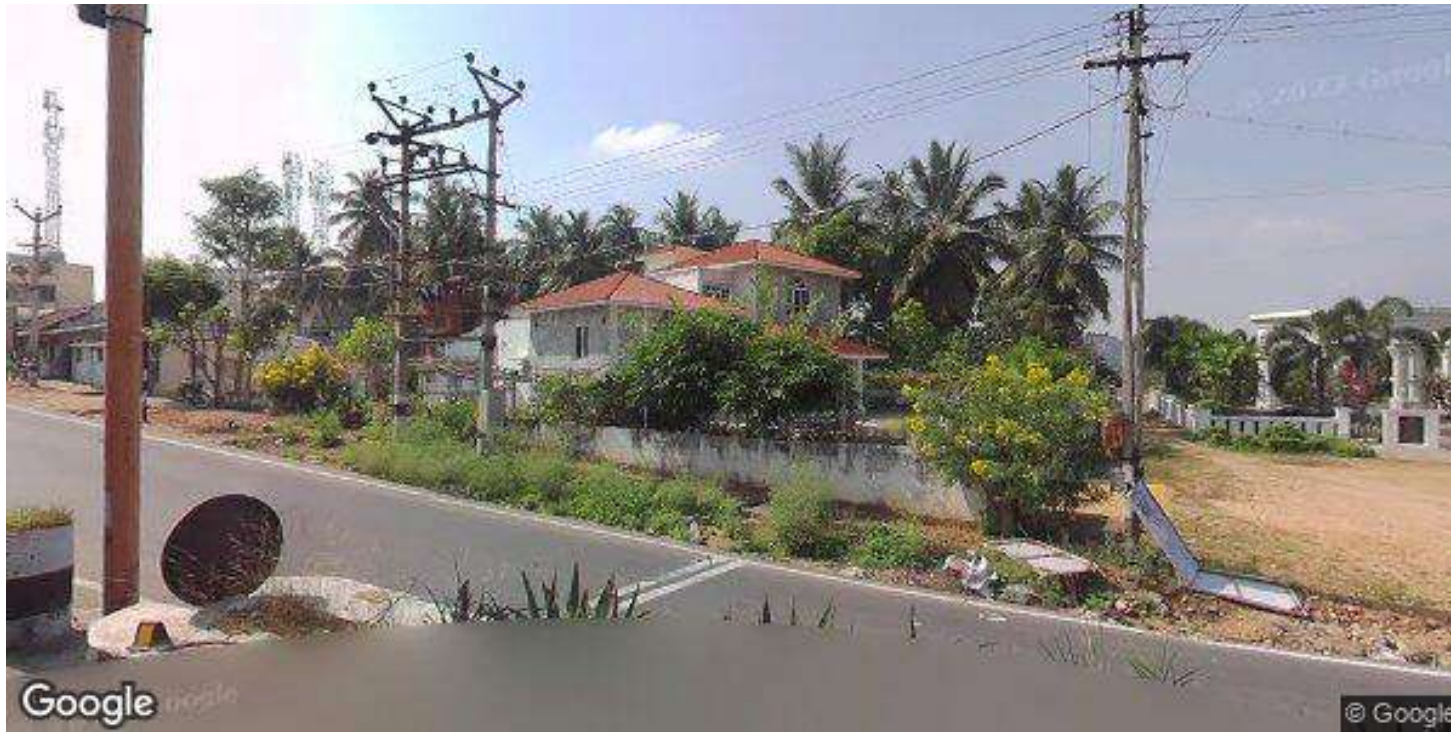
**Coordinates: 11.46303, 77.84945**

**Risk Type: Turn**

**Risk Level: High**

**Speed Limit: 15 KM/Hr**

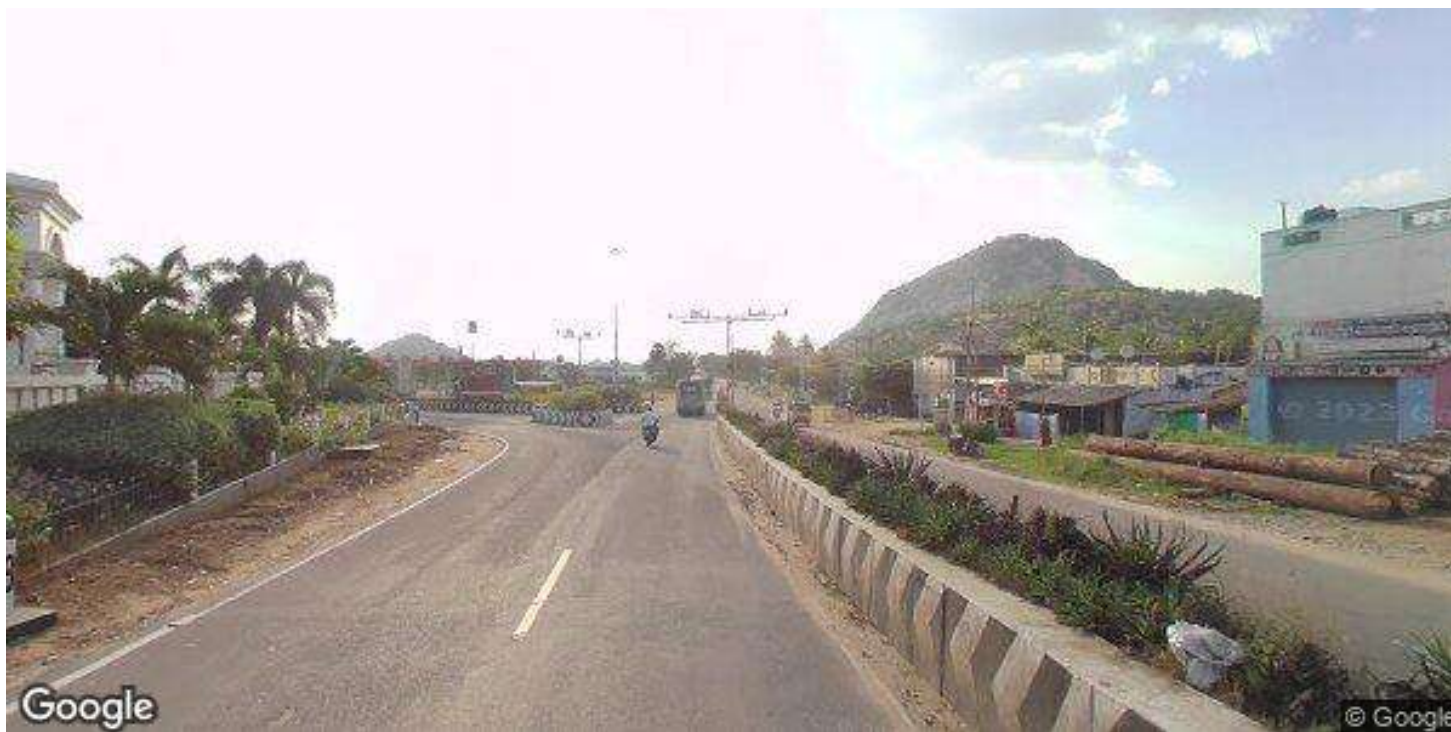
**Coordinates: 11.46317, 77.84906**

**Risk Type: Turn**

**Risk Level: Medium**

**Speed Limit: 30 KM/Hr**

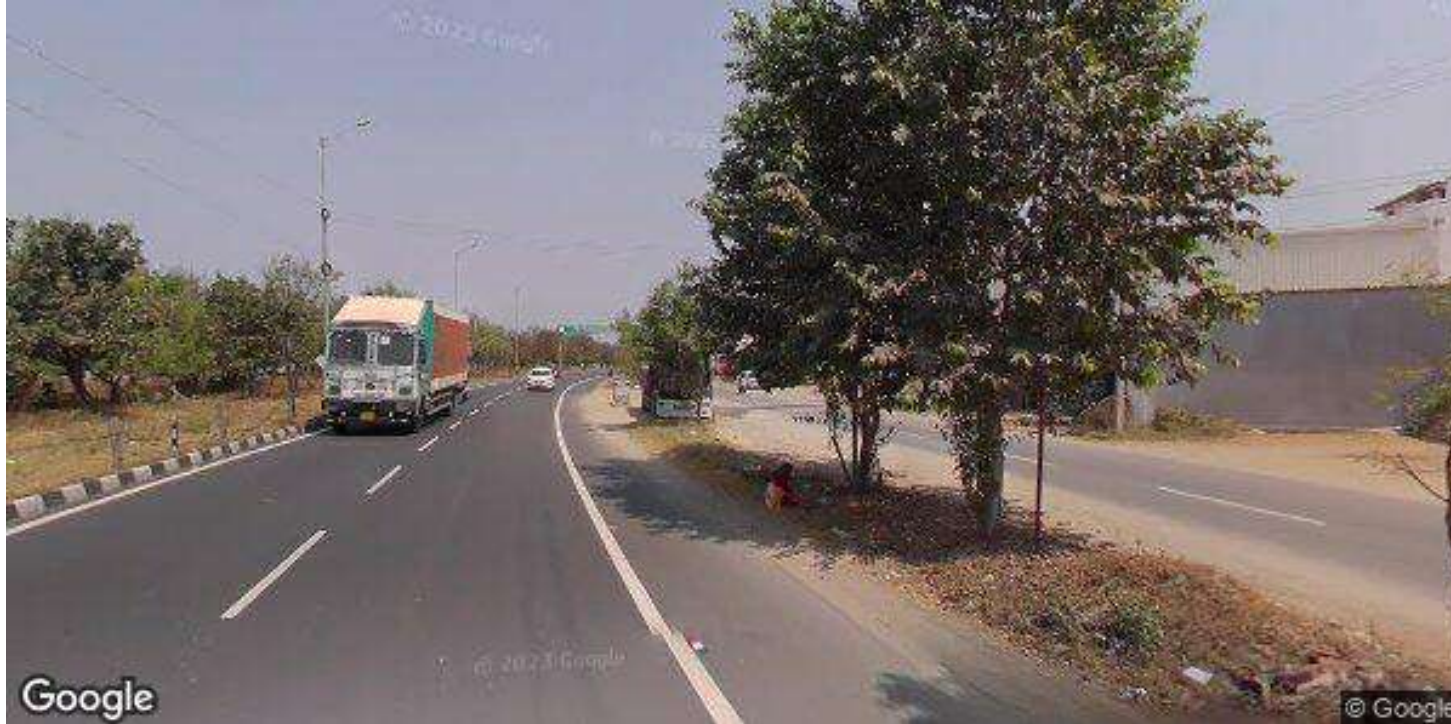
**Coordinates:** 11.43175, 77.67757

**Risk Type:** Turn

**Risk Level:** Medium

**Speed Limit:** 30 KM/Hr

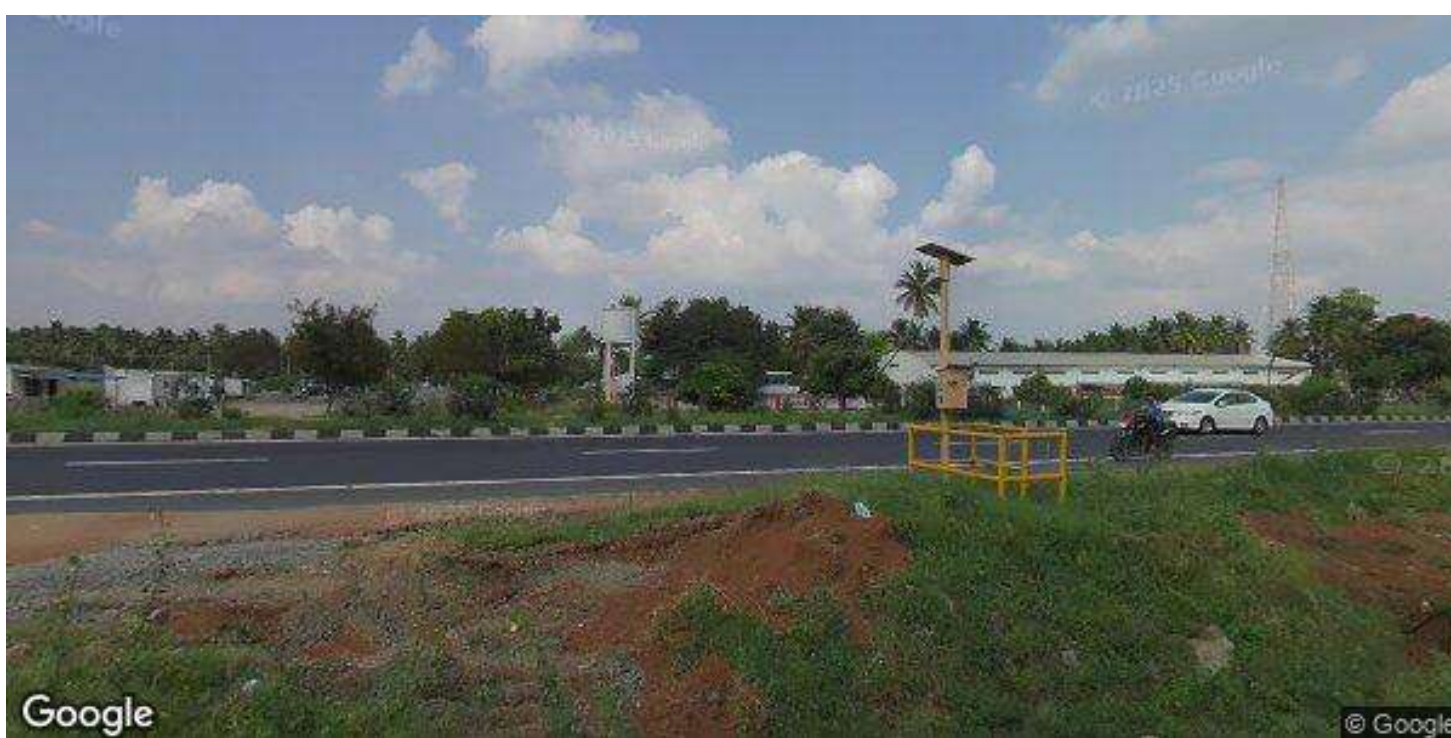
**Coordinates:** 11.29141, 77.58266

**Risk Type:** Turn

**Risk Level:** Medium

**Speed Limit:** 30 KM/Hr

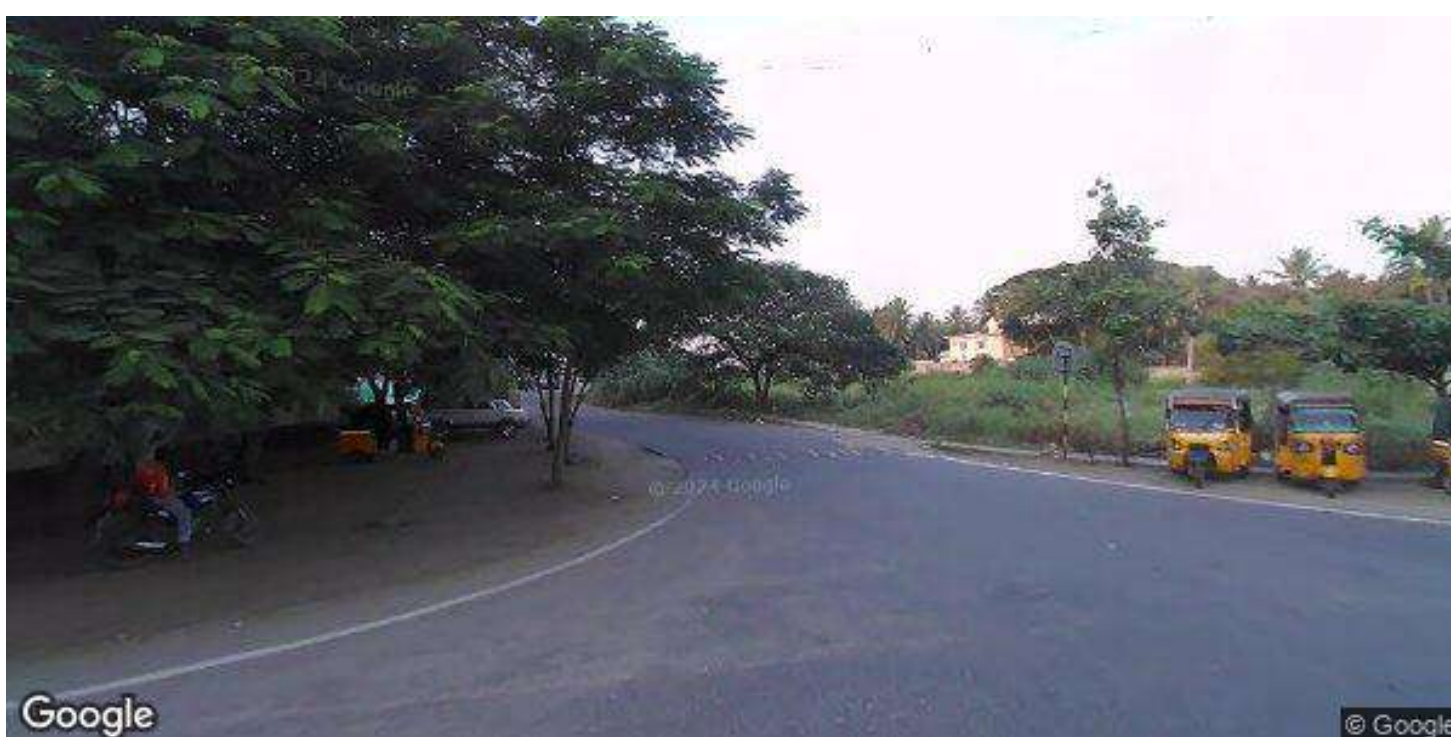
Coordinates: 11.18267, 77.28532

**Risk Type:** Turn

**Risk Level:** High

Speed Limit: 15 KM/Hr

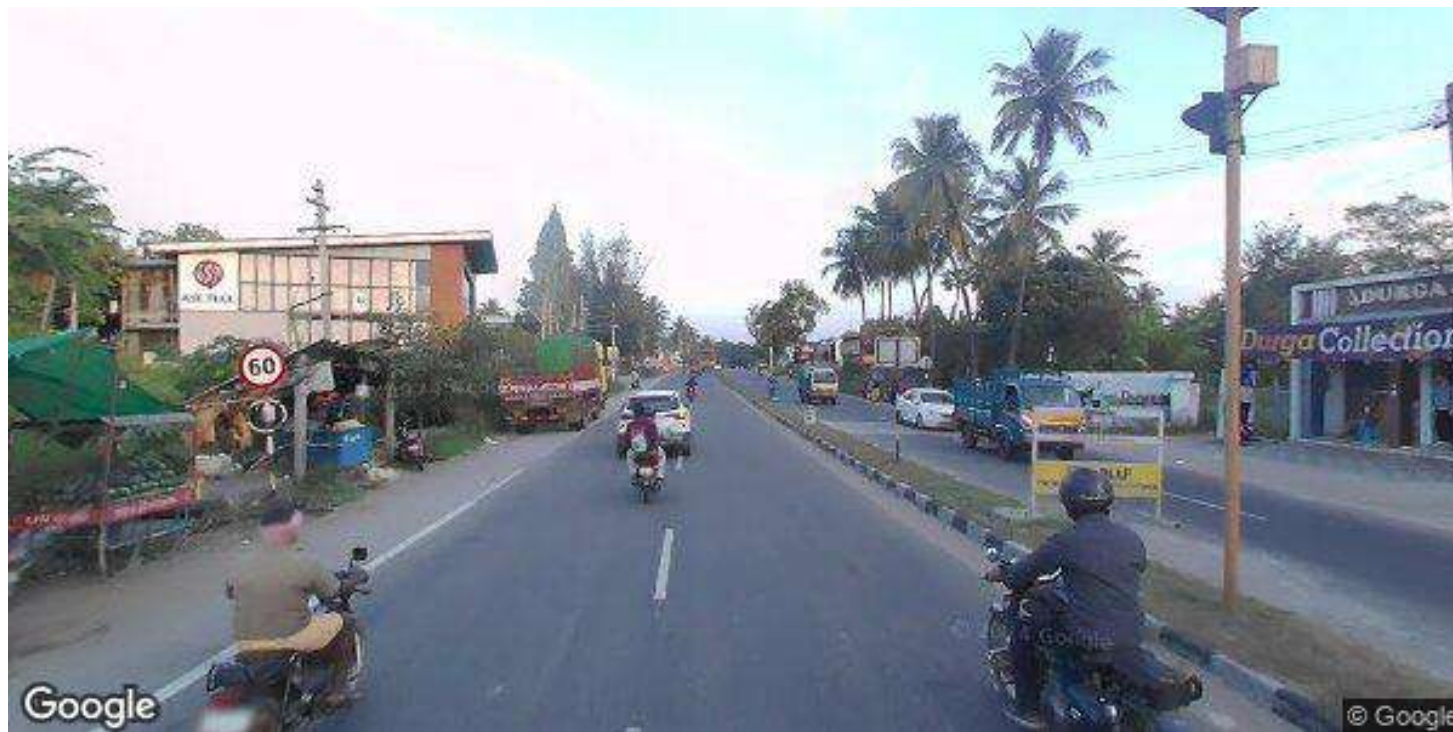
Coordinates: 11.18242, 77.28553

Risk Type: Turn

Risk Level: Medium

Speed Limit: 30 KM/Hr

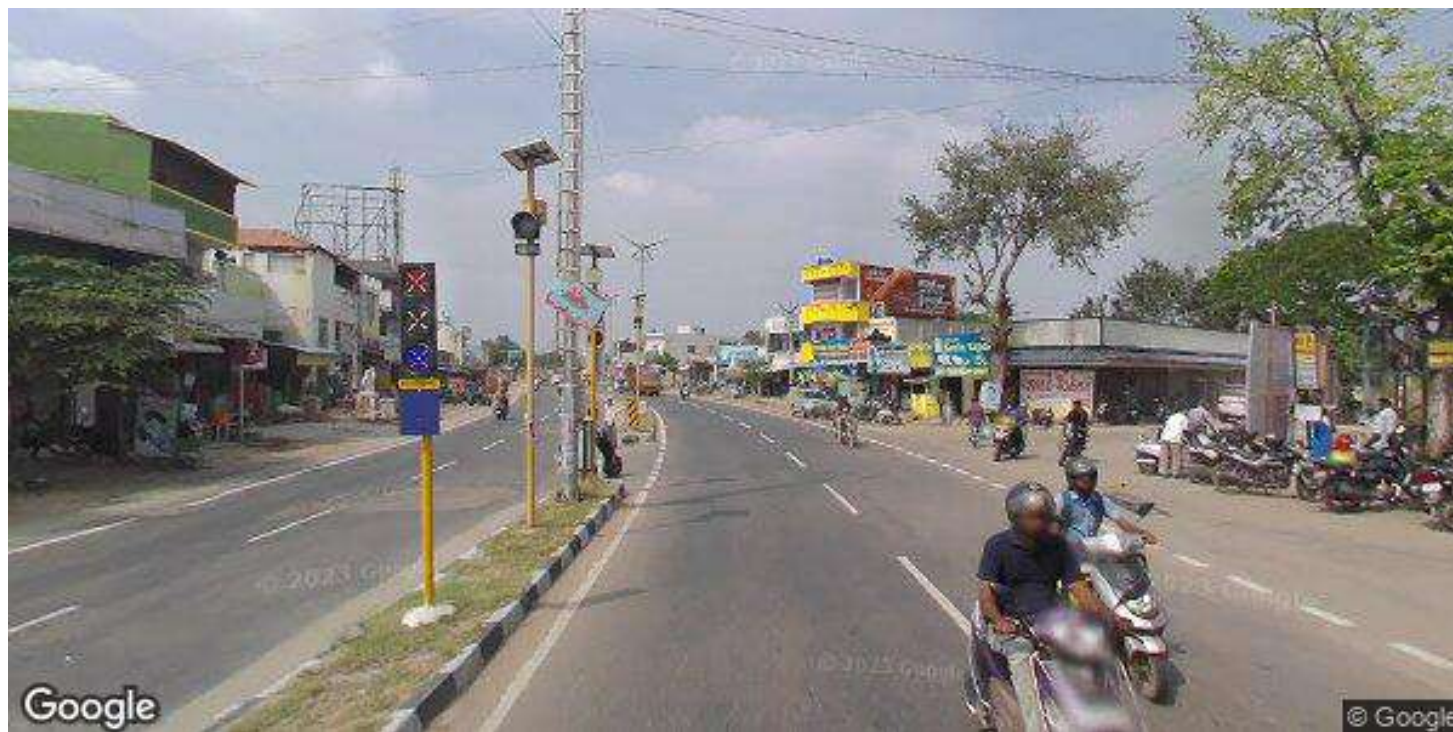
Coordinates: 11.16527, 77.30700

Risk Type: Turn

Risk Level: Medium

Speed Limit: 30 KM/Hr

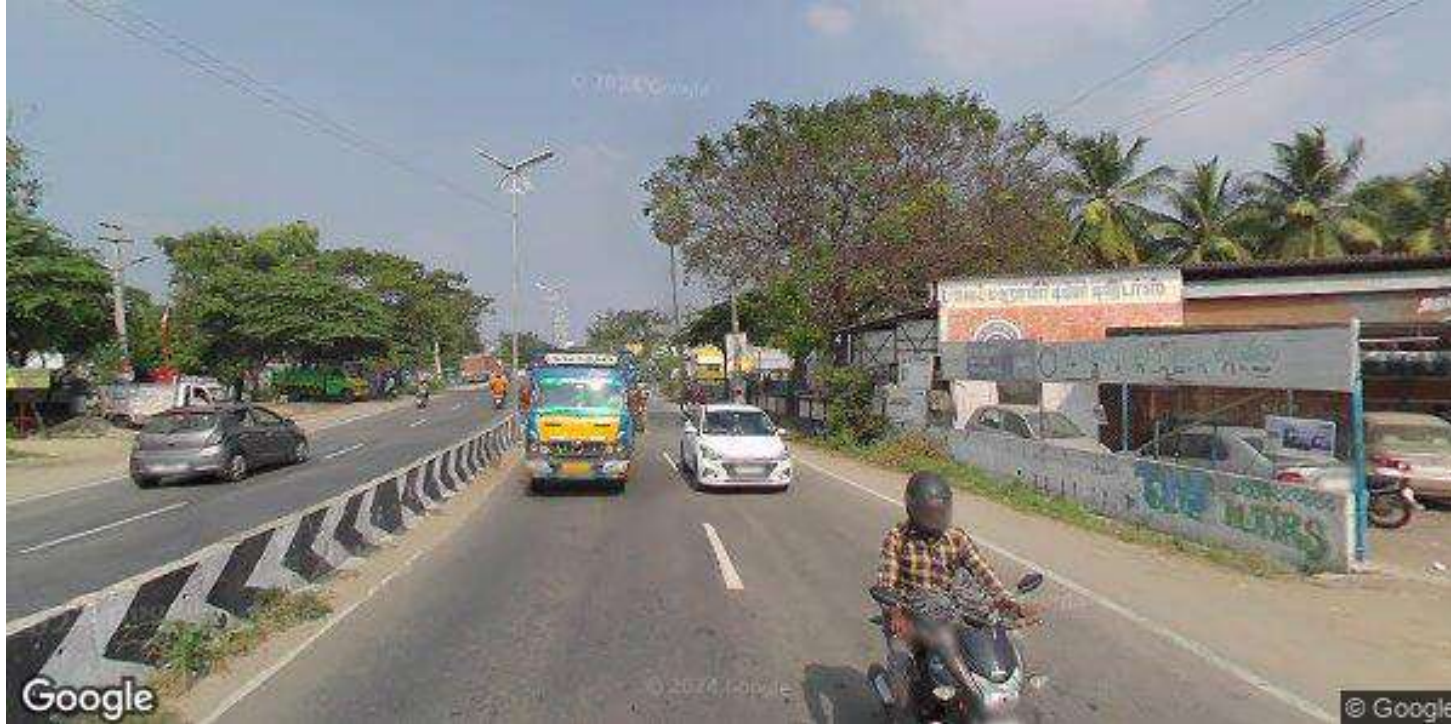
**Coordinates:** 11.16093, 77.30955

**Risk Type:** Turn

**Risk Level:** Medium

**Speed Limit:** 30 KM/Hr

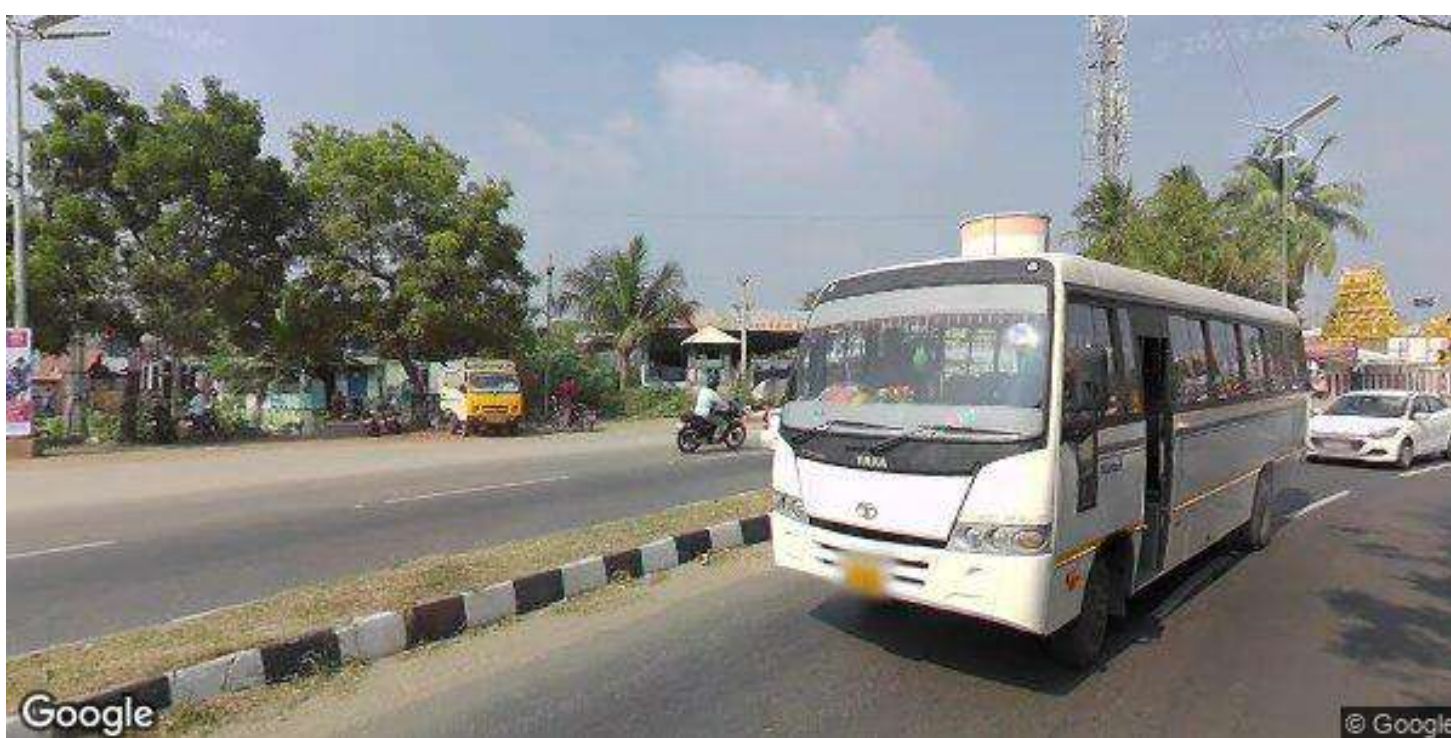
**Coordinates:** 11.15180, 77.30889

**Risk Type:** Turn

**Risk Level:** High

**Speed Limit:** 15 KM/Hr

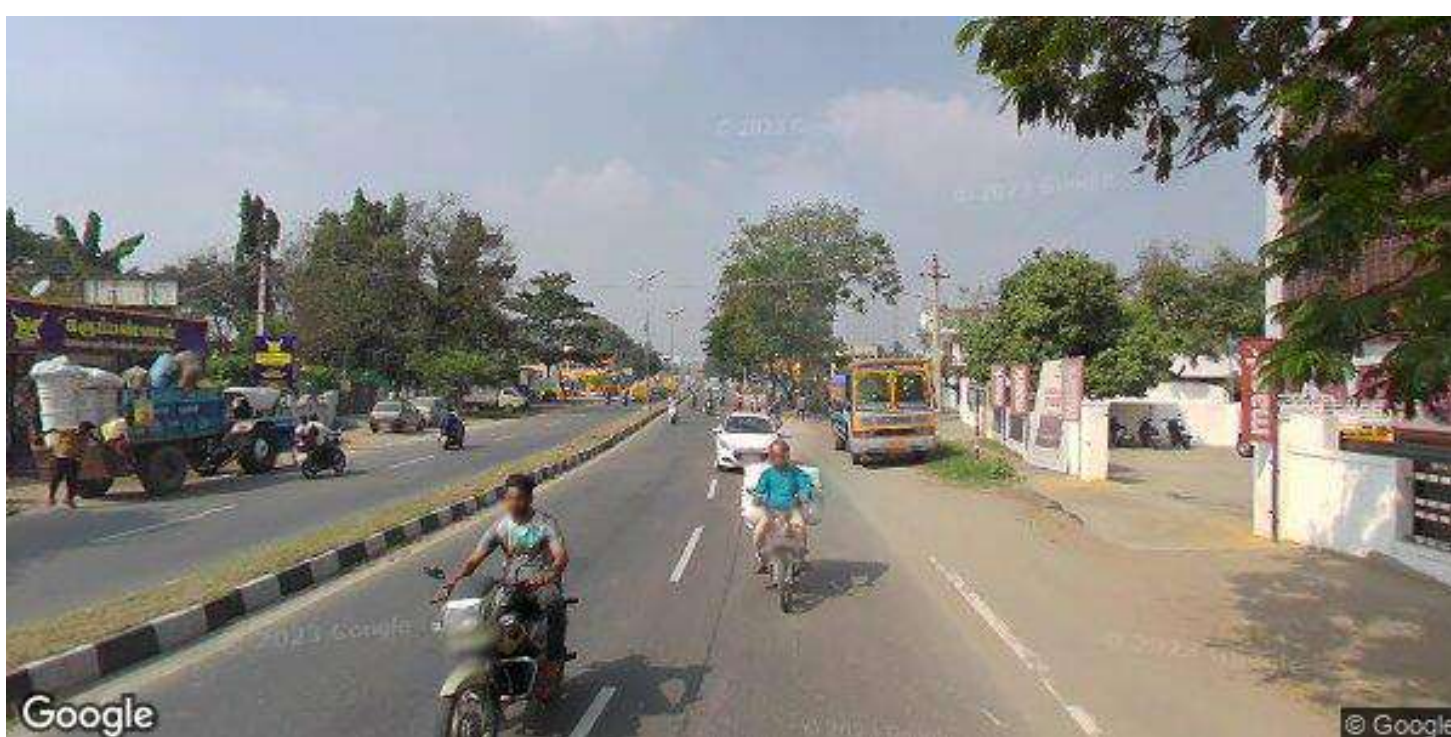
Coordinates: 11.15175, 77.31121

**Risk Type:** Turn

**Risk Level:** Medium

Speed Limit: 30 KM/Hr

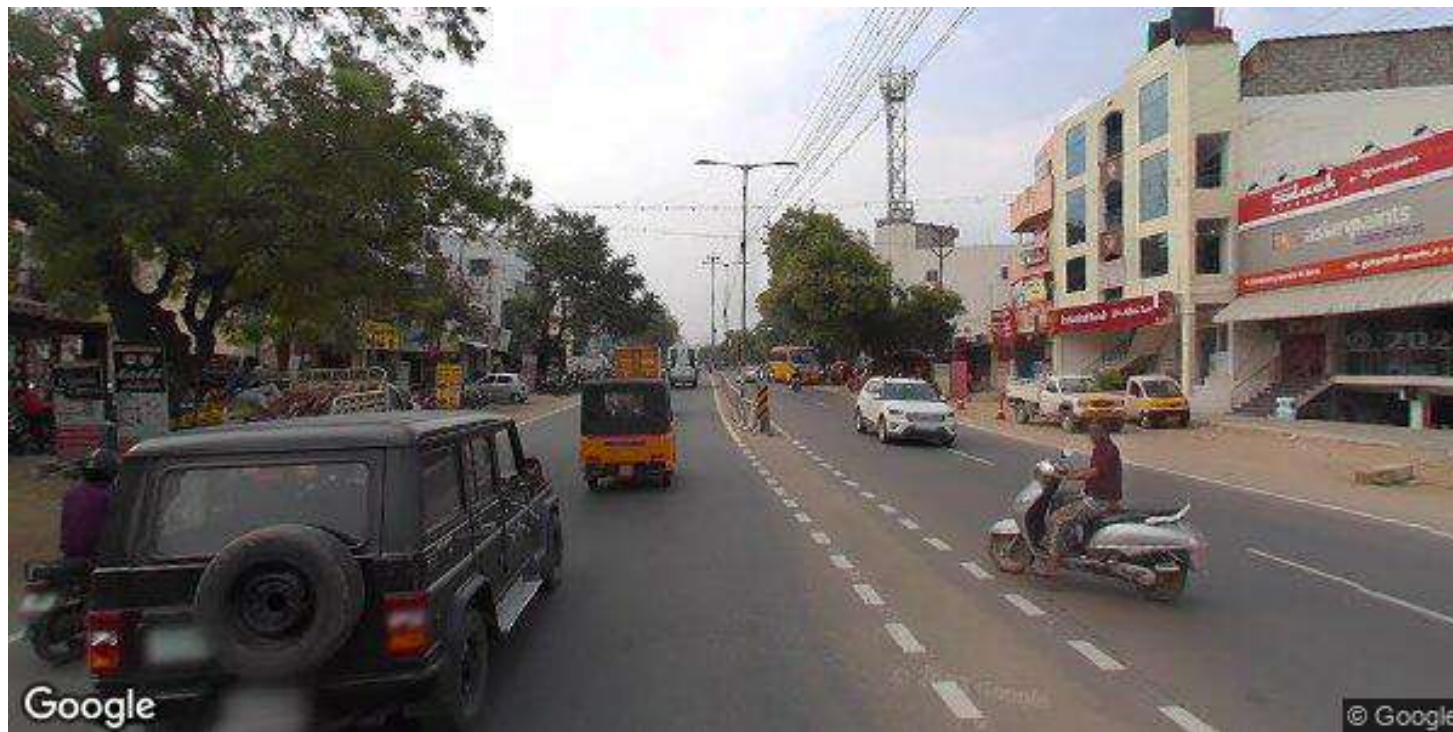
Coordinates: 11.13653, 77.32237

Risk Type: Blind Spot

Risk Level: Blind Spot

Speed Limit: 10 KM/Hr

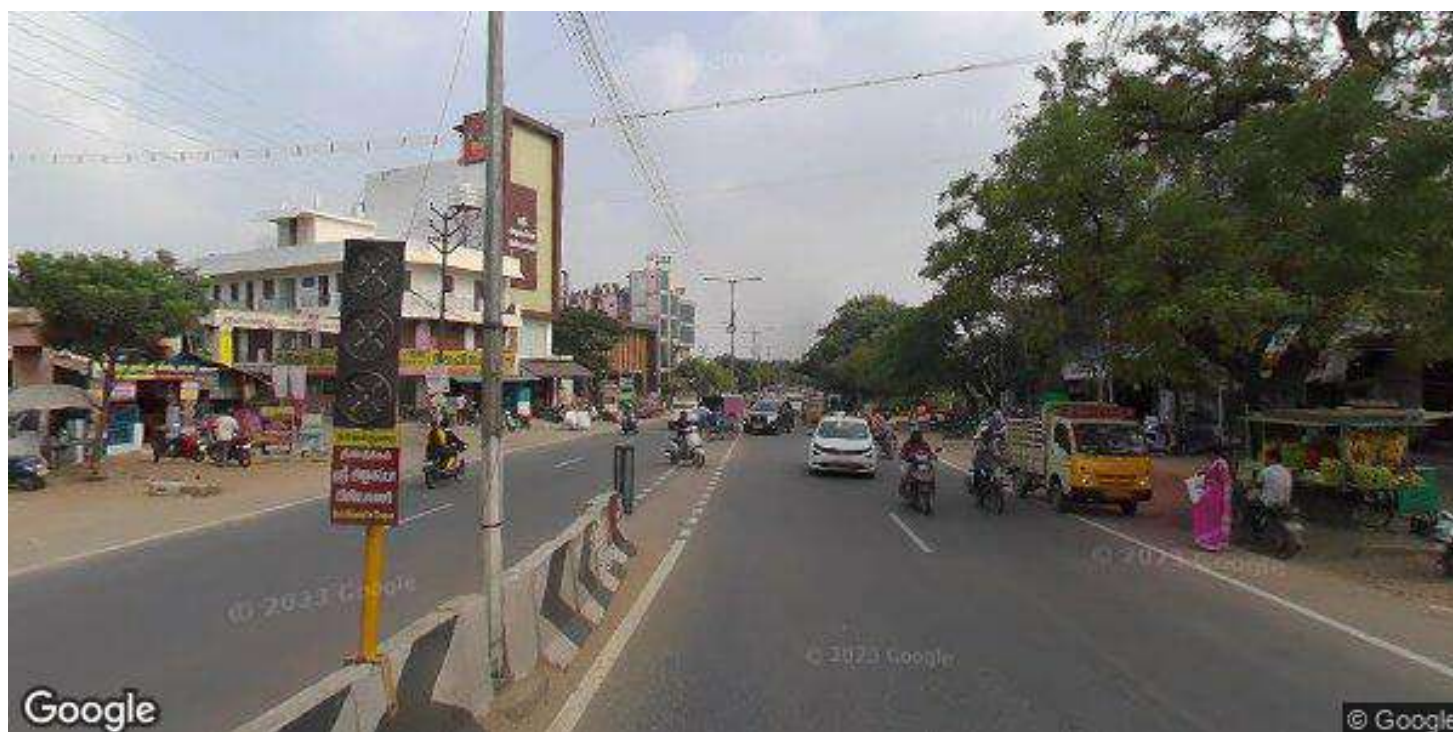
Coordinates: 11.13664, 77.32220

Risk Type: Turn

Risk Level: High

Speed Limit: 15 KM/Hr

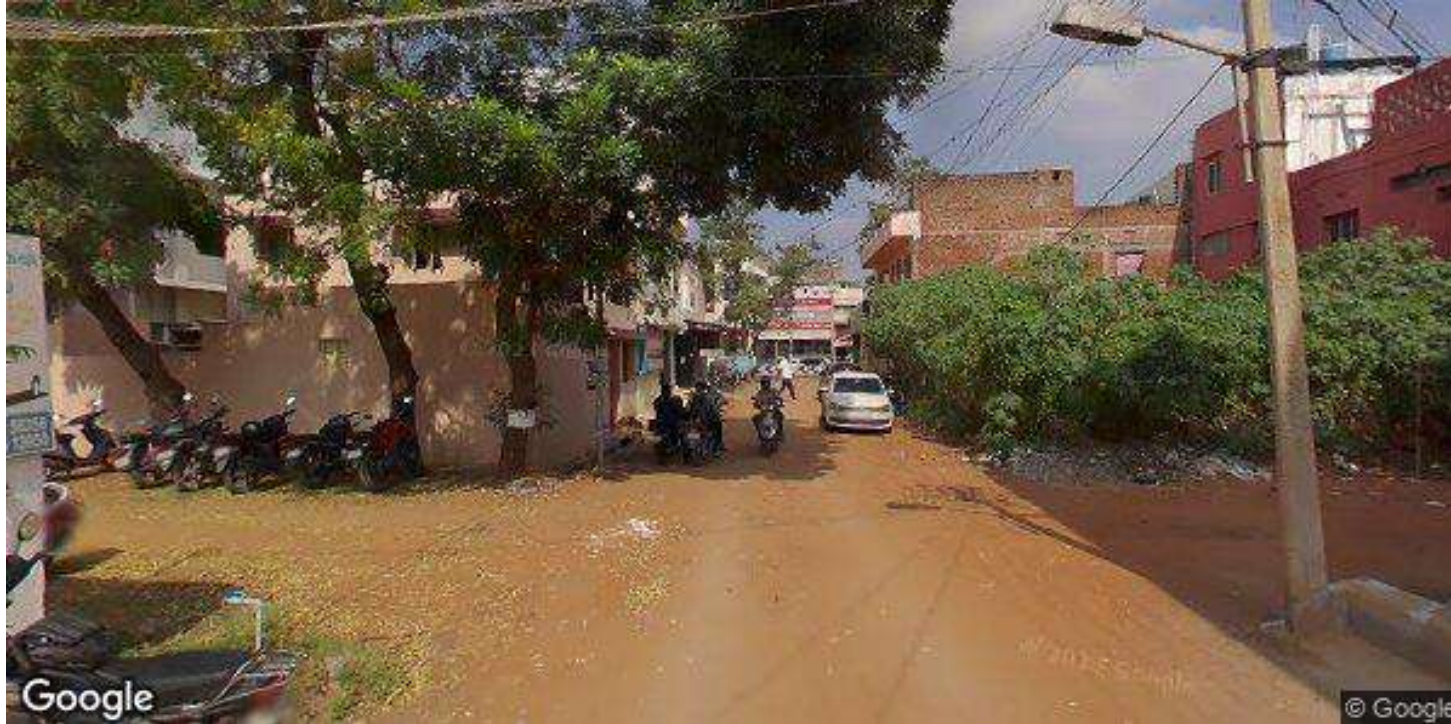
**Coordinates:** 11.13629, 77.32186

**Risk Type:** Turn

**Risk Level:** High

**Speed Limit:** 15 KM/Hr
