# IndianOil

## JOURNEY RISK MANAGEMENT (JRM) STUDY

### Salem Terminal TO VEMBANAN & CO P.N

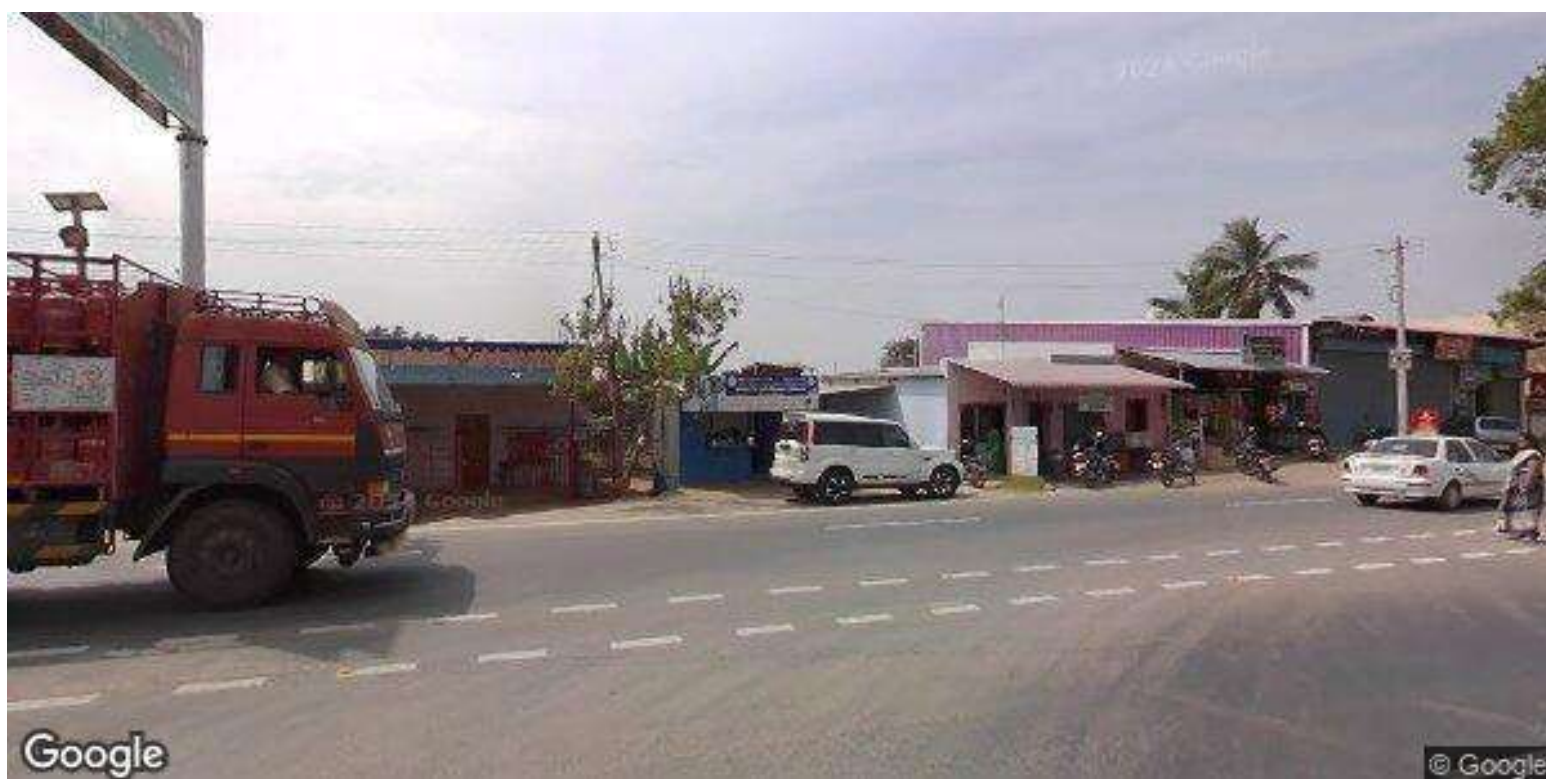
**Coordinates: 11.00065, 77.56884**

**Risk Type: Roundabout**

**Risk Level: High**

**Speed Limit: 15 KM/Hr**

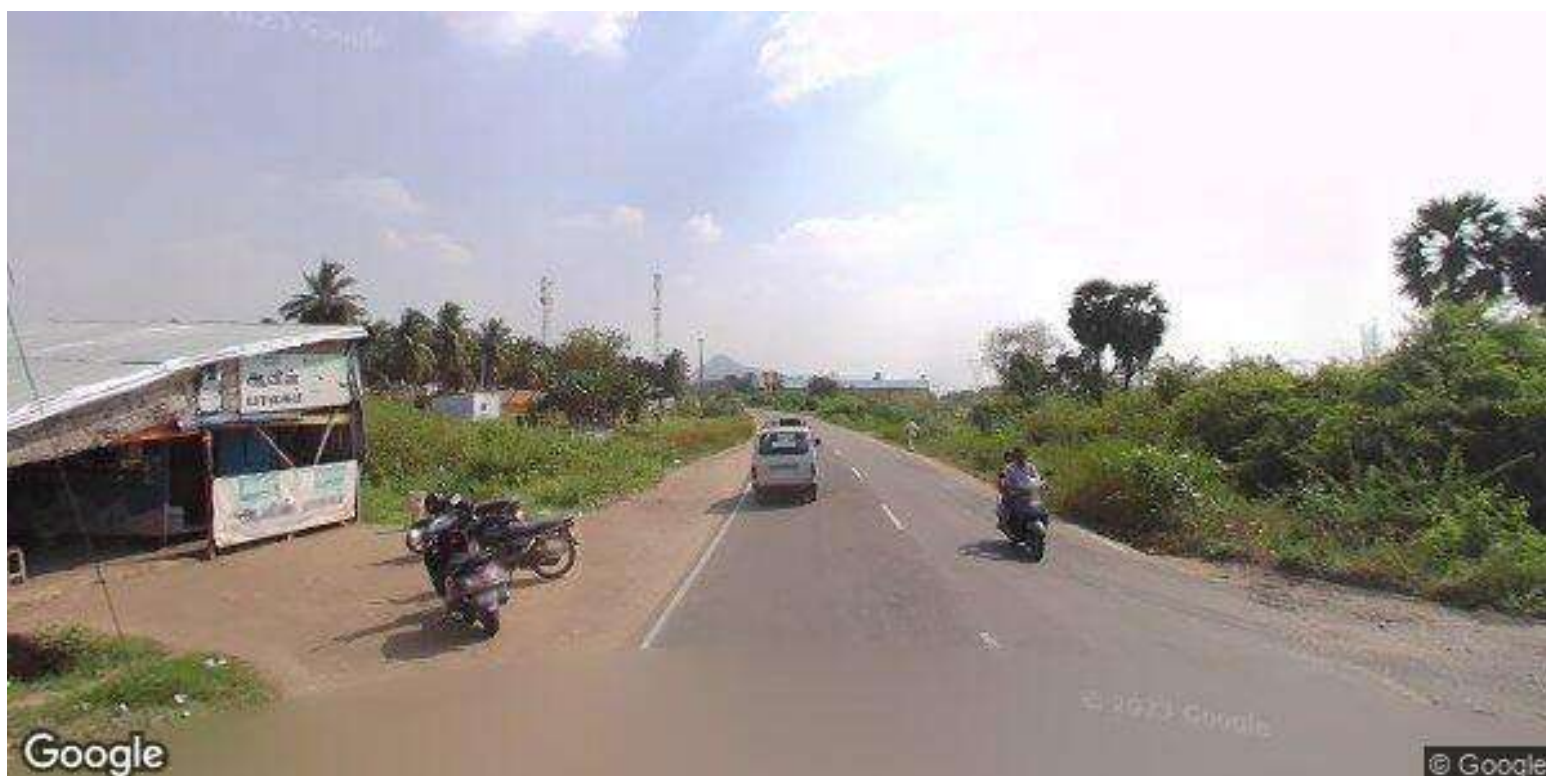
**Coordinates: 11.44022, 77.87546**

**Risk Type: Turn**

**Risk Level: High**

**Speed Limit: 15 KM/Hr**

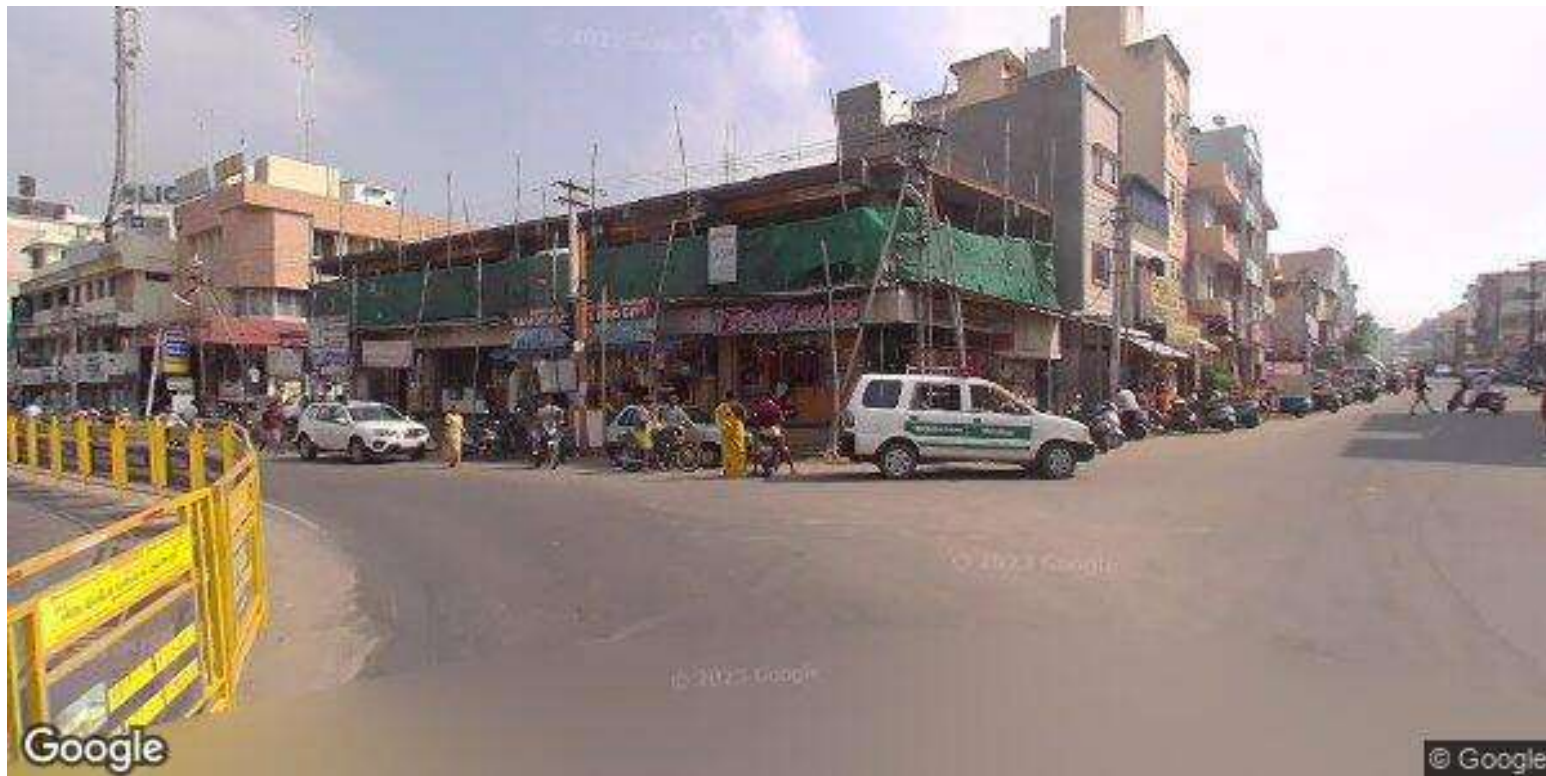
**Coordinates: 11.37868, 77.89498**

**Risk Type: Turn**

**Risk Level: High**

**Speed Limit: 15 KM/Hr**

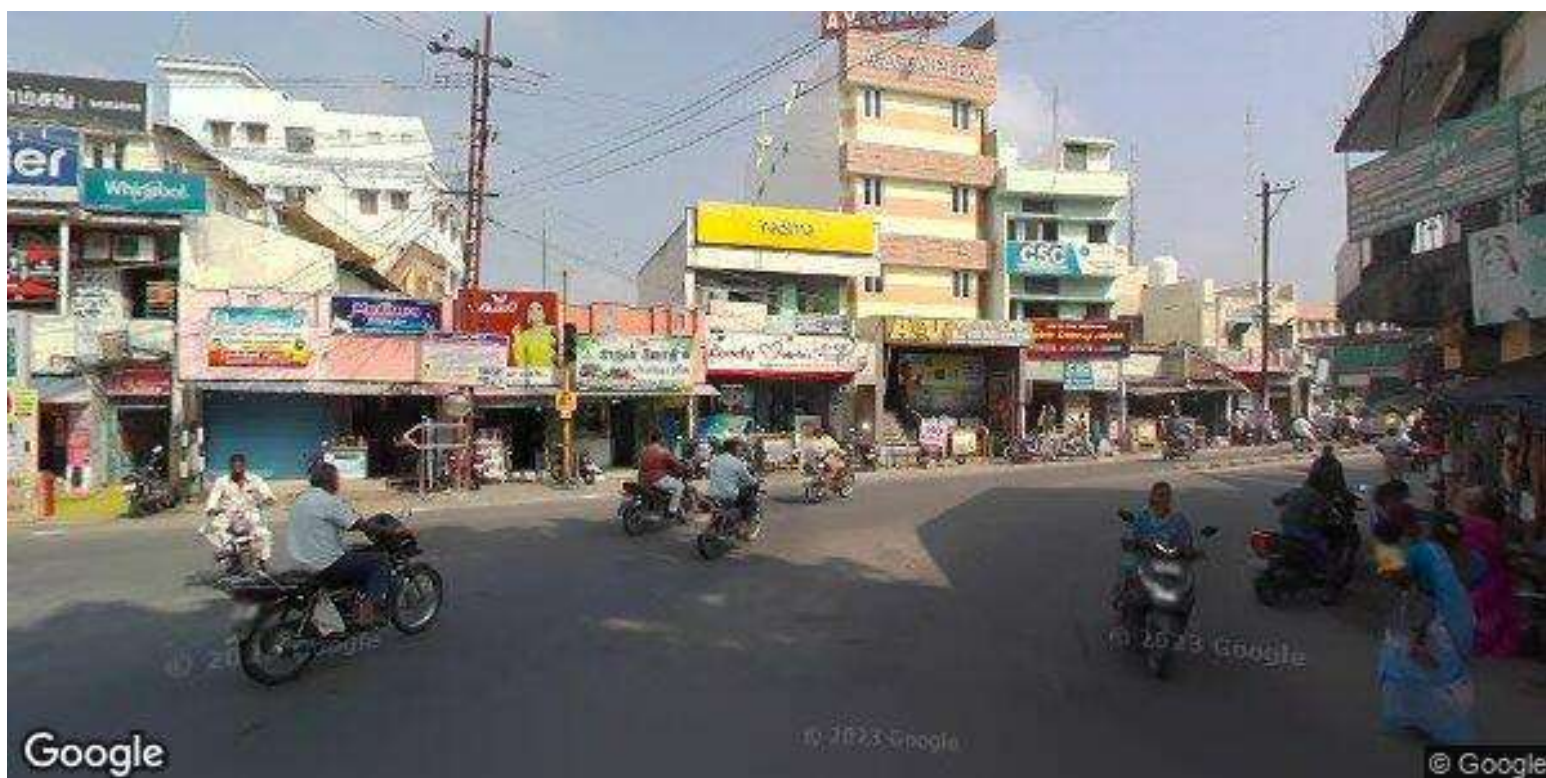
**Coordinates: 11.37842, 77.89452**

**Risk Type: Turn**

**Risk Level: Medium**

**Speed Limit: 30 KM/Hr**

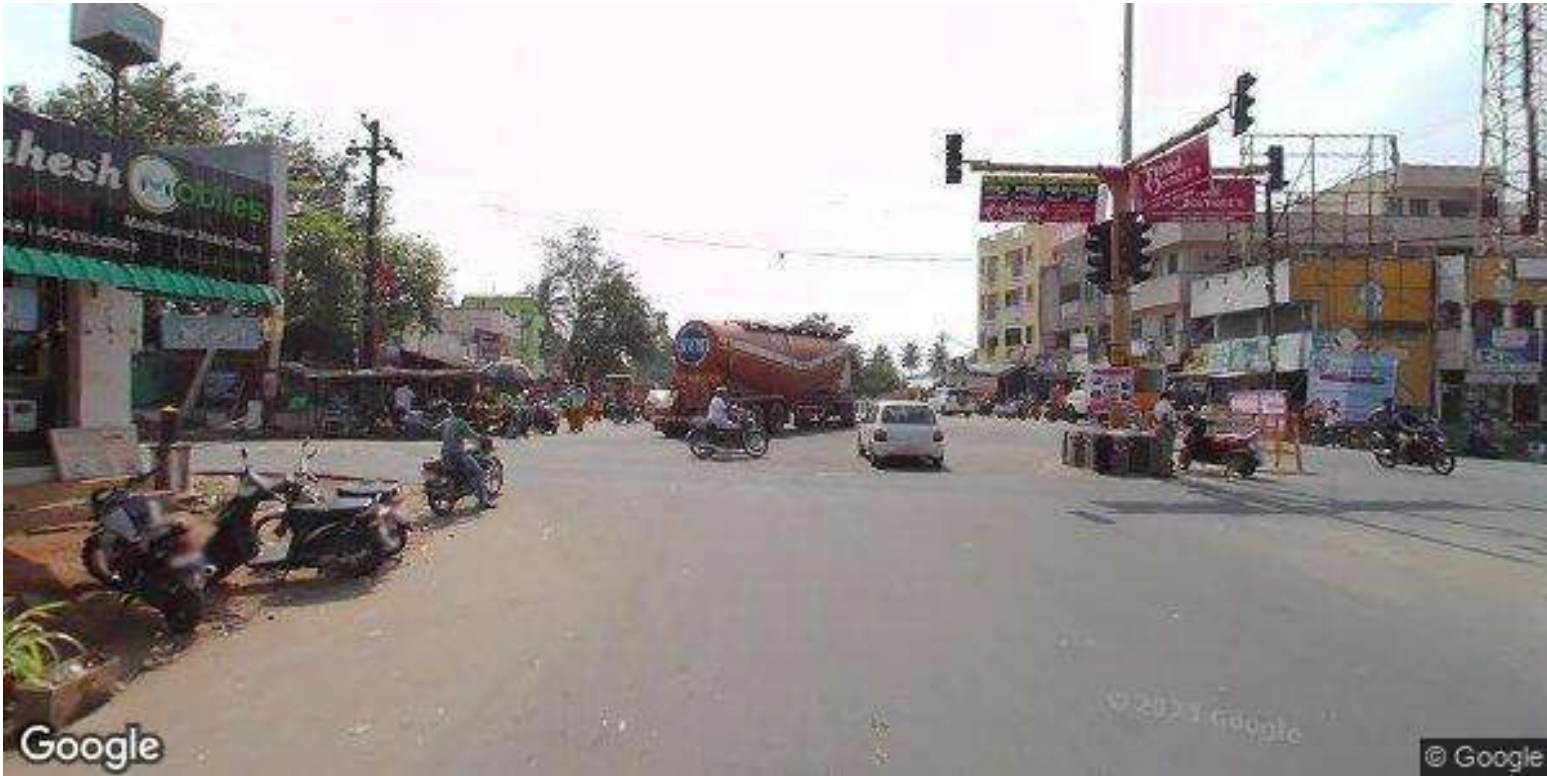
**Risk Type:** Turn  
**Risk Level:** Medium  
**Speed Limit:** 30 KM/Hr  
**Coordinates:** 11.36616, 77.88885

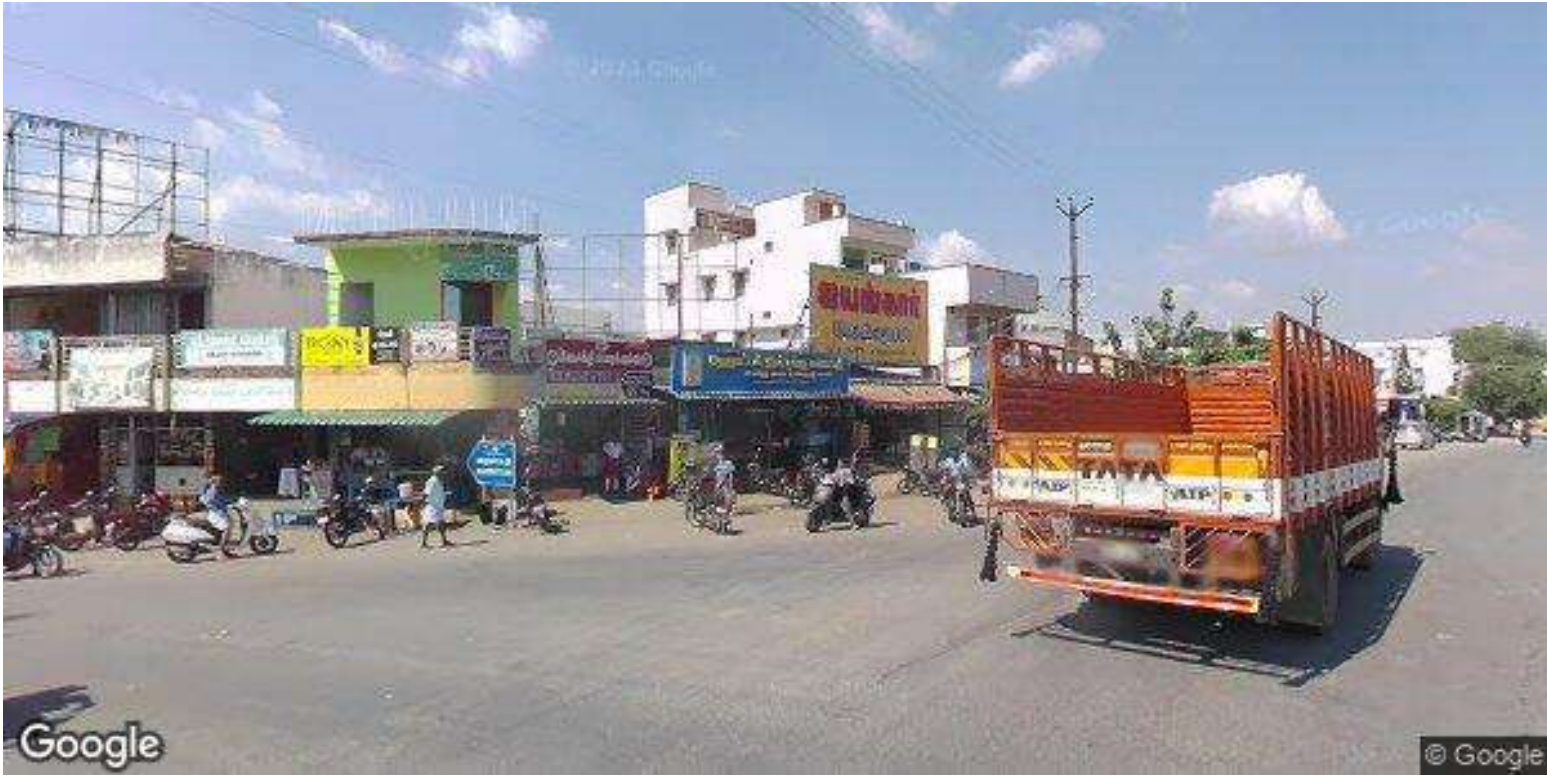
**Risk Type:** Turn  
**Risk Level:** Medium  
**Speed Limit:** 30 KM/Hr  
**Coordinates:** 11.36602, 77.88875

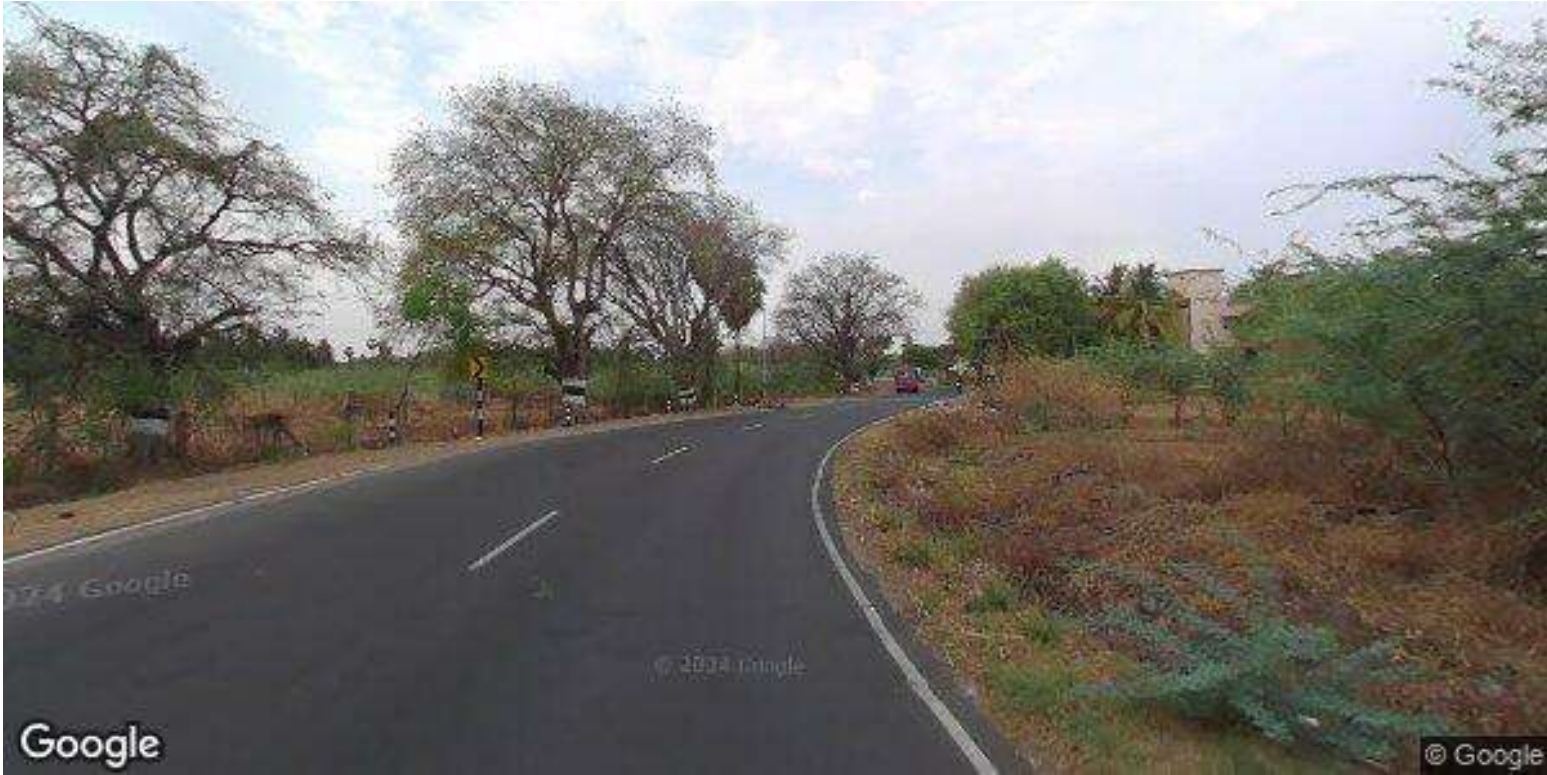
**Risk Type:** Turn  
**Risk Level:** Medium  
**Speed Limit:** 30 KM/Hr  
**Coordinates:** 11.34067, 77.86347

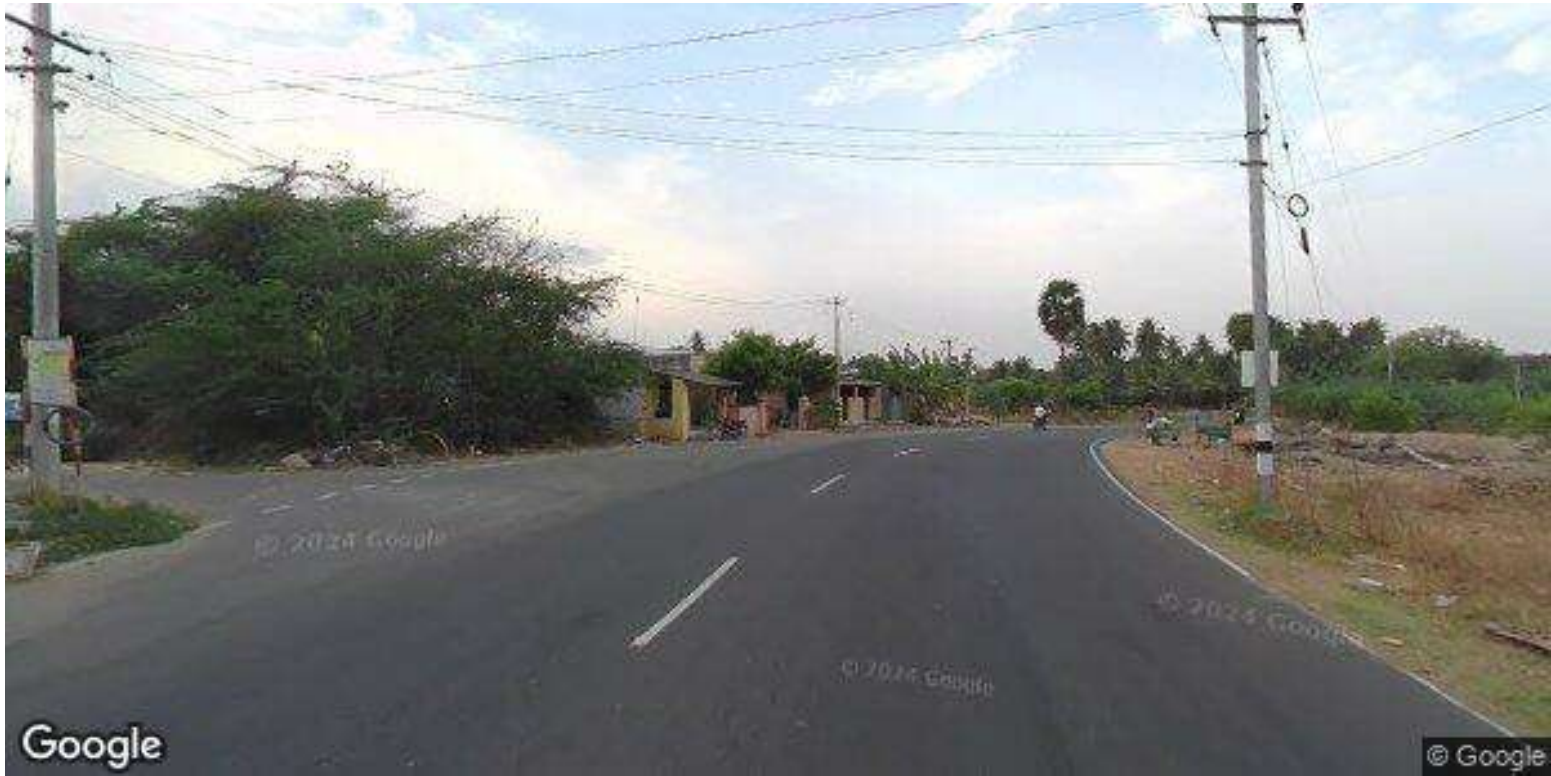
**Risk Type:** Turn  
**Risk Level:** Medium  
**Speed Limit:** 30 KM/Hr  
**Coordinates:** 11.33854, 77.86216

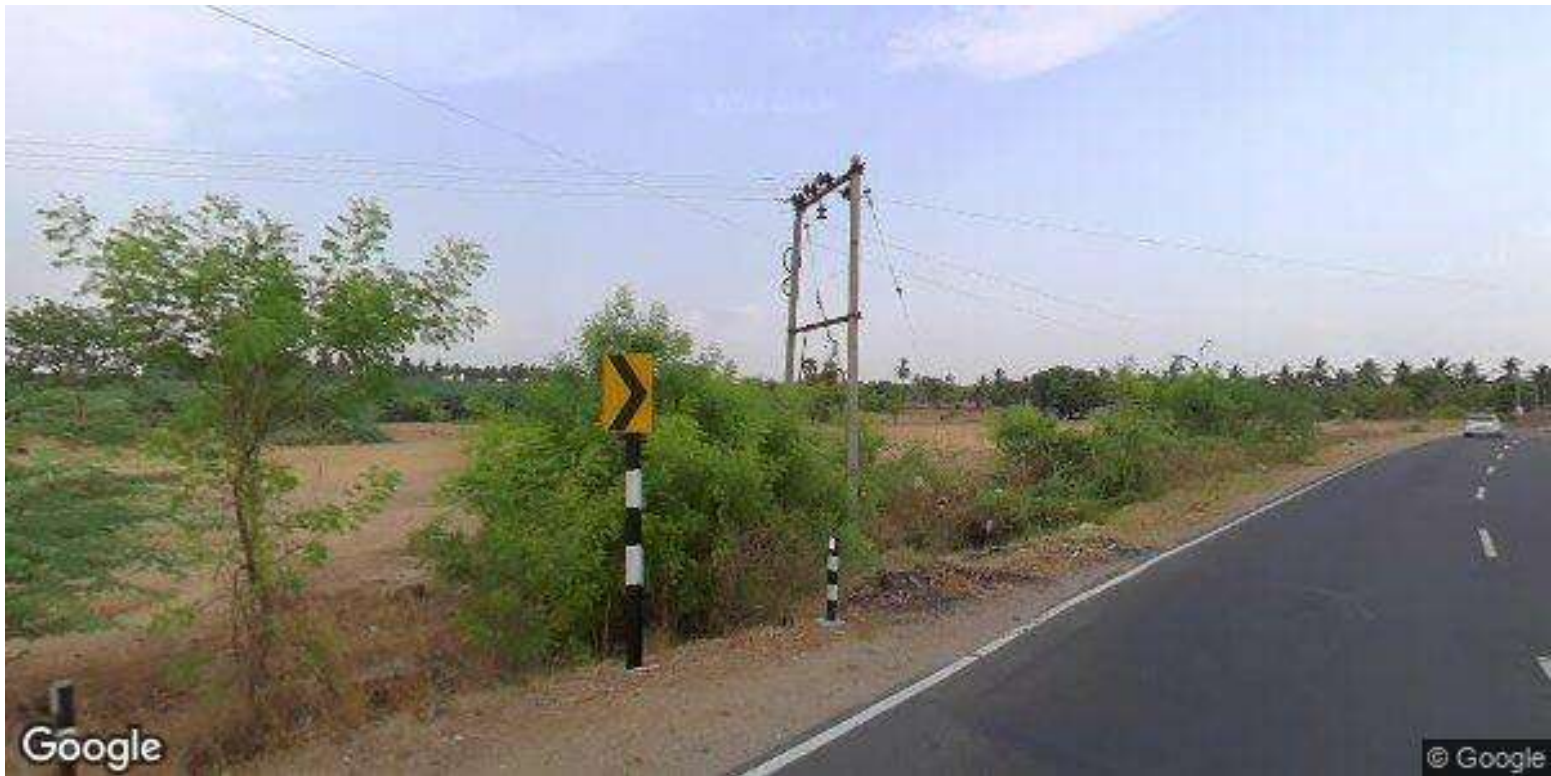
**Risk Type:** Turn  
**Risk Level:** Medium  
**Speed Limit:** 30 KM/Hr  
**Coordinates:** 11.33778, 77.86236

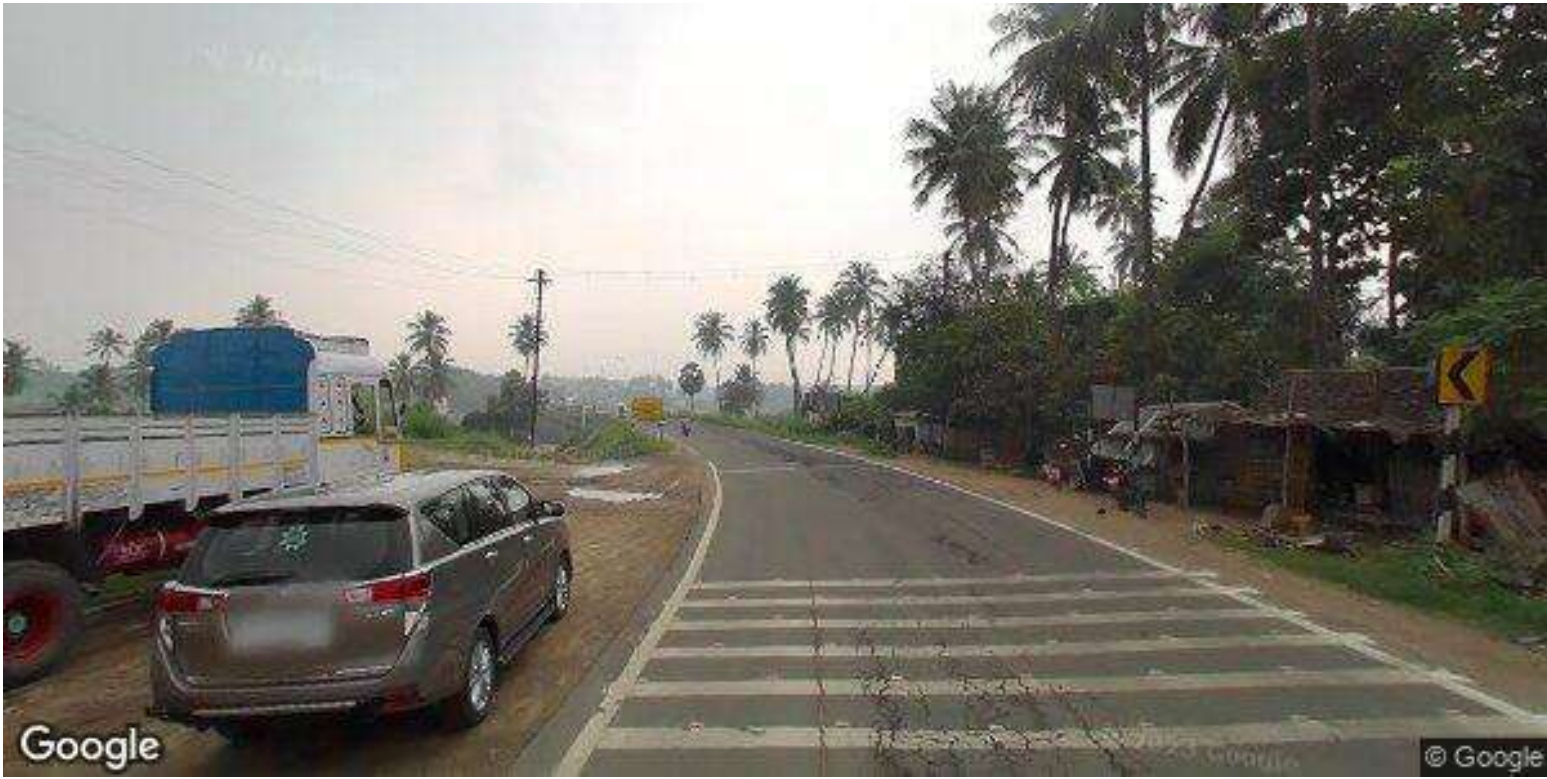
**Risk Type:** Turn  
**Risk Level:** Medium  
**Speed Limit:** 30 KM/Hr  
**Coordinates:** 11.30952, 77.77587

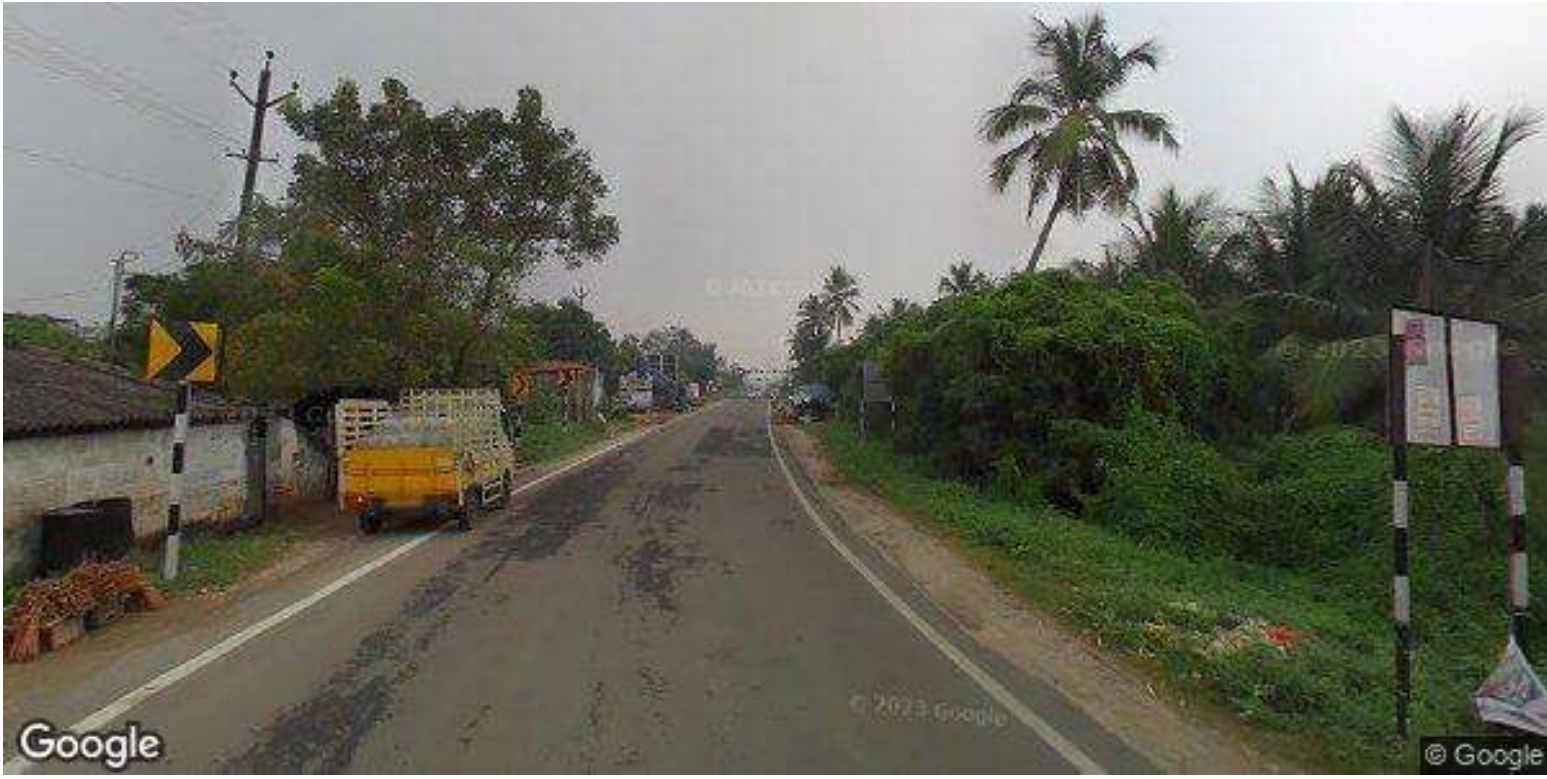
**Risk Type:** Turn  
**Risk Level:** Medium  
**Speed Limit:** 30 KM/Hr  
**Coordinates:** 11.30973, 77.76712

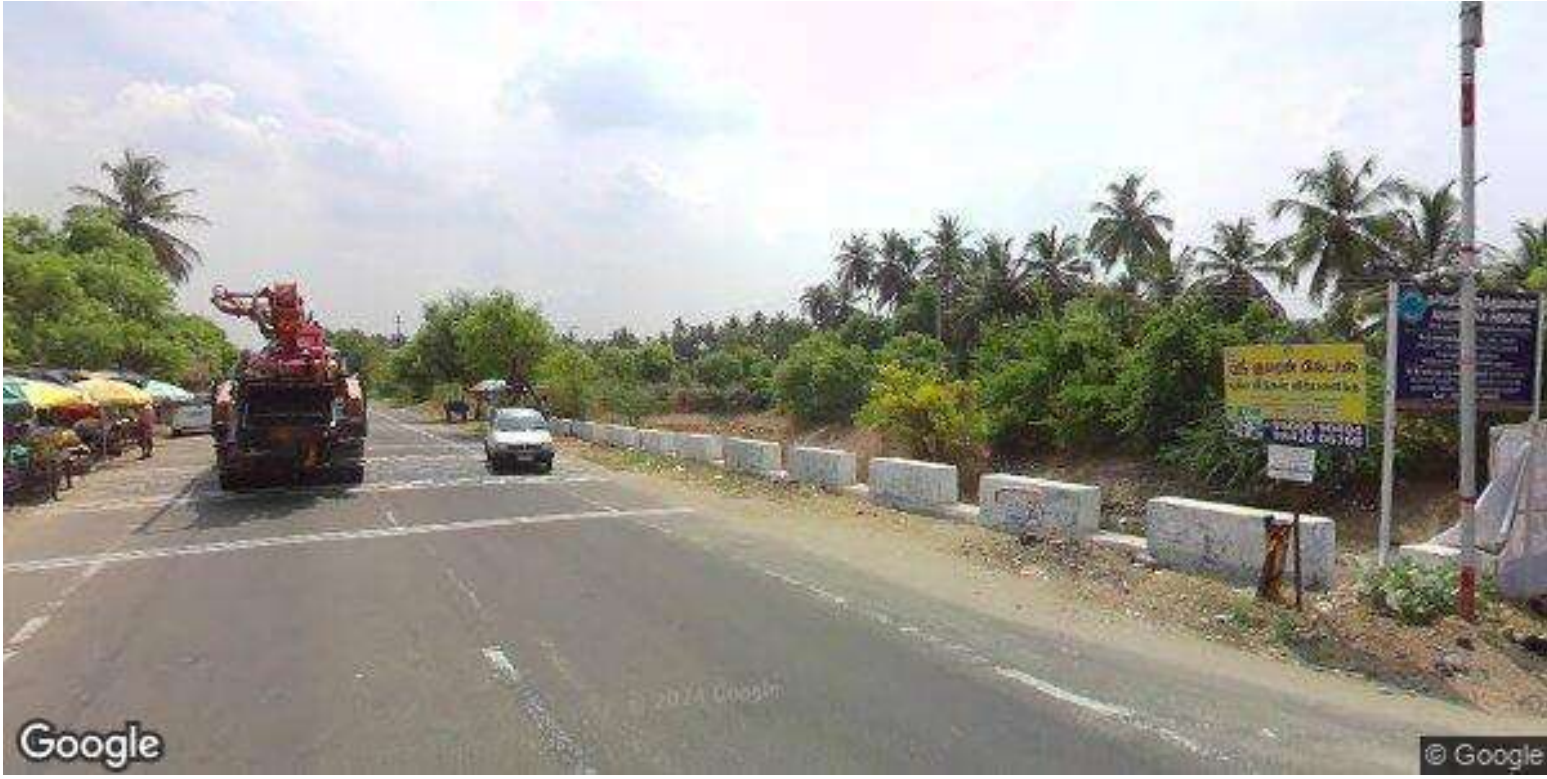
**Risk Type:** Turn  
**Risk Level:** High  
**Speed Limit:** 15 KM/Hr  
**Coordinates:** 11.29490, 77.74685

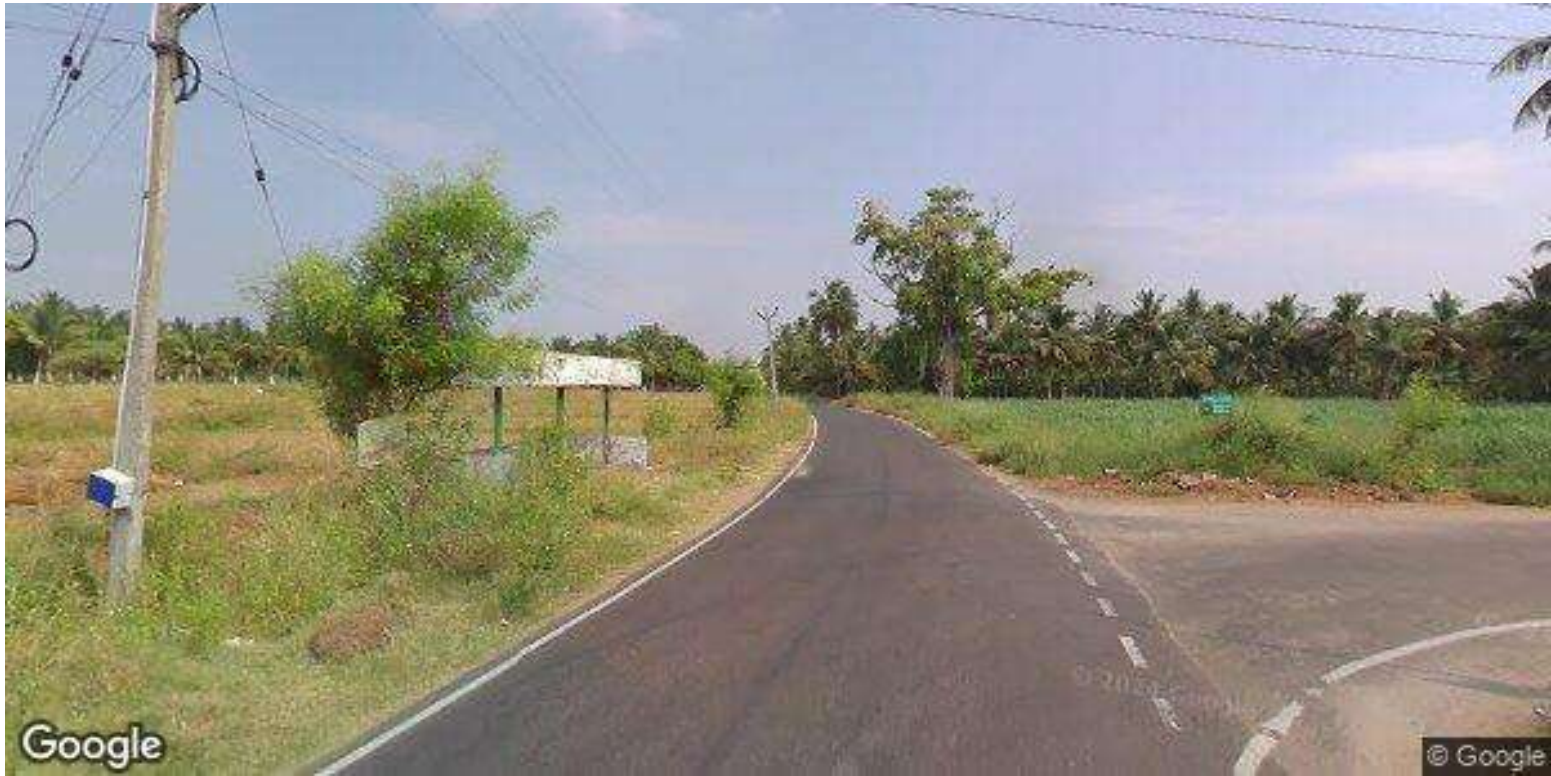
**Risk Type:** Turn  
**Risk Level:** High  
**Speed Limit:** 15 KM/Hr  
**Coordinates:** 11.29141, 77.74662

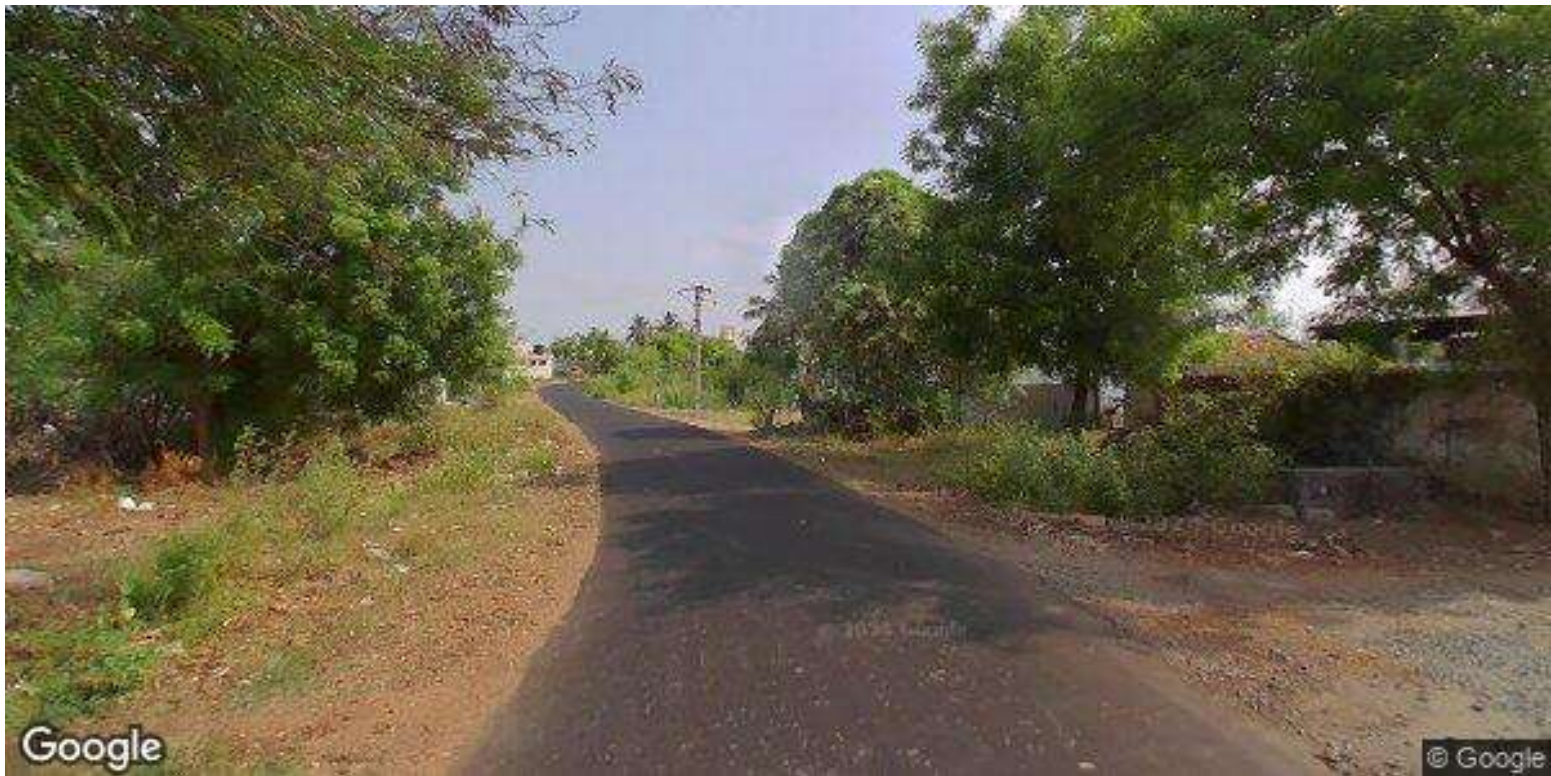
**Risk Type:** Turn  
**Risk Level:** Medium  
**Speed Limit:** 30 KM/Hr  
**Coordinates:** 11.28844, 77.74319

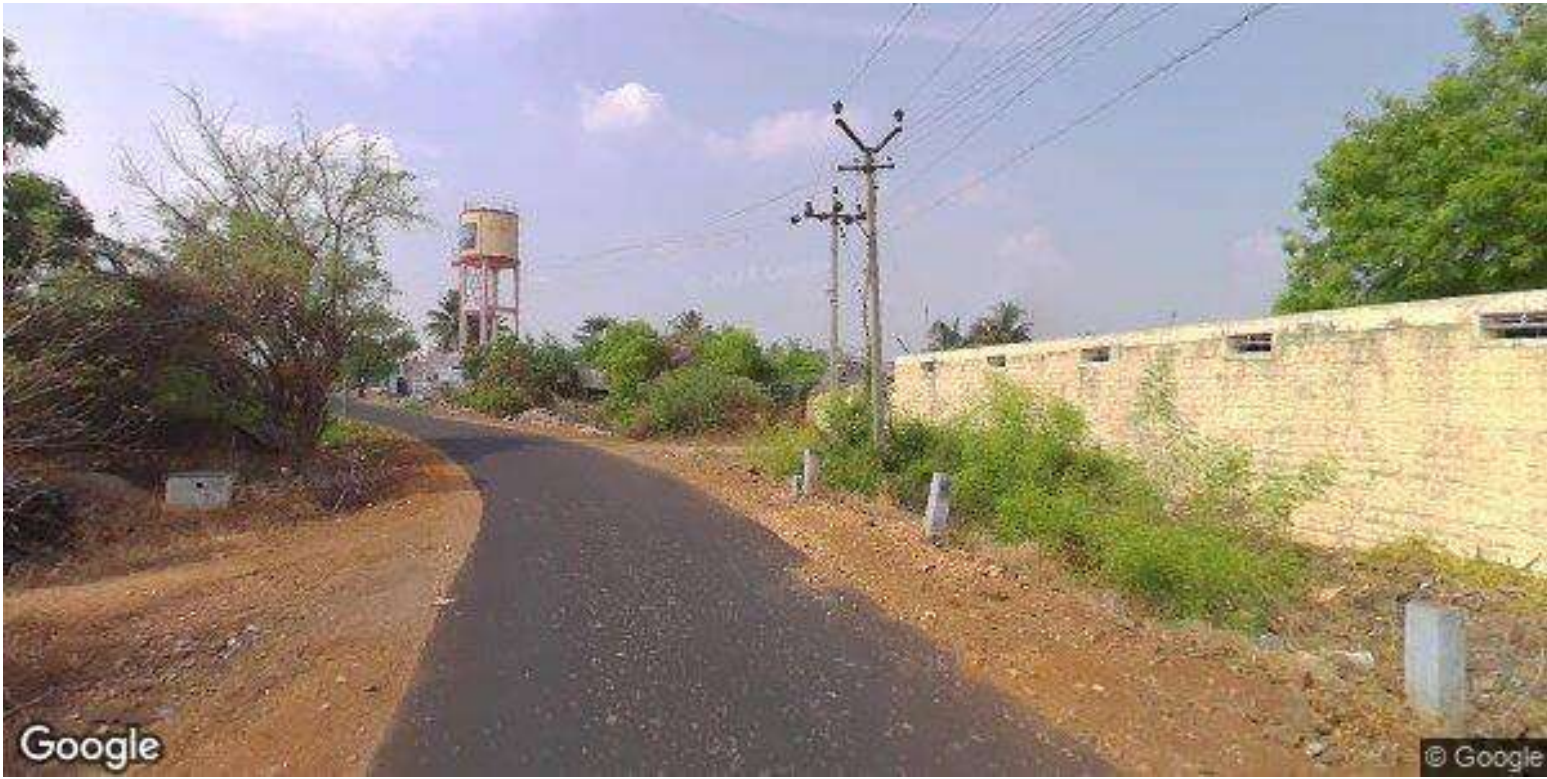
**Risk Type:** Turn  
**Risk Level:** Medium  
**Speed Limit:** 30 KM/Hr  
**Coordinates:** 11.28573, 77.74281

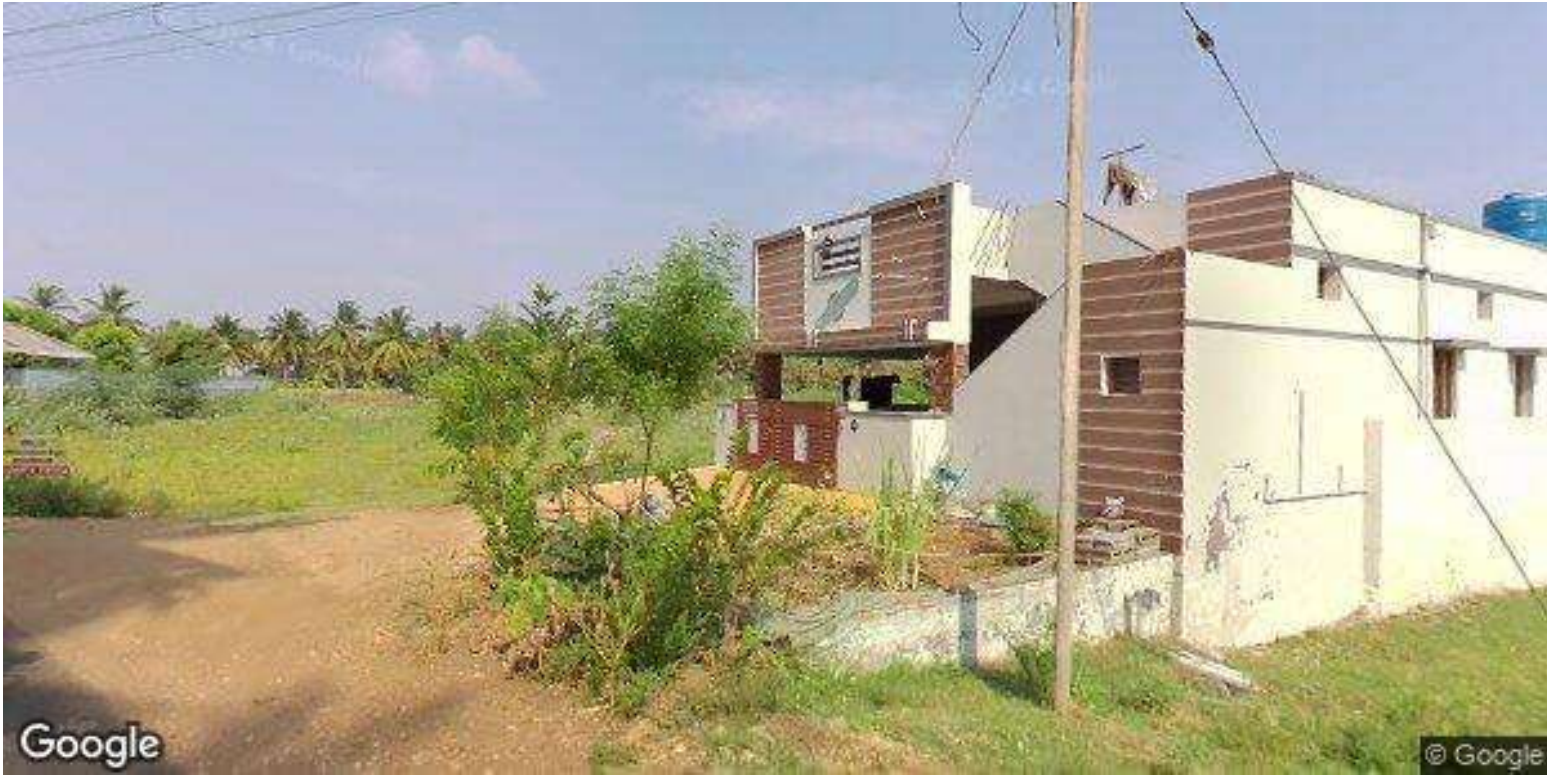
**Risk Type:** Turn  
**Risk Level:** High  
**Speed Limit:** 15 KM/Hr  
**Coordinates:** 11.27319, 77.72981

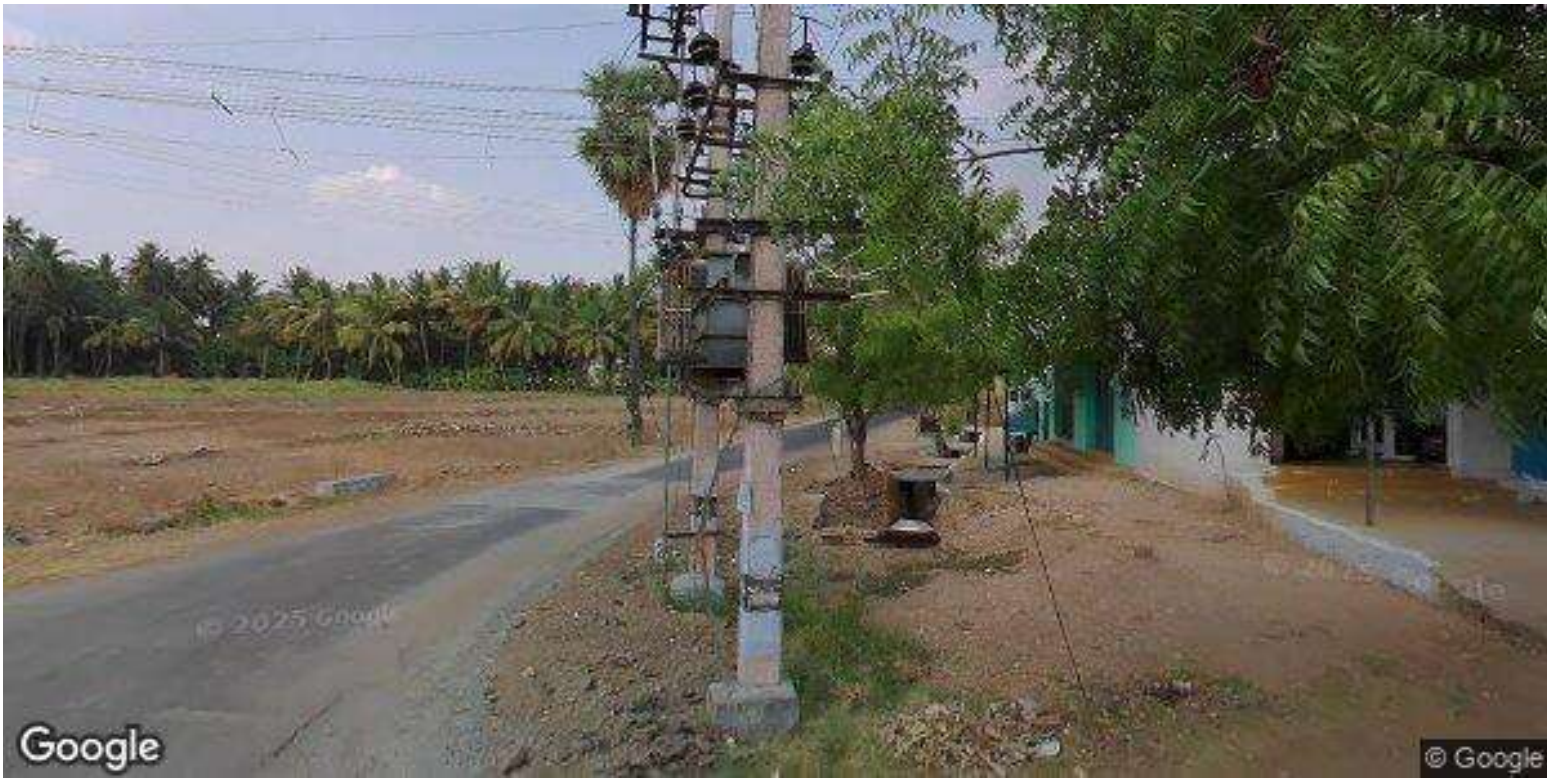
**Risk Type:** Blind Spot  
**Risk Level:** Blind Spot  
**Speed Limit:** 10 KM/Hr  
**Coordinates:** 11.27330, 77.72715

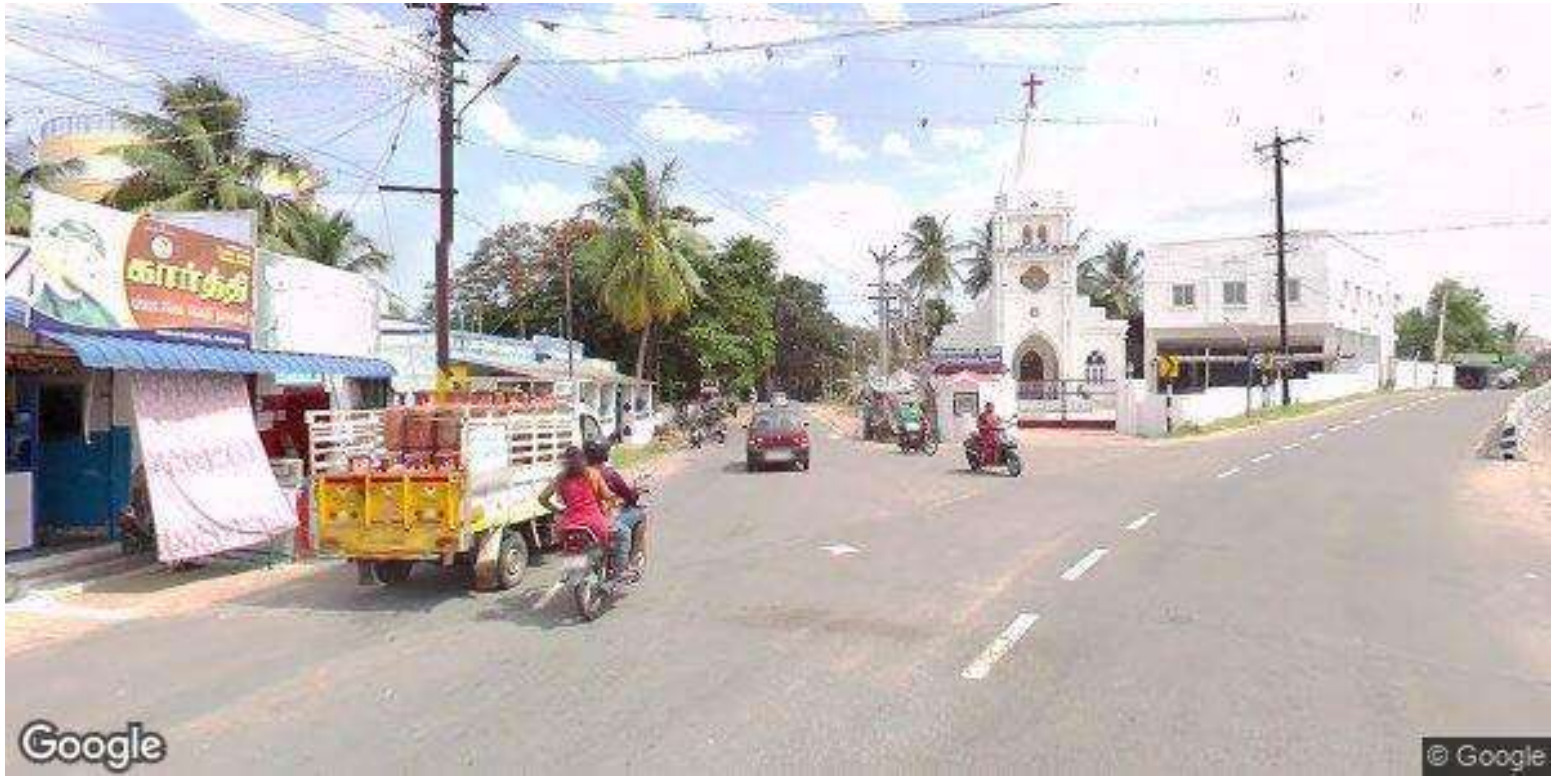
**Risk Type:** Turn  
**Risk Level:** Medium  
**Speed Limit:** 30 KM/Hr  
**Coordinates:** 11.23054, 77.71796
