# IndianOil

## JOURNEY RISK MANAGEMENT (JRM) STUDY

### Salem Terminal TO VEMBANAN & CO P.N

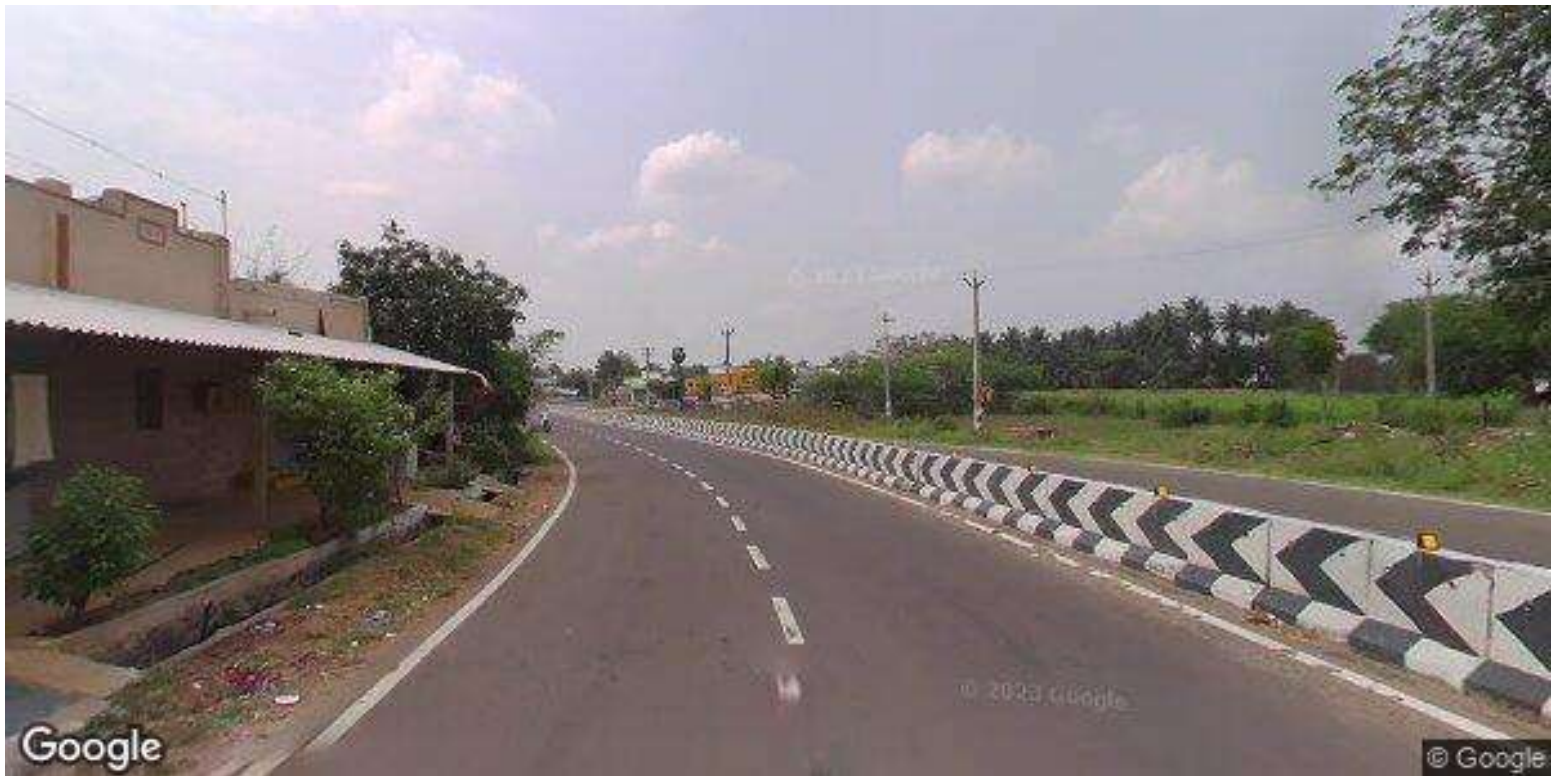
**Risk Type:** Turn  
**Risk Level:** Medium  
**Speed Limit:** 30 KM/Hr  
**Coordinates:** 11.22387, 77.71385

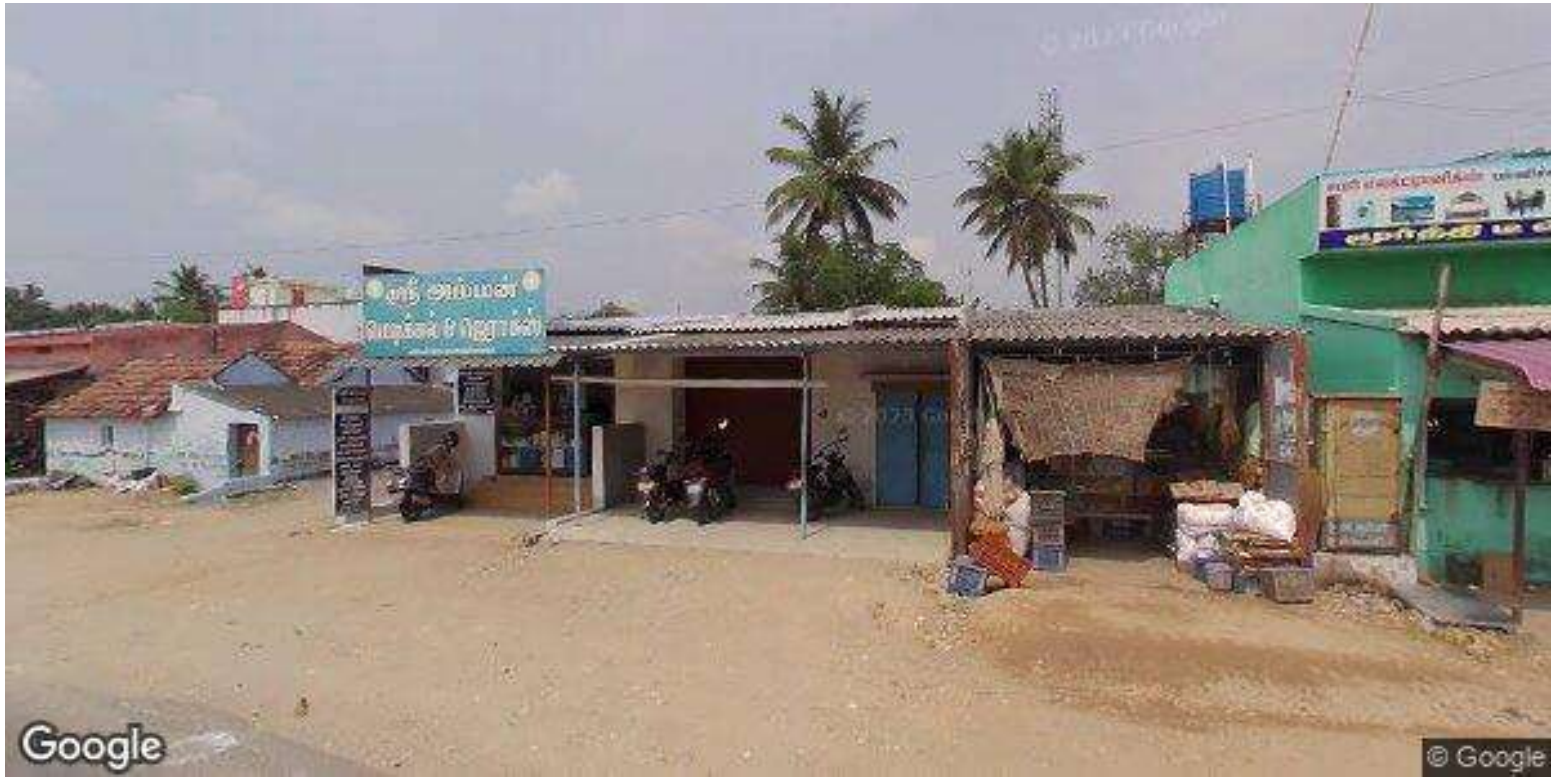
**Risk Type:** Turn  
**Risk Level:** Medium  
**Speed Limit:** 30 KM/Hr  
**Coordinates:** 11.20776, 77.70916

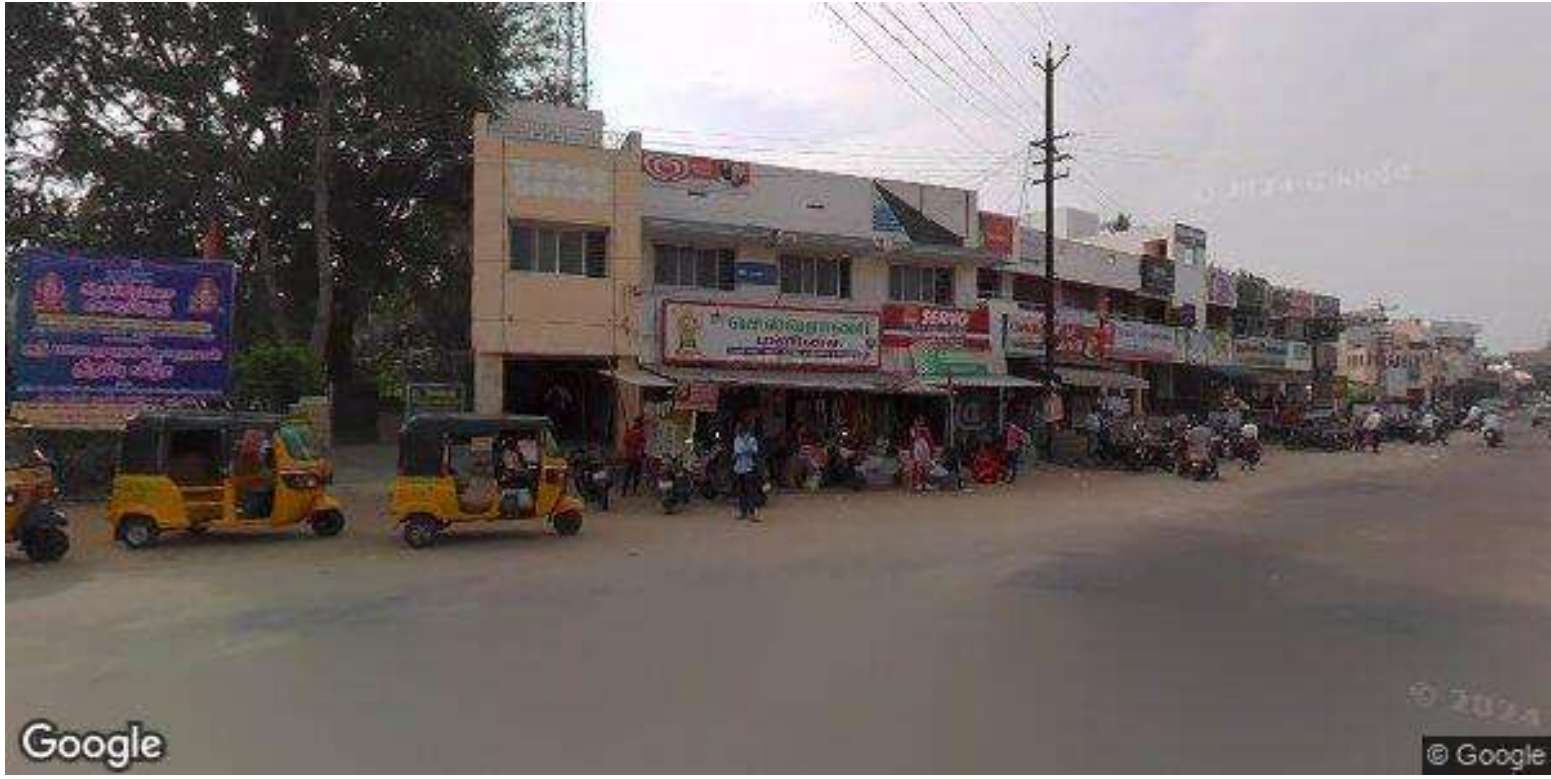
**Risk Type:** Turn  
**Risk Level:** High  
**Speed Limit:** 15 KM/Hr  
**Coordinates:** 11.15942, 77.70068

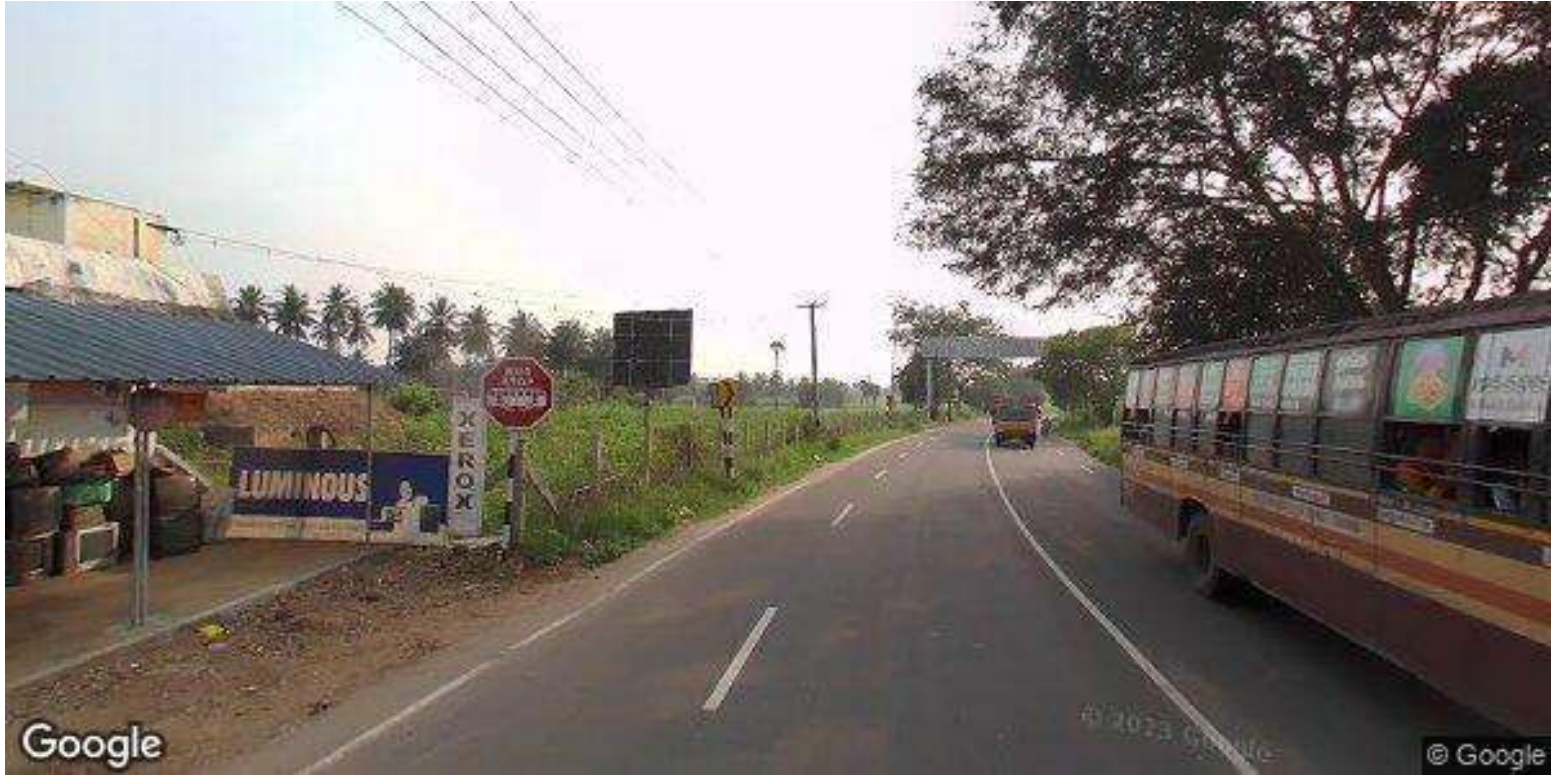
**Risk Type:** Turn  
**Risk Level:** Medium  
**Speed Limit:** 30 KM/Hr  
**Coordinates:** 11.12102, 77.67919

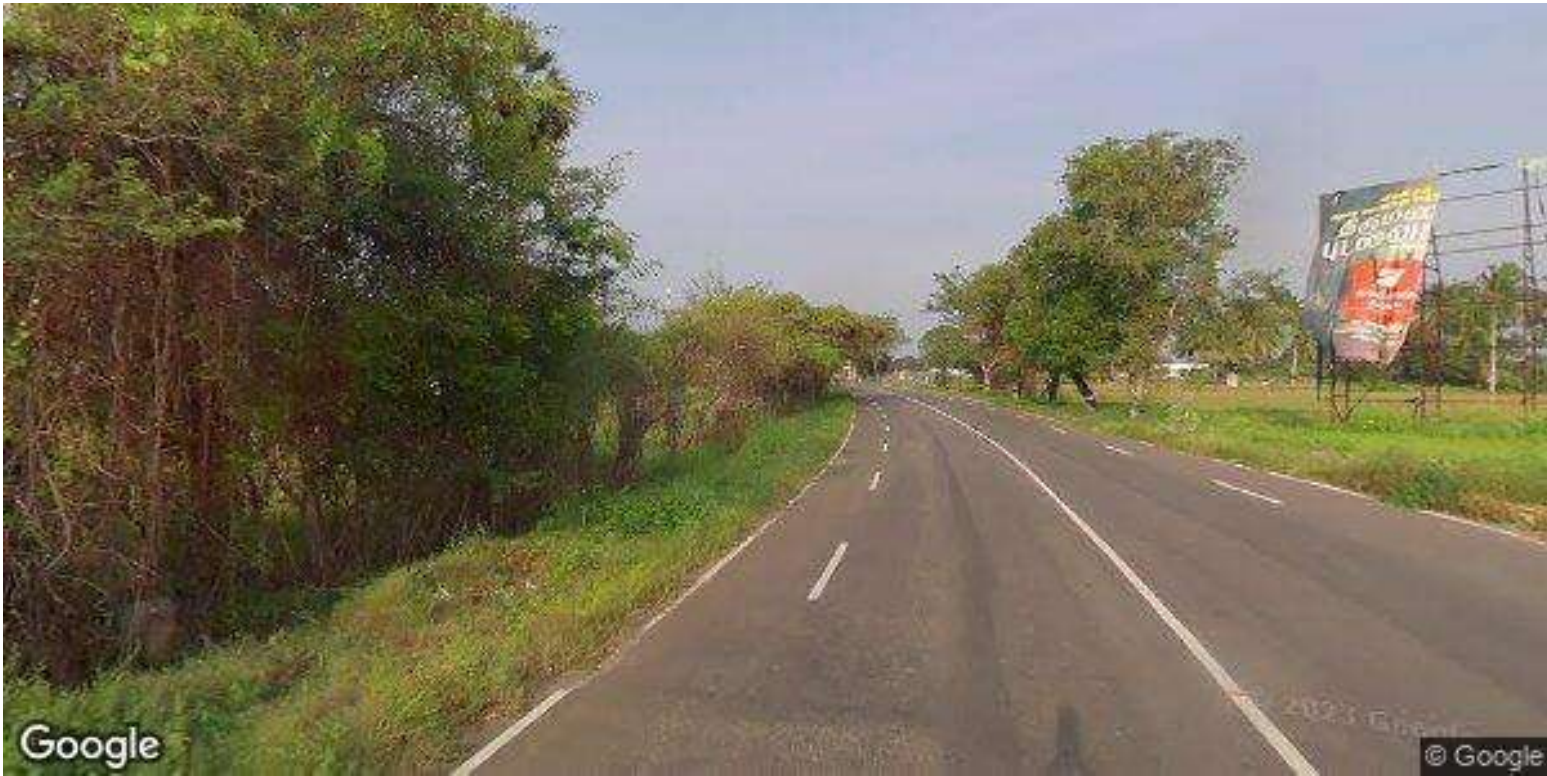
**Risk Type:** Turn  
**Risk Level:** Medium  
**Speed Limit:** 30 KM/Hr  
**Coordinates:** 11.11932, 77.67786

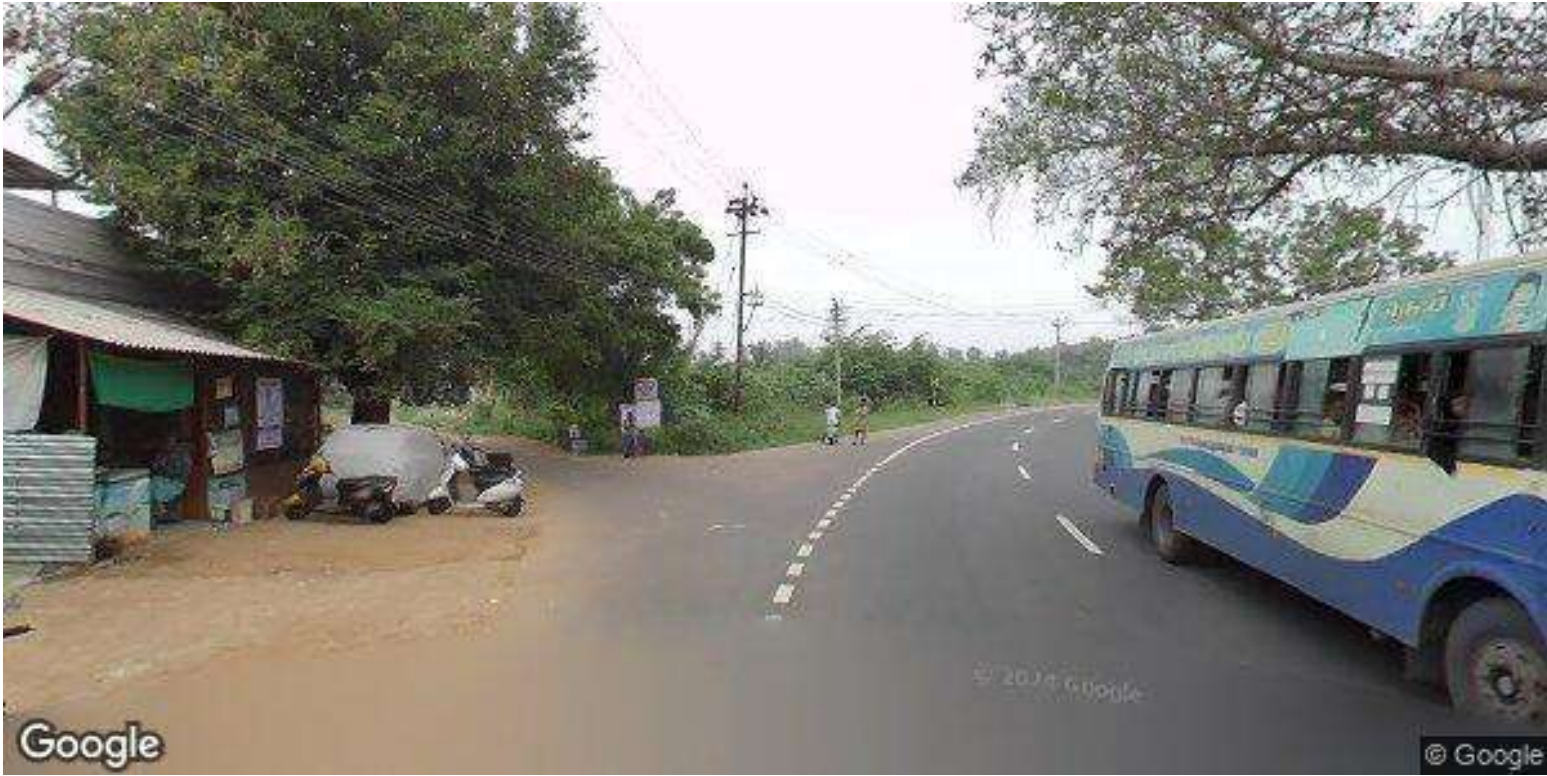
**Risk Type:** Turn  
**Risk Level:** Medium  
**Speed Limit:** 30 KM/Hr  
**Coordinates:** 11.11710, 77.67175

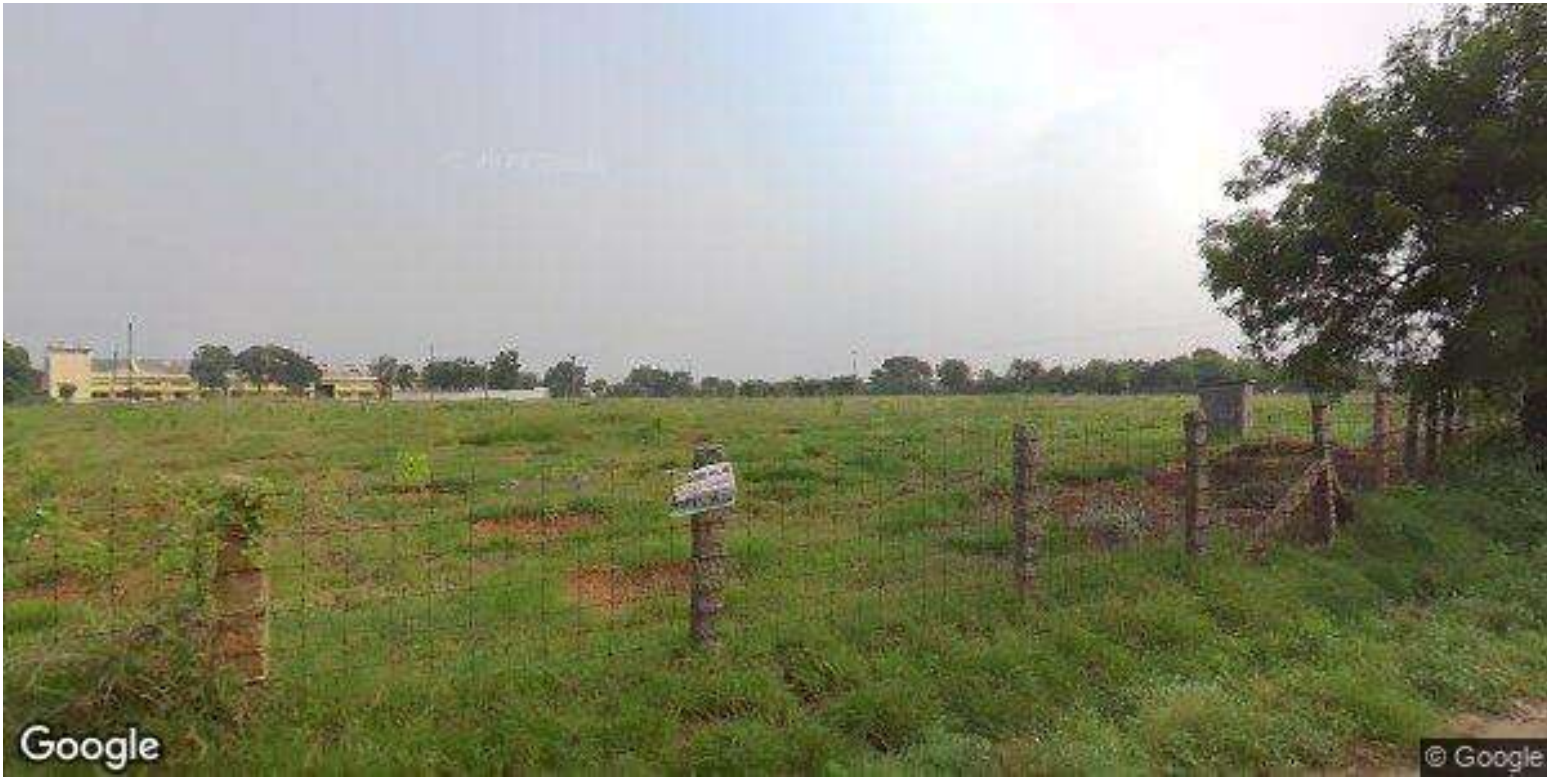
**Risk Type:** Turn  
**Risk Level:** Medium  
**Speed Limit:** 30 KM/Hr  
**Coordinates:** 11.09491, 77.66603

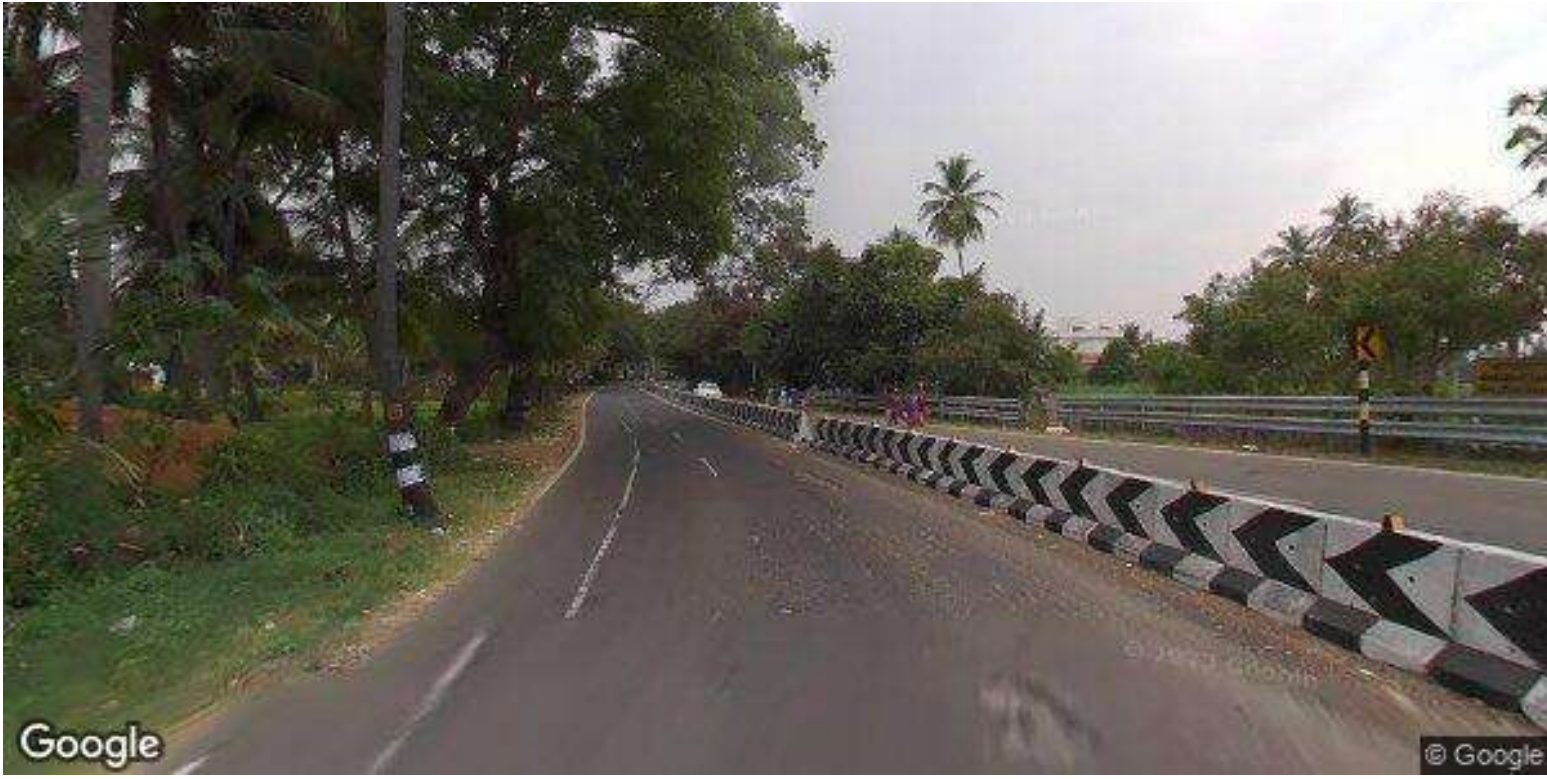
**Risk Type:** Turn  
**Risk Level:** Medium  
**Speed Limit:** 30 KM/Hr  
**Coordinates:** 11.08282, 77.65837

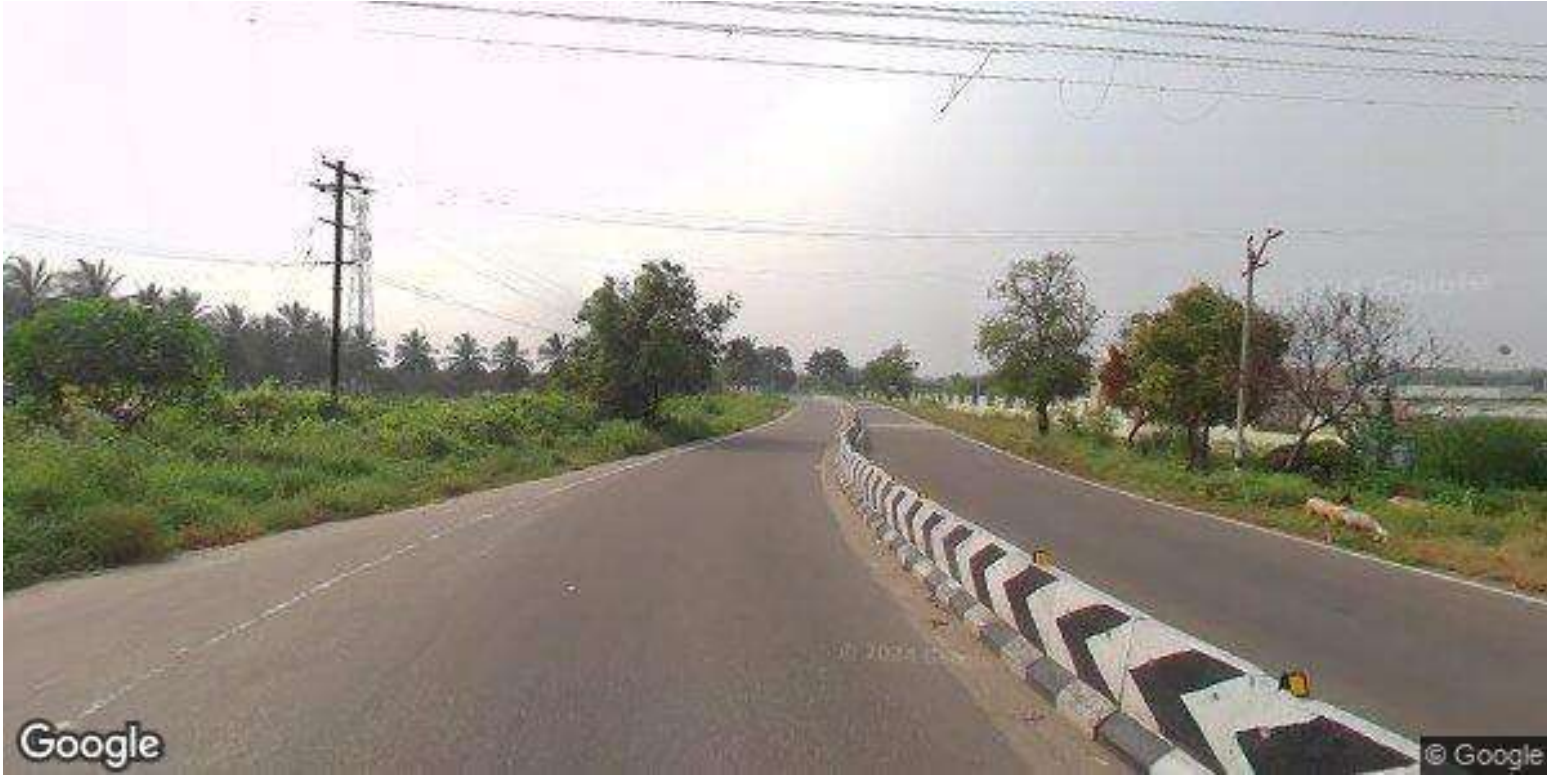
**Risk Type:** Turn  
**Risk Level:** Medium  
**Speed Limit:** 30 KM/Hr  
**Coordinates:** 11.06183, 77.63924

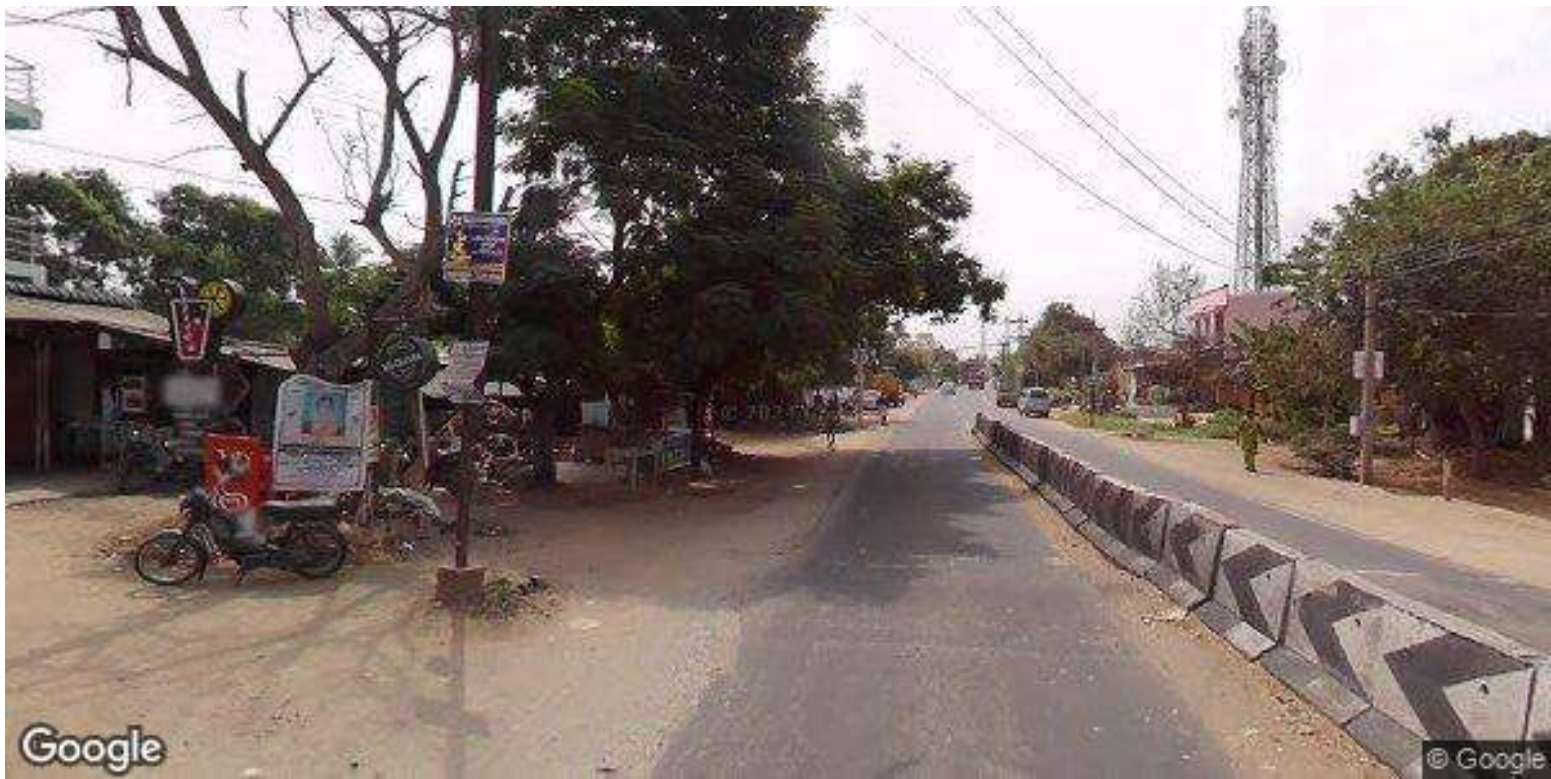
**Risk Type:** Turn  
**Risk Level:** High  
**Speed Limit:** 15 KM/Hr  
**Coordinates:** 11.00826, 77.56962

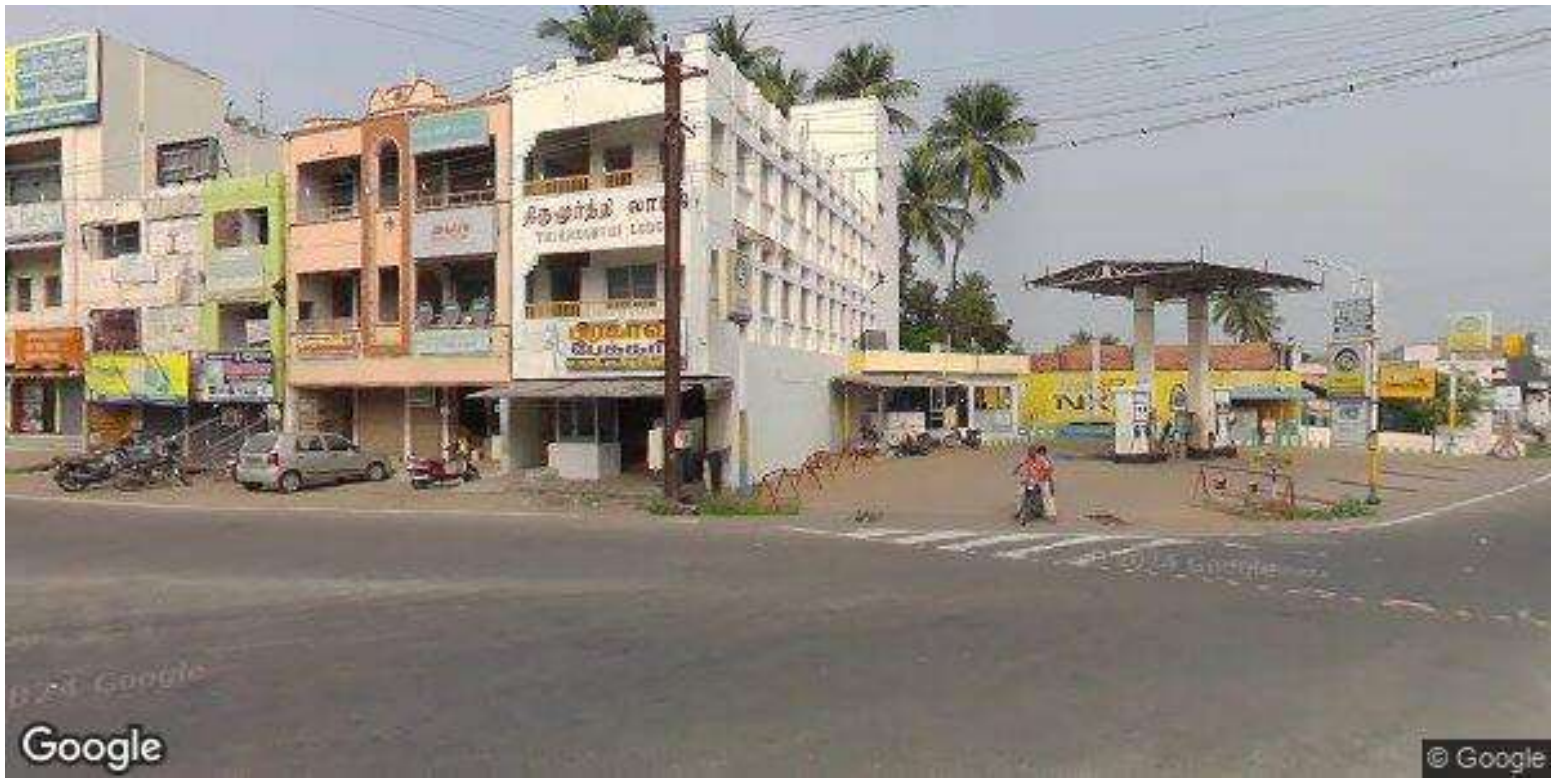
**Risk Type:** Turn  
**Risk Level:** High  
**Speed Limit:** 15 KM/Hr  
**Coordinates:** 11.00172, 77.56268

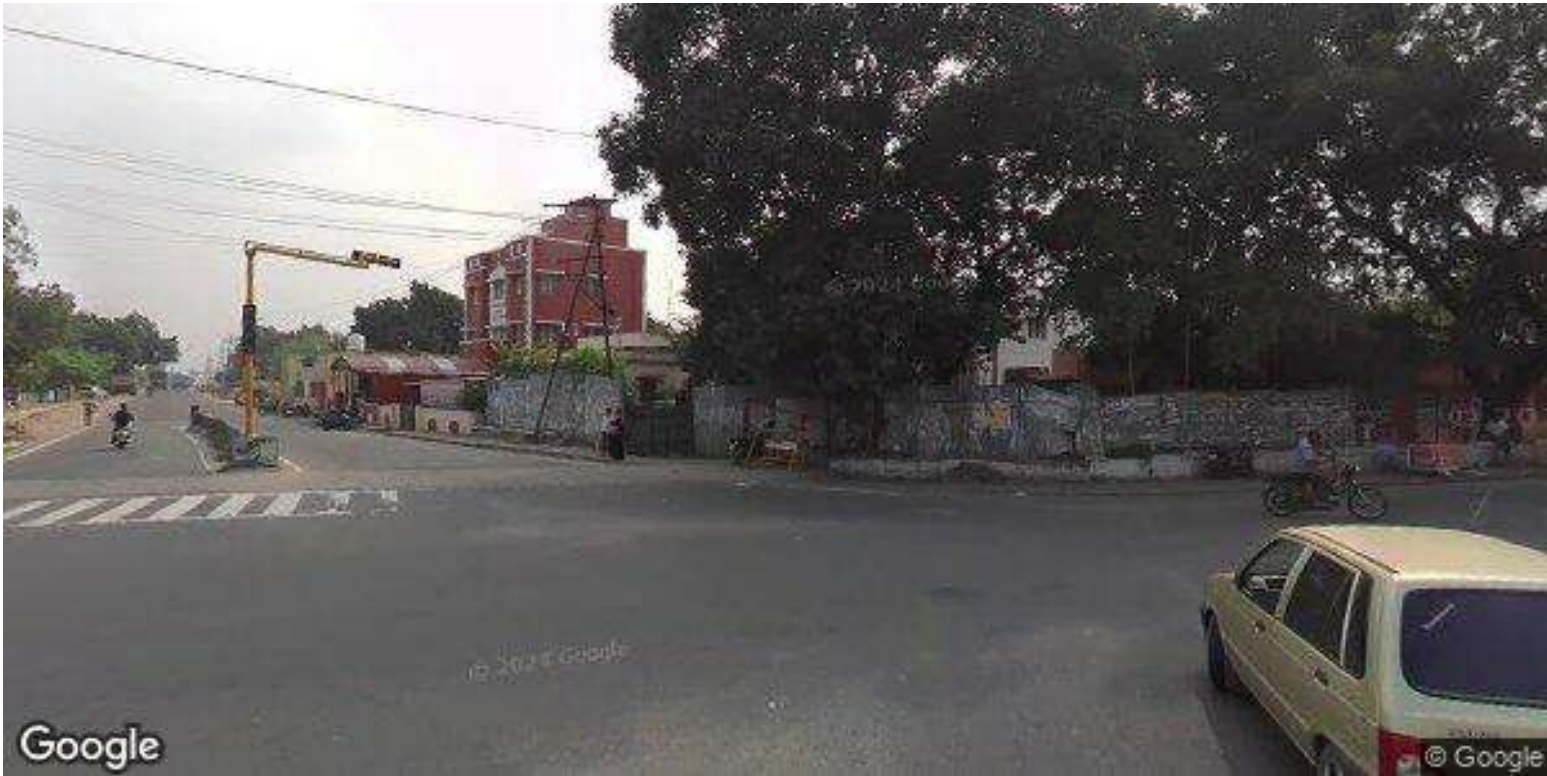
**Risk Type:** Turn  
**Risk Level:** Medium  
**Speed Limit:** 30 KM/Hr  
**Coordinates:** 11.00170, 77.56267

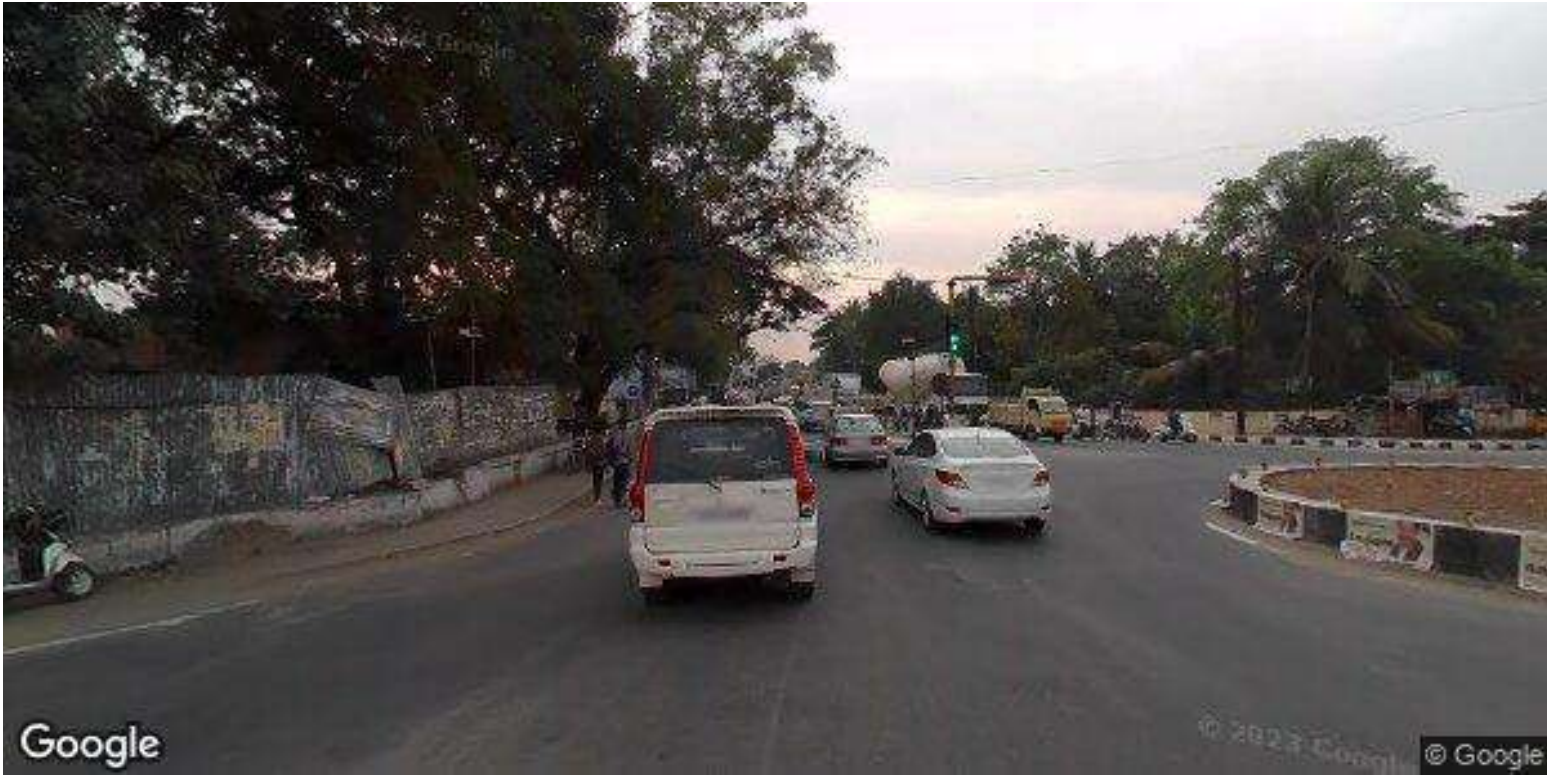
**Risk Type:** Turn  
**Risk Level:** Medium  
**Speed Limit:** 30 KM/Hr  
**Coordinates:** 11.00168, 77.56264

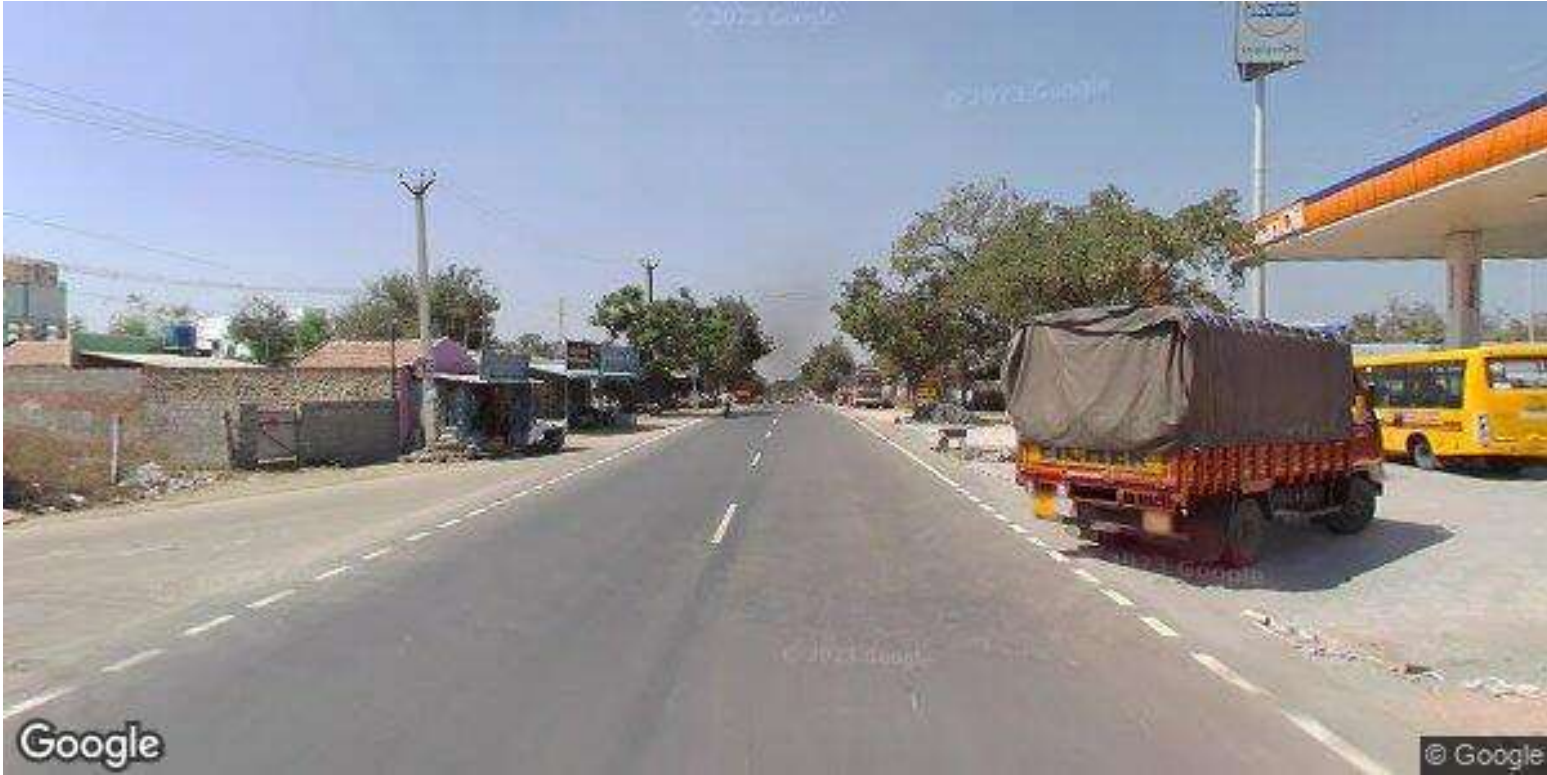
**Coordinates:** 11.00014, 77.55353

**Risk Type:** Turn

**Risk Level:** High

**Speed Limit:** 15 KM/Hr
