# IndianOil

## JOURNEY RISK MANAGEMENT (JRM) STUDY

### Salem Terminal to PRAKASH AGENCIES

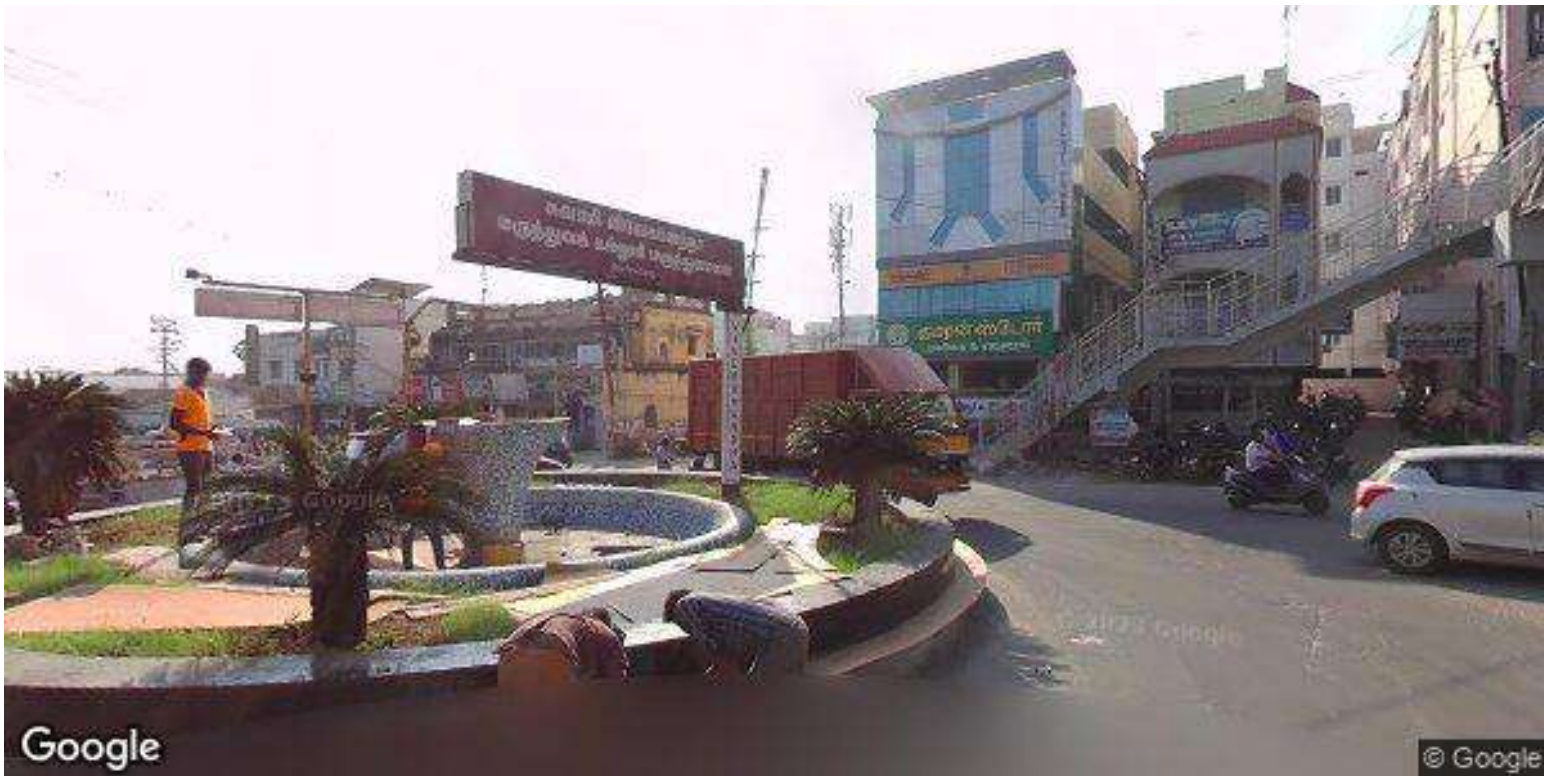
**Coordinates:** 11.38395, 77.89480

**Risk Type:** Roundabout

**Risk Level:** High

**Speed Limit:** 15 KM/Hr

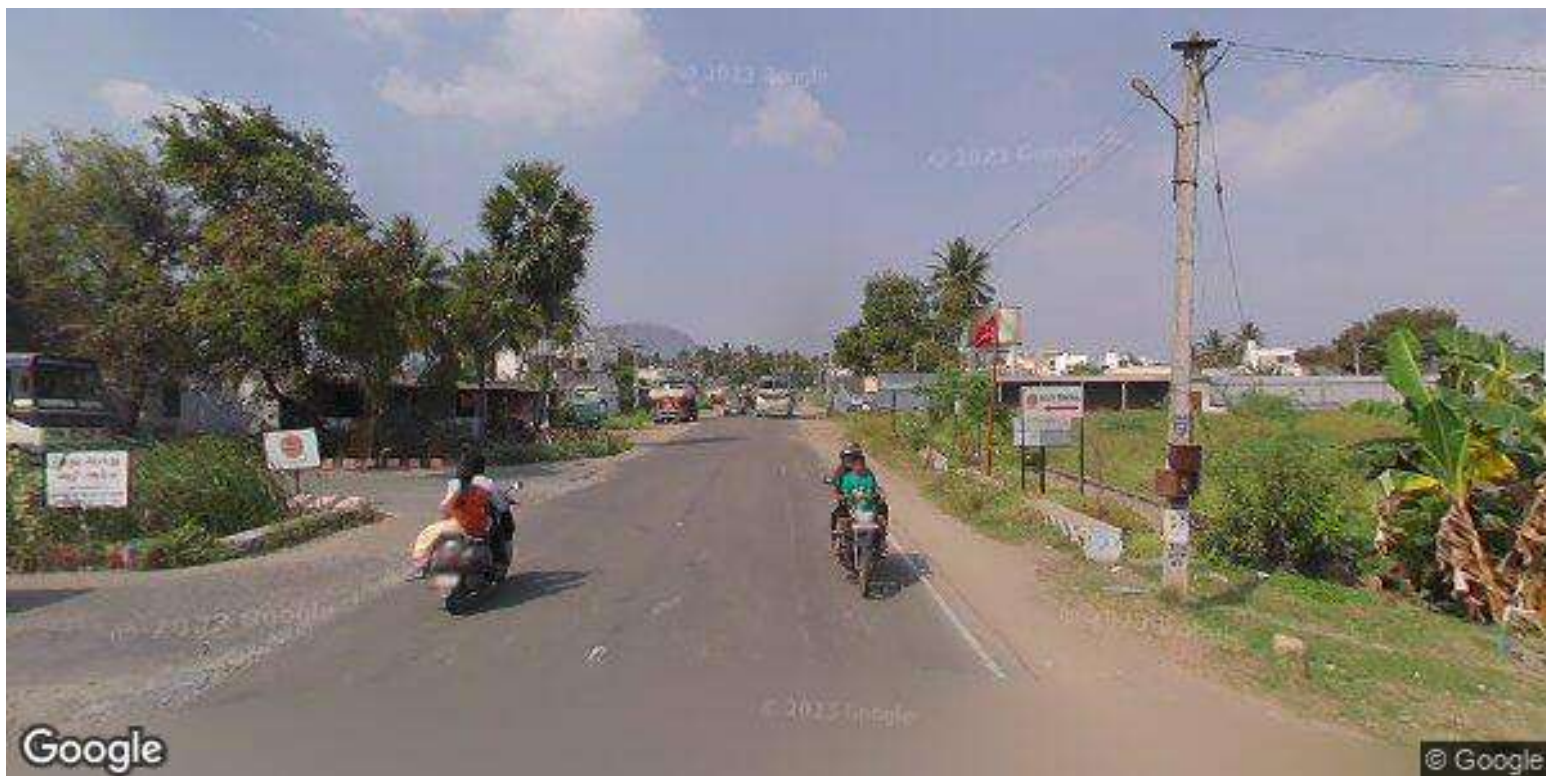
**Coordinates:** 11.44019, 77.87547

**Risk Type:** Turn

**Risk Level:** High

**Speed Limit:** 15 KM/Hr

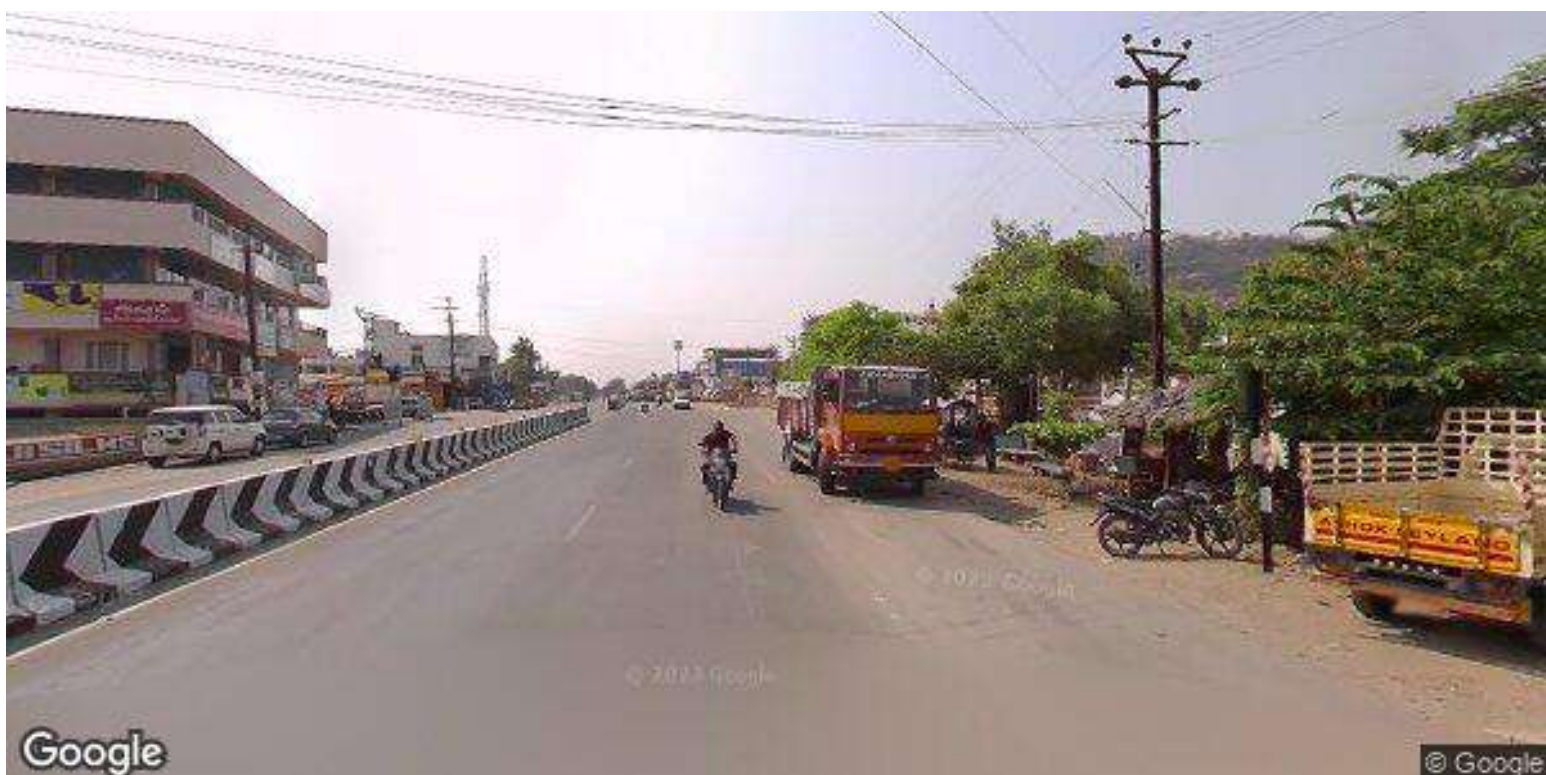
**Coordinates: 11.39685, 77.88861**

**Risk Type: Turn**

**Risk Level: Medium**

**Speed Limit: 30 KM/Hr**

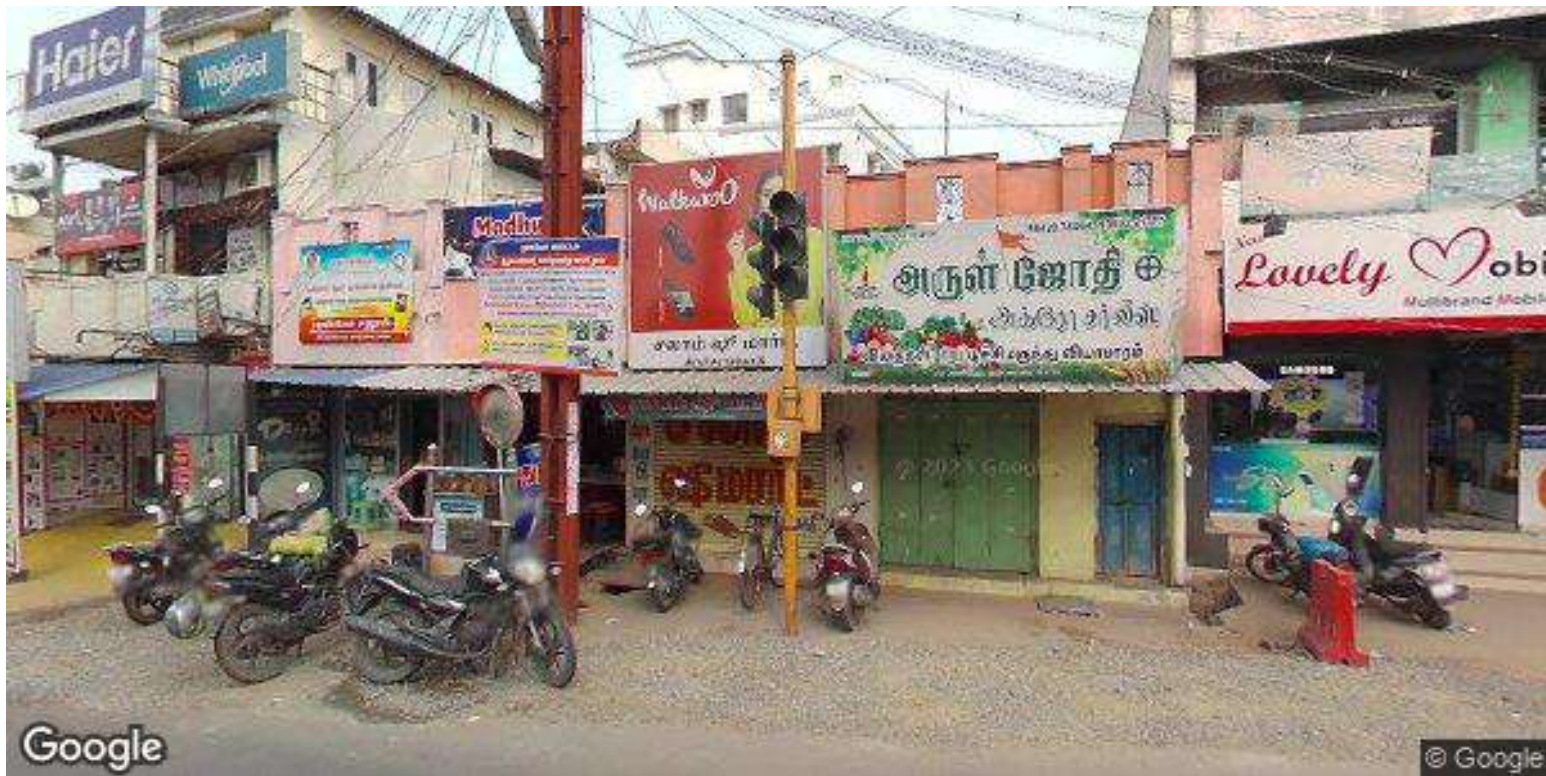
**Coordinates: 11.37850, 77.89453**

**Risk Type: Turn**

**Risk Level: High**

**Speed Limit: 15 KM/Hr**

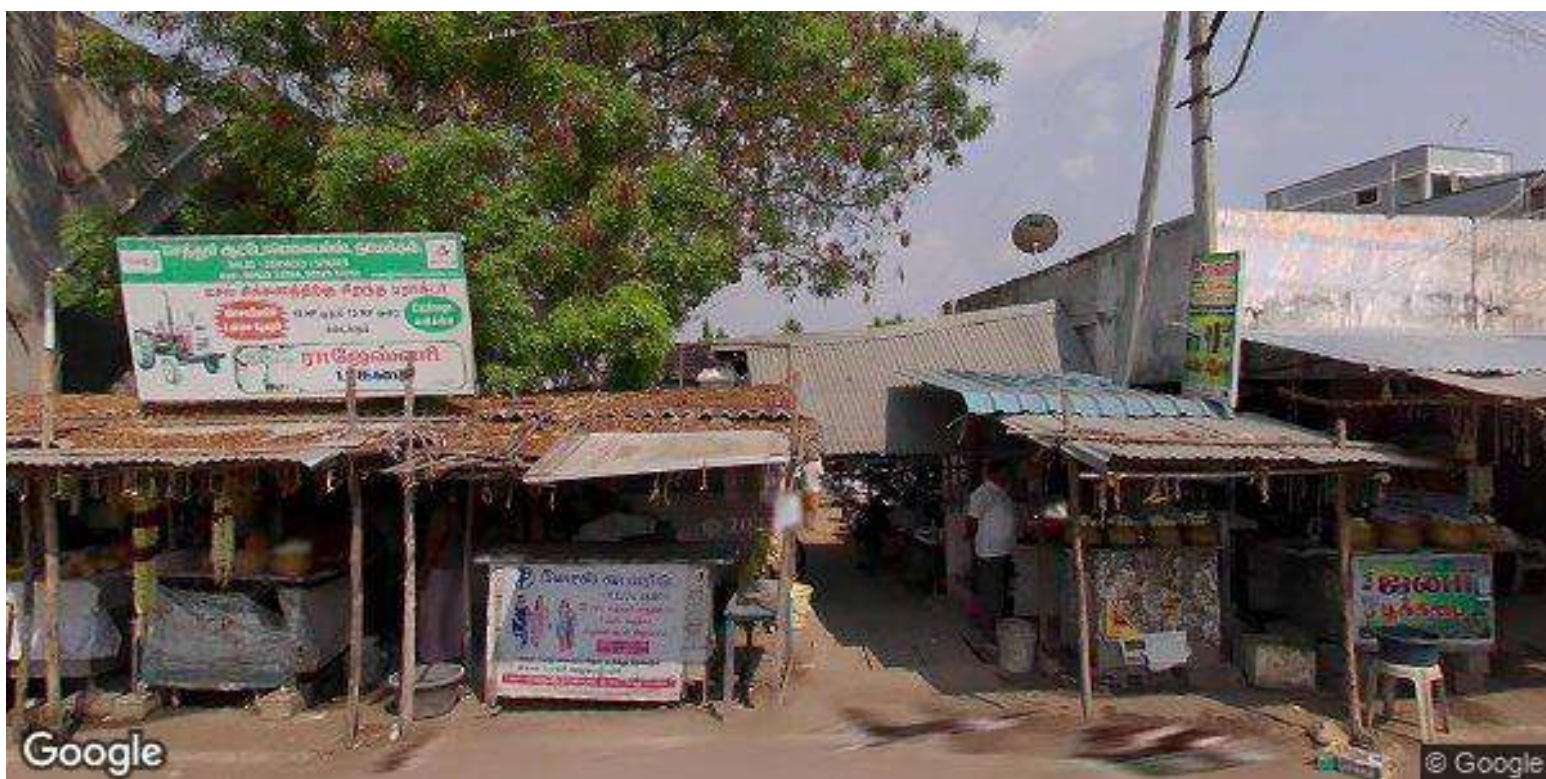
**Coordinates:** 11.15573, 78.02176

**Risk Type:** Turn

**Risk Level:** High

**Speed Limit:** 15 KM/Hr

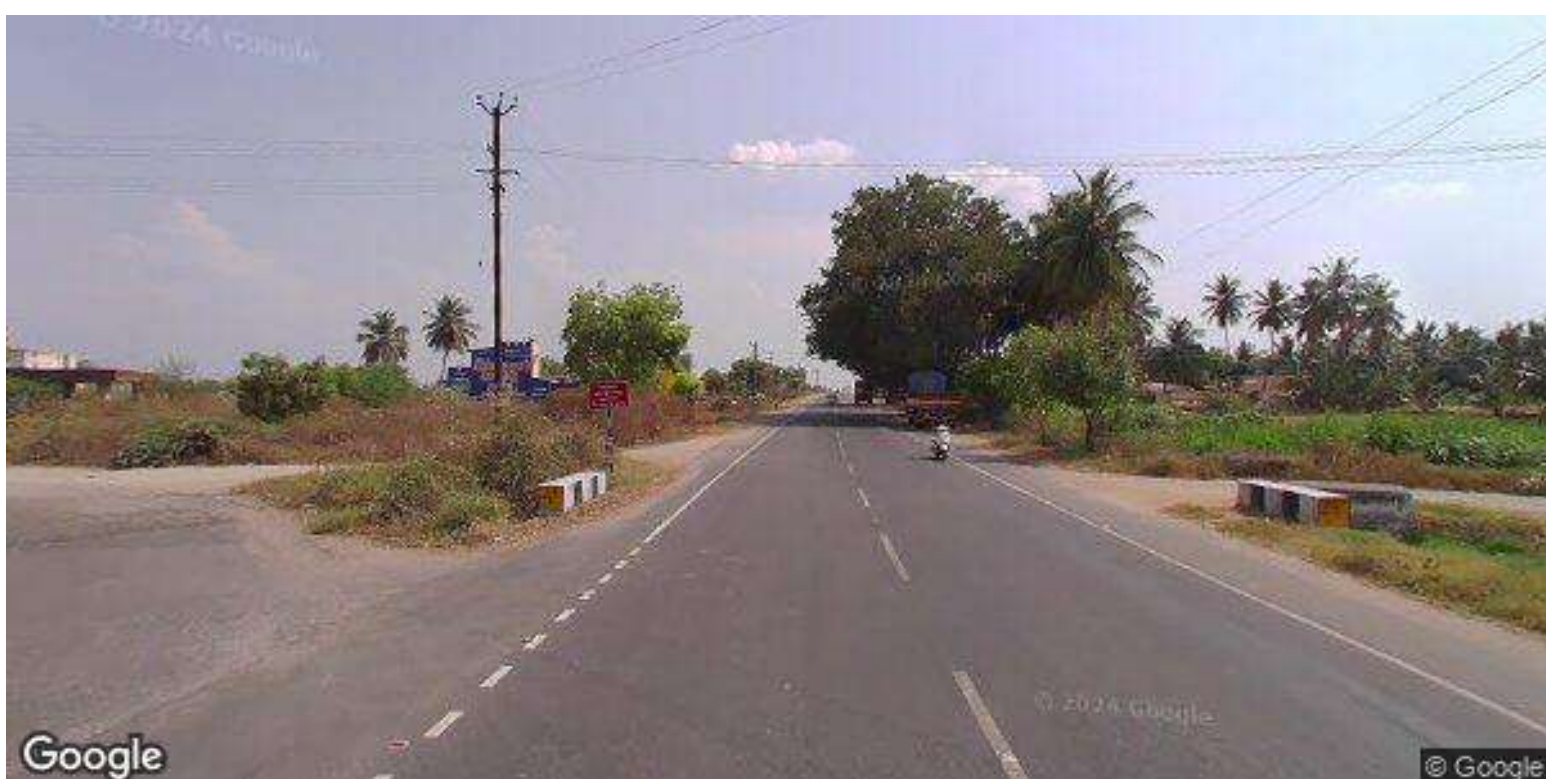
**Risk Type:** Turn  
**Risk Level:** High  
**Speed Limit:** 15 KM/Hr  
**Coordinates:** 11.14545, 78.02208

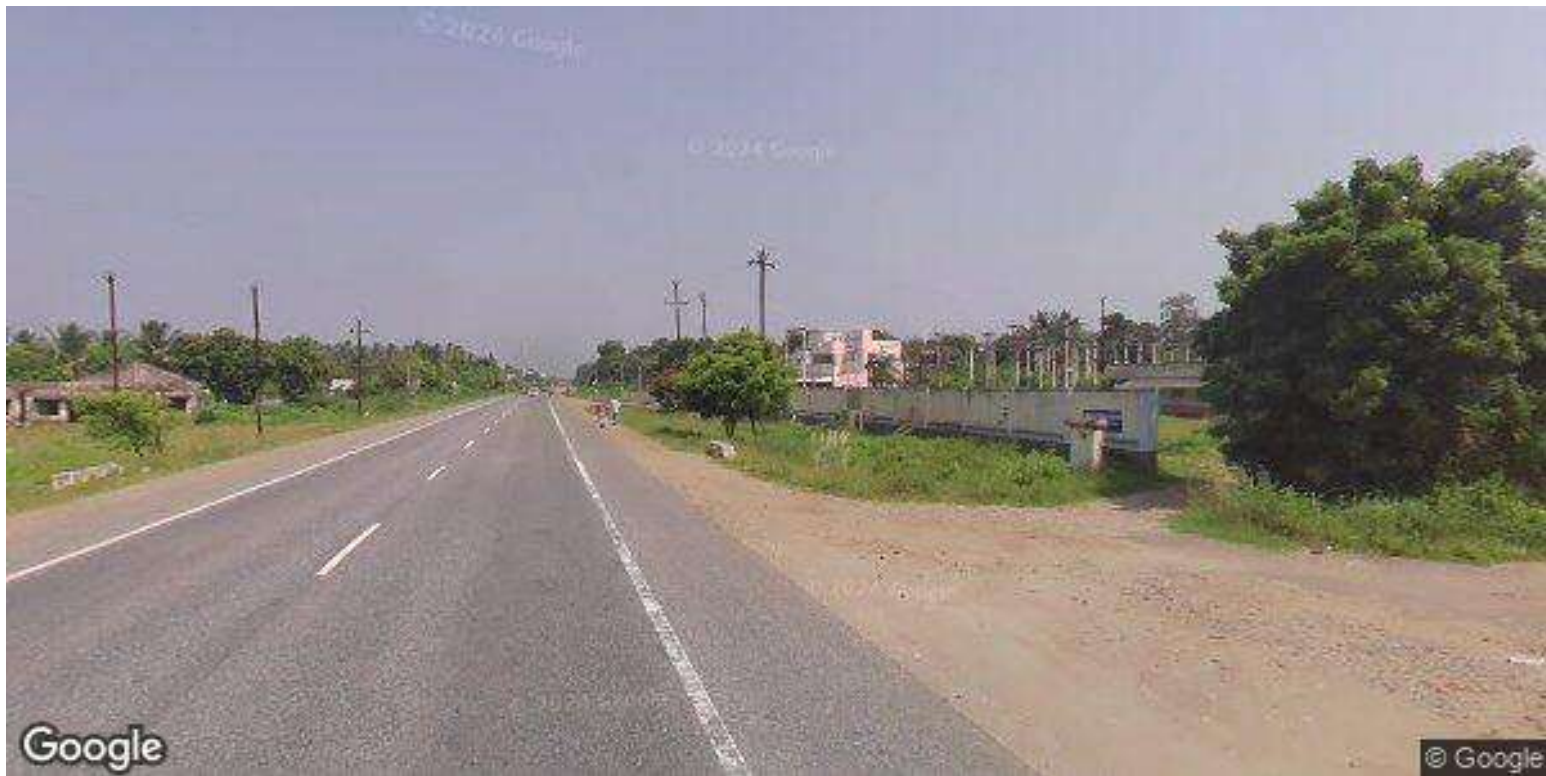
**Risk Type:** Turn  
**Risk Level:** High  
**Speed Limit:** 15 KM/Hr  
**Coordinates:** 10.94726, 78.23412

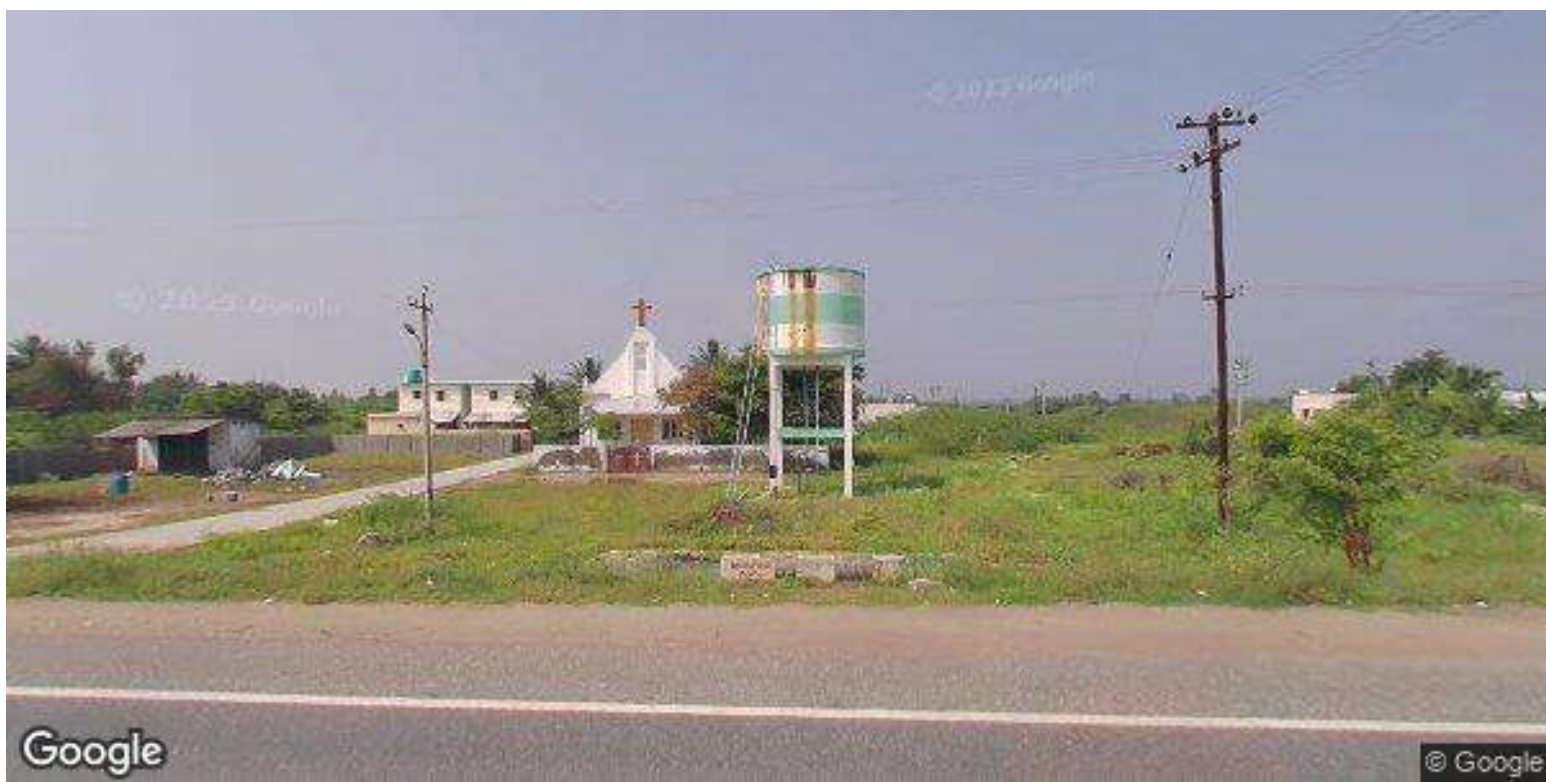
**Coordinates:** 10.94755, 78.23388

**Risk Type:** Turn

**Risk Level:** Medium

**Speed Limit:** 30 KM/Hr

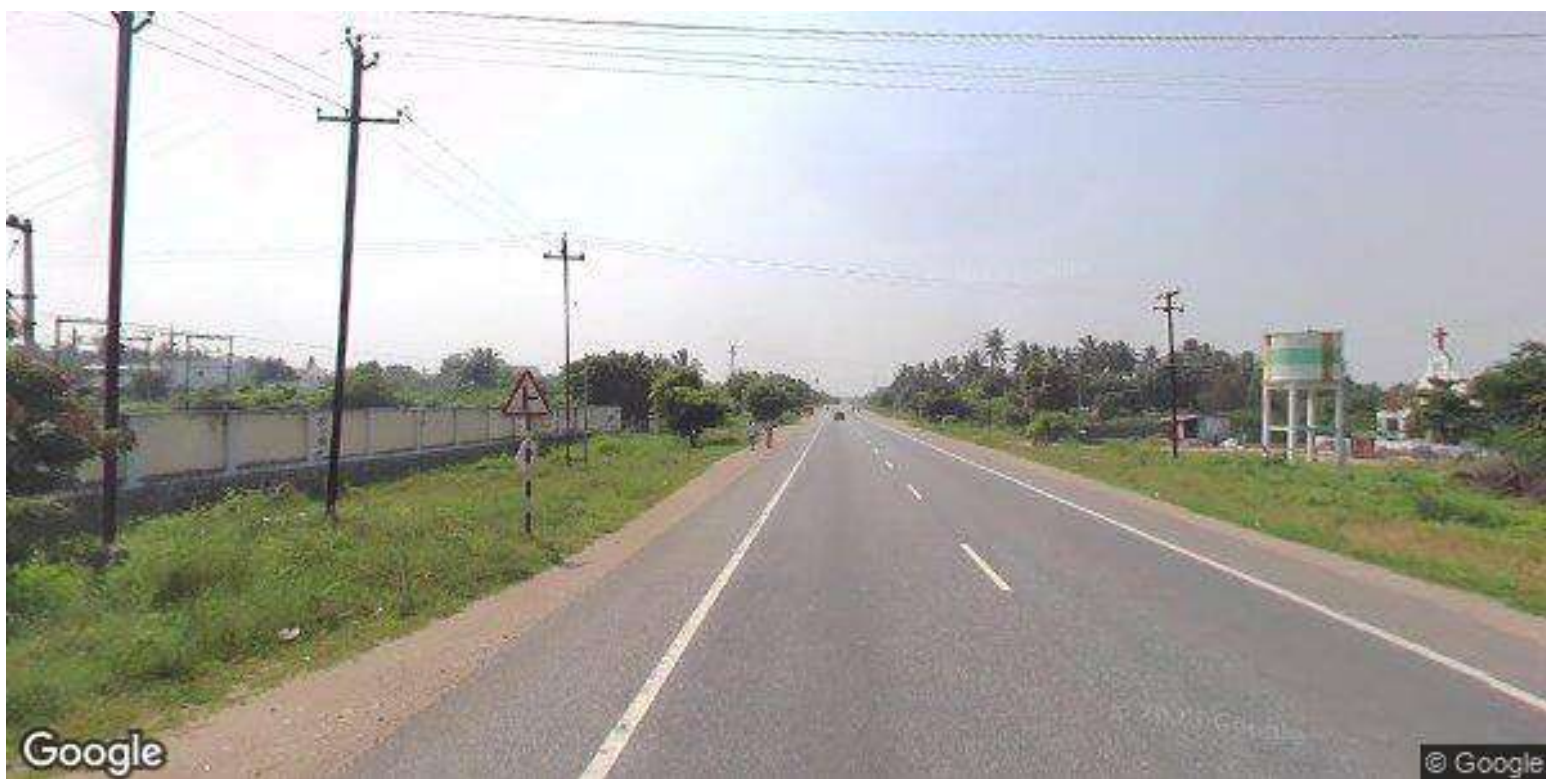
**Coordinates:** 10.94786, 78.23439

**Risk Type:** Turn

**Risk Level:** High

**Speed Limit:** 15 KM/Hr

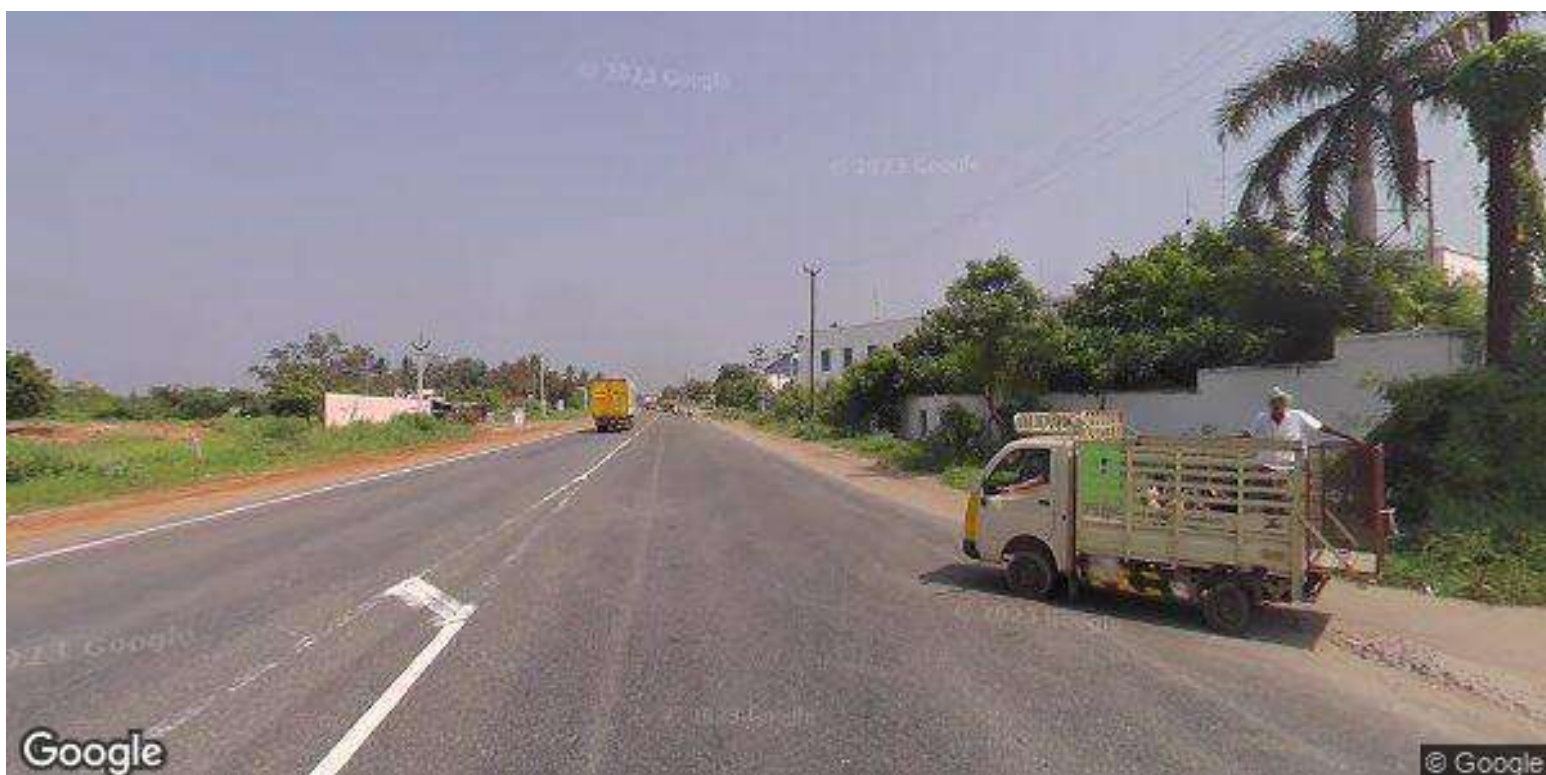
**Coordinates:** 10.94362, 78.23248

**Risk Type:** Turn

**Risk Level:** High

**Speed Limit:** 15 KM/Hr
