# IndianOil

## JOURNEY RISK MANAGEMENT (JRM) STUDY

### Salem Terminal TO SRI MURUGAN AGENCIES

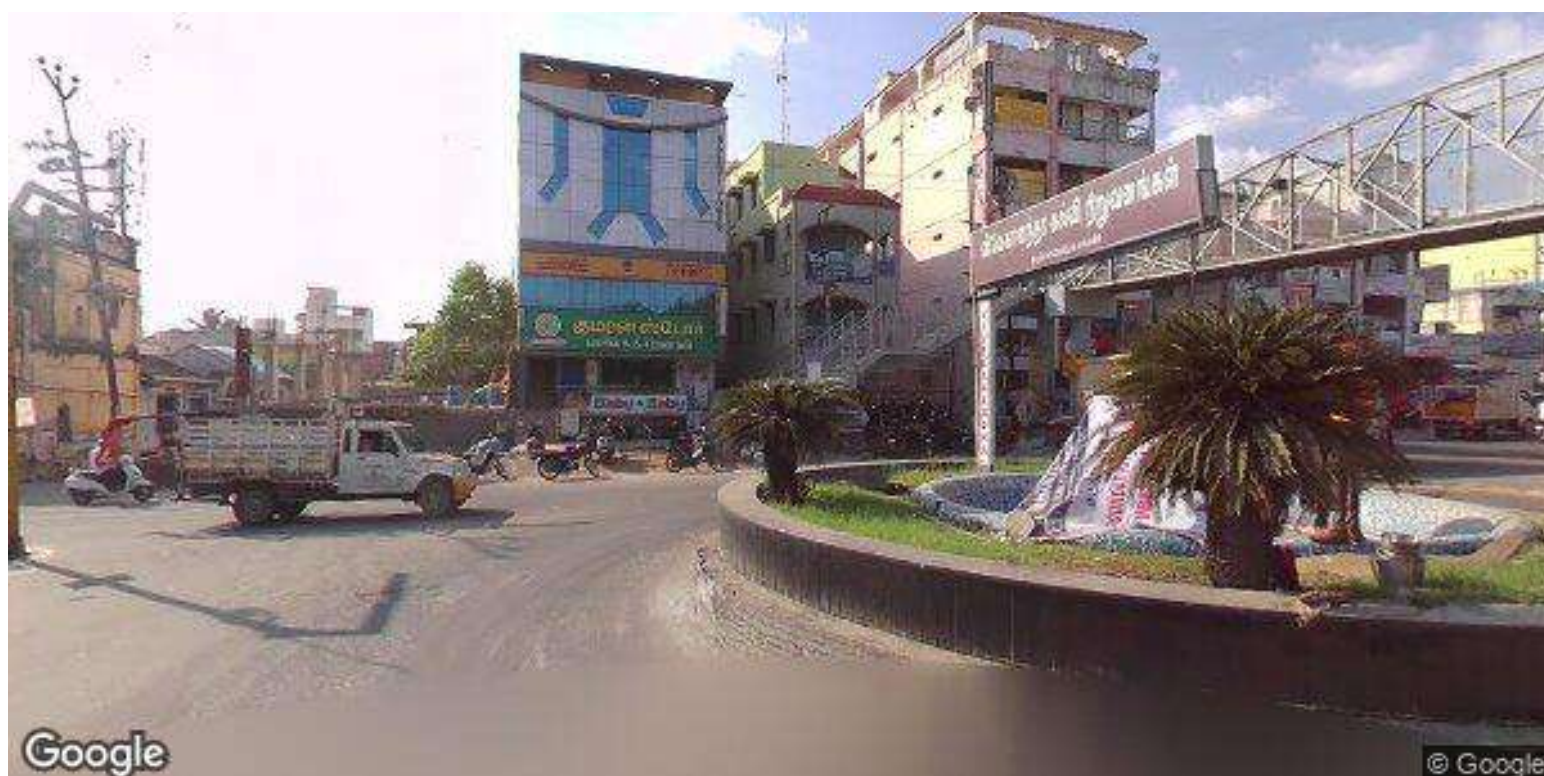
**Risk Type:** Roundabout

**Risk Level:** High

**Speed Limit: 15 KM/Hr**  
**Coordinates: 11.38386, 77.89482**

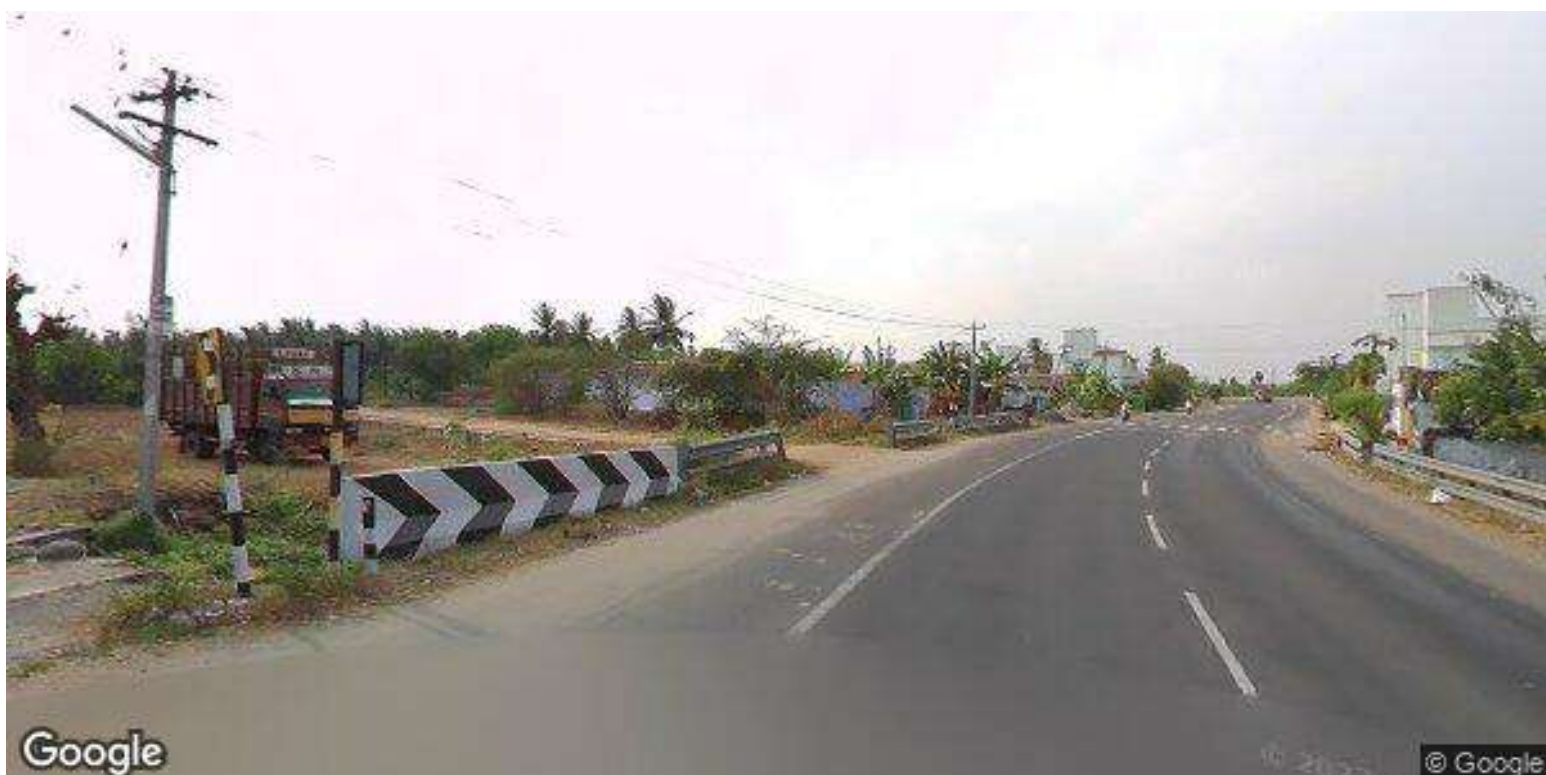
**Coordinates:** 11.16755, 78.01568

**Risk Type:** Turn

**Risk Level:** Medium

**Speed Limit:** 30 KM/Hr

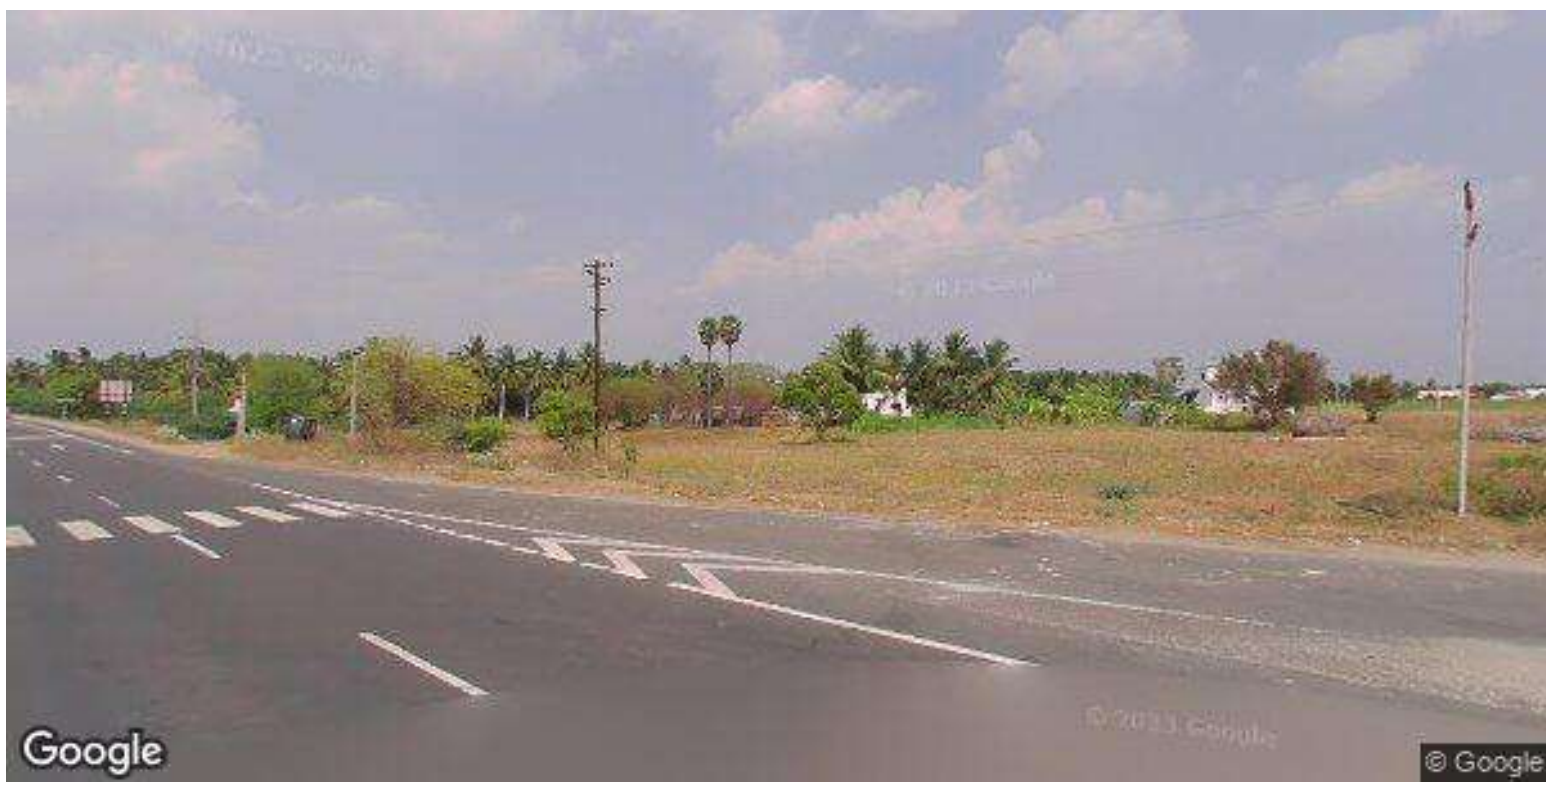
**Coordinates:** 11.14480, 78.02291

**Risk Type:** Turn

**Risk Level:** High

**Speed Limit:** 15 KM/Hr
