## JOURNEY RISK MANAGEMENT (JRM) STUDY

### Salem Terminal to SRI GOUNDER & CO.

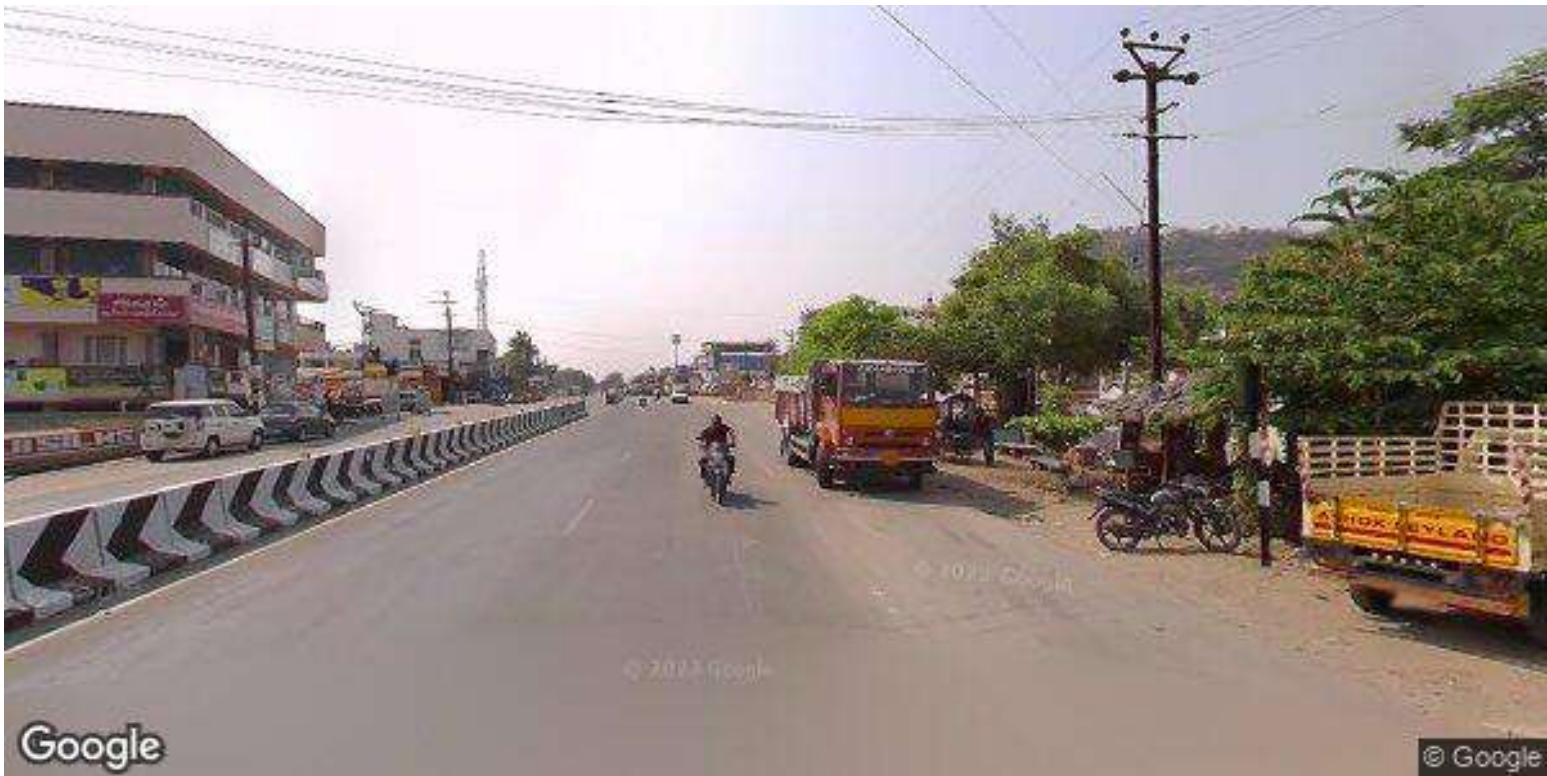
**Coordinates: 11.39685, 77.88861**

**Risk Type: Turn**

**Risk Level: Medium**

**Speed Limit: 30 KM/Hr**

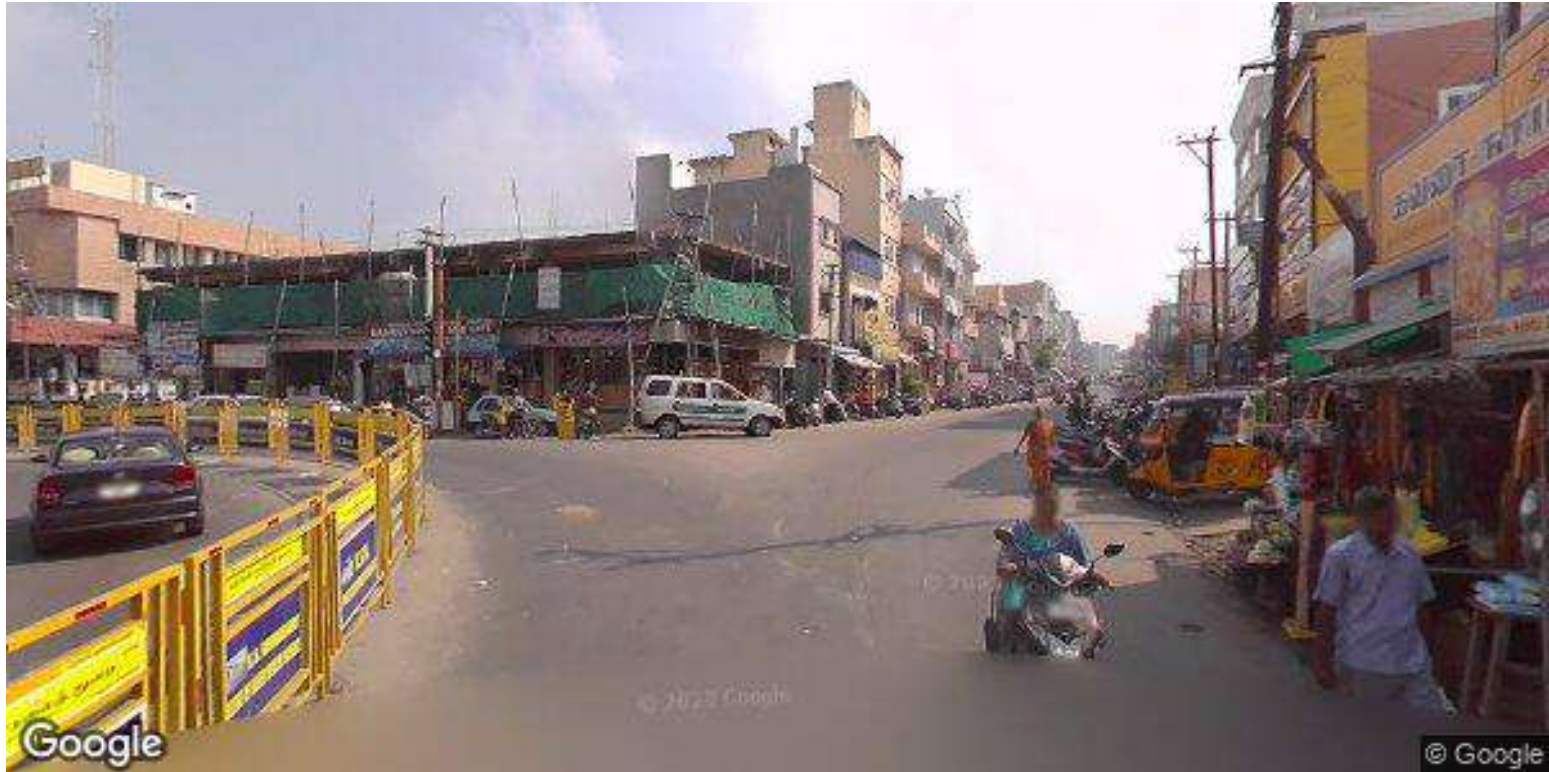
**Coordinates: 11.37862, 77.89488**

**Risk Type: Turn**

**Risk Level: High**

**Speed Limit: 15 KM/Hr**

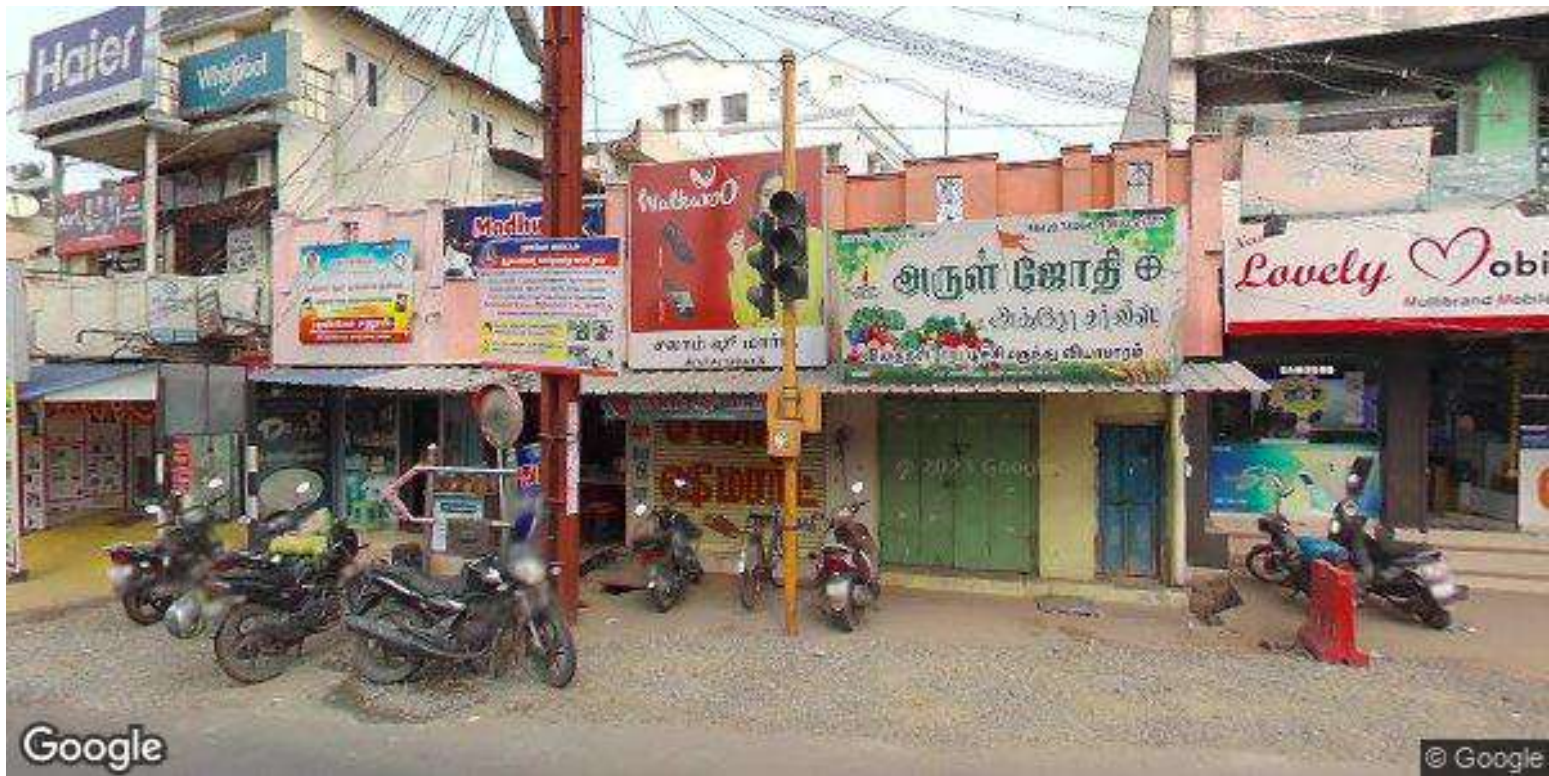
**Coordinates: 11.37850, 77.89453**

**Risk Type: Turn**

**Risk Level: High**

**Speed Limit: 15 KM/Hr**

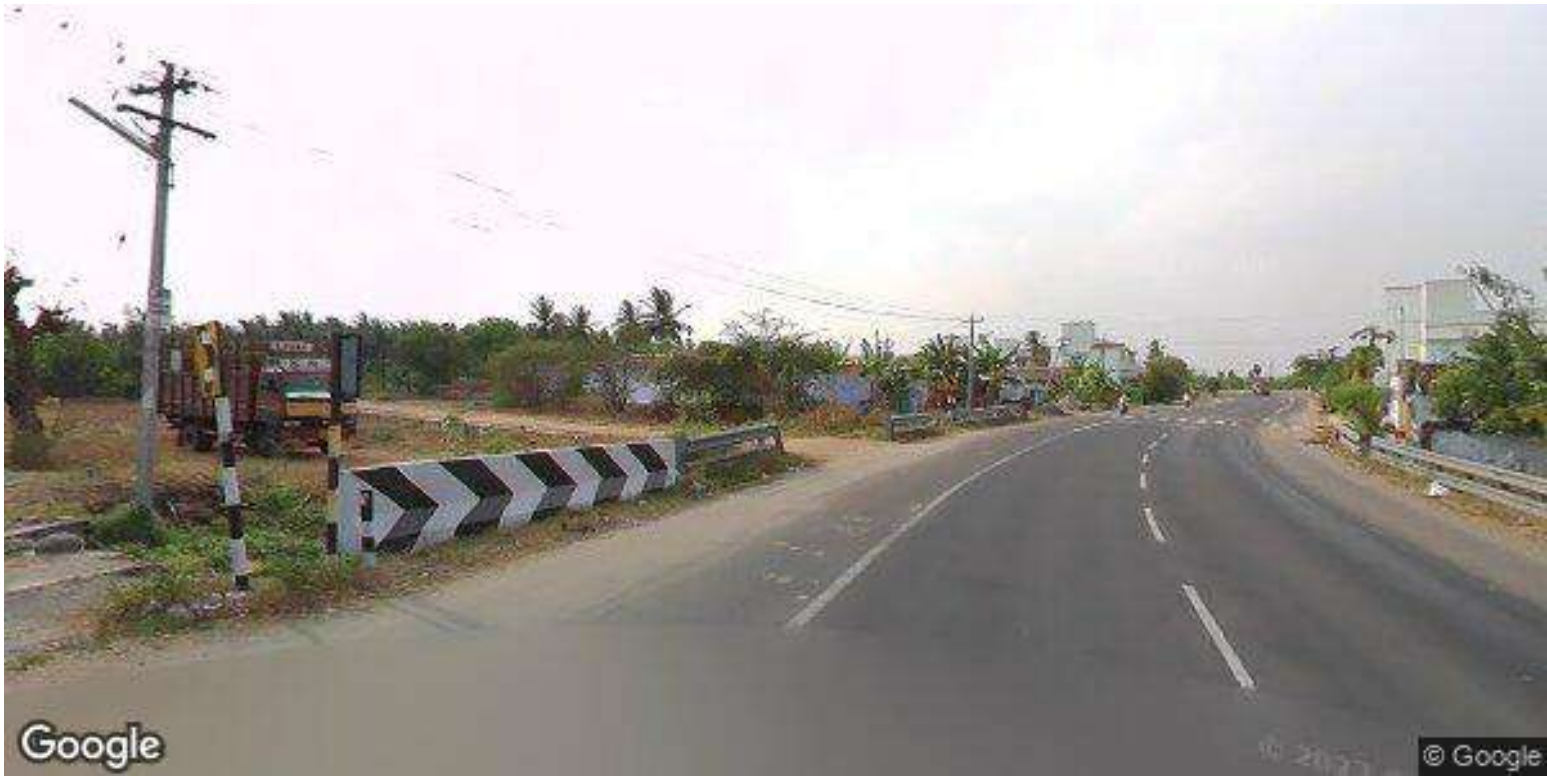
**Risk Type:** Turn  
**Risk Level:** Medium  
**Speed Limit:** 30 KM/Hr  
**Coordinates:** 11.16755, 78.01568

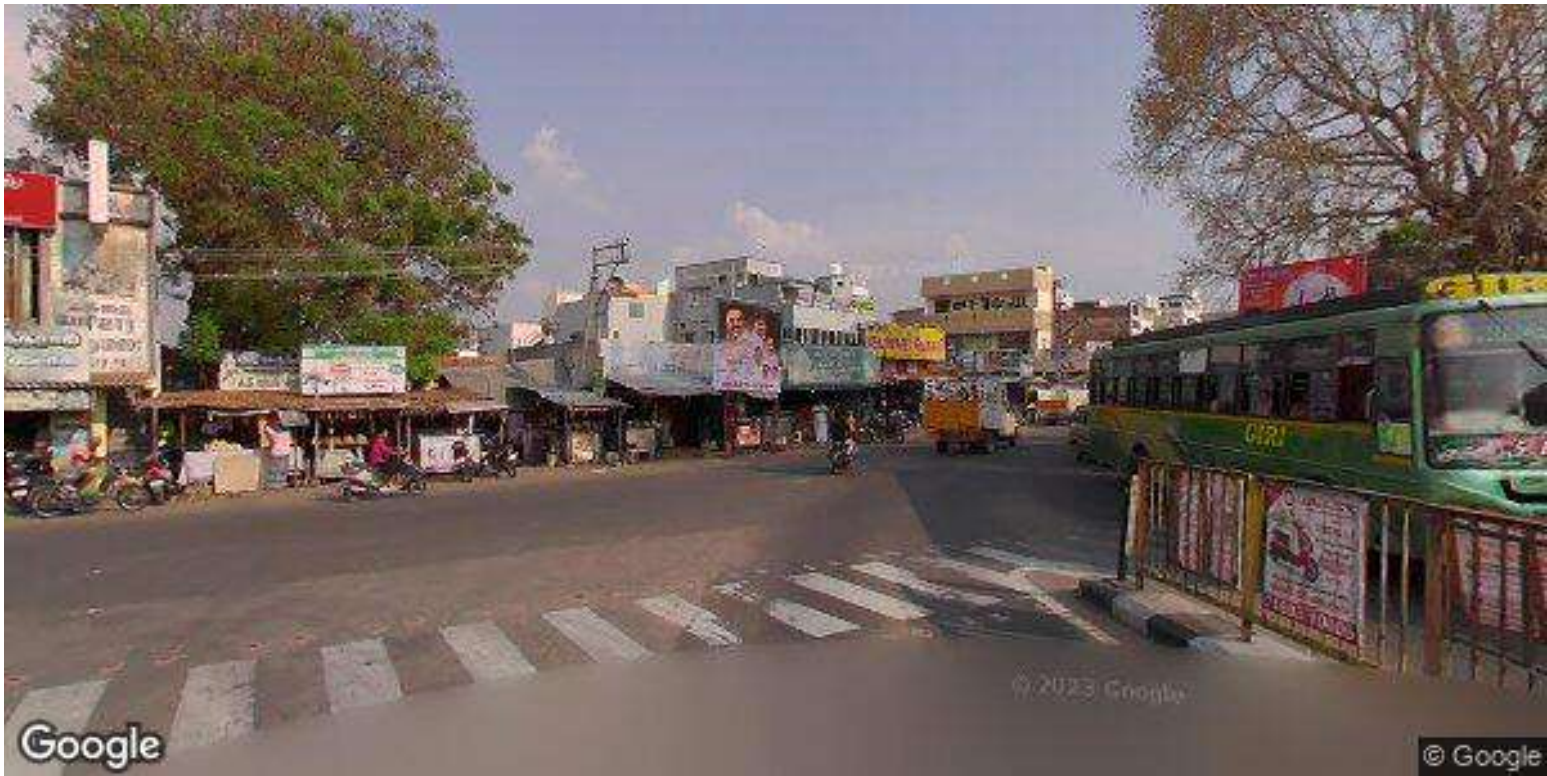
**Risk Type:** Turn  
**Risk Level:** Medium  
**Speed Limit:** 30 KM/Hr  
**Coordinates:** 11.15579, 78.02169

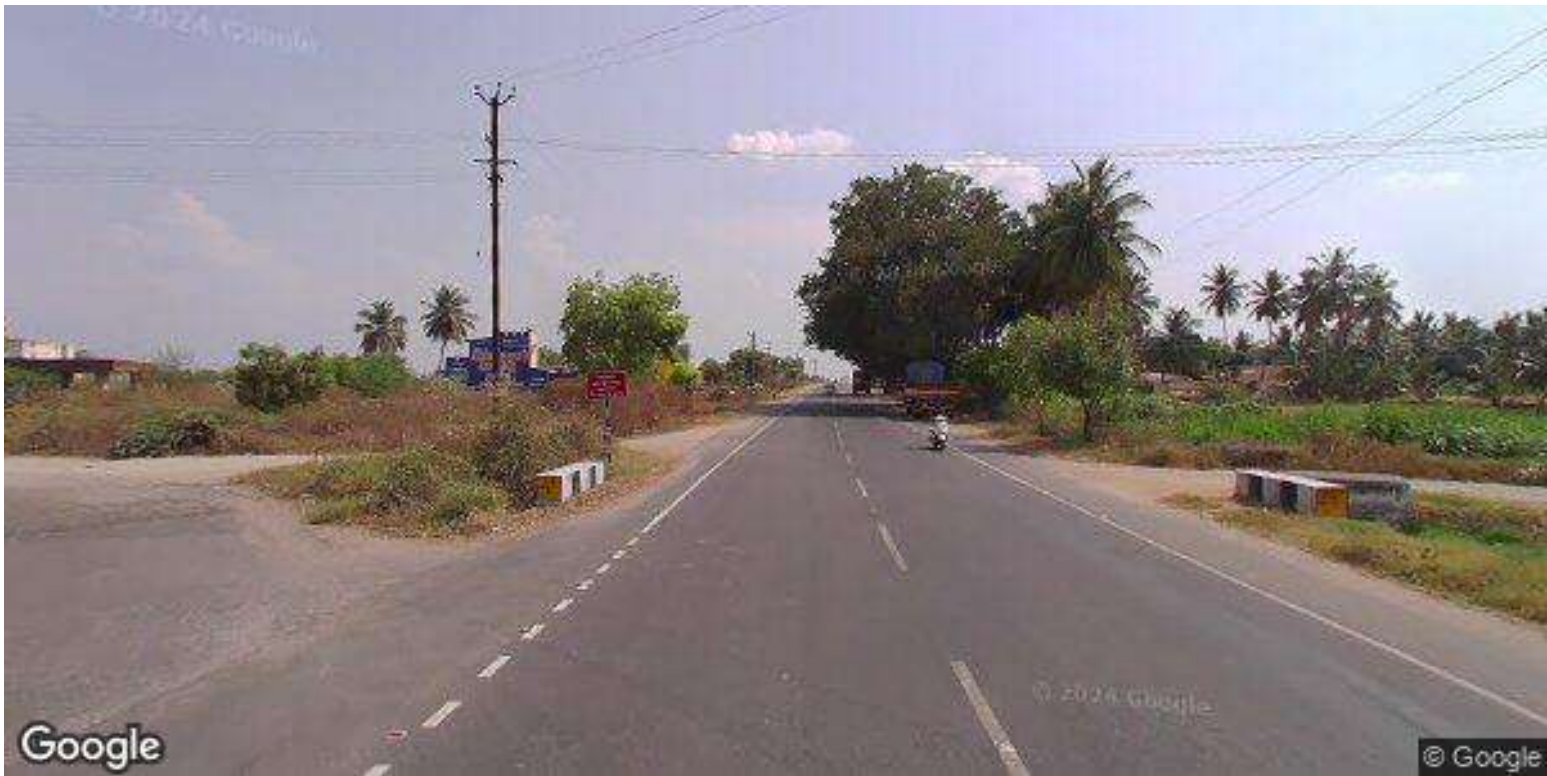
**Coordinates: 11.14545, 78.02208**

**Risk Type: Turn**

**Risk Level: High**

**Speed Limit: 15 KM/Hr**

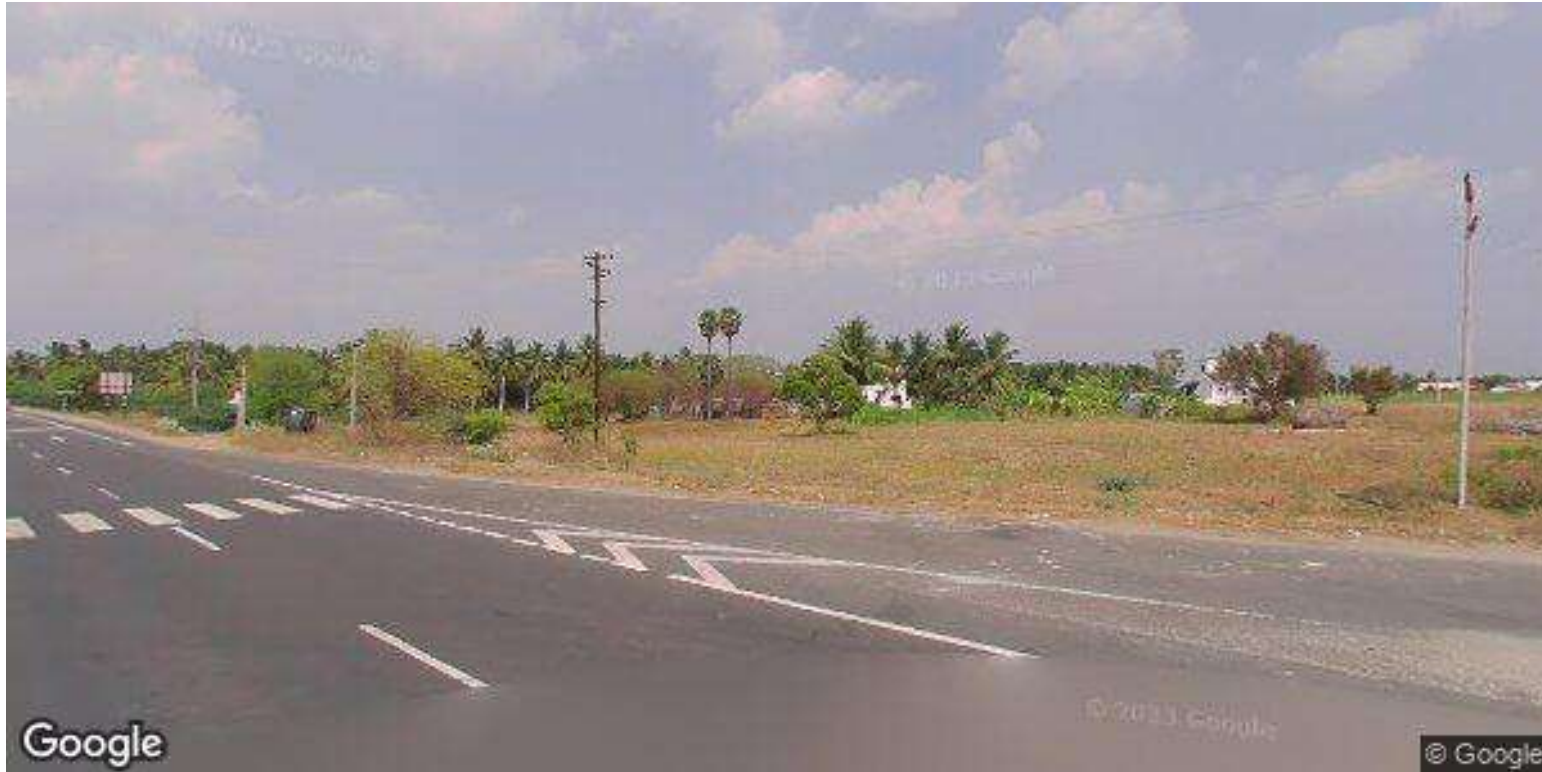
**Coordinates: 11.14480, 78.02291**

**Risk Type: Blind Spot**

**Risk Level: Blind Spot**

**Speed Limit: 10 KM/Hr**

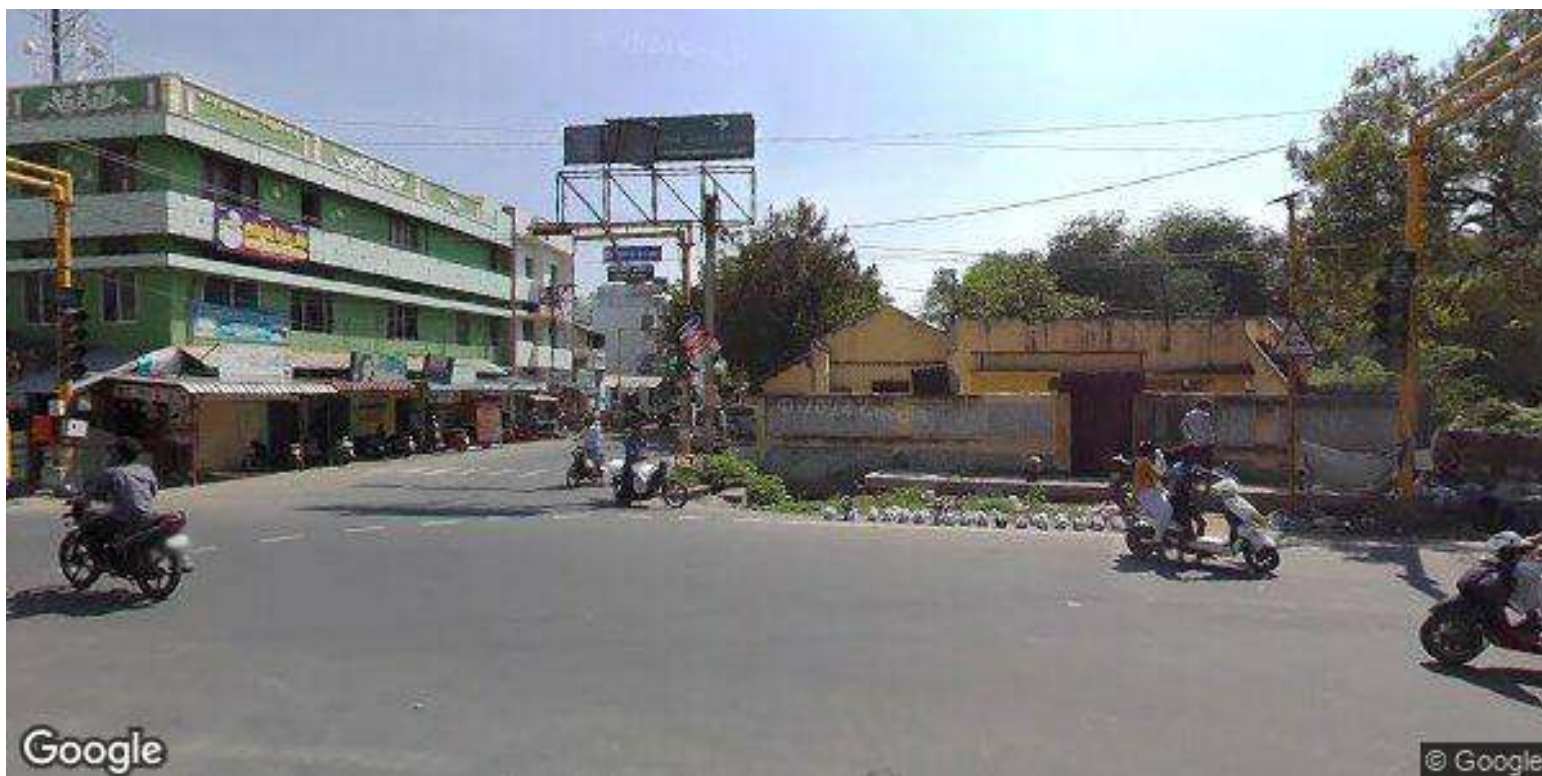
**Coordinates: 10.96264, 78.08183**

**Risk Type: Turn**

**Risk Level: High**

**Speed Limit: 15 KM/Hr**

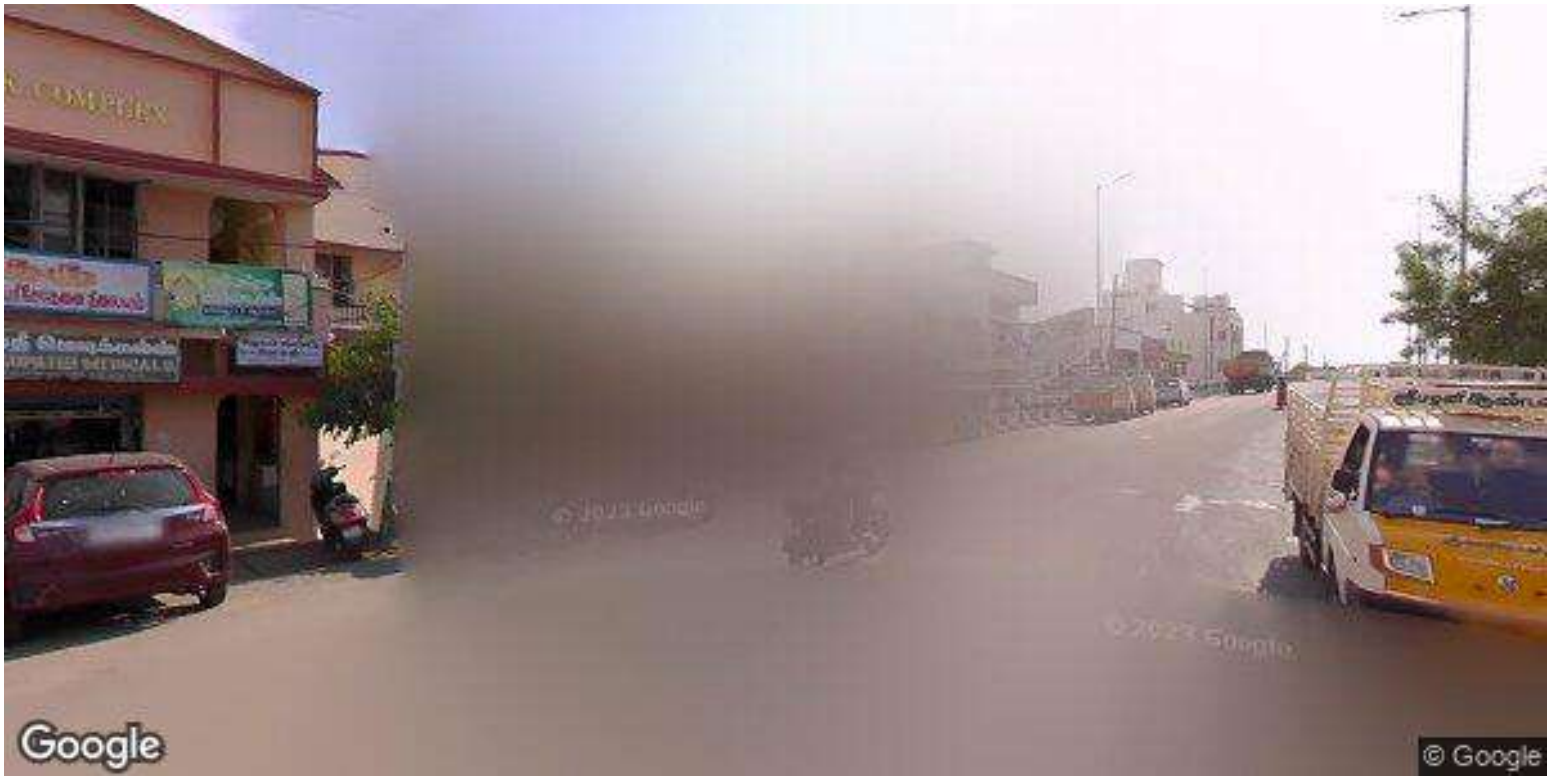
**Risk Type:** Turn  
**Risk Level:** Medium  
**Speed Limit:** 30 KM/Hr  
**Coordinates:** 10.96221, 78.09641

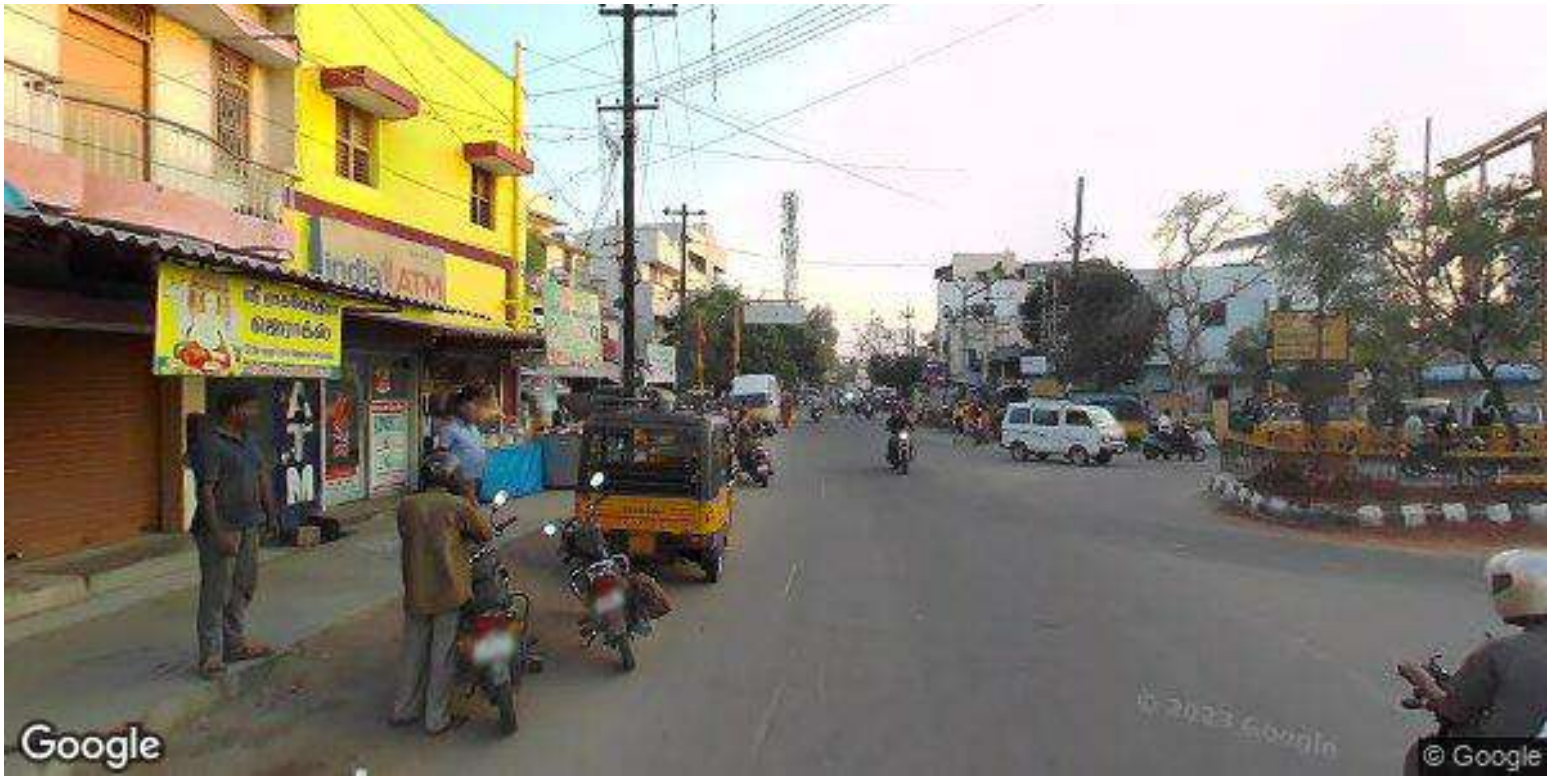
**Risk Type:** Turn  
**Risk Level:** High  
**Speed Limit:** 15 KM/Hr  
**Coordinates:** 10.96229, 78.09658

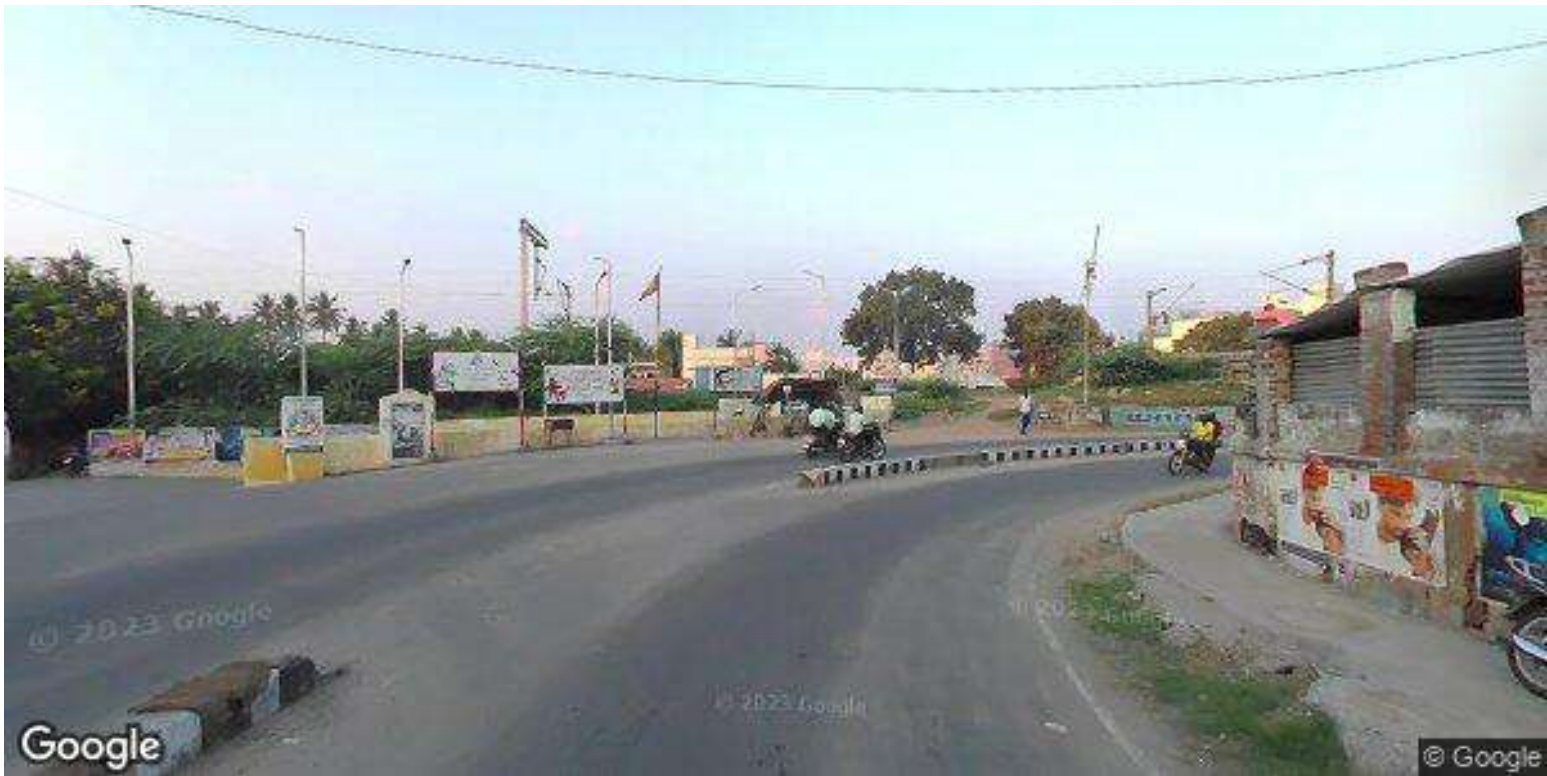
**Coordinates: 10.96314, 78.09655**

**Risk Type: Turn**

**Risk Level: High**

**Speed Limit: 15 KM/Hr**

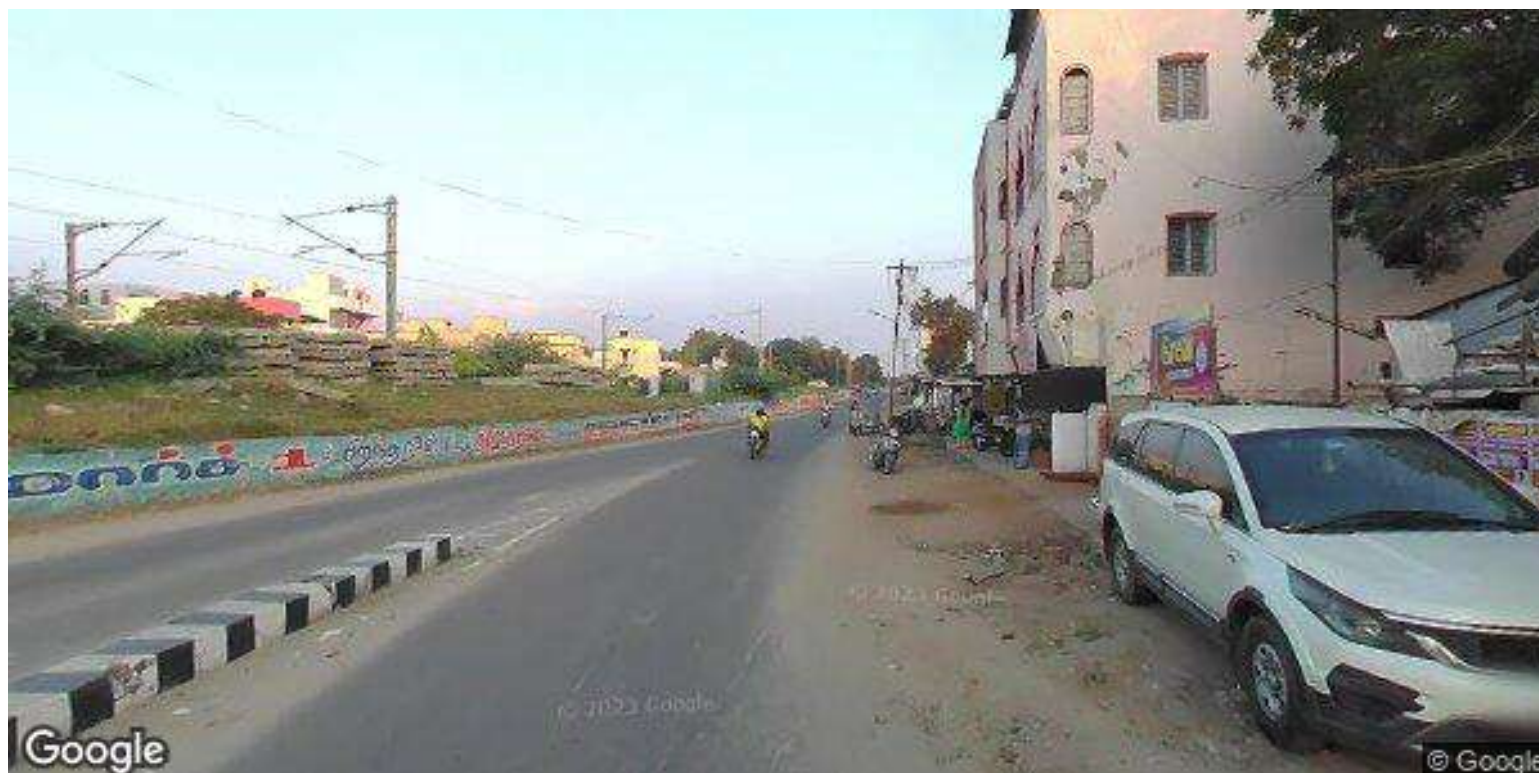
**Coordinates: 10.96323, 78.09676**

**Risk Type: Turn**

**Risk Level: Medium**

**Speed Limit: 30 KM/Hr**

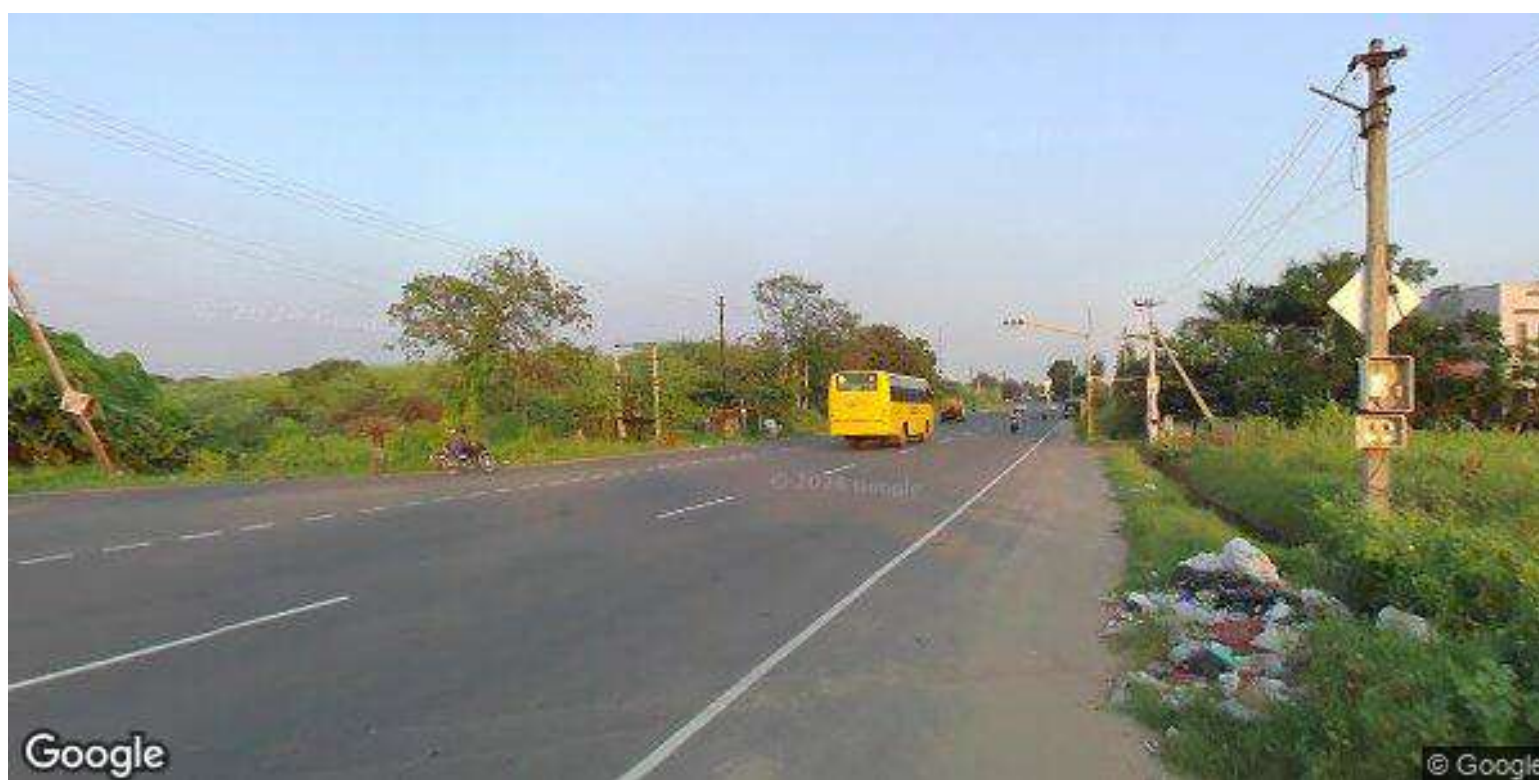
**Coordinates: 10.94214, 78.13025**

**Risk Type: Turn**

**Risk Level: High**

**Speed Limit: 15 KM/Hr**

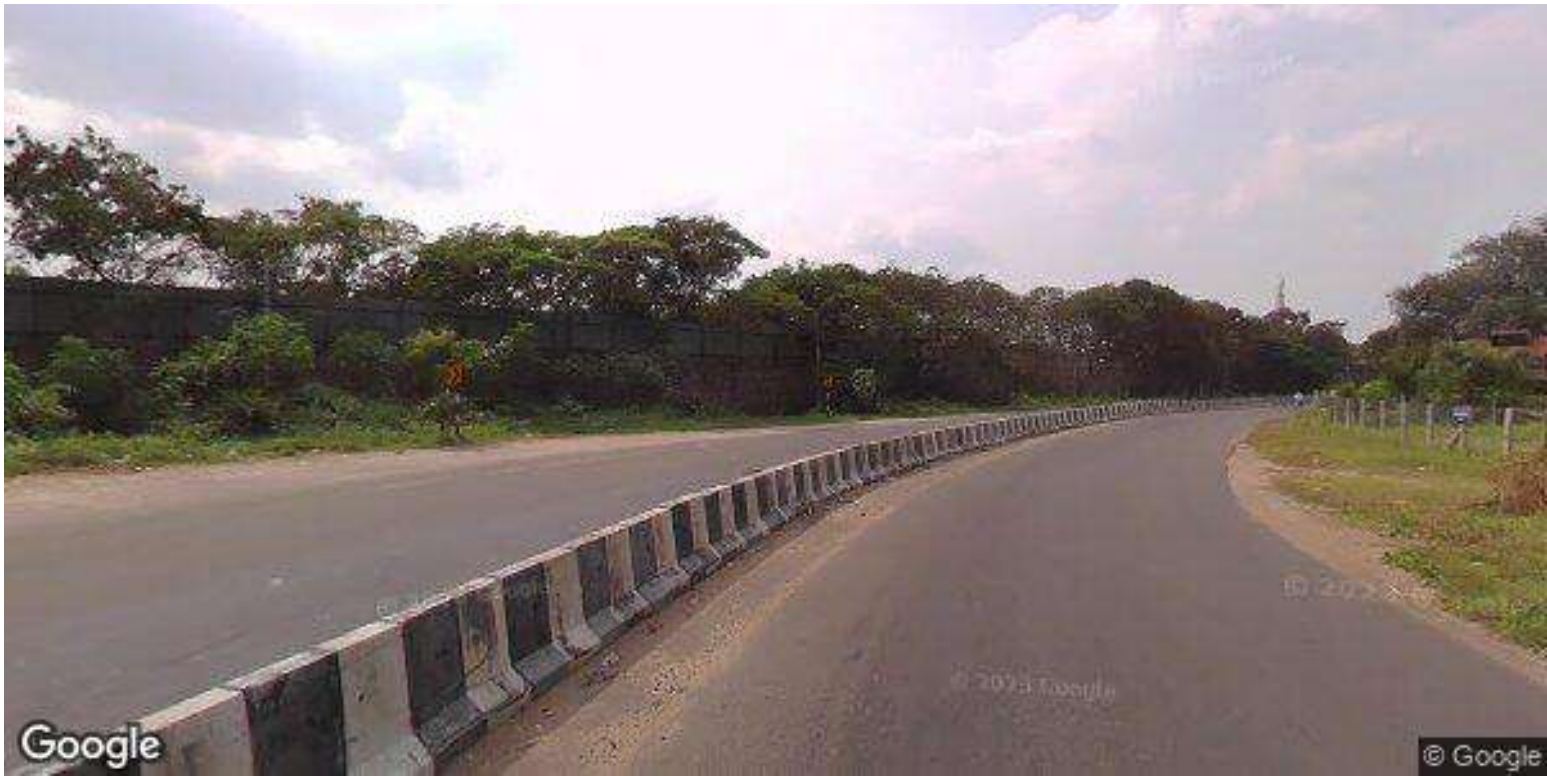
**Coordinates:** 10.93847, 78.14871

**Risk Type:** Turn

**Risk Level:** Medium

**Speed Limit:** 30 KM/Hr
