## **JOURNEY RISK MANAGEMENT (JRM) STUDY**

### **Salem Terminal to JASMINE ENTERPRISES**

### Route Safety Analysis: Sangagiri to Velur, Tamil Nadu

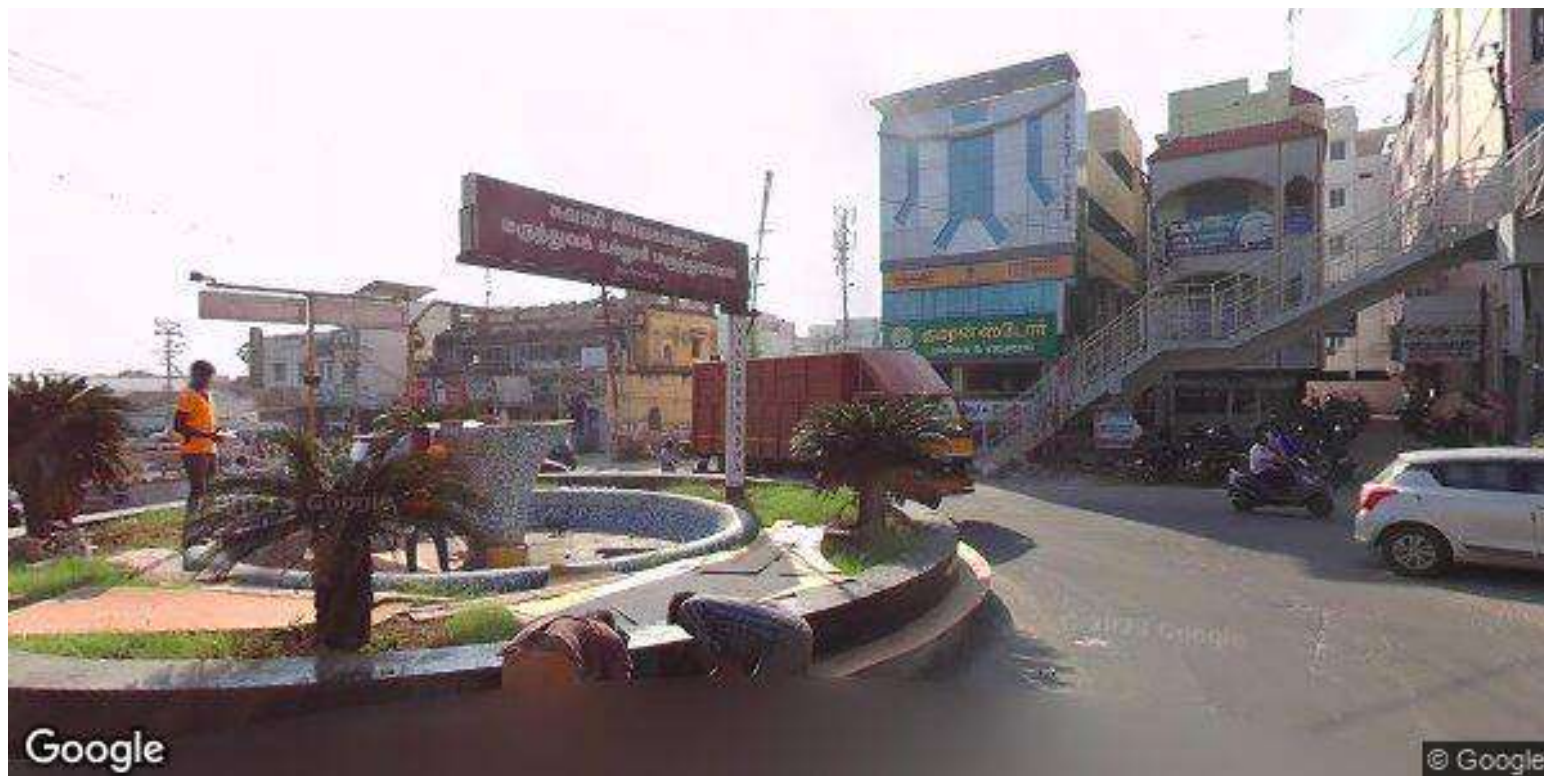
**Coordinates:** 11.38395, 77.89480

**Risk Type:** Roundabout

**Risk Level:** High

**Speed Limit:** 15 KM/Hr

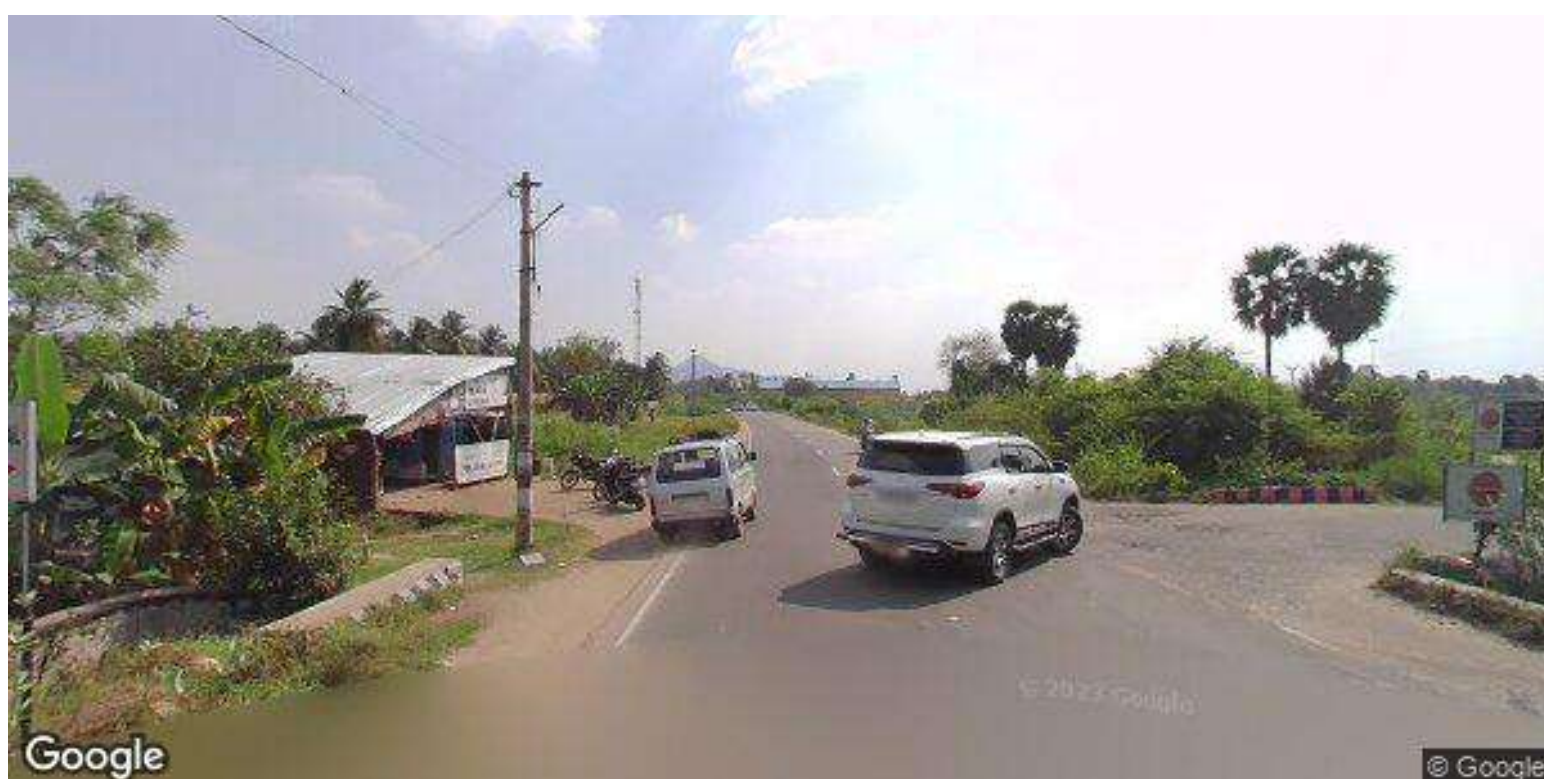
**Coordinates: 11.44029, 77.87544**

**Risk Type:** Blind Spot

**Risk Level:** Blind Spot

**Speed Limit: 10 KM/Hr**

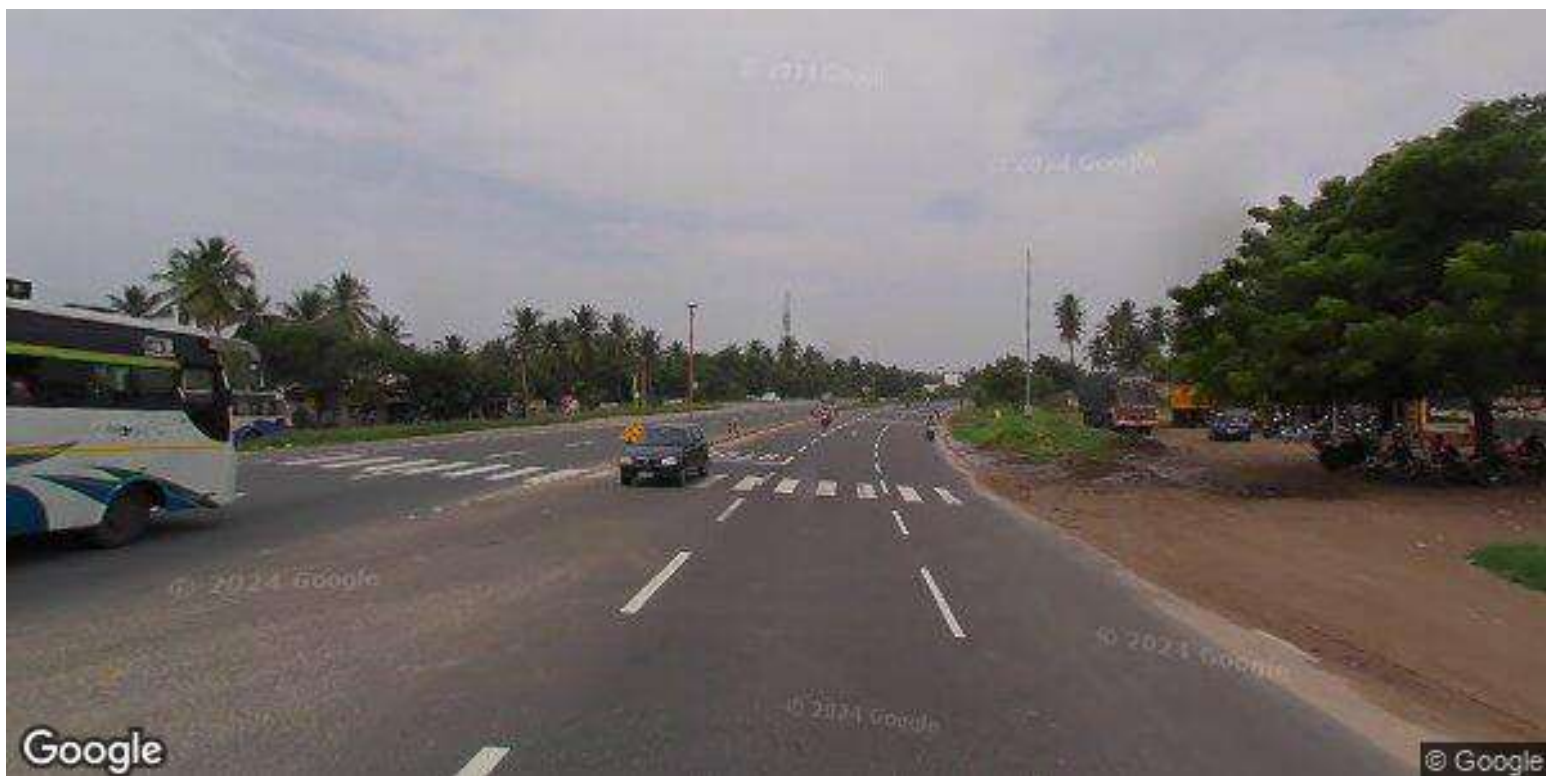
**Coordinates: 11.12555, 78.01664**

**Risk Type: Turn**

**Risk Level: High**

**Speed Limit: 15 KM/Hr**

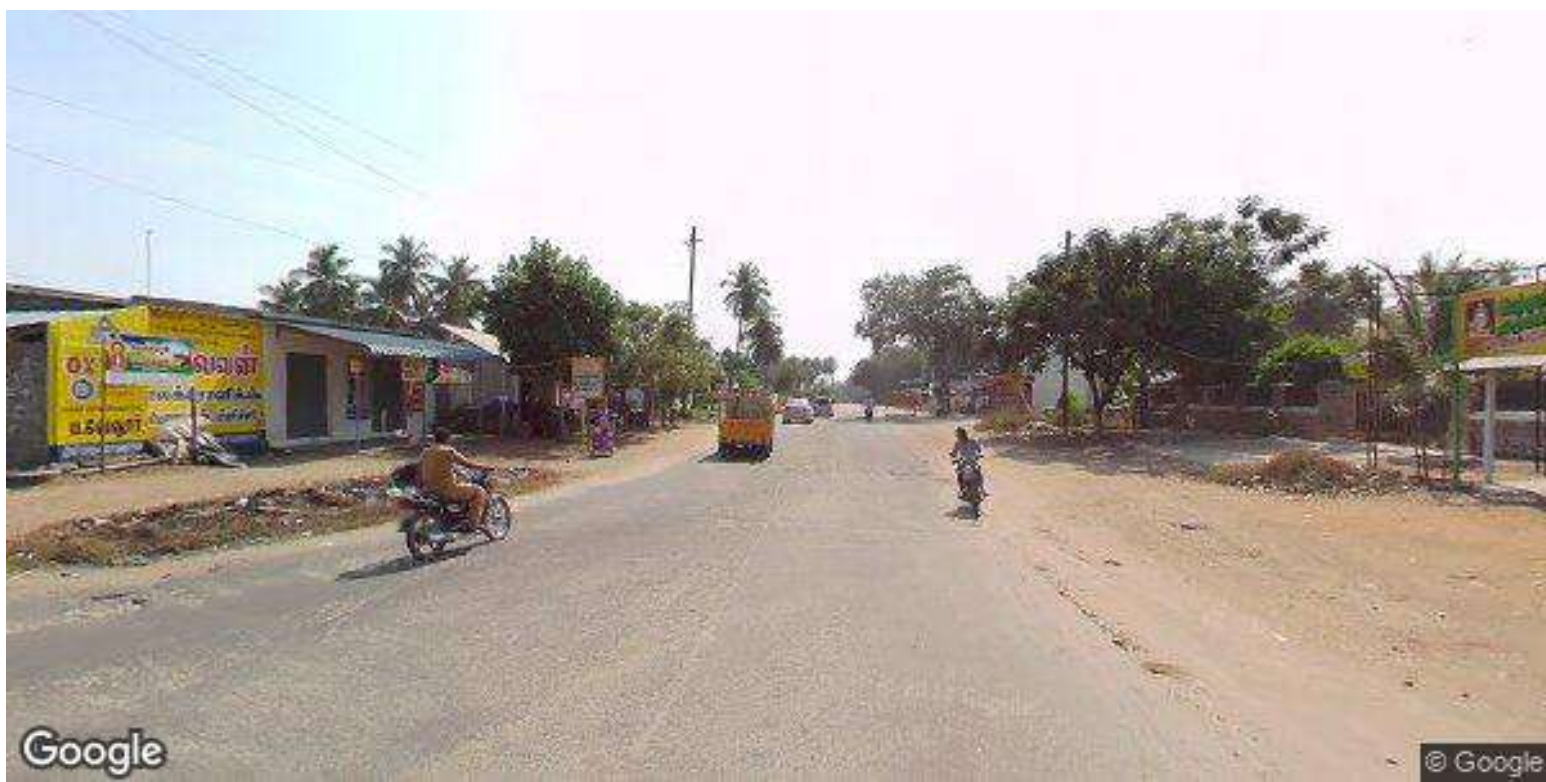
**Coordinates:** 11.12540, 78.01613

**Risk Type:** Turn

**Risk Level:** High

**Speed Limit:** 15 KM/Hr

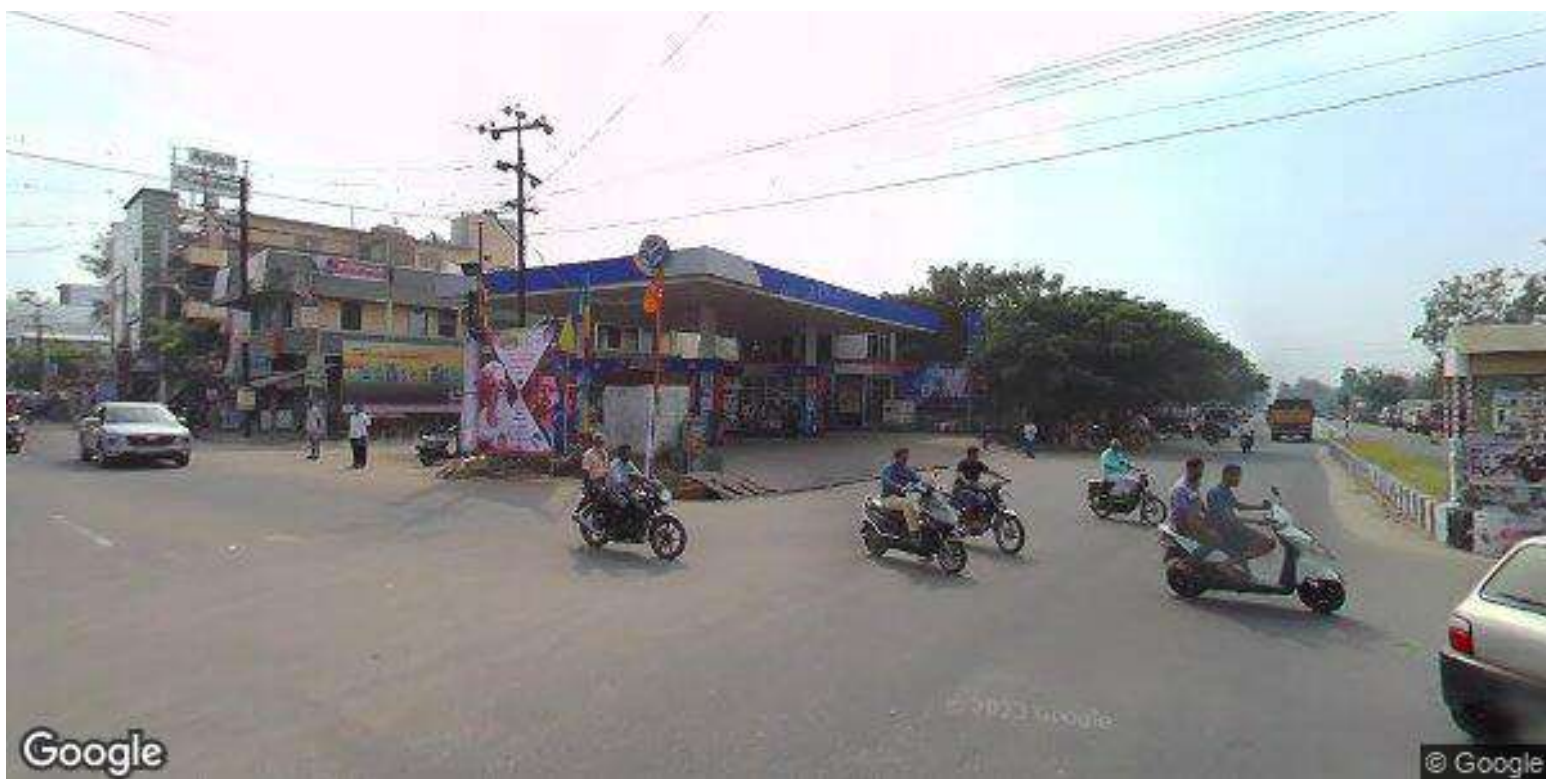
**Coordinates:** 11.10777, 78.00425

**Risk Type:** Turn

**Risk Level:** Medium

**Speed Limit:** 30 KM/Hr

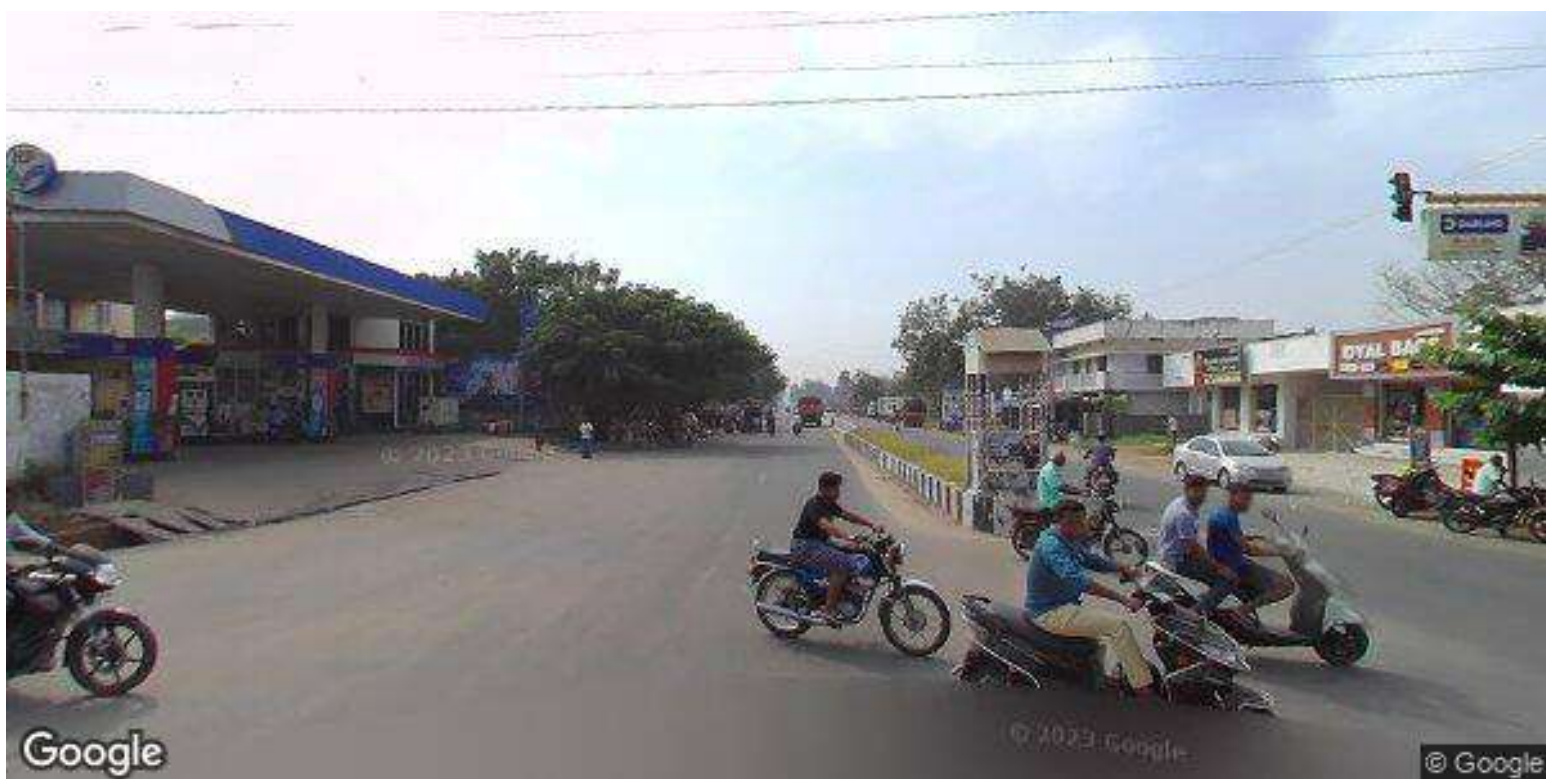
**Coordinates:** 11.10772, 78.00425

**Risk Type:** Turn

**Risk Level:** Medium

**Speed Limit:** 30 KM/Hr

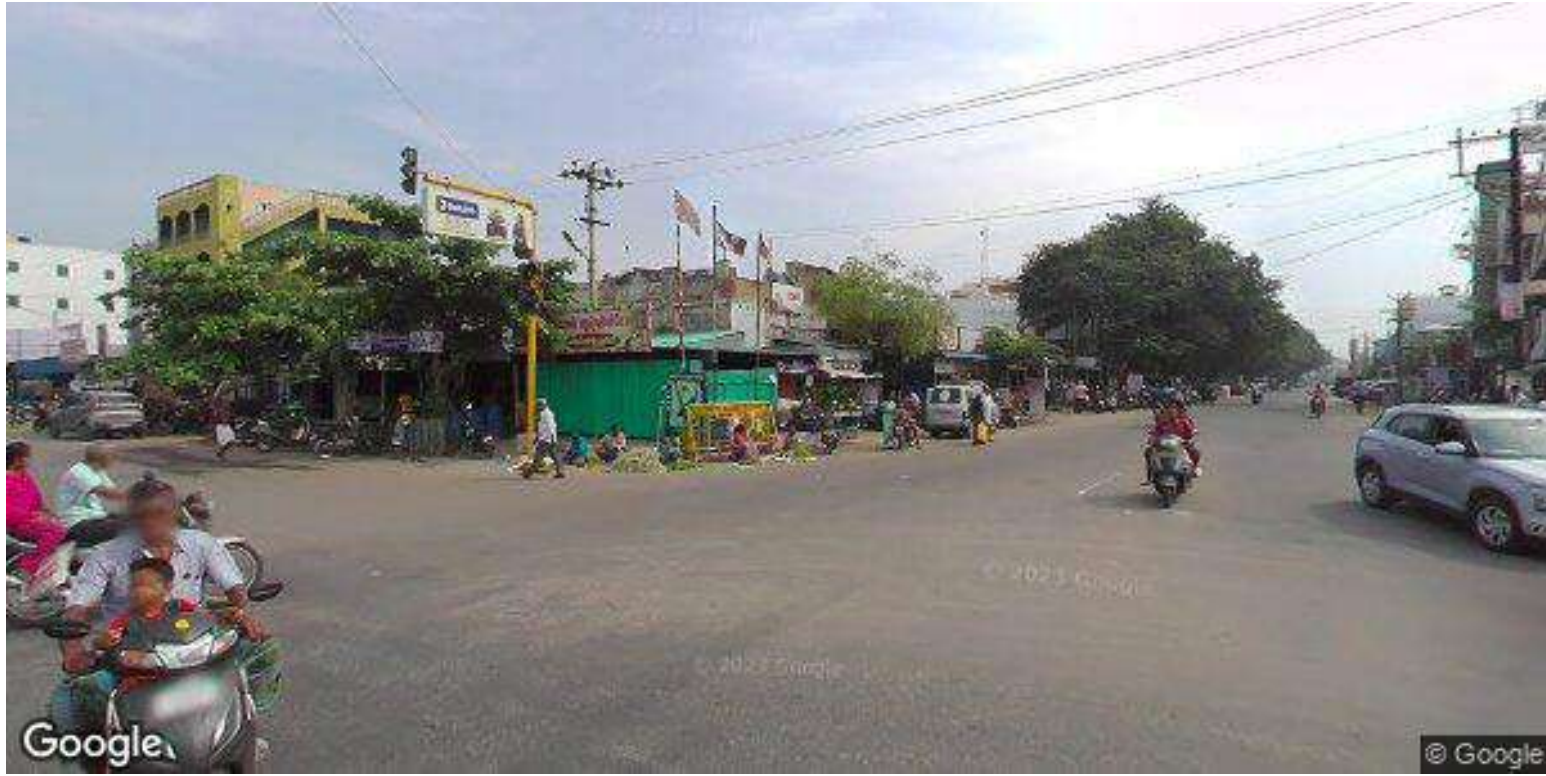
**Coordinates:** 11.10768, 78.00422

**Risk Type:** Turn

**Risk Level:** Medium

**Speed Limit:** 30 KM/Hr
