# IndianOil

## JOURNEY RISK MANAGEMENT (JRM) STUDY

### Salem Terminal to SRI SHANMUGA AGENCIES

## **Route Safety Analysis: Sangagiri to Vavikadai**

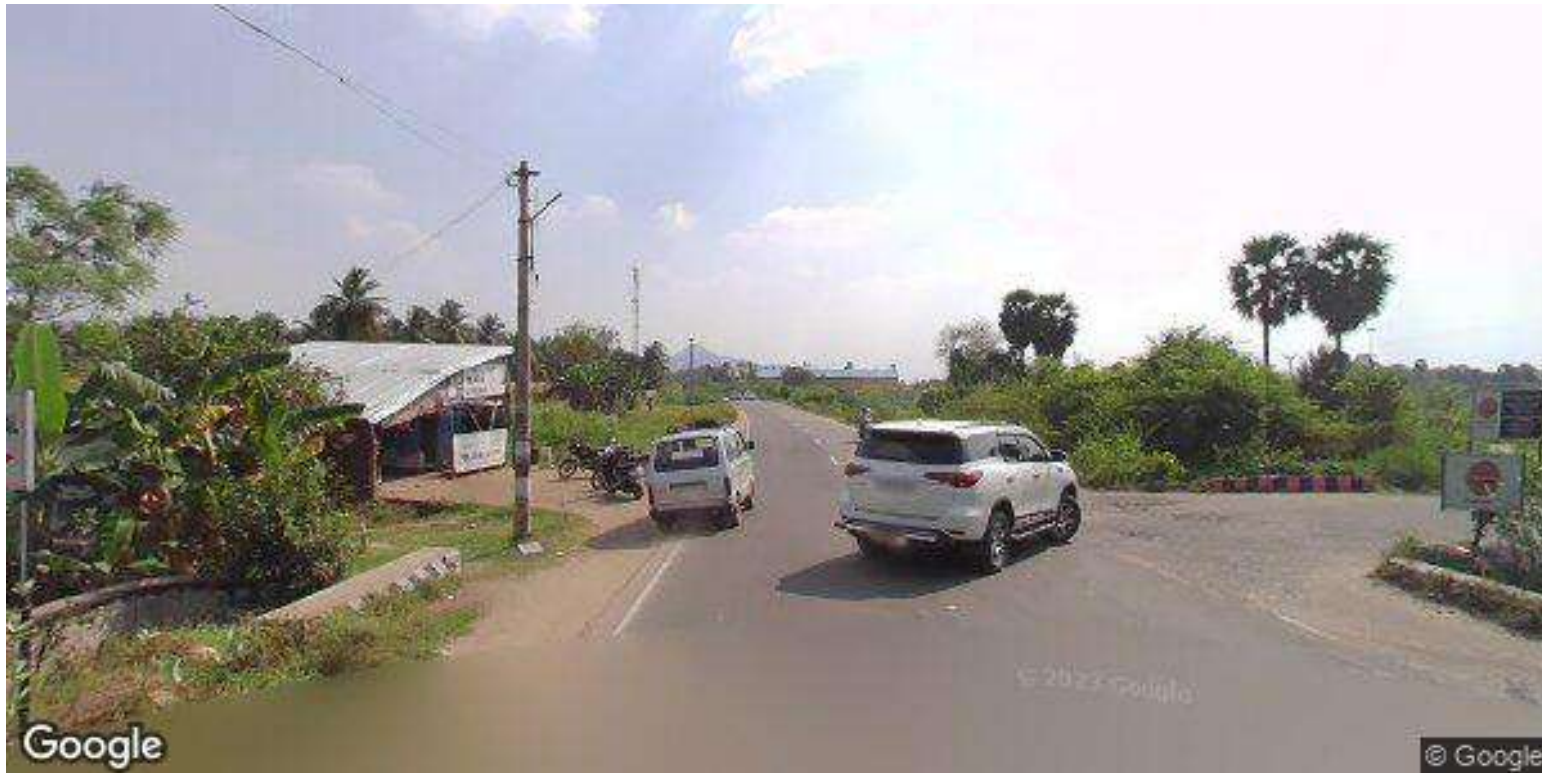
**Coordinates:** 11.44029, 77.87544

**Risk Type:** Turn

**Risk Level:** High

**Speed Limit:** 15 KM/Hr

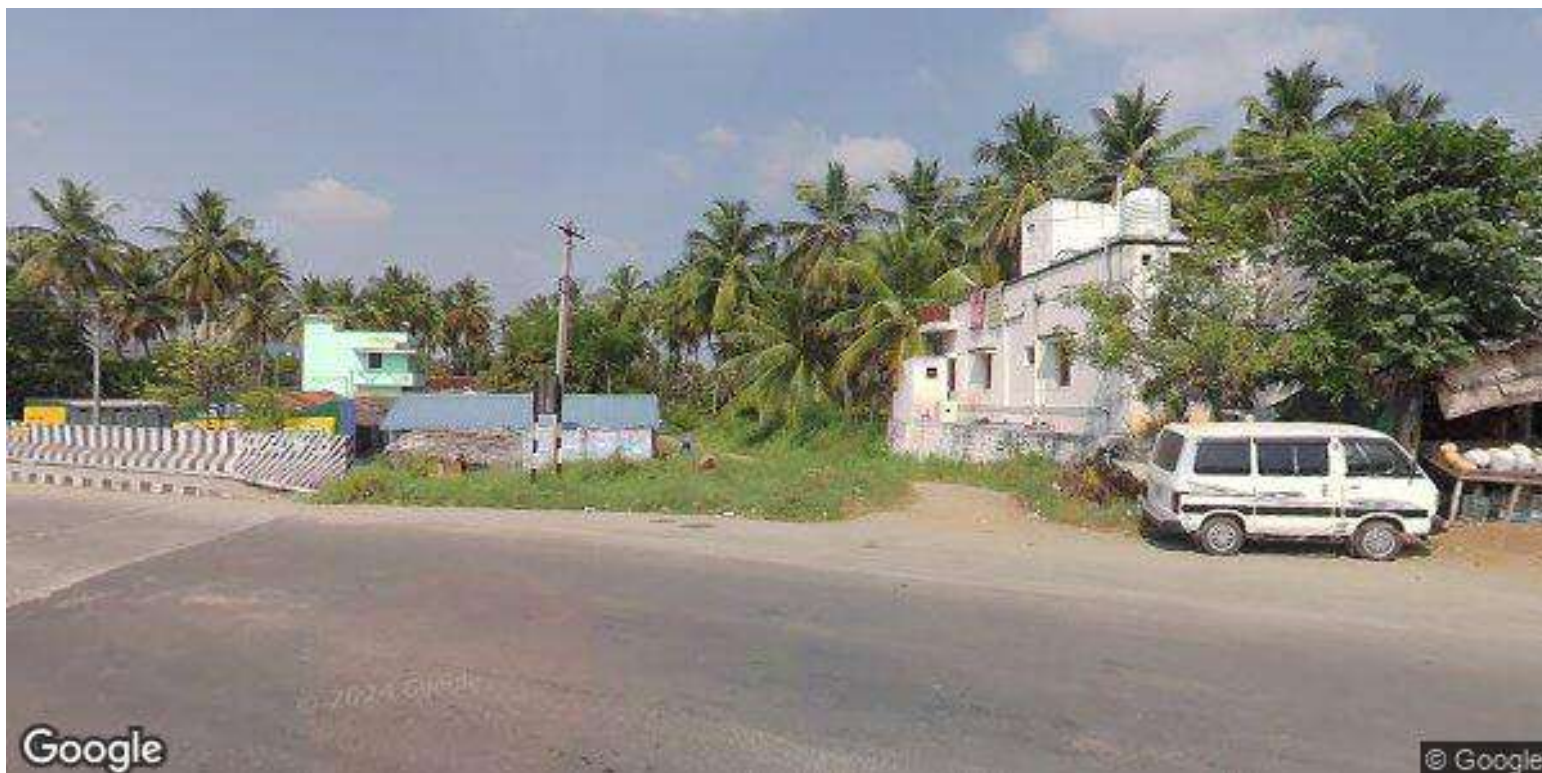
**Coordinates:** 11.44898, 77.87410

**Risk Type:** Turn

**Risk Level:** Medium

**Speed Limit:** 30 KM/Hr

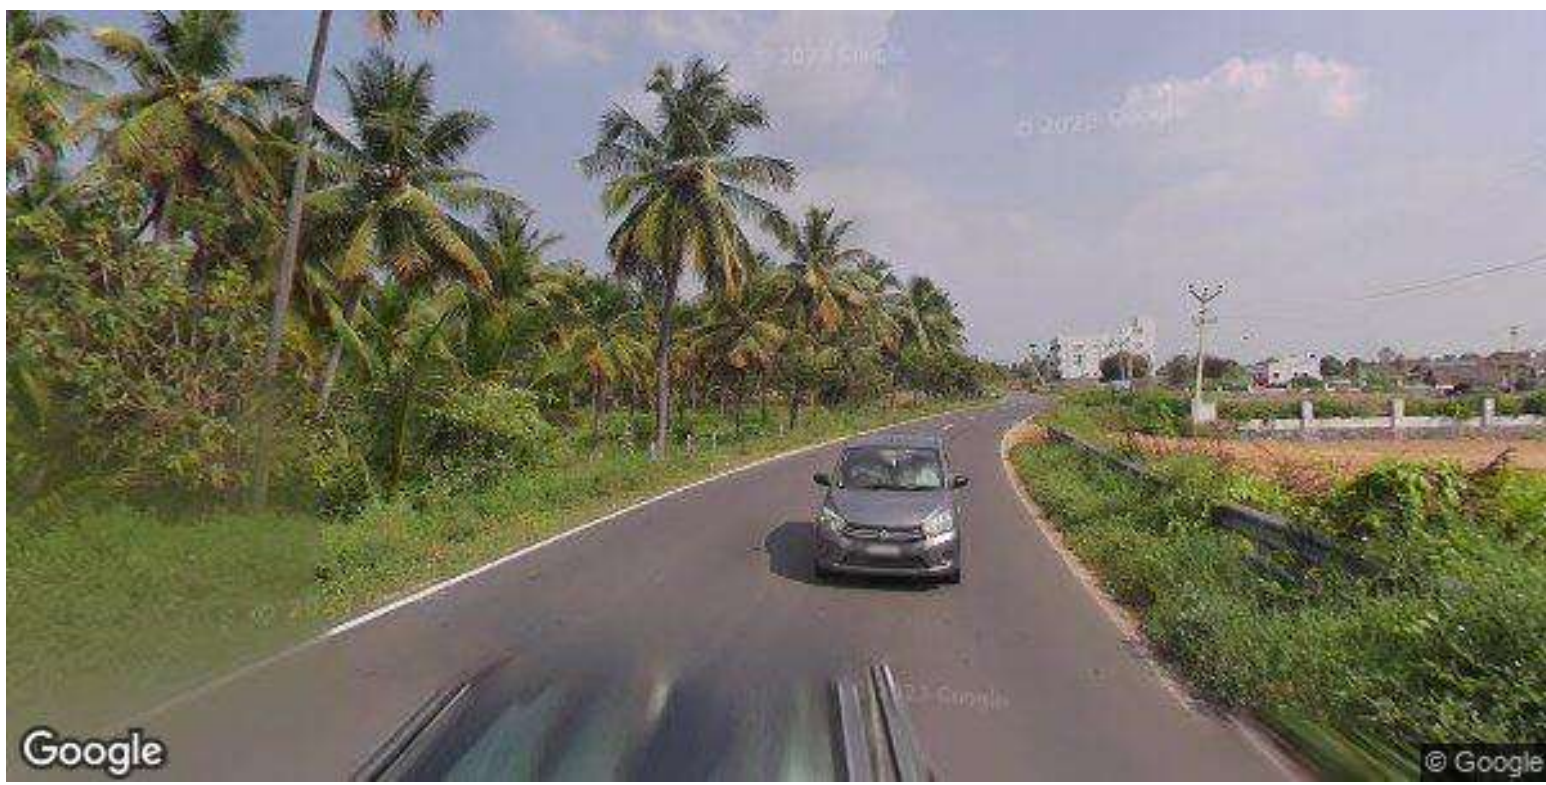
**Coordinates:** 11.45357, 77.85789

**Risk Type:** Turn

**Risk Level:** Medium

**Speed Limit:** 30 KM/Hr

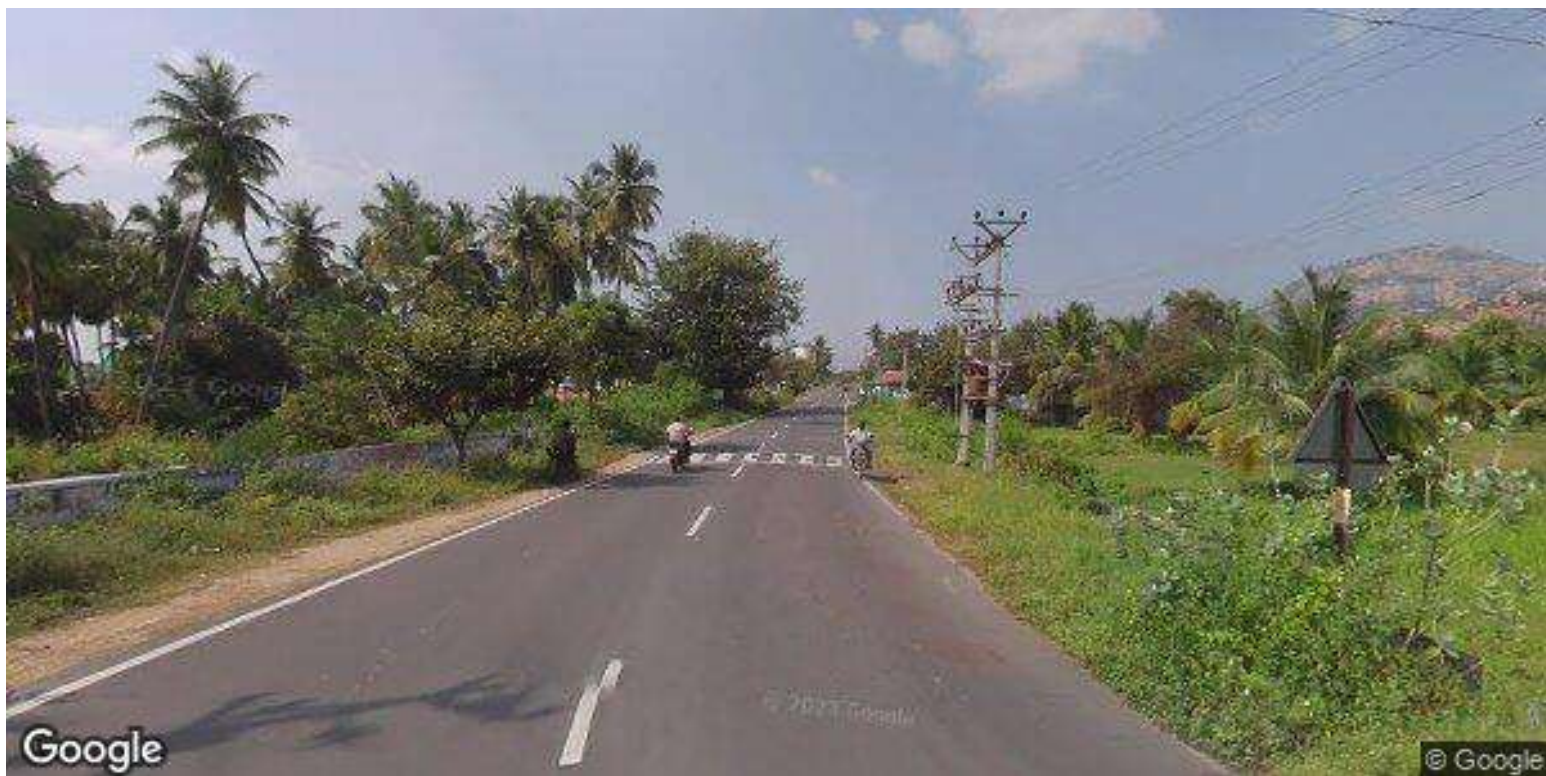
**Coordinates:** 11.45352, 77.85698

**Risk Type:** Turn

**Risk Level:** Medium

**Speed Limit:** 30 KM/Hr

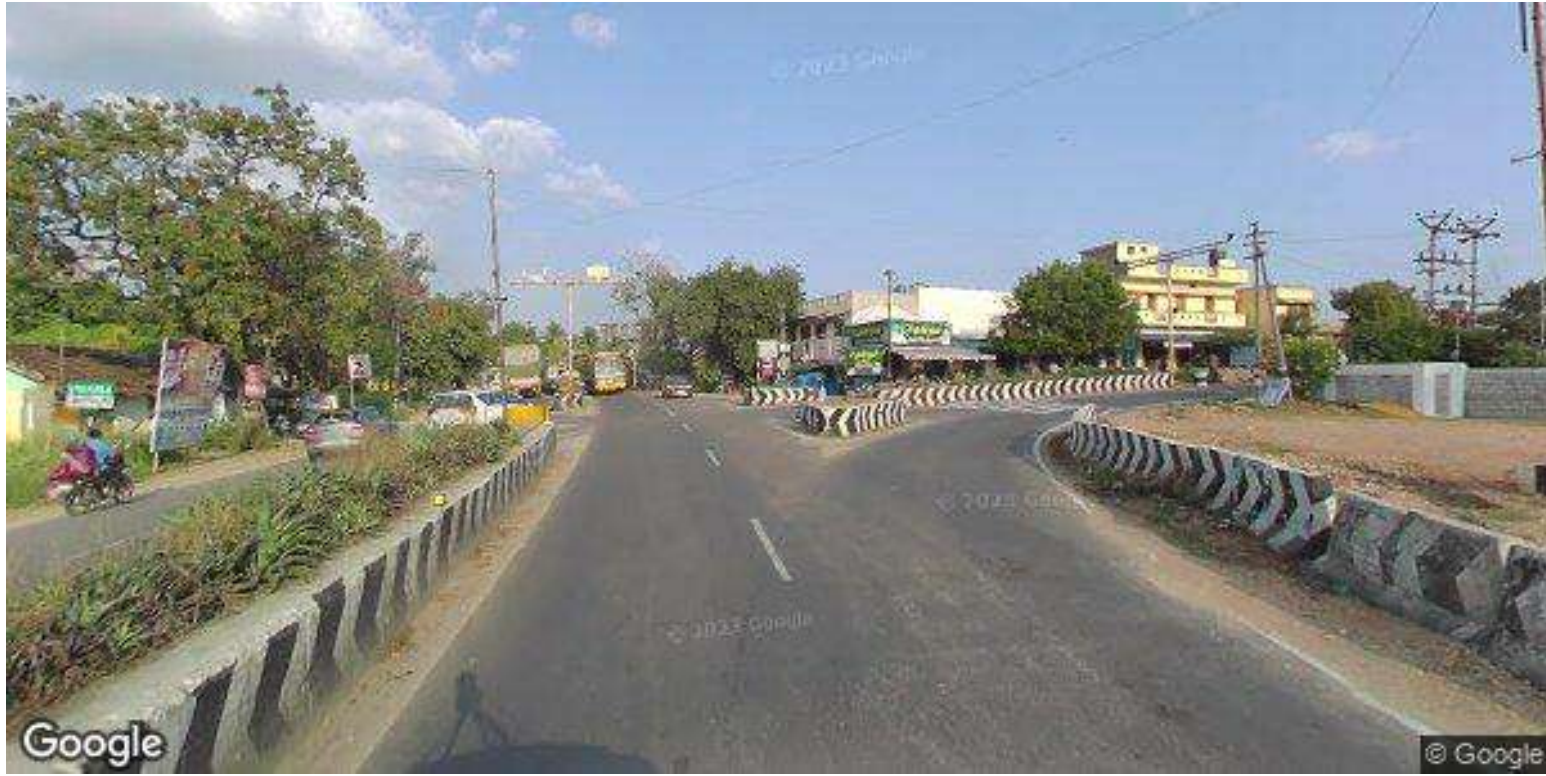
**Coordinates: 11.46318, 77.84913**

**Risk Type: Turn**

**Risk Level: Medium**

**Speed Limit: 30 KM/Hr**

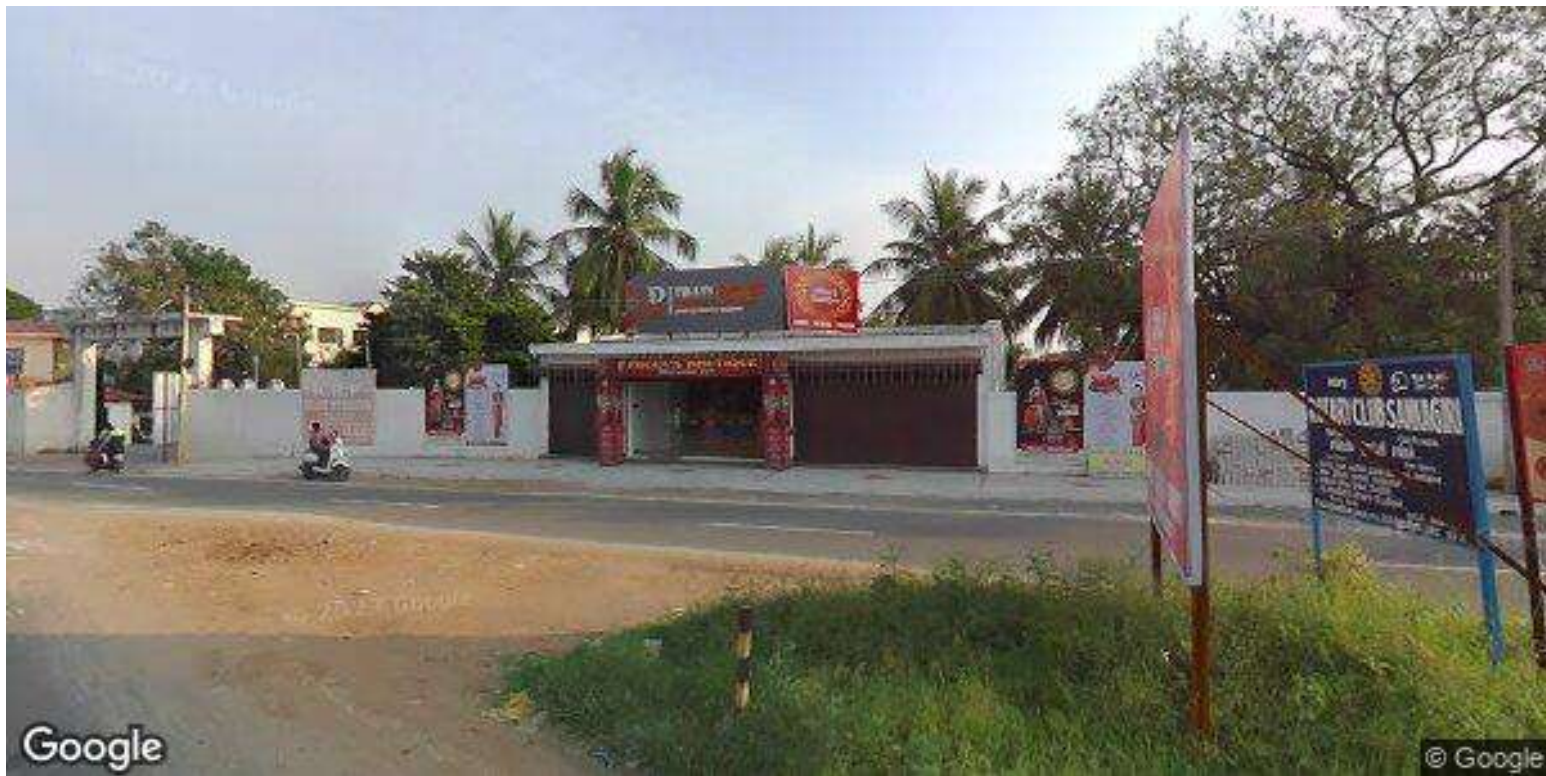
**Coordinates: 11.45516, 77.81346**

**Risk Type: Turn**

**Risk Level: High**

**Speed Limit: 15 KM/Hr**

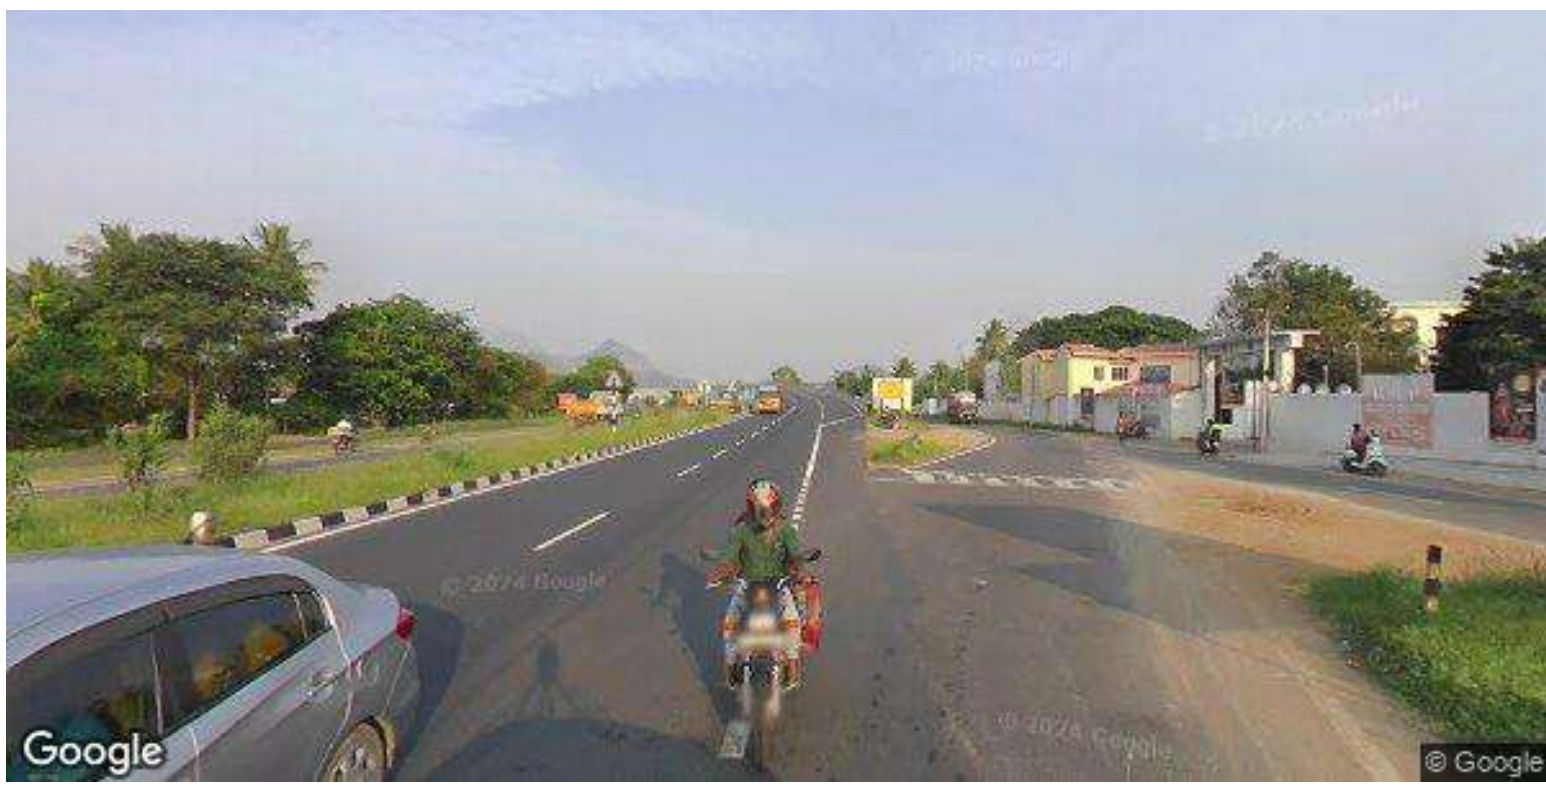
**Coordinates:** 11.45521, 77.81343

**Risk Type:** Turn

**Risk Level:** High

**Speed Limit:** 15 KM/Hr

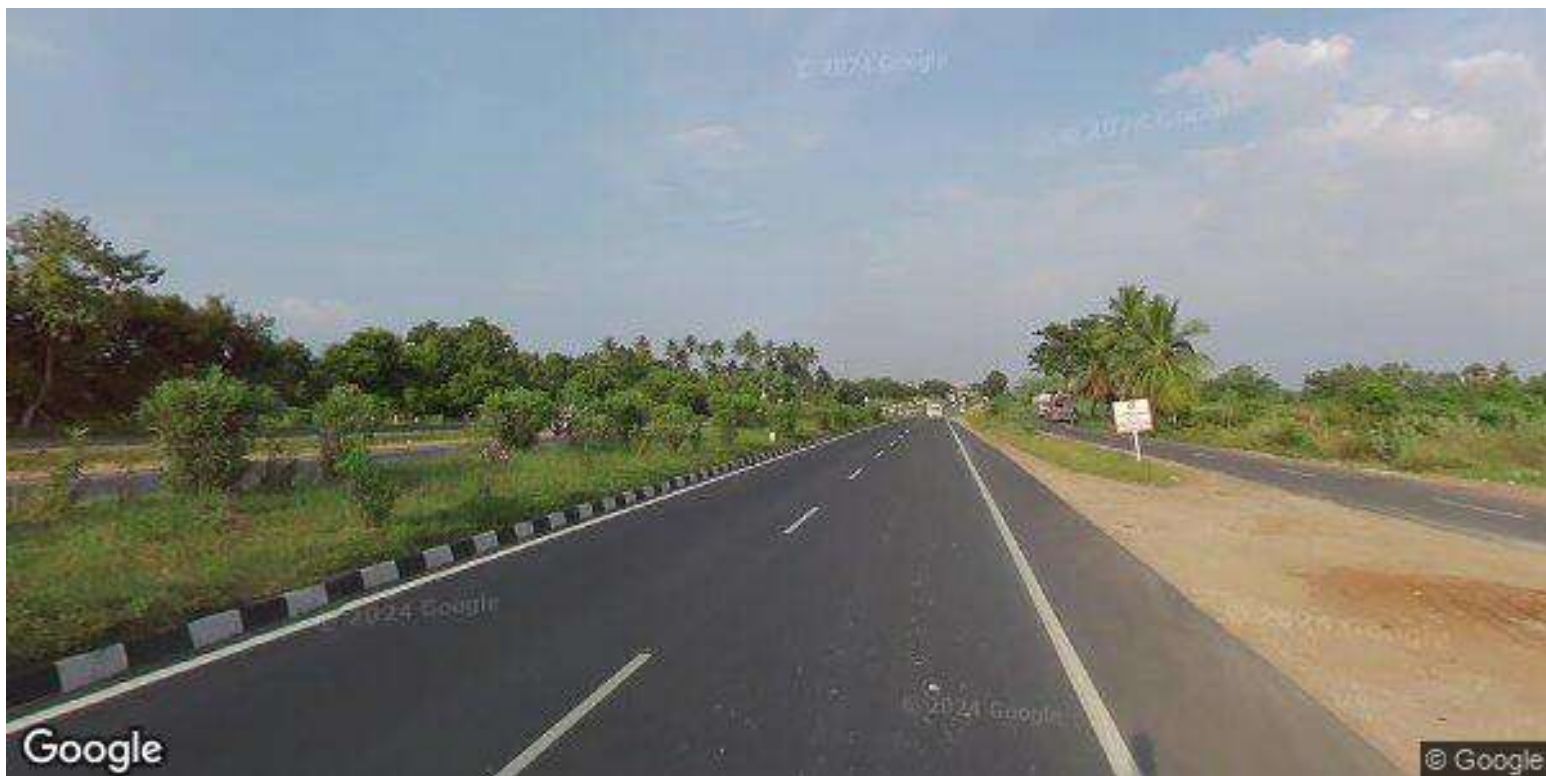
**Coordinates:** 11.31301, 77.61186

**Risk Type:** Blind Spot

**Risk Level:** Blind Spot

**Speed Limit:** 10 KM/Hr

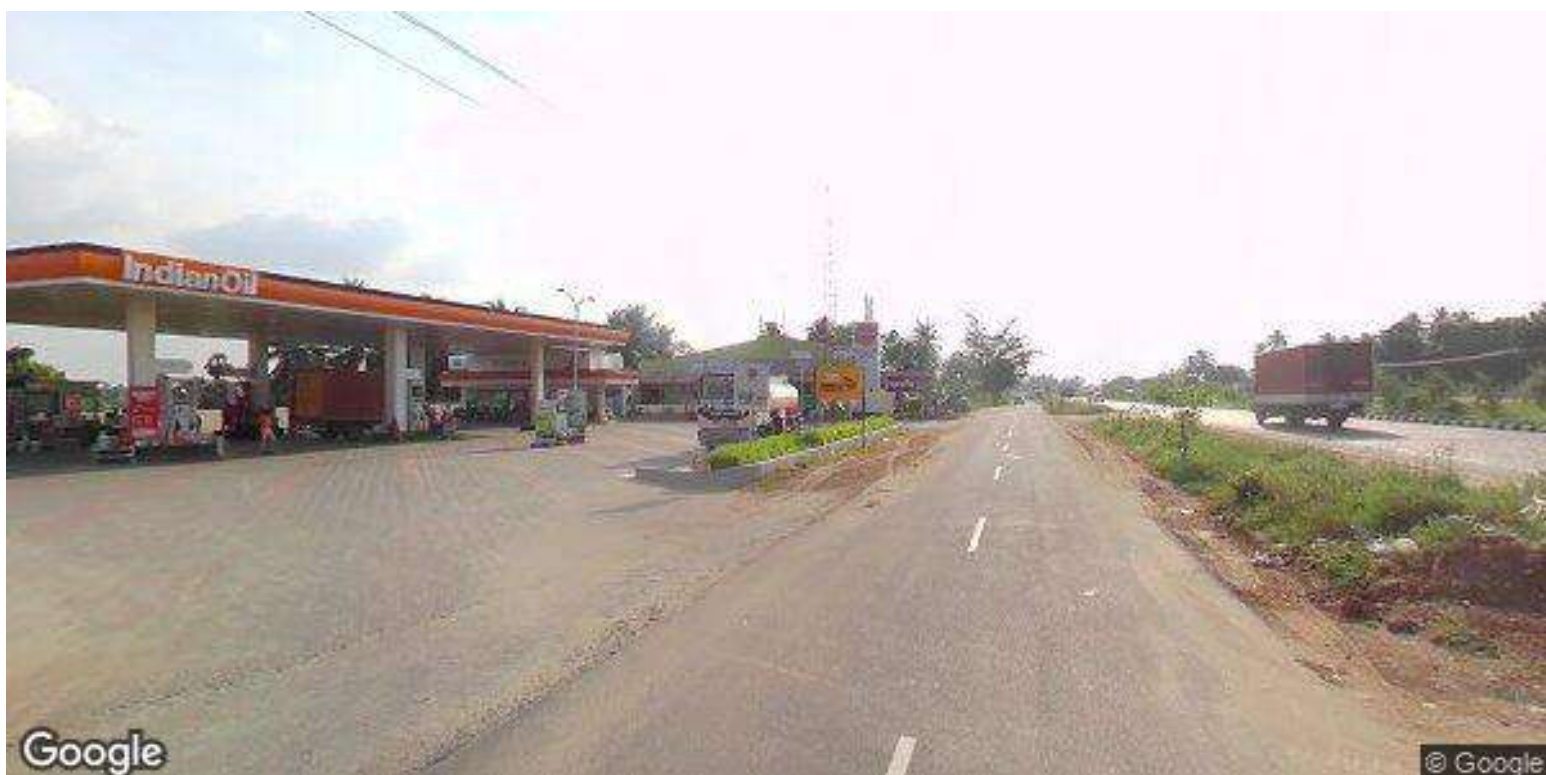
**Risk Type:** Blind Spot  
**Risk Level:** Blind Spot  
**Speed Limit:** 10 KM/Hr  
**Coordinates:** 11.31291, 77.61196
