# IndianOil

## JOURNEY RISK MANAGEMENT (JRM) STUDY

### Salem Terminal to RAMESH AGENCIES

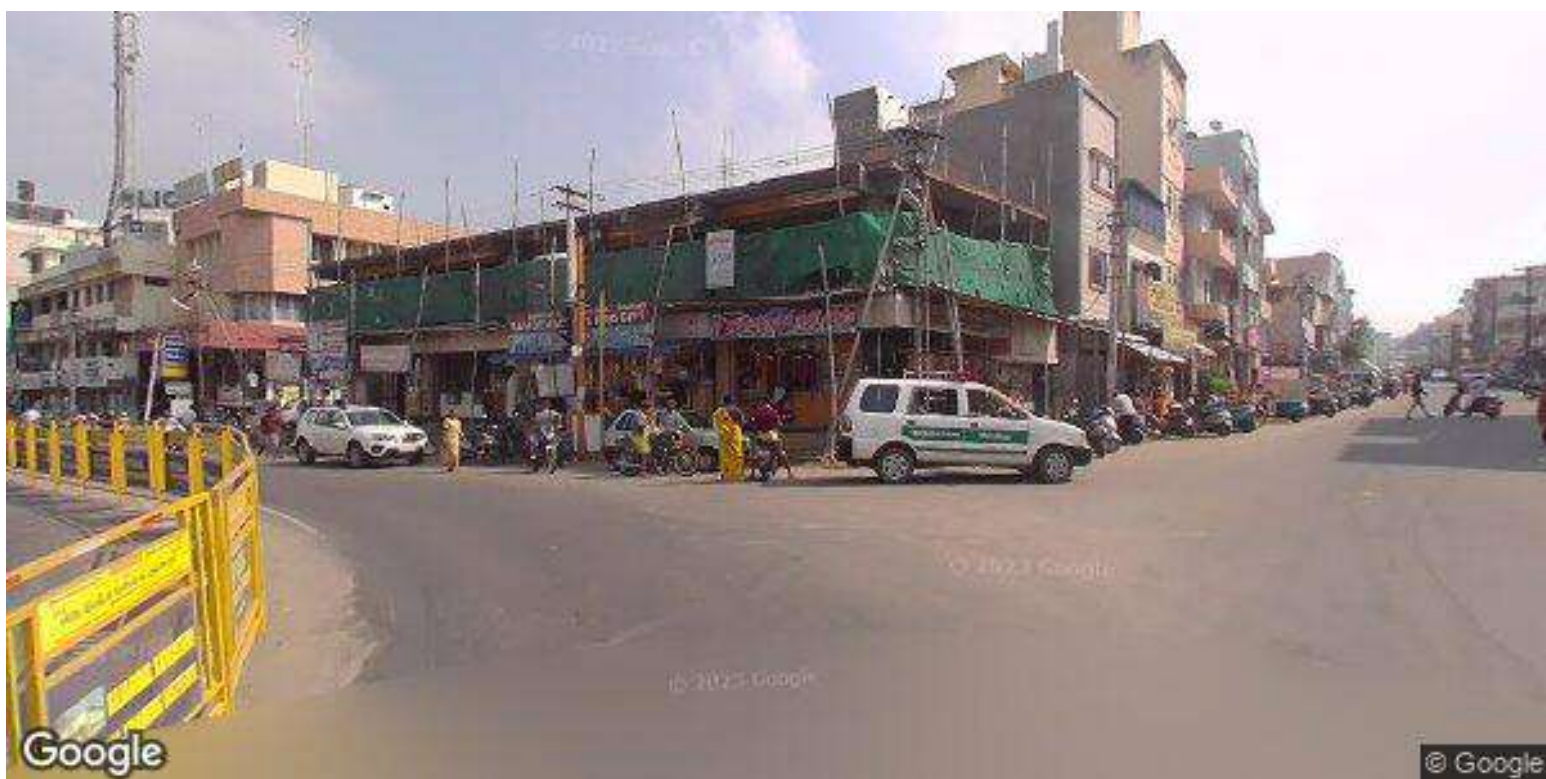
**Coordinates:** 11.37868, 77.89498

**Risk Type:** Turn

**Risk Level:** High

**Speed Limit:** 15 KM/Hr

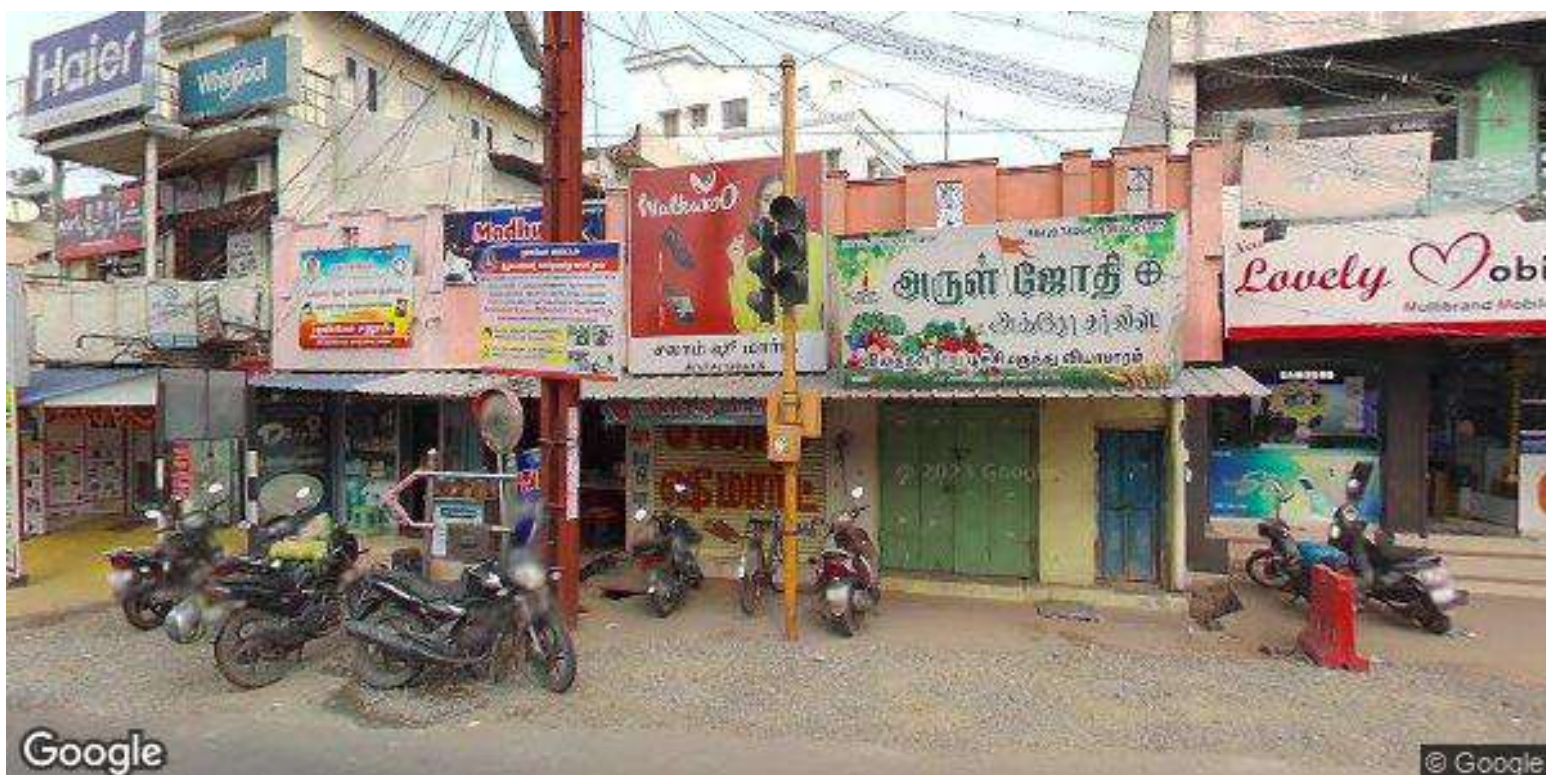
**Coordinates:** 11.37850, 77.89453

**Risk Type:** Turn

**Risk Level:** High

**Speed Limit:** 15 KM/Hr

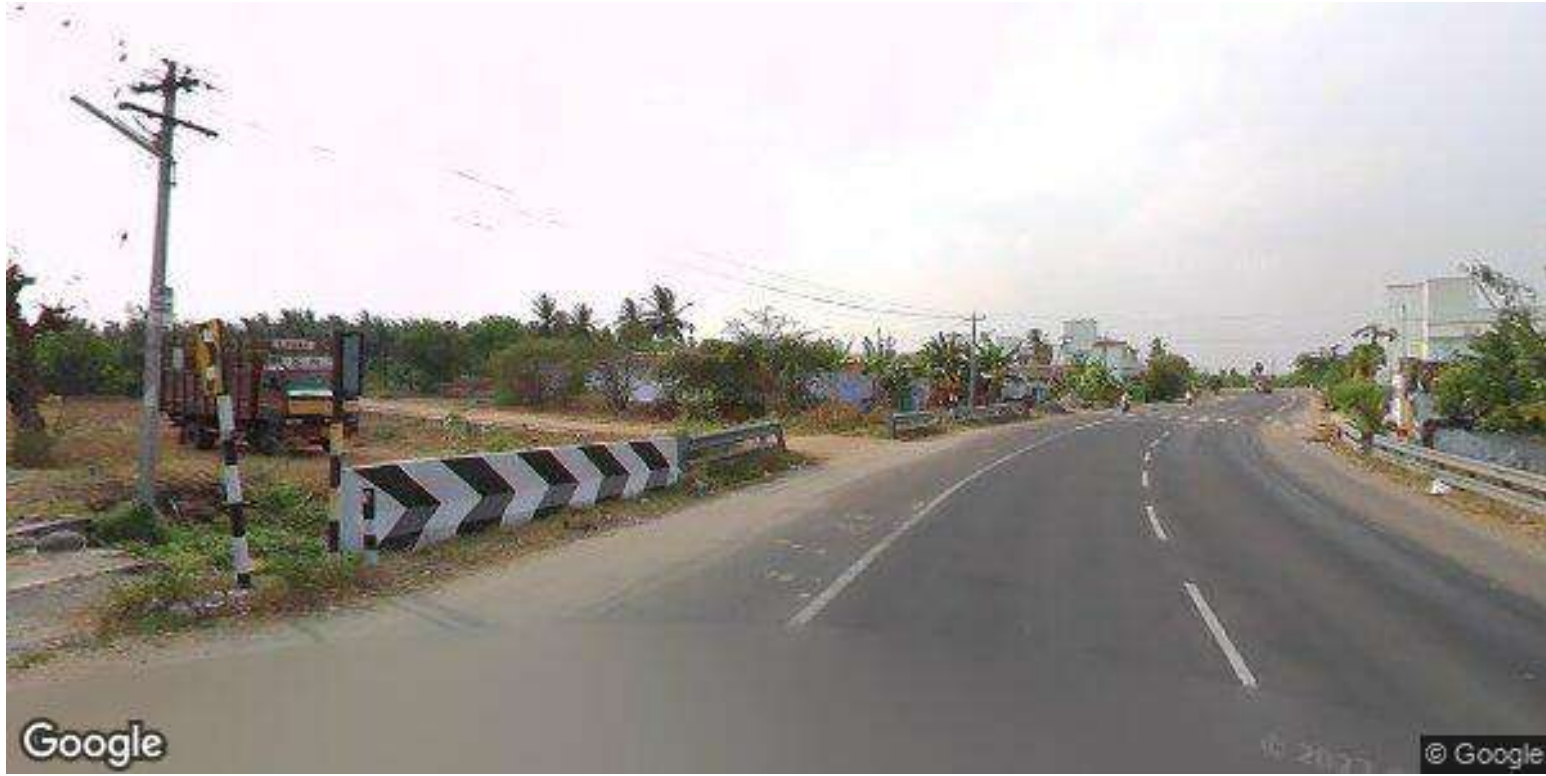
**Coordinates:** 11.16755, 78.01568

**Risk Type:** Turn

**Risk Level:** Medium

**Speed Limit:** 30 KM/Hr

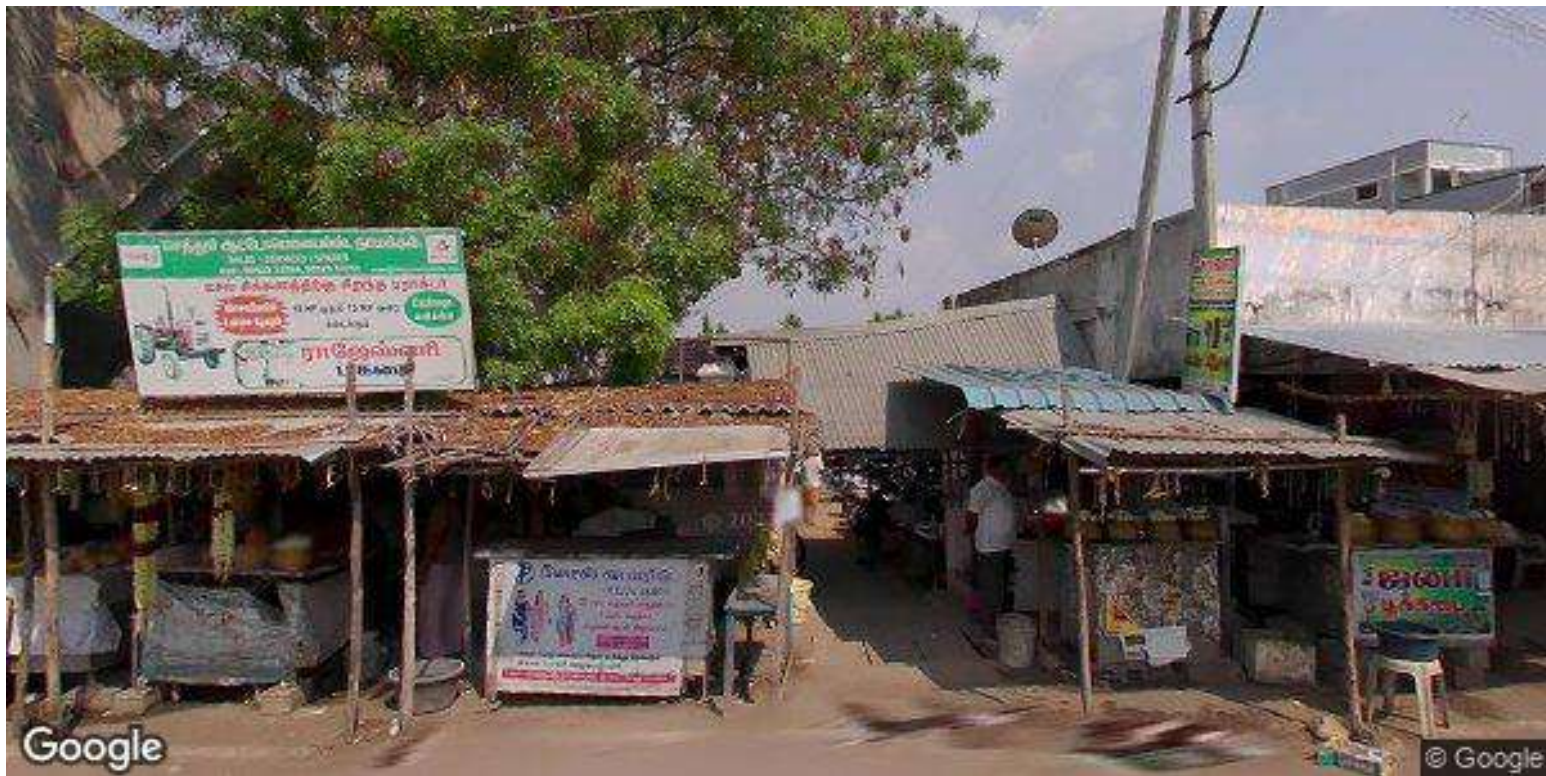
**Coordinates:** 11.15573, 78.02176

**Risk Type:** Turn

**Risk Level:** High

**Speed Limit:** 15 KM/Hr

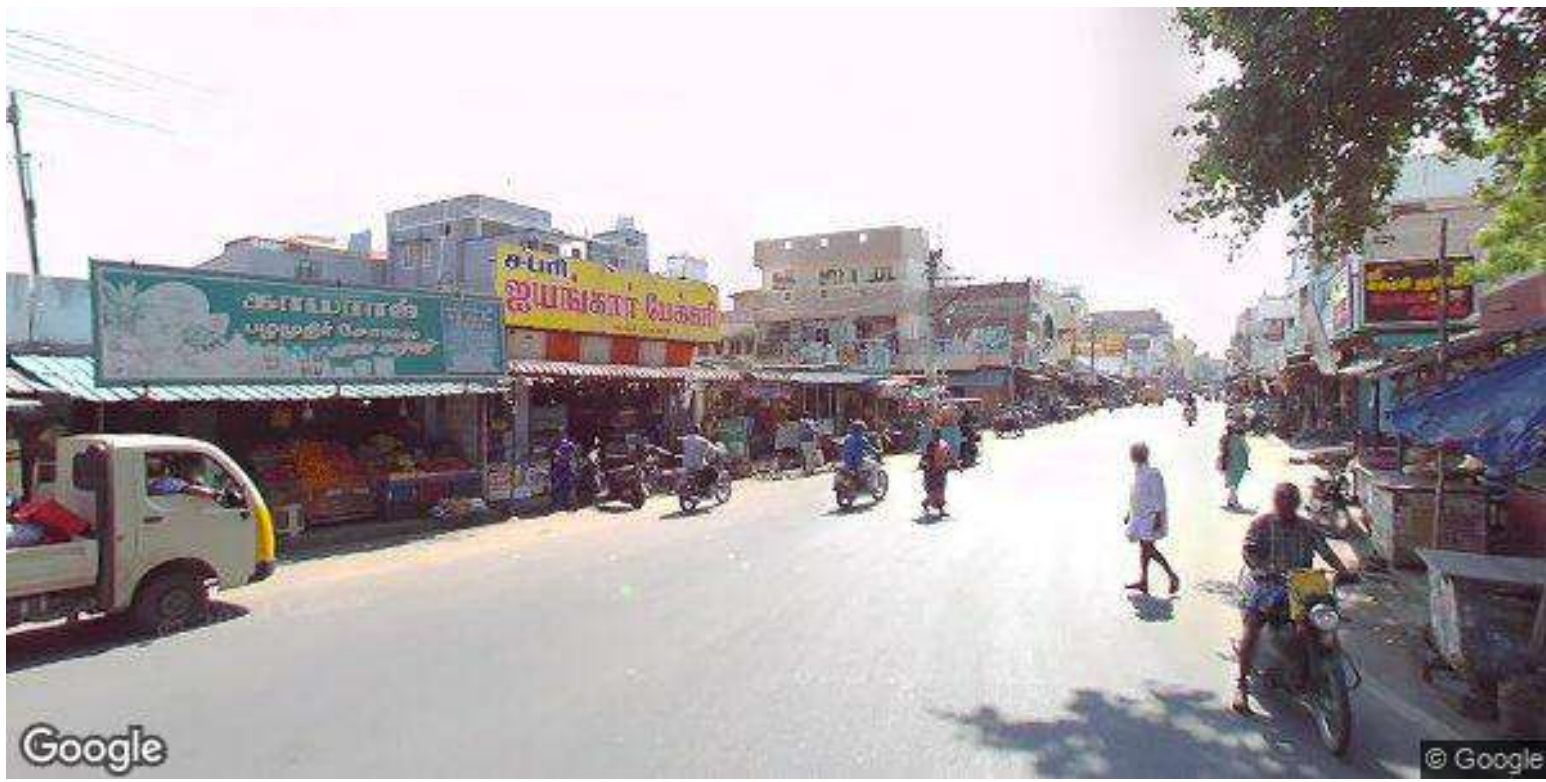
**Coordinates:** 11.15565, 78.02171

**Risk Type:** Turn

**Risk Level:** Medium

**Speed Limit:** 30 KM/Hr

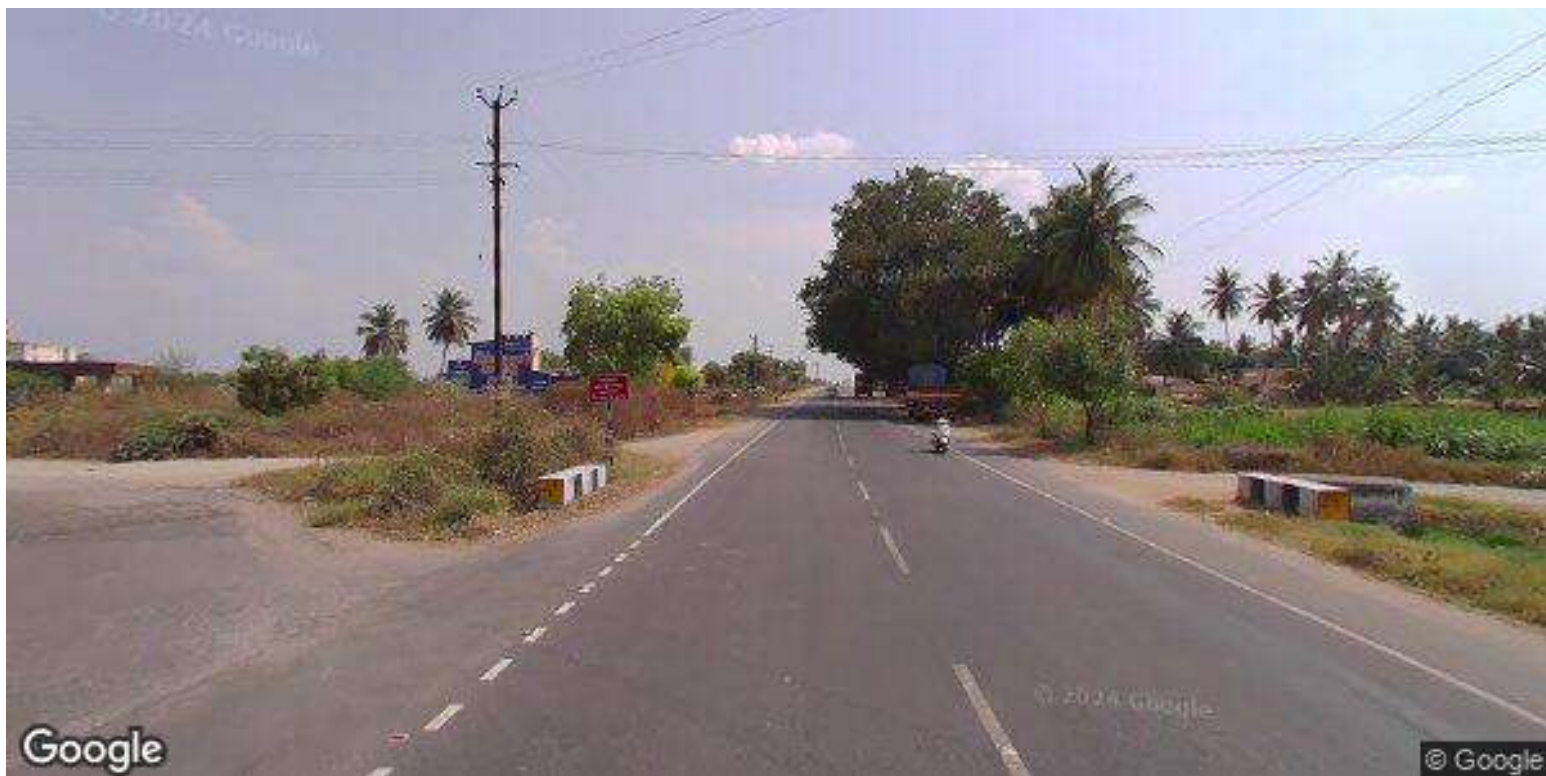
**Coordinates:** 11.14545, 78.02208

**Risk Type:** Turn

**Risk Level:** High

**Speed Limit:** 15 KM/Hr

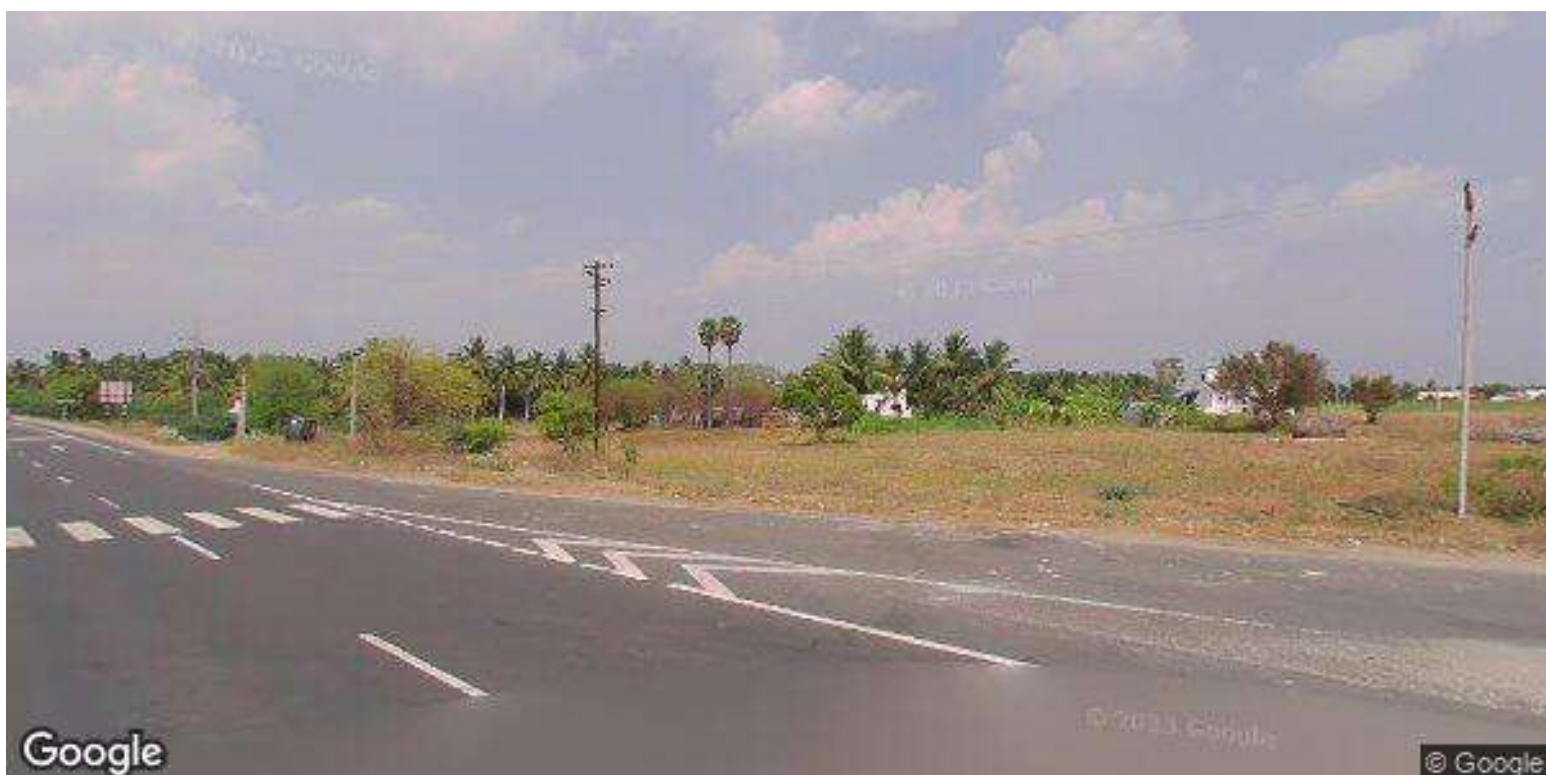
**Risk Type:** Blind Spot  
**Risk Level:** Blind Spot  
**Speed Limit:** 10 KM/Hr  
**Coordinates:** 11.14480, 78.02291

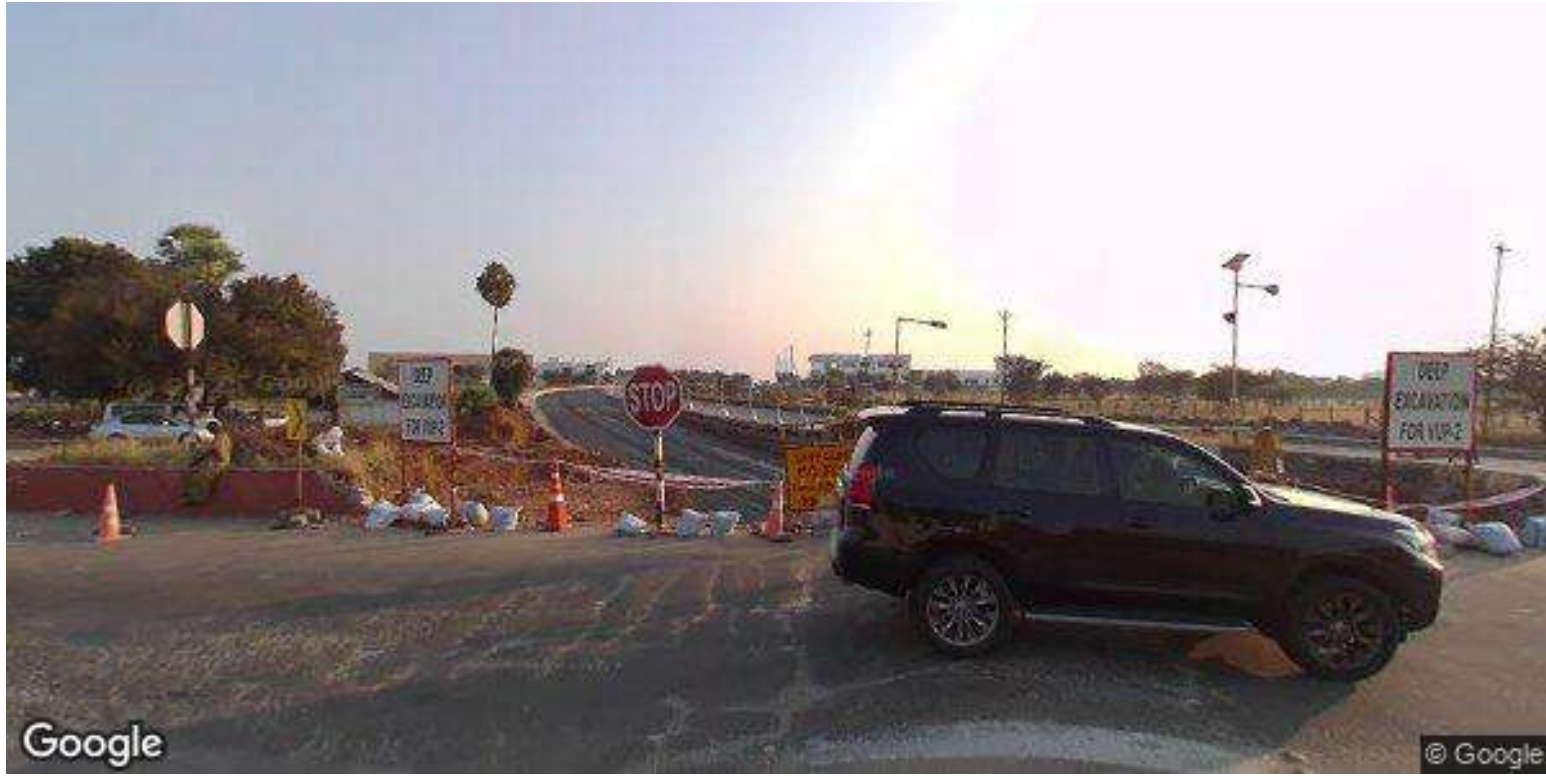
**Risk Type:** Blind Spot  
**Risk Level:** Blind Spot  
**Speed Limit:** 10 KM/Hr  
**Coordinates:** 11.01166, 78.06877

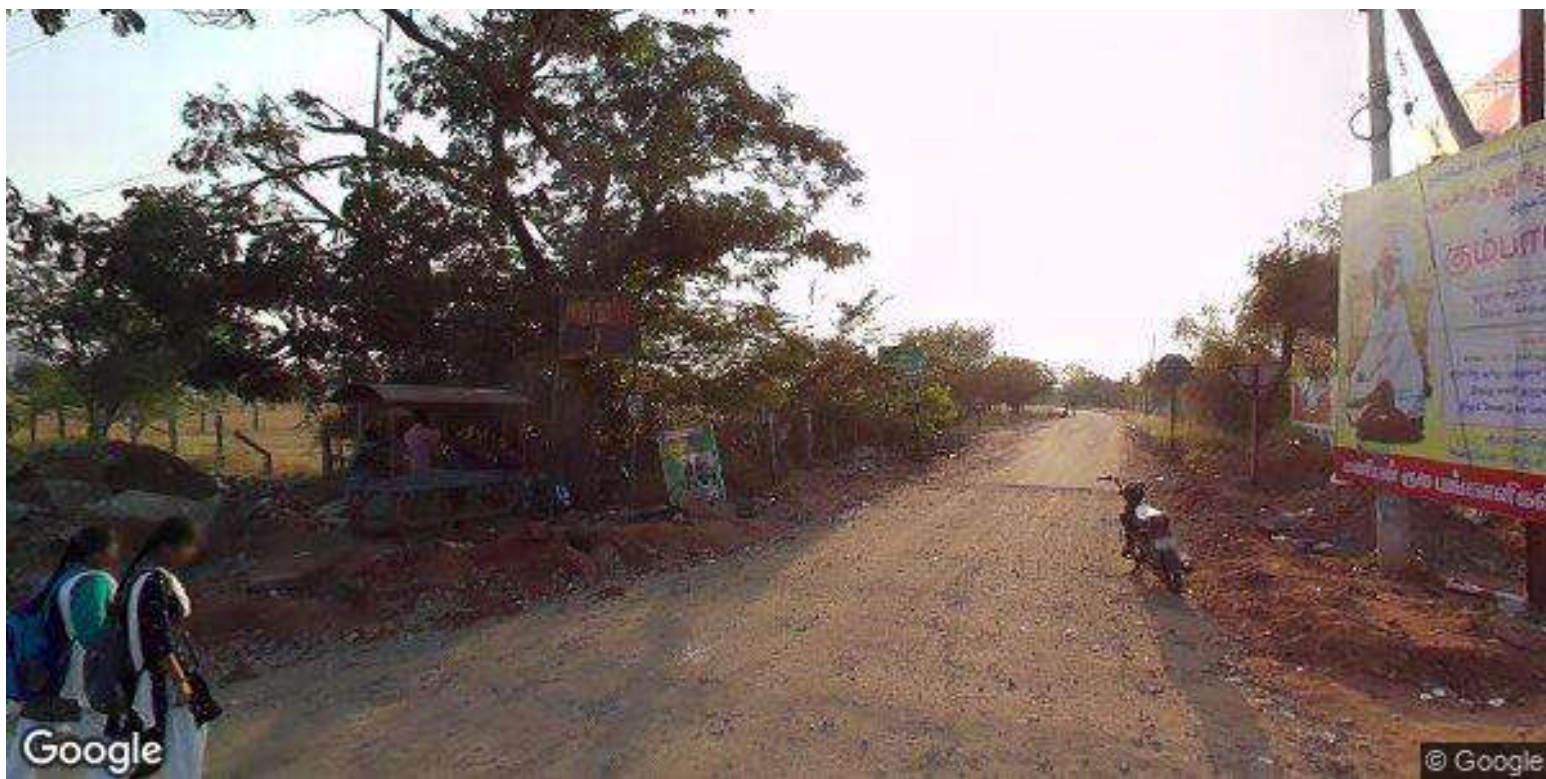
**Risk Type:** Turn  
**Risk Level:** High  
**Speed Limit:** 15 KM/Hr  
**Coordinates:** 11.01161, 78.06848

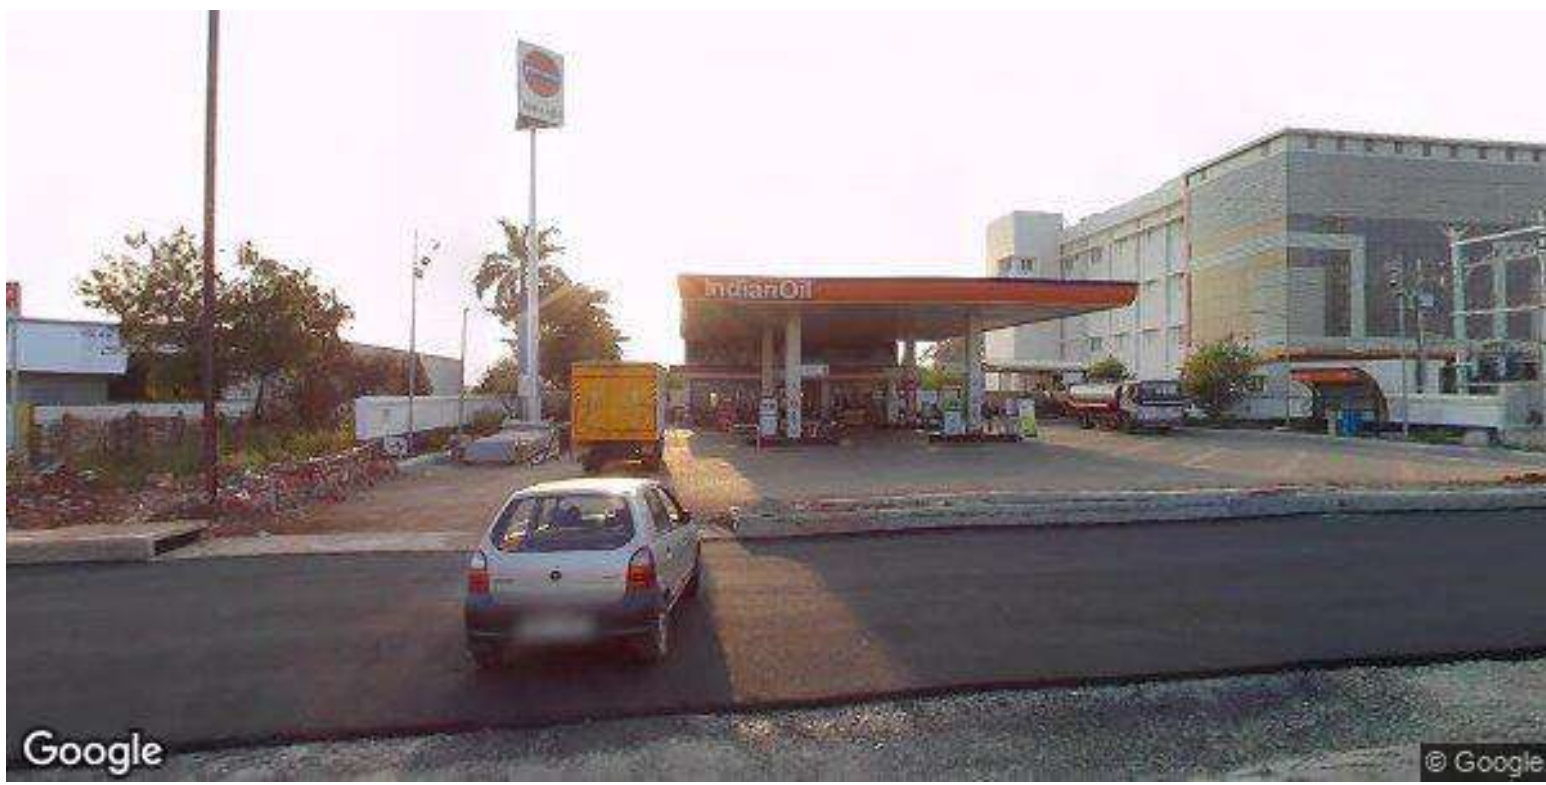
**Coordinates:** 11.01423, 78.06745

**Risk Type:** Turn

**Risk Level:** High

**Speed Limit:** 15 KM/Hr

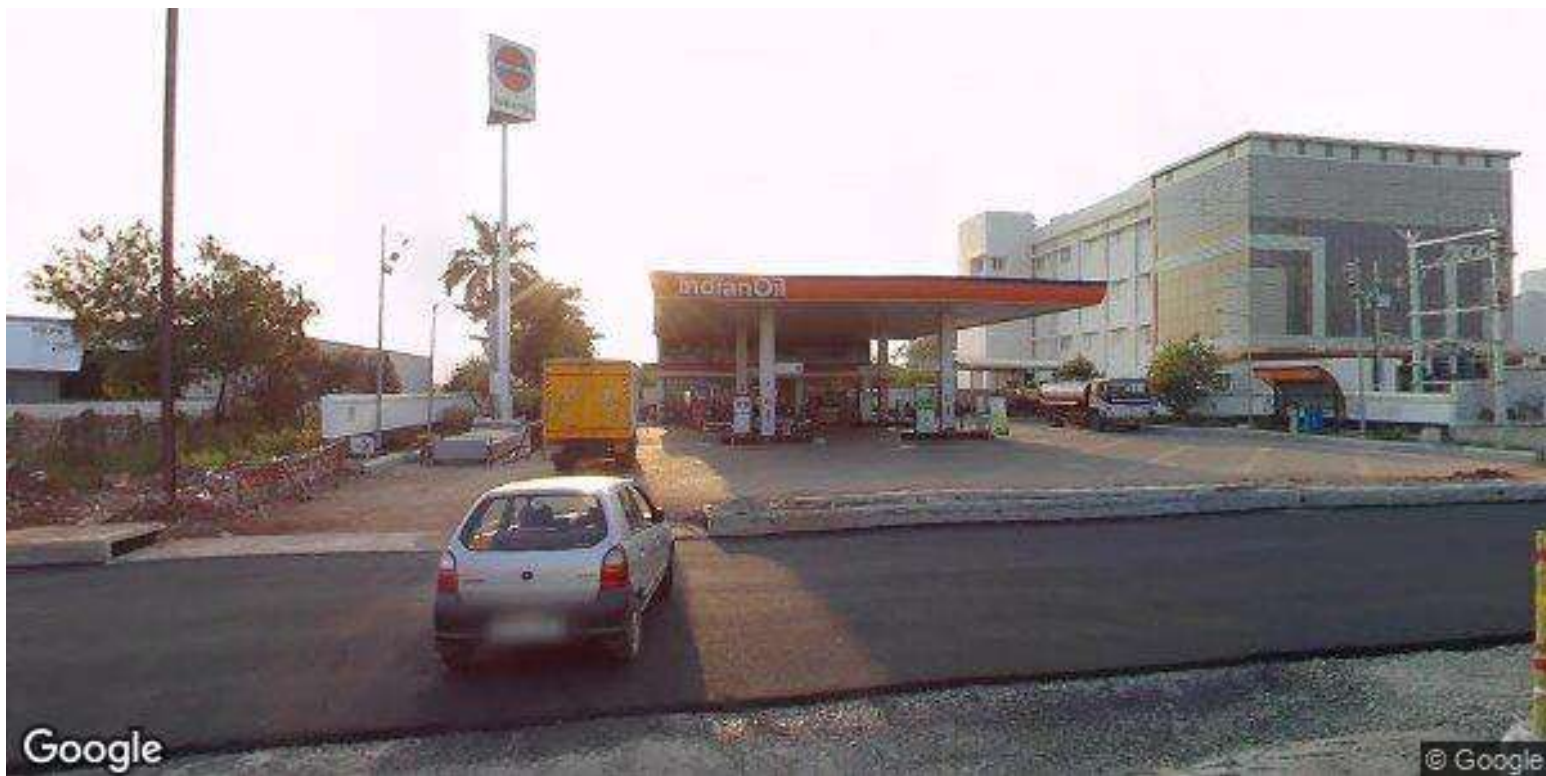
**Coordinates:** 11.01421, 78.06733

**Risk Type:** Turn

**Risk Level:** High

**Speed Limit:** 15 KM/Hr
