# IndianOil

## JOURNEY RISK MANAGEMENT (JRM) STUDY

### Salem Terminal to SRI AMARAVATHI AGENCIES

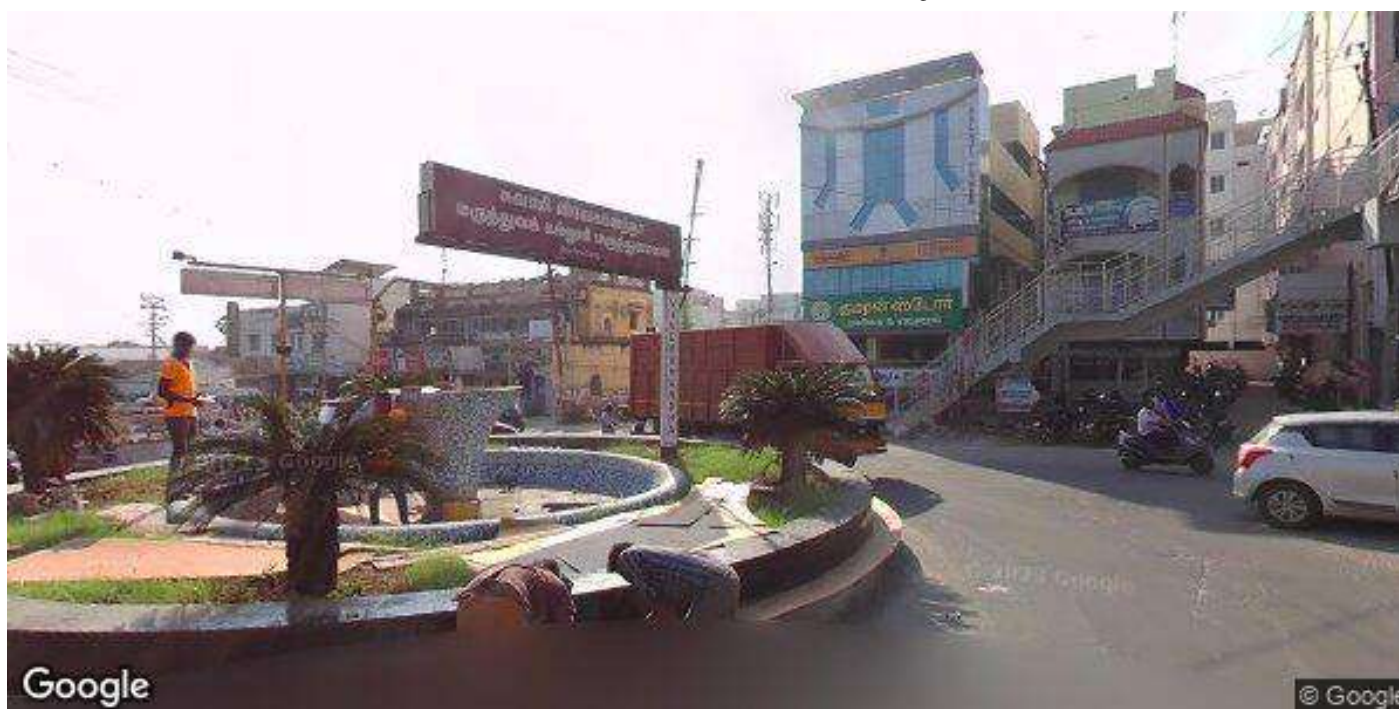
| | Risk Type | Risk Level | Coordinates | Speed Limit |
|---|---|---|---|---|
| 0 | Roundabout | High | 11.38395, 77.89480 | 15 KM/Hr |

**Risk Type:** Roundabout  
**Risk Level:** High  
**Speed Limit:** 15 KM/Hr  
**Coordinates:** 11.38395, 77.89480

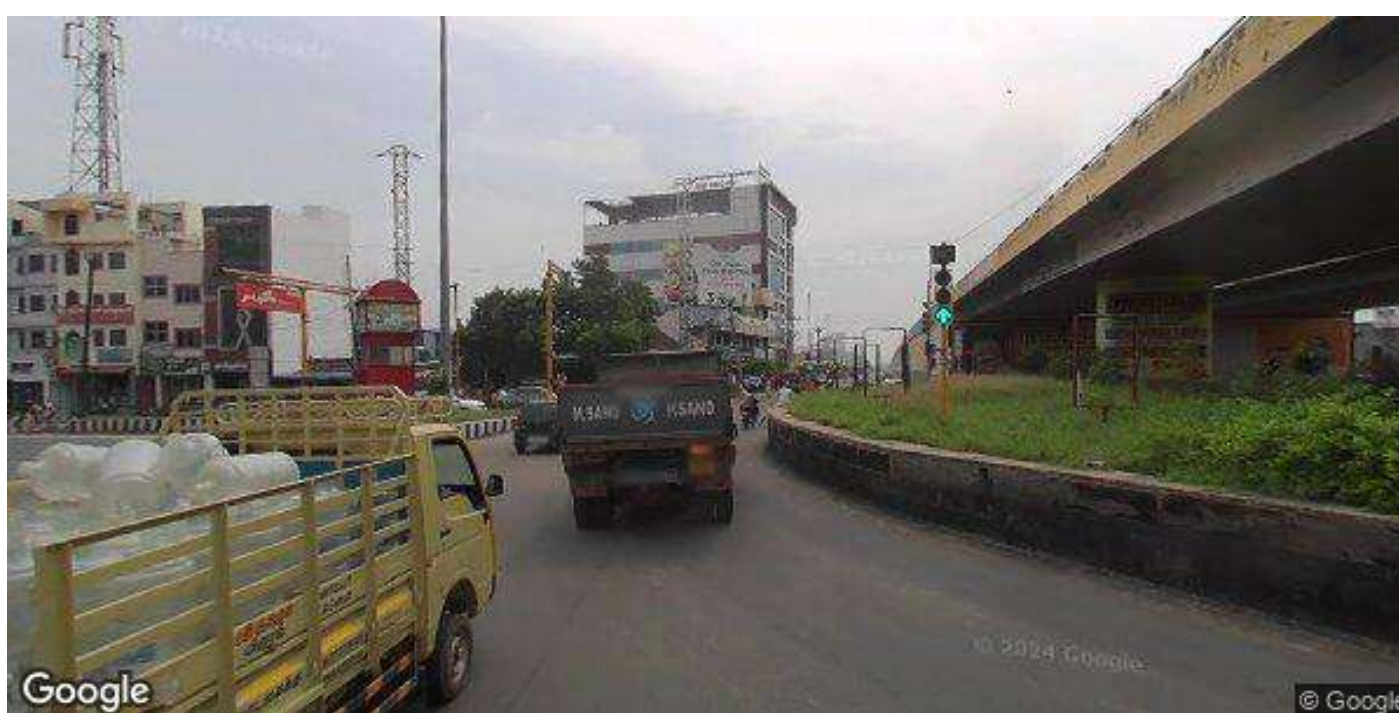
| | Risk Type | Risk Level | Coordinates | Speed Limit |
|---|---|---|---|---|
| 1 | Roundabout | High | 10.96304, 78.06131 | 15 KM/Hr |

**Risk Type:** Roundabout  
**Risk Level:** High  
**Speed Limit:** 15 KM/Hr  
**Coordinates:** 10.96304, 78.06131

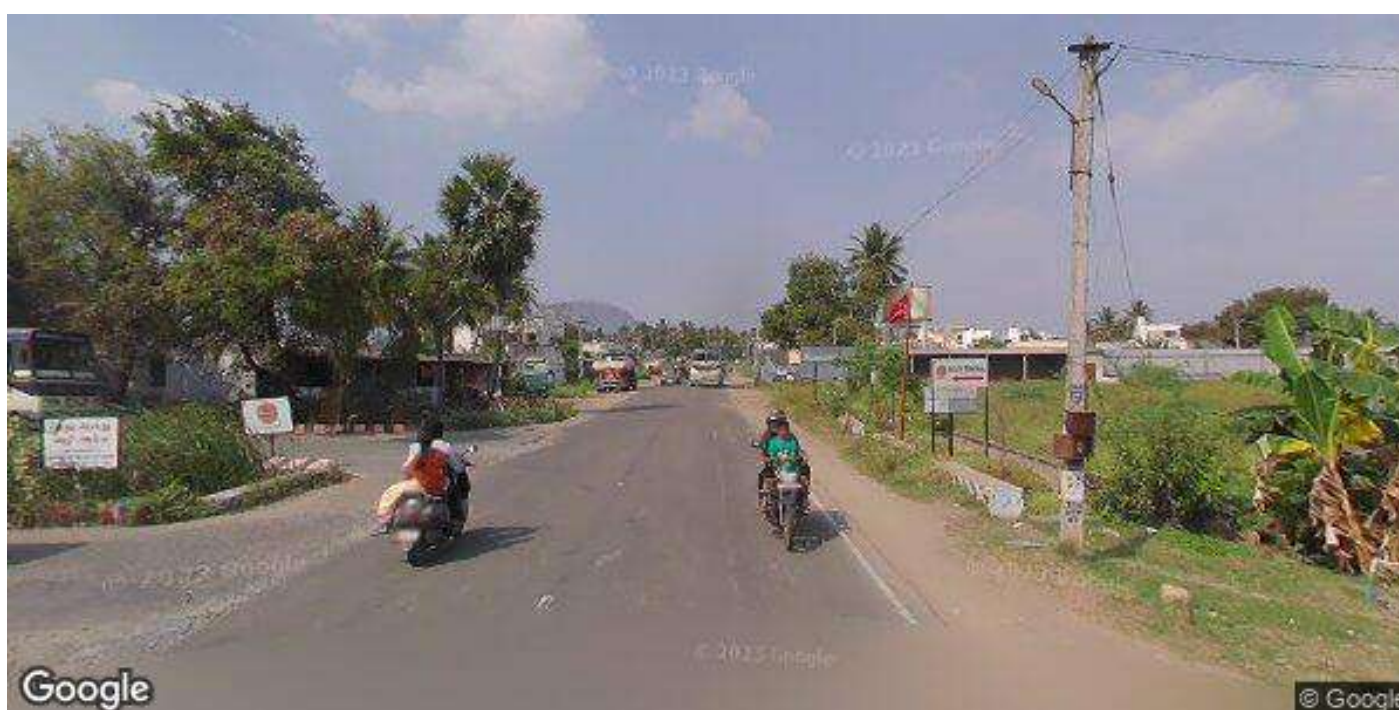
| | Risk Type | Risk Level | Coordinates | Speed Limit |
|---|---|---|---|---|
| 3 | Turn | High | 11.44019, 77.87547 | 15 KM/Hr |

**Risk Type:** Turn  
**Risk Level:** High  
**Speed Limit:** 15 KM/Hr  
**Coordinates:** 11.44019, 77.87547

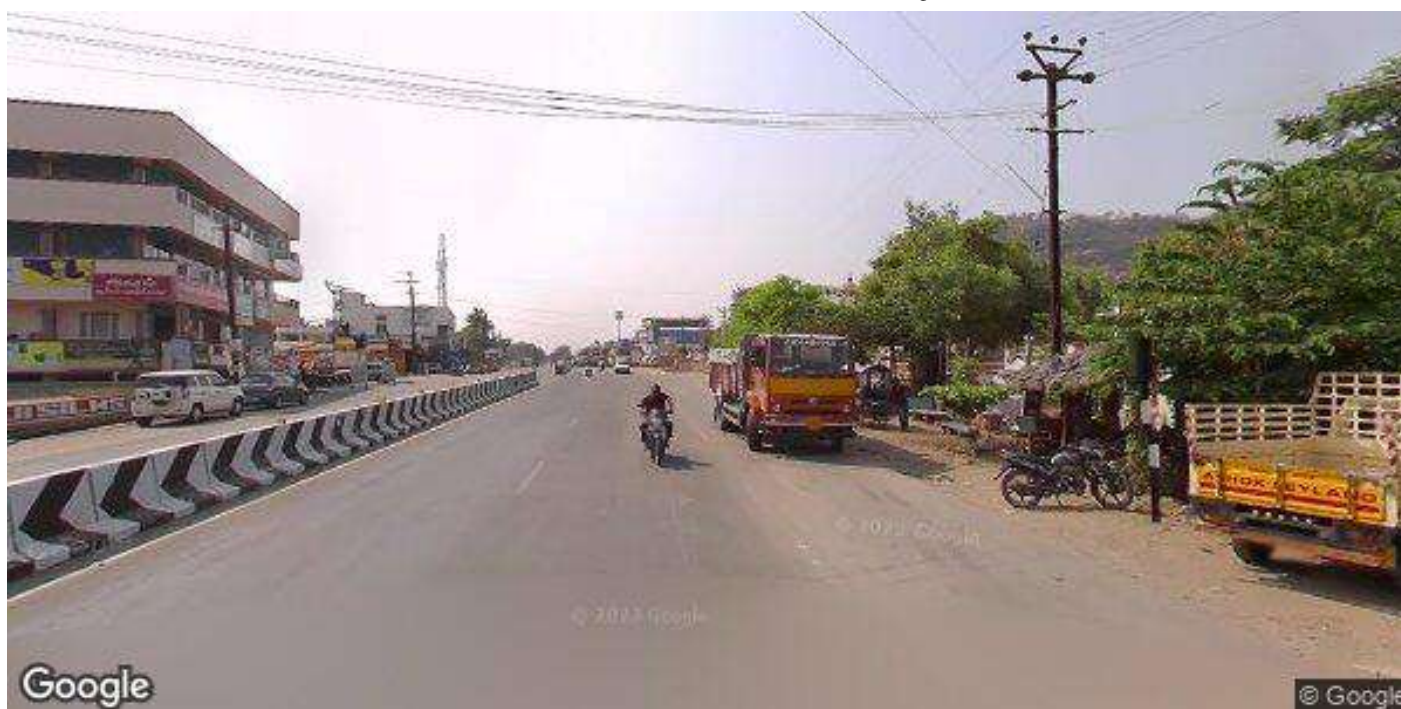
| | Risk Type | Risk Level | Coordinates | Speed Limit |
|---|---|---|---|---|
| 4 | Turn | Medium | 11.39685, 77.88861 | 30 KM/Hr |

**Risk Type:** Turn  
**Risk Level:** Medium  
**Speed Limit:** 30 KM/Hr  
**Coordinates:** 11.39685, 77.88861

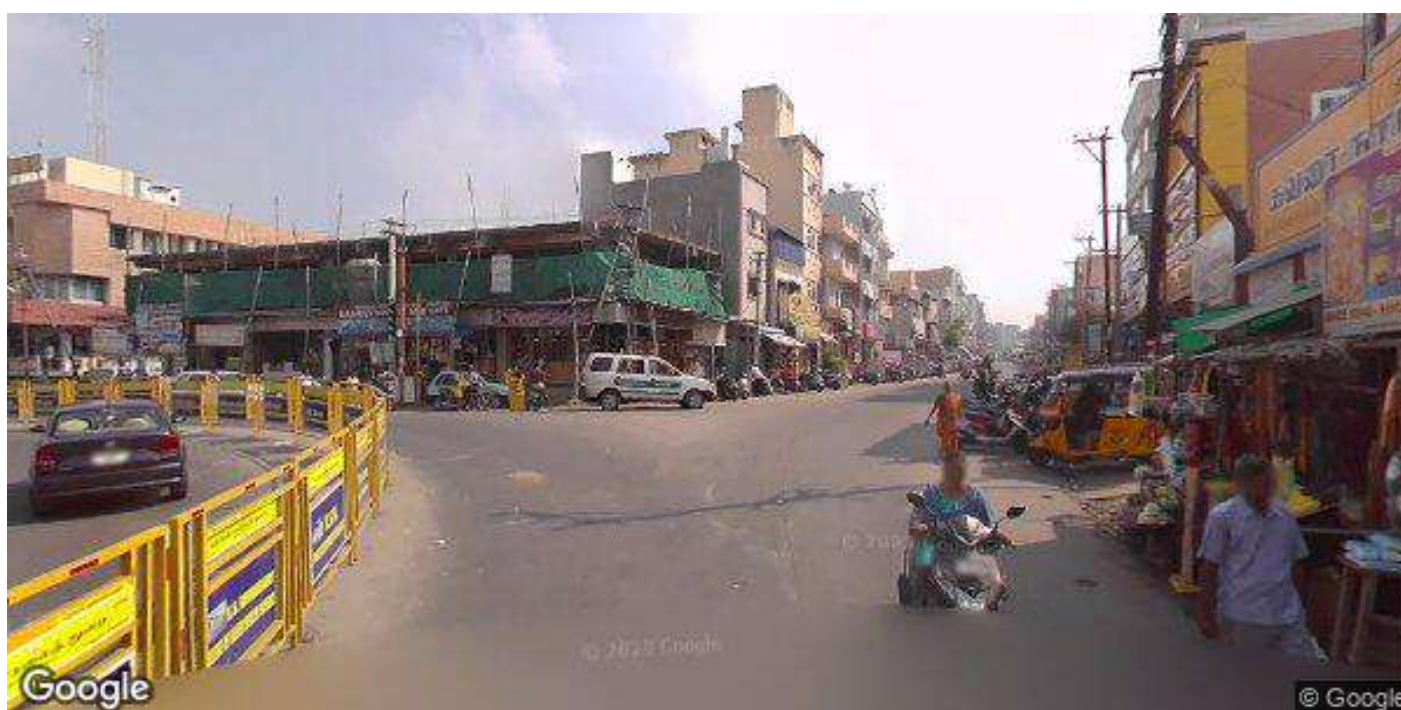
| | Risk Type | Risk Level | Coordinates | Speed Limit |
|---|---|---|---|---|
| 5 | Turn | High | 11.37862, 77.89488 | 15 KM/Hr |

**Risk Type:** Turn  
**Risk Level:** High  
**Speed Limit:** 15 KM/Hr  
**Coordinates:** 11.37862, 77.89488

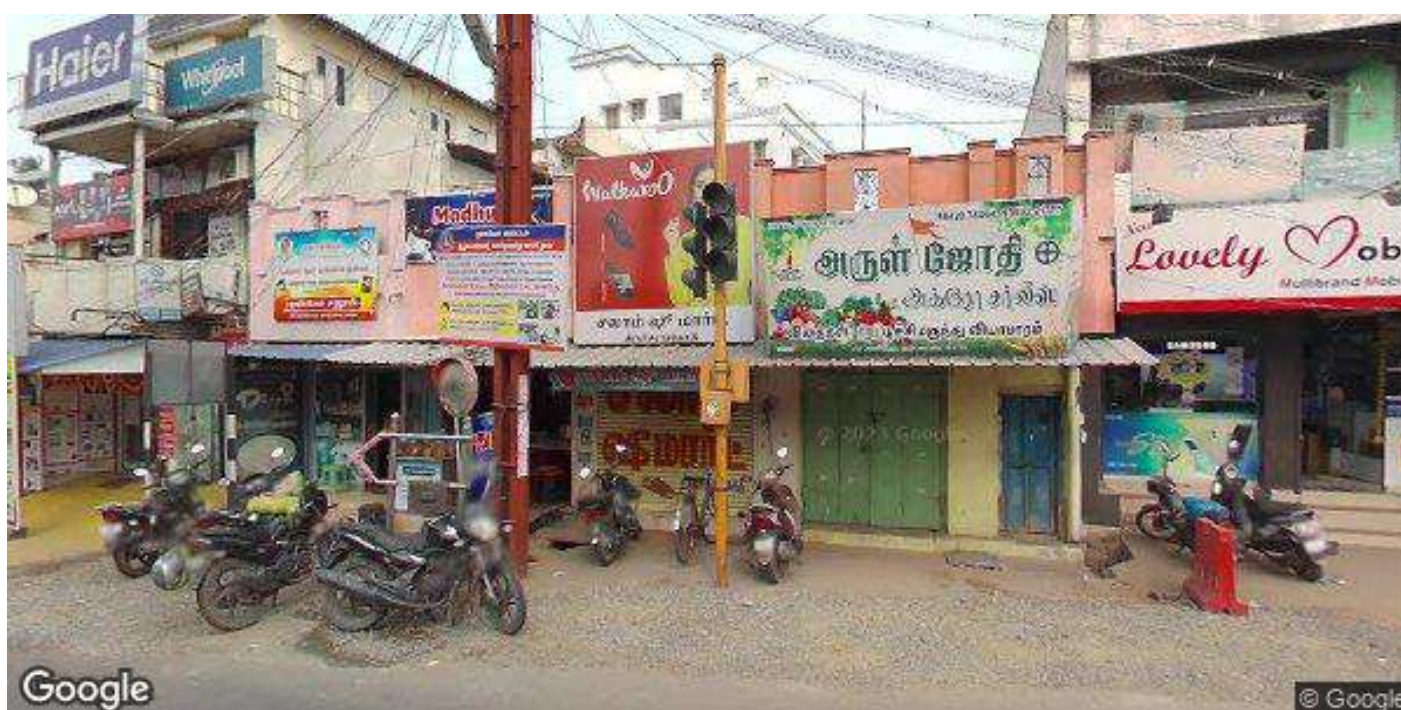
| | Risk Type | Risk Level | Coordinates | Speed Limit |
|---|---|---|---|---|
| 6 | Turn | High | 11.37850, 77.89453 | 15 KM/Hr |

**Risk Type:** Turn  
**Risk Level:** High  
**Speed Limit:** 15 KM/Hr  
**Coordinates:** 11.37850, 77.89453

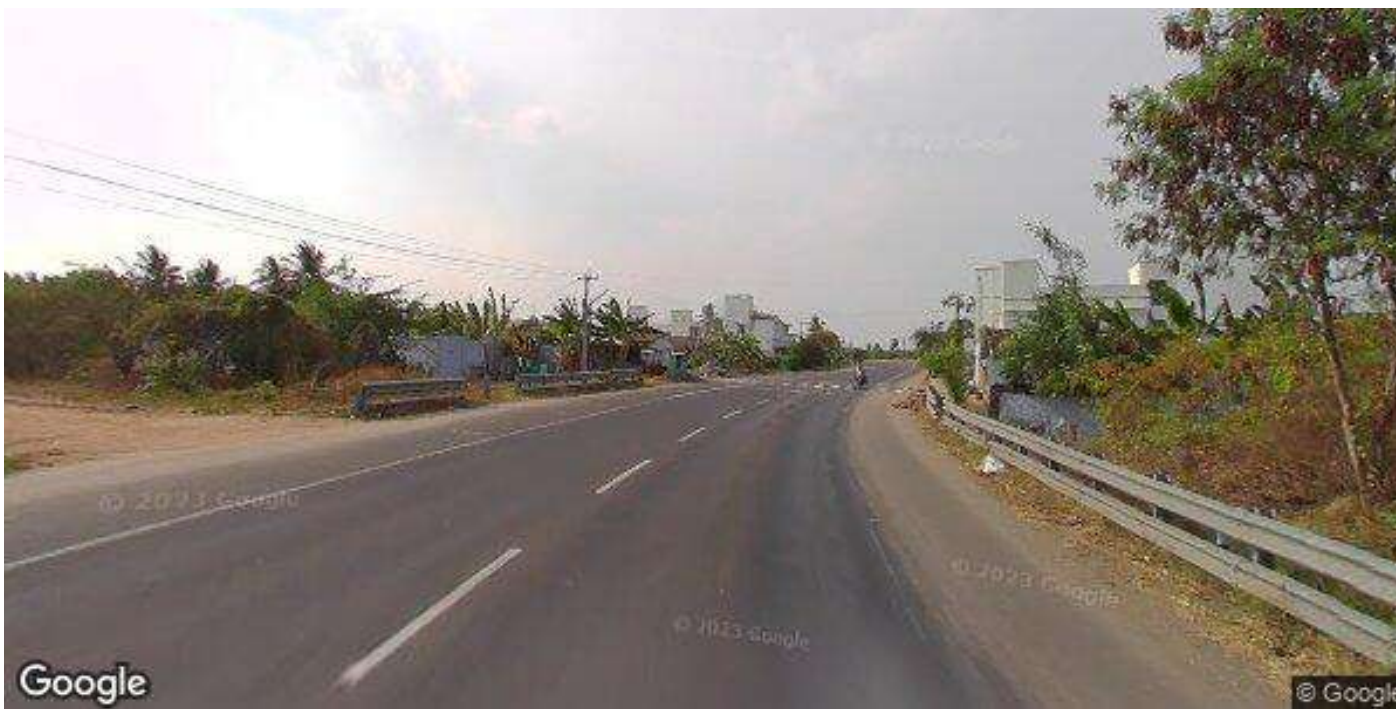
| | Risk Type | Risk Level | Coordinates | Speed Limit |
|---|---|---|---|---|
| 7 | Turn | Medium | 11.16764, 78.01565 | 30 KM/Hr |

**Risk Type:** Turn  
**Risk Level:** Medium  
**Speed Limit:** 30 KM/Hr  
**Coordinates:** 11.16764, 78.01565

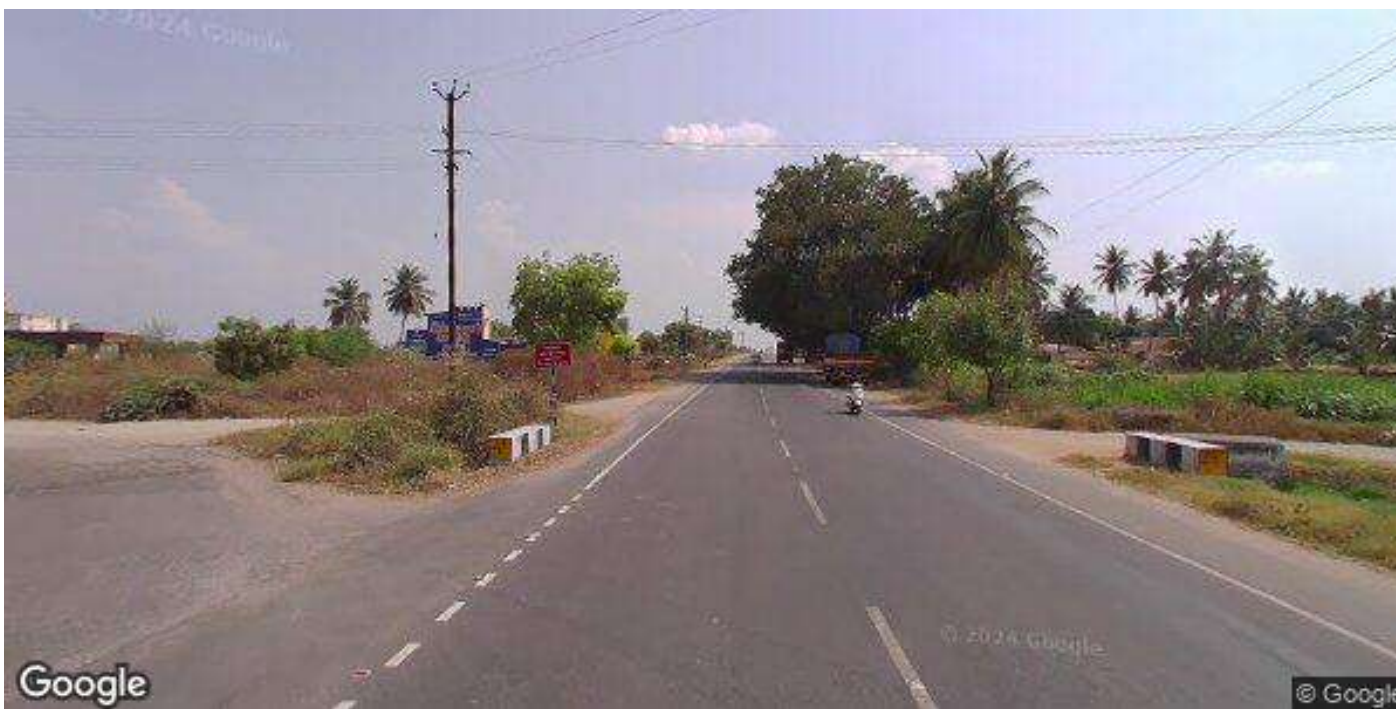
| | Risk Type | Risk Level | Coordinates | Speed Limit |
|---|---|---|---|---|
| 8 | Turn | High | 11.14545, 78.02208 | 15 KM/Hr |

**Risk Type:** Turn  
**Risk Level:** High  
**Speed Limit:** 15 KM/Hr  
**Coordinates:** 11.14545, 78.02208

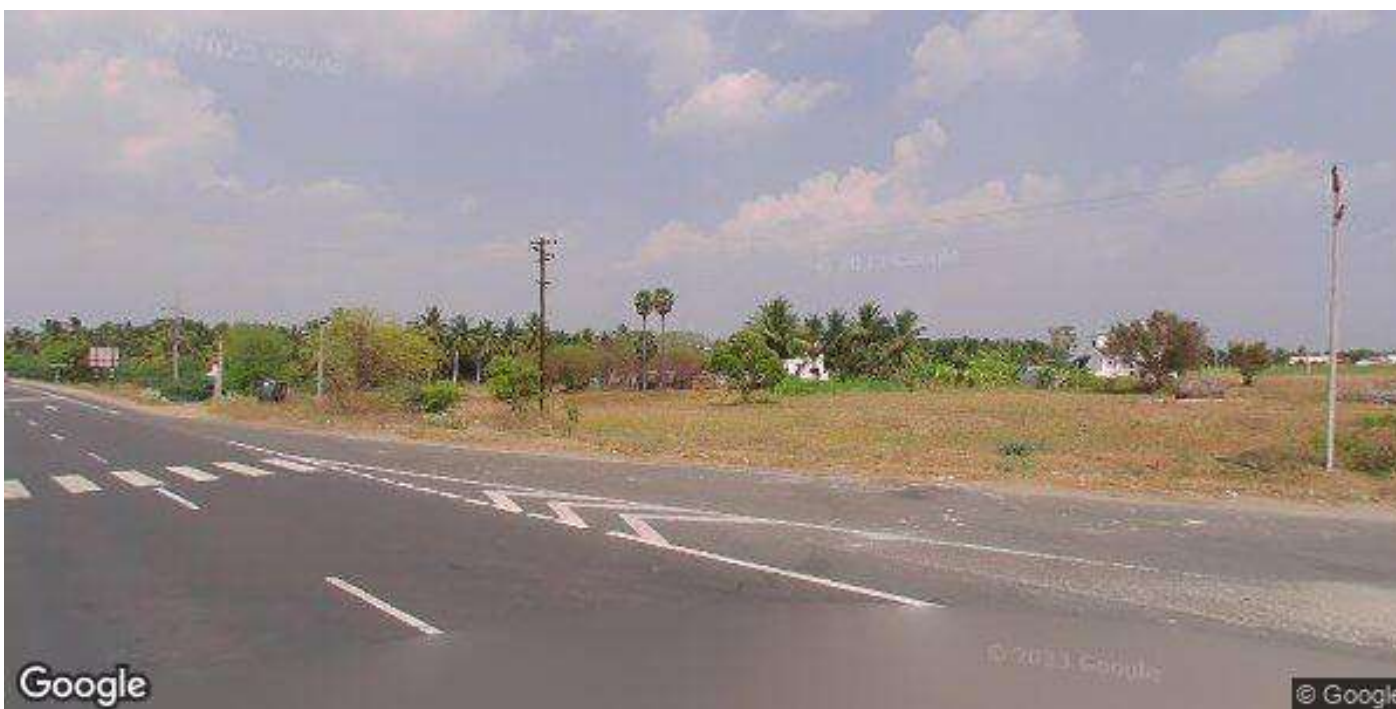
| | Risk Type | Risk Level | Coordinates | Speed Limit |
|---|---|---|---|---|
| 9 | Turn | High | 11.14480, 78.02291 | 15 KM/Hr |

**Risk Type:** Turn  
**Risk Level:** High  
**Speed Limit:** 15 KM/Hr  
**Coordinates:** 11.14480, 78.02291

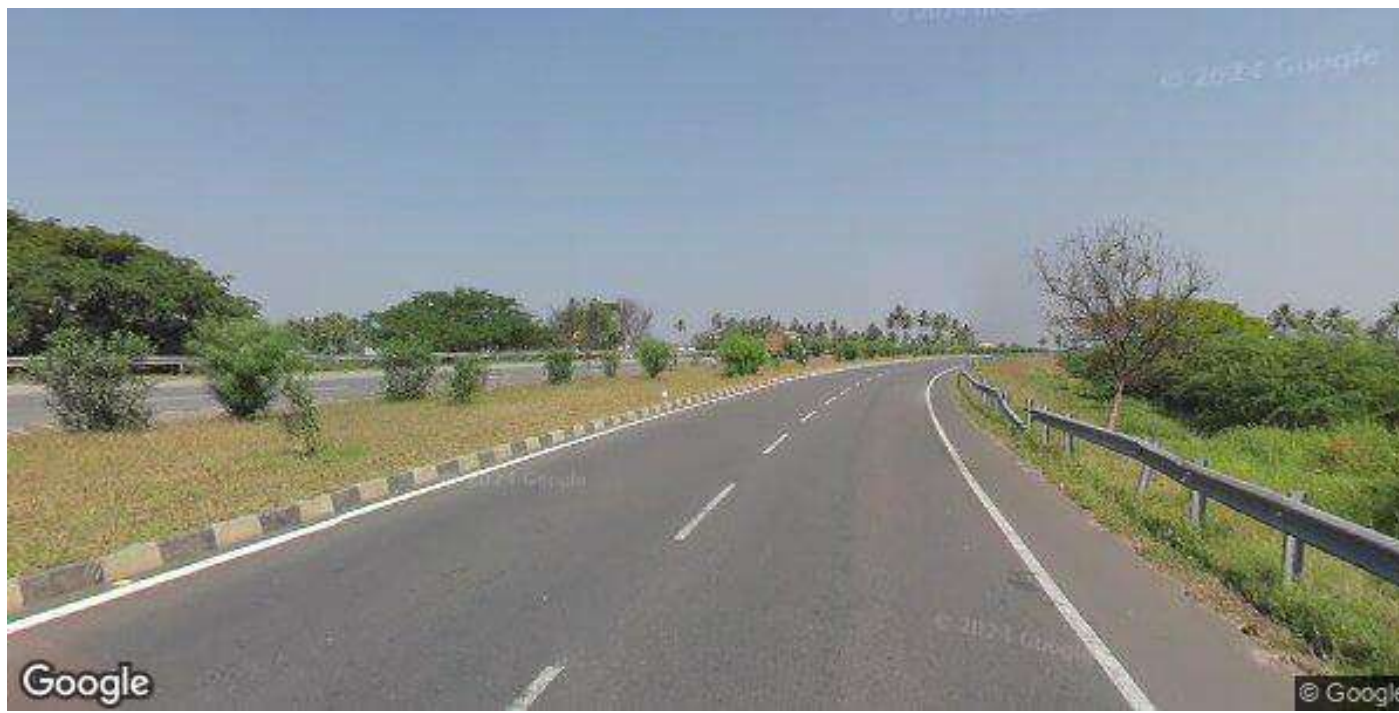
| | Risk Type | Risk Level | Coordinates | Speed Limit |
|---|---|---|---|---|
| 10 | Turn | Medium | 11.10125, 78.00603 | 30 KM/Hr |

**Risk Type:** Turn  
**Risk Level:** Medium  
**Speed Limit:** 30 KM/Hr  
**Coordinates:** 11.10125, 78.00603

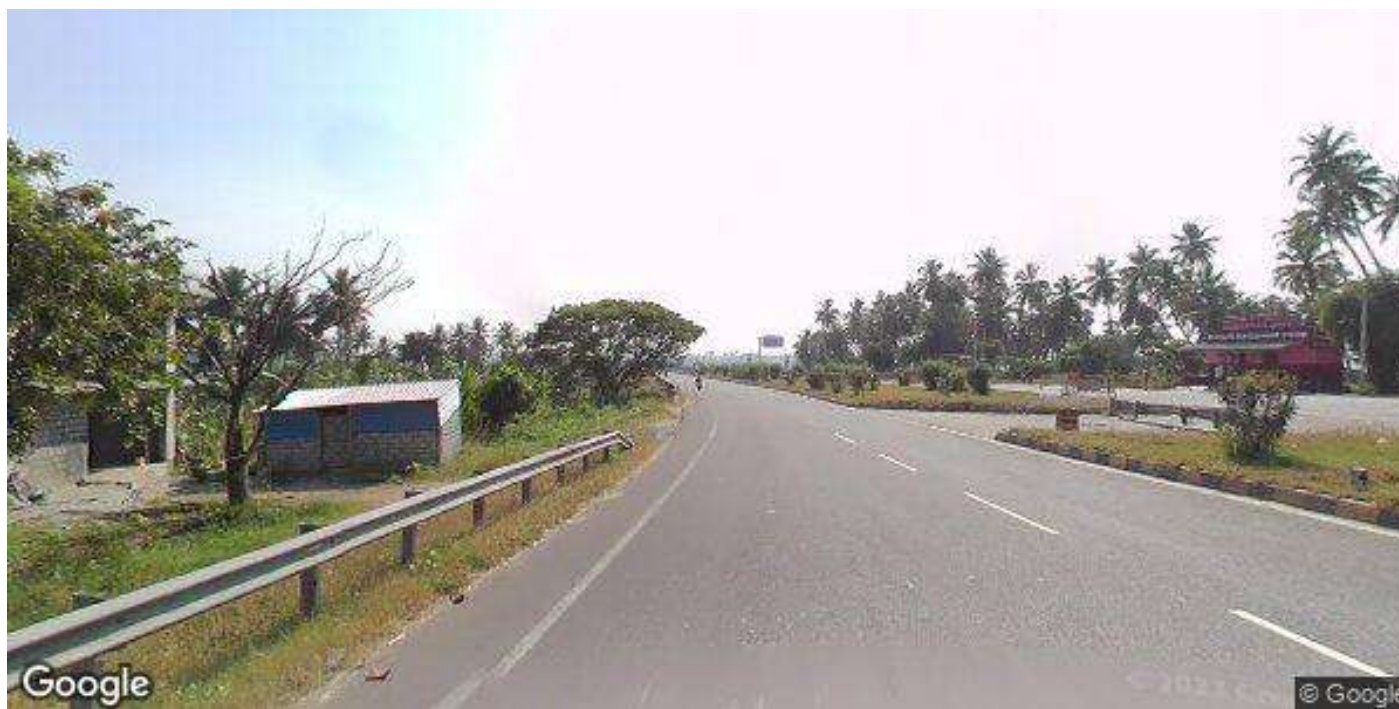
| | Risk Type | Risk Level | Coordinates | Speed Limit |
|---|---|---|---|---|
| 11 | Turn | Medium | 11.10012, 78.00502 | 30 KM/Hr |

**Risk Type:** Turn  
**Risk Level:** Medium  
**Speed Limit:** 30 KM/Hr  
**Coordinates:** 11.10012, 78.00502

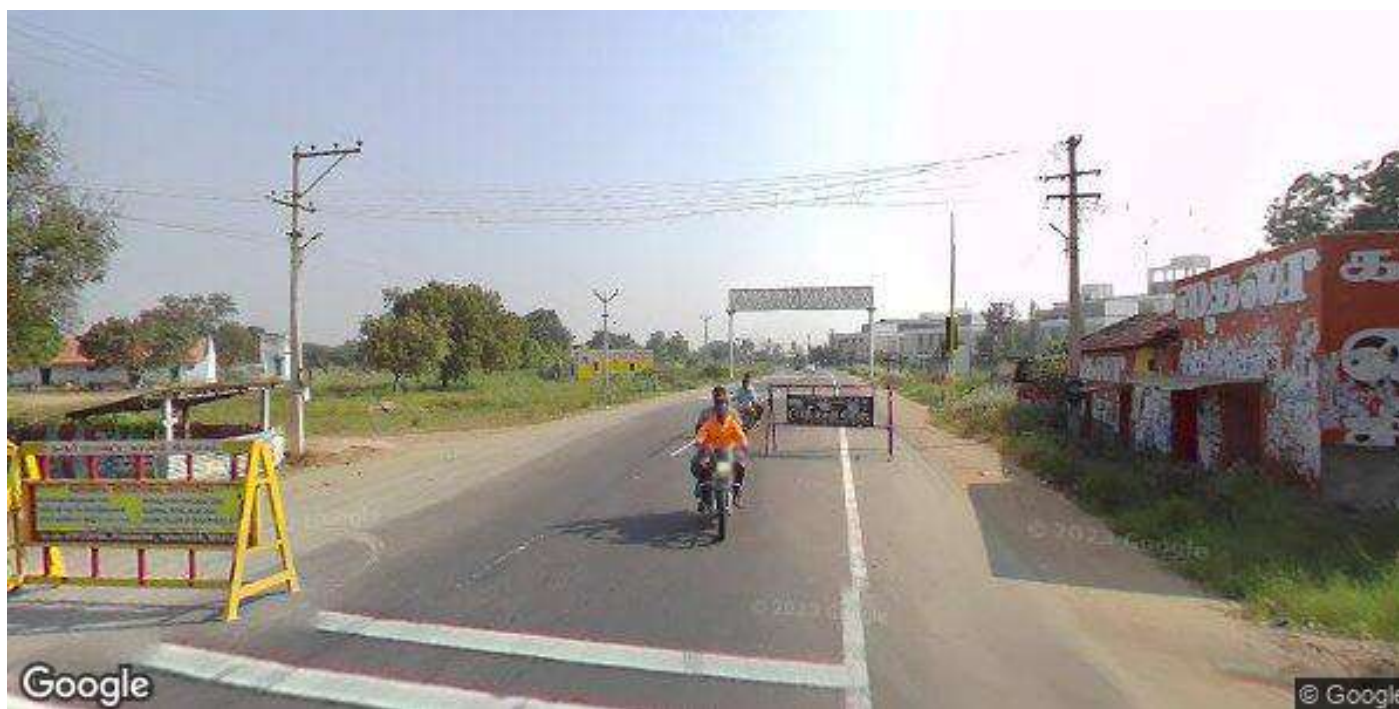
| | Risk Type | Risk Level | Coordinates | Speed Limit |
|---|---|---|---|---|
| 12 | Turn | Medium | 10.95701, 78.01249 | 30 KM/Hr |

**Risk Type:** Turn  
**Risk Level:** Medium  
**Speed Limit:** 30 KM/Hr  
**Coordinates:** 10.95701, 78.01249

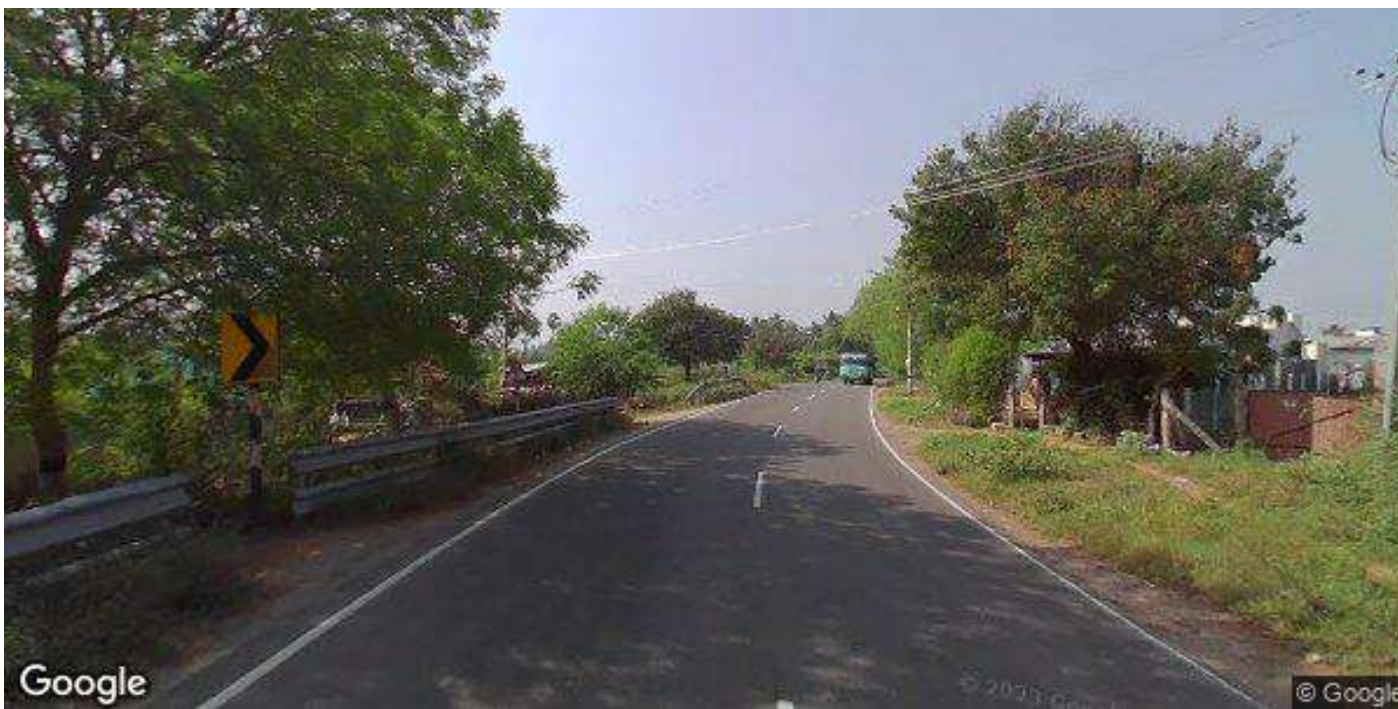
| | Risk Type | Risk Level | Coordinates | Speed Limit |
|---|---|---|---|---|
| 13 | Turn | Medium | 10.94431, 78.00335 | 30 KM/Hr |

**Risk Type:** Turn  
**Risk Level:** Medium  
**Speed Limit:** 30 KM/Hr  
**Coordinates:** 10.94431, 78.00335

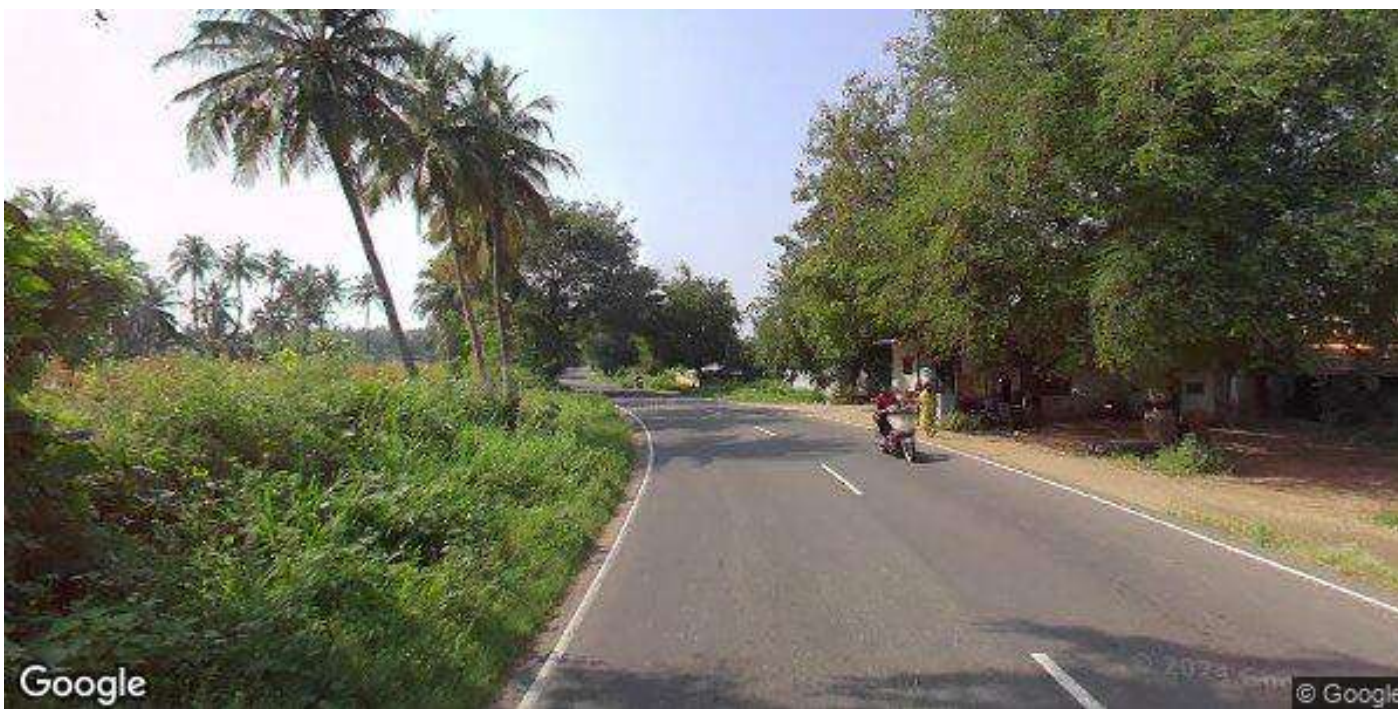
| | Risk Type | Risk Level | Coordinates | Speed Limit |
|---|---|---|---|---|
| 14 | Turn | Medium | 10.94317, 78.00168 | 30 KM/Hr |

**Risk Type:** Turn  
**Risk Level:** Medium  
**Speed Limit:** 30 KM/Hr  
**Coordinates:** 10.94317, 78.00168

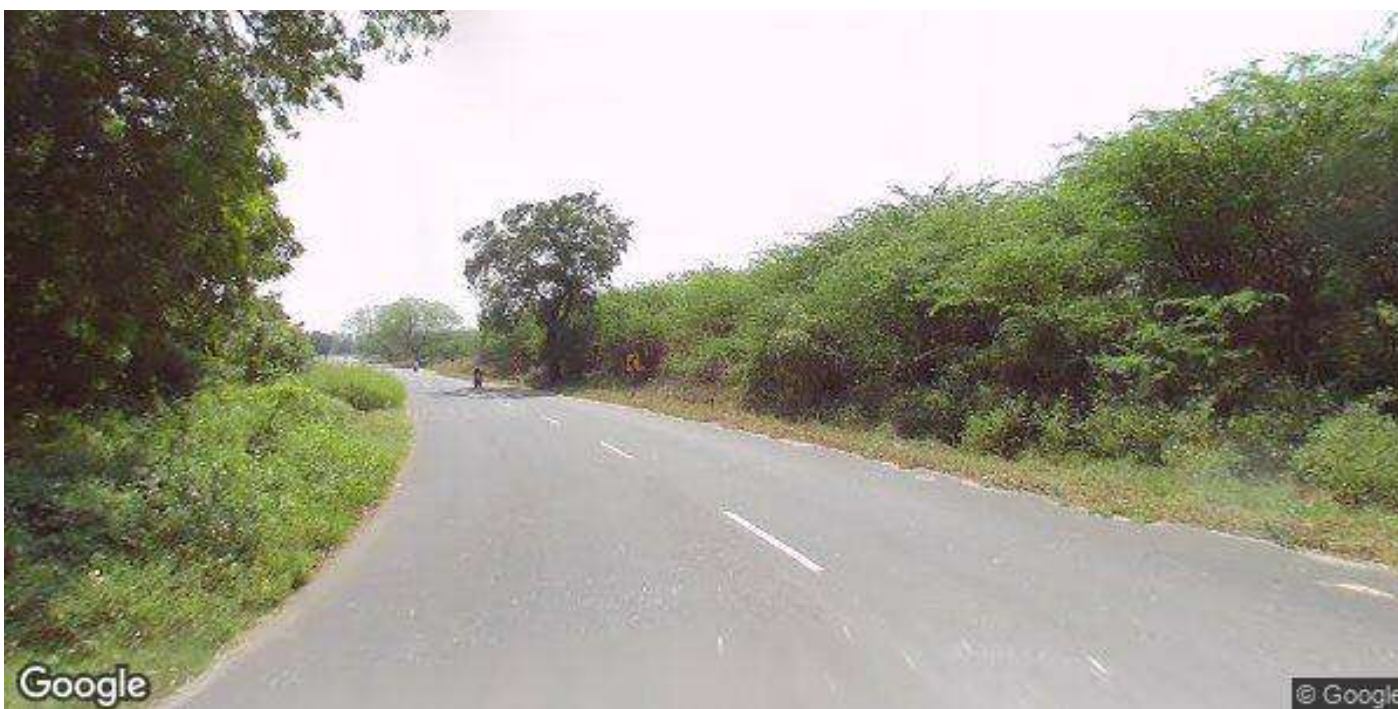
| | Risk Type | Risk Level | Coordinates | Speed Limit |
|---|---|---|---|---|
| 15 | Turn | Medium | 10.93382, 77.99870 | 30 KM/Hr |

**Risk Type:** Turn  
**Risk Level:** Medium  
**Speed Limit:** 30 KM/Hr  
**Coordinates:** 10.93382, 77.99870

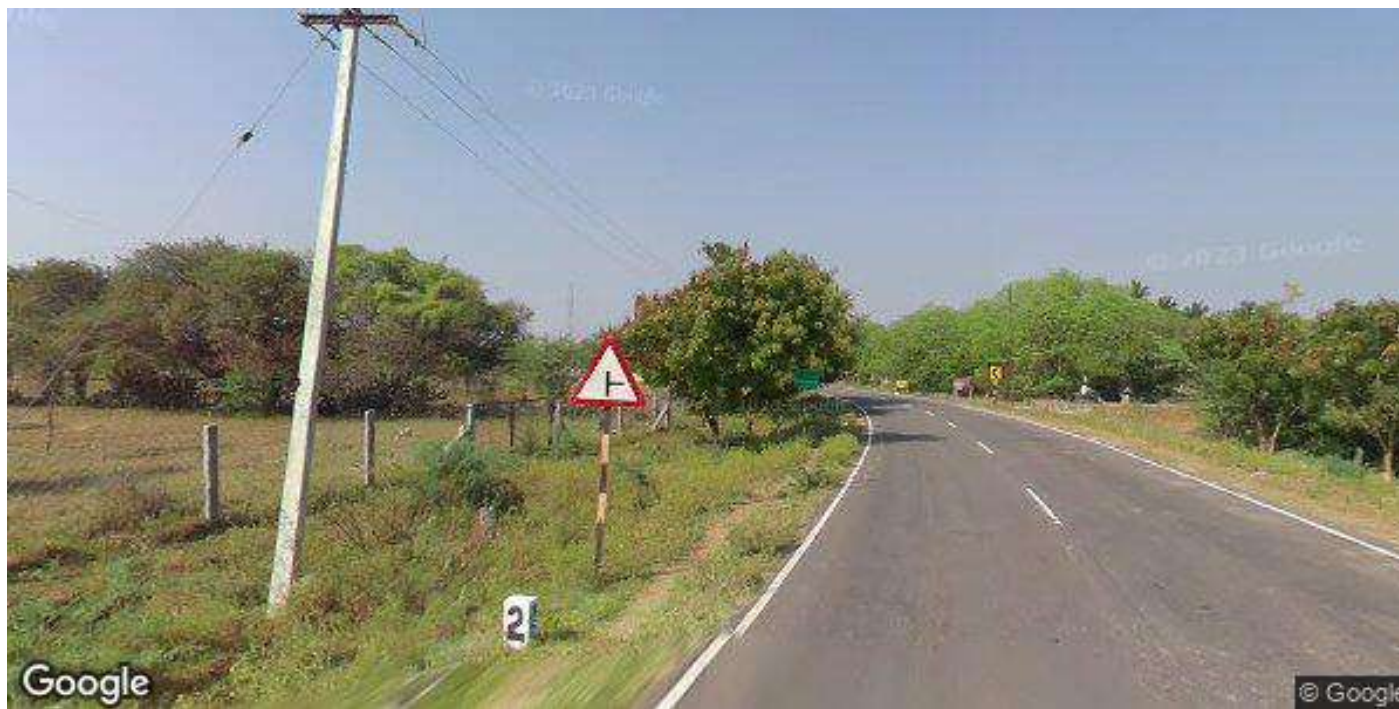
| | Risk Type | Risk Level | Coordinates | Speed Limit |
|---|---|---|---|---|
| 16 | Turn | Medium | 10.92666, 77.99911 | 30 KM/Hr |

**Risk Type:** Turn  
**Risk Level:** Medium  
**Speed Limit:** 30 KM/Hr  
**Coordinates:** 10.92666, 77.99911

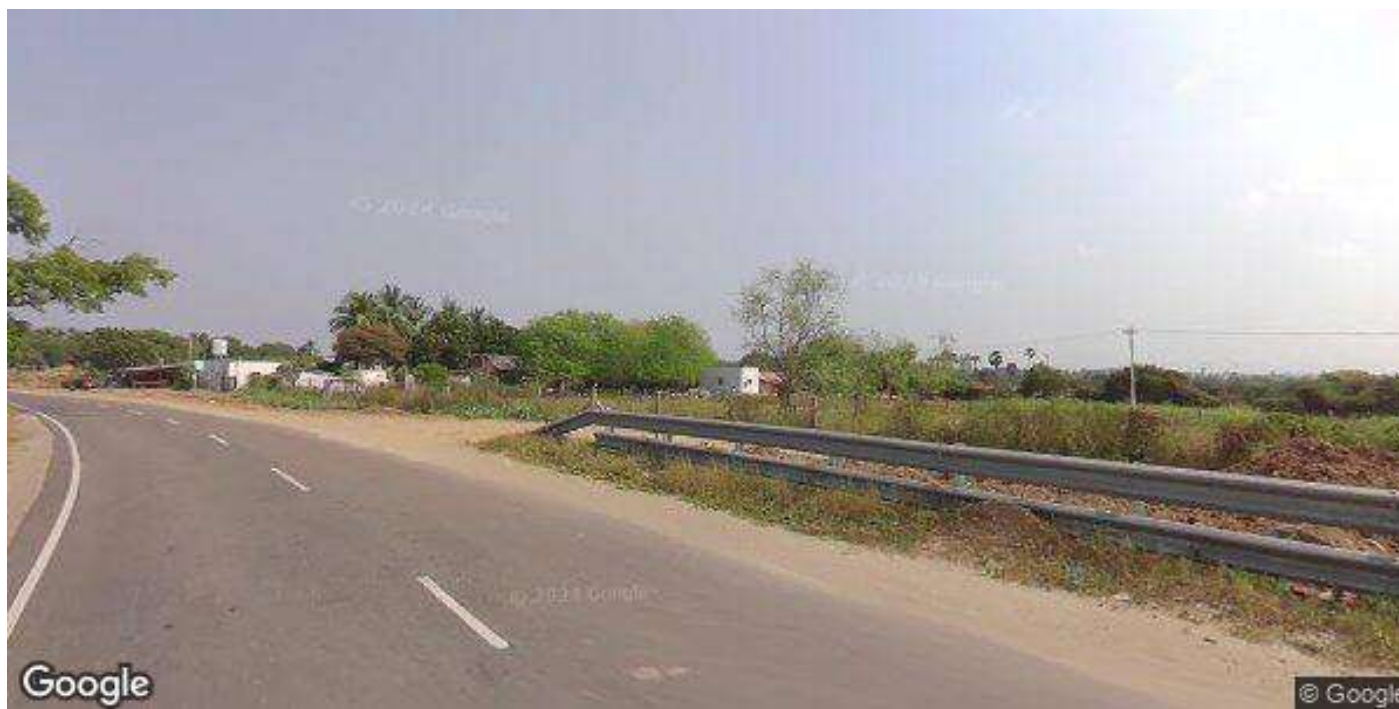
| | Risk Type | Risk Level | Coordinates | Speed Limit |
|---|---|---|---|---|
| 17 | Turn | Medium | 10.90391, 77.97828 | 30 KM/Hr |

**Risk Type:** Turn  
**Risk Level:** Medium  
**Speed Limit:** 30 KM/Hr  
**Coordinates:** 10.90391, 77.97828

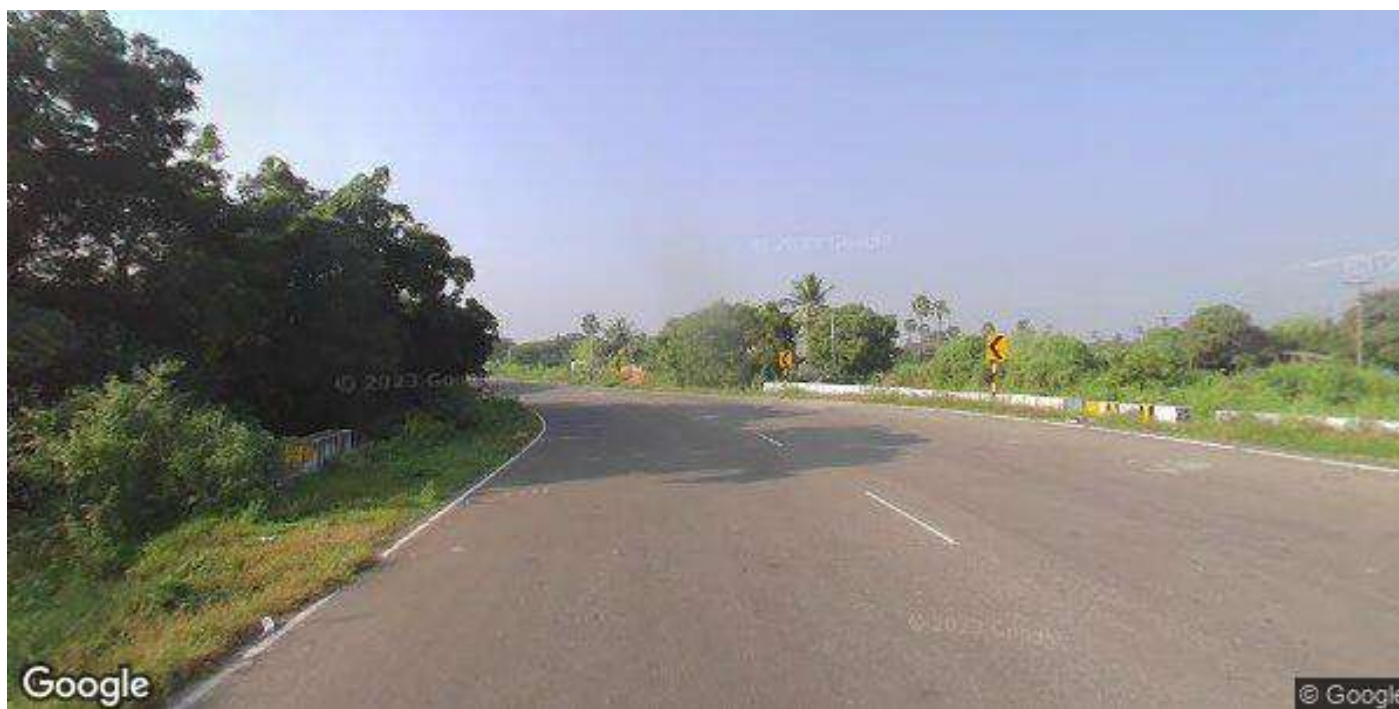
| | Risk Type | Risk Level | Coordinates | Speed Limit |
|---|---|---|---|---|
| 18 | Turn | Medium | 10.89755, 77.96991 | 30 KM/Hr |

**Risk Type:** Turn  
**Risk Level:** Medium  
**Speed Limit:** 30 KM/Hr  
**Coordinates:** 10.89755, 77.96991

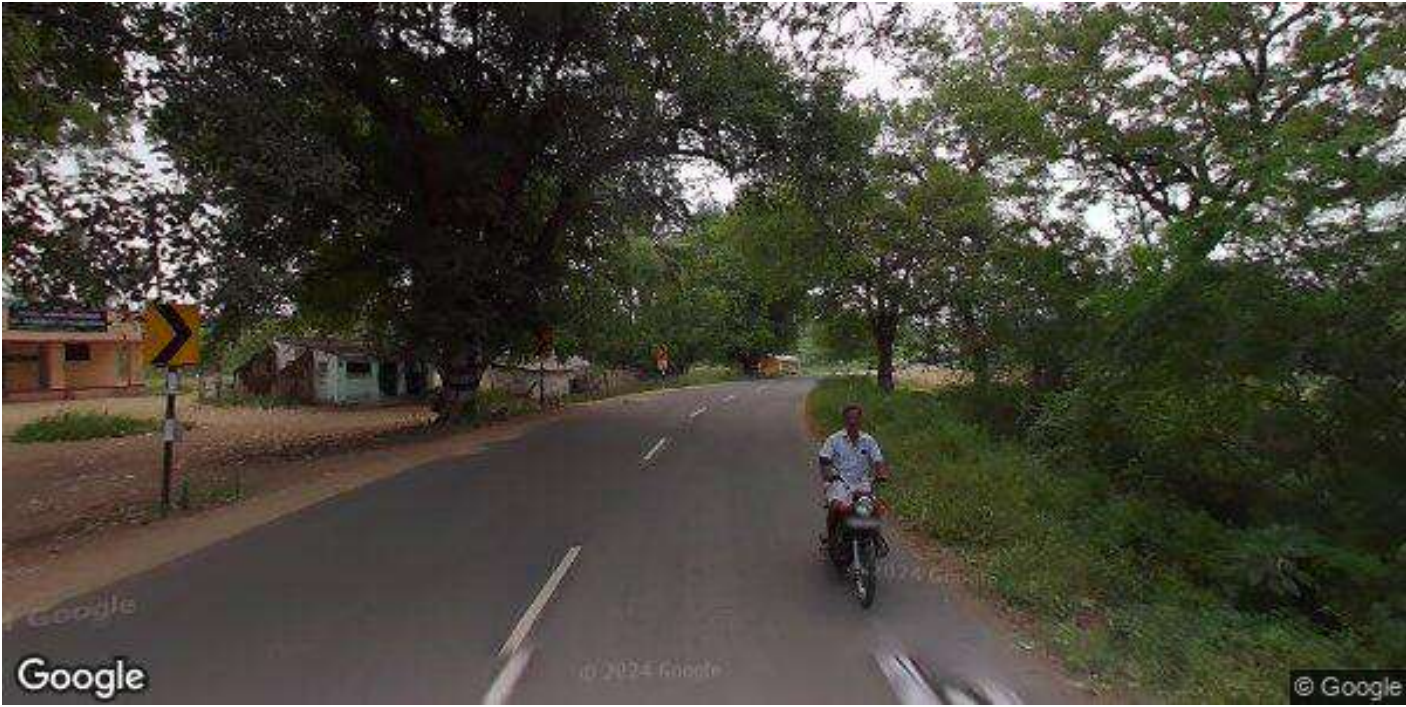
| | Risk Type | Risk Level | Coordinates | Speed Limit |
|---|---|---|---|---|
| 19 | Turn | High | 10.88006, 77.95528 | 15 KM/Hr |

**Risk Type:** Turn  
**Risk Level:** High  
**Speed Limit:** 15 KM/Hr  
**Coordinates:** 10.88006, 77.95528
