# IndianOil

## JOURNEY RISK MANAGEMENT (JRM) STUDY

### Salem Terminal to GUHAN AGENCIES

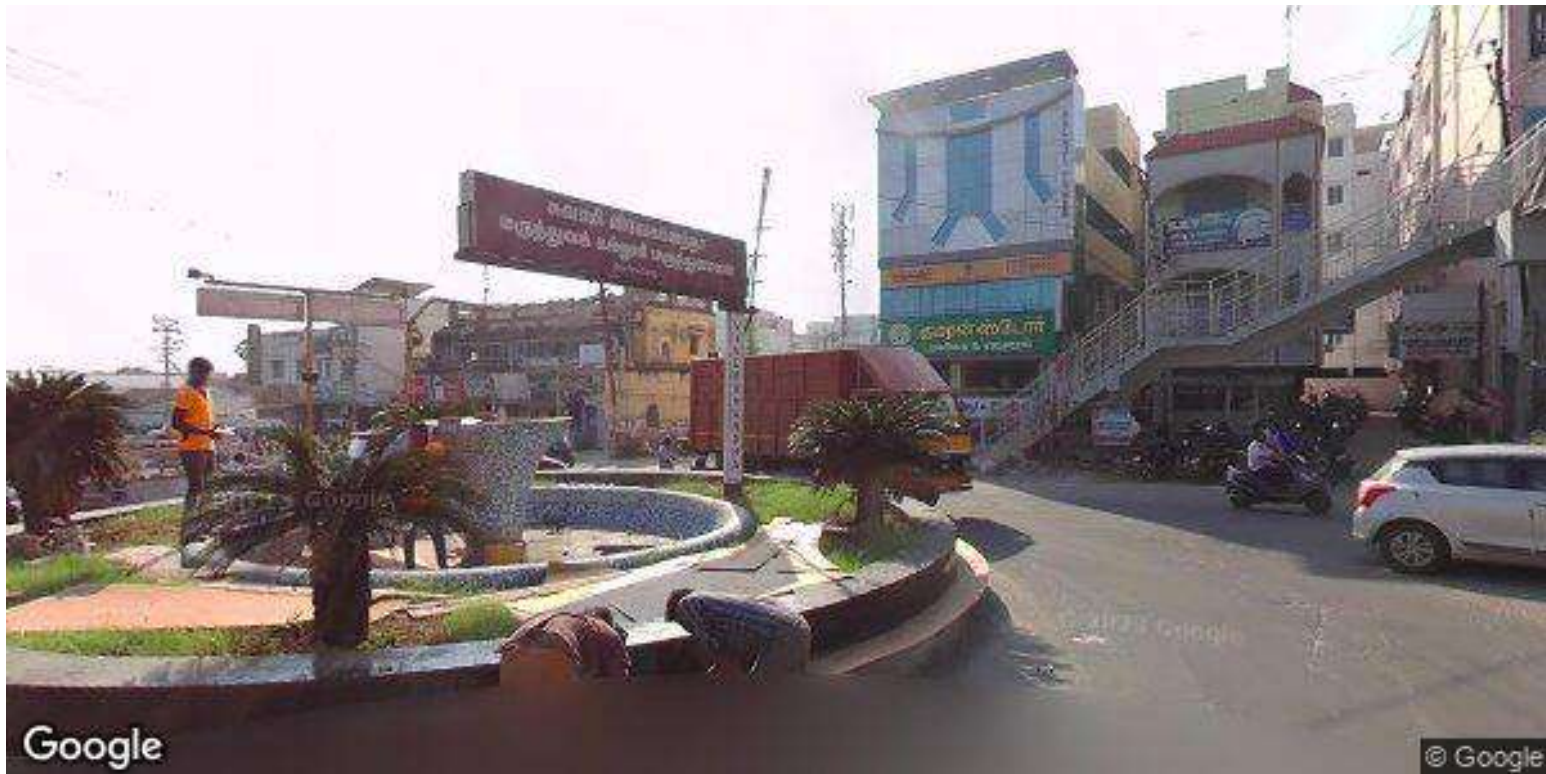
**Coordinates:** 11.38395, 77.89480

**Risk Type:** Roundabout

**Risk Level:** High

**Speed Limit:** 15 KM/Hr

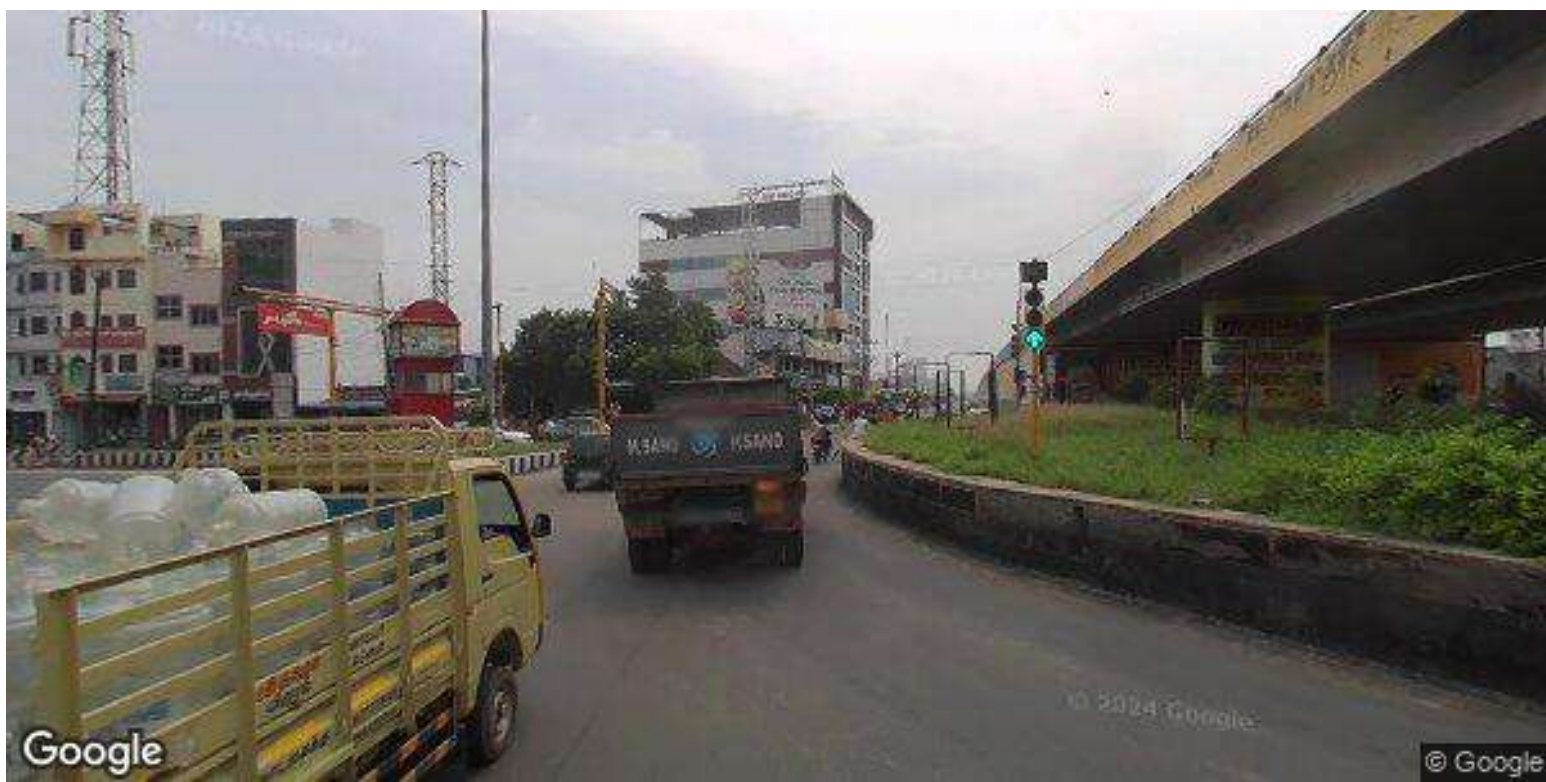
**Coordinates:** 10.96304, 78.06131

**Risk Type:** Roundabout

**Risk Level:** High

**Speed Limit:** 15 KM/Hr

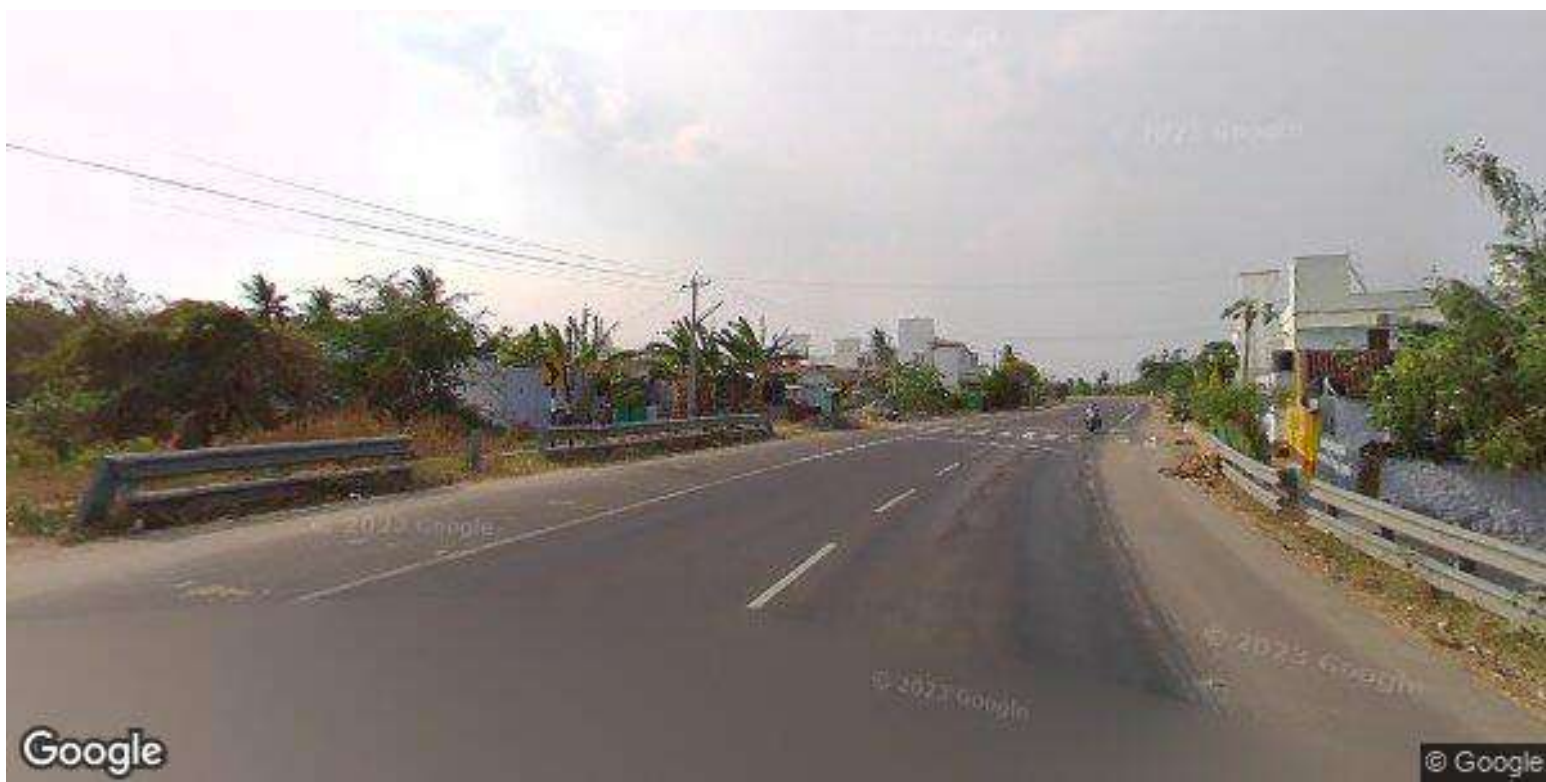
**Coordinates:** 11.16772, 78.01563

**Risk Type:** Turn

**Risk Level:** Medium

**Speed Limit:** 30 KM/Hr

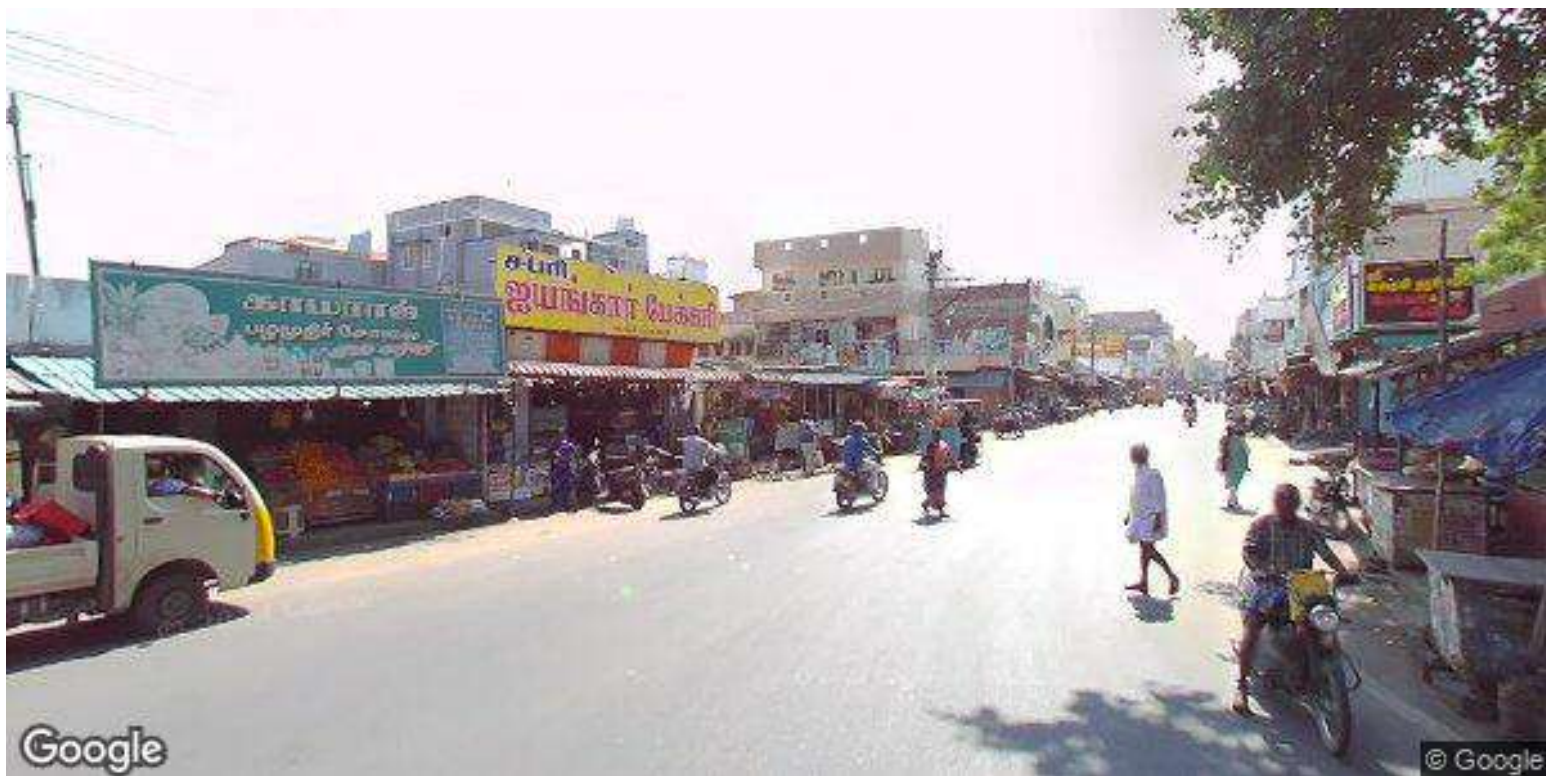
**Coordinates:** 11.15565, 78.02171

**Risk Type:** Turn

**Risk Level:** Medium

**Speed Limit:** 30 KM/Hr

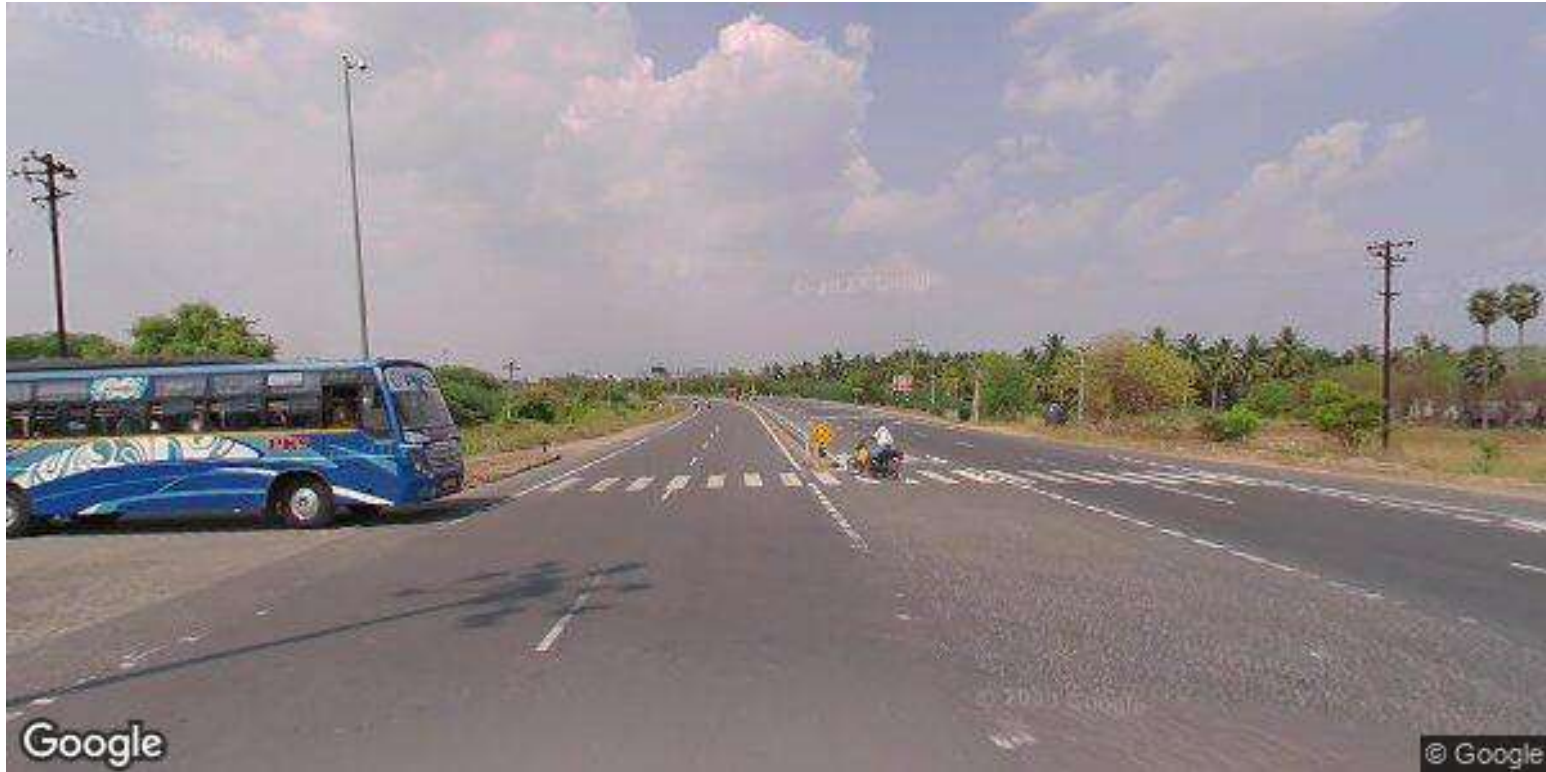
**Risk Type:** Turn  
**Risk Level:** High  
**Speed Limit:** 15 KM/Hr  
**Coordinates:** 11.14485, 78.02282

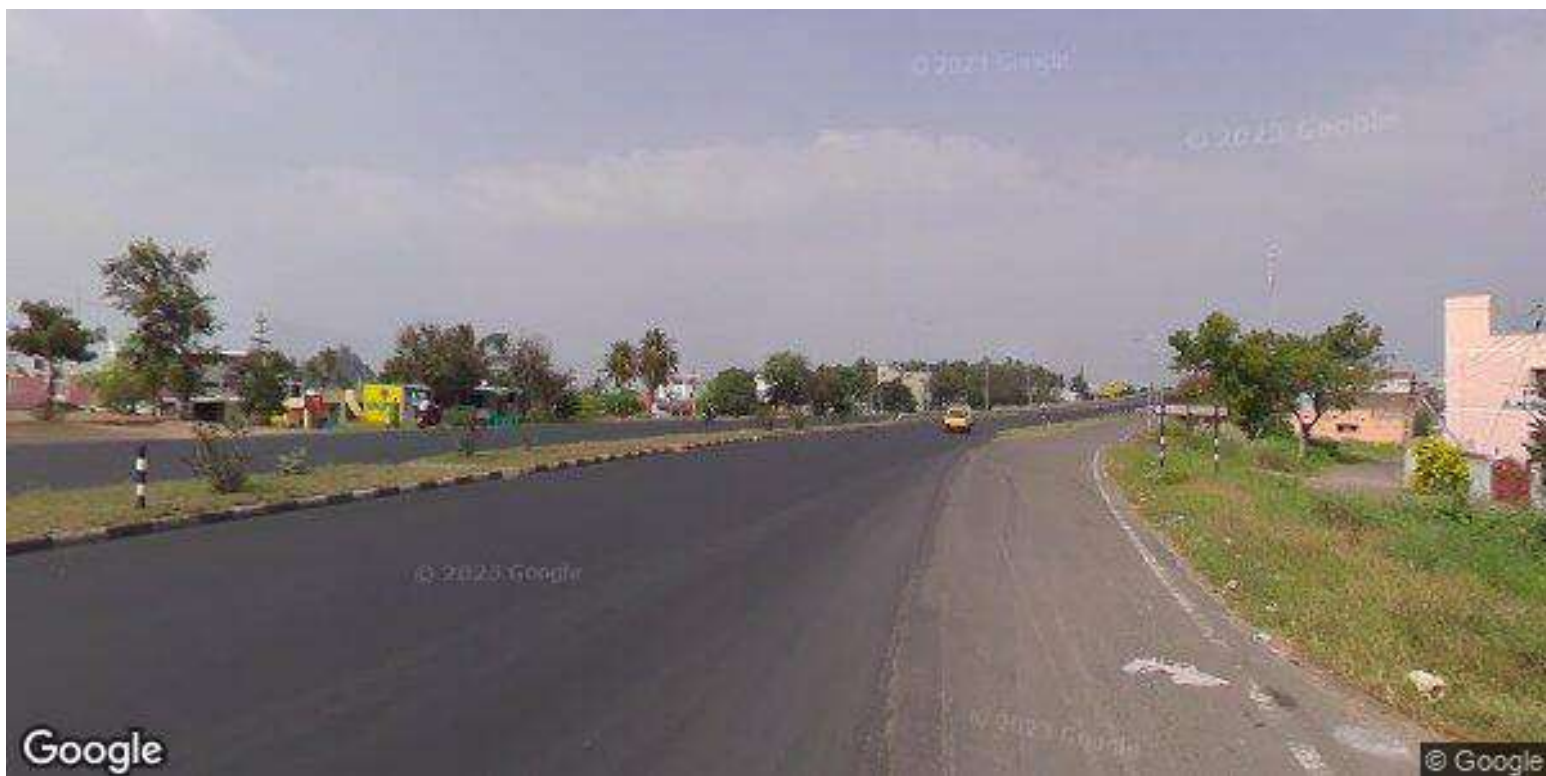
**Risk Type:** Turn  
**Risk Level:** Medium  
**Speed Limit:** 30 KM/Hr  
**Coordinates:** 11.06964, 78.00857

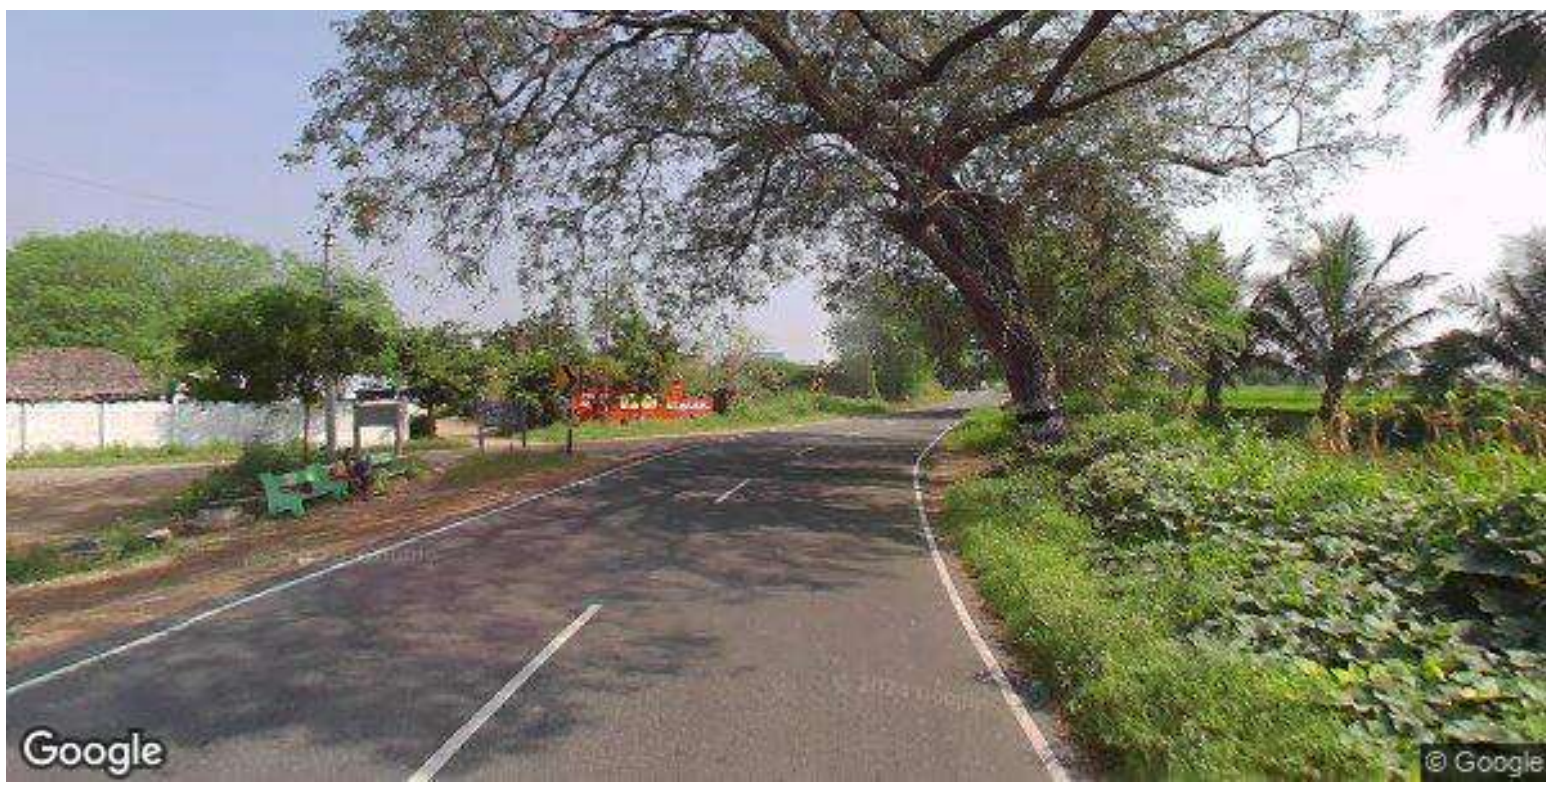
**Coordinates:** 10.94321, 78.00172

**Risk Type:** Turn

**Risk Level:** Medium

**Speed Limit:** 30 KM/Hr

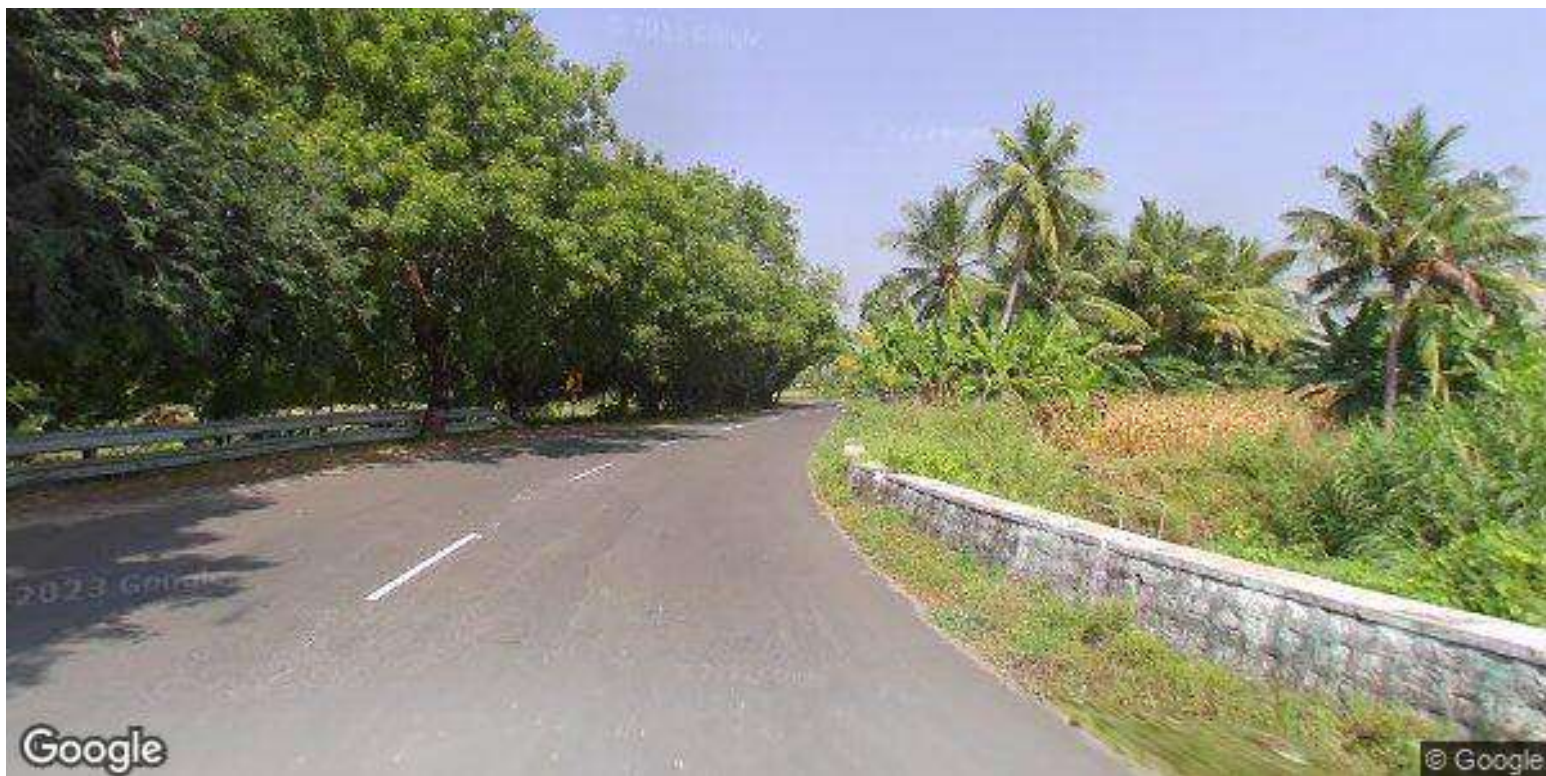
**Coordinates:** 10.93388, 77.99872

**Risk Type:** Turn

**Risk Level:** Medium

**Speed Limit:** 30 KM/Hr

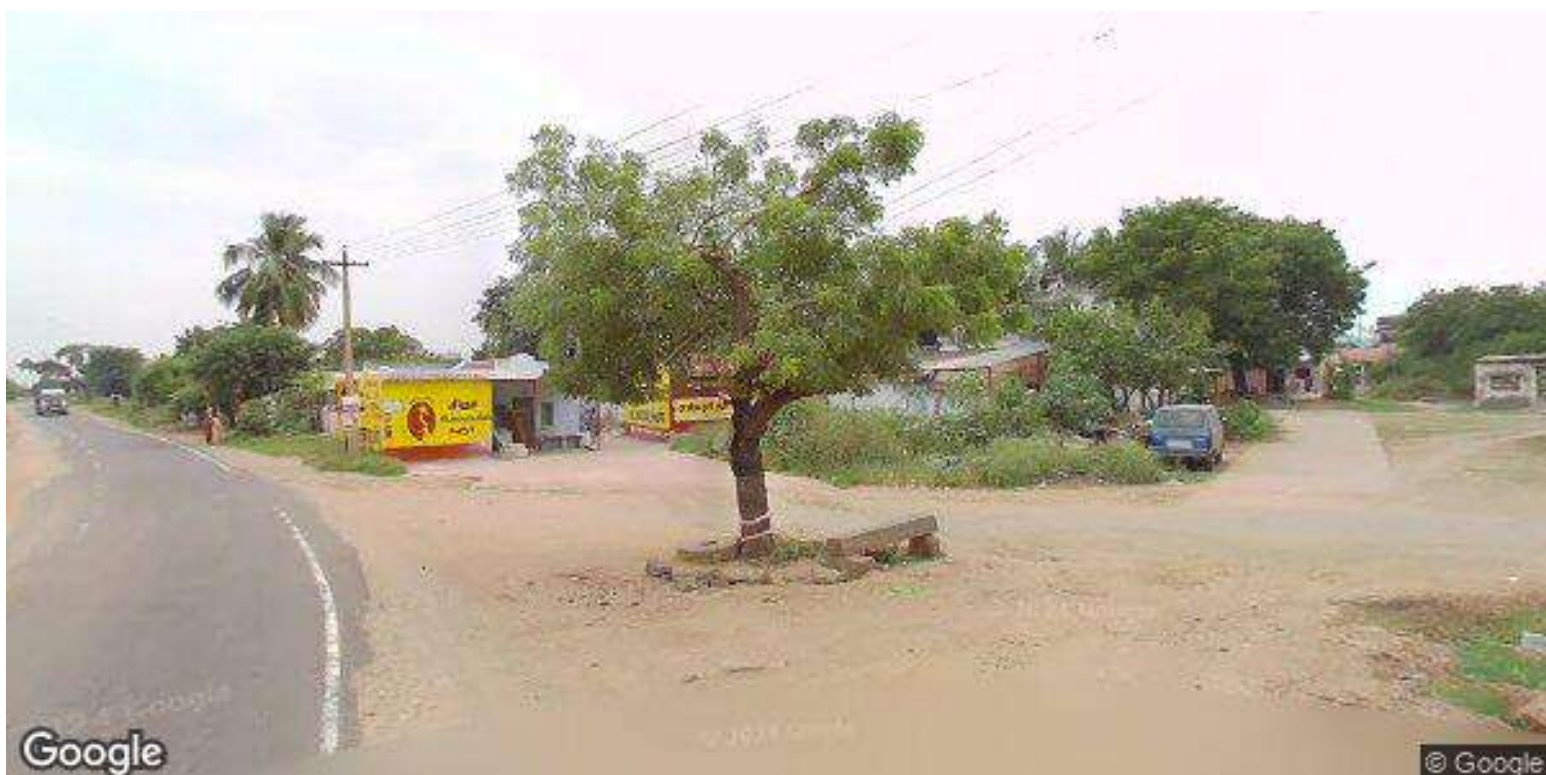
**Risk Type:** Turn  
**Risk Level:** Medium  
**Speed Limit:** 30 KM/Hr  
**Coordinates:** 10.90589, 77.97848

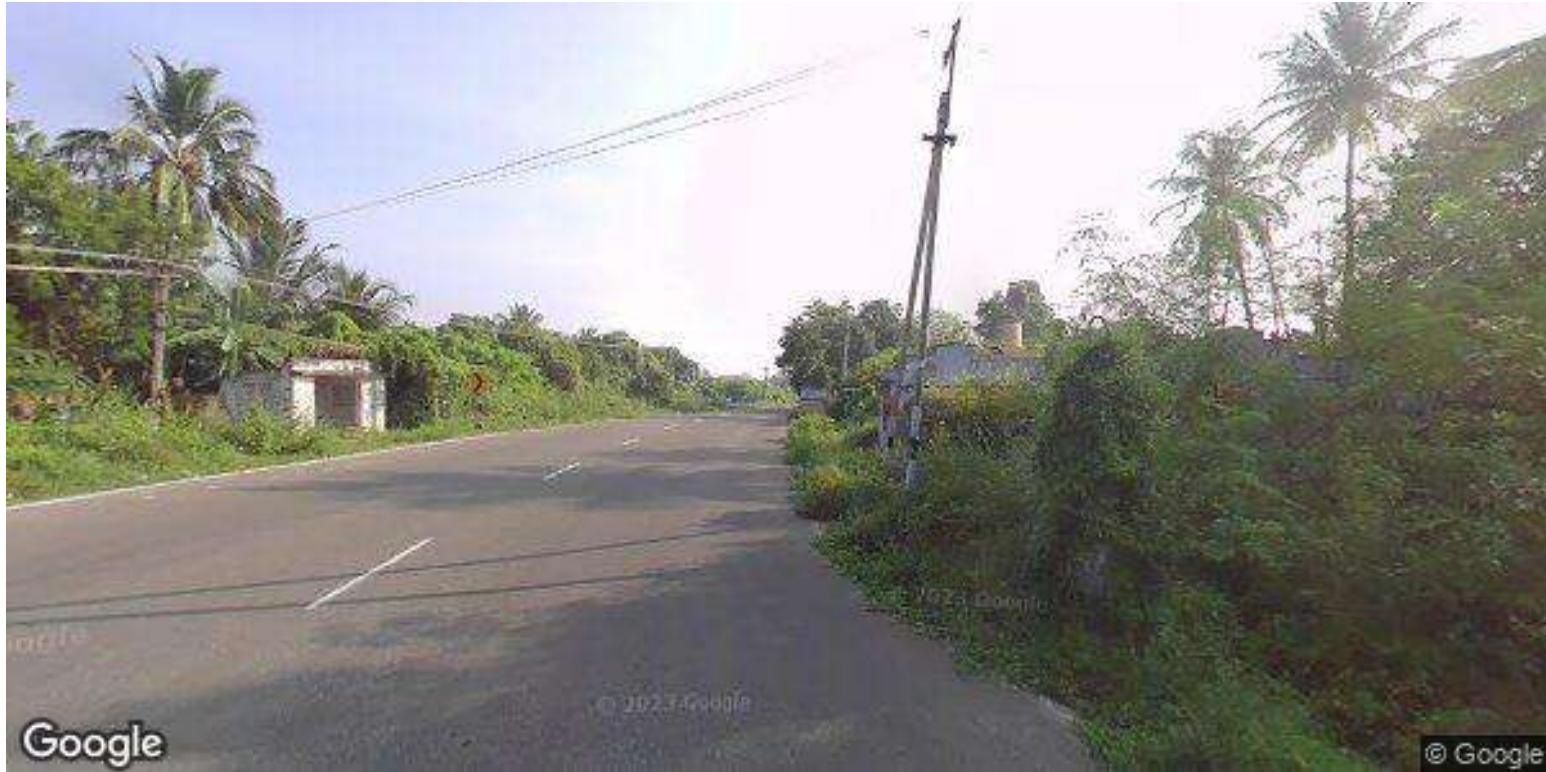
**Risk Type:** Turn  
**Risk Level:** Medium  
**Speed Limit:** 30 KM/Hr  
**Coordinates:** 10.89759, 77.96997

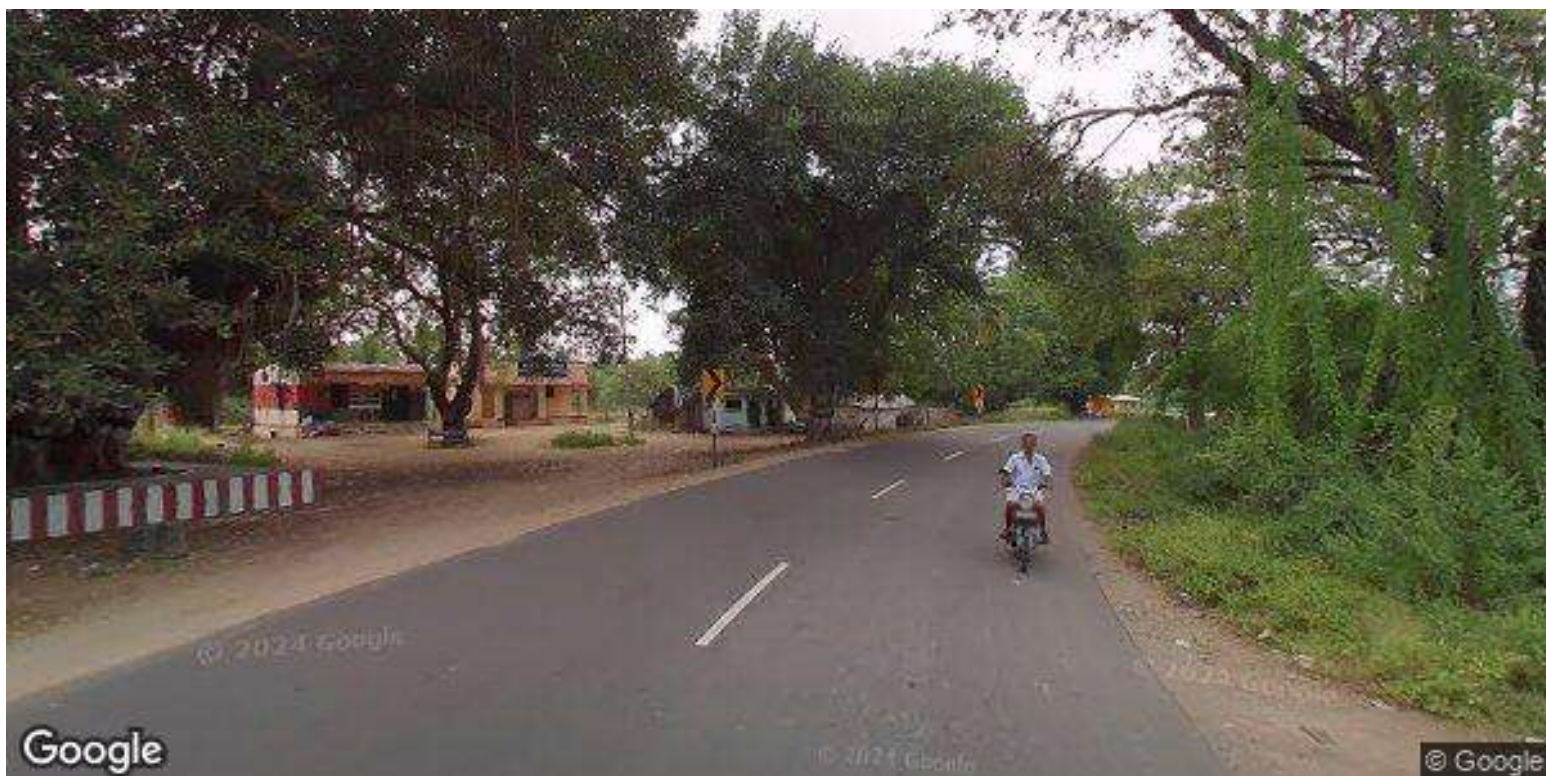
**Risk Type:** Turn  
**Risk Level:** High  
**Speed Limit:** 15 KM/Hr  
**Coordinates:** 10.88008, 77.95537

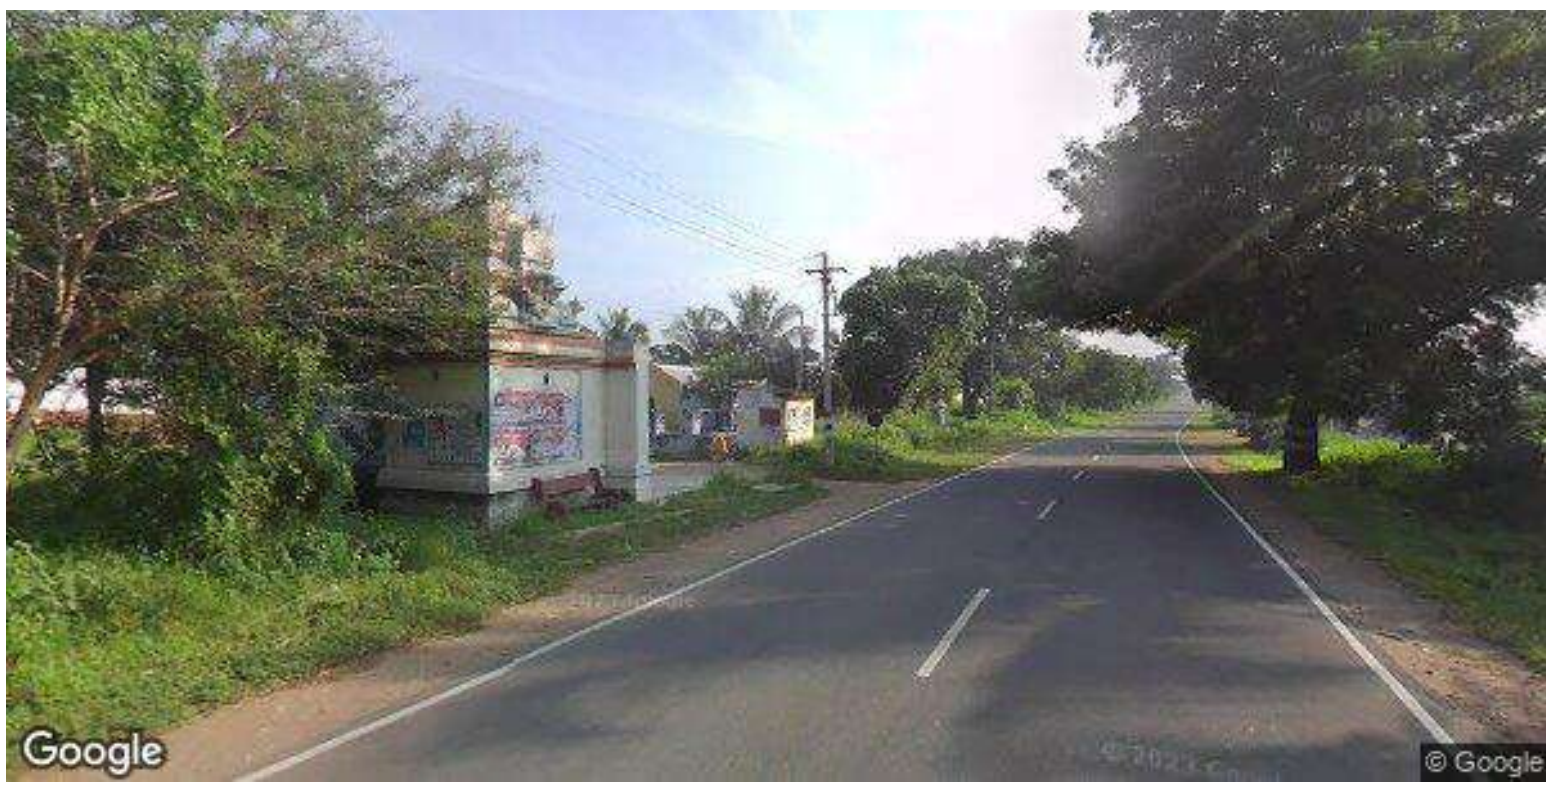
**Coordinates:** 10.85769, 77.86796

**Risk Type:** Turn

**Risk Level:** High

**Speed Limit:** 15 KM/Hr
