## **JOURNEY RISK MANAGEMENT (JRM) STUDY**

### **Salem Terminal To SRI KRISHNA & CO**

### Route Analysis from Sangagiri to Erode, Tamil Nadu

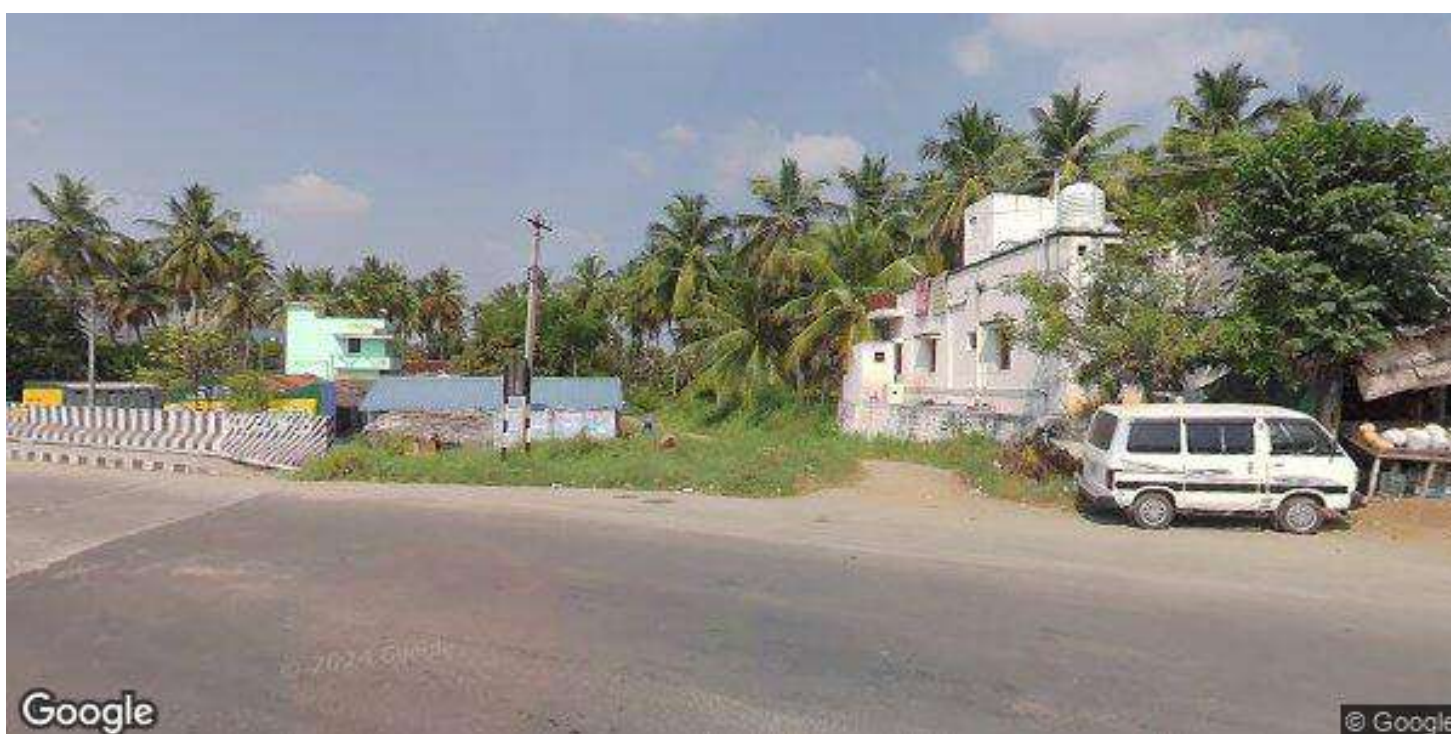
**Coordinates: 11.44898, 77.87410**

**Risk Type:** Turn  
**Risk Level:** Medium

**Speed Limit: 30 KM/Hr**

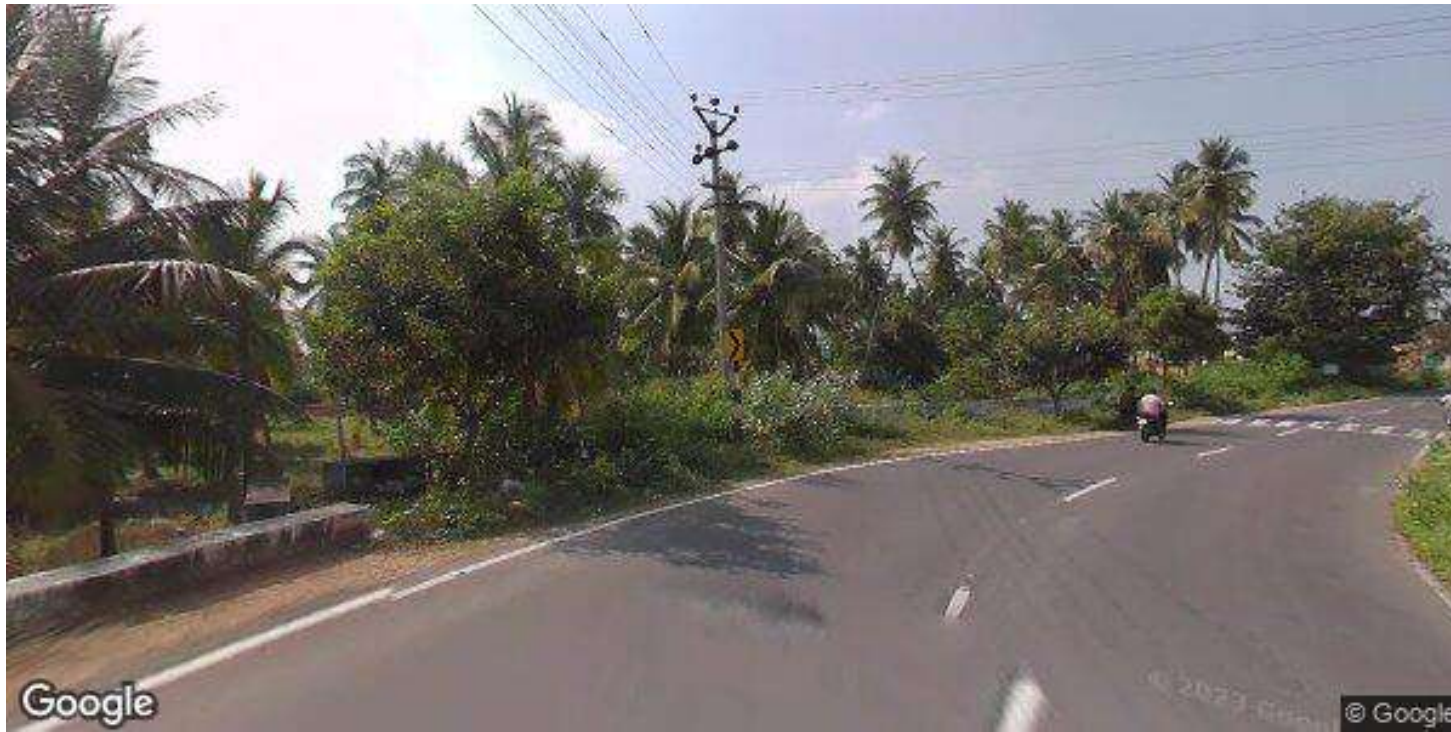
**Coordinates: 11.45348, 77.85706**

**Risk Type: Turn**

**Risk Level: Medium**

**Speed Limit: 30 KM/Hr**

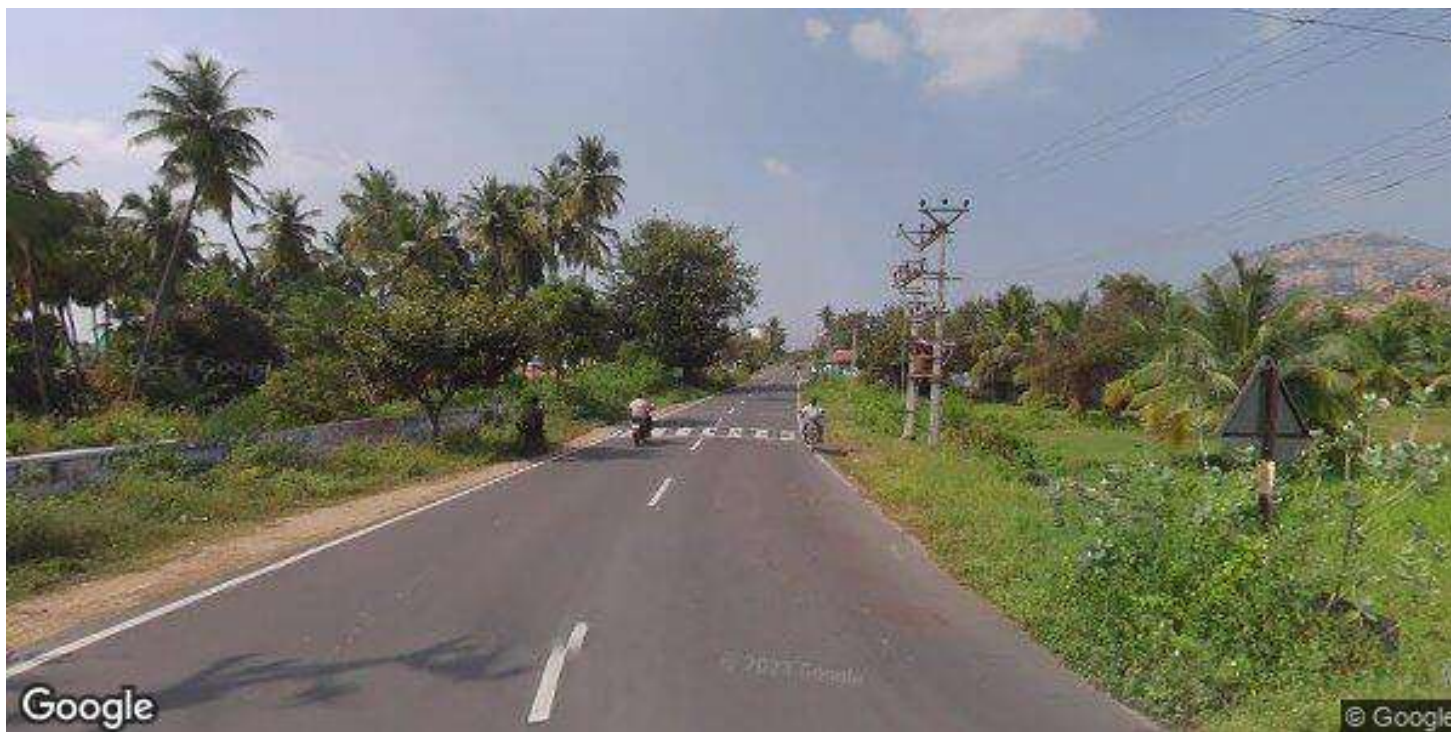
**Coordinates: 11.45352, 77.85698**

**Risk Type: Turn**

**Risk Level: Medium**

**Speed Limit: 30 KM/Hr**

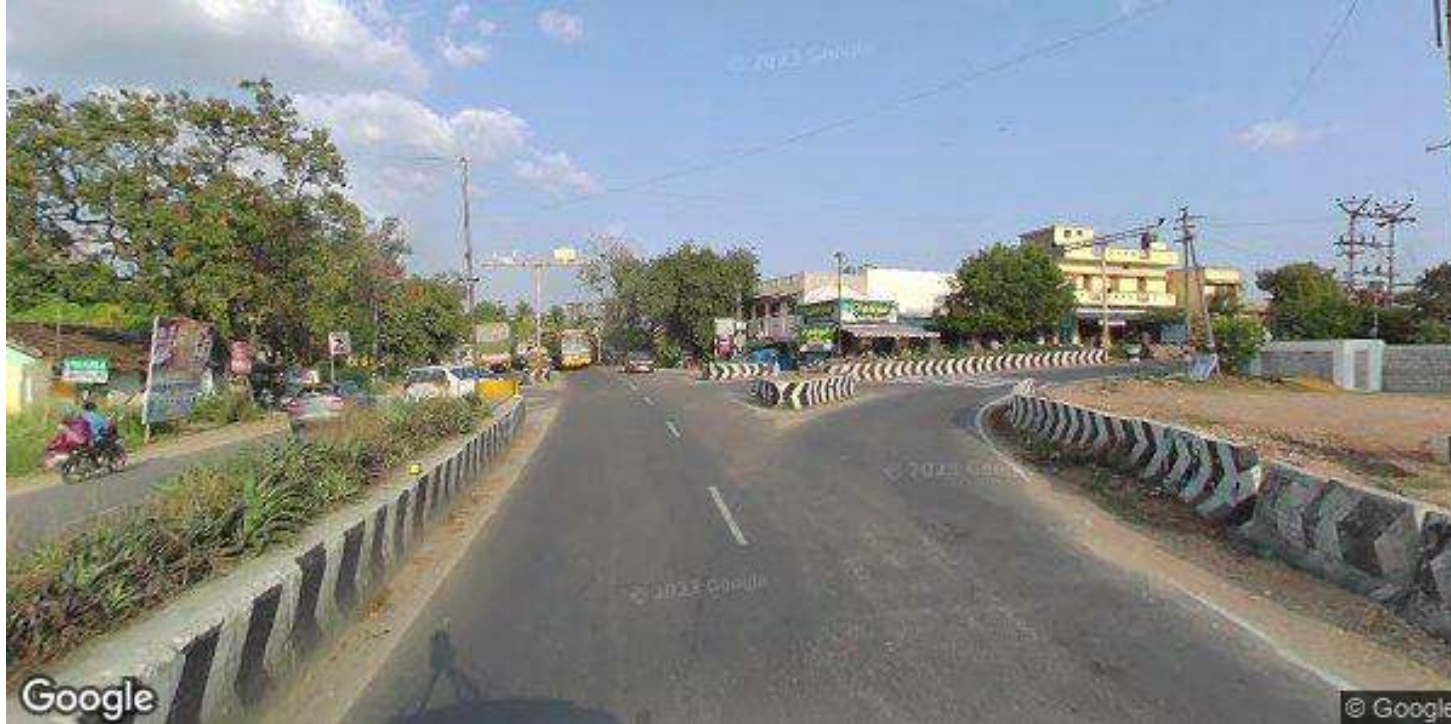
**Coordinates:** 11.46318, 77.84913

**Risk Type:** Turn

**Risk Level:** Medium

**Speed Limit:** 30 KM/Hr

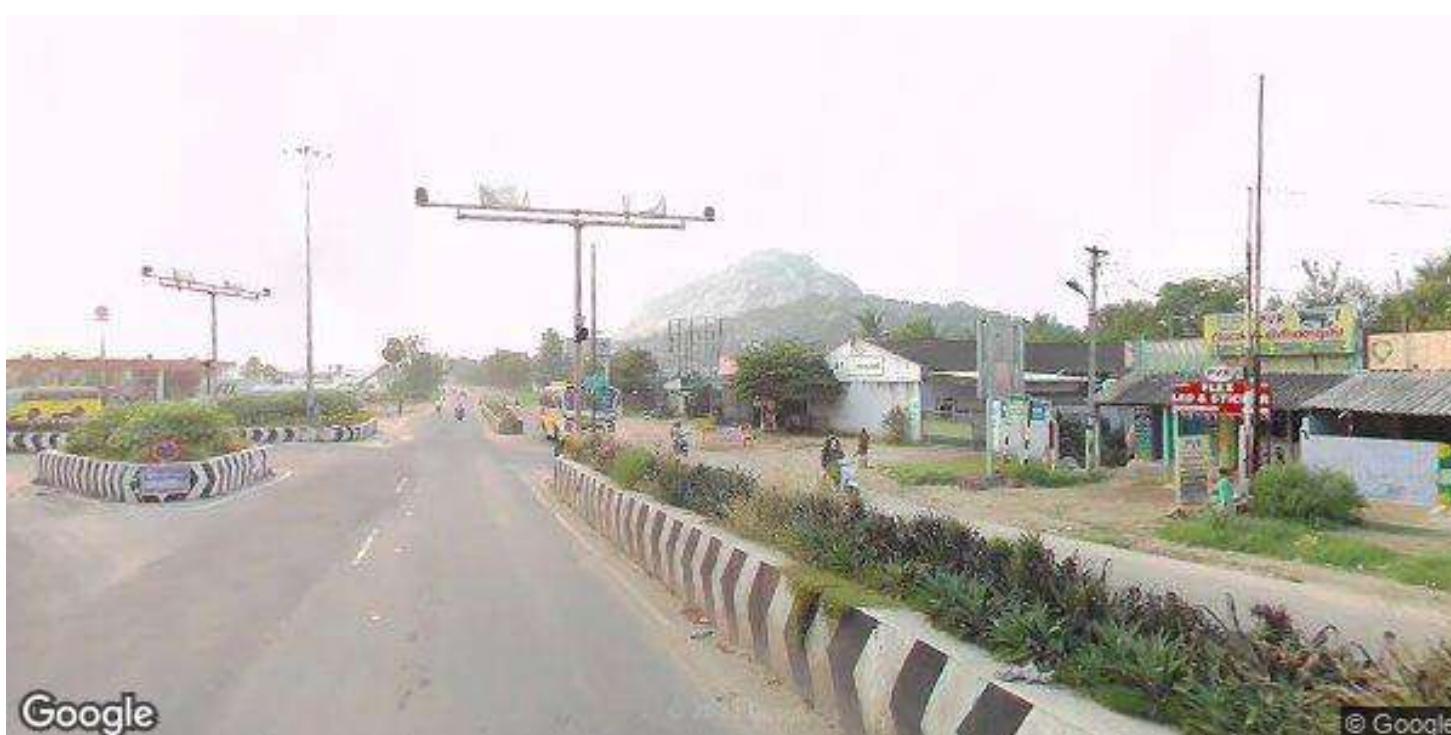
**Coordinates:** 11.46312, 77.84886

**Risk Type:** Turn

**Risk Level:** Medium

**Speed Limit:** 30 KM/Hr

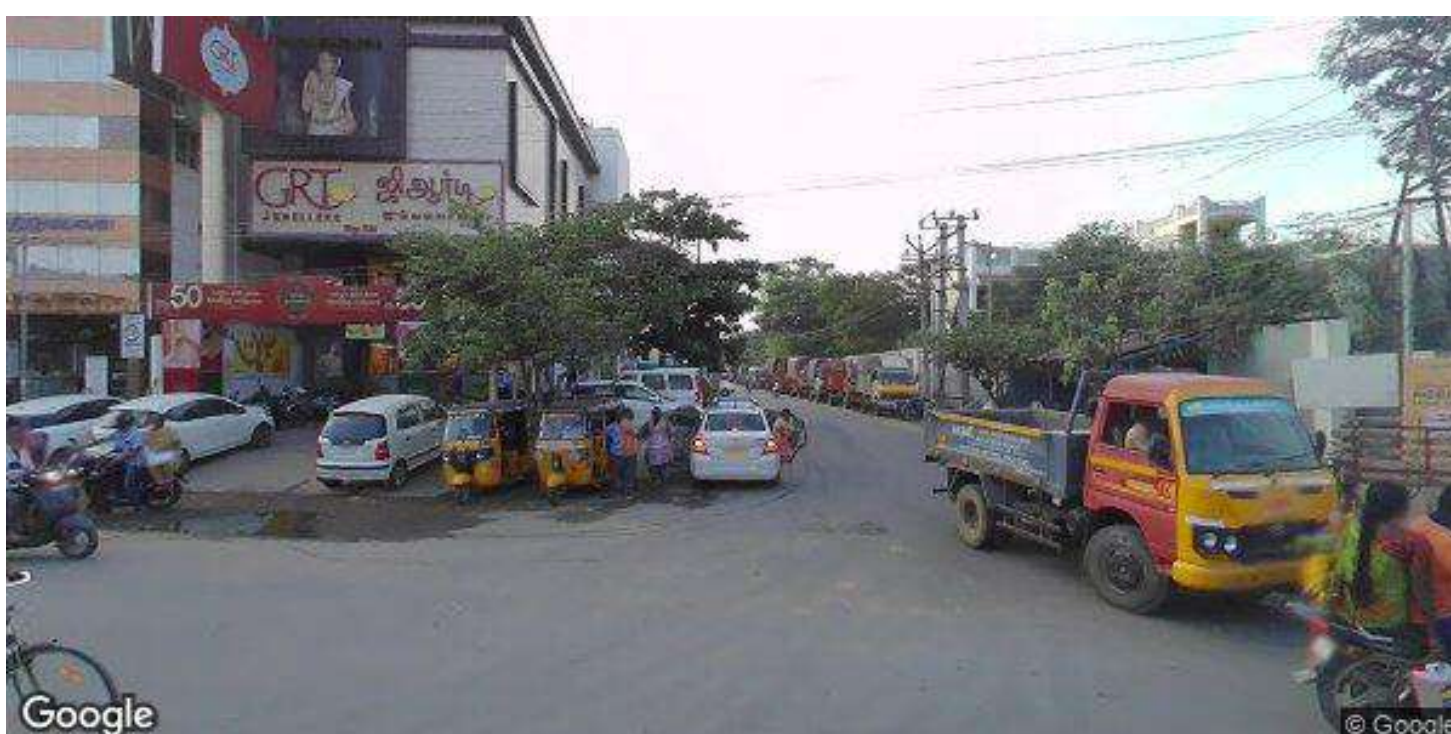
**Coordinates: 11.34678, 77.73104**

**Risk Type:** Turn

**Risk Level:** High

**Speed Limit: 15 KM/Hr**

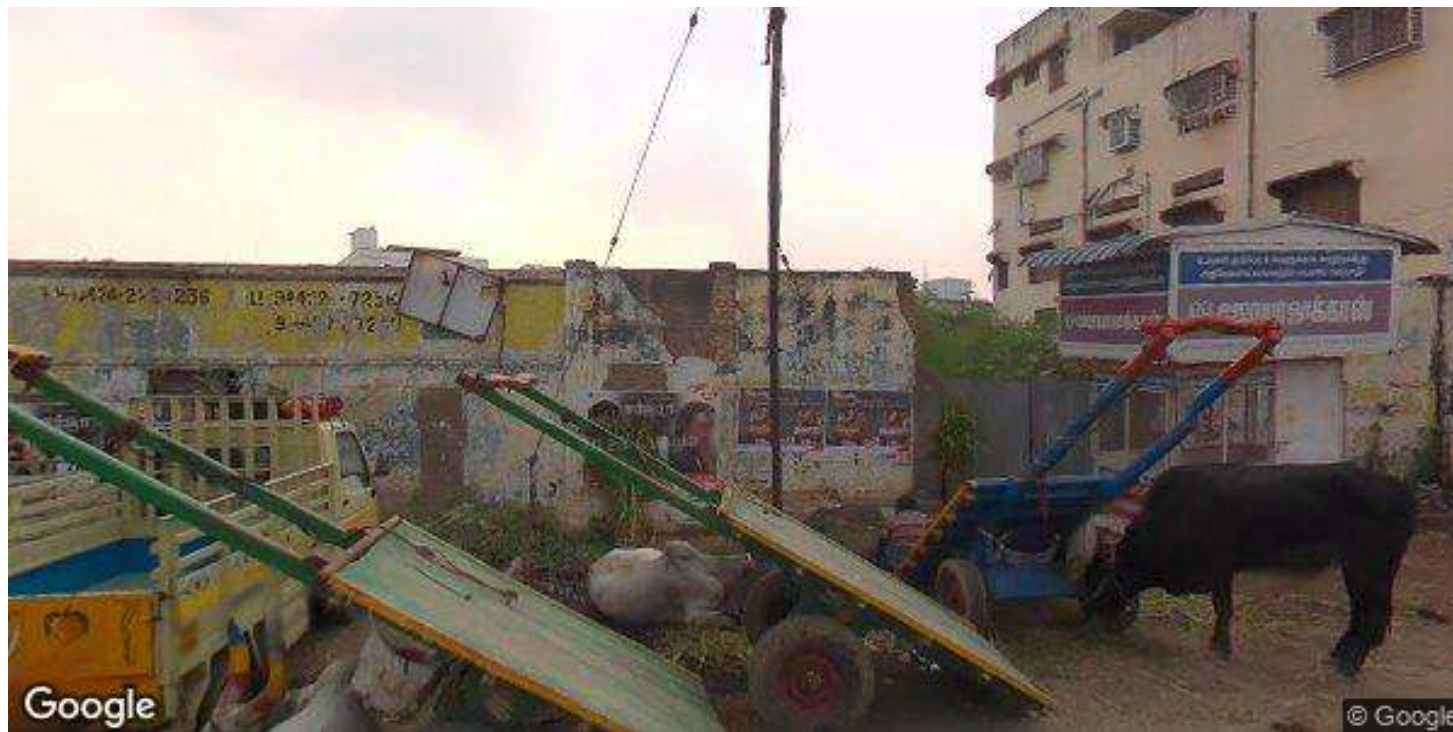
**Coordinates: 11.34678, 77.72581**

**Risk Type: Turn**

**Risk Level: High**

**Speed Limit: 15 KM/Hr**
