# IndianOil

## JOURNEY RISK MANAGEMENT (JRM) STUDY

### Salem Terminal TO THANGGAMANI AGENCIES

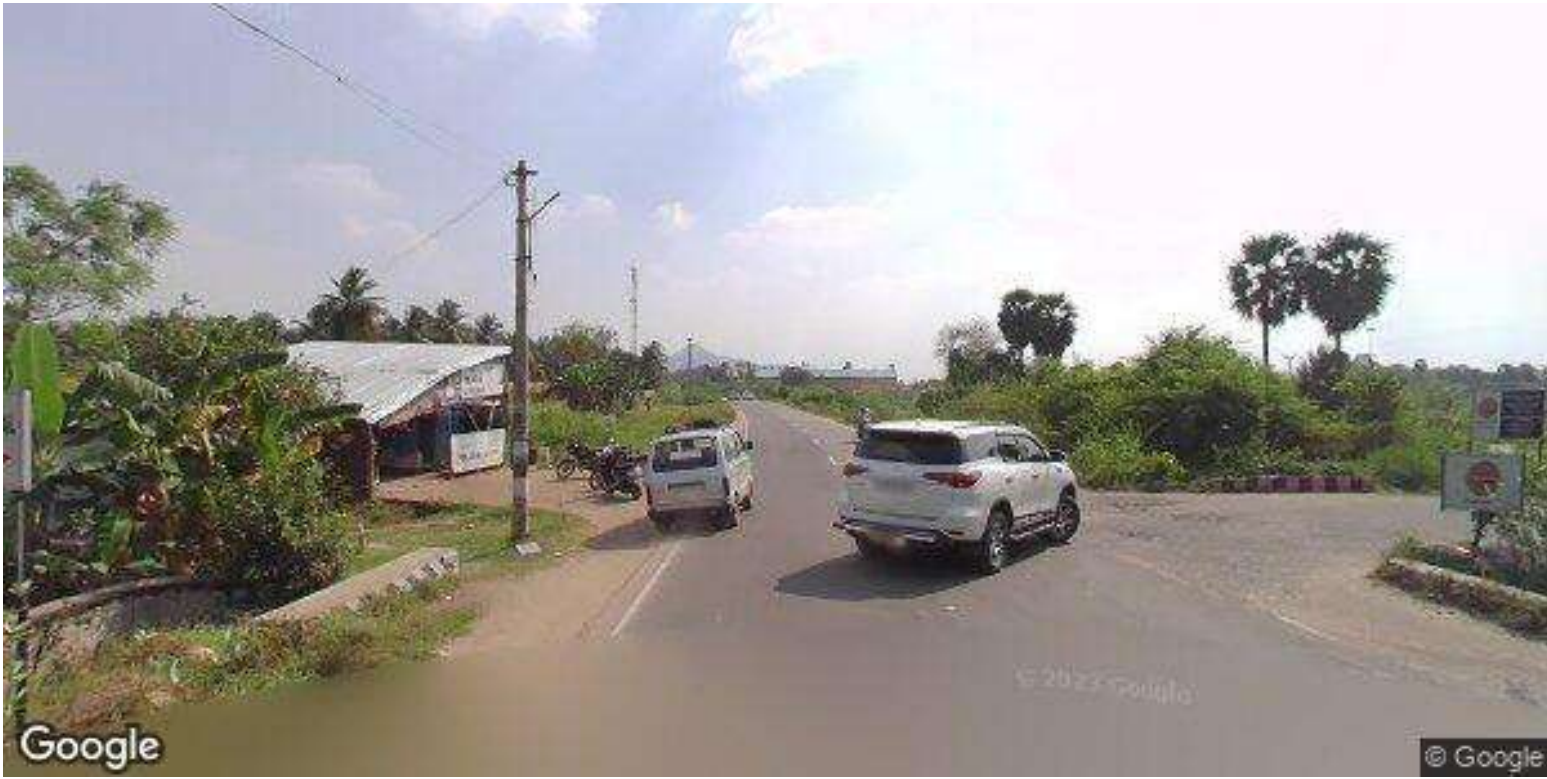
Risk Type: Turn  
Risk Level: High  
Speed Limit: 15 KM/Hr  
Coordinates: 11.44029, 77.87544

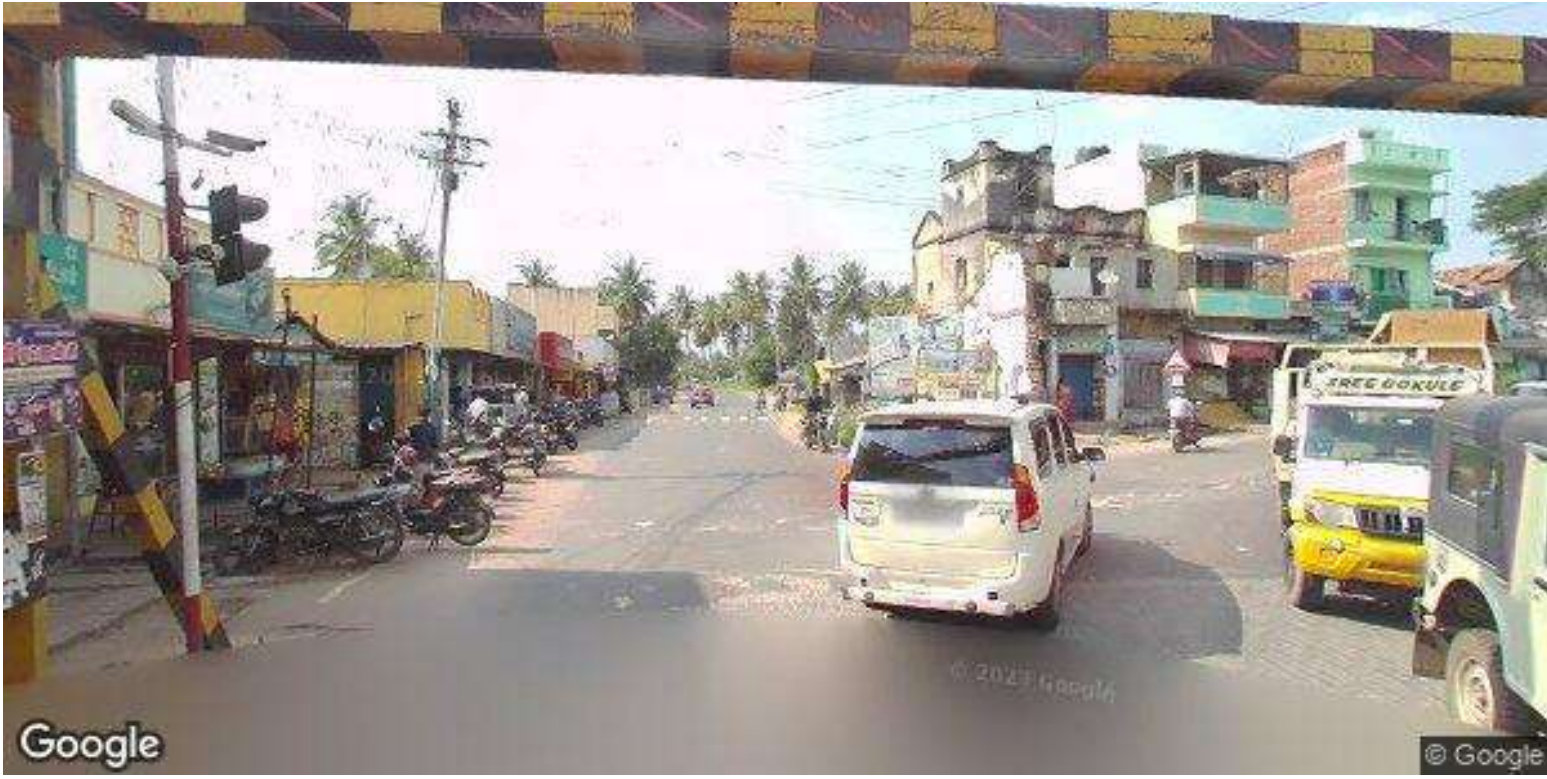
Risk Type: Turn  
Risk Level: High  
Speed Limit: 15 KM/Hr  
Coordinates: 11.45004, 77.87206

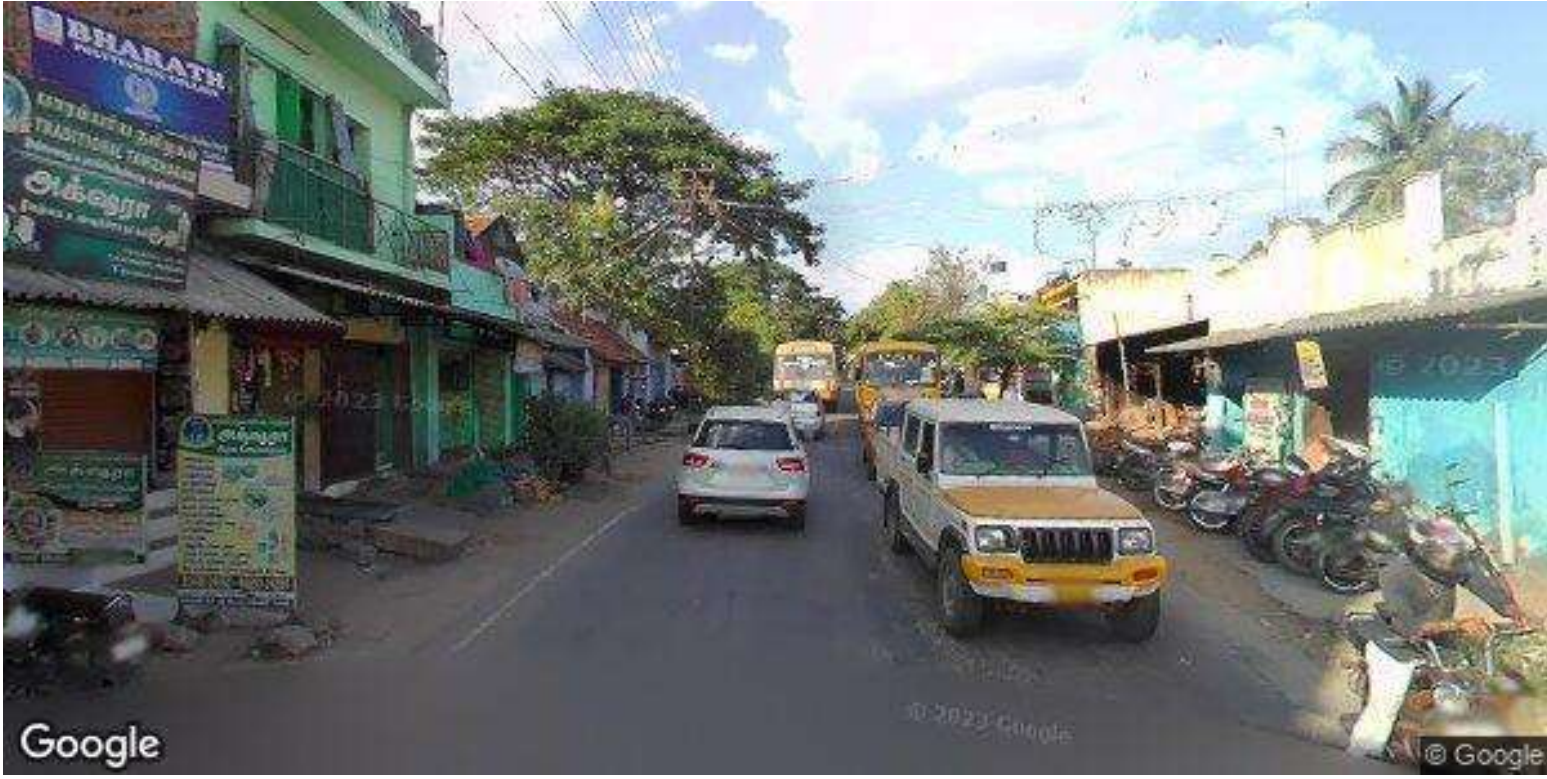
**Risk Type:** Turn  
**Risk Level:** Medium  
**Speed Limit:** 30 KM/Hr  
**Coordinates:** 11.45028, 77.87202

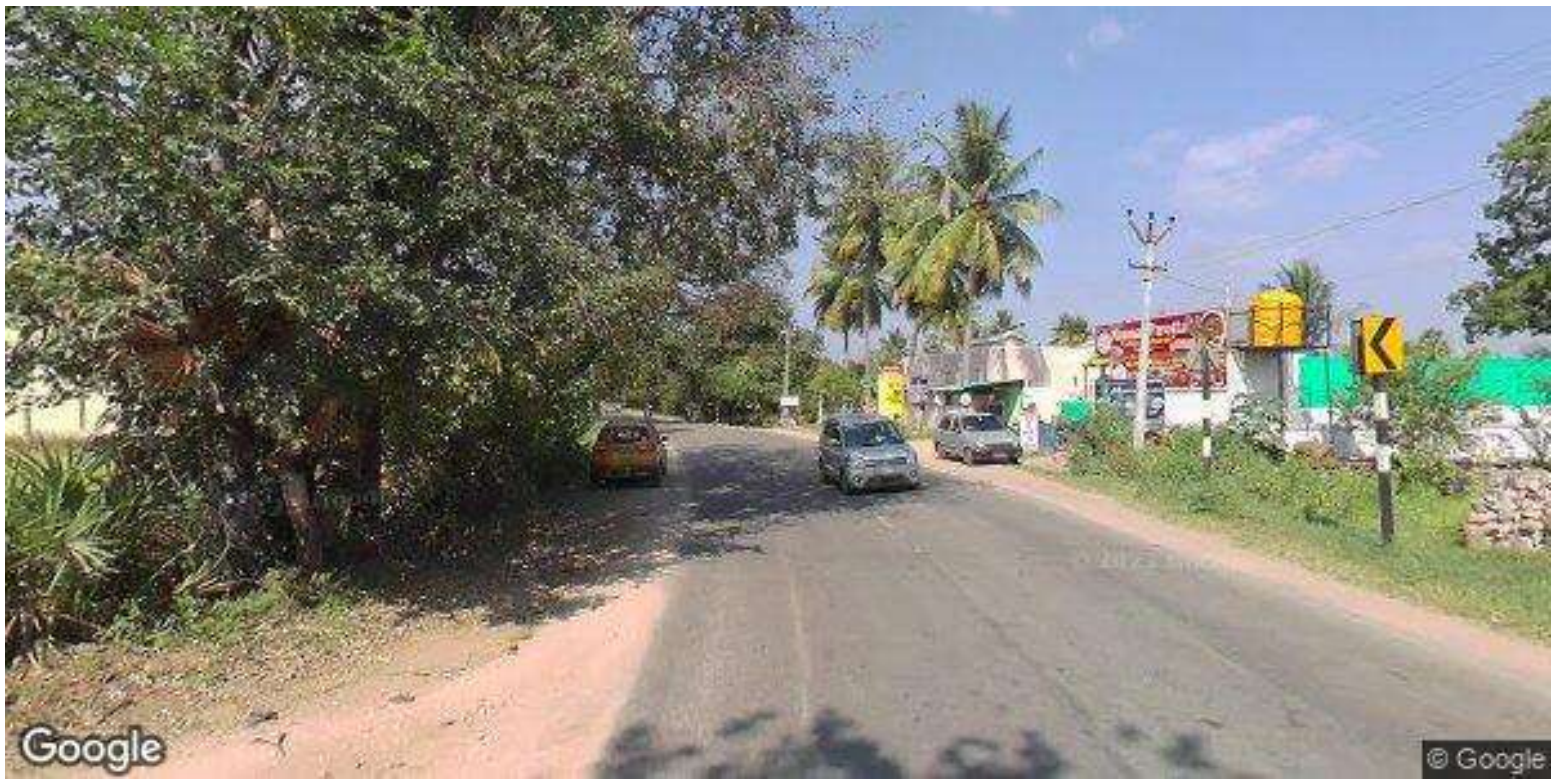
**Risk Type:** Turn  
**Risk Level:** Medium  
**Speed Limit:** 30 KM/Hr  
**Coordinates:** 11.45309, 77.87325

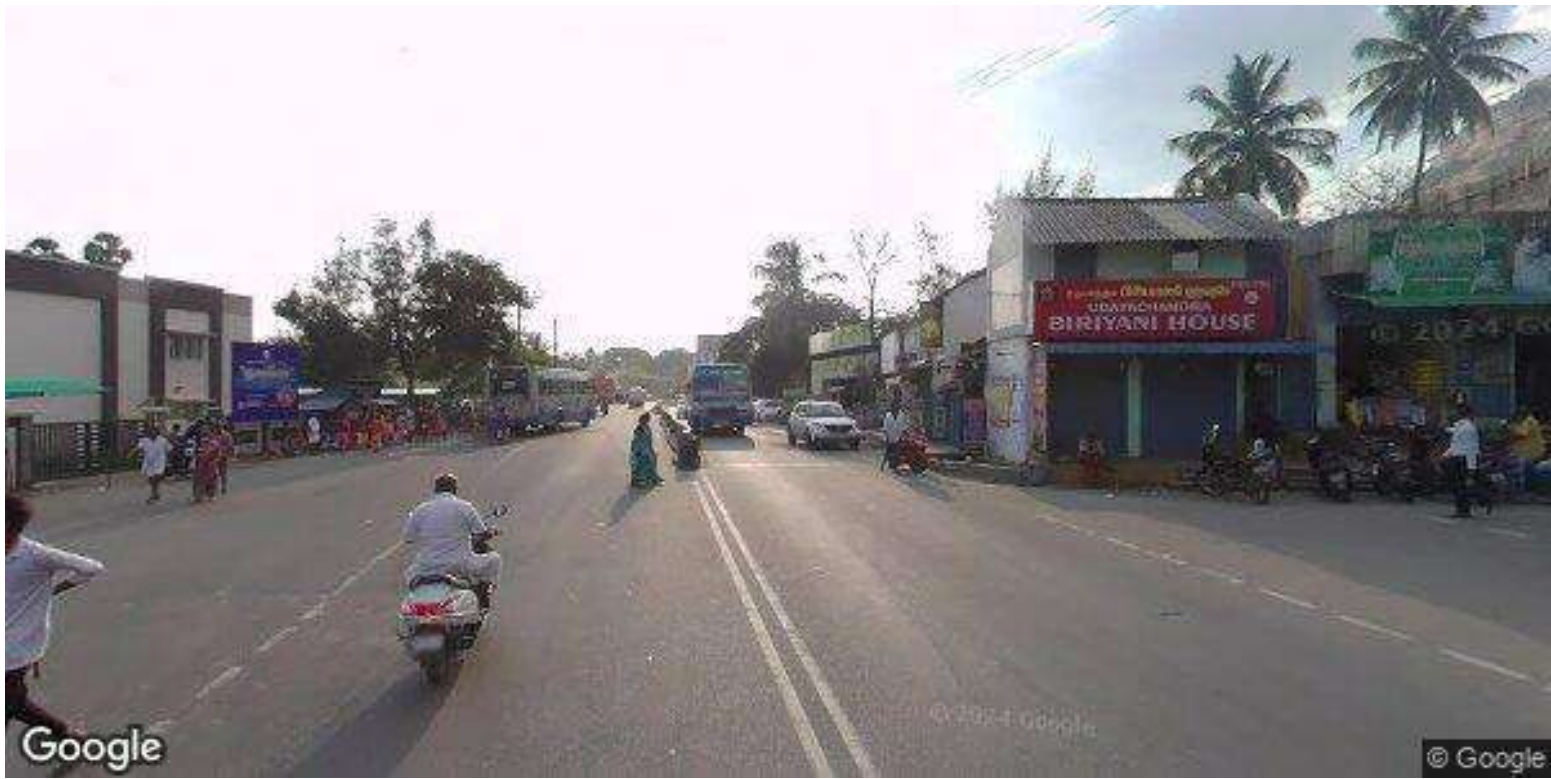
**Risk Type:** Turn  
**Risk Level:** High  
**Speed Limit:** 15 KM/Hr  
**Coordinates:** 11.47403, 77.86841

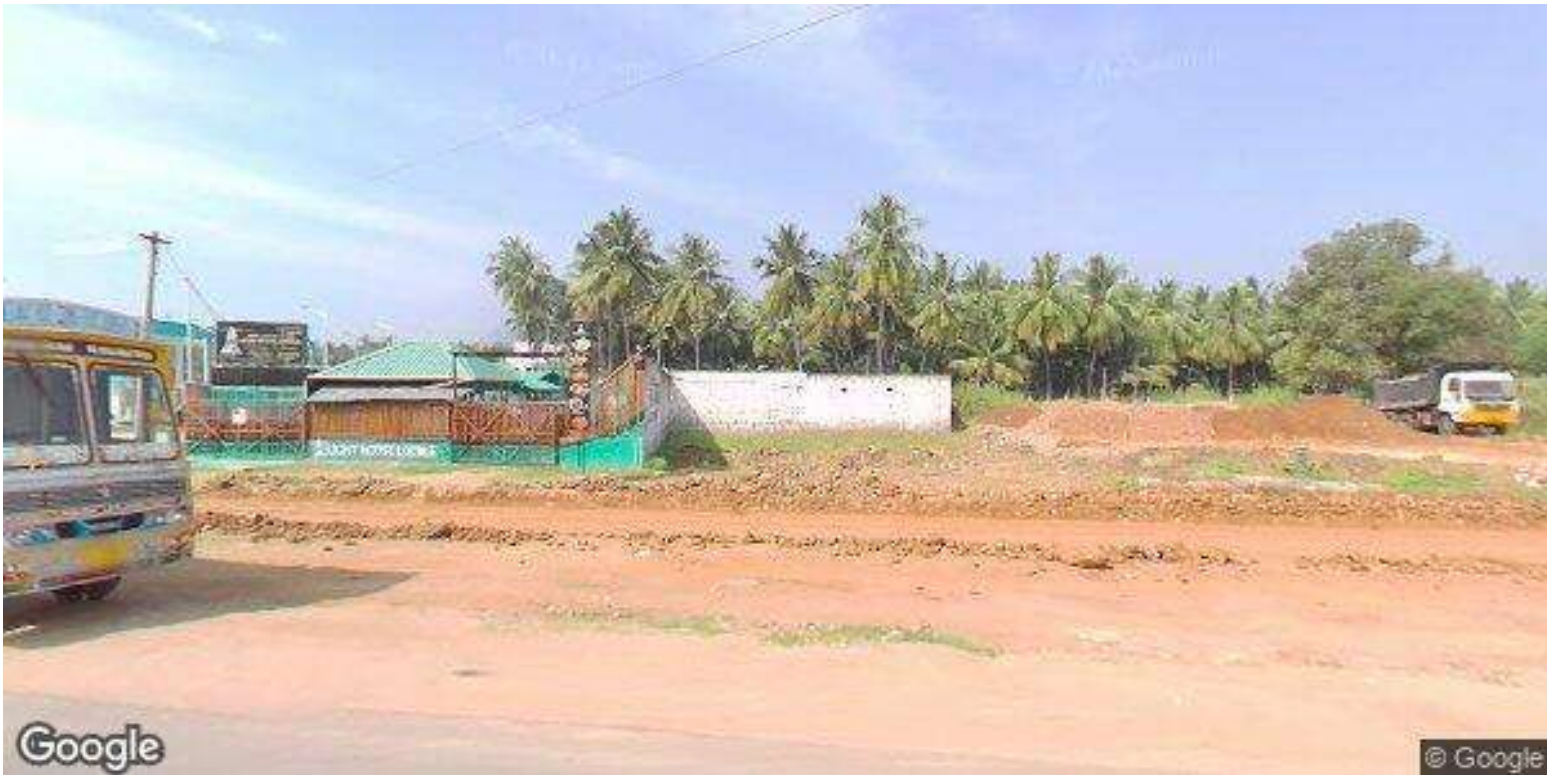
**Risk Type:** Turn  
**Risk Level:** Medium  
**Speed Limit:** 30 KM/Hr  
**Coordinates:** 11.61736, 78.10588

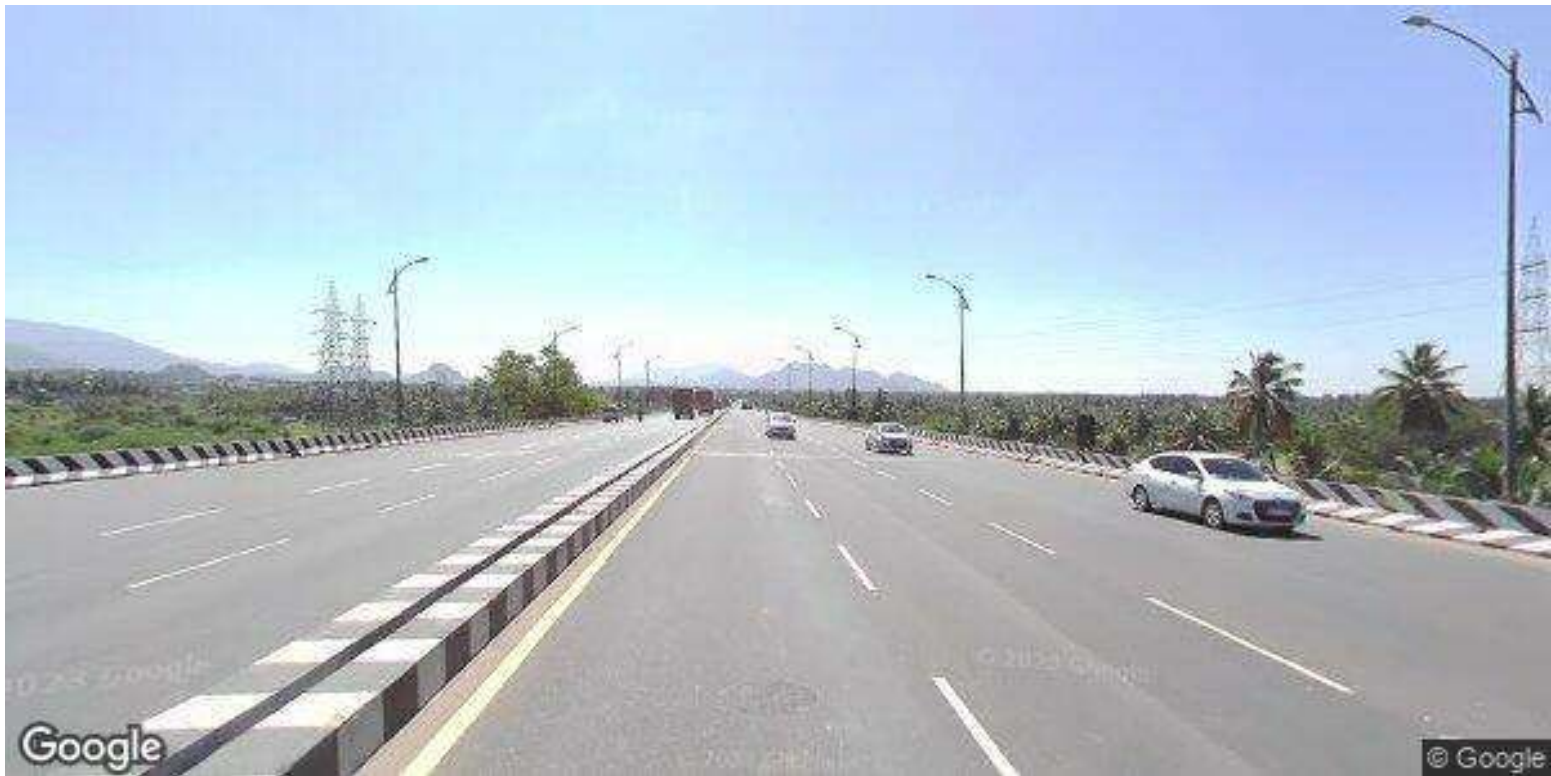
**Risk Type:** Turn  
**Risk Level:** Medium  
**Speed Limit:** 30 KM/Hr  
**Coordinates:** 11.64007, 78.11794

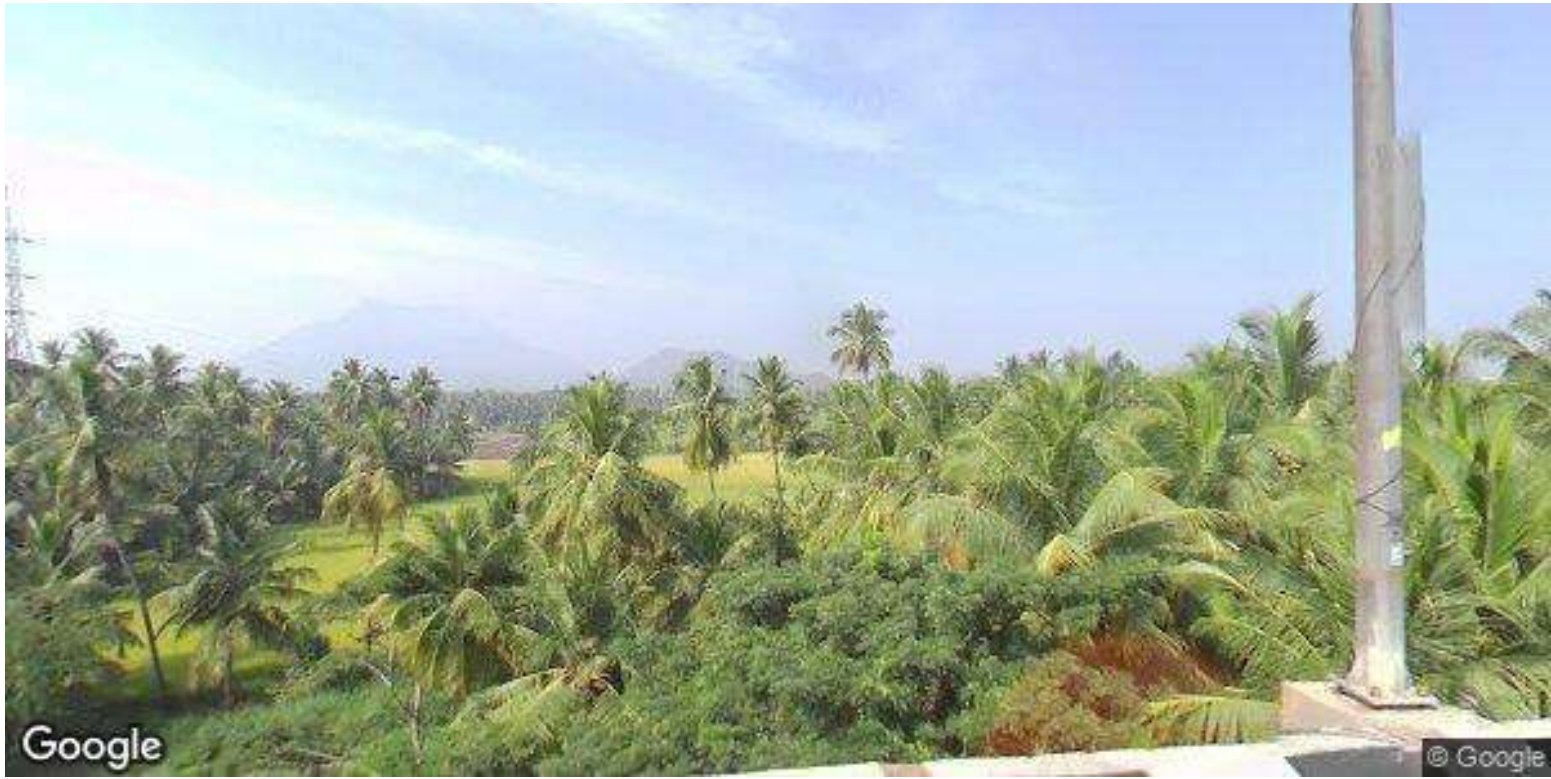
**Risk Type:** Turn  
**Risk Level:** Medium  
**Speed Limit:** 30 KM/Hr  
**Coordinates:** 11.64020, 78.11786

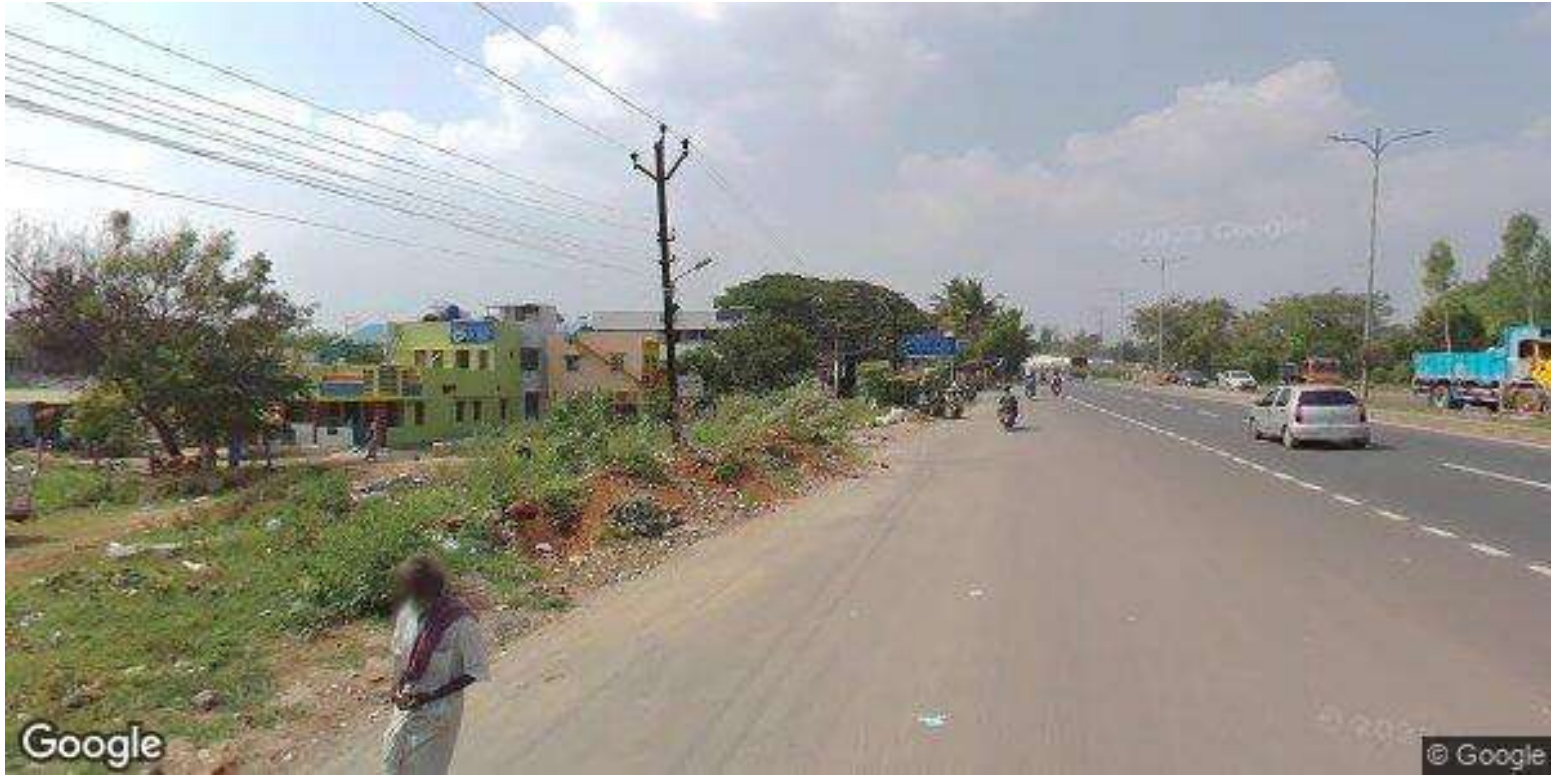
**Risk Type:** Turn  
**Risk Level:** High  
**Speed Limit:** 15 KM/Hr  
**Coordinates:** 11.69390, 78.10964

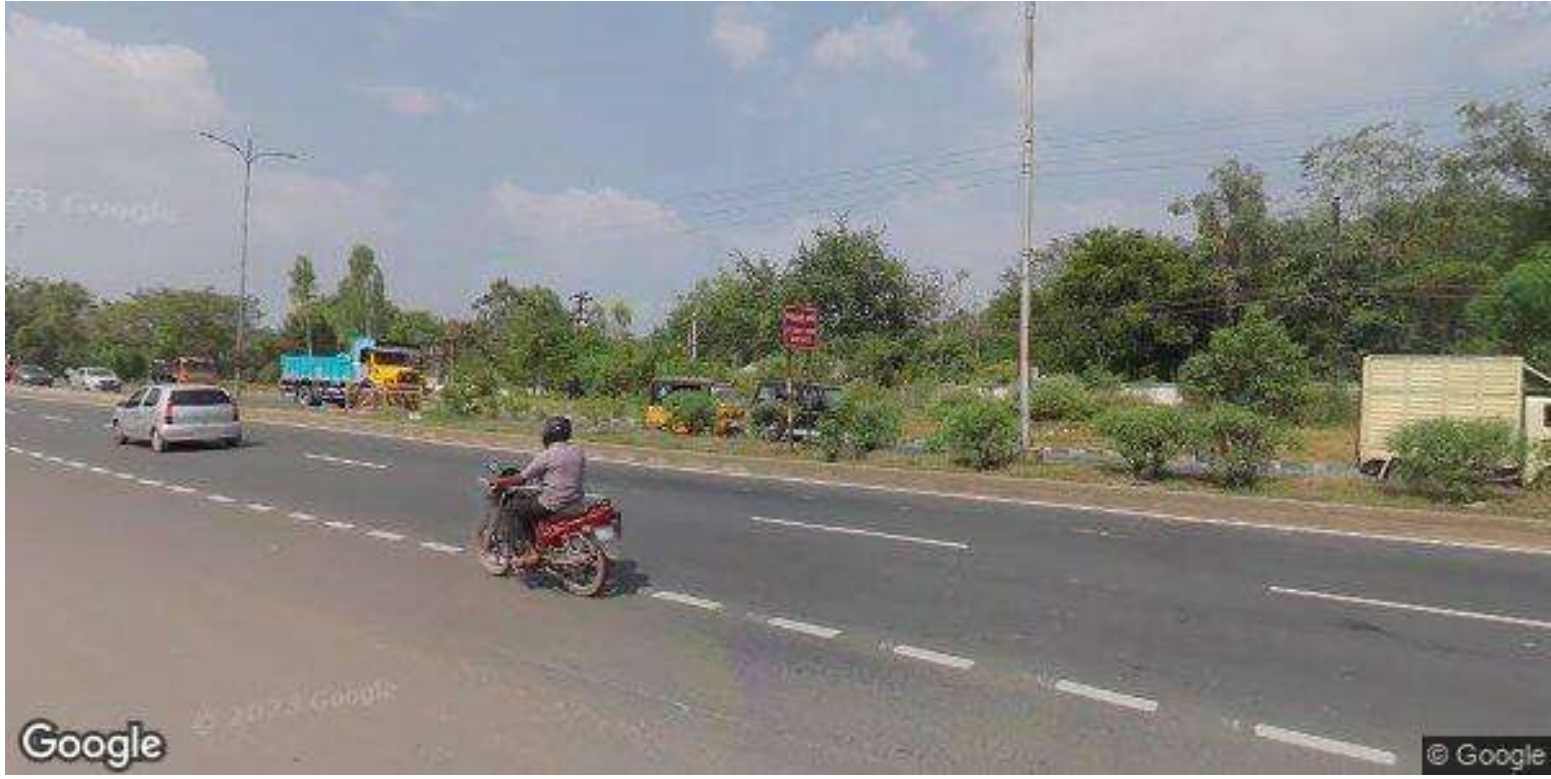
**Risk Type:** Turn  
**Risk Level:** High  
**Speed Limit:** 15 KM/Hr  
**Coordinates:** 11.69394, 78.10964

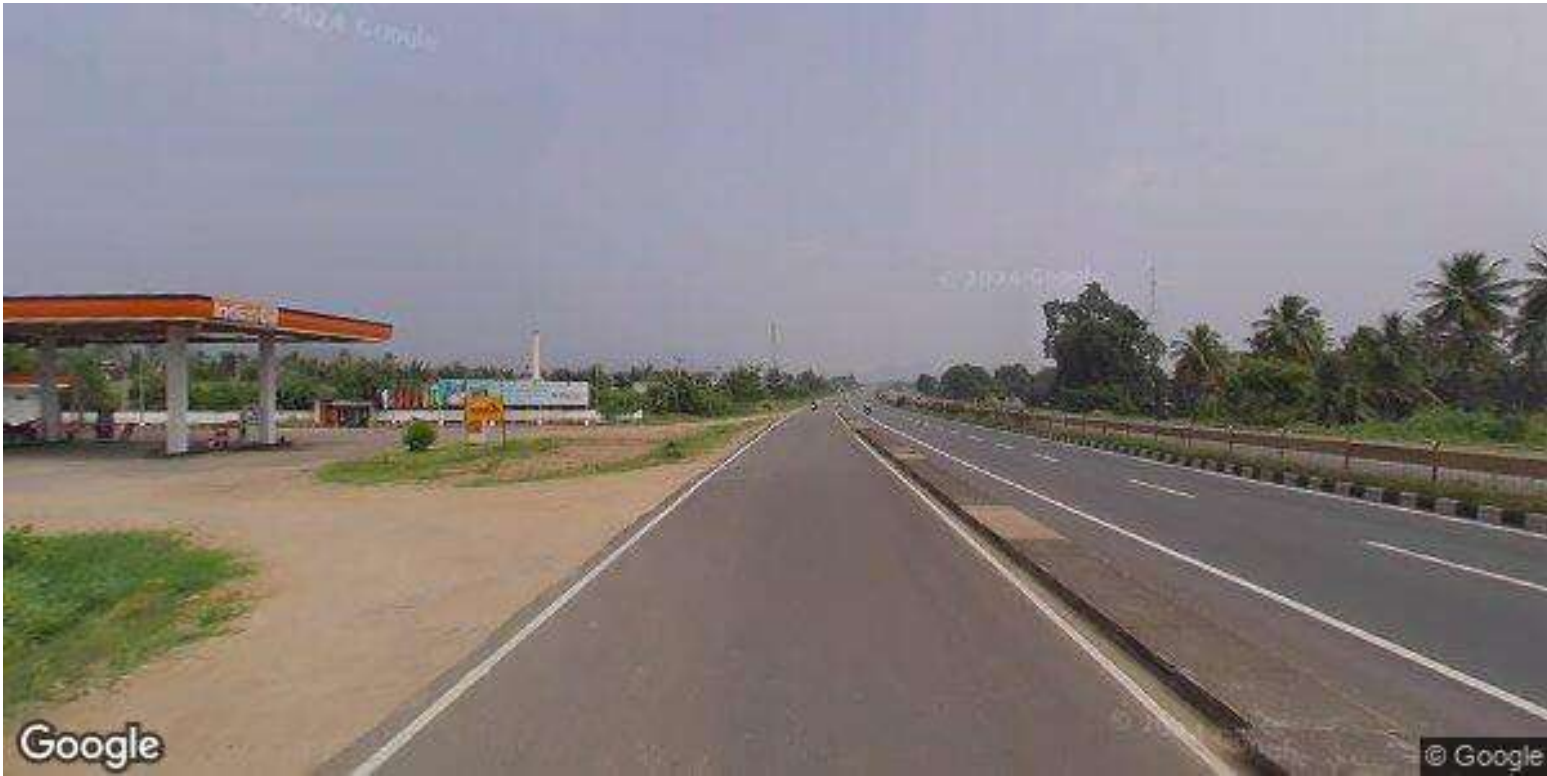
**Risk Type:** Turn  
**Risk Level:** Medium  
**Speed Limit:** 30 KM/Hr  
**Coordinates:** 11.85709, 78.07424

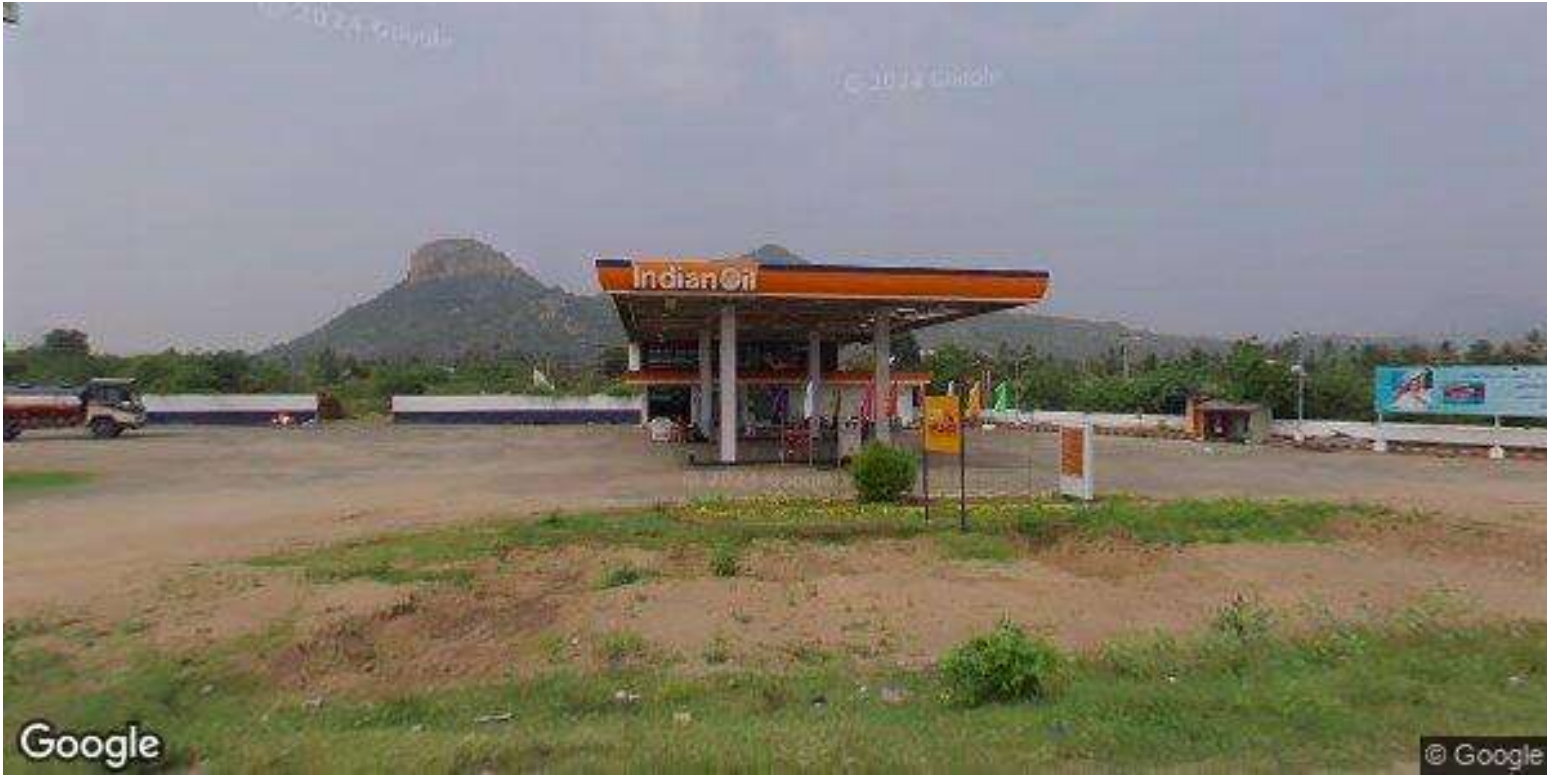
**Risk Type:** Turn  
**Risk Level:** High  
**Speed Limit:** 15 KM/Hr  
**Coordinates:** 11.85747, 78.07423

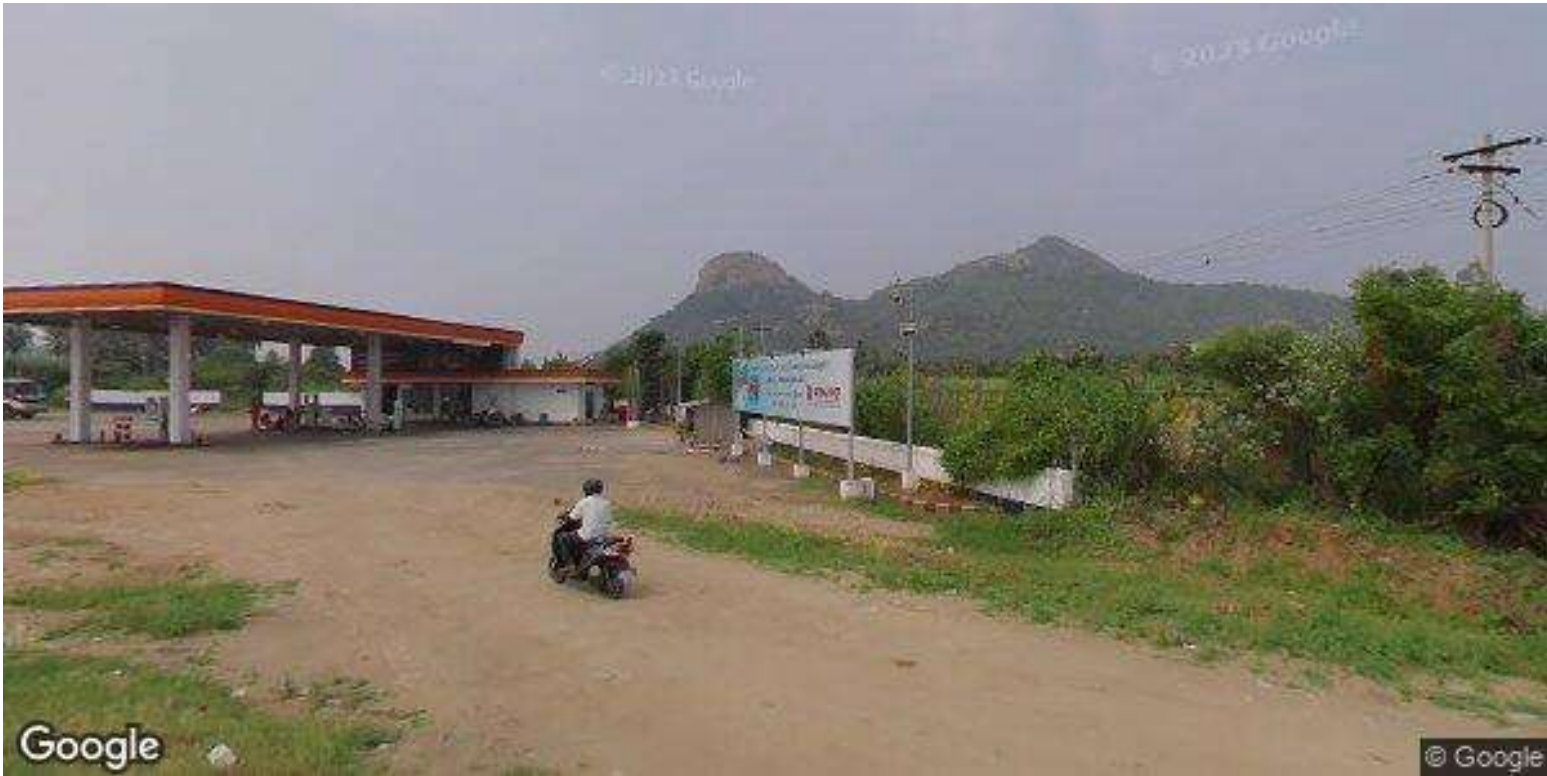
**Risk Type:** Turn  
**Risk Level:** High  
**Speed Limit:** 15 KM/Hr  
**Coordinates:** 11.85766, 78.07454

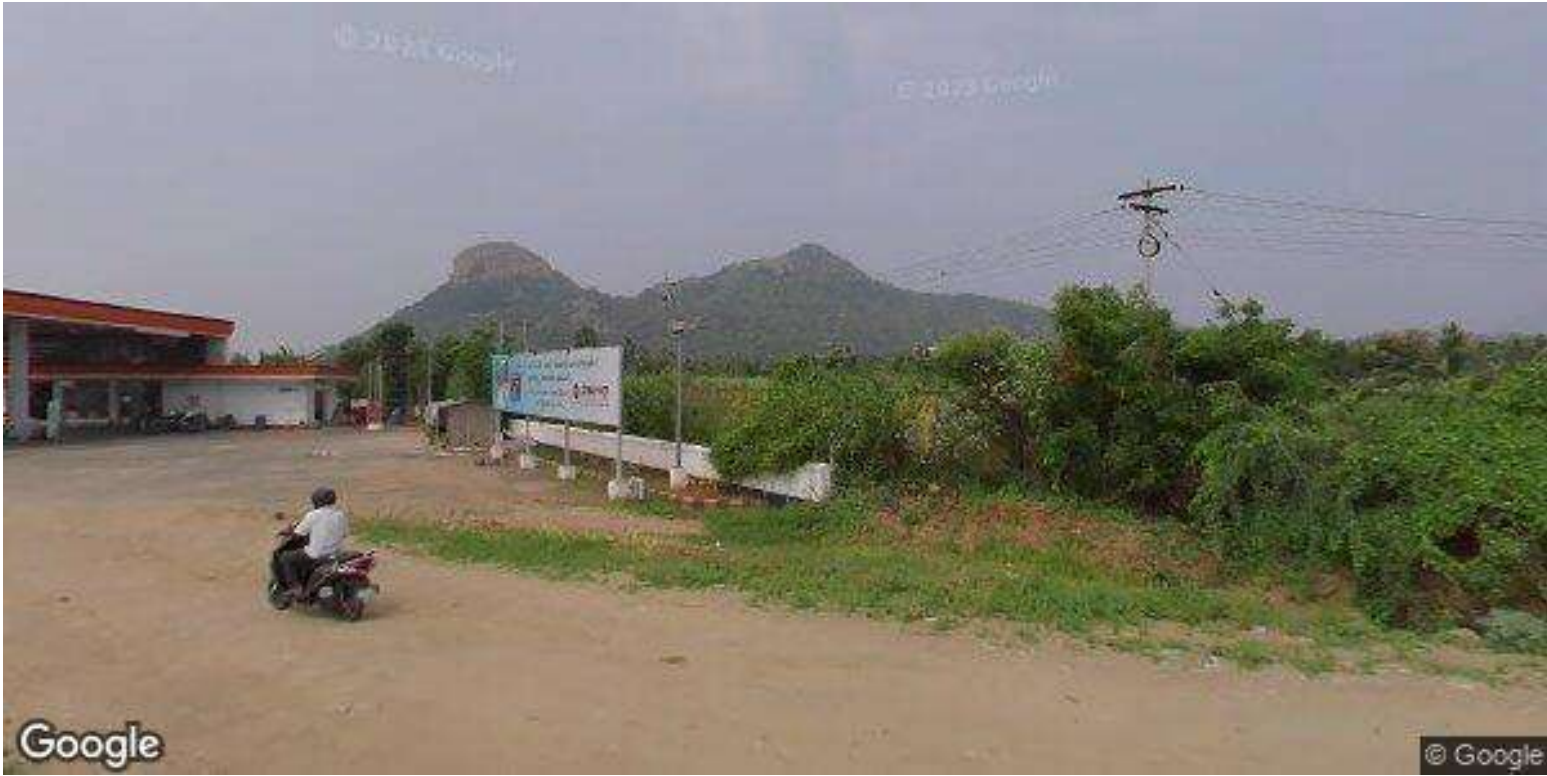
**Risk Type:** Turn  
**Risk Level:** High  
**Speed Limit:** 15 KM/Hr  
**Coordinates:** 11.85774, 78.07450
