## JOURNEY RISK MANAGEMENT (JRM) STUDY

### Salem Terminal TO KARPAGAM ENTERPRISES

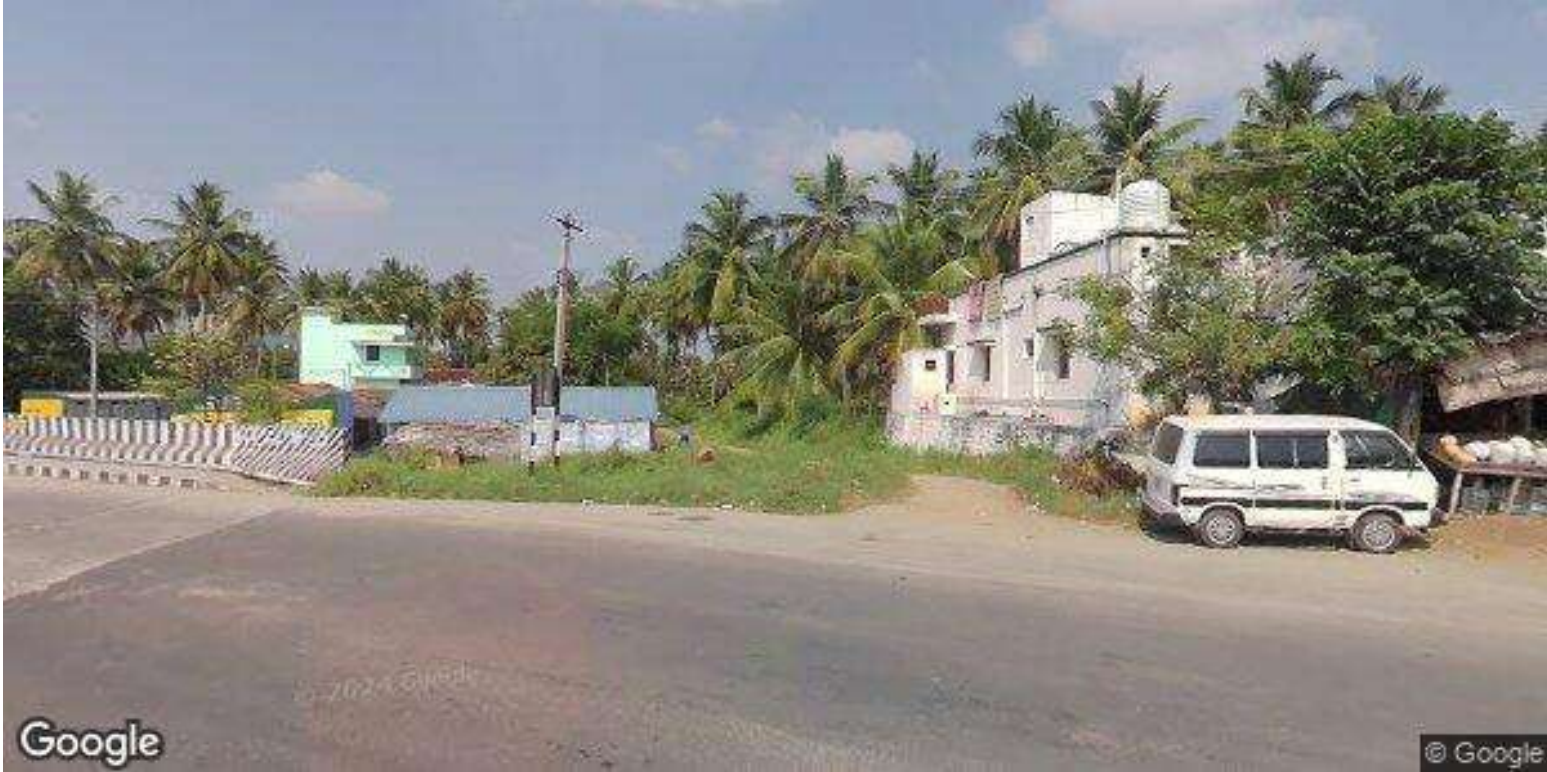
| | Risk Type | Risk Level | Coordinates | Speed Limit |
|---|---|---|---|---|
| 4 | Turn | Medium | 11.44898, 77.87410 | 30 KM/Hr |

Risk Type: Turn  
Risk Level: Medium  
Speed Limit: 30 KM/Hr  
Coordinates: 11.44898, 77.87410

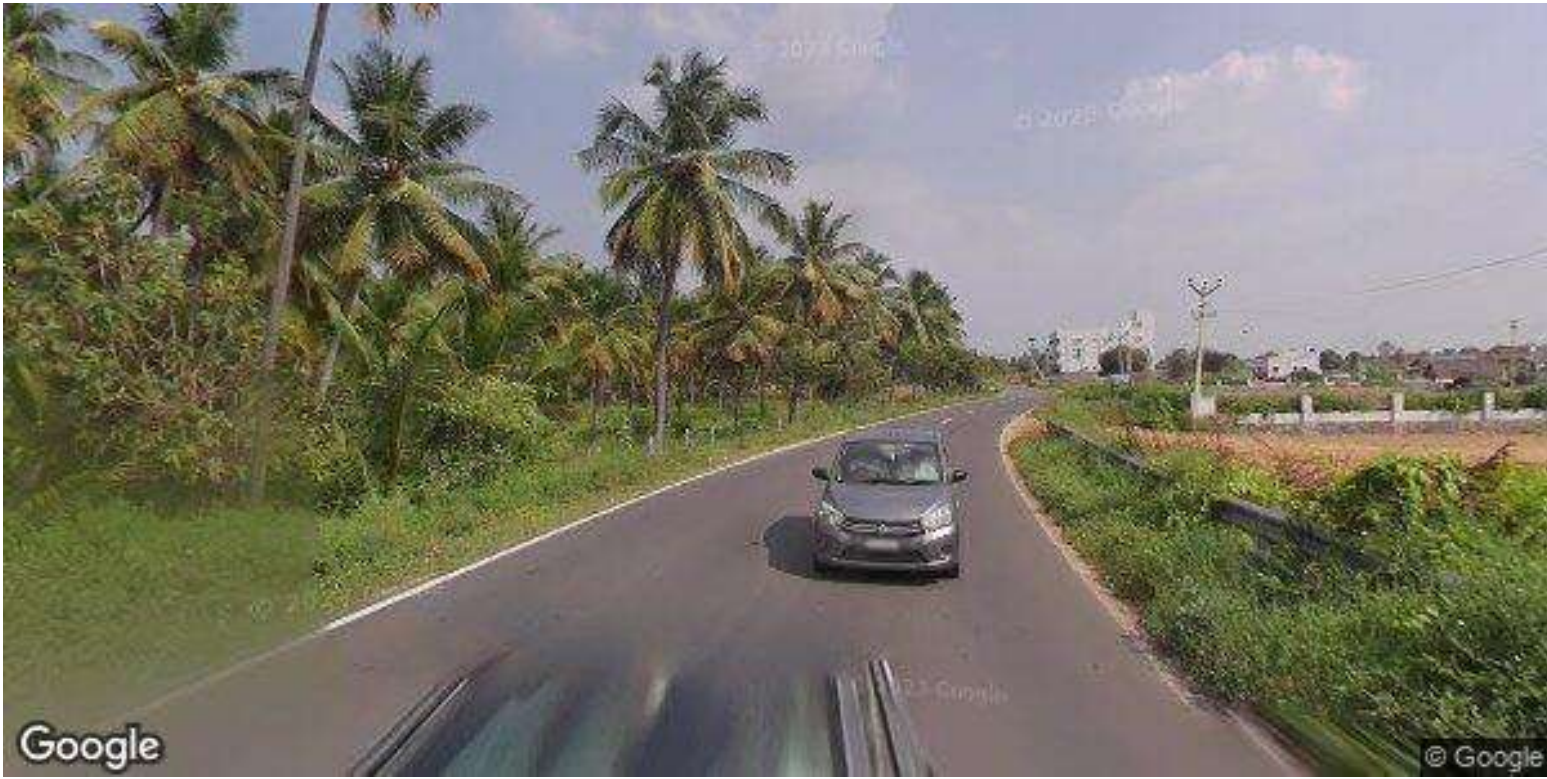
| | Risk Type | Risk Level | Coordinates | Speed Limit |
|---|---|---|---|---|
| 5 | Turn | Medium | 11.45357, 77.85789 | 30 KM/Hr |

**Risk Type:** Turn  
**Risk Level:** Medium  
**Speed Limit:** 30 KM/Hr  
**Coordinates:** 11.45357, 77.85789

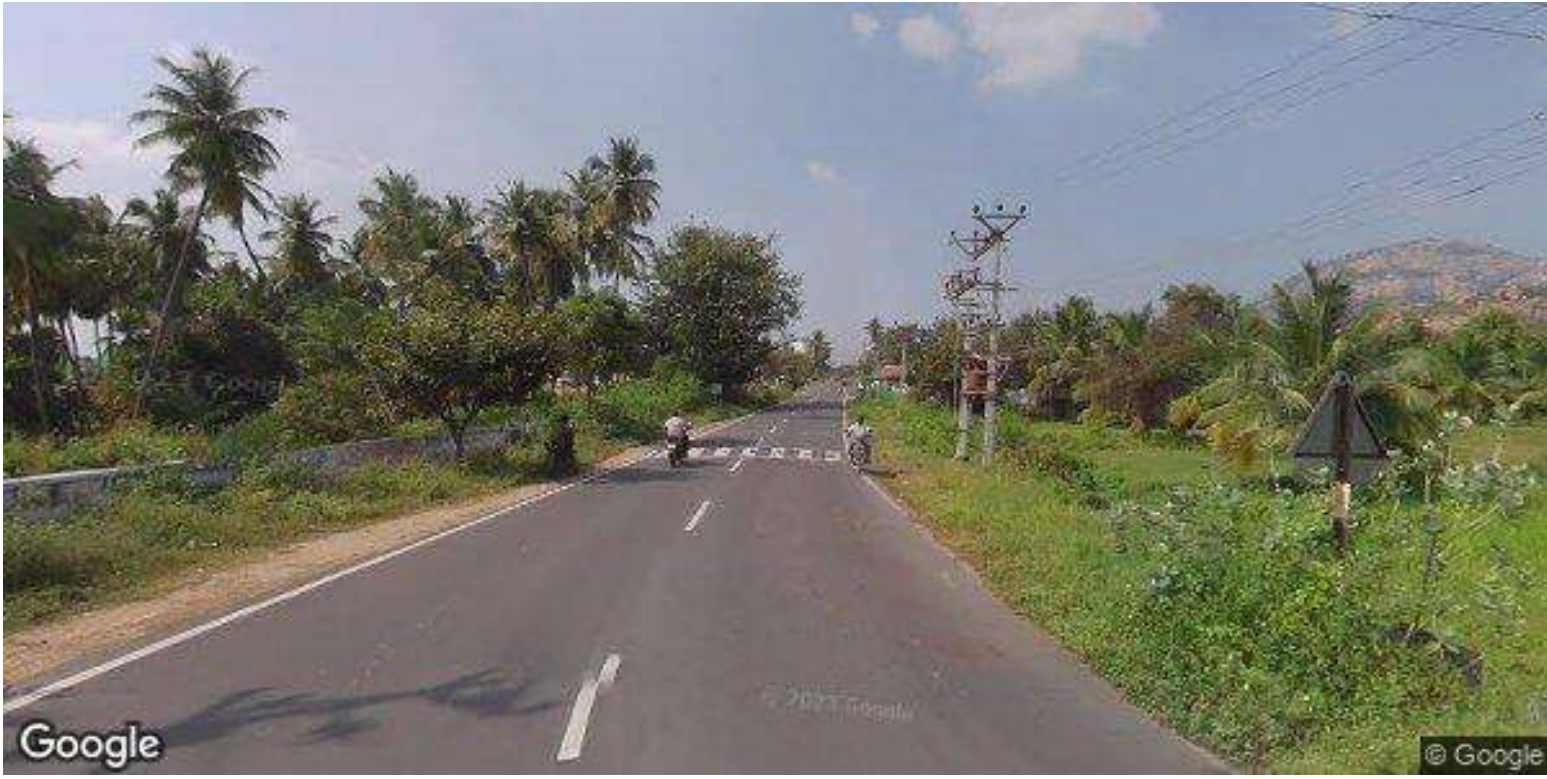
| | Risk Type | Risk Level | Coordinates | Speed Limit |
|---|---|---|---|---|
| 6 | Turn | Medium | 11.45352, 77.85698 | 30 KM/Hr |

**Risk Type:** Turn  
**Risk Level:** Medium  
**Speed Limit:** 30 KM/Hr  
**Coordinates:** 11.45352, 77.85698

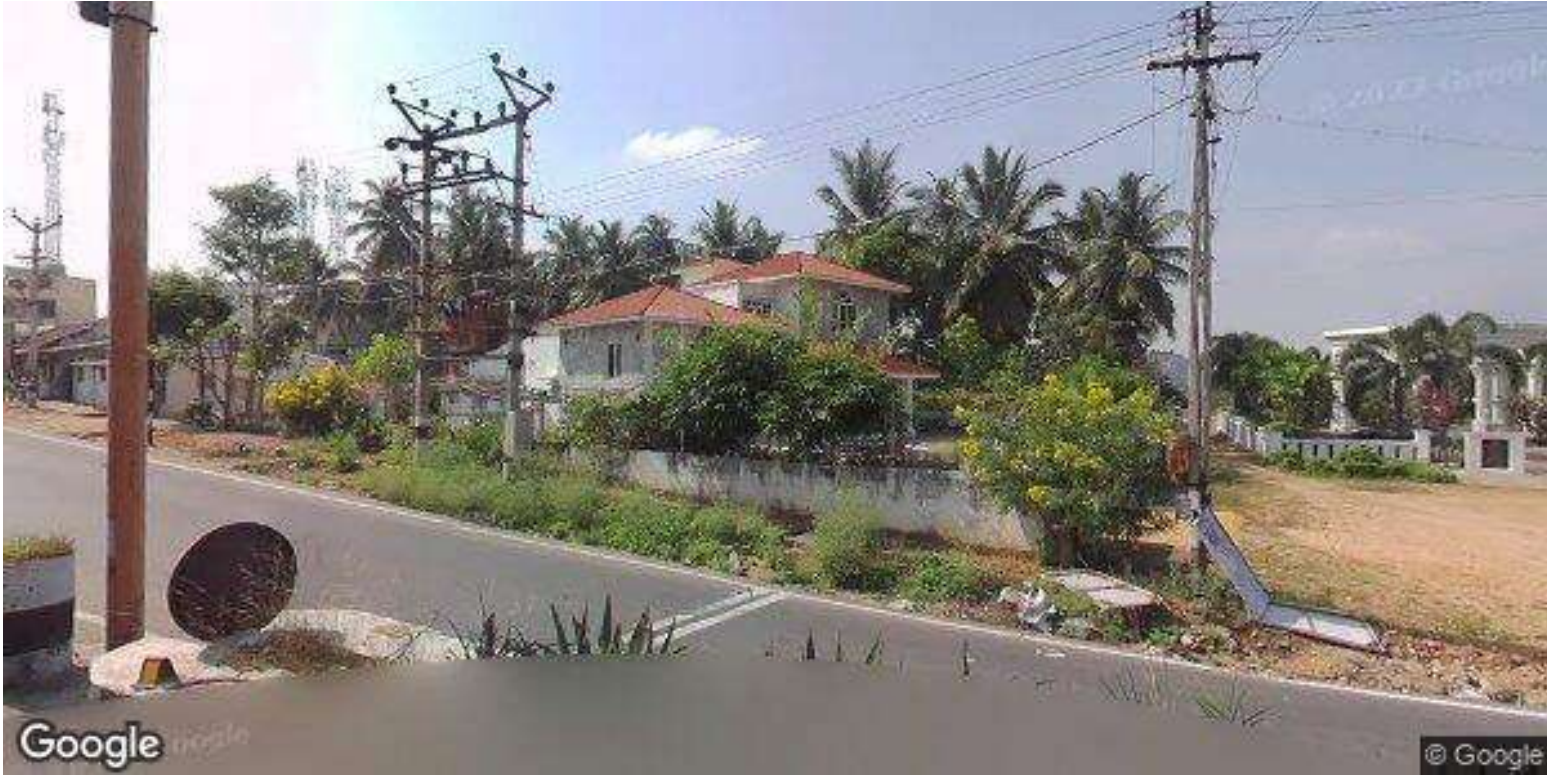
| | Risk Type | Risk Level | Coordinates | Speed Limit |
|---|---|---|---|---|
| 7 | Turn | Medium | 11.46303, 77.84945 | 30 KM/Hr |

**Risk Type:** Turn  
**Risk Level:** Medium  
**Speed Limit:** 30 KM/Hr  
**Coordinates:** 11.46303, 77.84945

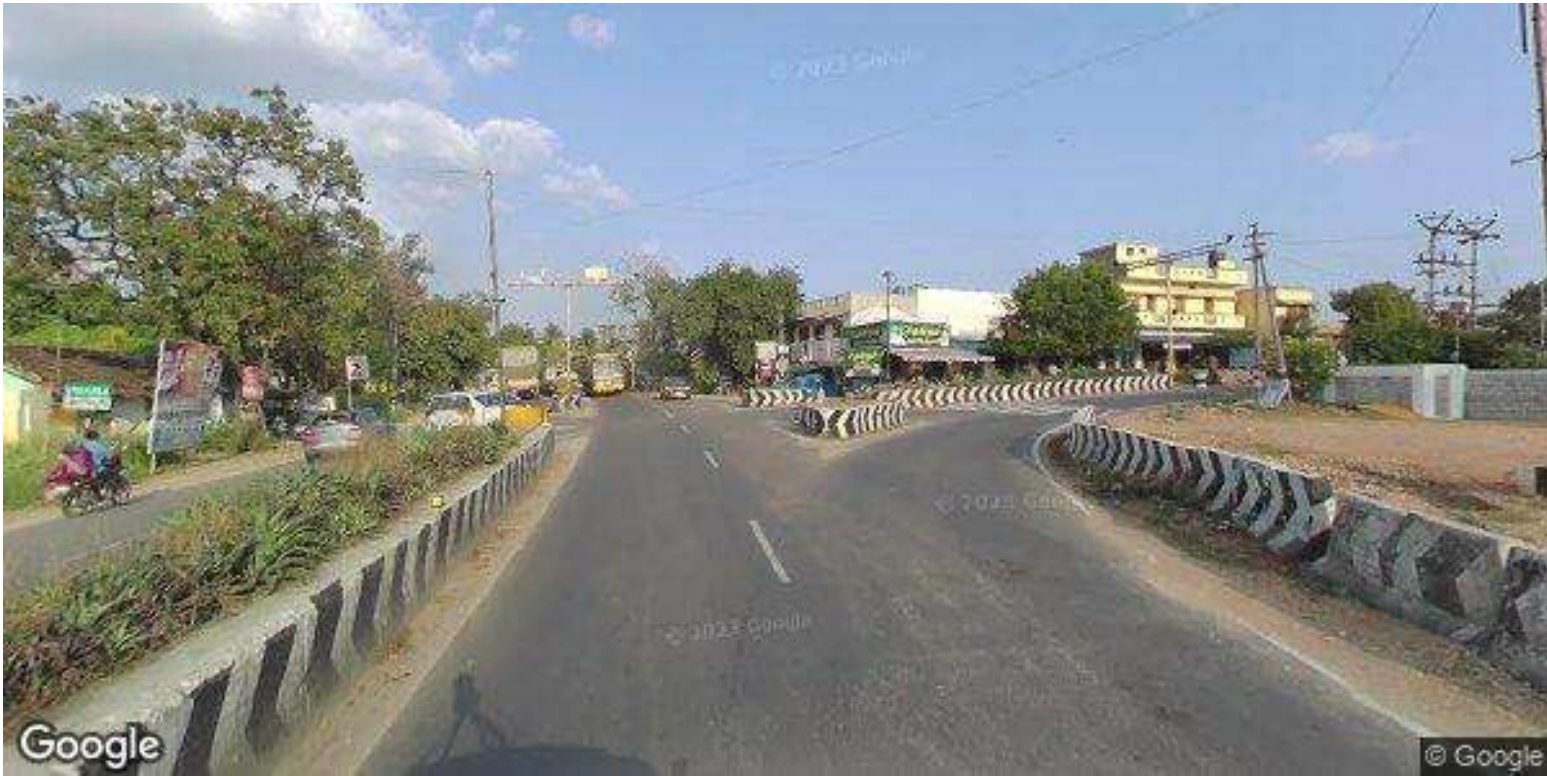
| | Risk Type | Risk Level | Coordinates | Speed Limit |
|---|---|---|---|---|
| 8 | Turn | Medium | 11.46318, 77.84913 | 30 KM/Hr |

**Risk Type:** Turn  
**Risk Level:** Medium  
**Speed Limit:** 30 KM/Hr  
**Coordinates:** 11.46318, 77.84913

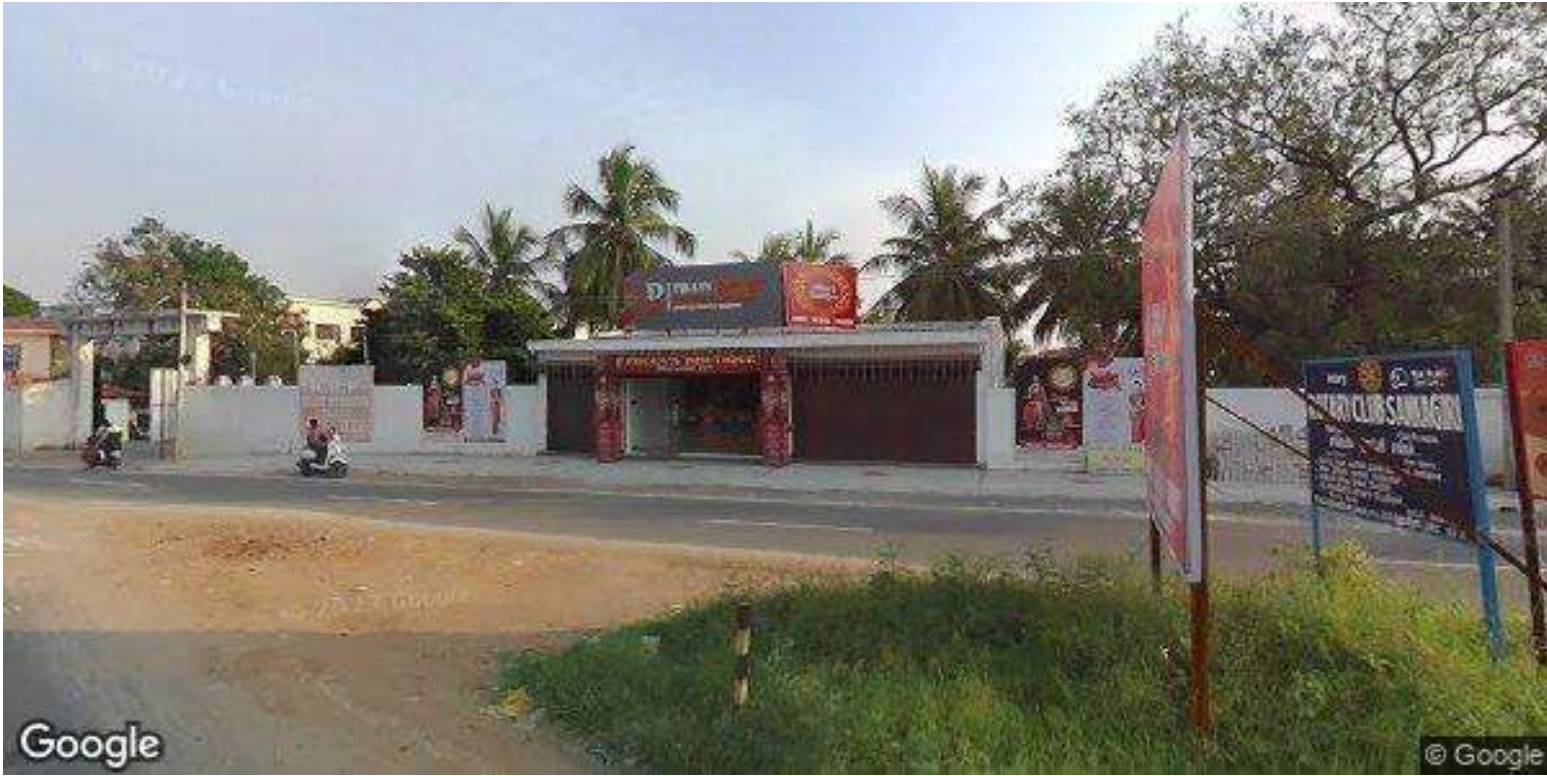
| | Risk Type | Risk Level | Coordinates | Speed Limit |
|---|---|---|---|---|
| 9 | Turn | High | 11.45516, 77.81346 | 15 KM/Hr |

**Risk Type:** Turn  
**Risk Level:** High  
**Speed Limit:** 15 KM/Hr  
**Coordinates:** 11.45516, 77.81346

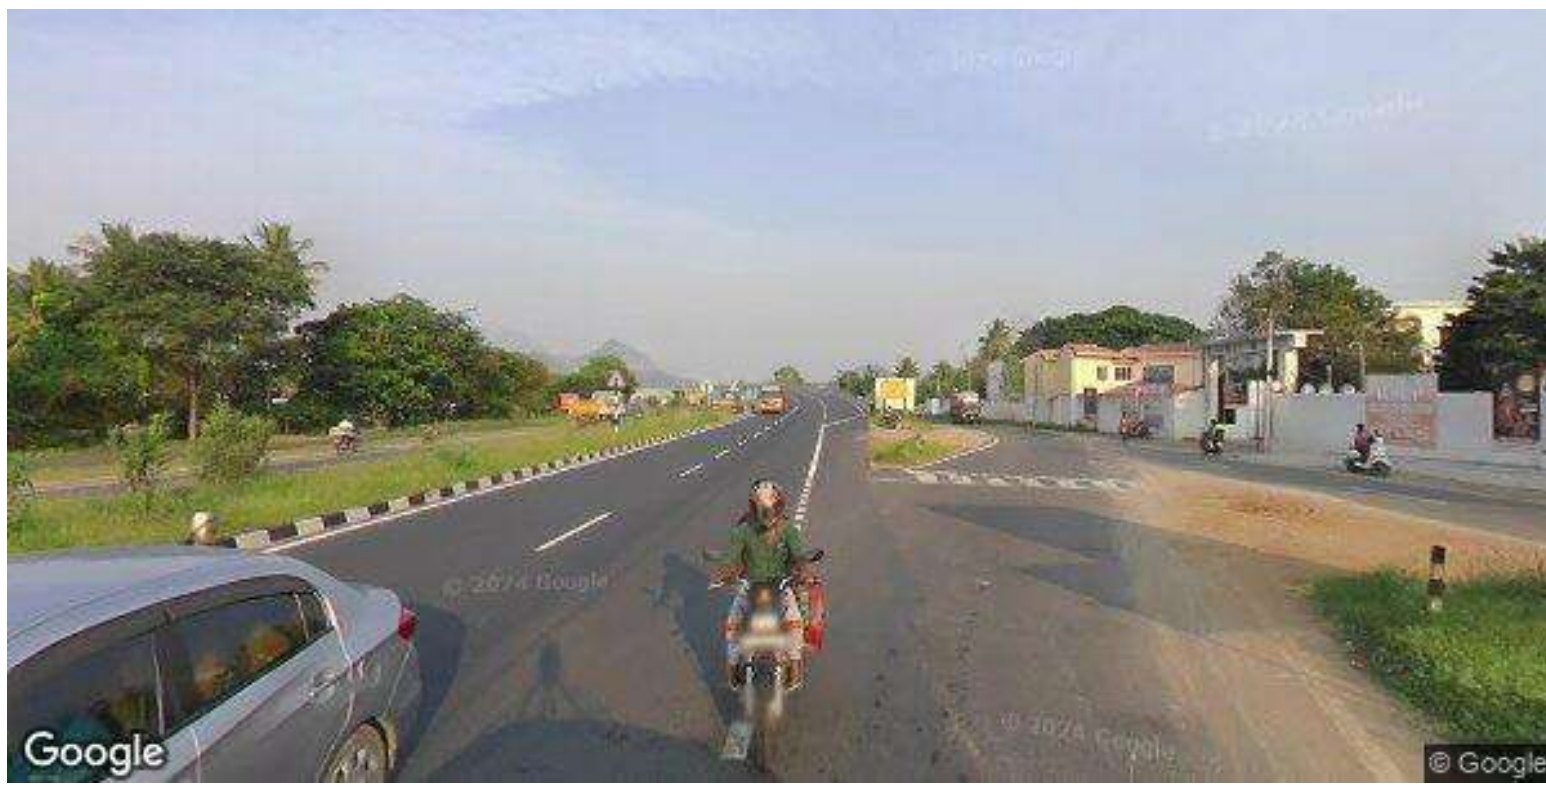
**Coordinates:** 11.45521, 77.81343

| | Risk Type | Risk Level | Coordinates | Speed Limit |
|---|---|---|---|---|
| 10 | Turn | High | 11.45521, 77.81343 | 15 KM/Hr |

**Risk Type:** Turn

**Risk Level:** High

**Speed Limit:** 15 KM/Hr

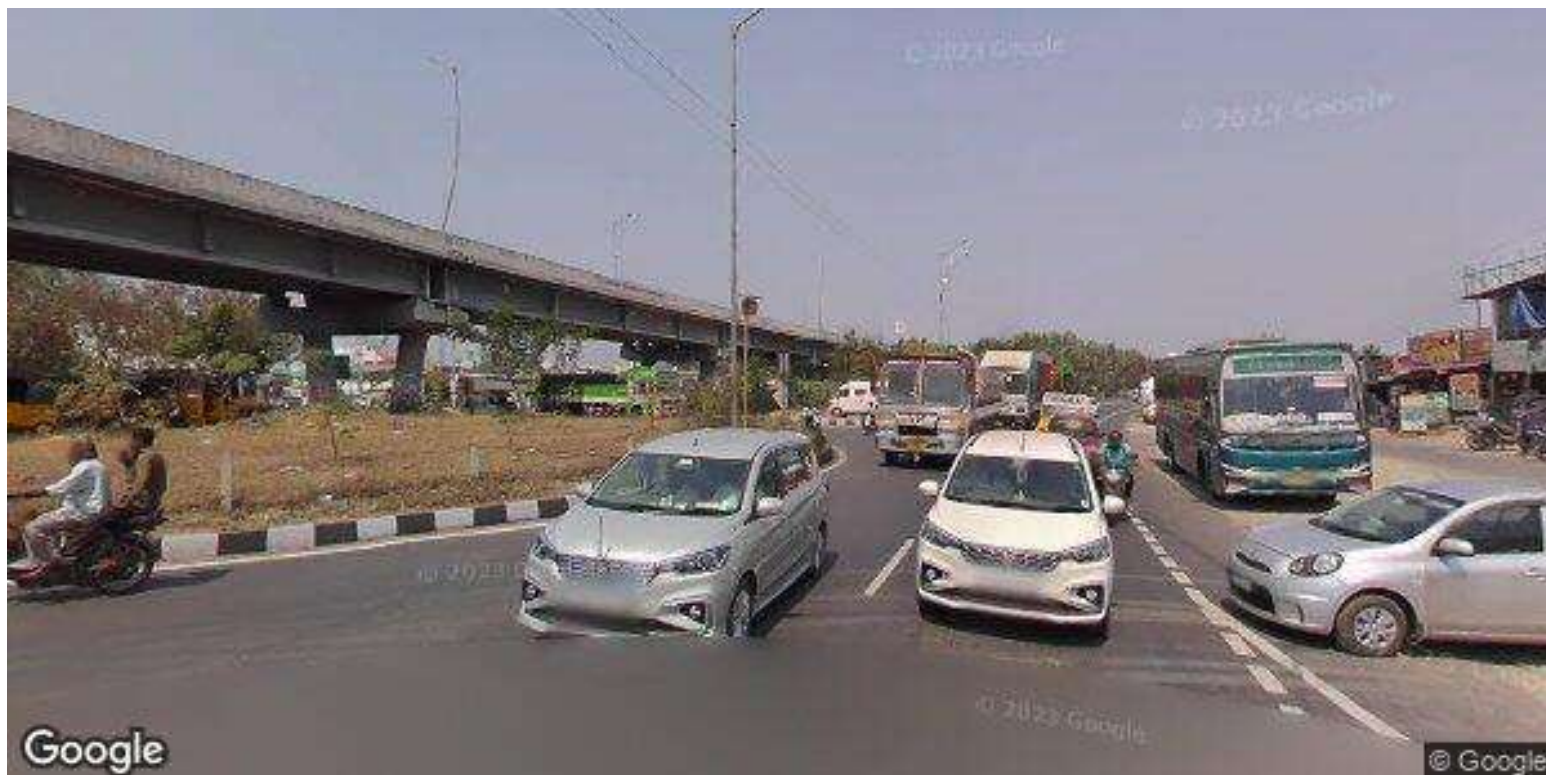
**Coordinates:** 11.43001, 77.67575

| | Risk Type | Risk Level | Coordinates | Speed Limit |
|---|---|---|---|---|
| 11 | Turn | High | 11.43001, 77.67575 | 15 KM/Hr |

**Risk Type:** Turn

**Risk Level:** High

**Speed Limit:** 15 KM/Hr

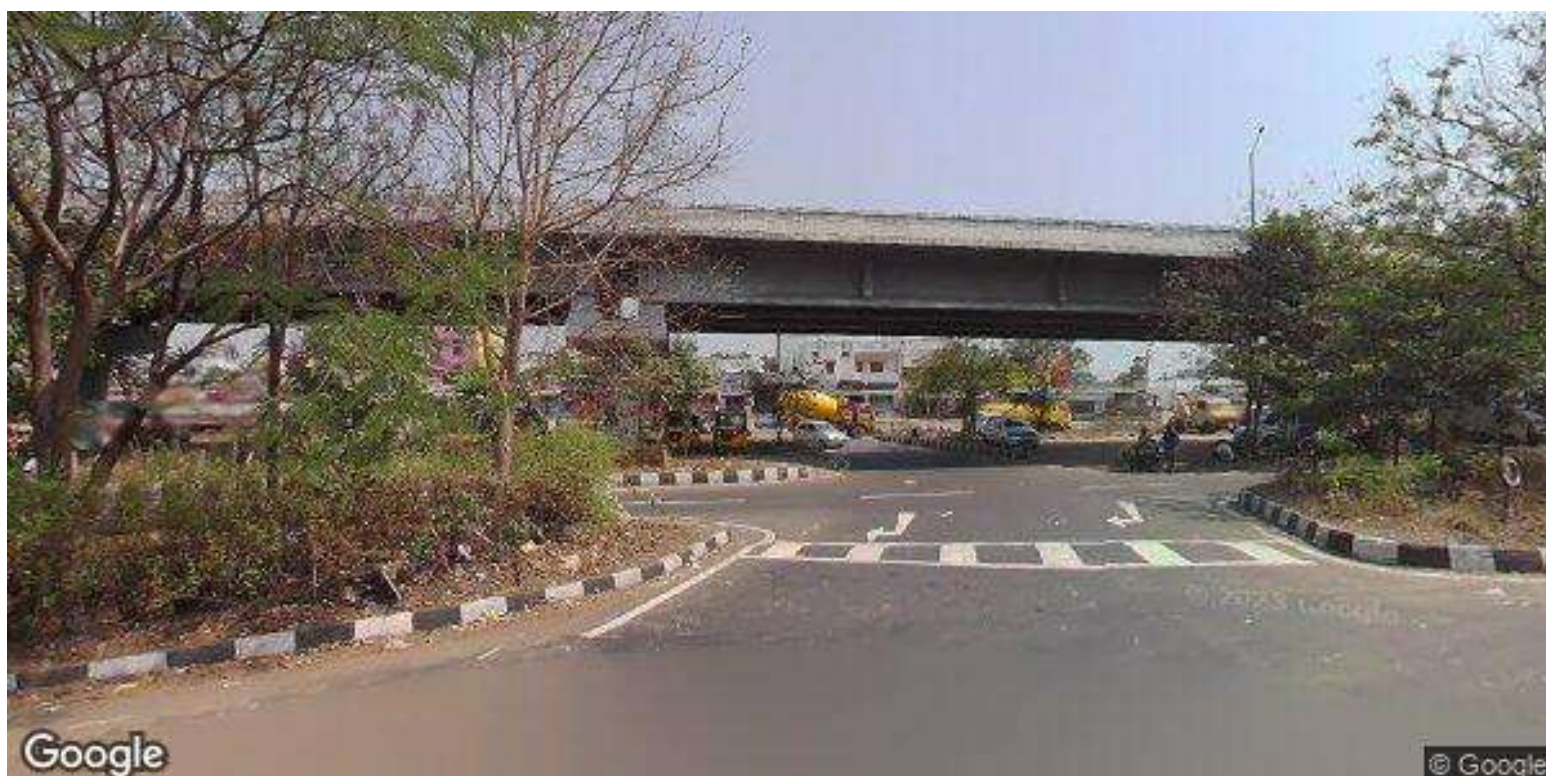
| | Risk Type | Risk Level | Coordinates | Speed Limit |
|---|---|---|---|---|
| 12 | Turn | High | 11.43026, 77.67525 | 15 KM/Hr |

**Risk Type:** Turn  
**Risk Level:** High  
**Speed Limit:** 15 KM/Hr  
**Coordinates:** 11.43026, 77.67525

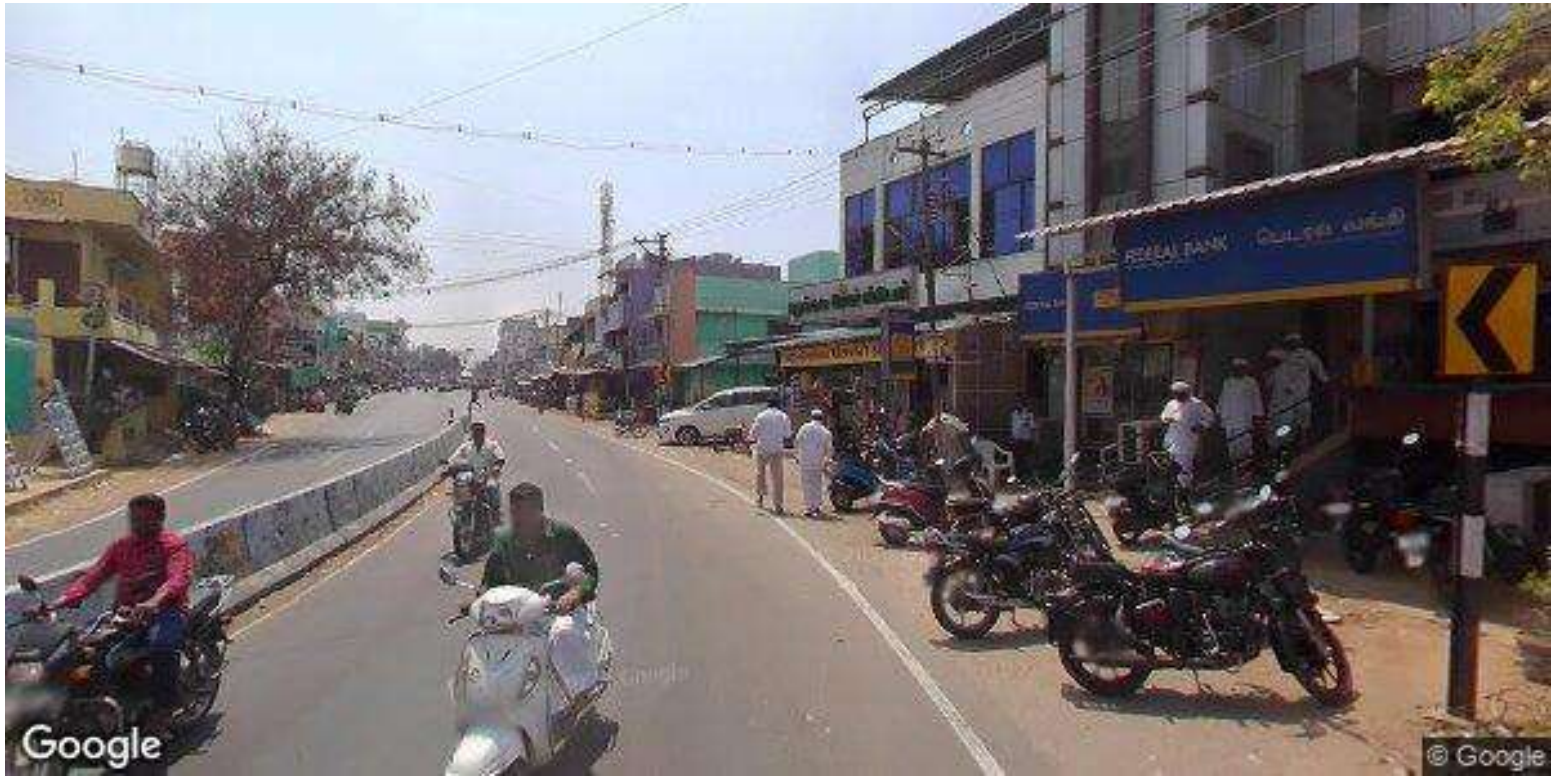
| | Risk Type | Risk Level | Coordinates | Speed Limit |
|---|---|---|---|---|
| 13 | Turn | Medium | 11.43769, 77.67810 | 30 KM/Hr |

**Risk Type:** Turn  
**Risk Level:** Medium  
**Speed Limit:** 30 KM/Hr  
**Coordinates:** 11.43769, 77.67810

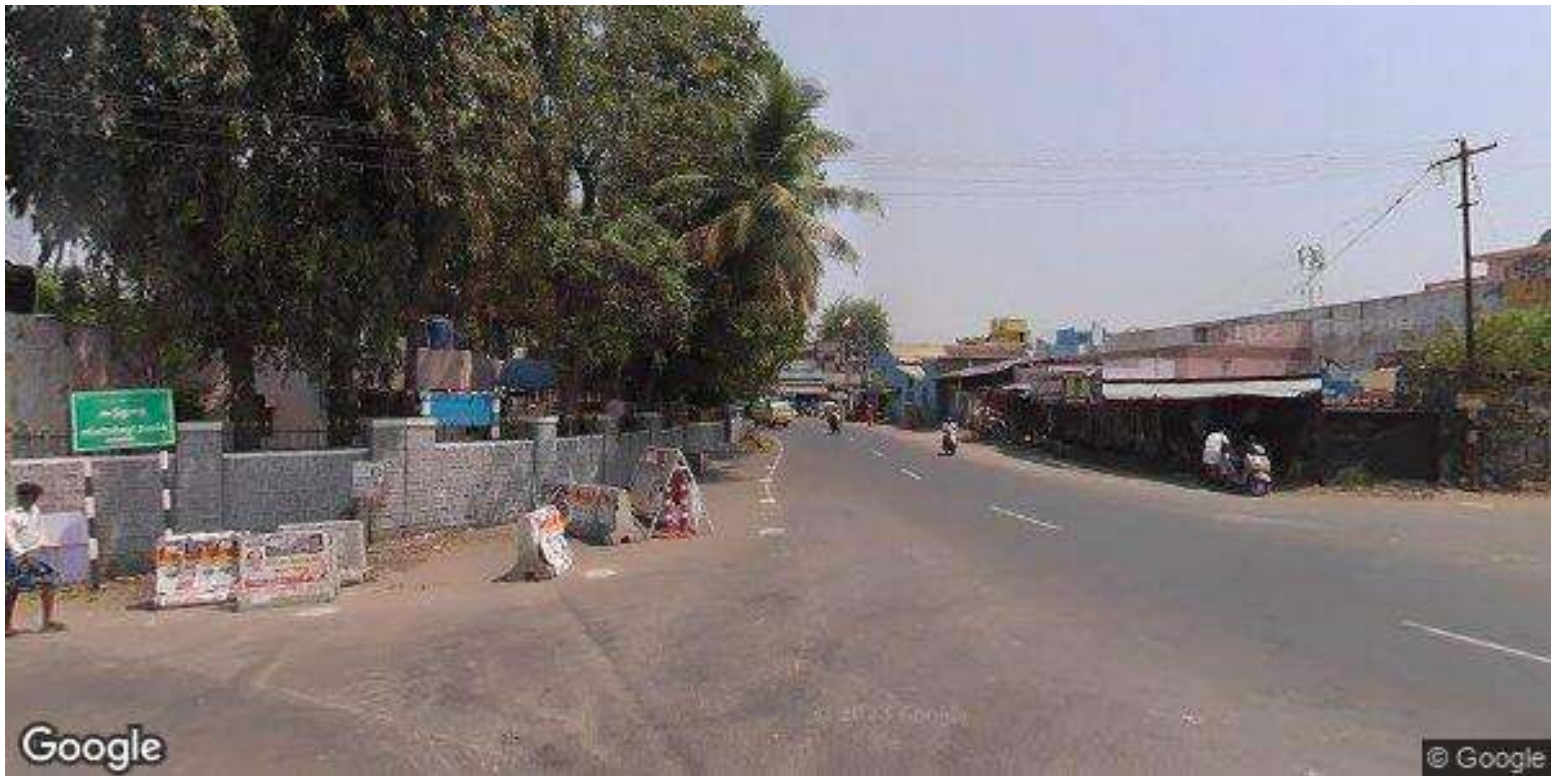
| | Risk Type | Risk Level | Coordinates | Speed Limit |
|---|---|---|---|---|
| 14 | Turn | High | 11.43863, 77.68223 | 15 KM/Hr |

**Risk Type:** Turn  
**Risk Level:** High  
**Speed Limit:** 15 KM/Hr  
**Coordinates:** 11.43863, 77.68223

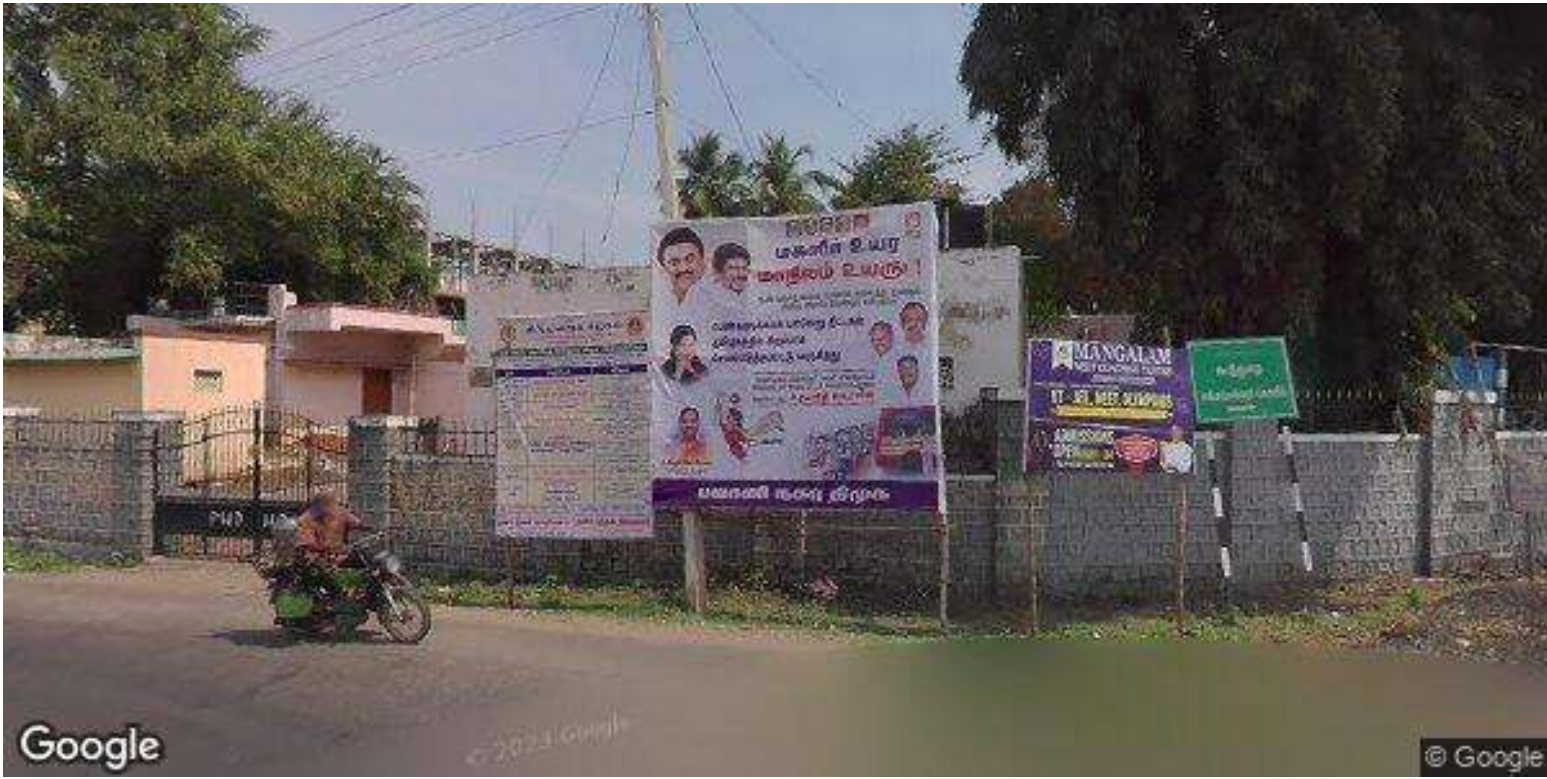
| | Risk Type | Risk Level | Coordinates | Speed Limit |
|---|---|---|---|---|
| 15 | Turn | Medium | 11.43871, 77.68228 | 30 KM/Hr |

**Risk Type:** Turn  
**Risk Level:** Medium  
**Speed Limit:** 30 KM/Hr  
**Coordinates:** 11.43871, 77.68228

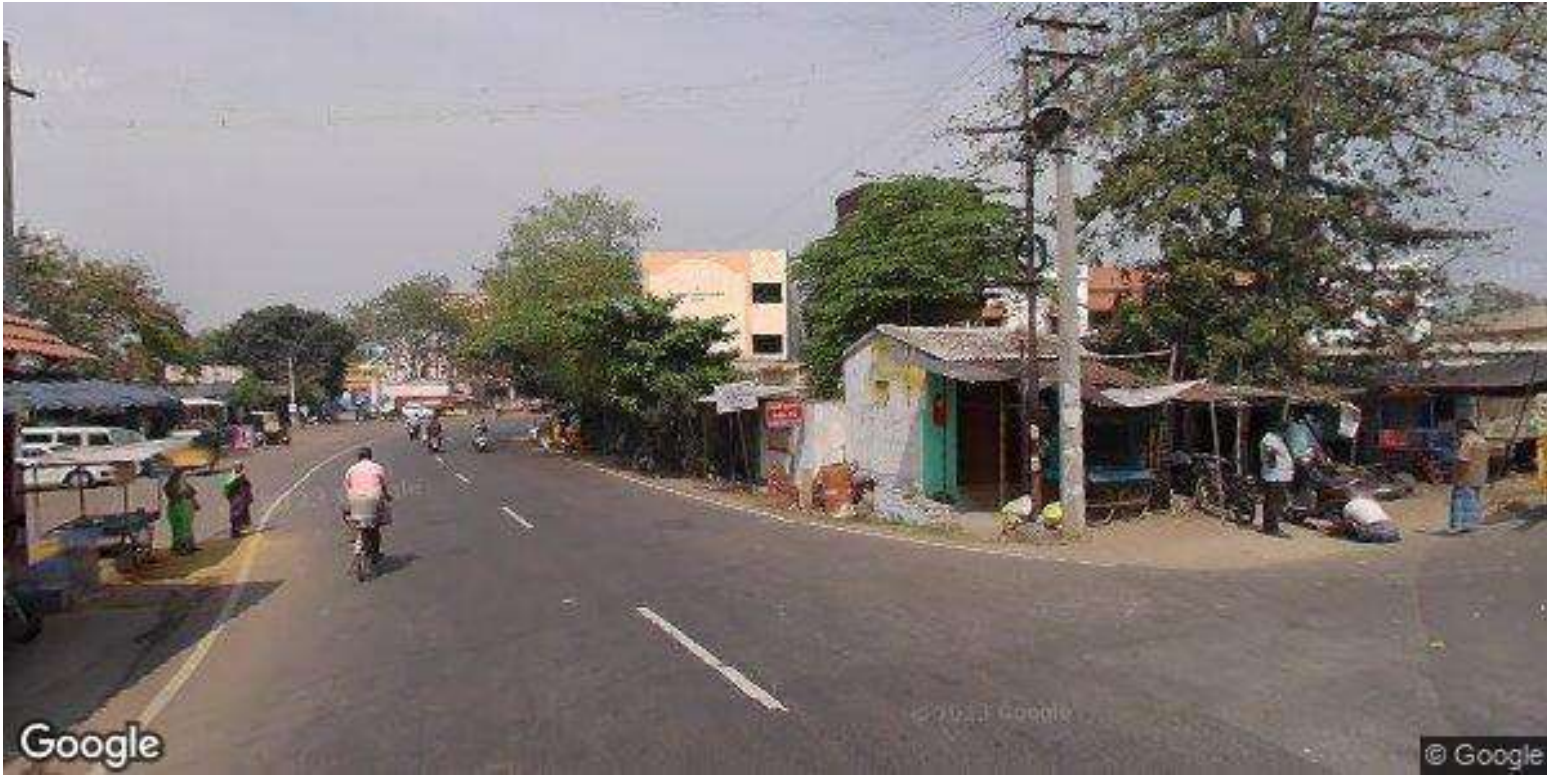
| | Risk Type | Risk Level | Coordinates | Speed Limit |
|---|---|---|---|---|
| 16 | Turn | Medium | 11.43965, 77.68224 | 30 KM/Hr |

**Risk Type:** Turn  
**Risk Level:** Medium  
**Speed Limit:** 30 KM/Hr  
**Coordinates:** 11.43965, 77.68224

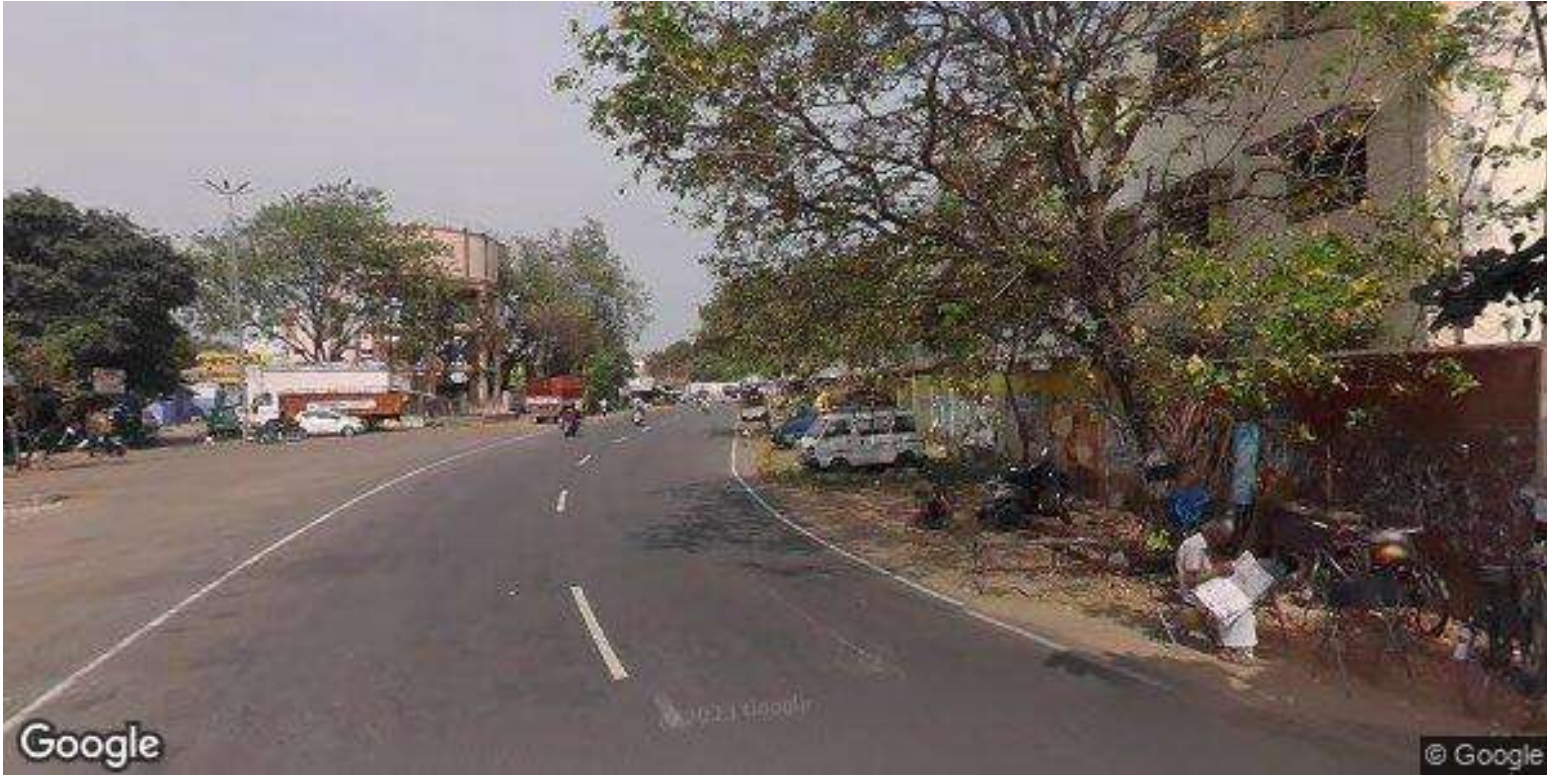
Coordinates: 11.43997, 77.68198

| | Risk Type | Risk Level | Coordinates | Speed Limit |
|---|---|---|---|---|
| 17 | Turn | Medium | 11.43997, 77.68198 | 30 KM/Hr |

Risk Type: Turn

Risk Level: Medium

Speed Limit: 30 KM/Hr

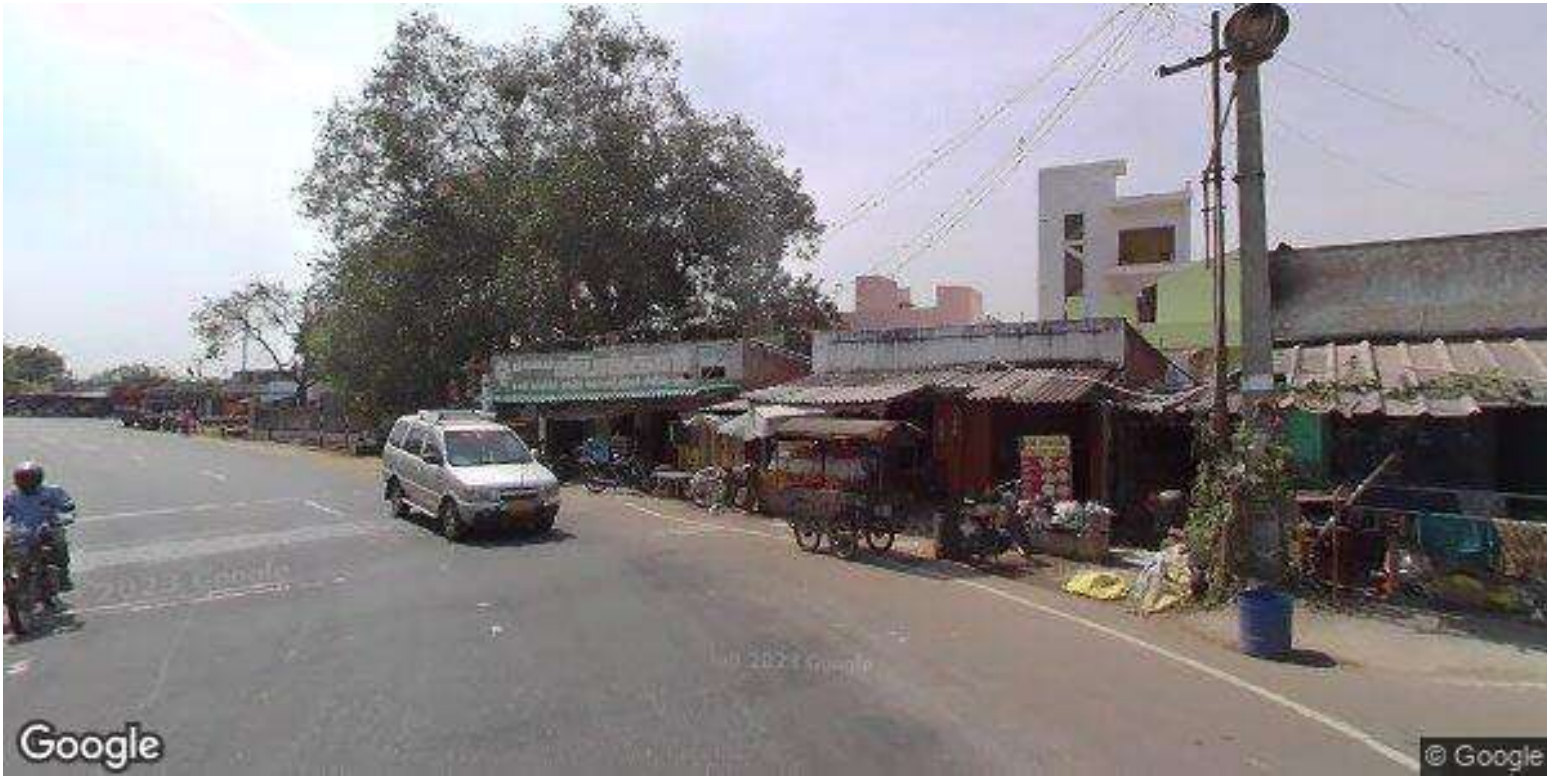
Coordinates: 11.44105, 77.68187

| | Risk Type | Risk Level | Coordinates | Speed Limit |
|---|---|---|---|---|
| 18 | Turn | High | 11.44105, 77.68187 | 15 KM/Hr |

Risk Type: Turn

Risk Level: High

Speed Limit: 15 KM/Hr

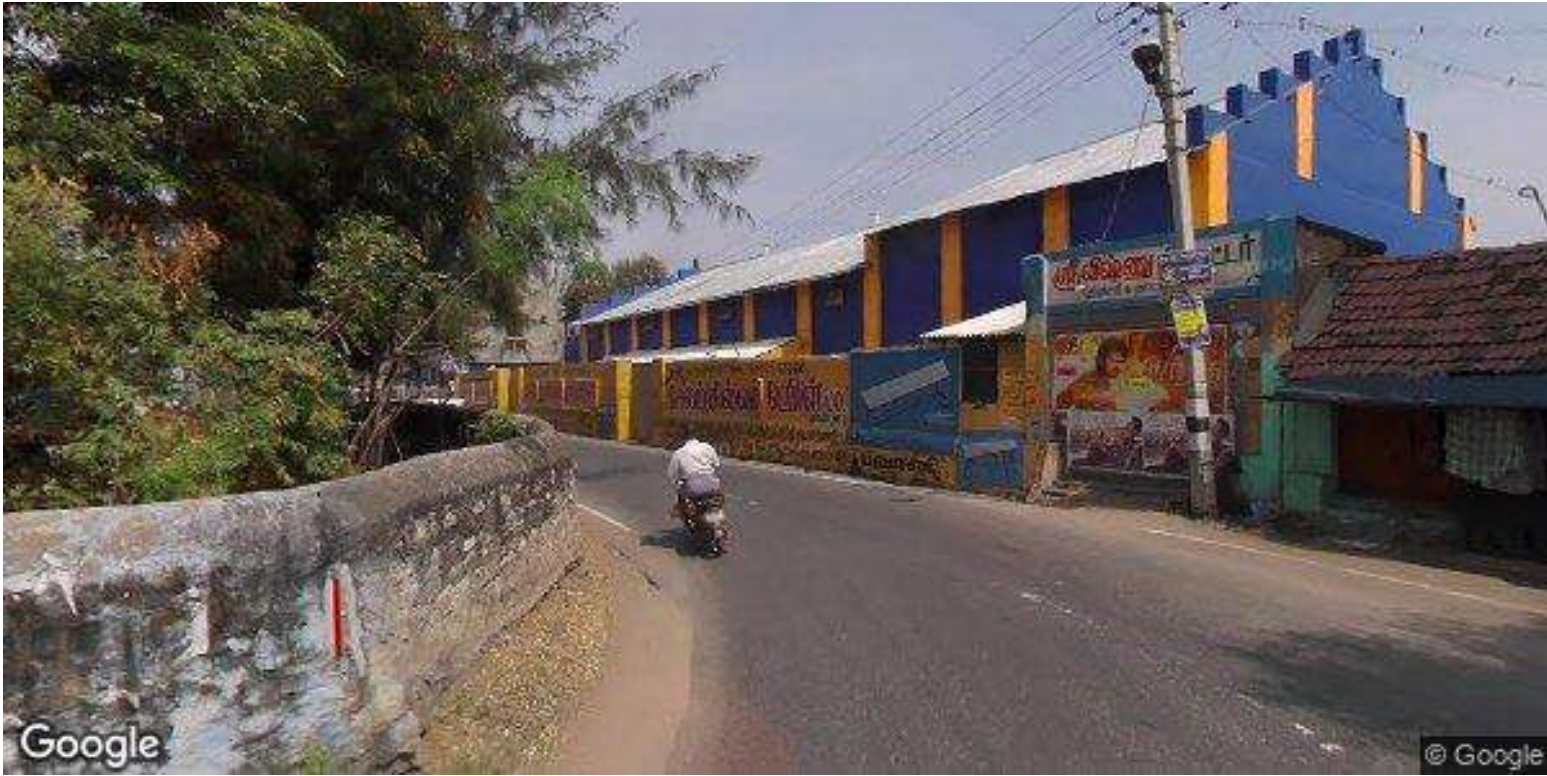
Coordinates: 11.44119, 77.68217

| | Risk Type | Risk Level | Coordinates | Speed Limit |
|---|---|---|---|---|
| 19 | Turn | High | 11.44119, 77.68217 | 15 KM/Hr |

Risk Type: Turn

Risk Level: High

Speed Limit: 15 KM/Hr

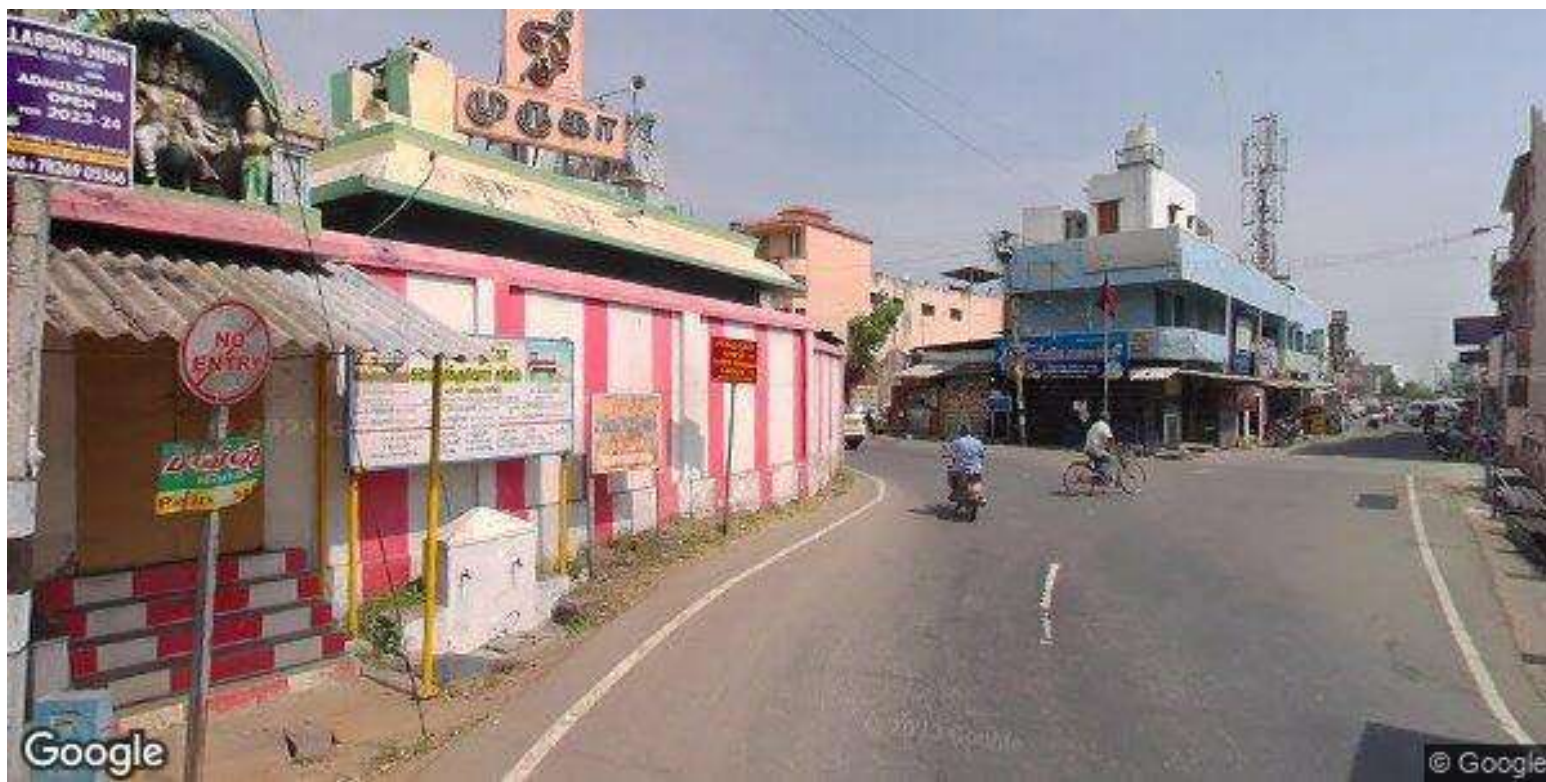
**Coordinates:** 11.44295, 77.68261

| | Risk Type | Risk Level | Coordinates | Speed Limit |
|---|---|---|---|---|
| 20 | Turn | Medium | 11.44295, 77.68261 | 30 KM/Hr |

**Risk Type:** Turn

**Risk Level:** Medium

**Speed Limit:** 30 KM/Hr

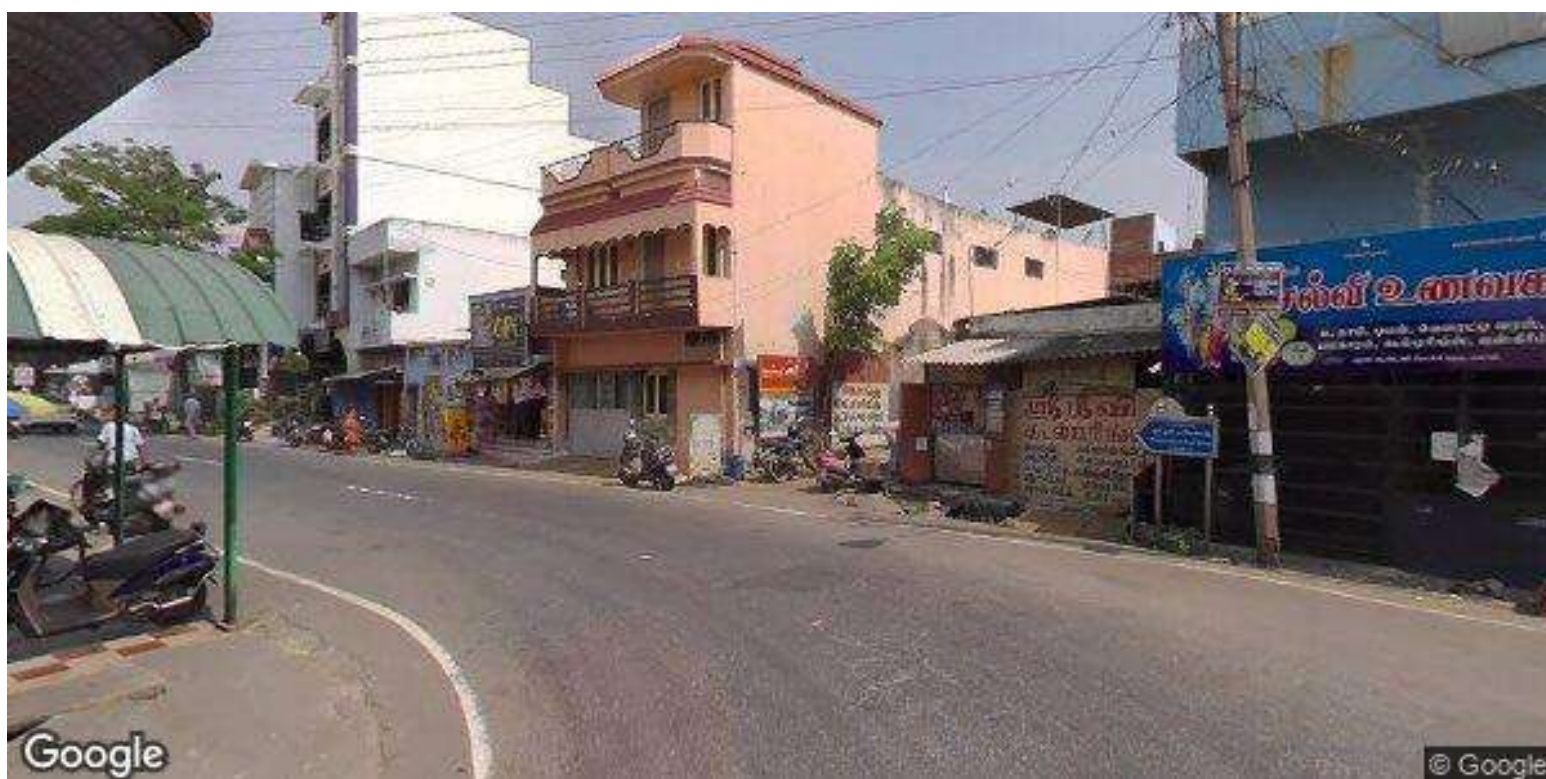
**Coordinates:** 11.44300, 77.68275

| | Risk Type | Risk Level | Coordinates | Speed Limit |
|---|---|---|---|---|
| 21 | Turn | High | 11.44300, 77.68275 | 15 KM/Hr |

**Risk Type:** Turn

**Risk Level:** High

**Speed Limit:** 15 KM/Hr
