## JOURNEY RISK MANAGEMENT (JRM) STUDY

### Salem Terminal TO KARPAGAM ENTERPRISES

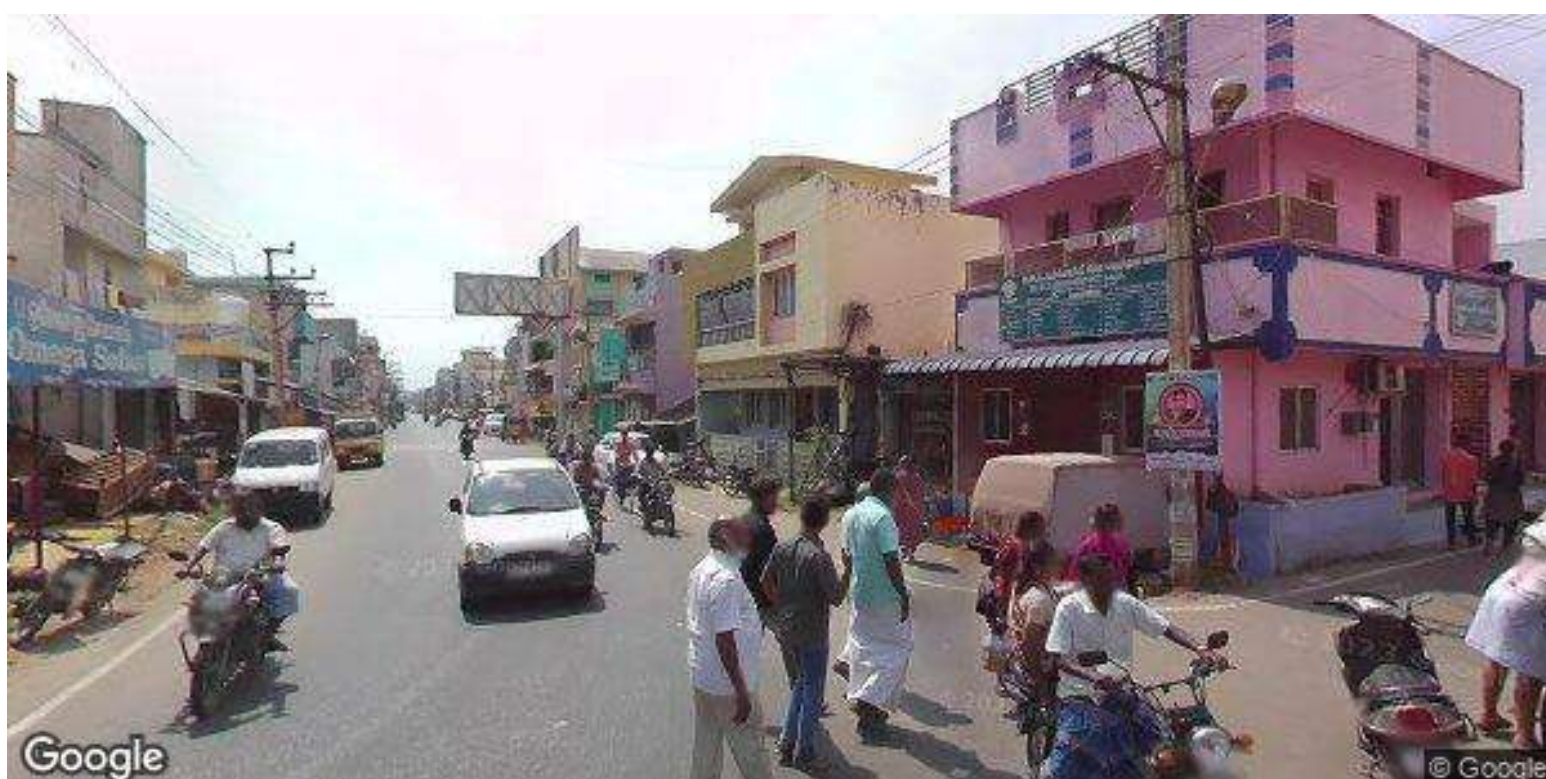
Coordinates: 11.44715, 77.68304

| | Risk Type | Risk Level | Coordinates | Speed Limit |
|---|---|---|---|---|
| 22 | Turn | High | 11.44715, 77.68304 | 15 KM/Hr |

Risk Type: Turn

Risk Level: High

Speed Limit: 15 KM/Hr

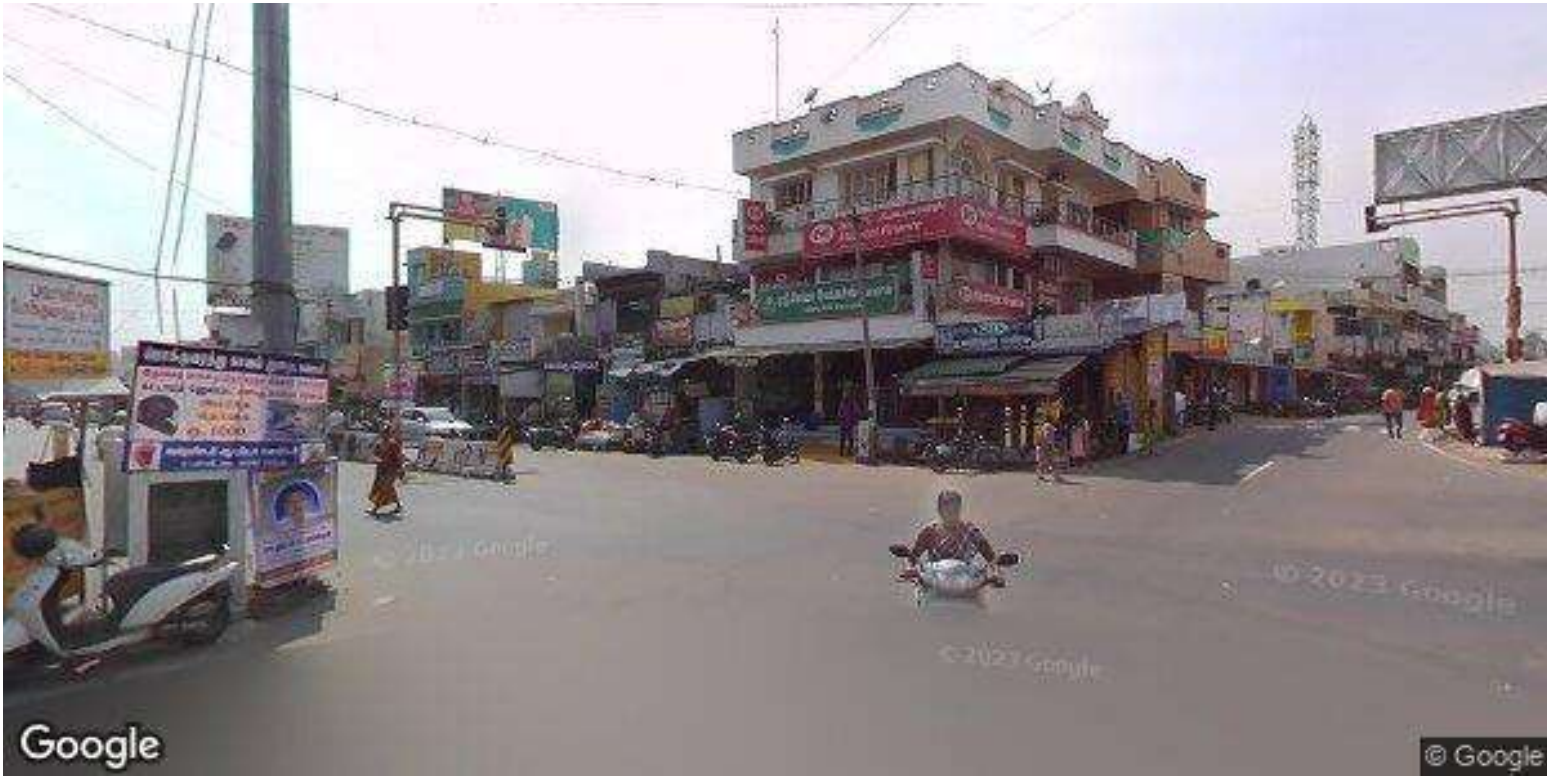
Coordinates: 11.44714, 77.68402

| | Risk Type | Risk Level | Coordinates | Speed Limit |
|---|---|---|---|---|
| 23 | Turn | Medium | 11.44714, 77.68402 | 30 KM/Hr |

Risk Type: Turn

Risk Level: Medium

Speed Limit: 30 KM/Hr
