# IndianOil

## **JOURNEY RISK MANAGEMENT (JRM) STUDY**

### **Salem Terminal TO STATE LORRY OWNERS FEDERATION**

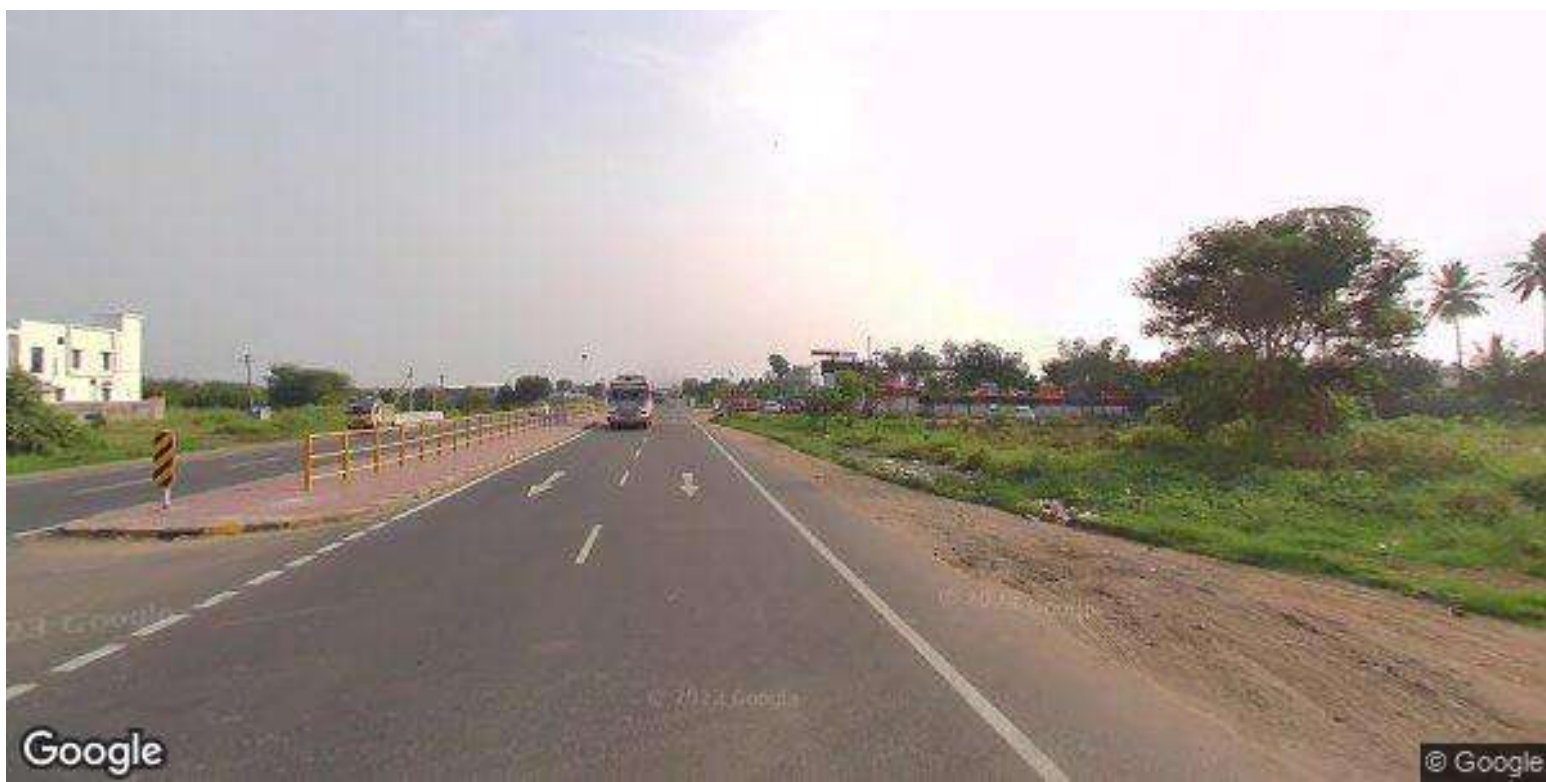
**Coordinates:** 11.2721854, 78.1639296

**Risk Type:** U-Turn

**Risk Level:** High

**Speed Limit:** 10 KM/Hr

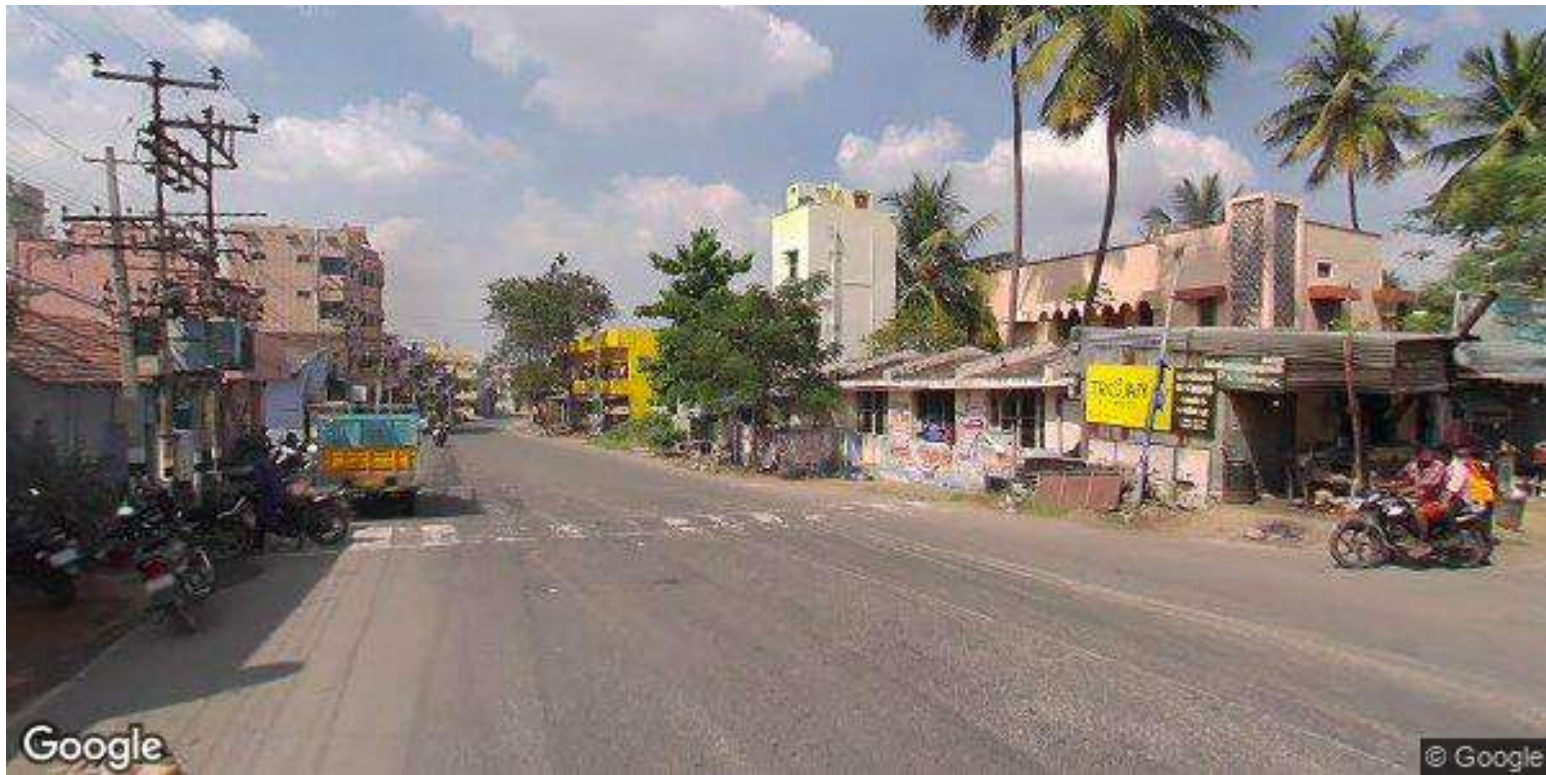
**Coordinates:** 11.38190, 77.90254

**Risk Type:** Turn

**Risk Level:** High

**Speed Limit:** 15 KM/Hr

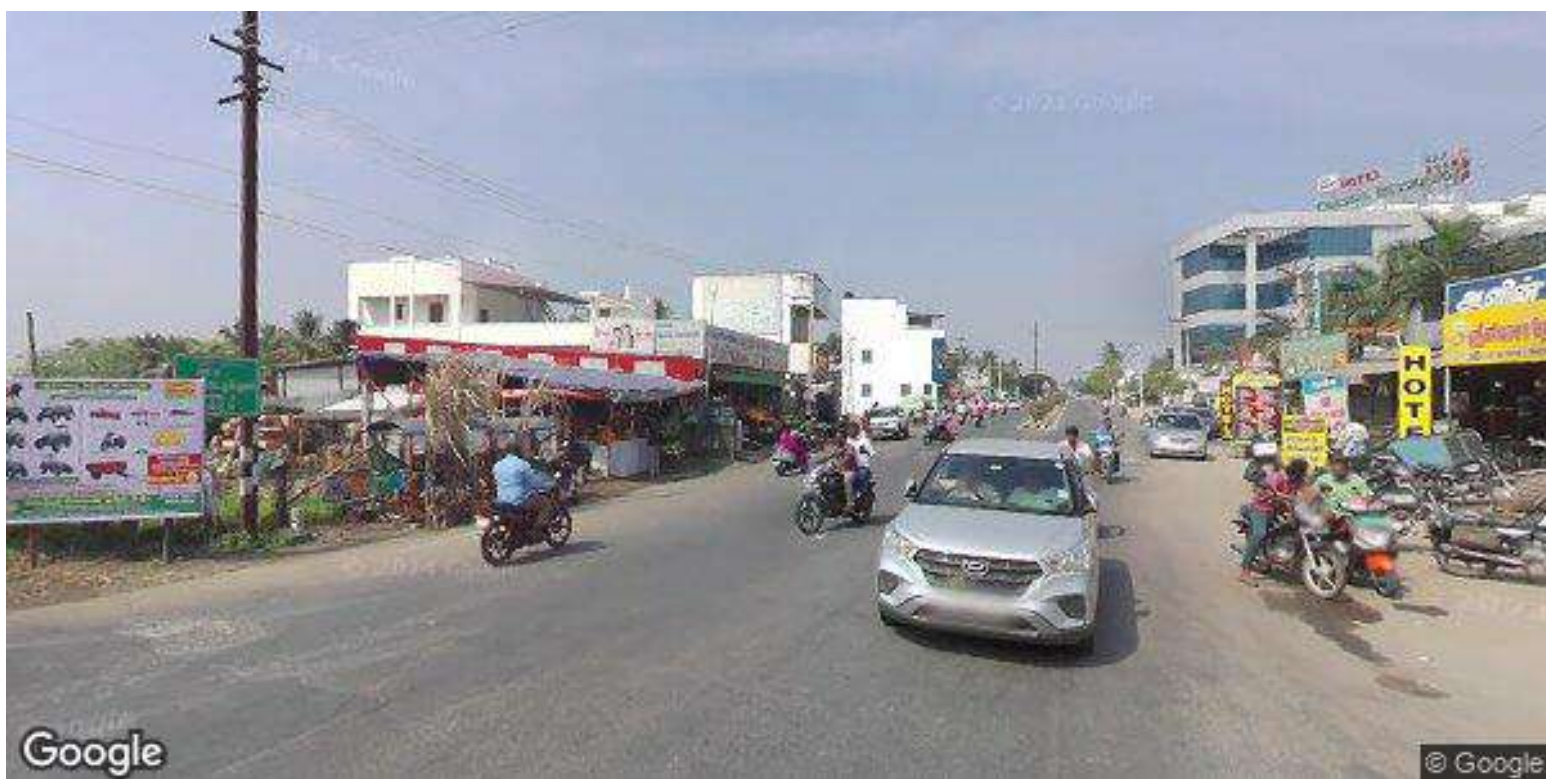
**Risk Type:** Turn  
**Risk Level:** High  
**Speed Limit:** 15 KM/Hr  
**Coordinates:** 11.23961, 78.14223

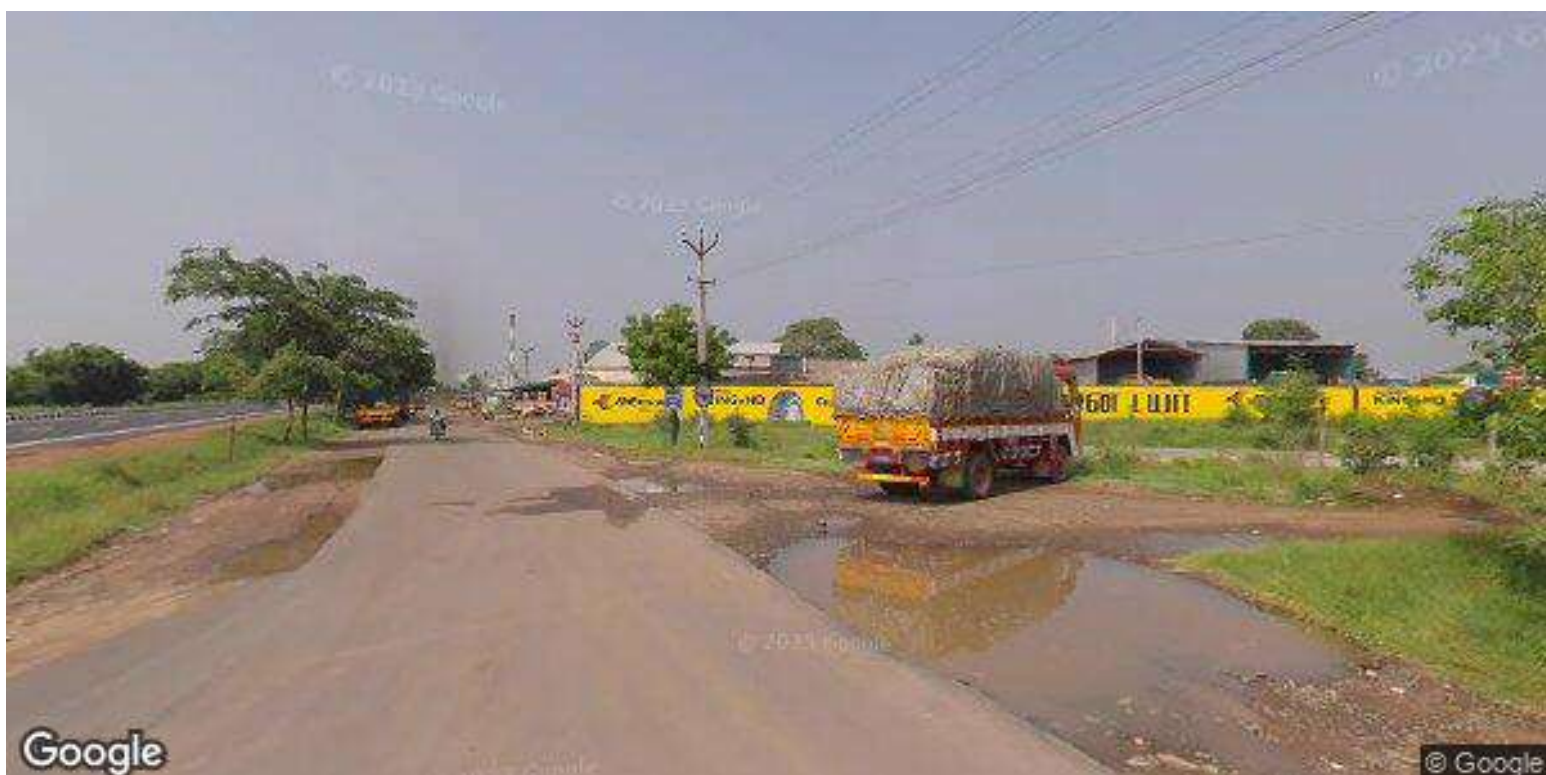
**Coordinates:** 11.24549, 78.14753

**Risk Type:** Turn

**Risk Level:** High

**Speed Limit:** 15 KM/Hr

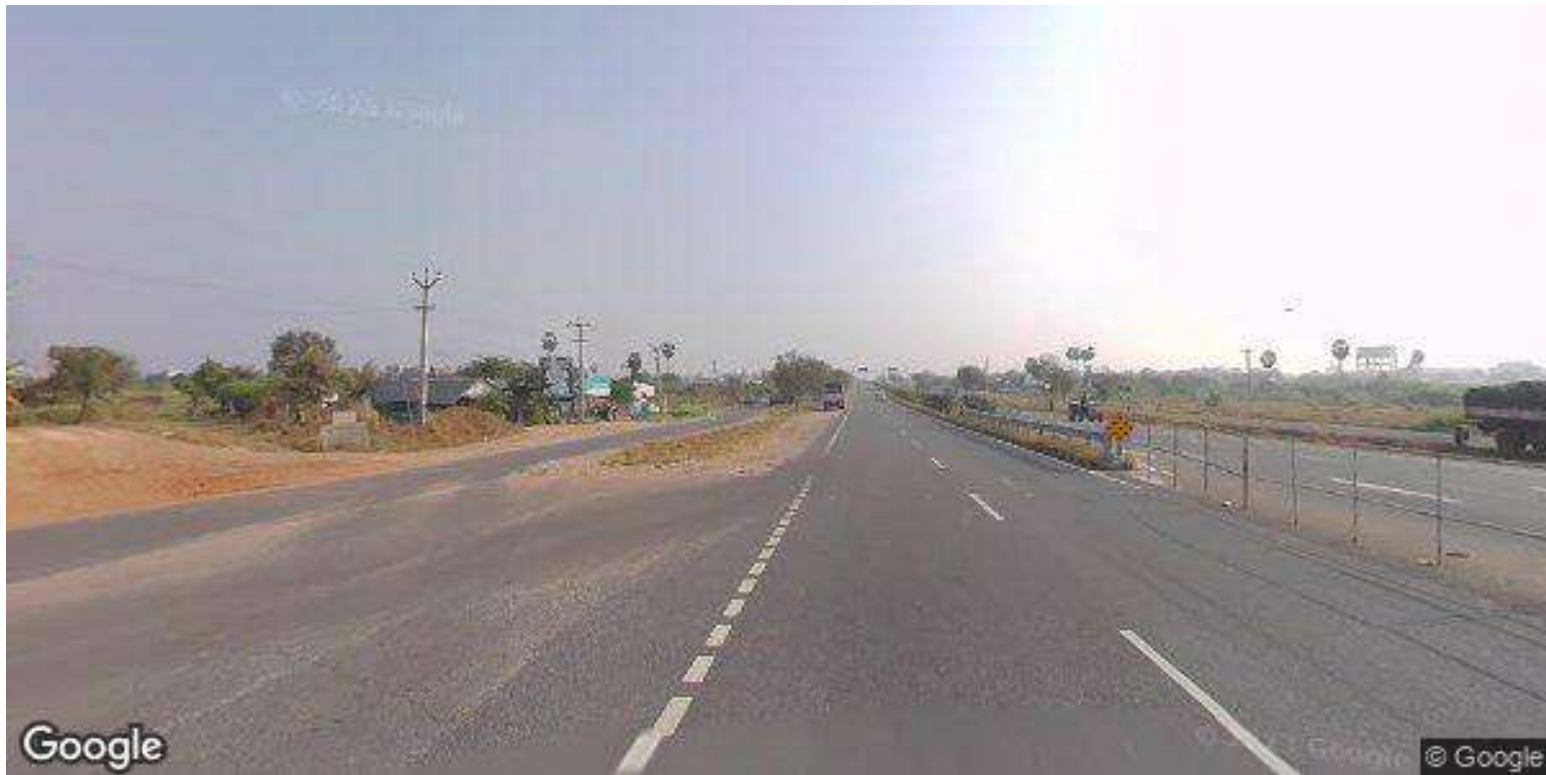
**Coordinates:** 11.24537, 78.14763

**Risk Type:** Turn

**Risk Level:** High

**Speed Limit:** 15 KM/Hr

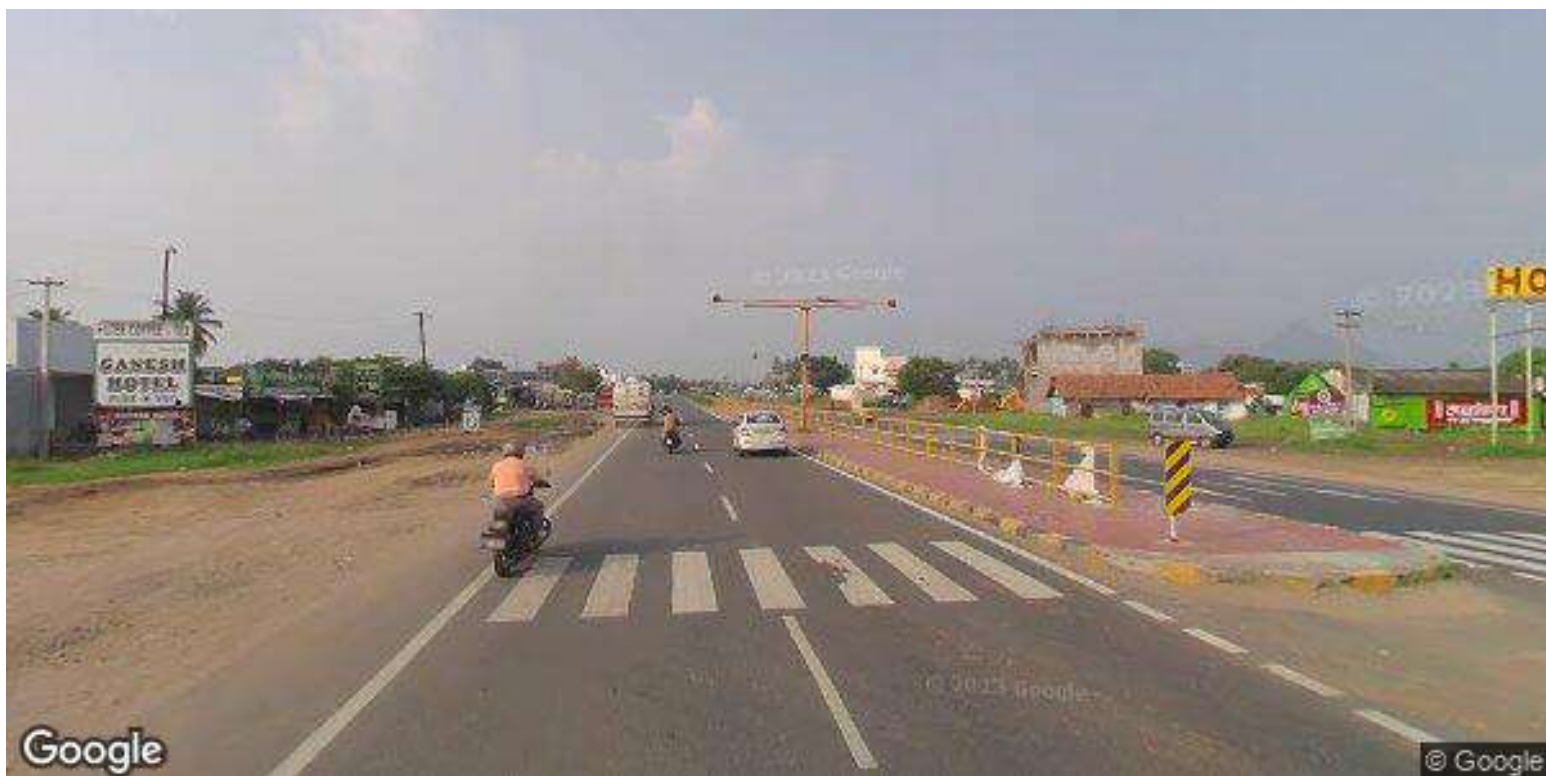
**Coordinates:** 11.27219, 78.16393

**Risk Type:** Blind Spot

**Risk Level:** Blind Spot

**Speed Limit:** 10 KM/Hr

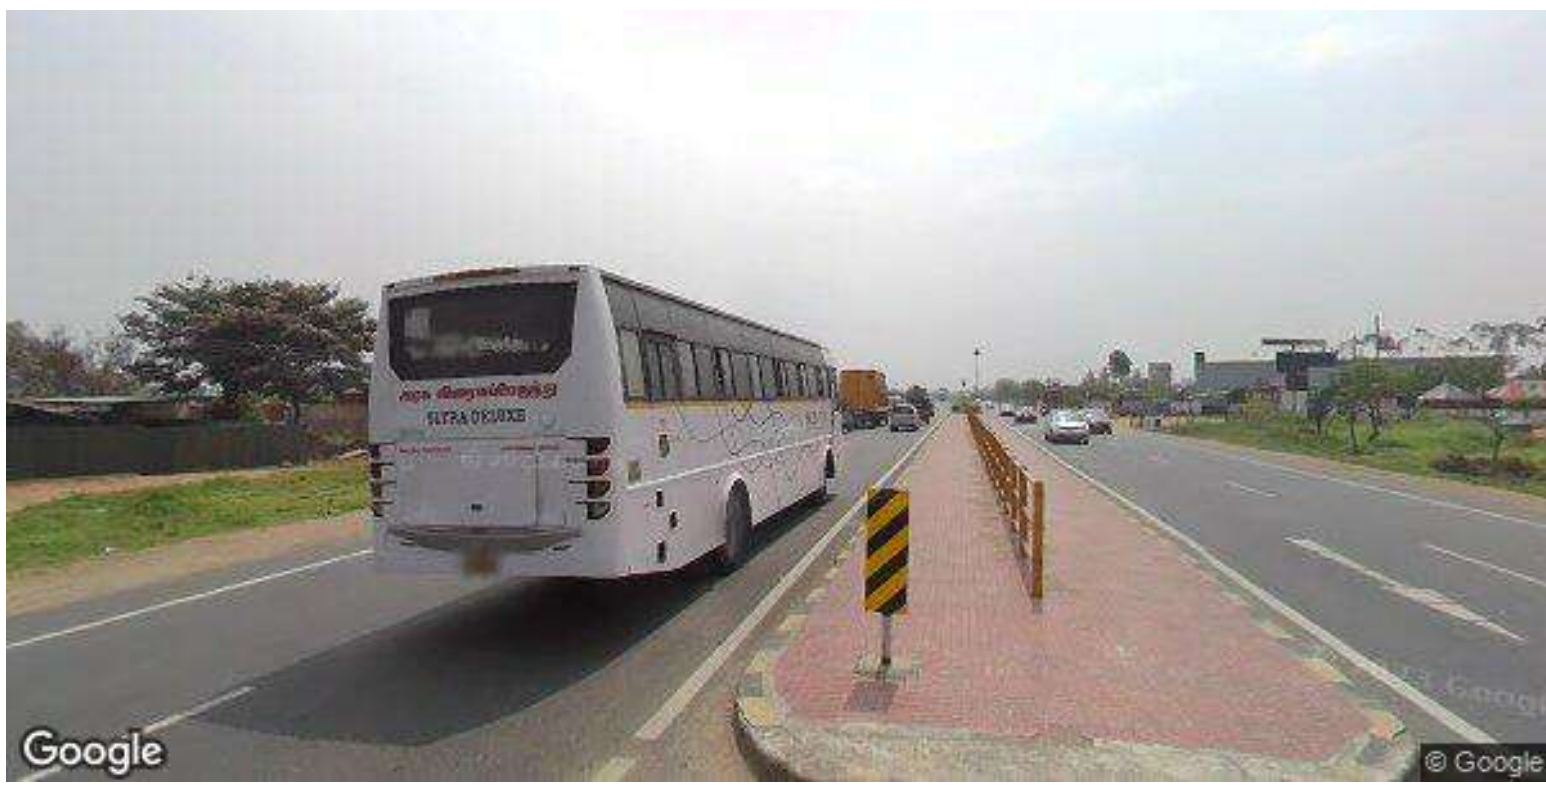
**Coordinates:** 11.27216, 78.16405

**Risk Type:** Turn

**Risk Level:** High

**Speed Limit:** 15 KM/Hr
